**Drumtochty Arms Hotel, Market Square, Auchenblae
Aberdeenshire, AB30 1WS
Report on Level 1 Standing Building Survey**

**APP/2015/3013 Erection of Replacement Hotel and Alterations to
Former Store to Form Managers Flat**

**Alison Cameron
Cameron Archaeology
29 July 2019**

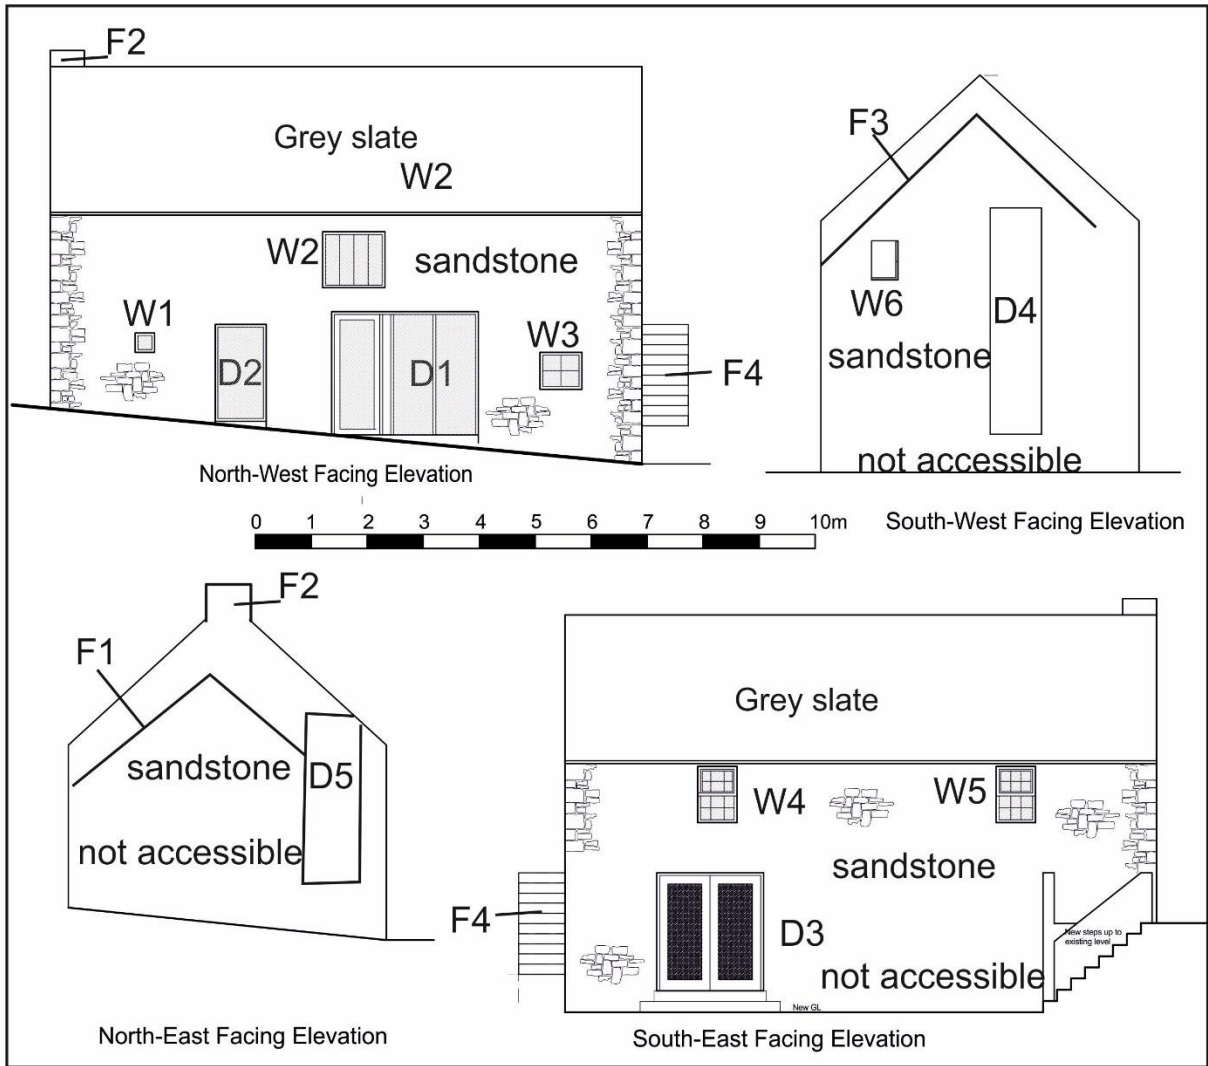
Illus 3 Elevations annotated with numbers used in this survey (copyright AB Roger & Young)

The building is 10.6m long and constructed of red sandstone blocks and rubble with a grey slate roof. There is one chimney (F2) on the NE gable. The window lintels, sills and jambs are all of red sandstone apart from the NE jamb of W1 which has been replaced more recently with light brown sandstone and the NE jamb of D1 which is constructed of sandstone rubble as the door has been extended to the NE.

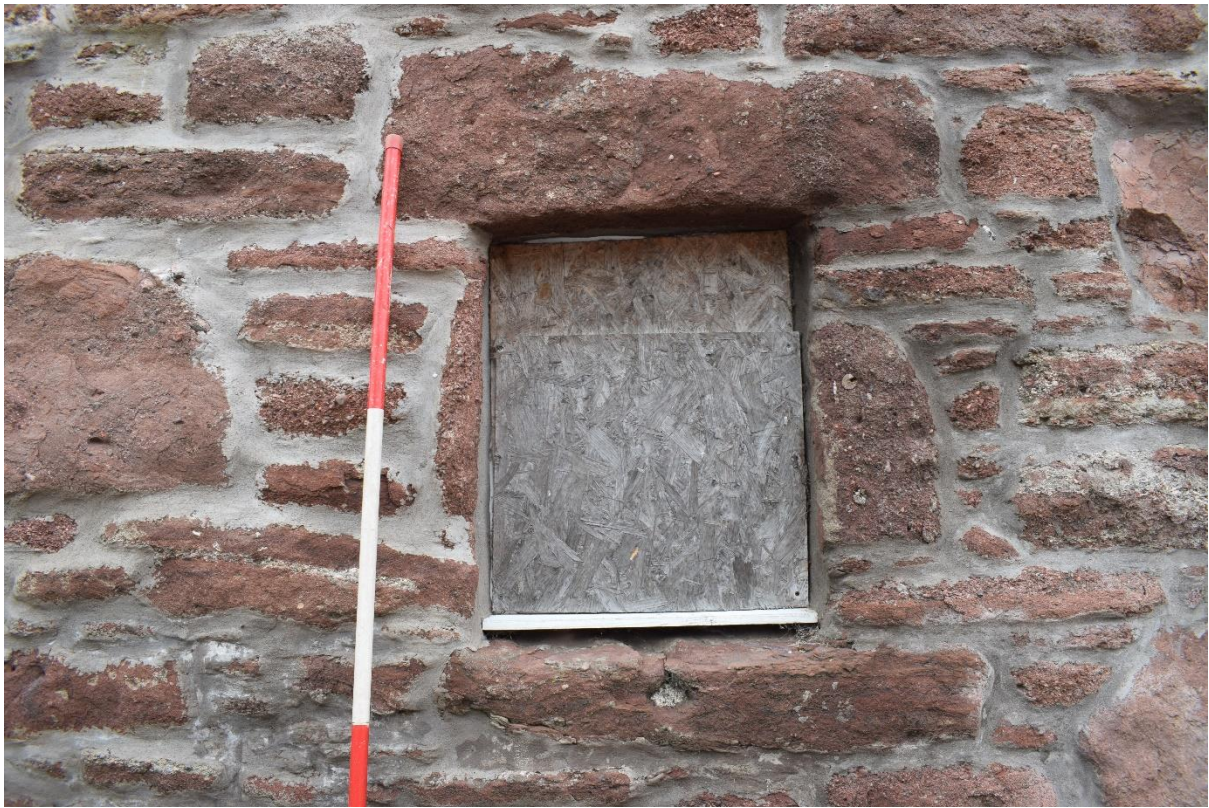
There are small ground floor windows on the NW façade (W1 and W3; Illus 4), medium sized first floor window (W2) and two doors D1 and D2. There is a first floor window W6 on the SW façade and first floor door (D4) which appears to have been extended down to the ground floor but this area is inaccessible.

Illus 4 Window W3 showing red sandstone lintel, sill and jambs; facing SE

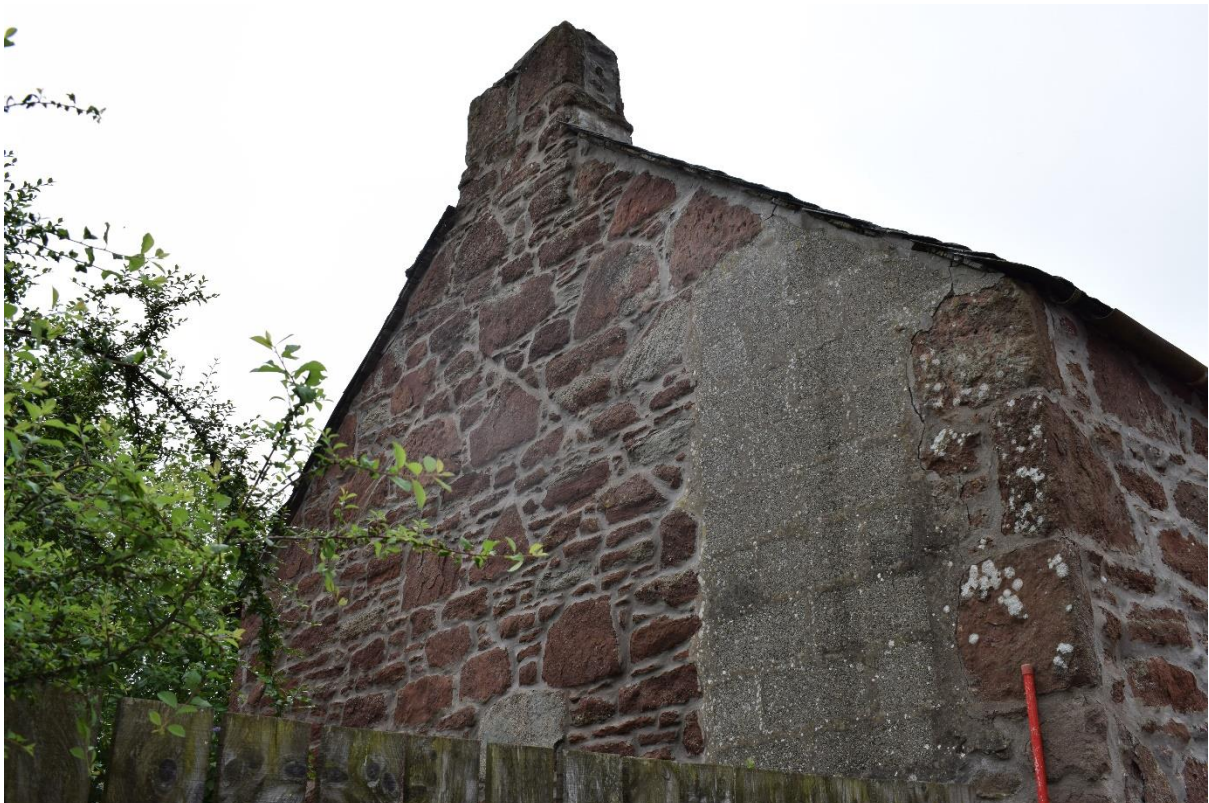
The SE wall has ground floor door D3 and first floor window W4 and W5 but these are inaccessible. The NE gable has door D5 blocked with concrete blocks and a roof raggle F1 where the building seen on the 1st and 2nd Edition OS maps has been removed (Illus 5). There is a roof raggle (F3; Illus 6) on the SW gable where a building has been attached but there is no evidence of this structure on the OS maps.

Illus 5 NE gable with roof raggle F1 (left), blocked door D5 (right) and sandstone chimney F2 (top); facing S

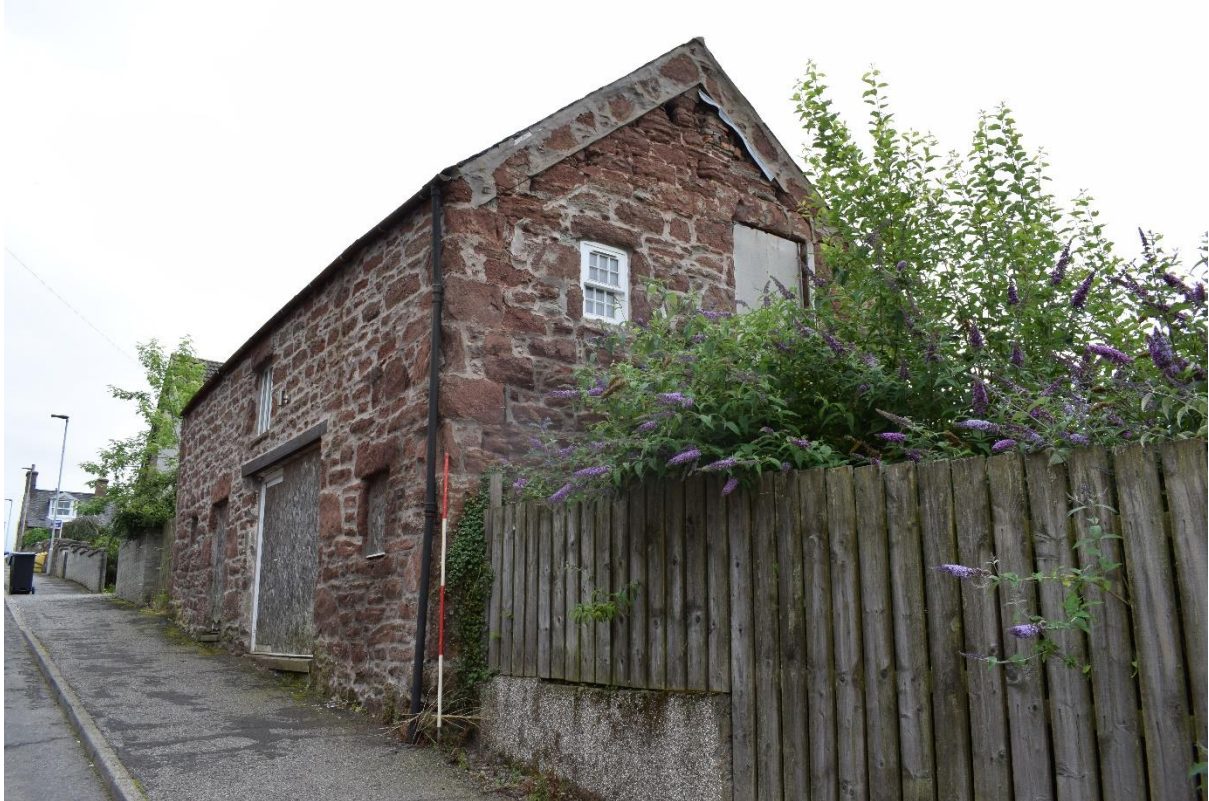
Illus 6 SW gable with W6 (left), blocked door (D4; right) and roof raggle F3; facing NE
