**Daisy Cottage, Chapelton, Ballindalloch,
Moray, AB37 9JP**
Report on Level 1 Standing Building Survey
Moray Council planning application 19/00078/APP

Alison Cameron
Cameron Archaeology
11 September 2019

SUMMARY

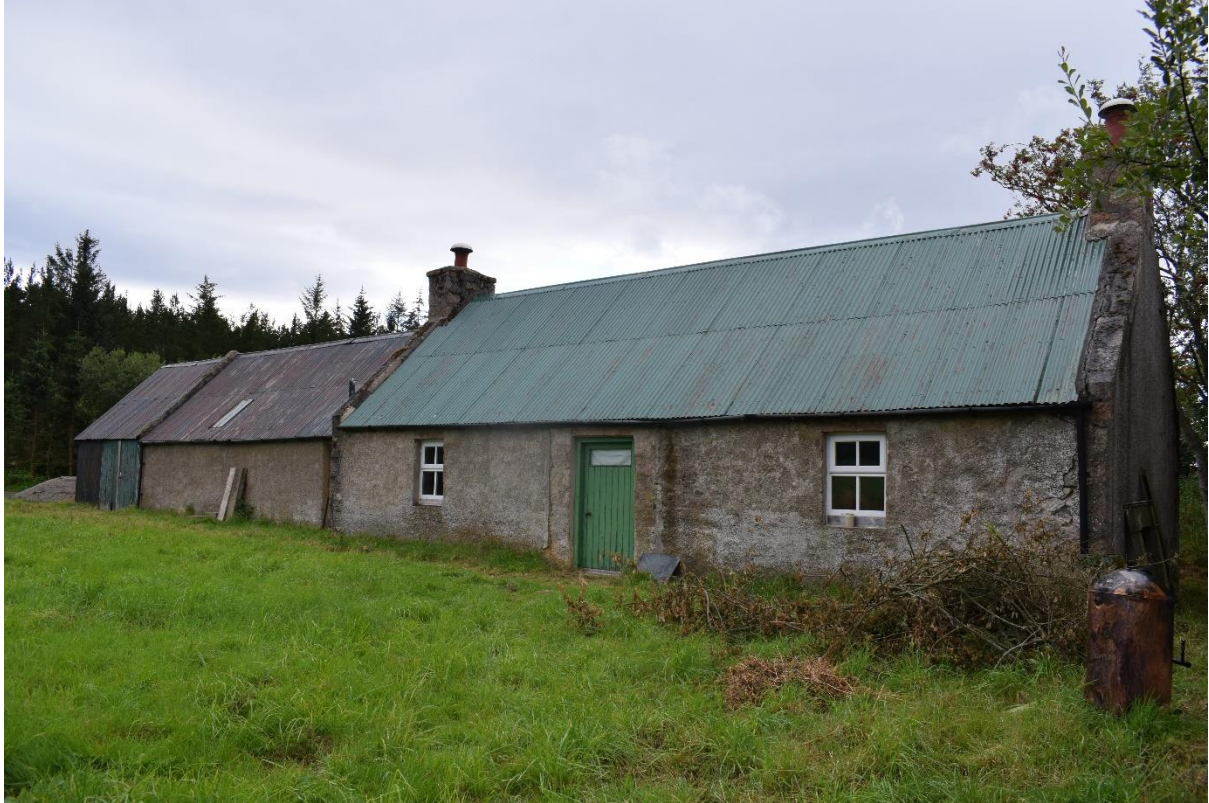
Cover: Building 1 (left), Building 2 (centre), Building 3 (right); facing SW

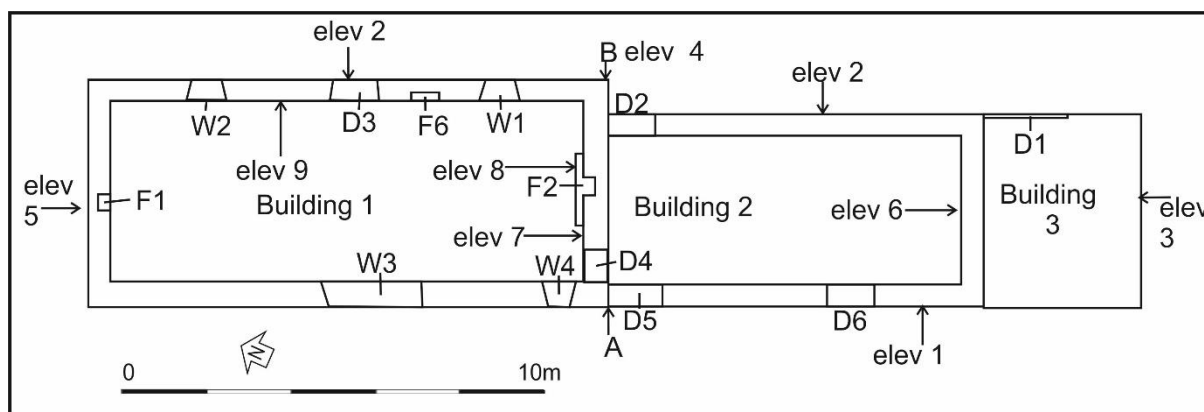
Illus 2 Plan of Buildings 1, 2 and 3

Building 1 is built of fieldstones (including quartz, sandstone and granite) covered with harling, with sandstone jambs and lintels and a corrugated iron roof. It is 12m long, 5.1m wide and 4.2m high. There is a main door (D3; see cover illus) in the centre of the ENE wall with windows flanking it (W1, W2) and windows in the WSW wall (W3 which has been extended to the SSE in the 20th century) and W4. The room has a small domestic fireplace on the NNW gable (F1, Illus 2, 3, 5) with chimney F3 above and there is a larger kitchen range (F2; Illus 2, 3, 6, 7) on the interior SSE gable with chimney F4 above.

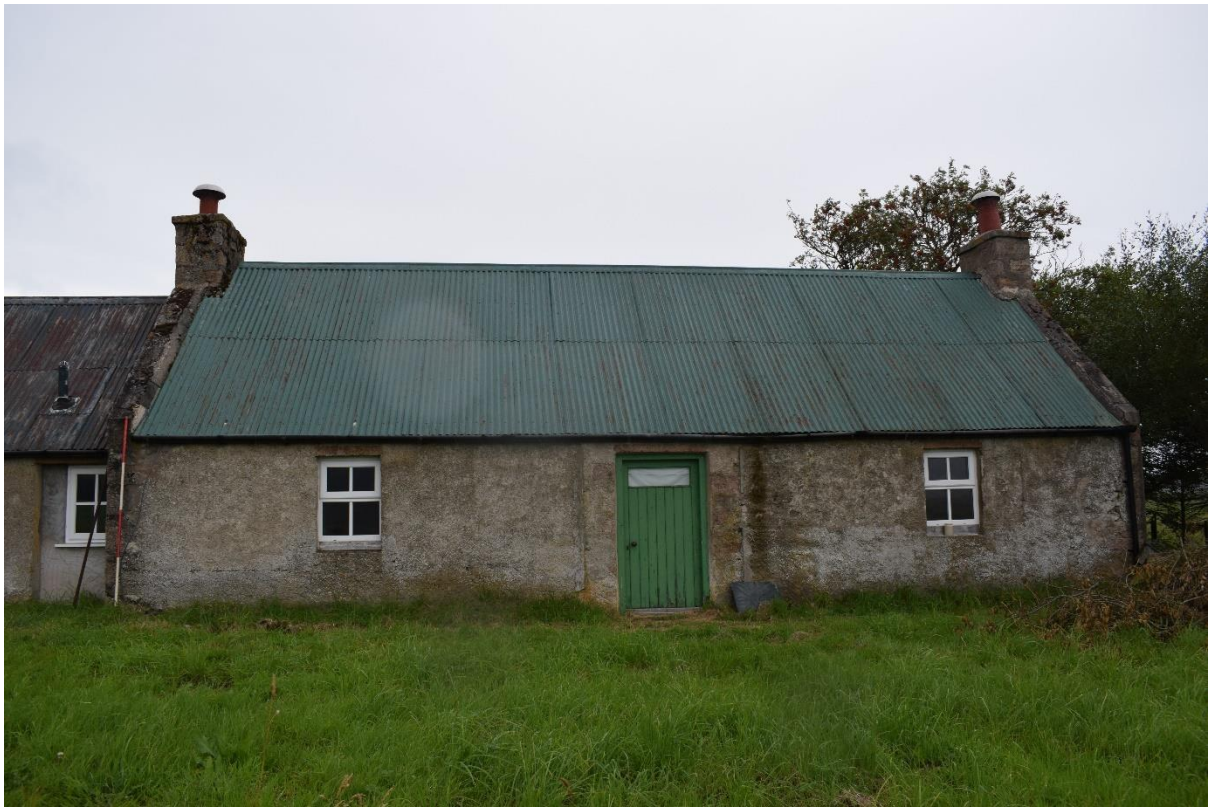
Illus 4 ENE front façade with W1, D3 and W2; facing WSW

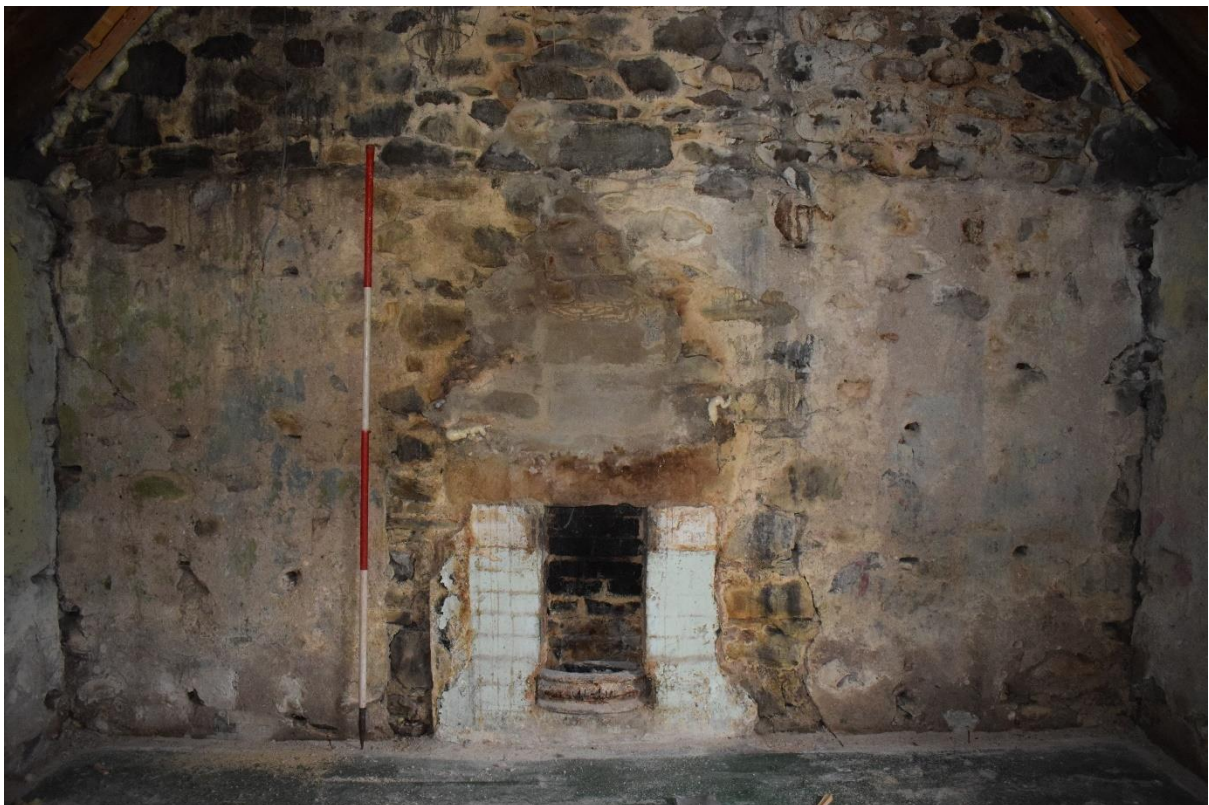
Illus 5 fireplace F1; facing NNW

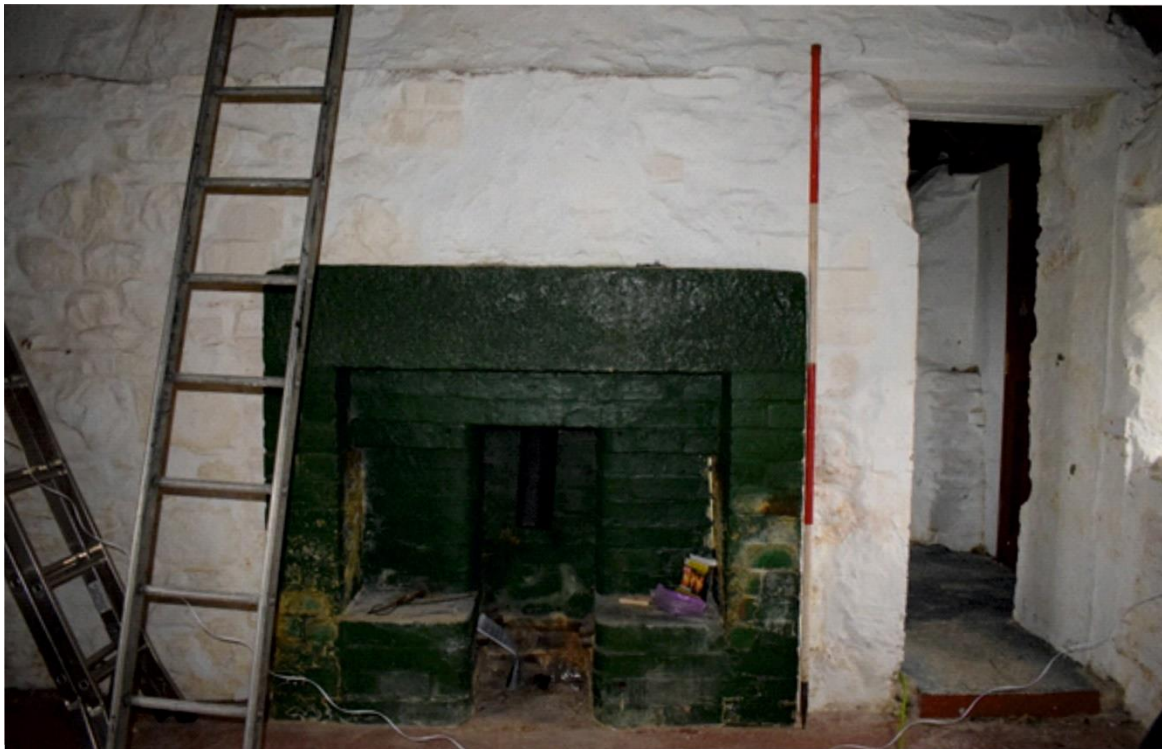
Illus 6 fireplace F2; facing SSE

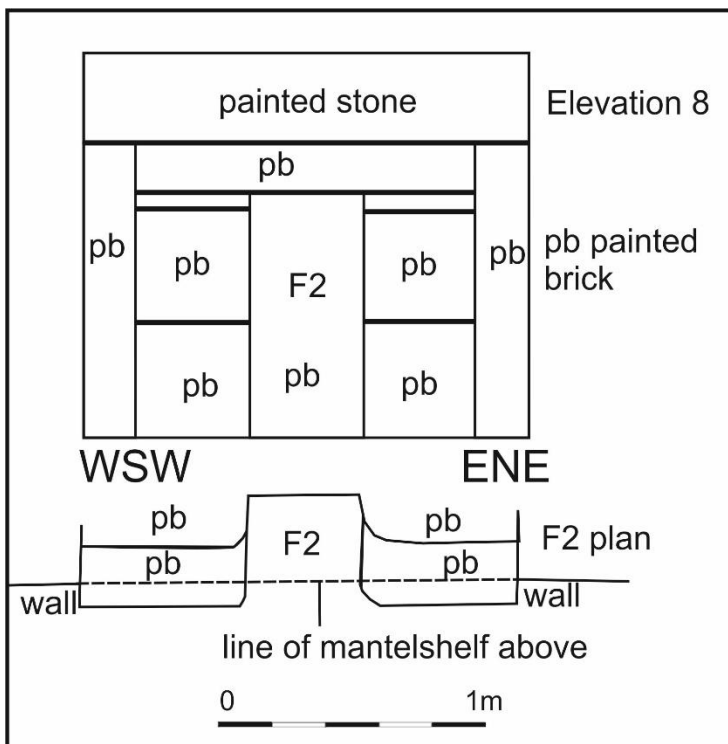
Illus 7 Plan and elevation of fireplace F2

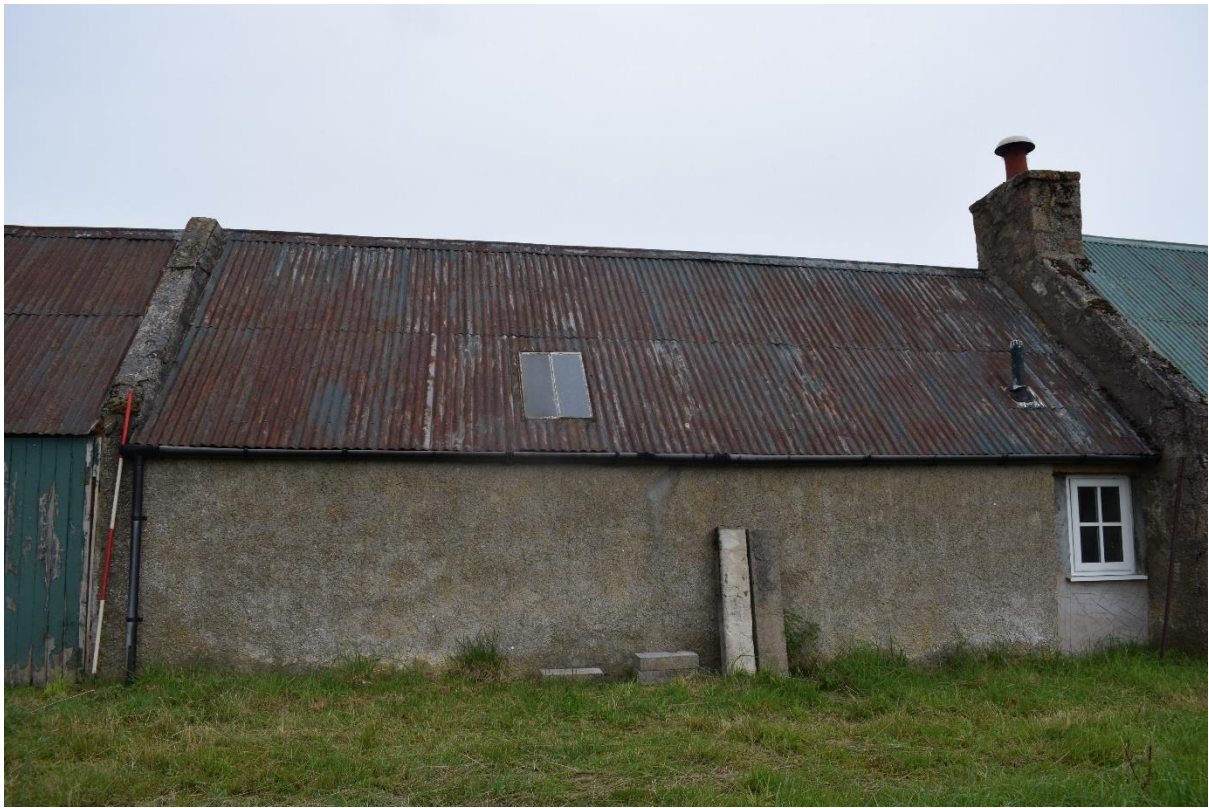
Building 2 is built of fieldstones covered with harling with sandstone jambs and lintels and a corrugated iron roof. It is 8.65m long, 4.3m wide with door D2 (Illus 2, 3, 8) on the ENE façade which has recently been converted to a window, D6 on the WSW façade, converted to a window and D5 which has been opened in the NNW end of the WSW wall.

Illus 8 Building 2 ENE façade with D2 (right); facing WSW

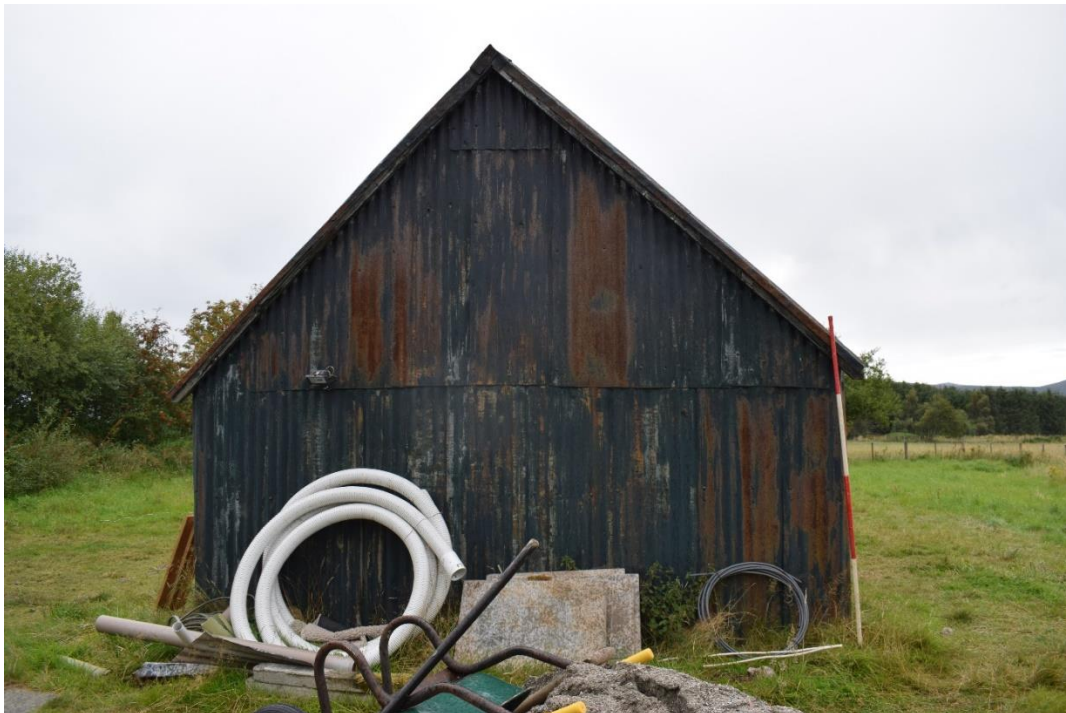
Building 3 is a corrugated iron shed 4.3m wide, 3.7m long NS 3.8m high (Illus 2, 3, 9).

Illus 9 Building 3 SE gable, facing NNW

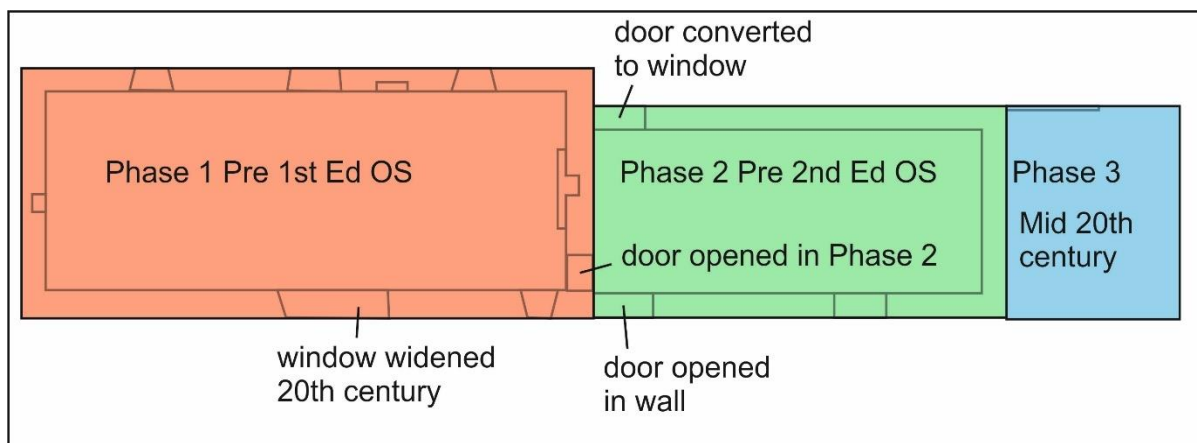
A Level 1 standing building survey was carried out on 29 August 2019. Three phases of the building were recorded with a cottage (Building 1; Illus 10) pre-dating the First Edition OS map, an agricultural building (Building 2) added before the Second Edition OS map and a door inserted between them and then a corrugated iron shed added to the SSE in the 20th century. It is recommended that no further archaeological work is required during the current planning application.

Illus 10 Phase plan showing three main phases and other minor alterations

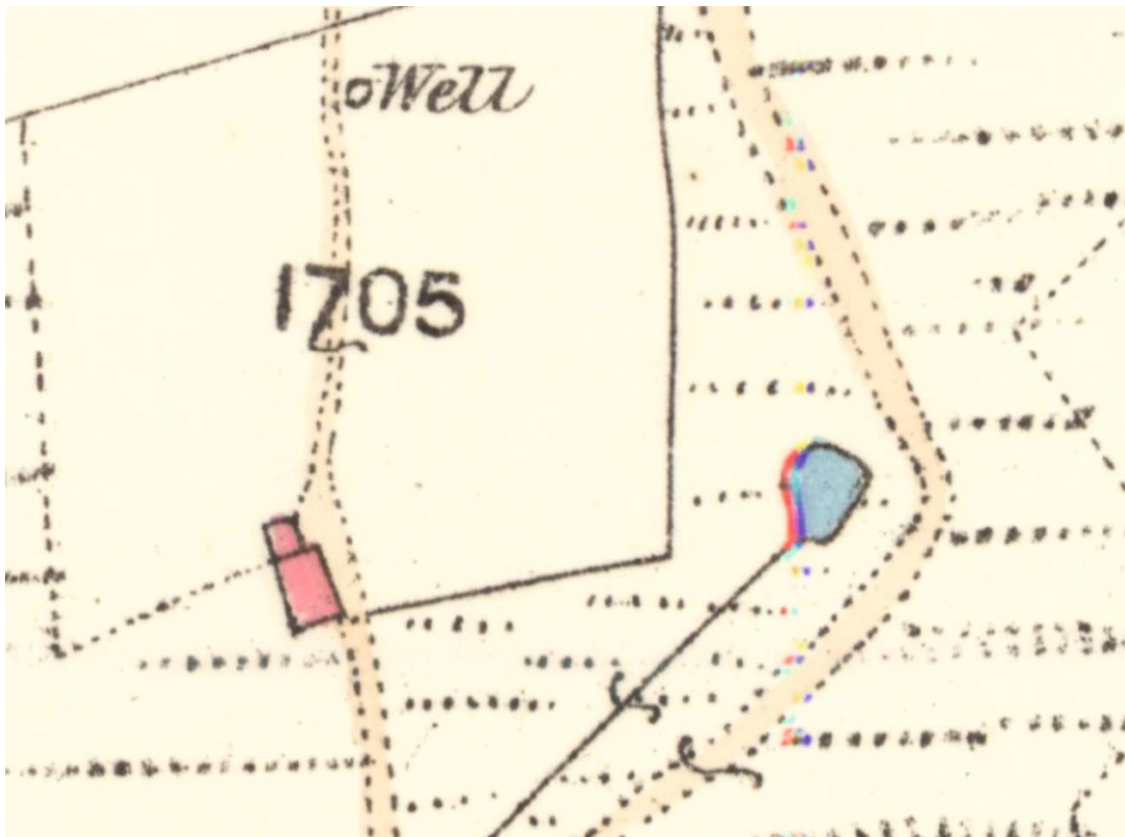
Daisy Cottage is on the Moray HER (NJ22SW0070). The cottage was still in use. It is depicted on the 1st edition OS map (Illus 11) of 1867 as a small rectangular building. On the 2nd edition of 1888 (Illus 12), it has been extended southwards and an enclosed garden area has been added to the west face. The original building appears to survive.

Illus 11 First Edition Ordnance Survey map showing Daisy Cottage. Banffshire XLI.6 (Inveraven) Survey date: 1868 Publication date: 1870 (copyright National Library of Scotland)

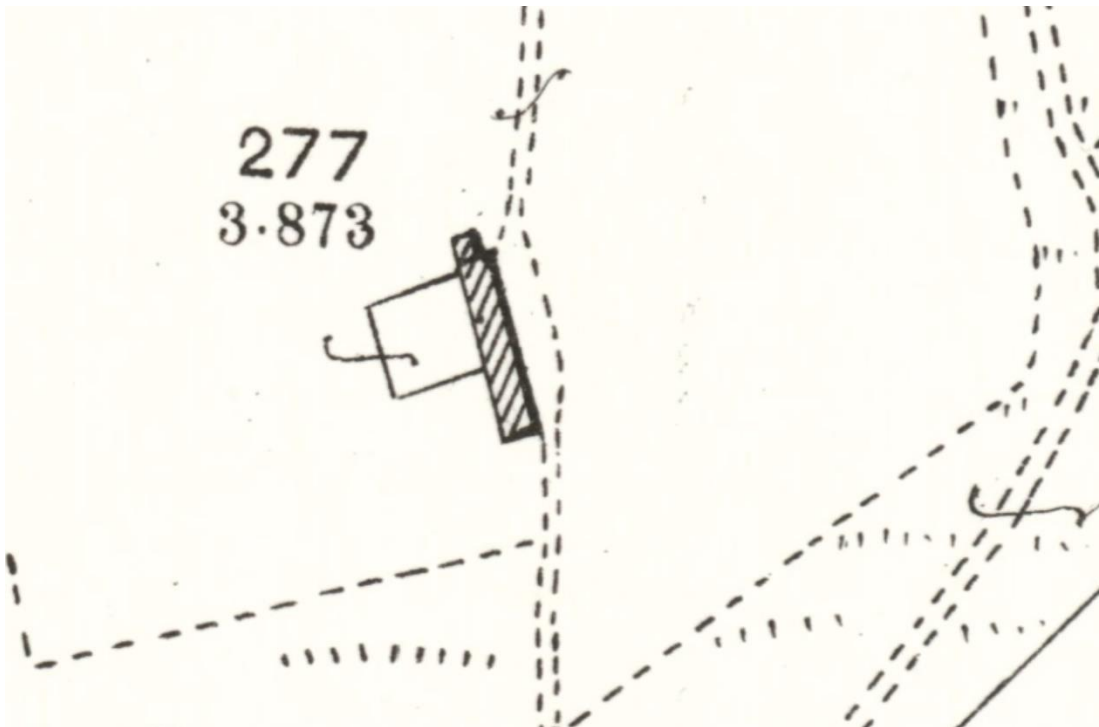
Illus 12 Second Edition Ordnance Survey map showing Daisy Cottage. Banffshire XLI.6 (Inveraven) Publication date: 1902 Revised: 1900 (copyright National Library of Scotland)
