Watching Brief, Aboyne Castle, Aboyne, AB34 5JP
Data Structure Report (DSR)
Site Code CA488-2019

Moyra Simon
Cameron Archaeology
16 December 2019

An archaeological watching brief was undertaken between 13th and 15th November 2019 at Aboyne Castle, Aboyne, AB34 5JP. The watching brief revealed the foundations of a 19th century building, surrounded by a granite cobble border (8), which is believed to have served as the castle laundry. Lead pipes were exposed in the interior of the building adjacent to a granite stand (3) which may have supported a laundry copper. Sundry cast iron sewer pipes and drain box were recovered and a decorative granite finial.

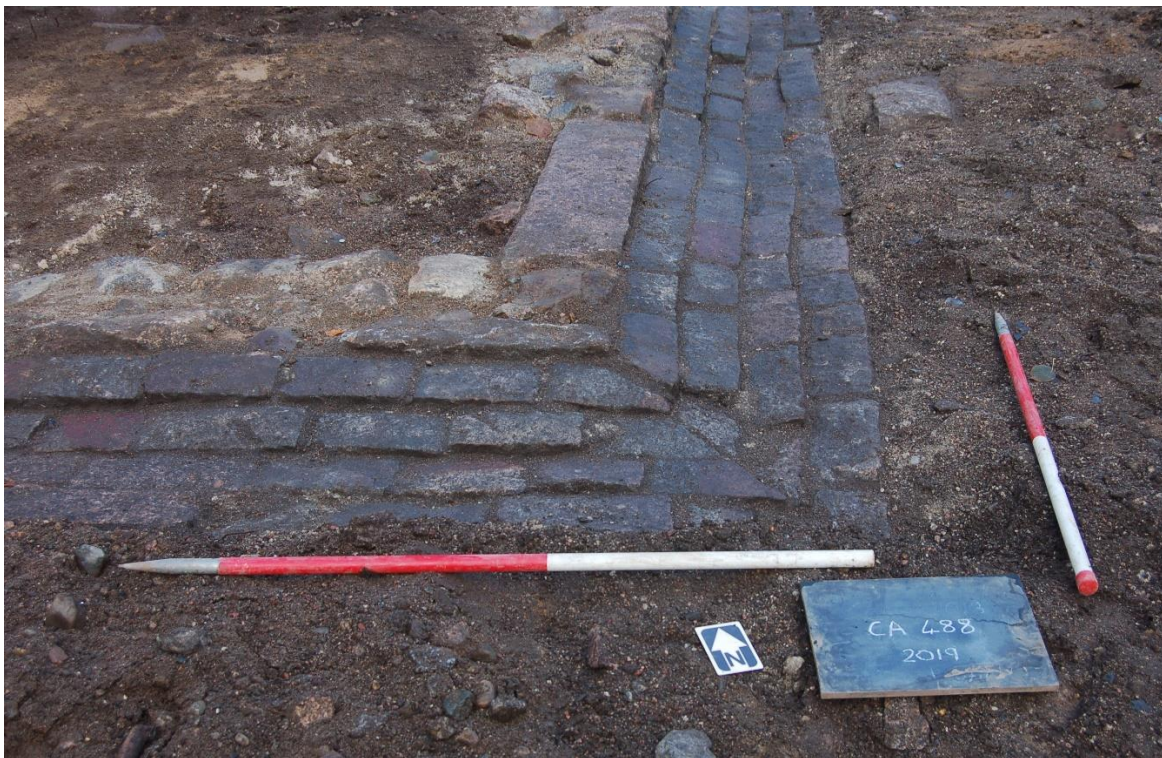
The walls were constructed of mixed granite blocks bonded with mortar. Wall foundation 5 adjoined the peripheral wall and ran 6.4m NW-SE and was 0.5m wide. Wall foundation 6 measured 13.8m SW-NE surviving to a width between 0.4m – 0.6m. Both walls survived to a maximum depth of 0.5m, no more than 2 courses of stone set directly onto soil. This wall was interrupted by three entranceways: the central and W entrances (Illus 5) were indicated by single red granite lintels whilst the E entrance was a short pathway (10).

Illus 5 Intersection of walls 5 and 6 with a cut pink granite lintel surrounded by granite cobbles (8): facing NNE

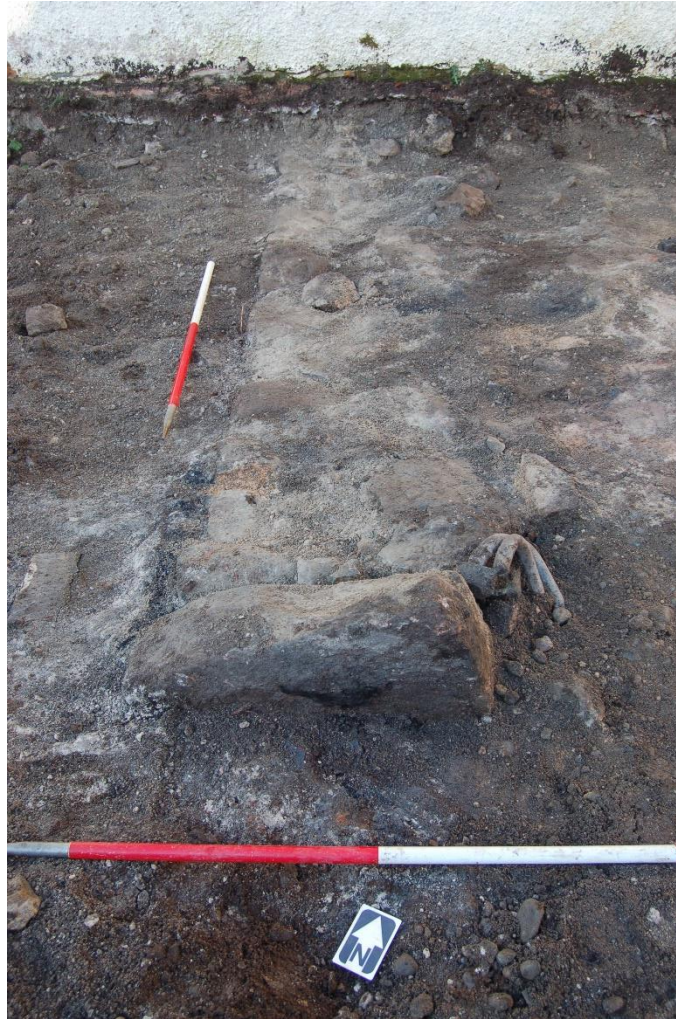
An interior wall (4) measuring 3.4m x 0.85m was positioned approximately central to the area enclosed by walls 5 and 6 and the perimeter wall and ran parallel to wall 5. To the N it abutted the perimeter and had large stone at the S end which was displaced from this wall (Illus 6). A second interior wall (7) ran from wall 5 to wall 4, parallel to 6, forming a smaller rectangular structure measuring 5.85m x 2.8m. Wall 7 was heavily robbed out and therefore it was not possible to ascertain whether it abutted or adjoined walls 4 and 5.

Illus 6 Wall 4 with trace of wall 7 to the W: facing NW

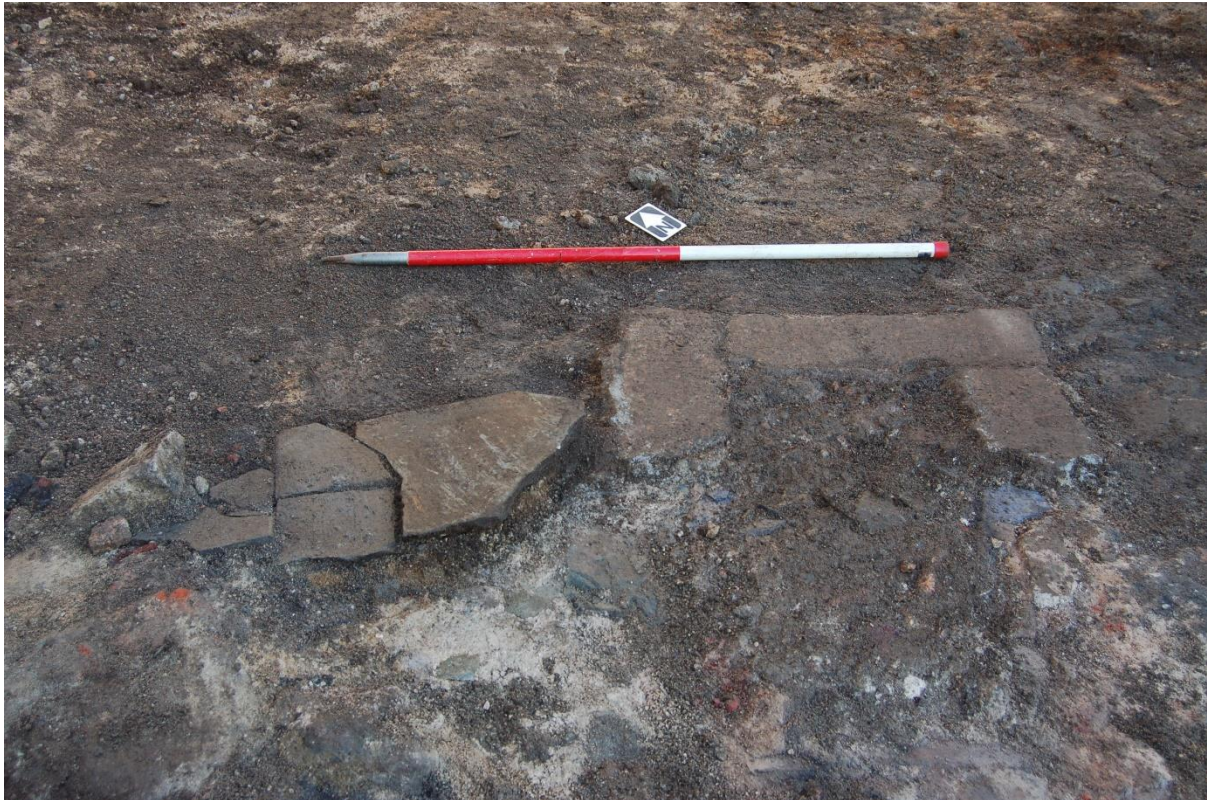
Wall 4 was abutted to the NE by an area of rough rubble flooring (2) 2.8m NW-SE by 1.6m SW-NE (Illus2) comprising a mix of stone, brick and mortar. A few of the brick fragments were burnt, but there was no evidence of further burning which indicates the bricks may have been part of a hearth rather than the entire structure being affected by an uncontained fire.

A plinth comprising 3 red granite blocks forming an open rectangle 0.62m x 0.53m (max) alongside a single broke flagstone (Illus 7), overlay floor 2. As the building was thought to have been a laundry the granite blocks may have been a sink stand or formed the base of a structure to hold a laundry copper.

Illus 7 Rubble floor 2 (foreground) with possible laundry copper base 3 (right): facing NE

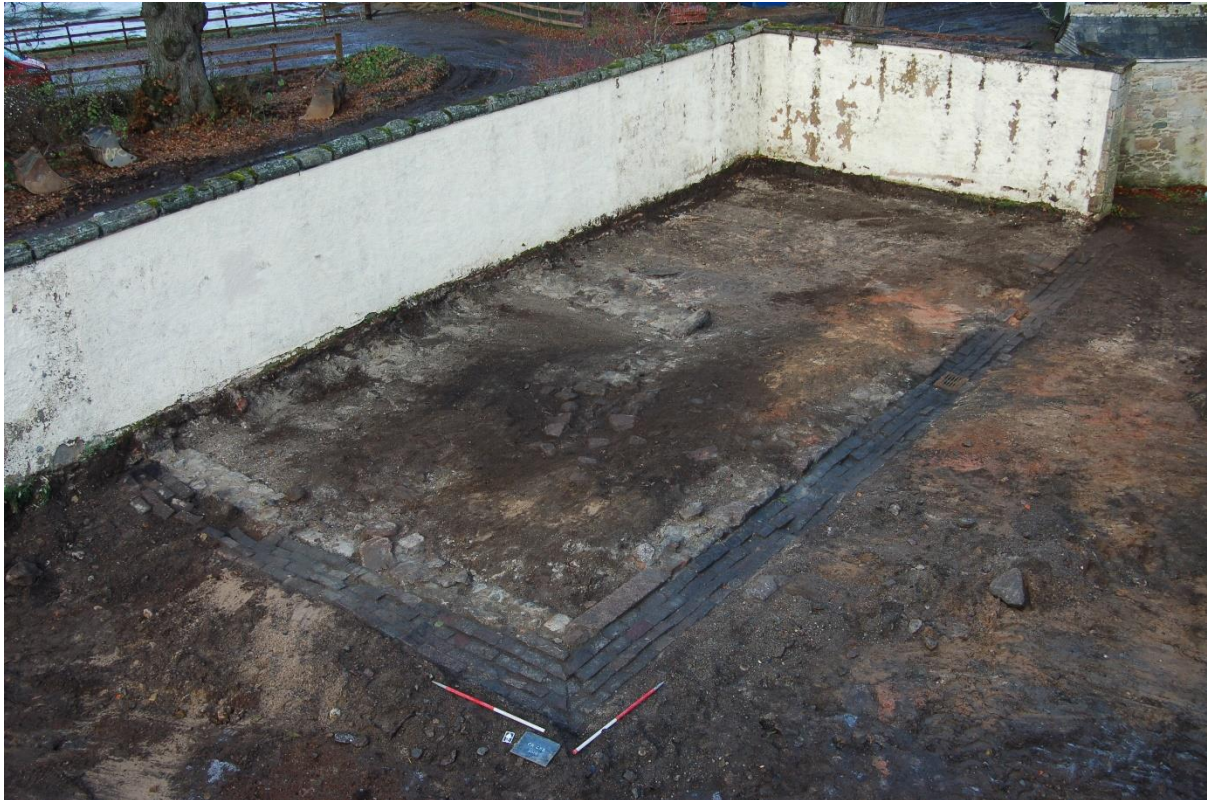
A large area of light yellow/ grey cement plinth (1) measuring a maximum 4.8m NW-SE by 3.4m SW-NE and 0.15m deep abutted the NE side of 2, but was distinct from it. The plinth lay directly over mid brown sandy soil. The level surface showed traces of degradation, but could originally have been smooth rather than textured. There was a 2m gap containing topsoil between 1 and the NE perimeter wall which could indicate that it was a later modification to the structure (Illus 8). However, examination of the second edition OS map shows that the building may have had 2 phases of construction; the first an early 19th century structure incorporating part of the original NE perimeter wall as a gable and a second phase built on the NW side, slightly shorter, with a NE gable separate from the perimeter wall. Therefore 1 could be part of this second phase of construction. The NE gable of the second phase of construction may have been lost during subsequent modification of the perimeter wall.

Illus 8 Outline of the building from above with the space between the NE perimeter wall and 1 visible (top right) as a darker band beyond the lighter yellow / grey of 1. The red/ orange patch of 9 can be seen middle right: facing N

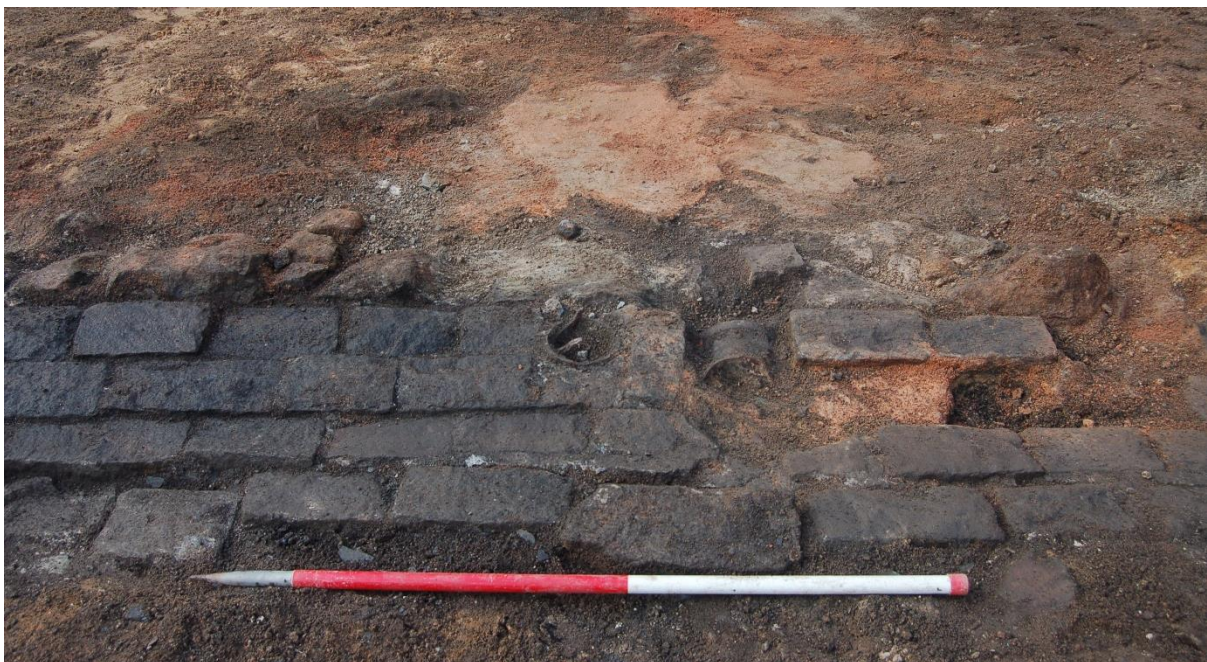
An area of red/ orange plaster floor (9) (Illus 9) 1.2m x 1.4m (max) measuring 0.02m deep was located to the SE half of the structure and was laid directly over soil. Feature 9 abutted wall 6, but was heavily degraded therefore it was not possible to establish its relationship to feature 1.

Illus 9 Feature 9 facing NW

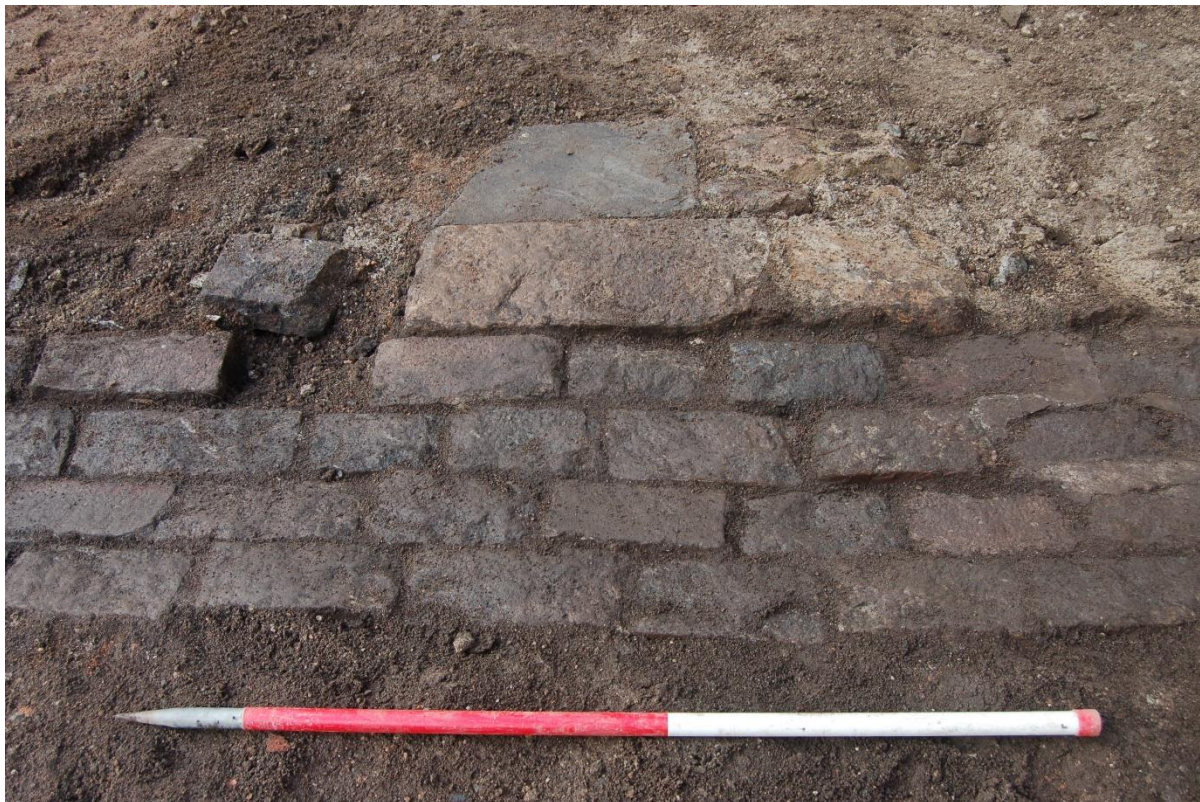
Feature 10 was a short section of stone pathway, 0.85m x 0.5m situated towards the NE end of the structure cutting through wall 6 (Illus 10). It comprised 3 cut red granite slabs and a single dark grey flagstone similar to that found adjacent to feature 3.

Illus 10 Feature 10 (top): facing NW

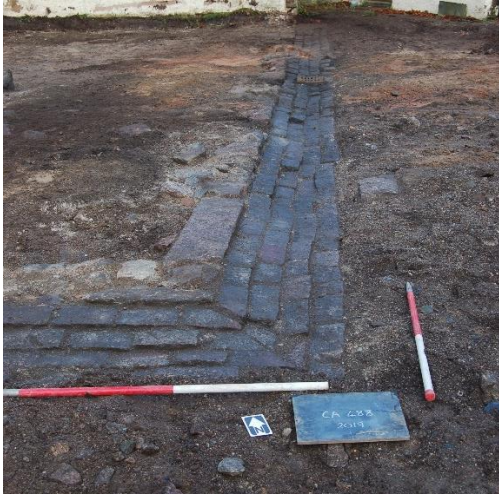
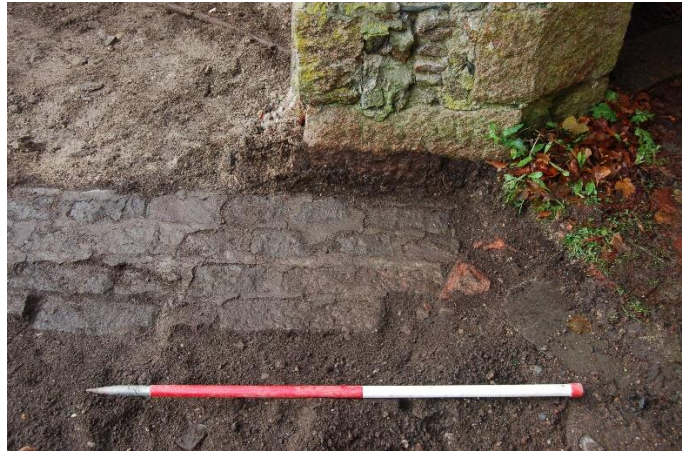
A band of dark grey granite cobbles surrounded the SW and SE walls of the structure abutting 5 and 6 extending 15m SW-NE by 6.8m NW-SE. It was composed of 4 rows of granite cobble of even size (0.28m x 0.16m x 0.13m deep) placed directly onto mid-brown sandy soil. At the SW corner the blocks were cut to form a mitred corner and on the NE they were staggered to follow the contour of the adjacent path (Illus 11).

Illus 11 SW corner of 8 facing NE (left) and NE corner of 8 facing NW (right)

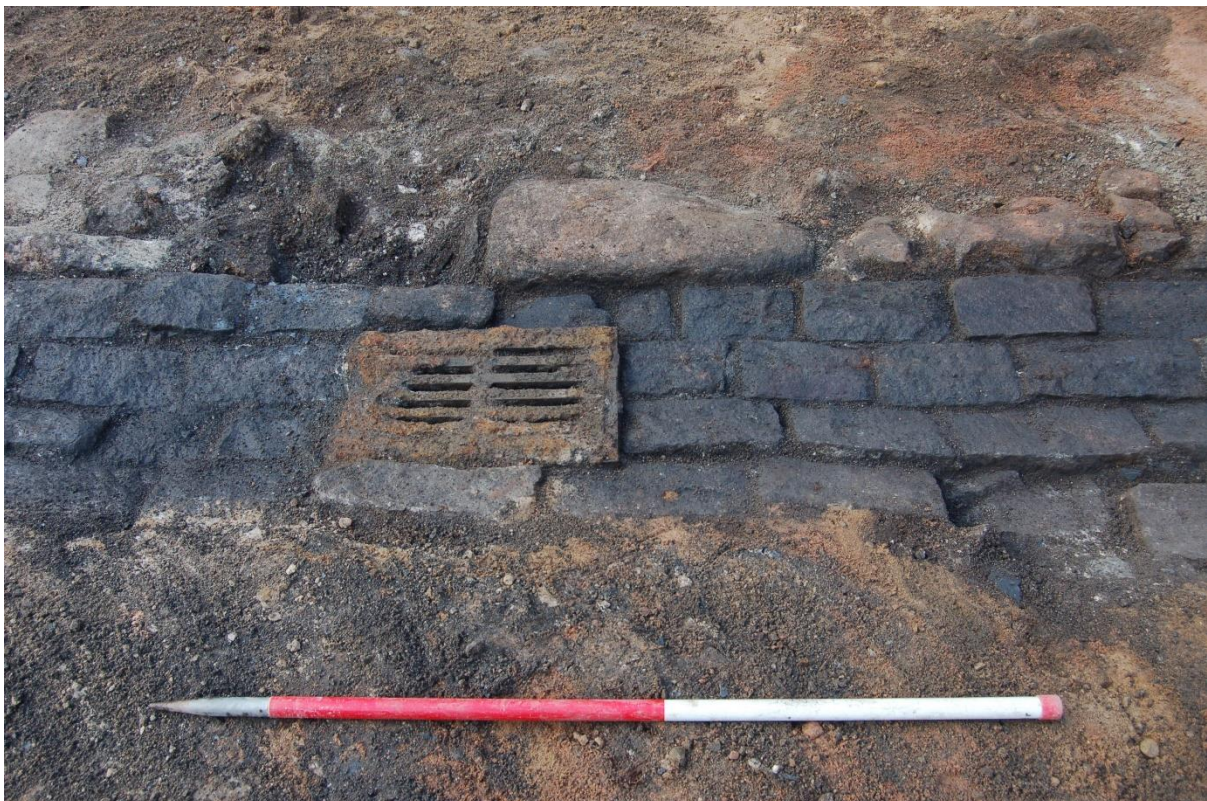
The position of the granite blocks had been distorted by pressure of overlying demolition debris and machine disturbance. However, it was possible to discern they originally formed a shallow u-shaped gully to collect and drain water away from the building. A box drain was situated approximately midway along the SE cobbles (Illus 12) which would indicate water was channel towards it.

Illus 12 Granite cobbles (8) with box drain: facing NW

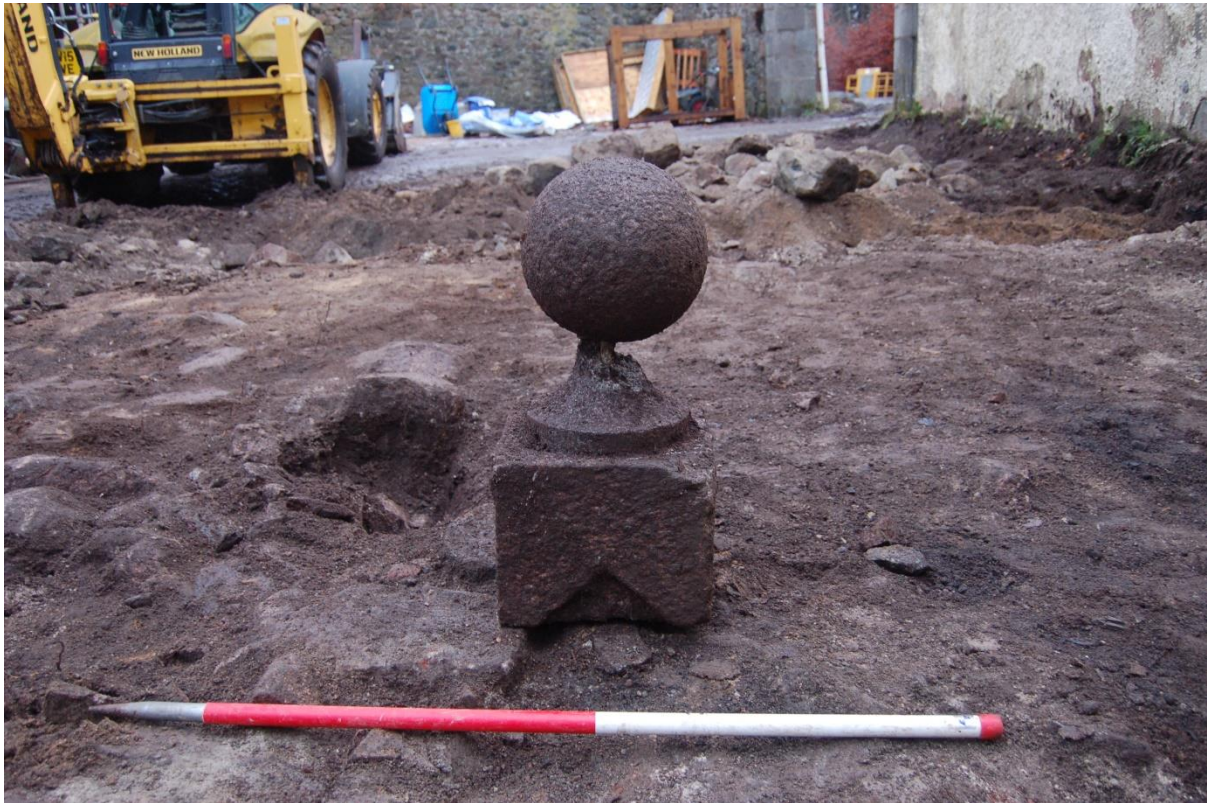
An area of tumbled demolition debris was found adjacent to 7. Though some of the stone components may have originated from 7 itself, a mid-grey granite finial (Illus 13) found within the spread, would originally have been positioned on a gable end. The styling of this feature- a round ball supported on a squared base- is similar to those which adorn the 19th century gate posts at the W end of the perimeter wall.

Illus 13 Recovered granite finial

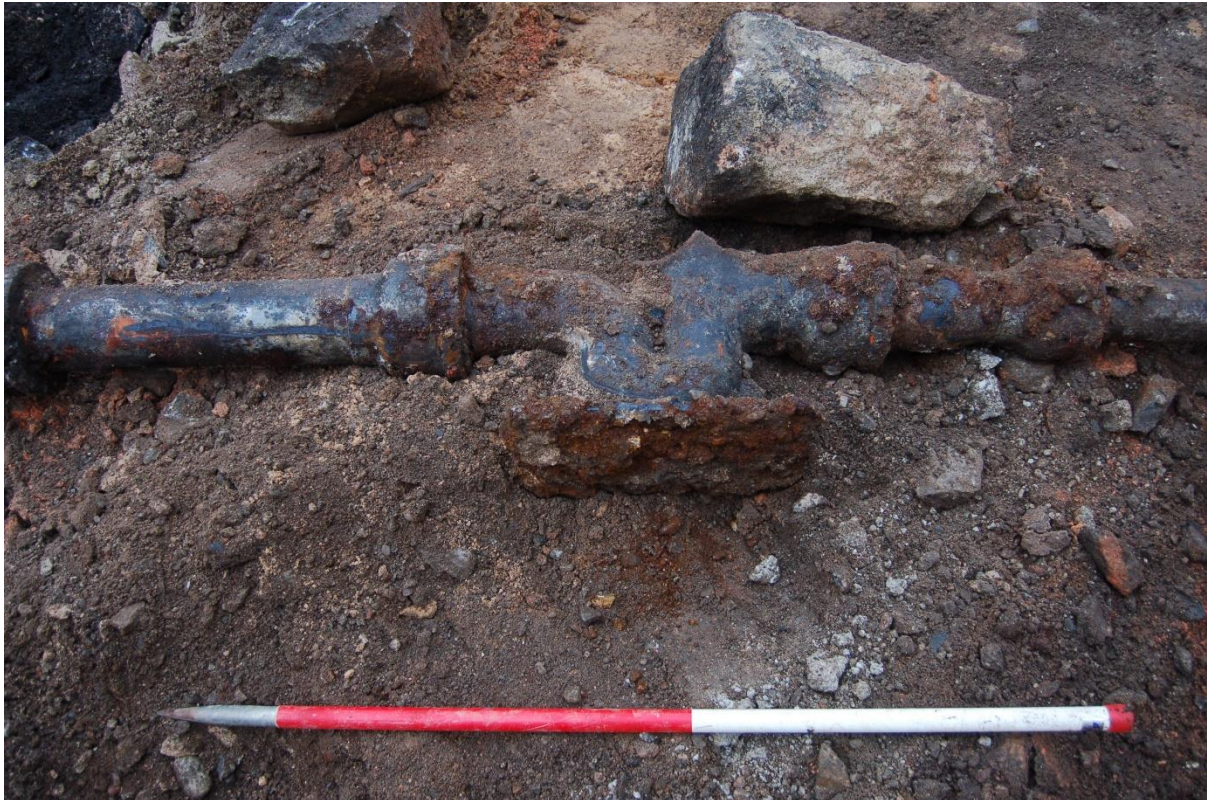
A section of cast iron sewer pipe was recovered from the interior of the structure and was notable for having a u-bend silt trap (Illus 14).

Illus 14 Section of cast iron sewer pipe with u-bend silt trap
