**Watching Brief, Site South of Park Place, Newtonhill,
AB39 3RZ**

Data Structure Report (DSR)

Site Code CA340

Aberdeenshire Council Planning Application APP/2018/1213

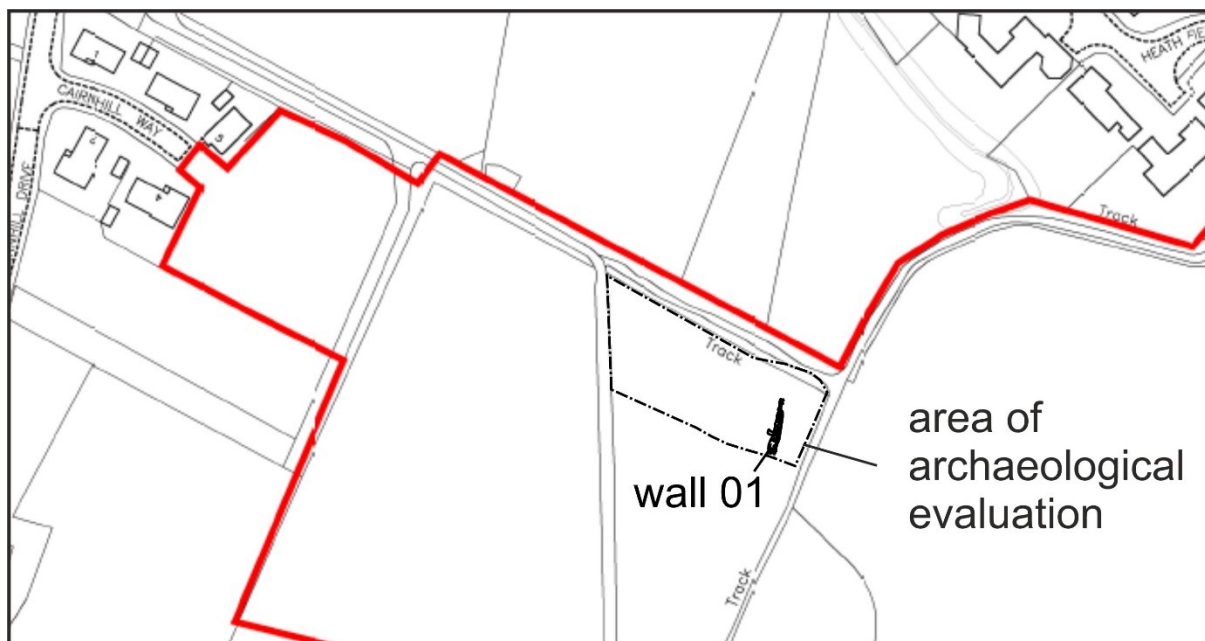
Illus 2 Plan of the watching brief area and wall 01

Removal of 0.2m – 0.30m of topsoil at the W end of the site showed it to be mixed with hardcore. It is most likely the site was affected by construction or repair of the adjacent farm track.

The S half of the site under the overhead cables was stripped on 9 March 2020 and it was a mix of gorse roots amongst large earthfast boulders; no evidence of any structure was identified.

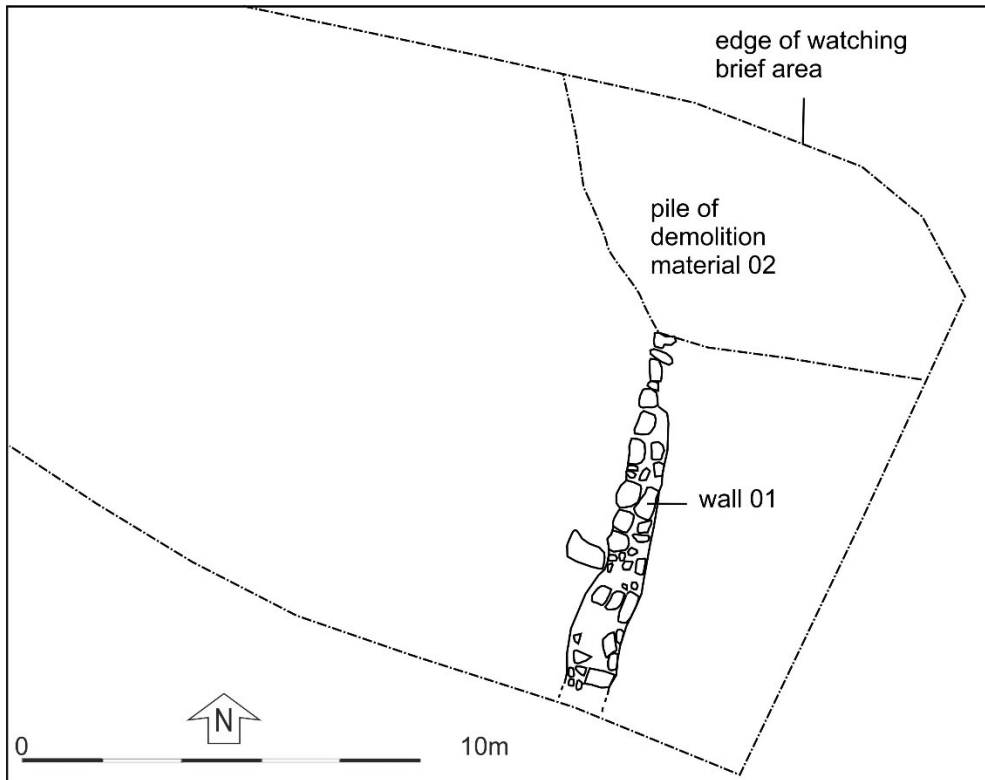
Illus 3 Plan of wall 01

A low turf covered bank with a NE - SW axis led away from the rubble pile. Removal of the turf revealed foundations of a drystone wall (Illus 3-5) comprising larger boulders interspersed with smaller field stones which could be the remains of the croft house depicted

The wall showed signs of collapse: the base was spread where pressure from above appeared to have caused stones to slip outwards and there was a significant amount of tumbled stone present in the surrounding topsoil. It was not possible to determine if the wall continued under the rubble pile to the N.

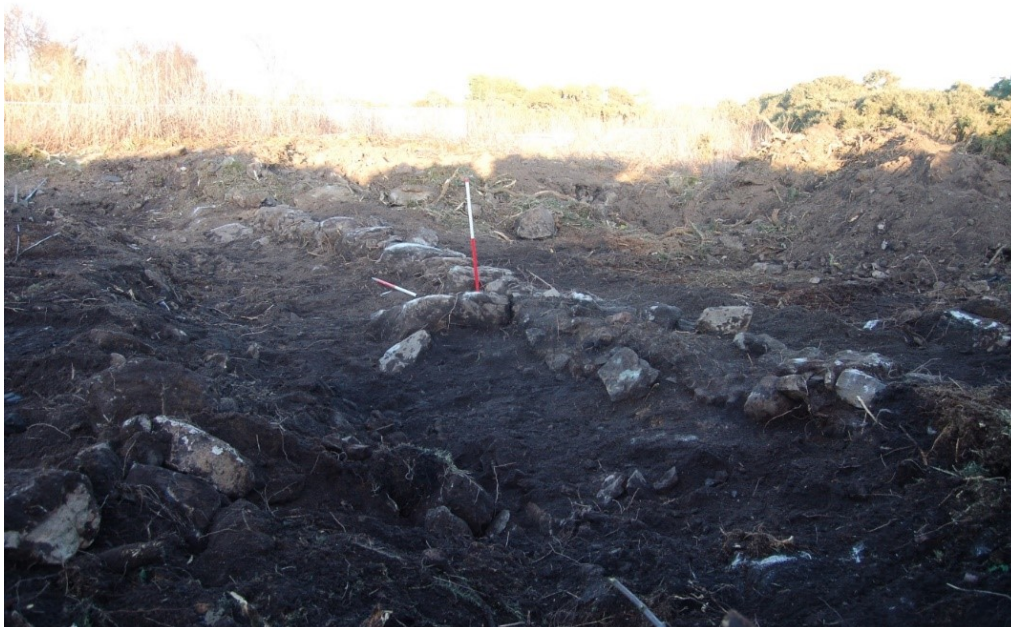
Illus 4 Wall foundation on first exposure with rubble pile (back left and centre)

The NE corner of the site was occupied by a large mound of demolition rubble comprising field stones, few shaped stones, bricks, modern tile, plastic and ferrous vehicle parts (Illus 3, 4). No foundations were discernible beneath this rubble. It is unclear whether this material was the remains of the croft house depicted on the 1st edition OS map (Illus 8).

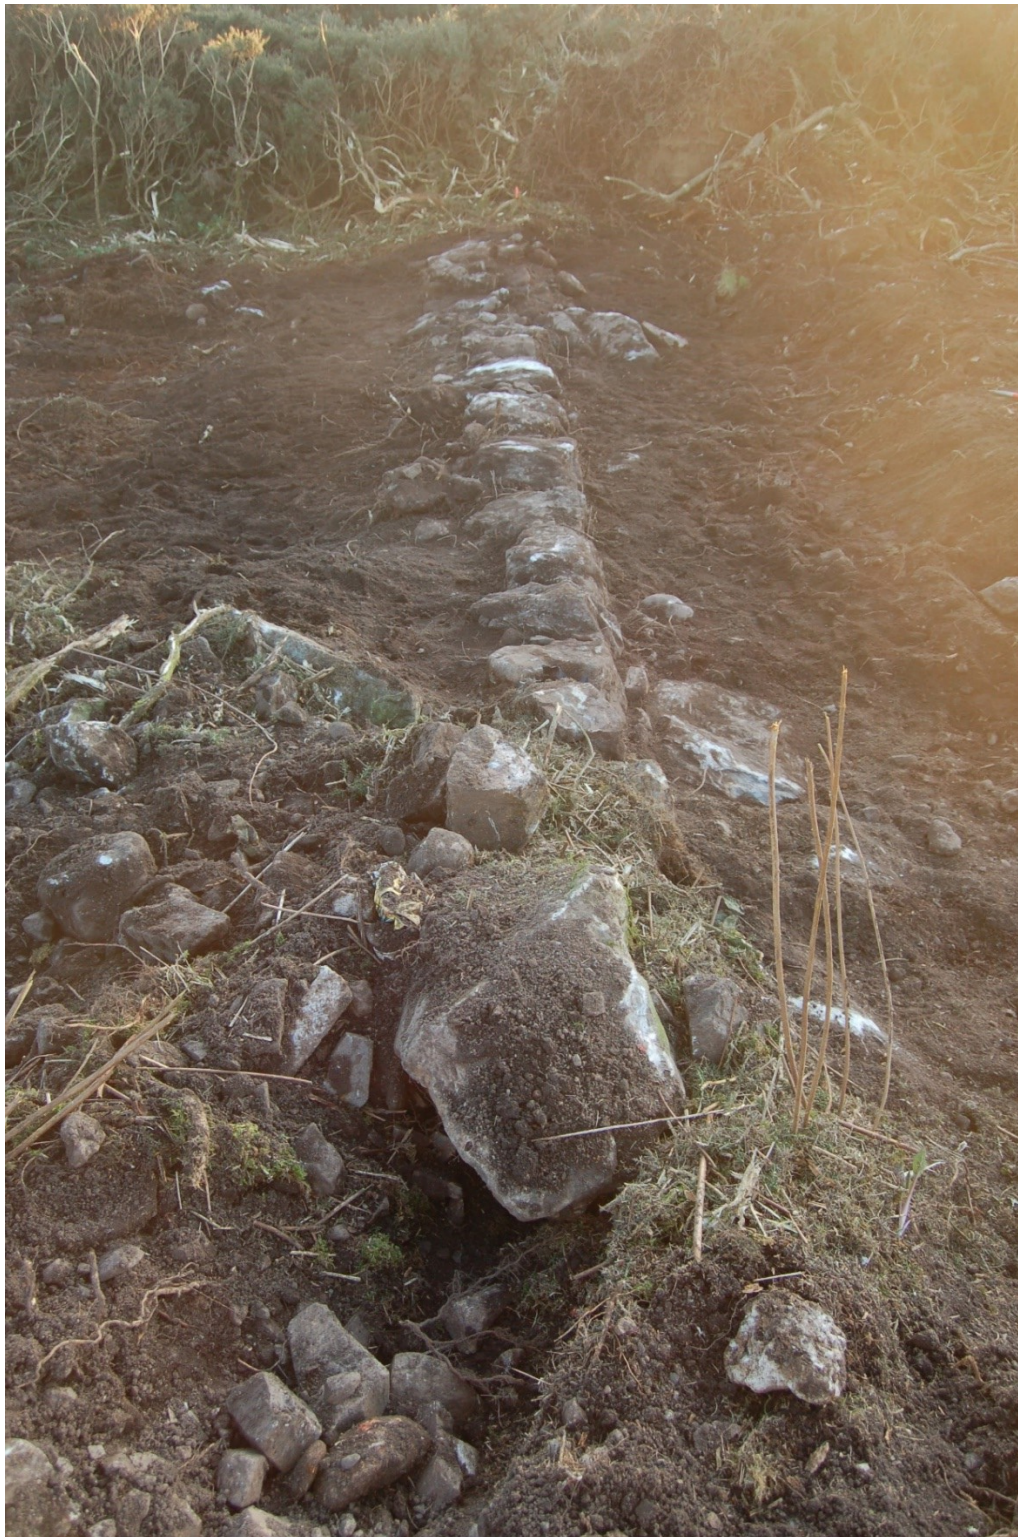
Illus 5 Wall with rubble heap (foreground) unexcavated portion visible as turf covered bank running into gorse scrub

on the 1st edition OS map (Illus 8) and previously described as a turf wall in the HER (NO99SW0023).

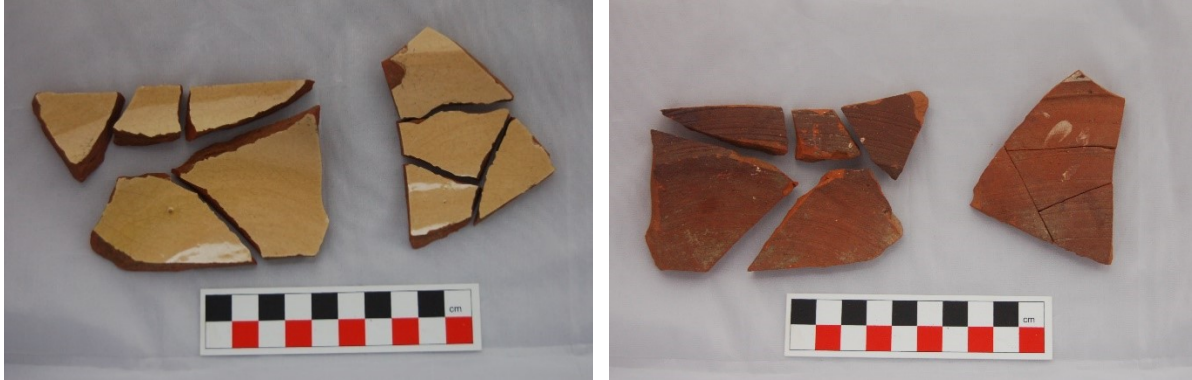
Illus 6 Refitted sherds of red earthenware dish with yellow glaze

Sherds of pottery, window glass, bottle glass and a clay marble were recovered from the topsoil in the immediate vicinity of the wall (Illus 6 & 7). The pottery was similar to that found in association with 19th century crofts on Bennachie (Taylor, 2015) with a mix earthenware and finer ceramics. However, it must be borne in mind that whilst it is likely that the Newtonhill collection originated from the croft, elements may have been transported to the site at a later date.

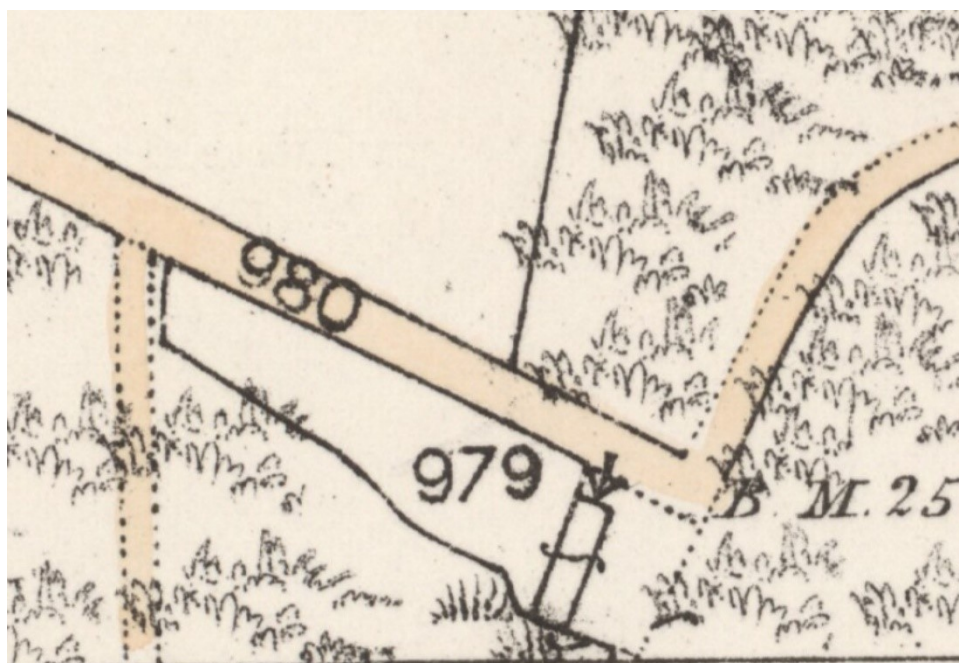
Illus 8 First Edition OS map showing rectangular building one wall of which was found during the watching brief (*copyright National Library of Scotland*) Kincardine Sheet VIII.13 (with inset VIII.14) (Fetteresso)/ Kincardine Sheet XIII.1 (Combined) Survey date: 1865 Publication date: 1868

- 2.8 The early maps show that the area is boggy marginal land and farmland and the First Edition OS map shows a small building at the N of the site (Illus 8) and the Second Edition the building is gone but the area is still mainly marginal upland ground as it is on the 1973 aerial photograph.

The foundations of a drystone wall located to the E of the watching brief area are probably the remains of a croft depicted on the 1st Edition OS map. This may be the structure reported to be a turf wall in the HER (HER NO99SW0023), but there is insufficient evidence to corroborate the use of turf in its construction at this time.
