Tillymauld Farmhouse, Garmond, Turriff, AB53 5TT

Report on Level 1 Standing Building Survey

Aberdeenshire Council Planning application APP/2020/1120

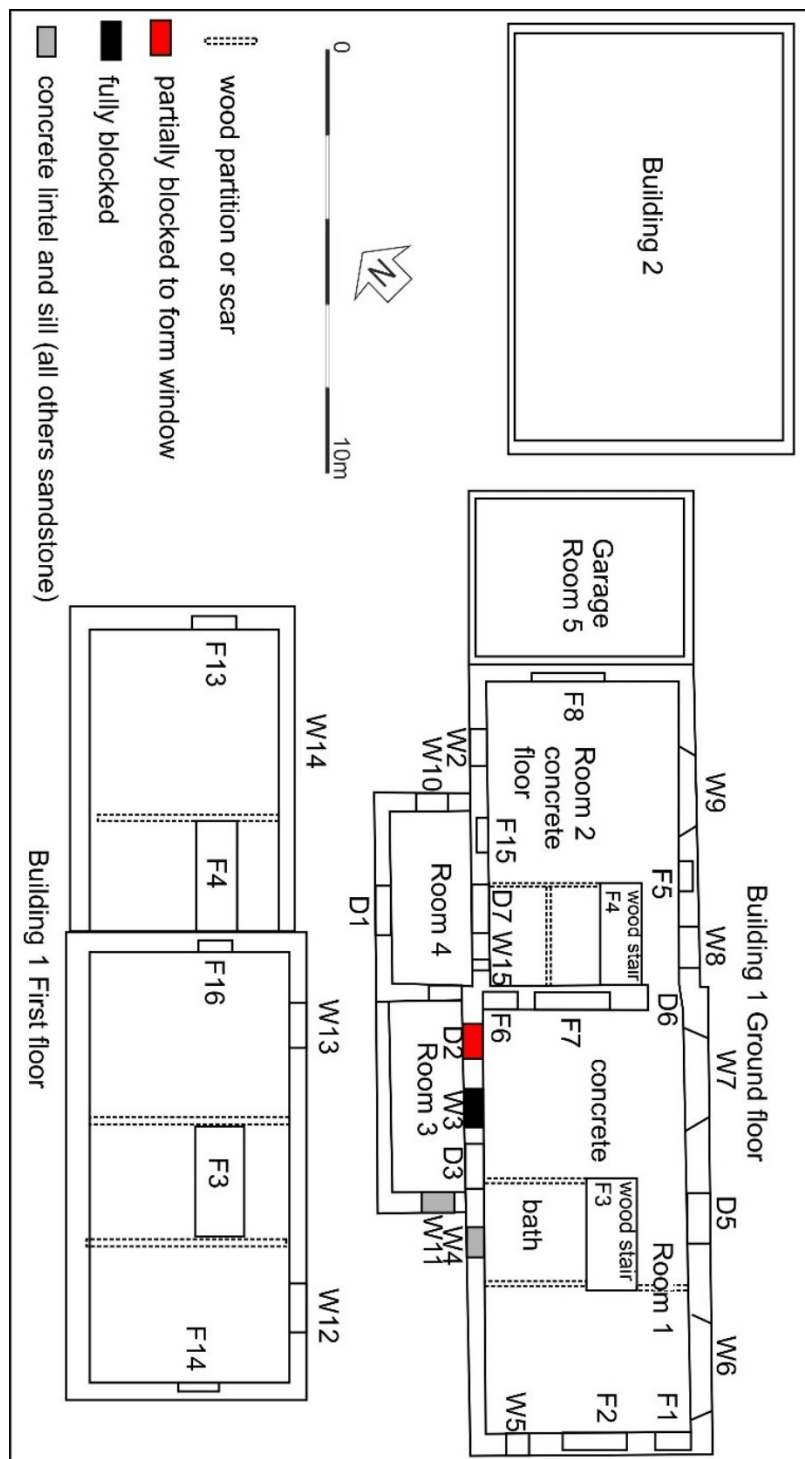
Illus 2 Plan of ground floor (top) and first floor (bottom)

Building 1 is a farmhouse which has been extended several times. The Phase 1 house (Room 1; Illus 2, 3, 4) is 11m long and 5.6m wide. The walls are 0.45-0.5m thick and it is harled on the exterior but the walls are fieldstones with red sandstone window and door lintels and sills. The front SE façade has central door (D5) and two large windows (W6 and W7), small window on the SW gable (W5; Illus 5, 6) and rear door (D3). There are fireplaces on the SW wall (F2; Illus 5) and NE wall (F7). The floors are now concrete and there is a central wooden stair (F3). No evidence of a stone stair was recorded. The roof is grey slate and there are red sandstone chimneys (F10 and F11).

In Phase 2 a stone extension (Room 2) was added on to the NE 7.7 x 5.5m in size (Illus 2, 3, 7). The sills and lintels are red sandstone. There are two windows on the SE wall (W8 and W9), two windows and a door on the NW wall (W2, D7, W15). There is a fireplace on the NE gable (F8) and the NW wall (F15). The floors are now concrete and there is a wooden stair (F4); no evidence of a stone stair was recorded. The roof is grey slate and there is a red sandstone chimney above the NE gable (F9; Illus 7).

In Phase 3 a lean-to 4.9 x 2.3m in size extension was added on to the NW (Room 4; Illus 2, 3) with D1 on the NW wall (see cover). In Phase 4 this was extended and Room 3 5m long and 2m wide added next to Room 4. Each room had a window (W10 with red sandstone sill and lintel, W11 with concrete lintel and sill) and in Phase 4 a door was added between the rooms (D4). Presumably at this time D2 and W3 were blocked but D3 remained open. Window W4 was opened in this phase with concrete sill and lintel (Illus 2, 3).

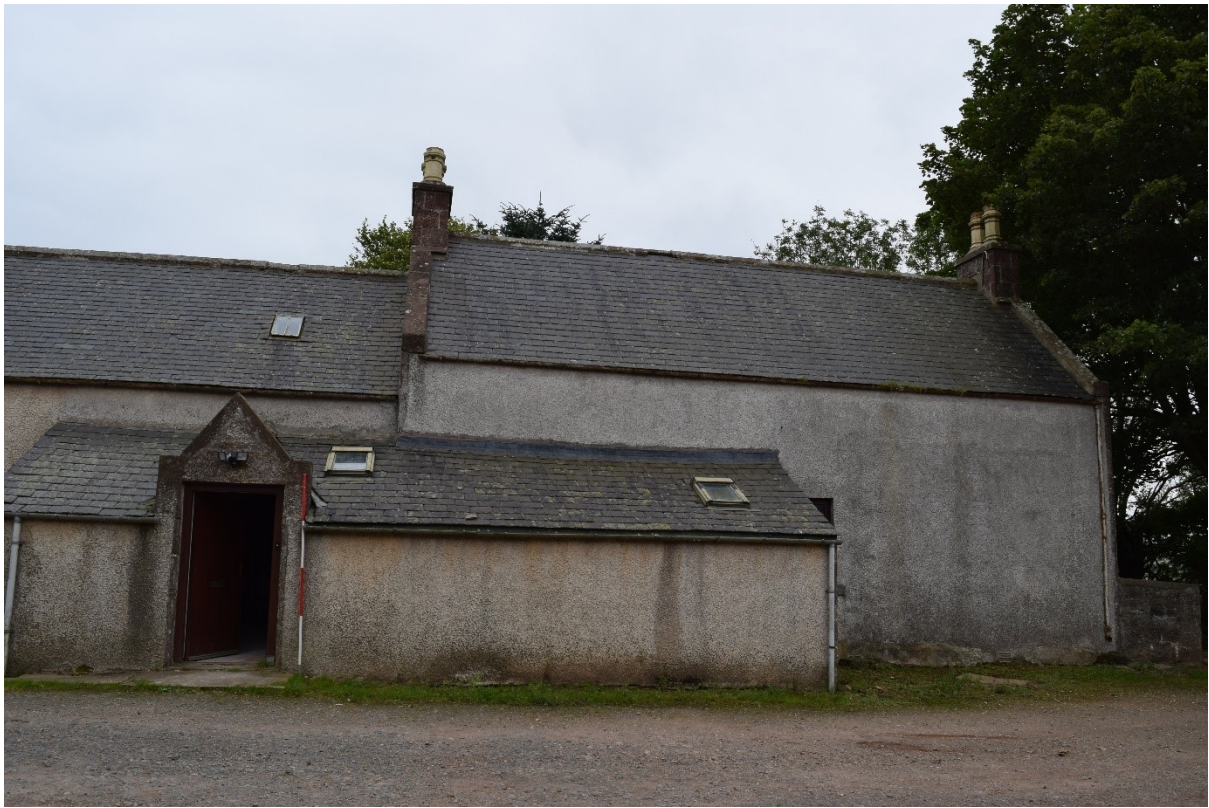
Illus 4 Phase 1 NW façade (right) with Phase 2 (left) and Phase 3/4 extension (foreground); facing SE

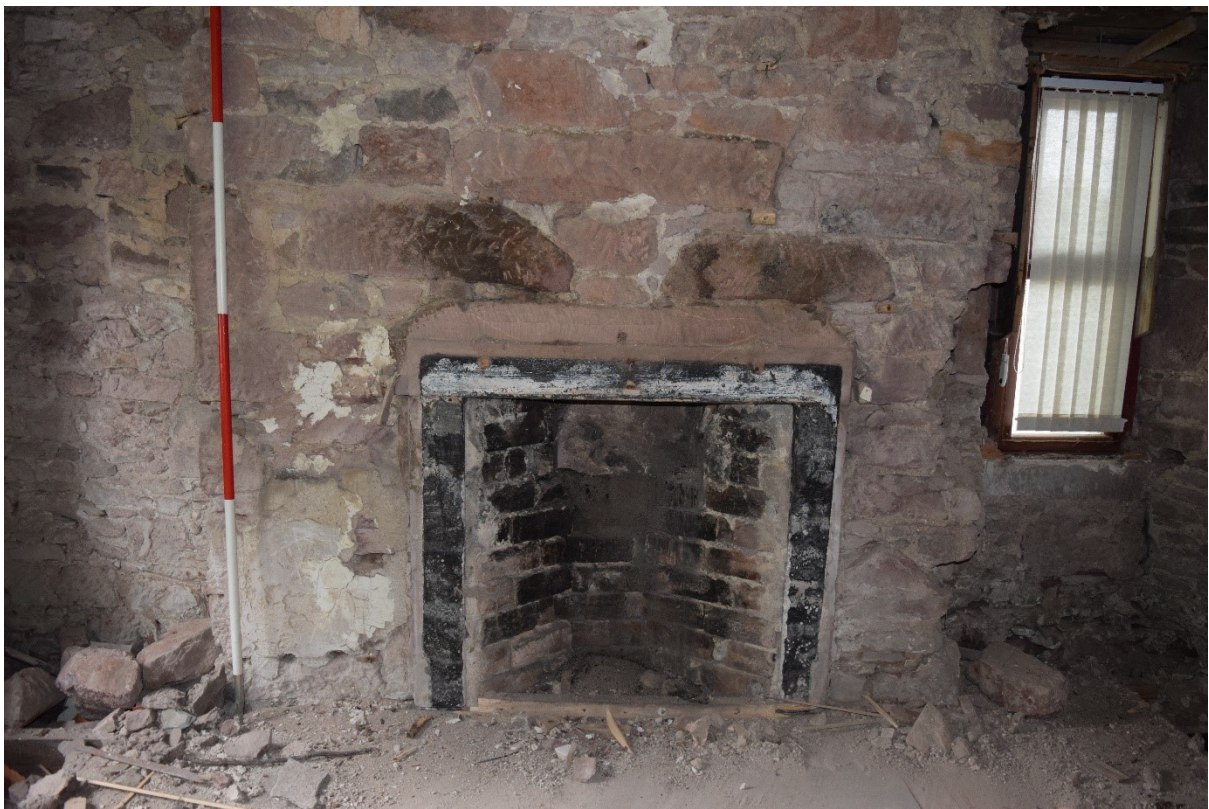
Illus 5 Phase 1 SW gable fireplace F2 with alcove F1 (left) and window W5 (right); facing SW

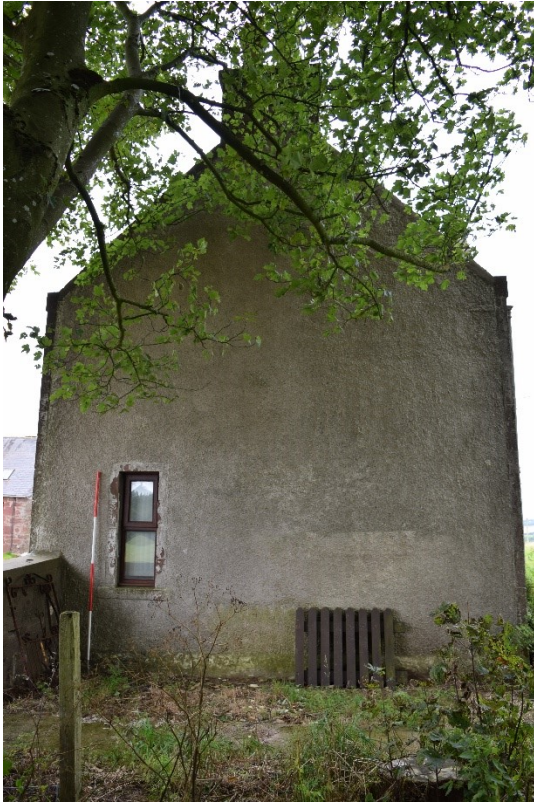
Illus 6 Phase 1 SW gable with W5 (left); facing NE

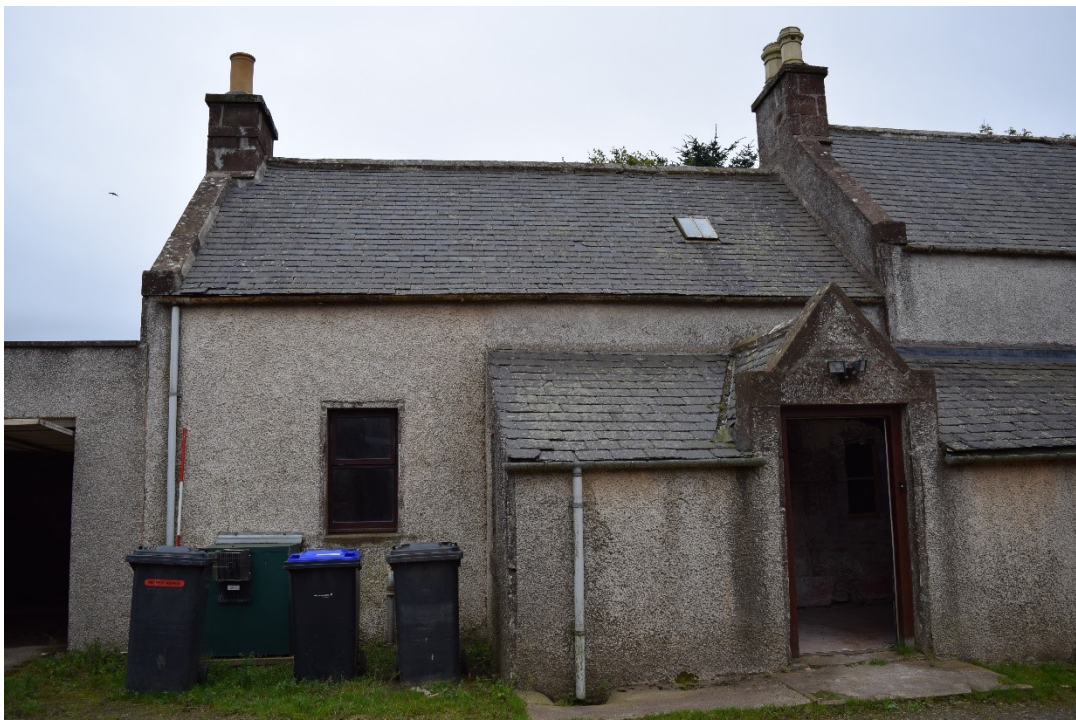
Illus 7 Phase 2 extension (left) with Phase 3 extension with D1 (foreground); facing SE

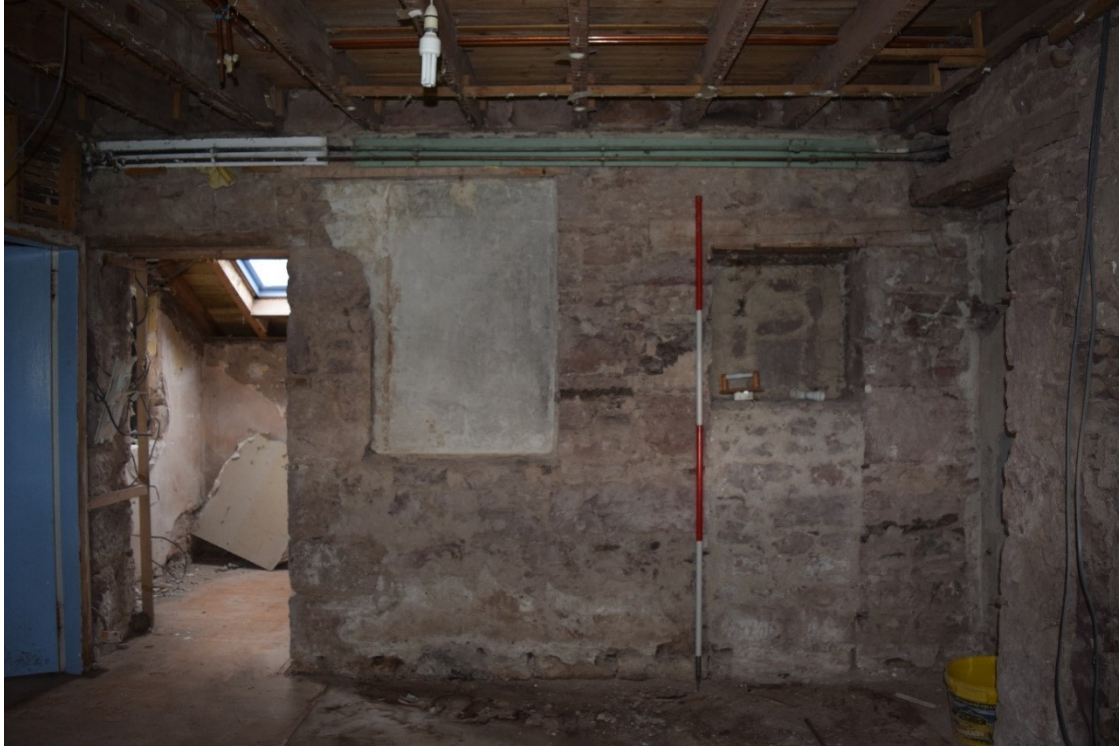
Illus 8 Phase 1 Room 1 NW wall with D3 (left), blocked window W3, door D2 later blocked to form window (right); facing NW

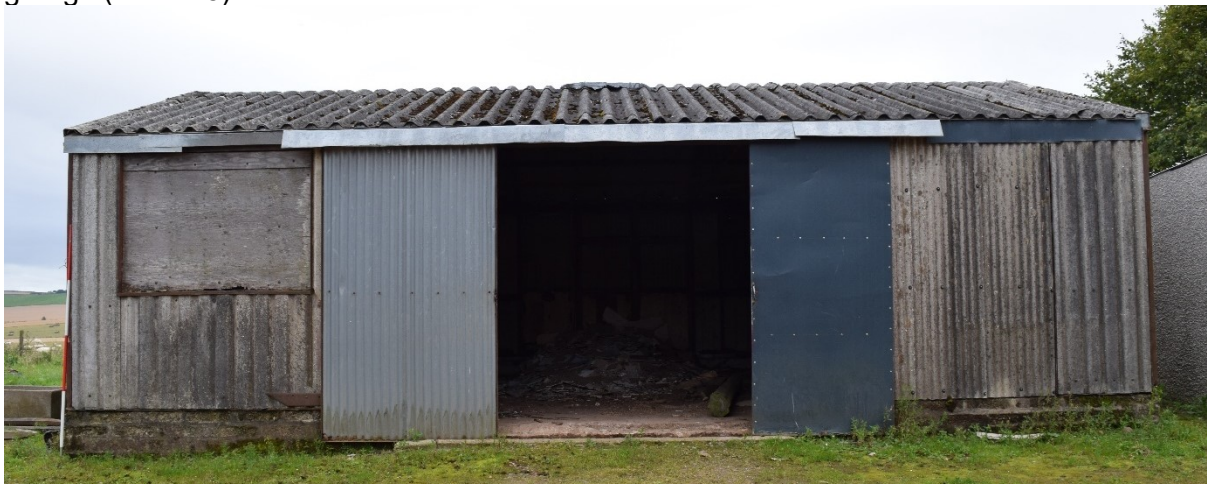
Building 2 is 10 x 6.6m in size (Illus 9). It was constructed after Building 1 and before the garage (Phase 5) and is a concrete block foundation with asbestos cement walls and roof.

Illus 9 Building 2 NW façade; facing SE
