**Land At Little Mill of Esslemont, Esslemont, Ellon,
AB41 8PD
Report on Level 1 Standing Building Survey**

Aberdeenshire Council Planning Application APP/2021/0271

**Alison Cameron
Cameron Archaeology
21 June 2021**

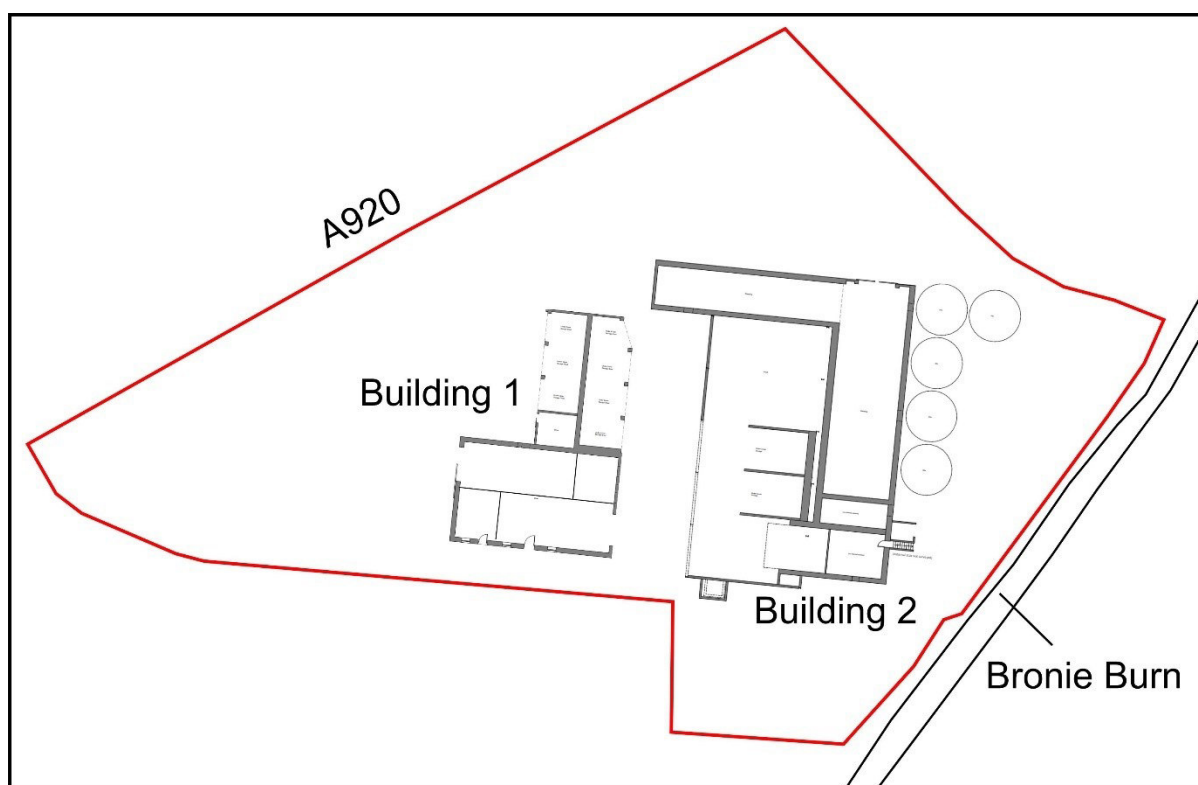
Illus 2 Plan of buildings surveyed (from copyright Cairnrowan Custom Homes Ltd)

A level 1 standing building survey was carried out on 17 June 2021; the weather was sunny and warm and architects plans and elevations were checked and annotated and a photographic survey carried out. There were areas on the exterior difficult to access including the SE corner which is very overgrown and the area around the tanks where there is undergrowth and broken asbestos roofing material. There are several interior areas which are inaccessible – Room 11 in Building 1 and Rooms 3, 4 and 5 in Building 2 as well as other areas where there are stacked bails.

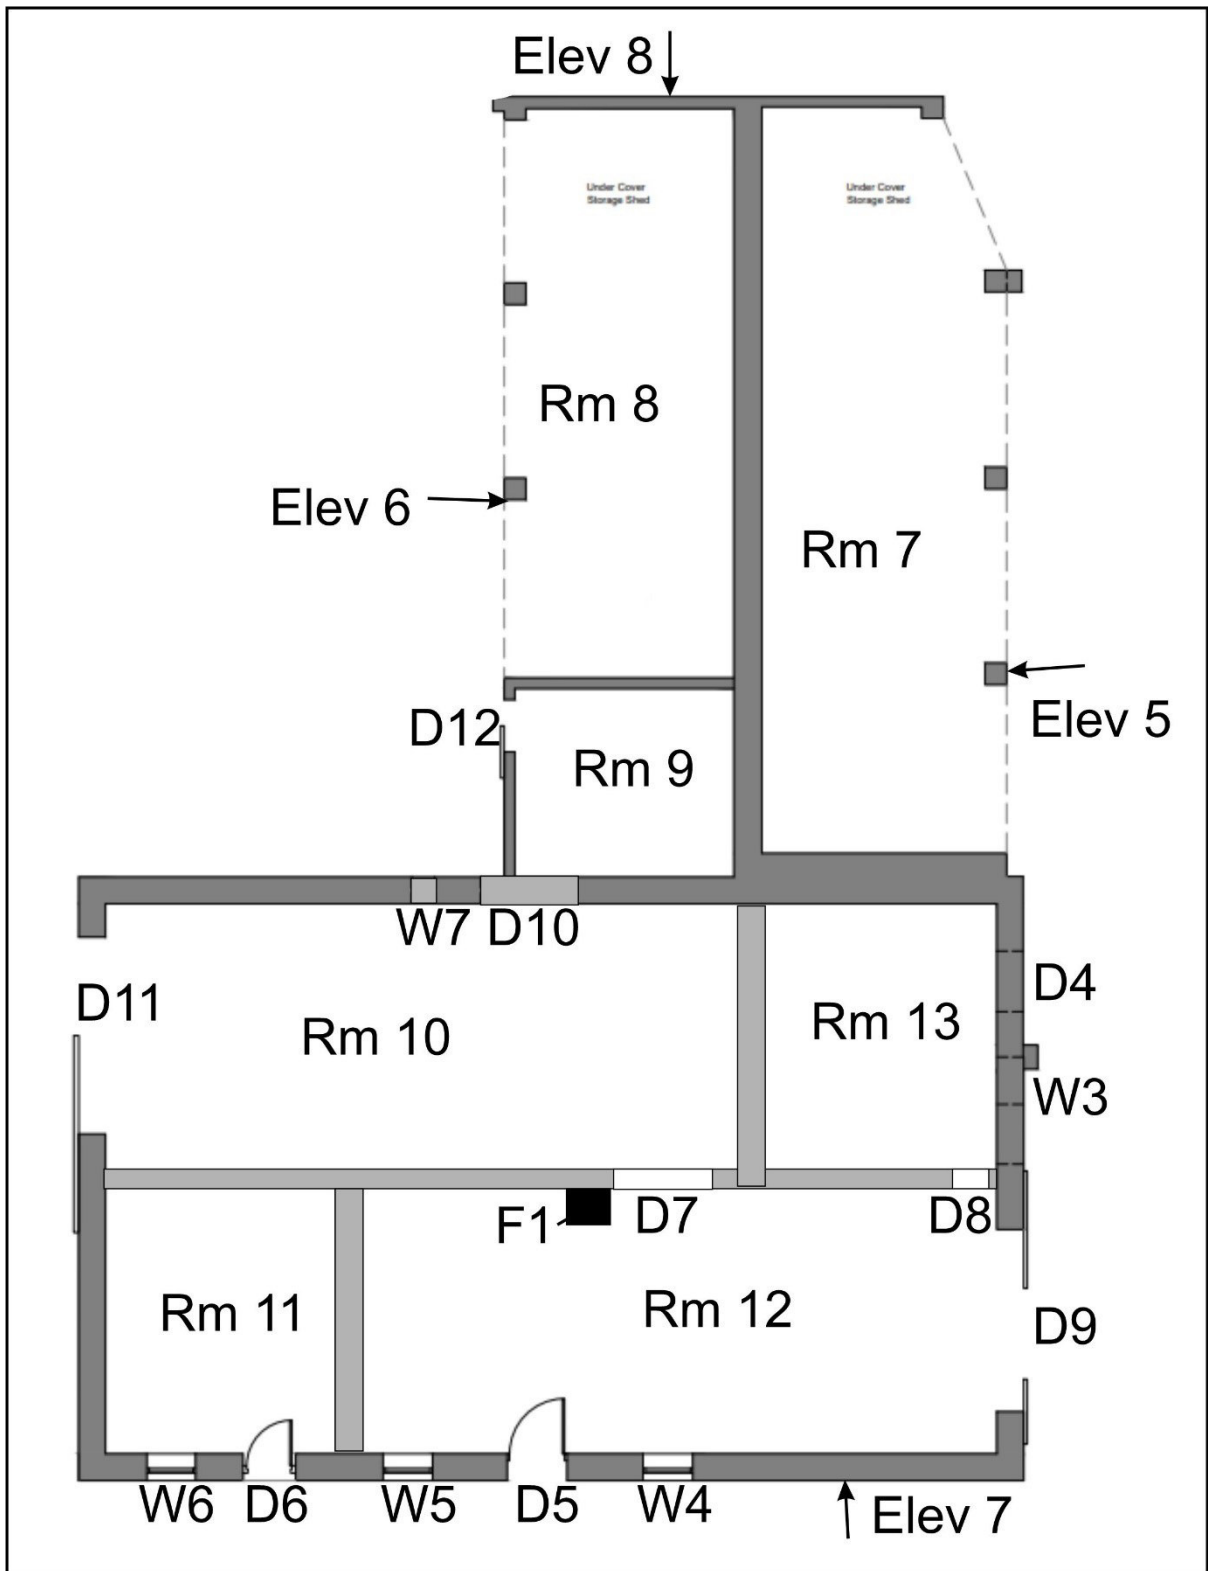
Ilus 3 Building 1 plan annotated with numbers used in this survey (copyright Cairnrowan Custom Homes Ltd)

Building 1 is an L-shaped structure consisting of single storey stone bothy in the SW corner (Room 11), workshop (Room 12), agricultural building (Rooms 10 and 13) and piggery (Rooms 7-9). The S façade of the building is 19.48m long, Rooms 11 and 12 are 6.8m wide and Room 10 is 6.4m wide. The piggery is 9.1m wide at the N end (Illus 3, 4). There are rooflights W8-10 and W12-14 in the grey slate roofs.

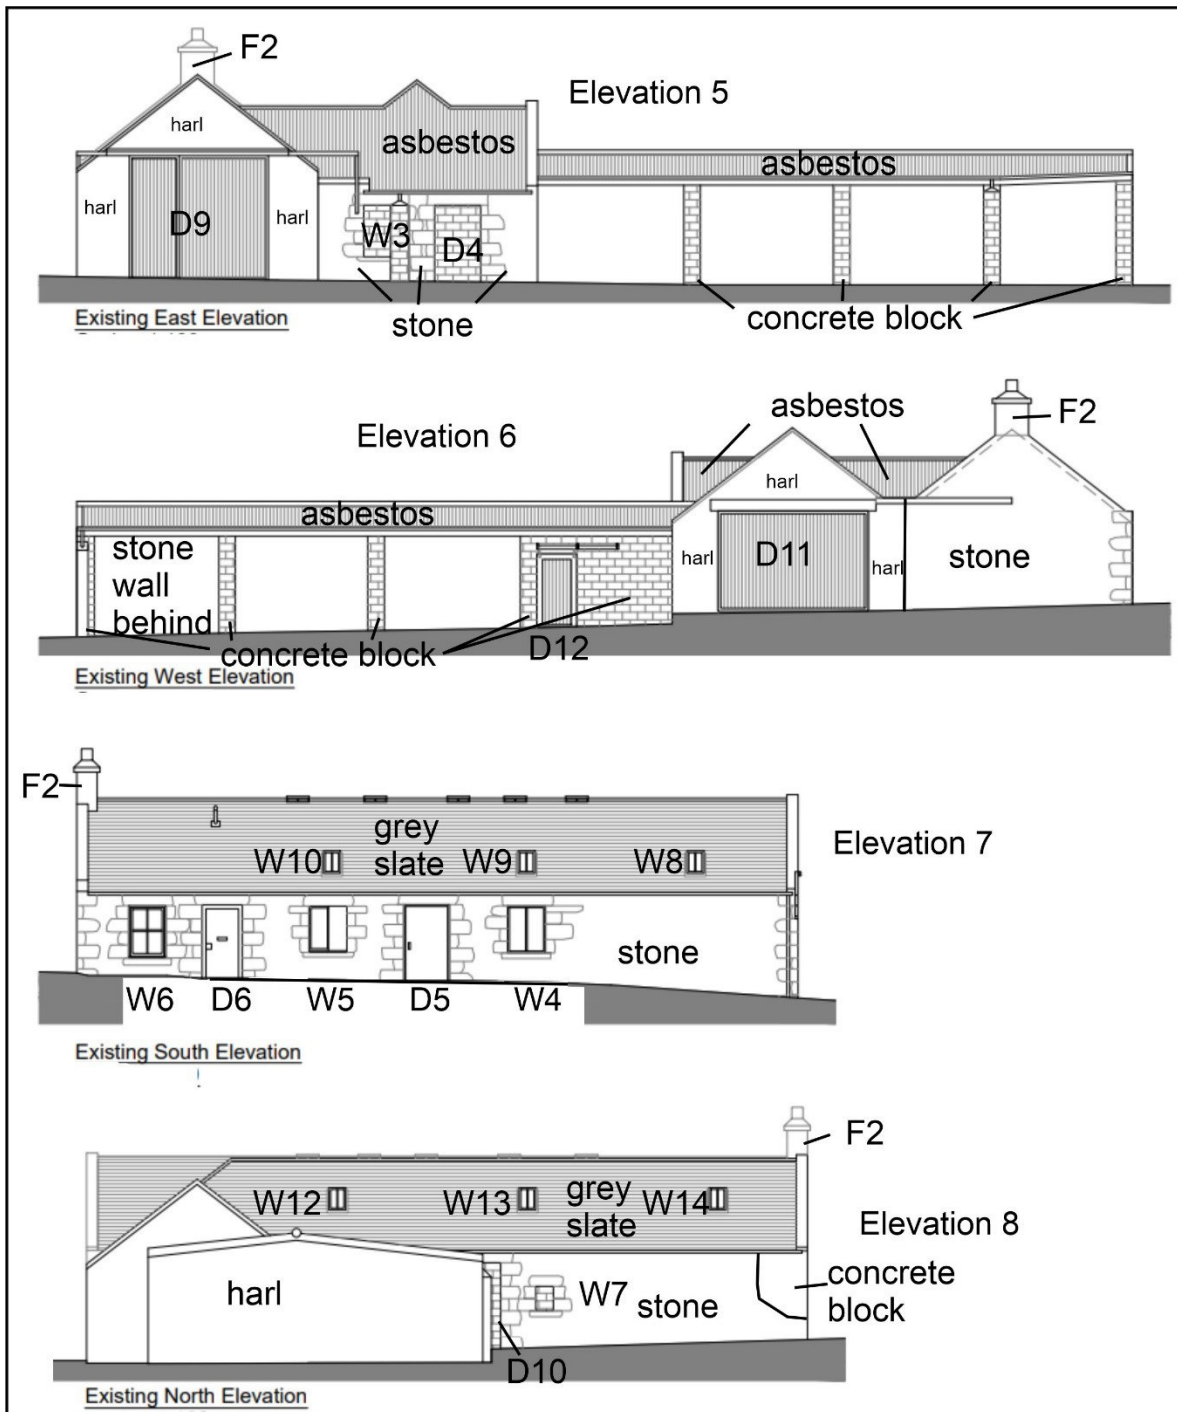
Illus 4 Building 1 elevations annotated with numbers used in this survey (copyright Cairnrowan Custom Homes Ltd)

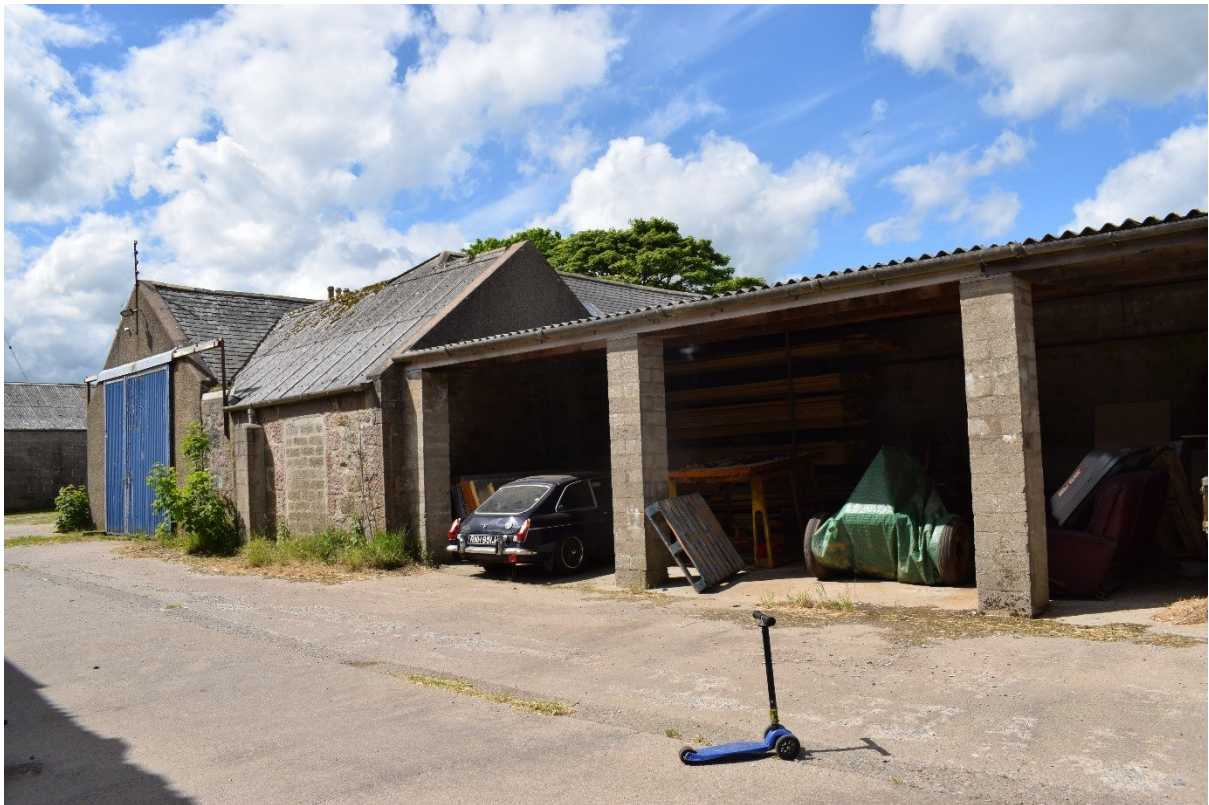
Illus 5 Room 12 E gable (left) Room 13 (centre), piggery Room 7 (right); facing SW

In Phase 4 a concrete building (Rooms 7-9; Illus 5) was added to the N; the W wall of the Phase 1 range was retained within the building. The extension is concrete block with asbestos cement roofing material and has a small enclosed room (Room 9) with exterior door (D12) and two open sided sheds (Rooms 7 and 8). A concrete block door was knocked through between Rooms 10 and 12 (D7) and between Rooms 12 and 13 (D8) and there is a small furnace on the N wall (F1)

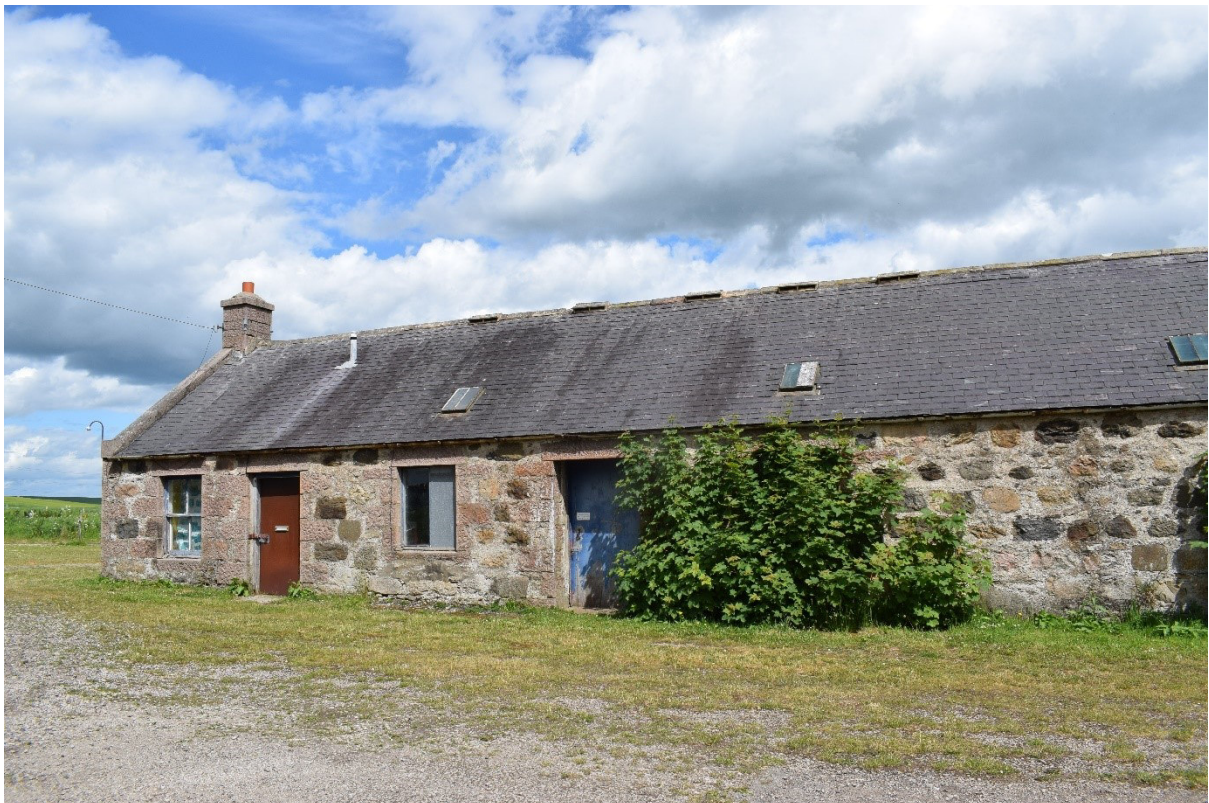
Illus 6 S façade Rooms 11 (left) and 12 (right); facing NW

In Phase 2 Rooms 10, 11 and 12 are added with a bothy (Room 11) with W6 and D6 on the S wall and chimney F2 on the W gable (Illus 6). Room 12 has W4, W5 and D5 on the S wall. There is also a window on the N wall of Room 10 (W7) and large door (D10), both of which

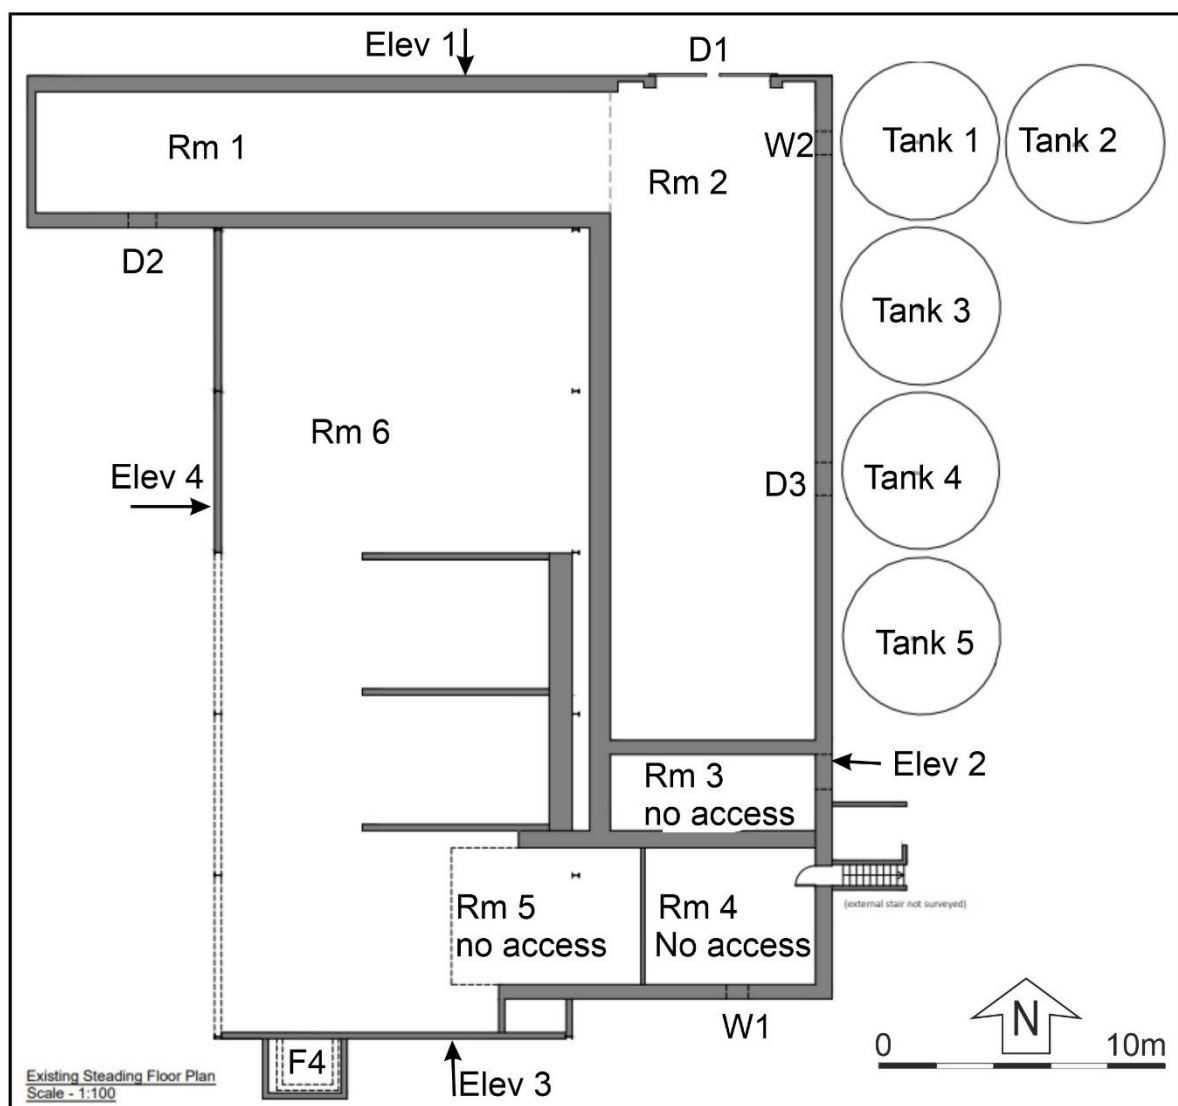
Building 2 is an L-shaped range with modern Dutch barn built into the courtyard; it has a metal roof and upper portion of the wall with harled concrete block below.

Illus 7 Building 2 plan annotated with numbers used in this survey (copyright Cairnrowan Custom Homes Ltd)

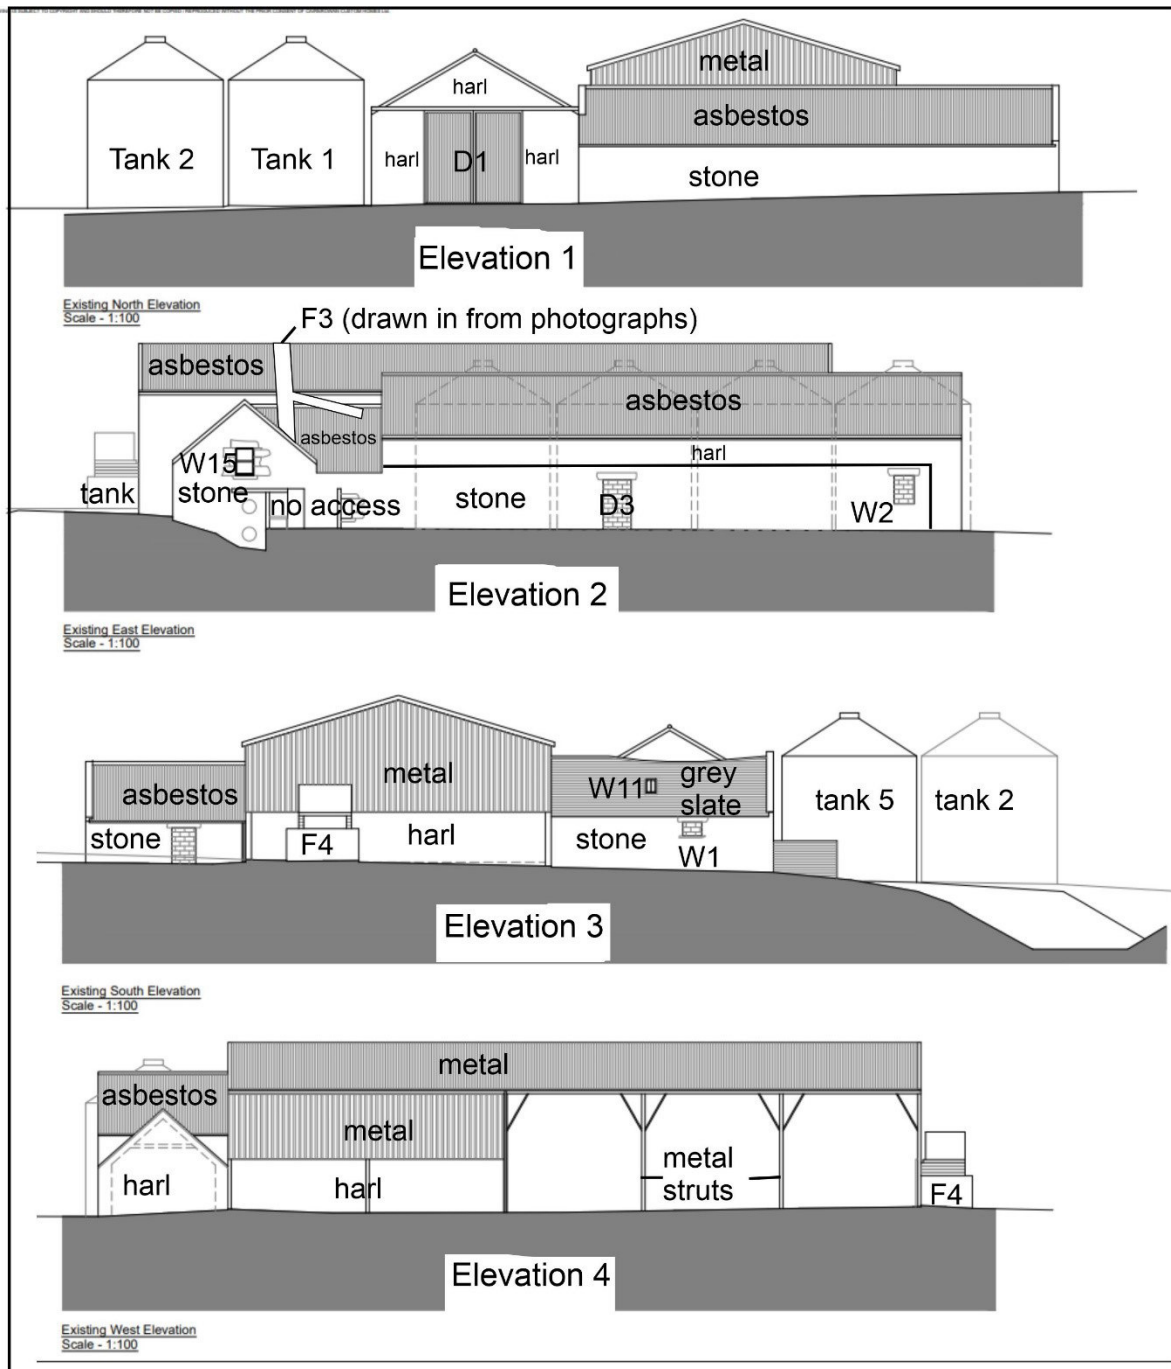
Illus 8 Building 2 elevations annotated with numbers used in this survey (copyright Cairnrowan Custom Homes Ltd)

In Phase 1 is a single storey stone N range (Rooms 1 and the N end Room 2; Illus 9, 10); later this room was lined with concrete and has been in use to store grain. In this phase Rooms 4 (Illus 11-12) and 5 survived as a separate two-storey stone building. Room 4 has a blocked window on the S wall (W1) and there is a first floor window on the E gable (W15). There may be a door on the E gable but this area is inaccessible because there is a collapsing shed on this gable and there is no access to the interior of the building. This appears to have been in use as a mill and there is a chute (F3; Illus 8, 11, 12) hanging off the roof. D2 on the S wall of Room 1 may be an original Phase 1 door.

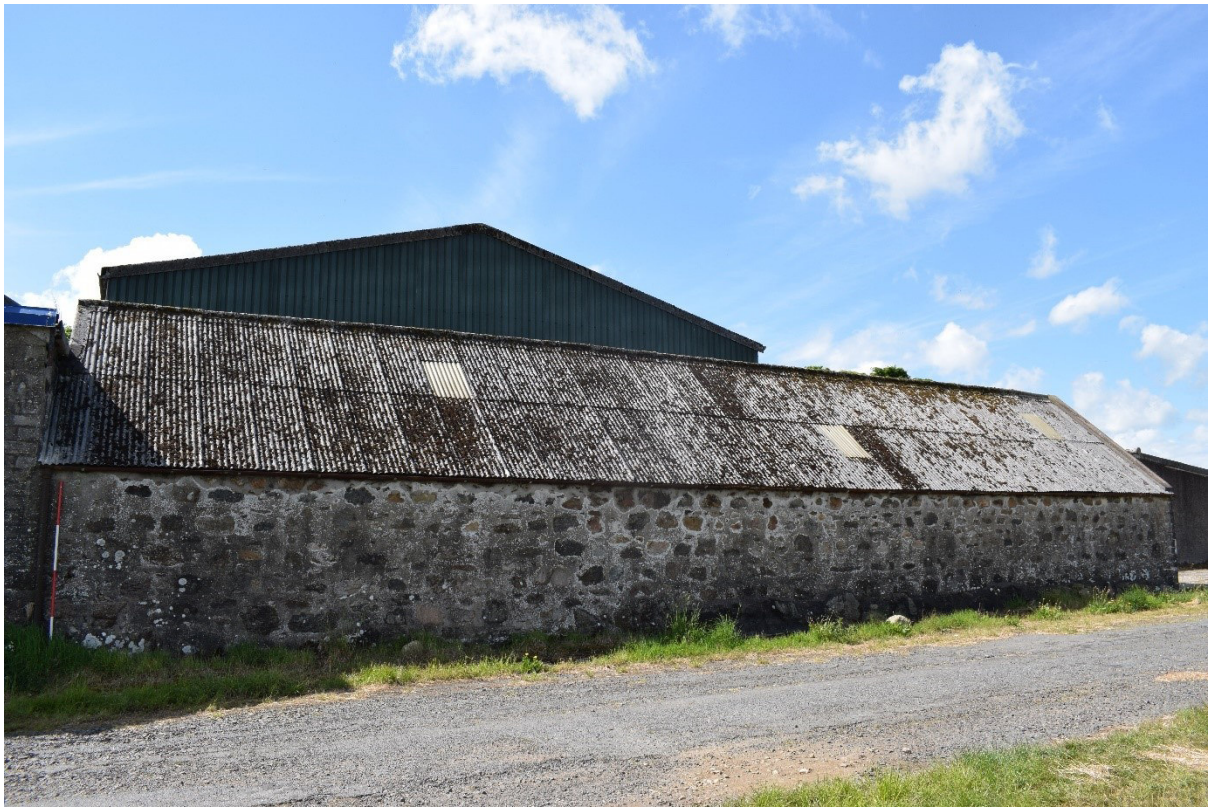
Illus 9 N wall Room 1; facing S

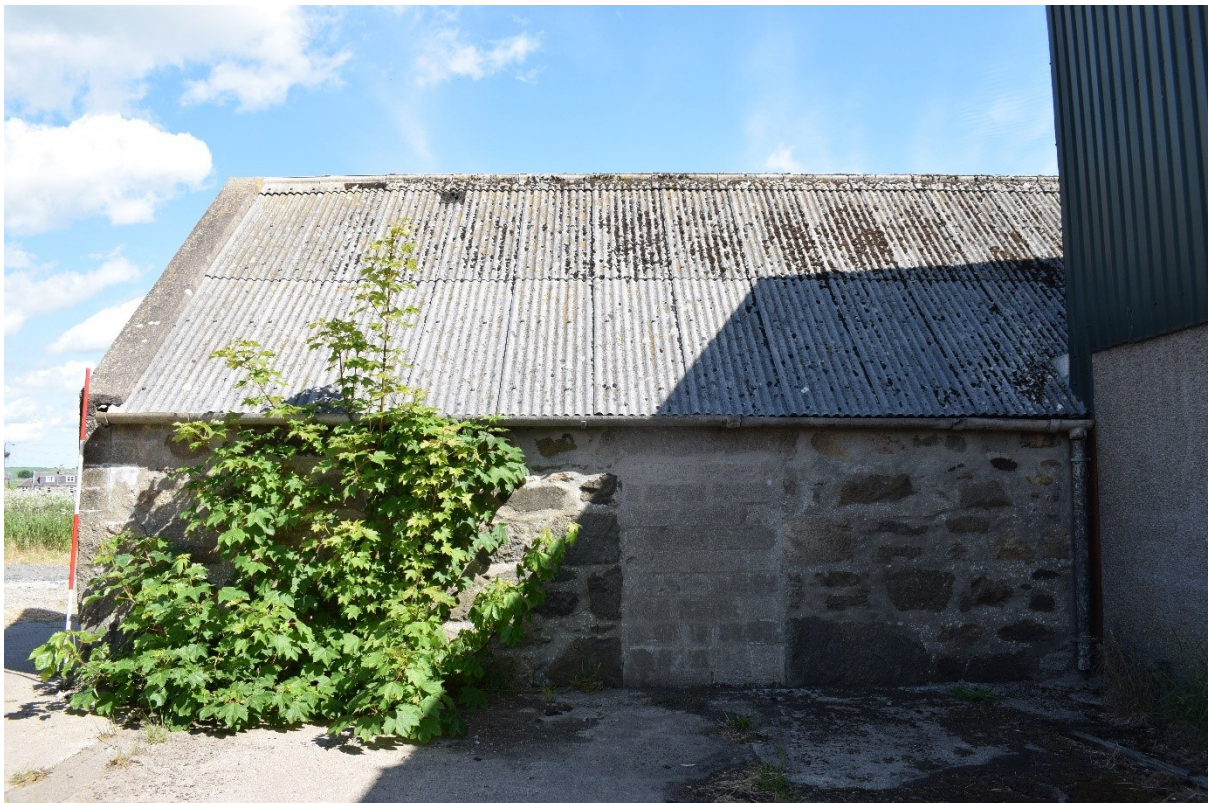
Illus 10 S wall Room 10 with blocked D2; facing N

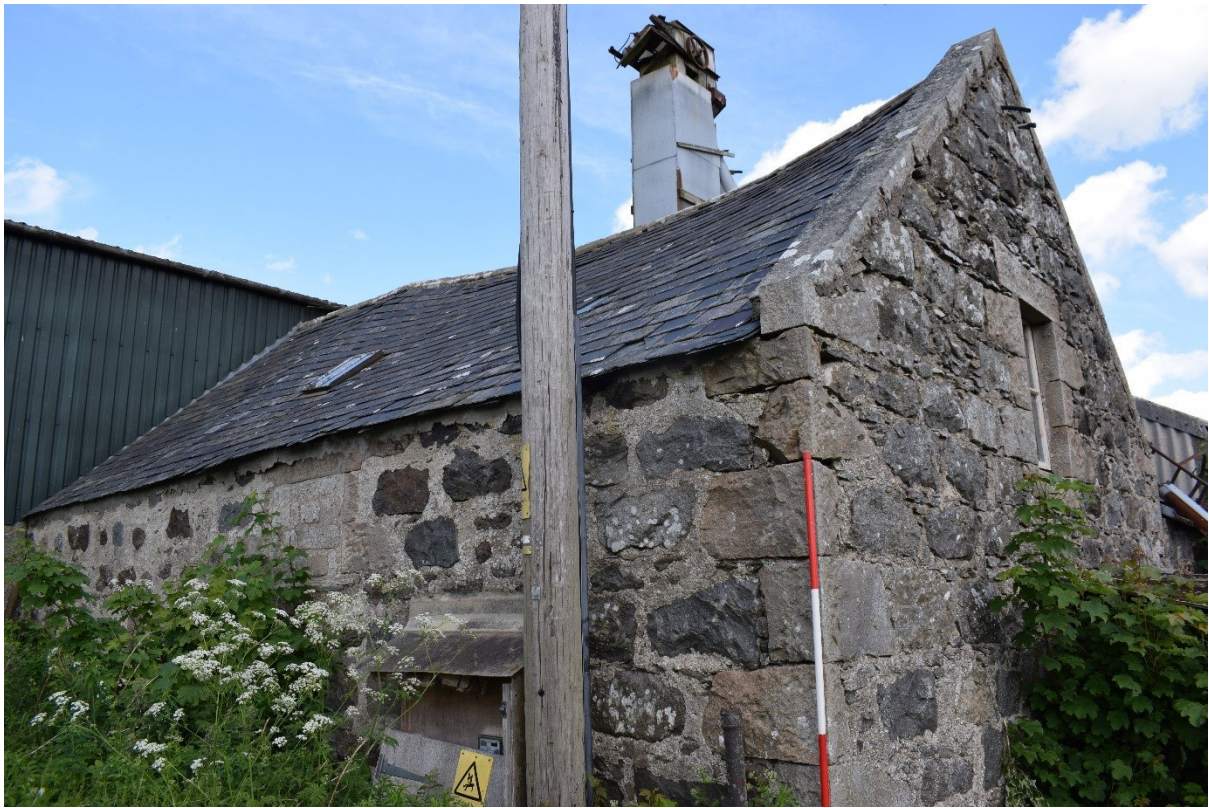
Illus 11 Rooms 4 and 5 with blocked W1 (left), W15 (right) and chute F3 (top centre); facing NW

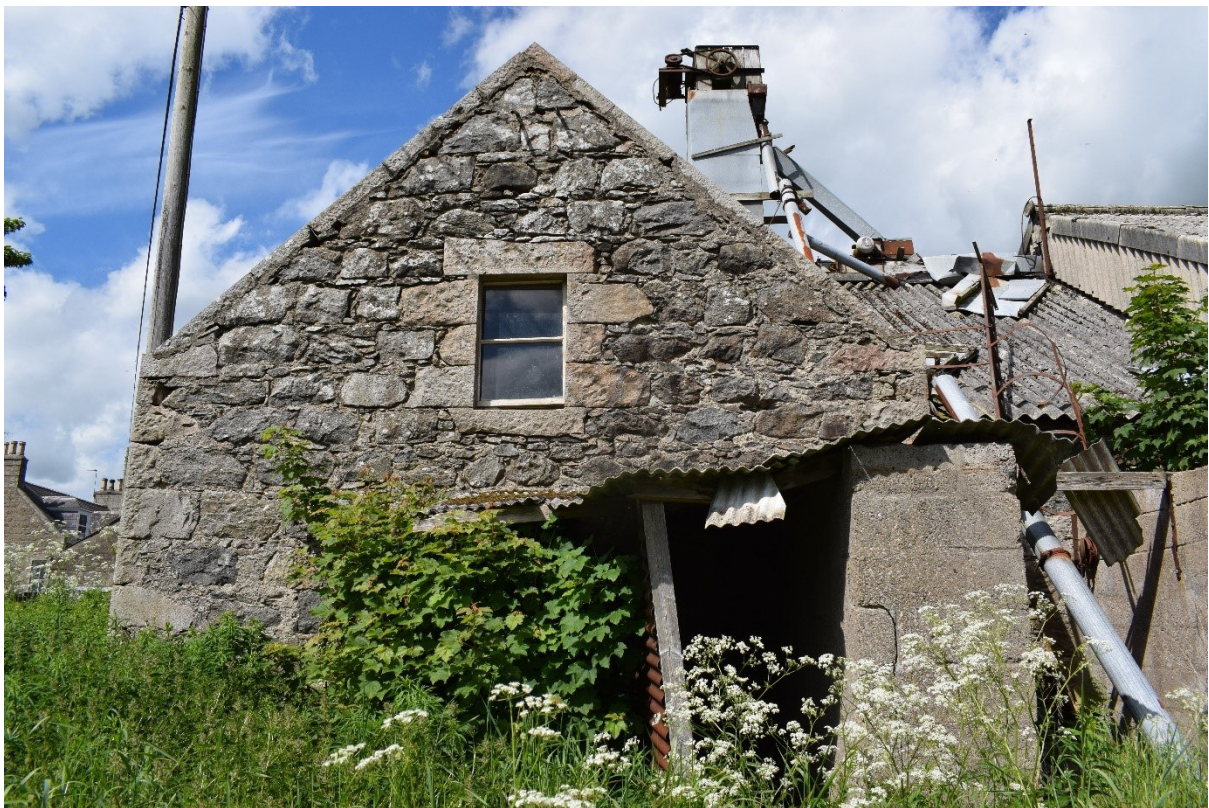
Illus 12 Room 4 E gable with W15 (top) and chute F3 (top right), overgrown and with unstable extension allowing little access; facing W

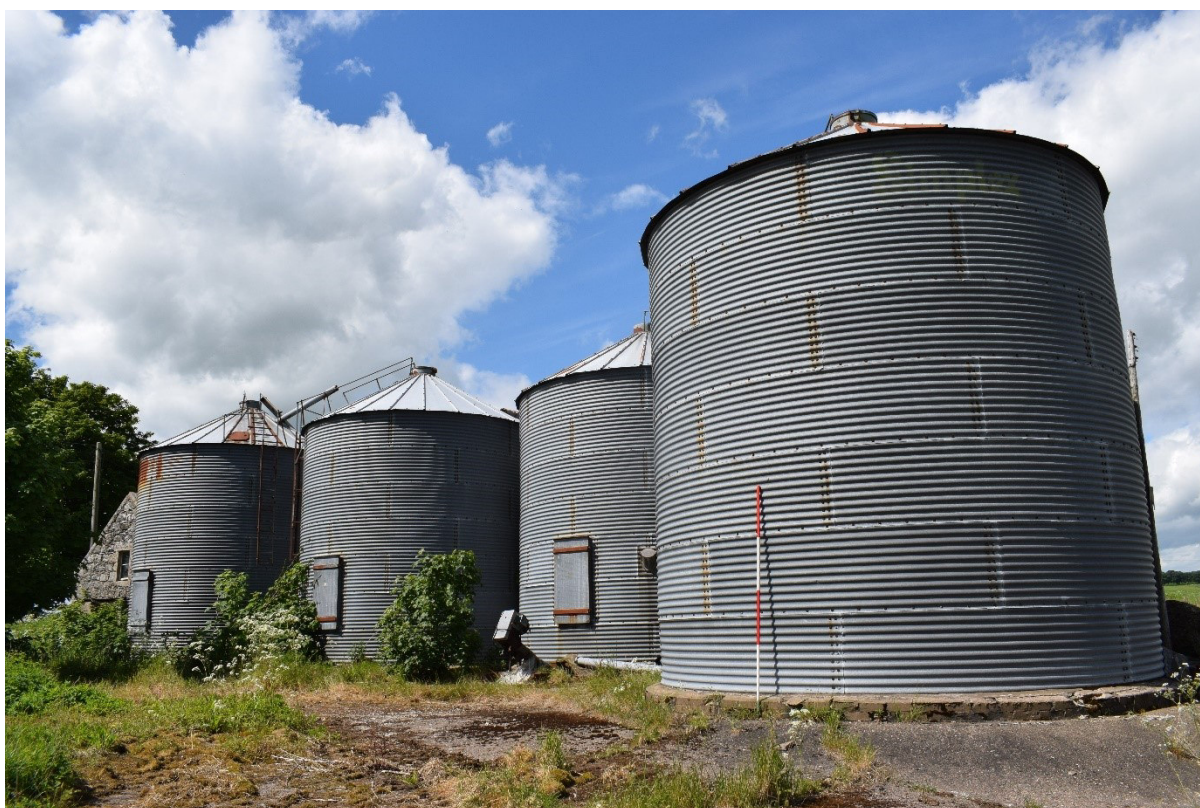
In a later phase five tanks (Illus 13) were added to the exterior E side of Building 2 and in Phase 6 a Dutch barn (Room 6) was added to the W side of the building within the former courtyard. These had been used to store grain from the Little Mill of Esslemont. D1 in the N wall of Room 2 was increased in size with concrete blocks during a later phase of the building.

Illus 13 Tanks 2, 3, 4, 5 (l-r); facing SW

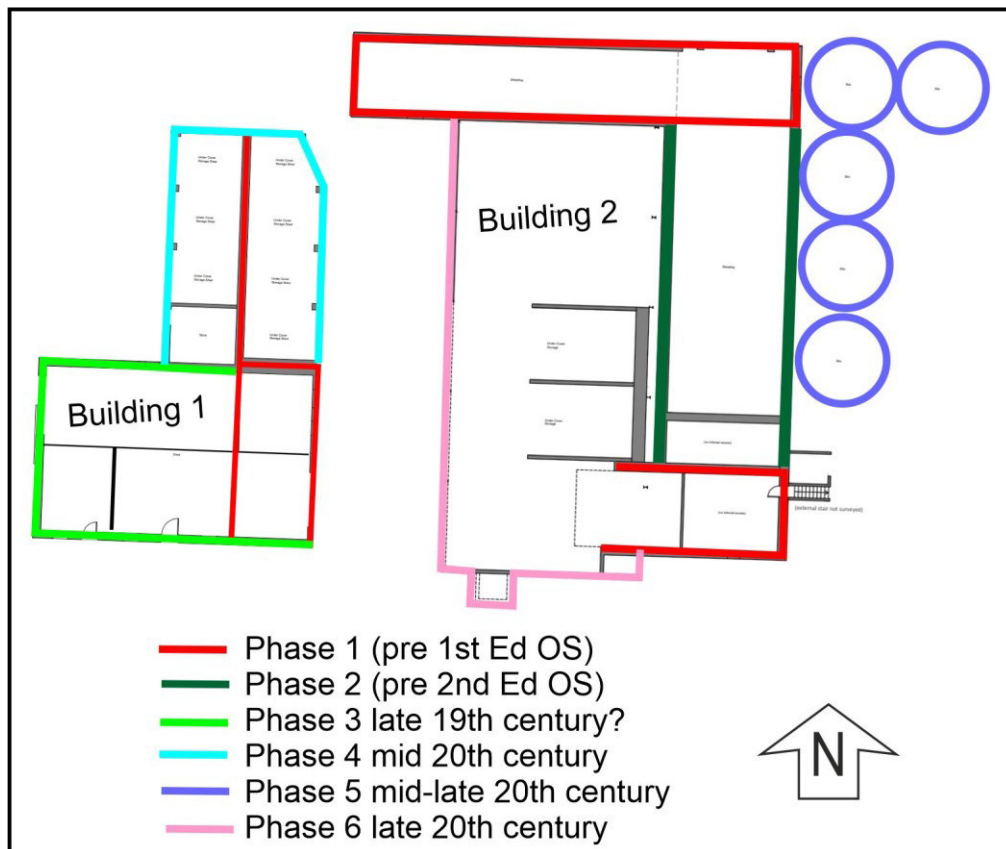
A Level 1 standing building survey was carried out on 17 June 2021; the weather was warm and sunny. Six main phases of development of the building were recorded. Prior to the 1st Edition OS the buildings consisted of an L-shaped range in the N and W and a stand alone building in the SE; parts of all these buildings survive (although some are inaccessible) and in Phase 2 (prior to the 2nd Edition OS) a U-shaped range with opening into courtyard at the S was created using the existing buildings. In Phase 3, probably in the late 19th century a bothy and workshop were added in stone in the SW and in the mid 20th century a concrete structure was built in the NW using one of the walls of the Phase 1 W range; at this time the W end of the N range was demolished to allow access into the courtyard from the N. Later tanks were built to the E and a Dutch barn added into the E side of the courtyard.

Illus 14 Phase plan (from copyright Cairnrowan Custom Homes Ltd)

It is recommended that no further archaeological work is required during the current planning application.

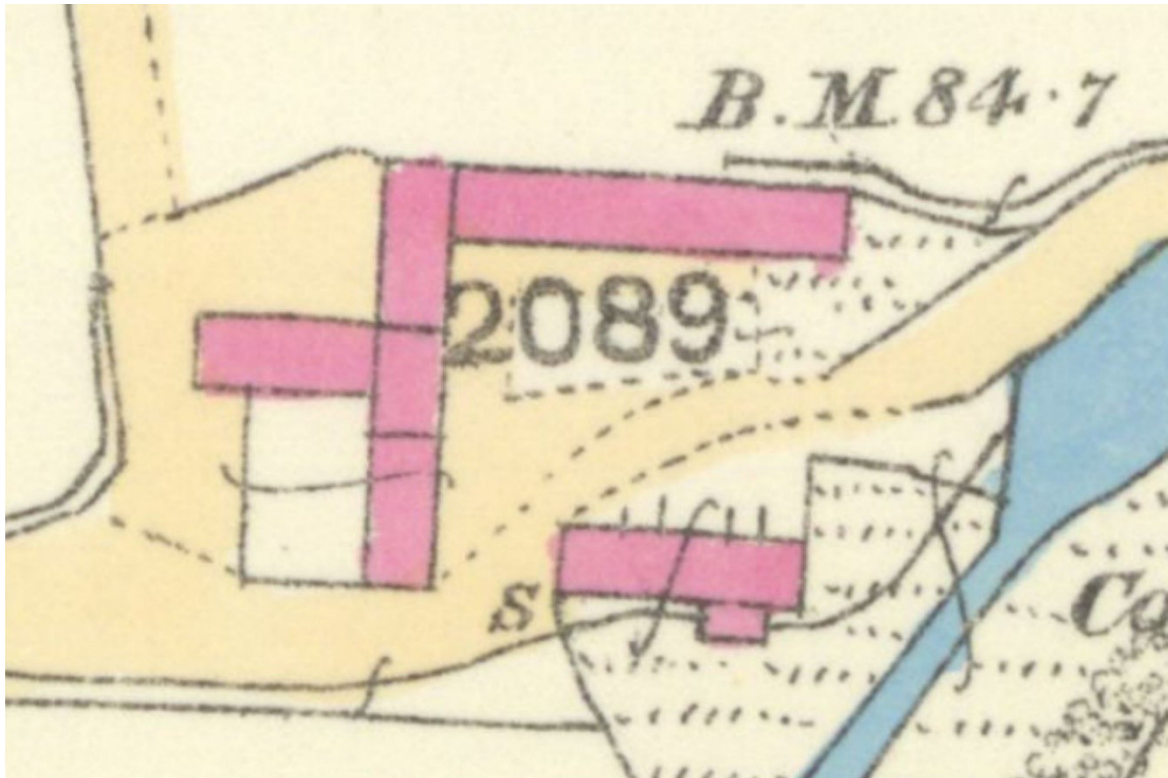
In Phases 1 and 2 the building was a linear range (1st Edition OS Illus 15) which survives as the central wall of the piggery (E wall Rooms 8 and 9, W wall Room 7) and the E and W walls of Room 13. The interior of Room 13 was not accessible and so the interior walls could also date to the earliest phase of this structure. The original apertures from either Phase 1 or 2 are D4 and W3 on the E wall of Room 13 (Illus 5); they have pink granite mouldings and have both been blocked with concrete blocks in a later phase. All the roofs of this section of the building have been replaced with asbestos cement roofing material. An extension seen on the 1st Edition OS map (Illus 15) and courtyard survived into Phase 2 as unroofed structures but is no longer extant.

Illus 15 First Edition Ordnance Survey map (copyright National Library of Scotland) Aberdeenshire XLVII.2 (with extension XLVII.1) (Ellon) Survey date: 1868 Publication date: 1869

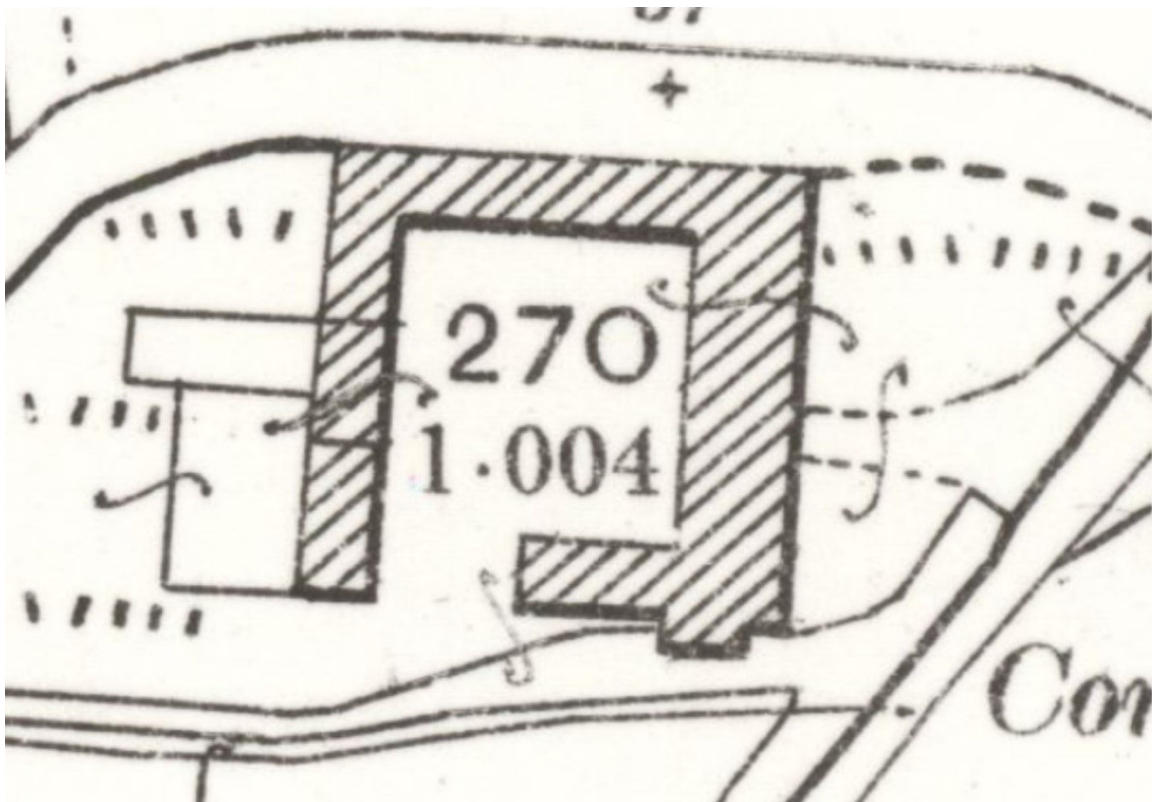
This steading is included in Little Mill of Esslemont (HER NJ92NW0019) which is a mill and steading, still in use, with the B-listed mill built in the early to mid 19th century. The building is an L-shaped steading with ancillary building on the 1st Edition OS map (Illus 15), converted to a U-shaped steading open on the S side by the 2nd Edition OS map (Illus 16).

Illus 16 Second Edition Ordnance Survey map (copyright National Library of Scotland) Aberdeenshire XLVII.2 (Ellon; Udney) Revised: 1899, Publication date: 1900
