**Strichen Town Hall, Strichen, AB43 6SS
Report on Level 1 Standing Building Survey
Aberdeenshire Planning and Listed Building consent
APP/2018/0495 and APP/2018/0494**

Alison Cameron
Cameron Archaeology
12 February 2022

A Level 1 standing building survey was carried out on 8 February 2022. The early 19th-century Town Hall was designed by John Smith with alterations in the late 19th and 20th centuries including blocking windows and covering and damaging plaster ceilings in the mid 20th century. There is a square tower with spiral stairs to first and second floor levels and a wood panelled room on the second floor with substantial graffiti from the early 20th century to the present day. All aspects of the building were recorded and it is recommended that no further archaeological work is required during the current planning application.

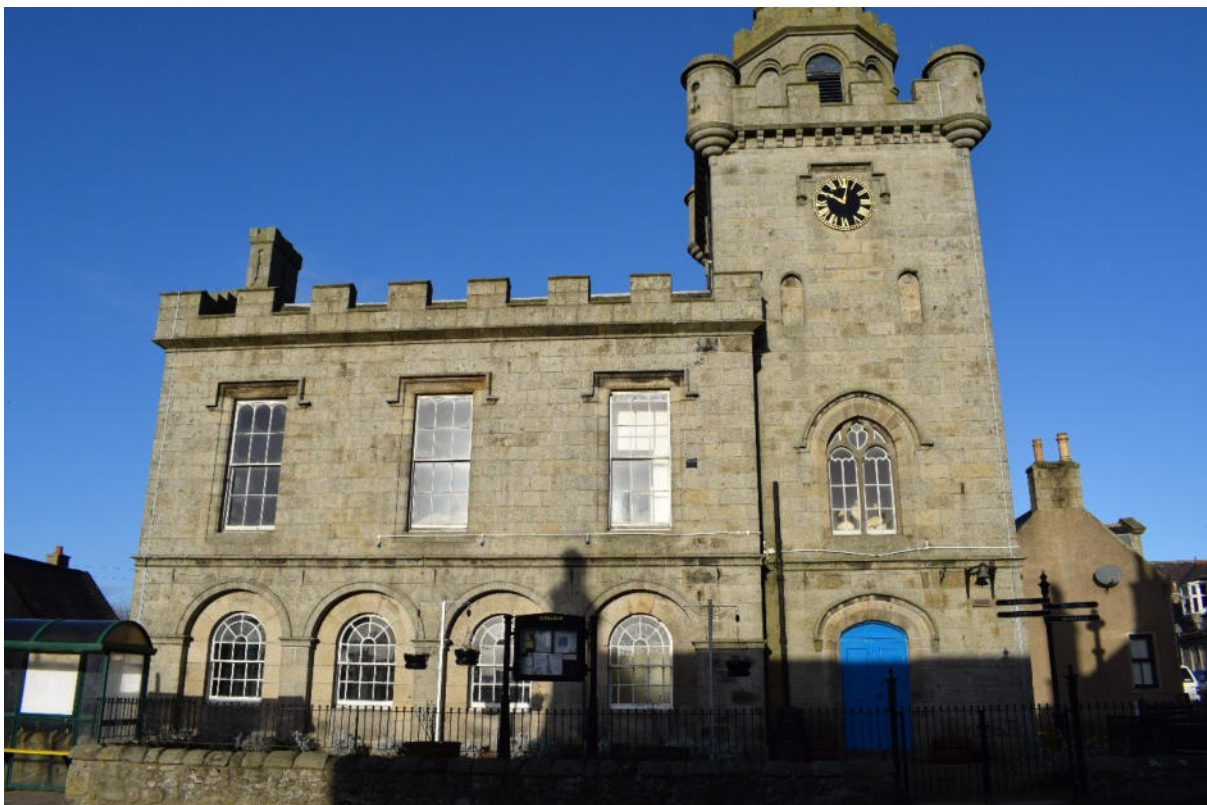
Illus 6 SE elevation; facing NW

The hall section of the building has a ground floor with hall (Room 1) with large windows on the SE wall (W5, W6, W7; Illus 6, 21), windows on the NW wall W13 and W14 and a blocked window on the SW wall W25. D4 is a later addition as is the kitchen area in the E corner of the room. Room 2 is an entrance hallway with alcove F14, arched door D8 to the tower stairs (Illus 18) and Room 3 a wood paneled bathroom with W8 on SE wall. There are two cast iron pillars in the centre of Room 1 (F8, F9) but their upper level is hidden by modern lowered ceiling. The first floor has hall Room 5 with windows on the SE wall W1, W2 and W3; there are modern partitions at the NE end of the room. The plaster has been stripped off the NW wall revealing recesses F5 (Illus 16) and F6, 0.92m wide, 2.4m high and 0.41m deep. The Phase 1 blocked windows W10, W11 and W12 which are visible on the exterior are not visible on the interior. There is a blocked window W26 on the SW and a Phase 3 door D5 (Illus 16) also on the SW wall with a fireplace F7 (Illus 16) between. Room 5 has a plaster ceiling which was recorded from floor level only (Illus 17). There are doors from the spiral stair into Room 5 D13 at the top of the stair and D14 on the NE wall of Room 5.

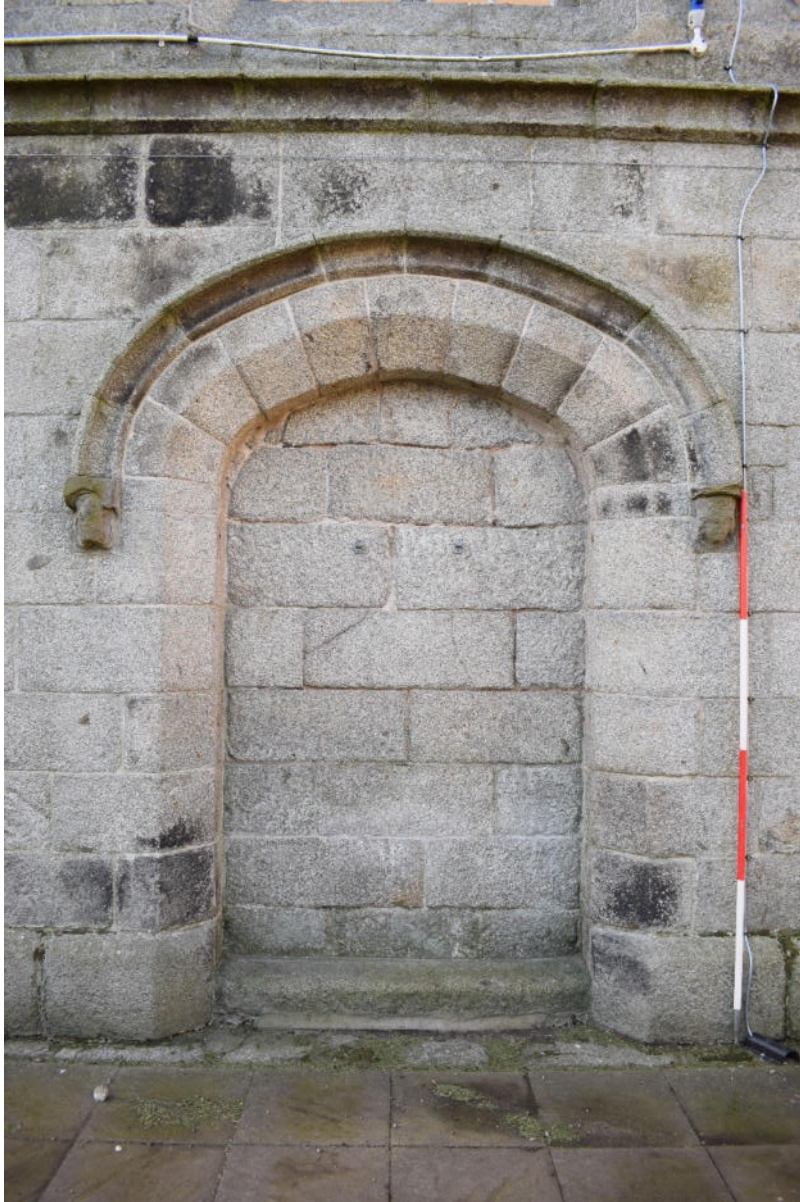
Illus 9 D1 facing SW

D1 the main access on the ground floor NE elevation was blocked with stone in Phase 2. The building converted to a female school around 1875 (HES Listed Buildings)

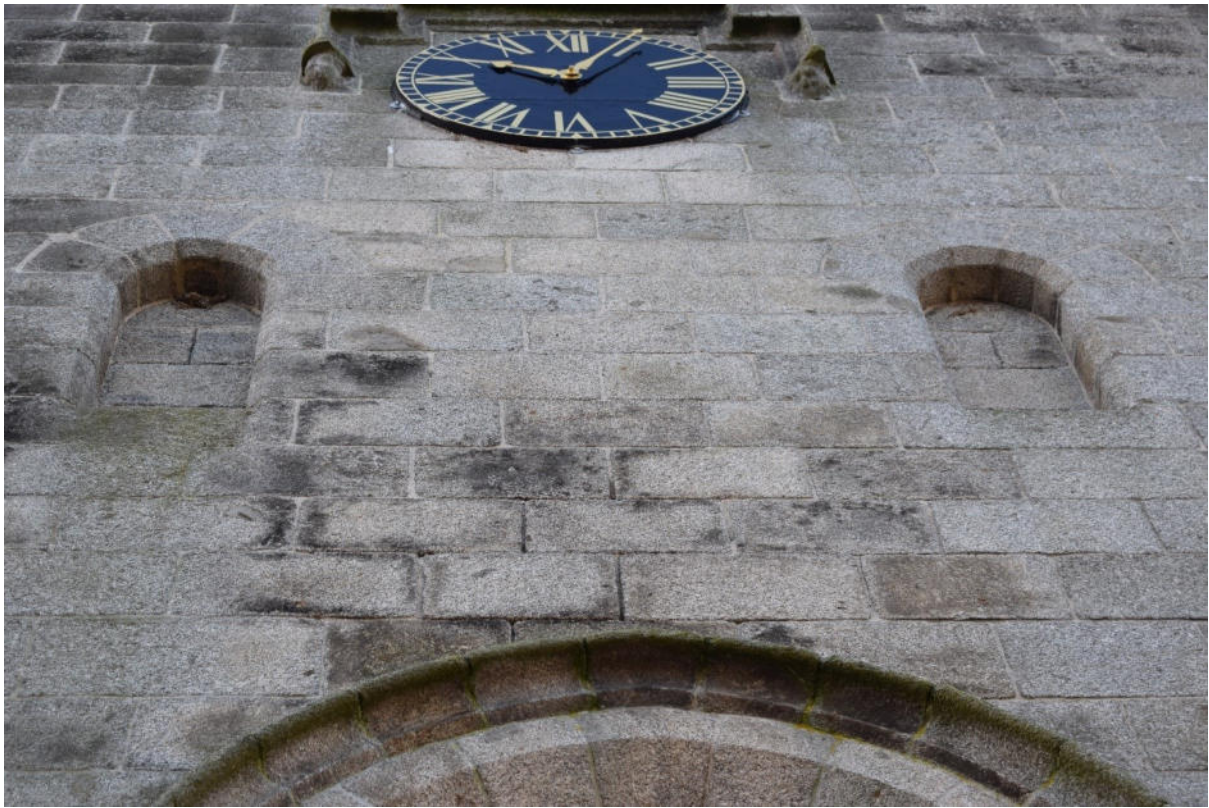
Illus 12 W15 (bottom, W21, W20 with clock F18 with hood moulding F24 with sandstone heads; facing SW

There are clock faces on each of the four facades of the tower at third floor level (F15, F16, F17, F18; Illus 12) all under hood mouldings (F24, Illus 12, F25, F26, F27) but these were only recorded from ground floor level. The belfry has a bell of 1818 by Thomas Mears. In Room 6B there is a winding mechanism (F12; Illus 30) and much of the graffiti is related to people climbing the tower to wind the clock and recording their visits on the wood paneling (F13). There are louvres on each façade of the lower spire, crenellations above with a weather vane and lightning conductor on the apex of the spire.

the tower second floor SE elevation (W22, W23) and NE elevation (W20, W21; Illus 12) all blocked in Phase 2.

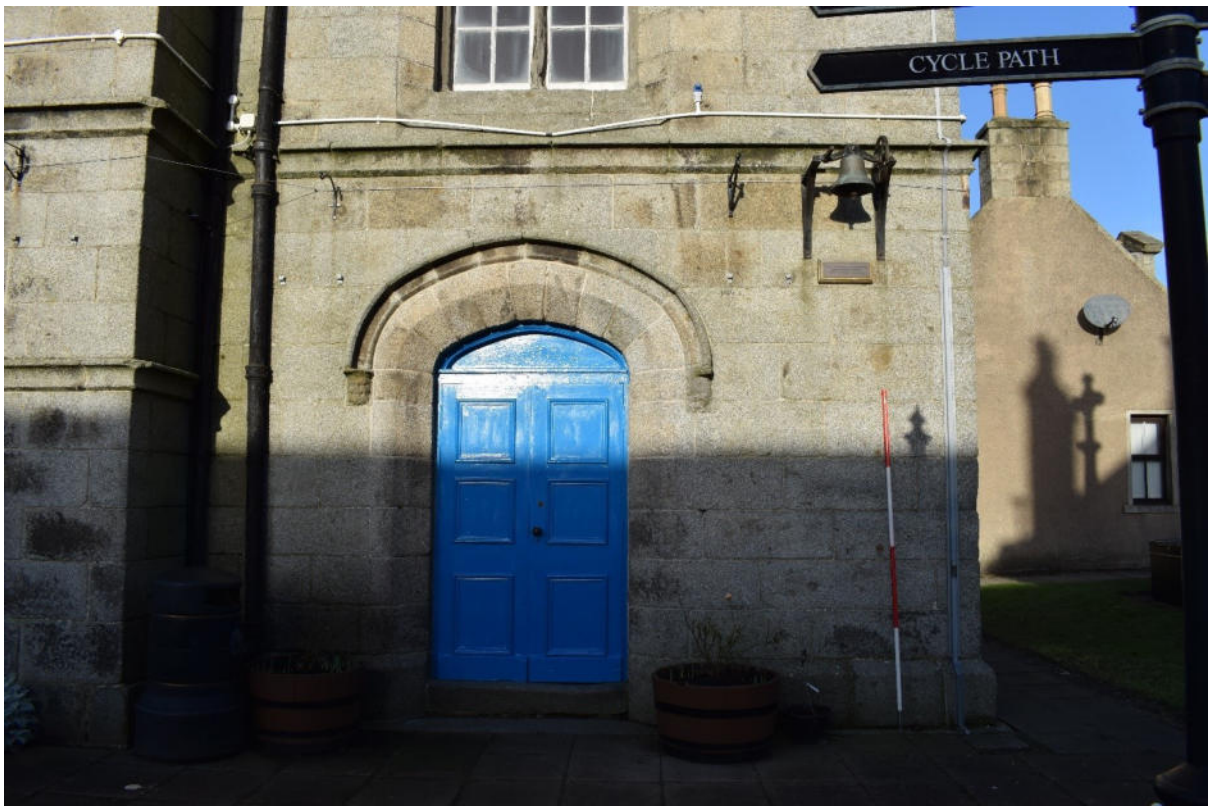
Illus 13 SE façade D3, hood moulding with sandstone heads F3 and F4 with W4 above and bell F23 (centre right); facing NW

There is a bell (F23) attached to the SE elevation which was removed from the old school on Market terrace prior to the demolition in 2003.

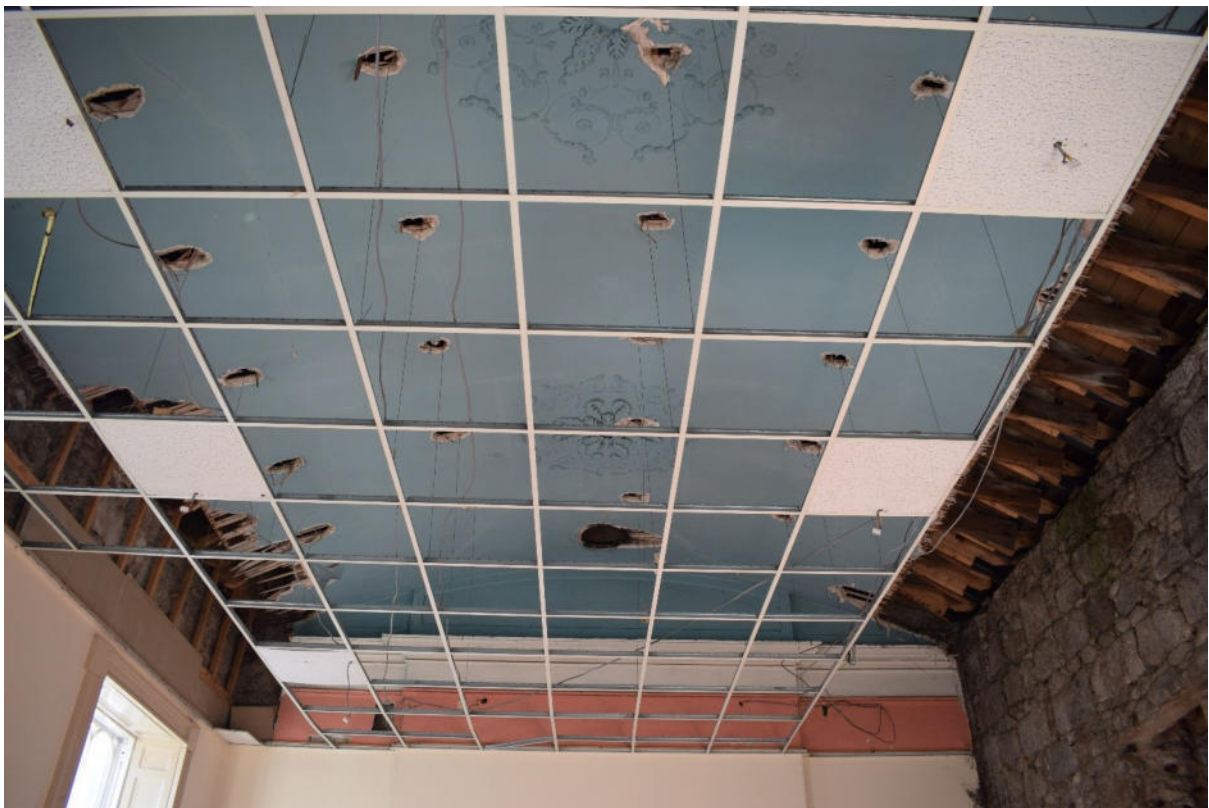
Illus 17 Room 5 plaster ceiling; facing SW

Modern partitions and ceilings were added to Rooms 1 and 3 damaging the plaster ceiling (Illus 17) in Room 5; Room 1 ceiling is tile presumably covering an earlier ceiling.

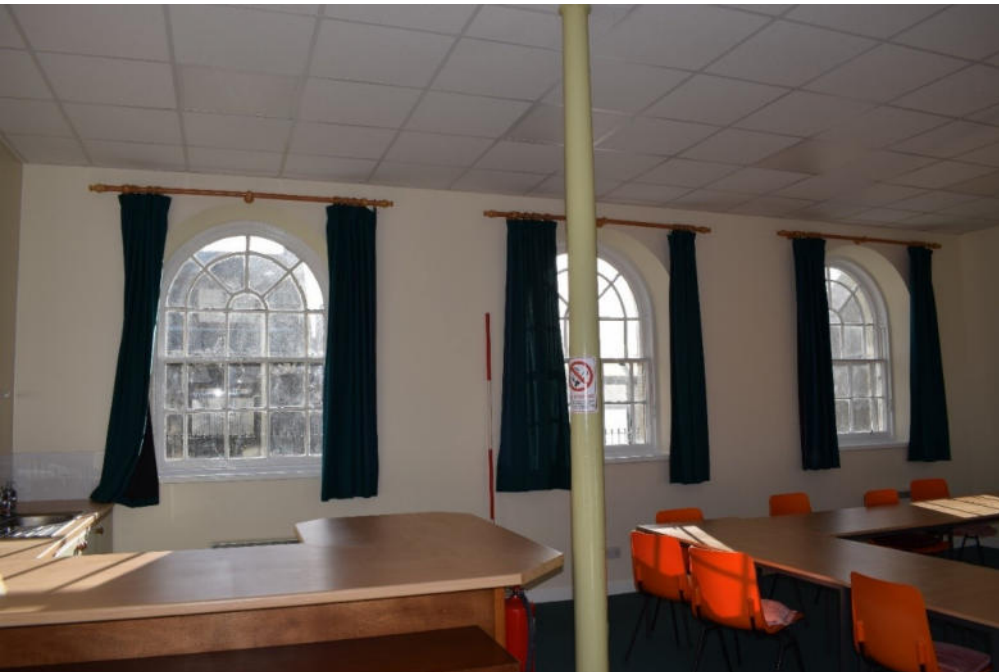
Illus 21 Room 1 SE wall W7, W6, W5; facing SE

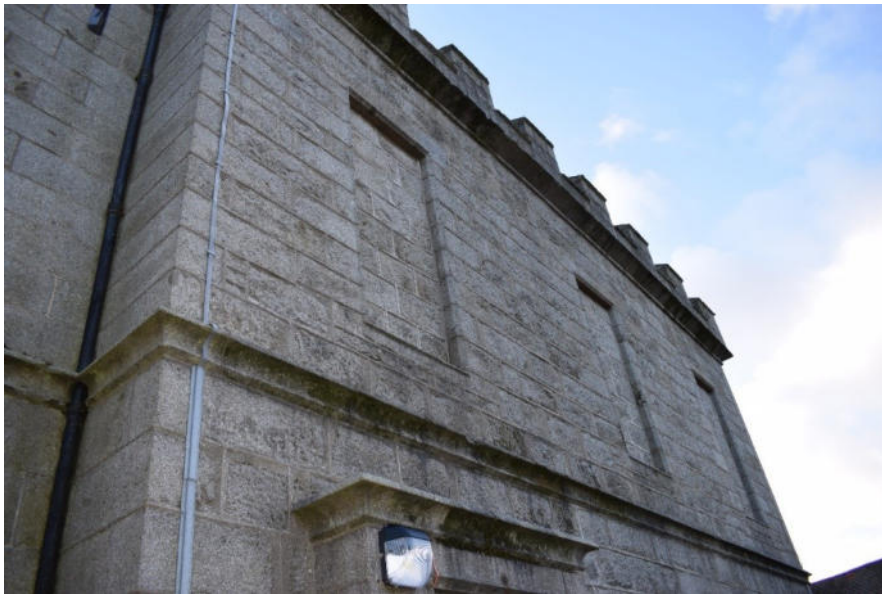
Illus 23 Blocked windows NW façade first floor W10, W11, W12; facing SSW

Windows were blocked with stone in Phase 2 including W10, W11 and W12 (Illus 23) on the NW wall of first floor Room 5; there is no trace of these within the room and later semi-circular recesses F5 and F6 (Illus 24) were added after the blocking of these windows. W17, W25 and W26 on the SW elevation were also blocked with stone; W17 was later converted to a door in Phase 3 (see below). Small arched windows on the tower second floor SE elevation (W22, W23) and NE elevation (W20, W21; Illus 12) were also blocked with stone. D3 may have been added in Phase 2 on the ground floor NW façade.

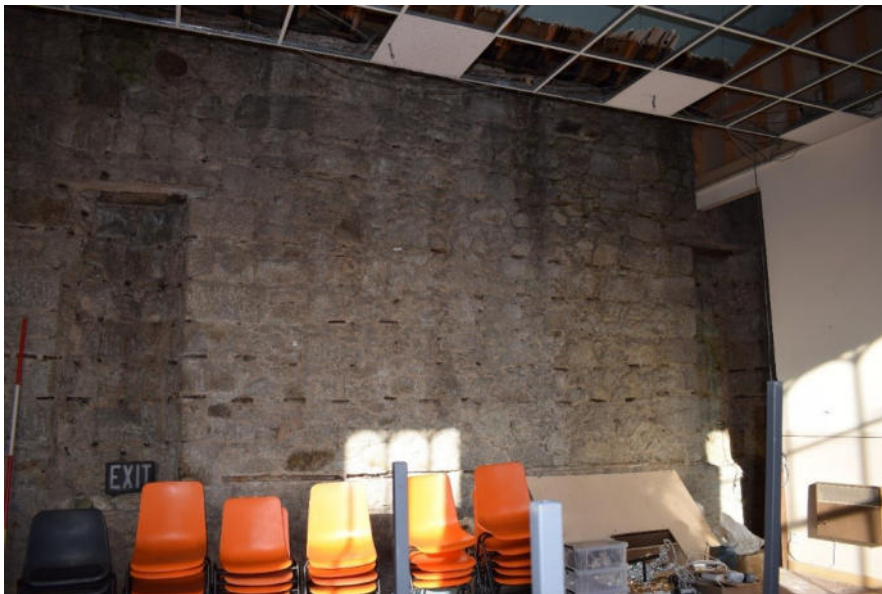
Illus 24 Room 5 NW wall F5 (left) F6 (right); facing NNW

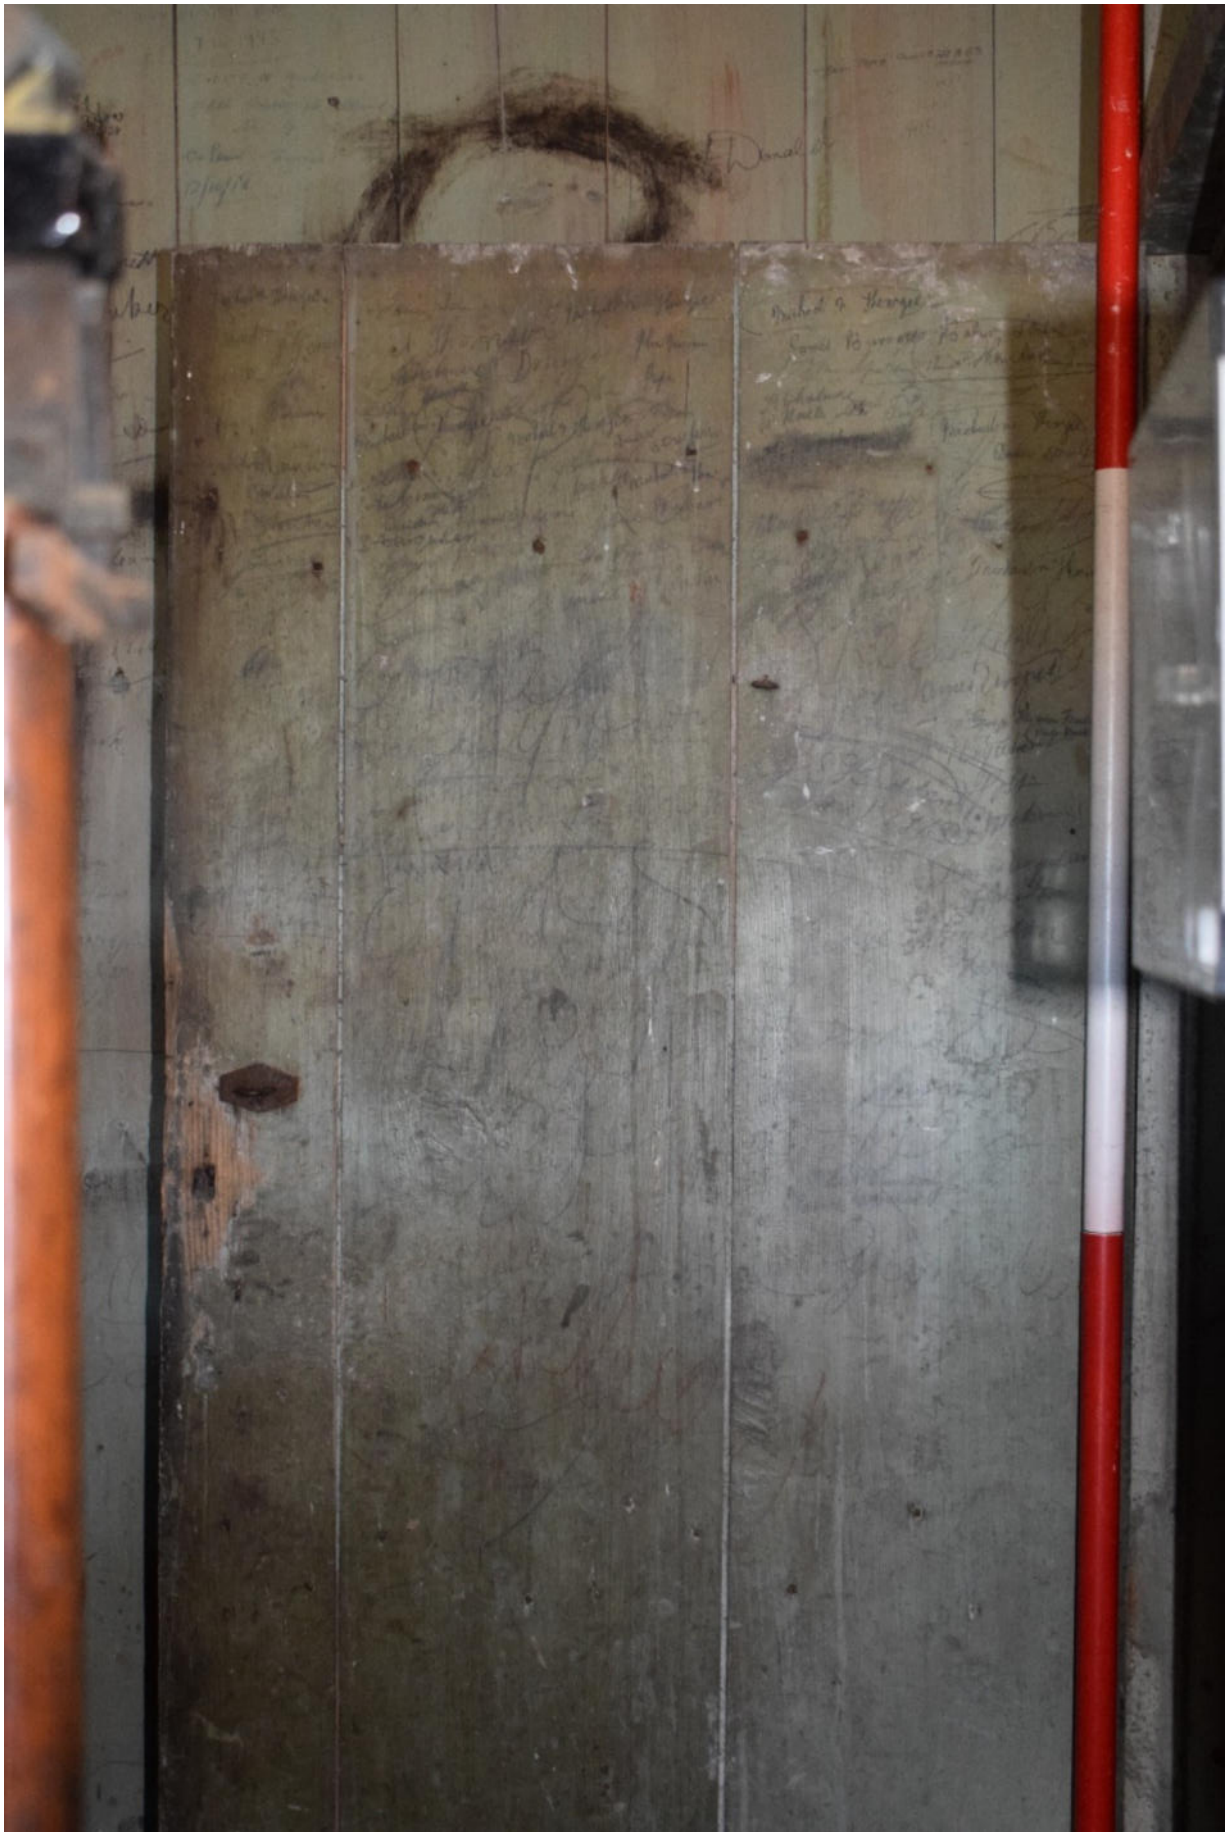
Illus 25 Outer SW facing when closed) face D11 with graffiti; facing SE

Wood paneling (F13) within Room 6B has extensive graffiti mostly in pencil (Illus 25-27) with also in other mediums. There are 29 full panels 0.16-0.18m wide and 2.33m high on the NW, NE and SE of Room 6B; there are also panels on the door D11, the paneling around W27 (Illus 28, 29) and some on the wooden SW partition wall. The wood ceiling in this room is modern and contains some recent graffiti.

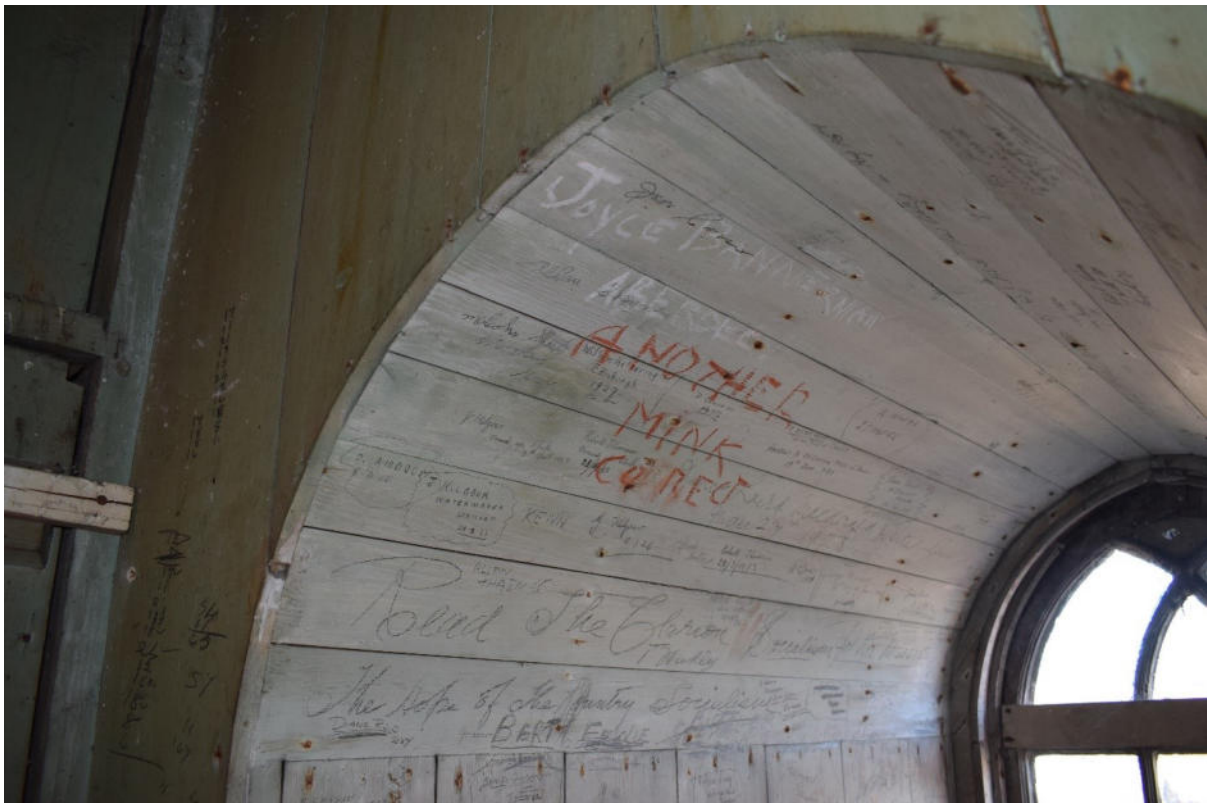
Illus 28 Graffiti on wood panels W27; facing W

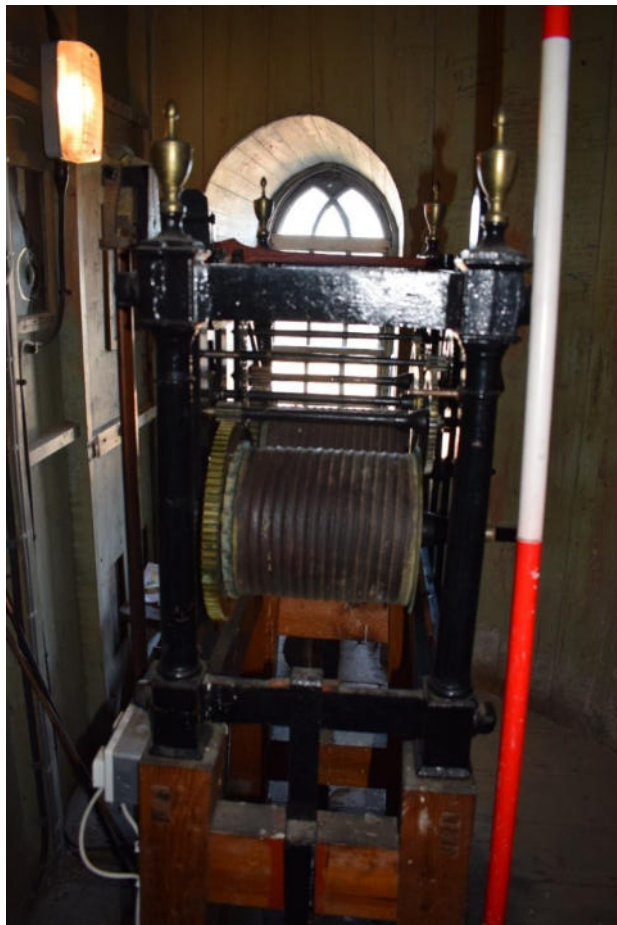
Illus 30 Mechanism for winding clock; F12; facing NW

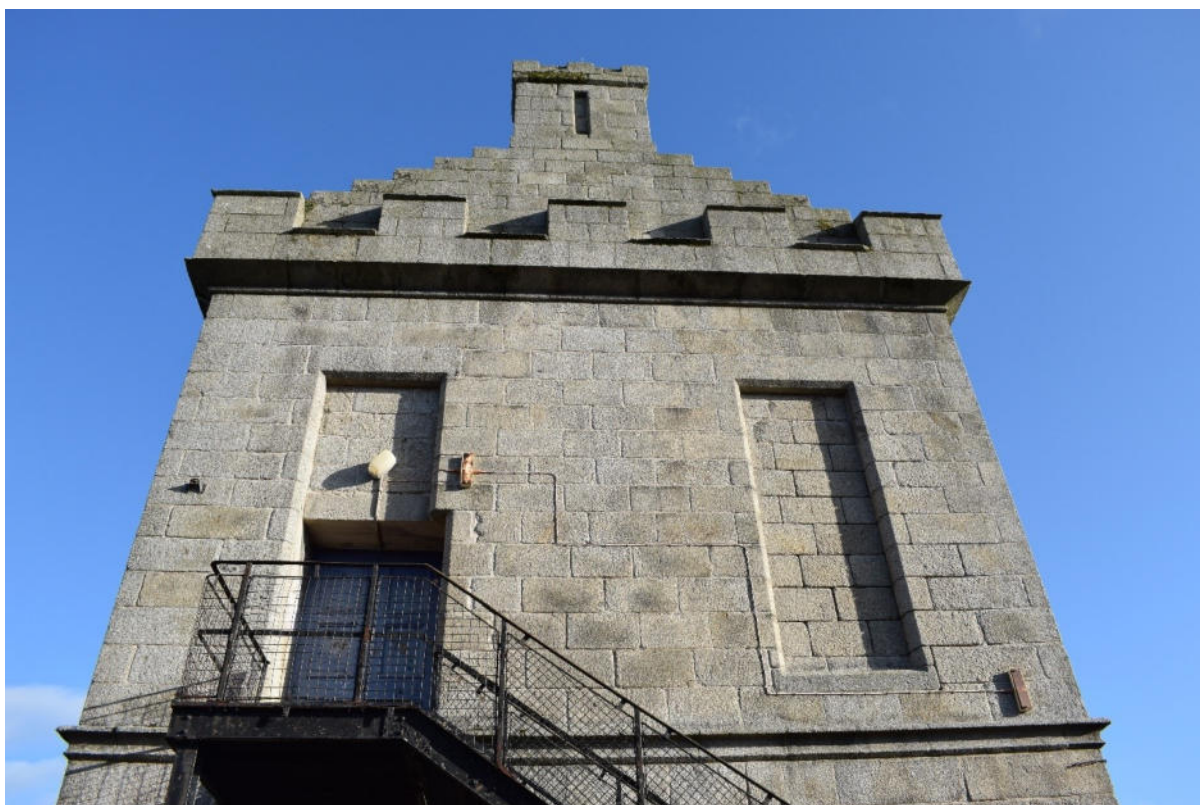
Illus 31 SW elevation showing W17 and W26 blocked with stone in Phase 2 and D5 opened in Phase 3 with iron stair F29; facing NE

In Phase 3 D5 was opened in the SW wall of Room 5 allowing access to iron stair F29 and D4 in the SW wall of Room 1 both for fire access to the exterior (Illus 31). There was presumably a Phase 1 window which was reused for D4.

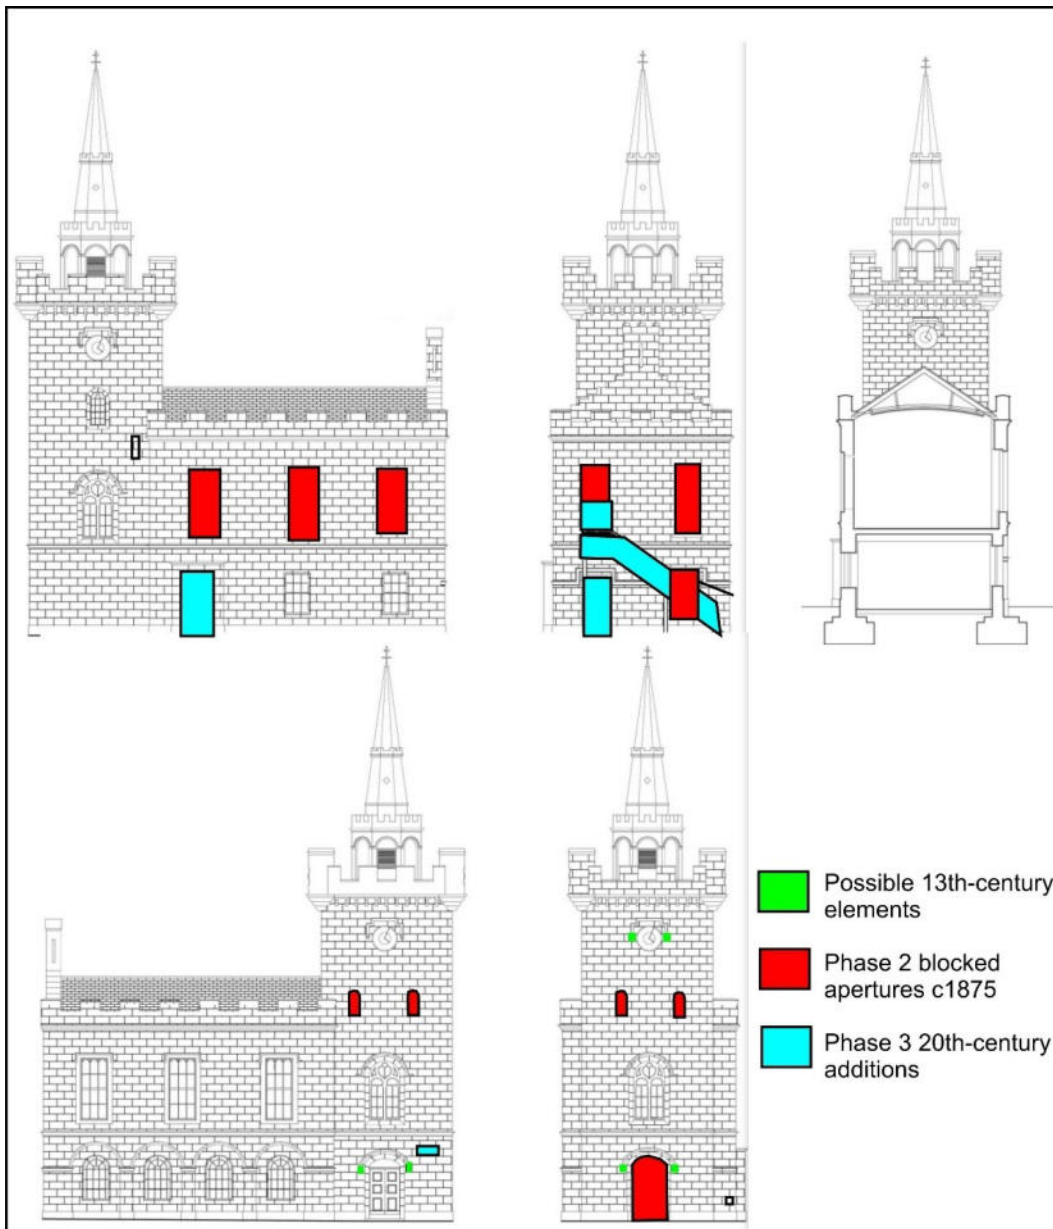
Illus 32 Elevations showing medieval stonework built into early 19th-century building and apertures blocked in Phase 2 and 3 (copyright Annie Kenyon Architects)

A Level 1 standing building survey was carried out on 8 February 2022. The early 19th-century Town Hall was designed by John Smith with alterations in the late 19th and 20th centuries including blocking windows and covering and damaging plaster ceilings in the mid 20th century (Illus 32). There is a square tower with spiral stairs to first and second floor levels and a wood paneled room on the second floor with substantial graffiti from the early 20th century to the present day. All aspects of the building were recorded and it is recommended that no further archaeological work is required during the current planning application.
