Standing building survey
Wynford, Kingswells, Aberdeen, AB15 8RQ

Cameron Archaeology
8 October 2010

Standing building survey

Wynford, Kingswells, Aberdeen, AB15 8RQ

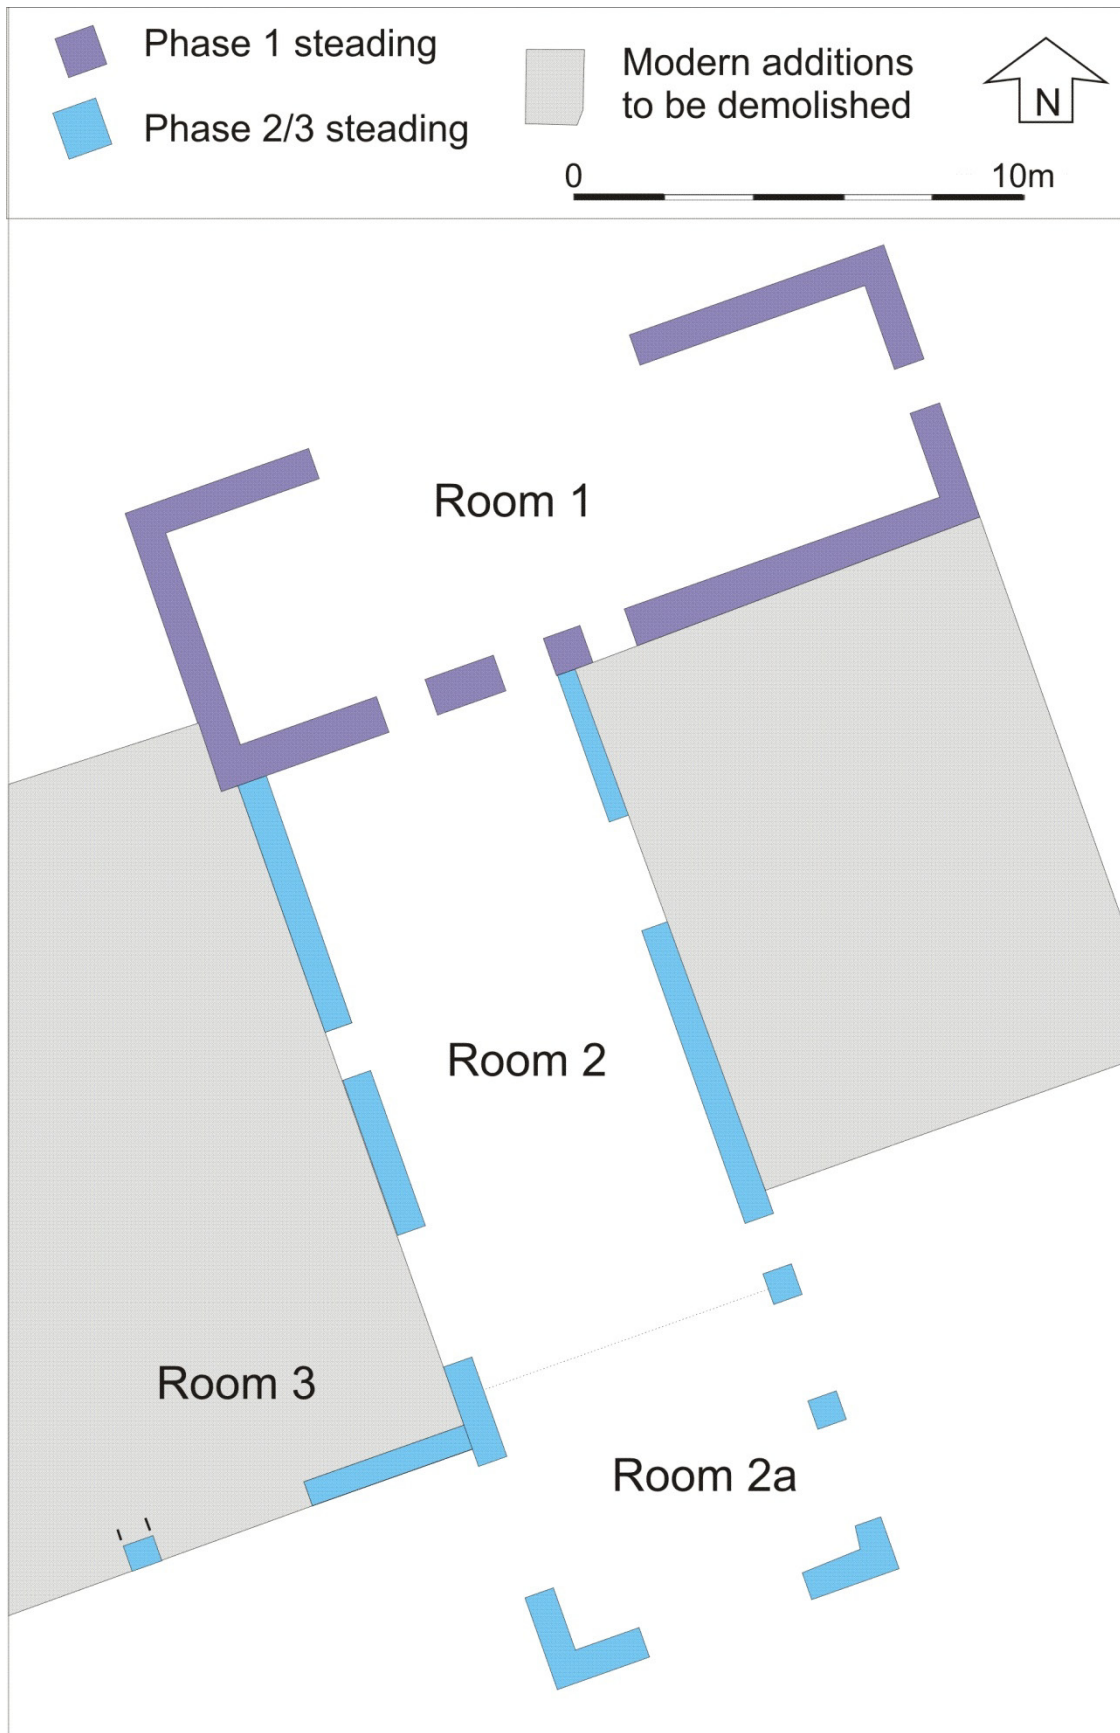
III 2 Steading phases recorded during survey

This standing building survey took place prior to the conversion of Wynford steading into a shop/cafe and playbarn (Aberdeen City Council Planning reference 090716). Three phases of steading were recorded.

Three phases of building have been recorded during this survey. The building has been heavily altered in the past and much of the original fabric has been lost.

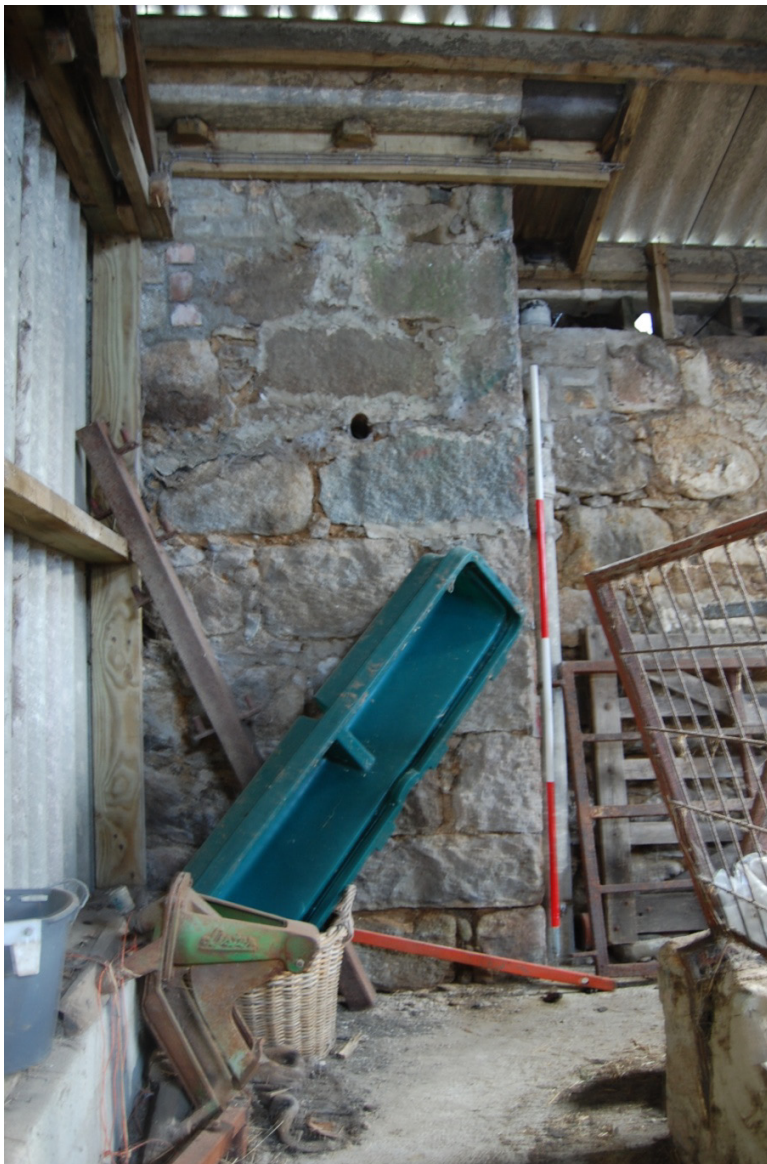
Room 1 is 16.2 x 5.1m internally and has its long axis on a SW-NE orientation. It is constructed of large granite blocks with small stone in between known locally as cherry-cocking. It is likely that this was the original building in the complex although the early edition OS maps suggest that the original buildings were aligned on a NW-SE axis.

III 3 Exterior south-west corner Room 1 (inside modern shed)

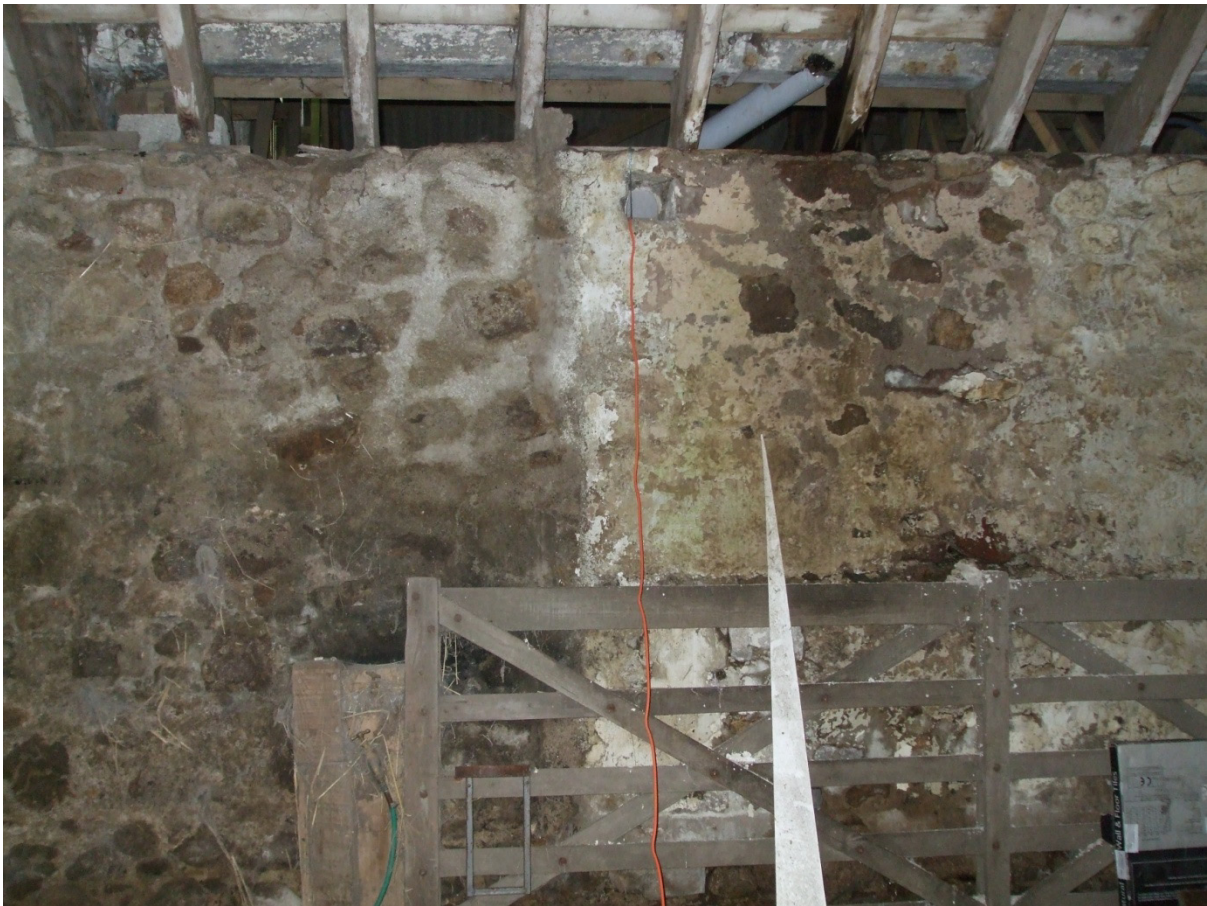
Room 2 is 20.4 x 7.4m in size and oriented on a NW-SE axis. It was probably added onto the south side of Room 1. It was divided at one time into two rooms (Ill 4). Room 2 is 12.8 x 6.8 internally and was probably originally divided from Room 2a with a stone partition but this was probably removed and later a soft partition inserted. It is also possible that Room 2a was a separate cottage and joined to Room 1 at a later date. The west and east walls of Room 2 have square holes just under the wallhead (Ill 5). Room 2a is 6.5 x 6.8m internally and has no similar holes. The current owner suggests that they were for ventilation (George Hogg pers comm). Room 2a was latterly accommodation for carts with two large doors in the east wall but may have originally been a cottage as there are two different roof lines (Ill 6)

Ill 4 Junction between Room 2 (right) and Room 2a (left)

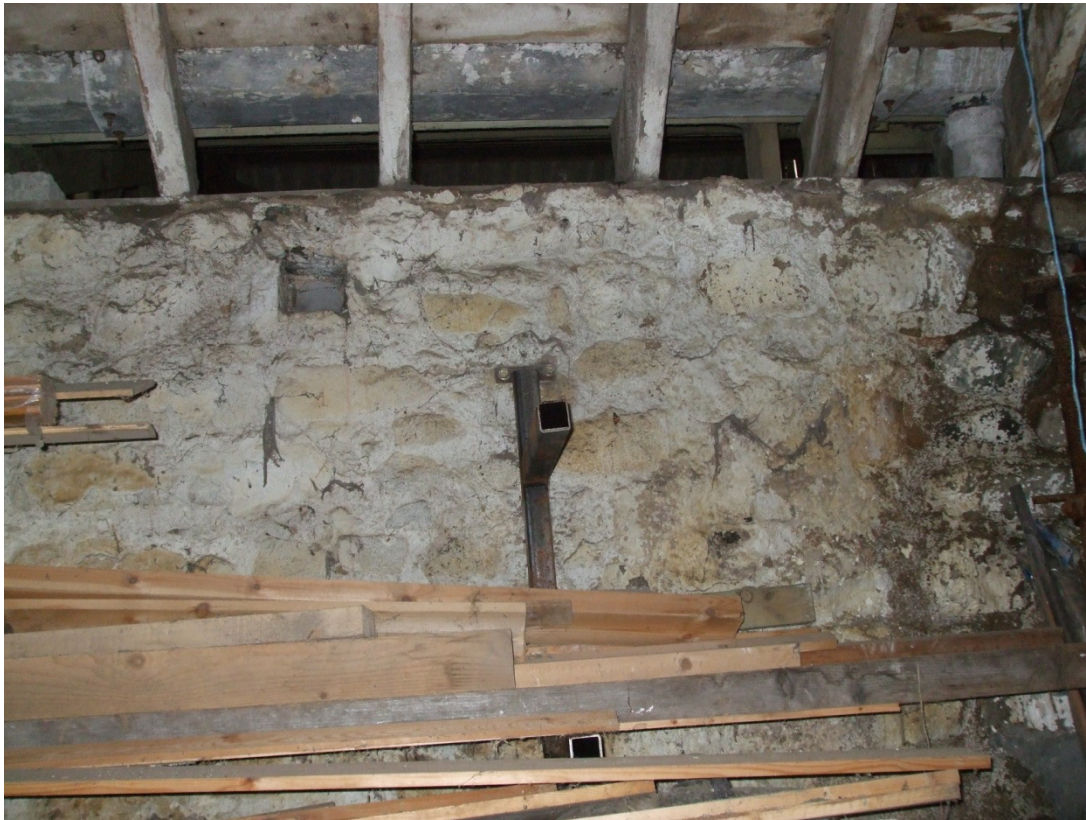
III 5 Square hole in wall west wall of Room 2

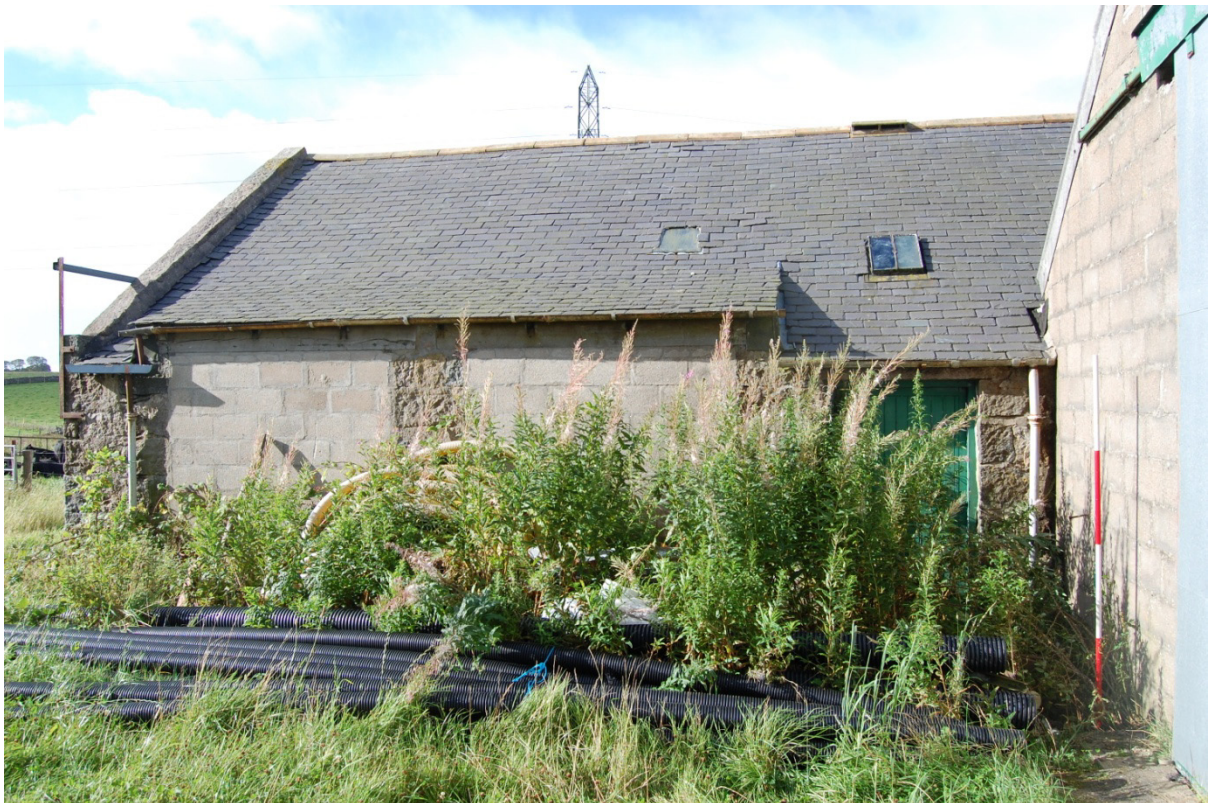
III 6 East wall Room 2a showing double doors and small 'cottage' entrance (right)

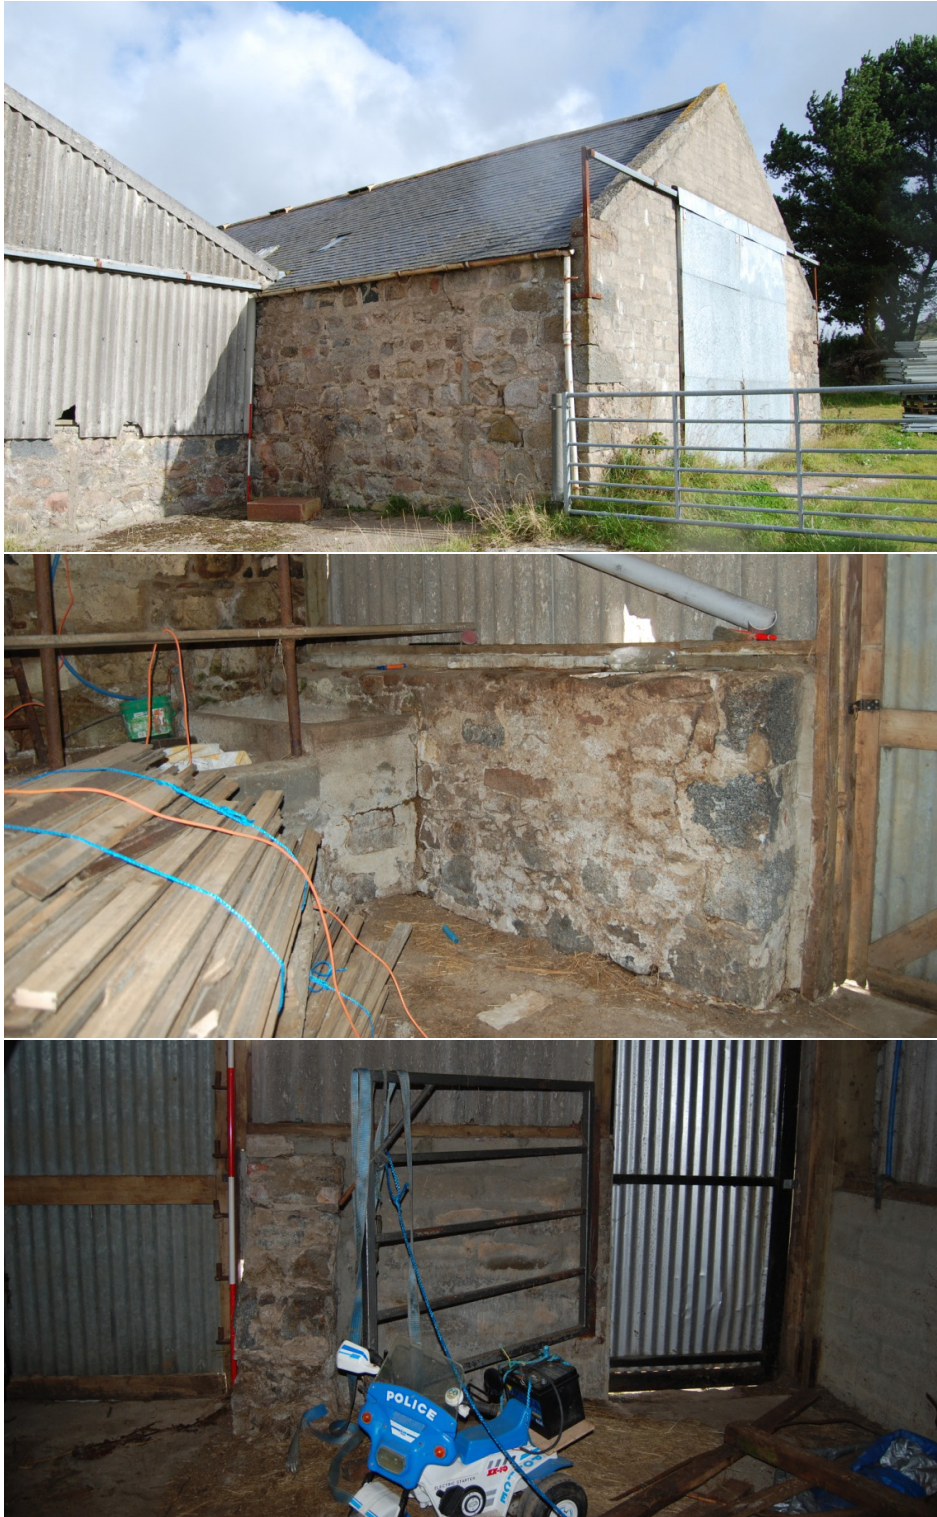
III 7 Top Junction Room 2a (left) and Room 3 (left); middle and bottom: two sections of south wall Room 3

Room 3 survives as two short lengths of wall and was at least 7.2m wide. It was not possible to determine the length of this building as modern concrete floors and modern extension had obliterated evidence of the remainder of this room. These walls were fully recorded as they are to be demolished during the current development.
