Germoe (land opposite Church Cottage), Cornwall

Archaeological recording

2011R053

Germoe – land opposite Church Cottage

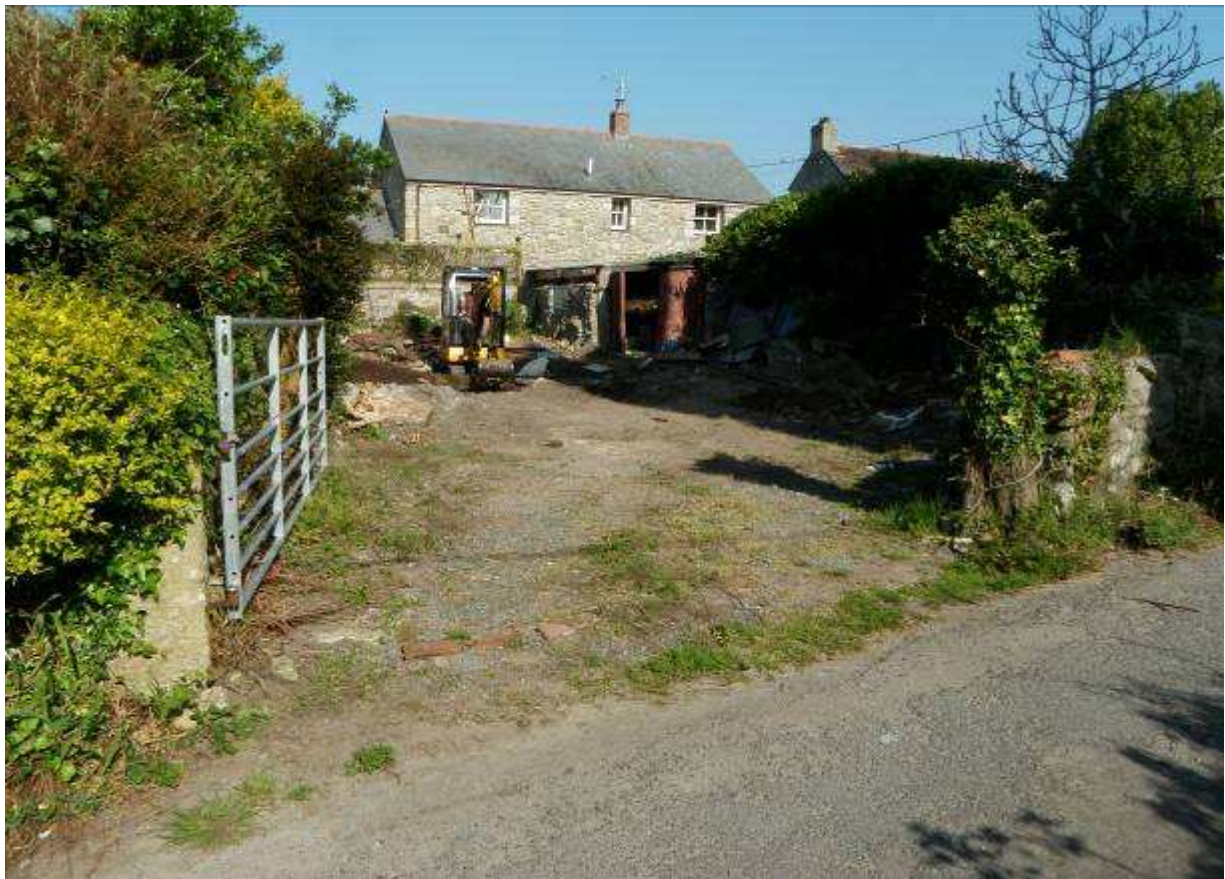
Front cover – Looking west across the length of the development site in central Germoe.

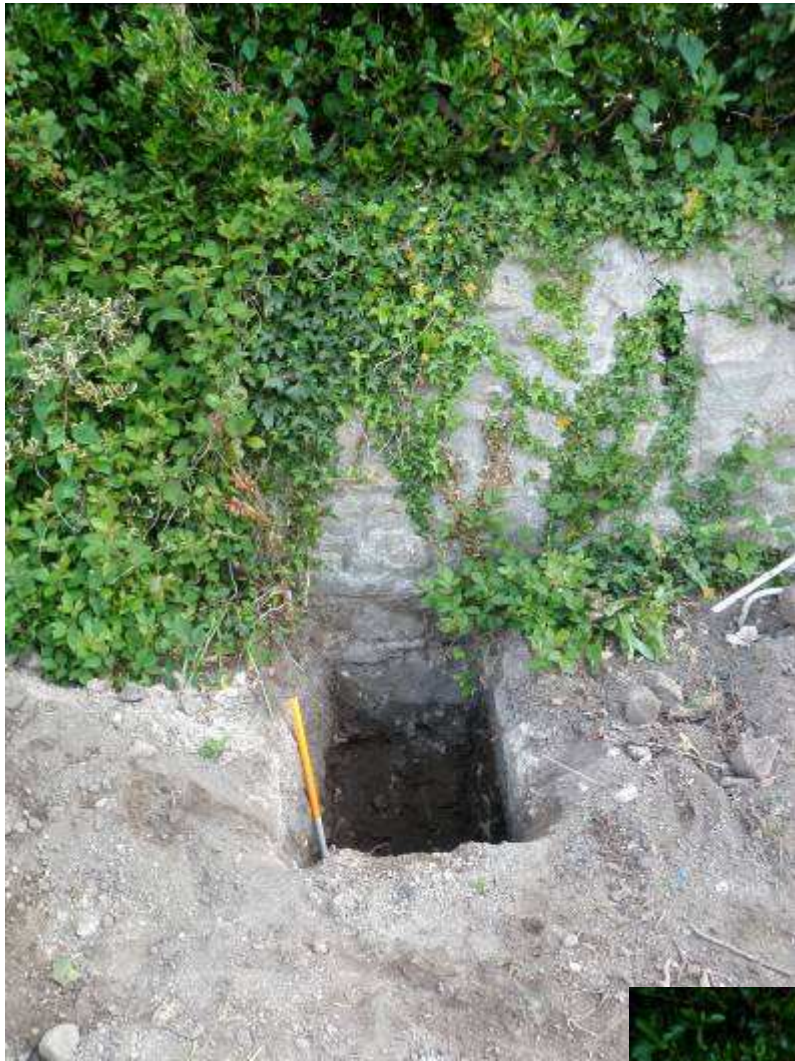
Fig 3 Photograph showing Pit A.

The wall footings are briefly described and then the layers visible in the most clear (east facing) section are described. There was nothing to suggest that the other sections differed (Fig 3).

This pit was located on the northern edge of the plot and immediately abutted the pre-1875 walling defining the northern long edge of the site. The pit measured 1m long by 0.75m wide by 1m deep. It showed the wall to be standing directly on rdb or decayed granite bedrock, which was visible below the wall at a 0.65m depth below surface level. It then dropped to a 0.9m depth as it moved south from the wall. Above the rdb was a

0.35m deep layer of dark brown stony loam, overlain by a compacted slightly gritty loam 0.2m thick; overlain by a 0.15m thick layer of rooty loose loam with occasional glass and roof slate fragments. Above this was a 0.1m thick layer of pale coloured mortar or gritty lime, topped by a 0.1m thick modern, mixed rooty spread of disturbed topsoil.

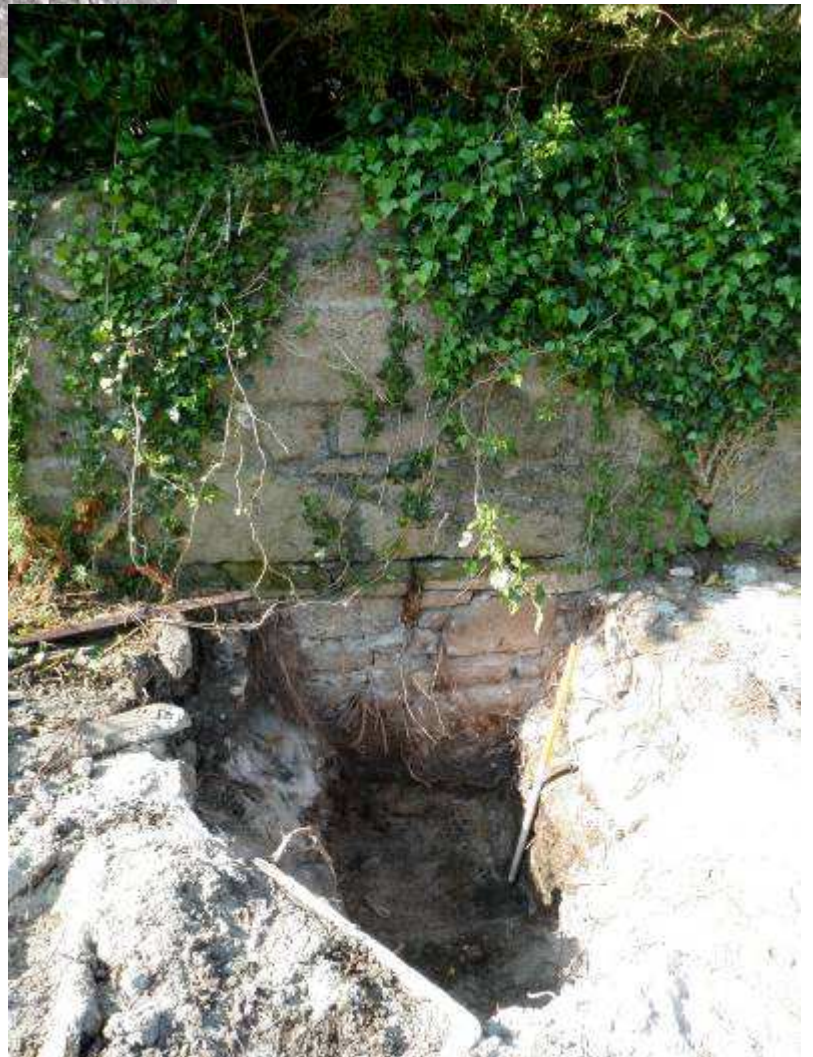
Fig 4 Photograph showing Pit B.

The wall footings are briefly described and then the layers visible in the most clear (east facing) section are described. There was nothing to suggest that the other sections differed, although the west facing section was largely disturbed due to the location of two sunken sinks representing an expansion of the former Perspex-lined pond setting (Fig 4).

This pit was located on the southern edge of the plot and immediately abutted the pre-1875 walling defining the southern long edge of the site. The pit measured 1m by 1m by 1m deep. It too showed the wall to be standing directly on decayed bedrock, which included an apparently natural clay content not seen in Pit A. This natural decayed bedrock layer dropped in depth by 0.1m to the north of the walls footings, which consisted of noticeably large granite blocks (0.7m long and 0.35m wide, laid horizontally with smaller stones laid horizontally above). Above this naturally formed layer was a compacted dark brown clay loam 0.35m deep with very occasional granite inclusions. Above this was a further deposit 0.05-0.1m thick of re-deposited rab. This may represent former surfacing, although it was not compacted and may simply have been the residue of former granite construction work. Above this was a 0.15m mixed dark brown loam, and above this a combination of granite blocks and re-deposited rab. The stones appeared vaguely horizontally lain, but did not form part of any built structure and were considered likely to relate to the proximity of the pond. Rooty, shallow grass partially overlay these stones.
