Hallenbeagle, Scorrier, Cornwall

Archaeological Impact Assessment of Cory Environmental proposals for a waste transfer station

Client	Business Location Services Ltd
Report Number	2011R051
Date	13/05/2011
Status	Final
Report author	Adam Sharpe BA MIfA
Checked by	Peter Rose, Projects Manager
Approved by	Peter Rose, Projects Manager

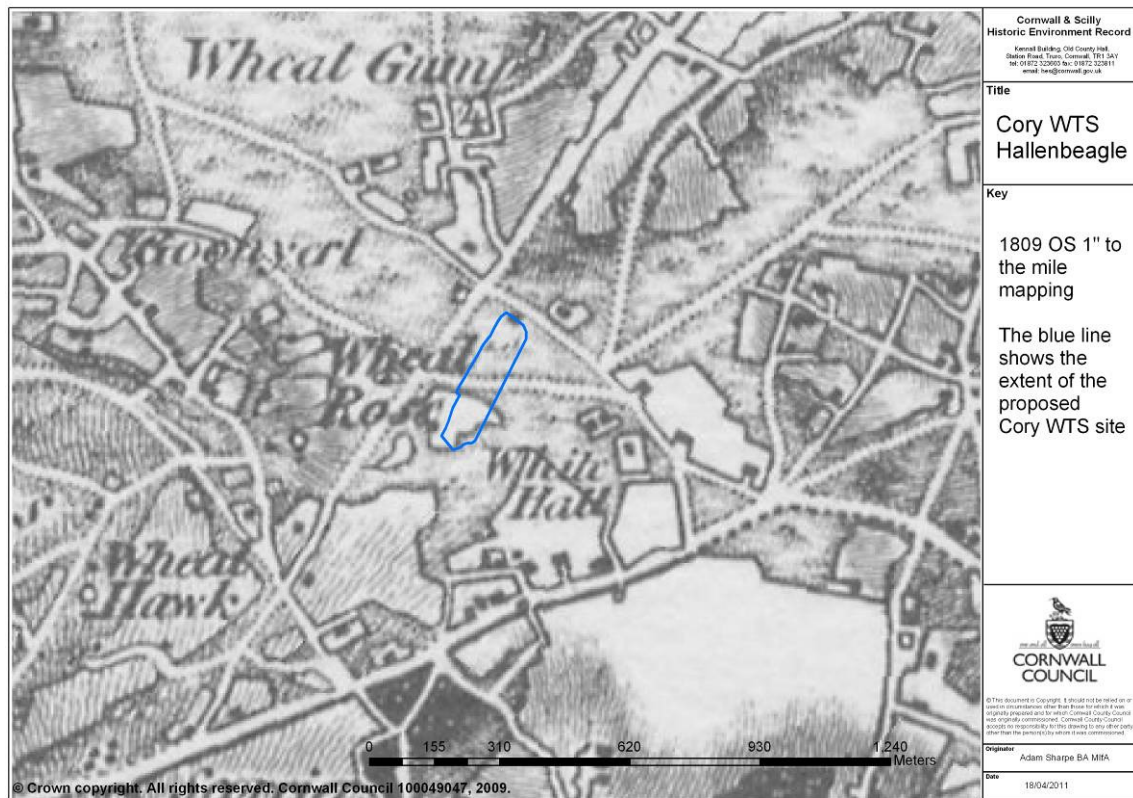
Fig 3. The area of downland, mines and miners' smallholdings at North Downs as shown on the 1809 OS 1st Edition 1" mapping.

Smallholdings appear to have been developed across North Downs during the late 18th century as a response to the need to house the greatly enlarging mining population as copper mining activity within this area began to expand exponentially during this period. This group of fields were shown on the 1809 OS 1" mapping (Fig 3). They were again shown in 1840 on the Kenwyn Tithe mapping, consisting of eight fields aligned west-south-west to east-north-east (following the trend of the strike of the local lodes), and surrounding a smallholders' cottage, outbuildings, yards and gardens.

The proposals will also result in the removal of surviving elements of a miners' smallholding dating to the late 18th century or early 19th century which is shown on the 1809 OS mapping (Fig 3). These impacts are judged to be **negative/moderate/permanent** without mitigation and **negative/minor/permanent** should appropriate mitigation be carried out.

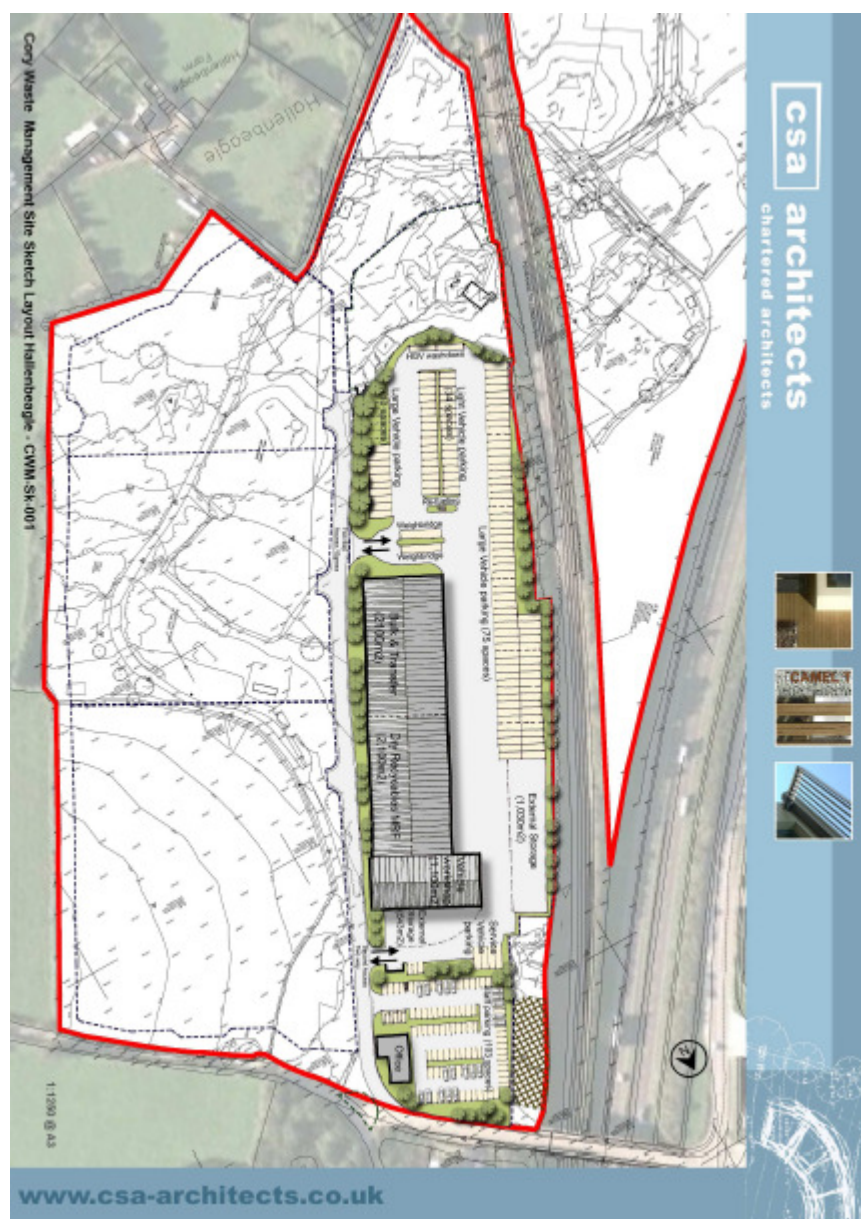
Fig 15. The CSA Architects plan showing the proposed layout of the Cory Environmental site.

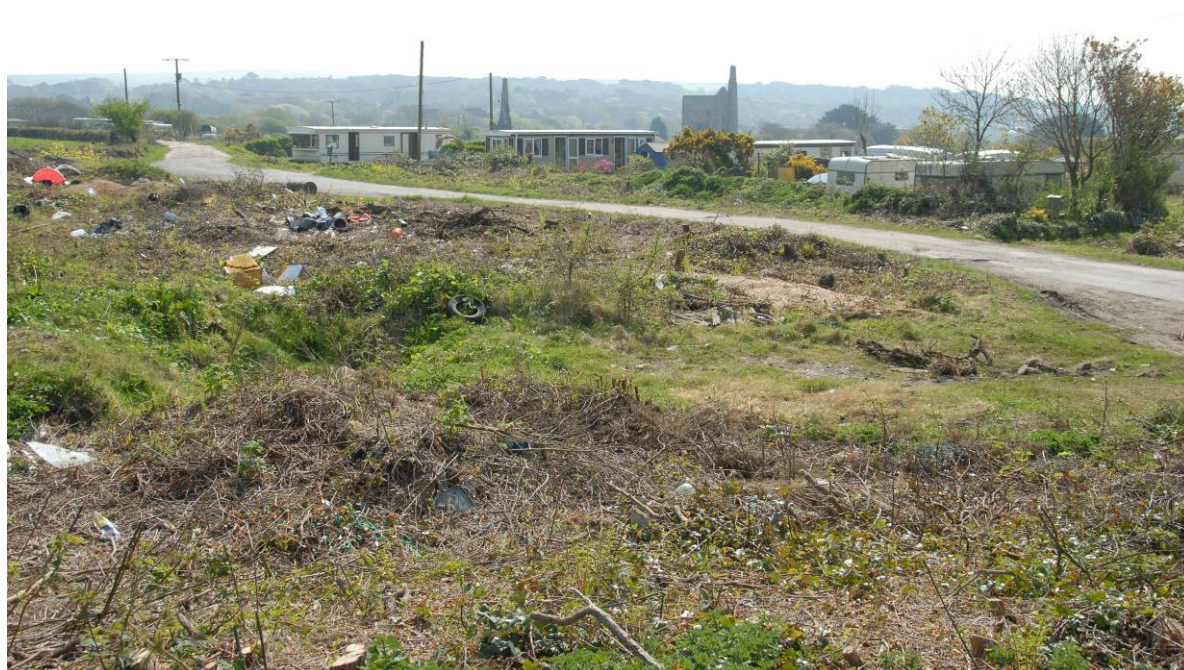
The survey confirmed that several phases of levelling and other groundworks have taken place within the area proposed for the Cory Environmental development (Figs 16-17, 20-21). Over the whole of the site some degree of reworking of dumps is recorded as having taken place during the final years of operation of the mine (Collins 1912, as noted above in Section 10.6.3); the northern part of the site is recorded by the NMP as having been levelled by the US Army in 1944 in preparation for a temporary camp prior to D Day, access roads also having been created at this date. Further localised disturbance is likely to have taken place during the mid-1980s when some of the shafts on the site were made safe under the Carrick District Council's Operation Minecap project. The eastern section of the northern part of the site exhibits evidence for a further, more recent phase of mechanical levelling and the creation of roadside ditches, presumably in order to prevent travellers gaining access to this part of the site.

Fig 16. Looking south-west from the site entrance towards the travellers' site.

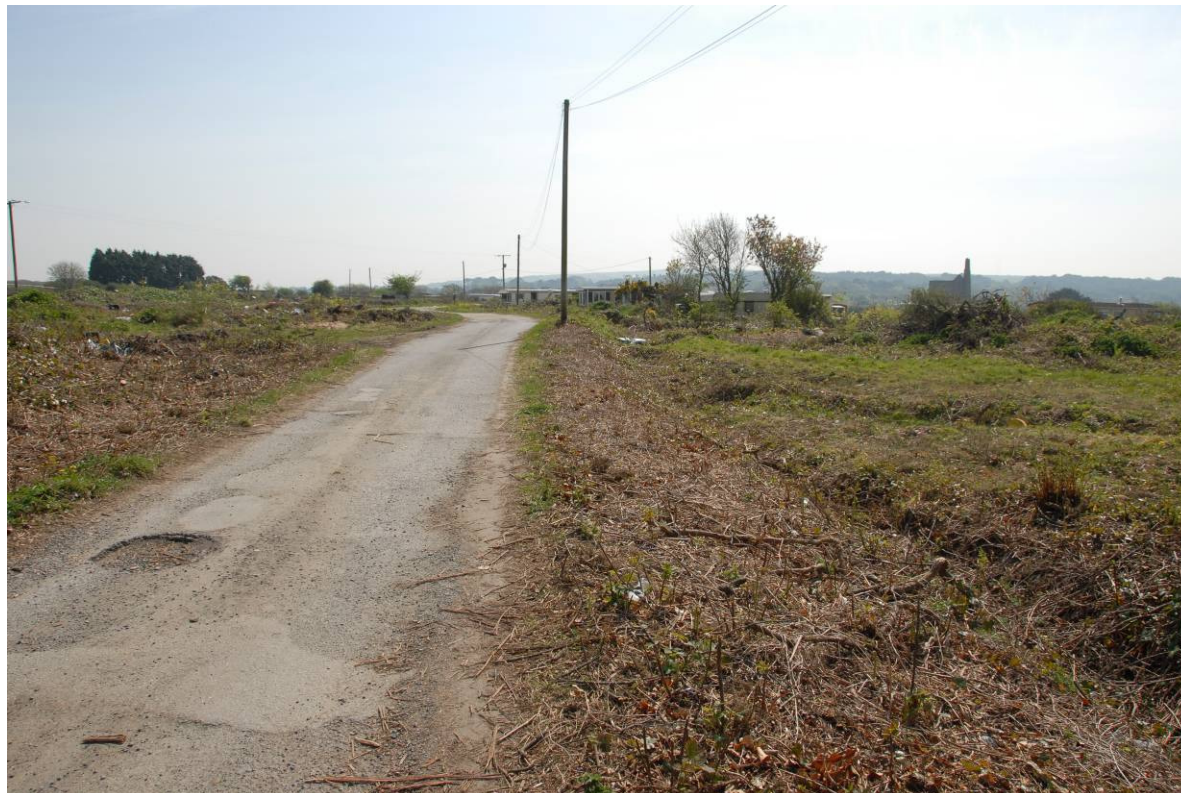
Fig 17. Looking south from the site entrance down the access track.

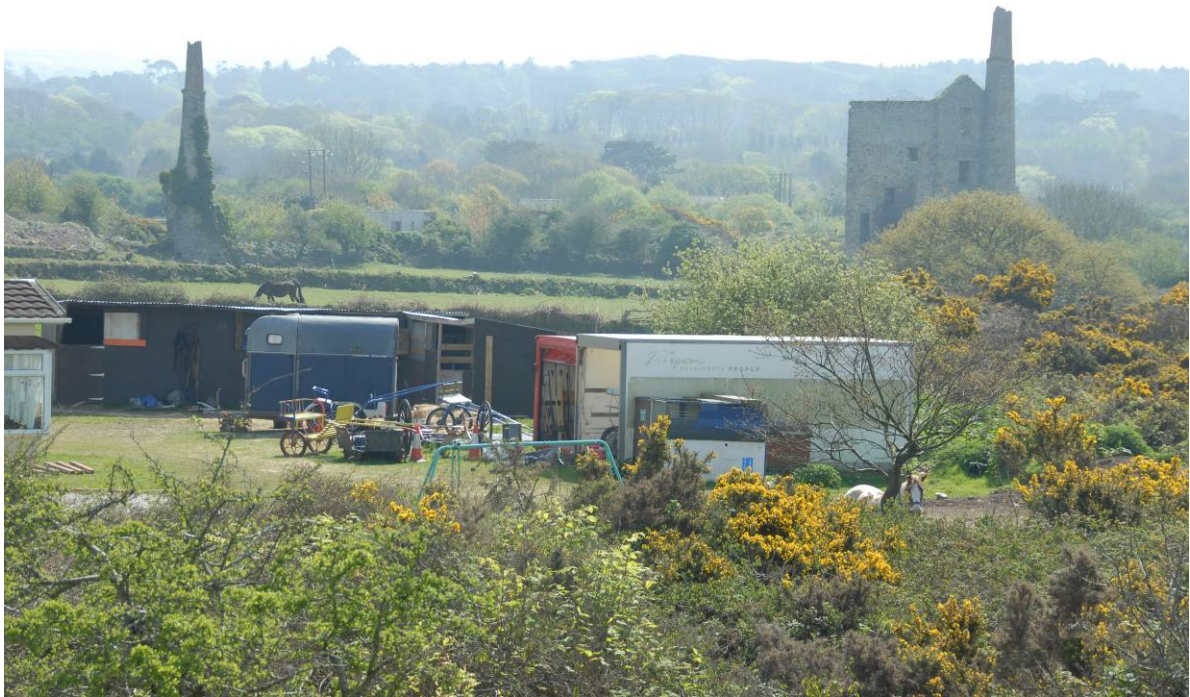
Fig 18. Looking south-west from the travellers' site across the smallholders' fields towards the Reade's Shaft engine houses.

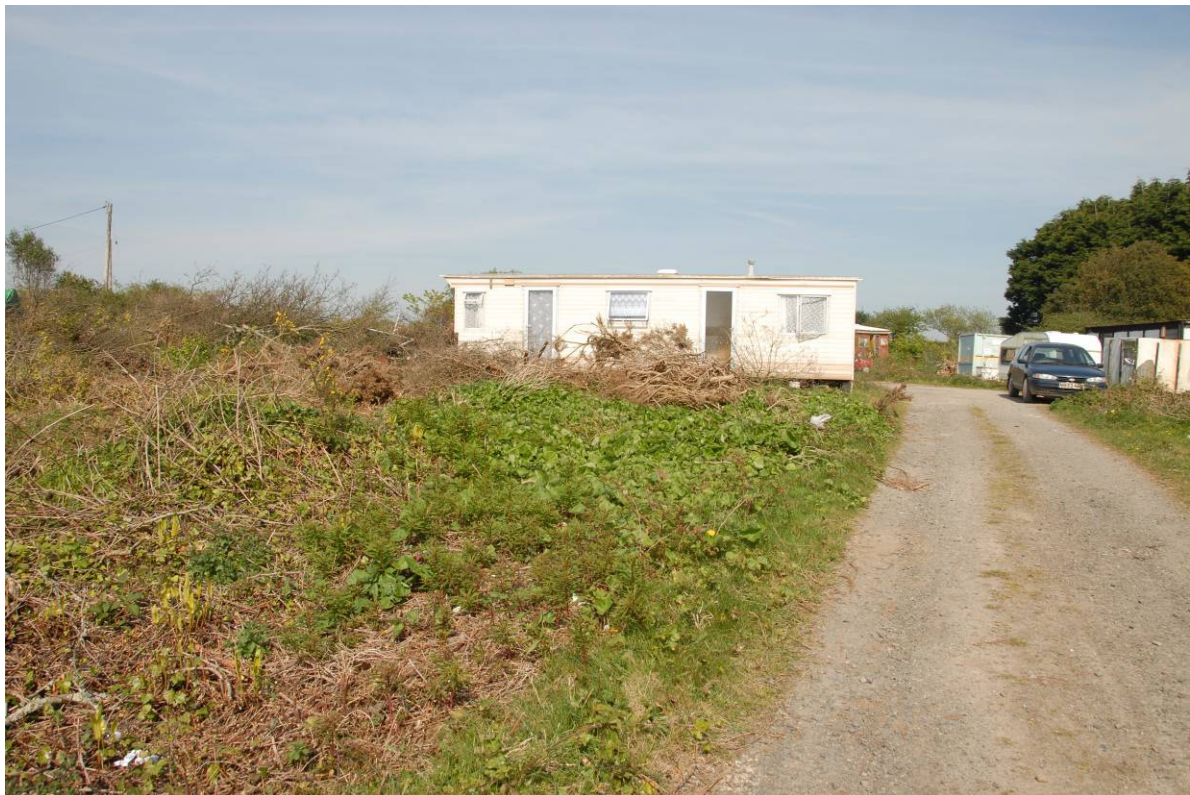
Within the area occupied by the mobile homes, no evidence was noted for archaeological features. It should be noted, however, that the mobile home at SW 72796 44674 in the south-eastern part of this area (just to the east of the proposed Cory Environmental development site) is located directly over a mine shaft documented on modern OS maps as being enclosed within a shaft hedge (Fig 19). No surface indications of the mine shaft could be seen at this location. There is some potential for other undocumented mine shafts or for large near-surface stopes (mined out areas of lodes) within other parts of the northern half of the site.

Fig 19. A mobile home sited on top of a documented mine shaft on the east of the central part of the site.

Given that most of the shafts on this site have, in the past, coned in due to the collapse of the collaring which supported loose ground above bedrock, capping operations to stabilise them and make them safe are likely to extend beyond the footprint of their original openings, and have the potential to result in the destruction of any surviving remains of engine houses or other associated surface structures. There are known to have been several phases of engine house construction at Hallenbeagle, though not all of these are well documented. No remains of the documented engine houses (other than those serving Reade's Shaft) survive at surface, though their locations are mapped.

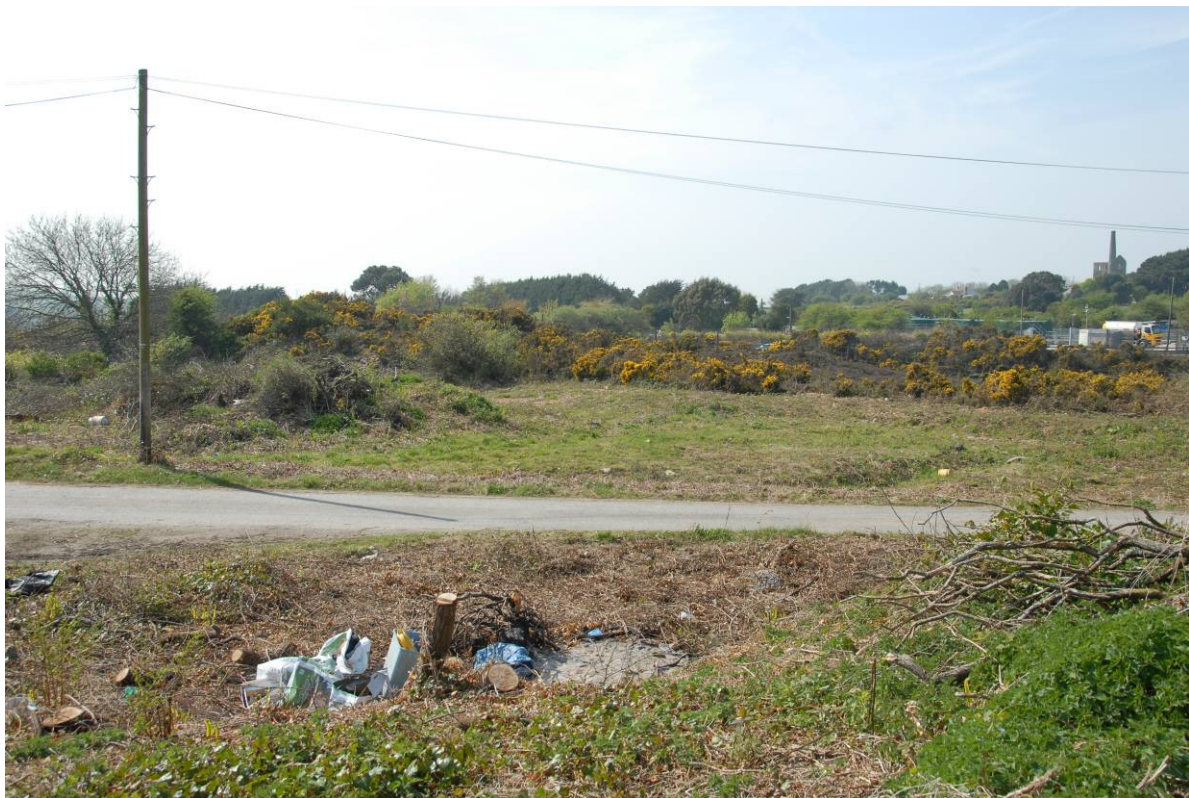
Fig 20. Looking west across the northern part of the site towards the location of Old Engine Shaft. The former pumping engine house was sited in the left part of this view.

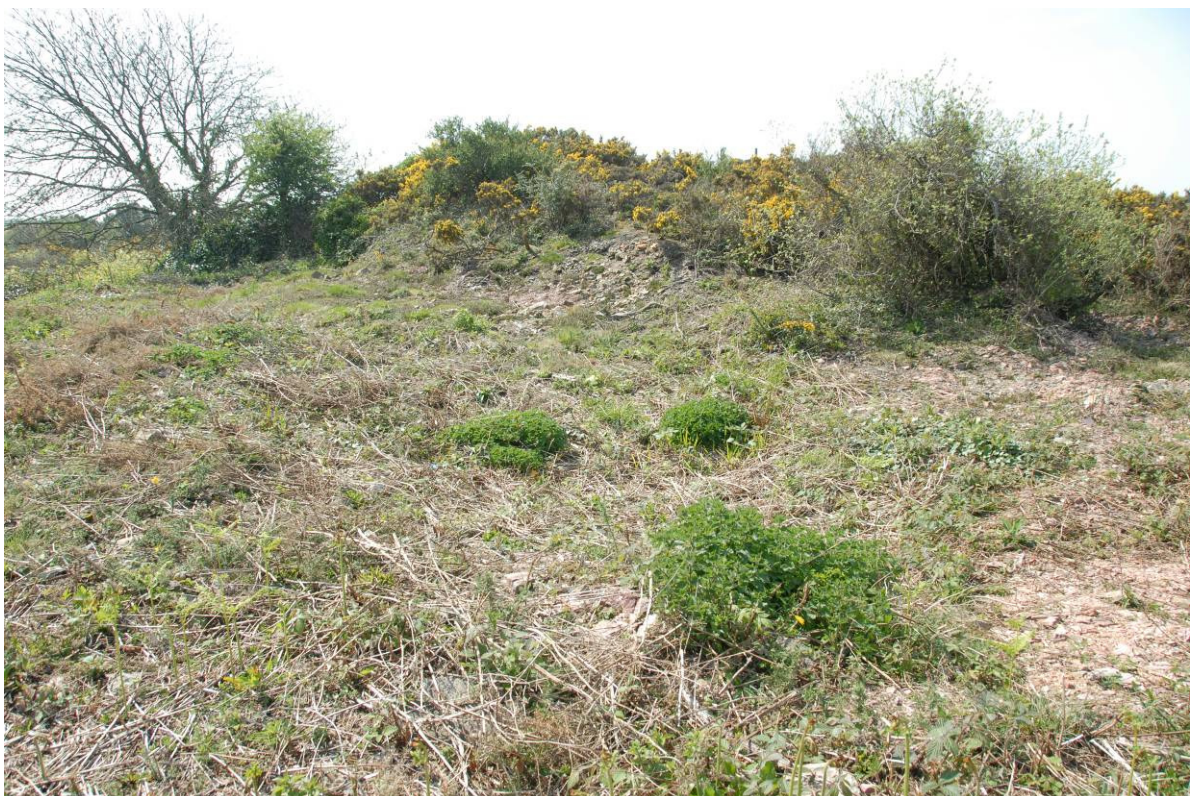
Fig 21. The remains of the Old Engine Shaft spoil dump from approximately the location of the former pumping engine house.

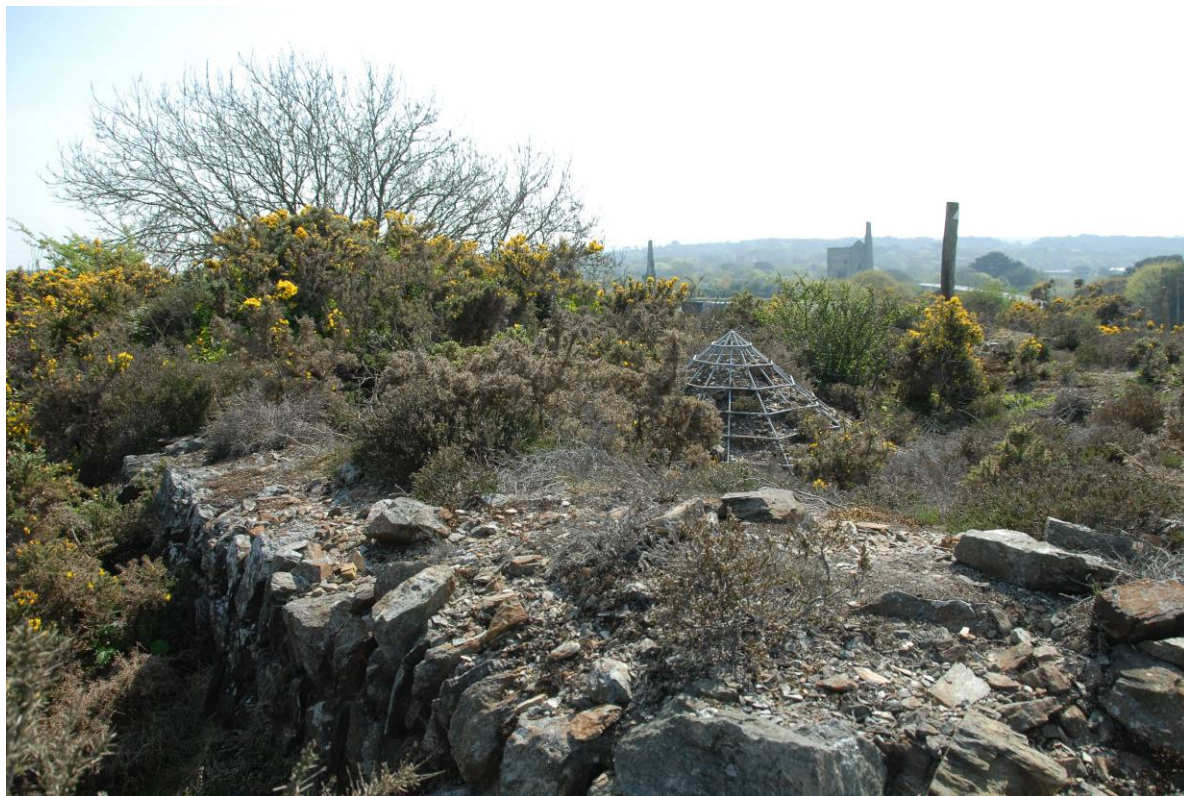
Set on the top of a remnant dump of heathy spoil between the edge of the development site and the railway cutting, a small Clwyd Cap marks the site of the shaft worked by the whim engine depicted on the 1st Edition OS 25" mapping. This appears to be separate from Engine Shaft, which seems to have been sited just to the south, adjacent to the pumping engine house. The shaft is filled at surface, and its depth and condition below ground are unknown.

Fig 22. The Clwyd Cap on Whim Shaft, together with the safety hedge surrounding it.

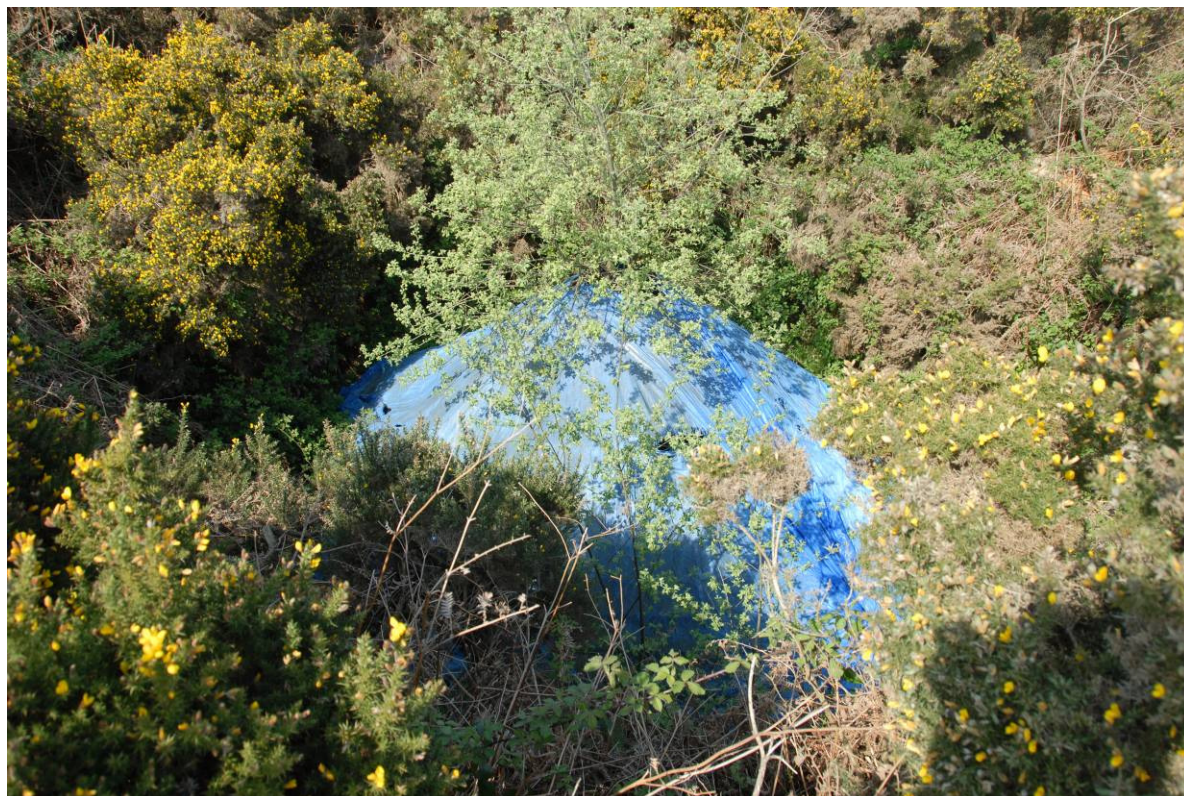
covered with a blue tarpaulin, and may be currently in use as a children's den (Fig 23). The condition of the shaft beneath the cap is unknown.

Fig 23. The blue tarpaulin covering the large Clwyd Cap over Piningers Shaft.

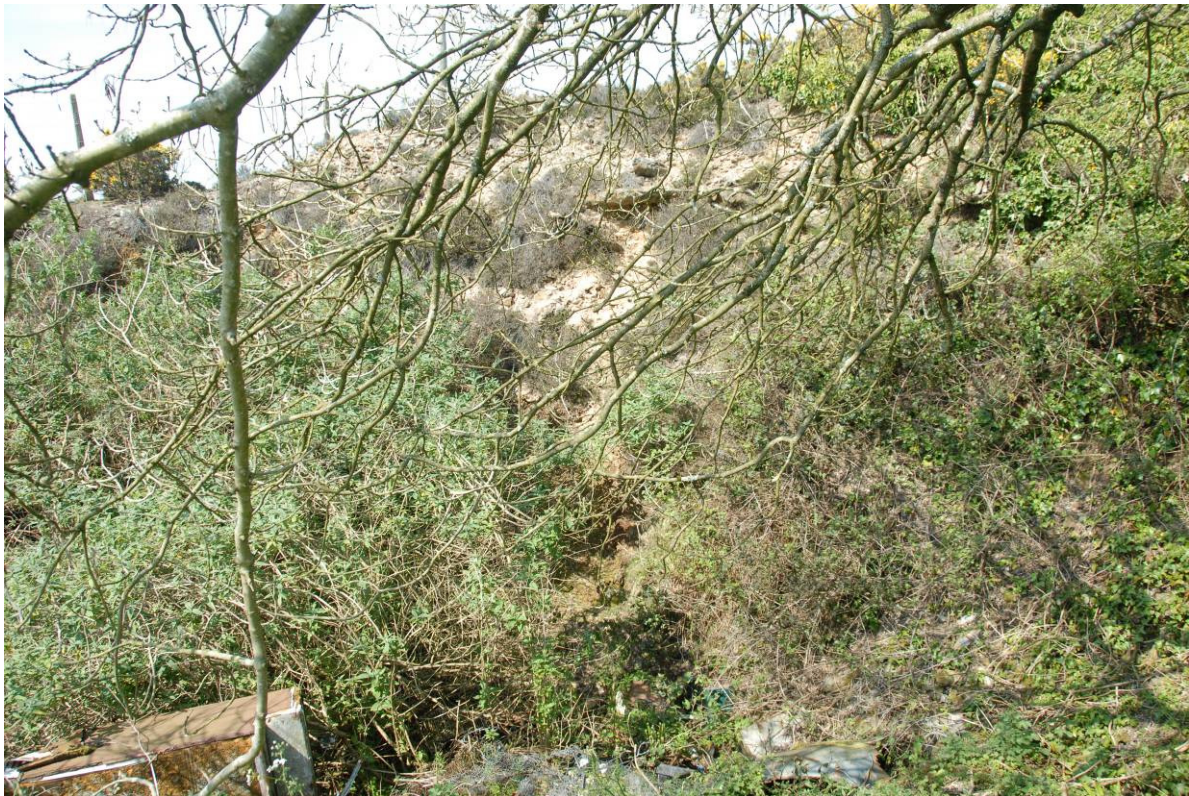
Immediately to the south-west of Engine Shaft a very substantial collapse of ground has occurred, presumably through the deterioration of old support work in near-surface stopes (Figs 24-25) and of Engine Shaft itself. The ground here continues to subside, and has been used as a rubbish disposal site. The presence of this area of collapsed ground indicates the likelihood that extensive areas of the Hallenbeagle Lode were mined away very near to surface and that there is a strong potential for ground instability along the lode strike to the east-north-east.

Fig 24. The south-western edge of the spoil dump at Old Engine Shaft. Immediately adjacent to this, a massive stope collapse has occurred, the hollow created at surface having been filled with rubbish.

Site preparation works will include capping or other safety works to mine shafts within the site, the removal and disposal of rubbish and other waste materials presently on site and the landscaping of the site prior to the installation of roadways, services and foundation works for structures on the site.

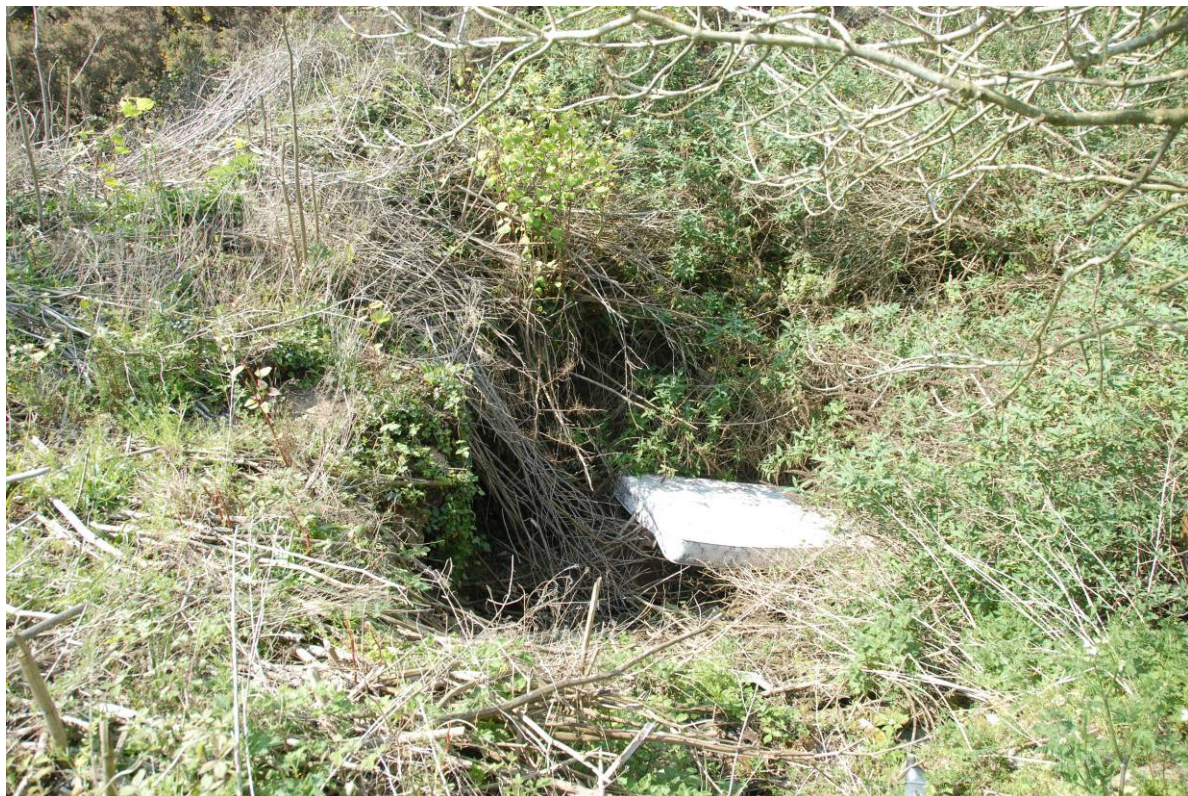
Fig 25. The southern edge of the stope collapse, where subsidence is continuing to occur.

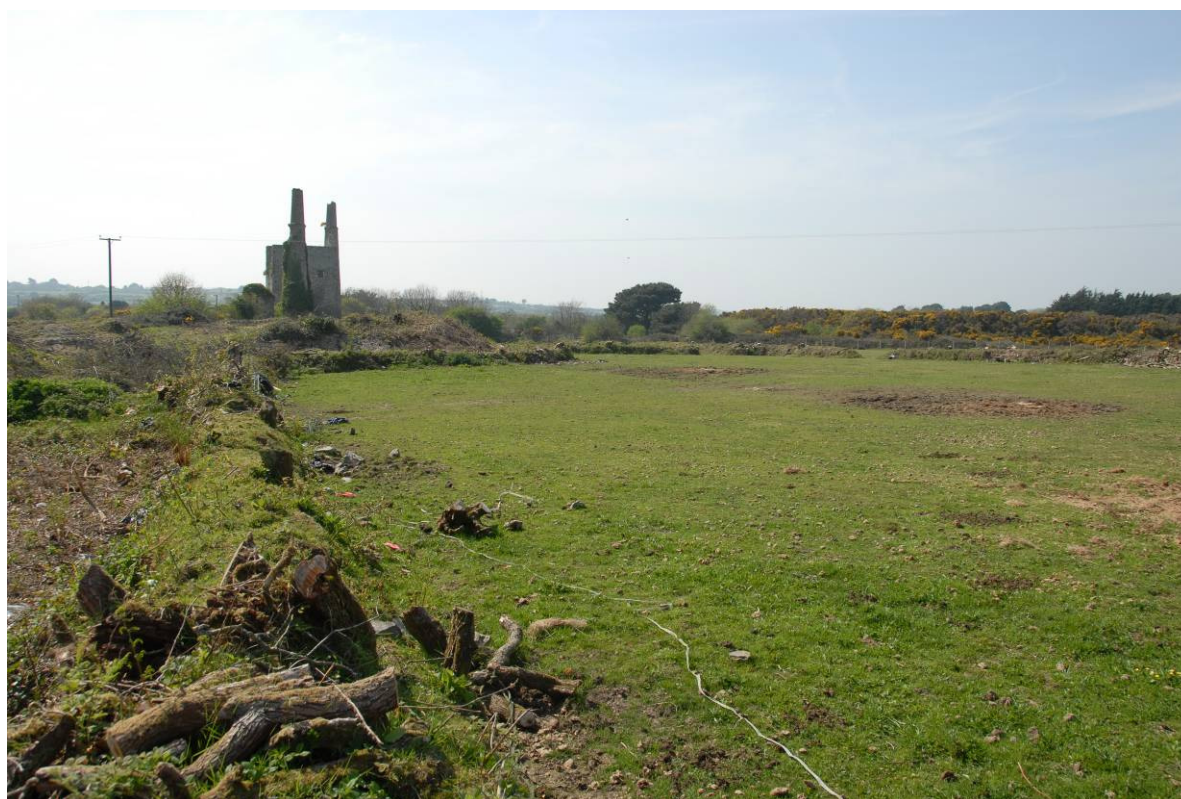
Fig 27. Looking west along the southern boundary of the smallholdings towards the Reade's Shaft engine houses.

By 2005 (CCC aerial photographic evidence, Fig 7) the central and north-eastern areas of the wider site had been reclaimed to agriculture and the southern parts of the site were in scrubby heathland (Figs 20-21). The north-eastern part of the wider mine site (Zone 4 on the site development proposals dated 01/10/2010) remained in agricultural use, whilst the north-western part of the site (the northern part of Zone 1 on the October 2010 plan) and the central eastern part of the site (Zone 5) were occupied by a number of static caravans and their curtilages (Figs 16-19); the southern part of Zone 1 was occupied by a number of smallholders' fields first shown on the 1809 OS mapping (Figs 26, 27). The south-eastern part of the site (Zone 6) had scrubbed in, as had the southern corner of the site (Zone 3) and the area around Read's engine houses (Zone 2) (Figs 27-29).

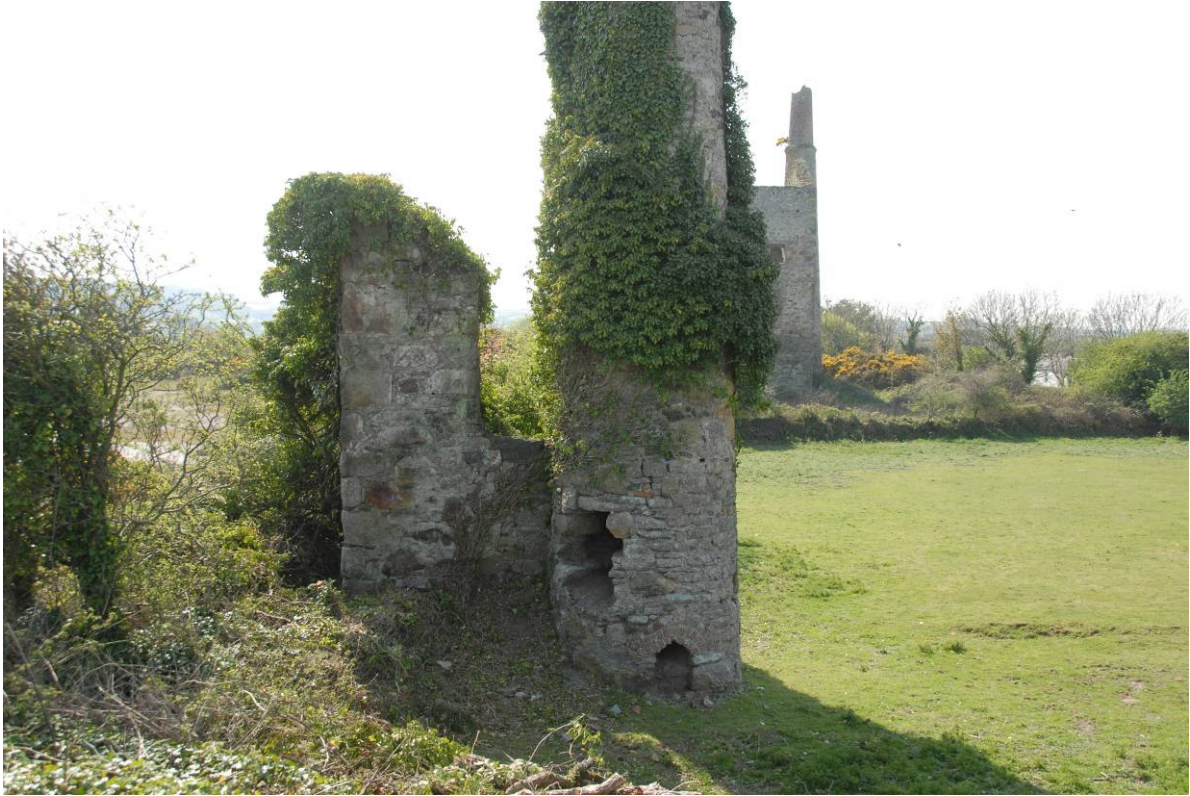
Fig 28. The Grade II Listed engine house serving Reade's Shaft, which will form part of the boundary of the waste transfer station.

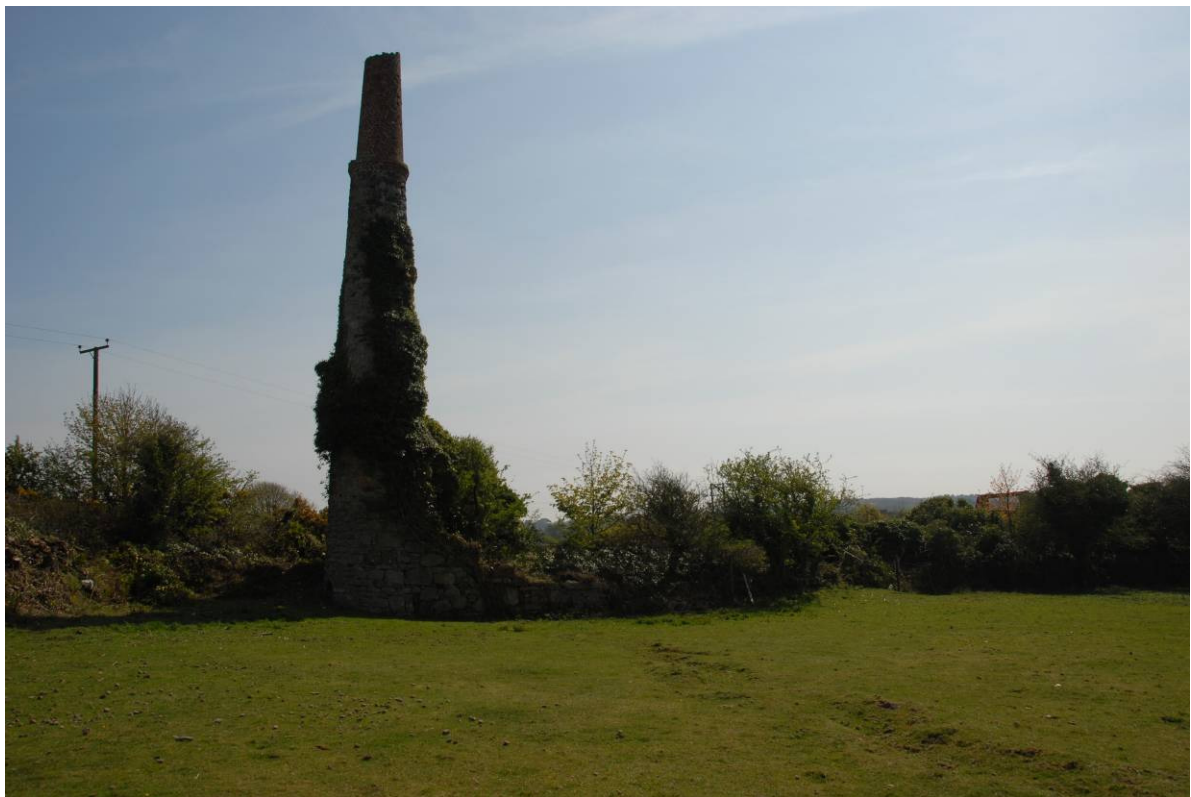
Fig 29. Reade's whim engine house, seen from the adjacent smallholdings. One of the shallow trenches crossing the fields can be seen running from lower right to lower centre.
