# **Creed Barns, Creed, Cornwall**

## **Historic building record**

2011R055

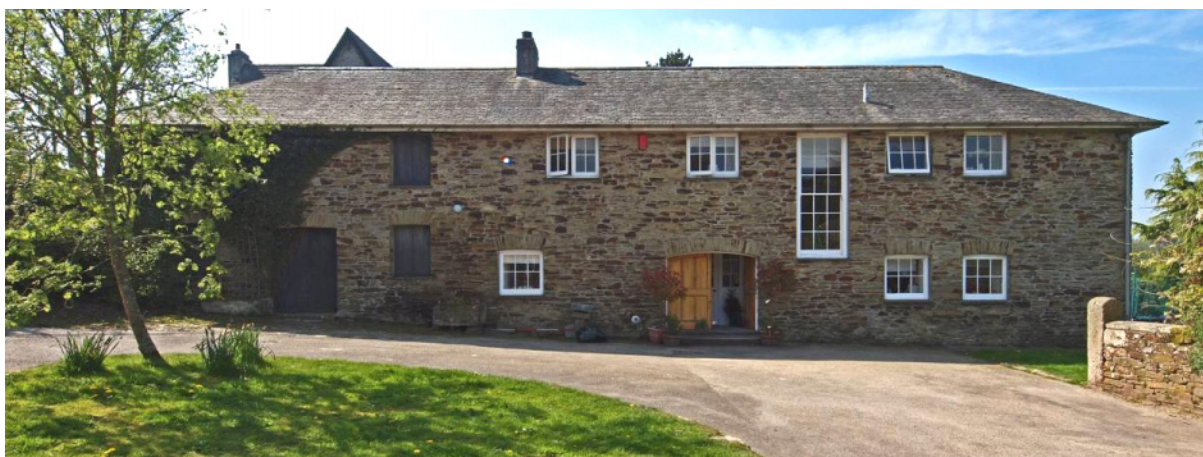
*Fig 6 N front of the whole stable block including the converted part to centre and right*

The subject buildings comprise the unconverted former stables part of a large 2-storey barn (Figures 6-9) and a small single-storey former carriage house with flanking stables (Figures 10-12). The subject stable building adjoins what appears to have been a general-purpose barn that is now converted to a house. At some time in the later 20<sup>th</sup> century the stables were converted to a cow-house. In recent years the stables have been re-roofed and re-floored but evidence survives for their former original design use as stables with four standings. There is a doorway and four shuttered windows in the front (north) wall that overlooks a courtyard and the loft is accessed by a doorway approached from higher ground at the east end. There is a further shuttered window central to the rear wall of the loft that is also built against higher ground. The wooden

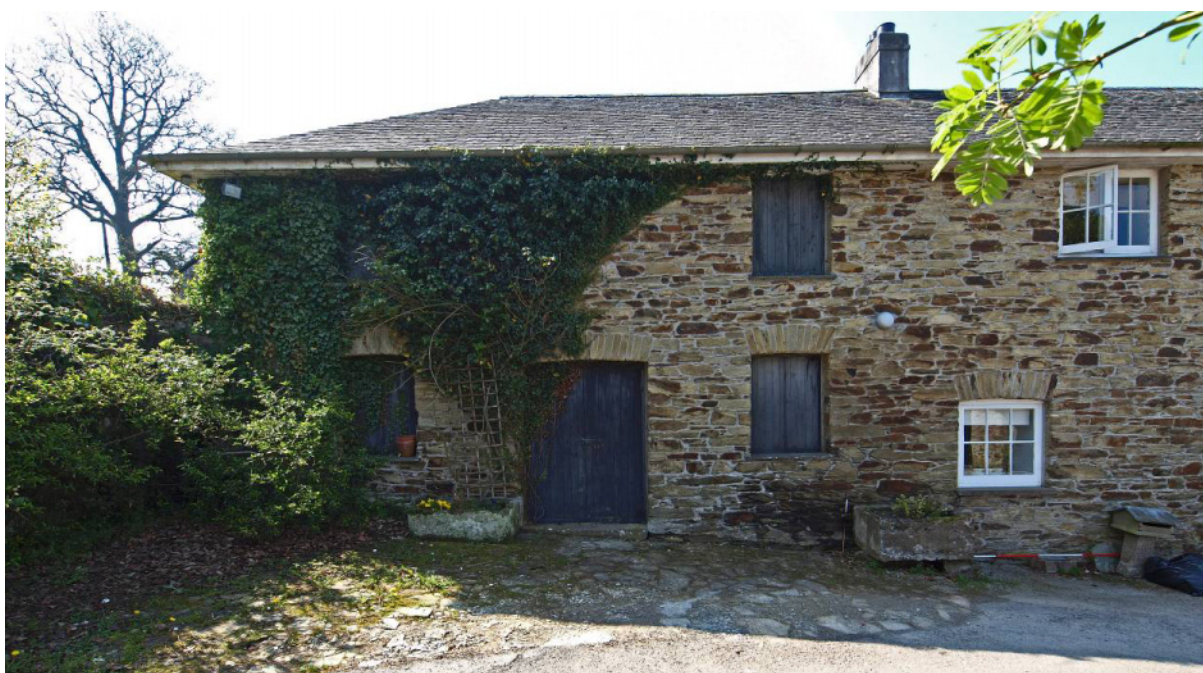
*Fig 7 Subject stables N front*

Each subject building has a rectangular plan. The 2-storey former stables have a wide central doorway to the north (front) wall and flanking shuttered window openings. Surviving chamfered and stopped top rail and two chamfered and stopped stall posts are evidence that the original plan had row of four stables to the south side of the building with probable mangers and hayracks against the south wall. The loft (Figure 14) has a loading doorway at its east end, two shuttered windows at the front and another shuttered window central to the rear.

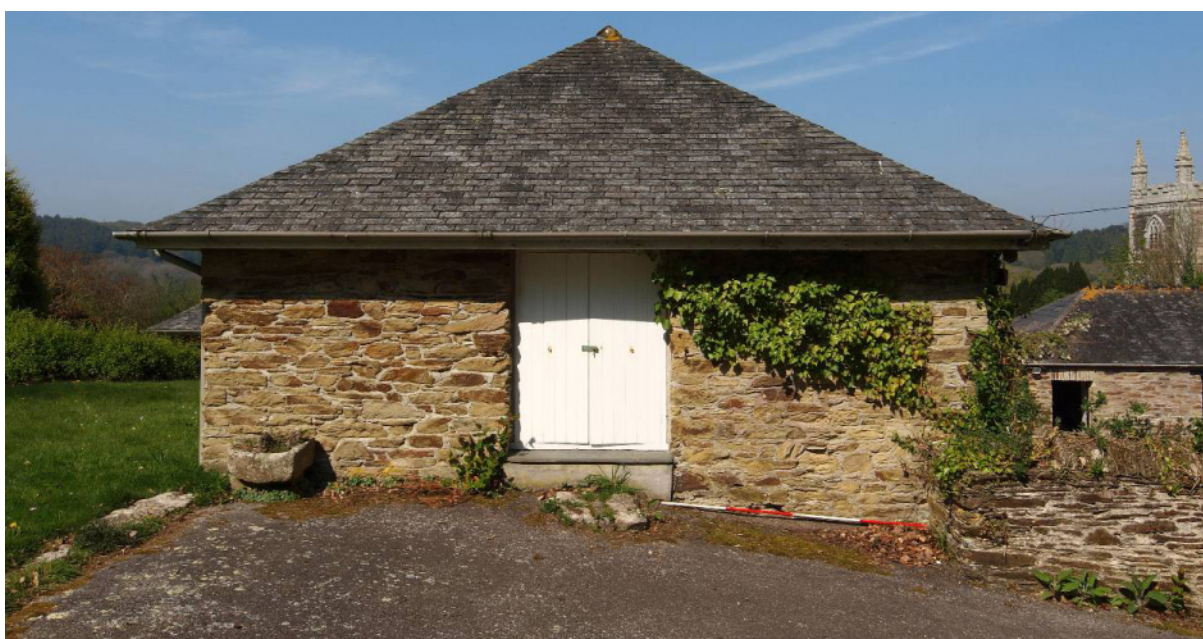
*Fig 8 Stables from southeast (note higher ground level)*

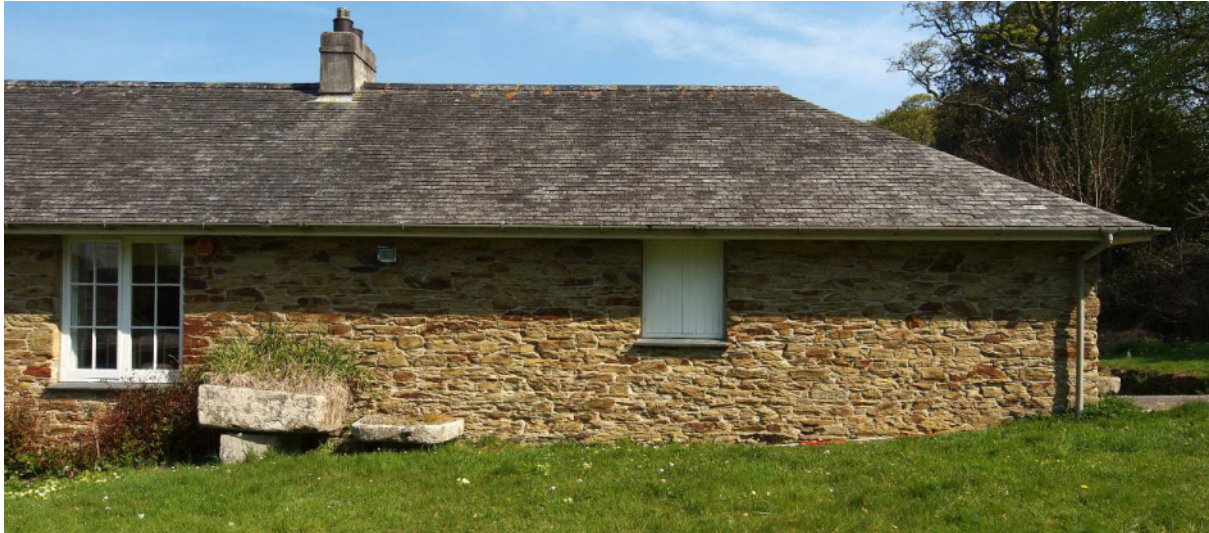
*Fig 9 Stables loft rear(south) elevation*

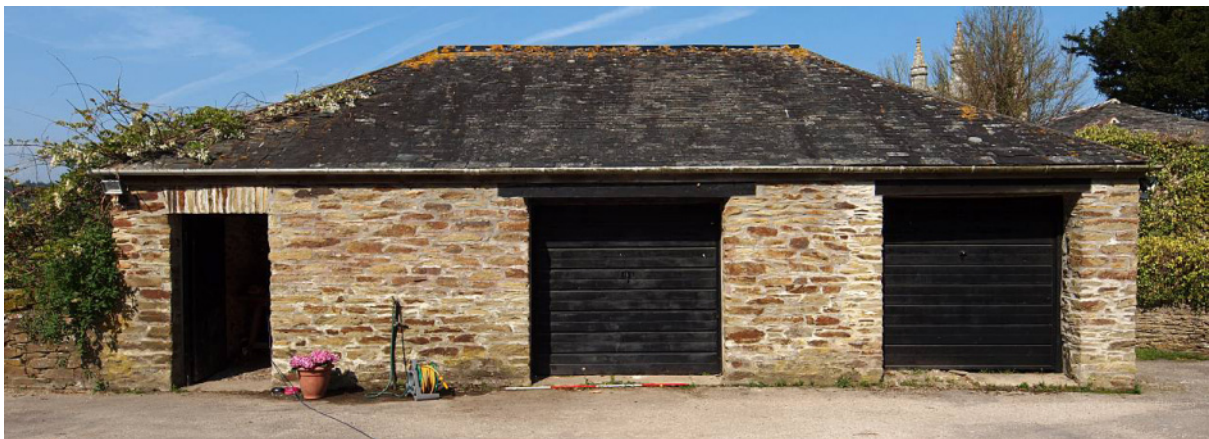
*Fig 10 Small carriage House E front (note widened former stable doorway to right)*

The smaller carriage house with stables has a hipped roof that incorporates an original hip at the north end and a hip adapted from a former gable end at the south end. Evidence for this is demonstrated in the original roof timbers that survive. The building has three doorways to its east front (facing into the courtyard). The central doorway is the original carriage doorway with rebated jambs; the left-hand doorway is an unaltered stable doorway; the right-hand doorway has been widened from an original stable doorway to create a garage facility. There are two window openings at the rear at extreme right and left. All the joinery detail within the openings is modern and the two wide openings have up-and-over garage doors.

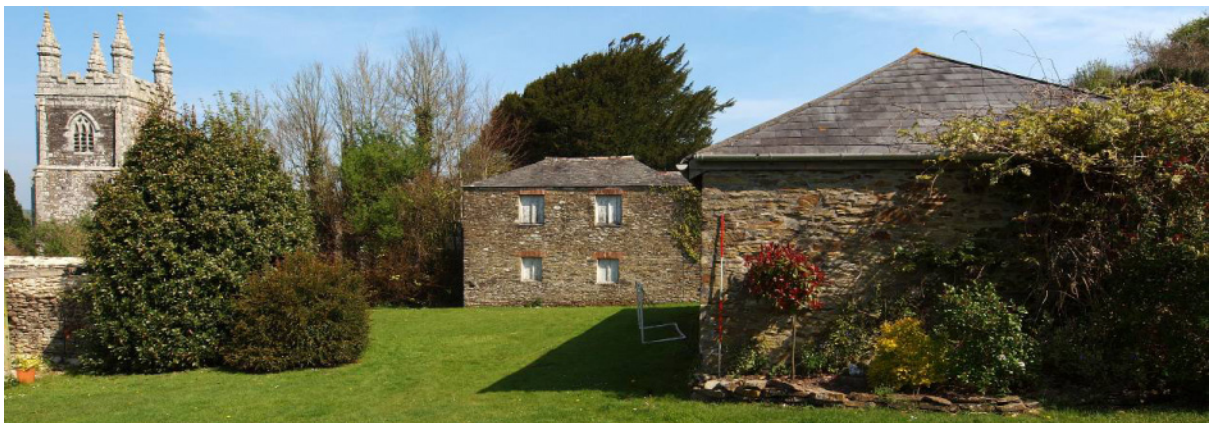
*Fig 11 Small carriage house (right) church tower(left) and church stables (centre)*

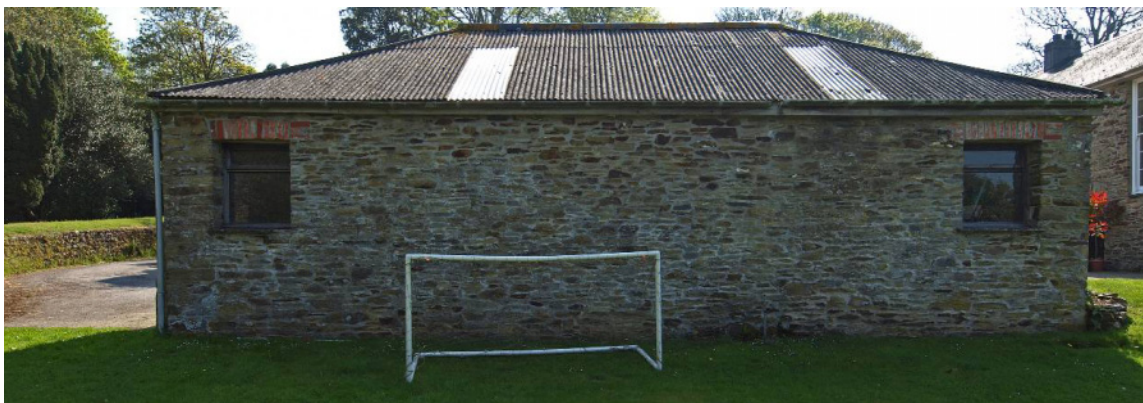
*Fig 12 Small carriage house from west*

The subject buildings are constructed from local slatestone bedded in earth mortar. Original ground-floor openings are spanned by slate-stone segmental-arches. The 2-storey stables have been re-roofed with dry slate. The single-storey carriage house has a small area of original rag slate to its east slope at far left but the roof has otherwise been re-laid with rag slate at the front and to the hipped ends, the south hip is an alteration from a former gable end. Former rag slate to the rear (west) roof slope has been replaced with corrugated fibre-cement sheeting.

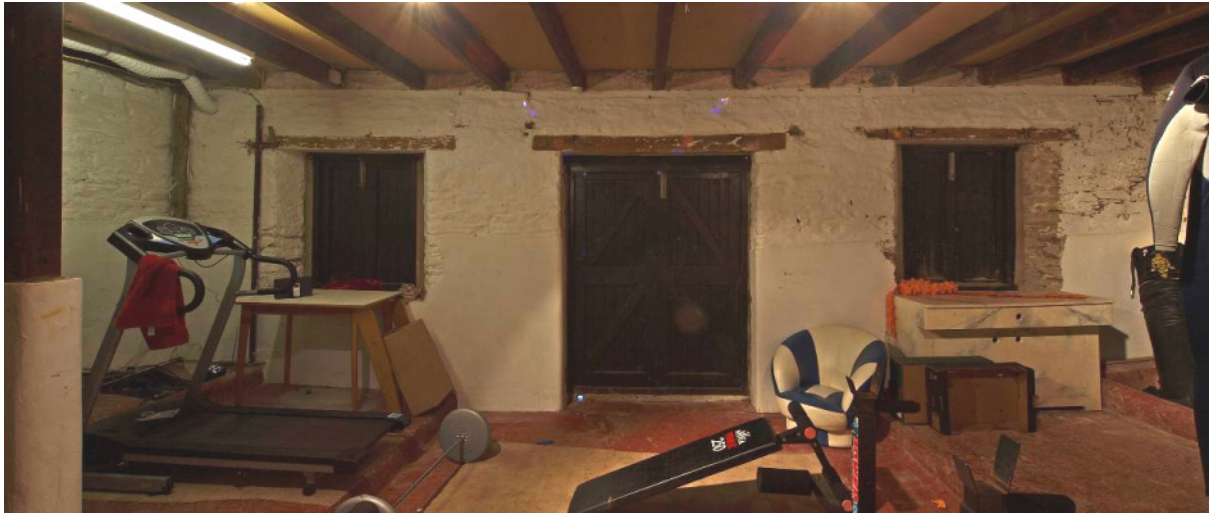
*Fig 13 Stables interior from south*

The 2-storey building that adjoins the converted building is a former stables with fodder and bedding loft above. Evidence for its original use includes two stall post and the top rail into which the stall posts are mortised (Figure 13). Concrete stalls were added at either end of the building in the later 20<sup>th</sup> century when the building was converted to provide cow-stalls.

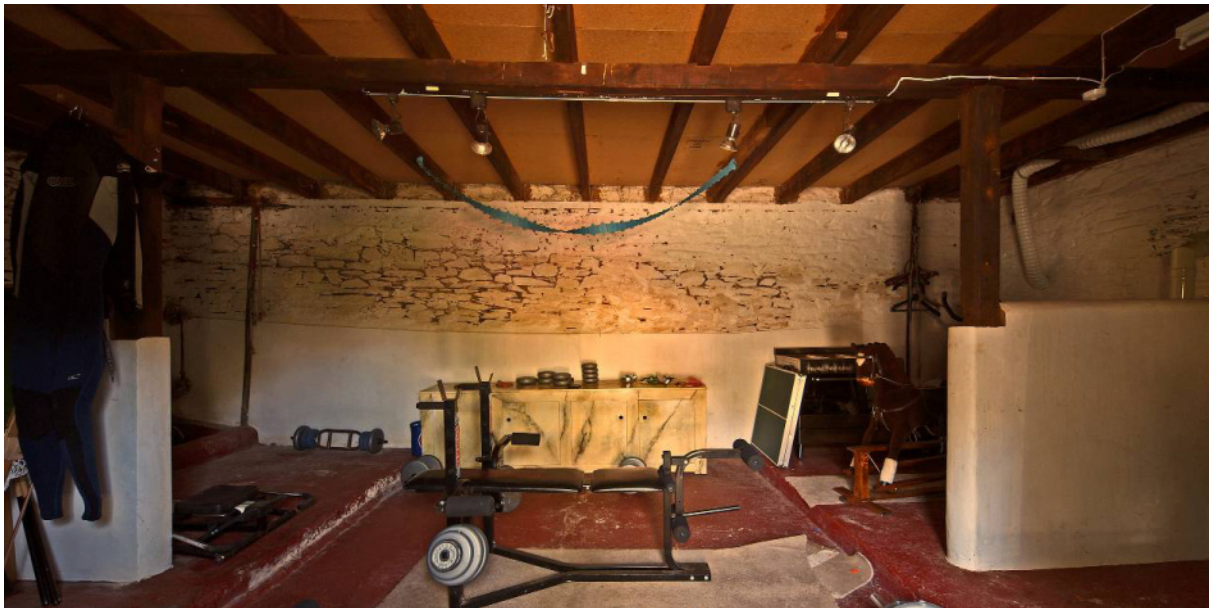
*Fig 14 Stables interior from north (note original standings posts and top rail)*

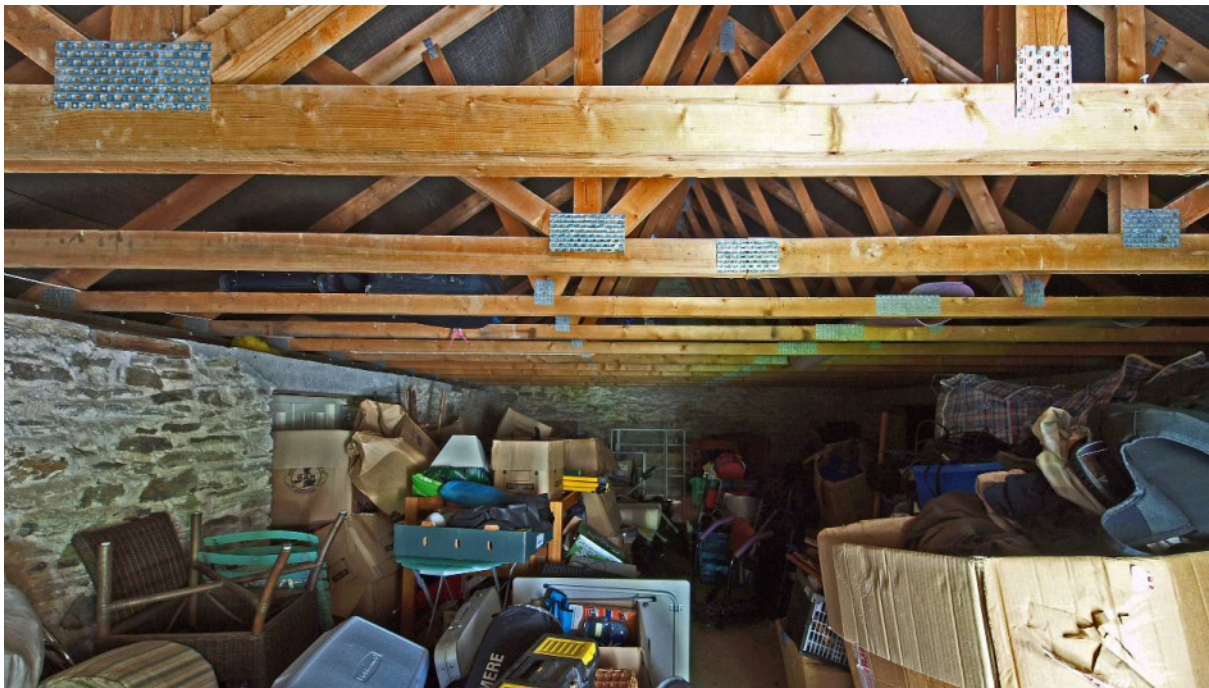
*Fig 15 Stables loft from east*

The single-storey building (Figures 15 and 16) was originally divided into three compartments by probable former timber partitions. The floor areas where the partitions formerly stood have been re-laid with cobbles but original cobbles otherwise survive, the cobbles laid to drain via runnels towards the doorways in the east wall. This evidence combined with the width of the doorway and the locations of windows in the rear wall shows that there was originally a central carriage bay and that there was a similar loose box at either end. A particular anomaly is that the south end of the building originally had a gable end whereas the north end was always a hip. Evidence for the alteration to the south end is in the original roof timbers. The north hip has a tusked tenon joint for the central hip tie whereas the south truss has no evidence for a hip tie and all the timbers of the present hip have been added to the original roof timbers.

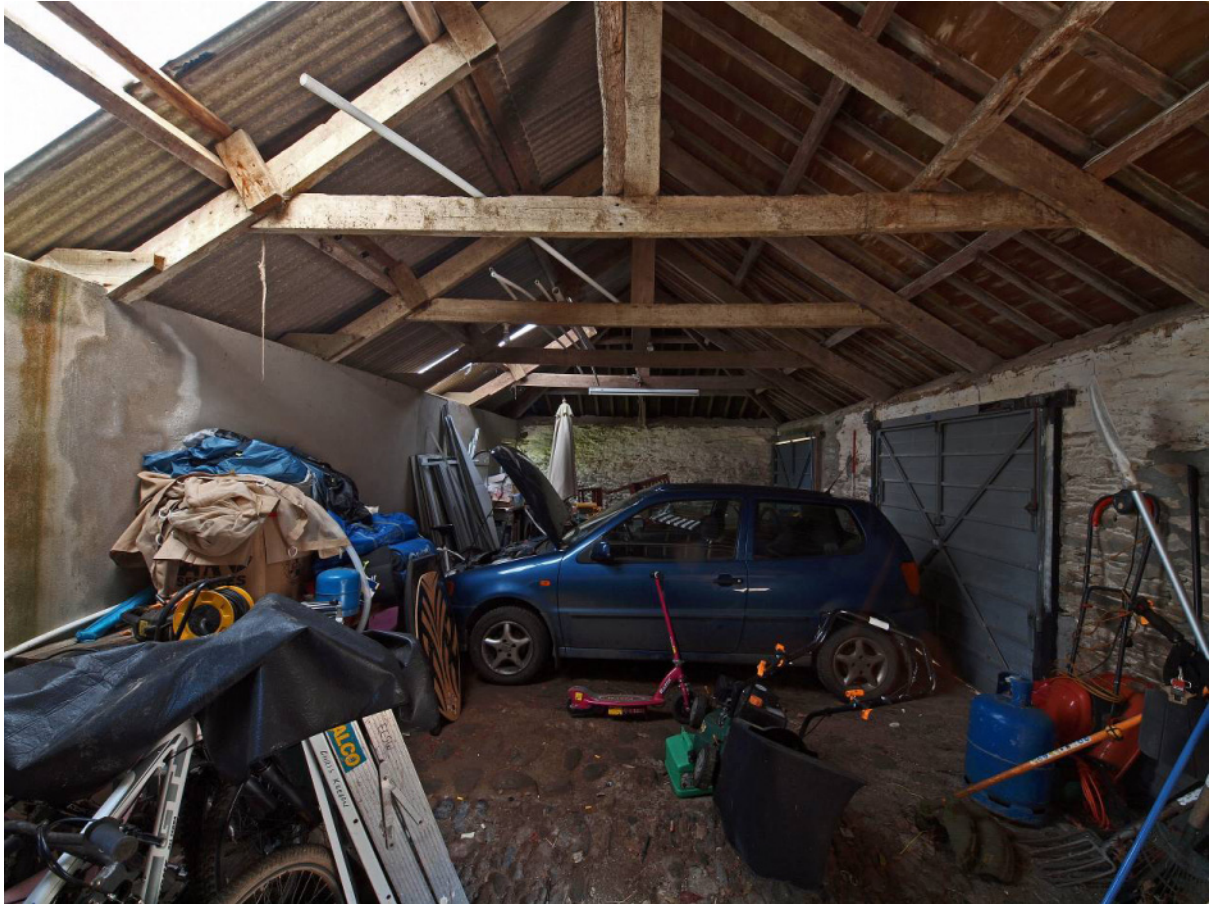
*Fig 16 Carriage house/loose boxes interior from south*

The smaller building is a former carriage house flanked by loose boxes for horses, all within one roofed space. The character and design of surviving cobbled floors shows no evidence for subdivision within the loose boxes.

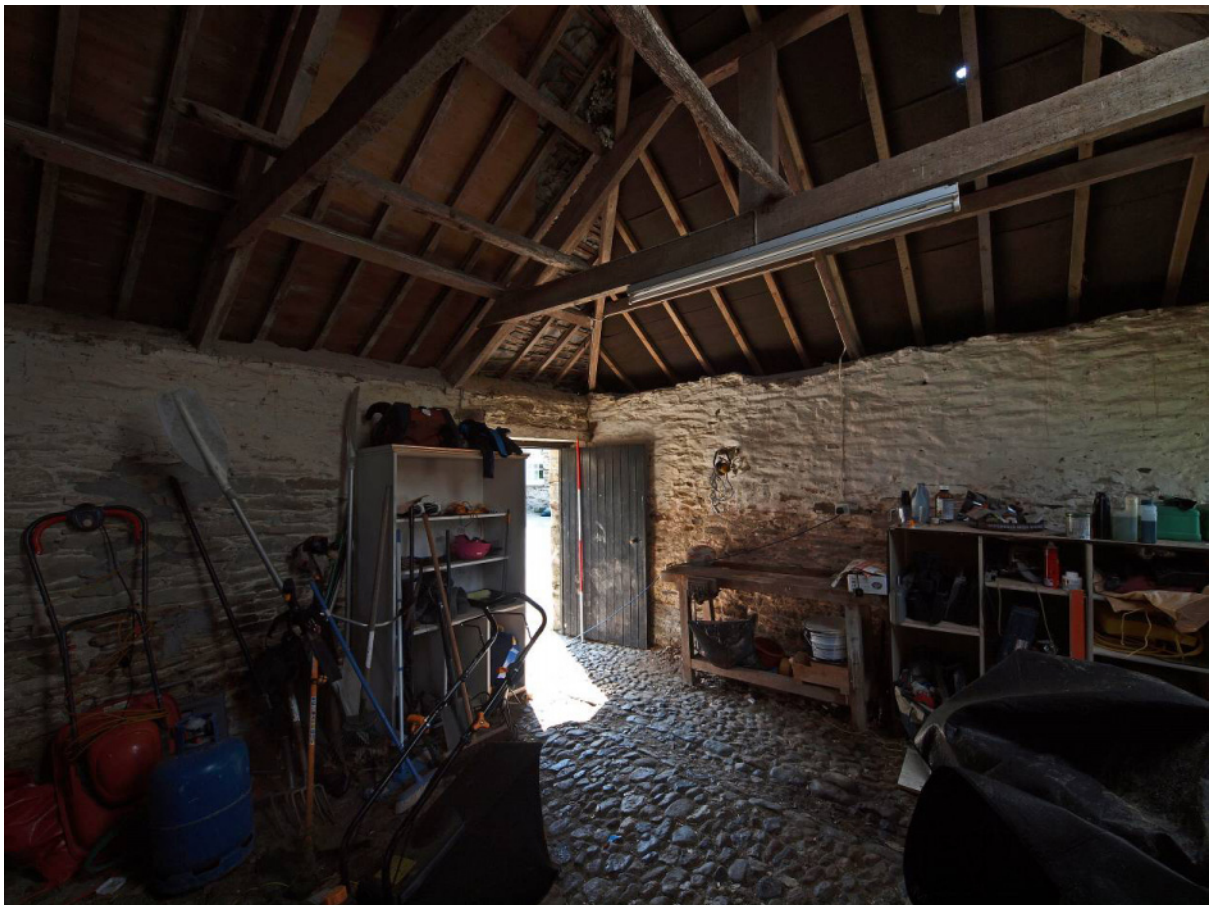
*Fig 17 Carriage house interior from northwest (hip at this end is later alteration)*
