# Wheal Mexico, Geevor, Cornwall

Archaeological consultancy and watching brief during the extension of the underground visitor tour route

<b>Client</b>	<b>Cornish Mining World Heritage Site Team</b>
<b>Report Number</b>	<b>2011R038</b>
<b>Date</b>	<b>31 March 2011</b>
<b>Status</b>	<b>Final</b>
<b>Report author</b>	<b>Adam Sharpe BA MIfA</b>
<b>Checked by</b>	<b>Peter Rose, Projects Manager</b>
<b>Approved by</b>	<b>Peter Rose, Projects Manager</b>

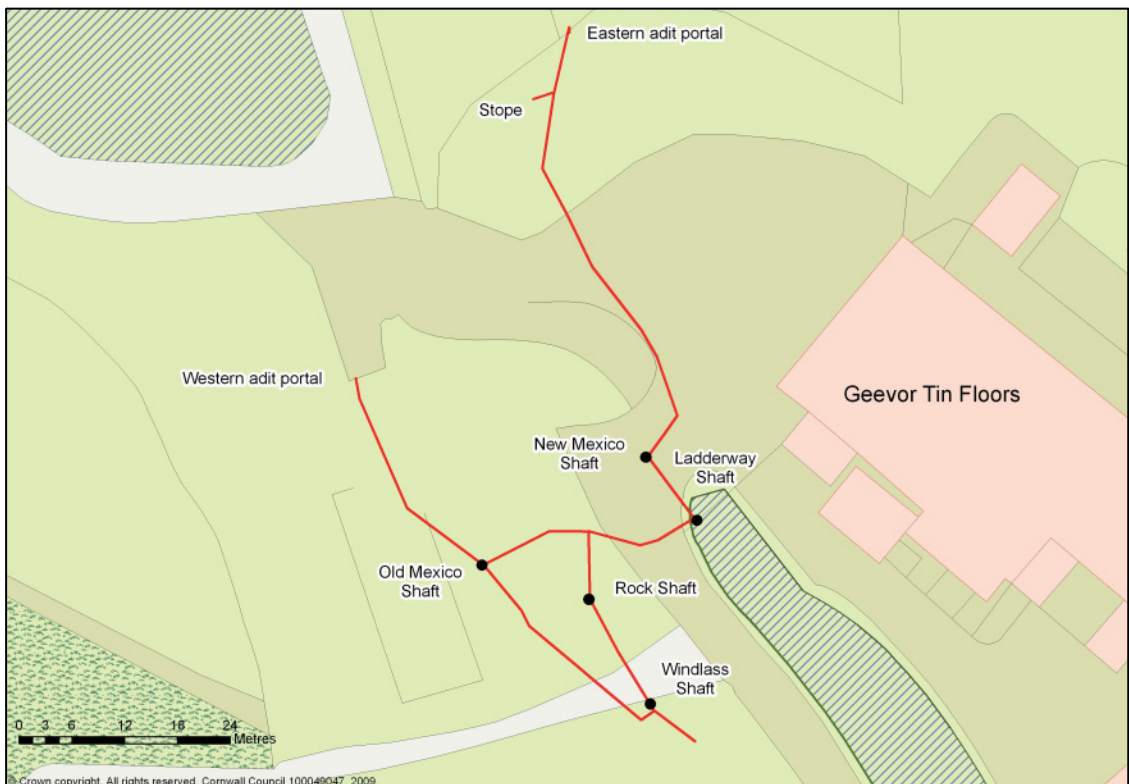
*Fig 2. The extent of the project area at Wheal Mexico, showing (in red) the proven sections of the Wheal Mexico shallow adit system. The new extension is the lower section linking Old Mexico Shaft, Windlass Shaft and Rock Shaft.*

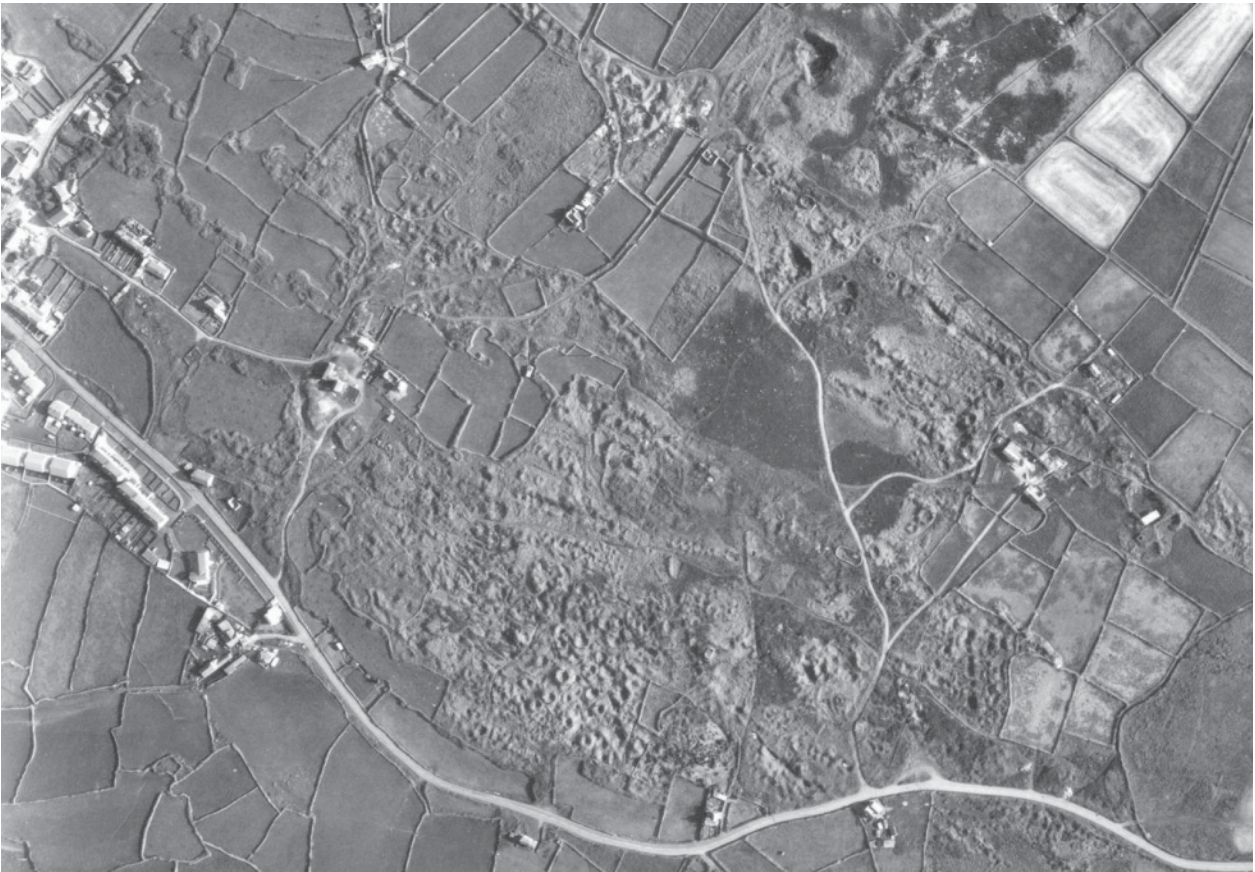
Fig 3. A 1973 PMB aerial photograph of the complex of mine workings on Trewellard Hill just to the south of the Geevor site, showing the huge number of small shafts which developed on many sub-parallel lode outcrops, many sunk during the 16<sup>th</sup> and 17<sup>th</sup> centuries. It is likely that the early mining landscape at Geevor would have been similar in form and appearance.

Prior to the recovery of mine dumps on the hill for reprocessing by Geevor during the 1980s, this was one of the best-preserved and most complex pre-19<sup>th</sup> century mining landscapes to be found anywhere in West Cornwall. Fig 3 shows an extract from a 1973 aerial photograph of part of this area, and gives a good impression of the degree of landscape impact typically resulting from such intensive pre-industrialised operations.

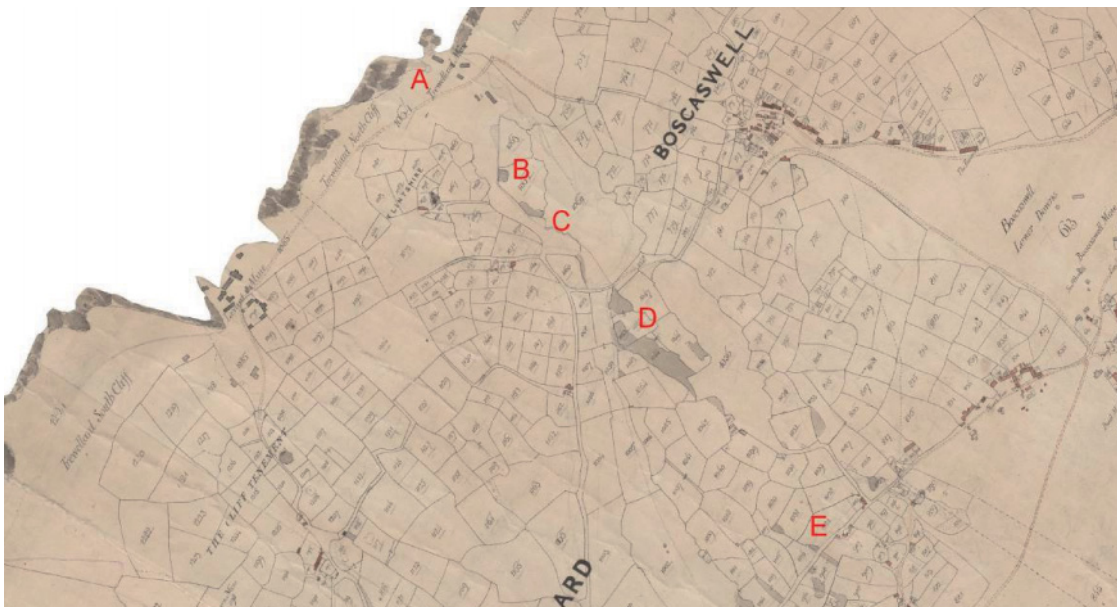
Fig 4. An extract from the c1840 rectified St. Just Tithe Map showing the area from the St. Ives road to the coast at Geevor, mine buildings on the coast at A) Trewellard Bottoms, and spoil dumps at B) Thorne's Shaft, C) Magazine Shafts, D) Borlase's Shaft and gunnis, E) Wethered Shaft.

The *circa* 1840 Tithe Map for St. Just (Fig 4) shows indications of mine workings on the Geevor site a decade before the formation of North Levant, extensive spoil dumps being depicted in the area between Redburrow Shaft and Borlase's Shaft (the core of the site of Wheal Gevor), a small area of spoil was also shown in the general area of the Wheal Mexico Shafts with further spoil dumps to the north on the western edge of

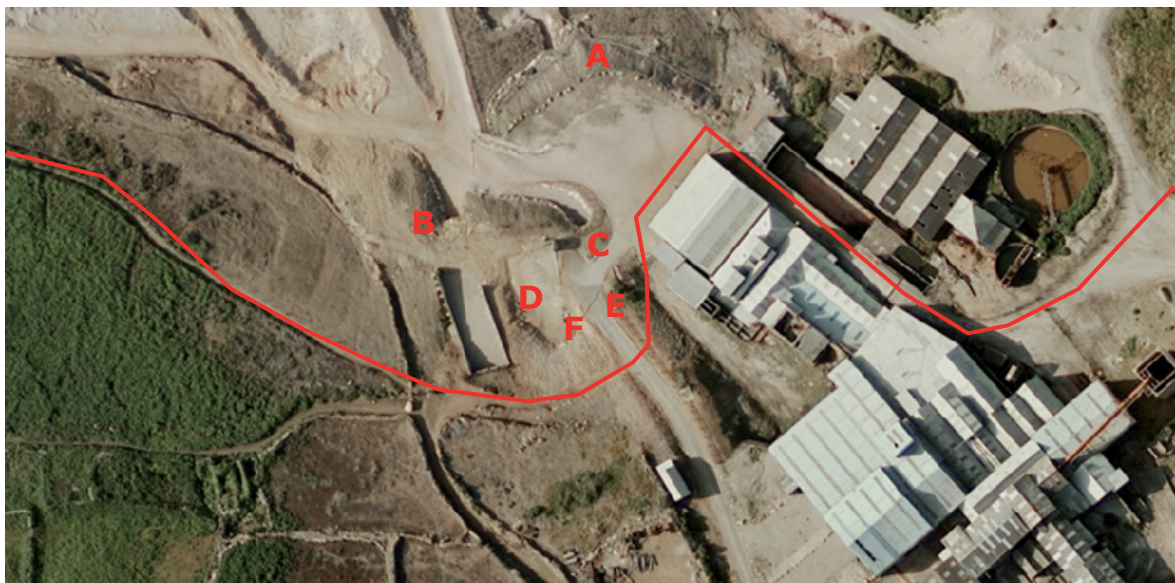
Fig 13. A 2005 Cornwall County Council aerial photograph of the lower part of the Geevor site showing (red line) the route of the main sewer and the locations of A) Mexico adit entrance, B) Mexico adit exit, C) New Mexico Shaft, D) Old Mexico Shaft, E) Mexico Ladderway Shaft, F) Sulphide Bay East Shaft. © Cornwall Council.

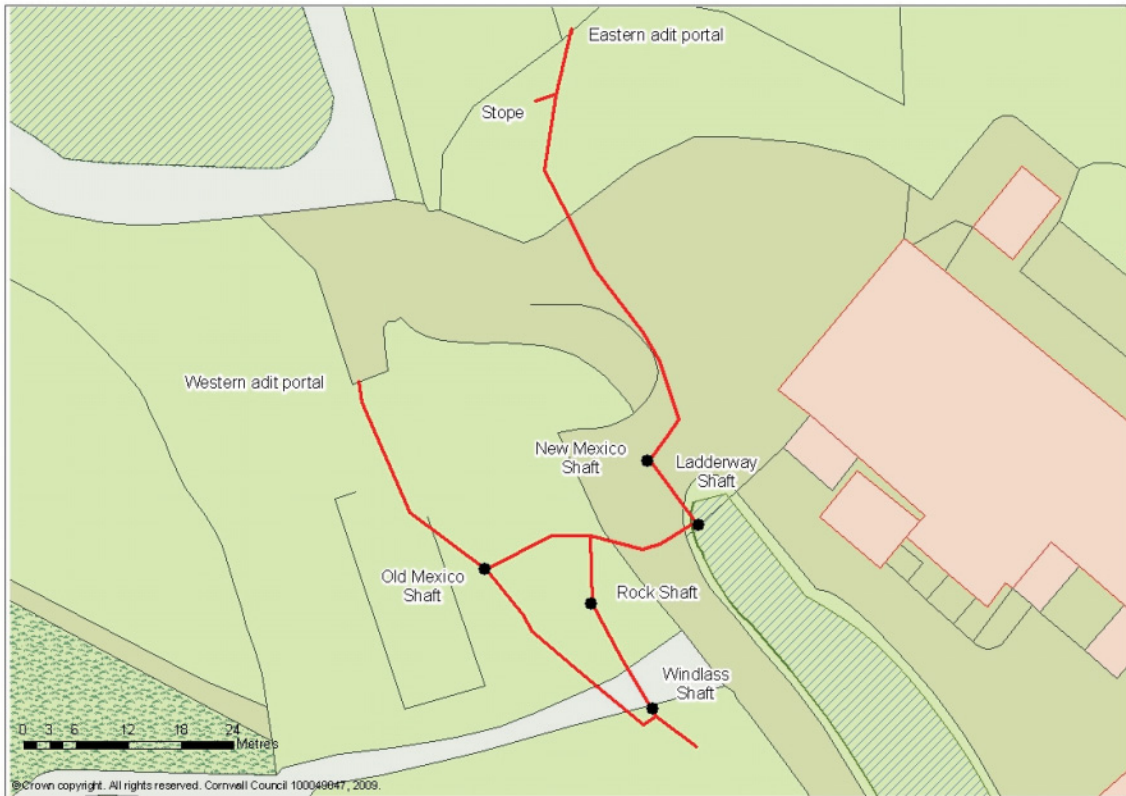
Fig 15. A rectified version of the 2010 Drillserve adit plan. A rectification algorithm incorporated into ArcGis 9.2 was used to geolocate the survey onto the OS Mastermap base. It should be noted that the position of the path from Levant (in grey, bottom of image) does not accurately reflect the position of this feature, which lies a little way to the south.

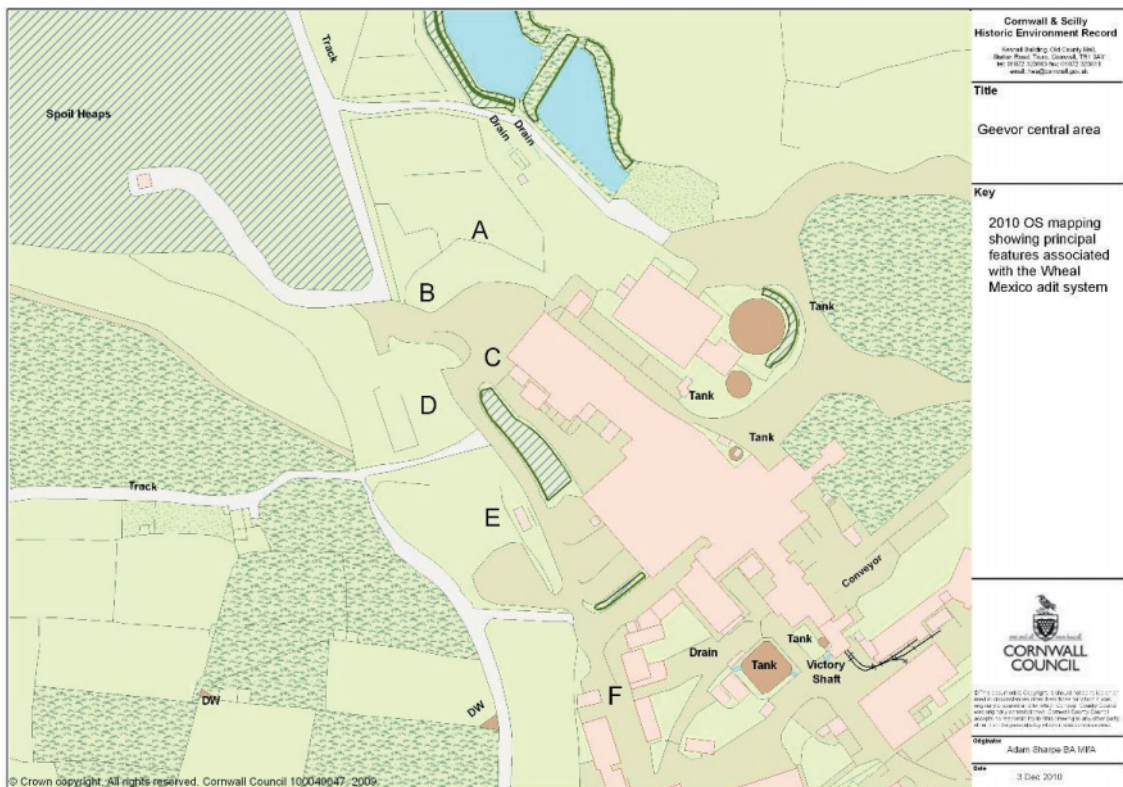
Fig 16. Features associated with the Wheal Mexico adit system. A) Adit entrance, B) Adit exit, C) New Mexico Shaft, D) Sulphide Bay, E) Assay Hut, F) Carpenters' Shop.

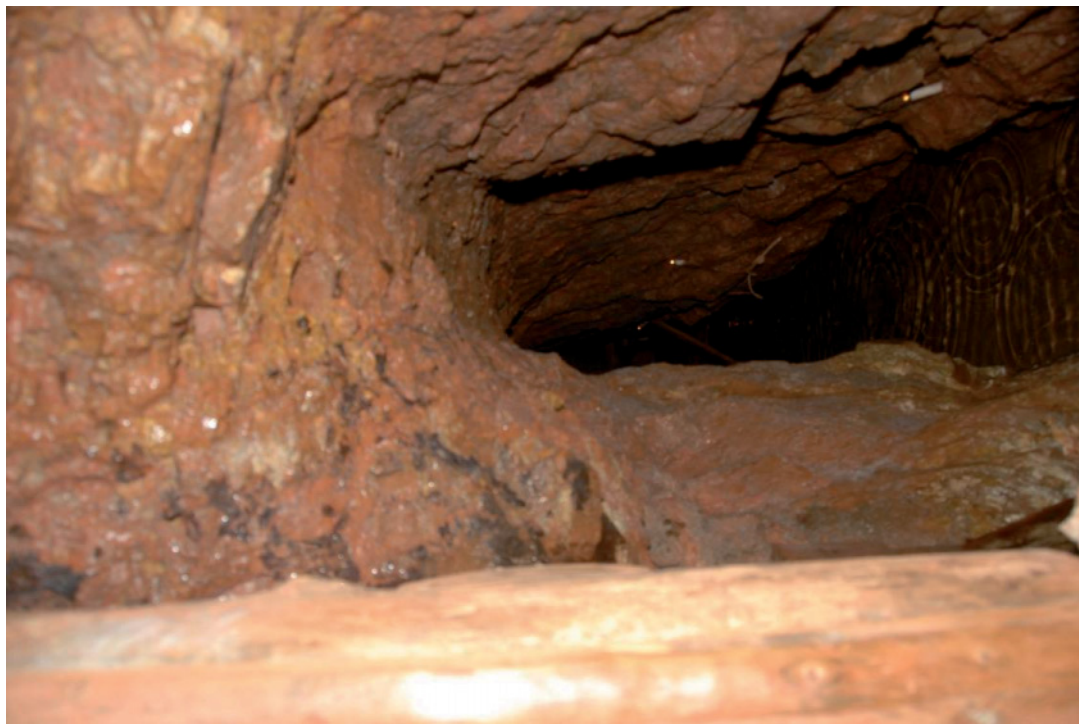
Fig 18. Looking south from Old Mexico Shaft into the western drive before work began, showing the water standing in it and the 'candles' installed by PCH. The drive was blocked a few metres upslope.

The western drive, running south-west from Old Mexico Shaft, had an arched roof, is rock-cut and, just to the south of the shaft, measured 1.45m high and was 0.6m wide in its base (Fig 18). A strong quartz vein was found on its western wall. The drive ran at an angle of 130 degrees magnetic for 5.5m from the shaft (to the location of the PCH sandbag dam), then changed direction slightly towards the east, running for 10m to the point where the slimes which elsewhere part-filled it rose up to meet the roof, possibly suggesting an entry point from surface nearby. Water ran continuously from the chokage, being piped via a sub-floor drainage system within the underground visitor route to discharge to Mexico Footway Shaft and thence to New Mexico Shaft. Other than the quartz leader exposed in the western side of the adit roof, there were no clear indications that this adit was driven on lode, though this was felt likely to have been the case, given its intersection with Old Mexico Shaft.

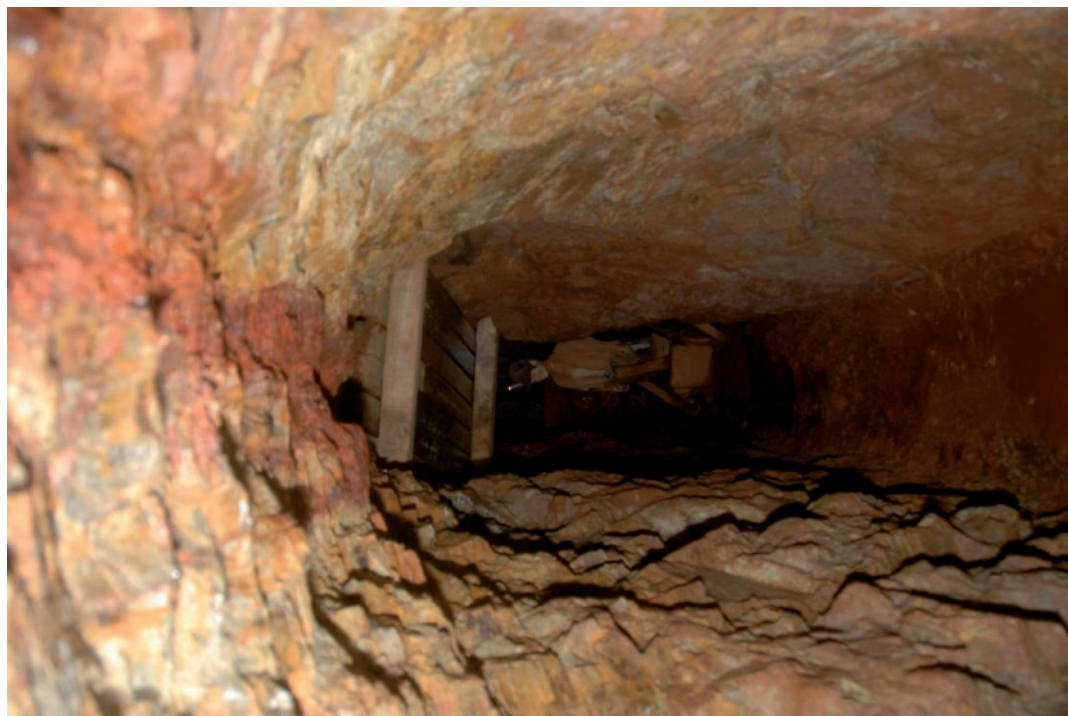
Fig 17. A view from the crosscut on the original visitor tour to Sulphide Bay East Shaft on the eastern drive prior to works, where PCH had set up a tableau including this mannequin.

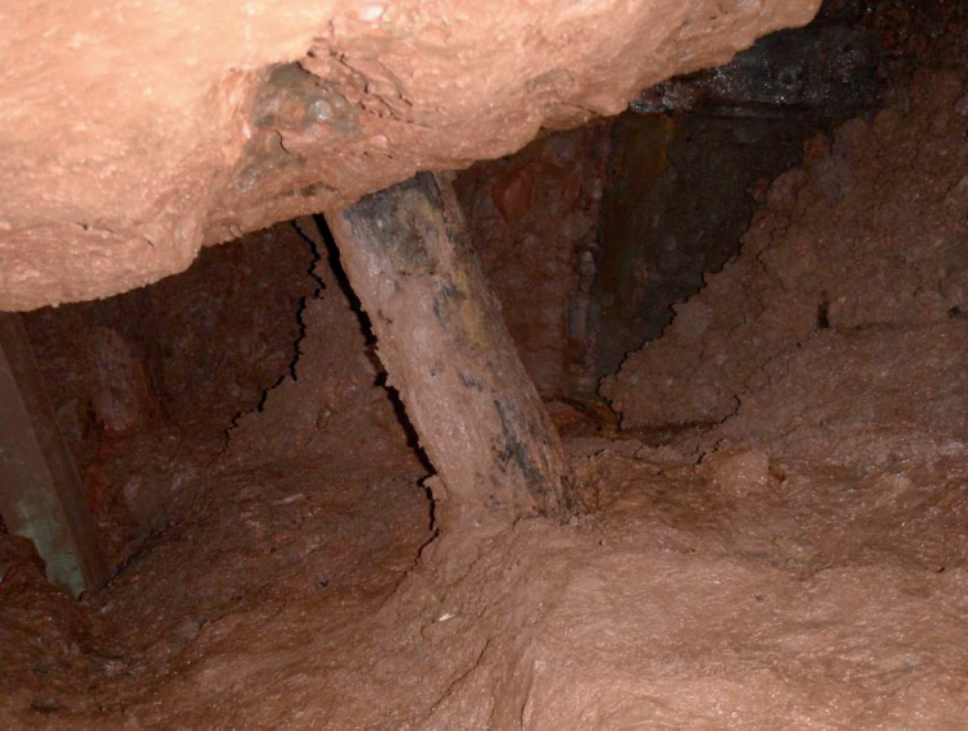
Fig 20. Some of the original timber stulls in the eastern drive. Note also the timber support lower right, which supported an overhanging section of the hanging wall.

Beyond the point where the pair of diagonal stulls propping the hanging wall were encountered vertical timbers could be seen (Fig 20) which were also supporting the hanging wall (which at this point formed a granite 'roof' over the western side of the tunnel). A small air gap was noted over the top of the slimes at this point, suggesting that it was possible that their surface level was going to reduce in height from this point on and that the shaft down which they had been disposed of had been sited in

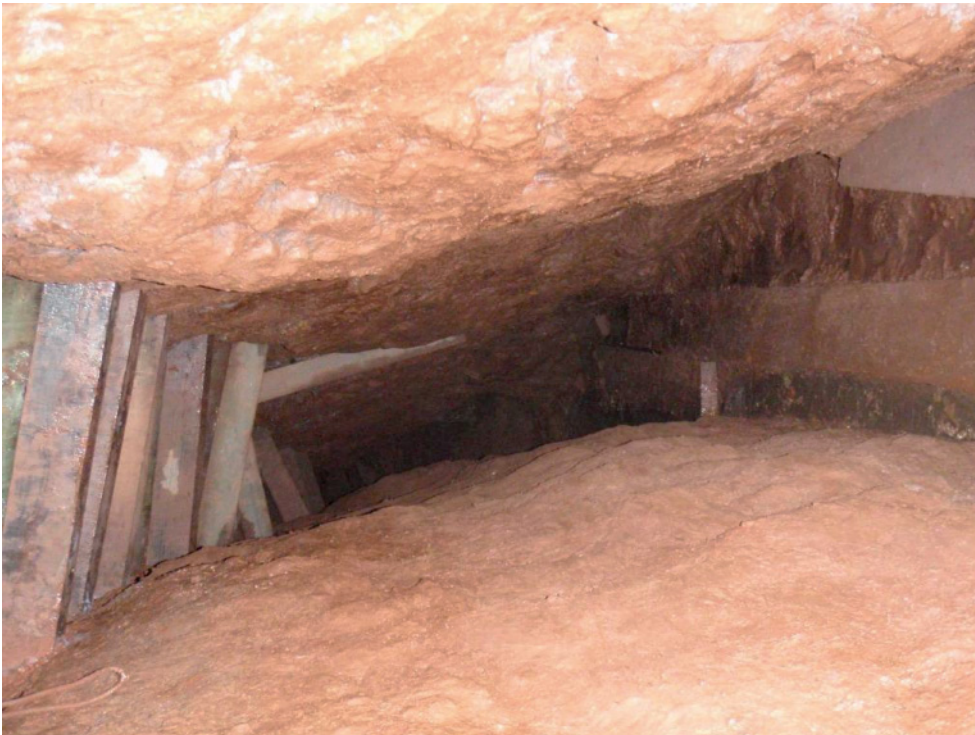
Fig 19. Looking up the eastern drive at an early stage of the works, showing the timber stulls on which the cover boards were set. The planks on the floor kept the contractors from sinking into the slimes filling the base of the stope.

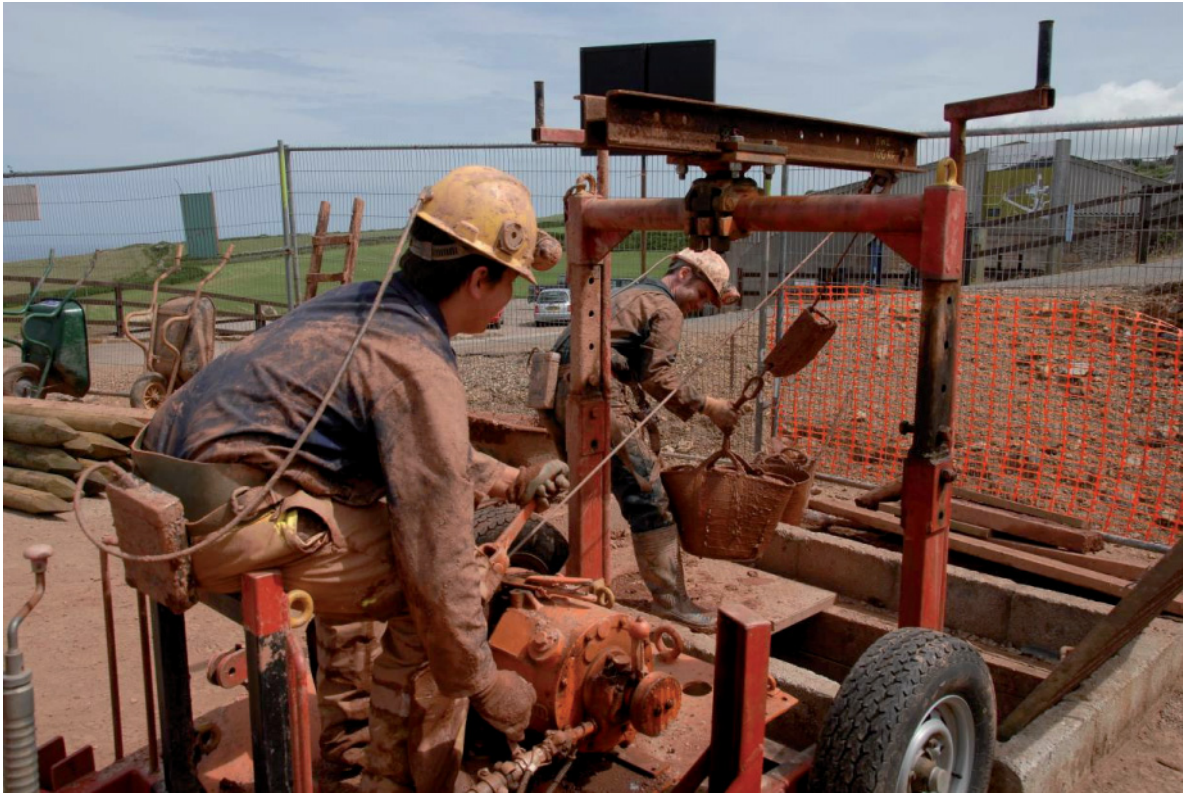
*Fig 25. Douglas Wheatcroft and John Dowling using a compressed-air Holmans' winch and gantry to haul buckets of spoil up from the eastern drive via Sulphide Bay East Shaft. This approach greatly reduced the amount of manual work involved in clearing the spoil in this drive, as well as limiting impacts on the visitor tour.*

surface for disposal (Fig 25), the material being temporarily stockpiled within the sulphide bay, though subsequently permanently disposed of downslope.

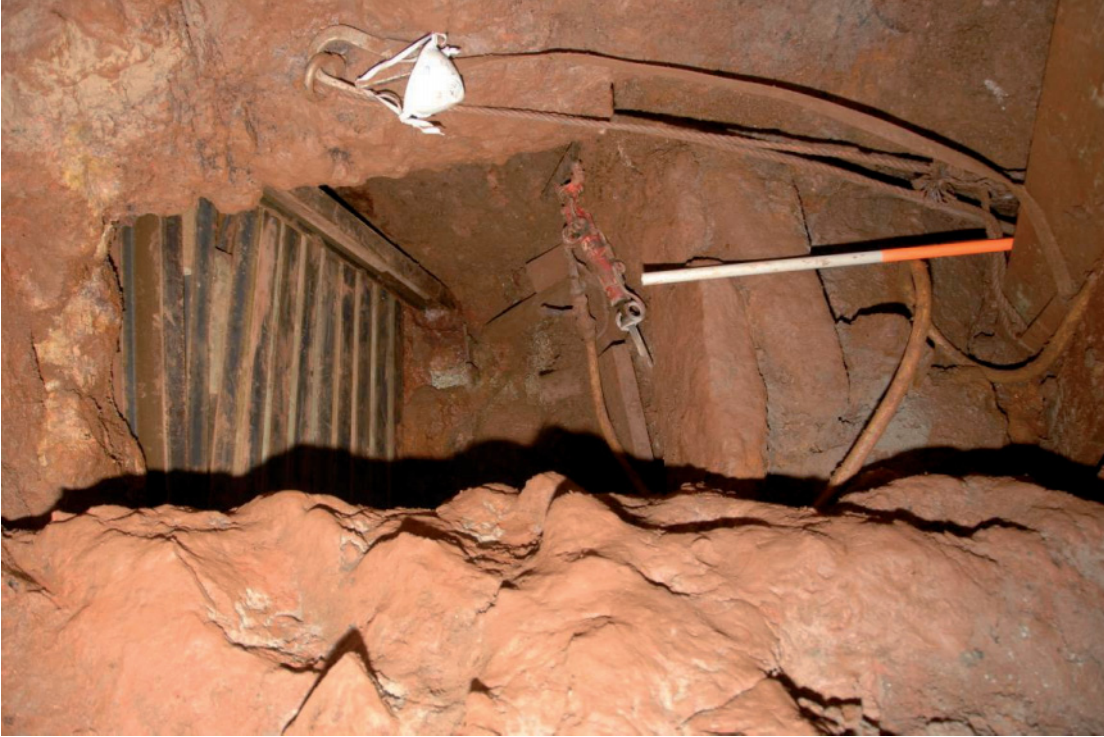
Fig 30. Looking from the southern end of the western drive into the connection with the eastern stope. The steelwork in the roof was installed to support the loose material above, which runs to surface. The stone wall between the two tunnels survived at this time.

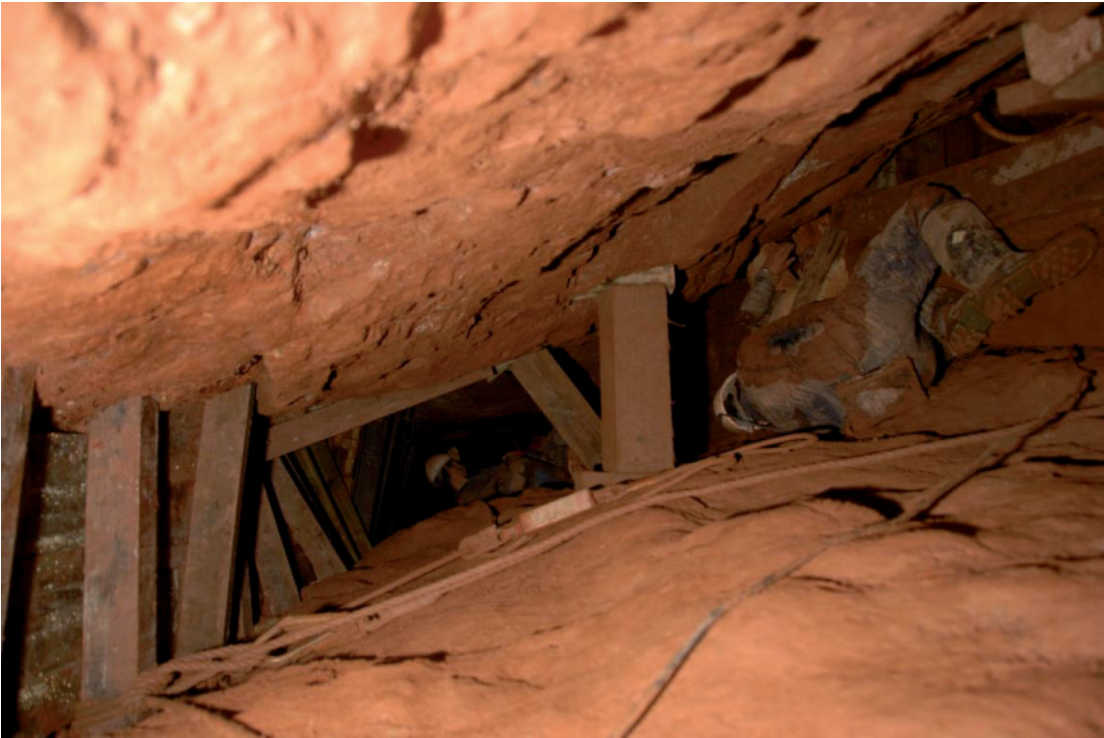
Fig 29. This view southwards in the eastern drive gives a good impression of the amount of timberwork needed to support the hanging wall during clearance operations. Further low-level props are being installed in this view.

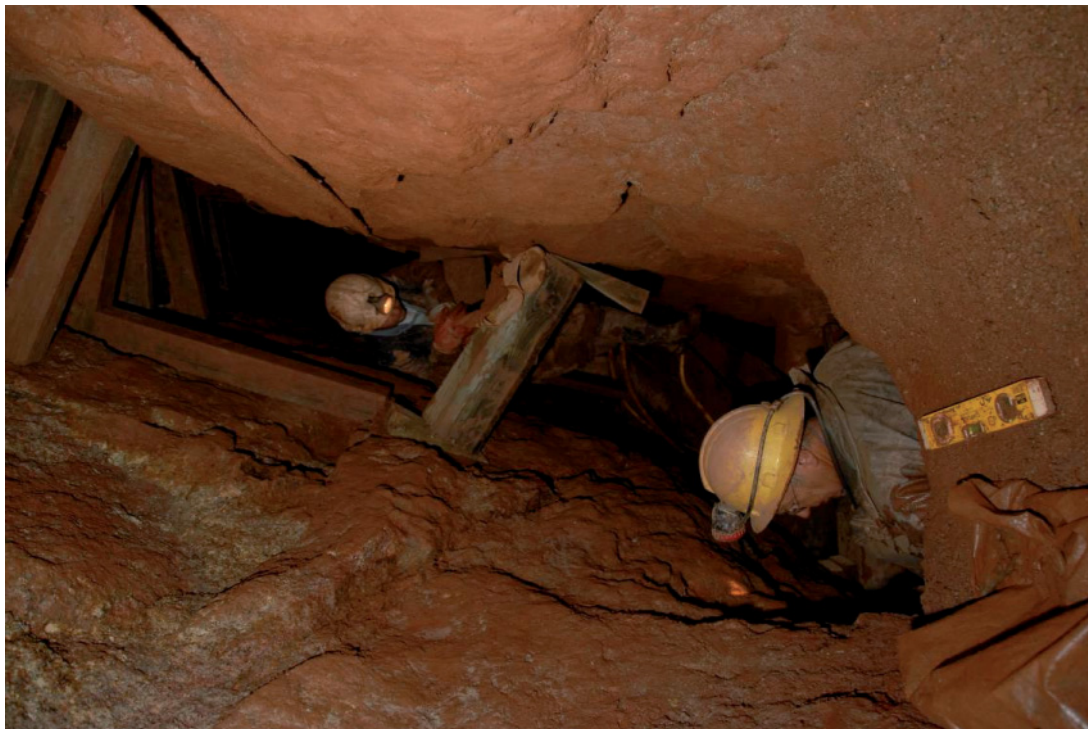
Fig 32. Work under way in the eastern drive, showing the permanent and temporary timberwork to support the hanging wall (Mervyn Brakespear and John Dowling shown at work).

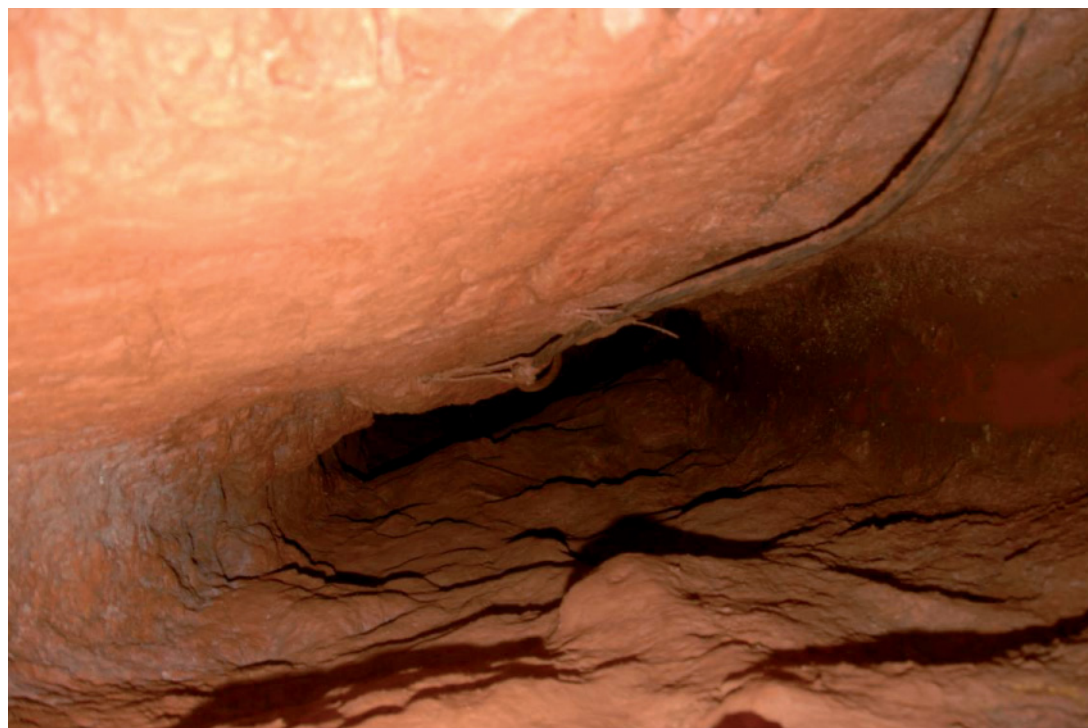
Fig 31. Looking south along the western drive following its excavation.

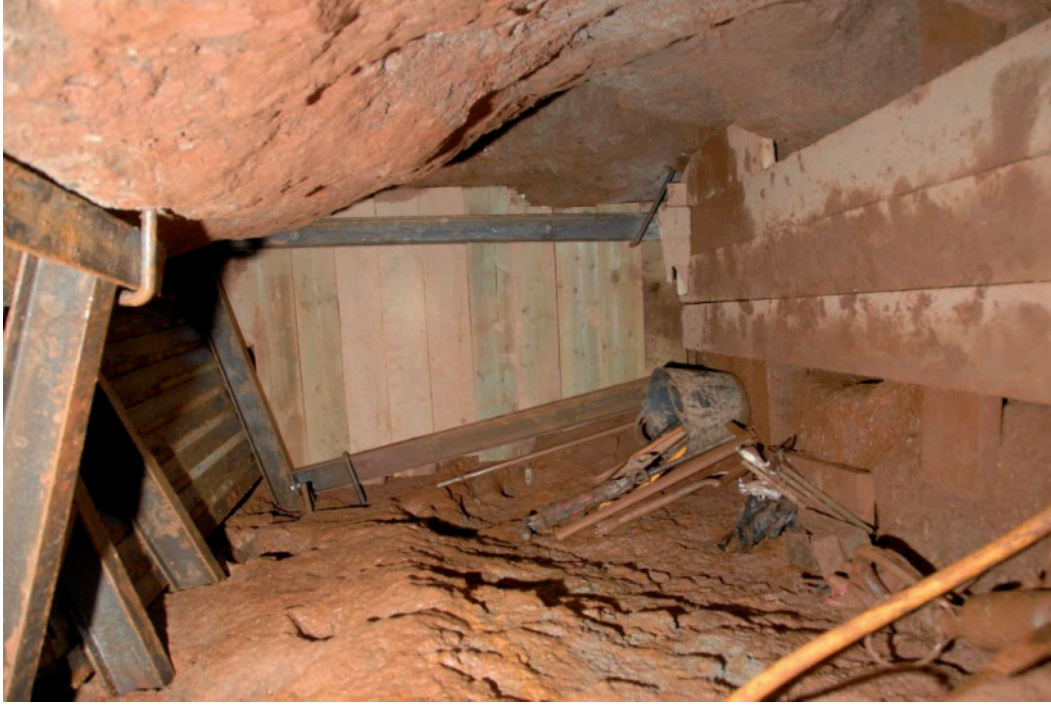
Fig 34. The limits of excavation on the eastern stope once the unexcavated fills had been bratticed off and the timber floor had been partially constructed.

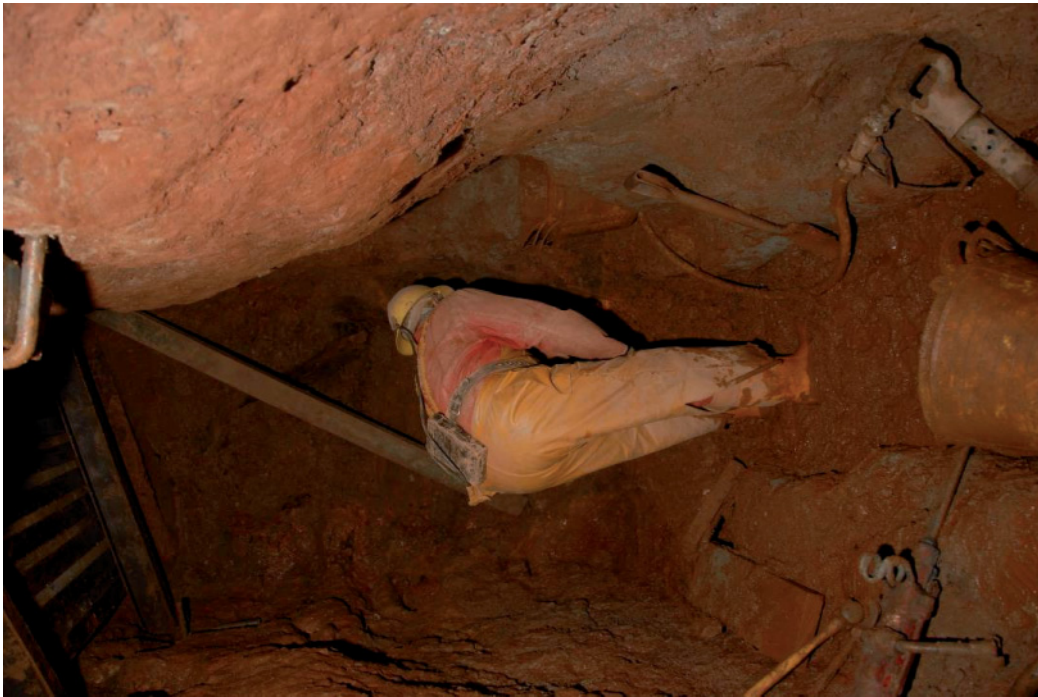
Fig 33. Work under way at the southernmost extent of the excavated part of the eastern stope. Mervyn Brakespear is standing on the fills of 'Windlass Shaft', whose curved eastern wall is just visible to his left.

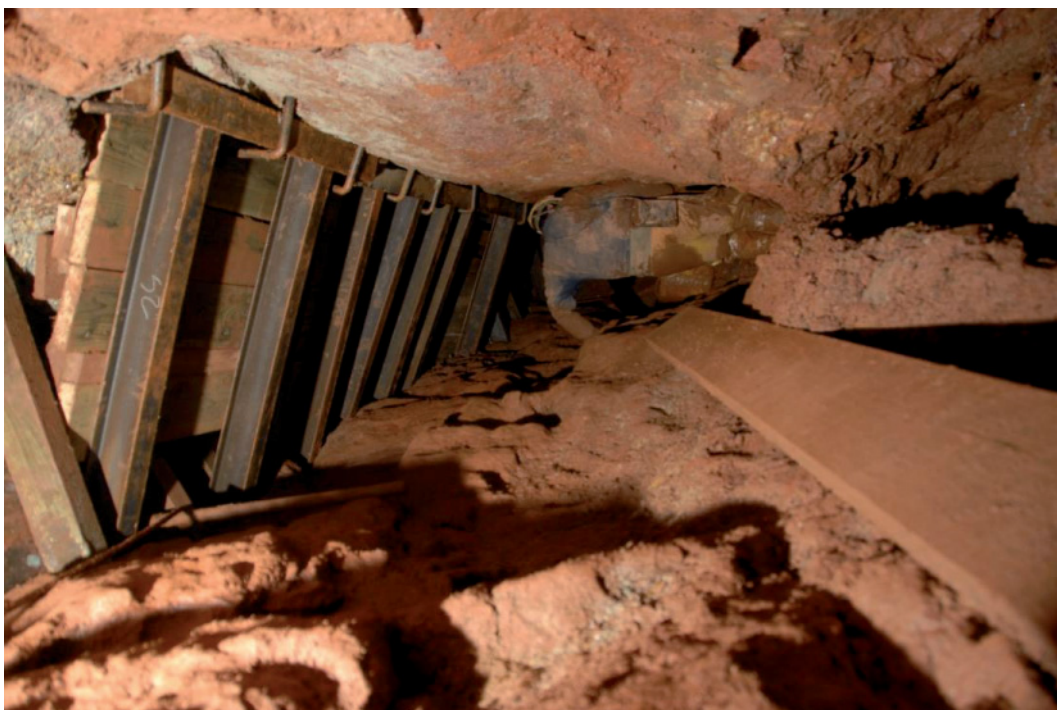
Fig 35. Looking south in the eastern stope. The plank is resting on the rock pillar found at this point.

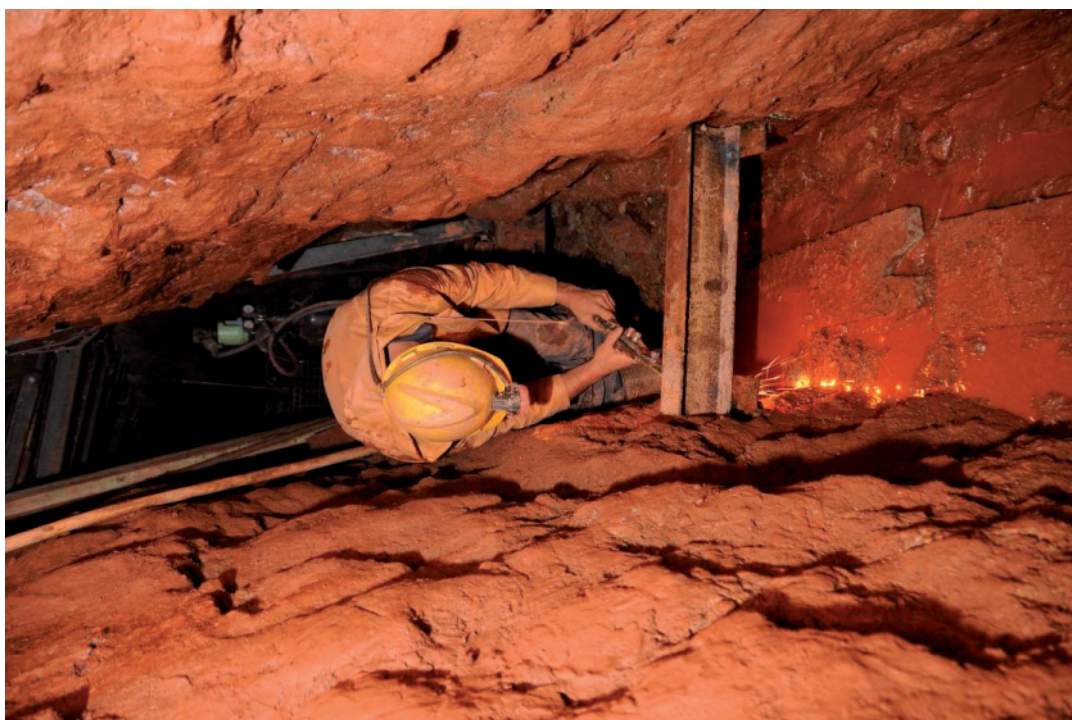
Fig 38. Pat Orient flame cutting a low level floor support UB to length in the eastern drive.

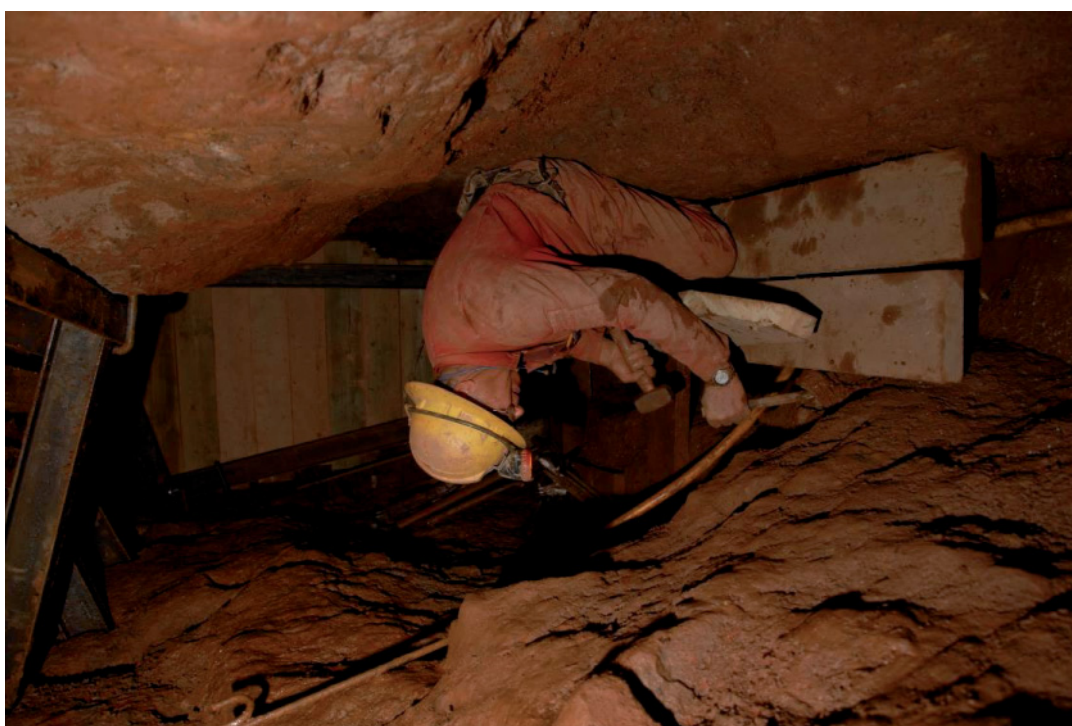
Fig 37. Mervyn Brakespear constructing the planked floor at the southern end of the eastern drive.

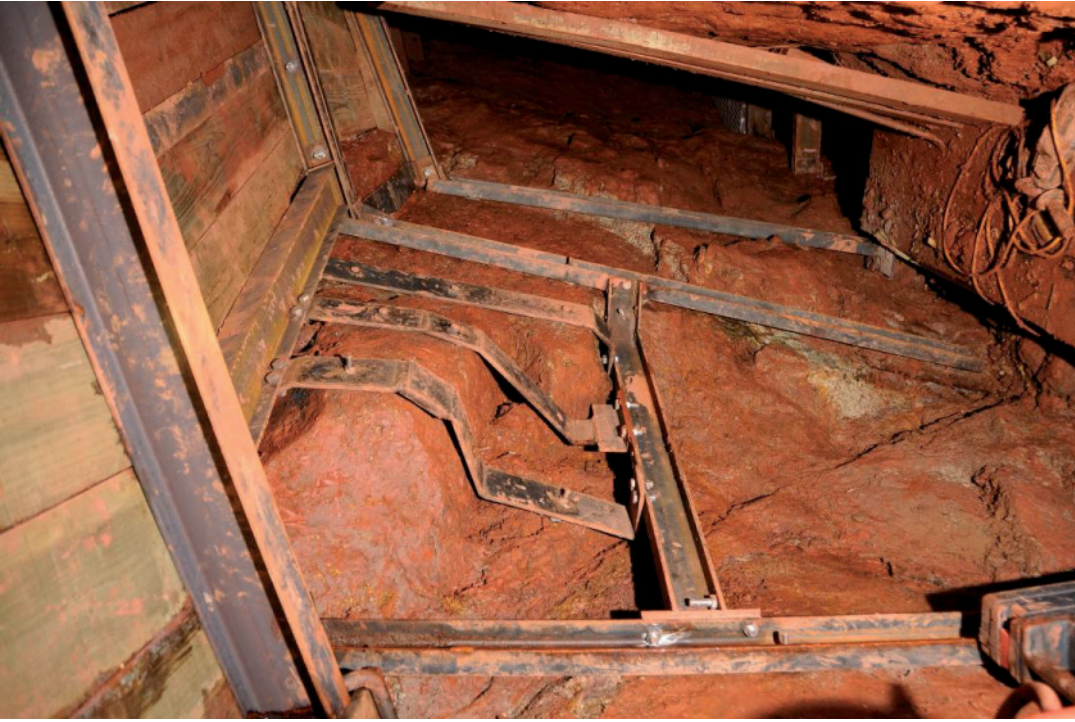
Fig 40. The steel channels and strapping used to create the necessary support for the weak section of the hanging wall in the eastern stope.

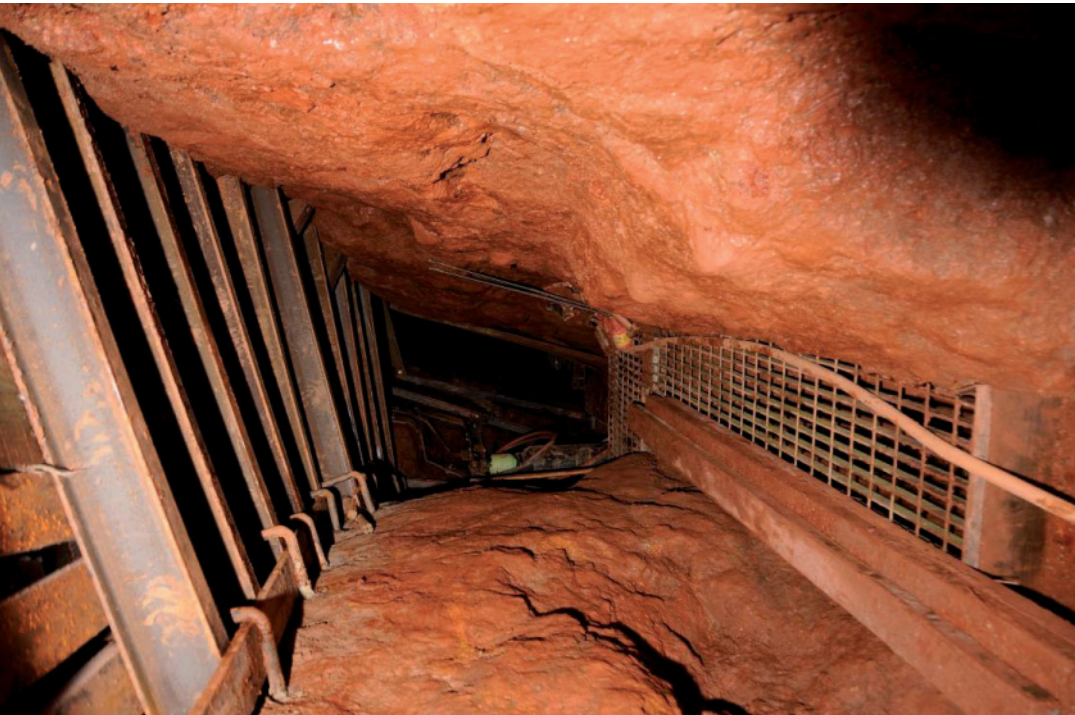
Fig 39. The steel mesh floor set on UBs installed over most of the length of the eastern stope.

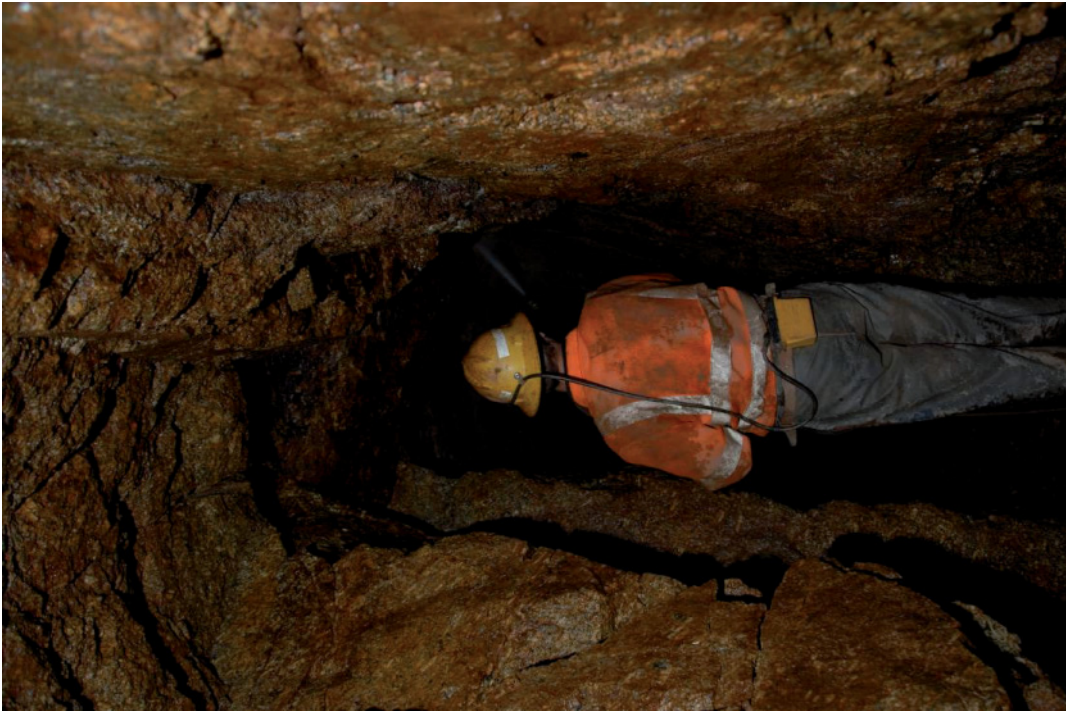
Fig 42. Nick Hall pressure washing slimes from the walls of the western drive.

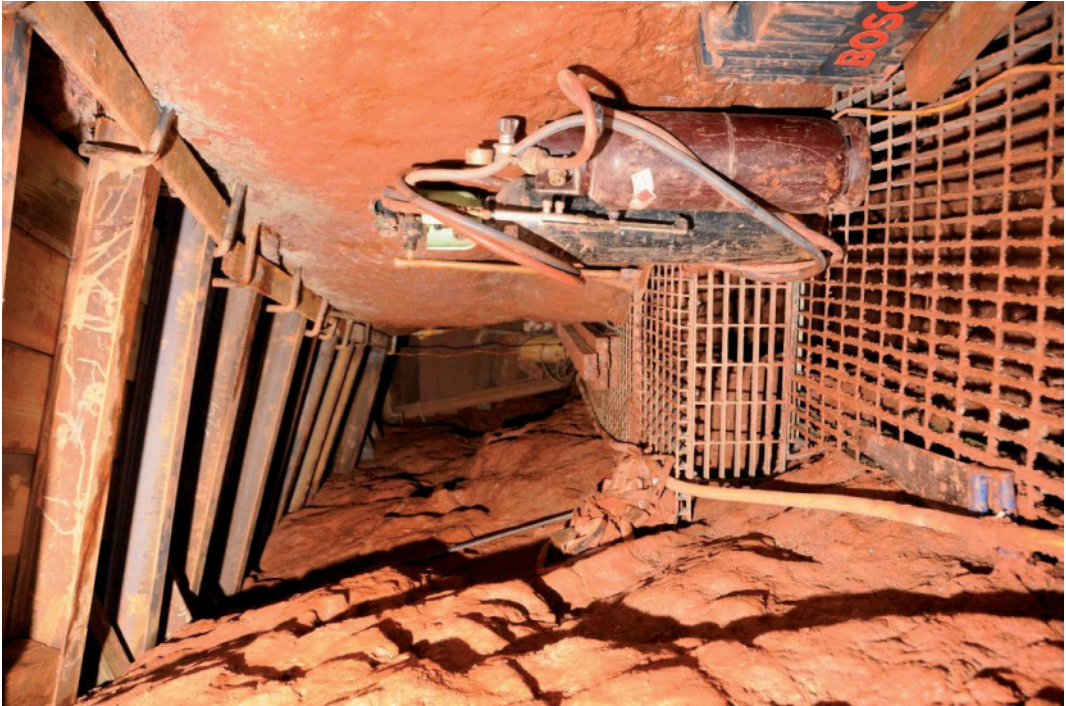
Fig 41. The completed steel mesh flooring in the eastern stope, showing the greatly reduced headroom between the floor and the roof support at this point in the adit system.

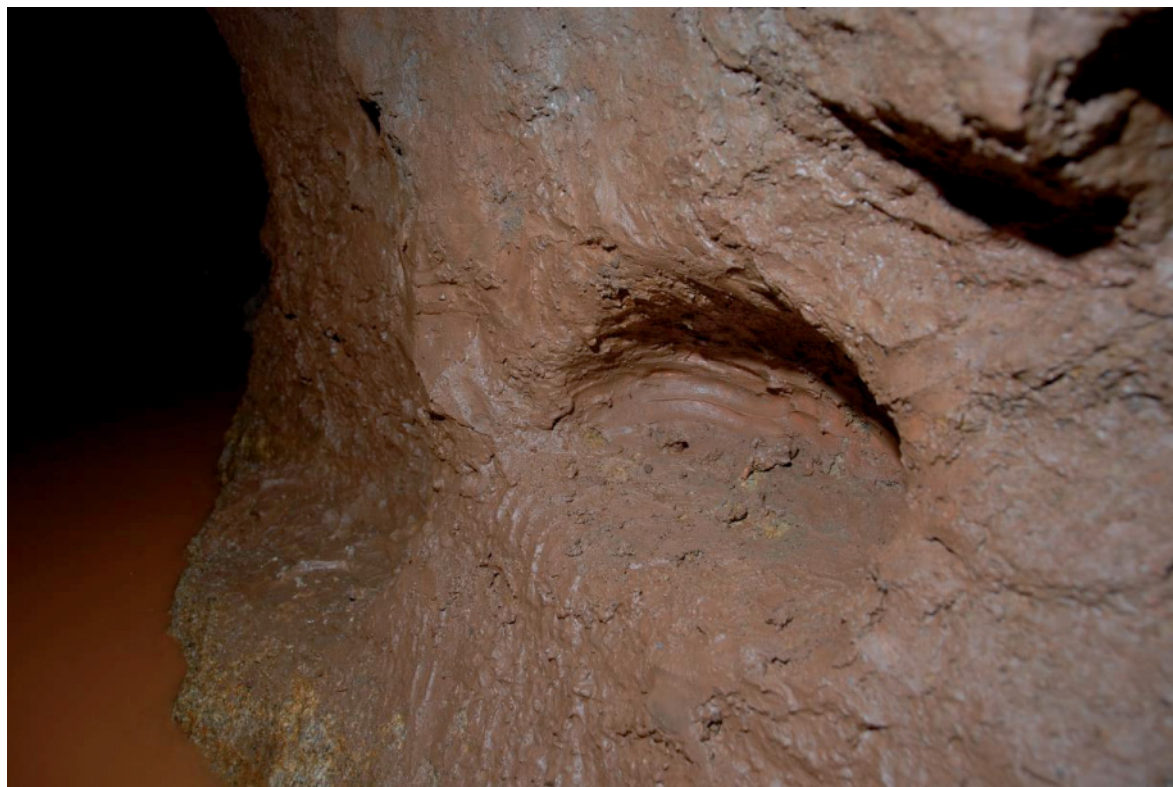
*Fig 44. A low-level candle niche excavated into the footwall of the western drive.*

By the end of the first full week of work on this tunnel the heading was clear for 17m from the point where it branched off the cross-cut, the fill material in this section of the tunnel sloping up to meet the roof to the south just beyond this point. Only one short (and obviously hand-cut) drill hole was observed in (the roof of) this first section of the tunnel (see Fig 45 for a similar drill hole), which passed from killas to granite about 5.0m from the cross-cut, the rock near the contact point being notably friable, cheesy and readily removable. A substantial quartz leader which had been noted on the western side of the tunnel at its junction with Old Mexico Shaft could be traced for several metres. Shallow pick-marks were observed on the eastern side wall over most of the length of the north-eastern end of the tunnel (Fig 46) suggesting that this end of the adit had been almost wholly hand-cut, or at least trimmed to shape by hand, the rock near the contact point between the killas and granite being relatively soft. A low-level candle recess was also revealed cut into the wall of the first section of the adit to be cleared (Fig 44).
