# Wheal Mexico, Geevor, Cornwall

Archaeological consultancy and watching brief during the extension of the underground visitor tour route

<b>Client</b>	<b>Cornish Mining World Heritage Site Team</b>
<b>Report Number</b>	<b>2011R038</b>
<b>Date</b>	<b>31 March 2011</b>
<b>Status</b>	<b>Final</b>
<b>Report author</b>	<b>Adam Sharpe BA MIfA</b>
<b>Checked by</b>	<b>Peter Rose, Projects Manager</b>
<b>Approved by</b>	<b>Peter Rose, Projects Manager</b>

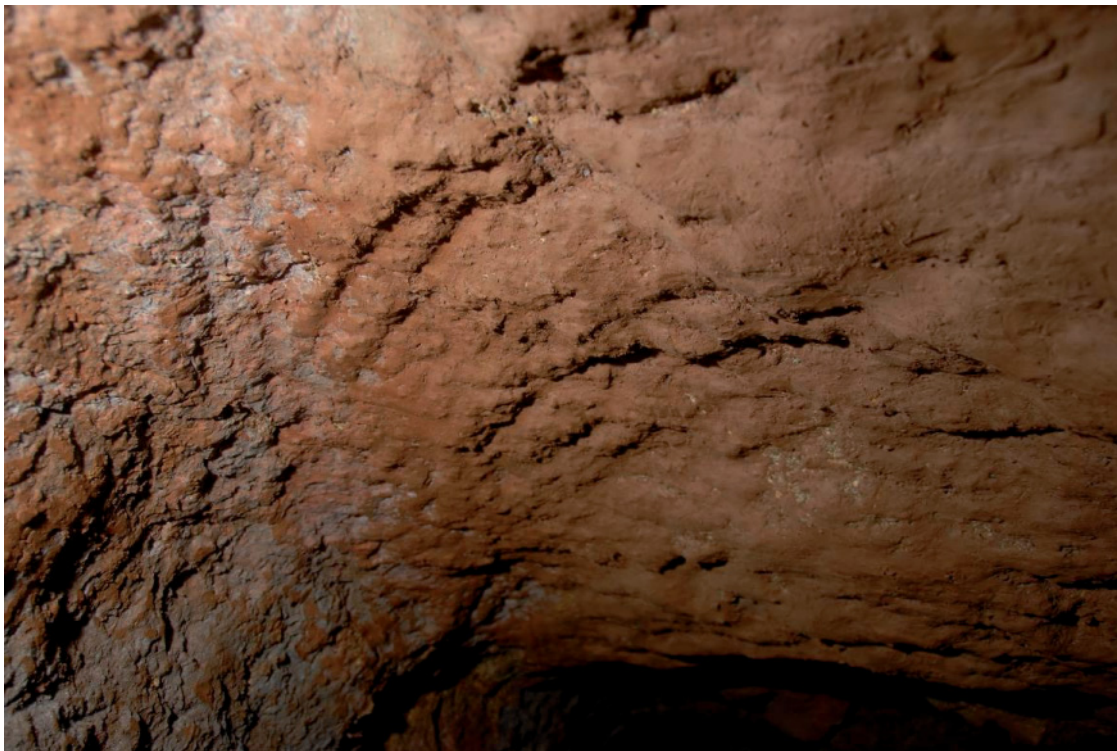
Fig 46. A section of the wall of the western drive showing evidence for having been dressed with a pick.

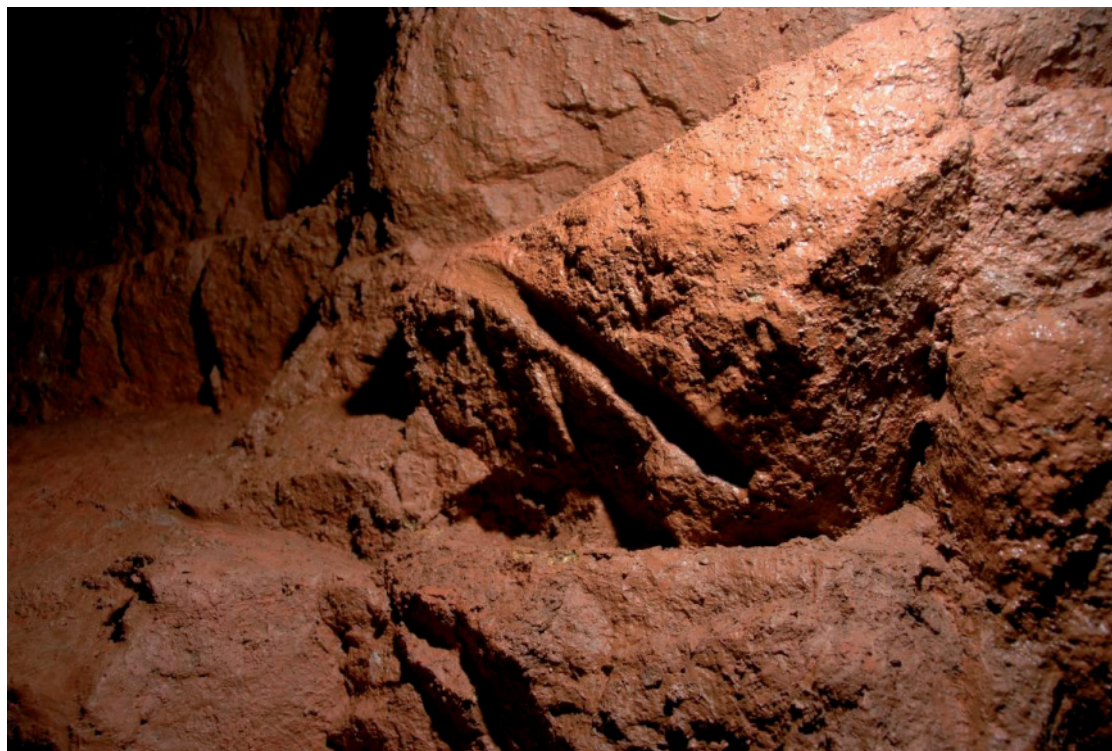
Fig 45. A hand-cut drill hole in the roof of the western adit near its southern end.

By the end of the first full week of work on this tunnel the heading was clear for 17m from the point where it branched off the cross-cut, the fill material in this section of the tunnel sloping up to meet the roof to the south just beyond this point. Only one short (and obviously hand-cut) drill hole was observed in (the roof of) this first section of the tunnel (see Fig 45 for a similar drill hole), which passed from killas to granite about 5.0m from the cross-cut, the rock near the contact point being notably friable, cheesy and readily removable. A substantial quartz leader which had been noted on the western side of the tunnel at its junction with Old Mexico Shaft could be traced for several metres. Shallow pick-marks were observed on the eastern side wall over most of the length of the north-eastern end of the tunnel (Fig 46) suggesting that this end of the adit had been almost wholly hand-cut, or at least trimmed to shape by hand, the rock near the contact point between the killas and granite being relatively soft. A low-level candle recess was also revealed cut into the wall of the first section of the adit to be cleared (Fig 44).

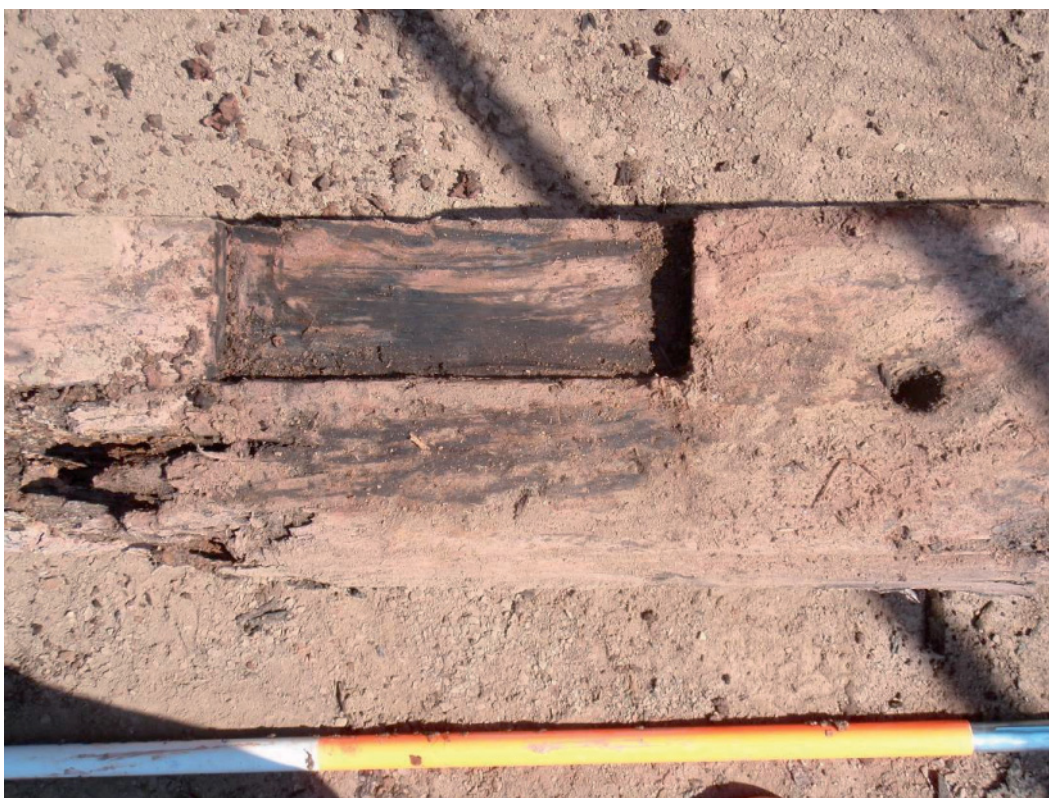
*Fig 50. One of the timbers recovered from the eastern stope. Although last used as a prop to support the hanging wall, it had clearly previously been used for other purposes.*

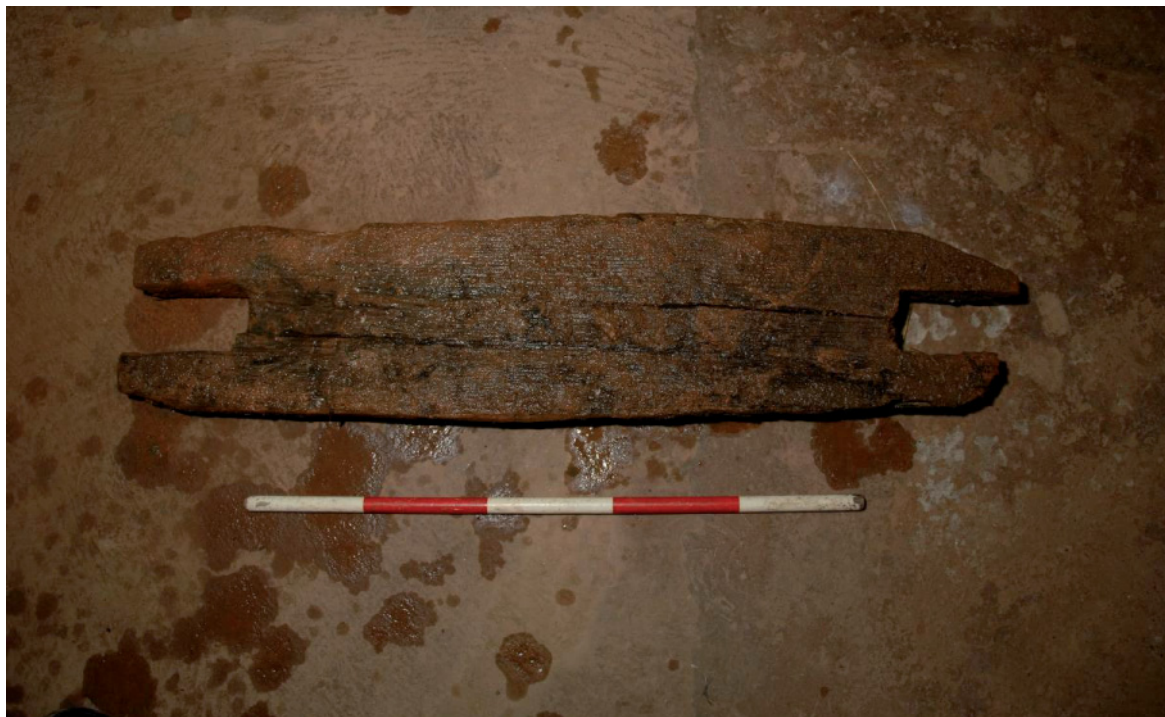
*Fig 54. One of the timbers recovered from the stope fills near the internal shaft. It has been suggested that the paired cut-outs and careful shaping suggest that it was part of an early windlass support, though it may be part of a ladder. 500mm scale.*

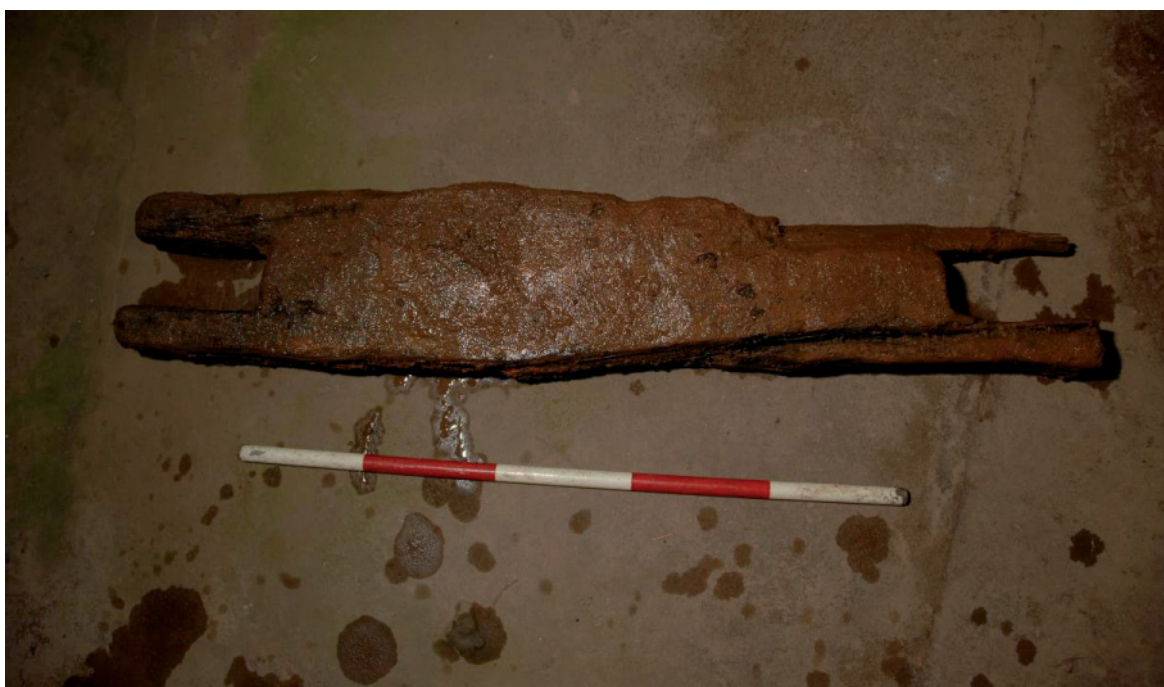
*Fig 55. A less well preserved piece of timber, but clearly intended to perform the same function as that shown in Fig 54.*

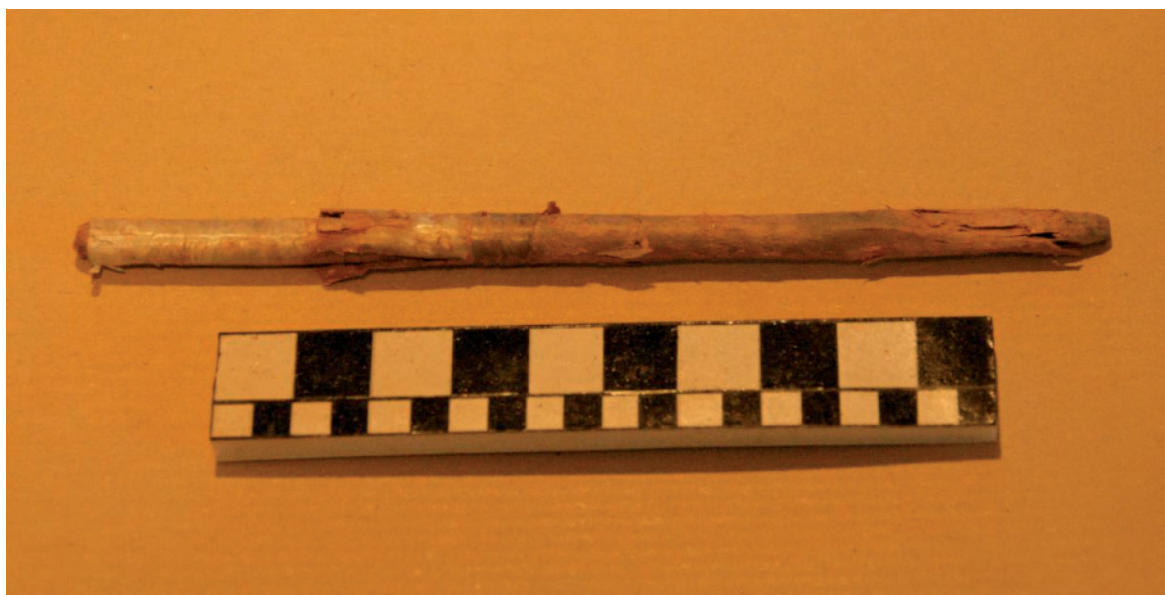
Fig 56. The goose quill fuse found in the western adit backfill. 100mm scale.

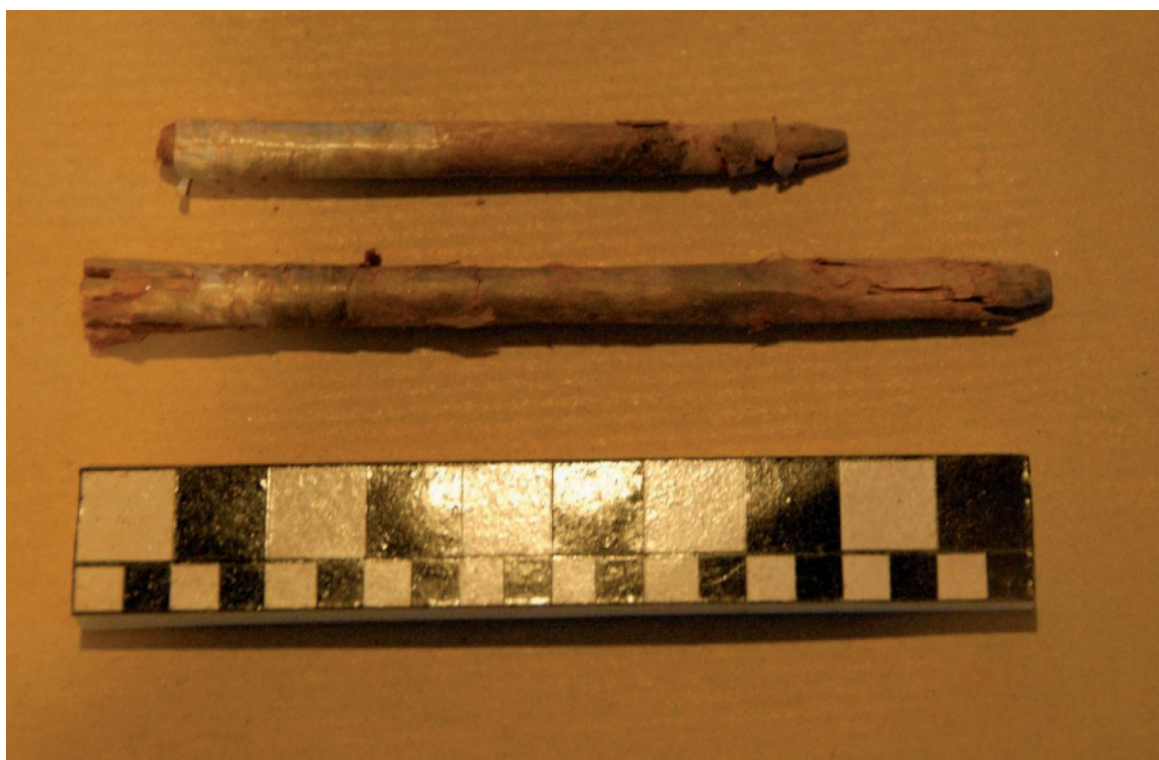
Fig 57. The disassembled goose quill fuse. The material protruding from the left hand end of the upper section is the dried clay which fills it, whilst its reddened section indicates the extent to which it was inserted into the lower piece of quill. 100mm scale.

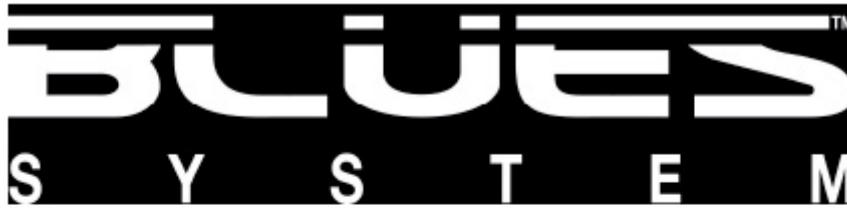
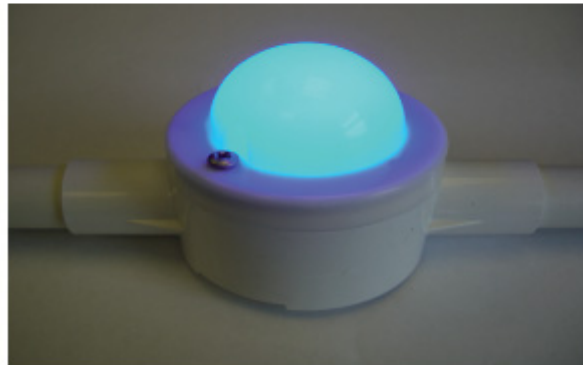
- Polycarbonate Opaque Dome giving 180° light throw
- Available in Luxeon standard LED's and the New K2 LED
- Power consumption 2.7 Watts
- Colours—Warm White K2, Cool White K2, Green, Cyan, Blue and Royal Blue
- Onboard Dimming
- RoHS Compliant (Restriction of Hazardous Substances)
  - CUL Compliant
  - EMC Compliant (Marine Standard)
- 88,000 hour lamp life (with data available at 68,000 hours)
- Maintenance Free operation for up to 15 years

The Opaque Dome is virtually unbreakable, made from Poly Carbonate it is the ideal replacement for a standard Bulk Head fixture for general lighting wall mounted. It can also be used as a ceiling light for corridors and low level work for both emergency lighting and ambient lighting. With unprecedented thermal, drive and current light output capabilities, it offers lighting industry leading lumens per package and enclosed in the BlueDome housing it offers a totally flexible IP68 solution for any type of application.

*Fig 62. The product information sheet for the Blue Dome unit which was used at roughly 3.0m spacings to provide background lighting for the visitor tour at Wheal Mexico. These are run via a battery backup system to provide emergency lighting should there be a power failure.*

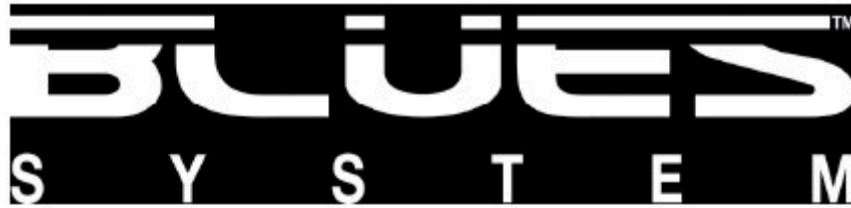
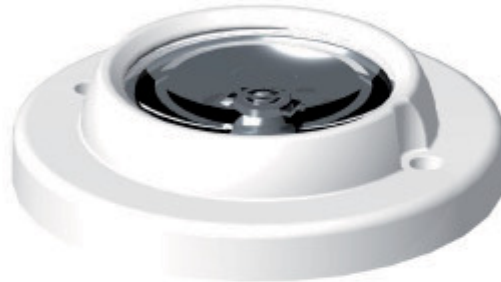
- Ideal Projected distance is from 2m(6.5ft) – 6m (19ft)
- Available in Luxeon standard LED's and the New K2 LED
- Power consumption 2.7 watts
- Colours—Warm White K2, Cool White K2, Green, Cyan, Blue and Royal Blue
- Onboard Dimming
- RoHS Compliant (Restriction of Hazardous Substances)
  - CUL Compliant
  - EMC Compliant (Marine Standard)
- 88,000 hour lamp life (with data available at 68,000 hours)
- Maintenance Free operation for up to 15 years

The 10 Degree Beam fixture is a very versatile fixture in the range and can be used for anything from emergency lighting to ambient lighting from 2m to 6m. With unprecedented thermal, drive and current light output capabilities, it offers lighting industry leading lumens per package and enclosed in the BlueBeam housing it offers a totally flexible IP68 solution for any type of application.

**At an average mounting of 3m using the K2 Warm White the size of the beam would be 1.4m Diameter with a light level of 34 LUX.**

Fig 63. The product information sheet for the Blue Beam LED spotlight, ten of which have been installed at Wheal Mexico to light specific features of interest.

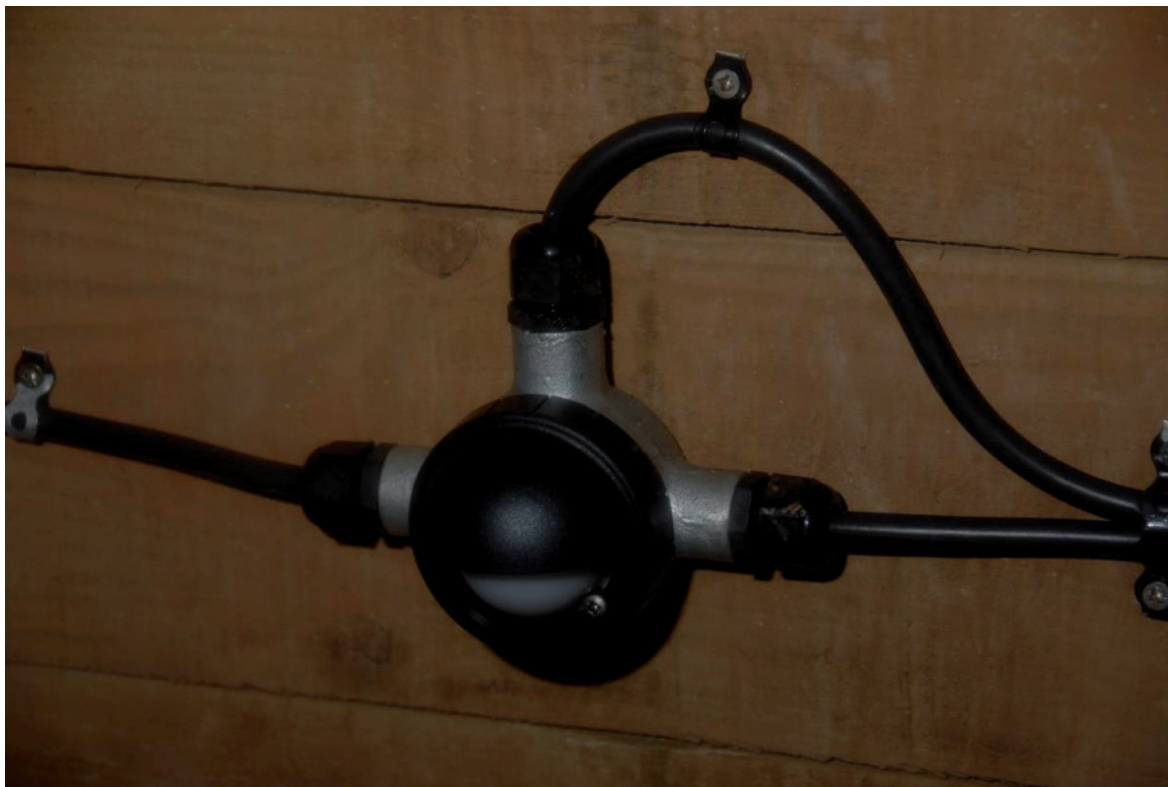
*Fig 64. One of the Blue Dome LED lighting units, fitted with a cowl which effectively directs the light. The majority of the cowls on the low level lights were angled so as to light the route ahead.*

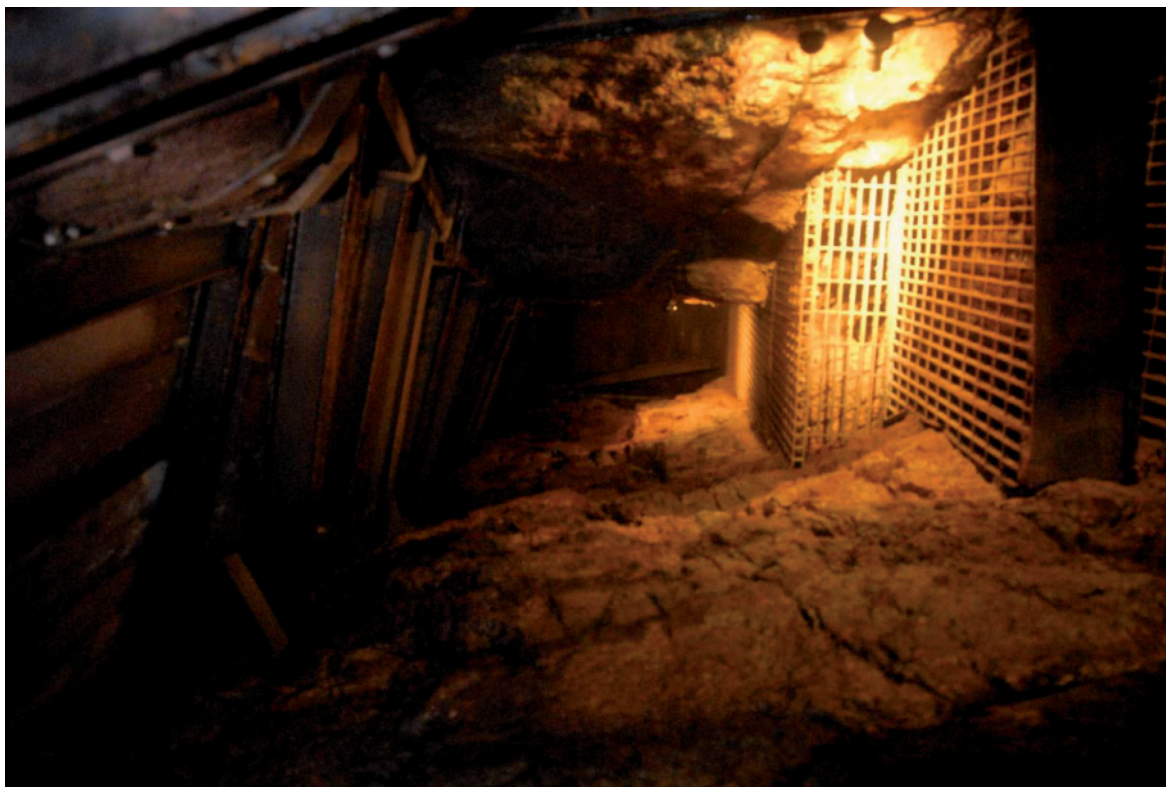
Fig 67. Looking south along the eastern drive showing the mesh flooring over the stope and the steel roof supports.

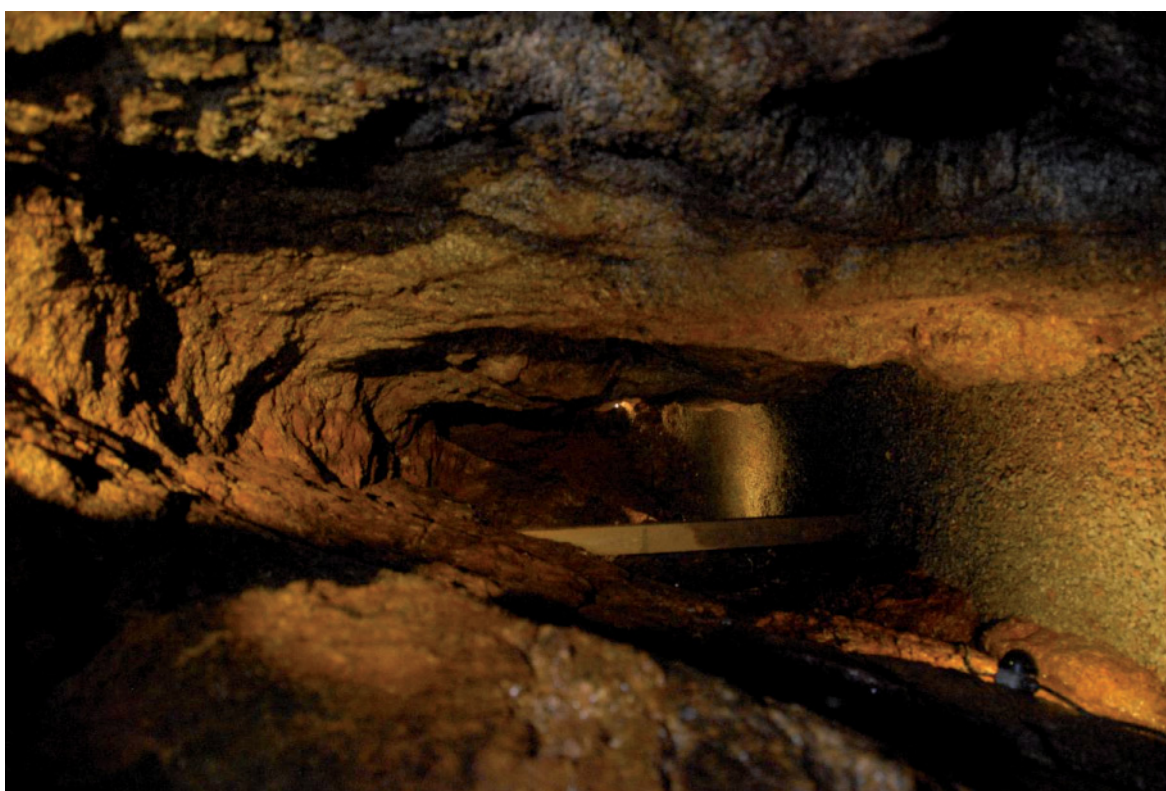
Fig 66. Looking north along the western drive showing the gravel flooring and a timber prop supporting the wall.
