# **St Agnes Beacon, Tubby's Head, Wheal Coates, Chapel Combe, Charlotte and Towan Moors, St Agnes, Cornwall**

## **Archaeological and ecological assessment**

**Archaeological and ecological assessment for  
the National Trust**

<b>Client</b>	<b>The National Trust</b>
<b>Report Number</b>	<b>2011R037</b>
<b>Date</b>	<b>01/04/2010</b>
<b>Status</b>	<b>Final</b>
<b>Report author(s)</b>	<b>Adam Sharpe BA MIFA, Graeme Kirkham MA MIFA, Spalding Associates</b>
<b>Checked by</b>	<b>Peter Rose, Projects Manager</b>
<b>Approved by</b>	<b>Peter Rose, Projects Manager</b>

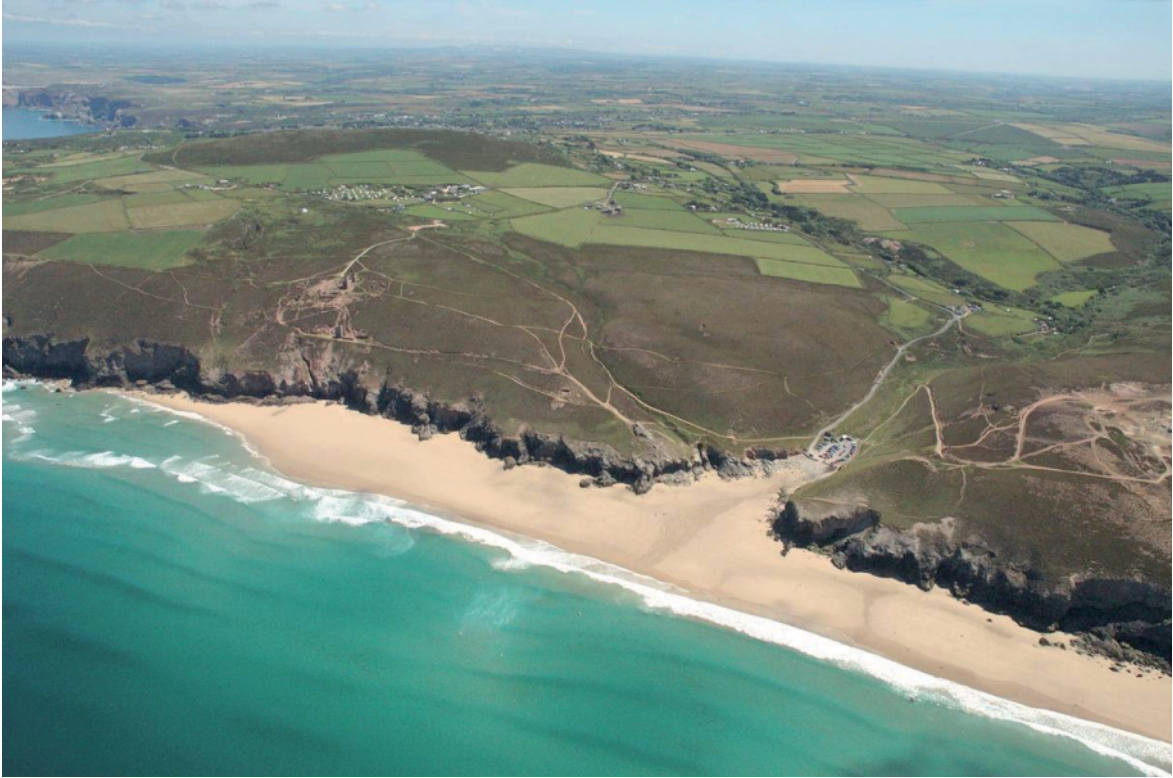
*Fig 16. An aerial view of the central part of the project area from the sea, with St. Agnes Beacon in the distance (upper left), Wheal Coates (left), Chapel Porth and Chapel Combe (centre) and Great Wheal Charlotte (right). HE Photograph F69-011.*

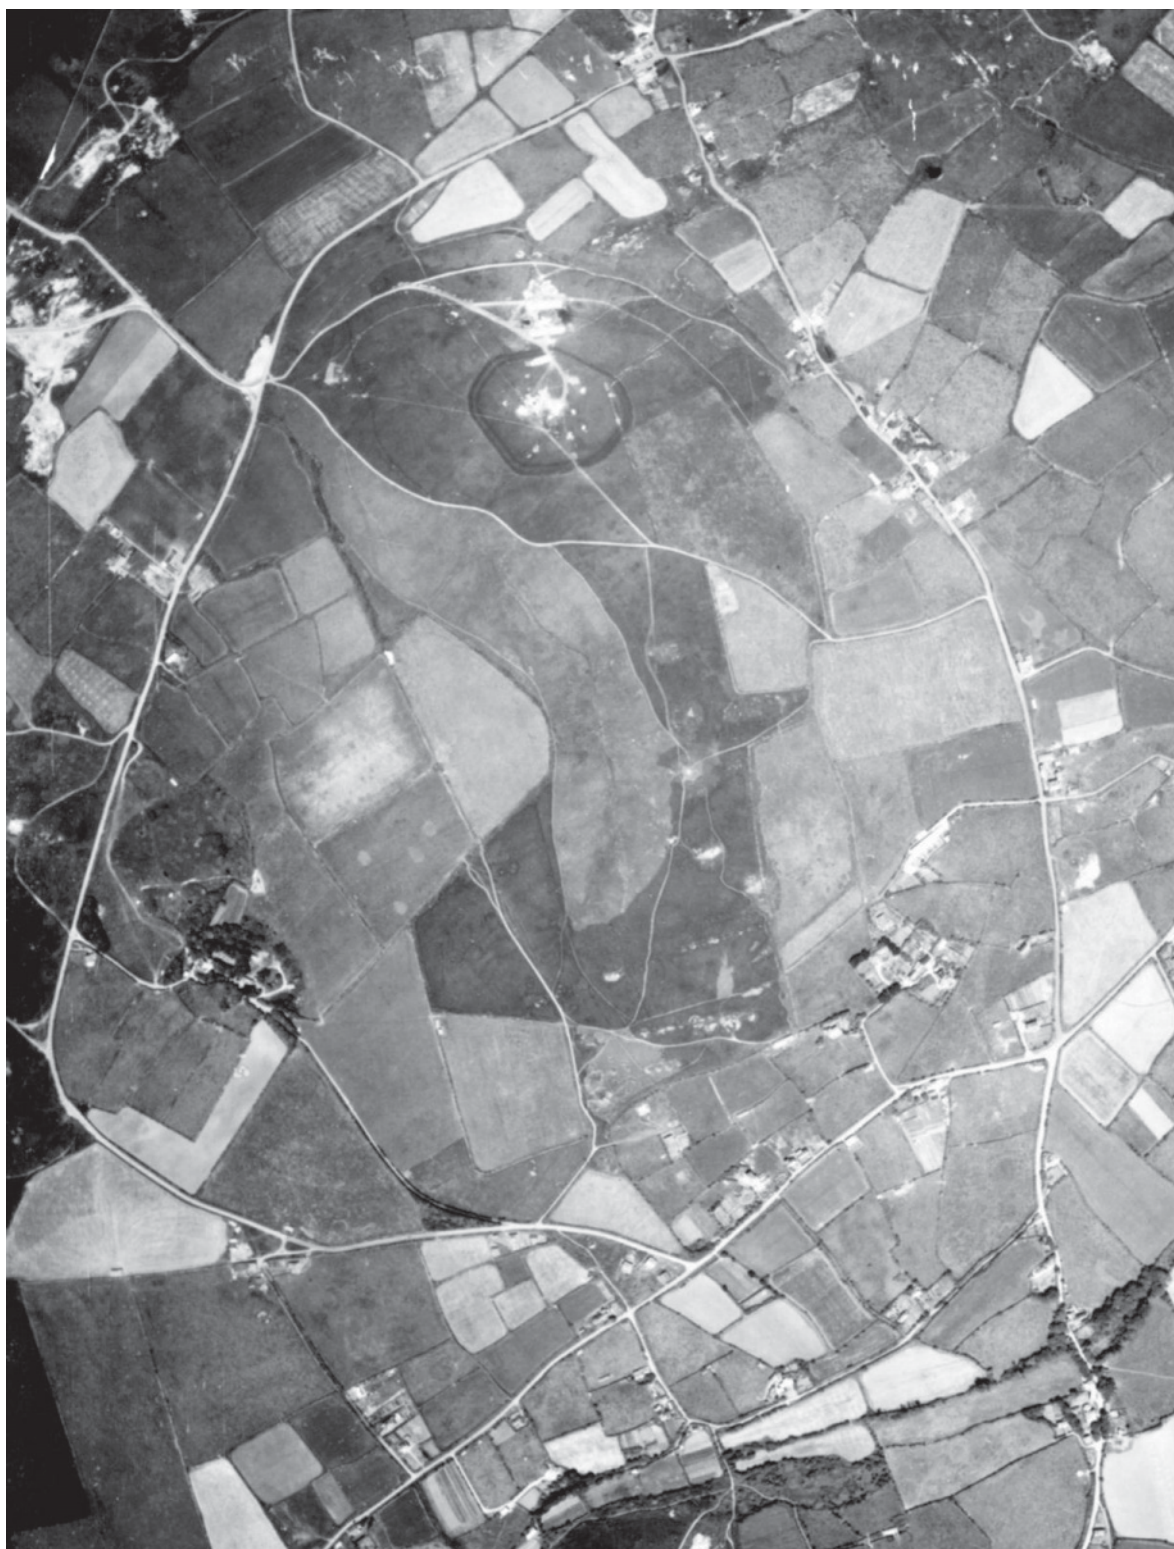
*Fig 18. An RAF vertical aerial photograph of St. Agnes Beacon dating to 1946. The oval fenced enclosure around the radar station is particularly clear. (RAF 3G-TUD-5182).*

It is clear both from air photographs taken in 1946 and the surviving physical evidence that there were at least ten buildings on the northern slope and summit: [190020], [190021], [190039], [190046], [190047] (two structures), [190048], [190057], [190069] and [190074]. Those on the northern summit were enclosed by a double perimeter fence [90352]. This shows on the 1946 photographs as a dark irregular polygon up to 160m across (Fig. 18). In the early 1960s this feature was proposed as the remains of an Iron Age hillfort surviving solely as a vegetation mark (Warner 1962, 114). The dark band is remembered locally as the result of vegetation having been burnt along the fence circuit (Preston-Jones 1990, 8). Preston-Jones (1990, 8) was told that the double perimeter fence on the Beacon lay around a 'Royal Observer Corps lookout'. There is no record of an ROC post on the Beacon, however; the St Agnes ROC post was established in 1941 some 2 km south east of the Beacon (Lawrence Holmes, pers. comm.). It has been suggested that personnel working on experimental radar stations were sometimes issued ROC uniforms in order not to attract attention.

One of the buildings on the northern slope [190046] appears on the 1946 photographs to be a structure in the form of a laterally reversed letter G; this resembles a blast wall around a building or technical equipment although only a levelled platform with concrete edges survives on the site. The form of most other buildings is unclear but Benney (1988, 47) has published a photograph of a group of servicemen standing outside a building of Nissen-hut type with a brick-built porch on the end, identified as their 'billet' on St Agnes Beacon; this is probably the structure represented by building base [190074] (Fig. 57). A similar building, probably [190069], is visible in the background. The 1946 RAF air photographs (Fig. 18) show various tracks linking the military buildings with the road skirting the northern edge of the Beacon and with access routes on the eastern side of the hill.

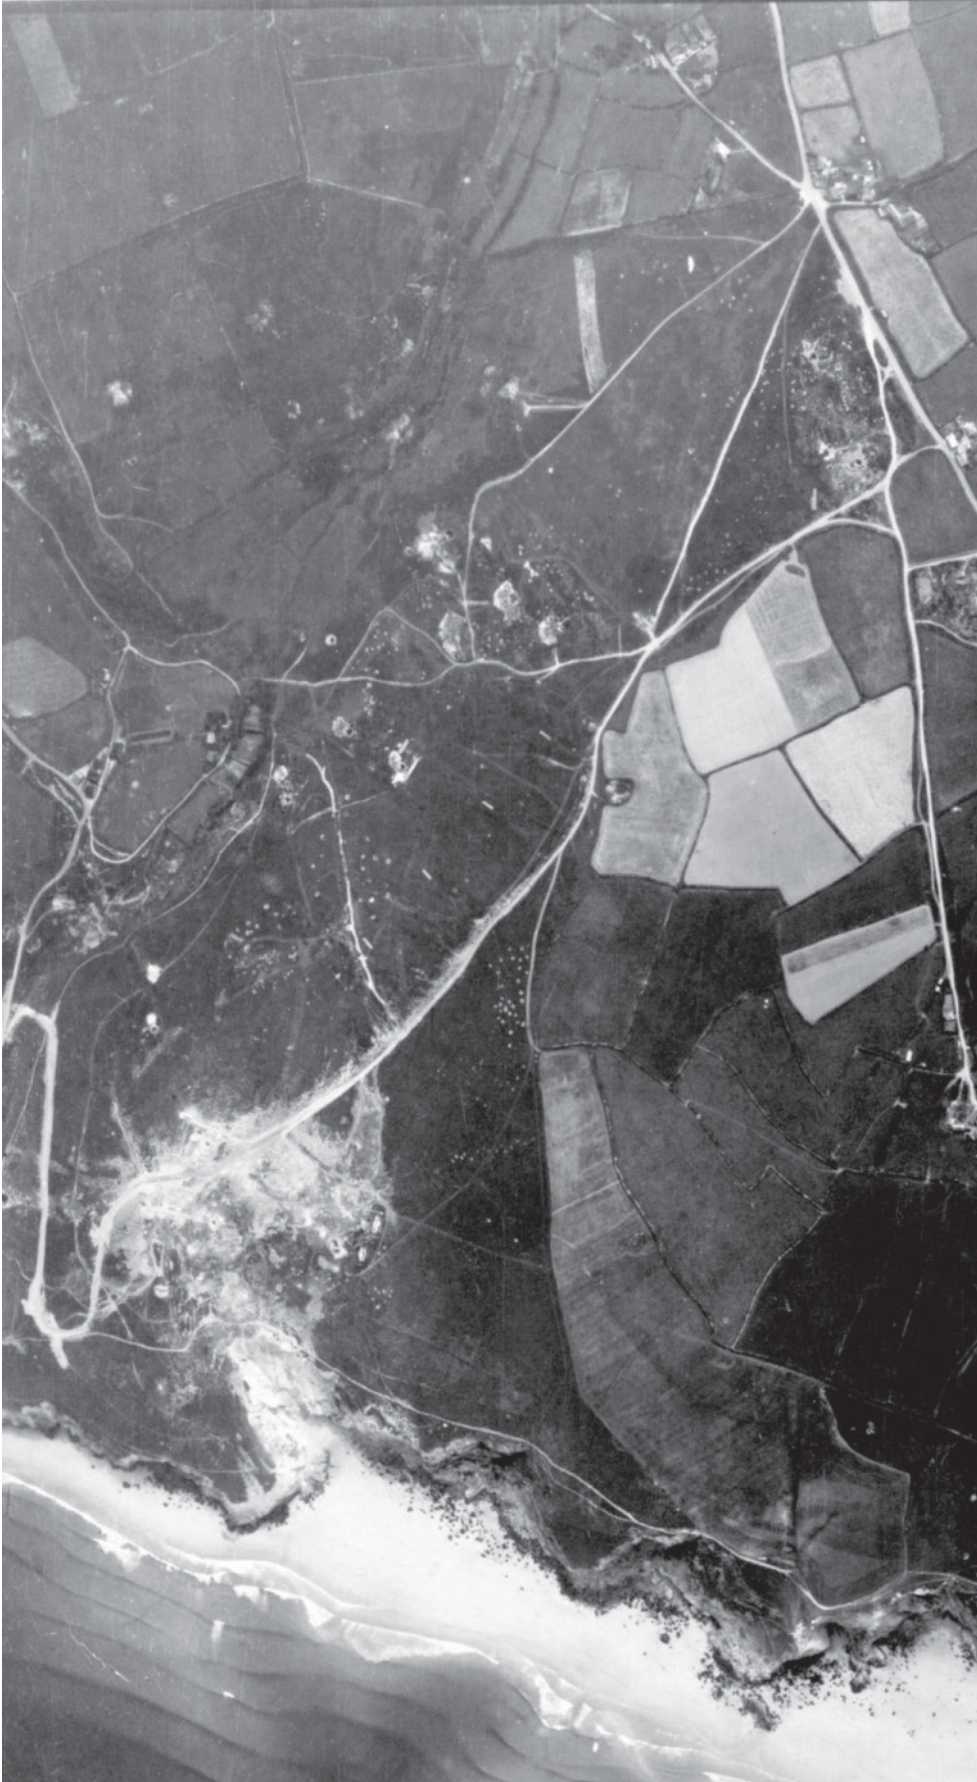
*Fig 19. An RAF vertical aerial photograph of Charlotte Moor and Towan Cross dating to 1946. The Holman Projector range is visible as a series of parallel lines near the centre of the view. Many of the small white dots represent slit trenches excavated during 1944 by the GIs encamped here in the run up to D Day. (RAF 106G-UK 1663-3380).*

Air photographs taken in 1946 show extensive disturbance around the former Wheal Charlotte mine workings together with a series of features set out in a straight line at approximately 100-yard intervals which seems likely to have been the test firing range for the field trials of the Holman Projector in 1940/41 [190634] (Figs. 141-3). This was also used for training merchant seamen whose ships were equipped with this compressed air (and sometimes steam-powered) anti-aircraft mortar, the men spending three days on the range for familiarisation (Carter 2001). However, the function of the new track [190526] constructed up the side of Chapel Coombe to Mulgram Hill by the American troops (Figs. 139-140) remains obscure. It links to an engineered track running onto Wheal Charlotte Moor/Towan Downs from Towan Cross, suggesting some form of training circuit may have been intended, or that it was itself intended as a training exercise; however, it was not apparently completed until after D-Day, by which time the extensive use of sites in southern Britain for training was at an end. Additionally, it is evident that the alignment of the northern end of the track running down into Chapel Combe would only have allowed traffic to enter it from, or to leave it, the downhill side towards Chapel Porth. Charlotte and Towan Downs are also notable for the large number of slit trenches left here by the troops encamped in this area prior to D-Day. Fig. 39 shows their arrangement, suggesting that they may have been excavated as part of an exercise.

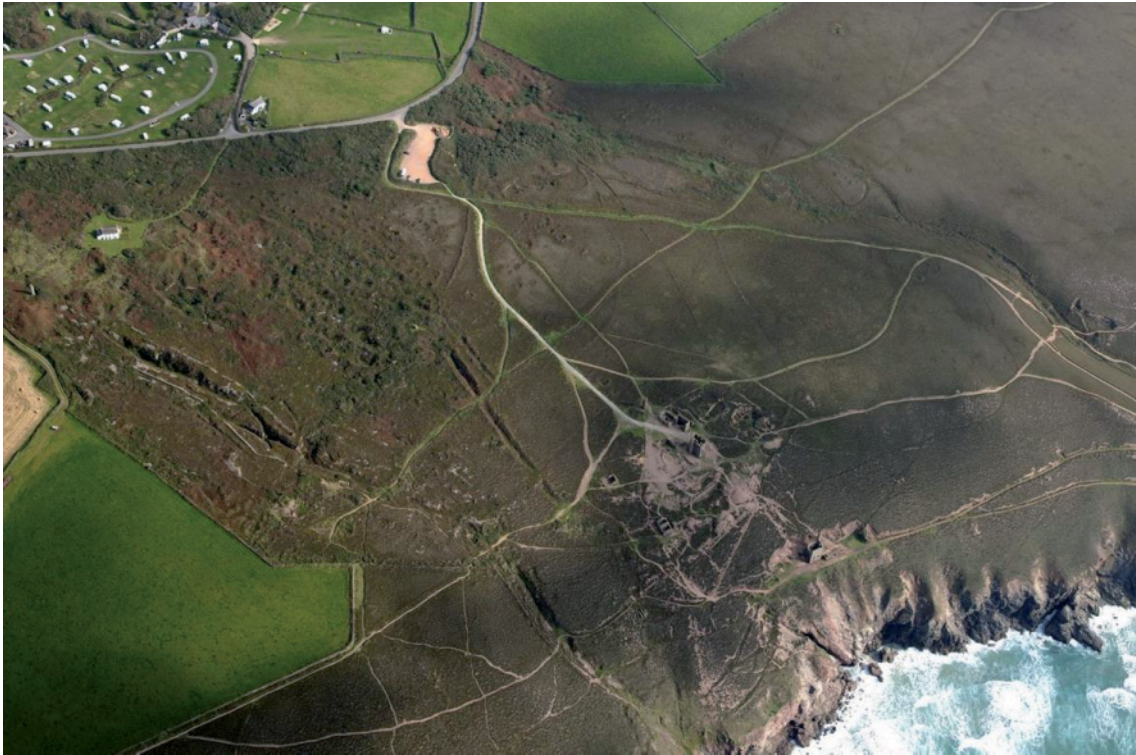
*Fig 36. An aerial view of Wheal Coates showing the building complex at the clifftops, the openwork (left), outcrop working pit (left centre), leats (centre) and clay pits (top centre). Also visible is the extensive path network and the considerable erosion around the building complex. HE F68-041.*

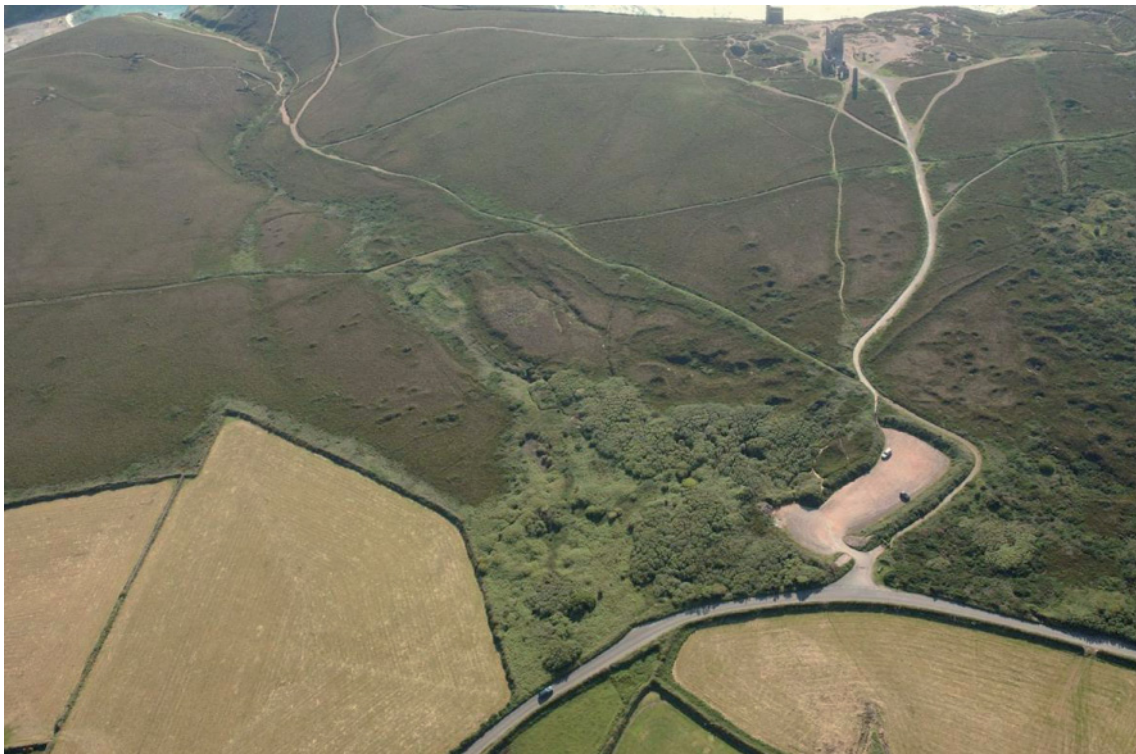
*Fig 37. The inland section of Wheal Coates showing the modern visitor car park, overgrown clay pits (lower centre), streamworks (centre), groups of prospecting pits (left centre) and outcrop workings (right centre). HE F68-038.*

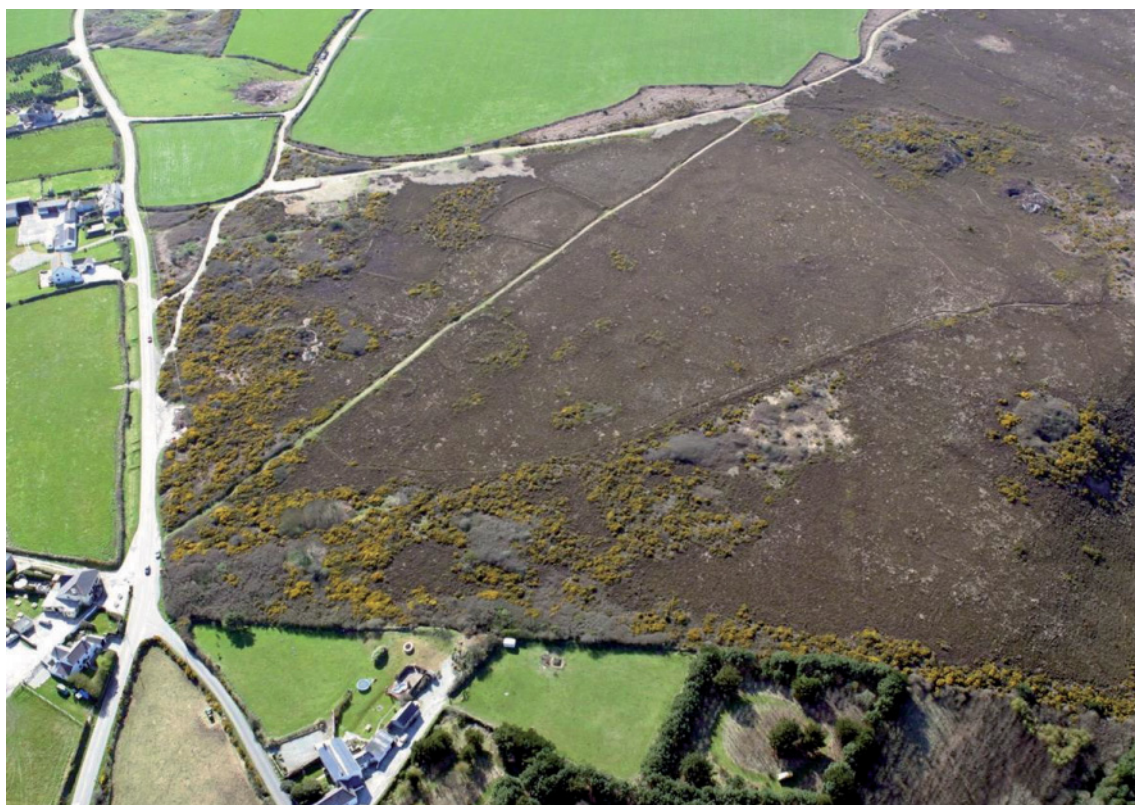
Fig 38. A recent NT aerial photograph of Towan Moor adjacent to Towan Cross, showing the enigmatic enclosures (just left of centre), field system (upper left centre), quarry (right centre) and the spread of gorse and blackthorn scrub from the peripheries of the area. Copyright National Trust.

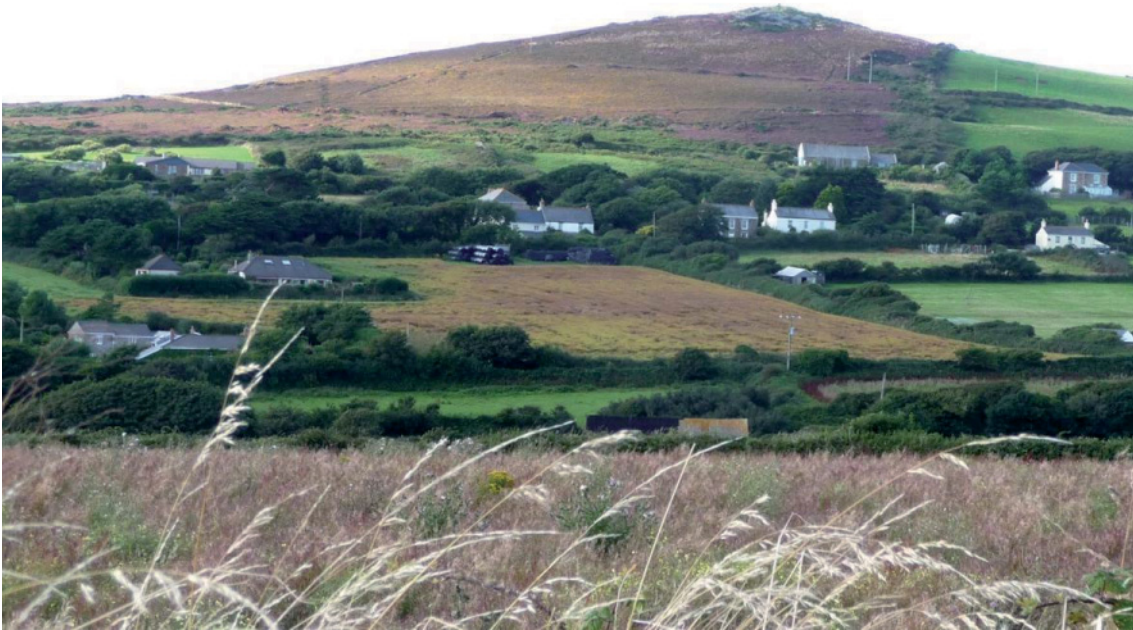
*Fig 40. St Agnes Beacon from the south. Cairn [90355] is prominent on the summit above the quarried natural rock outcrop known in the eighteenth century as Garder Wartha [190143]. The well-settled and distinctive landscape created by the enclosure of smallholdings from the former rough ground of Goonvrea is evident in the middle ground. HE Archive.*

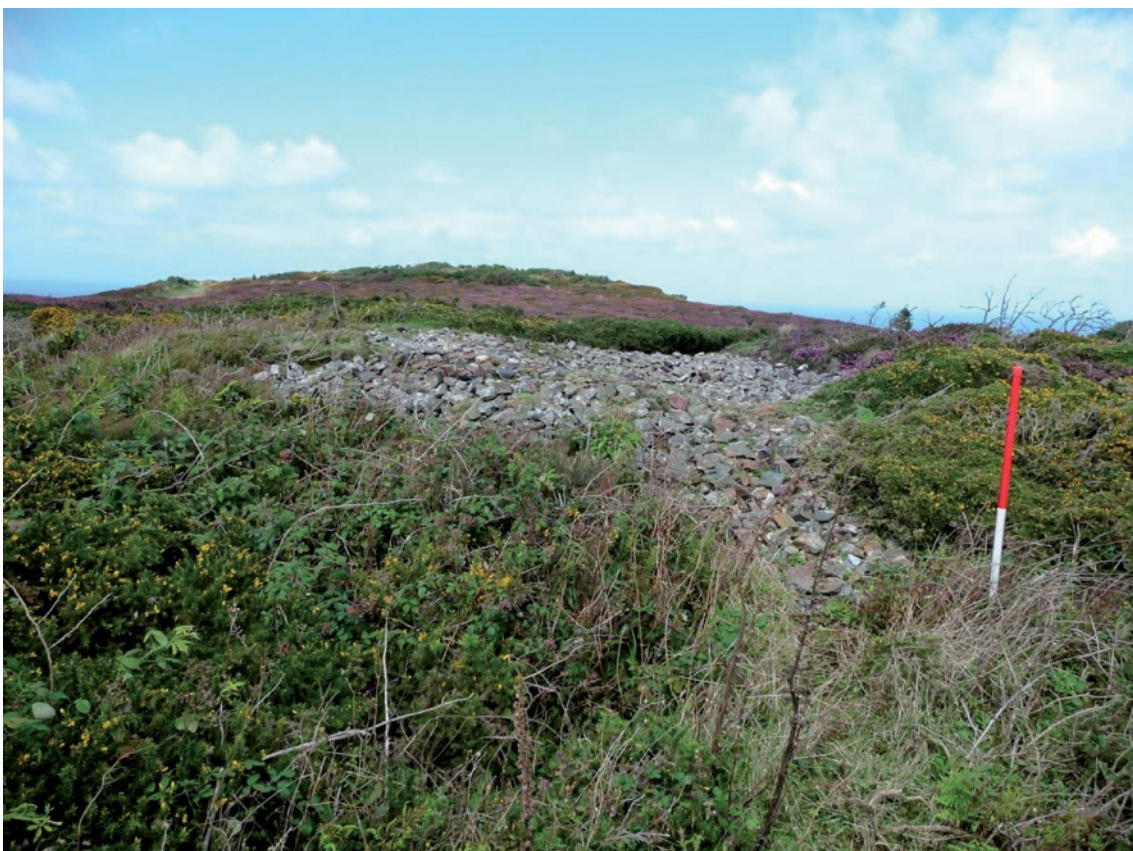
*Fig 41. Cairn [90353], the middle of three on the southern ridge of the Beacon, with cairn [90357] on the skyline beyond. Both have been much reduced in size by 'quarrying' of stones for nearby enclosure boundaries. HE Archive.*

The four barrows or cairns located on the summit ridge of the Beacon (Figs. 41-2, 44) are likely to date to the Bronze Age, between approximately 2200 and 1600 BC. All four have been considerably damaged, probably by robbing for adjacent enclosure boundaries (below) and, in the case of the northern cairn [90359], for building the World War II radar station [190060]. Nothing is known of any finds from them. Their original form is also uncertain, although it is clear that the three southern cairns ([90353], [90355], [90357]) were formerly much larger than at present. Thomas Tonkin (1975-6, 203-4), writing in the early eighteenth century, referred to them as '*three great heaps of stones*'. William Hals, writing at about the same time, derived the former name for the Beacon, Carne Breanick, from

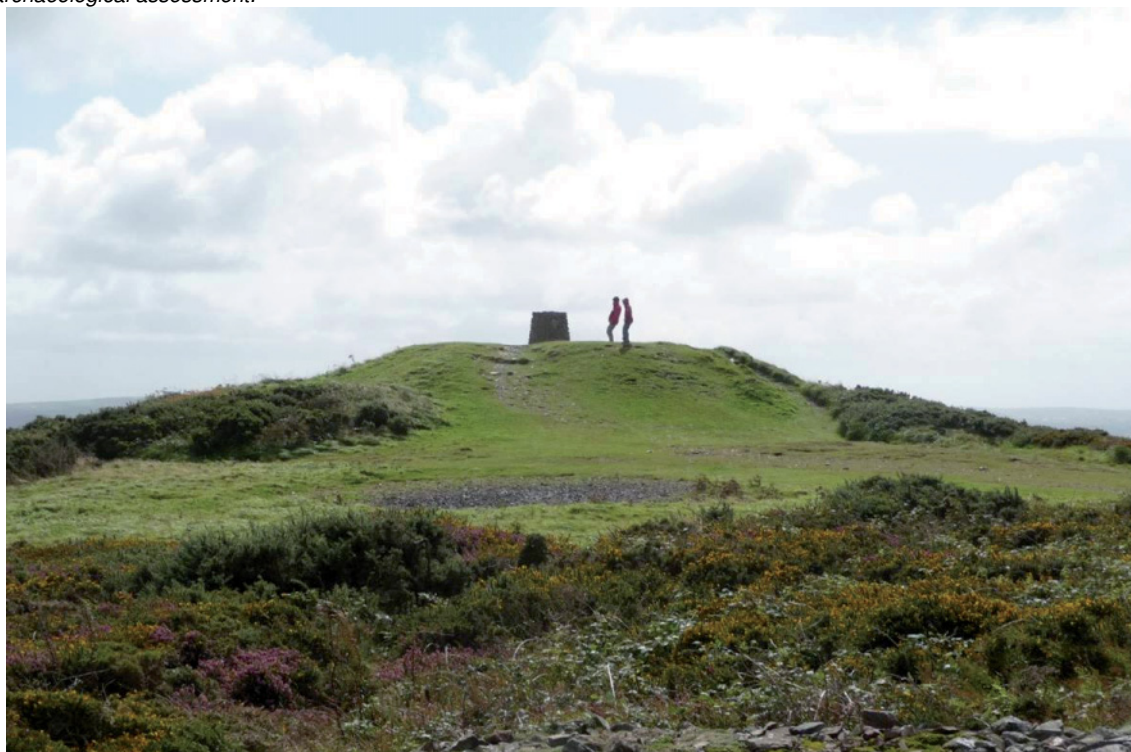
*Fig 42. The summit cairn [90355] on St Agnes Beacon, viewed from cairn [90353] to the north. This has been the location not only of the cairn itself but also of a beacon, a late eighteenth century summerhouse and an Ordnance Survey triangulation point. HE Archive.*

The trig point [190127] marking the survey point on the southern cairn was erected in 1937. A base 3ft (0.9m) square was dug and a brass bolt set in a 1ft (0.3m) concrete cube was set in the ground at a depth of 2ft 3in (0.66m). The 4ft tall concrete pillar was then erected over this mark. The trig point was subsequently re-used by the Ordnance Survey every few years and they also carried out maintenance: in 1958; this included filling an erosion hollow around the trig point with stones, soil and turf (*ibid.*). Trig points are no longer used by the Ordnance Survey for regular survey purposes and at some time in the late 1990s the one on the Beacon was encased in stonework and a topograph was located on it, giving distances and directions to local and more distant landmarks (Fig. 42).

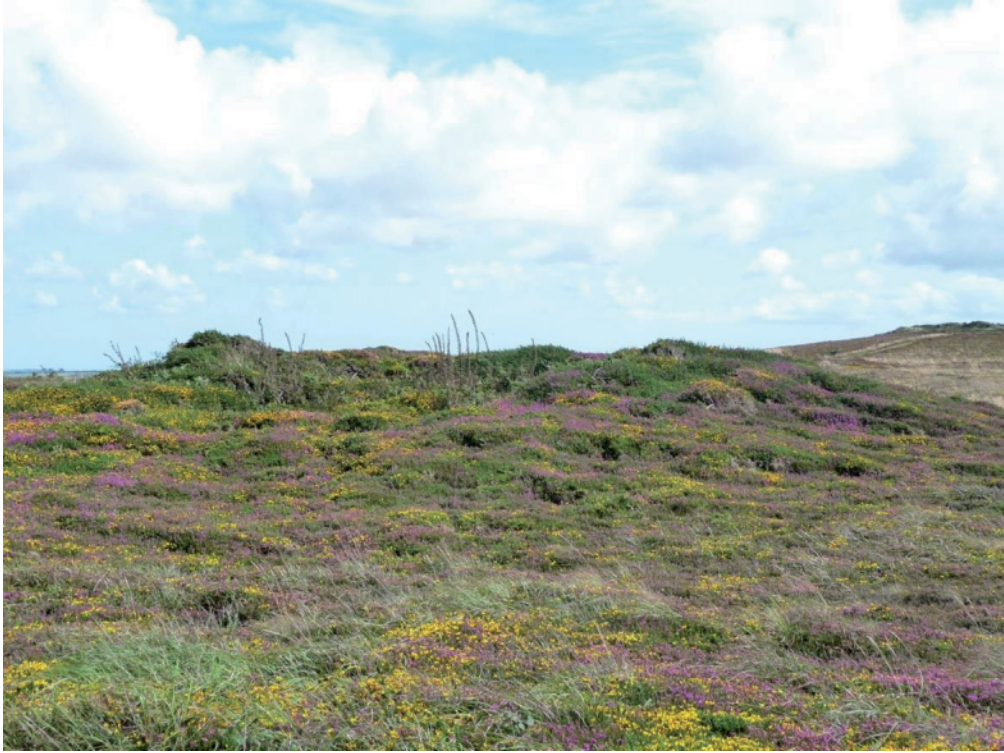
*Fig 44 Cairn [90359] has been much damaged by the removal of material from its core, probably for construction of parts of the World War II radar station. HE Archive.*

Fig 44 Cairn [90359] has been much damaged by the removal of material from its core, probably for construction of parts of the World War II radar station.

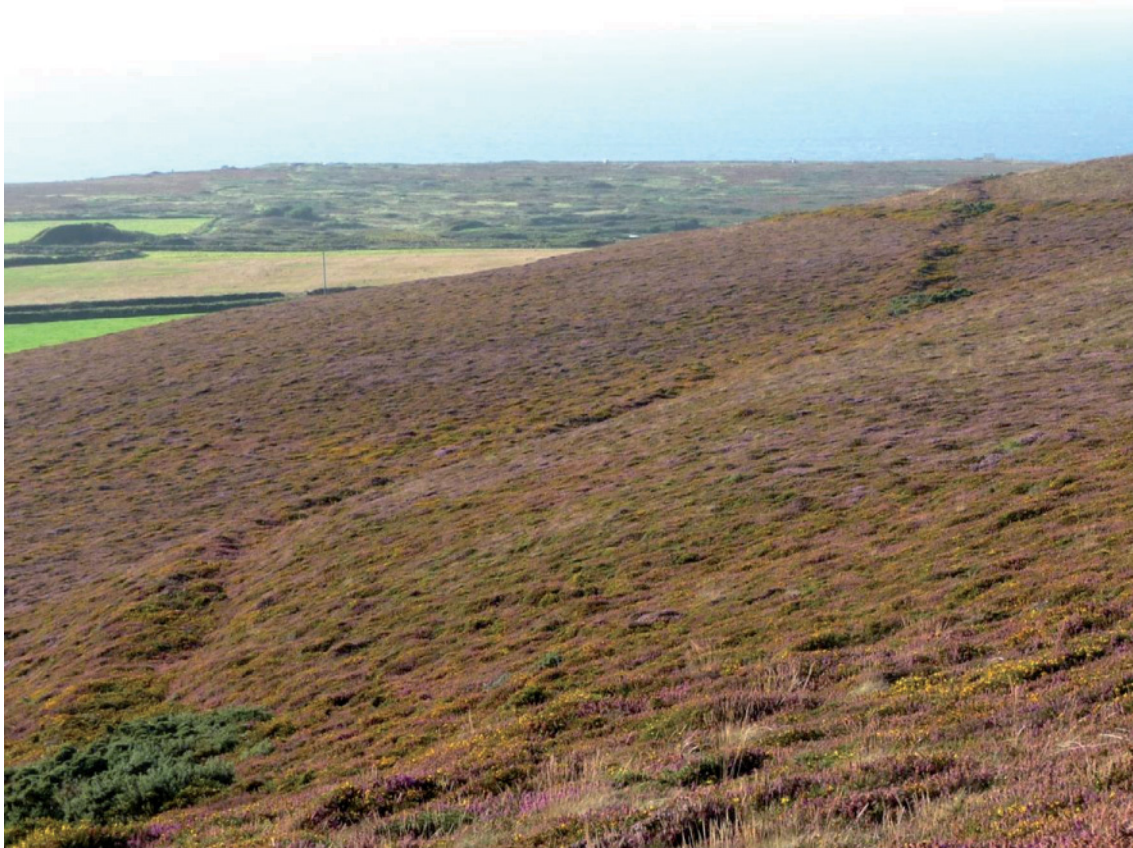
*Fig 45. Pasture boundary [190066] follows a sinuous course along the western flank of the Beacon. It is probably of post-medieval origin, aiding in management of grazing and other resources on Goonvrea Common. HE Archive.*

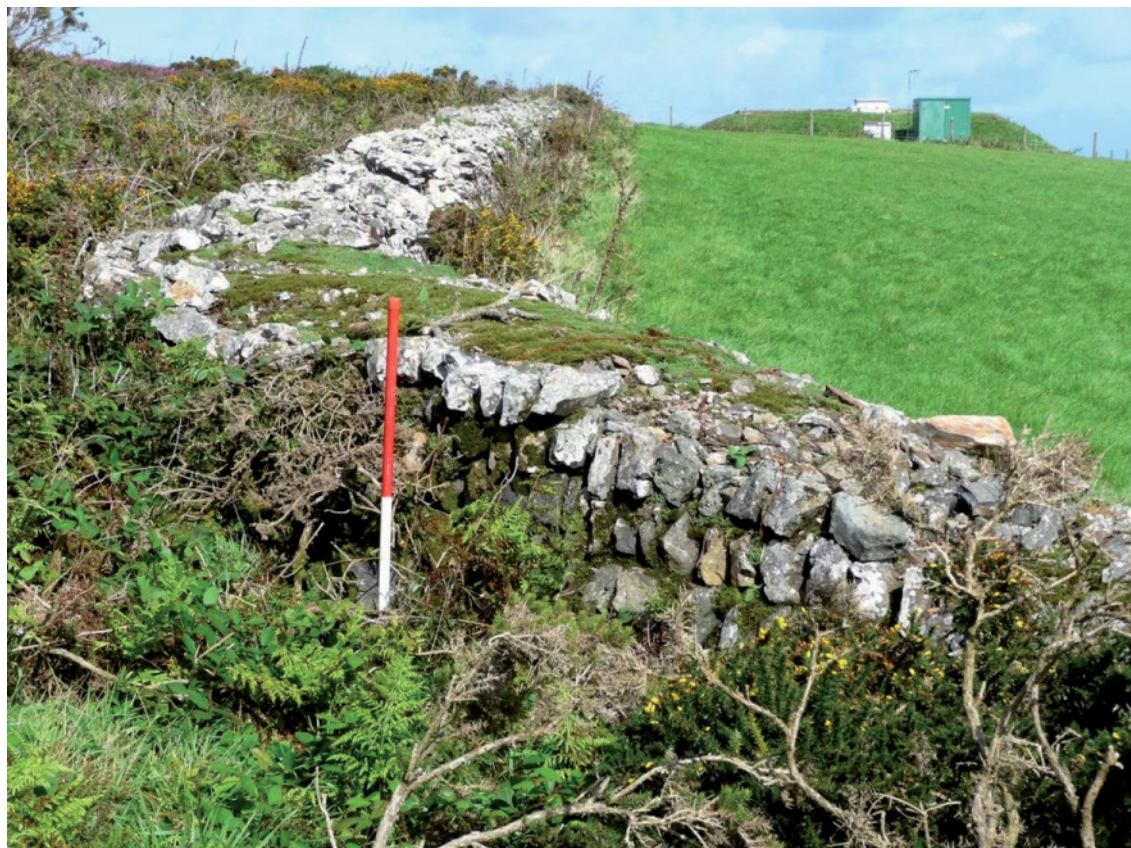
Fig 46. A stone-faced hedge [190101] bounding enclosed land on the east side of the Beacon. Stone for these boundaries would have been obtained from clearing the land but also from the prehistoric cairns on the Beacon and from a number of small quarries. HE Archive.

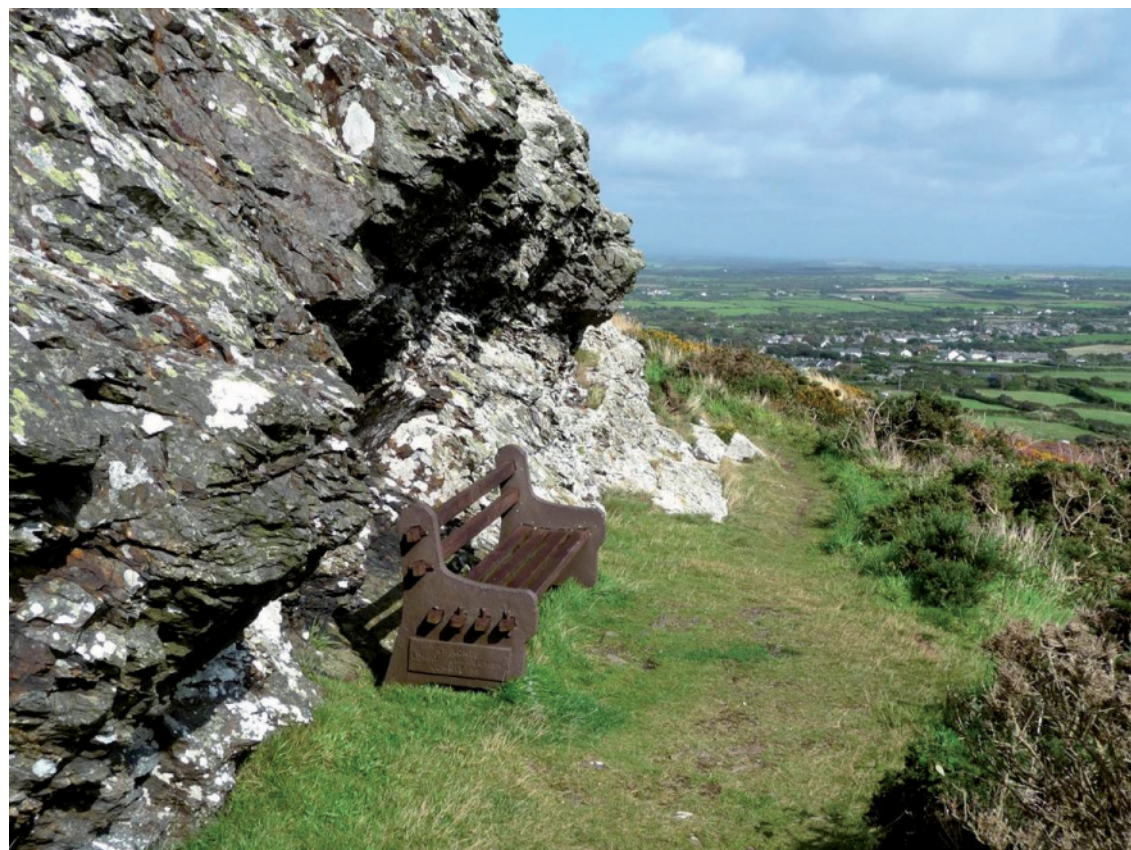
Fig 47. Quarrying [190143] on the southern face of the rock outcrop named by Thomas Tonkin in the early eighteenth century as Garder Wartha, 'the higher seat'. HE Archive.

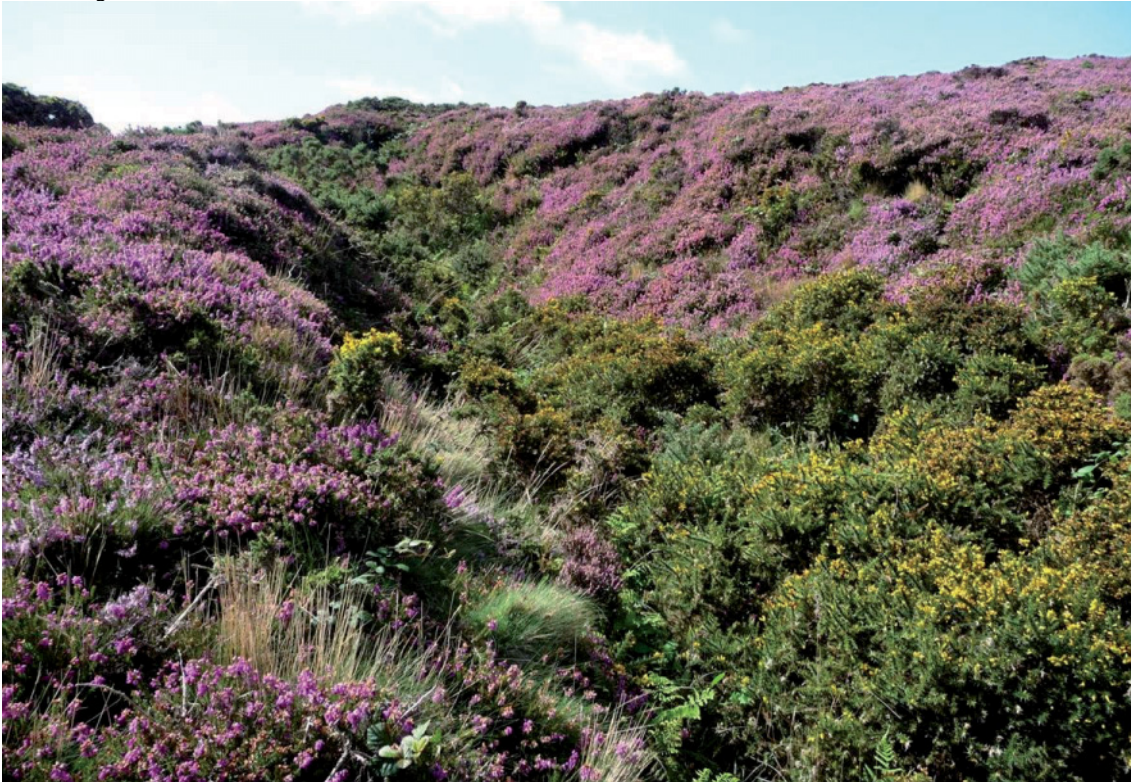
*Fig 48. A substantial linear quarry [190113] cut into the slope on the east side of the Beacon. This is likely to have provided hedging stone for the enclosures created from former rough ground in this area in the later nineteenth century. HE Archive.*

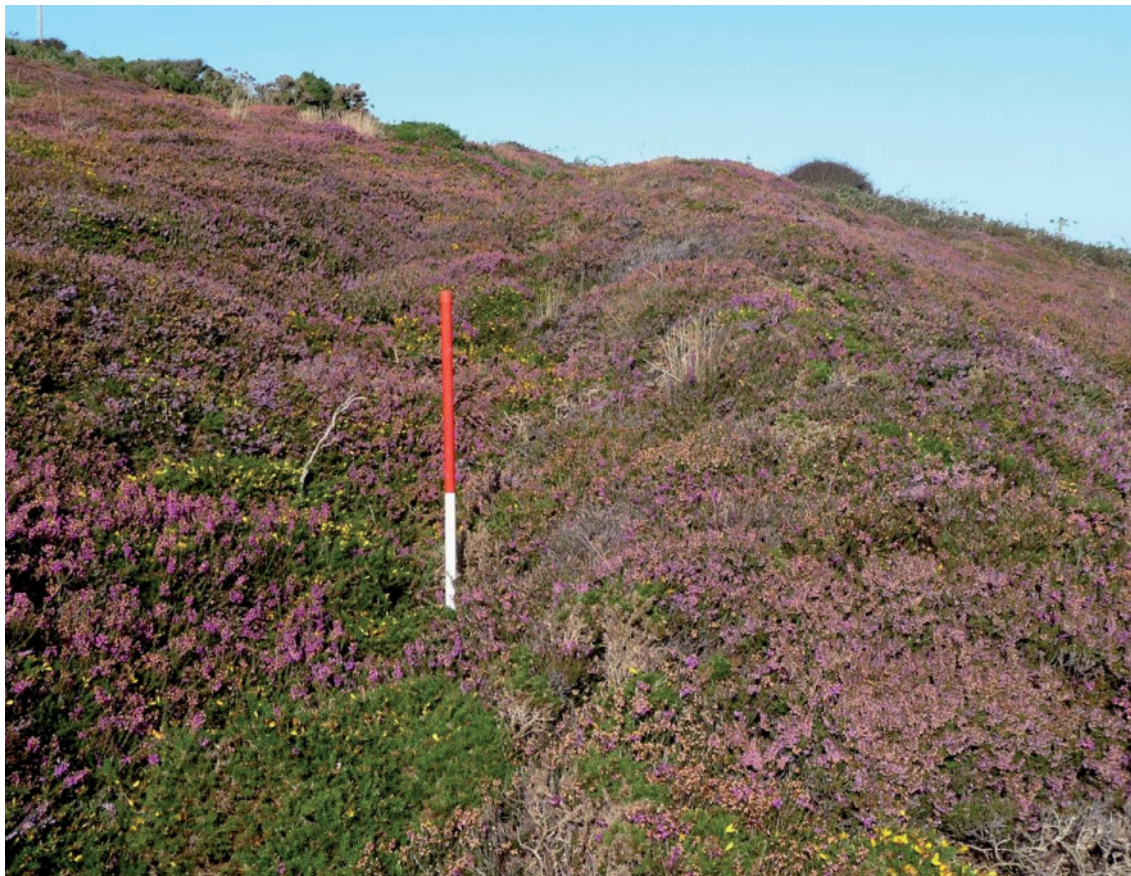
*Fig 49. A bank and ditch which may have formed a leat [190171] carrying water to pumping equipment in lodeback workings [190169] on the southern slopes of St Agnes Beacon. HE Archive.*

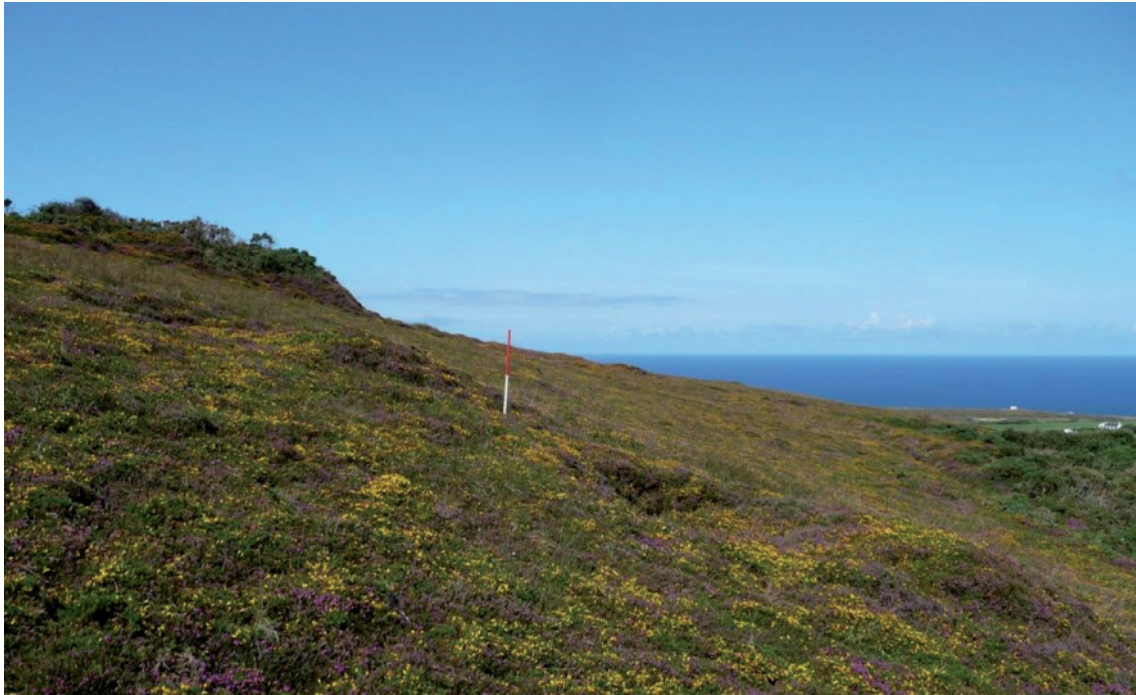
Fig 50. Prospecting pits [190023] on the northern slope of St Agnes Beacon, with spoil heap [190022] in the background. These features are likely to be associated with workings on Wheal Coit lode. HE Archive.

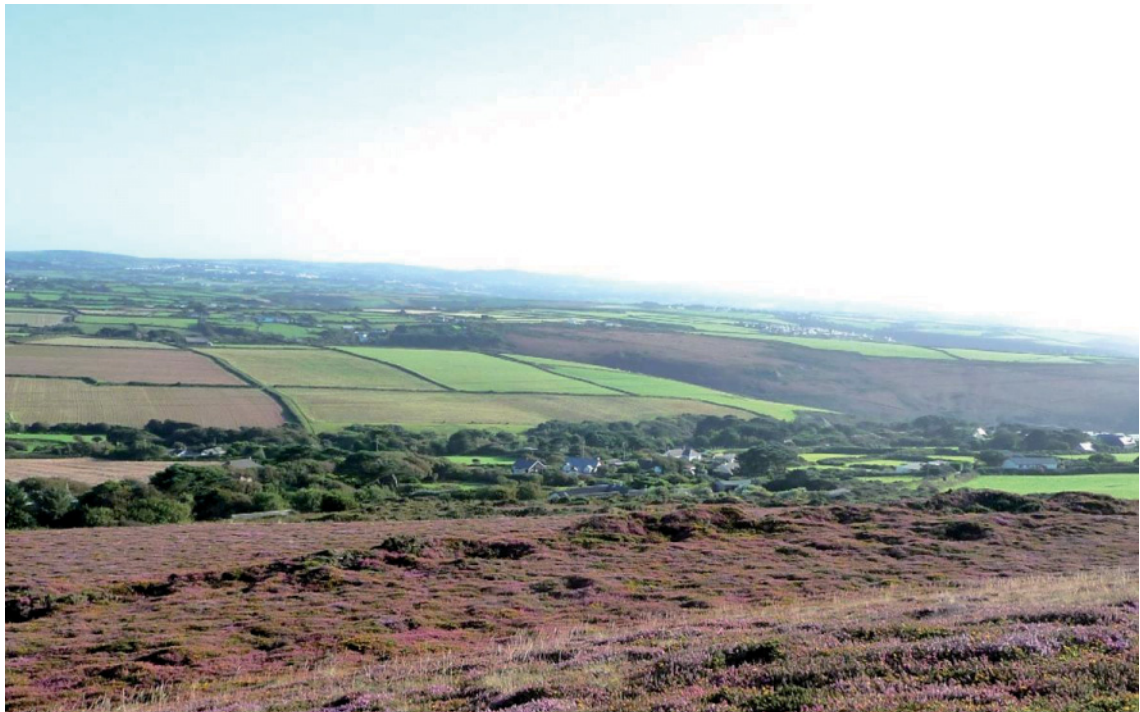
Fig 51. The chain of pits and spoil heaps forming lodeback working [10154] running east-west across the southern slopes of St Agnes Beacon. HE Archive.

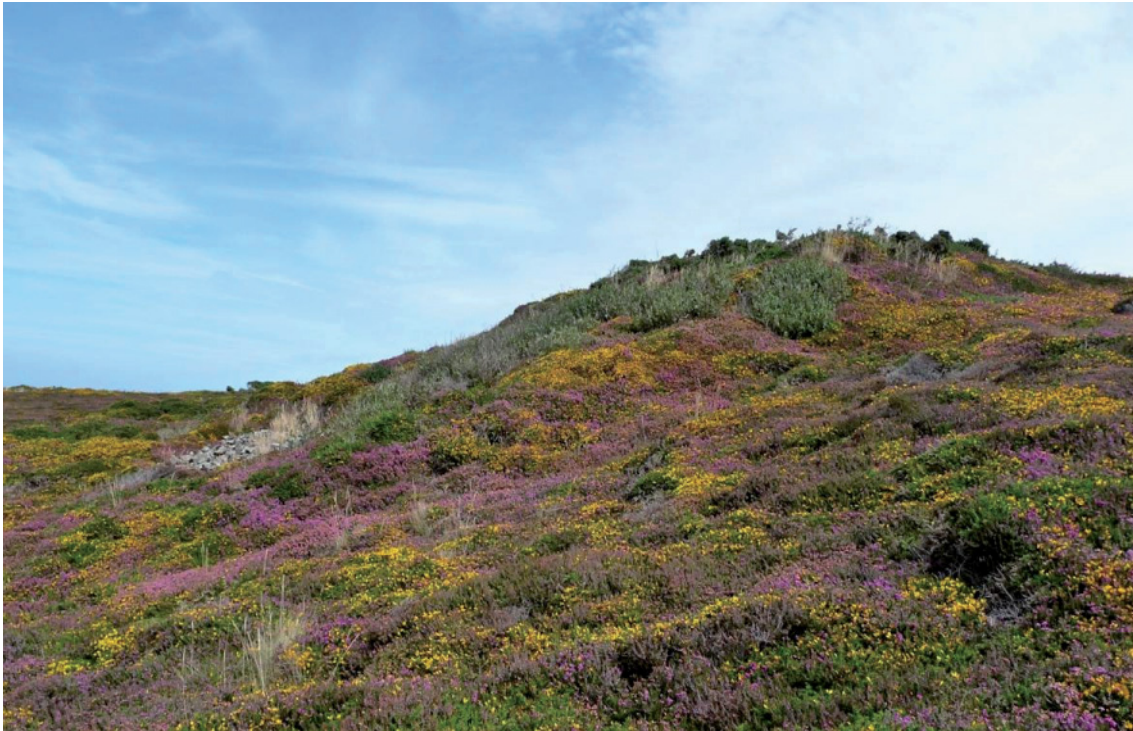
Fig 52. A substantial spoil heap [190024] downslope from shaft [190025], viewed from the south west. This and some of the other mining features at the northern end of the Beacon may be of twentieth-century origin. HE Archive.

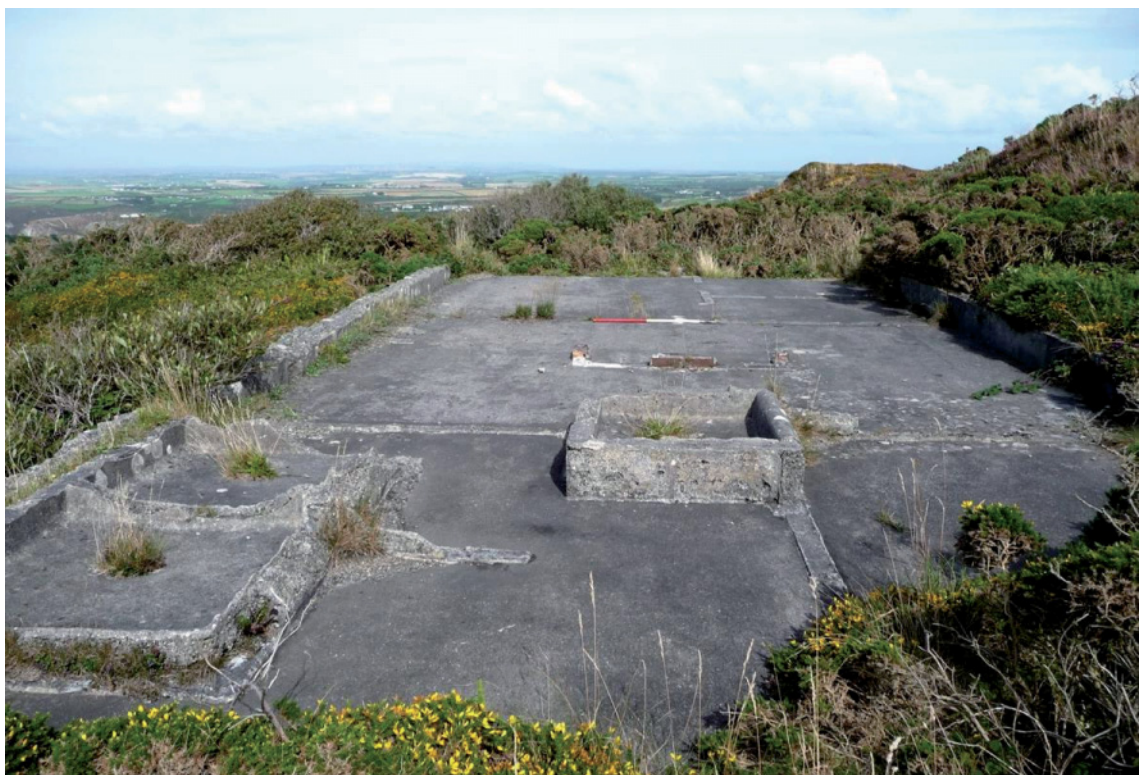
*Fig 55. The concrete base of building [190039]. What were probably the cement bases of three shower stalls are evident, suggesting that this was accommodation for personnel stationed on the Beacon. HE Archive.*

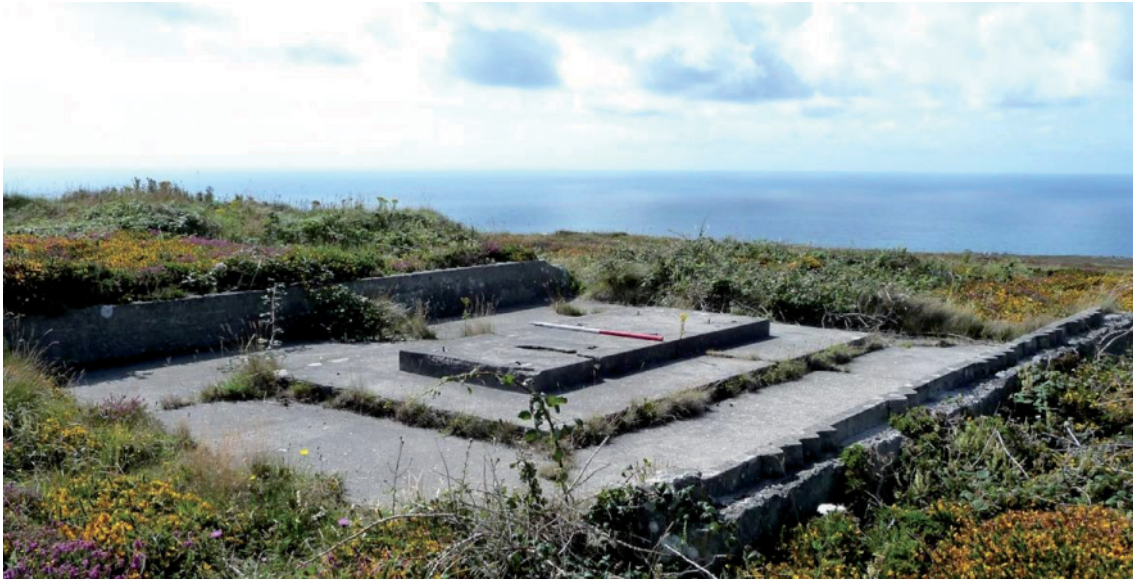
*Fig 56. The concrete base of a building [190069] forming part of the World War II radar installation on the Beacon. The central plinth, on which fixing bolts are still visible, is likely to have been the base for some form of machinery. HE Archive.4*

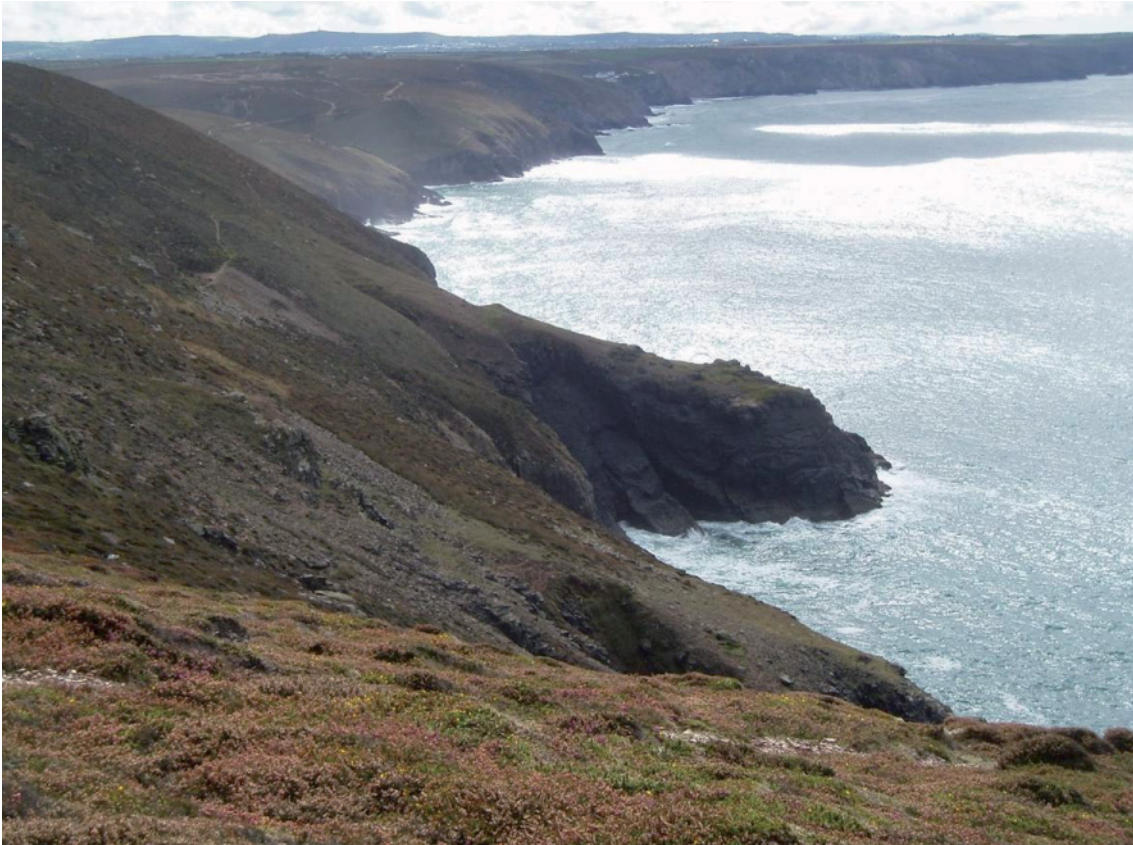
*Fig 60. Tubby's Head cliff castle [96054] seen from the north. The rampart is just visible at the inland end of the promontory. The degree to which the cliff castle is overlooked from the land is readily apparent. HE Archive.*
