# **St Agnes Beacon, Tubby's Head, Wheal Coates, Chapel Combe, Charlotte and Towan Moors, St Agnes, Cornwall**

## **Archaeological and ecological assessment**

**Archaeological and ecological assessment for  
the National Trust**

<b>Client</b>	<b>The National Trust</b>
<b>Report Number</b>	<b>2011R037</b>
<b>Date</b>	<b>01/04/2010</b>
<b>Status</b>	<b>Final</b>
<b>Report author(s)</b>	<b>Adam Sharpe BA MIFA, Graeme Kirkham MA MIFA, Spalding Associates</b>
<b>Checked by</b>	<b>Peter Rose, Projects Manager</b>
<b>Approved by</b>	<b>Peter Rose, Projects Manager</b>

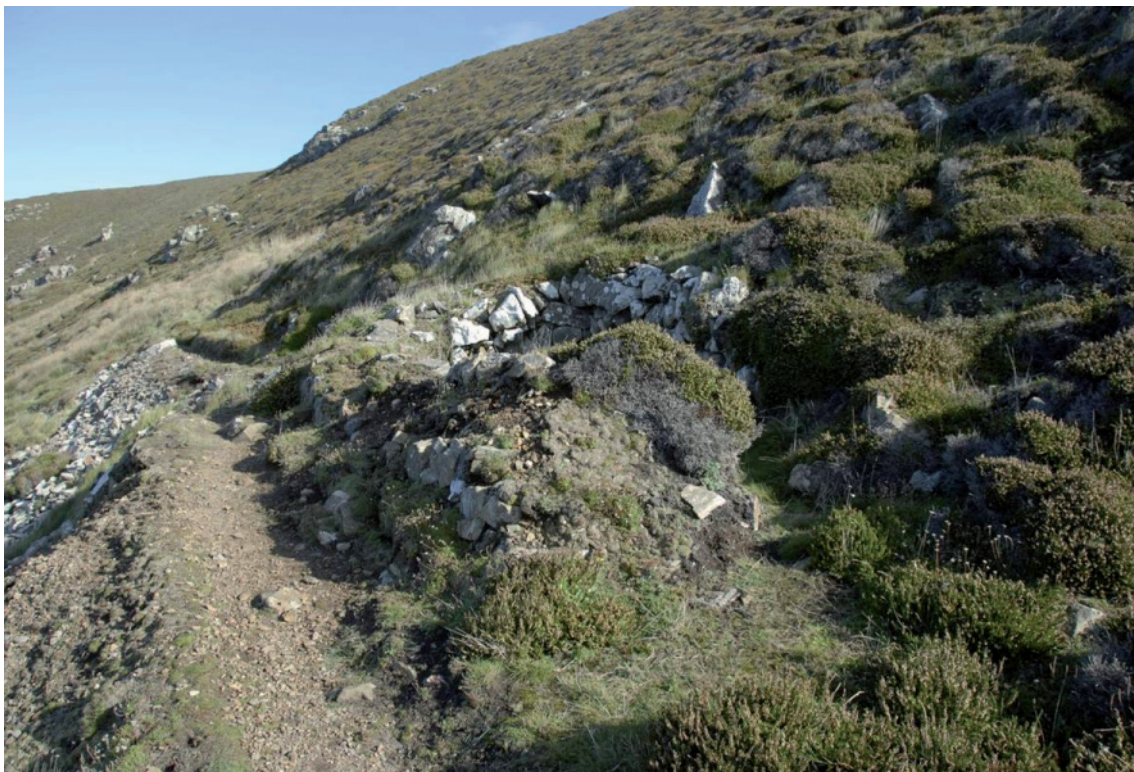
*Fig 61. The small miners' building [96780] adjacent to an openwork [96799] and small dressing floor [96777] to the north of Tubby's Head. This small and early building may have been part of Wheal Owles. HE Archive.*

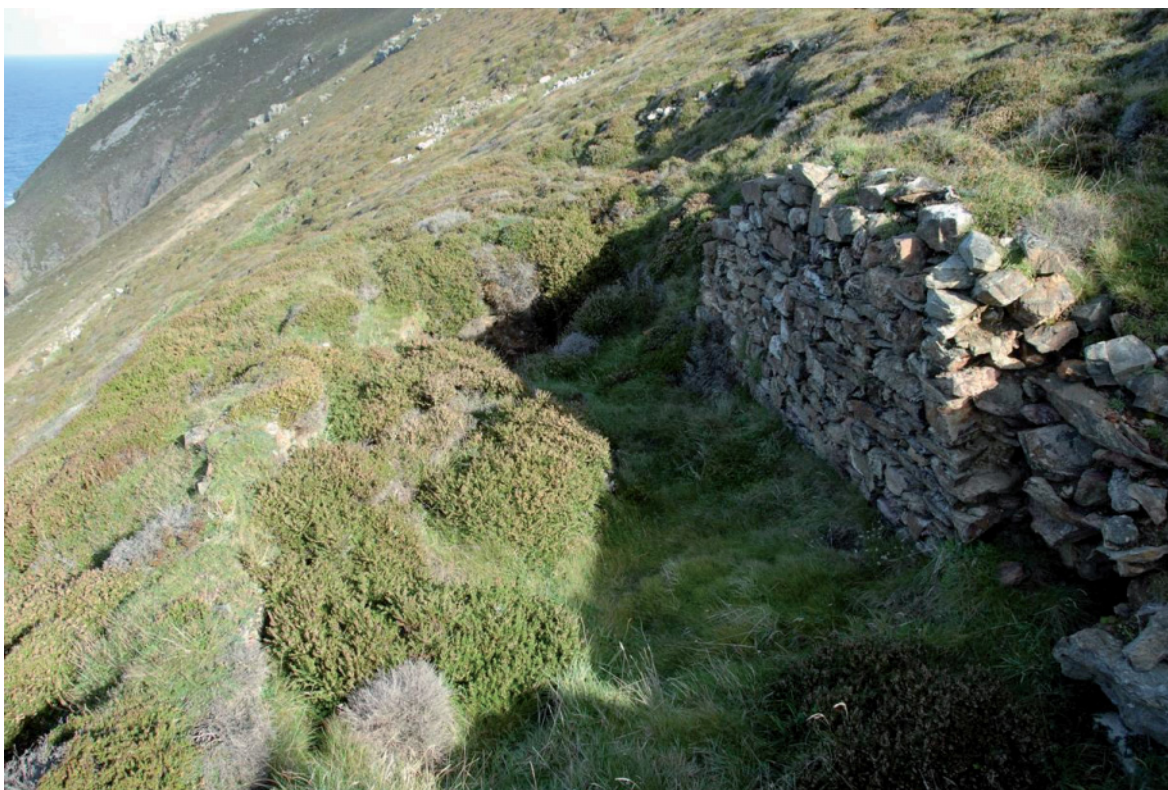
*Fig 62. The remains of the early mine building [96764] to the north of Tubby's Head. The probable footway shaft [96765] lies at the northern (furthest) end of the building. HE Archive.*

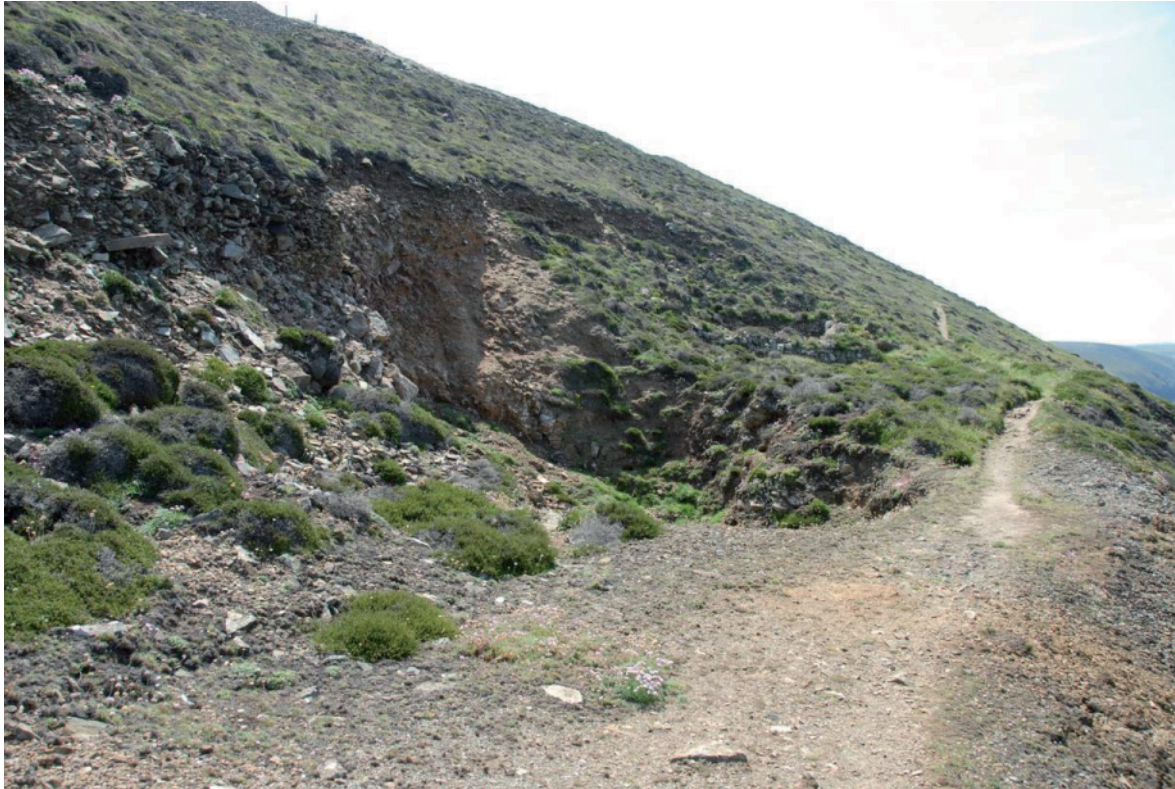
Fig 64. The openwork [96779] on the cliffslope near Tubby's Head. Small early buildings [96780] and [96778] lie to the north and south of the excavation (left and right in this view), whilst dressing floors [96779] lie on the cliffslope to the right. HE Archive.

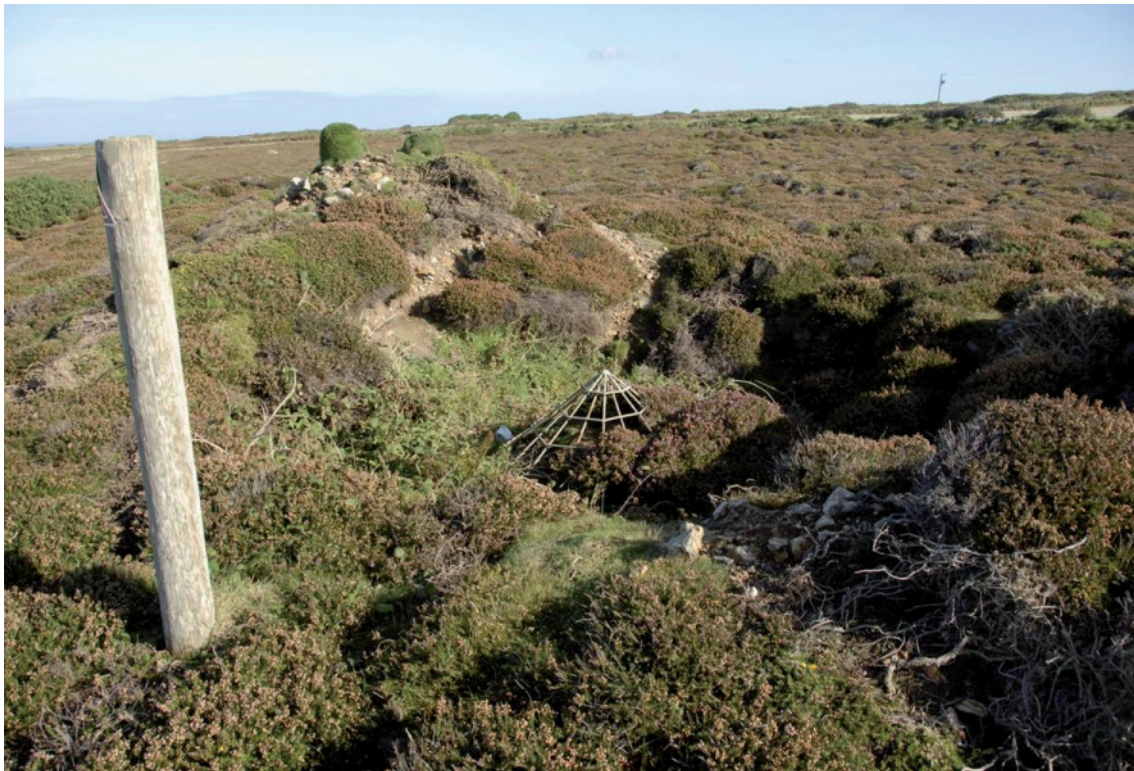
Fig 65. The backfilled Chyd Cap on shaft [96749] in the inland section of Wheal Bungay. HE Archive.

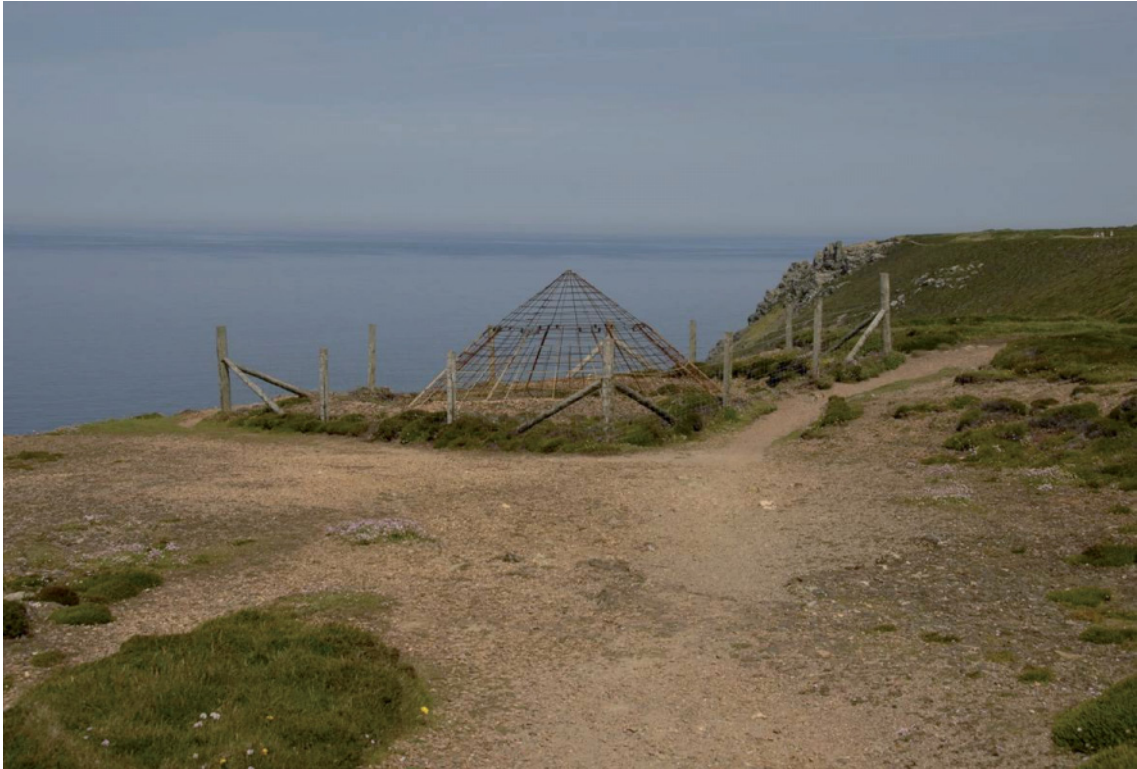
*Fig 66. The large Chmyd Cap over open shaft [90048] in Wheal Bungay. The cobbled dressing floor [96758] is in the foreground. HE Archive.*

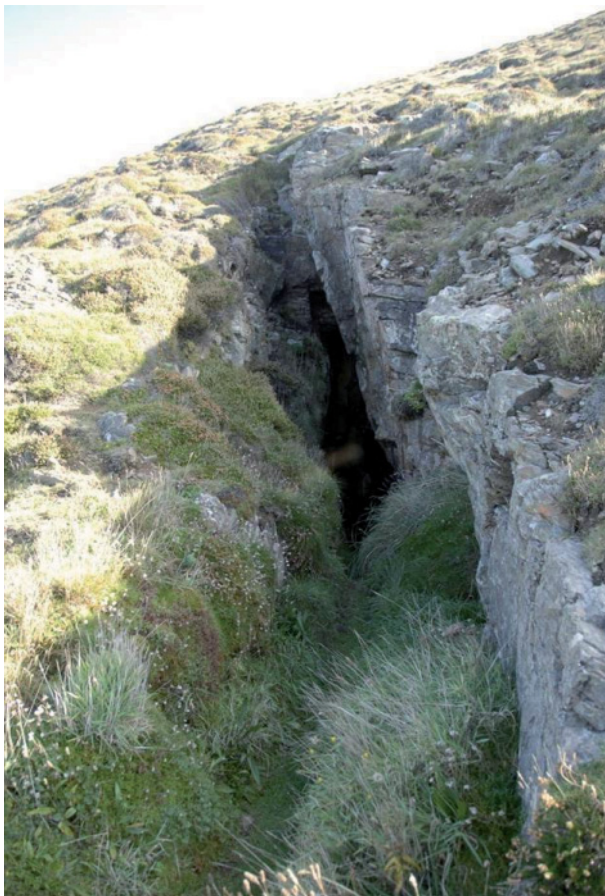
*Fig 67. The elongated rock-cut lobby and tall stoped entrance to adit [90052] on the cliffside to the north of Tubby's Head. This adit probably served West Polberro to the east-north-east. HE Archive.*

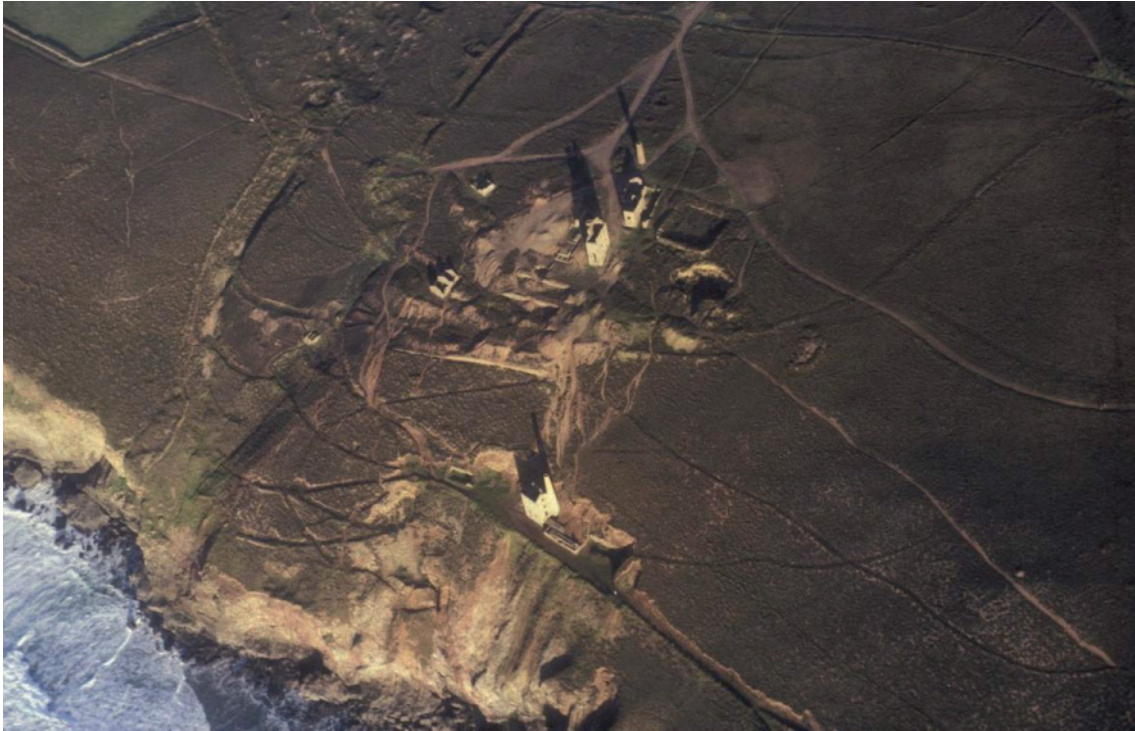
*Fig 68. An aerial view of the Wheal Coates complex in the late 1980s showing, in addition, the extensive network of paths and tracks including those leading to Towanroath Vugga, several leats (top right), the lower part of the openwork [190305]/[190306] (left) and the considerable erosion scarring around the buildings. Adam Sharpe Collection.*

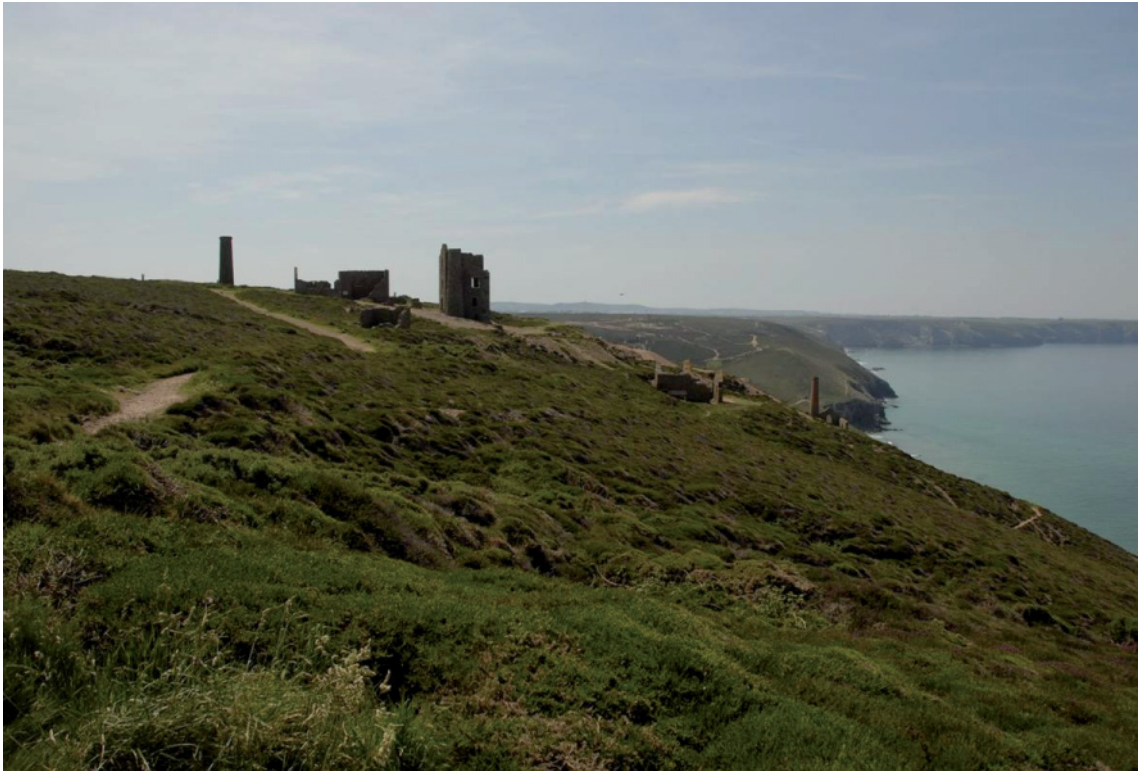
*Fig 70. The Wheal Coates complex from the north, looking across the site of the original water-powered dressing floors [190299]. Again the buildings are prominent in the landscape. HE Archive.*

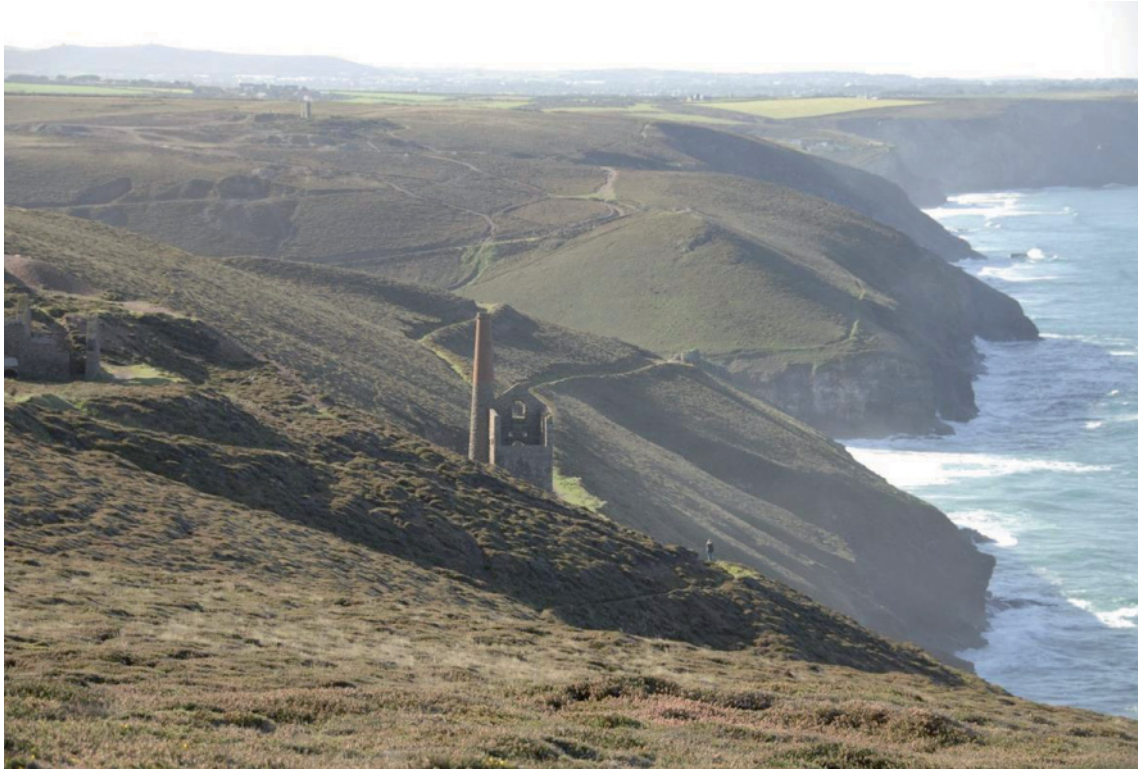
*Fig 71. Towanroath shaft pumping engine house from the north, with Mulgram Hill and Charlotte Moor in the background. Two roadways can be seen running diagonally up from the left towards the summit of Mulgram Hill, the lower of these having been re-cut by the US Army in 1944. HE Archive.*

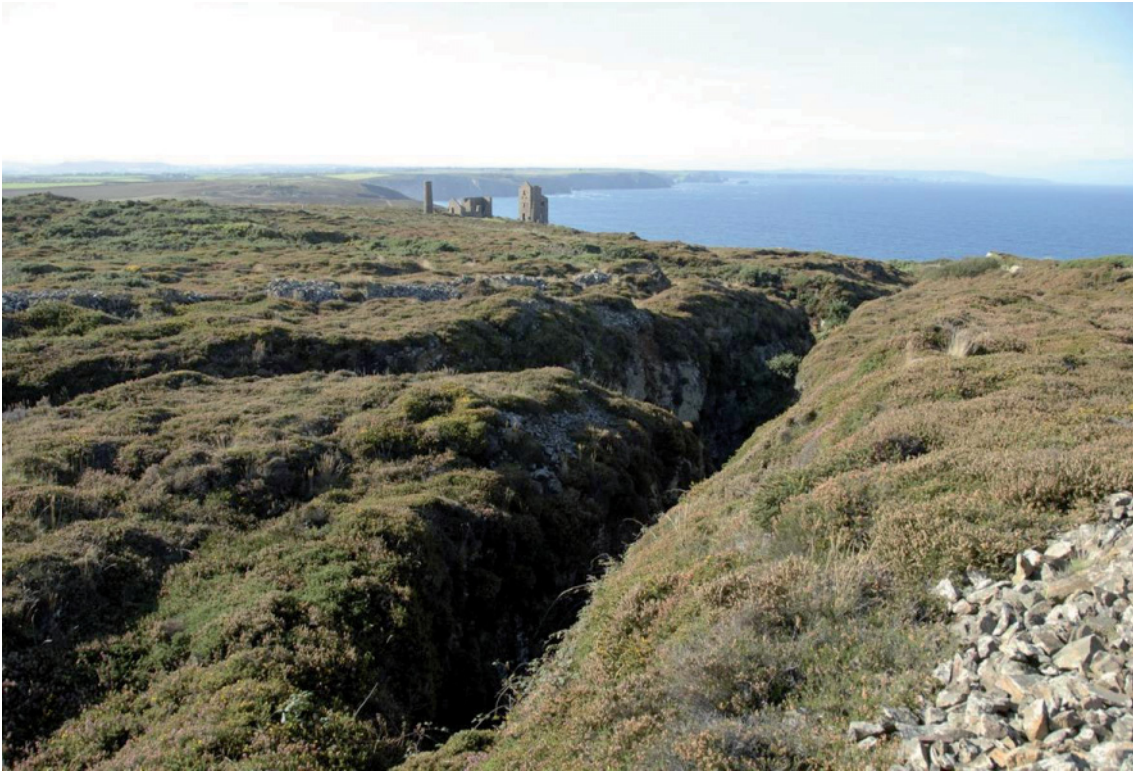
*Fig 76. The central part of the openwork in the northern part of Wheal Coates [190289][190287] showing the point at which it bifurcates, following the splitting of the lode outcrop. HE Archive.*

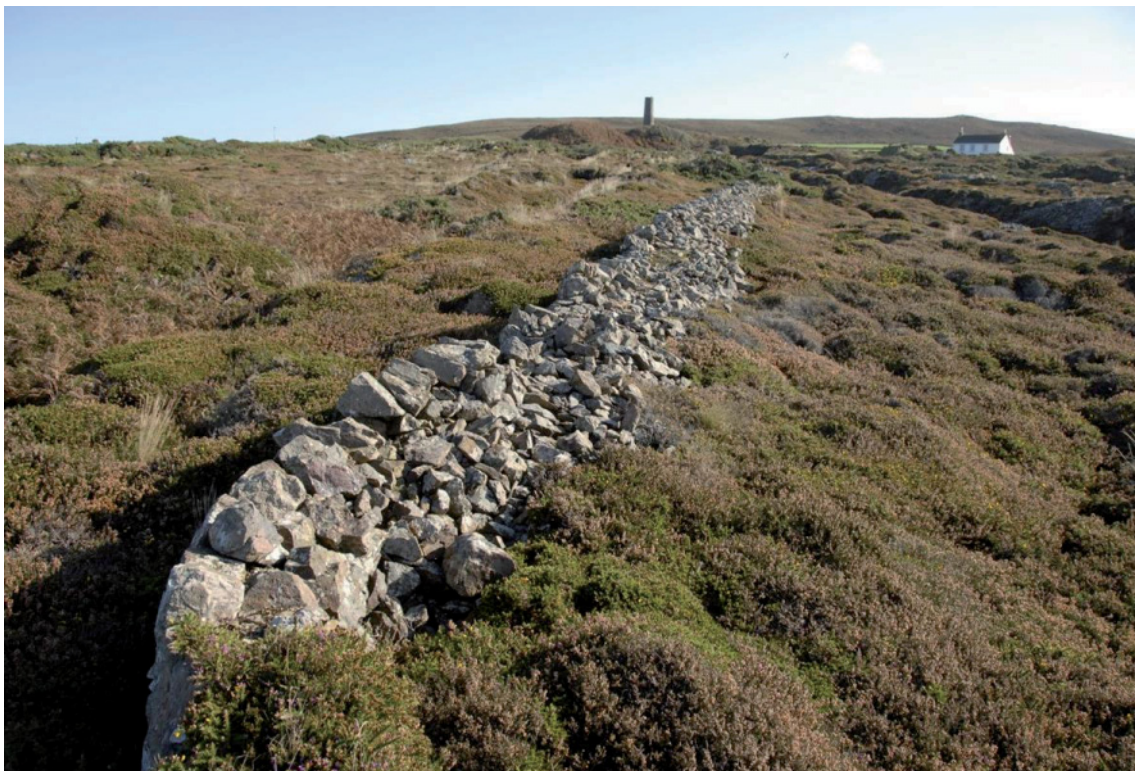
*Fig 77. The stock barrier wall around the openwork in the northern part of Wheal Coates [190286] which has been found to incorporate a number of possibly prehistoric mining tools. HE Archive.*

Fig 77. The stock barrier wall around the openwork in the northern part of Wheal Coates [190286] which has been found to incorporate a number of possibly prehistoric mining tools.

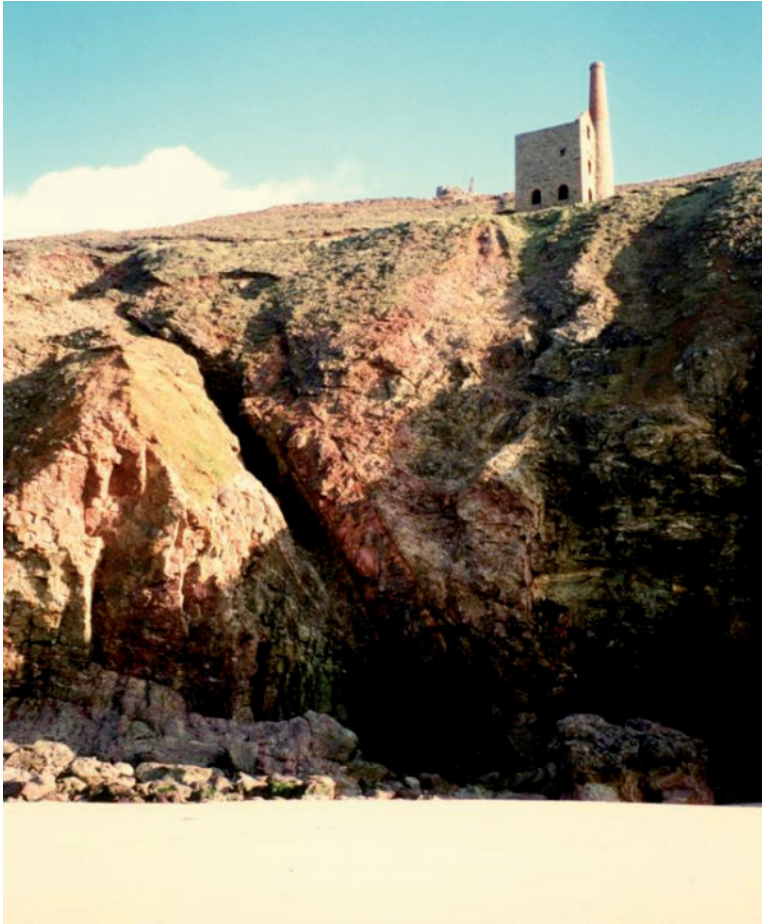
*Fig 78. The cliff-face outcrop workings on the Towanroath Lode, showing its south-dipping nature. Towanroath Vugga is at its base, whilst the vertical upper section of Towanroath Shaft intersects the lode below sea level. HE Archive.*

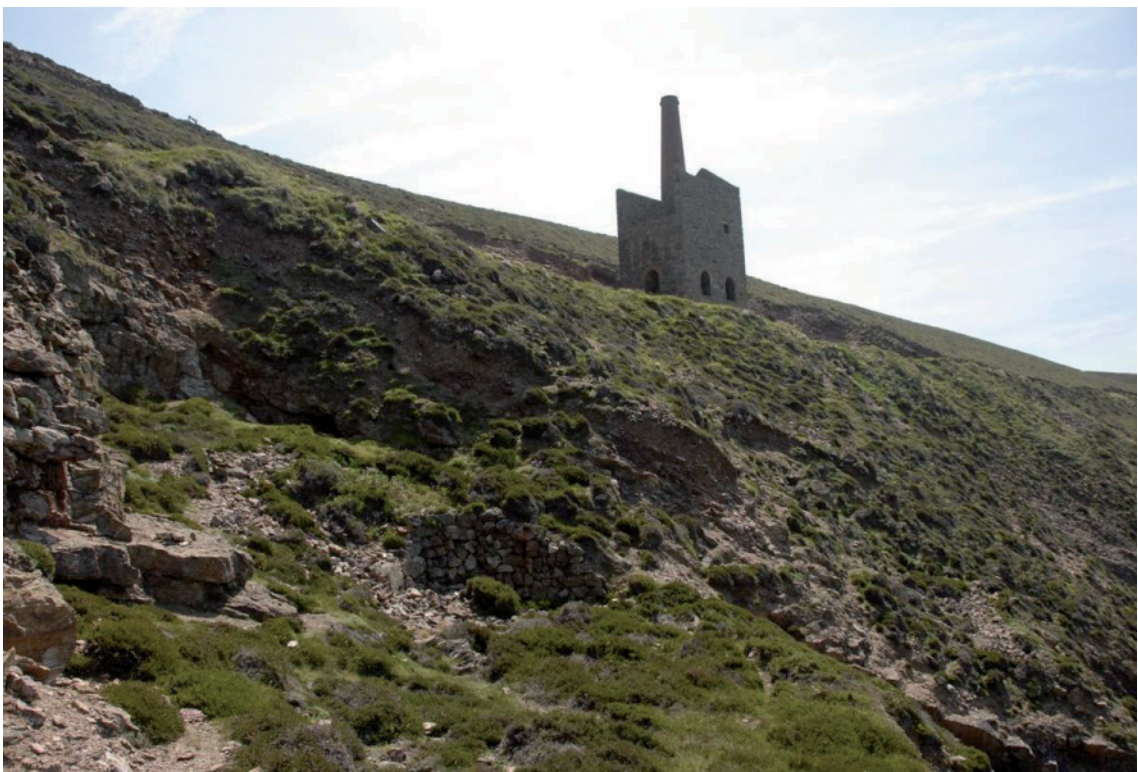
*Fig 79. The upper part of the outcrop workings on Towanroath Lode (crossing the view from lower right to upper left) are accompanied by the remains of an early miners' building [190387] (left of centre) set on a quarried platform. HE Archive.*

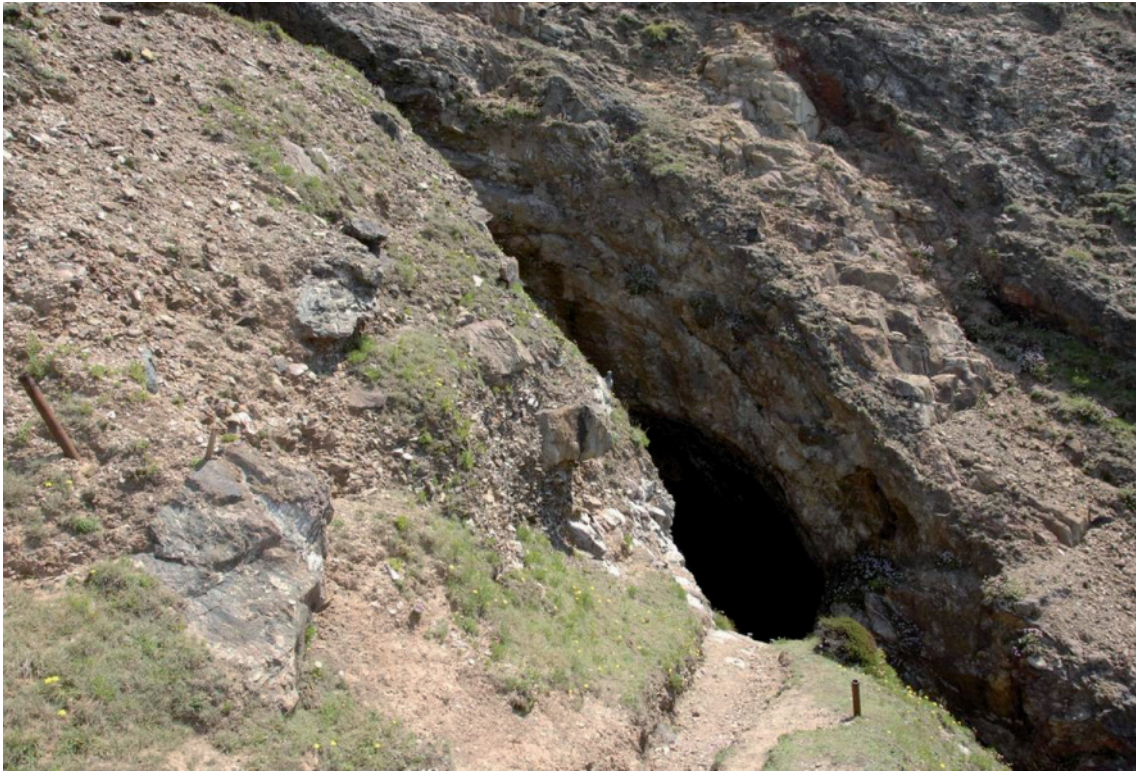
*Fig 80. The lower end of the miners' path [190386] where rock-cut steps lead to the early outcrop workings on the Towanroath Lode [190393]. HE Archive.*

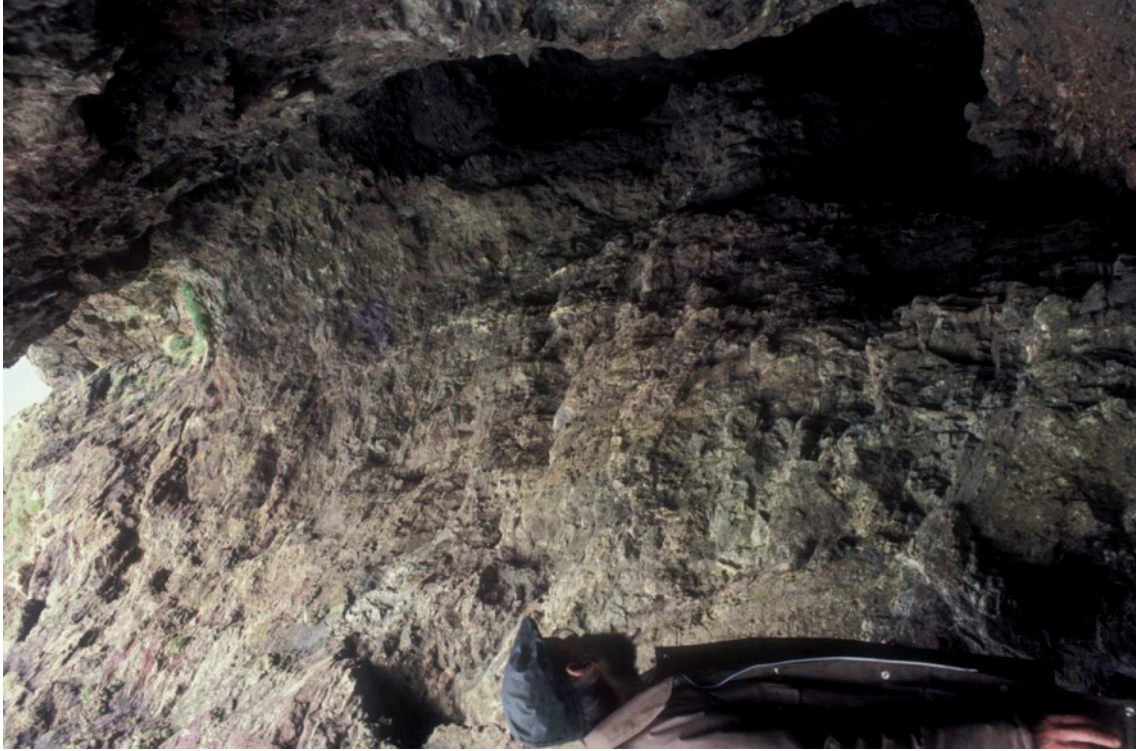
*Fig 81. John Smith examining apparently fire-set workings on the upper part of the outcrop of the Towanroath Lode. Adam Sharpe Collection.*

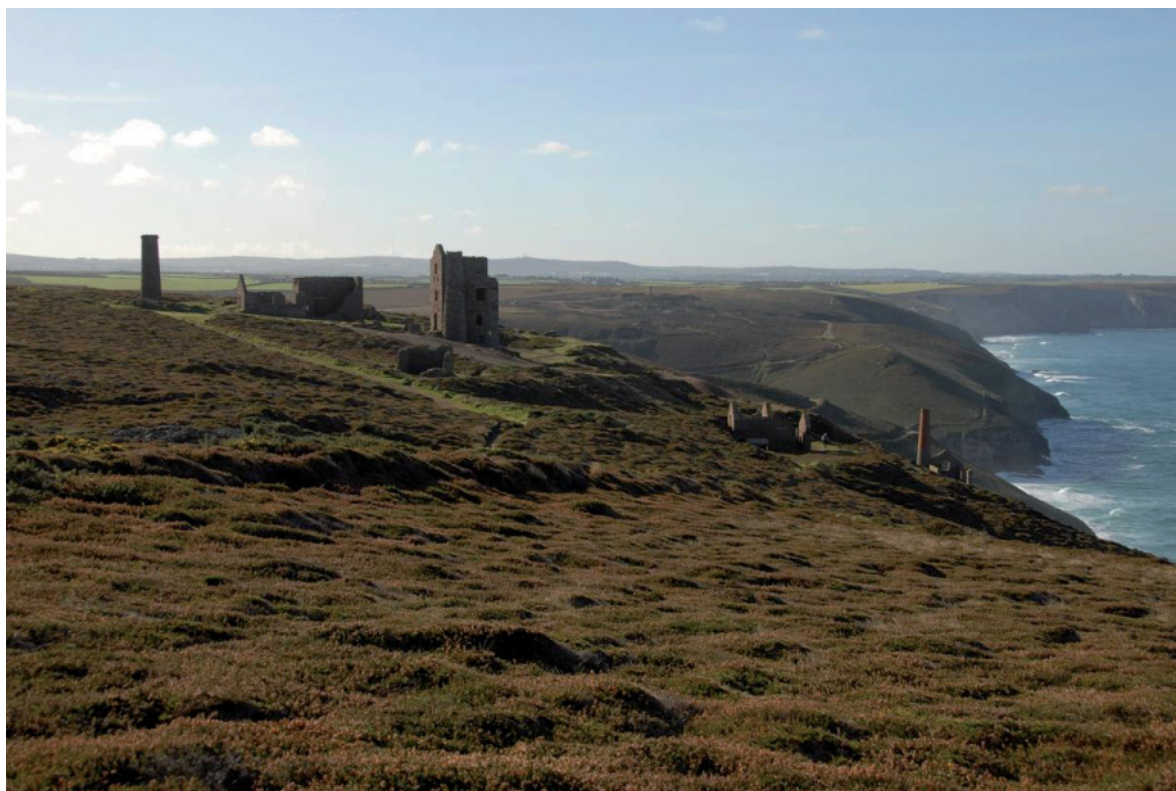
Fig 90. The clifftop building group at Wheal Coates, including (right to left) the boiler house [190377], all-indoor beam whim engine house [190378], chimney [190373], the horizontal whim engine house [190376] and the stamps engine house [190381]. HE Archive.

Wheal Coates beam whim [190378]. Replace timber lintel.

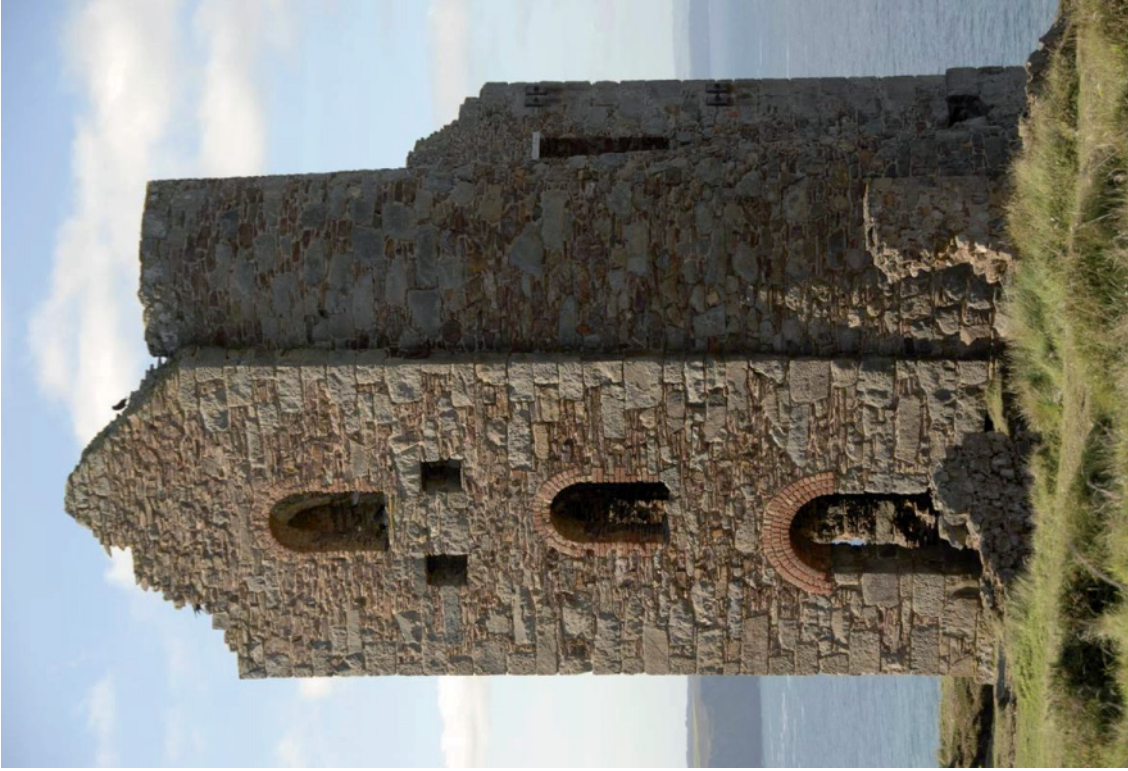
Fig 93. The stamps engine house [190381] following its conservation. On this elevation the replacement of some failed pointing and minor rebuilding of the cable were all that were undertaken. HE Archive.

Fig 93. The stamps engine house [190381] following its conservation. On this elevation the replacement of some failed pointing and minor rebuilding of the gable were all that were undertaken.

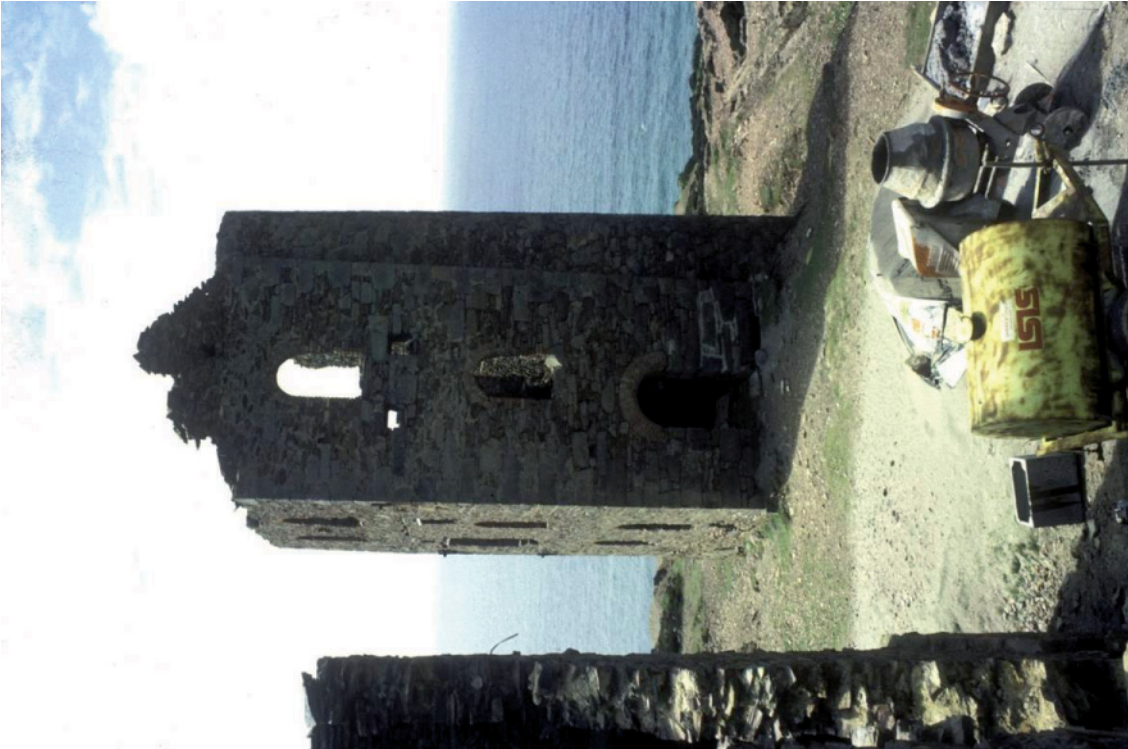
Fig 92. A view of the stamps engine house [190381] prior to its conservation in 1986. Adam Sharpe Collection.

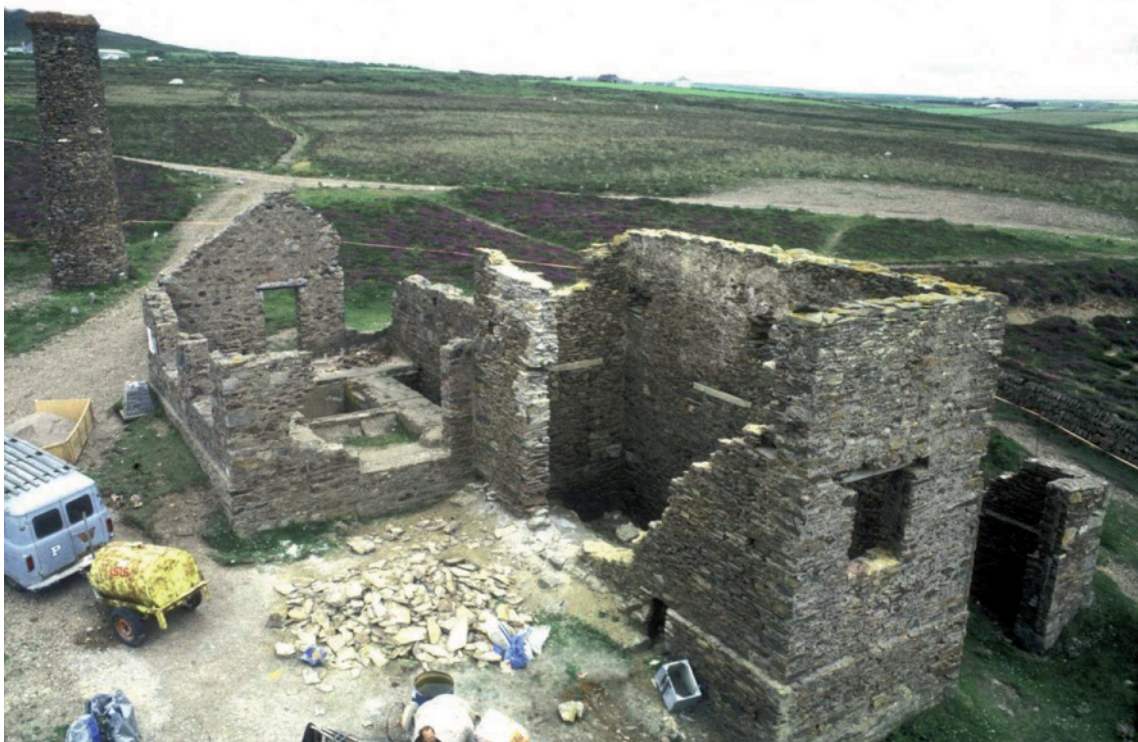
Fig 94. The boiler house [190377] (foreground), the all-indoor beam whim engine house [19037] (immediately behind) and the chimney [190373] seen from the reservoir [190394]. HE Archive.

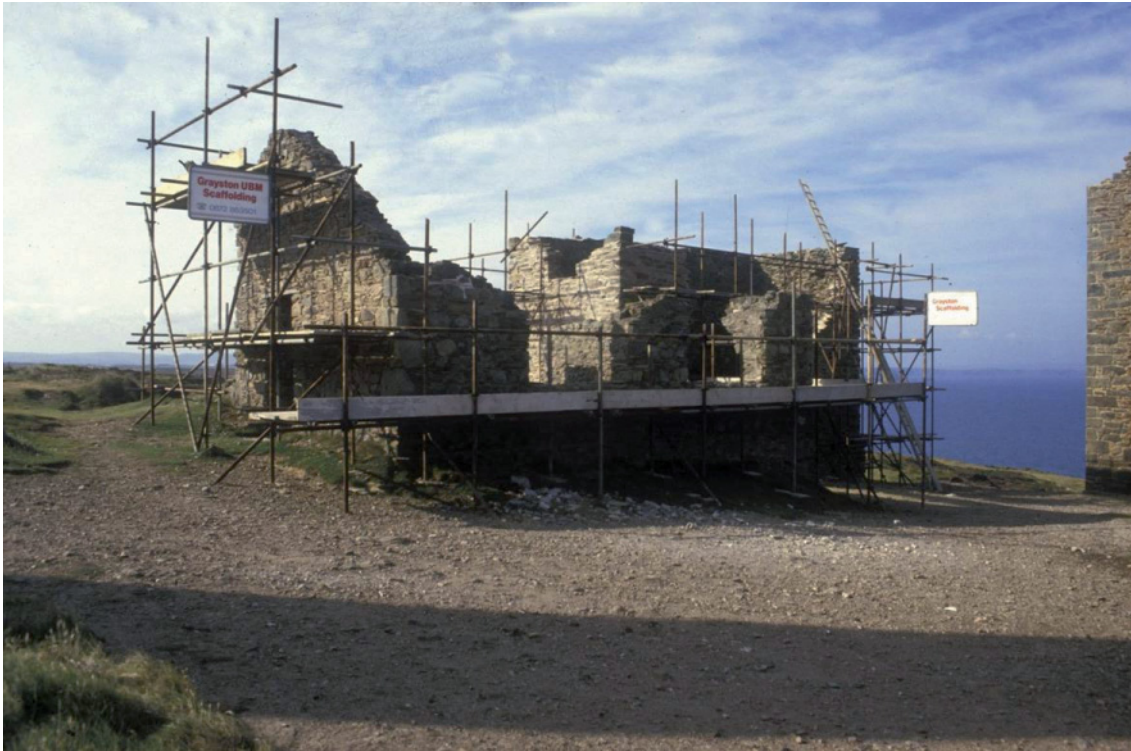
Fig 95. Conservation work under way to the horizontal whim engine house [190376] (left) and all-indoor whim engine house [190378] (right) during 1986. Adam Sharpe Collection.

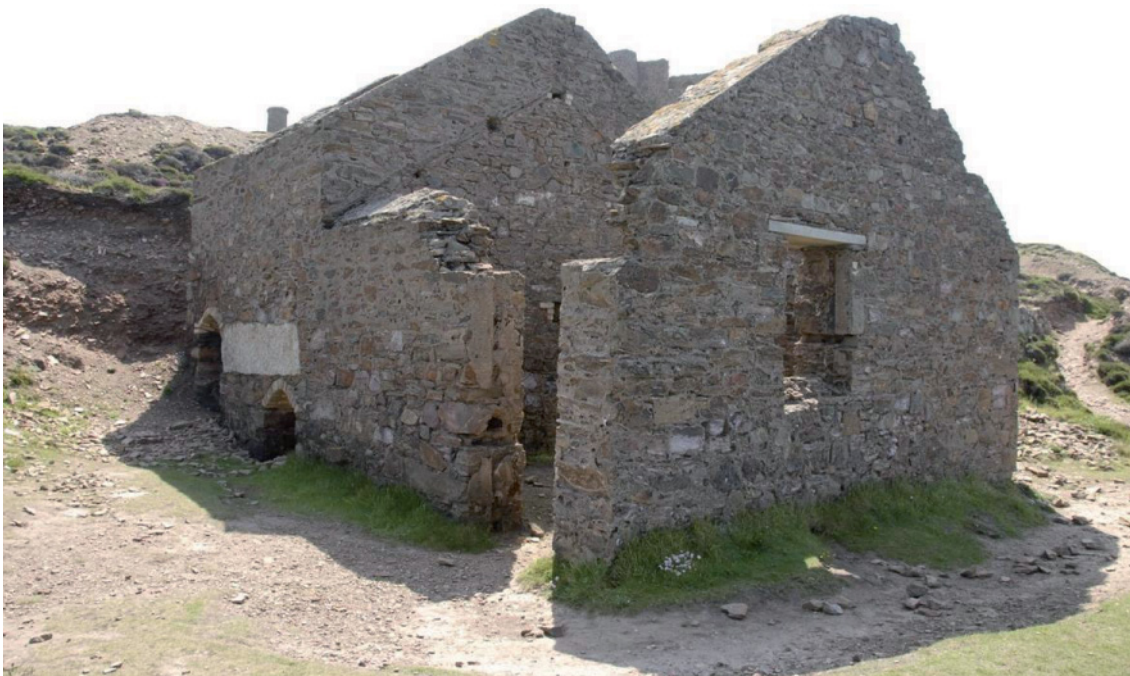
Fig 97. The reverberatory arsenic calciner [190346] seen from the north-west. The nearest section of the building housed the stoking area, whilst the calcining beds are in the farther section of the structure. The arched opening at the rear gives onto one of the twin hearths, whilst the nearer arch is the discharge opening. Matching openings are found on the opposite side of the building. HE Archive.

Fig 97. The reverberatory arsenic calciner [190346] seen from the north-west. The nearest section of the building housed the stoking area, whilst the calcining beds are in the farther section of the structure. The arched opening at the rear gives onto one of the twin hearths, whilst the nearer arch is the discharge opening. Matching openings are found on the opposite side of the building.

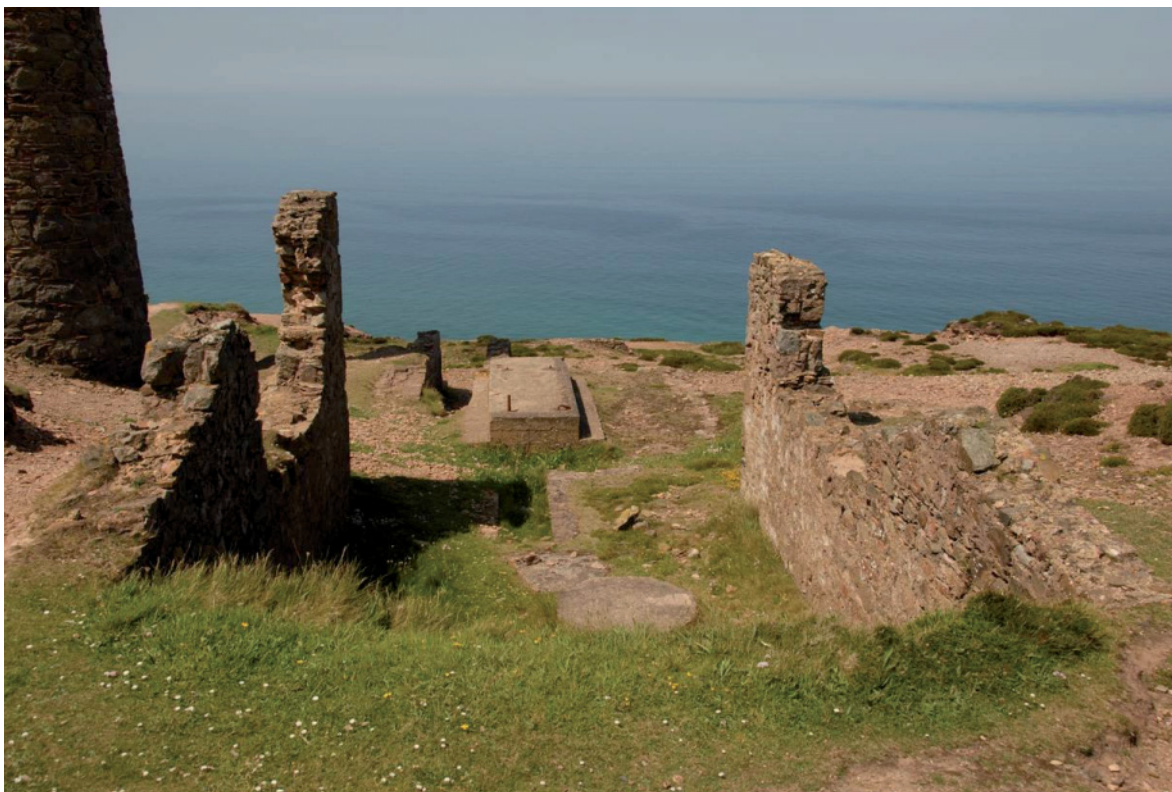
*Fig 100. The mine smithy [190343] with its forge base (inside rear wall) seen from the north, with the stamps engine house [190381] in the background. HE Archive.*

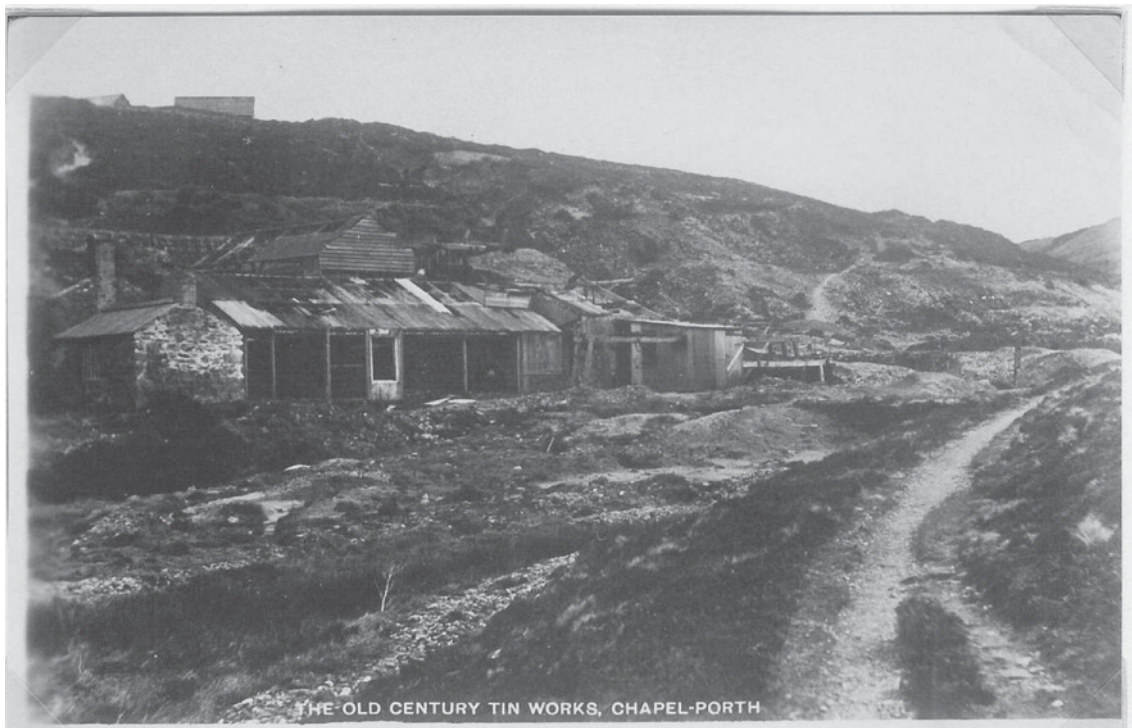
Fig 108. A probably early 20<sup>th</sup> century archive view looking down Chapel Combe across the Old Century tin works [190510]. The disturbed nature of the valley bottom indicates abandoned tin streaming activity. In the background (left) can be seen the bungalow [198501]. Clive Benney Collection

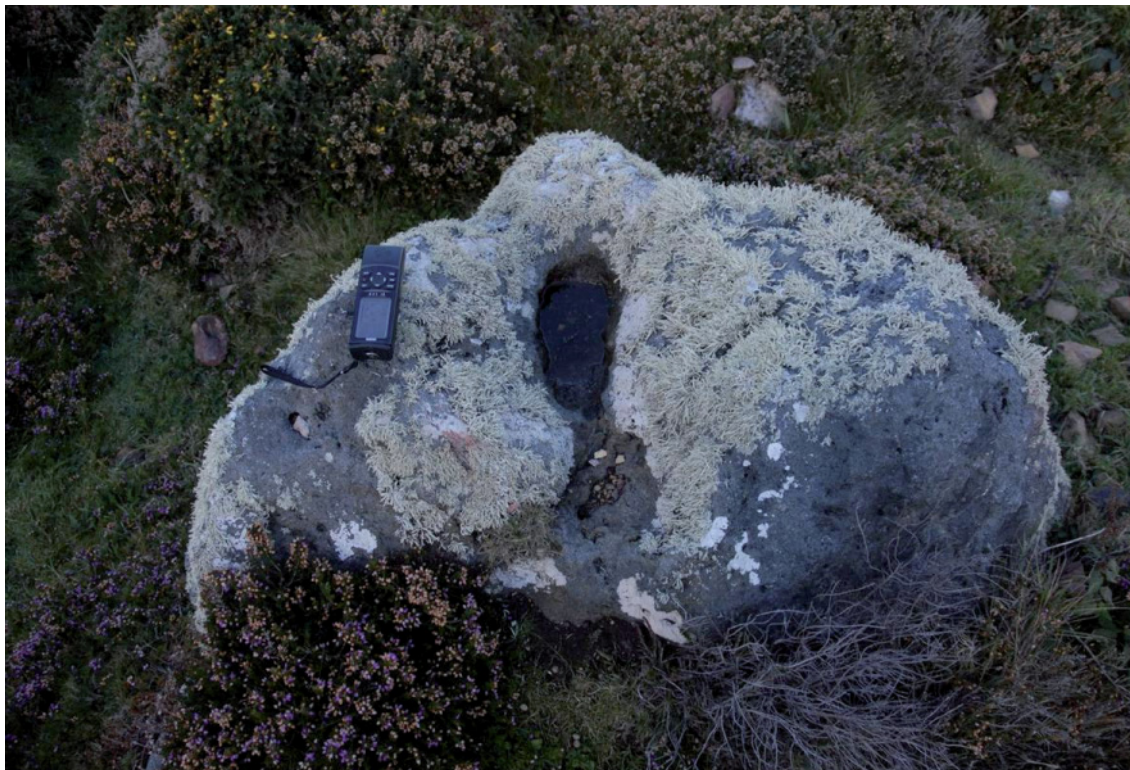
*Fig 121. The Giant's Footprint [190451] – a natural erosion hollow in a surface boulder in base of the narrow Coombe running north-eastwards from Chapel Porth, and associated with the legend of Giant Bolster. GPS unit included for scale. HE Archive.*

Tonkin (1975-6, 204) also noted that St Agnes '*left the mark of her foot on a rock, not far from it [the well], still called St Agnes Foot, which they tell you will fitt a foot of any size, and indeed it is large enough so to doe.'* This element of the tradition appears to have undergone some alteration: the 1st edition Ordnance Survey 25in: 1 mile map of c 1880 marks a stone about 220m higher up the narrow coombe in which the chapel and well were set as the 'Giant's Footprints' [sic] (Fig 121).
