# **St Agnes Beacon, Tubby's Head, Wheal Coates, Chapel Combe, Charlotte and Towan Moors, St Agnes, Cornwall**

## **Archaeological and ecological assessment**

**Archaeological and ecological assessment for  
the National Trust**

<b>Client</b>	<b>The National Trust</b>
<b>Report Number</b>	<b>2011R037</b>
<b>Date</b>	<b>01/04/2010</b>
<b>Status</b>	<b>Final</b>
<b>Report author(s)</b>	<b>Adam Sharpe BA MIFA, Graeme Kirkham MA MIFA, Spalding Associates</b>
<b>Checked by</b>	<b>Peter Rose, Projects Manager</b>
<b>Approved by</b>	<b>Peter Rose, Projects Manager</b>

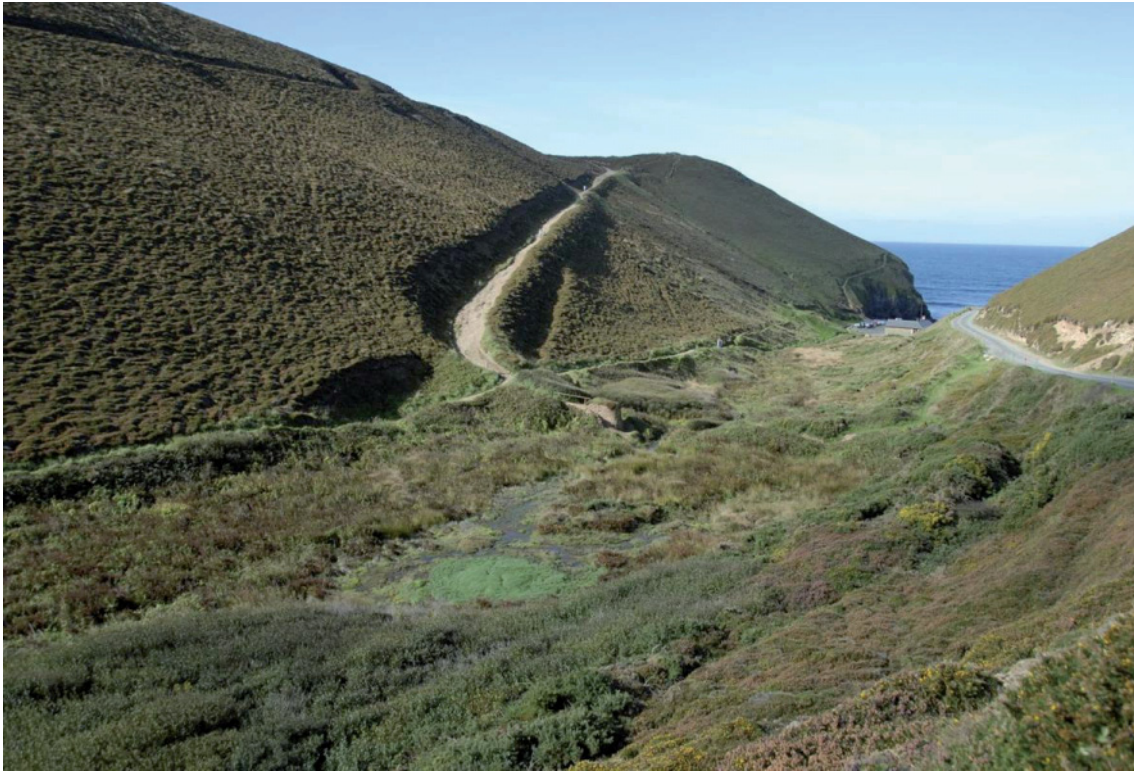
Fig 138. A series of closely-set outcrop workings [190758], part of Wheal Towan or one of its predecessors on the southern boundary of the property. HE Archive.

The southern part of the project area includes the northern part of the Wheal Towan sett [190759], where three closely-set north-east to south-west trending parallel lodes have been worked from surface by means of outcrop workings [190752], [190756] and [190757] (Fig. 138). There is no evidence of deep mining in this part of the Wheal Towan sett, unlike the area to the south which formed the core of this rich copper mine.

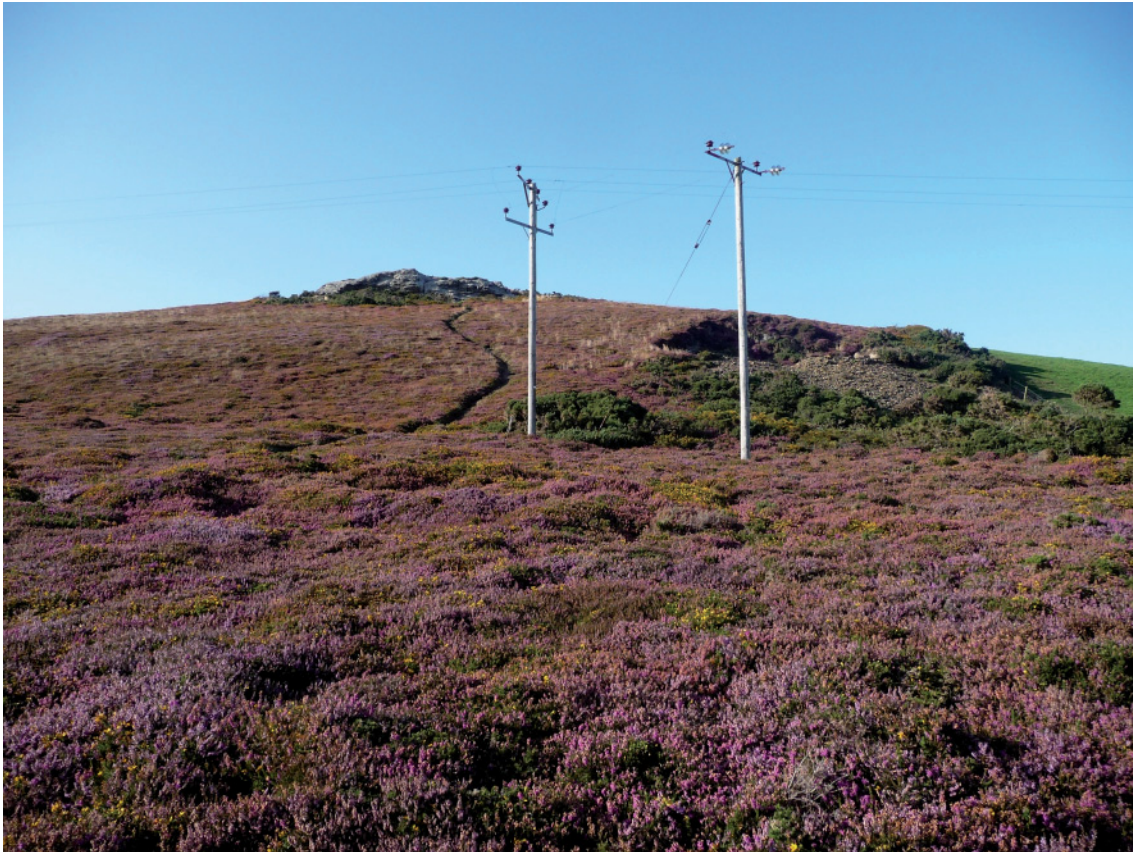
*Fig 147. Post-medieval quarrying on the rock outcrop on the southern flank of the Beacon, named by Thomas Tonkin in the early eighteenth century as Garder Wollas, 'the lower seat' [190156]. The prominent overhead power cables and poles diminish the strong visual amenity and historic character of the landscape. HE Archive.*

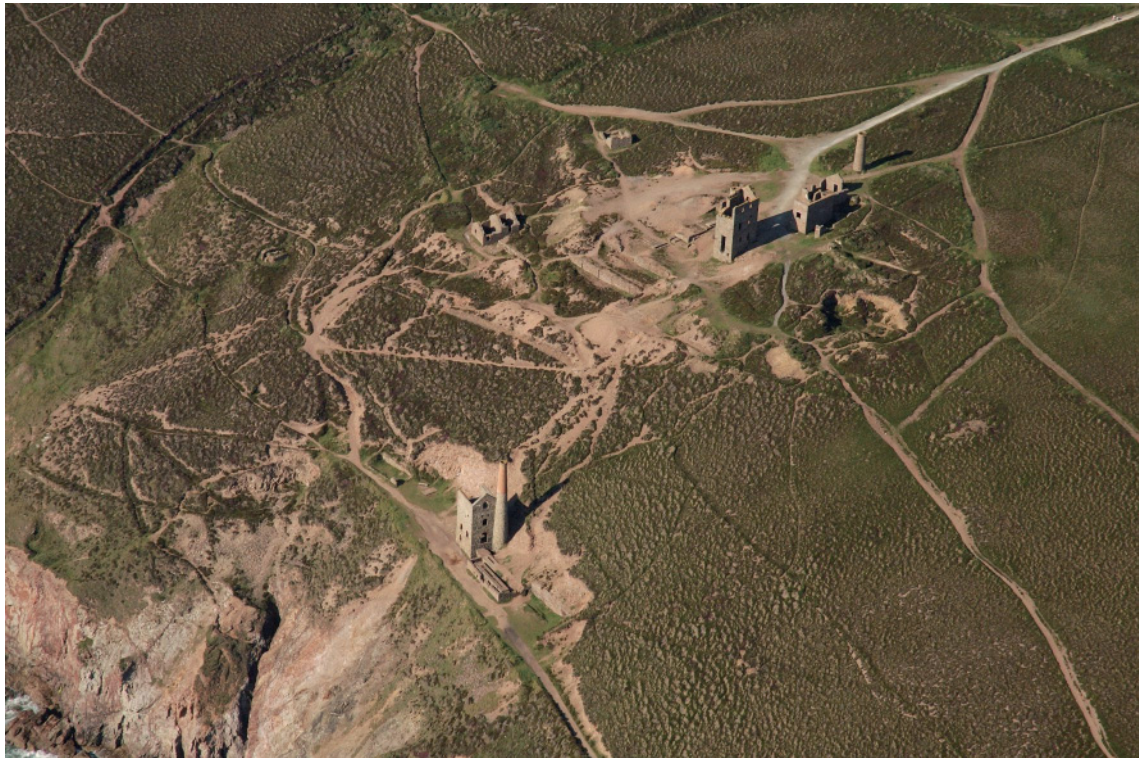
*Fig 149. The effects of visitor pressure on thin soils can be found at many points within the project area, but are particularly evident in this aerial photograph of Wheal Coates. Multiple, braided paths have developed on thin soils, removing the vegetation and topsoil and promoting erosion. HE Archive.*

Fig 149. The effects of visitor pressure on thin soils can be found at many points within the project area, but are particularly evident in this aerial photograph of Wheal Coates. Multiple, braided paths have developed on thin soils, removing the vegetation and topsoil and promoting erosion.

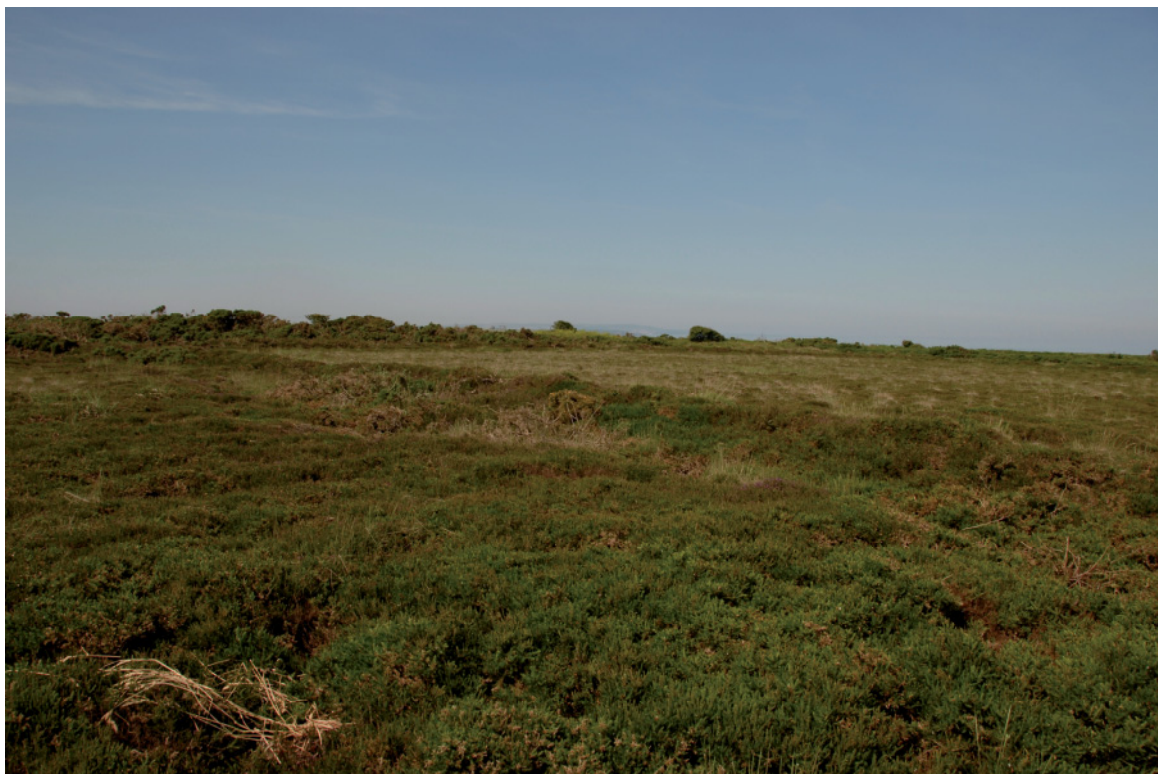
*Fig 150. On Charlotte Moor, Towan Moor and St. Agnes Beacon, many relatively subtle archaeological features have become swamped by unmanaged growth. In this view of Towan Moor a relatively substantial earth bank and ditch defining the western boundary of field system [190719] runs across the view from top left to bottom right. For other examples of this issue see Figs 45 and 49. HE Archive.*

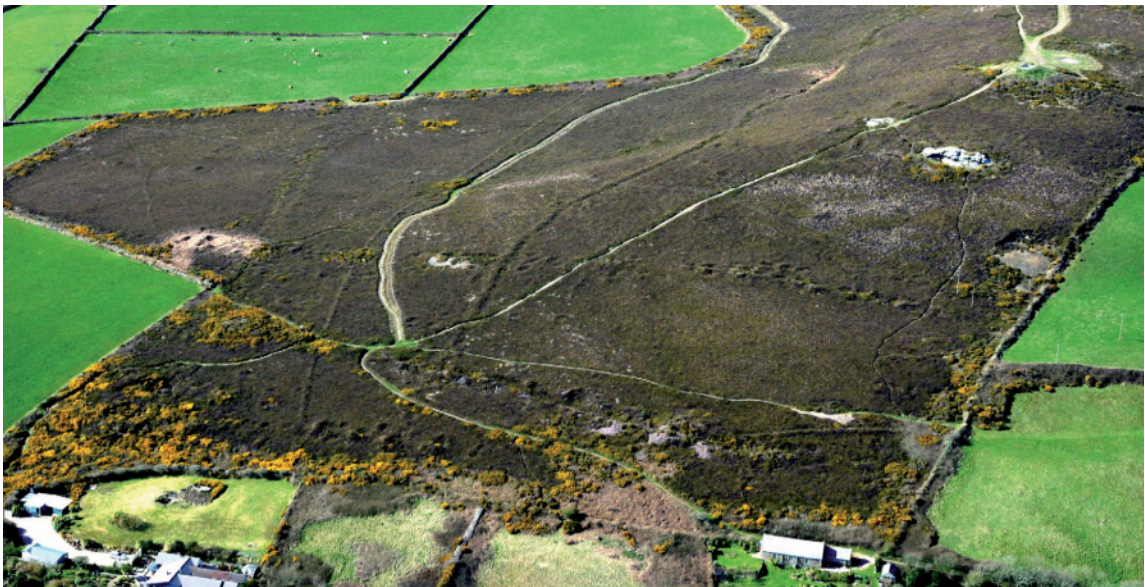
*Fig 151. Dense growth of furze and scrub masks significant remains of both industrial and military activity on the northern end of the Beacon ridge. HE Archive.*

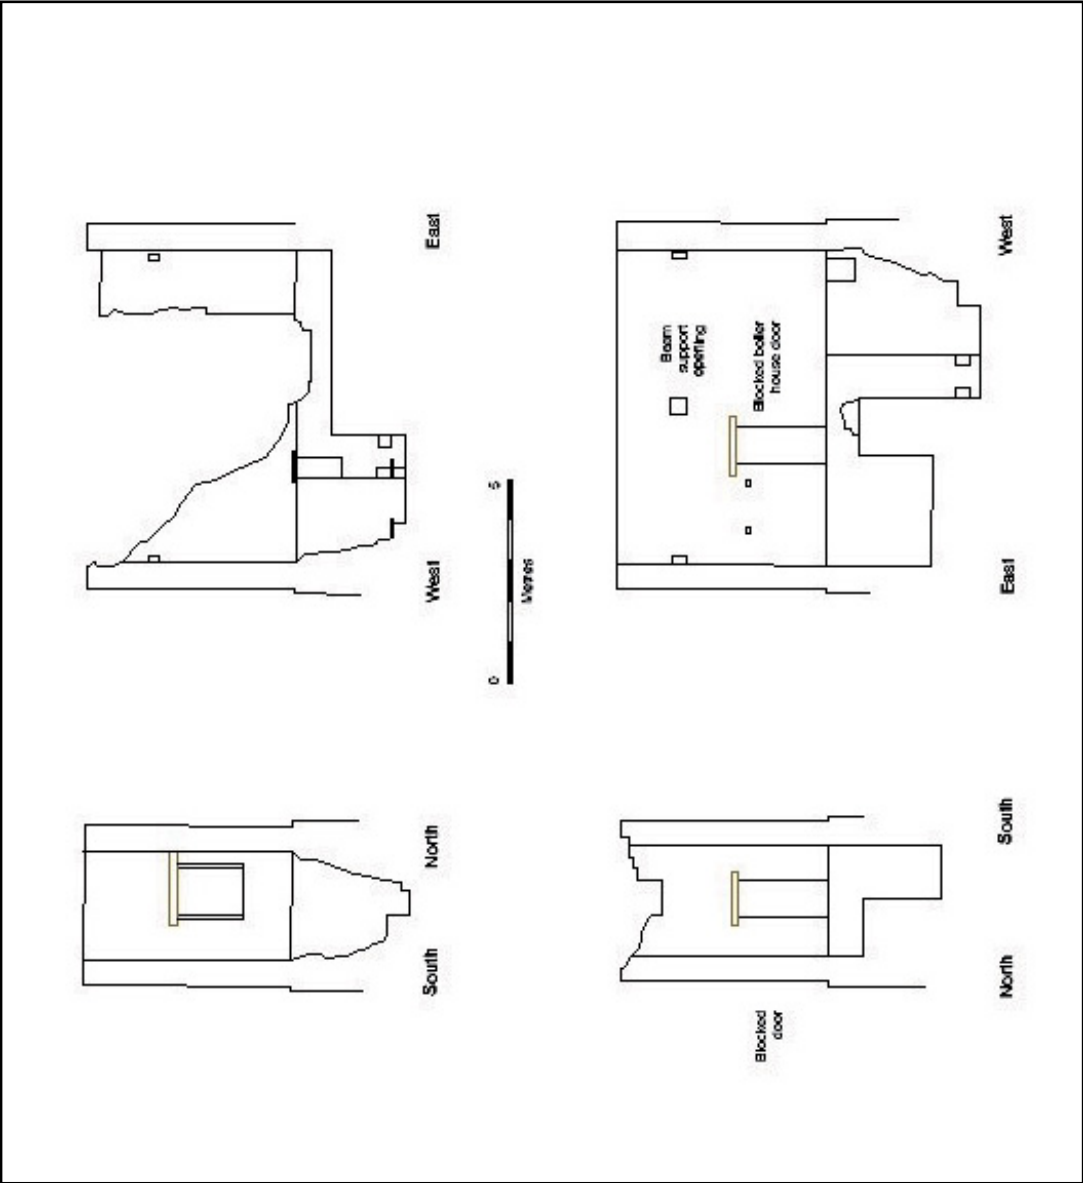
Fig 164. Internal elevations of Wheal Coates beam whim engine house [190378].

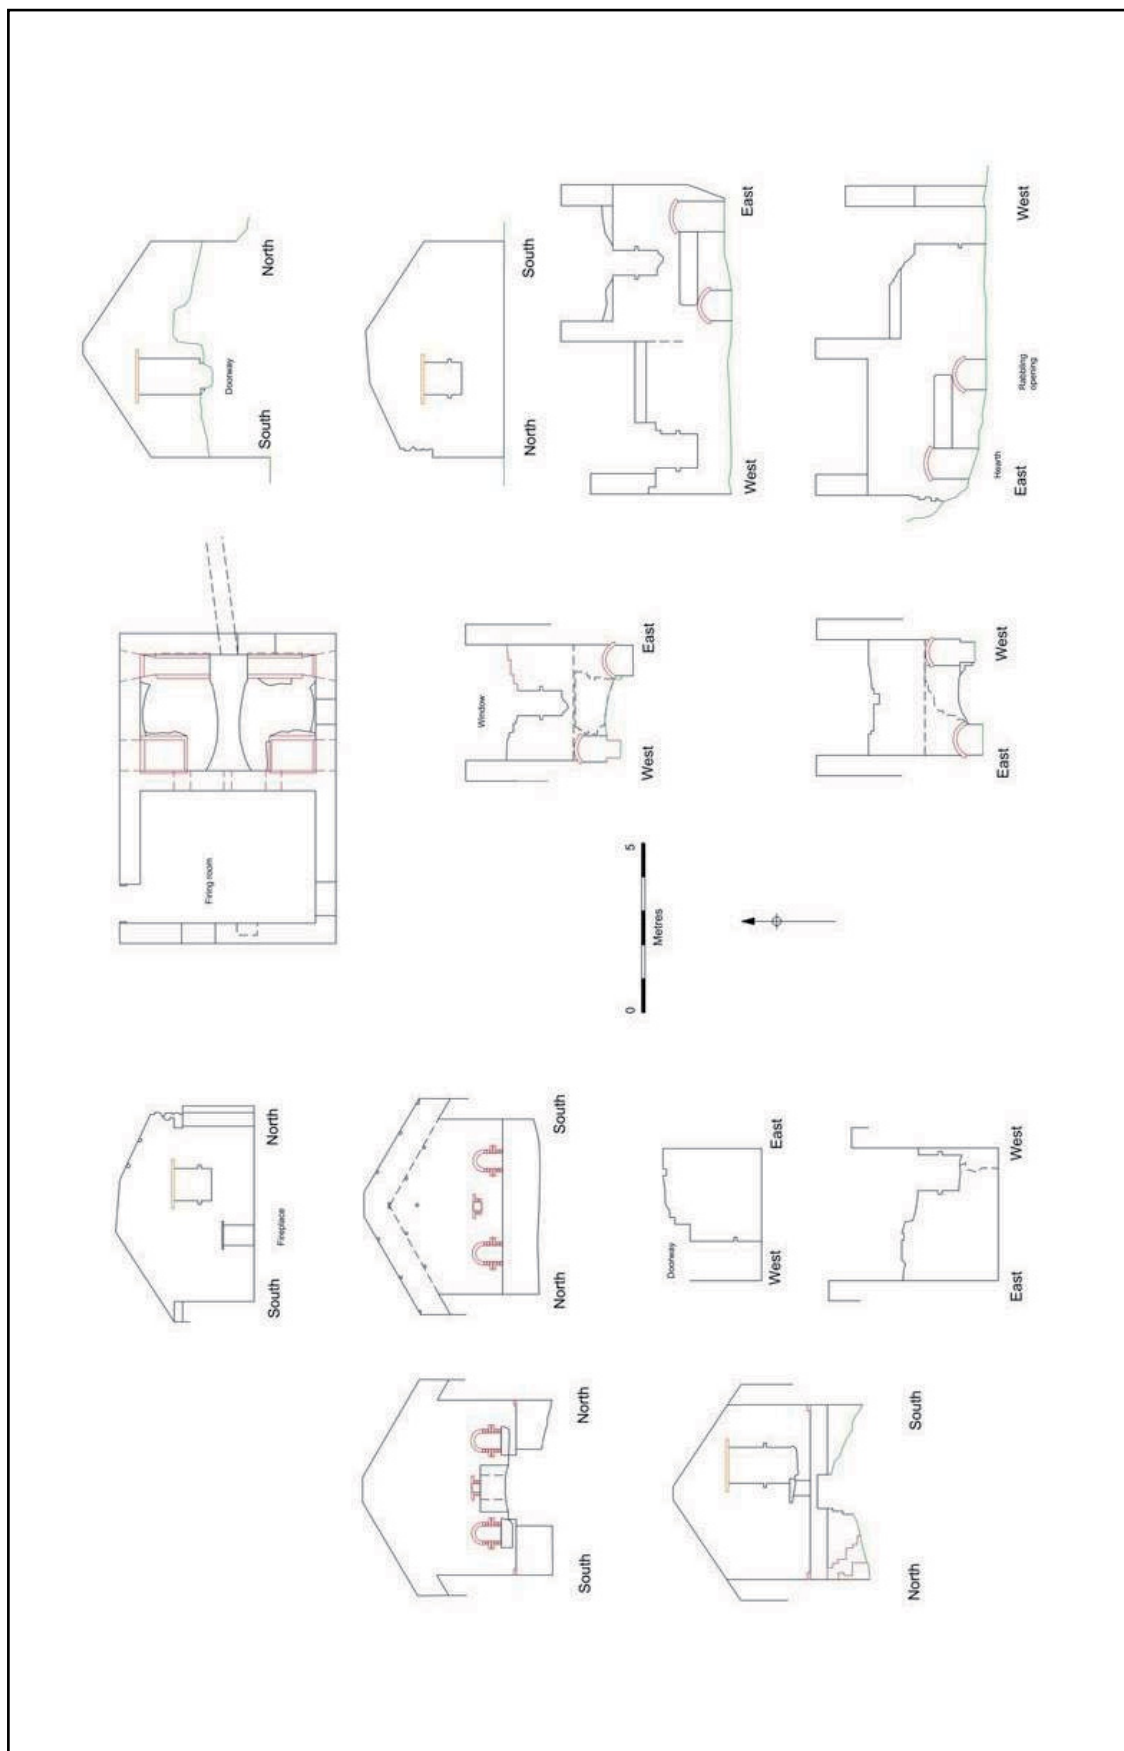
Fig 172. Plan, external and internal elevations of the Wheal Coates calciner [190346].

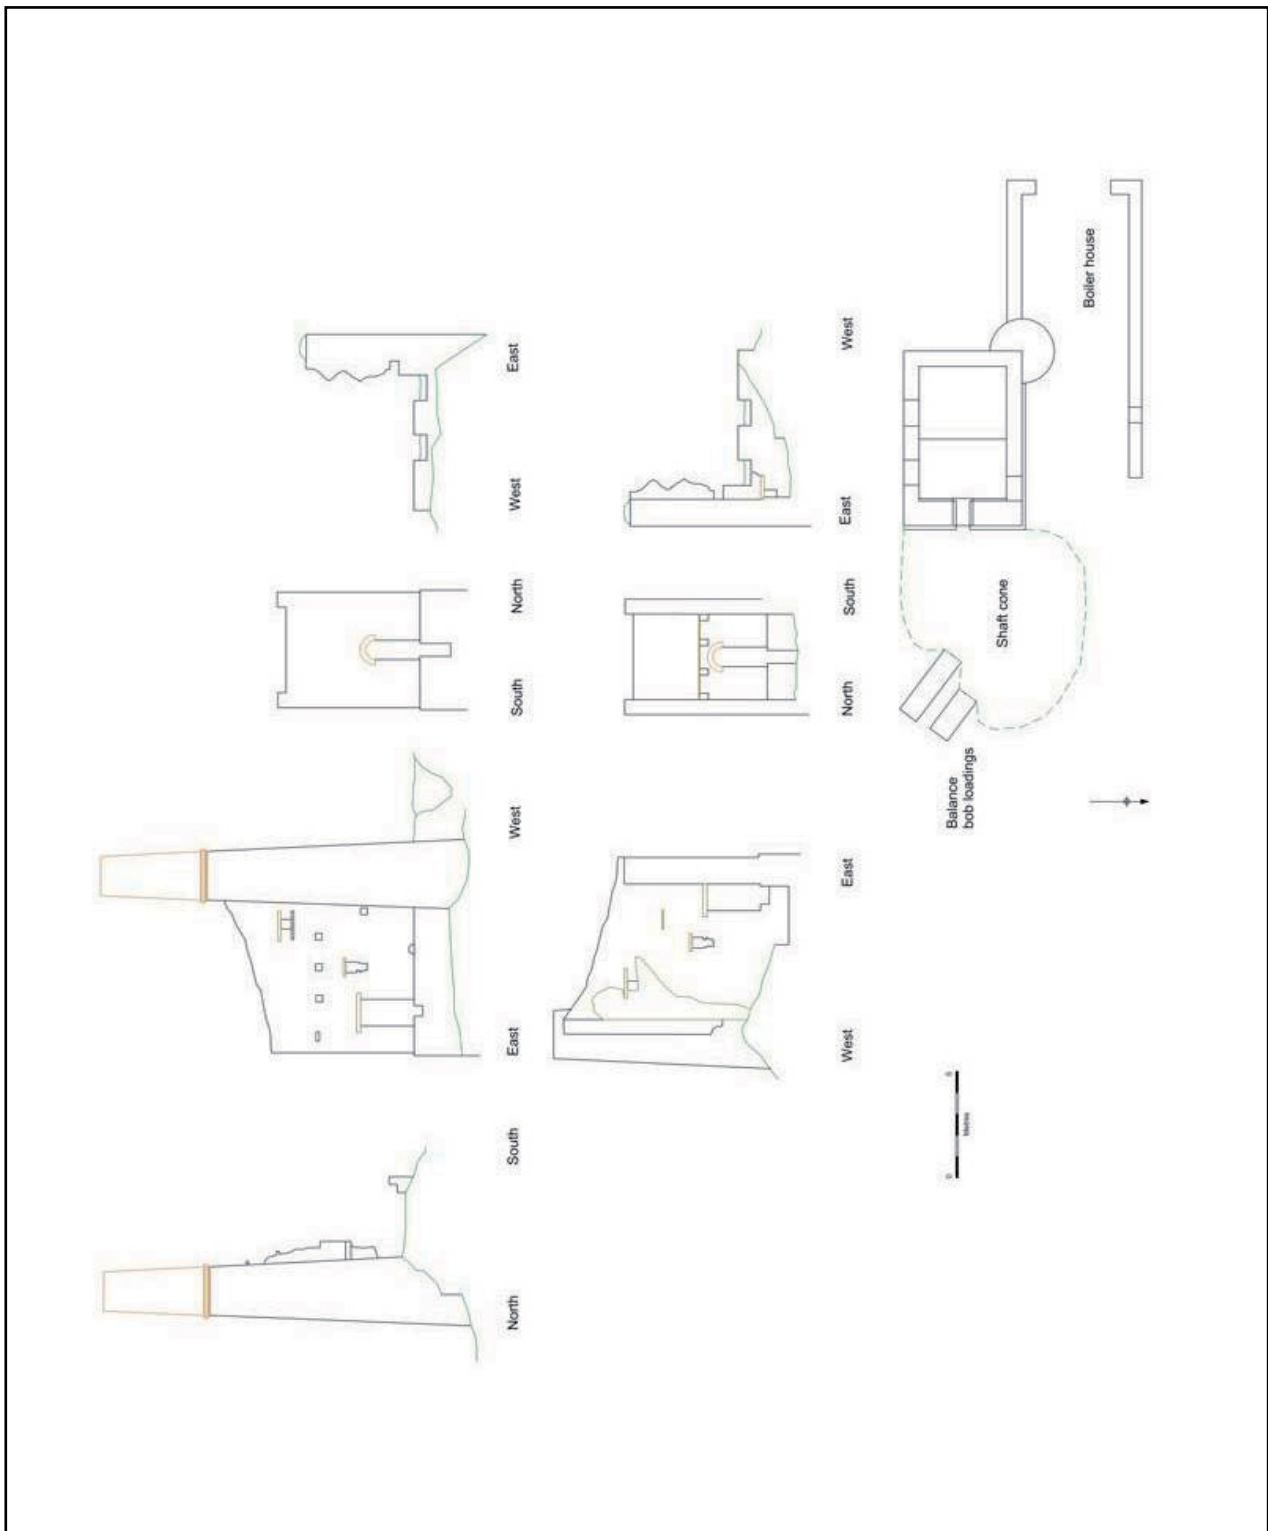
Fig 174. Plan, external and internal elevations of Charlotte United pumping engine house and boiler house [190616]/[190617], together with plan of shaft [190618] and balance bob mountings [190619].
