# Tregargus, St. Stephen in Brannel, Cornwall

## Conservation Management Statement

## **Tregargus Valley, St. Stephen in Brannel, Cornwall**

### **Conservation Management Statement**

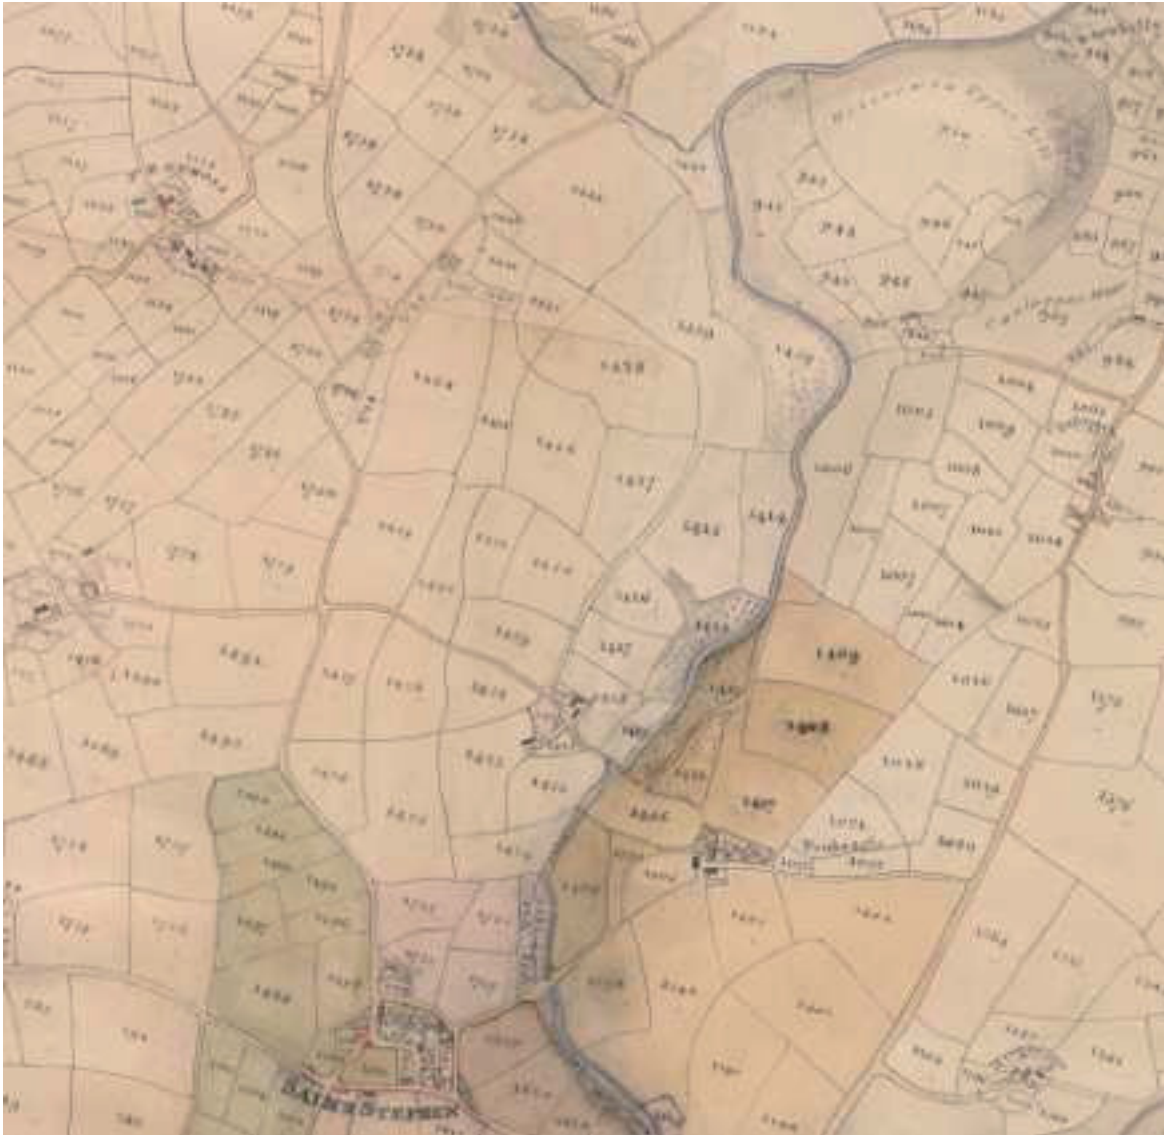
*Fig 14. An extract from the circa 1840 Tithe Map for St. Stephen in Brannel showing the section of the Barn River valley occupied by the Tregargus sites (centre). None of the structures described in this report are shown on this mapping. Block 1459 (upper centre) including the site of the Rescrowns china clay works was recorded as 'Moor and Clay Pits', whilst Block 1415 (lower centre), the site of the Higher and Lower Tregargus Quarries was recorded as 'Quarry Close'. Digitised image © Copyright Cornwall Council.*

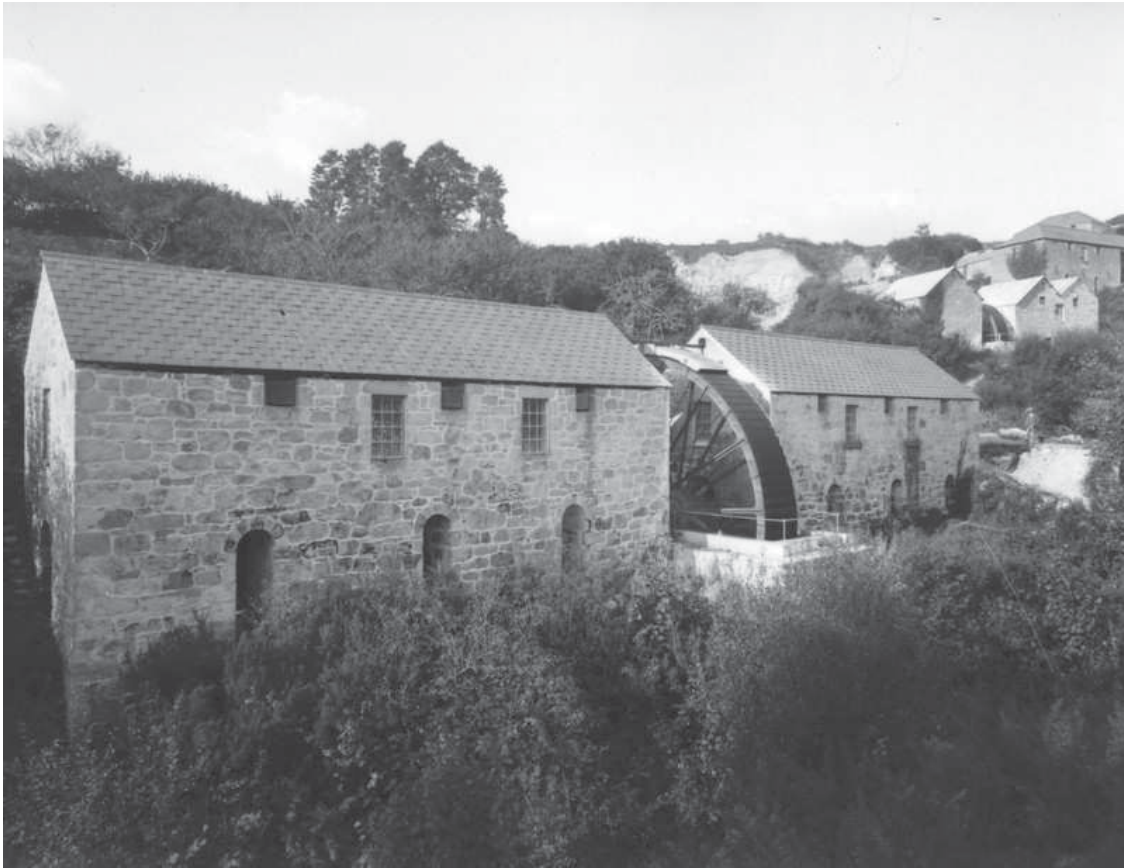
*Fig 21. An archive view of Big Wheel Mill, with Short Incline Mill, Top Wheel Mill and Blacksmith's Shop Mill in the background. British Geological Survey © NERC. All rights reserved. IPR/121-15CT*

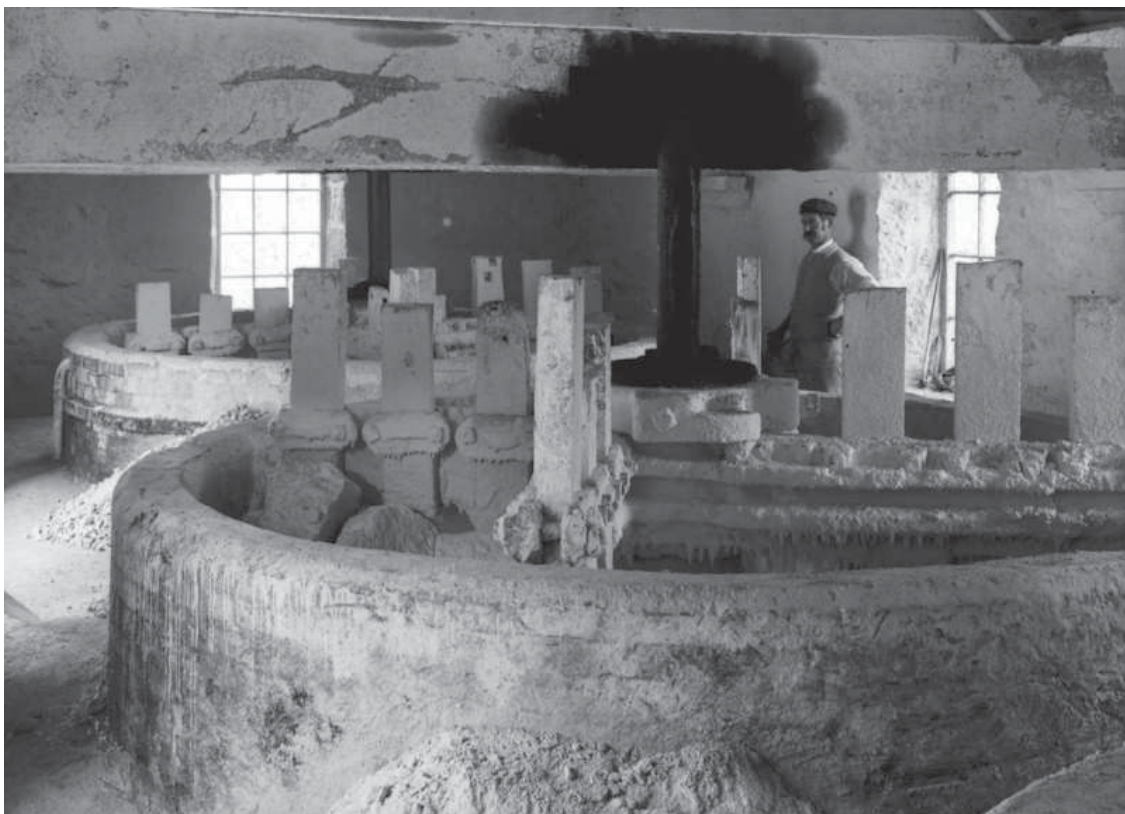
*Fig 22. An archive view of the interior of Big Wheel Mill, showing two of its grinding pans. British Geological Survey © NERC. All rights reserved. IPR/121-15CT*

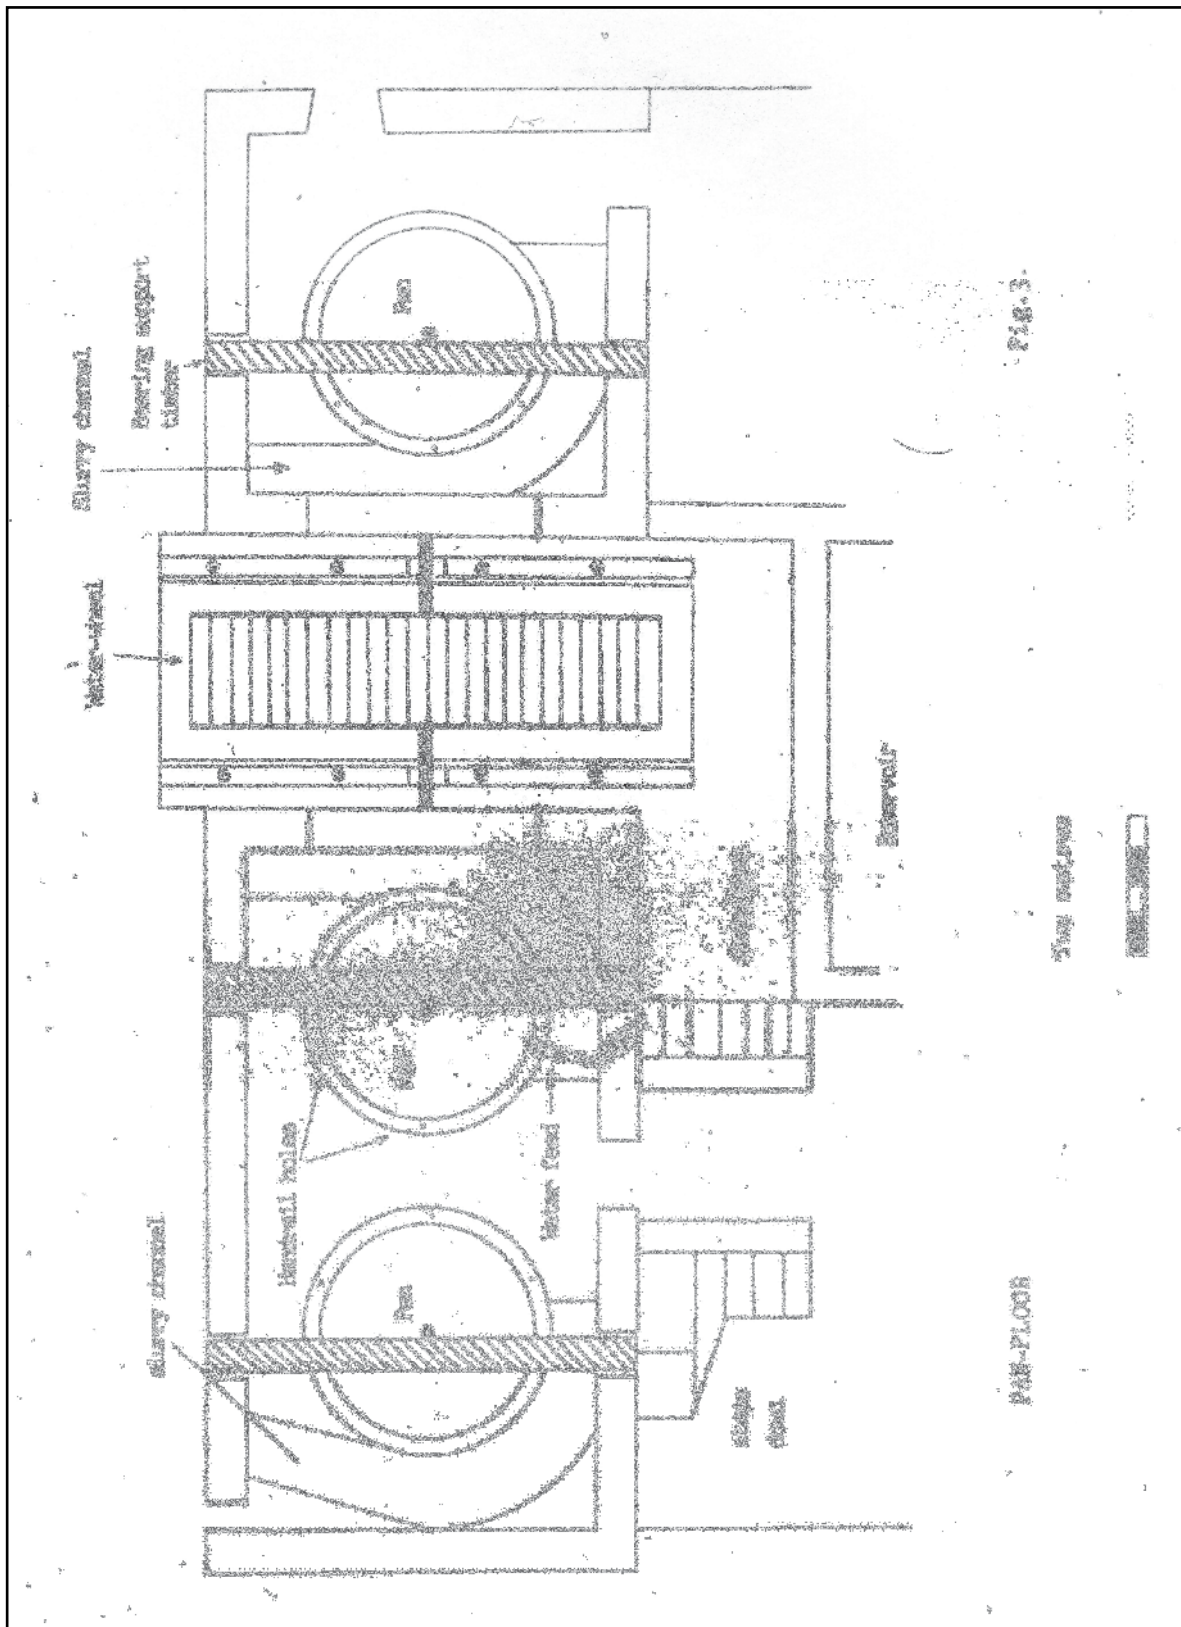
Fig 25. A typical arrangement of the ground floor of a china stone mill (Chapel Mill), showing the water wheel in its wheel-pit, the grinding pans flanking it and the bressmers over them which supported the upper ends of the vertical axles. Source: Sharpe and Smith 1985.

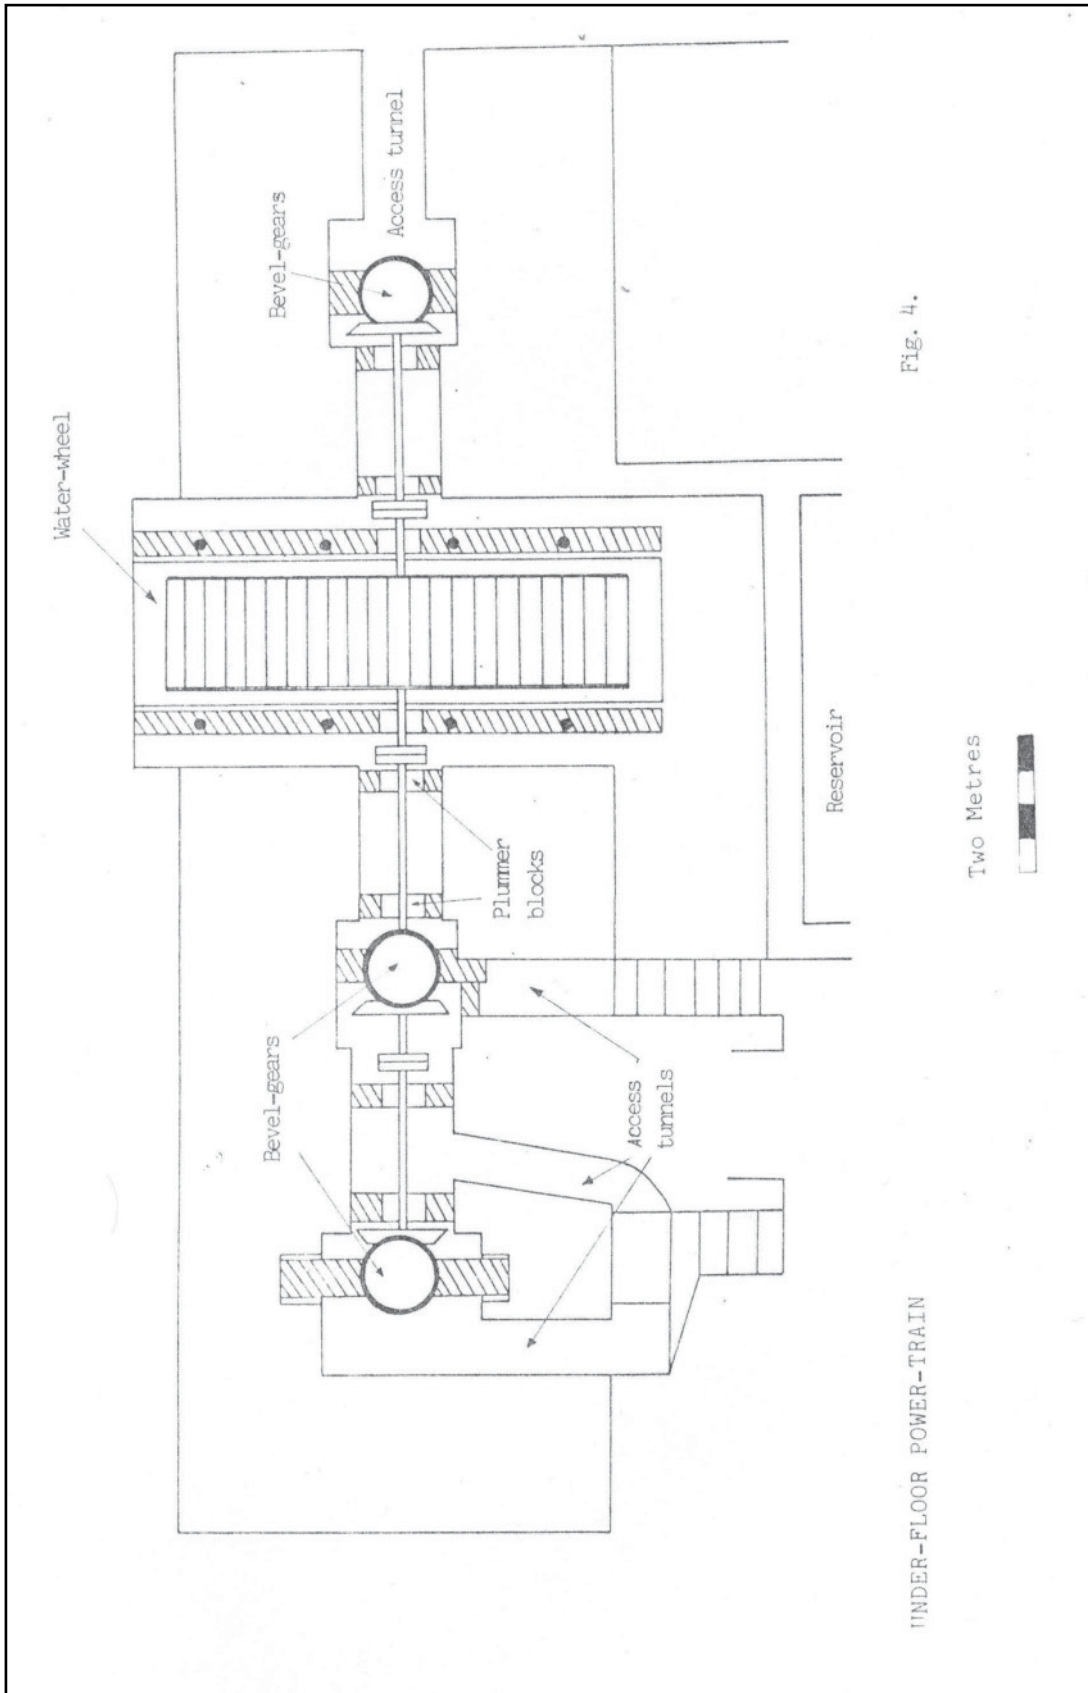
Fig 26. A typical under-floor arrangement in a china stone mill (Chapel Mill), showing the horizontal drive axles from the water wheel, the bevel gears which powered the axles running up to the grinding pans and the access tunnels from the exterior of the building. Source: Sharpe and Smith 1985.

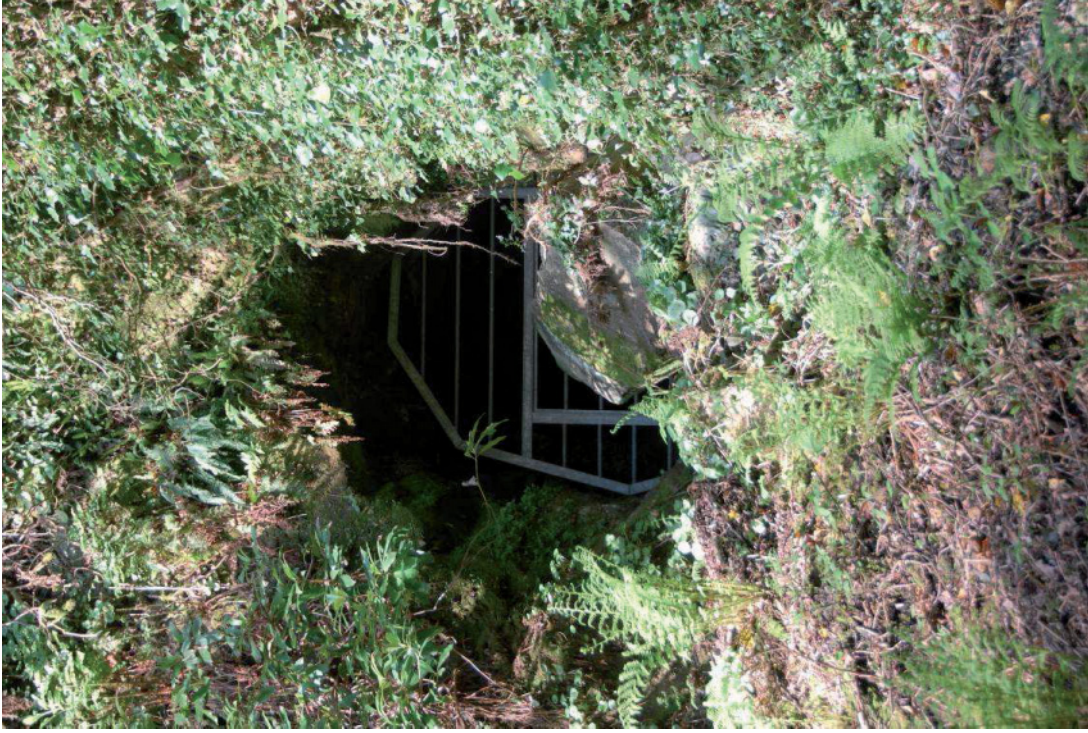
*Fig 28. One of the bat-friendly galvanised steel grilles [3] fitted in the adits in Wheal Arthur Quarry [1]. The quarry is outside the area managed by the Tregargus Trust. HE Digital Image Archive.*

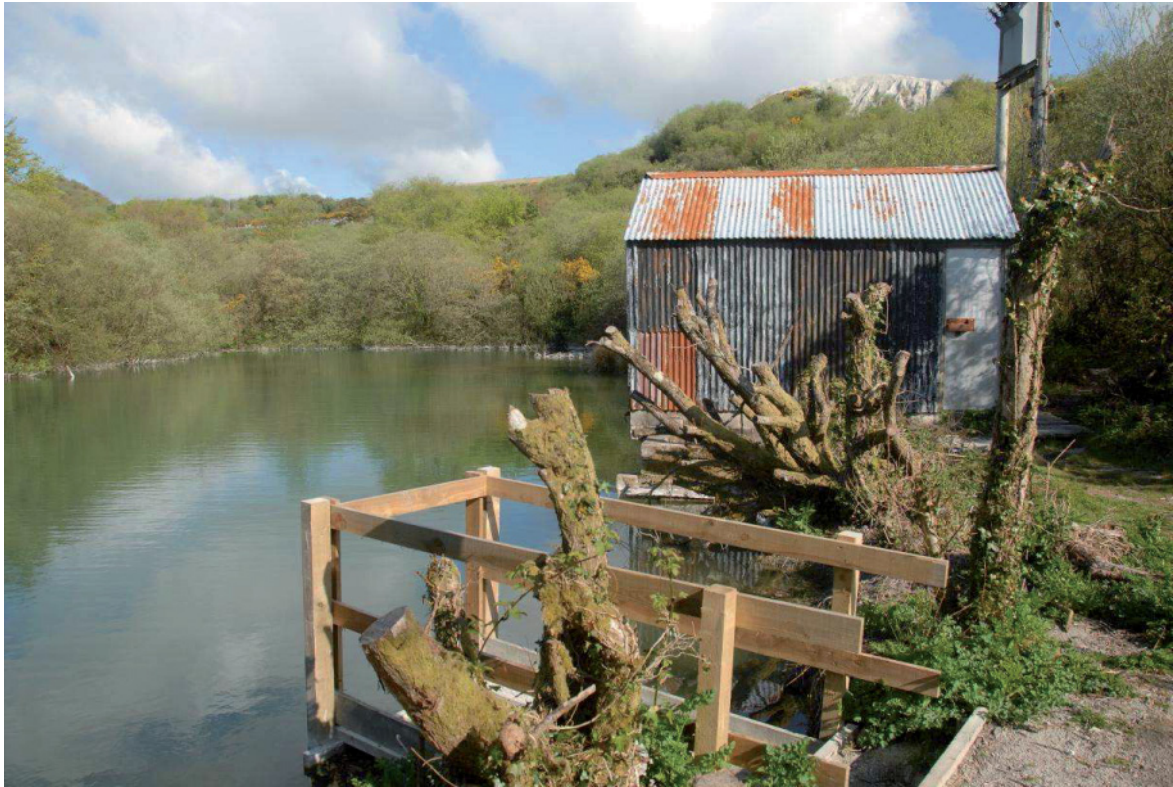
*Fig 29. The pond and pump house just to the north of the Wheal Arthur complex. This site is just to the north of the area managed by the Tregargus Trust. HE Digital Image Archive.*

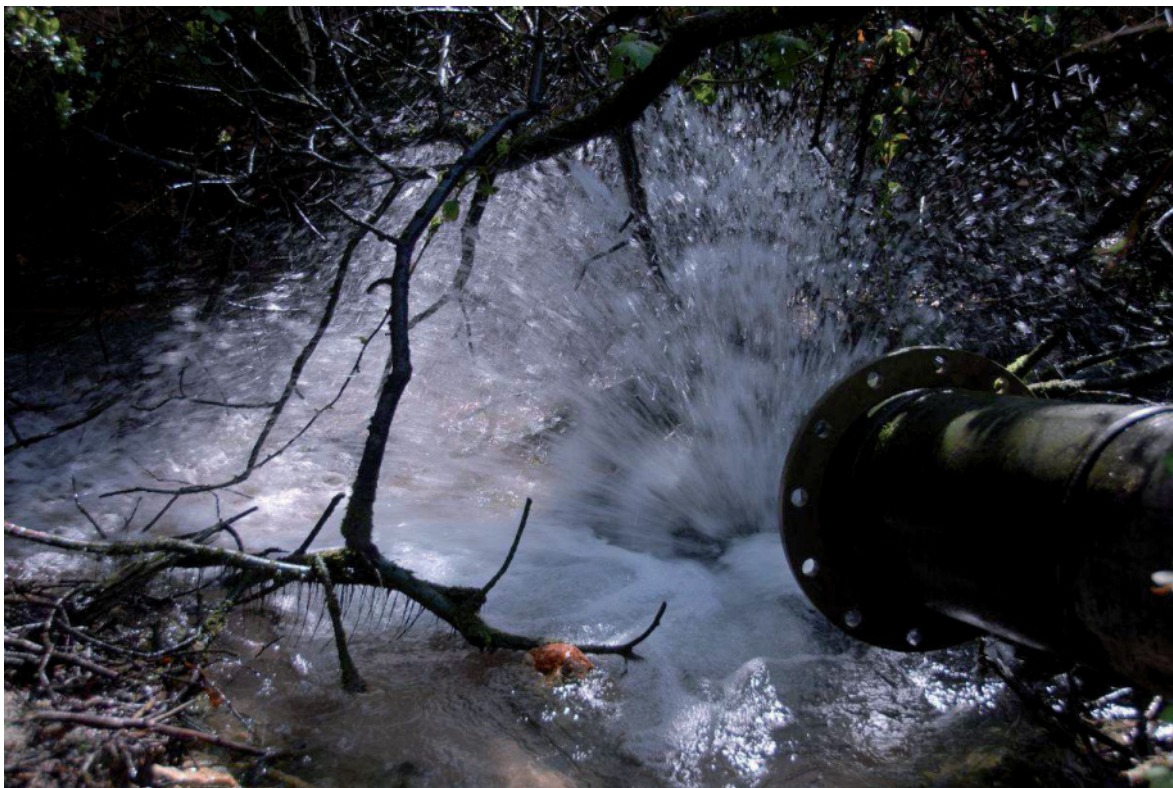
*Fig 30. The overflow water discharge from the pond above the Wheal Arthur complex, just to the north of the area managed by the Tregargus Trust. HE Digital Image Archive.*

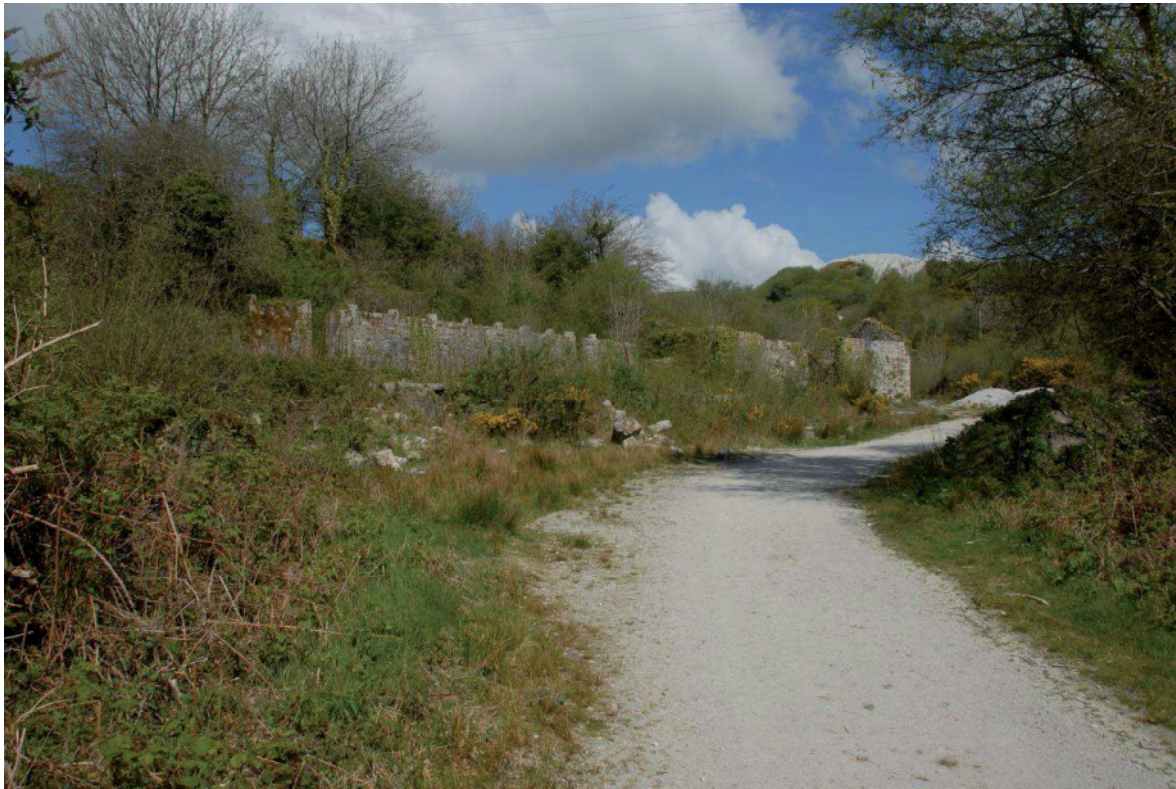
*Fig 32. The Wheal Arthur complex from the south, with the dry [11] to the left and china stone mill [10] to the right. HE Digital Image Archive.*

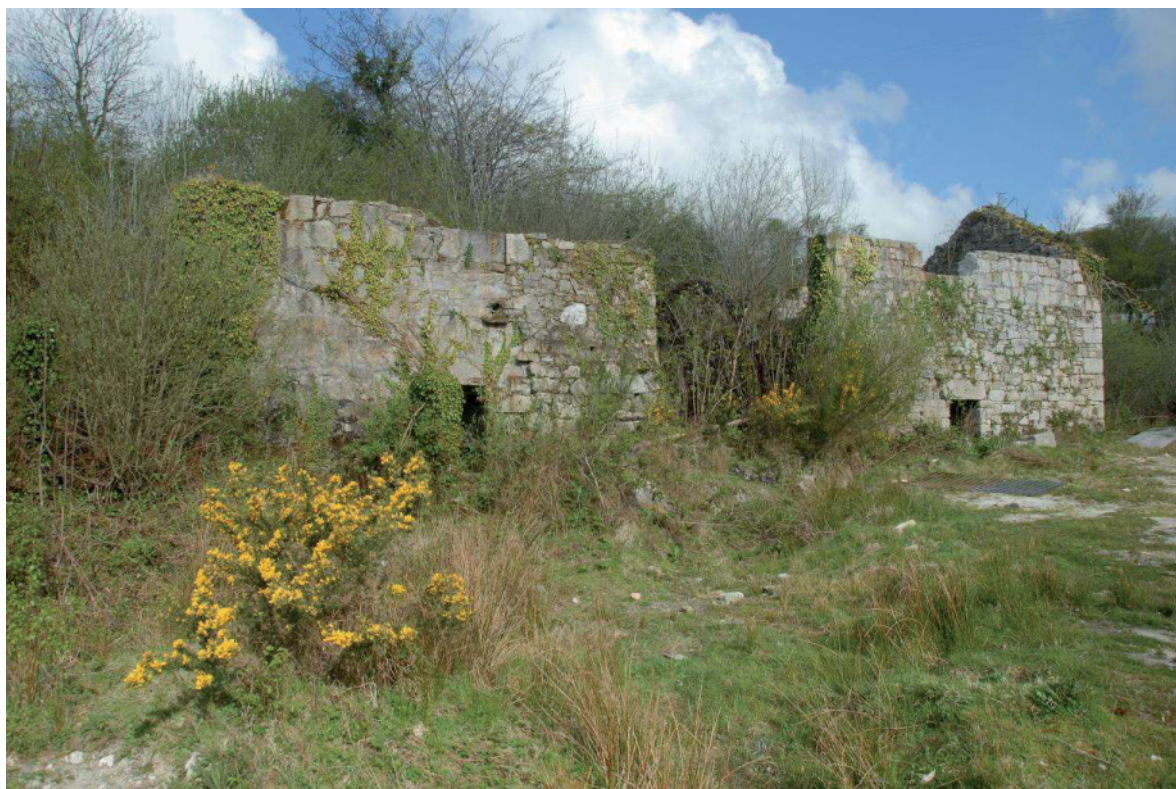
*Fig 33. The china stone mill [10] at Wheal Arthur from the south-east, showing the vegetation which has grown up in the central wheelpit. HE Digital Image Archive.*

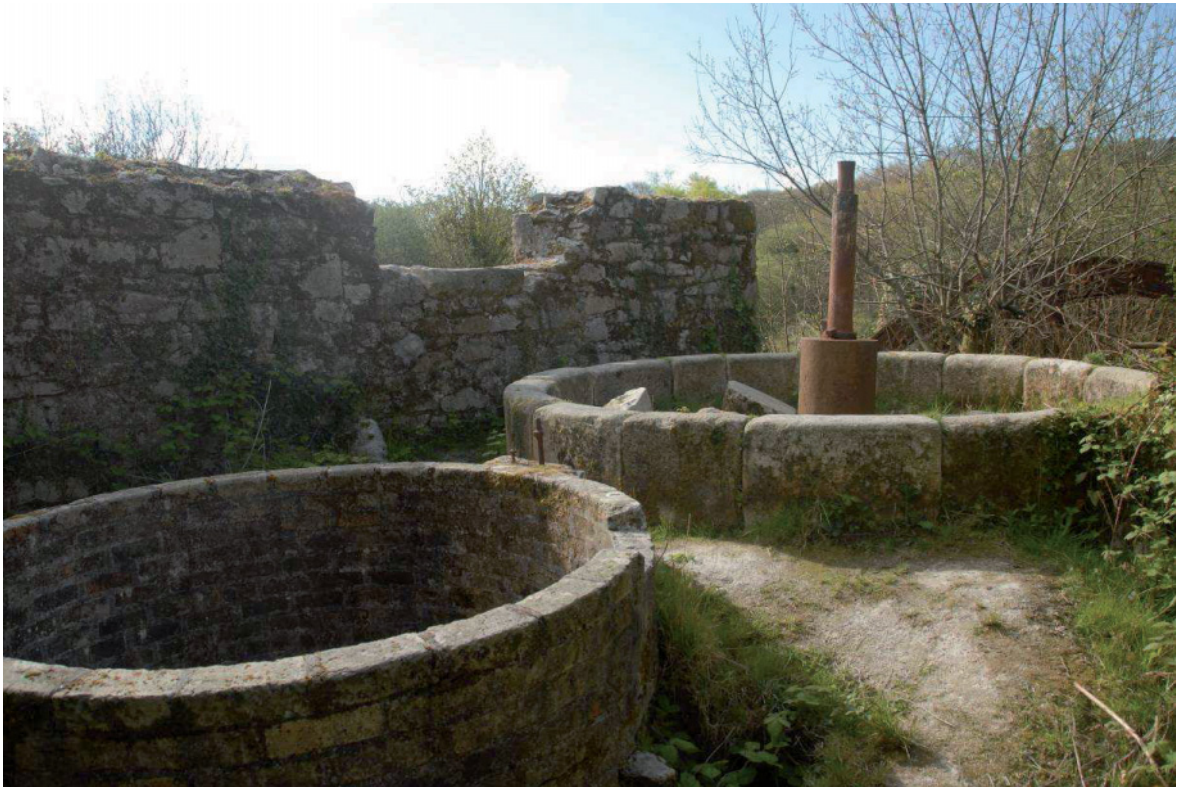
*Fig 34. The brick-built grinding pans in the northern section of Wheal Arthur china stone mill [10]. The crown of the central waterwheel can be seen in the background. HE Digital Image Archive.*

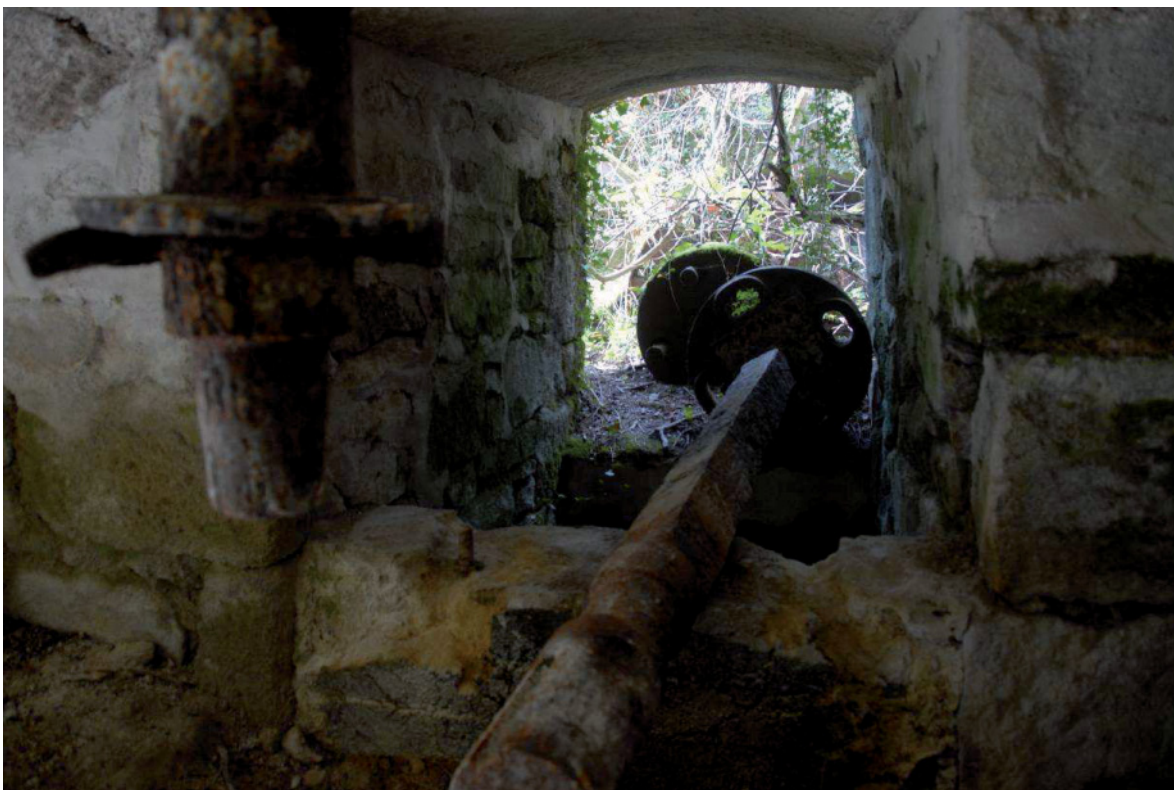
*Fig 35. The under-floor axle from the water wheel and one of the vertical axles driving the grinding pans in the southern section of Wheal Arthur china stone mill [10]. HE Digital Image Archive.*

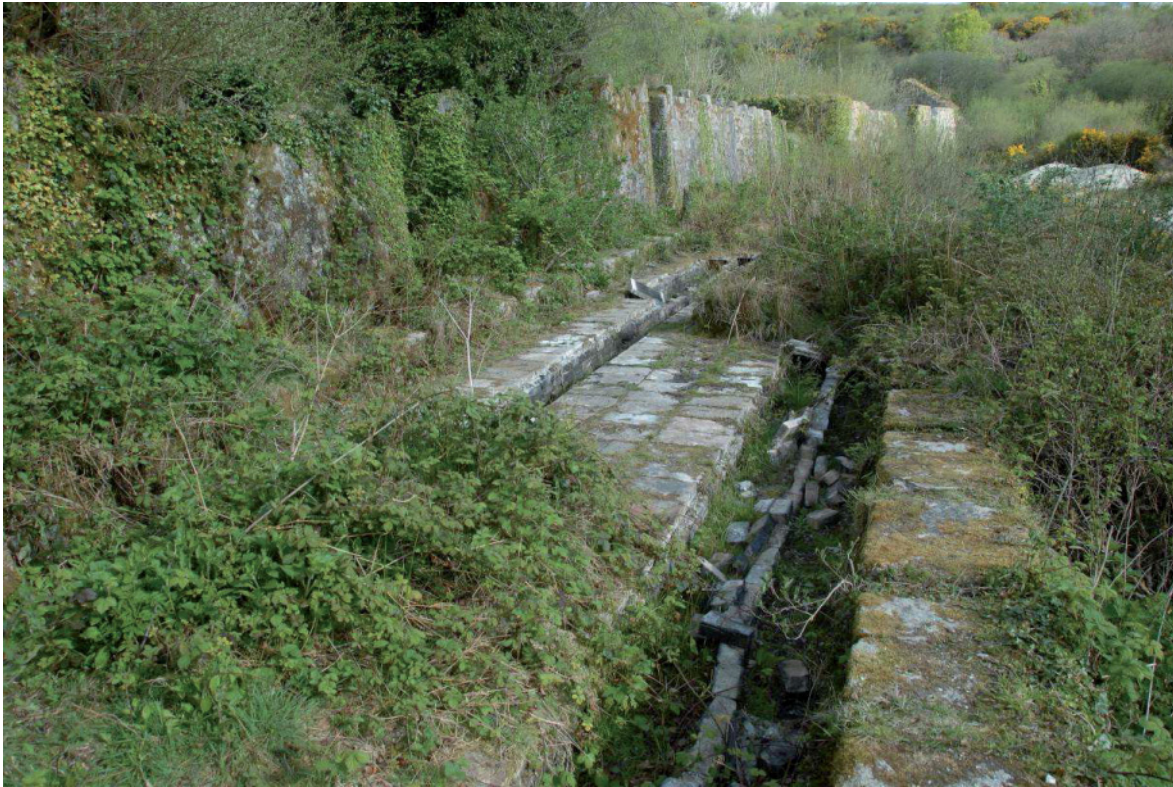
*Fig 36. The interior of the Wheal Arthur pan kiln [11], showing the area from which the hypocaust tiles were recently removed. HE Digital Image Archive.*

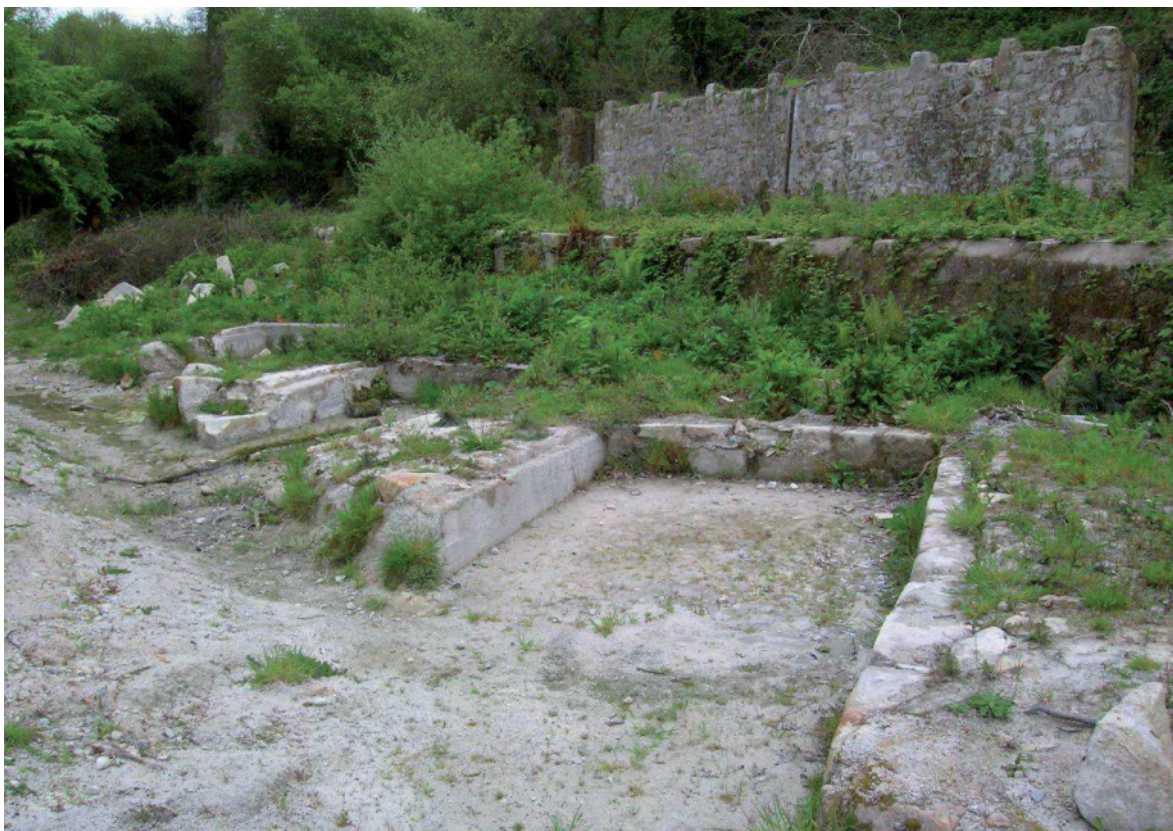
*Fig 37. The linbay [12] to the east of the Wheal Arthur dry [11], showing one of the bays which has been cleared out by the Tregargus Trust. HE Digital Image Archive.*

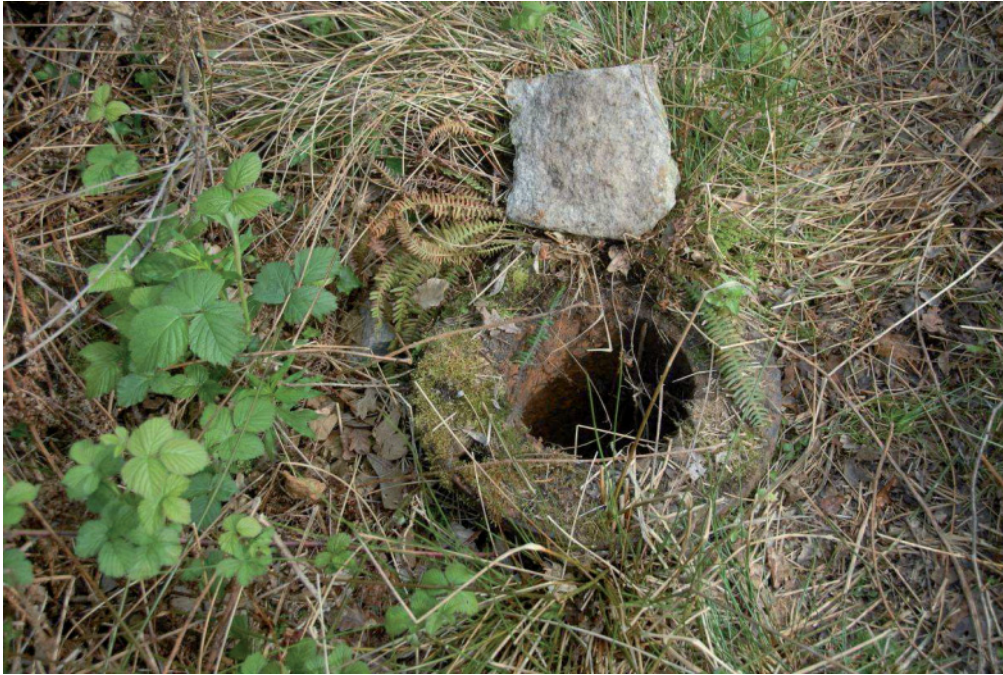
*Fig 38. The top of the cast iron rising main adjacent to the pumping shaft [8] at Wheal Arthur mill. HE Digital Image Archive.*

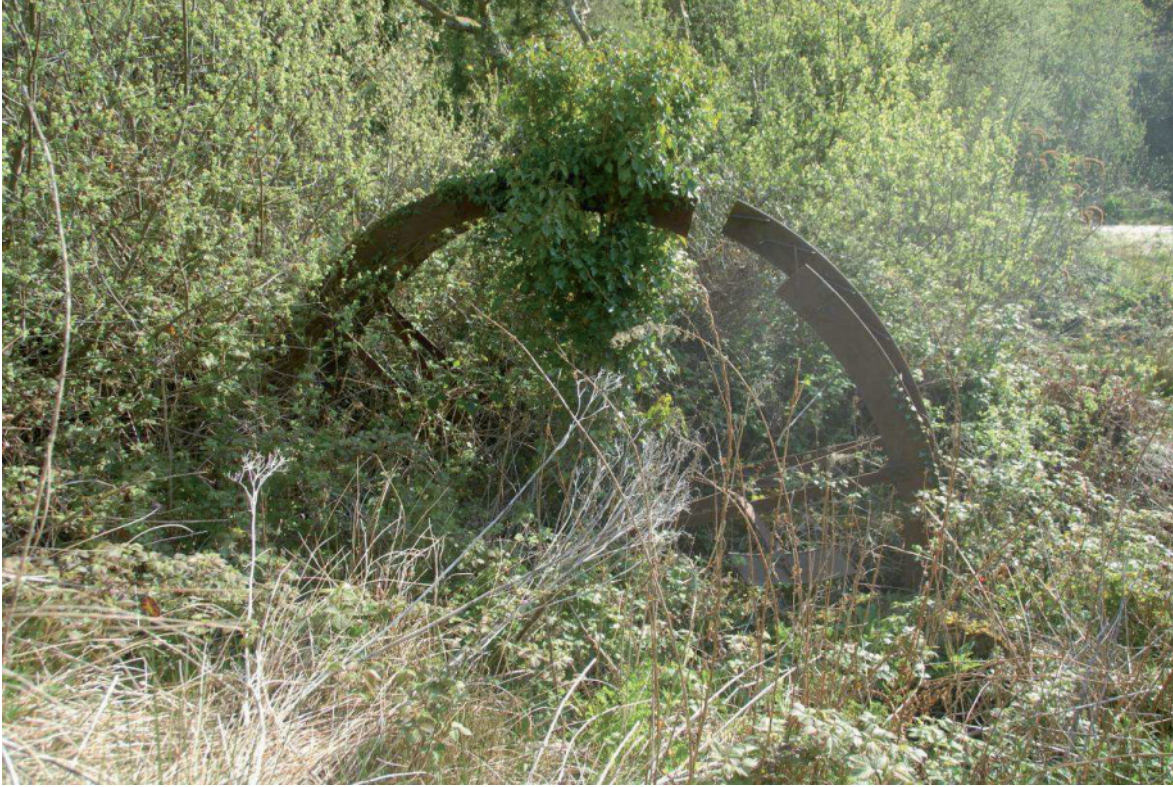
*Fig 40. The pumping water wheel [5] at the northern end of the Wheal Arthur complex. HE Digital Image Archive.*

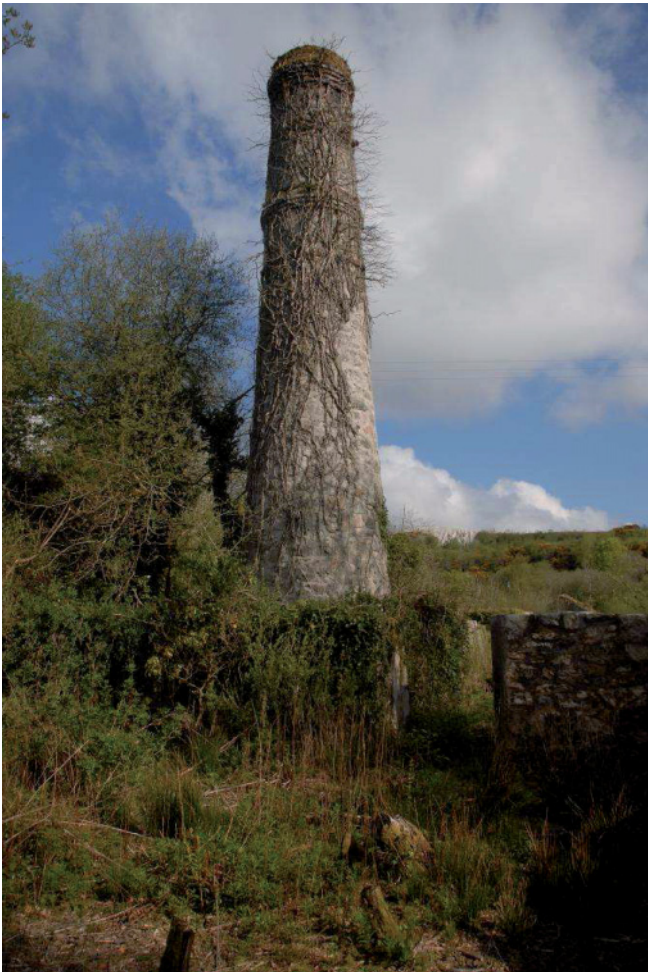
*Fig 41. The chimney [13] attached to the dry at the southern end of the Wheal Arthur complex. HE Digital Image Archive.*

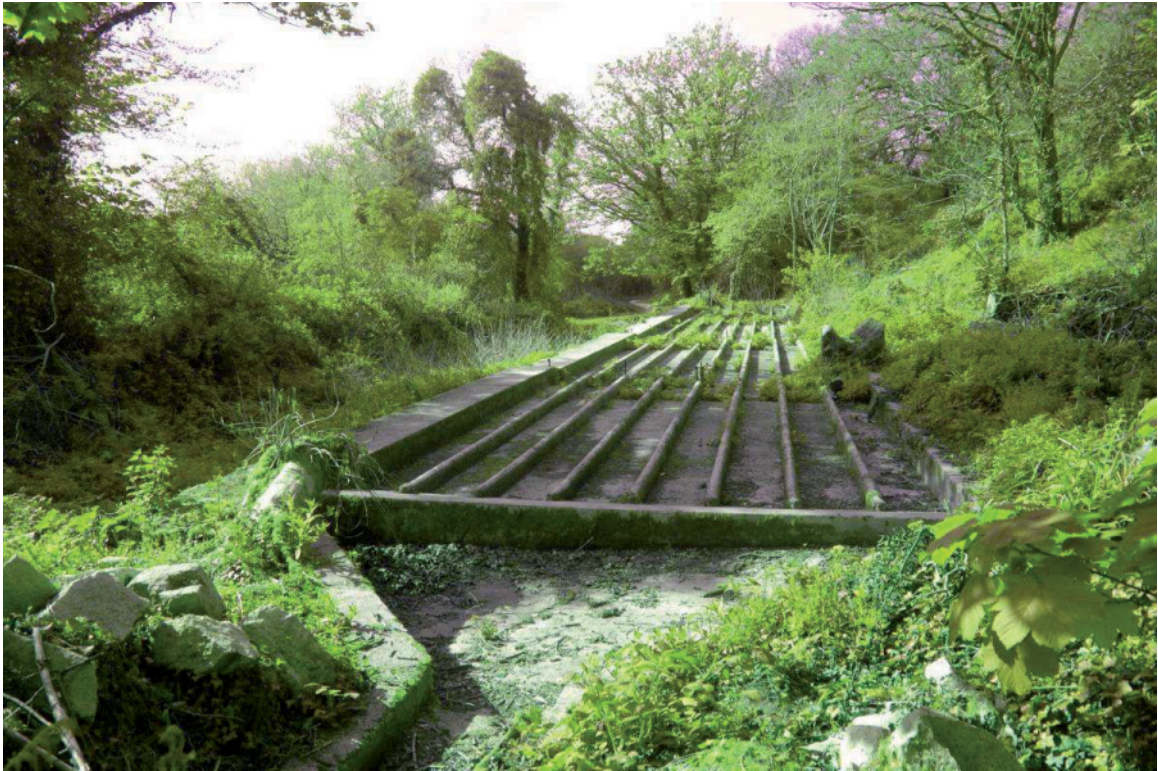
*Fig 42. The mica drags [19] from the north, showing the regenerating stumps of some of the trees which formerly covered them. HE Digital Image Archive.*

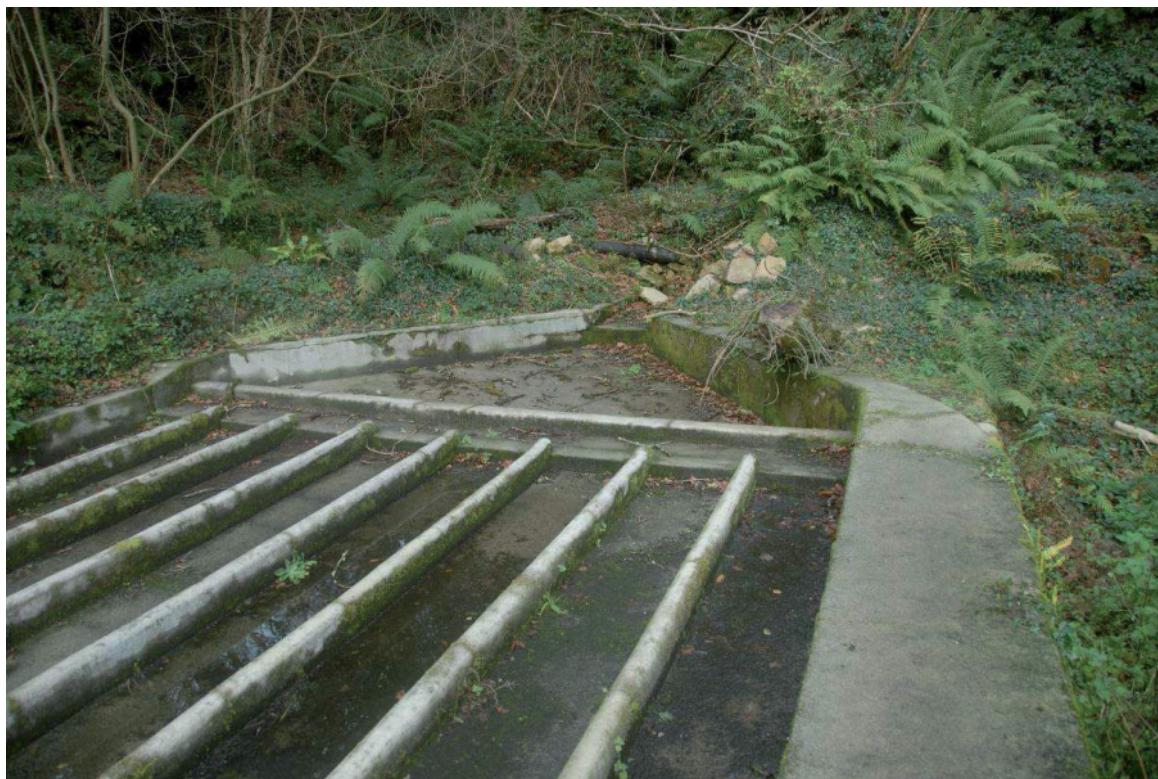
*Fig 43. The northern end of the mica drags [19]. The entrance to its Adit [17] lies just beyond the clump of ferns. HE Digital Image Archive.*

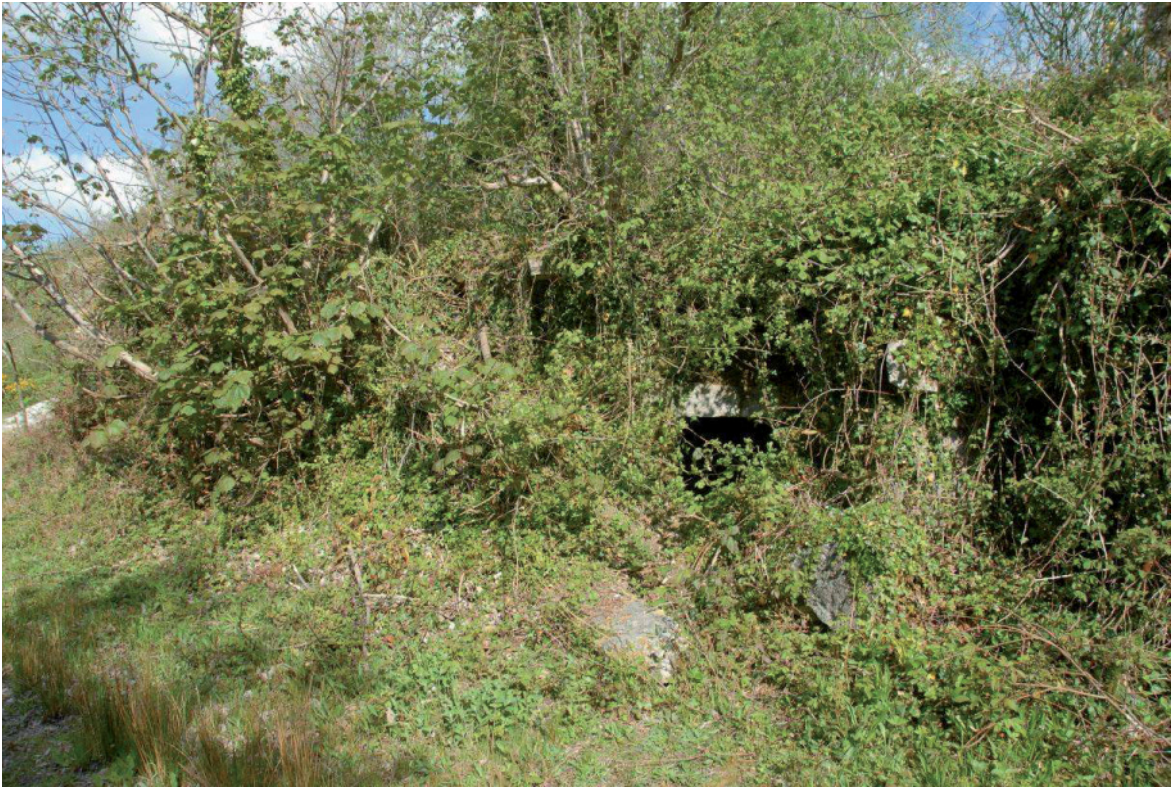
*Fig 44. The overgrown and fragmentary remains of Top Mill [22] at the entrance to the infilled Tregargus upper quarry. HE Digital Image Archive.*

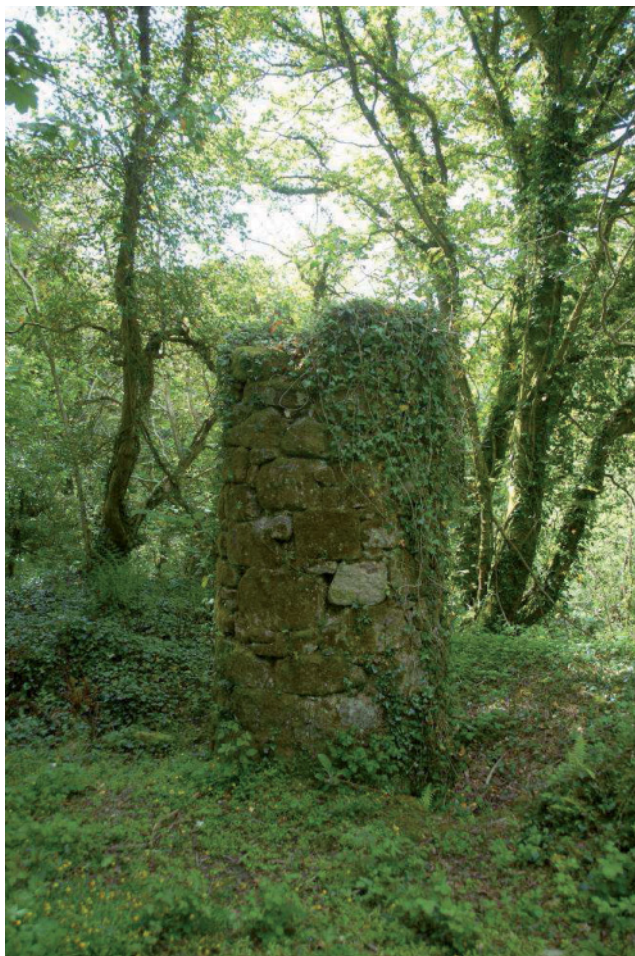
*Fig 45. The stump of the chimney [24] just to the north of the Barn River to the north-east of Big Wheel Mill. HE Digital Image Archive.*

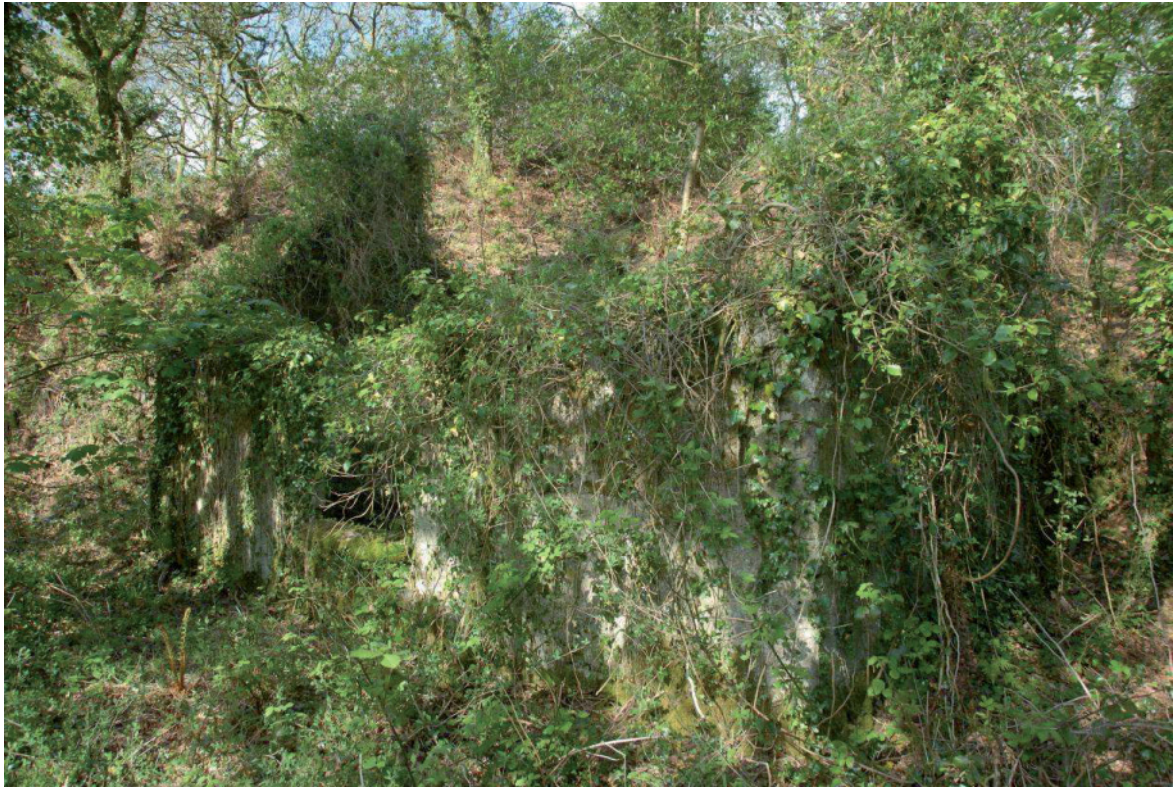
*Fig 46. The overgrown remains of the blacksmith's shop [16] at the southern entrance to Rescrowsa china clay pit. HE Digital Image Archive.*
