# Tregargus, St. Stephen in Brannel, Cornwall

## Conservation Management Statement

## **Tregargus Valley, St. Stephen in Brannel, Cornwall**

### **Conservation Management Statement**

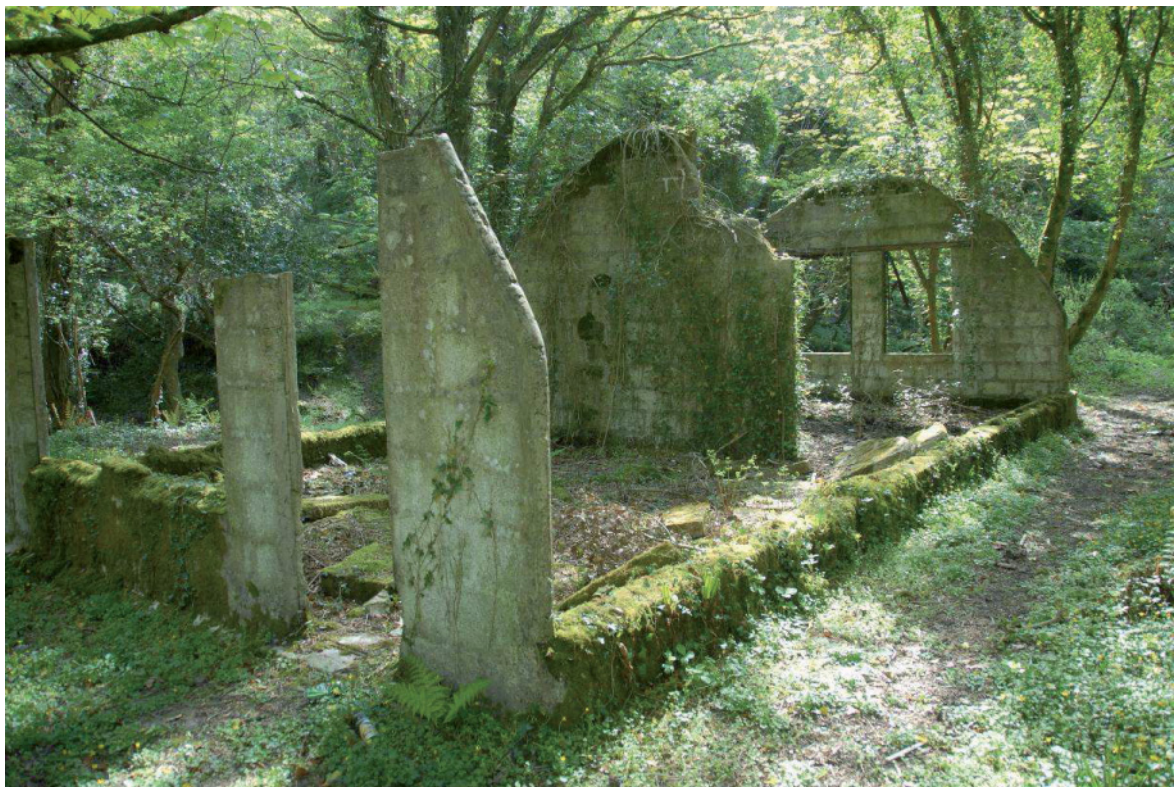
*Fig 47. The remains of the blockwork-built crib hut [31] to the east of Big Wheel Mill. HE Digital Image Archive.*

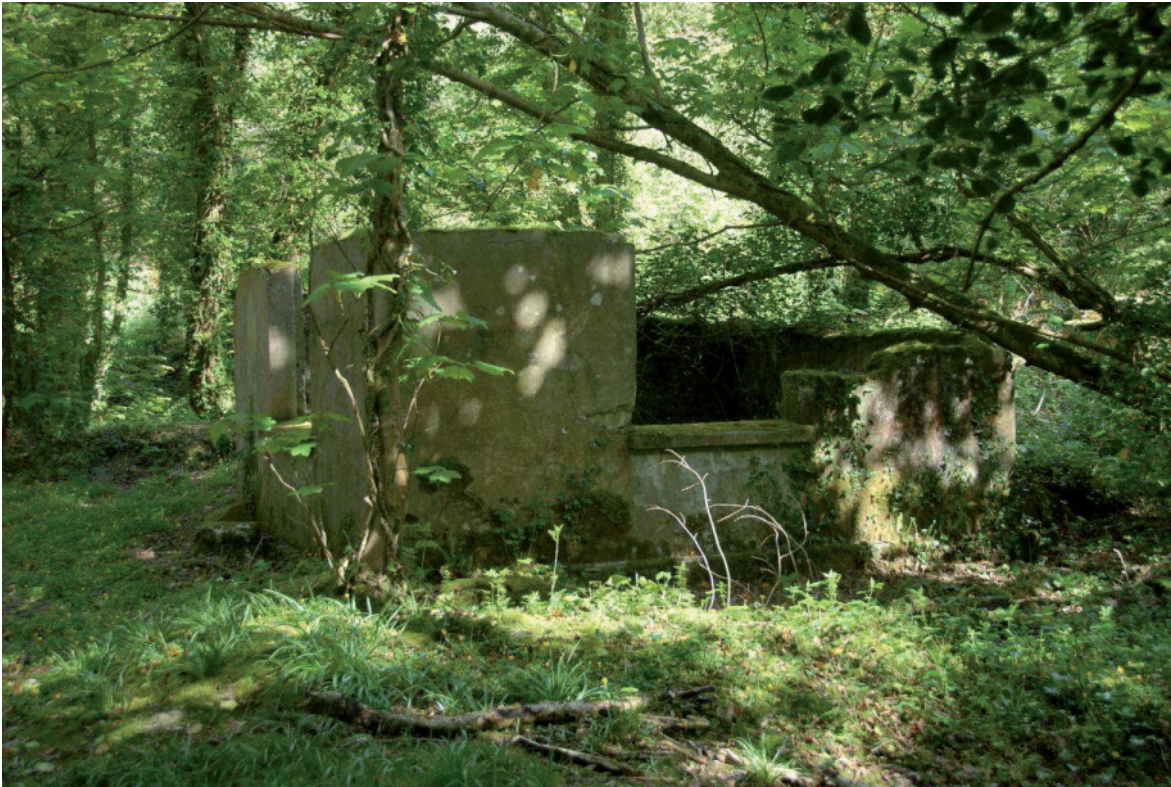
*Fig 48. The ruinous rendered blockwork building [28] to the east of Big Wheel Mill. HE Digital Image Archive.*

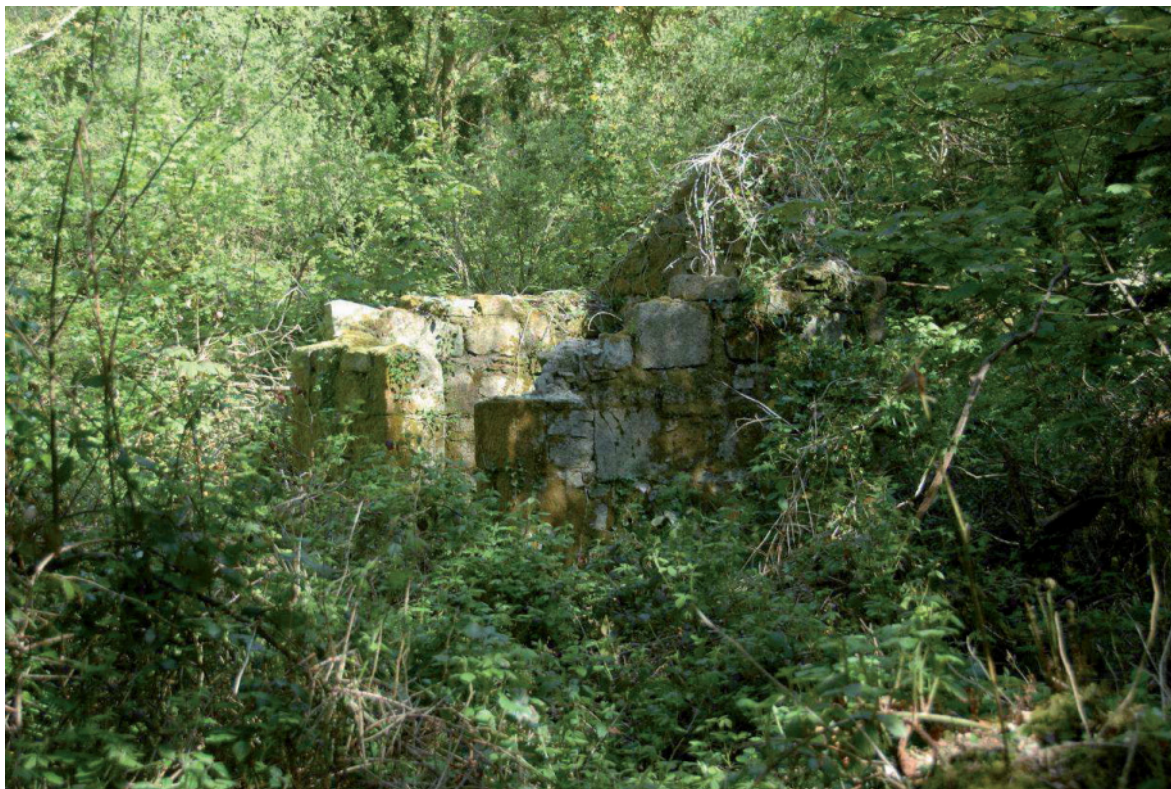
*Fig 49. The overgrown remains of the masonry-constructed powder house [27] to the east of Big Wheel Mill. HE Digital Image Archive.*

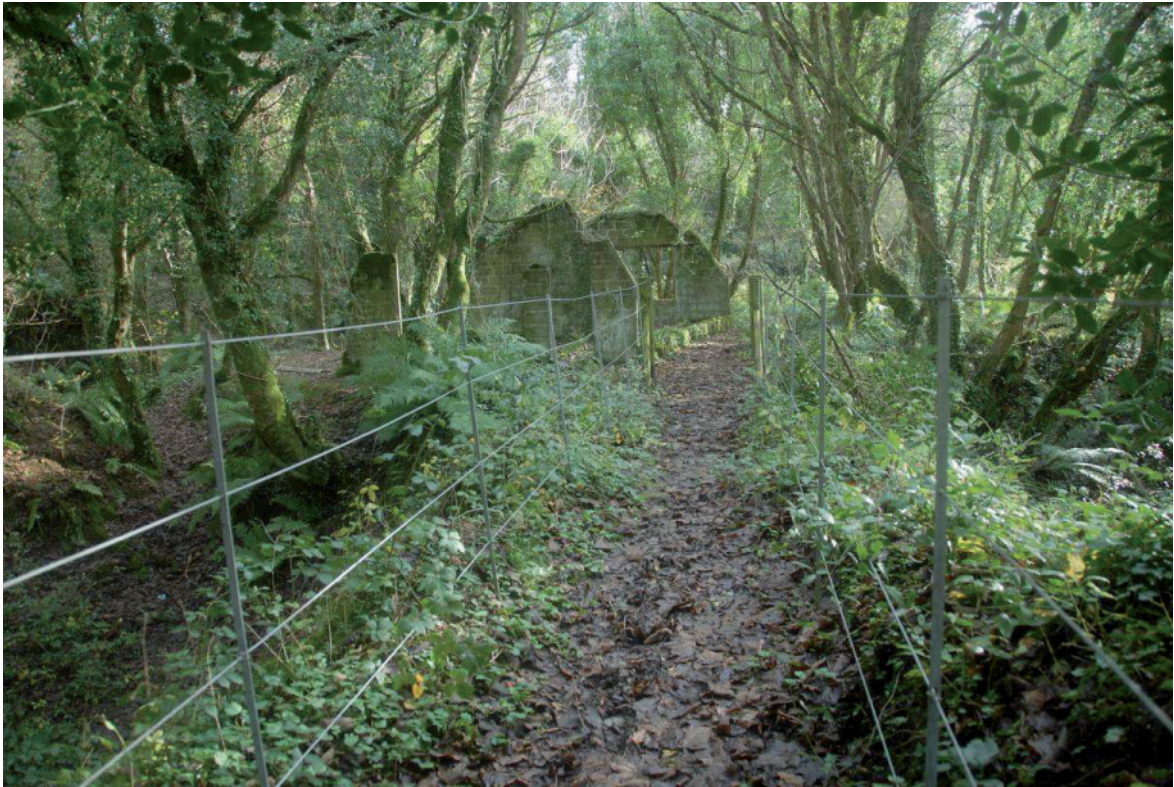
*Fig 50. The guard fencing on the tramway bridge to the east of Big Wheel Mill, with the crib but [31] in the background. HE Digital Image Archive.*

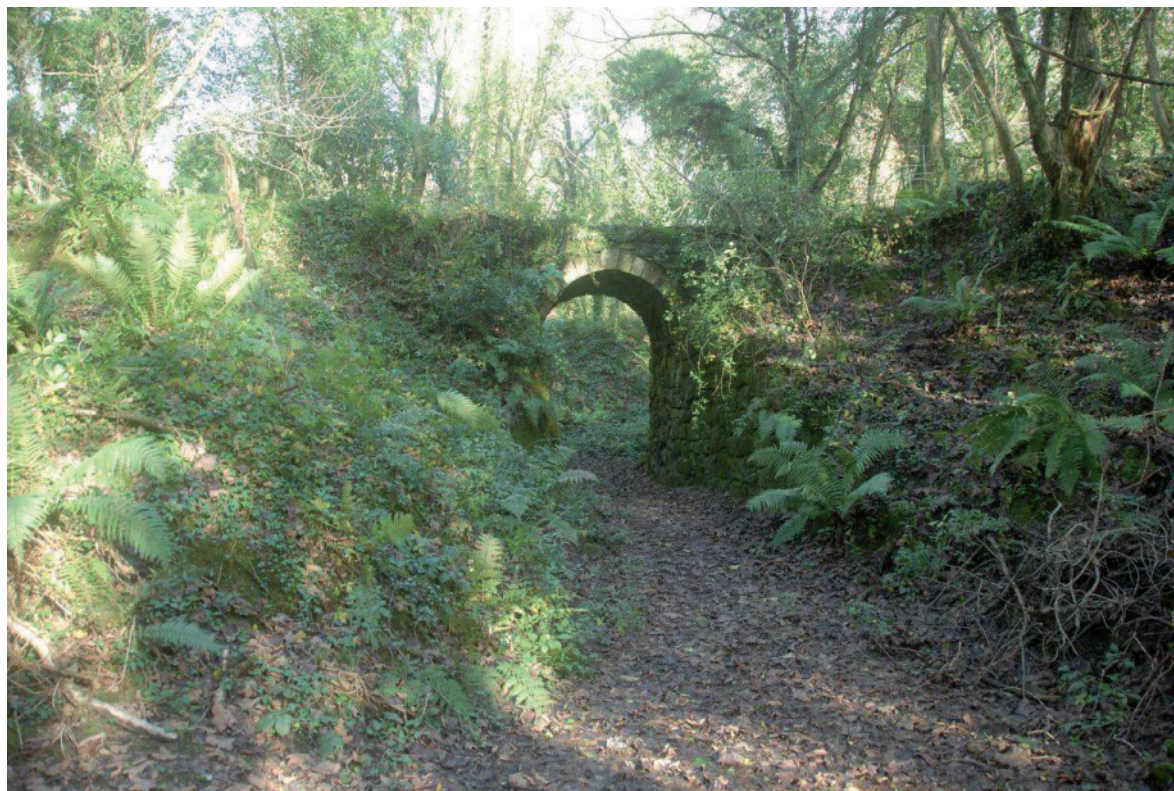
*Fig 51. The recently-consolidated tramway bridge over the roadway to the east of Big Wheel Mill. HE Digital Image Archive.*

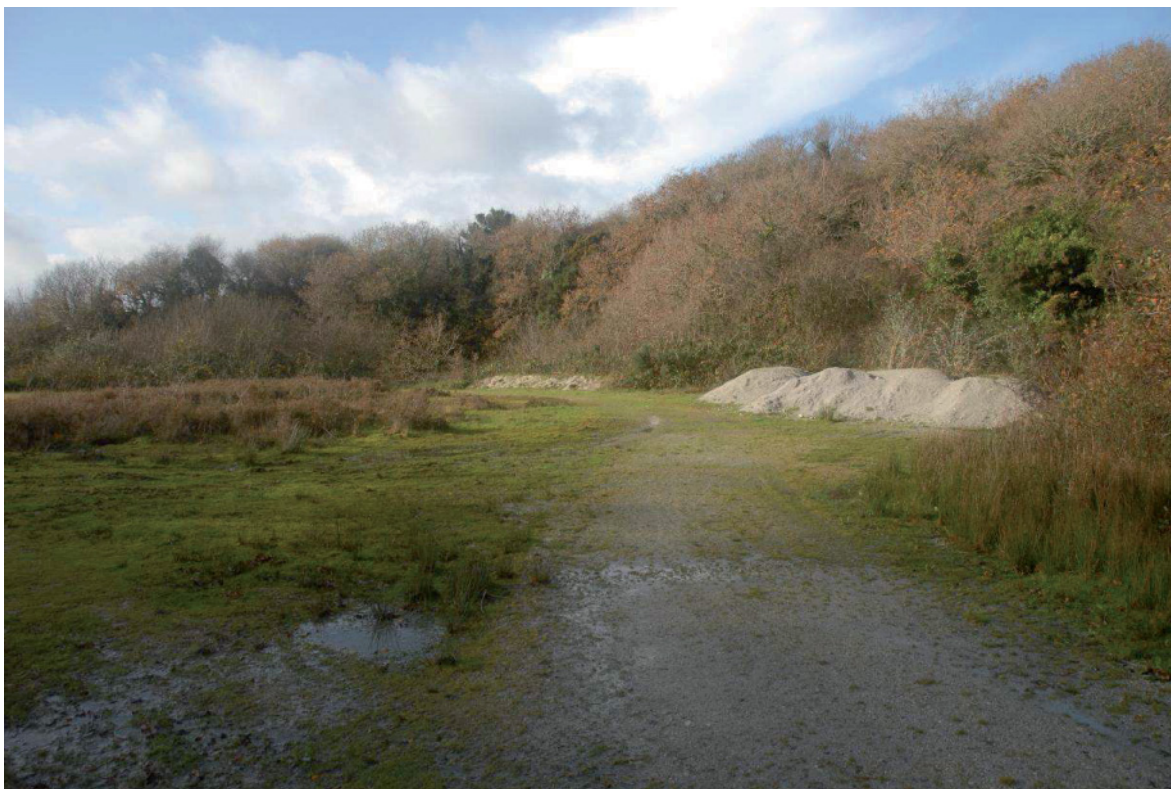
*Fig 53. The infilled Lower Tregargus Quarry. The protected section of quarry face is below the trees at centre left. HE Digital Image Archive.*

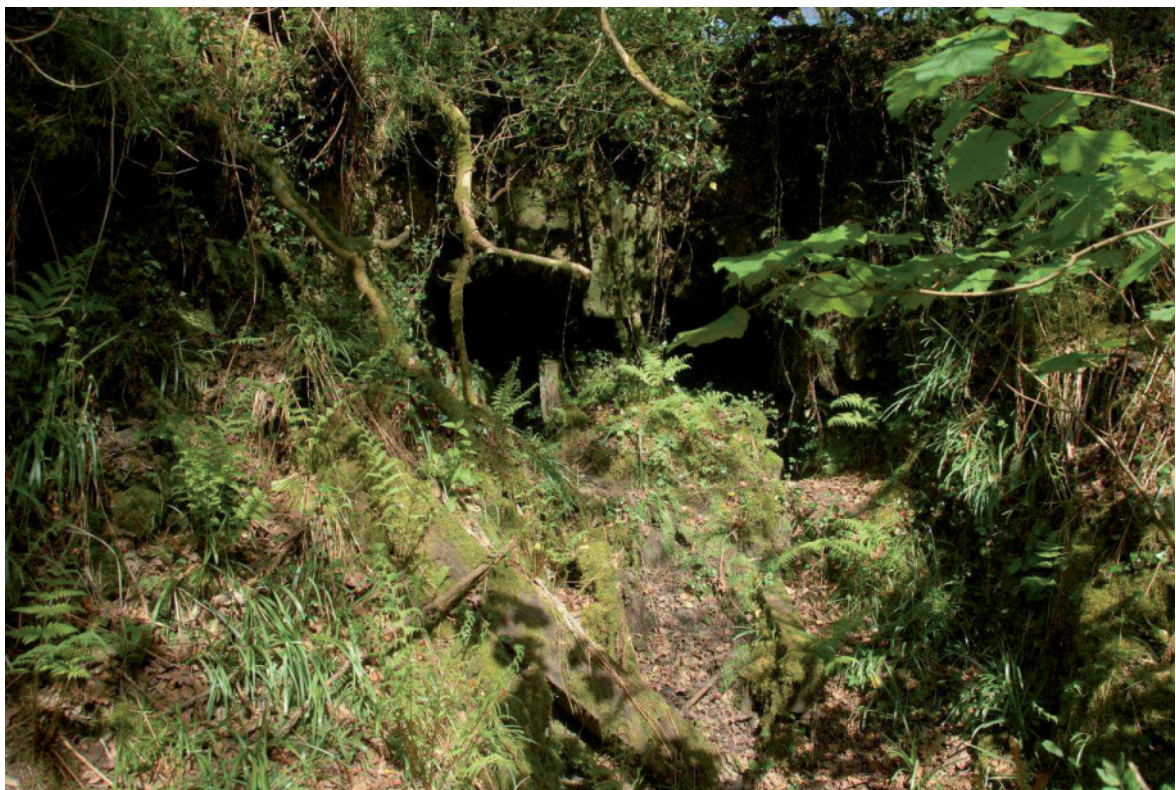
*Fig 55. The partially-collapsed entrance to the adit [18] leading into Rescrowsa china clay pit. HE Digital Image Archive.*

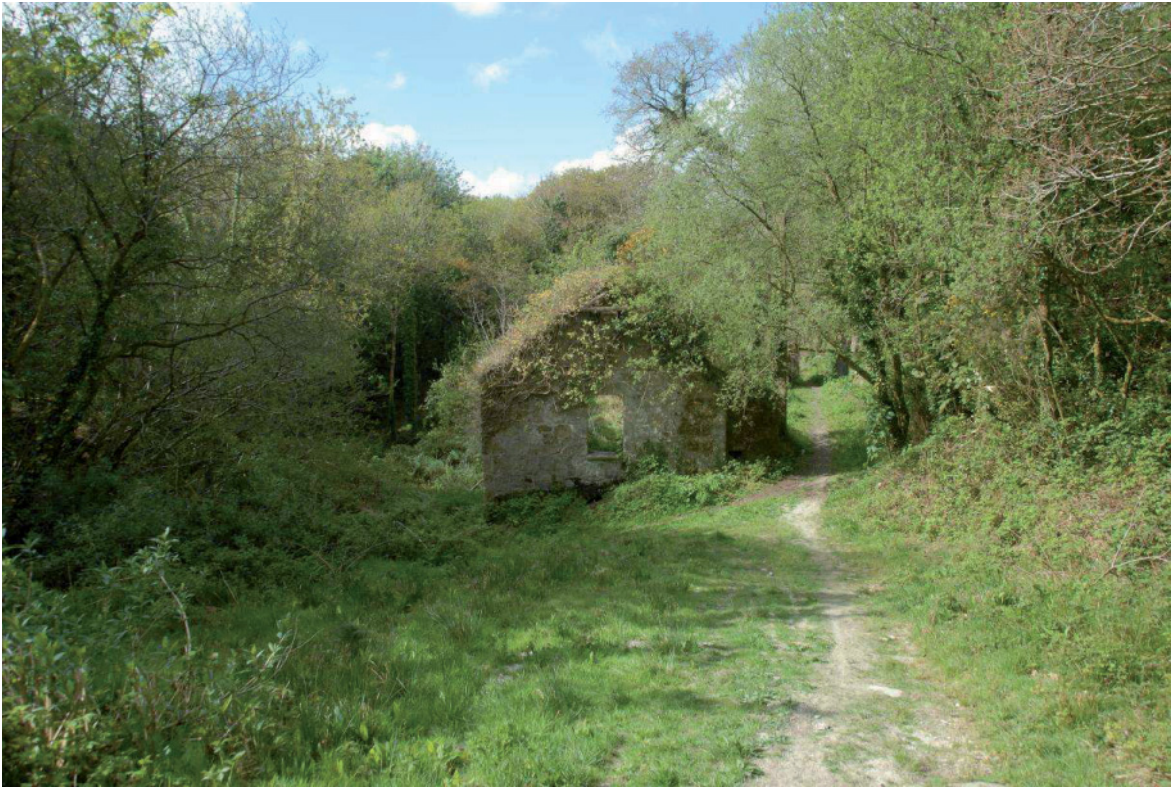
*Fig 56. Big Wheel Mill [29] from the north. The site of the winder house [24] is to its right under the trees. HE Digital Image Archive.*

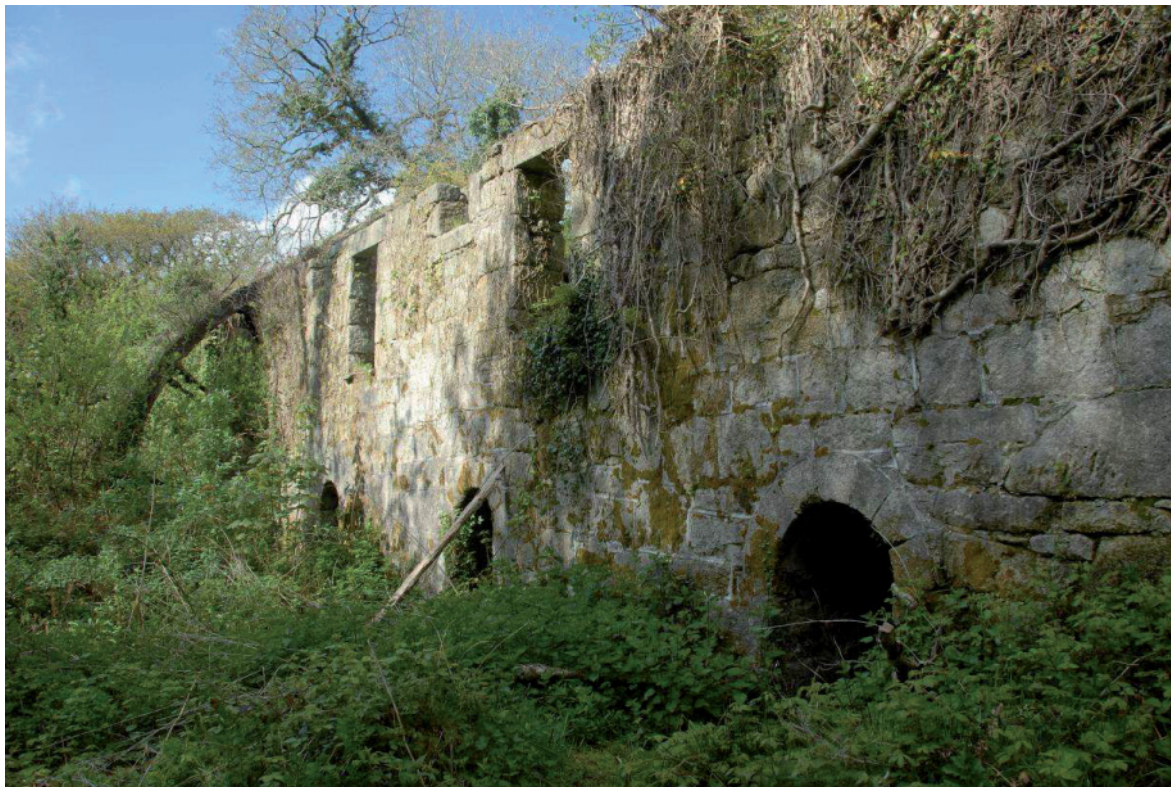
*Fig 57. Big Wheel Mill [29] from the north-east, showing the overgrown water wheel and the eastern face of the building, partly cleared of ivy growth. HE Digital Image Archive.*

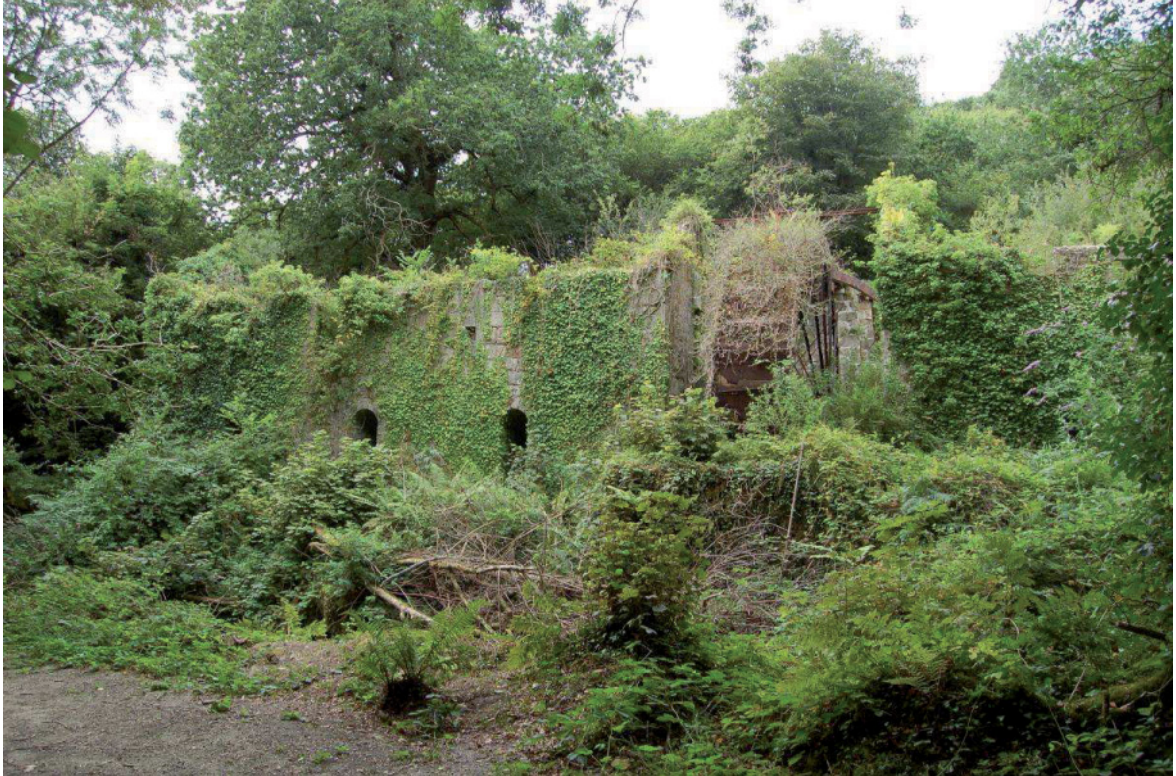
*Fig 58. Big Wheel Mill [29] from the east showing the vegetation growing over and adjacent to it. HE Digital Image Archive.*

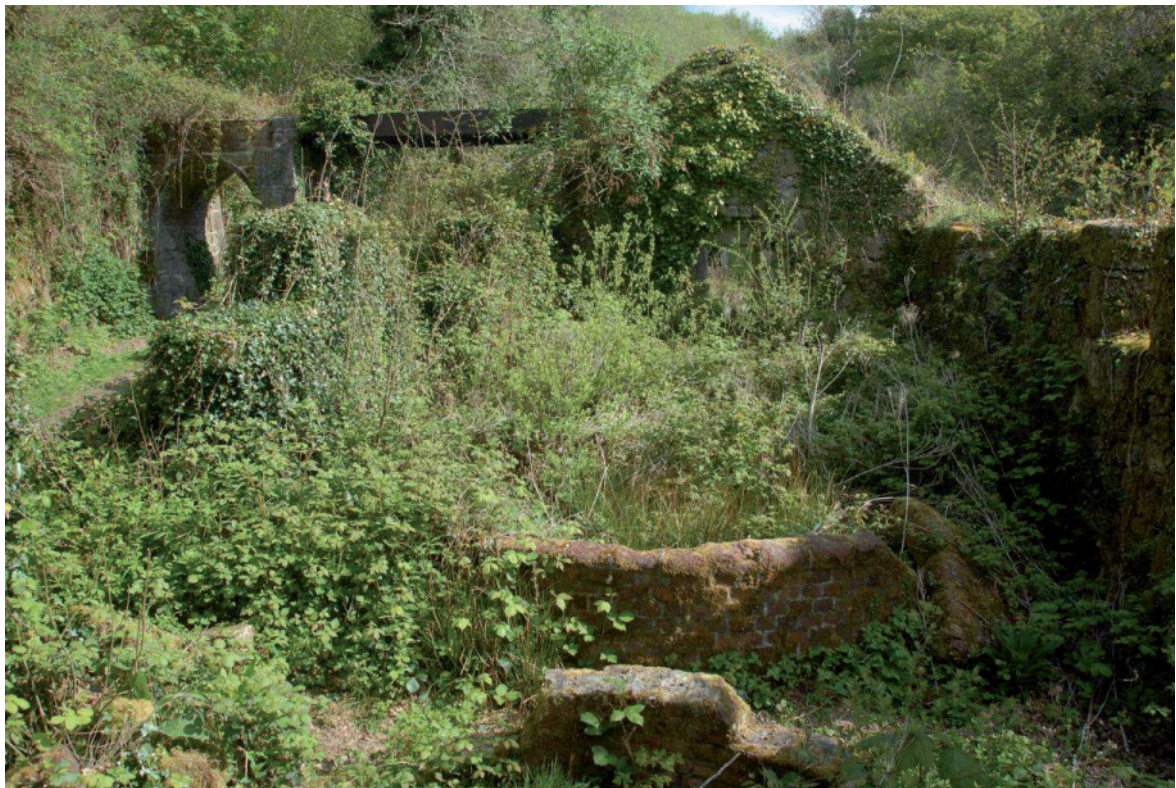
*Fig 59. The remains of the brick-built grinding pans in the southern section of Big Wheel Mill [29]. HE Digital Image Archive.*

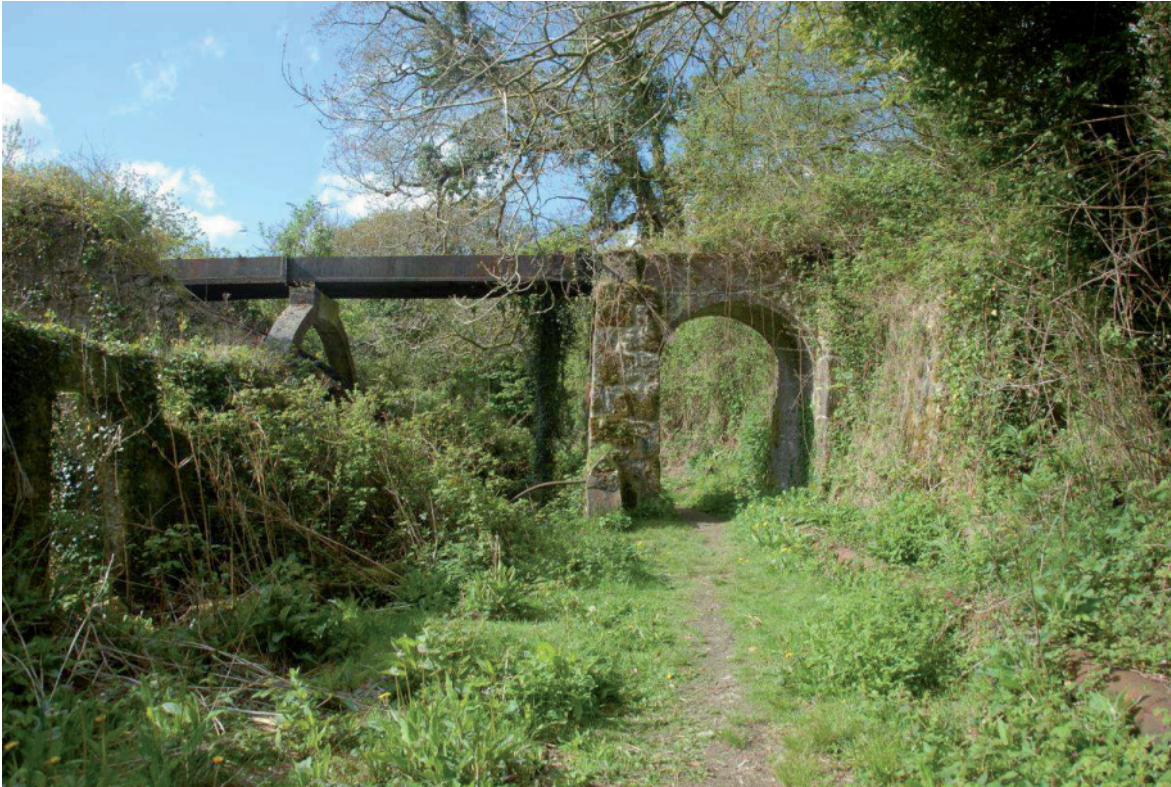
*Fig 60. The recently-conserved laundry bridge and the launder to the west of Big Wheel Mill [29]. HE Digital Image Archive.*

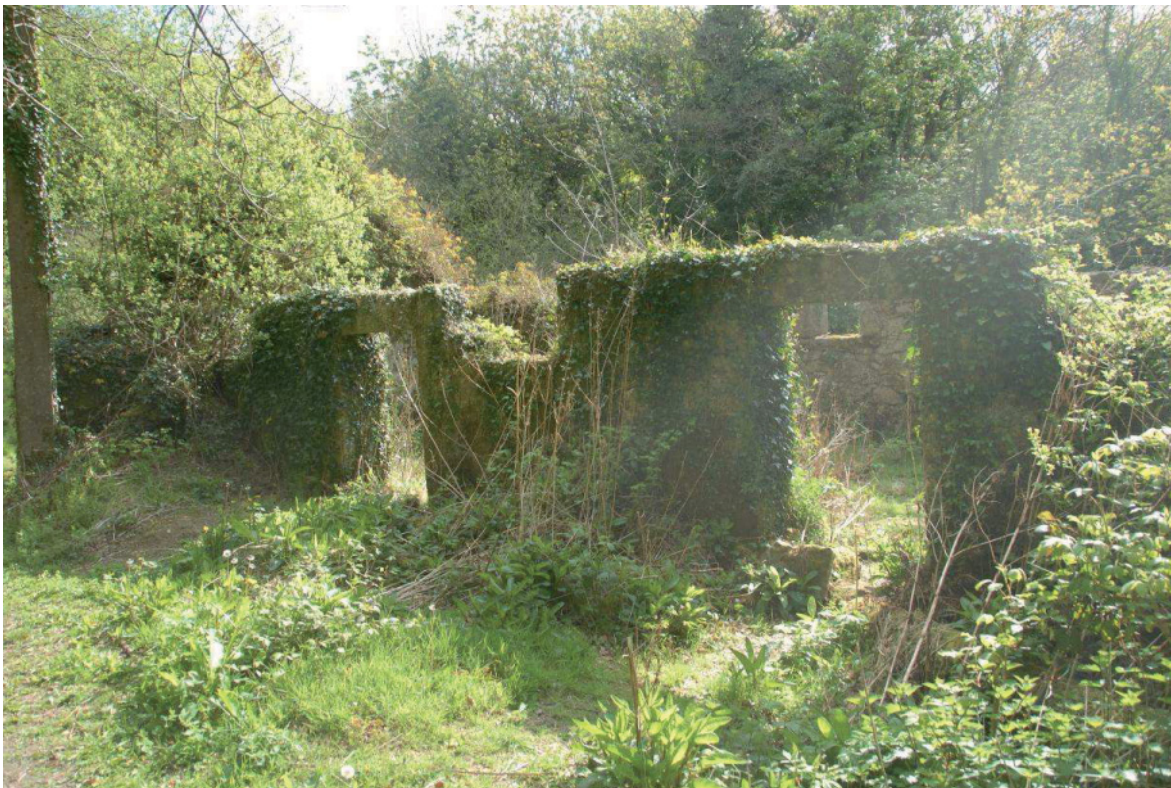
*Fig 61. The northern section of the grinding floor of Big Wheel Mill [29] seen from the south-east. HE Digital Image Archive.*

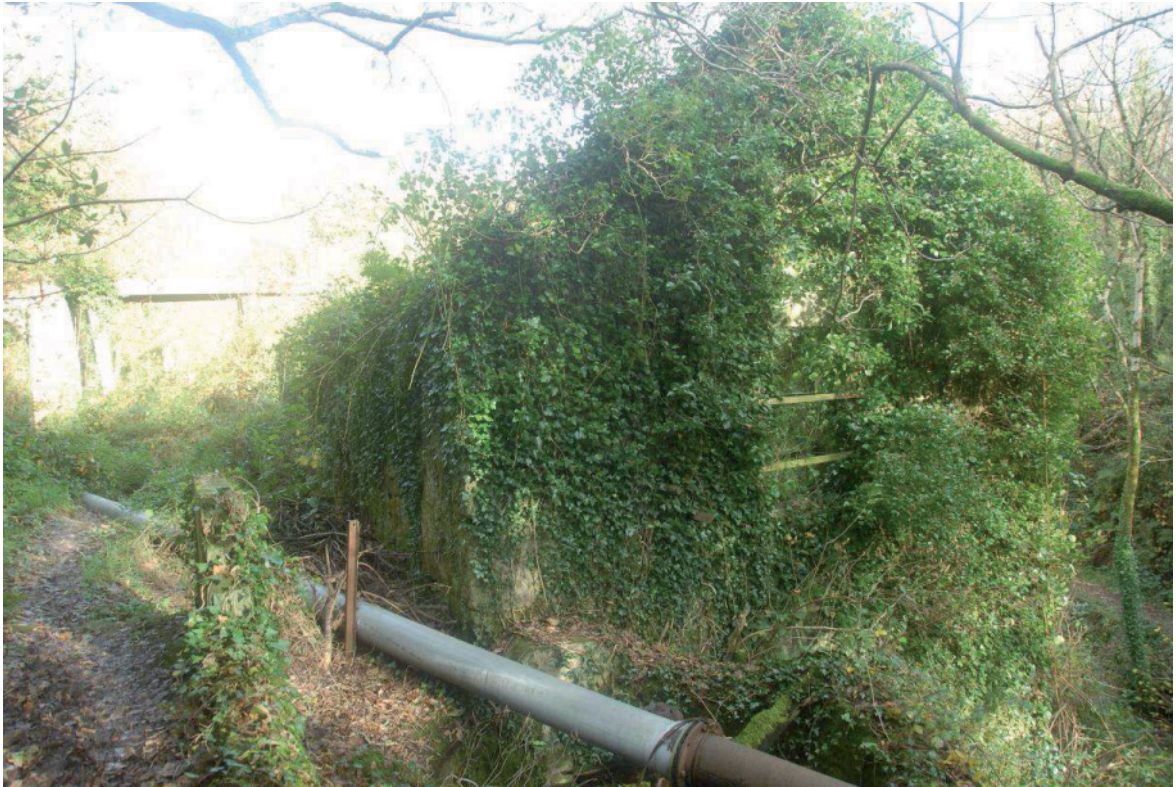
*Fig 62. The southern end of Big Wheel Mill [29], showing the pipeline running just to the east of the mill. HE Digital Image Archive.*

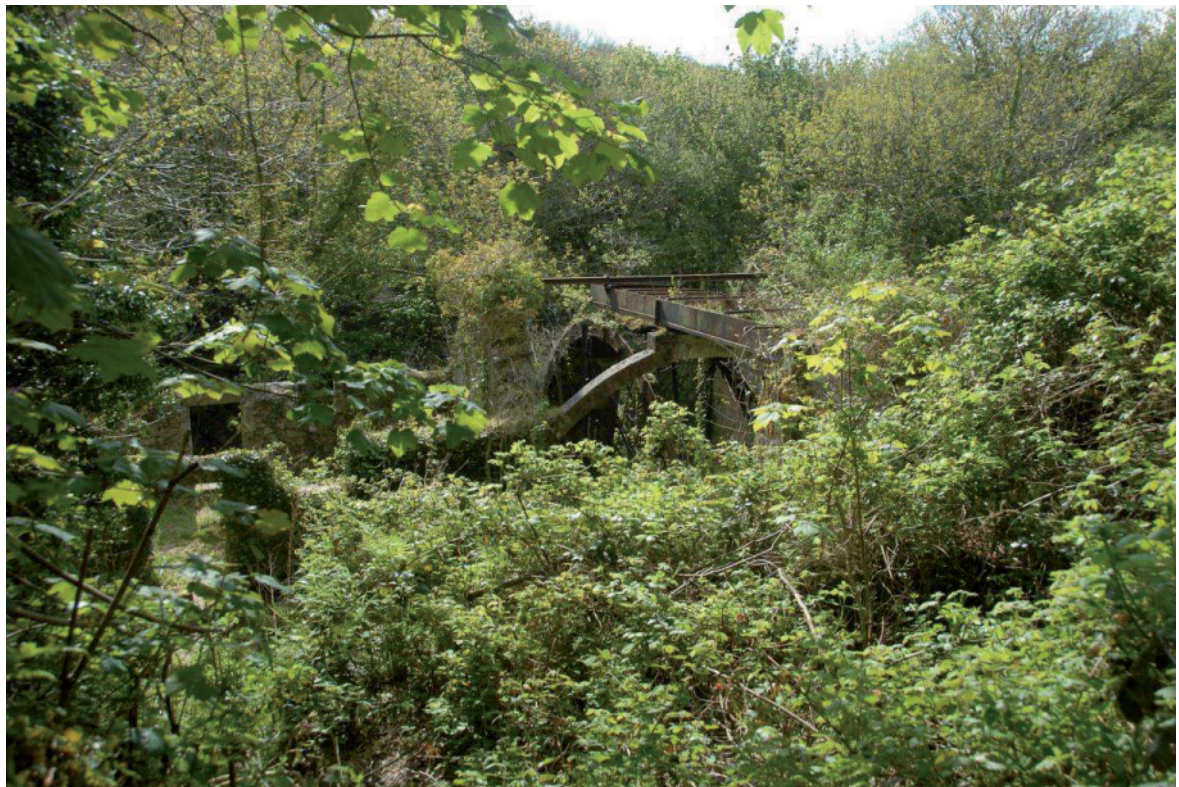
*Fig 63. The iron launder serving the central water wheel at Big Wheel Mill, seen from the site of its reservoir just to the west. HE Digital Image Archive.*

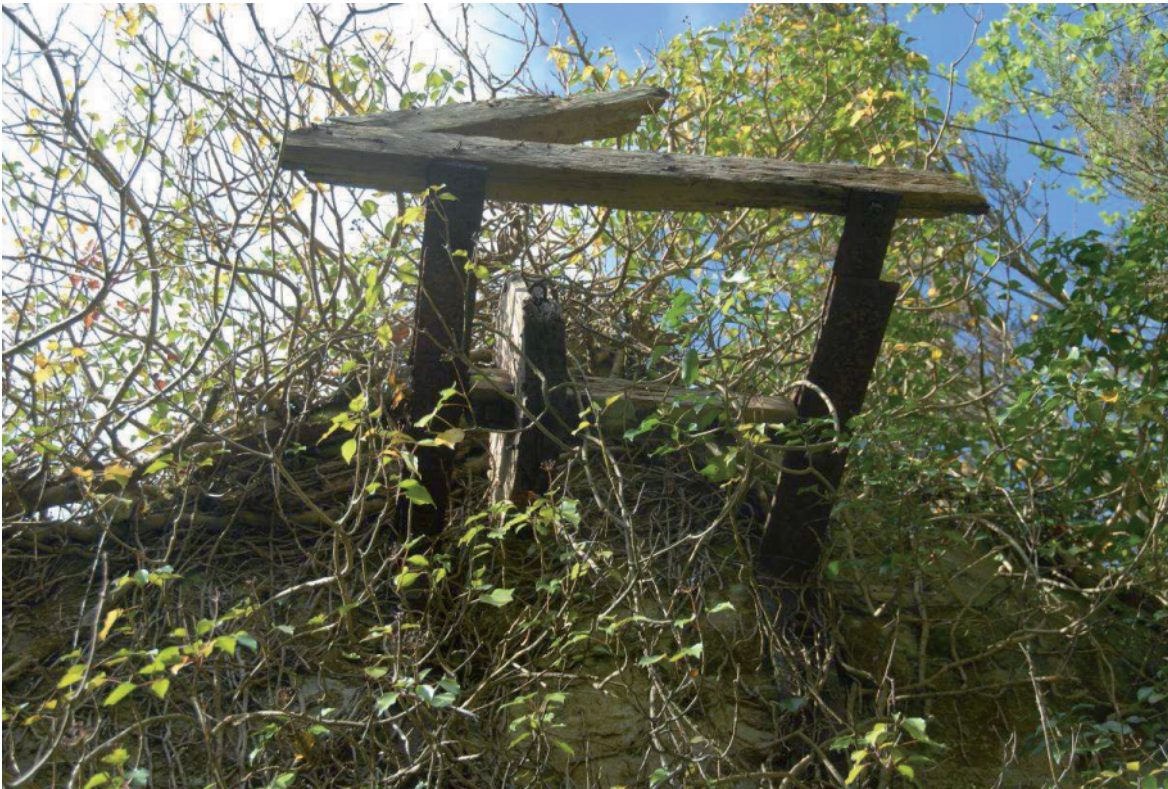
*Fig 64. The remains of the timber canopy within which a bell was hung on the northern gable of Big Wheel Mill is typical of the detailing which could easily be lost if works are not undertaken. HE Digital Image Archive.*

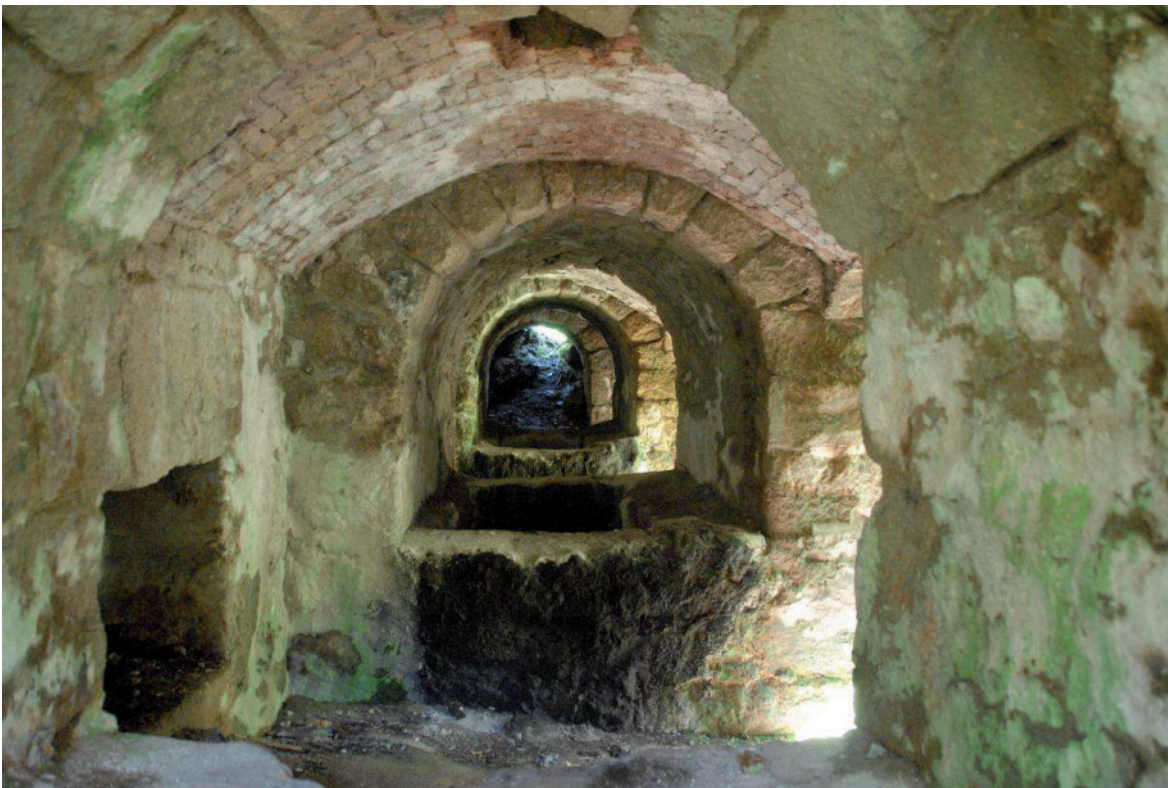
*Fig 65. The ground level power vault running beneath Big Wheel Mill. HE Digital Image Archive.*

*Fig 65. The ground level power vault running beneath Big Wheel Mill.*

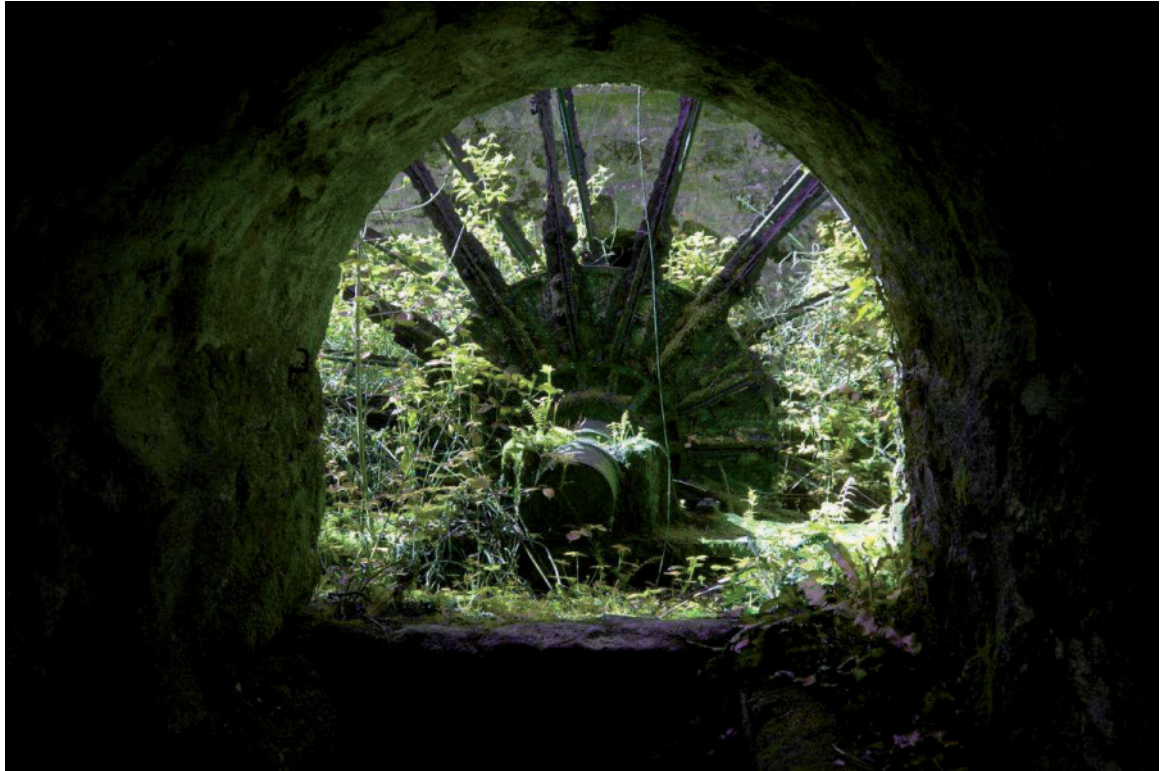
*Fig 66. The hub of the Big Wheel Mill central water wheel, seen from the power vault running under the building. HE Digital Image Archive.*

*Fig 66. The hub of the Big Wheel Mill central water wheel, seen from the power vault running under the building.*

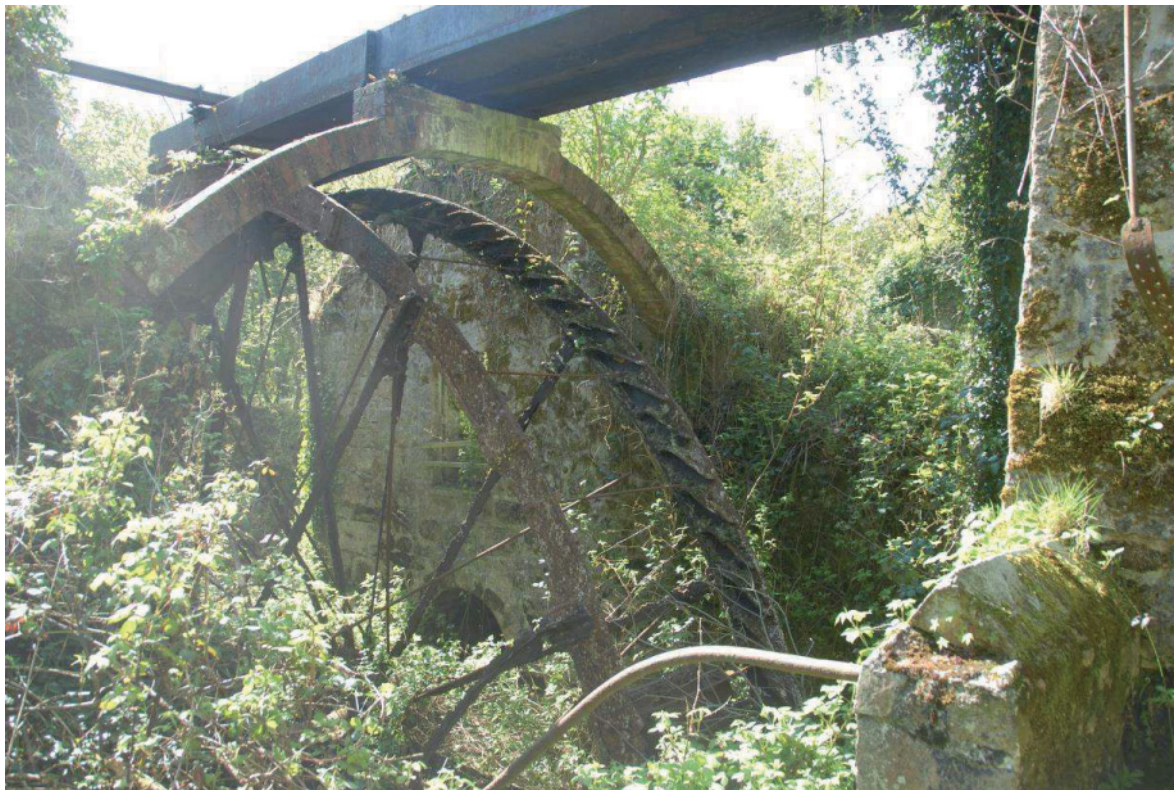
*Fig 67. The central water wheel, arched brick launder support and cast iron launder at Big Wheel Mill, seen from the north-west. HE Digital Image Archive.*

*Fig 67. The central water wheel, arched brick launder support and cast iron launder at Big Wheel Mill, seen from the north-west.*

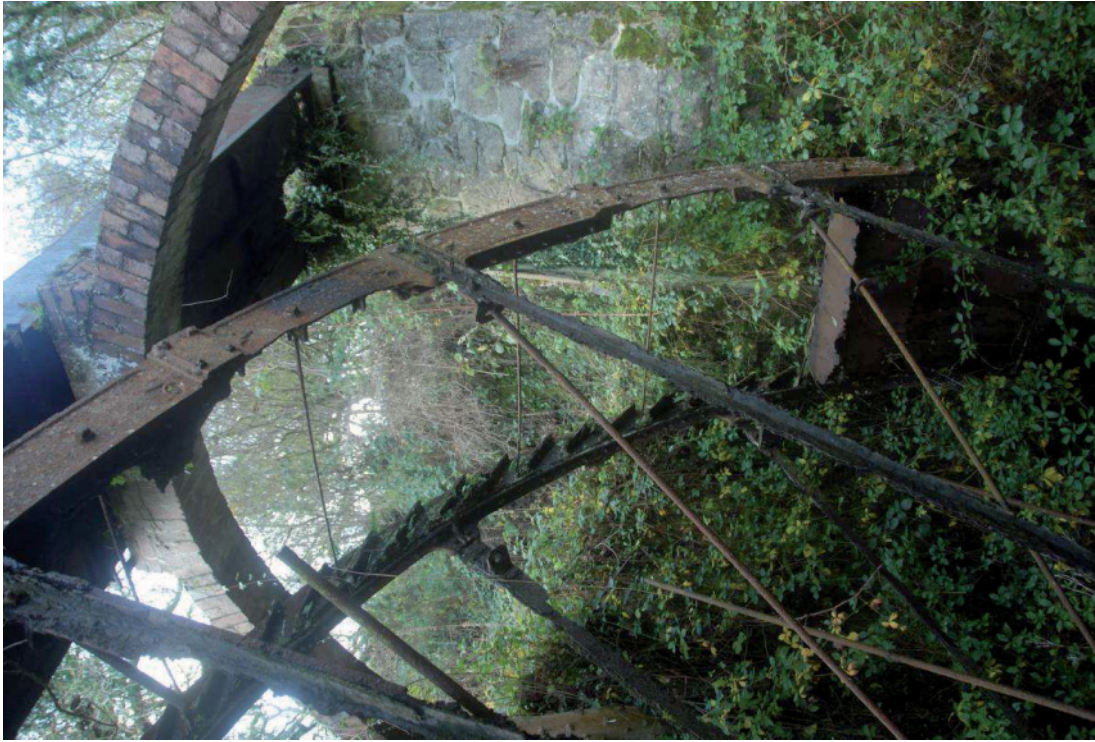
*Fig 69. The western end of the central water wheel at Big Wheel Mill, showing the almost complete loss of the buckets and very poor states of the iron spokes. HE Digital Image Archive.*

*Fig 69. The western end of the central water wheel at Big Wheel Mill, showing the almost complete loss of the buckets and very poor states of the iron spokes.*

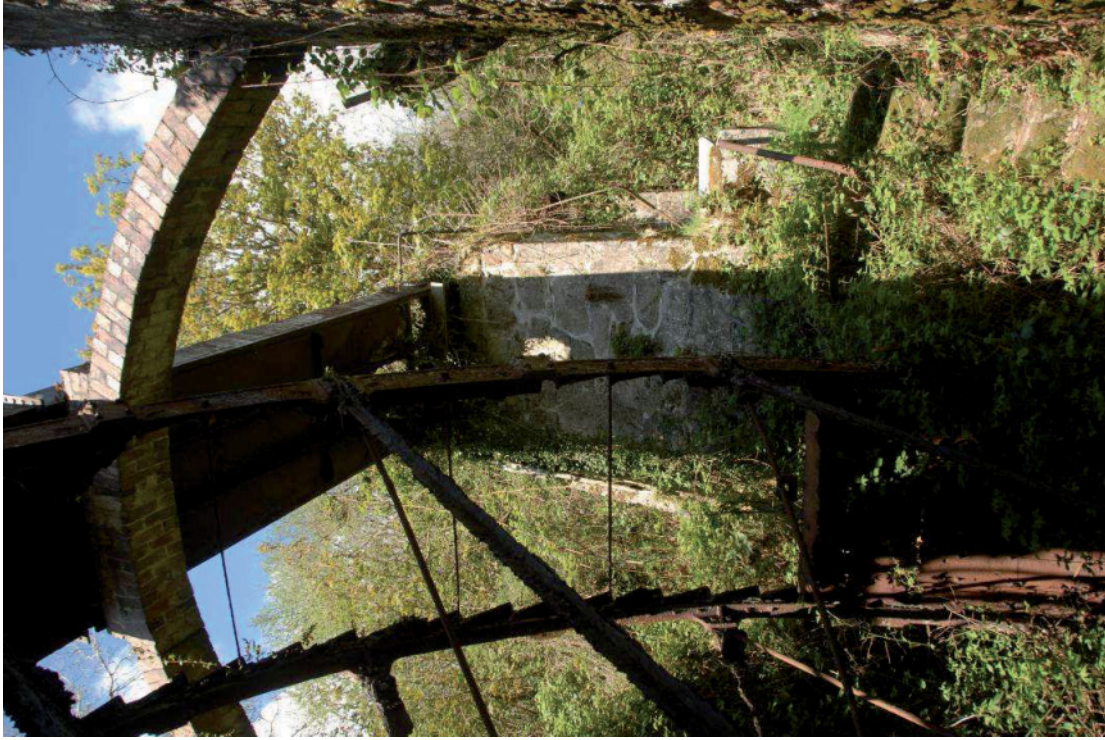
*Fig 71. The western end of the wheelpit at Big Wheel Mill, showing the laundry support and the very poor state of the water wheel. HE Digital Image Archive.*

*Fig 71. The western end of the wheelpit at Big Wheel Mill, showing the launder support and the very poor state of the water wheel.*

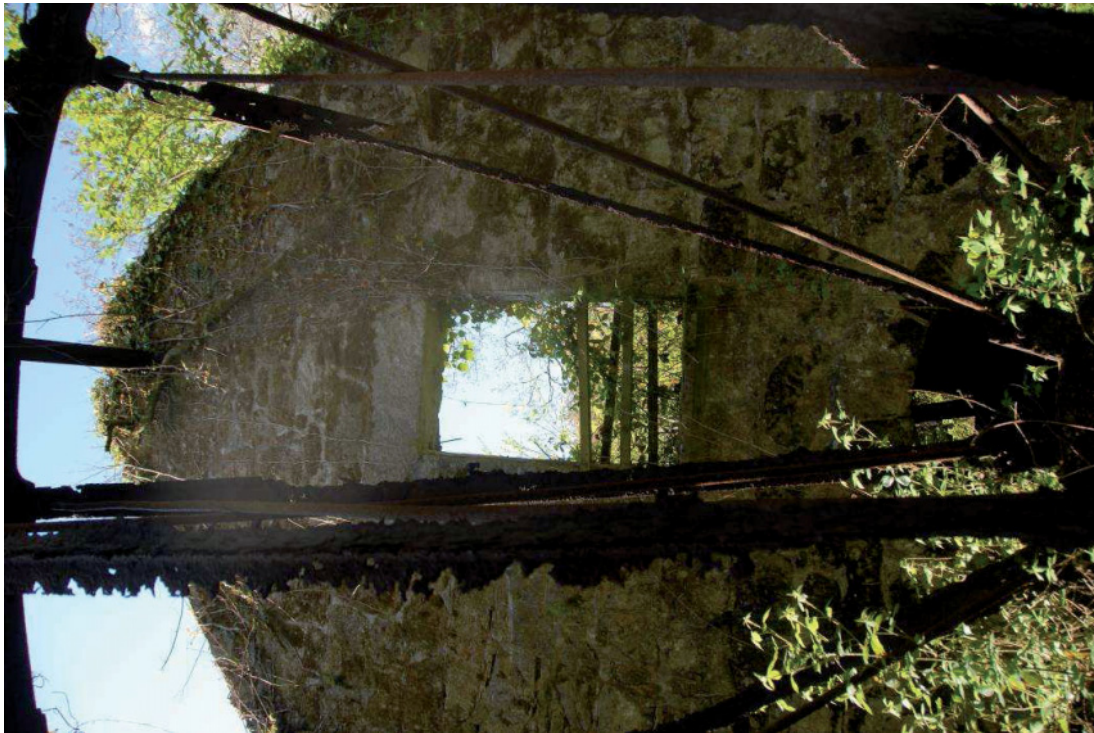
*Fig 70. The southern side of the wheelpit at Big Wheel Mill. The water wheel spokes in the foreground demonstrate the need for very urgent remedial works. HE Digital Image Archive.*

*Fig 70. The southern side of the wheelpit at Big Wheel Mill. The water wheel spokes in the foreground demonstrate the need for very urgent remedial works.*

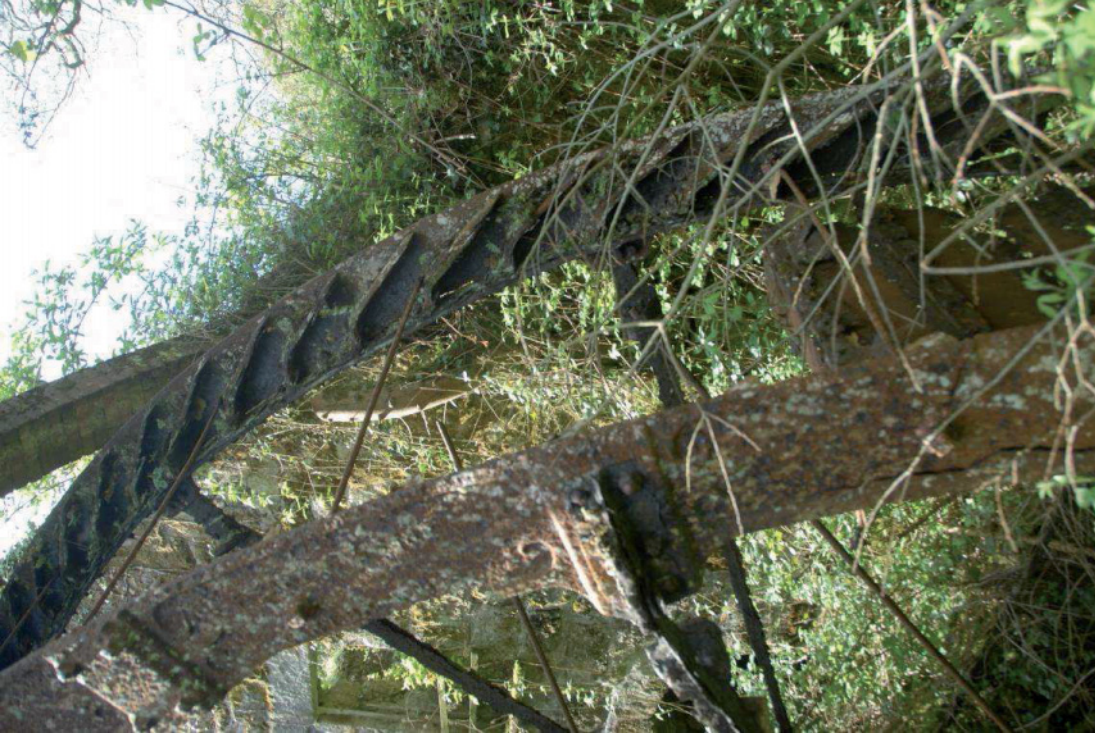
*Fig 73. The now poorly-supported cast iron shrouds (rims) of the water wheel, increasingly at risk of severe damage through the likely collapse of the wheel. HE Digital Image Archive.*

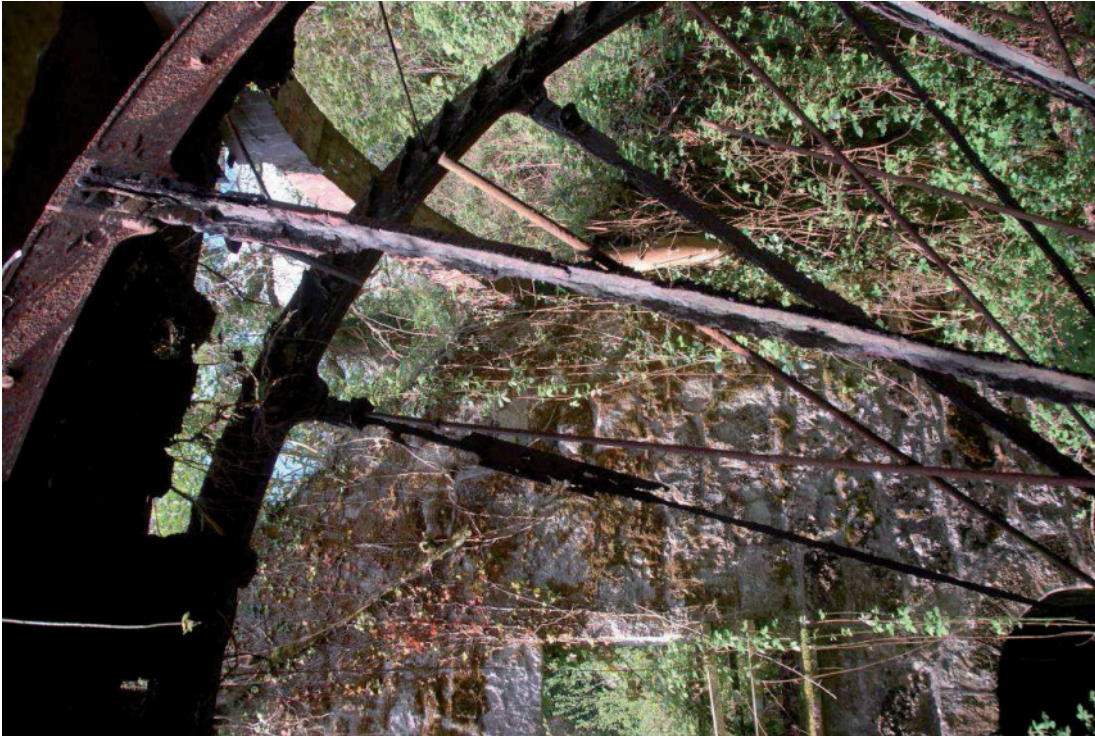
*Fig 72. Another view of the very poor state of the water wheel spokes the Big Wheel Mill. HE Digital Image Archive.*
