# Tregargus, St. Stephen in Brannel, Cornwall

## Conservation Management Statement

## **Tregargus Valley, St. Stephen in Brannel, Cornwall**

### **Conservation Management Statement**

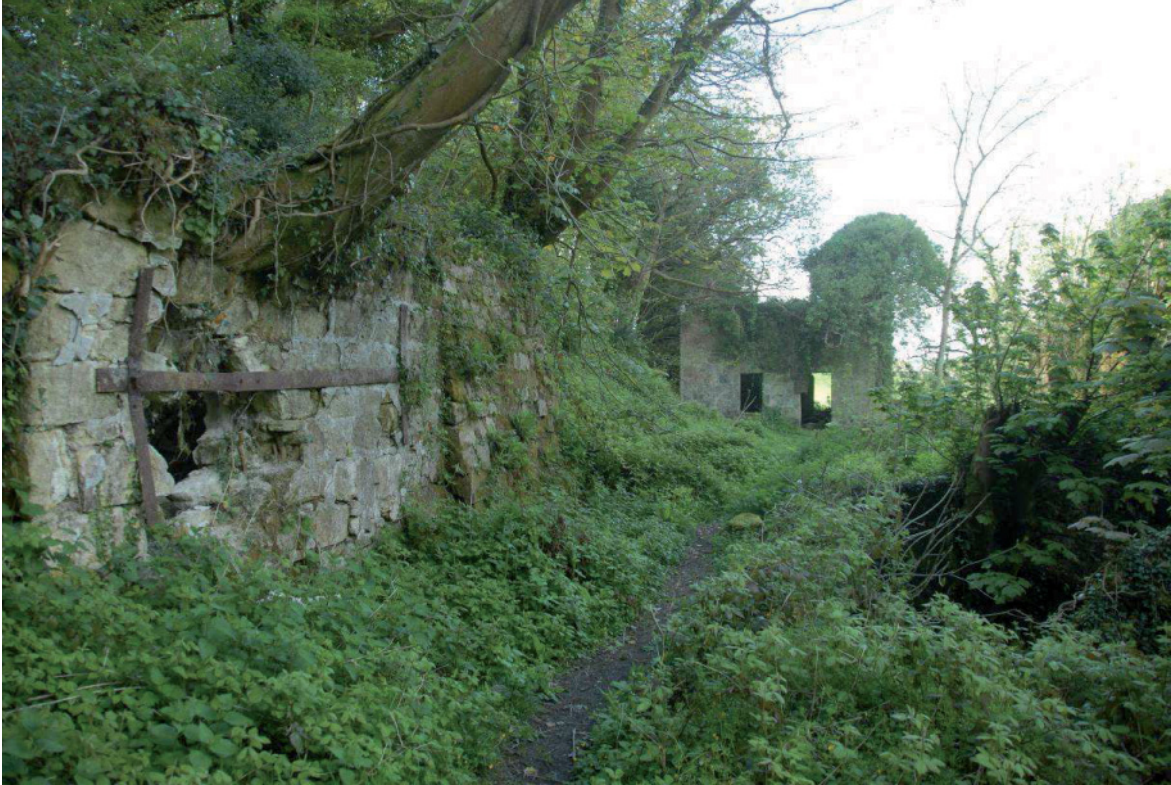
*Fig 76. Trees growing out of the stonework of the Trevear Mill reservoir [33] are already causing significant damage to it. Their collapse would also damage Trevear Mill immediately to the right. HE Digital Image Archive.*

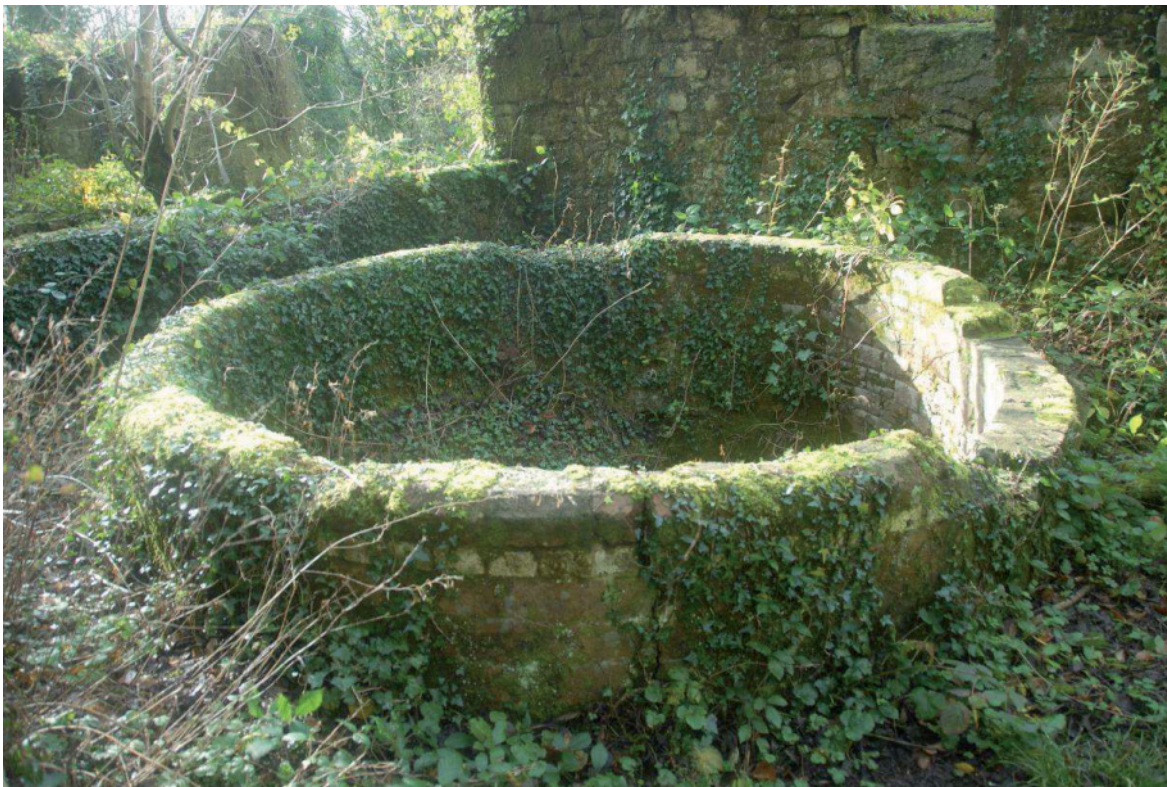
*Fig 77. One of the brick-built grinding pans in the northern section of Trevear china stone mill. HE Digital Image Archive.*

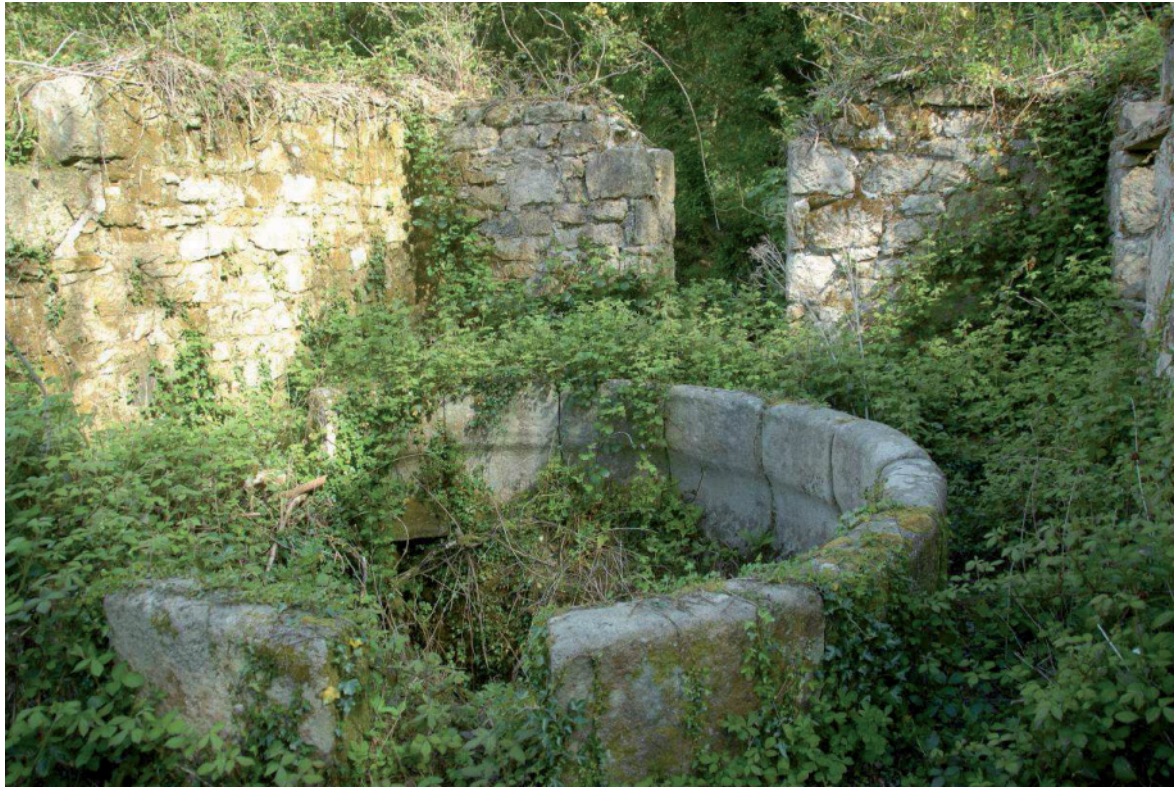
*Fig 78. A stone-constructed grinding pan at Trevear Mill, showing the characteristic wear on its inner face. HE Digital Image Archive.*

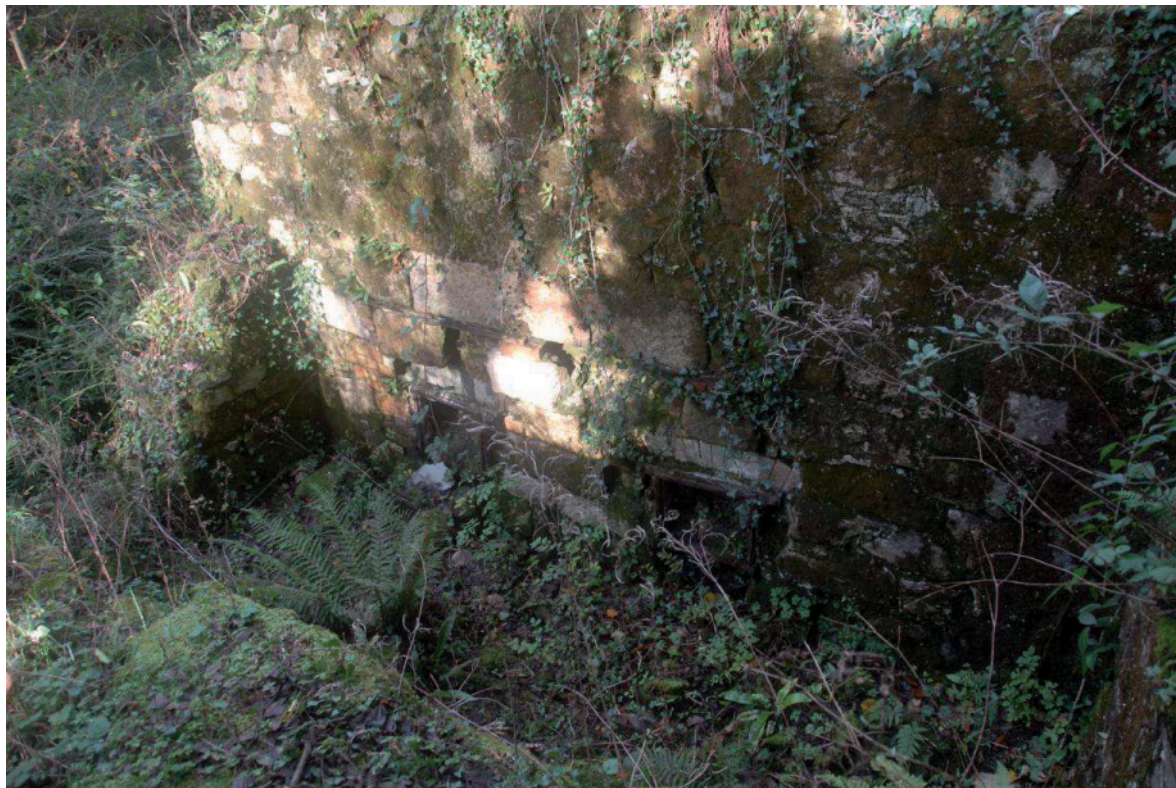
*Fig 79. The southern end of the Trevear Mill dry, with its paired stoking doors. HE Digital Image Archive.*

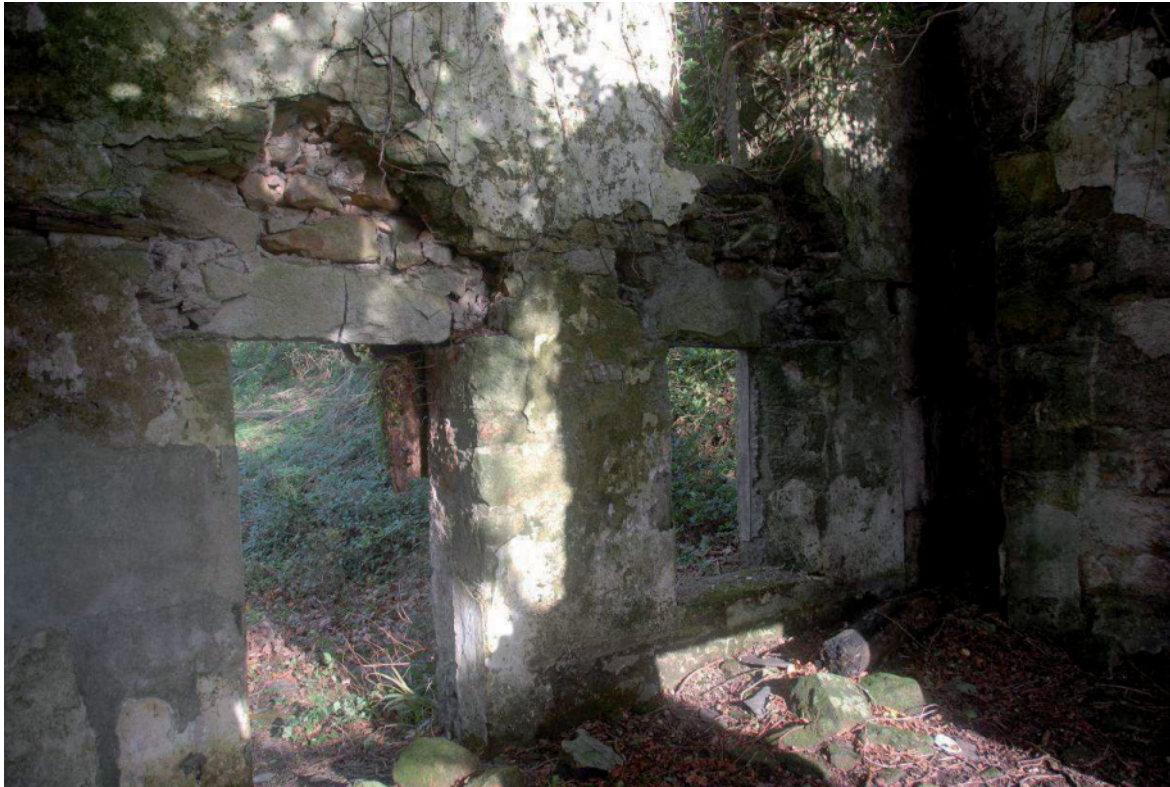
*Fig 80. The internal face of the northern wall of Trevear Miller's Cottage [35], showing the surviving lime-washed plaster, but also the cracked granite lintels and lost masonry. HE Digital Image Archive.*

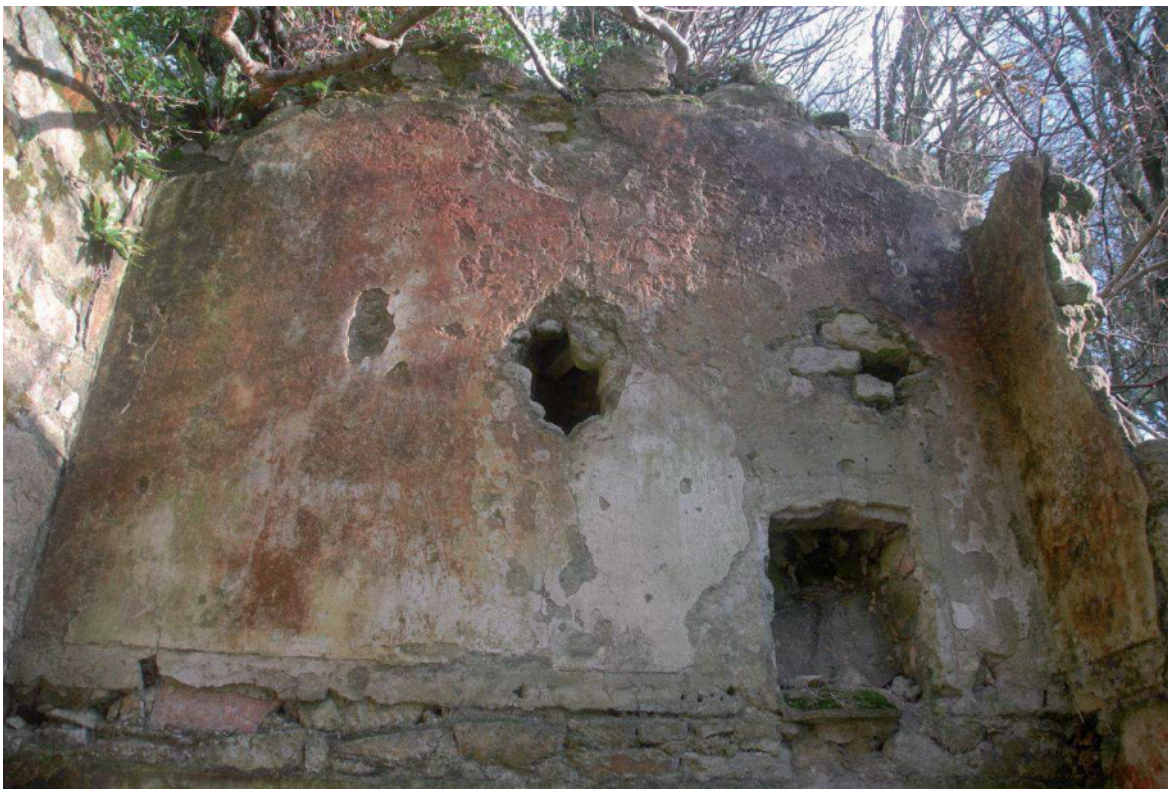
*Fig 81. The interior of the upper floor on the eastern wall of Trevear Miller's Cottage, showing the surviving plaster and the aperture for the bedroom fireplace. HE Digital Image Archive.*

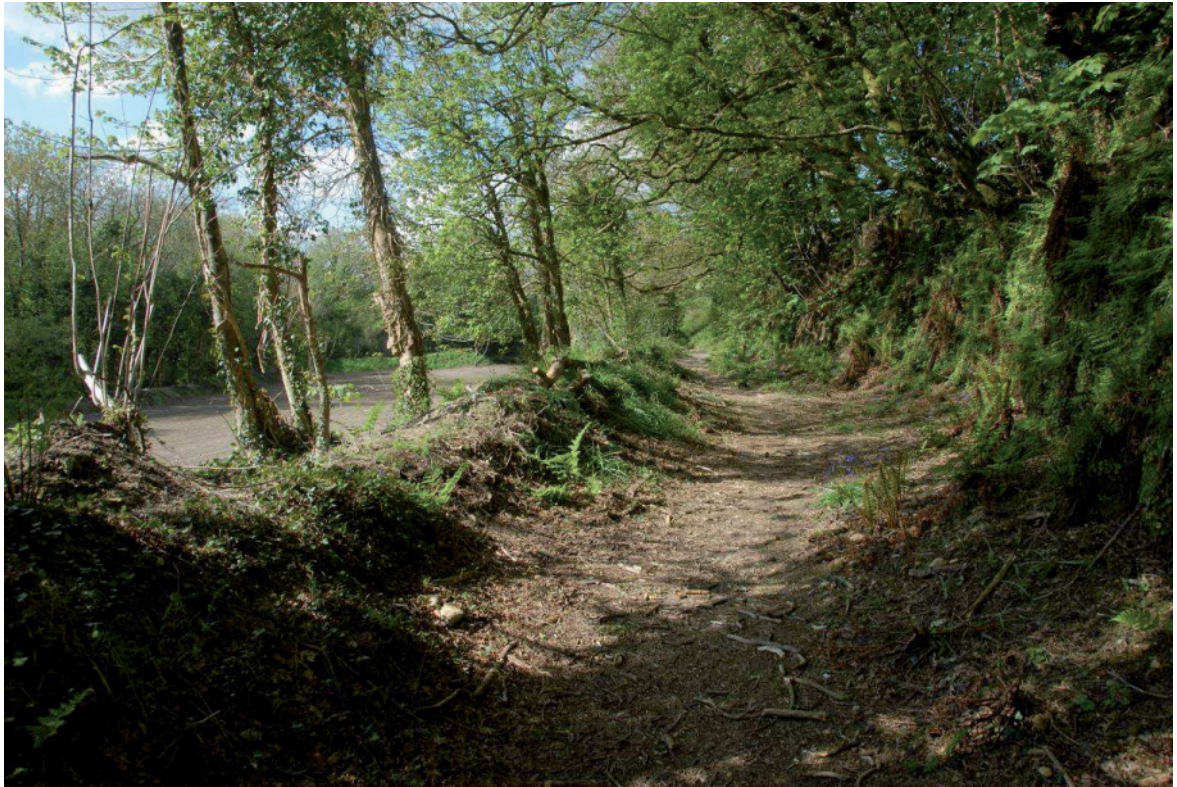
*Fig 82. The former leat [36] leading down the western side of the site, forming a path from Big Wheel Mill [29] to Mica Mill [39]. HE Digital Image Archive.*

*Fig 82. The former leat leading down the western side of the site, forming a path from Big Wheel Mill to Mica Mill.*

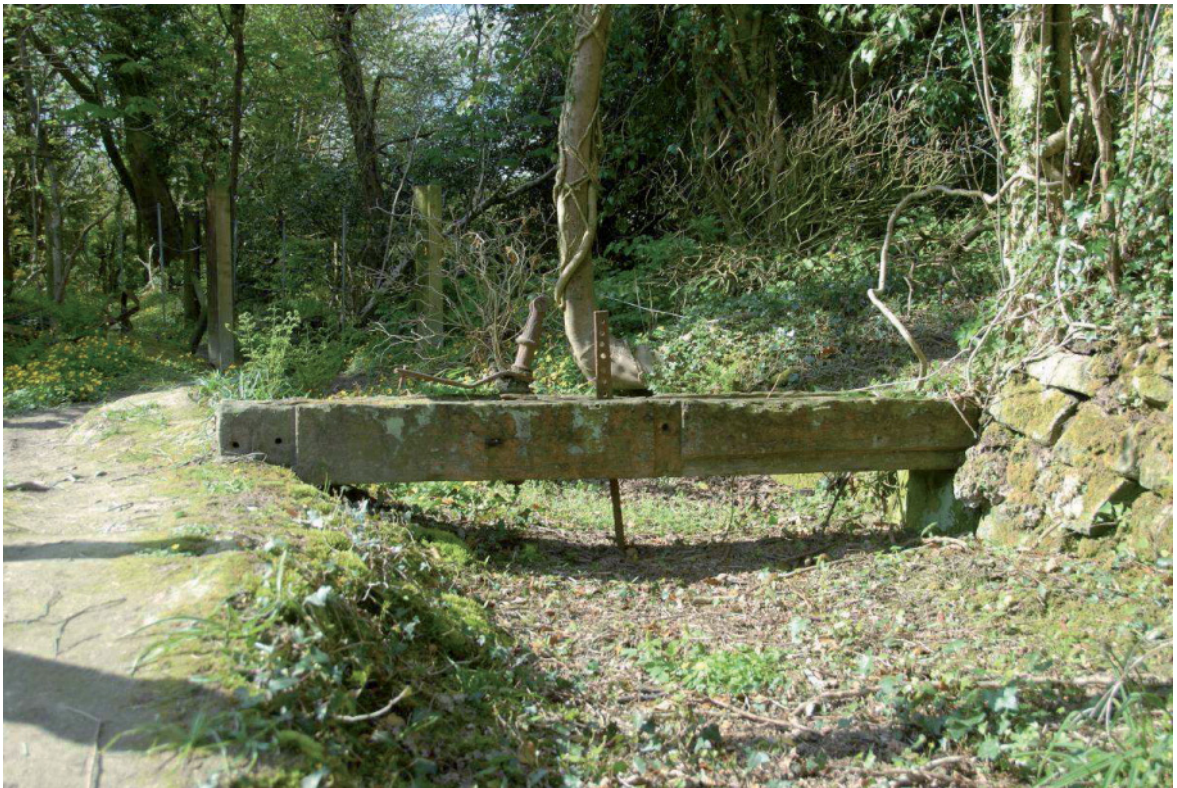
*Fig 83. The sluice in the leat [36] not far to the north of Mica Mill. HE Digital Image Archive.*

*Fig 83. The sluice in the leat not far to the north of Mica Mill.*

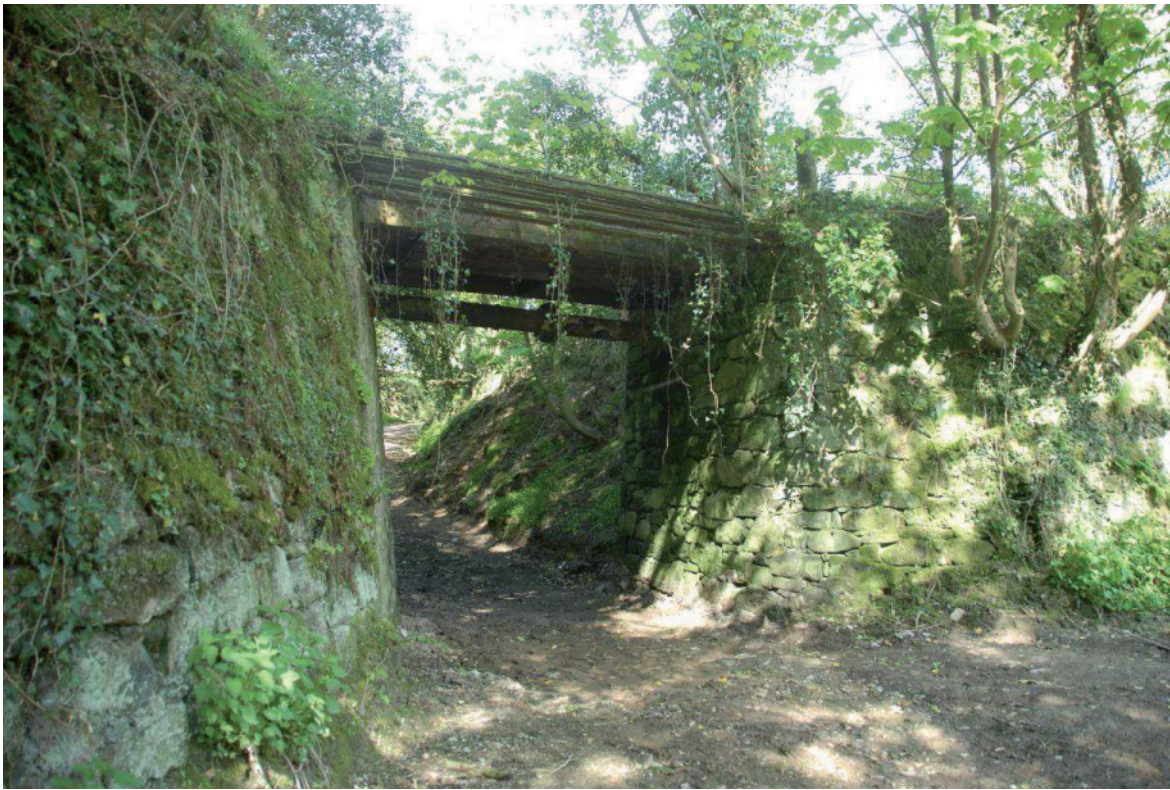
*Fig 84. The tramway bridge/aqueduct [38] immediately to the north of Mica Mill which carried leat [36] seen from the south-east. A more recent pipeline runs under the bridge. HE Digital Image Archive.*

*Fig 84. The tramway bridge/aqueduct immediately to the north of Mica Mill which carried leat seen from the south-east. A more recent pipeline runs under the bridge.*

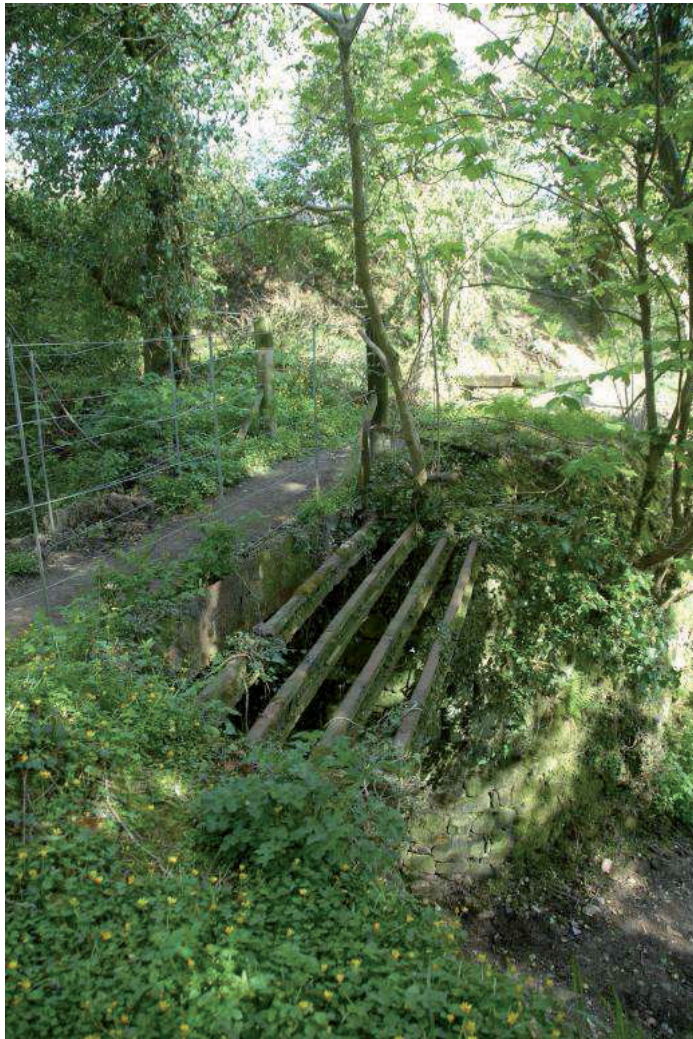
*Fig 85. A view of the aqueduct/tramway bridge [38] seen from the south. The cast iron leat bridge has been infilled to form a path, whilst the deck of the tramway has been lifted, leaving only its support rails. HE Digital Image Archive.*

*Fig 85. A view of the aqueduct/tramway bridge seen from the south. The cast iron leat bridge has been infilled to form a path, whilst the deck of the tramway has been lifted, leaving only its support rails.*

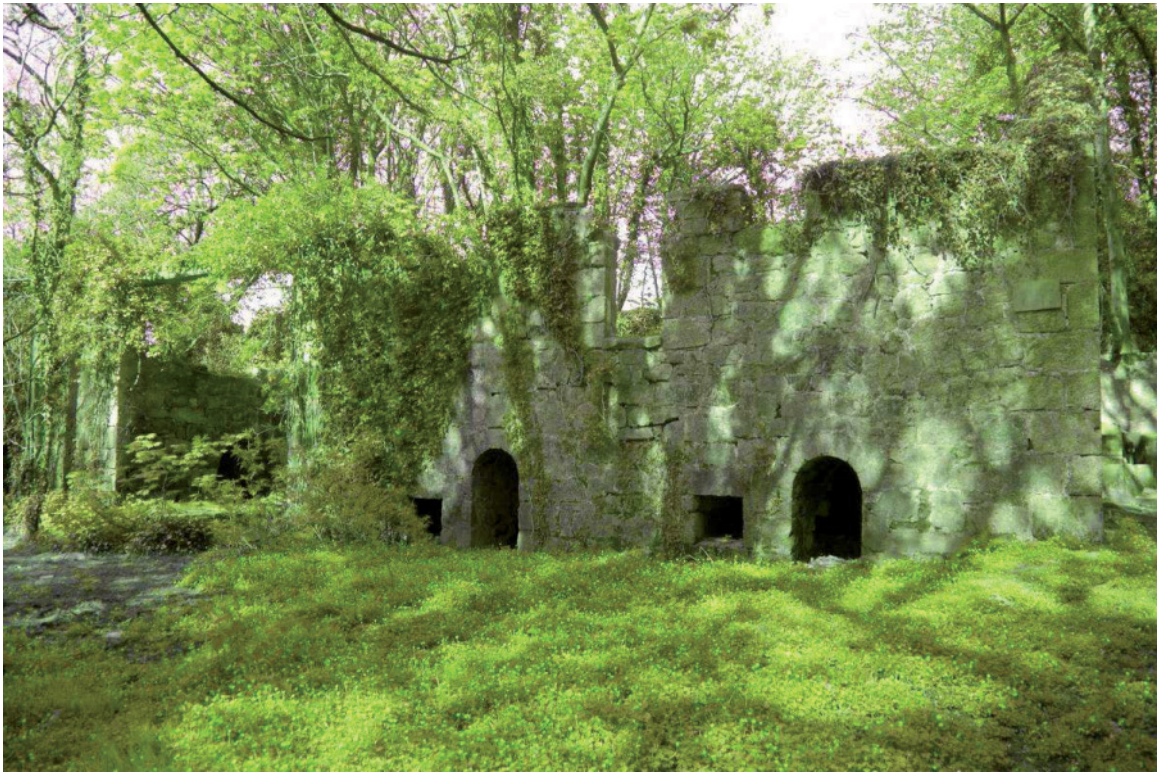
*Fig 86. The northern section of Mica Mill [39] seen from the north-east. The massive central wheelpit can be seen to the left. HE Digital Image Archive.*

*Fig 86. The northern section of Mica Mill seen from the north-east. The massive central wheelpit can be seen to the left.*

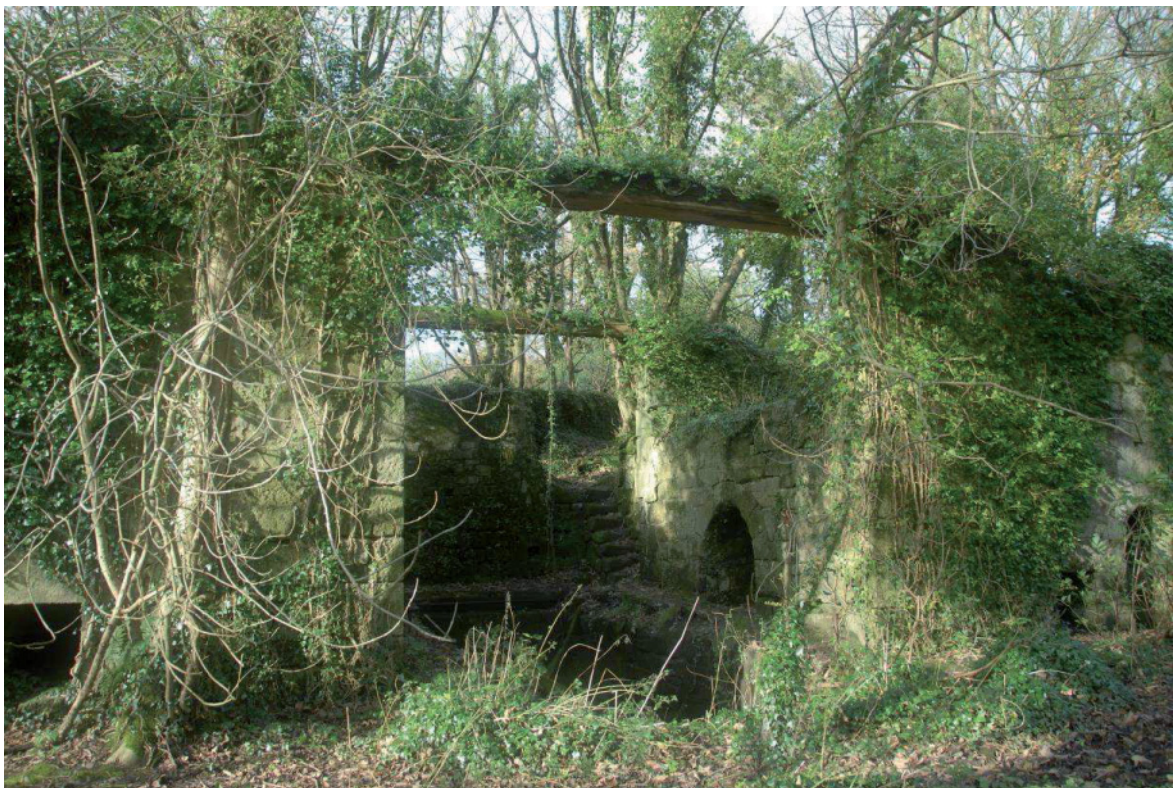
*Fig 87. The central wheelpit at Mica Mill [39] seen from the east. The surviving spanning timbers can be seen in this view. HE Digital Image Archive.*

*Fig 87. The central wheelpit at Mica Mill seen from the east. The surviving spanning timbers can be seen in this view.*

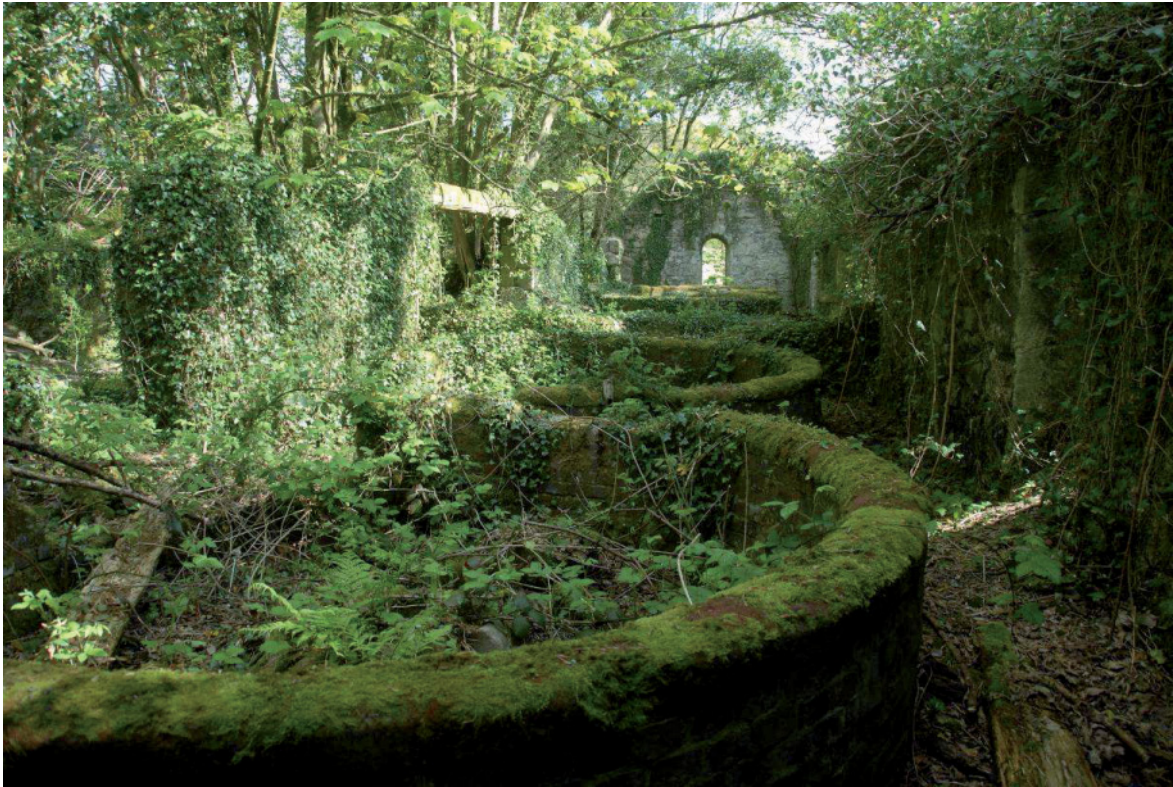
*Fig 88. Looking north along the grinding floor in Mica Mill [39], showing the well-preserved brick-built grinding pans. HE Digital Image Archive.*

*Fig 88. Looking north along the grinding floor in Mica Mill, showing the well-preserved brick-built grinding pans.*

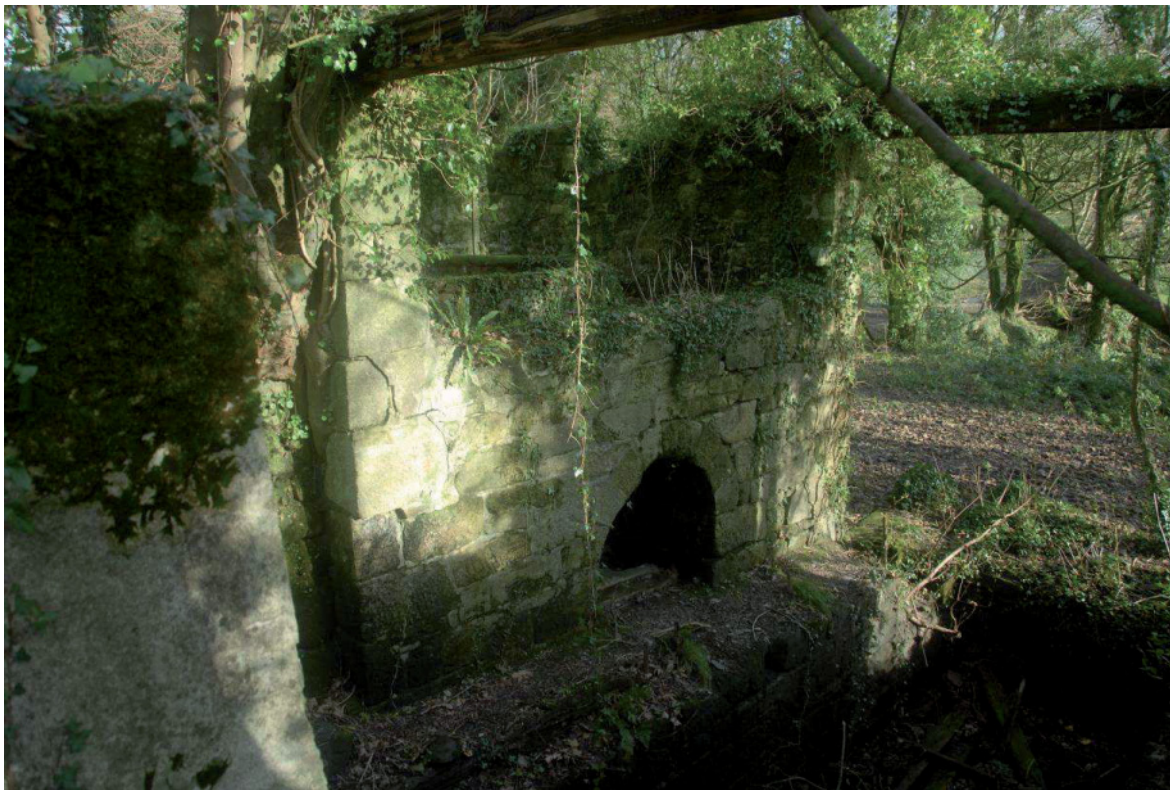
*Fig 89. The large central wheelpit at Mica Mill [39] seen from the south-west. HE Digital Image Archive.*

*Fig 89. The large central wheelpit at Mica Mill seen from the south-west.*

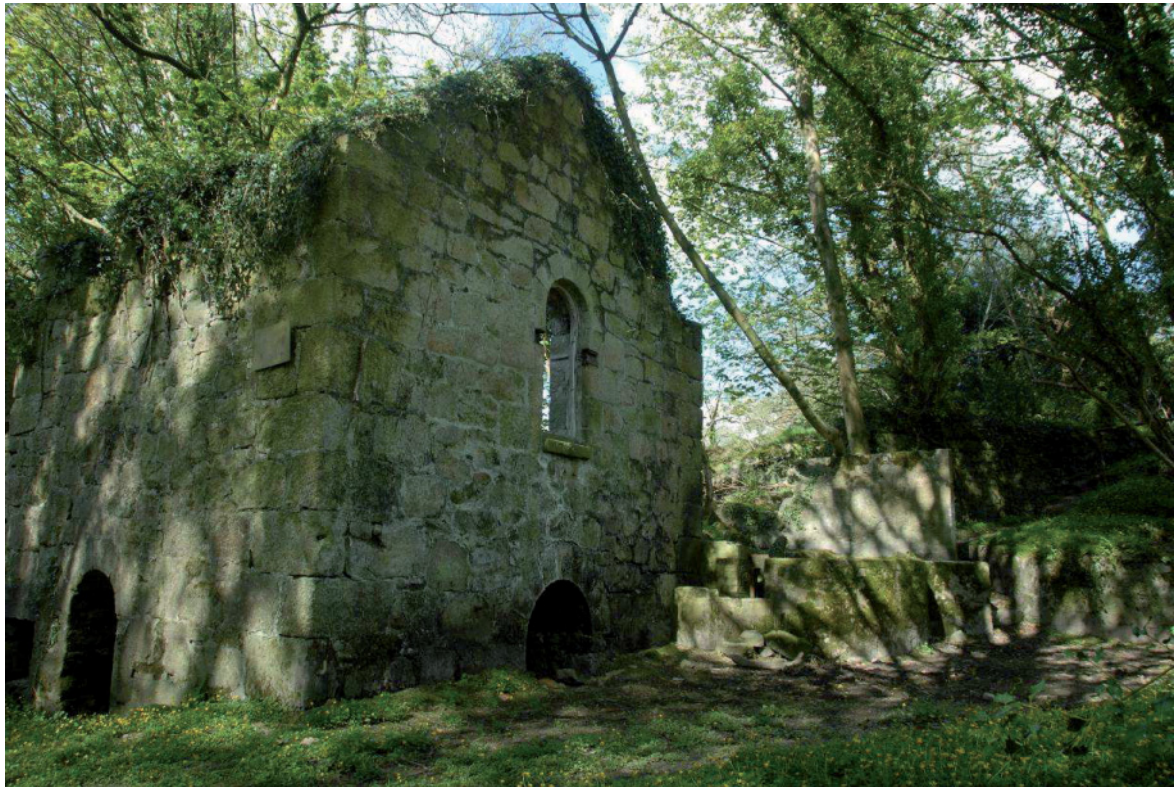
*Fig 90. The northern gable of Mica Mill [39] seen from the north-east. HE Digital Image Archive.*

*Fig 90. The northern gable of Mica Mill seen from the north-east.*

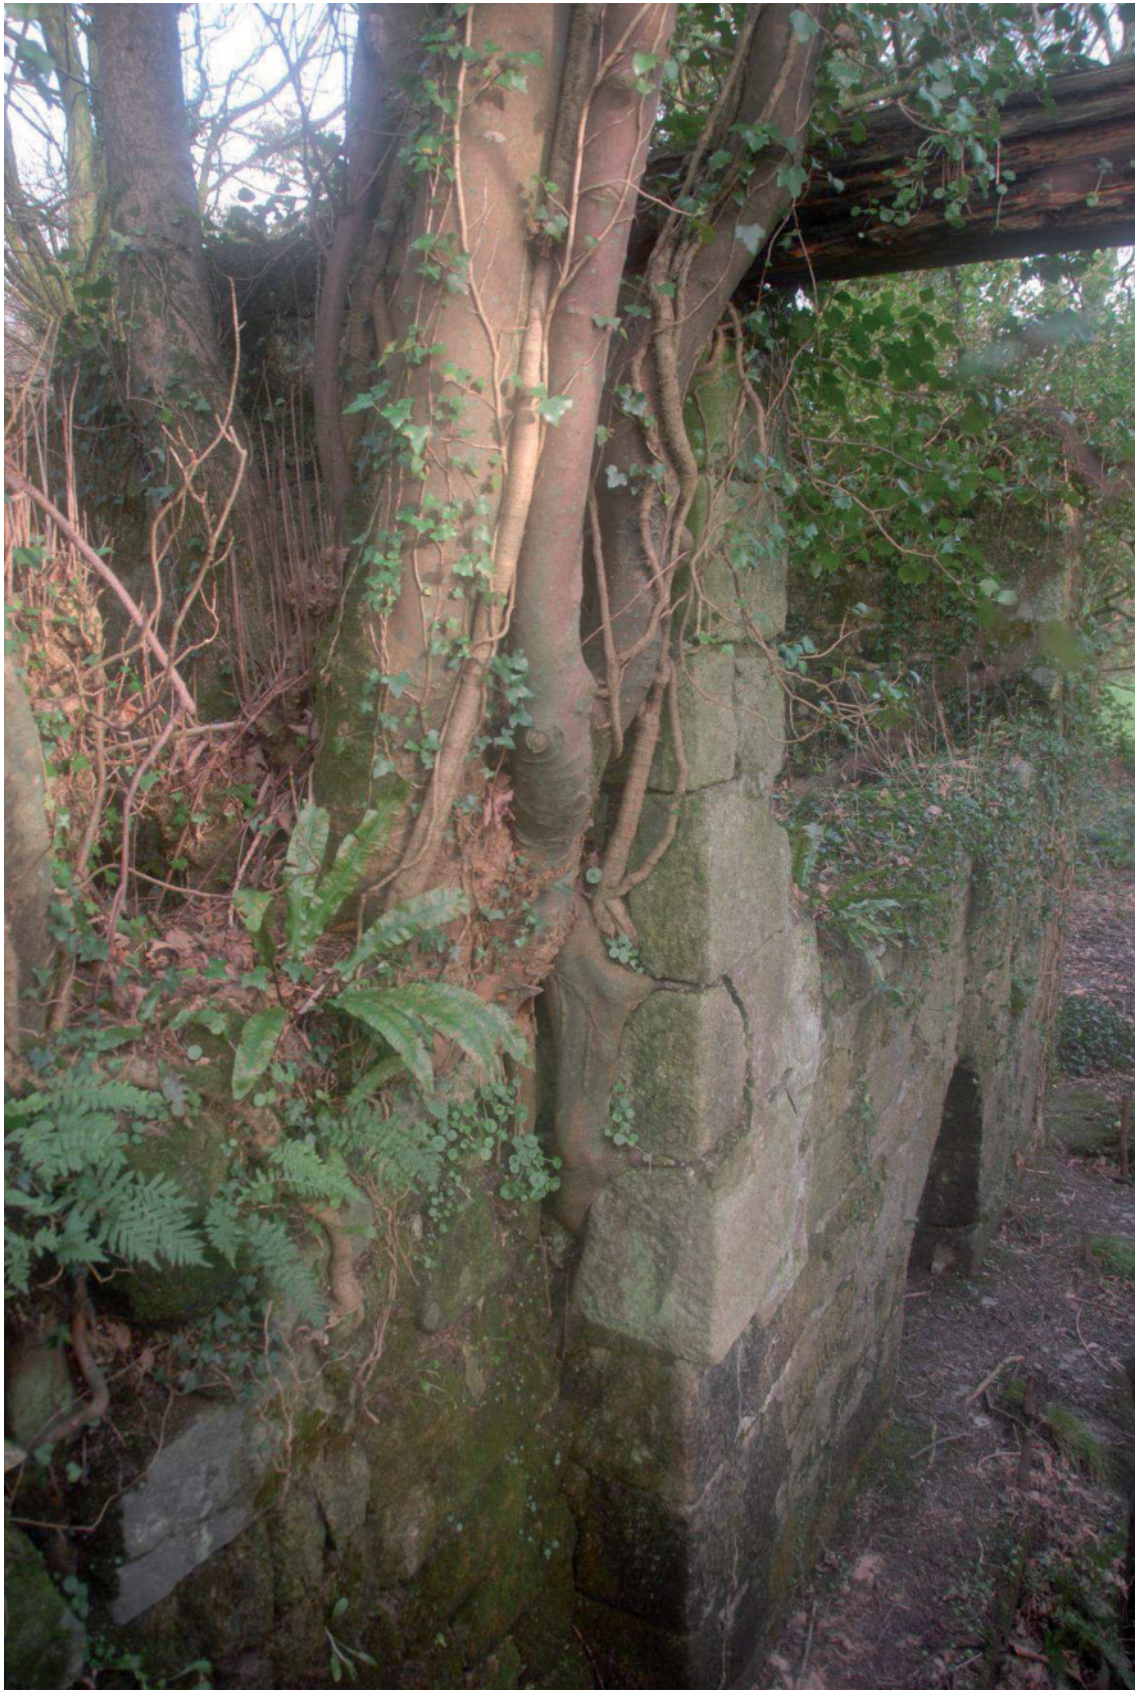
*Fig 92. Tree roots infiltrating the masonry on the northern side of the wheelpit at Mica Mill exemplify the types of problems affecting sites at Tregargus which require urgent attention if this rare group of structures are not to suffer severe deterioration. HE Digital Image Archive.*

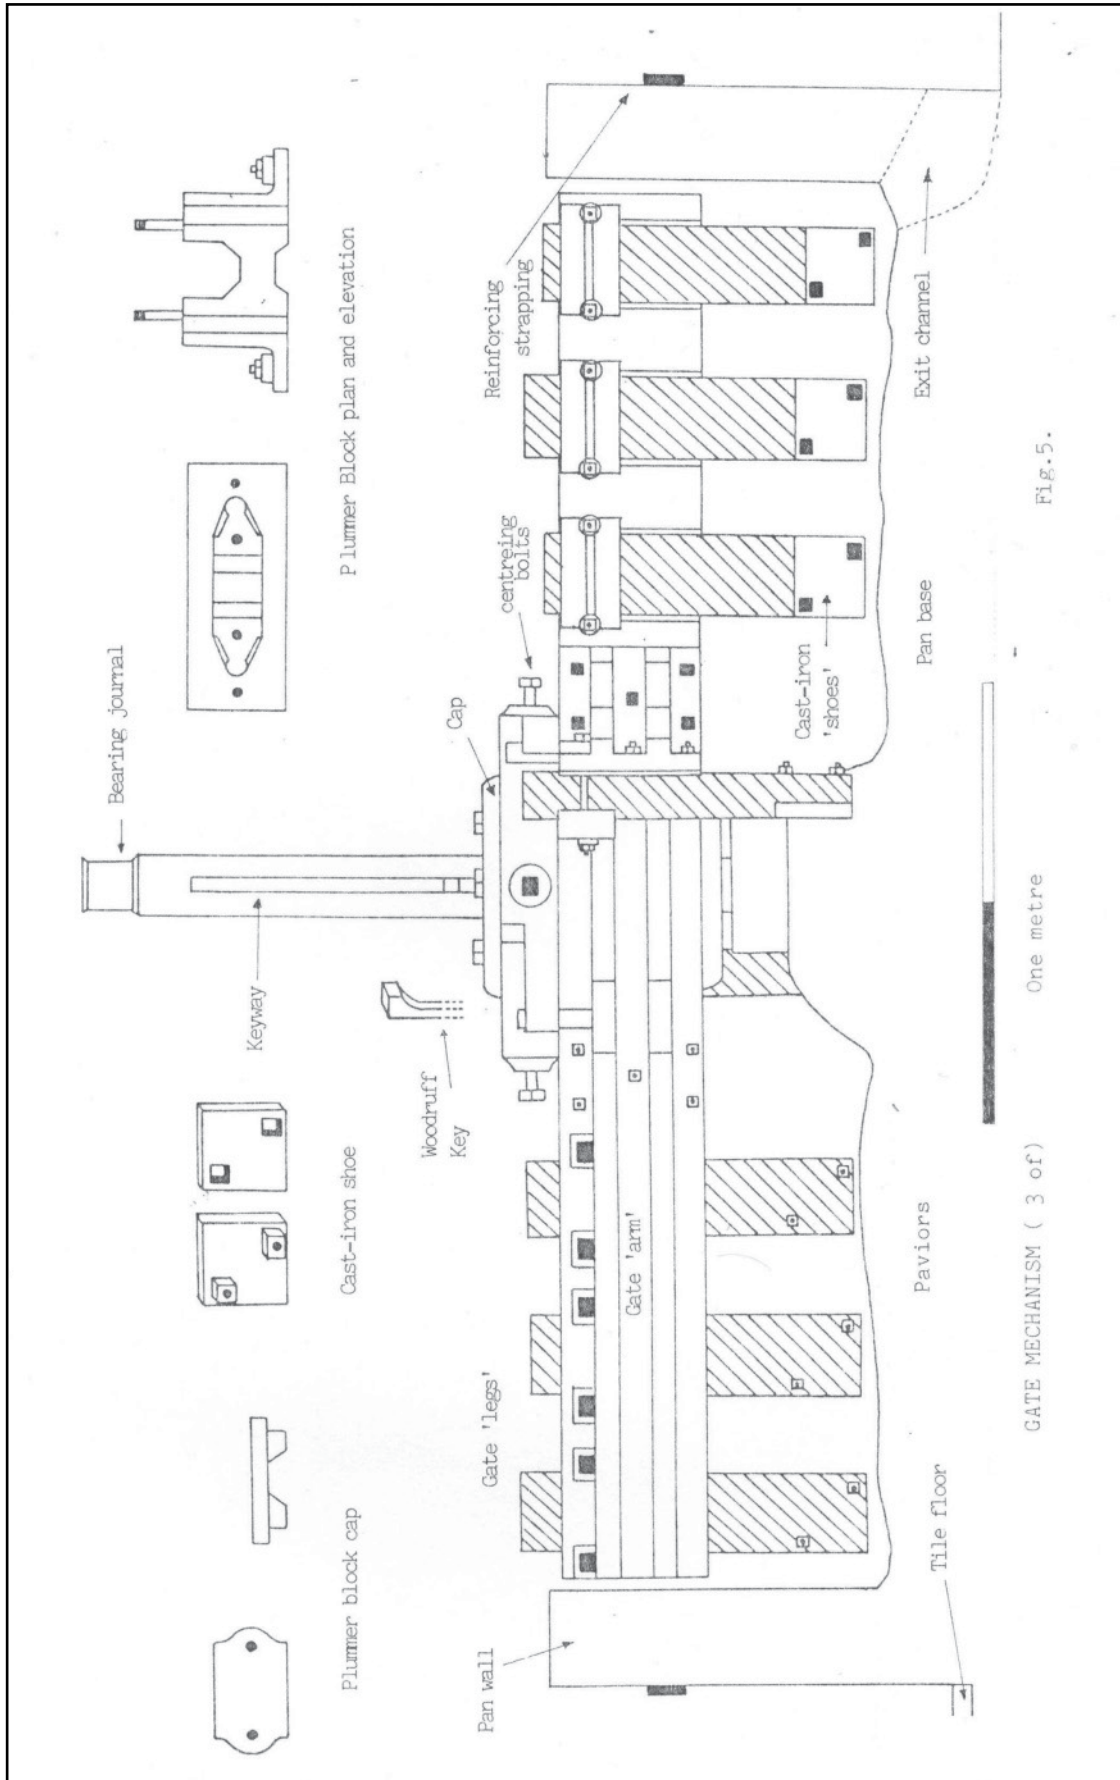
Fig 23. The arrangement of the components of a china stone grinding pan, in this case one of the surviving examples at Chapel Mill, St. Stephen in Brannel. The gate legs are vertically adjustable so that they can be lowered as the paviors in the pan base wear down. Source Sharpe and Smith 1985.

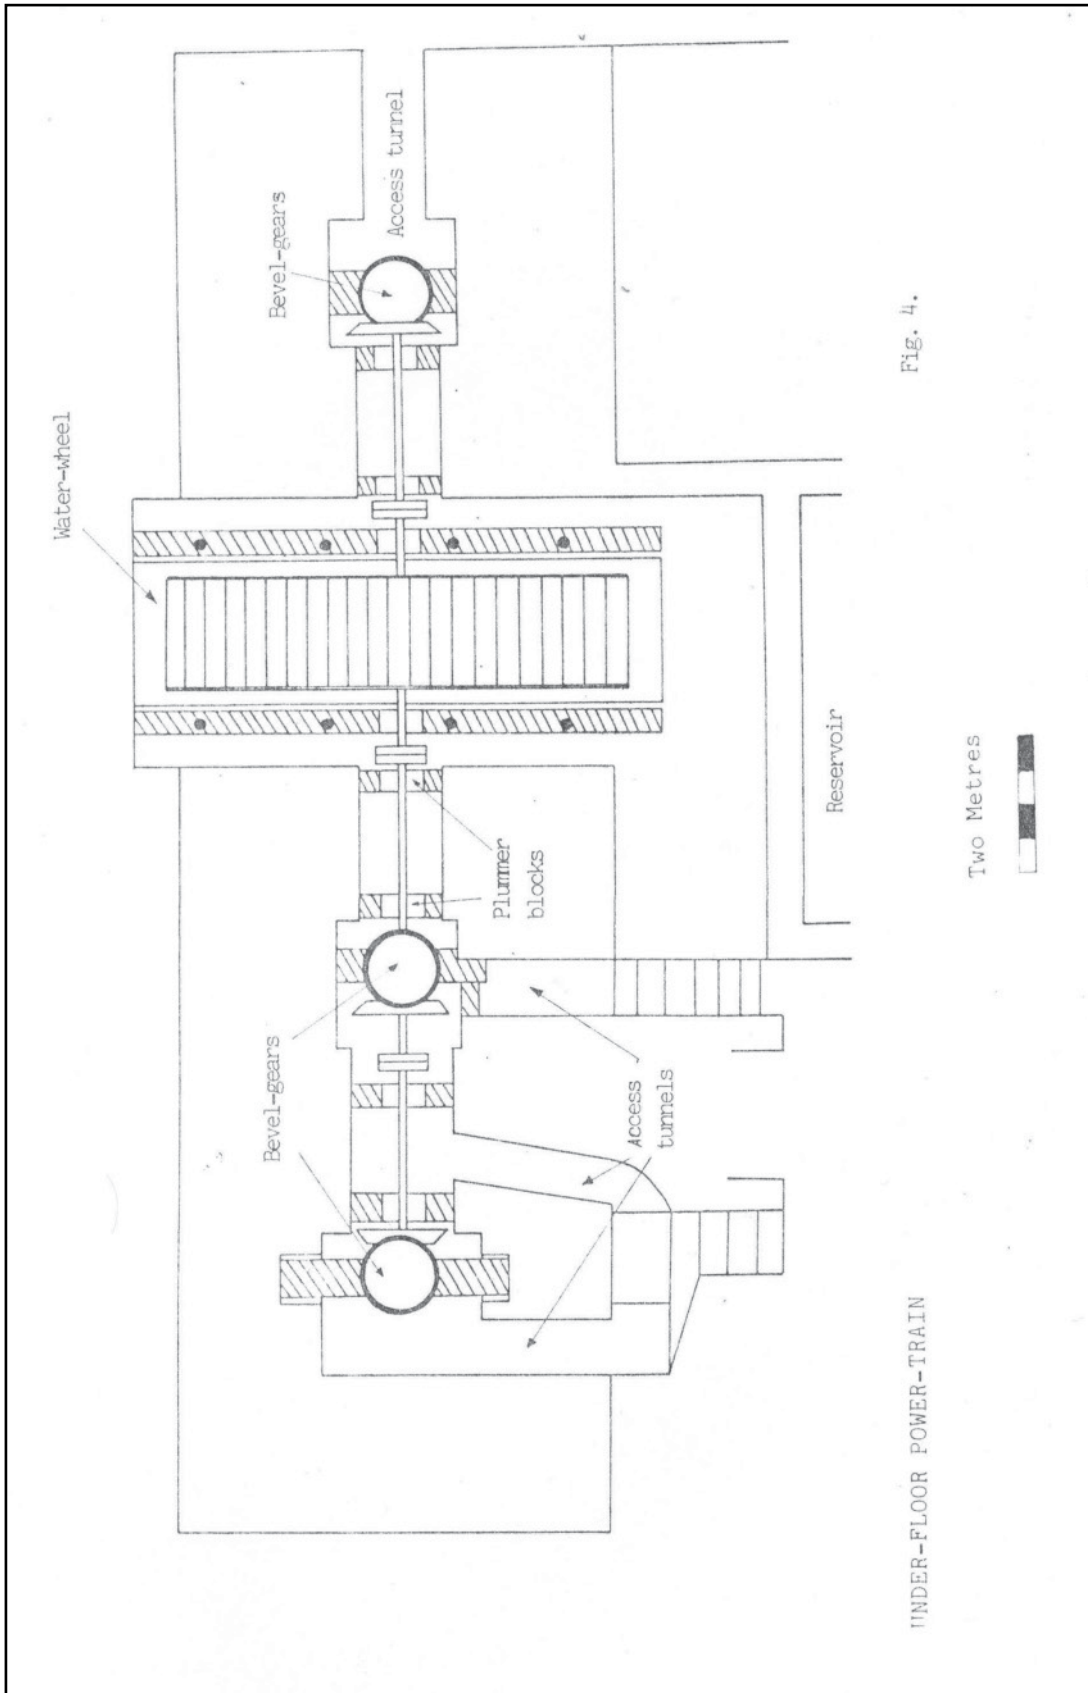
Fig 26. A typical under-floor arrangement in a china stone mill (Chapel Mill), showing the horizontal drive axles from the water wheel, the bevel gears which powered the axles running up to the grinding pans and the access tunnels from the exterior of the building. Source: Sharpe and Smith 1985.

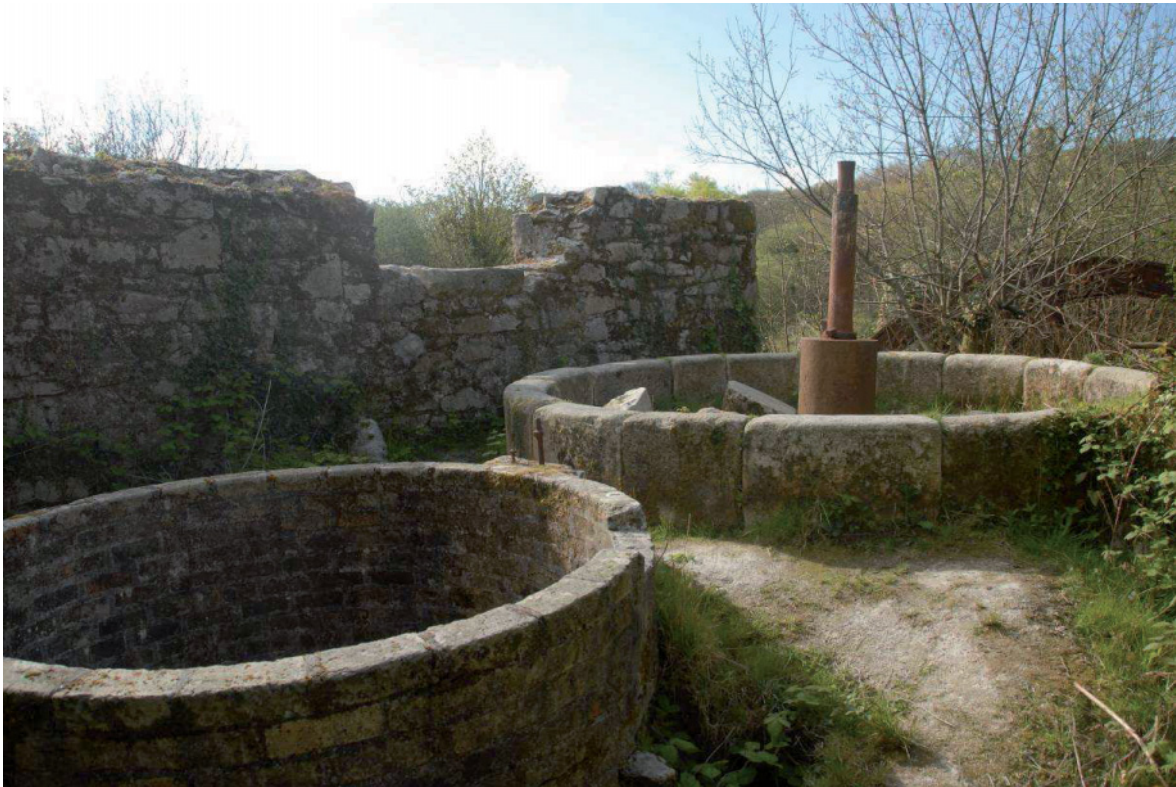
*Fig 34. The brick-built grinding pans in the northern section of Wheal Arthur china stone mill [10]. The crown of the central waterwheel can be seen in the background. HE Digital Image Archive.*

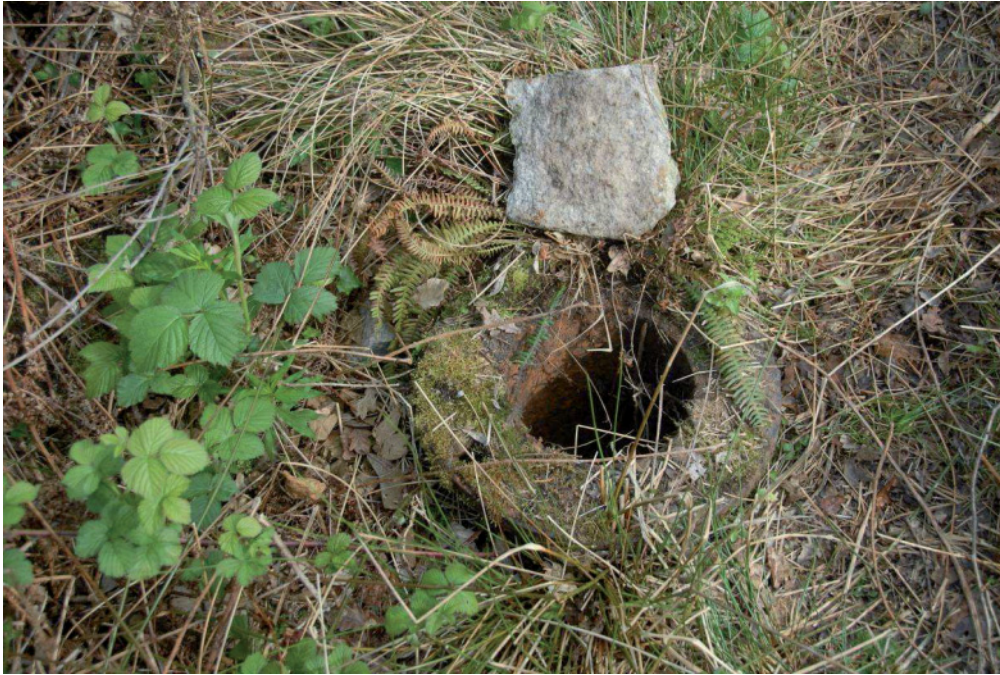
*Fig 38. The top of the cast iron rising main adjacent to the pumping shaft [8] at Wheal Arthur mill. HE Digital Image Archive.*

- Fig 38. *The top of the cast iron rising main adjacent to the pumping shaft at Wheal Arthur mill.*
- Fig 39. *The in situ tramway to the east of the southern settling tanks at the Wheal Arthur complex.*
