# Tregargus, St. Stephen in Brannel, Cornwall

## Conservation Management Statement

## **Tregargus Valley, St. Stephen in Brannel, Cornwall**

### **Conservation Management Statement**

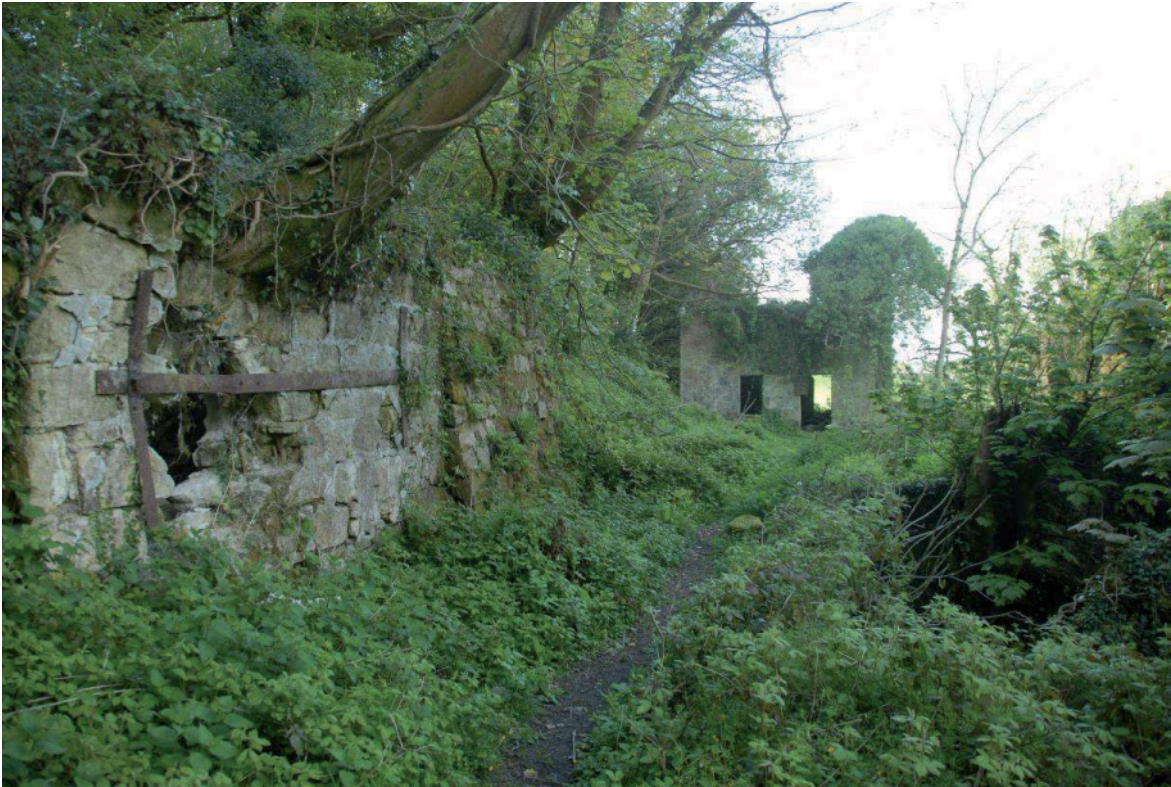
*Fig 76. Trees growing out of the stonework of the Trevear Mill reservoir [33] are already causing significant damage to it. Their collapse would also damage Trevear Mill immediately to the right. HE Digital Image Archive.*

*Fig 76. Trees growing out of the stonework of the Trevear Mill reservoir are already causing significant damage to it. Their collapse would also damage Trevear Mill immediately to the right.*

In places (in particular at Trevear Mill and Lower Tregargus Mill), trees have rooted into or immediately adjacent to structures. As these trees have become mature their roots have disrupted masonry, in some cases significantly (see Figs 76, 91-92). Elsewhere, mature trees were found to be leaning on or over structures (as for example at Trevear Mill), or had already collapsed onto them, causing significant levels of damage. Preferentially, any tree growing within five metres of any of these historic and important buildings, or any tree which has the potential to fall onto a building and cause significant damage should be felled. It is recognised, however, that given other interests in the site it will probably be necessary to negotiate the removal of any tree on a case by case basis.

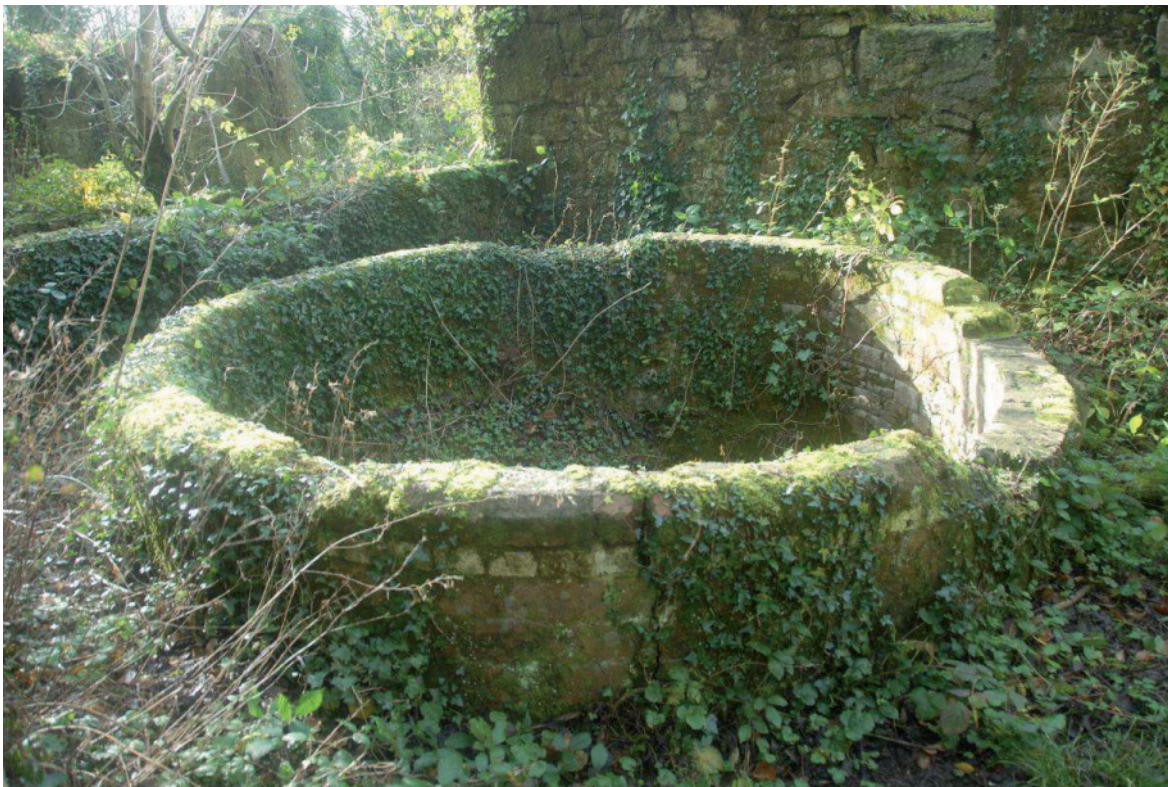
*Fig 77. One of the brick-built grinding pans in the northern section of Trevear china stone mill. HE Digital Image Archive.*

*Fig 77. One of the brick-built grinding pans in the northern section of Trevear china stone mill.*
