Paul Churchyard Crosses, Cornwall

Report of conservation and investigation

Paul, Cornwall
Churchyard crosses
conservation and investigation

Client	The 'Conserving Cornwall's Past' project
Report Number	2010R137
Date	November 2010
Status	Final report
Report author(s)	Ann Preston-Jones
Checked by	Peter Rose
Approved by	Peter Rose

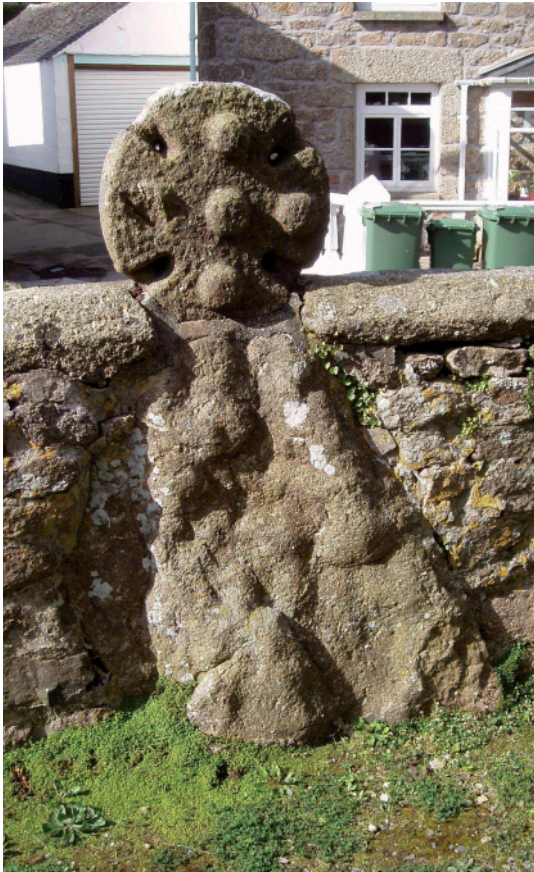
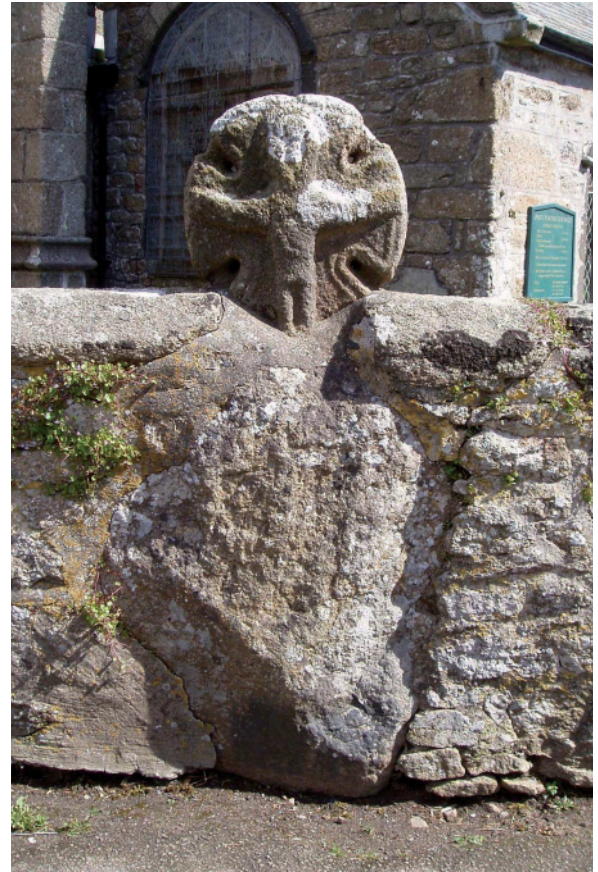
Fig 8 The cross-head before conservation: from inside and outside the churchyard

Prior to conservation work, the cross-head was set on top of a large boulder in the churchyard wall, between two coping stones (Fig 8). It was wedged underneath each shoulder with iron wedges on the inside face and another iron fixing (a nail?) under the centre (Fig 10). All these fixings had rusted, those on the shoulder pushing up the coping stones to either side, particularly on the west. This movement was pushing off the cement, which was cracking around the base of the head. It was not known whether there was also a central iron dowel holding the cross-head onto the boulder, although it was suspected; however there were no visible signs of any deterioration associated with the corrosion and expansion of such a fixing.

expand but on the south side was still in good condition, although it obscured details of the monument, especially the lower part of the crucifixion (see Figs 8 and 10).

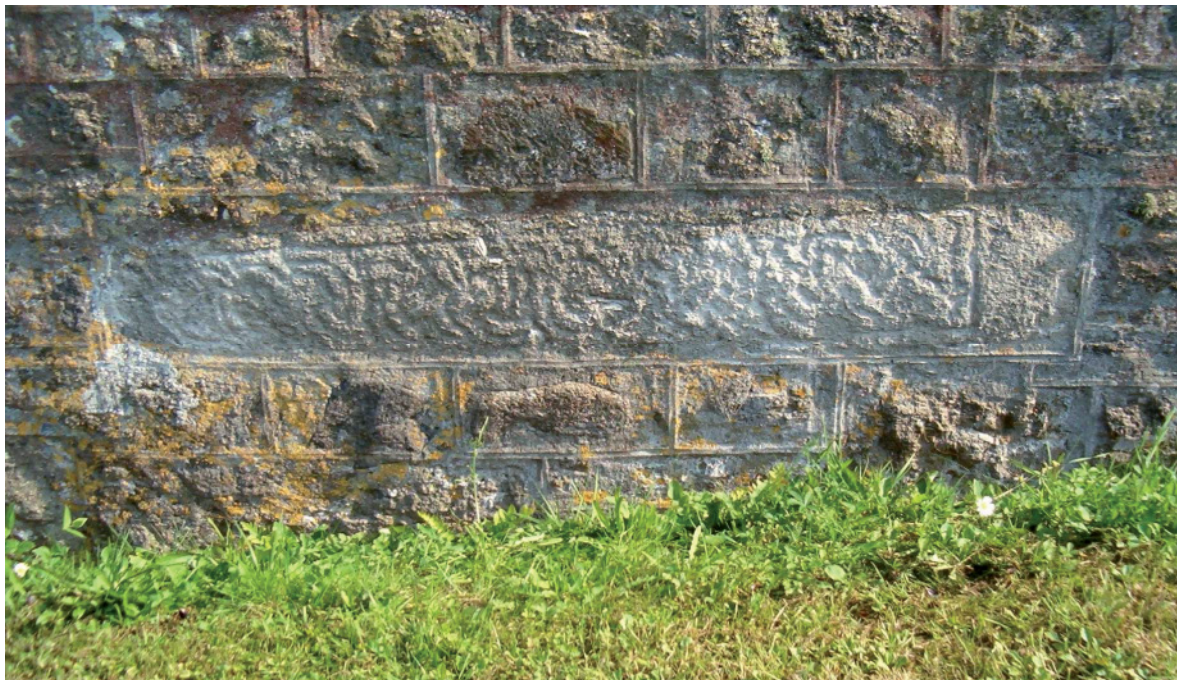
Fig 9 The shaft before conservation

The cross-shaft is stable in its position in the north wall of the church, although it is not conspicuous. Prior to the project, however, the wall here was pointed with cement, which had been spread over the edges of the stone, obscuring the outline of the monument.

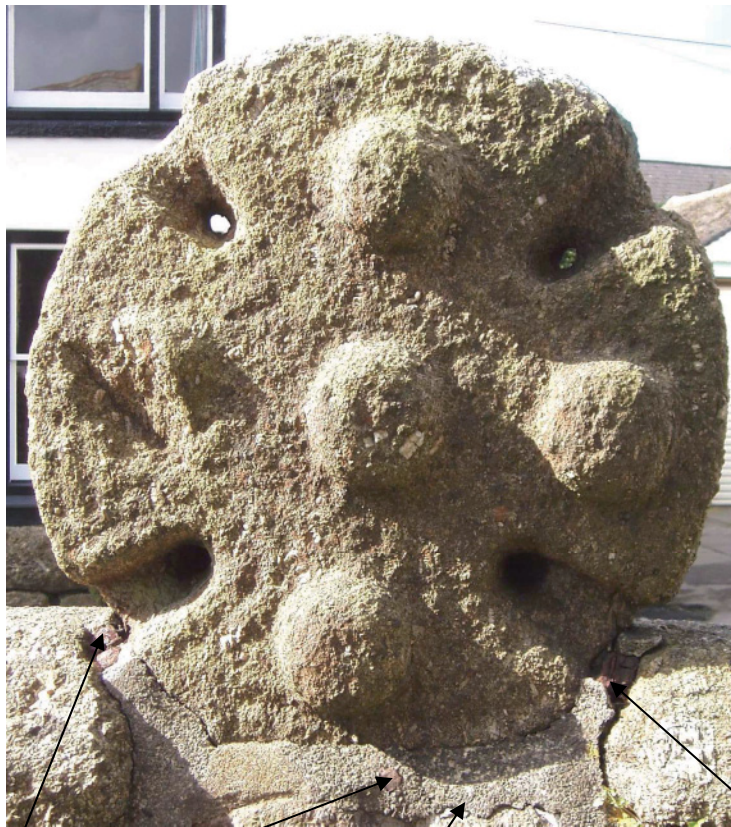
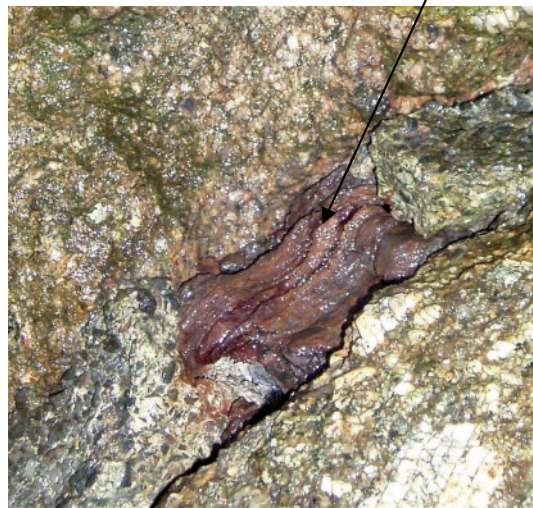
Fig 10 Detail of the ironwork visible in the mortar around the cross-head

The cross-head is fixed to the top of a large boulder and the churchyard wall butts up against this on two sides. Prior to work commencing, the head was fixed to the boulder with iron wedges, pins, possibly a central iron dowel and thick applications of cement. The latter was cracking on the north side where the iron work had started to corrode and

- The visible, rusting ironwork around the base of the head was found to have had no significant role in supporting the cross-head, whose main support came from the thick cement collar alone. The rusting iron that could be seen before work started proved to be nails and other small pieces of iron whose function was uncertain. Given its role in supporting the cross-head, the fact that the rusting of the fixings was causing the cement to crack was a significant problem.

Iron pin
holding cross-
head to wall

Cracked
cement
pointing

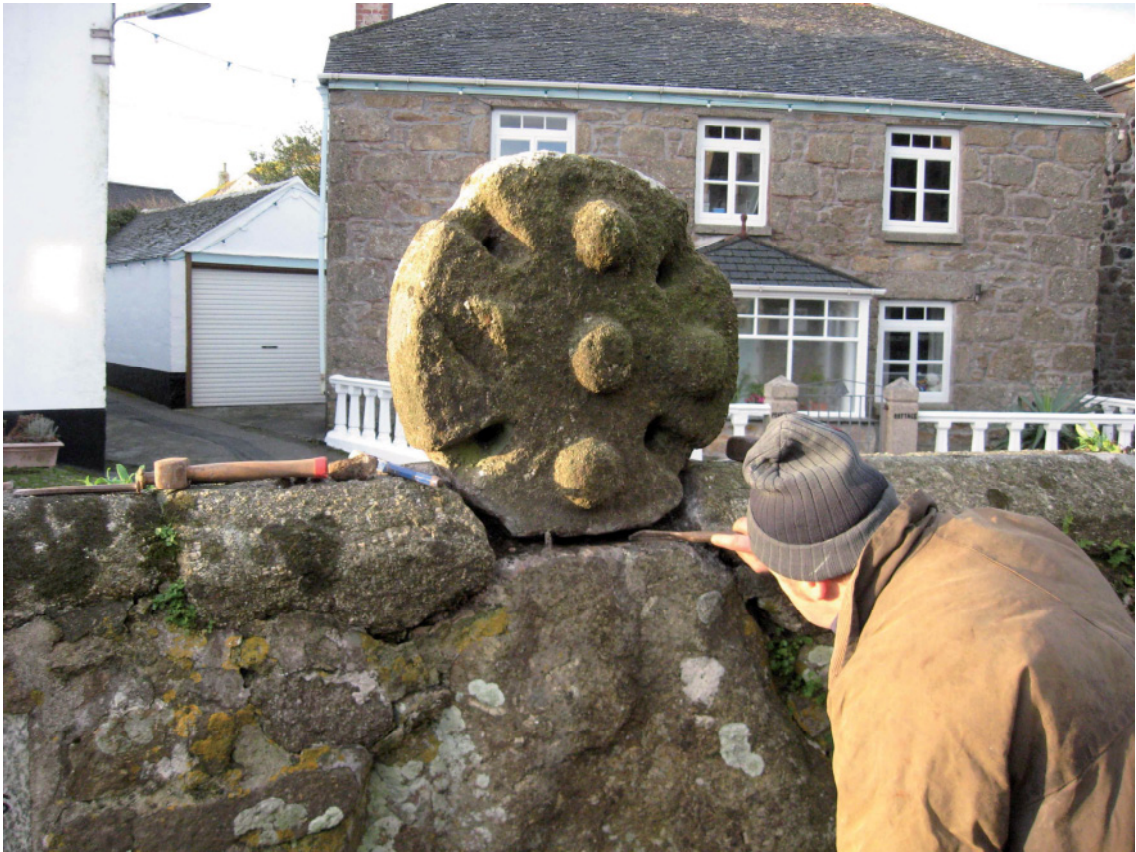
Fig 11 Removing cement pointing from around the cross-head

1. All the cement pointing was removed from around the monument, taking great care not to damage the granite of the cross-head: some of the cement came away very easily, but some proved extremely tough (Fig 11).

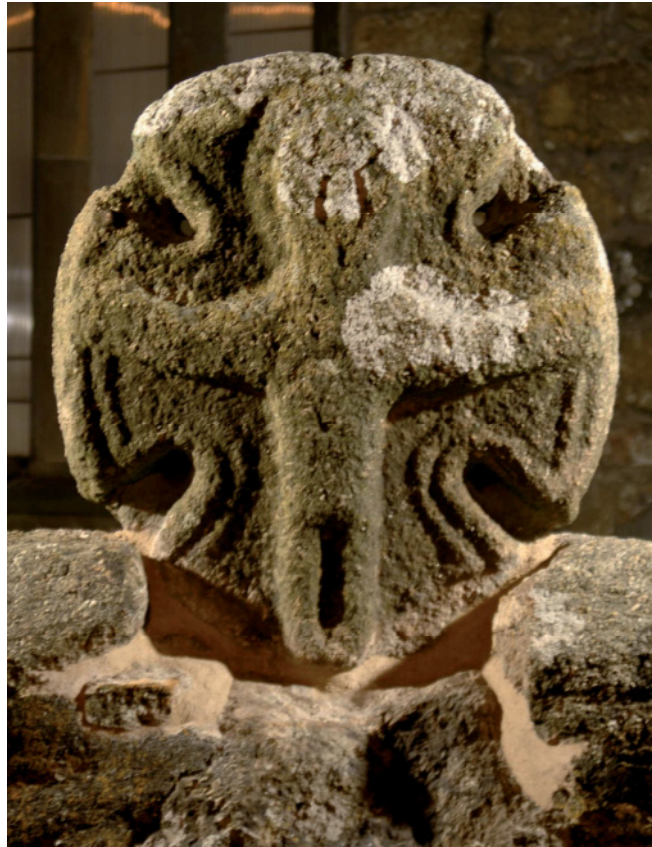
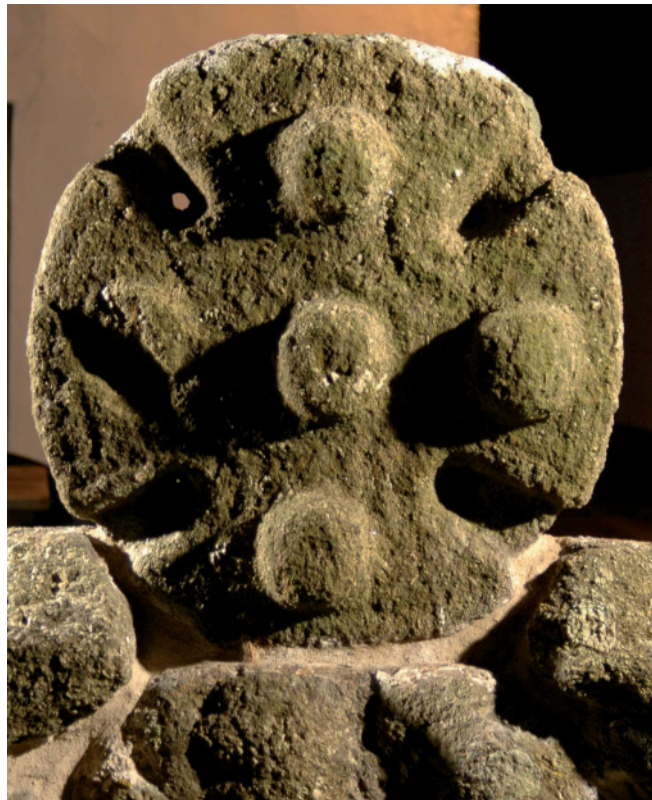
Fig 15 The cross-head after maintenance in January 2009: note that by comparison with Figs 8 and 10 (above), far more of the carving is visible

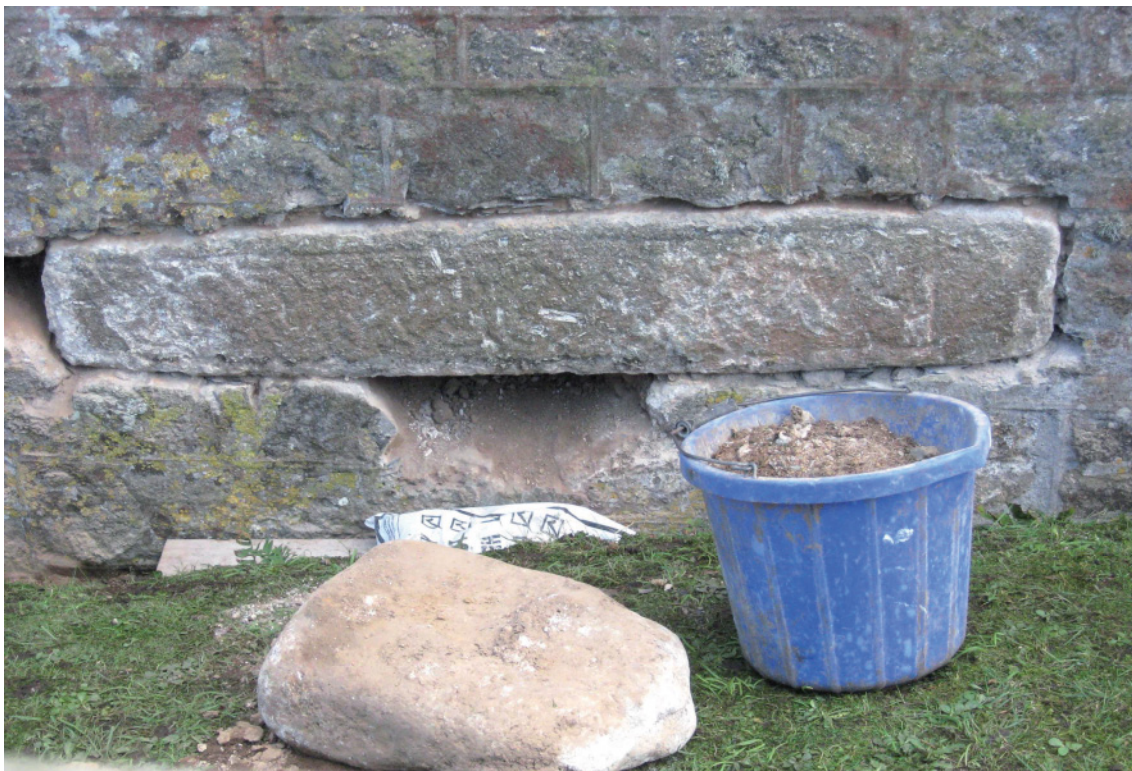
Fig 17 The shaft fully exposed

4. The exploratory work was made very much easier by the fact that behind the shaft, the core of the wall was found to be hollow. This suggested that the wall here had been previously disturbed – perhaps there had been a vent here, under the shaft, at some point, for which the shaft acted as a lintel, but which had subsequently been blocked.

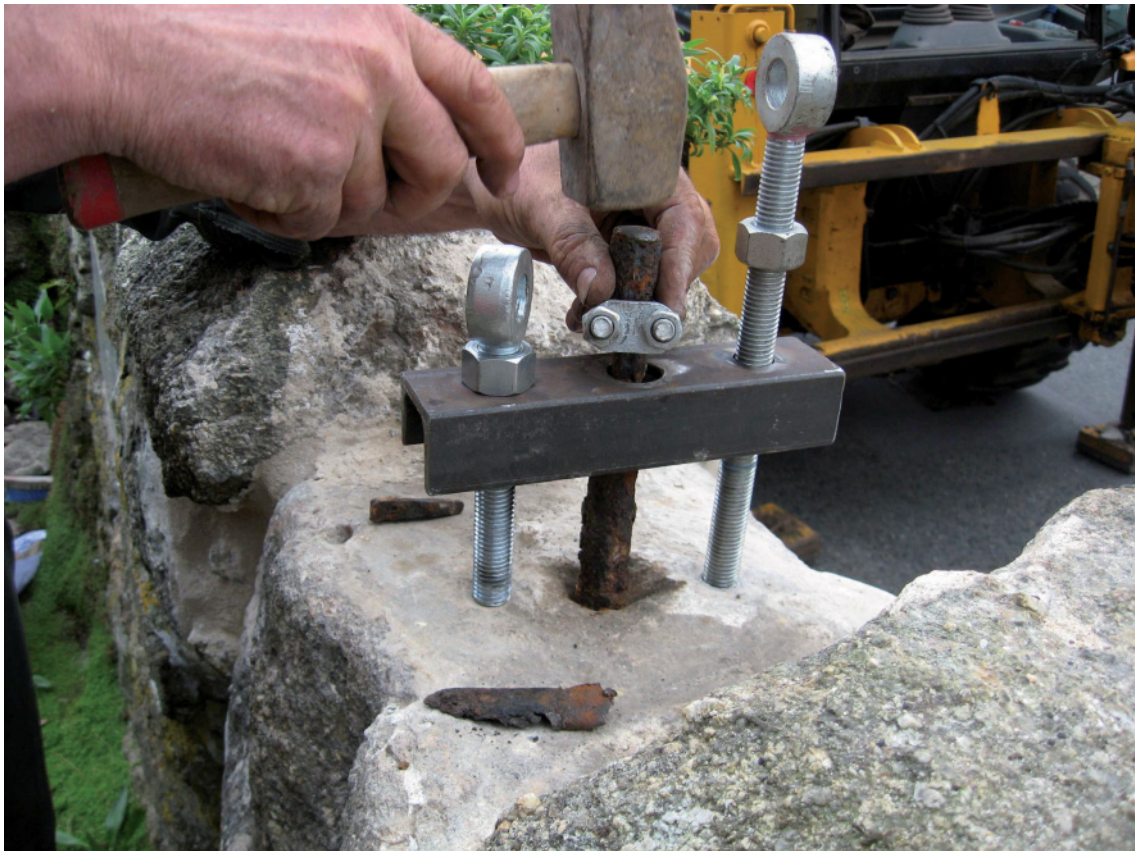
Fig 21 Removing the pin with a specially-designed puller

2. Two days later, on 7th October, the rusted pin was extracted from the boulder-base, using a specially designed 'puller' to lift it. (Fig 21).

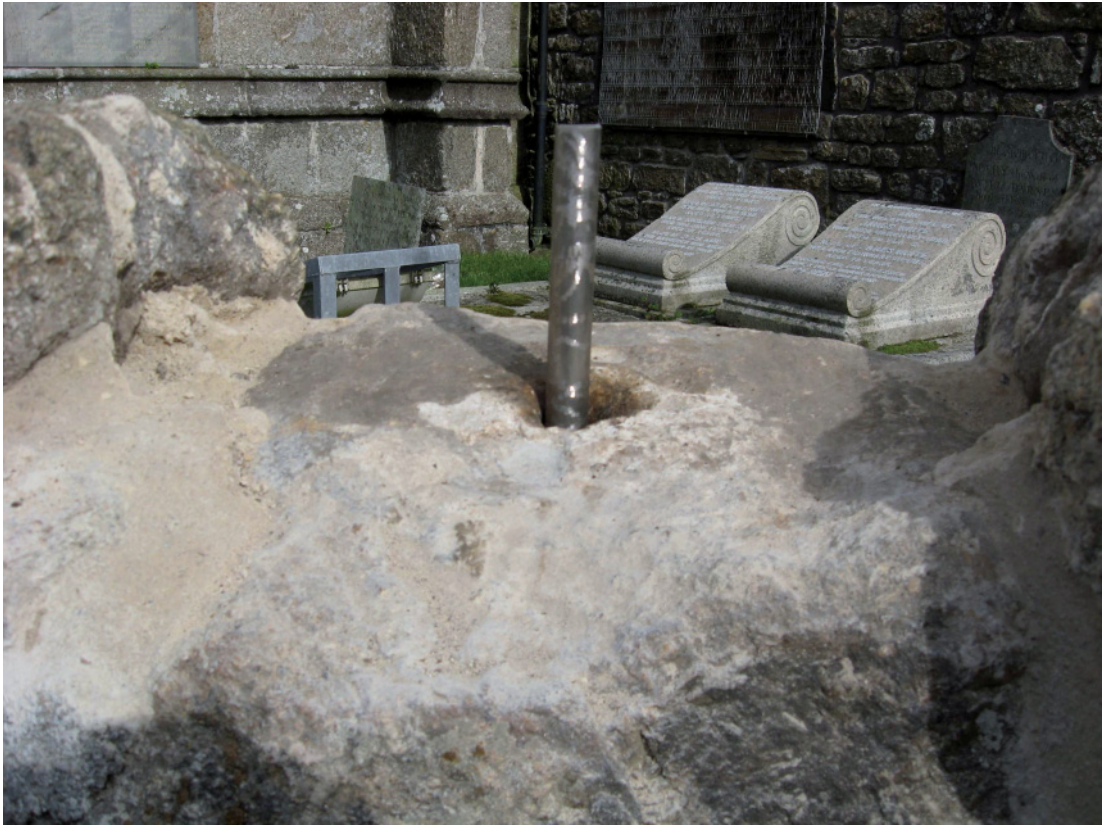
Fig 22 The new stainless steel pin in position in the boulder-base

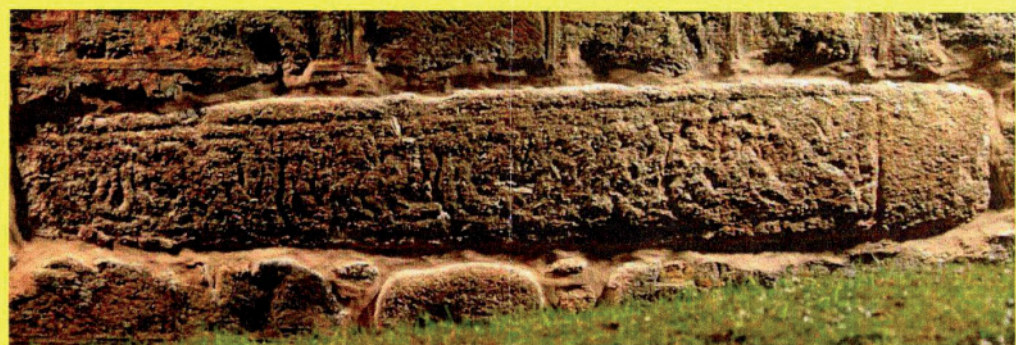
7 Decorated cross-shaft recently discovered built into the north wall of the Paul parish church

In February 2006, an interlace-decorated cross-shaft was noted, built into the north wall of Paul Church. It was considered possible, but by no means certain, that the cross-head and shaft both came from the same original monument.
