# **Cross south-east of Tremethick Cross, Madron, Cornwall**

## **Restoration following vehicle collision**

November 2008

Report No: 2008R131

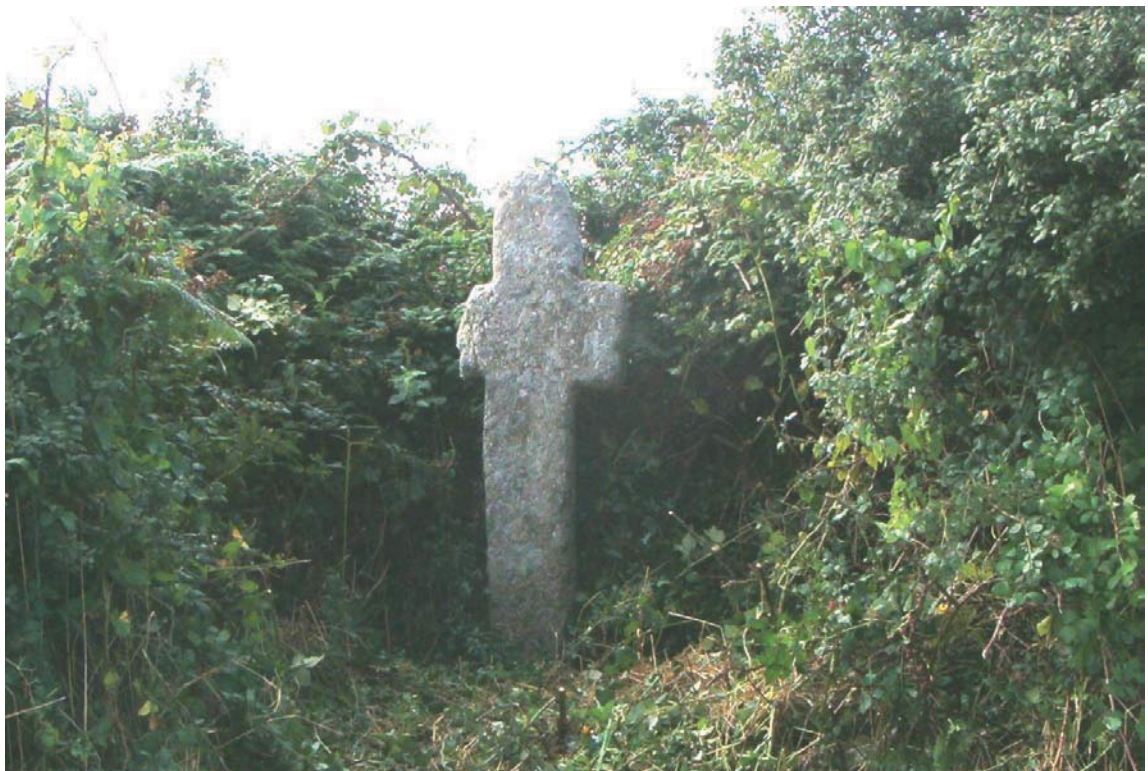
*Fig 7 The cross before damage*

The cross is a simple granite latin cross set in a granite base. Before the damage, the cross stood 1.67 metres high, with a shaft 0.25 metres wide and 0.56 metres across the arms (Figs 5 and 7).

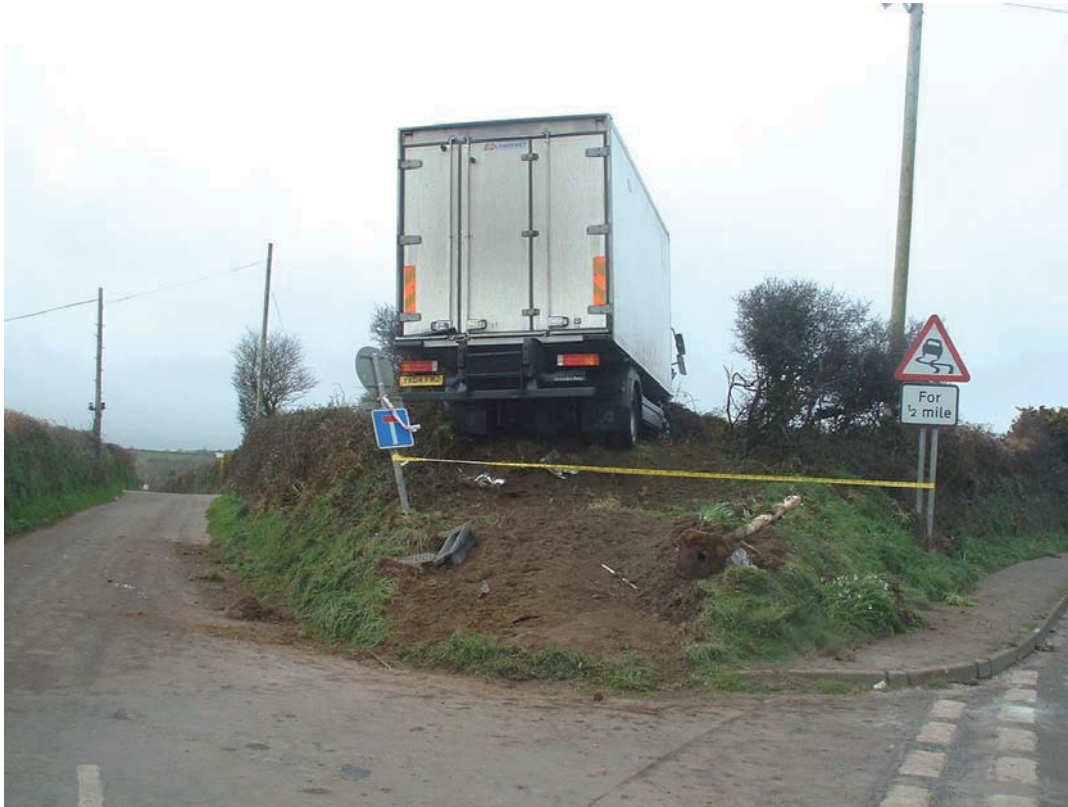
*Fig 8 The lorry on the bank, on top of the cross, on 22<sup>nd</sup> February 2008 (photo Peter Lugg, Cornwall County Council)*

However, a recent accident confirmed the belief that any monument in a roadside location is potentially at risk from damage. On the morning of Friday 22<sup>nd</sup> February a lorry travelling north-west from Penzance to St Just veered off the road, up the bank on which the cross stands, and came to a halt right on top of the cross (Figs 8 and 9). In the process, as subsequent inspection revealed, the cross was broken into three. The head was thrown off and landed in the field to the west while the shaft was pushed into the mound of earth and stone ploughed up by the lorry as it climbed the bank. A few smaller fragments and flakes of granite were also broken from the shaft (Figs 10, 11, 12), while the bottom of the shaft remained buried in the base.

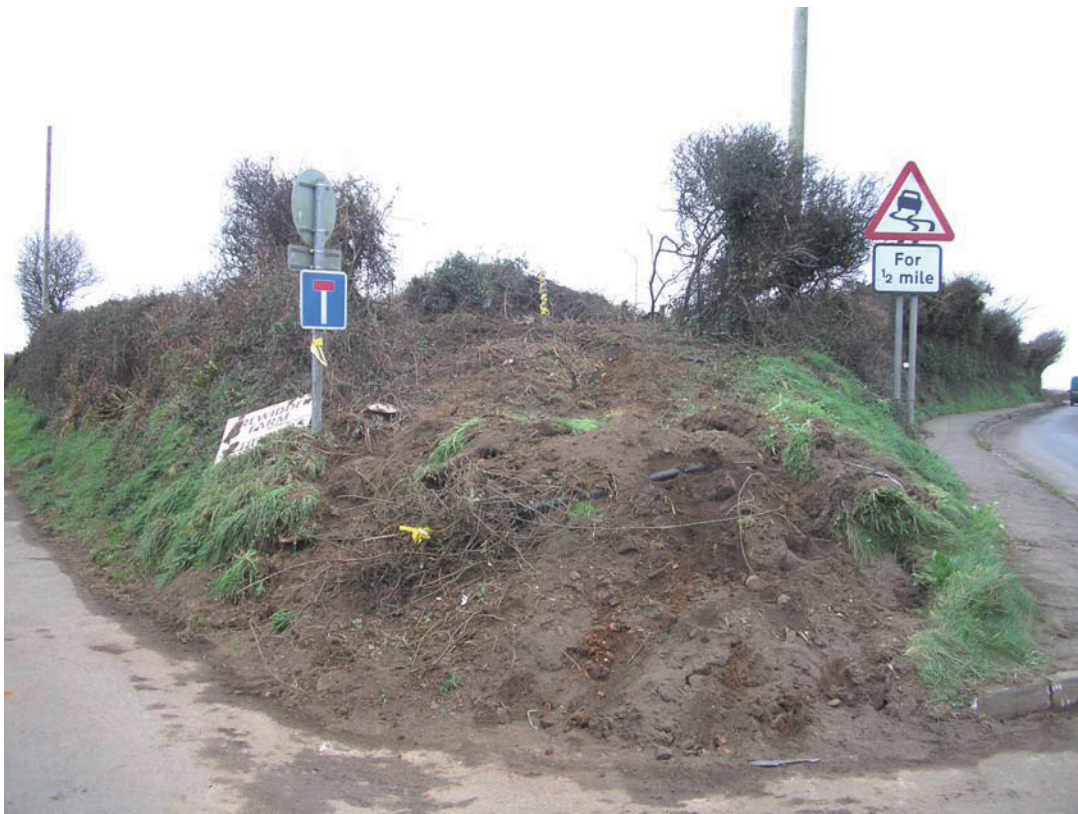
*Fig 9 The site after removal of the lorry*

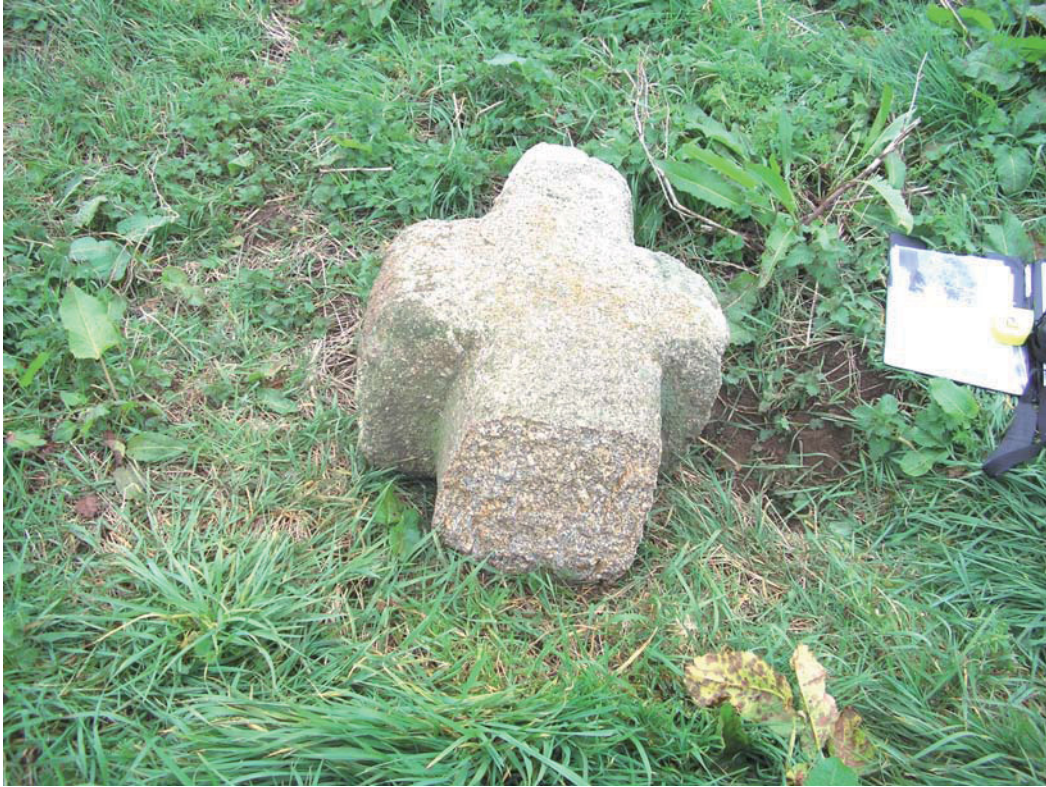
*Fig 10 The damaged cross-head, lying in the grass in the field behind its actual site*

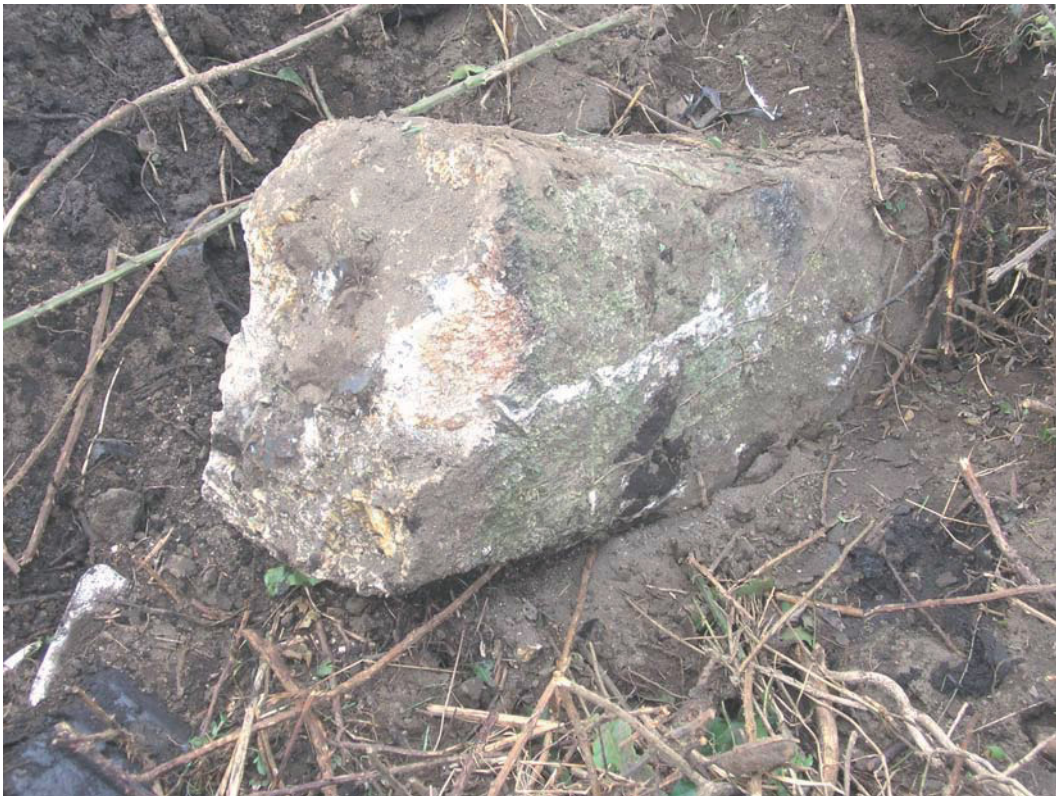
*Fig 11 The damaged cross: the shaft lodged in the rubble ploughed up by the lorry*

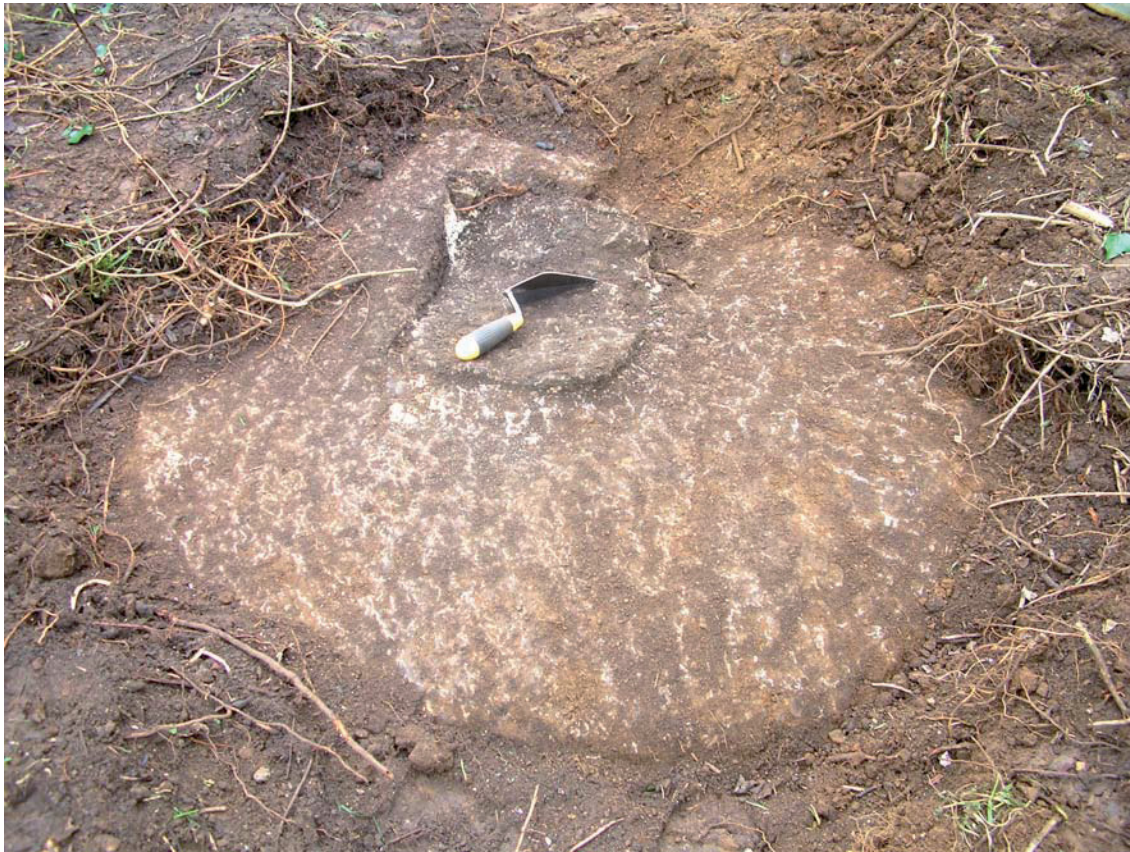
*Fig 12 The in situ cross-base, with the stump of the shaft visible at the centre*

The broken pieces of the cross were rescued on Sunday 24<sup>th</sup> February and taken to nearby Trewern Farm by Tony and Ann Jenkin (the latter the chairman of Madron Parish Council) for safe-keeping (Fig 13). The only part of the cross which remained on site was the base, with the lowest part of the shaft still lodged in it (Fig 12).

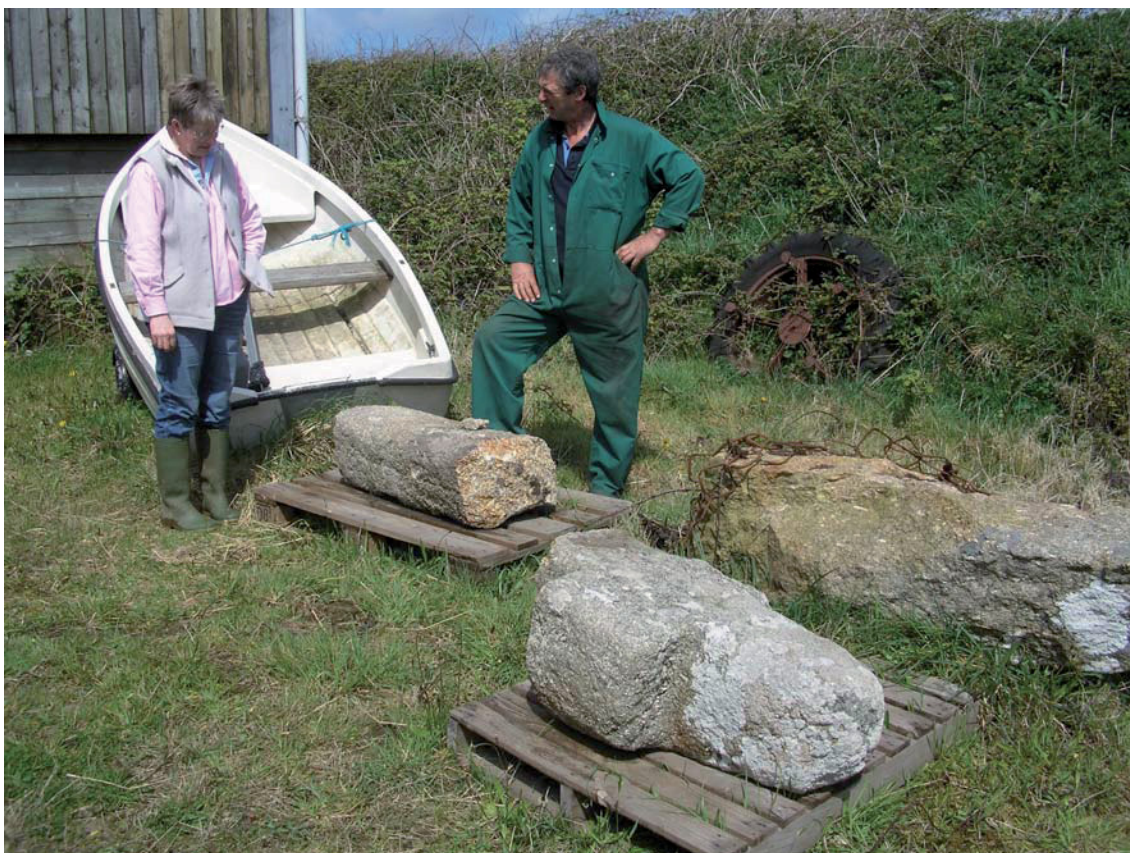
*Fig 13 The pieces of the cross at Trewern Farm: Ann Jenkin discusses their restoration with Adrian Thomas*

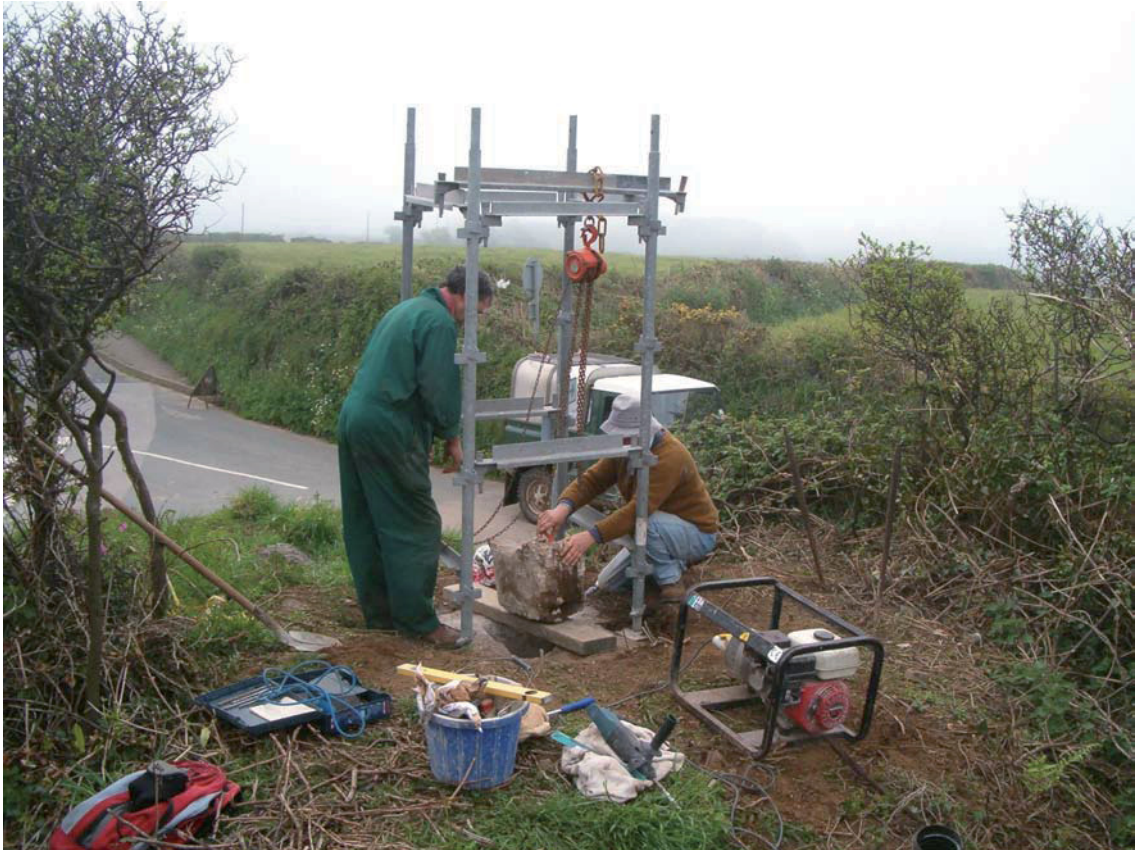
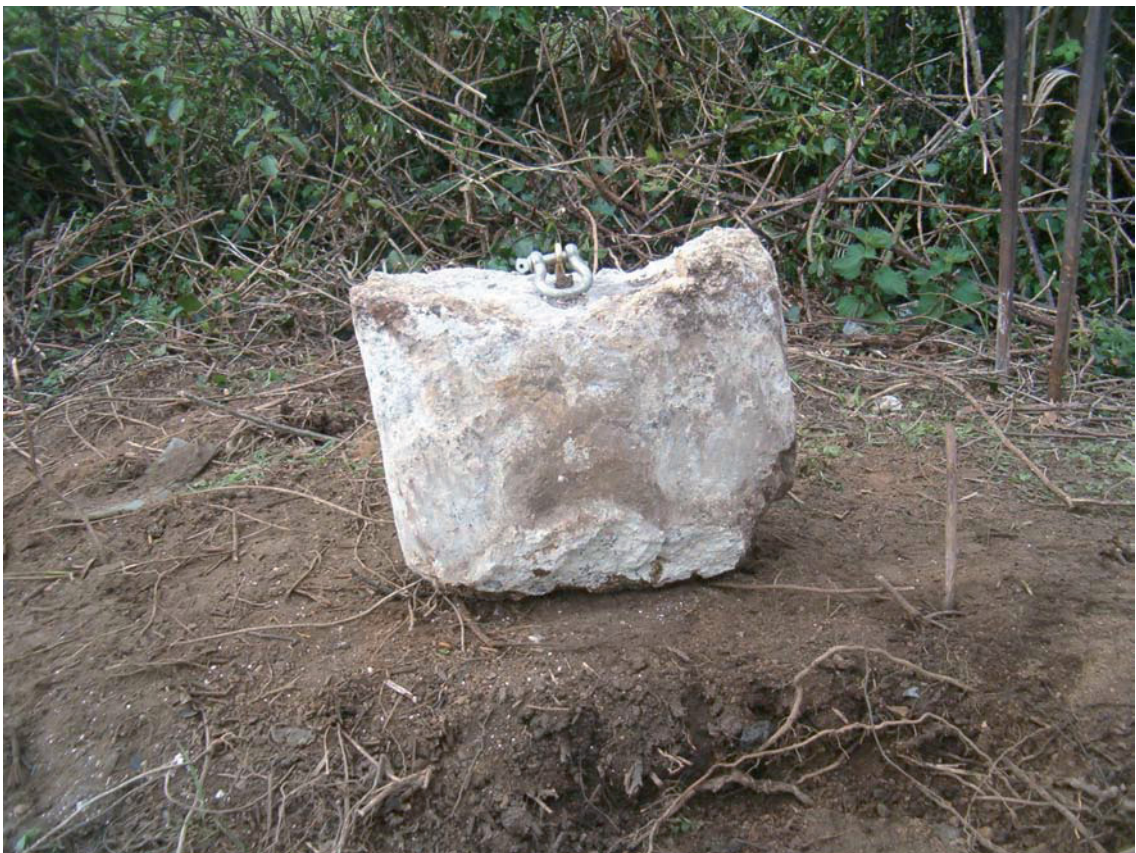
*Fig 14 Removing the bottom of the cross-shaft from the base*

*Fig 15 Removing the bottom of the cross-shaft from the base*

The lowest part of the cross was removed from the base on Wednesday 7<sup>th</sup> May 2008. As the cross was found to be mortared into the base, this involved a day chipping away at the hard lime mortar between the cross-shaft fragment and the base-stone. A small hole was drilled into the top of the cross-shaft fragment and a small eye-bolt with an expanded end fitted in the hole for lifting the fragment from the base-stone. Once the fragment of cross-shaft was loose, a scaffold tower was built over the base-stone, and the shaft fragment lifted out with a block and tackle supported on the scaffold (Figs 14 and 15). The same hole was later increased in diameter to receive a stainless steel dowel to pin the two broken parts of the cross-shaft together. The two upper pieces of the cross were taken from their temporary home at Trewern to Nanquidno, during September.

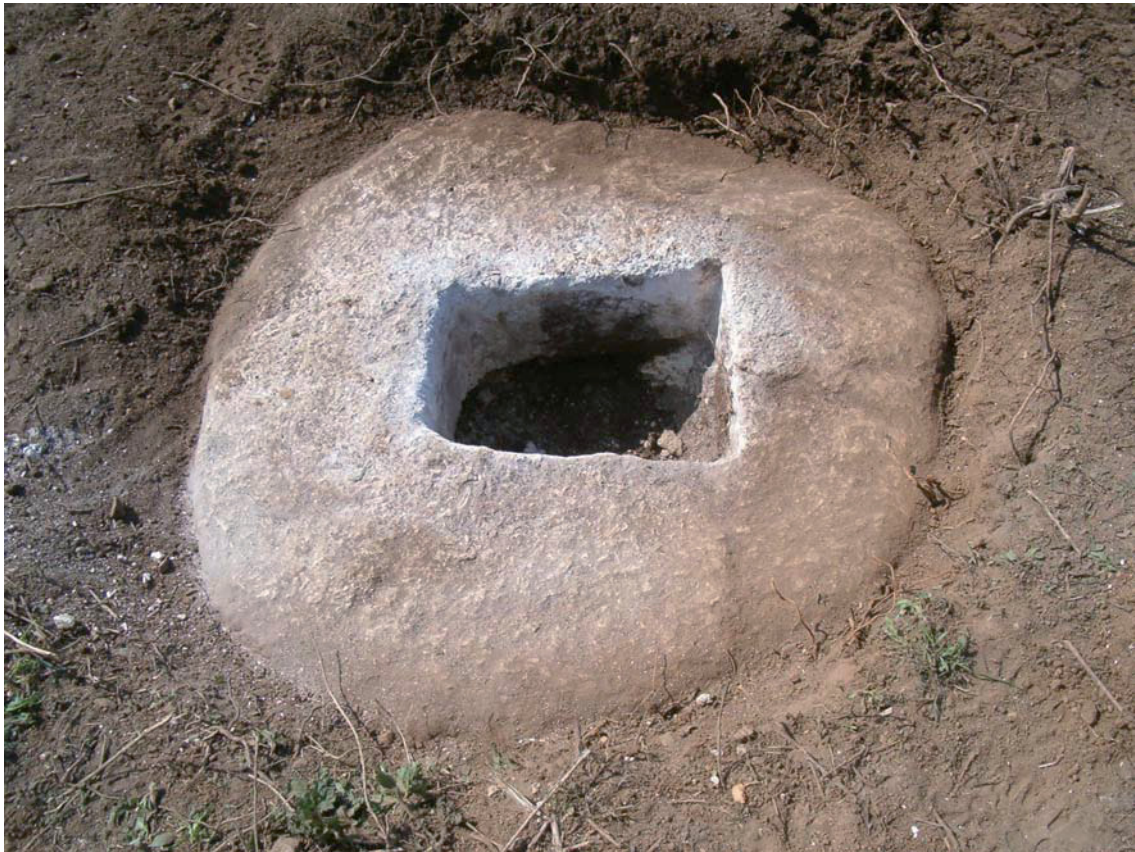
*Fig 16 The cross-base after the cross-shaft was removed.*

No record survives to indicate whether a base-stone was removed from Rose-an-Beagle to the present site, along with the cross. However, when the shaft fragment was pulled from the base-stone, many pieces of broken granite chippings were discovered beneath the mortice suggesting that either an originally smaller mortice had been enlarged to take the cross-shaft, or that the mortice was completely formed *in situ* from a new boulder at the time the cross was brought to its present site. The authors consider the latter is most probable. The sharp freshness of the sides of the mortice certainly supports the notion that the mortice in its present form was cut in the 19<sup>th</sup> century (Fig 16). A very fine white lime mortar had been used to bed the cross at this time and had evidently not been disturbed until the recent incident.

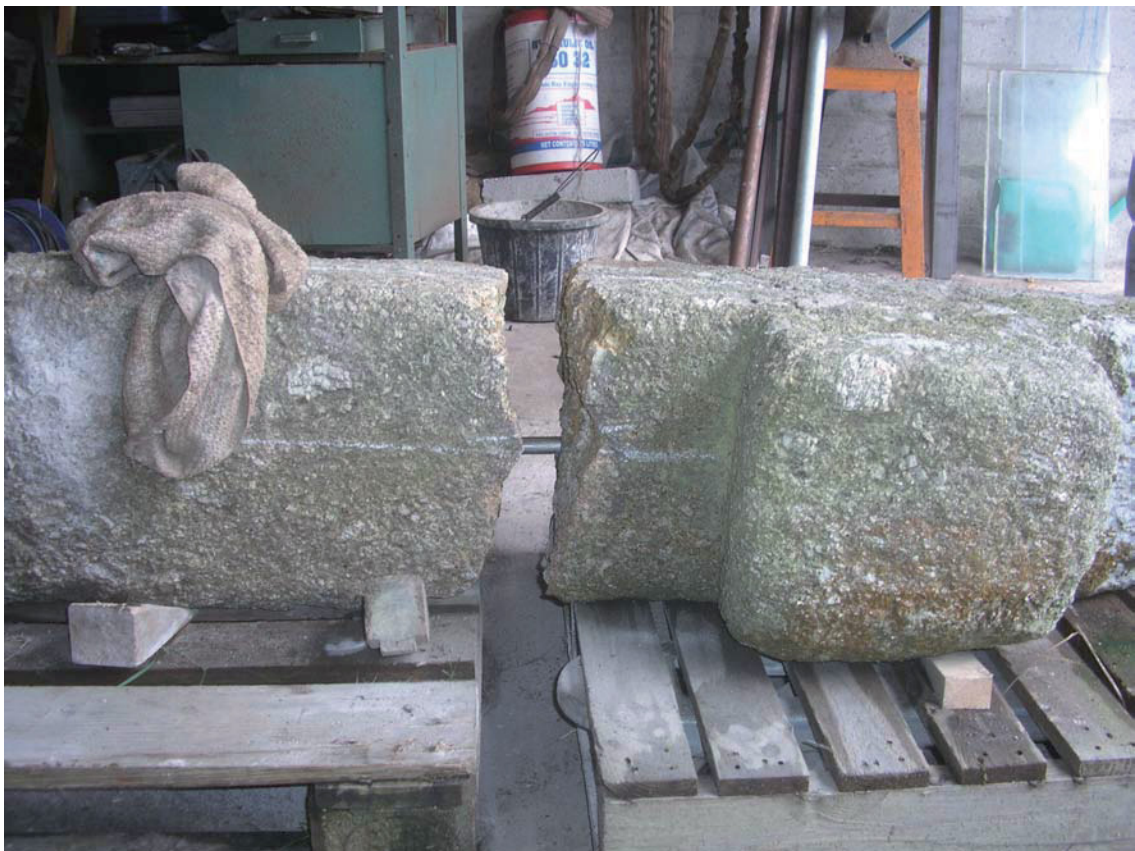
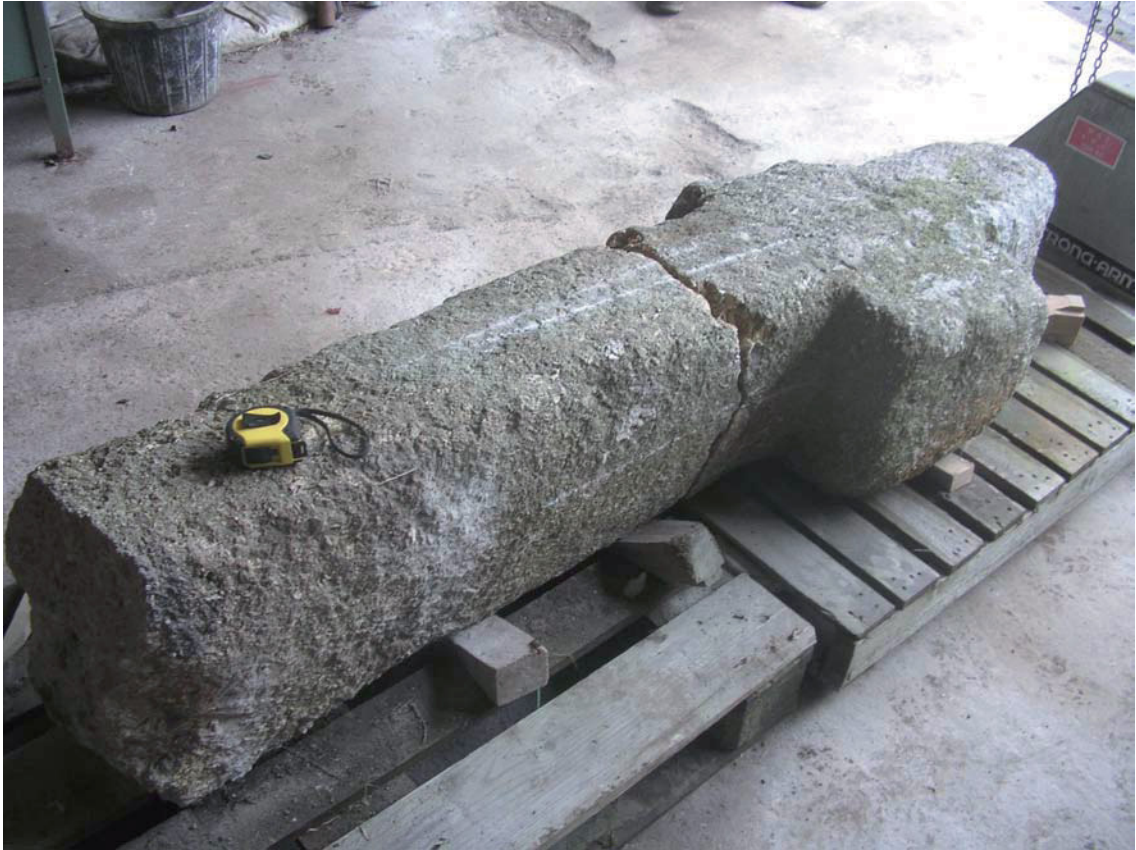
*Fig 17 The cross at Nanquidno*

*Fig 18 The cross at Nanquidno*

1. At their workshop at Nanquidno, Adrian Thomas and David Cutting carefully measured the broken surfaces of the cross to determine the positions for the pins to join the pieces together.
2. 2.5 cm diameter holes were drilled to a depth of just over 20 cms into the body of the cross-shaft and cross-head to receive the stainless steel pins.
3. The pins were cut to a length of 40 cms, allowing for 20 cms in each piece of the cross.
4. A trial fitting took place to ensure that all parts of the cross would fit together squarely before the pieces of cross were removed to site for the final assembly (Figs 17 and 18).
5. The stainless steel pins were glued into the upper cut surface of each fragment to make the final re-assembly easier.

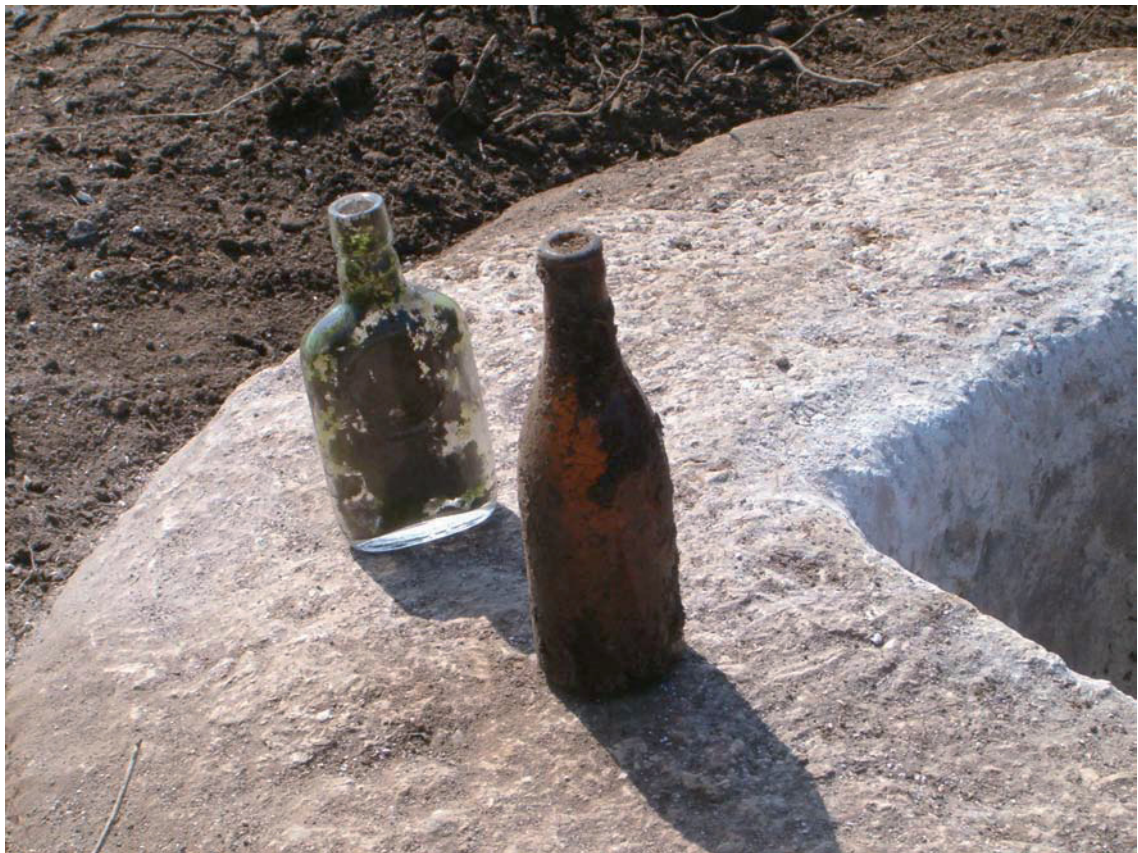
*Fig 19 Old bottles discovered during the removal of top soil from around the cross-base*

A number of broken and whole 19<sup>th</sup> or 20<sup>th</sup> century bottles were found in the ground around the base-stone (Fig 16). The reason for these is not known. Perhaps the cross, being a very prominent landmark, was used as a venue for occasional picnics; but the idea that they may have resulted from the activities of the drunken St Just men cannot unfortunately be confirmed!

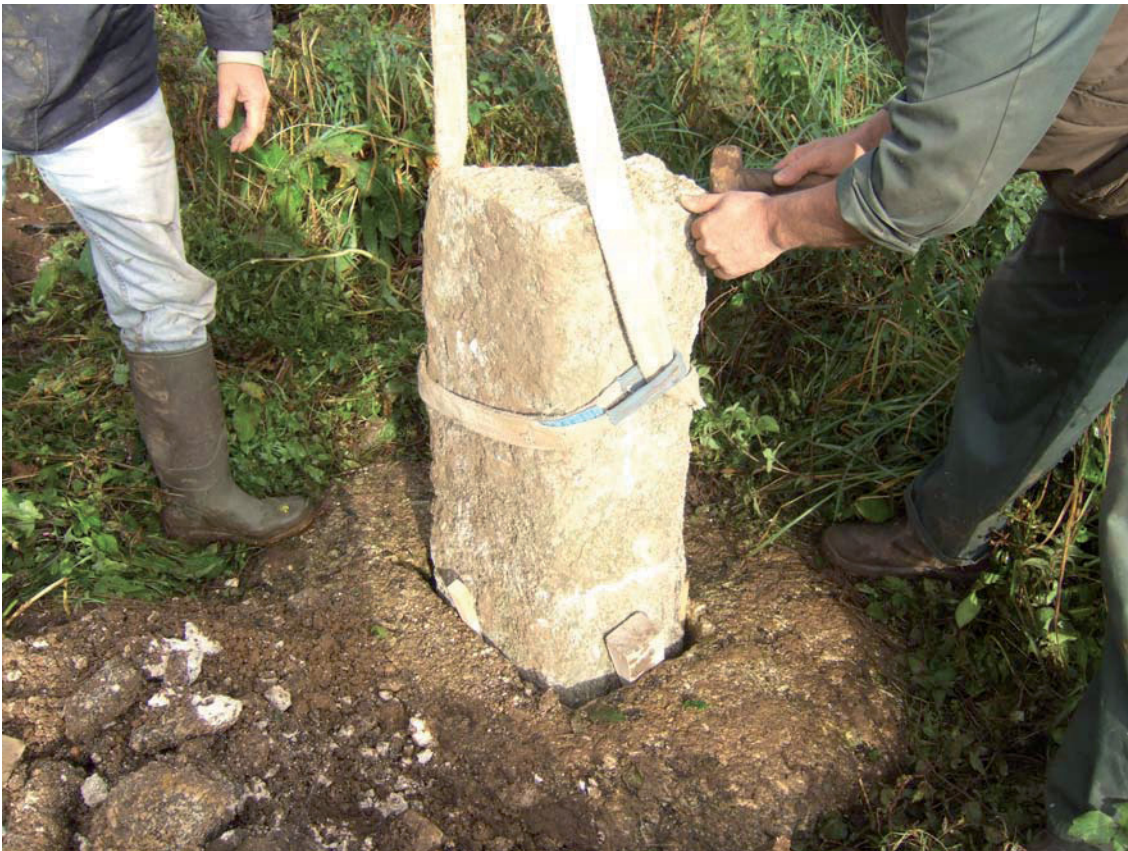
*Fig 21 Restoring the cross on site: the shaft is put in position*

3. The middle part of the cross was lifted onto the pin in the bottom part of the shaft, and the pin and joint secured with resin (Fig 21).
4. Once the resin had gone off, the cross-head was lifted into place, with a preliminary trial fitting before the resin was applied. (Fig 22) At this point, there was a small technical hitch when the head refused to sit snugly on the shaft, and in fact rocked a little. At first it was thought that the pin might be a little too long, but eventually, the head settled securely onto the shaft when a very small piece of granite was chipped from the centre of the broken face. Once this had been sorted out, the pin and joint were resined and the head finally lifted into place.

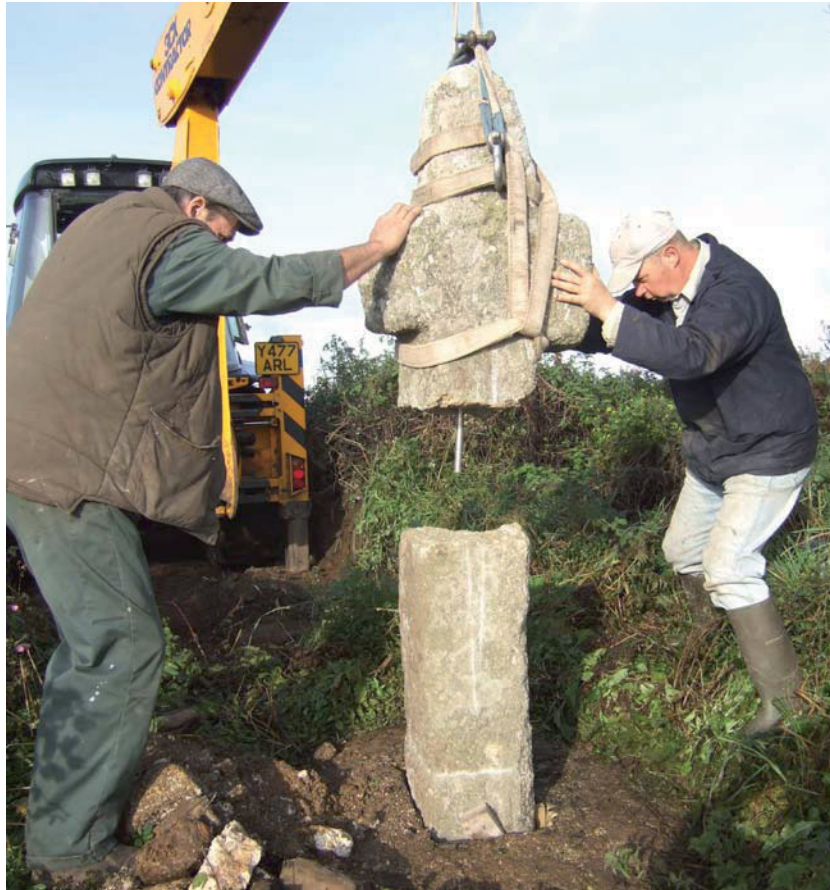
*Fig 22 Restoring the cross: the cross-head is lifted back*

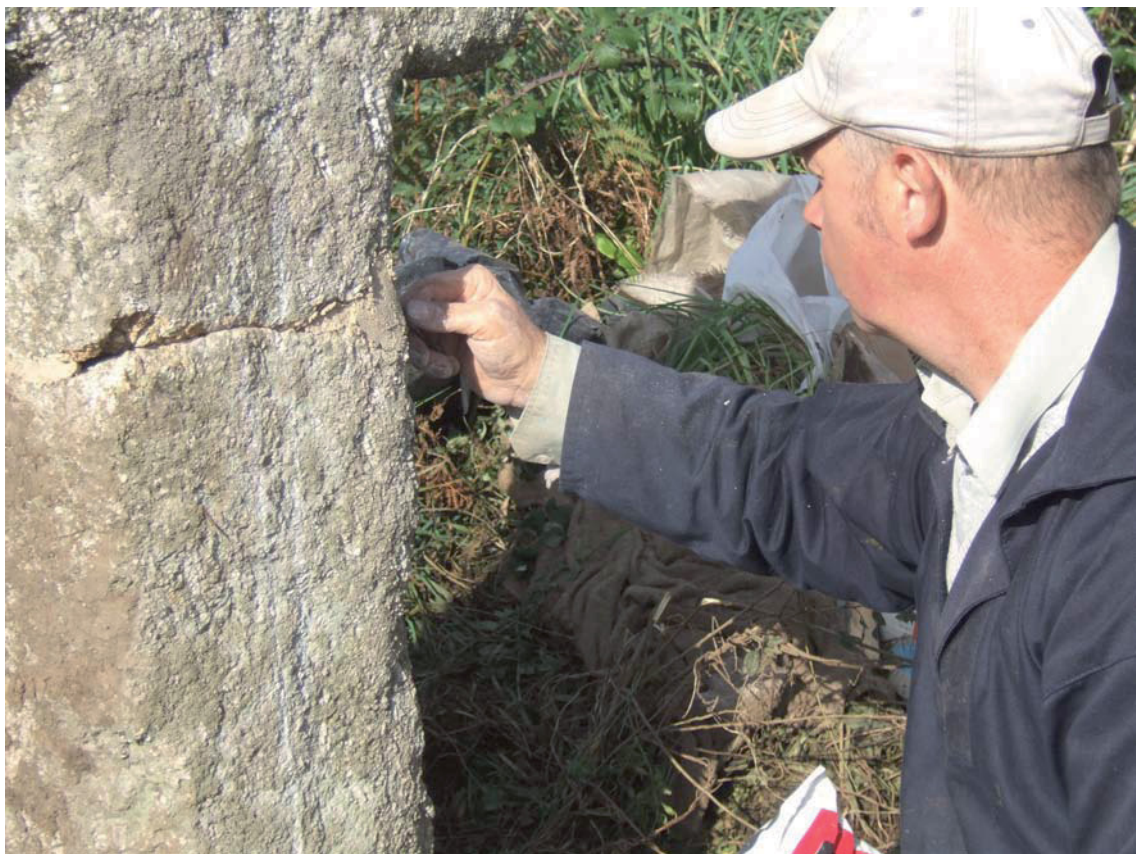
*Fig 23 Pointing the joint in the shaft with lime mortar*

5. Once all resin had set, the joints in the shaft and the base were finished with lime mortar. (Fig 23)

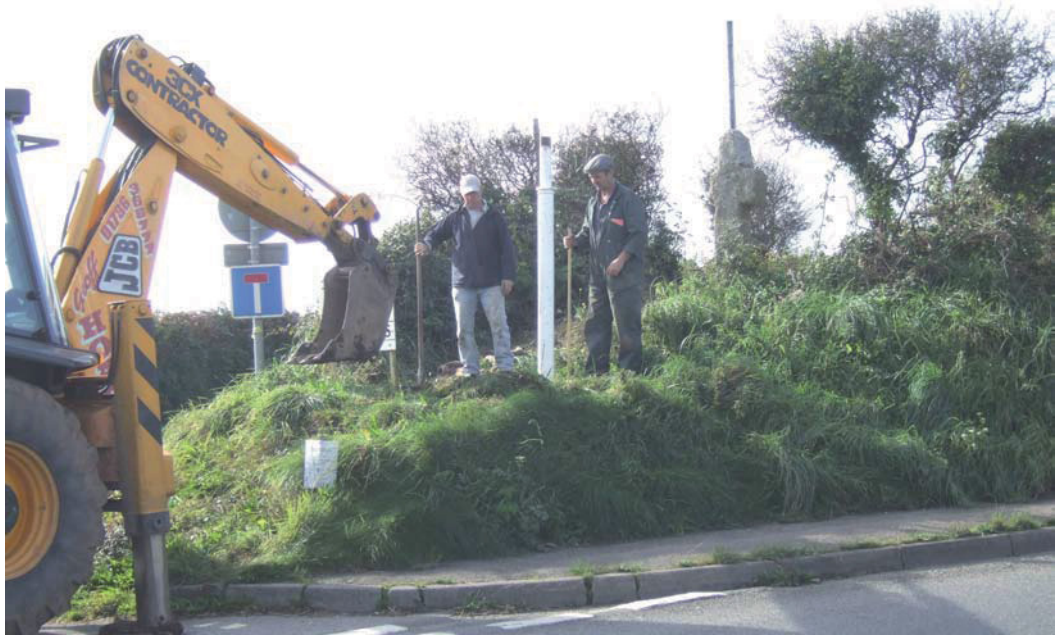
*Fig 25 The finger post is restored (note the restored cross behind it)*

The iron finger post adjacent to the cross, which had also been damaged in the accident in February 2008, was removed after the incident to the local Highways depot at Marazion, and from there taken to Falmouth boatyard to be welded and painted. The post was restored on the same day as the cross (Fig 25). As it had been buried in earth previously, it was put up again in the same way, without using any cement. The 'finger' and cap were replaced a few days later, by Peter Lugg of Cornwall County Council.

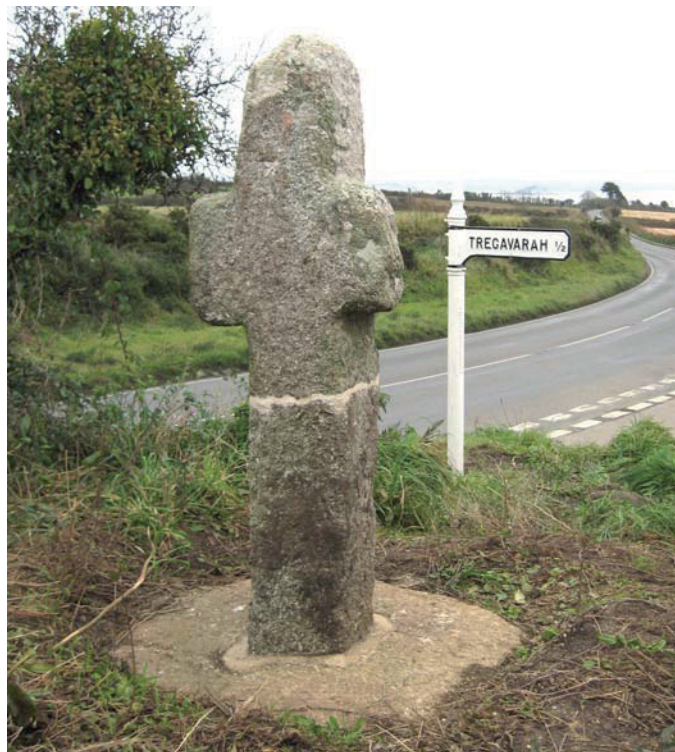
*Fig 26 The restored cross, from the west*

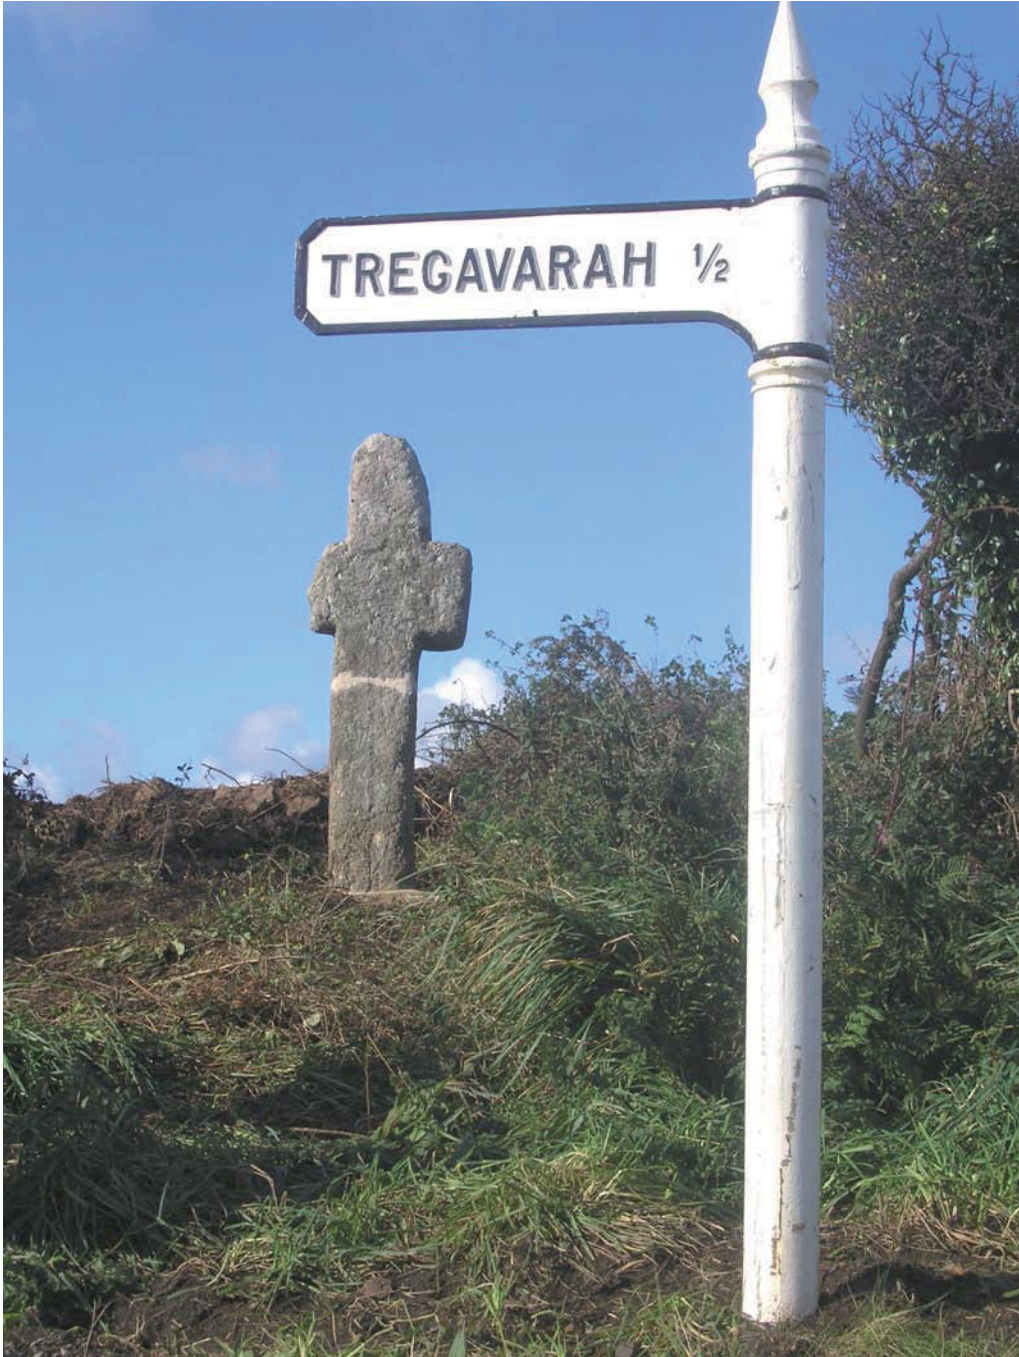
*Fig 27 The restored cross, from the east*
