Falmouth Jewish and Congregationalist cemeteries, Cornwall

Archaeological Assessment

Client	The 'Conserving Cornwall's Past' project
Report Number	2010R039
Date	July 2010
Status	Final report
Report author(s)	Catherine Parkes BA MfA
Checked by	Ann Preston-Jones
Approved by	Peter Rose

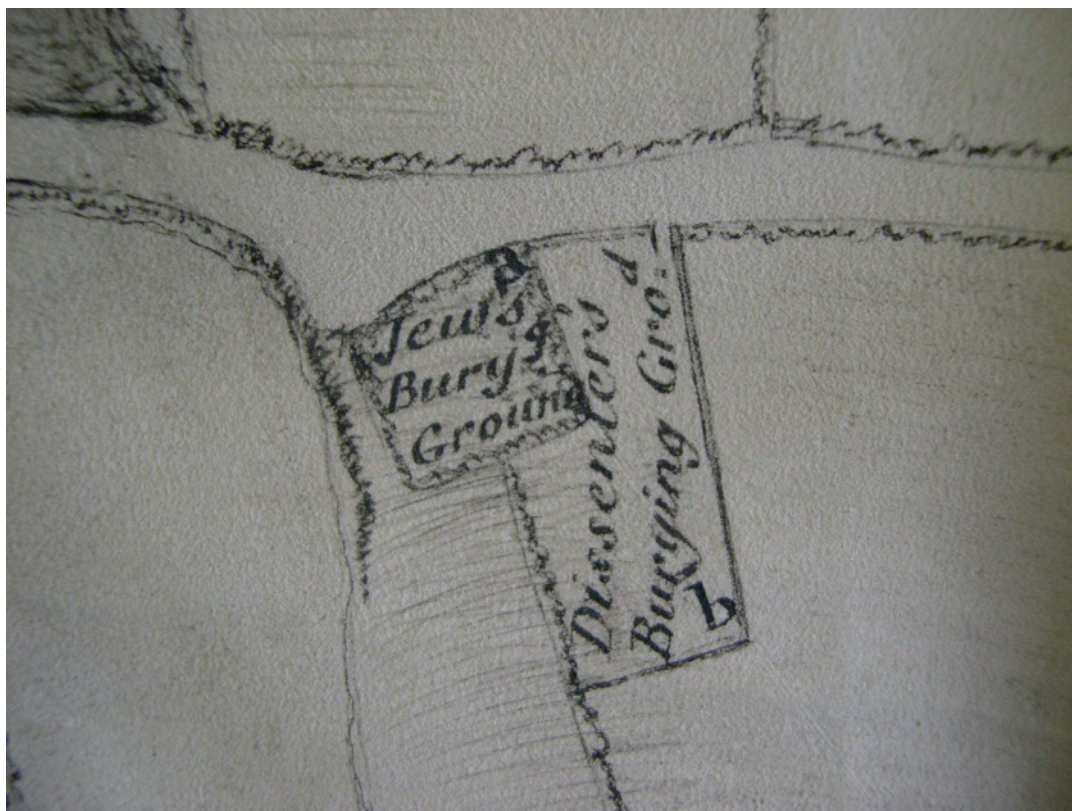
Fig 2 Detail from an 1814 Tebidy estate survey, recording the two 'burying grounds', and marking the walling on the east of the Congregationalist ground, and the entrance on its north east

The Congregationalist cemetery was laid out around the west side of the earlier plot, its plan respecting this and so reflecting its secondary origin. It dates from the period between the 1793 mapping already mentioned, and another survey for the Bassets made in 1814 (Figs 2, 25). The earliest of the gravestone inscriptions readily decipherable by the MPPA in 2002 was 1815 (English Heritage scheduling documentation), so it may have been founded not long before 1814. Closer dating may be possible through further research in the surviving Congregationalist archive.

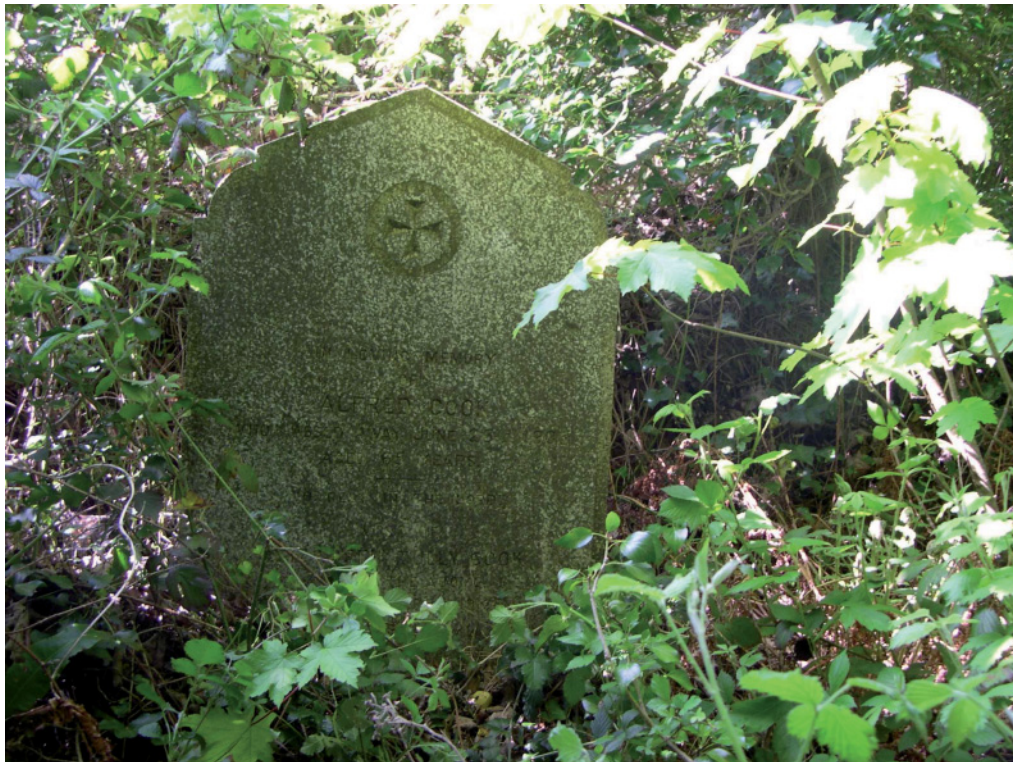
Fig 3 Headstone in the south east corner of the Congregationalist cemetery marking some of the last burials in the joint grounds, isolated in time from the main period of use, as shown by the more modern design

The Congregationalists fell away from the later 19th century, the Congregational and English Presbyterian Church finally uniting nationally in 1972 to form the United Reform Church (Orme 1991, 191), though the decline of the Falmouth group like much of its history remains relatively obscure at present in terms of published research. As with the Jewish ground, the last regular use of their Falmouth cemetery is dated to the 1880s, with one later grave, in this case that of Alfred and Elizabeth Cook buried in 1903 and 1912 (Fig 3).

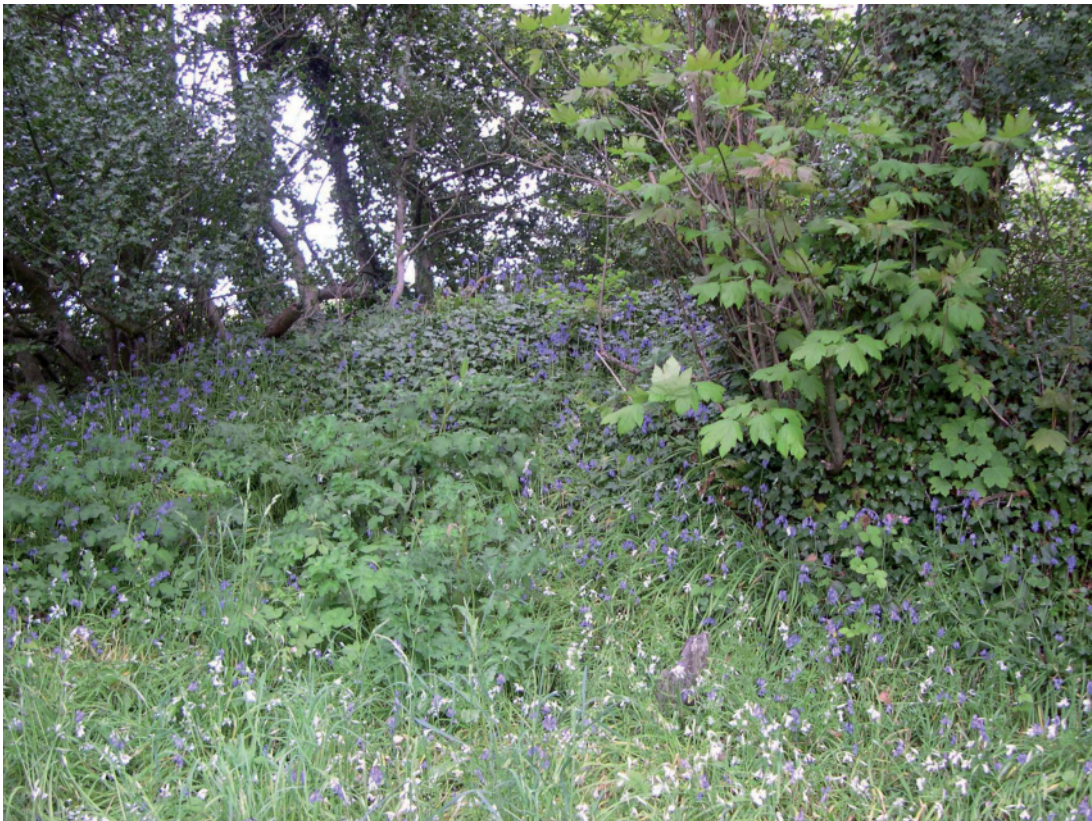
Fig 4 Bluebell covered mound on the north of the site, on the line of the hedge bank between the cemeteries

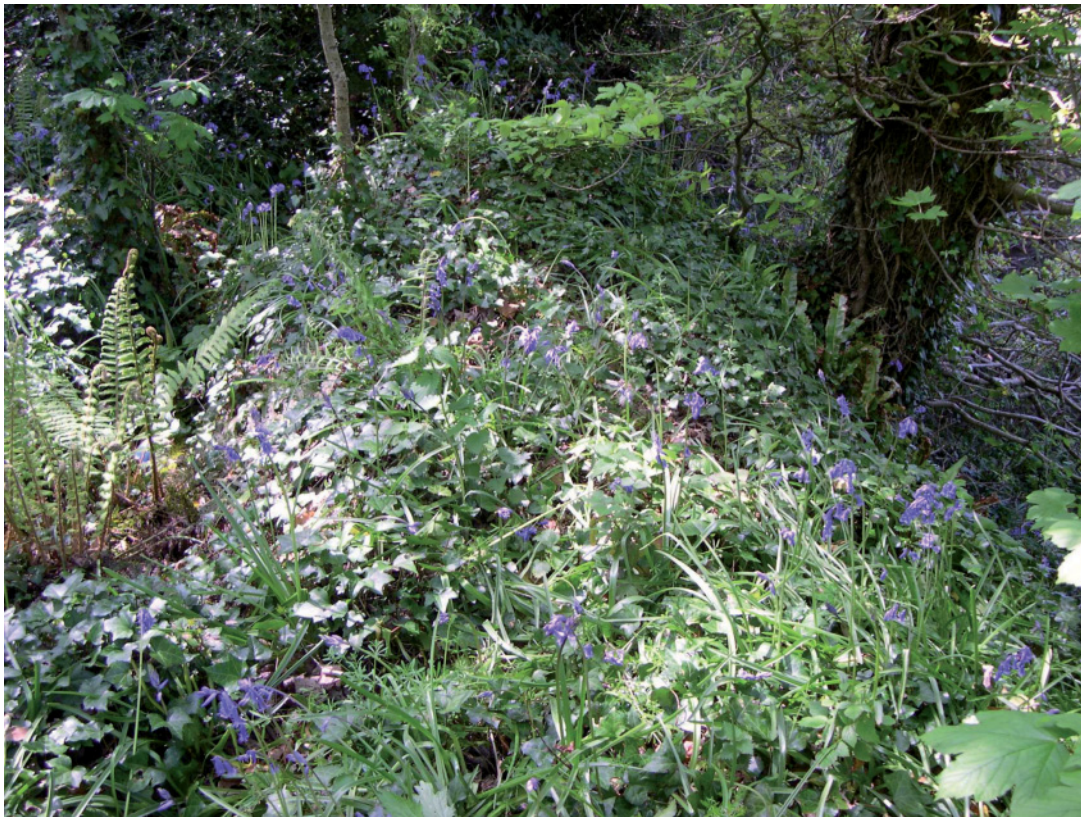
Fig 5 Hedge bank on the west of the Congregationalist ground, a re-used early field boundary, supporting oaks marked on the 1880 OS map which records individual large trees

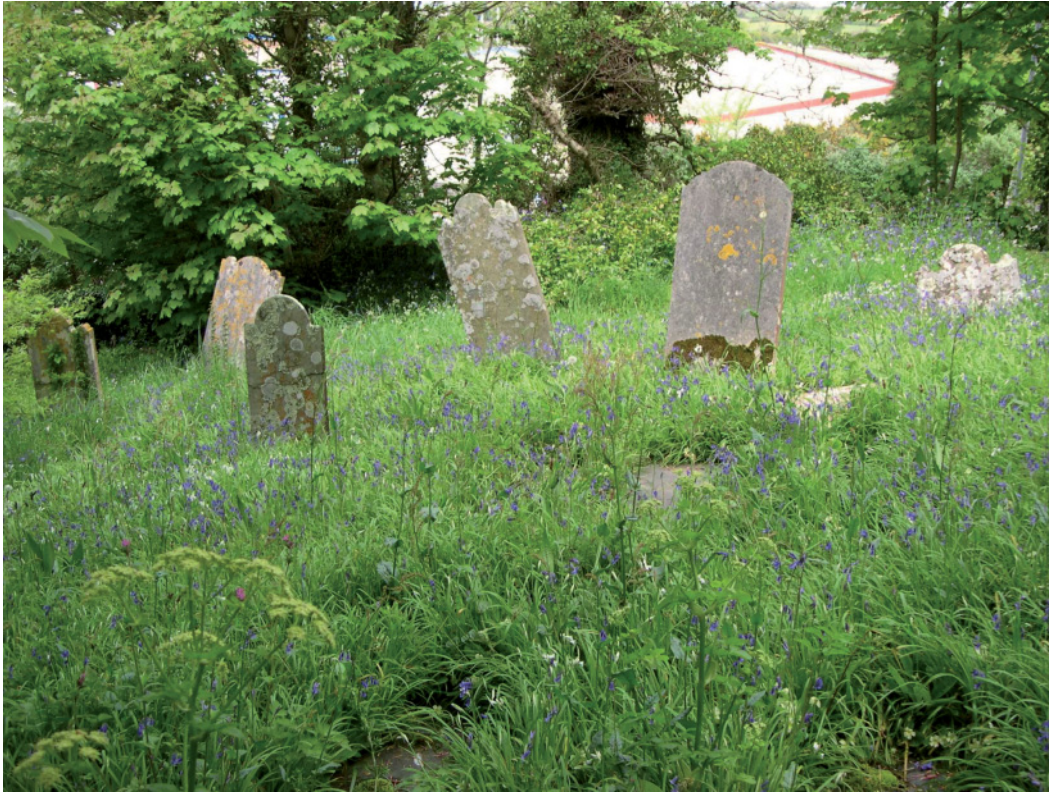
Fig 6 View across the Jewish cemetery west of its centre from its south boundary, showing the steepness of the site, with a break in slope here possibly marking an old boundary line

The Jewish cemetery is a compact, quite steeply sloping site surrounded by tree-covered hedge banks, with rows of slanting headstones running over much of its flower-rich grassy ground, and traces of a ruined structure in the lower corner by its modified walled entrance (Fig 6).

discussion of the landscape history of the site and surroundings (Fig 6; see also Section 5.1). No old internal routes are marked on the historic maps consulted, or evident on the ground, apart from those naturally suggested by the arrangement of the graves in rows; but pathway/s could be buried under turf.

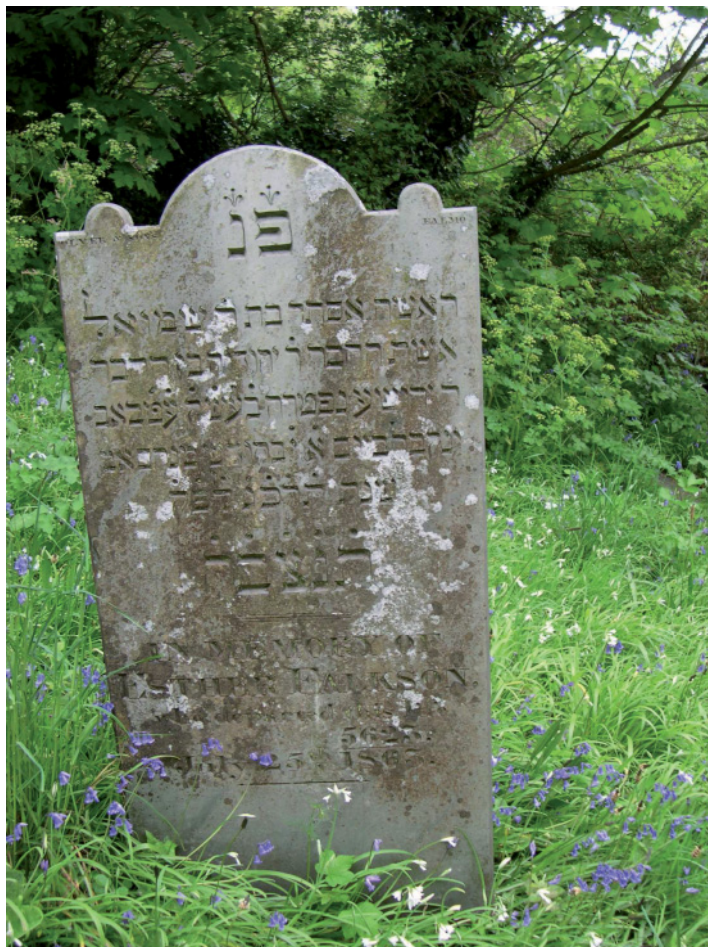
Fig 7 Headstone to Esther Falkson who died in 1863, with text in both Hebrew and English; under the ornamental top of the slate stone is the maker's name, Olver of Falmouth

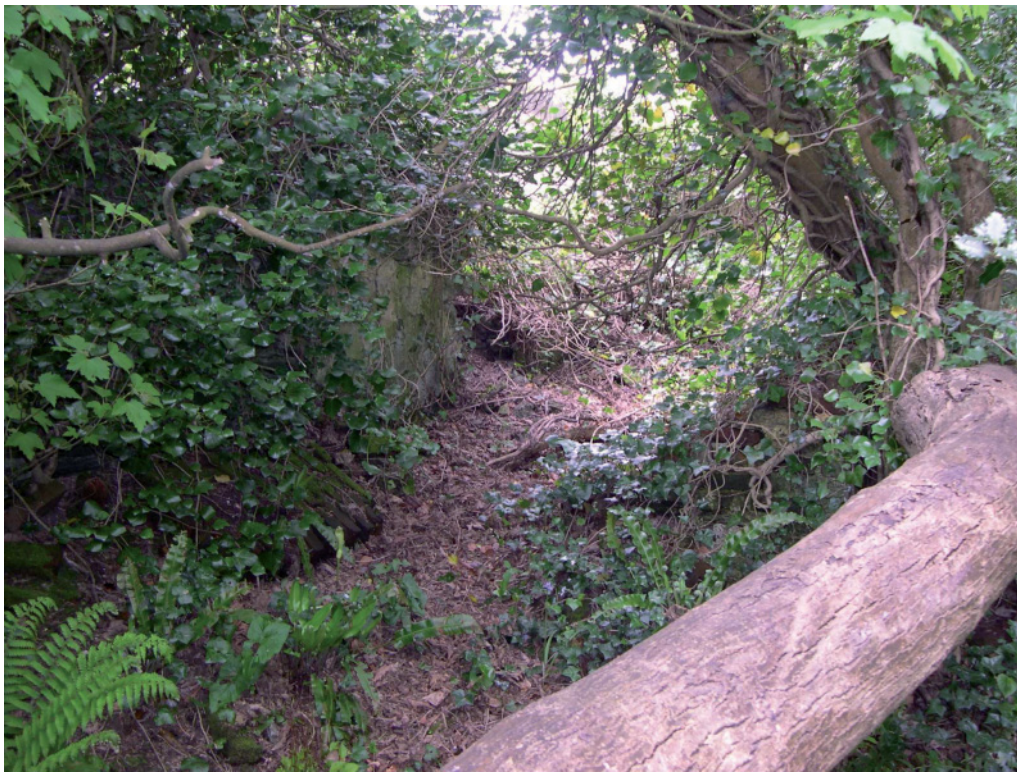
By the top of the steps is a ruined building on the east of the cemetery, interpreted as a mortuary chapel (English Heritage scheduling documentation). This is rectangular in plan, measuring like the ruin in the Jewish ground around 5m NNE-SSW by 4m WNW-ESE overall (see Section 5.3.1). Its walling of brick and laid shillet slabs with lime render stands up to around 1.5m high in places but is obscured by ivy and a large fallen tree lying across it (Fig 9). The MPPA in 2002 recorded traces of one or two openings.

Fig 9 Ruined mortuary chapel at the head of the steps into the Congregationalist ground, with walling obscured by ivy, and overhung by trees, one of which has recently fallen over the entrance steps (foreground)

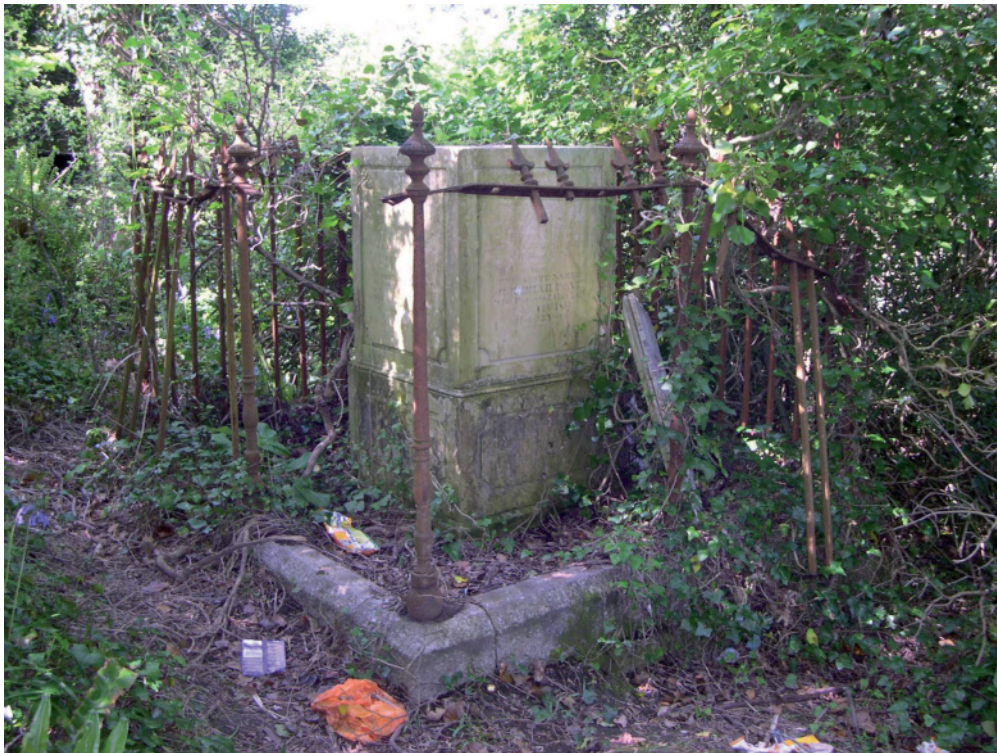
Fig 10 Ornate tomb of the Poat family, in the south west corner of the Congregationalist ground, damaged by woody growth and by vandalism; the top slab of the central structure has been recently displaced (right)

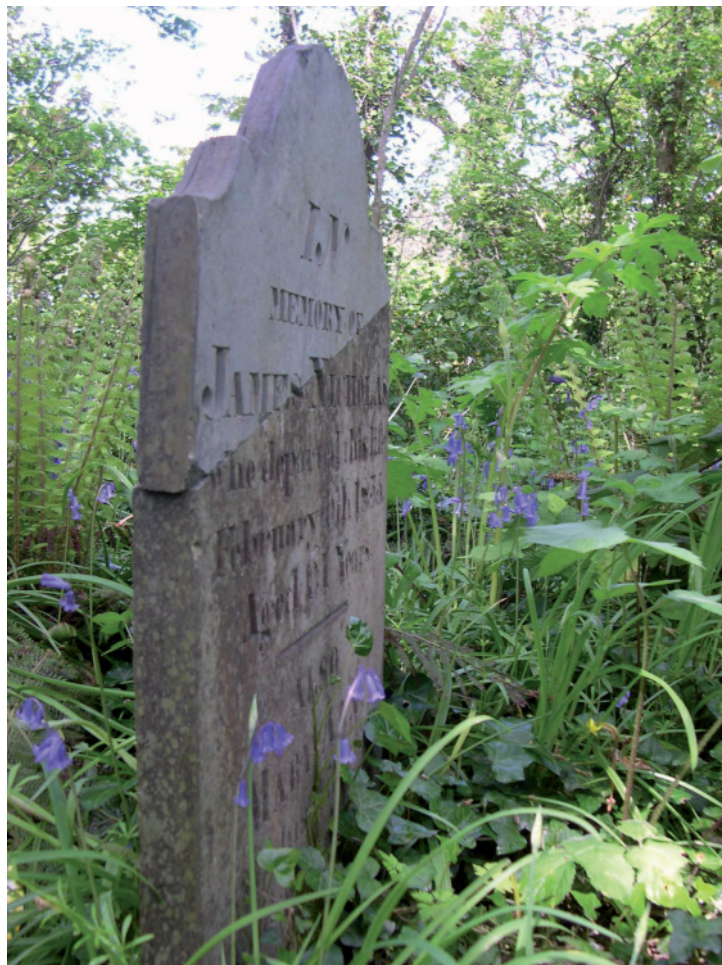
Fig 11 Headstone with inscription commemorating James Nicholas buried in 1835, north of centre in the Congregationalist cemetery; the stone is now broken across, and has lost its rear surface above the fracture

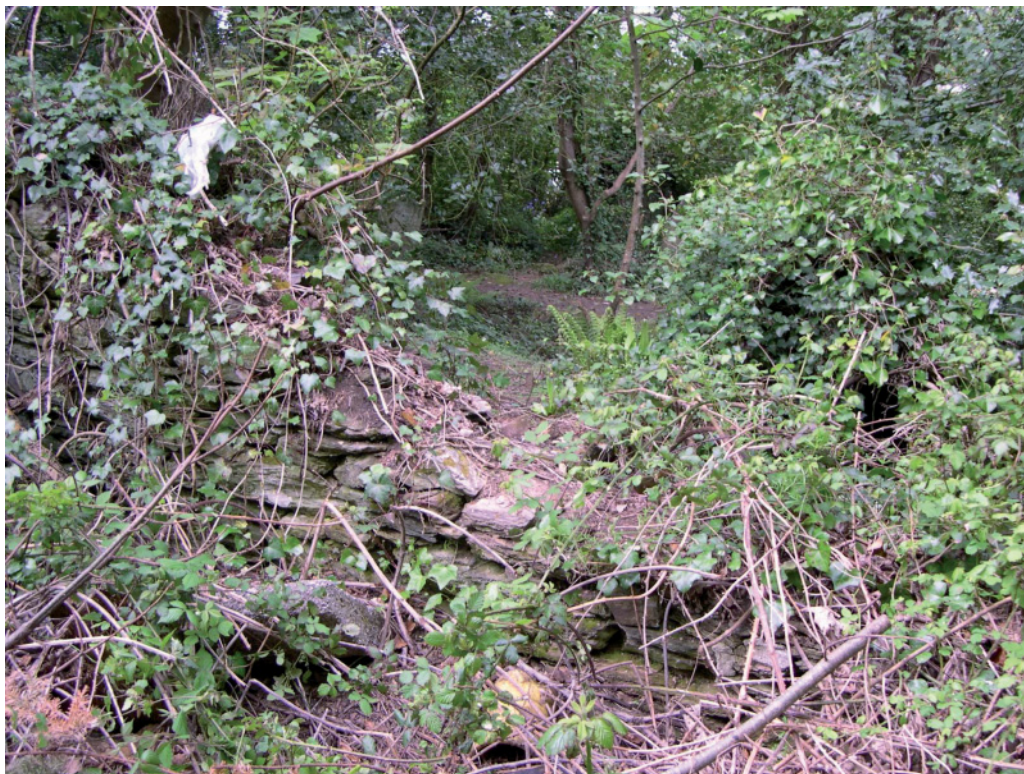
The cemeteries have no regular supervision, and as there are no residential areas adjoining or busy pedestrian public spaces such as footpaths overlooking them, they do not benefit from daily informal supervision by the public in the neighbourhood. The general physical neglect and lack of supervision and security of the site have contributed to vulnerability to vandalism as well as collapse of structures, and disturbance by tree growth (Fig 12, and see Section 8.3).

Fig 12 View across the north part of the Congregationalist ground from outside its eastern wall, showing its long neglect and resulting collapse of walling, growth of self-sown trees, erosion and spread of rubbish

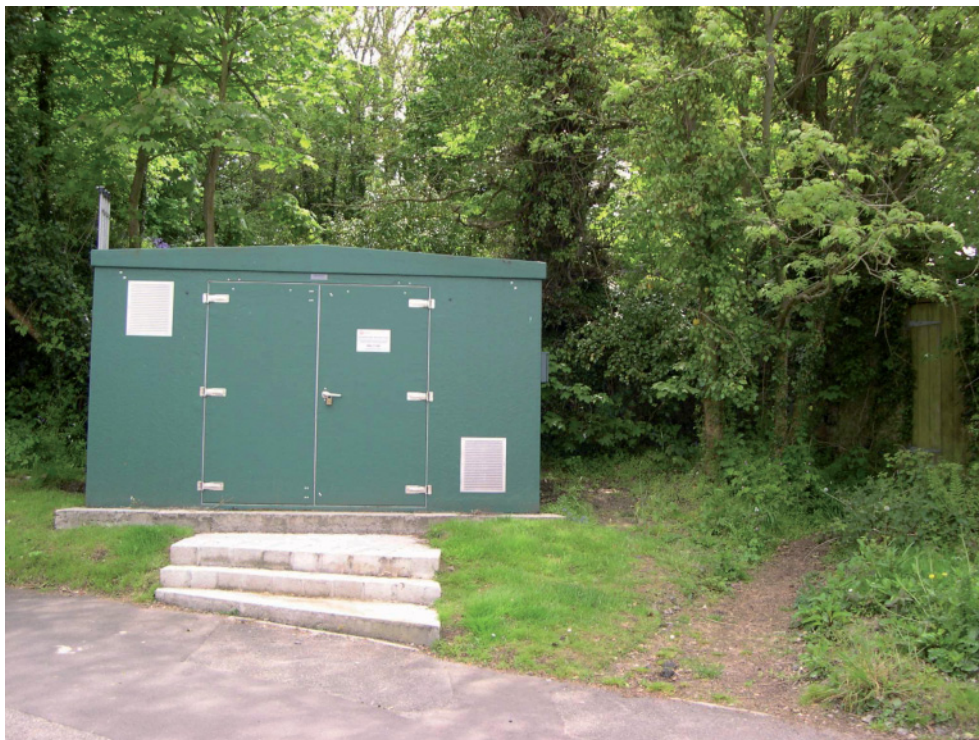
- **Recent intrusion on the north margin of the scheduling** The gas installation already mentioned has been set within the constraint area of the Scheduled Monument. The scarp forming the north side of the cemeteries and the roadside bay below this on the NNE is specifically included in the protection (English Heritage 2002). The box-like structure stands inside the bay, only 1.6m from the base of the scarp. The concrete platform it stands on extends to 1.2m from the scarp, and the cut for it is only 0.85m from this, in the spread material at its foot.

Fig 13 The roadside bay, at the entrance to the Jewish cemetery (right of photo), with gas installation affecting the approach and setting of the site and extending back into the scheduling

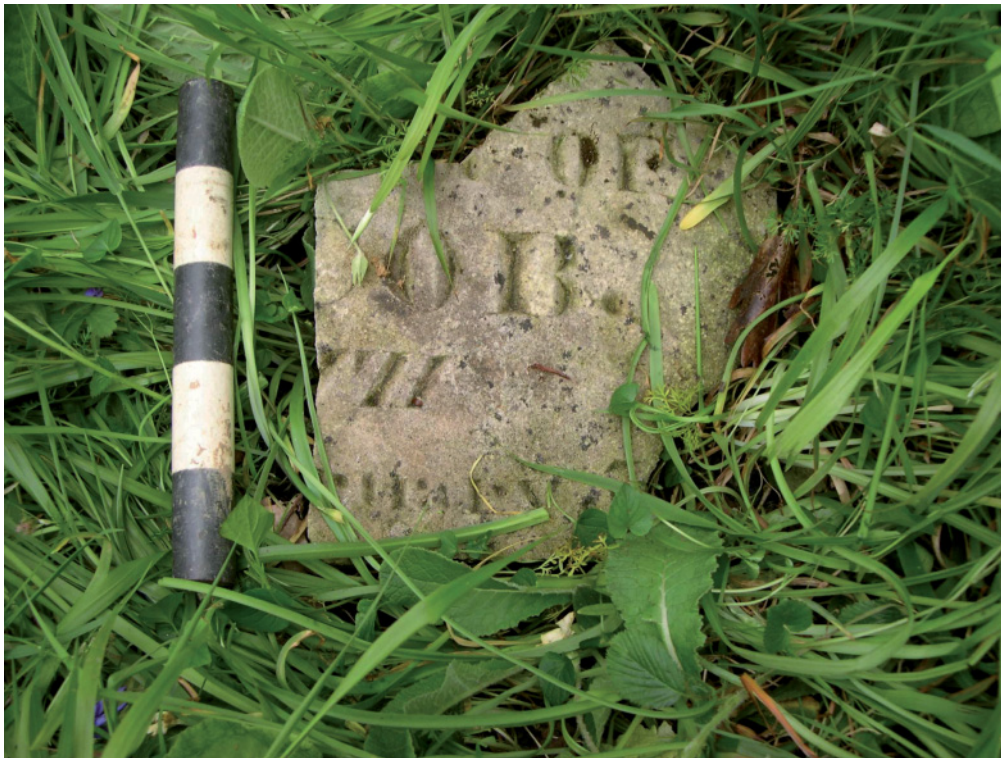
Fig 14 Displaced fragment of a headstone lying on the grass in the Jewish cemetery, illustrating the general vulnerability of the site to loss of remains and of irretrievable knowledge (the scale is 25cm long)

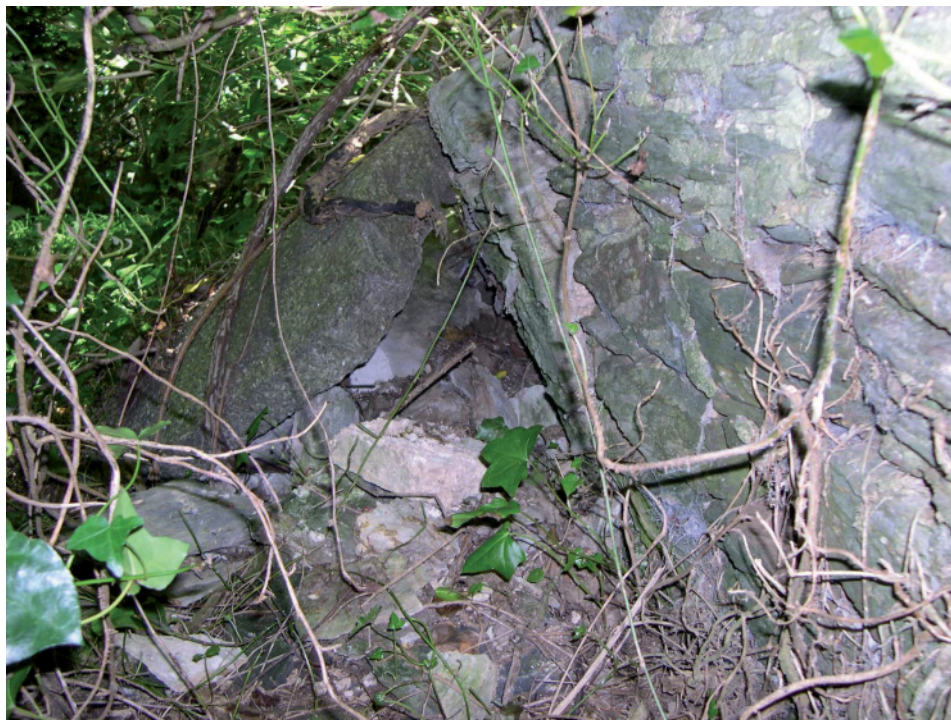
Fig 15 The boundary on the east of the Congregationalist cemetery south of its centre, showing instability, bulging and partial collapse of the walling and its granite coping, with tree and ivy growth

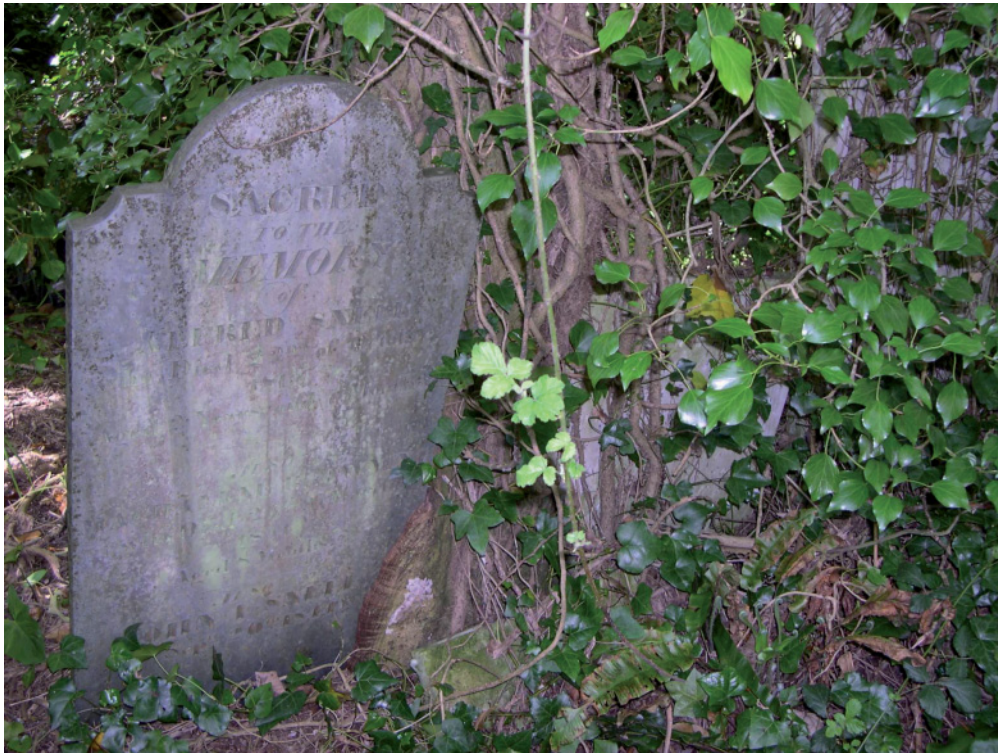
and Pearce, in Simons and Pearce 2000a, 102), and the impacts evident on the 2010 visit are indeed varied and widespread. The self sown trees here are obscuring graves, grave rows, the original path, and even in places the cemetery boundaries; and the relationships between these features. Trees are growing on graves and on at least one memorial, embedding stone in wood (Fig 16); greatly limiting restricting movement around the cemetery; and blocking views. Their roots are breaking and displacing gravestones, and causing subsidence of graves. Altogether the extent and level of active damage and risk is extremely high, and the adverse impact on perception and appreciation of the site as a cemetery is severe.

Fig 16 One of the earlier slate headstones in the Congregationalist cemetery, dated 1813, still standing in the east end of a row of graves but embedded in one of the many trees invading this ground

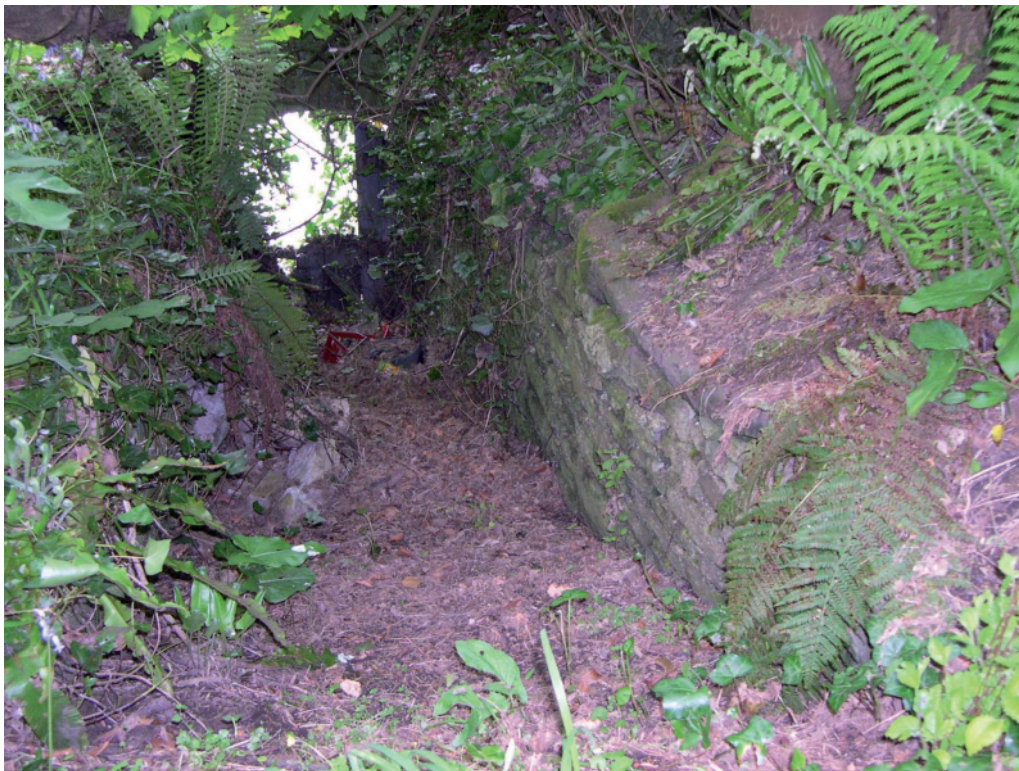
Fig 18 View down the steps to the arched Congregationalist doorway, one of the original features potentially offering rich experiences of aspects of past lives, but now disused, ruinous, unstable and possibly dangerous

Careful clearance of woody growth at the entrances, and securing of their doorways, was recommended at the time of the scheduling in 2002. This would prevent imminent collapse of brickwork and masonry, and further damage to the early door to the Congregationalist ground; and with the repair of the associated boundaries, may be expected to greatly improve security and enhance perceptions of the cemeteries as a valued and historic place, and so reduce the risk of vandalism more generally. The Congregationalists' doorway can be expected to be lost in the near future unless recording and restoration are undertaken (Fig 18).

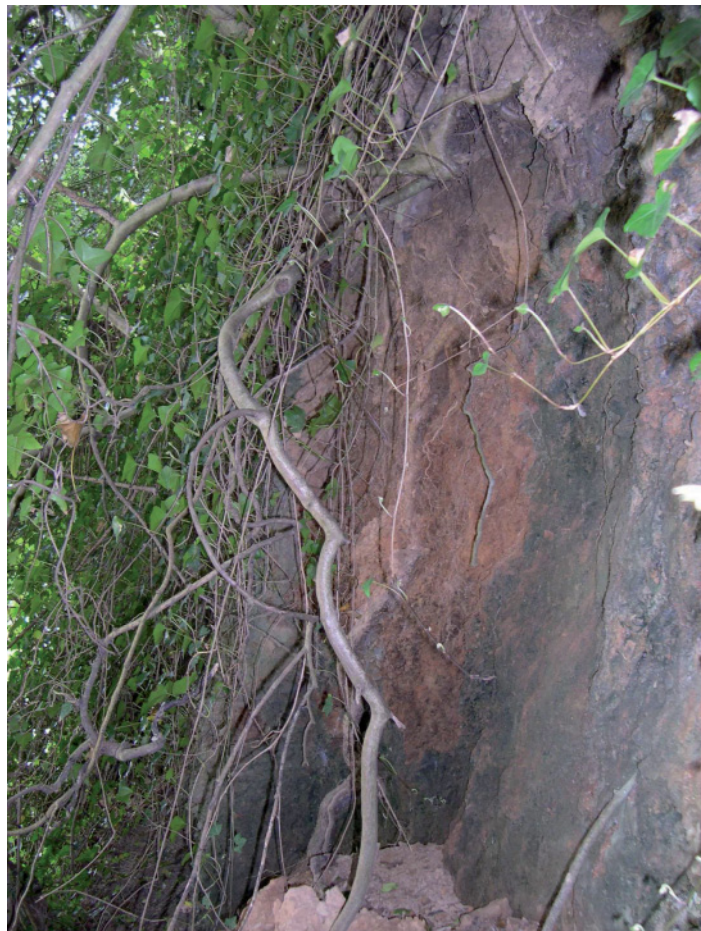
Fig 19 Slumping fresh in 2010 on the cut scarp forming the north side of the cemeteries, requiring assessment

A professional safety assessment of the scarp is recommended in view of the significant slumping above the road evident in 2010; if appropriate, measures to address this damage should be carefully considered, in liaison with the authorities responsible for road maintenance or other interested bodies.

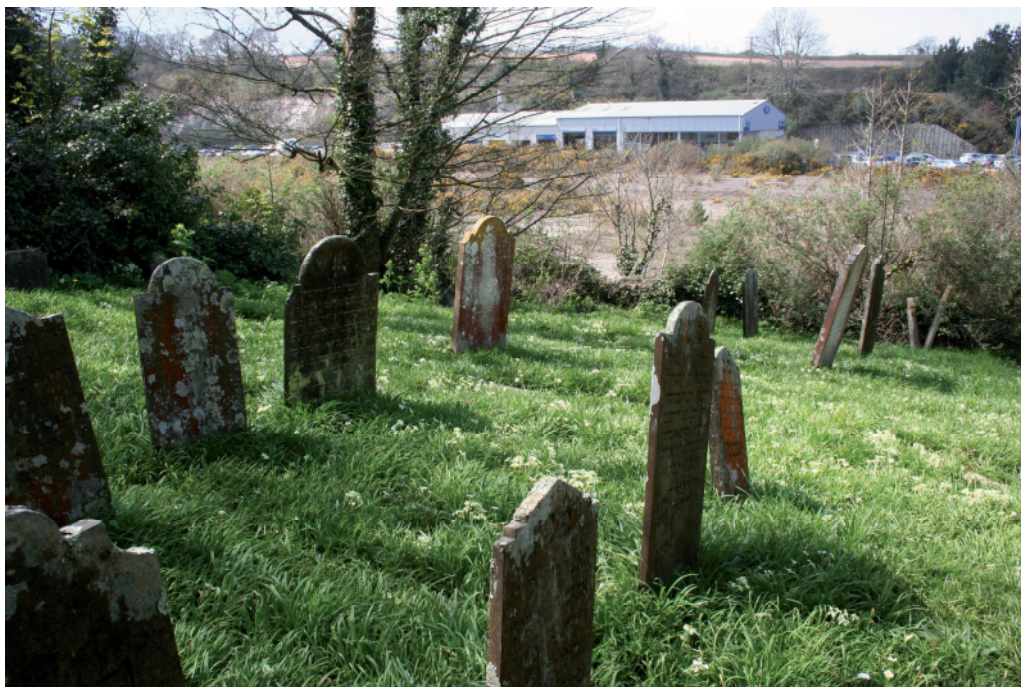
Fig 20 View from the Jewish cemetery, showing how it overlooks low ground to the west currently for sale as development land

Future use of the area west of the site at Ponsharden, advertised on the ground as development land at the time of writing, can be expected to affect it in several ways. The area immediately adjoins the cemeteries, and is overlooked from them (Fig 20). The impact of any proposed development on the Scheduled Monument should therefore be very carefully considered through any due process of assessment.

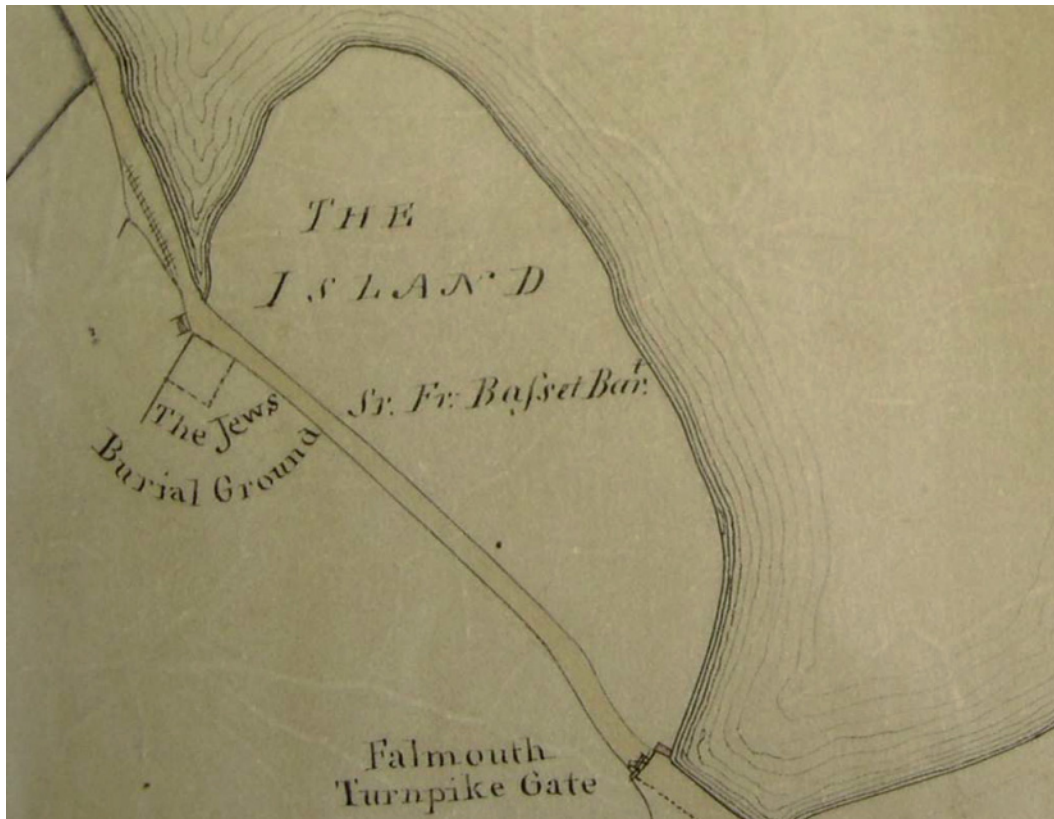
Fig 23 The site captured on the edge of a Duke of Leeds' estate map, 1788, showing the Jewish cemetery only with dashed, possibly fenced inner boundaries. Note also 'The Island', surrounded by the river and turnpike

The Jewish cemetery only appears on the 1788 map of part of the Duke of Leeds’ manor of Penryn Forryn (Fig 23); it lay outside the manor but is clearly marked and labelled ‘The Jews Burial ground’, perhaps to help locate the manor’s boundary which ran close by to the west. The use on this survey of dashed lines for its inner boundaries, indicative of fencing perhaps intentionally temporary, may suggest it was then relatively newly laid out. A 1793 survey for the Basset estate of the Barton of Penwerris (which did include the site) also shows the Jewish ground alone, named in the accompanying schedule as ‘Jew’s Burying Place’ (Fig 24).

The ground is enclosed Cornish hedges, the stone revetted hedge banks traditional for field boundaries in the region, with some walling by its entrance (see below). The inner, south and east boundaries may originally have been fenced rather than hedged, as they appear as dashed instead of solid lines on the 1788 survey (Fig 23); they were definitely hedged in 1814, as shown by the detailed plan of that date (Fig 2). The hedges are mostly around 1-1.5m wide and 0.8m high. Facing of vertically set small local stone is detectable in places under the vegetation on the inner side of the south hedge; some similar work is visible in the outer revetment on the north, and larger, laid slabs are also exposed near the centre of this where a recent track has been worn up over it. This north side has a steep scarp some 3 or 4m high running down from it to the bay beside the road, the former turnpike. The ground also falls very sharply outside the boundary of the cemetery west of its junction with the Congregationalist ground, but this area may have been partly cut away in more recent times as part of the levelling of the land below on the west for re-development.

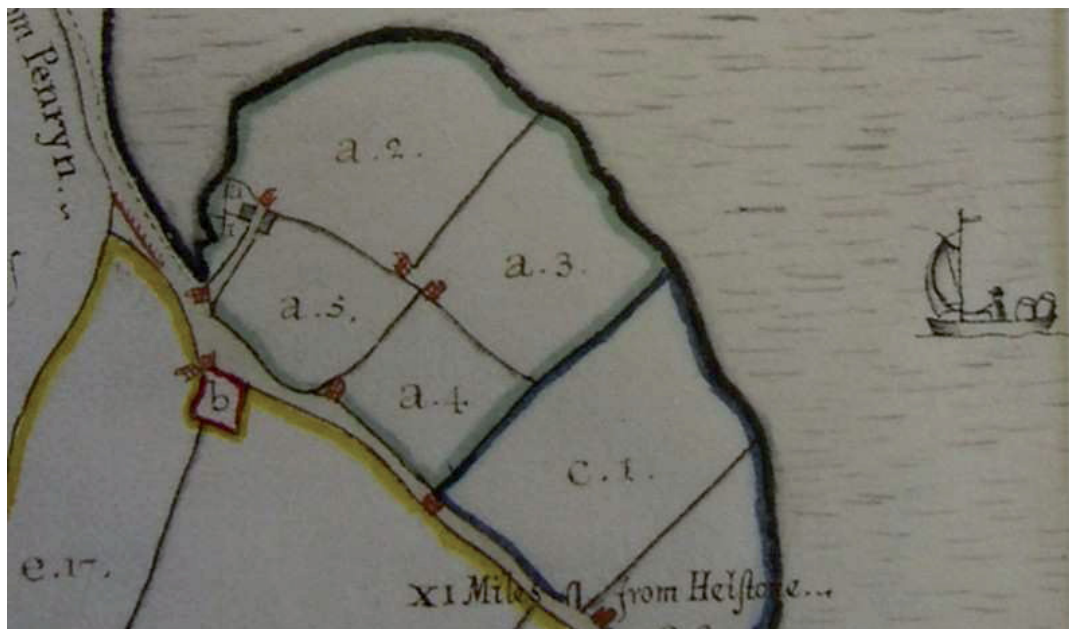
Fig 24 The area as surveyed for the Basset Estate in 1793 showing the Jewish ground (labelled 'b' on the plan) still standing alone, with a gate symbol depicting the entrance in the north west corner

Other notable features of the historic environment during the period of use of the cemeteries were a rope walk to the south east where rope was made for ships or mines shown on the 1793 Penwerris survey (Fig 24) and later historic mapping, which introduced a mercantile character to the surrounding agricultural land; and of course the creek below the site on the north. Before the re-development of the shore across the road, the Jewish cemetery in particular offered views of the waterway and passing shipping, providing associations with the lives and livelihoods of the people visiting the cemetery, and for the many immigrants among the Jews, with their origins and relatives across the seas.

The access to the Jewish ground, recorded with a gate symbol on the 1793 survey (Fig 24), lies in its north west corner, at the deepest point of the bay beside the turnpike (see Section 5.1). The entrance has a simple opening in a rendered brick and stone wall now fitted with a standard modern wooden frame and board garden-type door. It opens into the site of a former cemetery structure. This post-dates the 1788, 1793 and 1814 surveys, appearing on the 1840 tithe map (Fig 26). The site is marked by similar walling surviving to around 0.9 m high to the west, with earlier walling on the east up to 2.2m high made of shillet with granite and shillet slab quoins (the south wall is no longer upstanding). The earlier fabric could represent another phase of the building, or perhaps a previous entrance walling or archway.
