Tregeseal Stone Circle St Just, Cornwall

Conservation work

Tregeseal Stone Circle, St Just in Penwith, Cornwall

Stabilisation of stones and clearance of vegetation

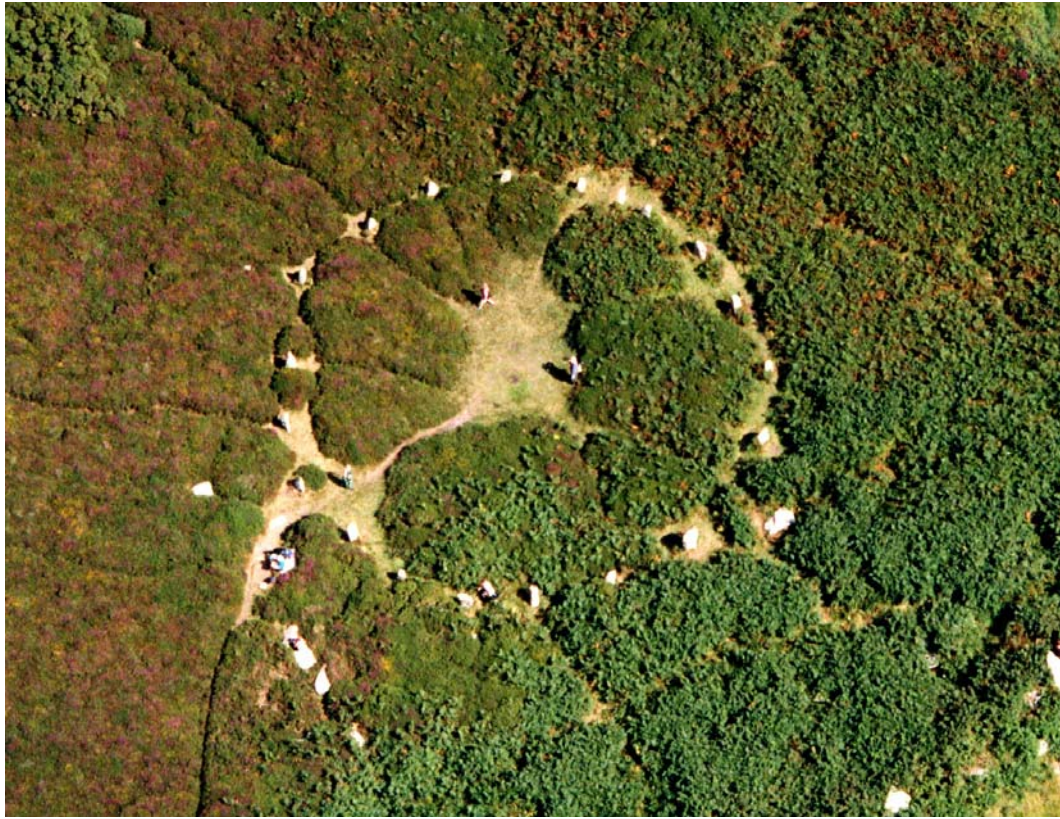
Fig 6 The stone circle from the air in 1999 (NMR 18470.12) showing the setting, with heathland vegetation to the north (ie left in this picture) and bracken to the south (right). The encroachment of vegetation into the circle is clearly seen, and contrasts with the situation by 2005

centre of the circle, previously dense heather and gorse, was cleared by volunteers from Cornish Ancient Sites Protection Network (CASPN) and the British Trust for Conservation Volunteers (BTCV) in 2000 and in subsequent years has been maintained by CASPN, whose members also monitor the site and repair any fire pits (see air photos in Figs 6 and 7). The site is approached by two paths from the north-north-west and north-north-east.

Around the circle, the vegetation consisted of dense bracken and bramble to the south and heathland (principally heather and gorse) to the north (see the air photos, Figs 6 and 7). July is exactly the right time of year for managing bracken whether by spraying, rolling or cutting, because the bracken is putting all of its energy into growing and least into the rhizomes. Cutting at this time of year therefore had the potential to not only reduce pressure on the circle at the present time but also to reduce the vigour of the bracken in the area more generally. On the other hand, it was not a good time of year for cutting heathland because of the risk to nesting birds and other fauna.

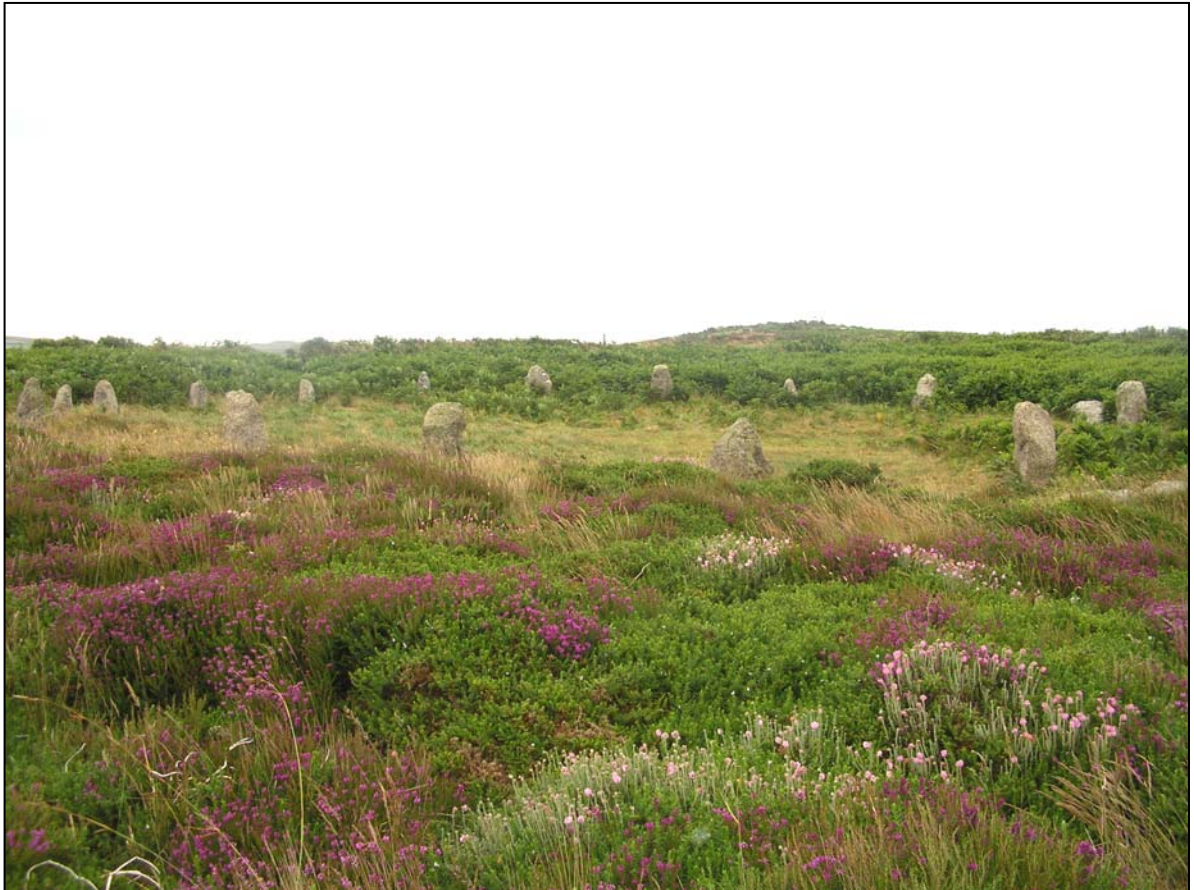
Fig 8 Tregeseal stone circle from the north in July 2009, showing heathland in the foreground and dense bracken to the south

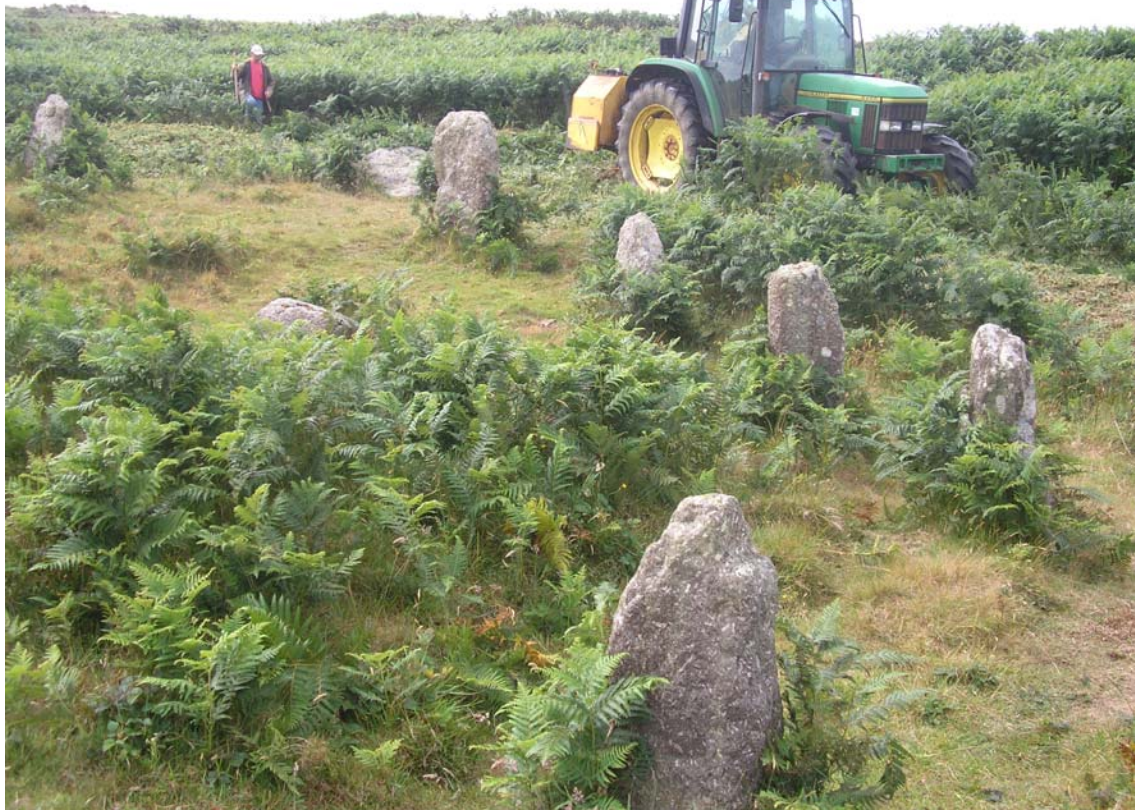
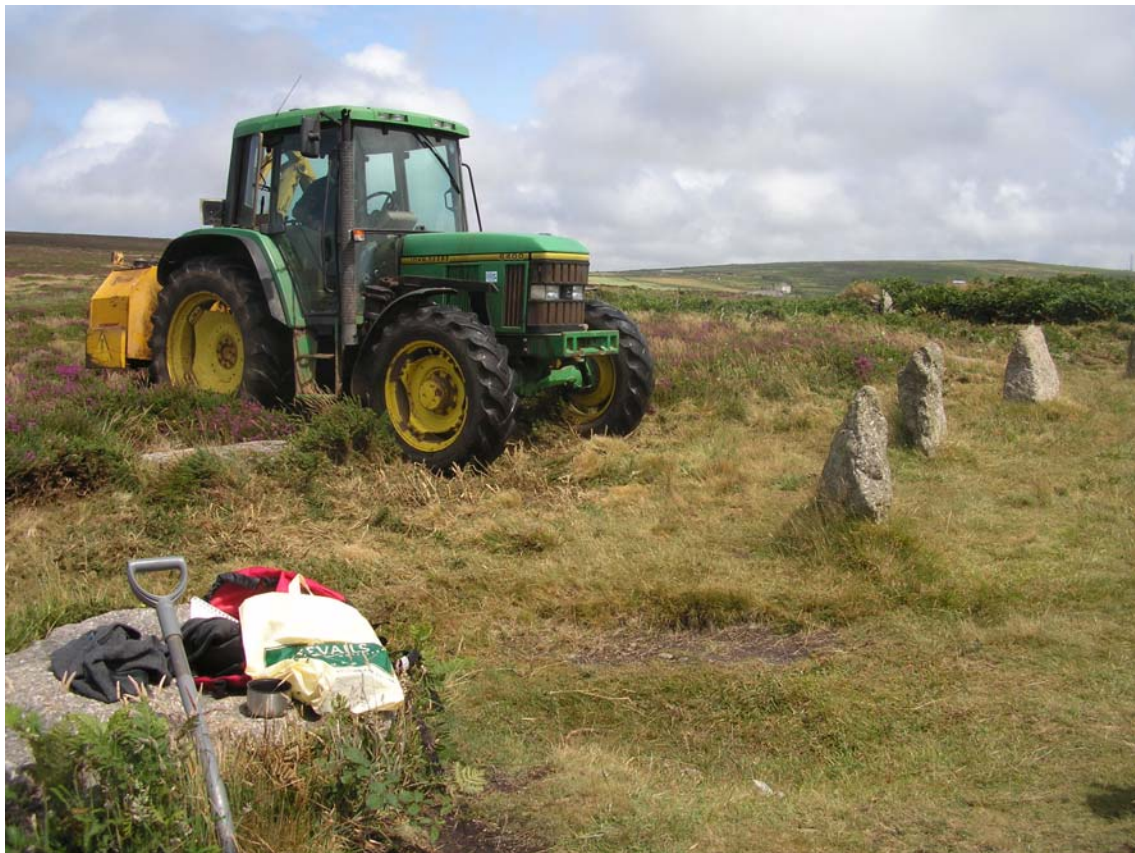
Fig 9 Cutting bracken around the site in July 2009

In the event, only the bracken was extensively cleared, while the heathland was cut along the paths leading to the site and around the northern perimeter of the circle only. All vegetation clearance was done using a tractor-mounted flail (Fig 9), except inside the circle, where the bracken was hand-pulled

- The vegetation flanking the paths leading into the site from the north-north-west and north-north-east was cut back by approximately one metre to either side.
- The vegetation around the northern perimeter of the circle was cut back by approximately one metre.
- The bracken growing around the stones of the circle was hand-pulled.
- Vegetation around the circle on the south, west and east, was cut back as far as the surrounding hedge, in so far as the uneven nature of the ground permitted.
- Cuttings were raked up from around the edge of the circle and dumped in the ditch of the surrounding hedge, but time did not allow the cuttings over the whole area to be raked up.

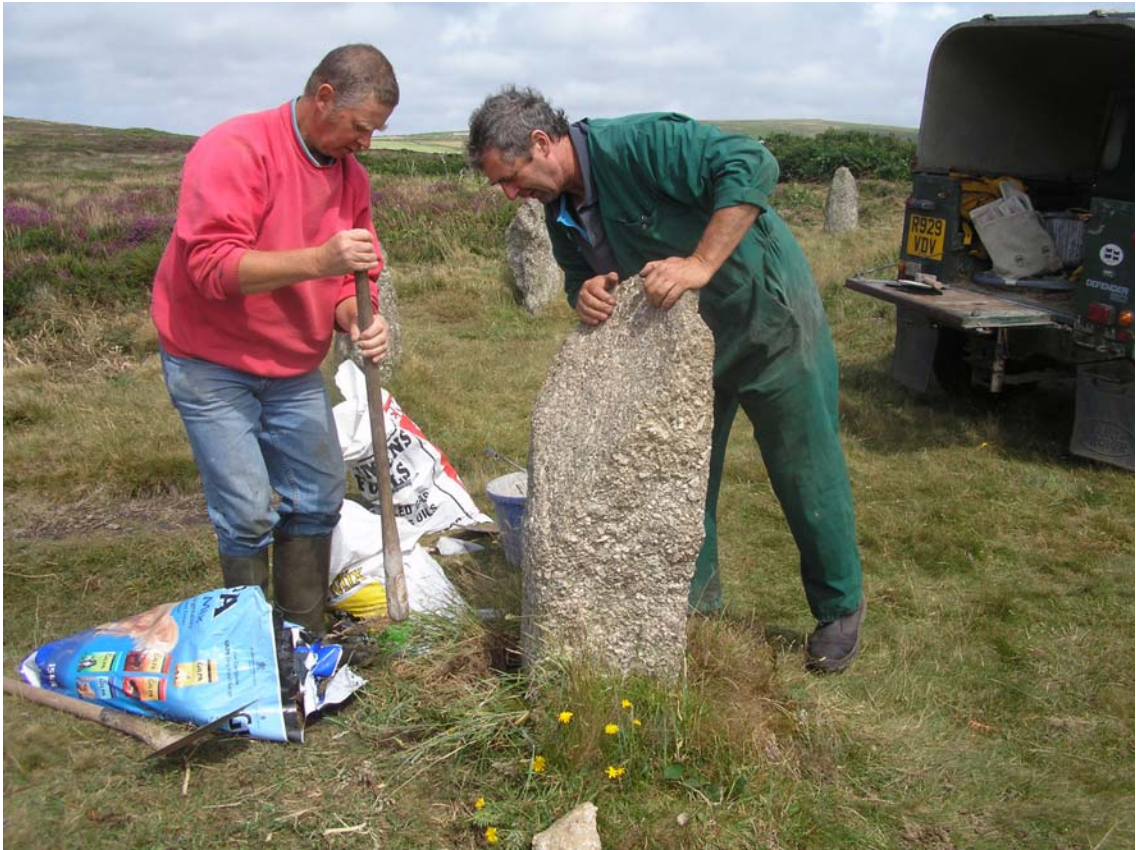
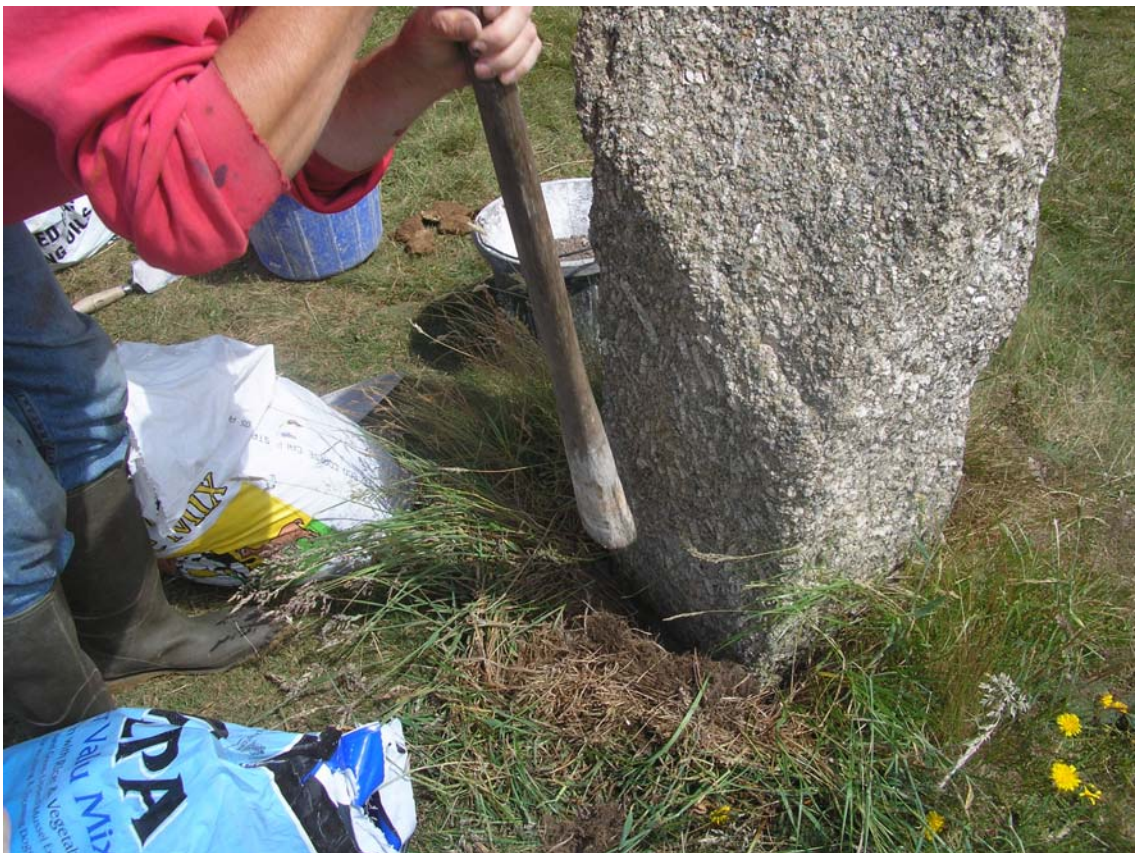
Visits to the site established the fact that at least five stones were loose, and confirmed the potential for conflict between stock and visitors. The stones which were loose were all stones that had been re-erected or were replacements for originals; their loose state at the time was thought to be in part due to the fact that the ground was parched and cracked following exceptionally dry weather in June 2009.

Fig 10 Stabilising the stones by tamping rab into the cracks between the stones and the ground

- Cut all vegetation from around the loose stones, to expose the cracked ground at their base.
- Tamp rab (granite subsoil, brought in from outside the Scheduled area) into the crack in the ground at the base of the stone until the crack was filled and there was no longer any movement in the stones.
- Where the crack was not large enough to fill easily it would not be touched and the stones' stability would be monitored only.

In reality, due to concern about the need to make the stones as solid as possible, as quickly as possible, and given the prevailing very dry hot weather, a small amount of lime was added to the rab (1:10) to stiffen the earth and make the local 'clob'; the mixture was put in dry and then wetted. Some small stones and slates were also used to wedge and secure the standing stones.

An initial assessment was made of the stability of all of the stones in the circle: this confirmed that five were noticeably loose. Four of the loose stones were stabilised following the method described above. All these stones were on the north side of the circle, adjacent to the points at which people enter the circle, and where they were therefore particularly vulnerable. Three were stones which had been re-erected in the 19th century (one of which had fallen and been set up again about two decades ago) and one was the stone re-erected twenty-five years ago. A fifth loose stone, on the opposite side of the circle, which moved only very slightly, was not stabilised because the gap in the ground at the base of the stone was not sufficiently large for filling.

The stabilisation of the stones is illustrated in Fig 10; the stones which were affected are shown in Fig 11.

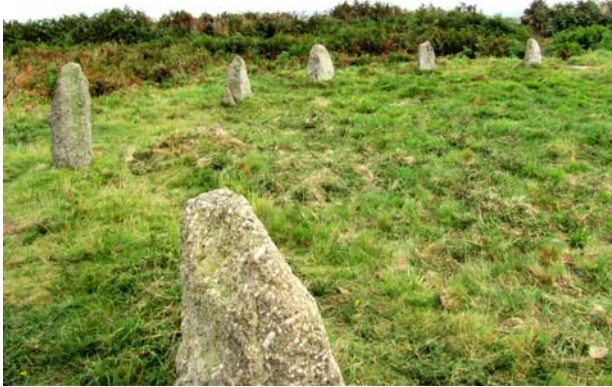
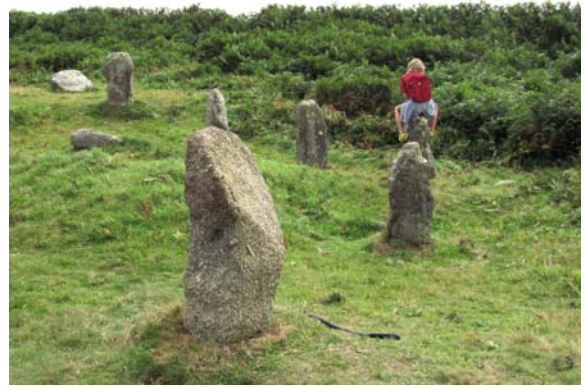
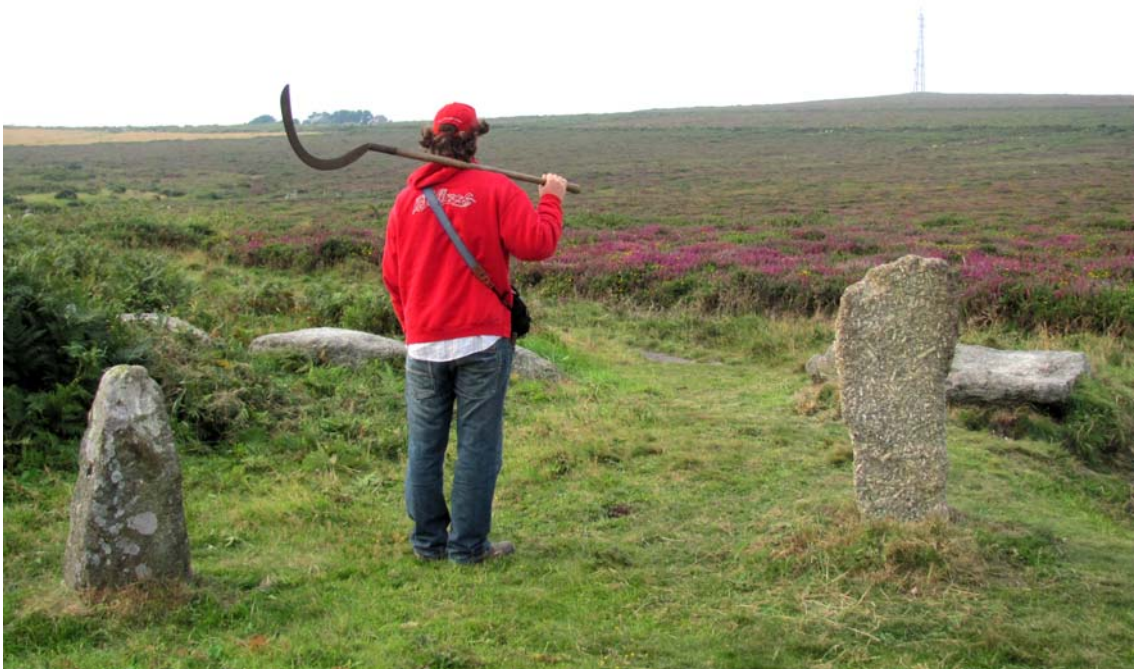
The bracken has returned, but it is thinner and far less vigorous, and in a state which is very much easier now for CASPN volunteers to maintain. Continued grazing will hopefully also help maintain this improvement. (Fig 12).

Fig 12 The stone circle in 2010, a year after conservation work, following a 'clear-up' by CASPN

A month later, all the stones were still solid, and it was not at all apparent that anything had taken place. Cutting the bracken and bramble to the south had not only created a much larger clearing around the site, but had also enhanced the setting of the monument, enabling it to be appreciated in a more open landscape, more akin to its original heathland setting.

- Monitor the site and the stability of the individual stones regularly, especially the stones which still move a little, and others known to have been re-erected in the more recent past.
- Clear bracken from around the south side of the circle (by annual cutting or rolling) to reduce vigour and create more space around the circle, if cattle grazing does not seem to be proving effective in controlling its growth.
- The vegetation clearance revealed the fact that cuttings arising from CASPN clear-ups have been dumped amongst the heather quite close to the circle. This has caused the vegetation underneath to die back, leaving an unsightly brown patch once removed. It is recommended that in future, CASPN volunteers remove the cuttings from site, or at least find somewhere more discrete to dump them.
