The Trippet Stones, Blisland, Cornwall

Erosion repair

June 2007

Report No: 2007R038

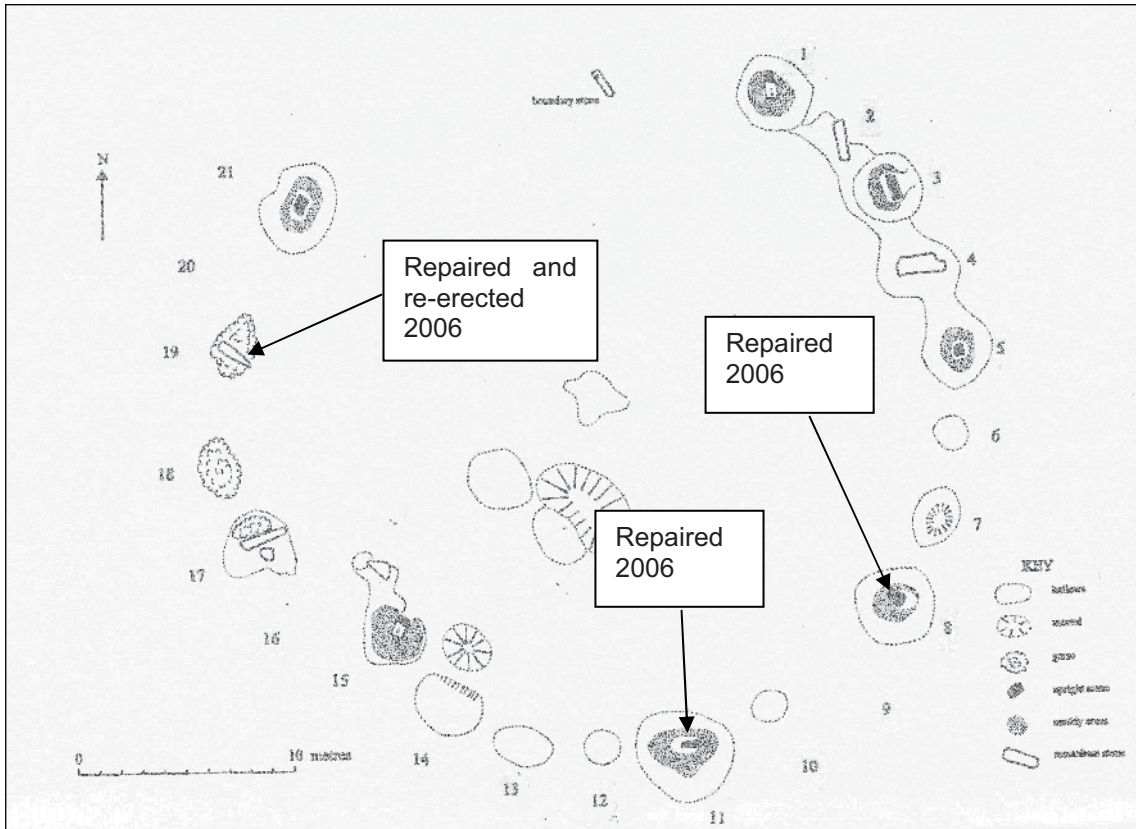
Fig 2. CAU's 1998 plan of the Trippet Stones, showing the erosion holes repaired in 2006

occasion, the eroded holes around stones 8, 11 and 19 were tackled (Fig 2). The recumbent stone 19 was re-erected.

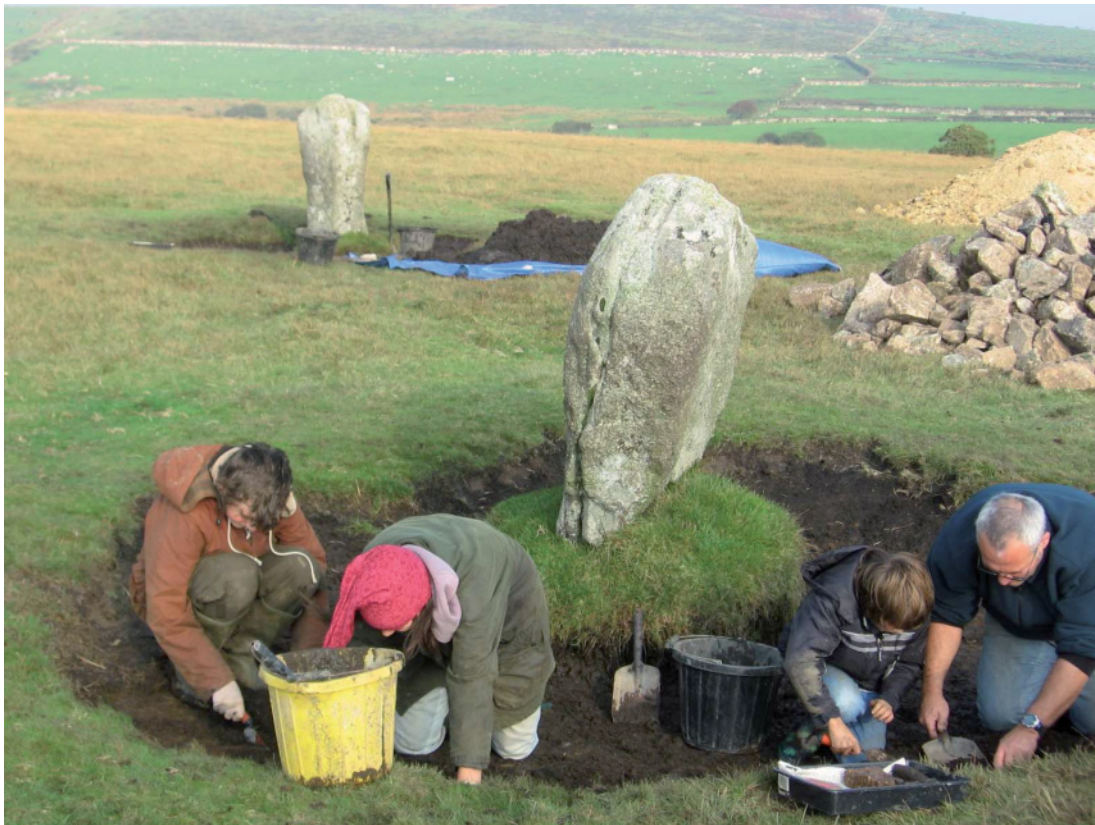
Prior to infilling, all loose material - mud, silt, rooty topsoil, and turf - was cleared from the bottom of the hollows, down to a firmer undisturbed level, and the sides of the hollows were cut vertical. This process was carefully monitored so that any finds or features revealed could be recorded, and was carried out by members of the Young Archaeologists Club (Fig 3).

Fig 3. Members of the YAC clean out the eroded hollows around stone 11, prior to filling with stone.

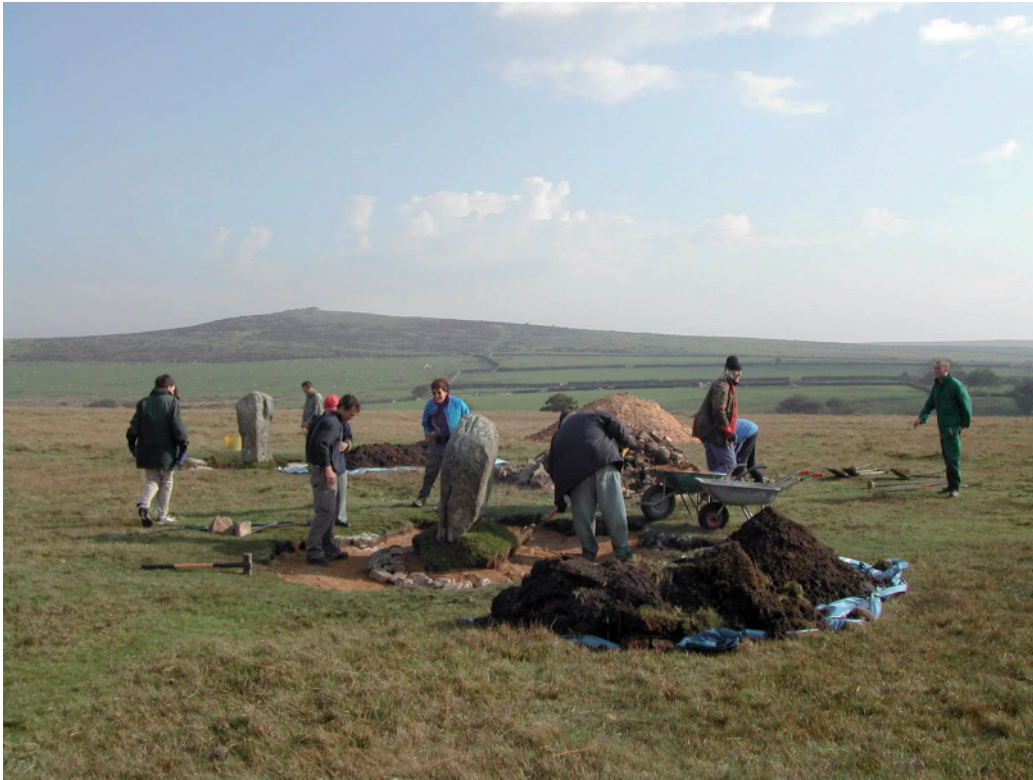
Fig 4. The Trippet Stones Stone Circle, repairs underway.

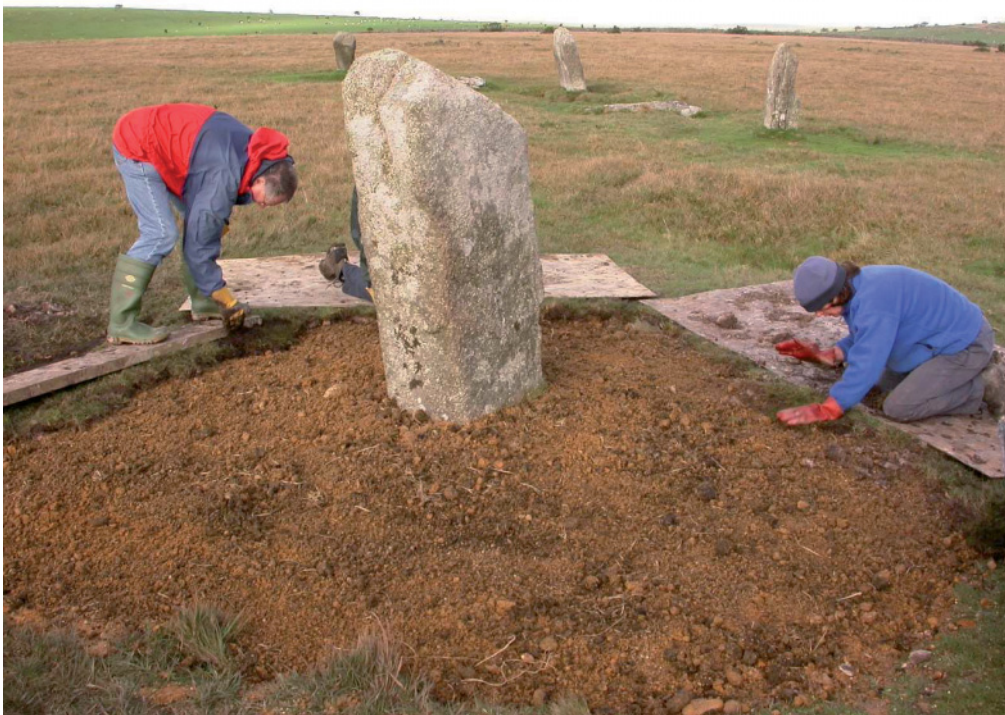
Fig 5. A layer of earth and horse dung is spread over the rab prior to returfing around stone 8.

8. A 10cm layer of topsoil and horse dung (the latter collected locally) was spread over the rab, the purpose of the dung being to enrich the soil and help the final turf layer to grow.

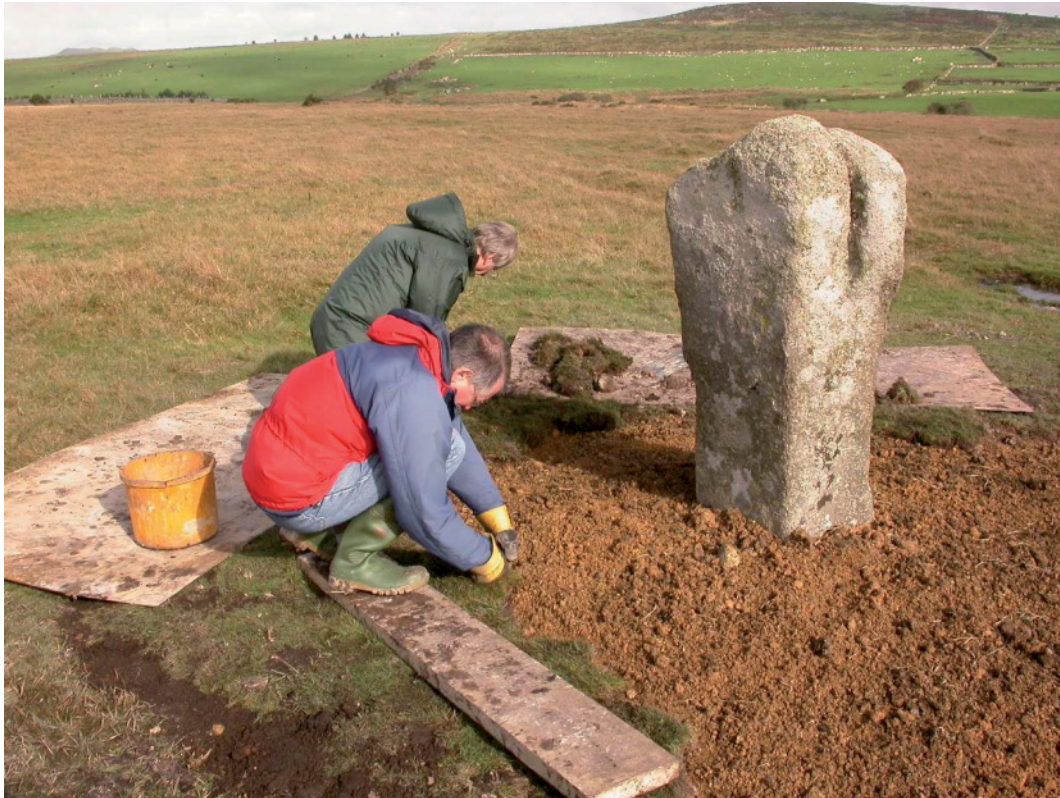
Fig 6. Returfing around stone 8.

9. Finally, the whole of the infilled hollow was turfed over, using turves on average 15cm thick. Care was taken in laying the turves, to ensure a good, solid surface which would 'take' quickly and survive scuffing and kicking by animals and visitors. Where possible turves used were:

- Joins between the turves were filled with earth if necessary or had a layer of fine earth sprinkled over, to help the turves to 'knit' together as soon as growth recommenced. The final surface was domed by 20 to 30cm above the level of the surrounding ground, and the edge of the re-turfed area blended smoothly with the surrounding ground.

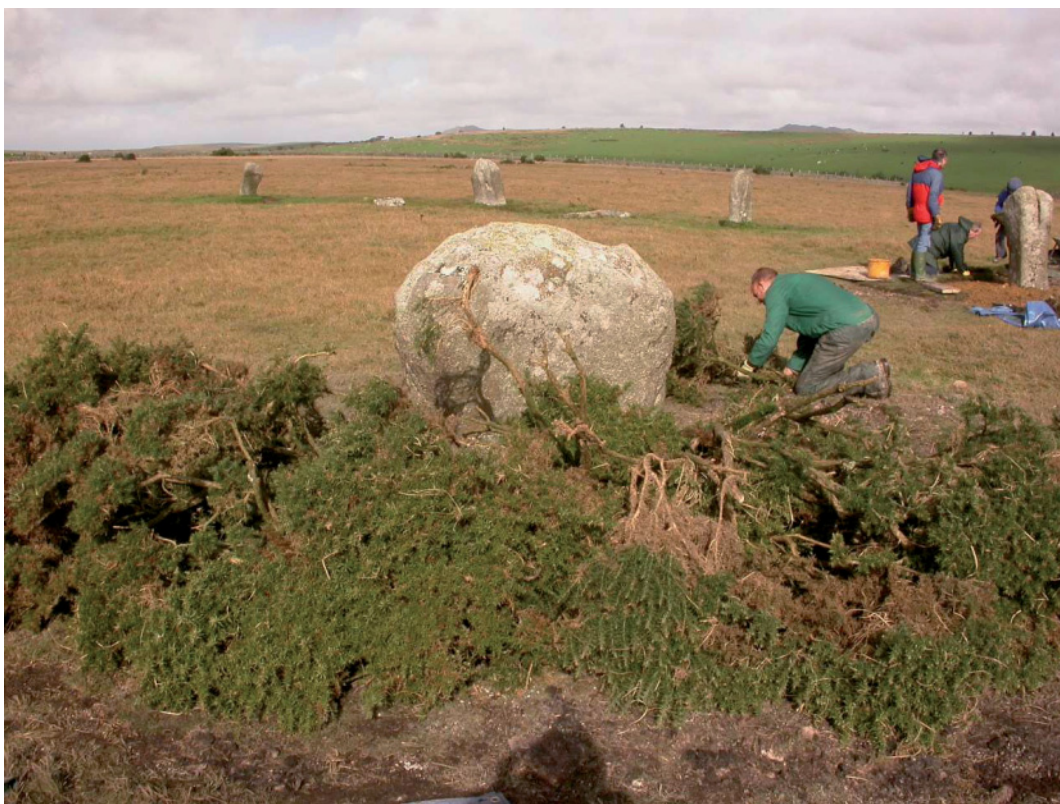
Fig 7. Gorse is tied around the repaired stones to protect the freshly-laid turf from livestock.

10. As a final protection, gorse cut from the surrounding down was tied around the stones to prevent stock from trampling on the repaired area for as long as possible, and thereby to give the turf a chance to consolidate.

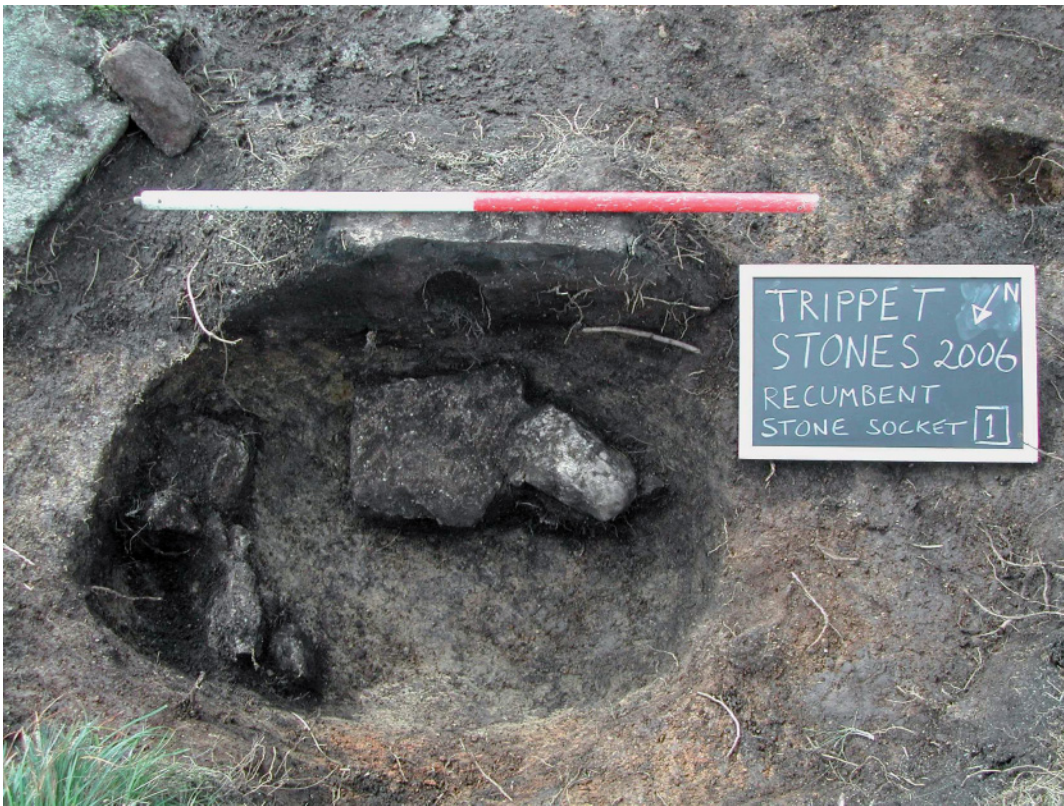
Cleaning of the hollow to clean rab revealed an oval pit representing the original socket for the upright stone. The feature was located close to the northern edge of the hollow and was half-sectioned revealing a sequence of deposits.

[1] – concave oval cut through natural subsoil ('rab' or 'growan') with a steep southern edge and a more gentle concave northern edge (Fig 9). The cut measured 1m long (east-west axis) and 0.8m wide (north-south axis) and was a maximum of 0.26m deep from the top of its cut through the rab (0.75m below ground surface). Large granite packing stones had been pushed into the southern and eastern edges of the cut.

(9) – granite and quartz packing stones built into the side of the base of cut [1], apparently undisturbed on the southern and eastern sides of the pit. The tops of the stones occur at a depth of 0.1m below the surface of the rab (ie the top of the cut).

The oval cut [1] represents the original socket-pit excavated for the stone at the time the stone circle was constructed. The north side of the cut shows disturbance by the movement of the stone. Silts have accumulated in the socket around the stone, progressively filling the void as the leaning stone made more space available. There is no evidence for repair or maintenance, and it appears as though the packing stones are also original to the construction. Others may have been present on the north side of the stone, but were disturbed by the leaning stone prior to its final collapse.

Fig 9. The original socket [1] for recumbent stone 19, showing in situ packing.

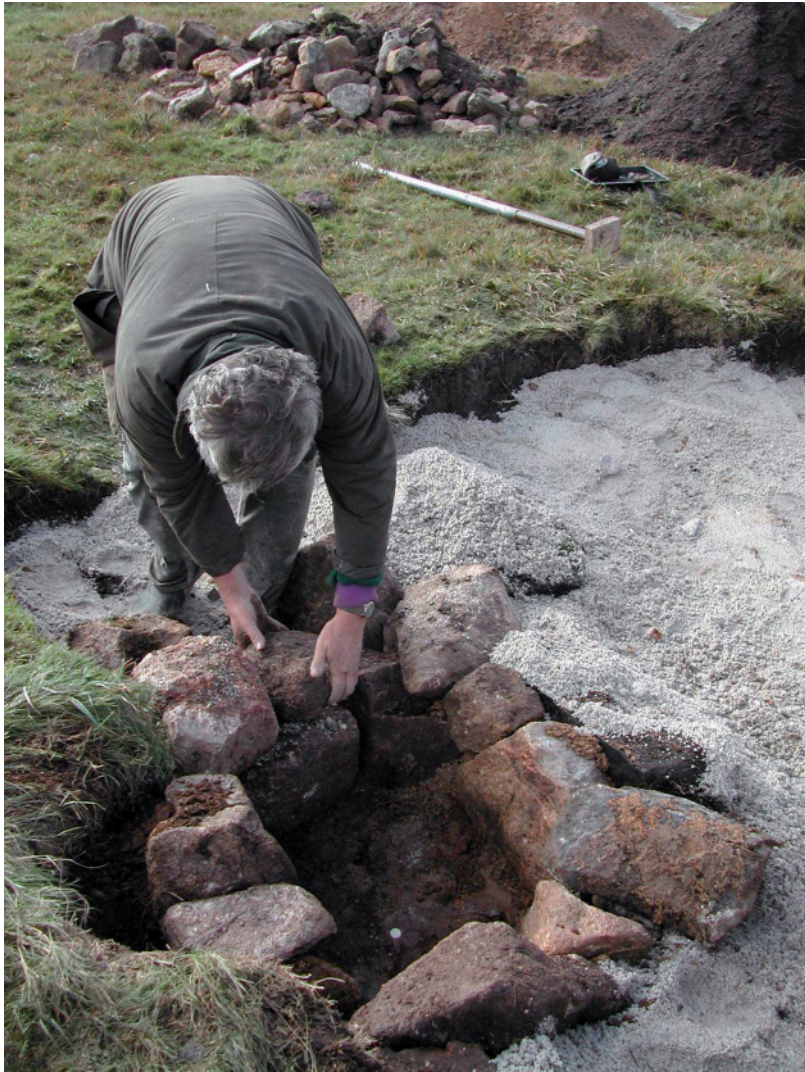
Fig 10. Construction of the new stone-lined socket for recumbent stone 19.

A dry-stone surround was constructed by Graham Lawrence in the sides of the original socket cut [1] in order to create a sound foundation for the stone (Fig 10). This surround was built from local granite, and although this necessitated partial destruction of the original cut, survival of the *in situ* packing stones was ensured. Clean sand was placed in the base of the cut and covered with rab, making it clear to any future excavators that there had been a previous intervention and raising the level of the stone. The stone was raised by straps attached to a JCB driven by the landowner Adrian Mansfield and lowered into the new socket, guided by Graham Lawrence and the author (Fig 11). The surrounding hollow was then repaired in the same way as the other hollows (Fig 12). The stone was set into the ground to a depth that was consistent with the other stones of the circle and where differential growth of lichens suggested this was the case.

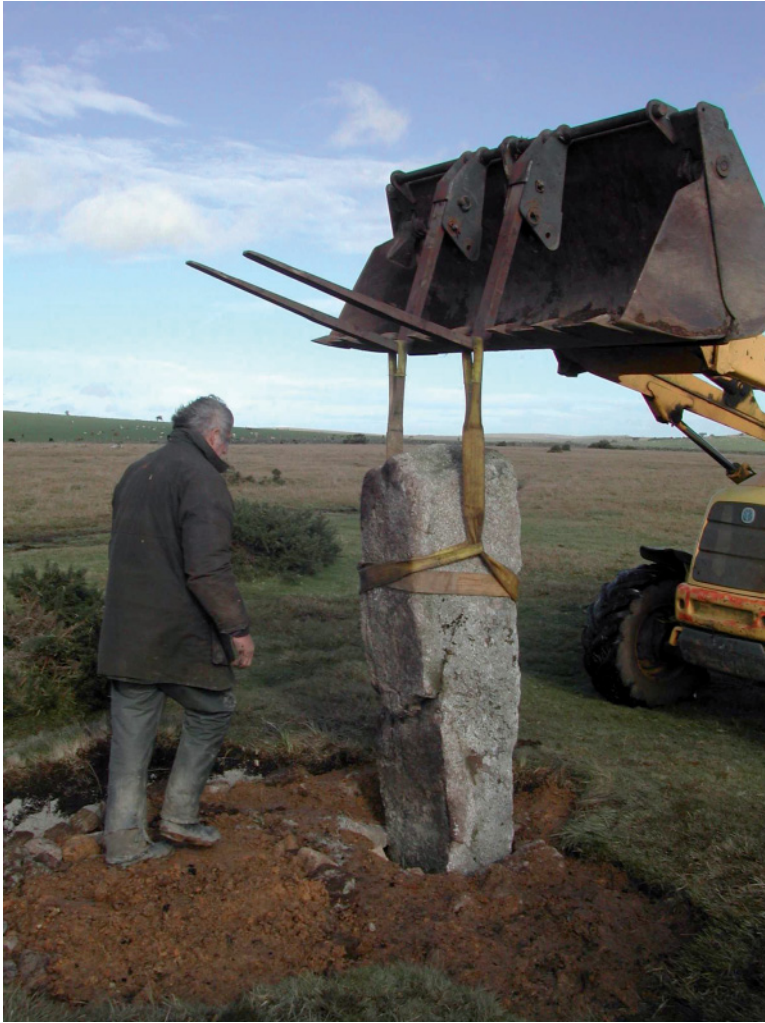
Fig 11. Re-erection of recumbent stone 19

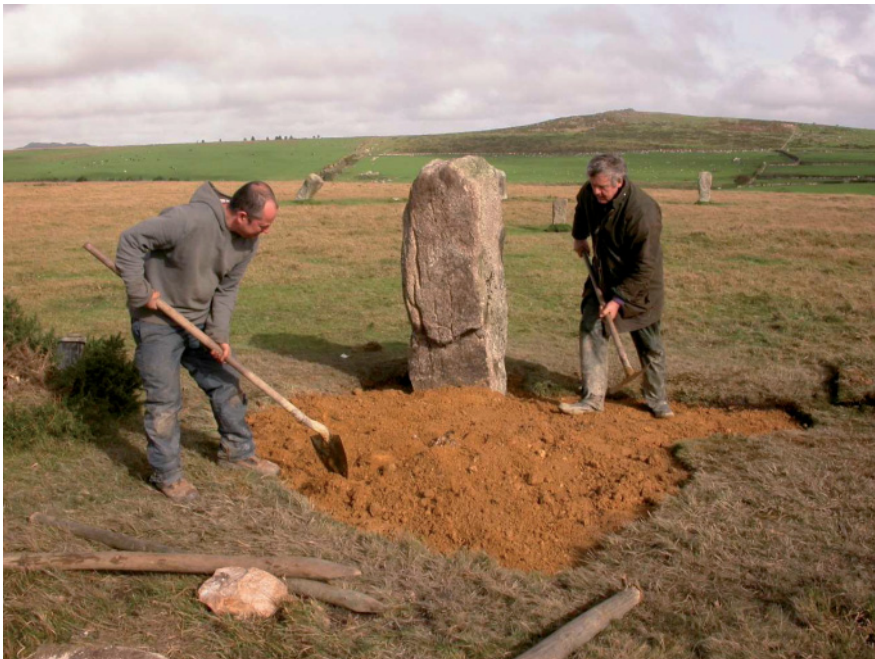
Fig 12. Infilling around recumbent stone 19 with clean rab.

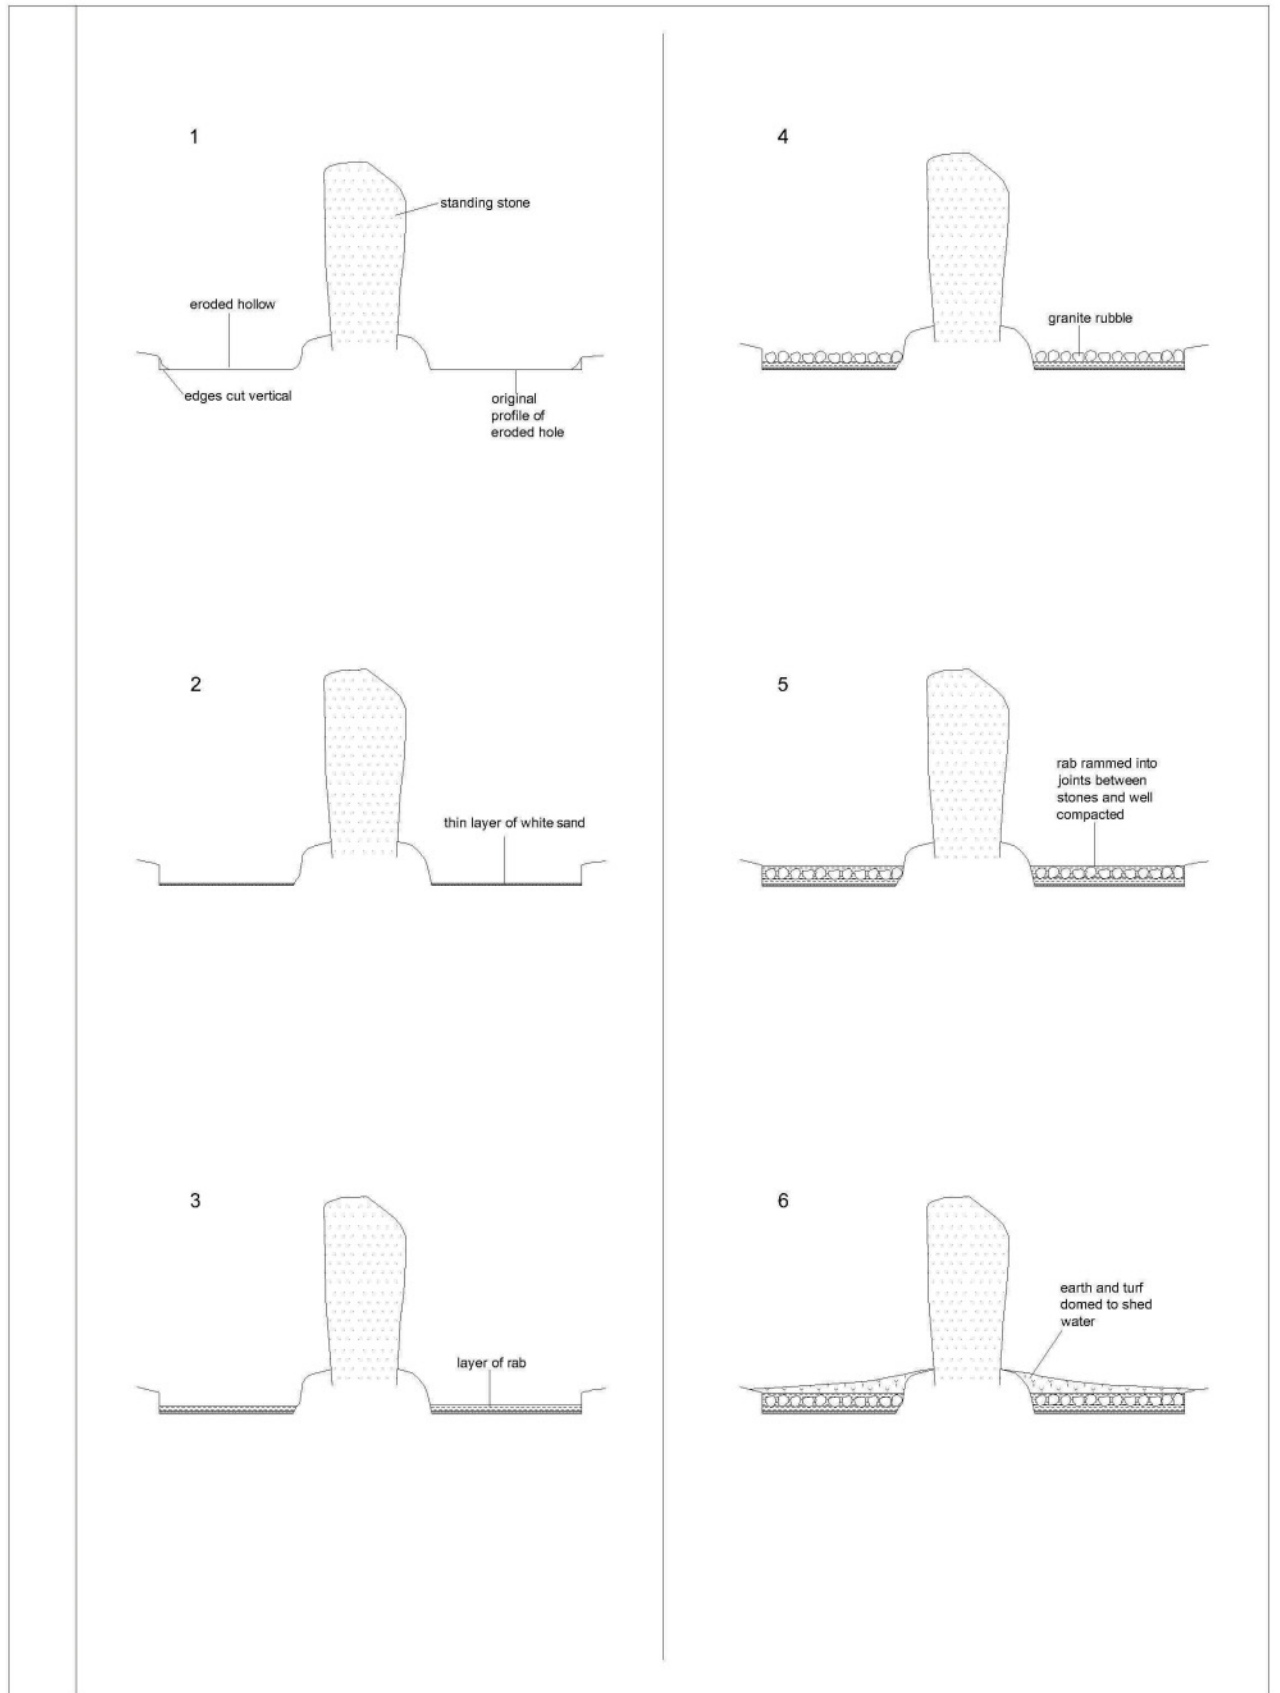
Fig 13. Method of erosion repair used at the Trippet Stones

The conservation work followed exactly the same method as that used successfully in 1999 and 2003 (Preston-Jones 2000 and 2003) shown in Fig 13:

1. Silt and mud was cleared from the bottom of the hollows, to the firm subsoil, to provide a solid base to build up from.
 2. The edges of the hollows were cut back to vertical, to form a solid edge up against which filling materials could be firmly wedged. The collar of uneroded ground around the base of the stones was disturbed as little as possible, in order to maintain stability.

3. A layer of white sand was put in the base of the hollows, to provide an archaeologically distinct layer.
 4. A thin layer of light orange-brown, clean rab (growan) was spread over the top of the white sand, to bed the next layer (the stones) in.

5. The hole was then filled with blocks of (mostly) weathered granite, wedged as closely together as possible, jig-saw fashion, generally to within 10 cm of the ground surface. Every effort was made to ensure that these blocks were kept below ground surface level, to prevent them from being exposed too quickly, should the repair work subsequently be worn away.

6. The gaps between the stones were filled with rab (growan), well rammed in.
 7. A layer of rab (growan) was spread over the stones, and thoroughly compacted. This was brought up approximately to ground level at the edge of the hole, but a bit higher at the centre, so as to form a slightly domed surface which would drain surface water away from the stone.

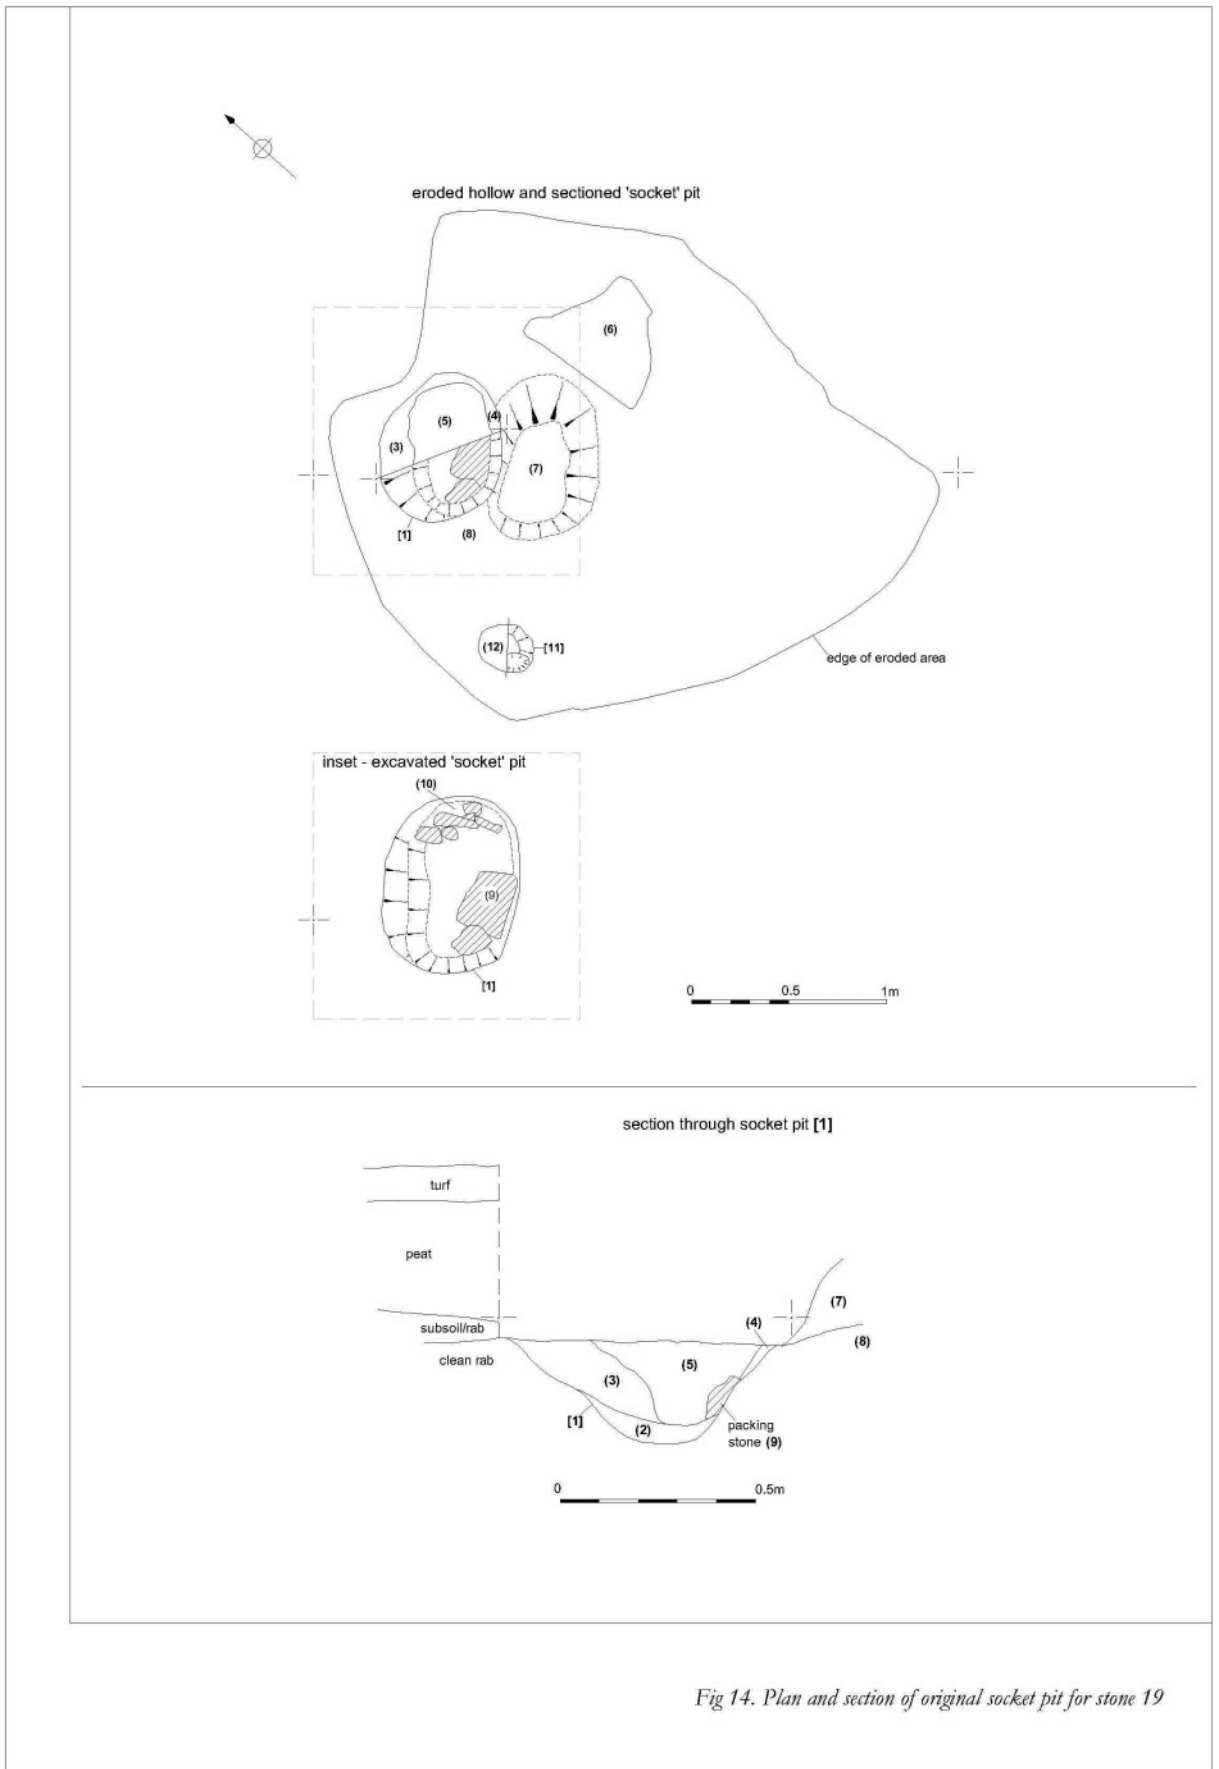
(10) – compact, dark grey or black peaty silt against eastern edge of cut [1], sealed behind packing stones (9). A small sample <2> was taken of this material.
