Wharncliffe Arms Hotel, Tintagel, Cornwall

The restoration of an 11th century cross

November 2006

Report No: 2006R071

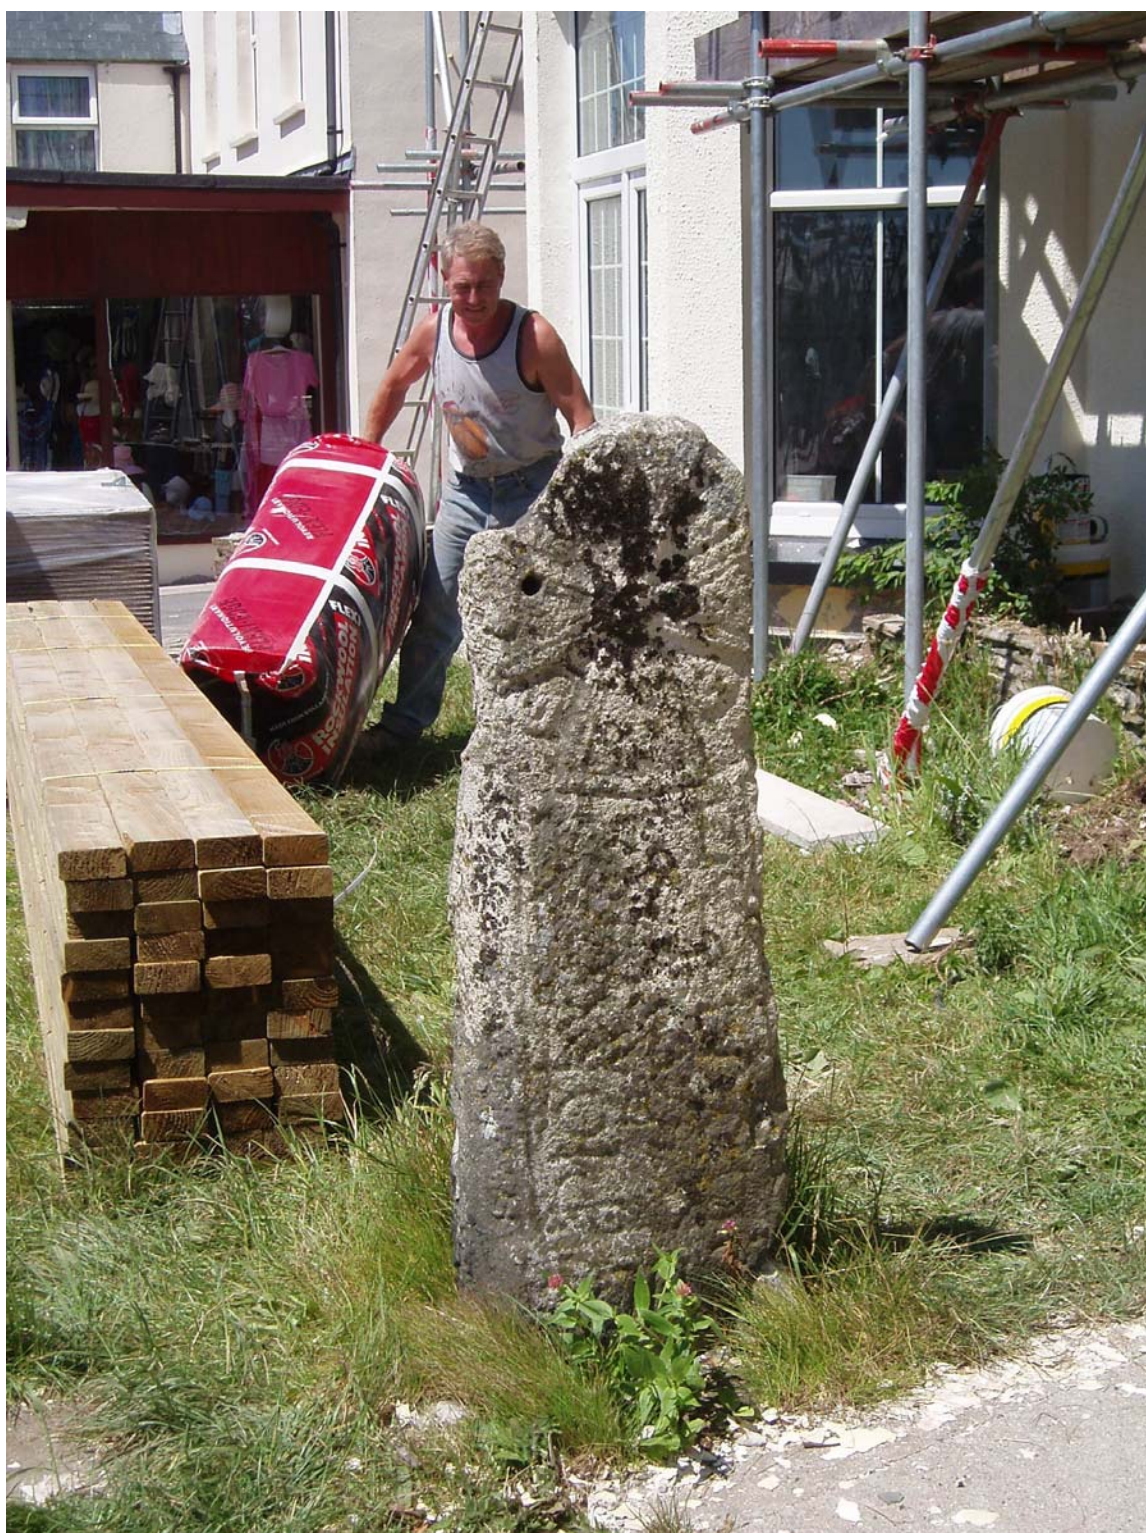
Fig 8 The cross threatened by building work in 2005

As indicated above, negotiation regarding the need to stabilise the cross was finally precipitated by the conversion of the pub to flats, and the building works associated with that, which placed the cross at considerable risk of accidental damage (although it is to be noted that all the builders concerned had been appraised by Lee Sharpe, the owner, of the significance and status of the monument). With building work nearly completed, an opportunity existed to finally restore the cross, using appropriate materials and methods. This work was organised by the Historic Environment Service at the request of the English Heritage Field Monument Warden.

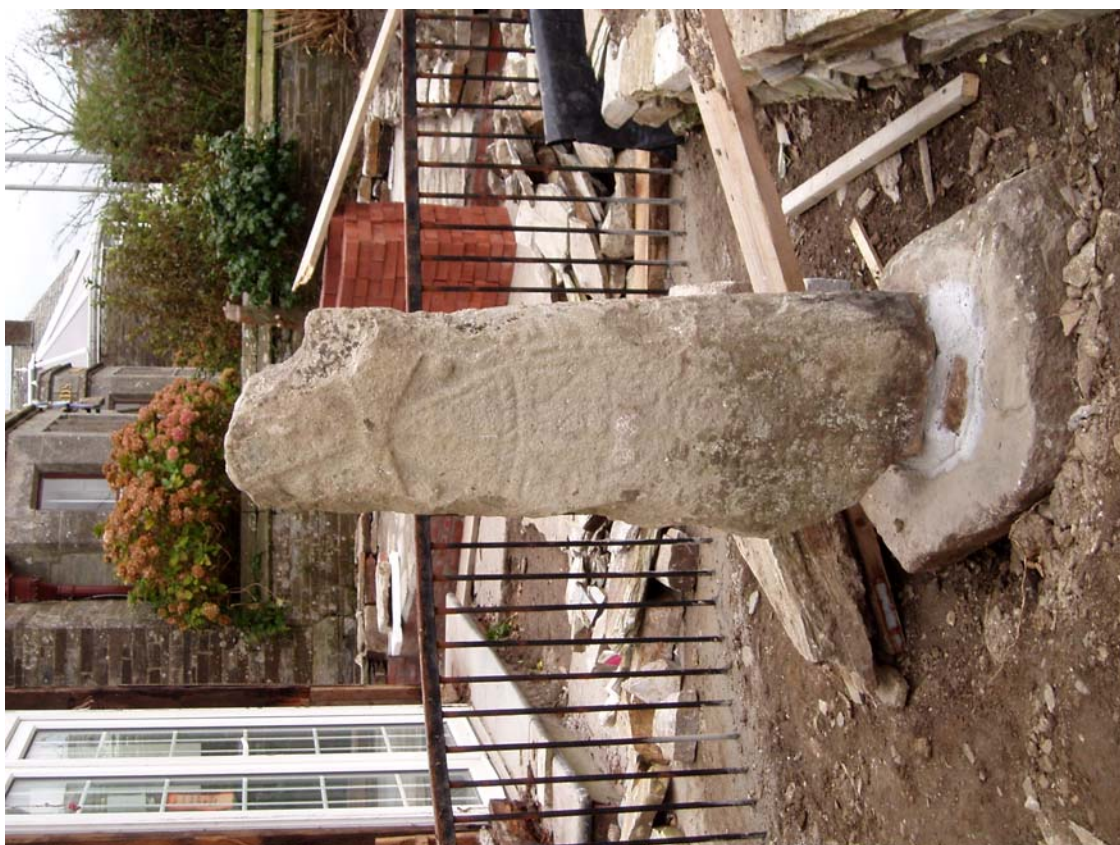
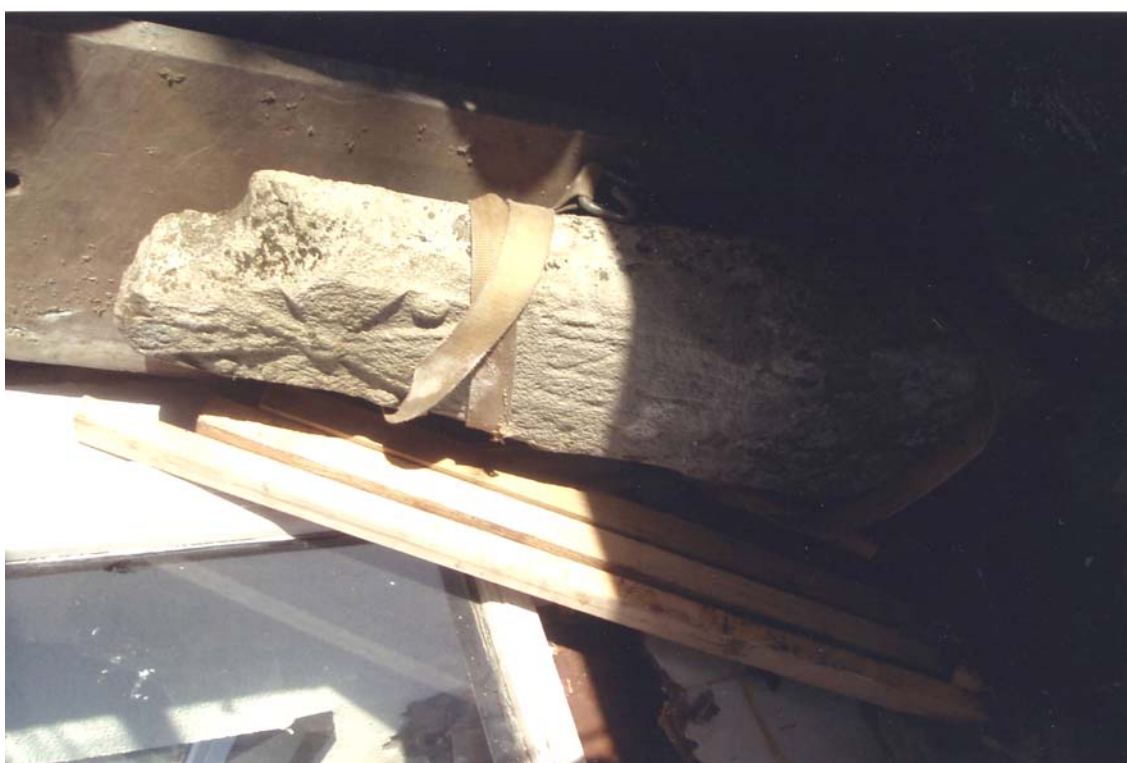
disappeared. This replacement involved simply cementing the cross onto its base and wedging it upright with pieces of slate (Fig 9). No attempt was made to provide new internal fixings or to pack the dowel hole with mortar.

Fig 9 The cross in storage in the hotel's porch in 2005 (left) and then temporarily restored in December 2005(right)

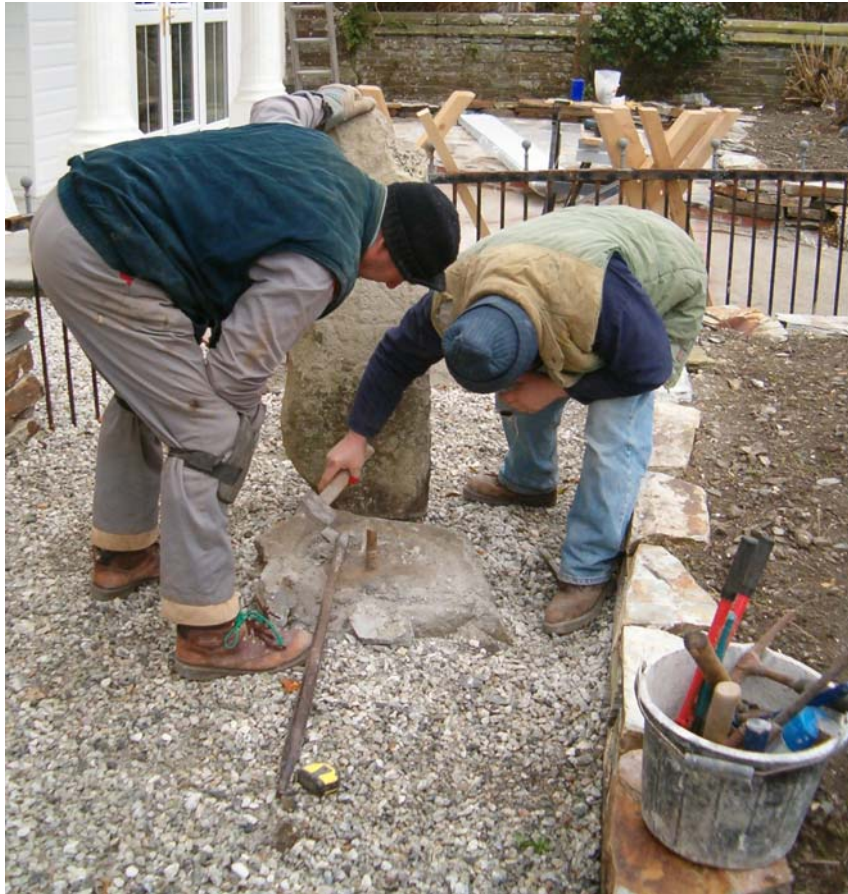
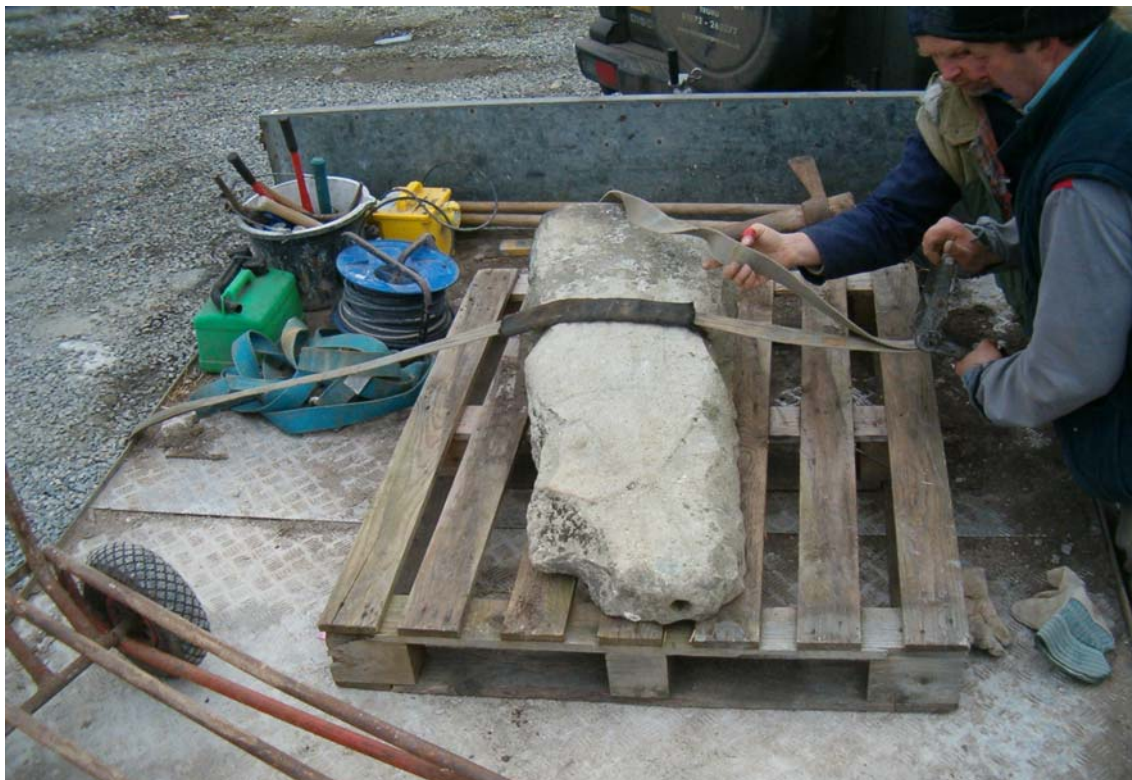
1. The cross was lifted on Wednesday 1st February. Once the cement from the temporary restoration had been carefully chipped away and the packing stones removed, the cross was easily lifted off its old pin, which remained firmly set into the base-stone. Once the pin had been removed from the base-stone, by carefully tapping and loosening it, the hole in the base was deepened to 12.5 cm (5½ ins). (Fig 10)

Fig 10 Lifting the cross for removal to St Just for drilling and pinning

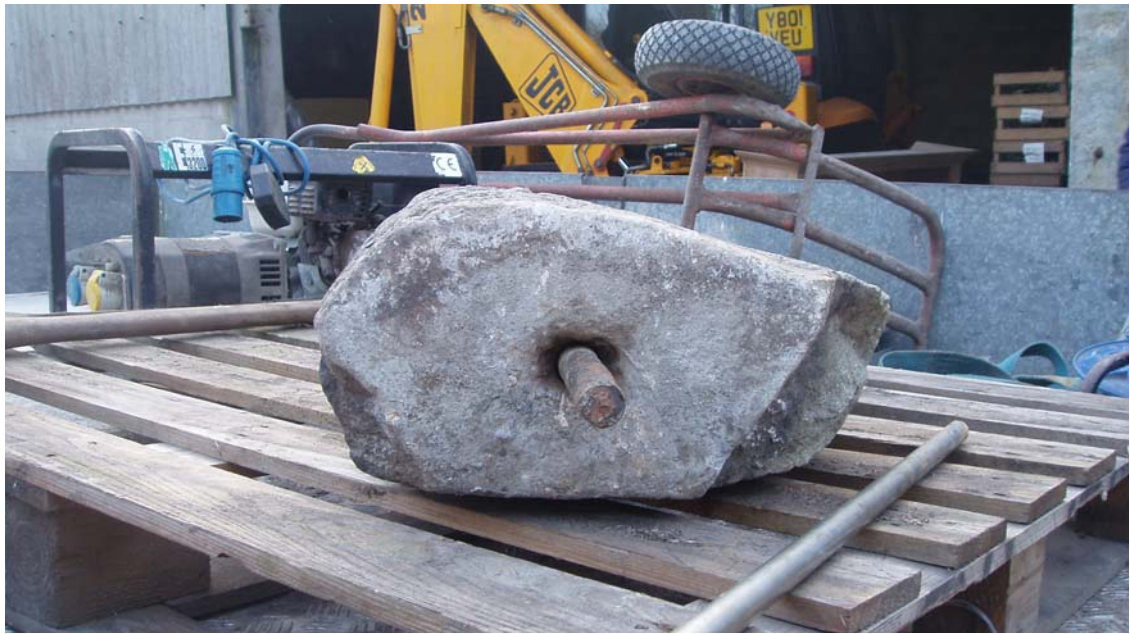
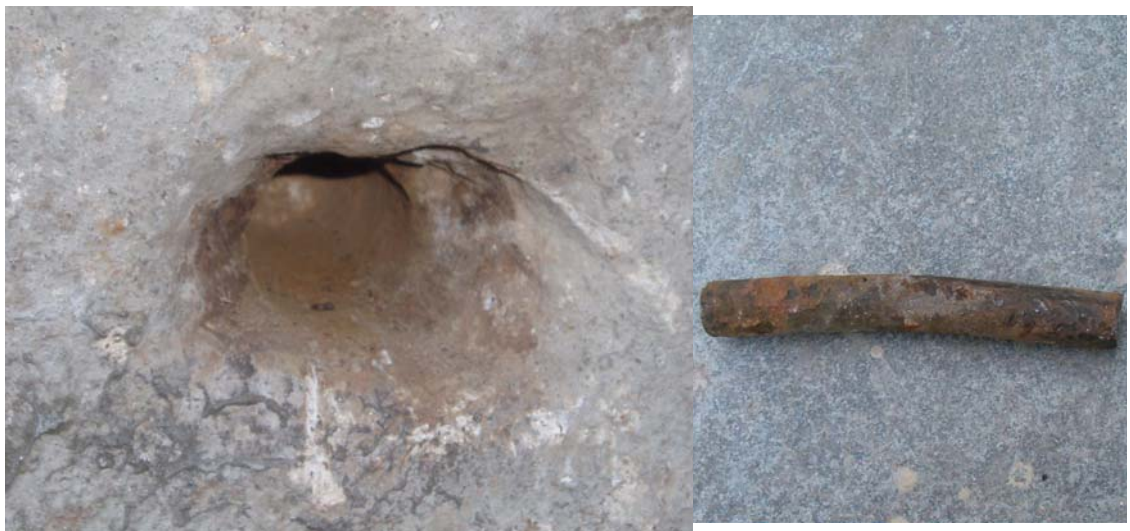
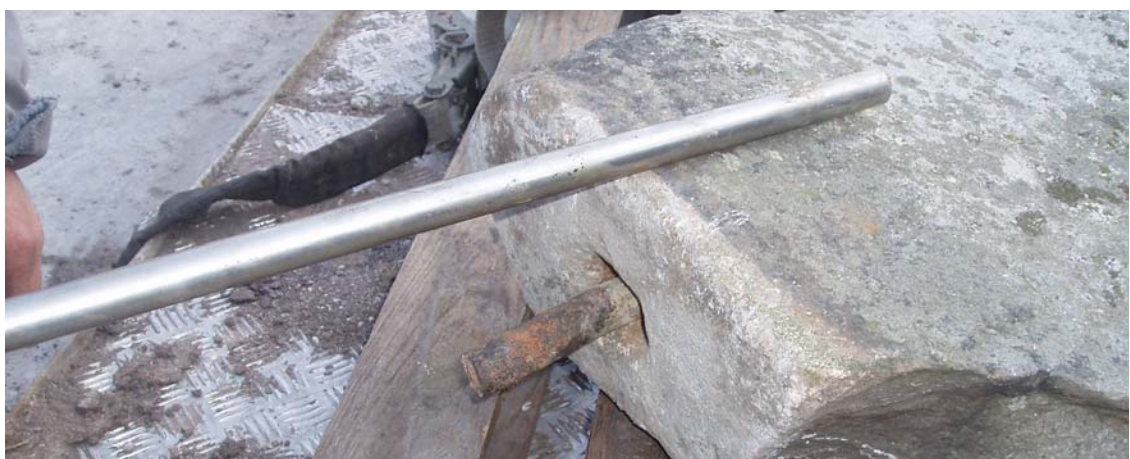
1. Once the old pin was removed it was found to be of mild steel with only a little corrosion. It measured 7½ ins (19cm) long and had a diameter of an inch (2.5 cm). Owing to an incorrect previous restoration, in which the base-stone was wrongly oriented in relation to the cross, thus leaving a gap between the two, it had been bent slightly to fit it into place. When this happened is not certain, but possibly at the restoration prior to this one (ie 2005). The hole in the bottom of the shaft to receive the stone was 4 ins (10cm) deep while the hole in the base-stone was 3½ ins (9 cm) deep.
2. This pin is not believed to have been the original one provided in 1870, when the cross was first moved to the Wharnccliffe Arms. Iron, rather than mild steel, is likely to have been used at that time. Therefore some interim move must have taken place, perhaps when the

3. Possibly at the same time as the mild steel pin was provided, the dowel hole in the base of the cross appears to have been deepened. The original was a 2 inch deep, tapering and irregular hand-drilled hole of roughly triangular section, but the inner inch of the hole was circular and straight-cut, probably the result of further drilling to allow a slightly longer pin to be used (Fig 11).

Fig 11 The cross while at St Just: detail of the original hole for the pin; the former pin, and the new stainless steel rod to be used for the new pin

2. Back at the workshop in St Just, the hole for the central pin in the bottom of the cross-shaft was drilled to 2.5 cm (6 ins) deep, and a new 20mm diameter, stainless steel pin leaded in, the lead taking up all the slack of the old rather irregular hole. Lead was used on this occasion, rather than the more usual polyester resin, because it is a softer material with a certain amount of give in it. This very small post-like cross is always likely to be leant against, even though the garden now belongs to a private flat rather than a pub: and it is hoped that the lead may give it a bit more resilience in this situation, as well as being easier to remove if there is a need in the future.

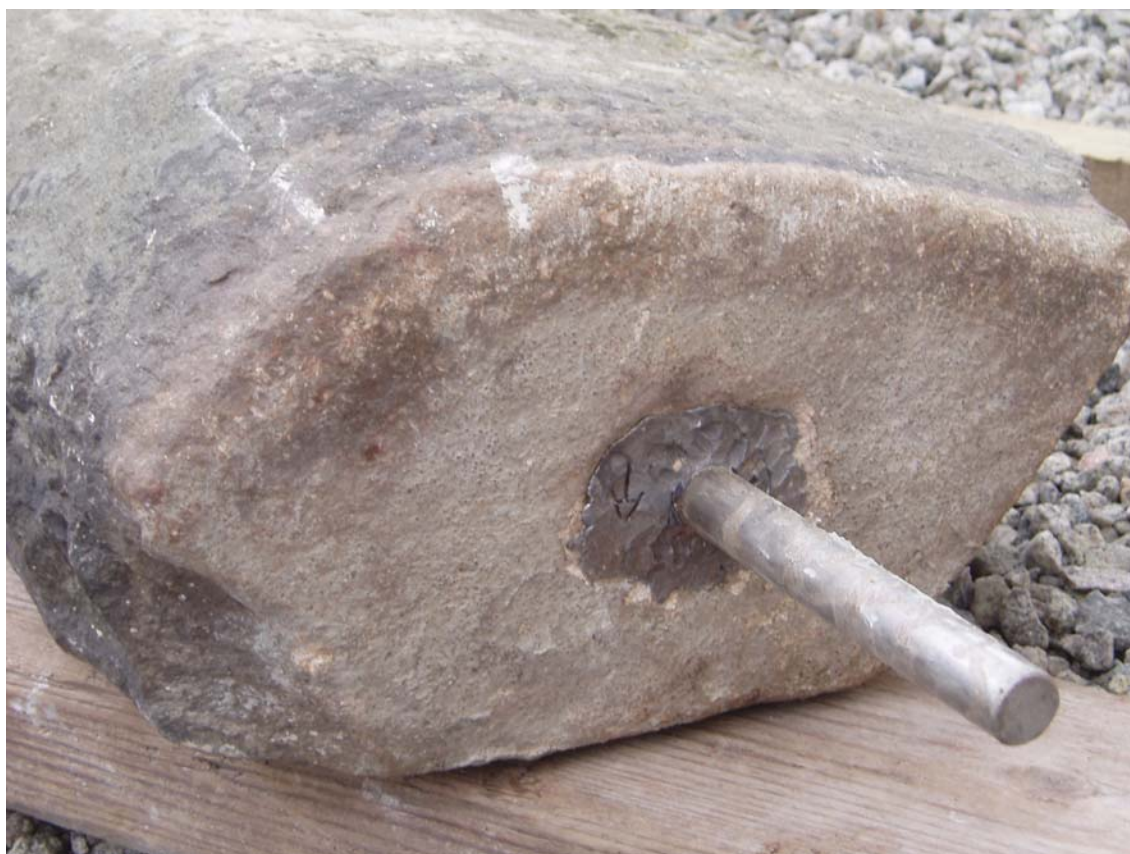
Fig 12 The new pin, leaded into place

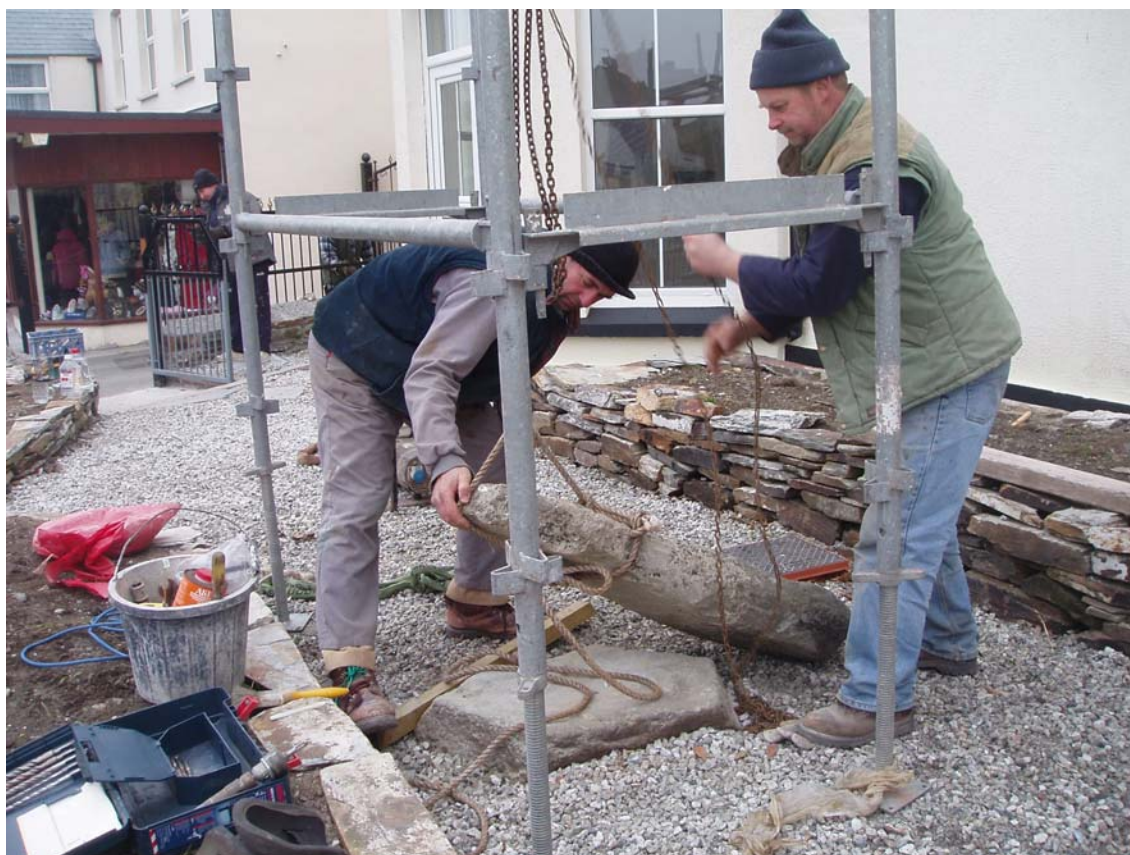
Fig 13 Lifting the cross back into position

cross. A scaffold was erected around the cross base, and a block and tackle hung from this, so that the cross could be carefully lowered onto the base-stone. An important consideration was that the cross should be replaced with exactly the same orientation as originally and when the cross was first lowered onto the base, it was found that it was unevenly seated, with a gap between the base-stone and the bottom of the cross. This could have been wedged with stones, as previously, but it was clear that the cross would be very much more stable if it were resting fully on the base-stone. The base was therefore swivelled around by 180 degrees and when the cross was lowered down onto it again, it was found to be an excellent fit: the slightly sloping surface of the base stone matching the non-horizontal bottom of the cross almost perfectly (Fig 14). The cross was therefore lifted, the dowel hole filled with stone resin, and the cross lowered back down for the final time. As a finishing touch, the joint between the base and the cross was filled with a narrow fillet of lime mortar, to help keep the joint water-tight and light from degrading the resin (Fig 15).

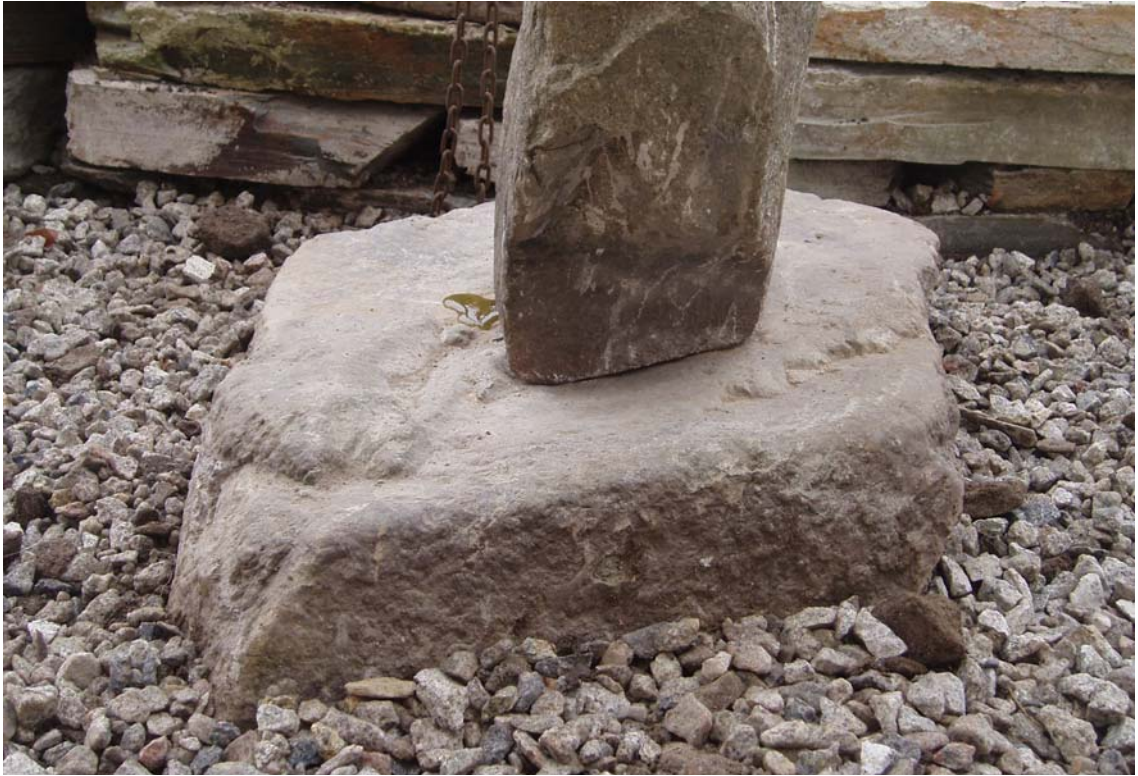
3. The base, which prior to the recent events, was hidden by turf, was found to be a solid block of local greenstone, of rather irregular shape, and surprisingly sloping on top. On restoring the cross, it was realised that this stone had in fact been carefully selected and dressed to provide a perfect match for the bottom of the cross, which is also not horizontal.

Fig 14 Detail of the sloping joint between cross and its base

3. In the event, the final restoration of the cross went very smoothly, because it was found that the uneven surface of the old base stone, originally thought to be an ugly but suitably large bit of stone, had in fact been carefully selected and dressed to fit the bottom of the

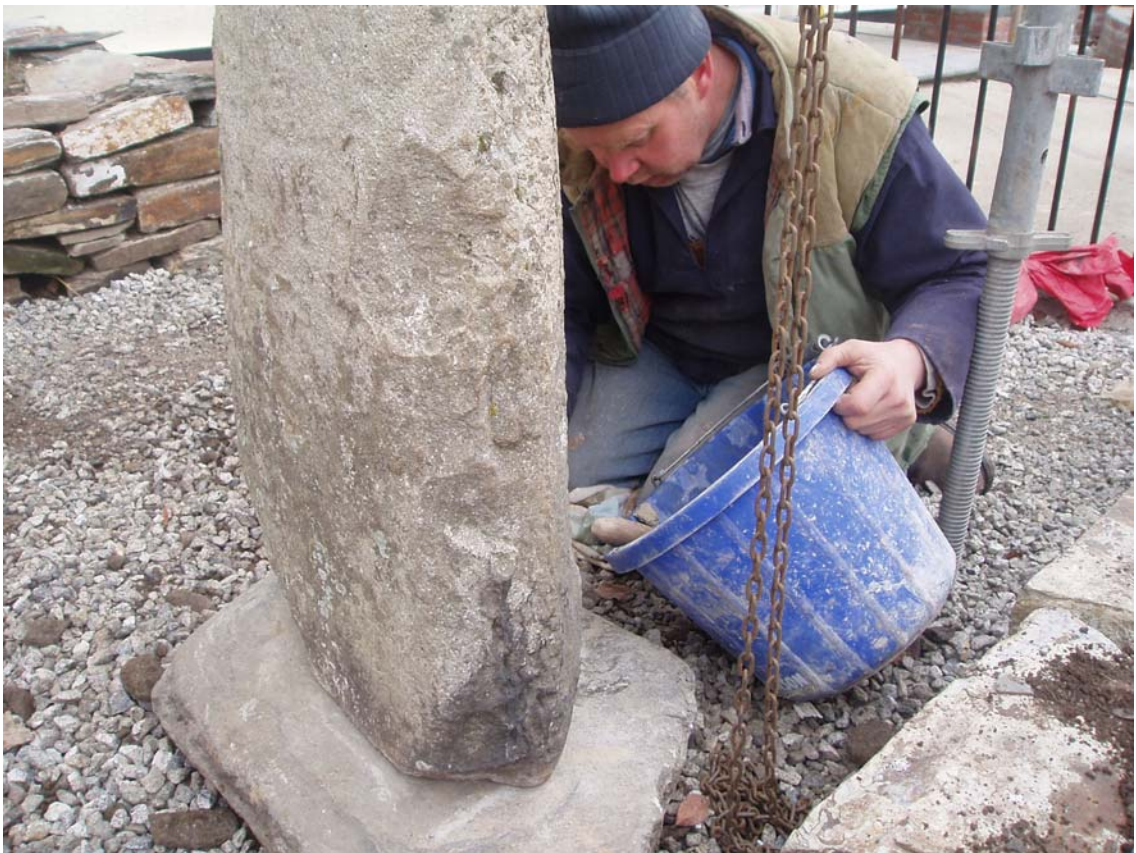
Fig 15 Mortaring the joint at the base of the cross

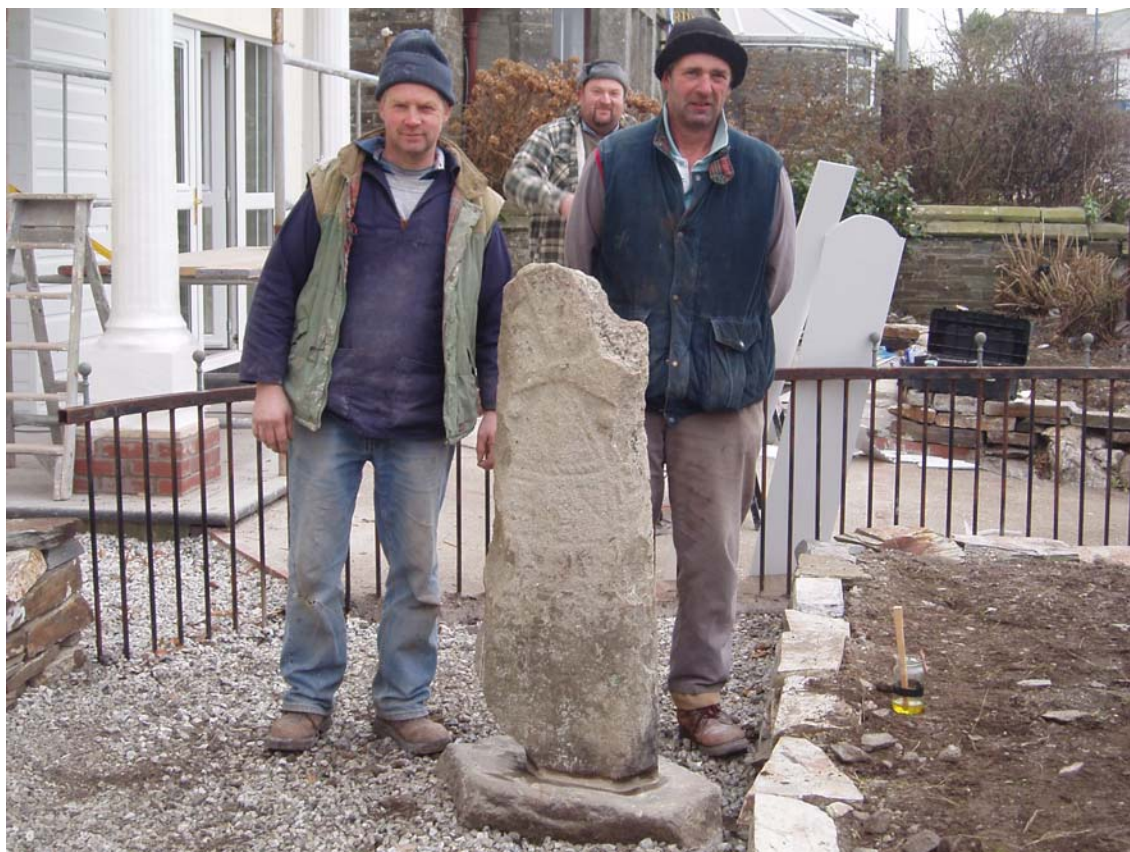
Fig 16 The restored cross

The cross now sits in what will become a small private garden, and this much will itself provide a better measure of protection than in the past. In addition, the new fixings, described above, should provide long-term security. Despite the new, private, setting, the cross remains fully visible from the main street in Tintagel and in that sense is viewable for anyone at any time.
