The Nine Maidens Madron Cornwall

Restoration

**(scrub clearance, drainage, re-erection of
three fallen stones)**

Report No: 2008R048

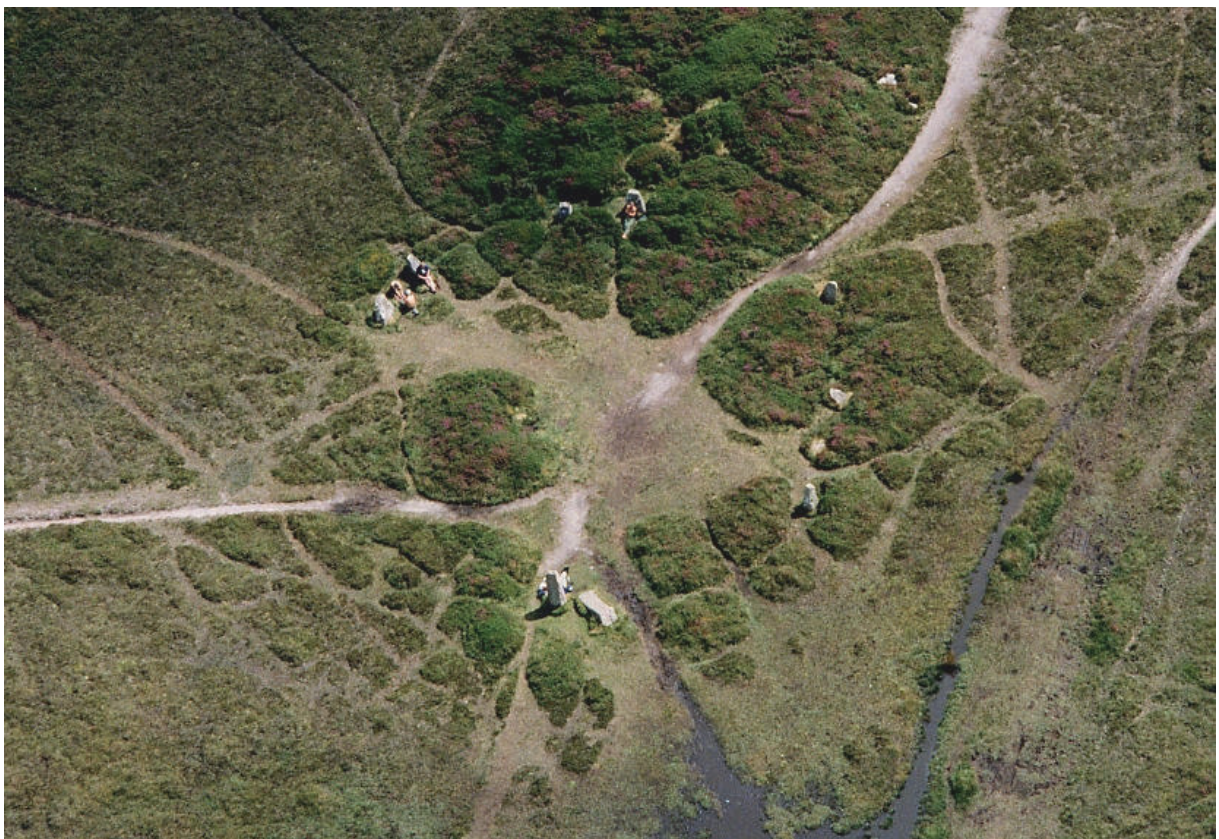
unstable. Since this time, pagan activity has remained relatively stable, but the general problem of ground erosion associated with the popularity of the area has become progressively worse. Figure 6 shows the condition of the monument in 1999, at the time of the Total Eclipse in Cornwall.

Fig 6 The Nine Maidens from the air in 1999 (English Heritage air photo NMR 18469, frame 20).

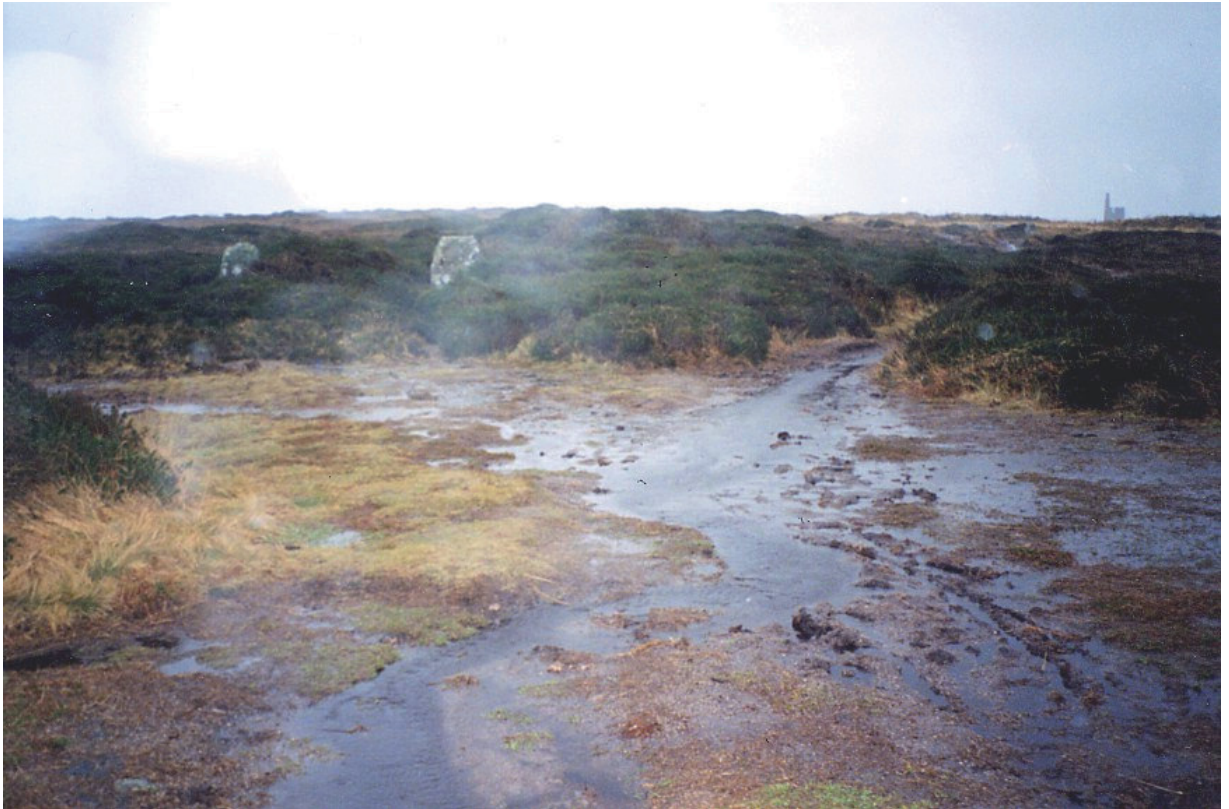
Fig 7 The centre of the Nine Maidens in the winter of 2003. Note the extremely muddy ground and gorse growth around stones.

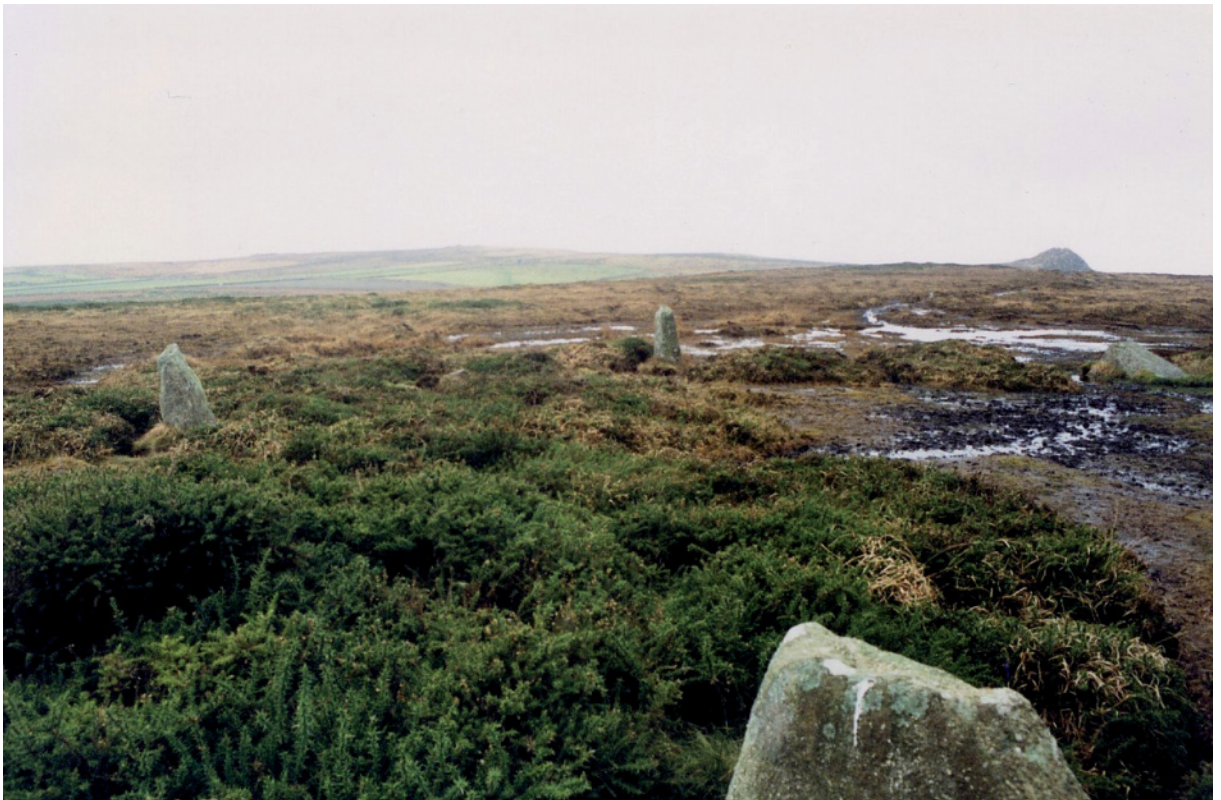
Fig 8 The Nine Maidens in the winter of 2003 from the south, with Carn Galva visible on the horizon (right side of photo). Note the gorse growth around the stones.

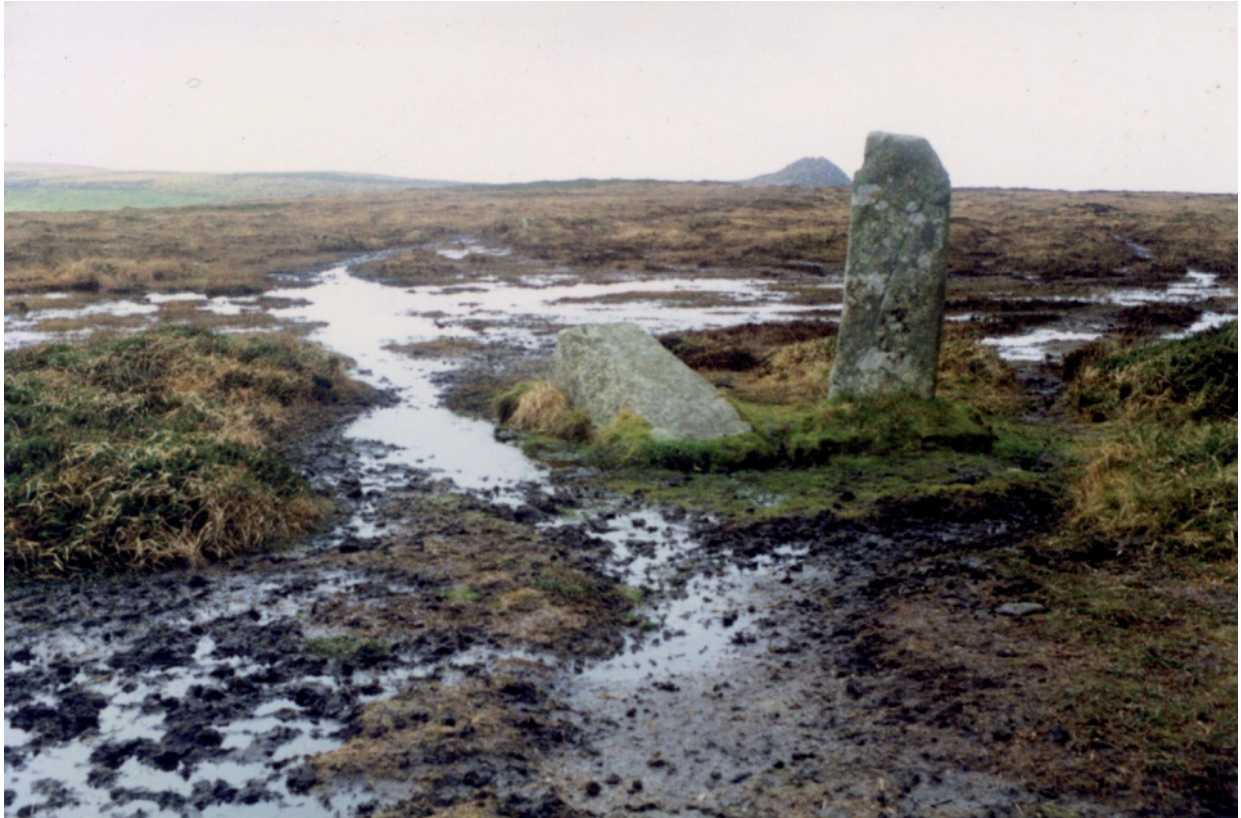
Fig 9 The largest stone and its fallen partner, with a view towards Carn Galva. Note also the extremely muddy ground.

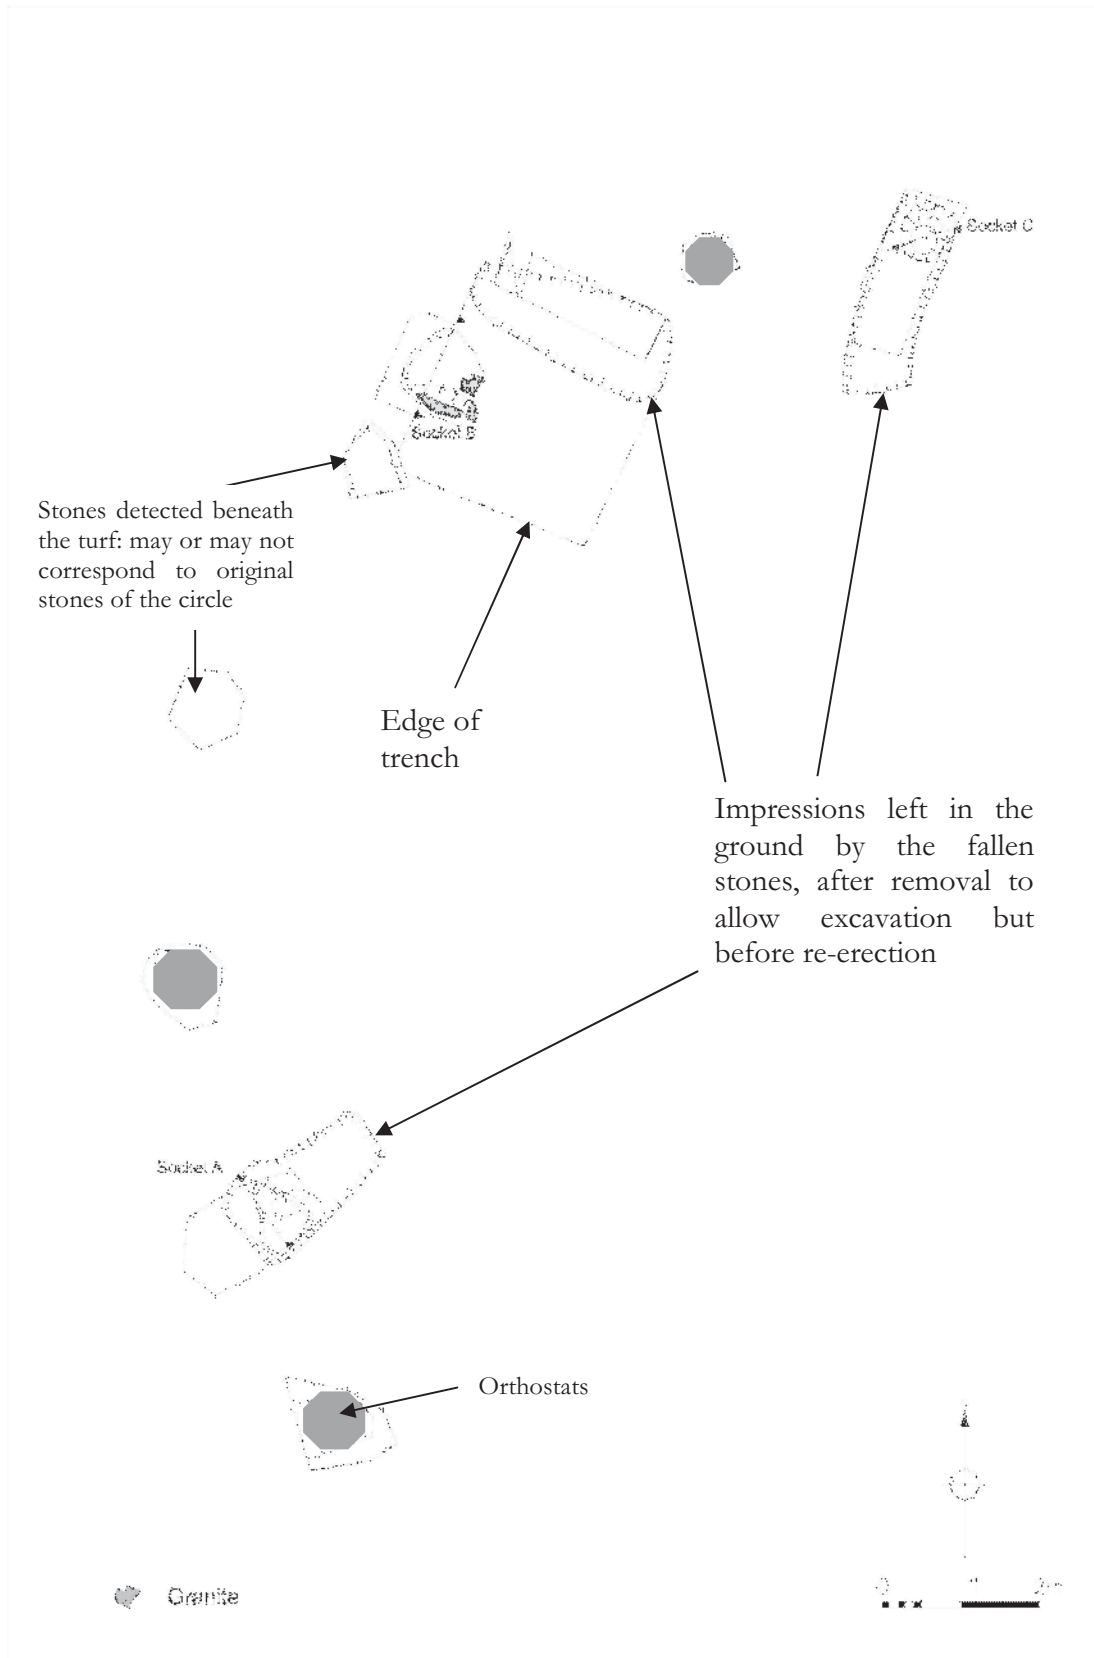
Fig 17 Plan of the excavation trenches by Sean Taylor

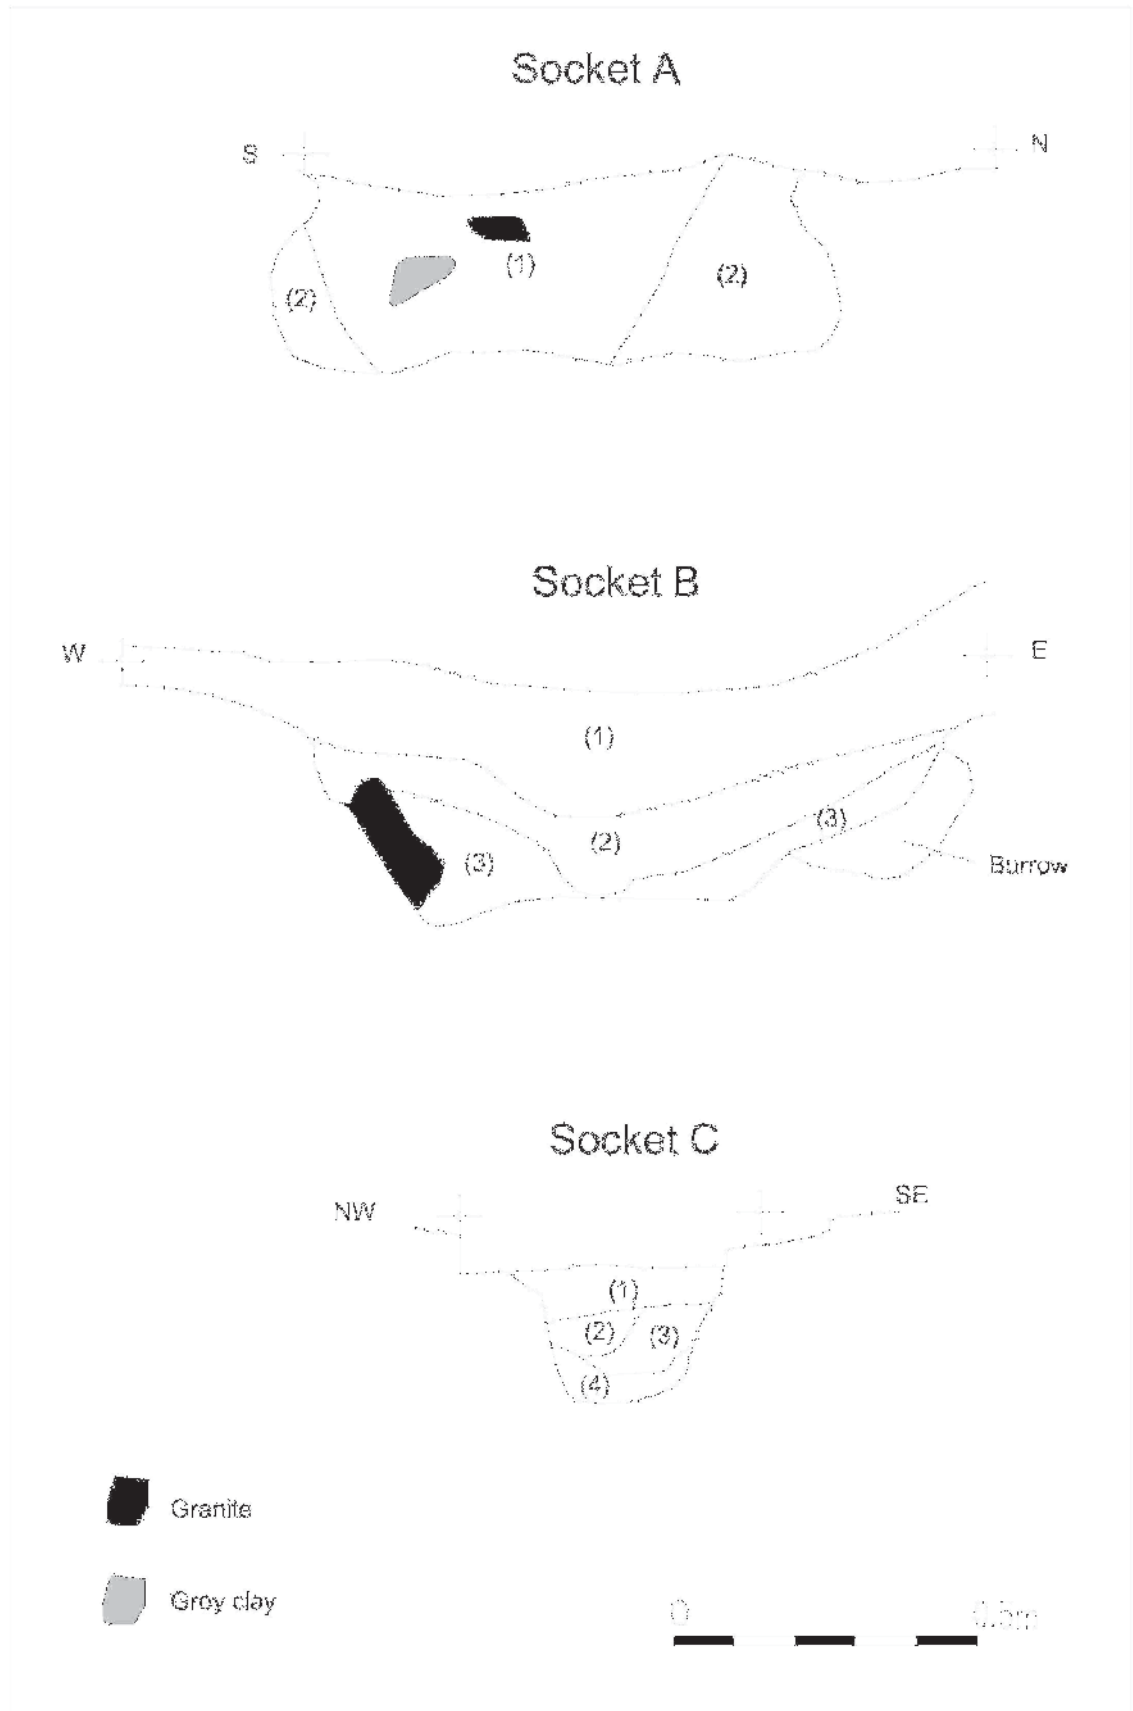
Fig 18 Section drawings of the excavated sockets for the stones that were subsequently re-erected (Sean Taylor)

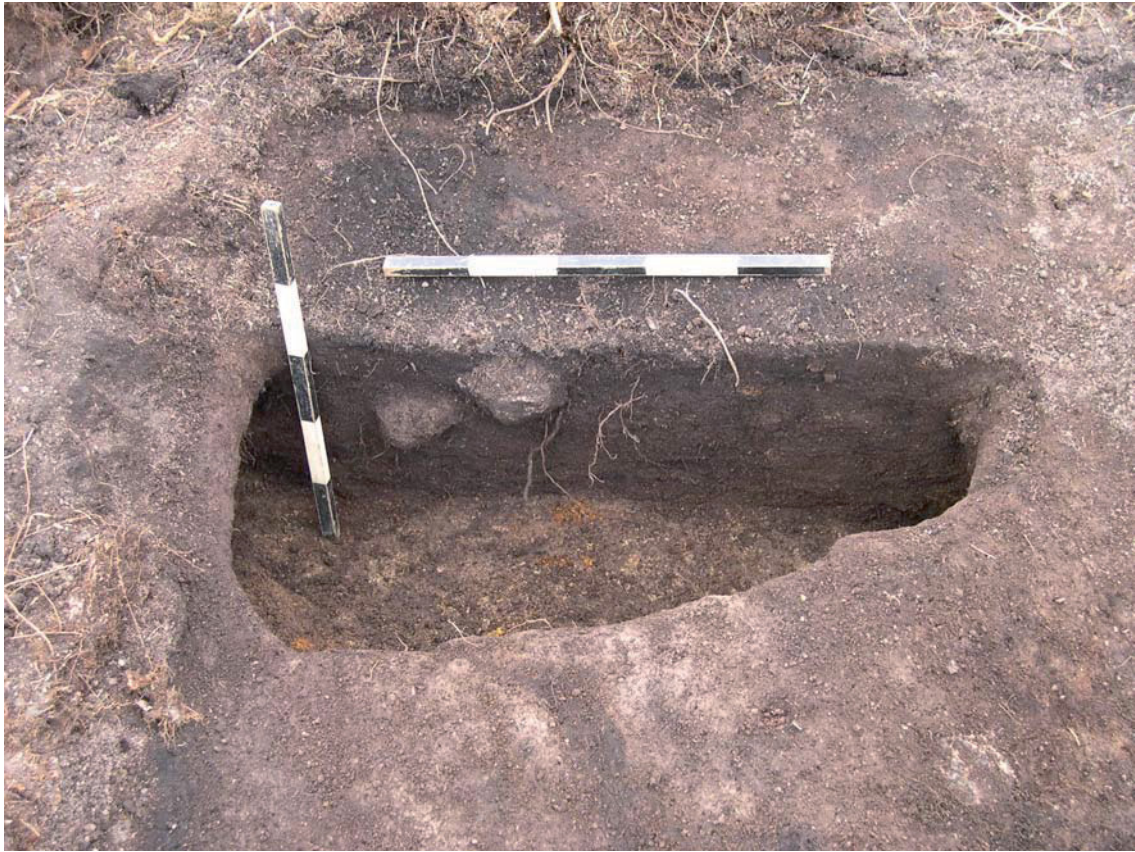
Fig 19 Socket A half-sectiond

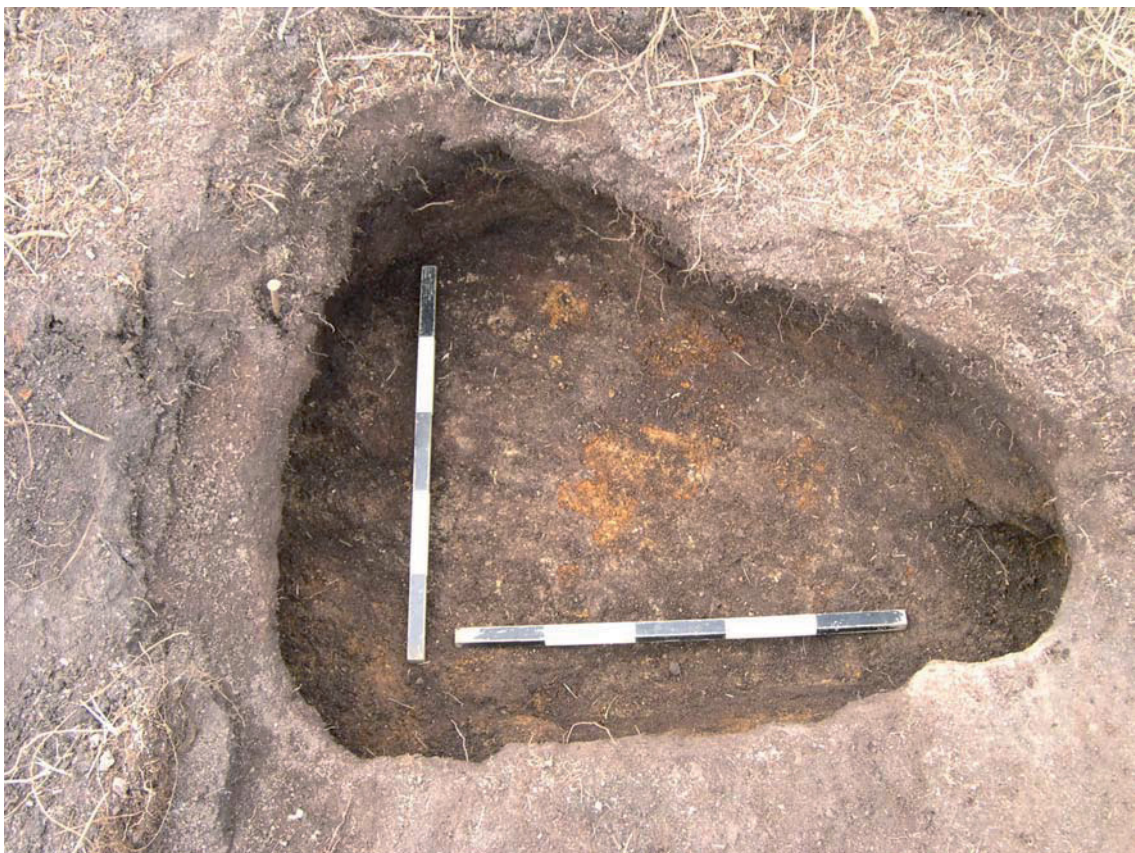
Fig 20 Socket A fully excavated

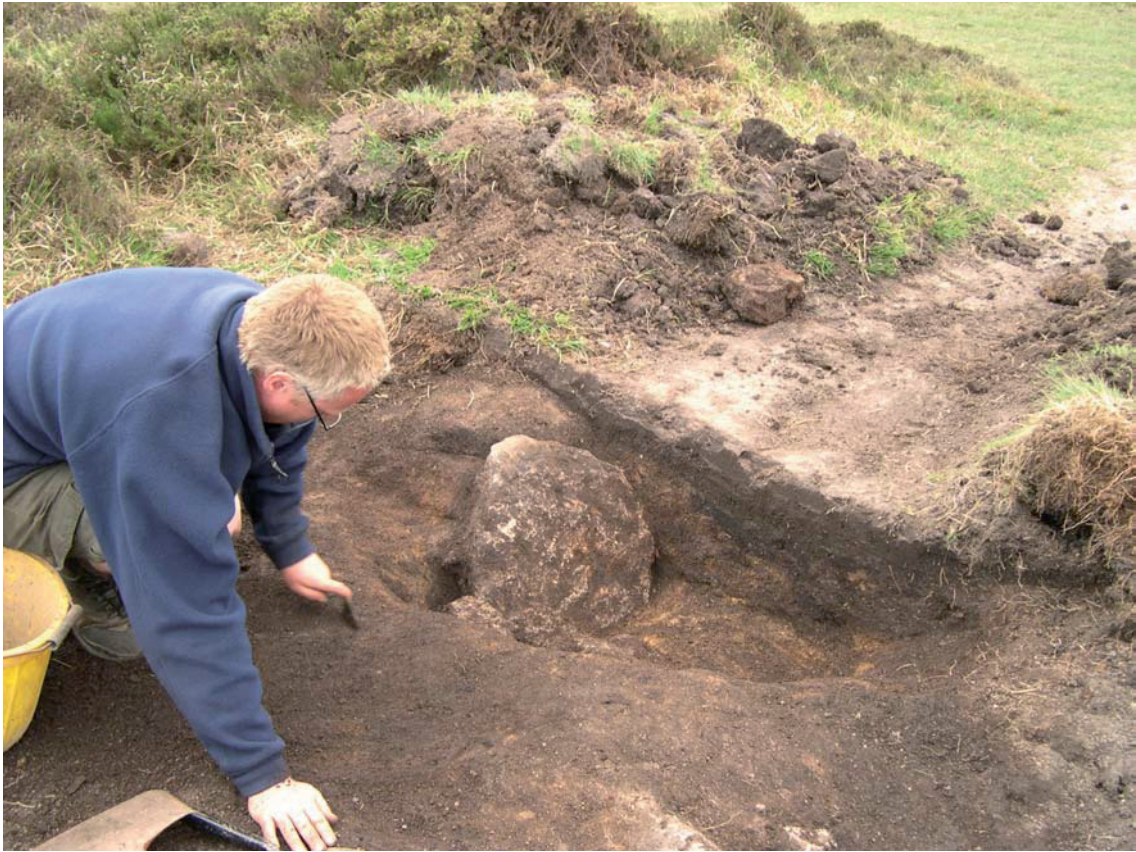
Fig 21 Sean Taylor excavating Socket B; packing stones can be seen in the excavated socket

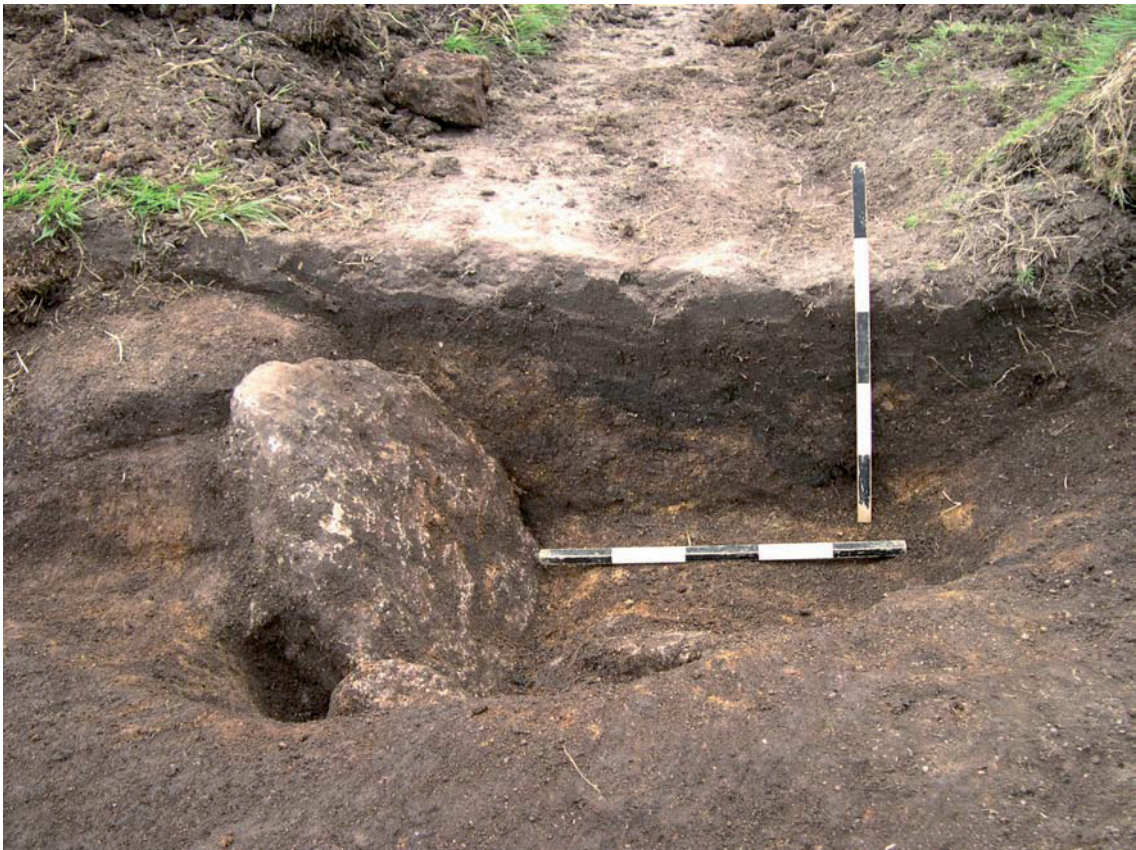
Fig 22 Socket B half-sectioned

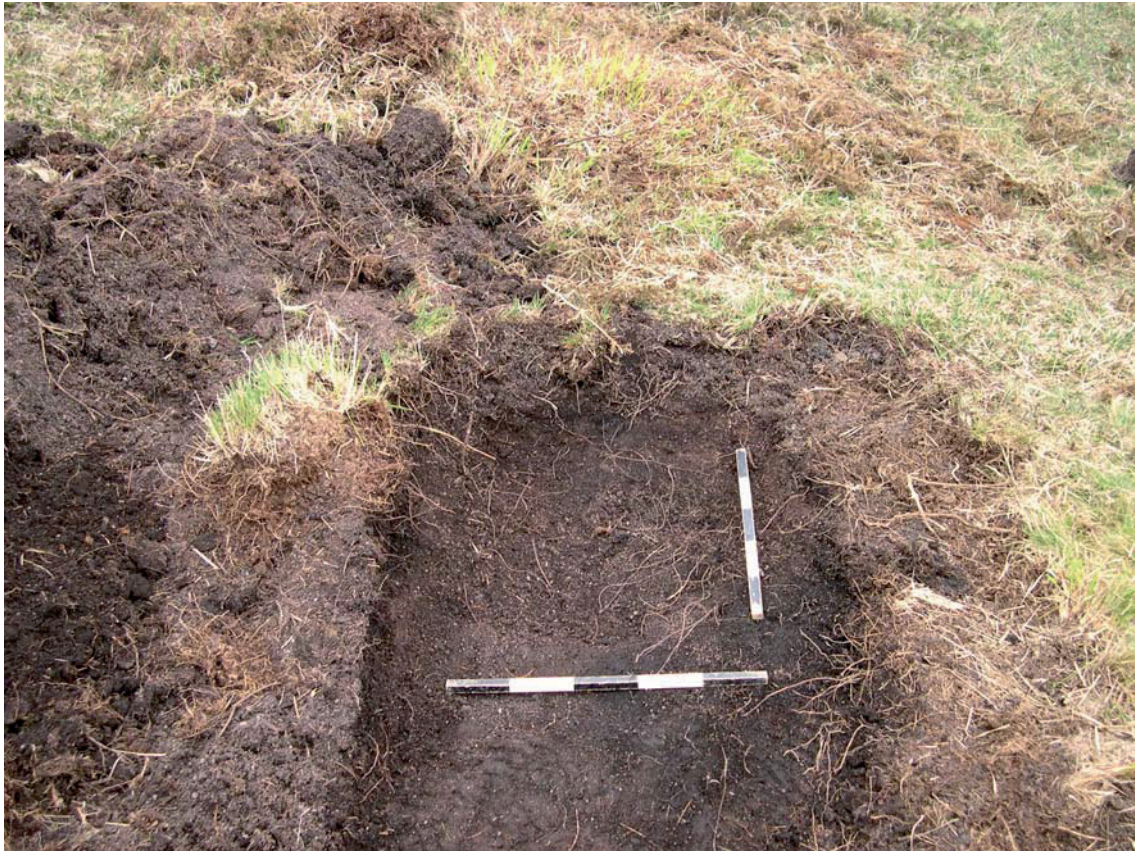
Fig 23 Top of fill for socket C at the end of the stone's impression in the ground

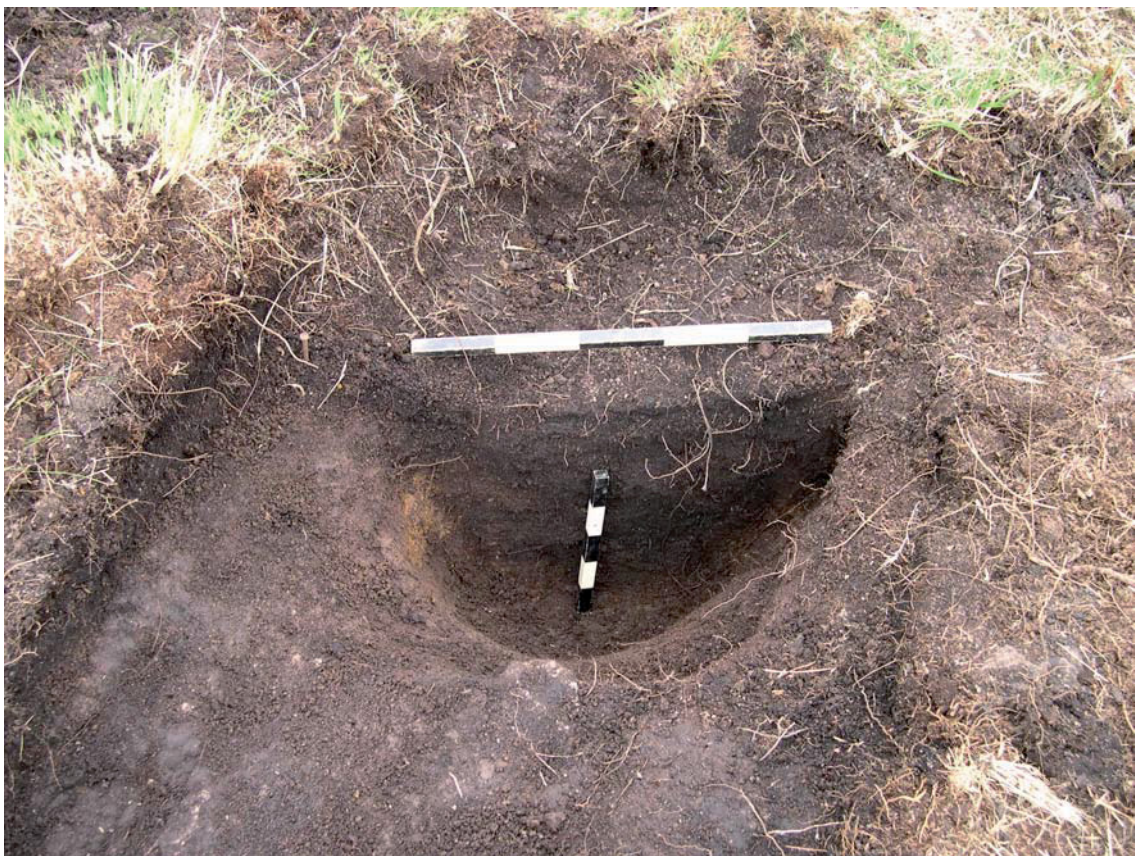
Fig 24 Socket C half-sectioned

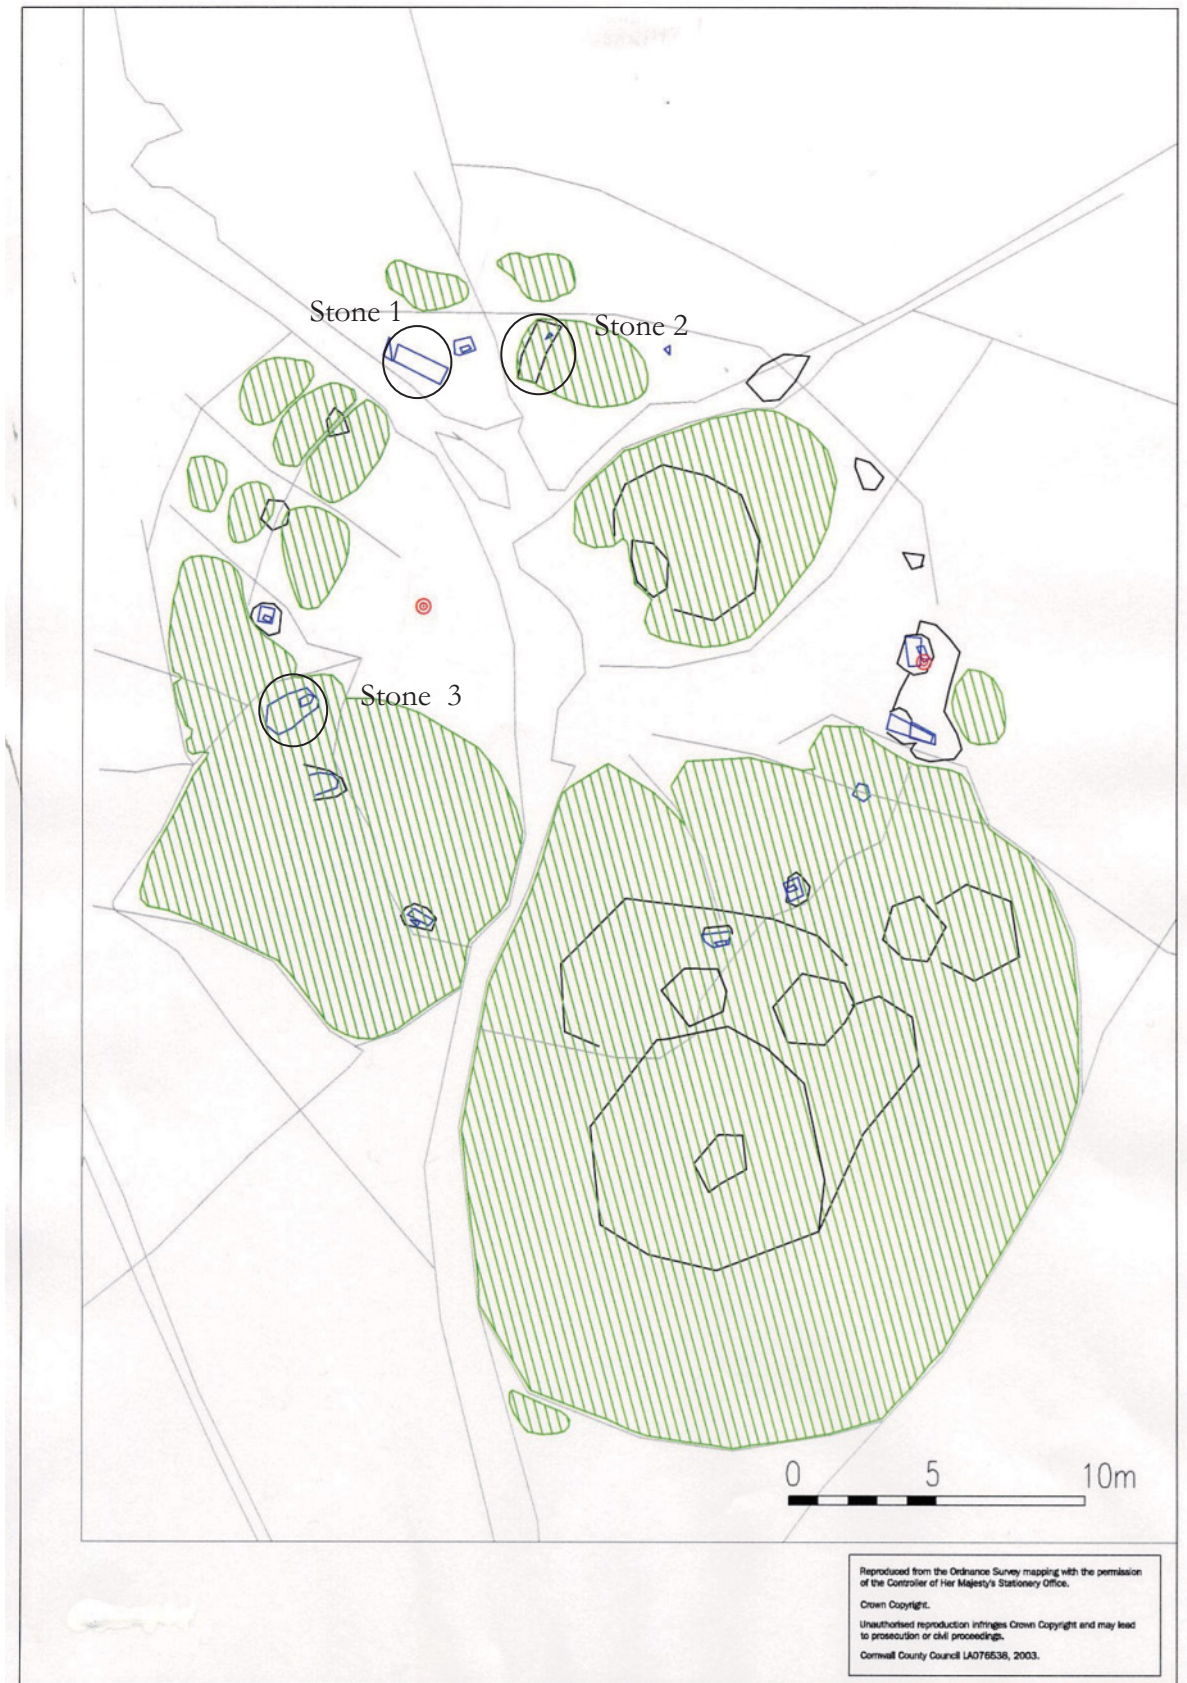
Fig 25 HES plan of the Nine Maidens, showing areas of dense gorse (in cross-hatching) that were removed in 2004, and the positions of the stones that were re-erected.

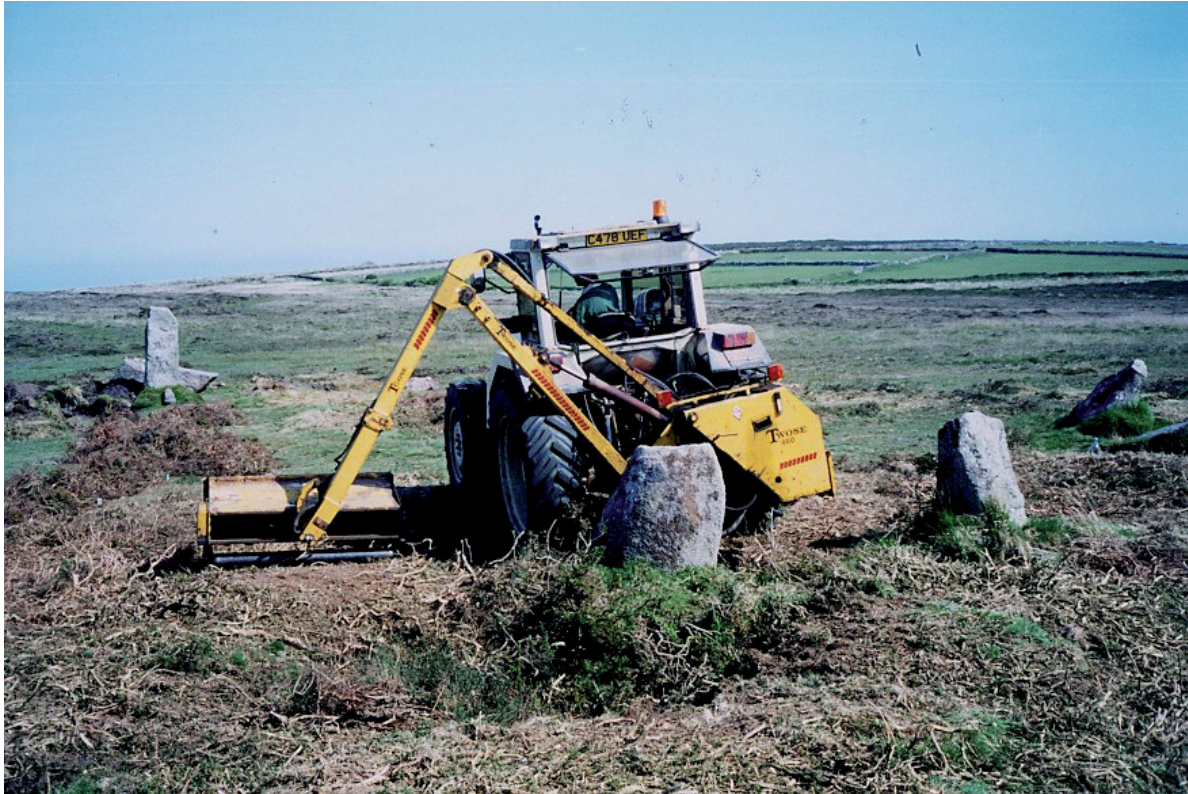
Fig 26 Scrub clearance under way at the Nine Maidens in May 2004

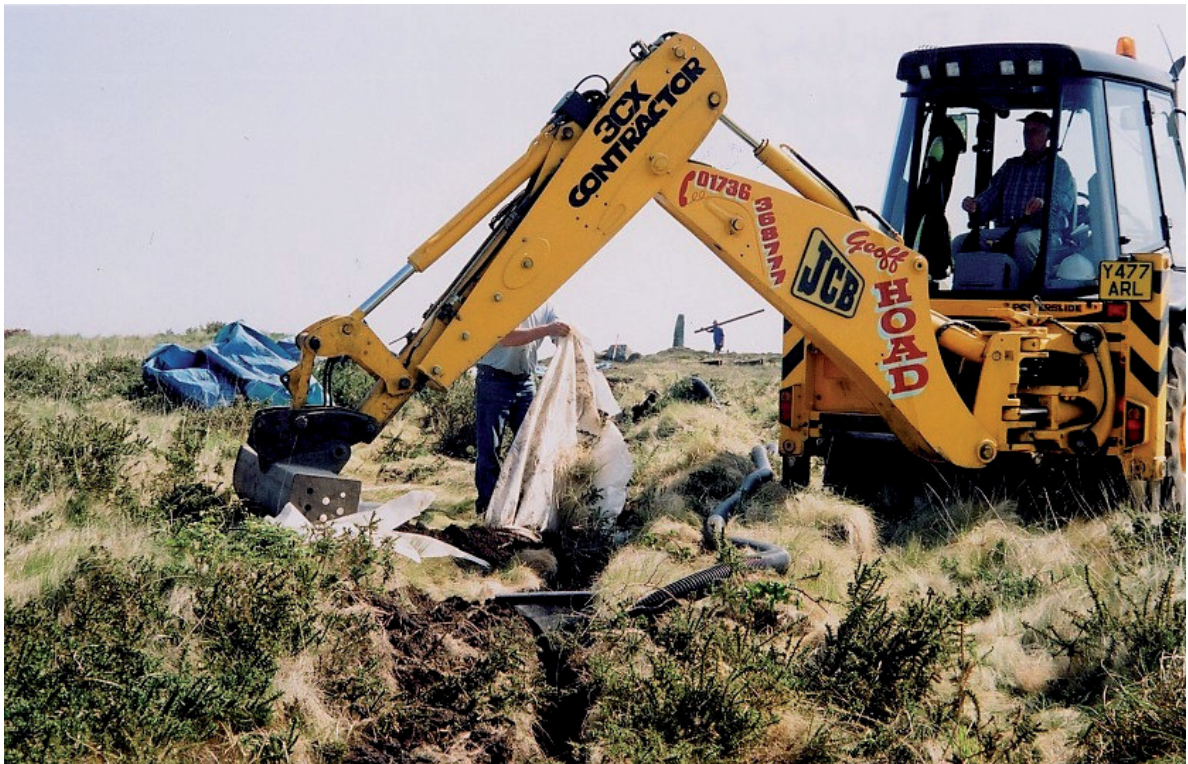
Fig 27 Drainage work underway at the Nine Maidens in May 2004

- In the trenches over heathland, the same procedure was used, except that the trench was directly back-filled with rab, and chippings used only at the pipe's exit, to allow water to drain out freely. The heathland vegetation was replaced over the back-filled spoil, and any loose rab left on the ground was raked, to restore the surface.

- The work took only a couple of days and because ground conditions were dry at the time, minimal damage was caused to the heathland.
- As this work proved effective in helping to keep the monument free of water, but not as effective as had been hoped, a second phase of drainage was carried out in June 2005. In this instance, an extra line of pipe was laid along the line of the path to the west of the one drained previously, and this was connected into the 50 metre pipe taking water downhill over heathland.

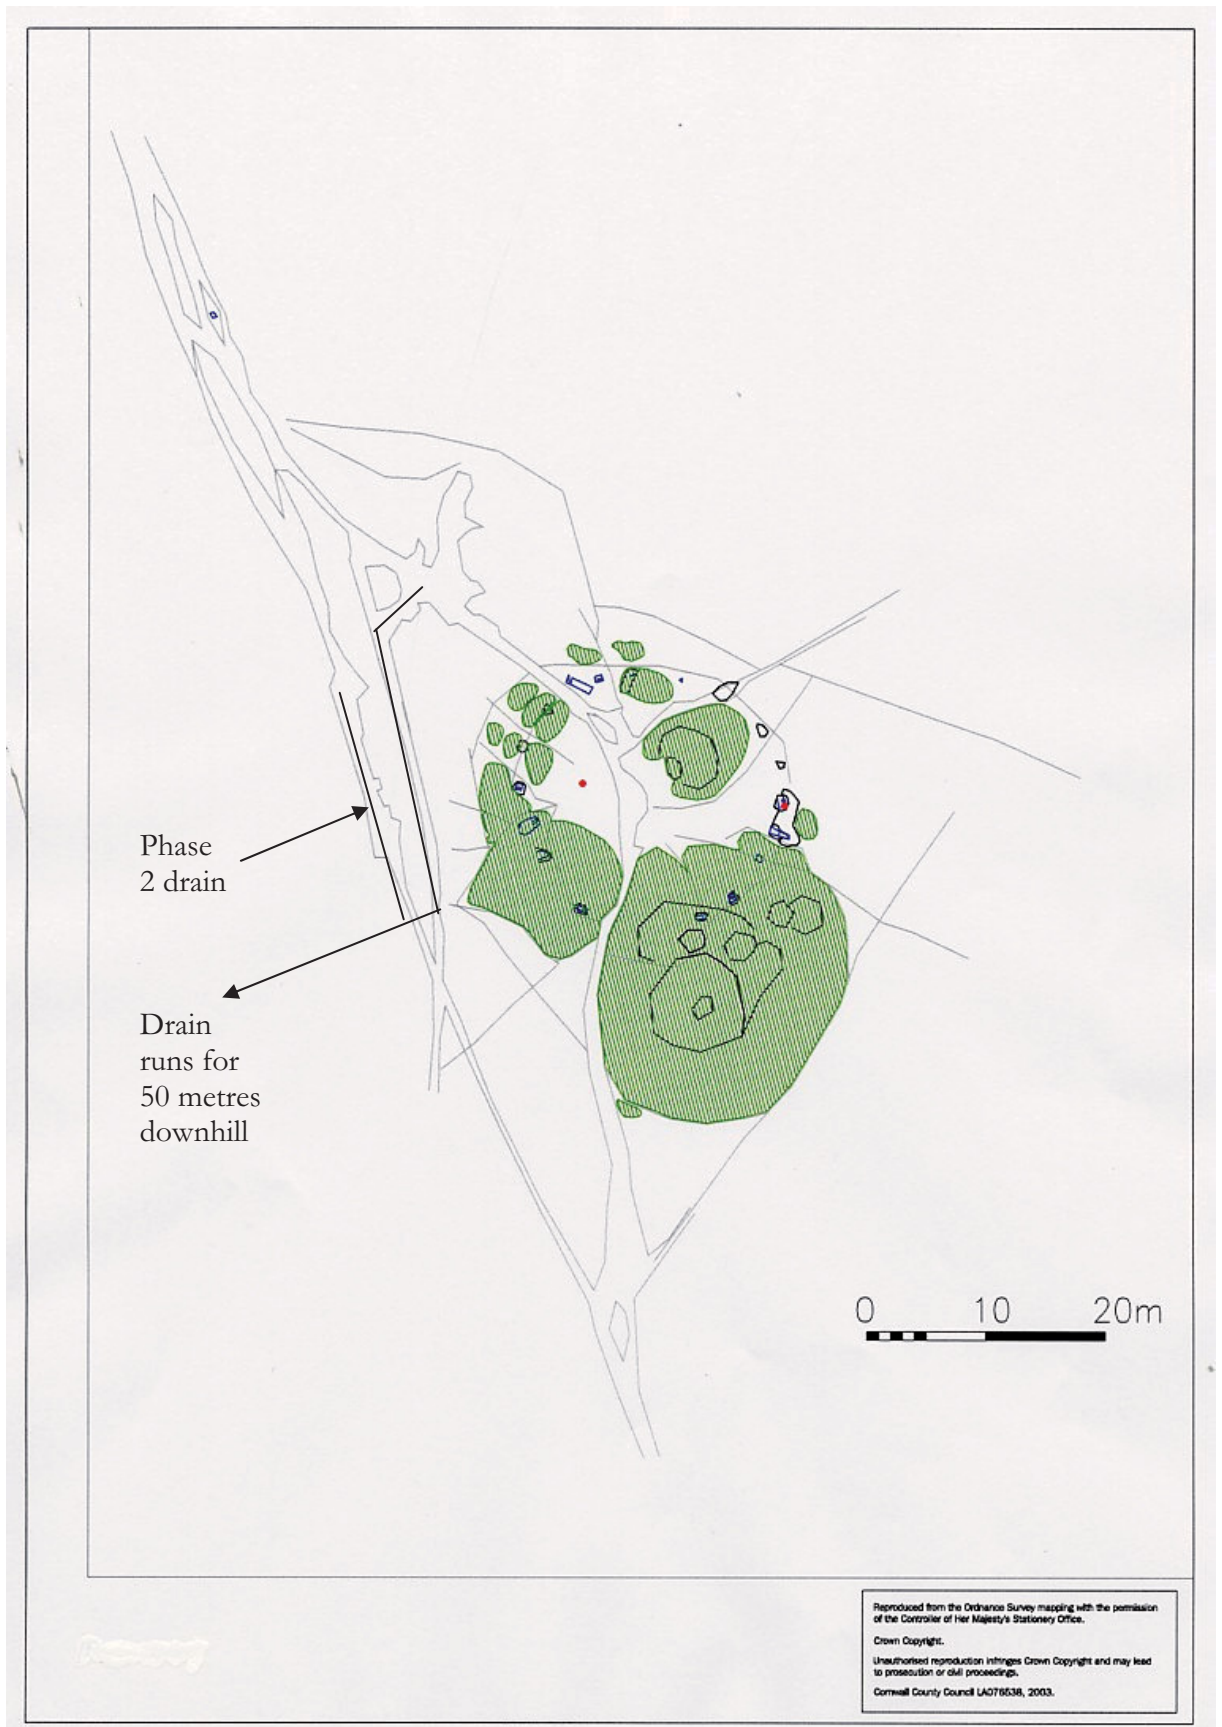
Fig 28 Plan of the Nine Maidens, showing the locations of the drainage trenches (with, in light grey: the paths and bare areas)

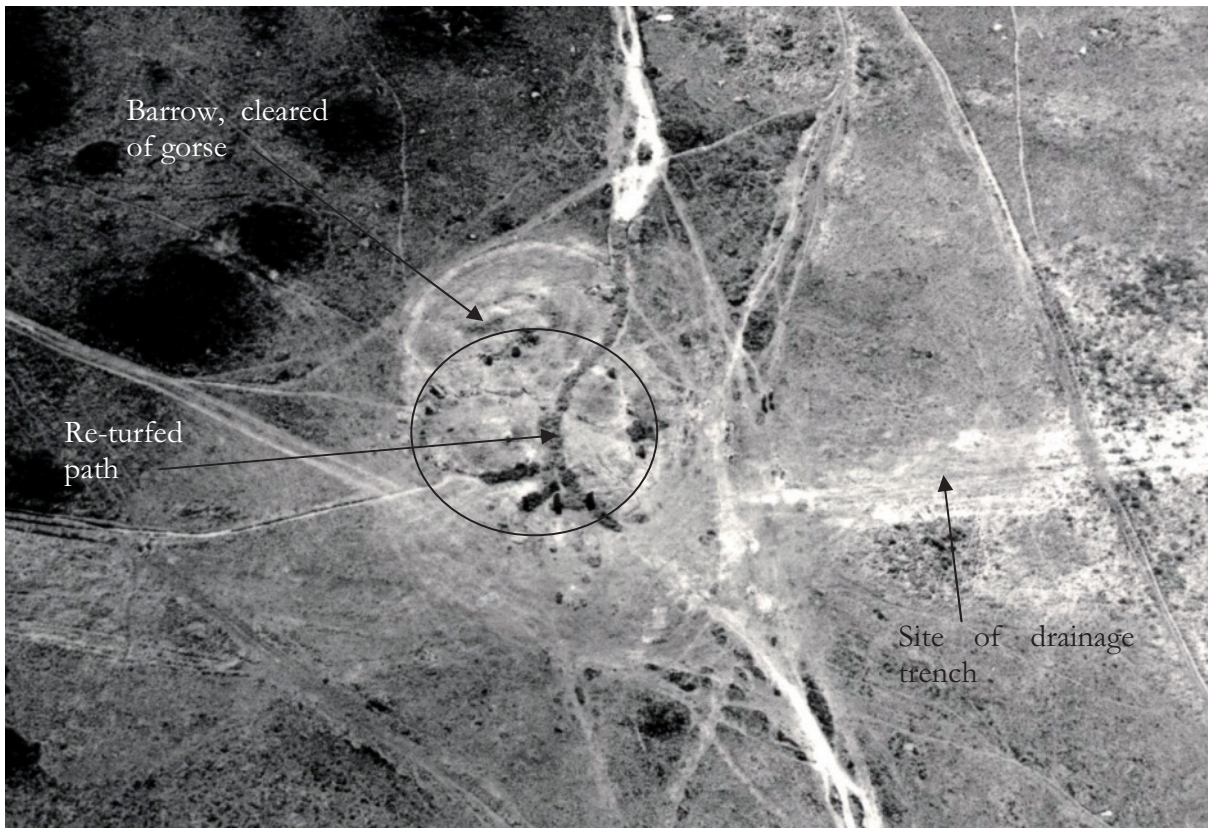
Fig 29 Air photo of the Nine Maidens, shortly after the management work. Though not the best photo of the site, it does show the re-turfed path very clearly; but most obvious are the many paths focussing on the circle, demonstrating the immense pressure that it is under. (CAU air photo F63/8)

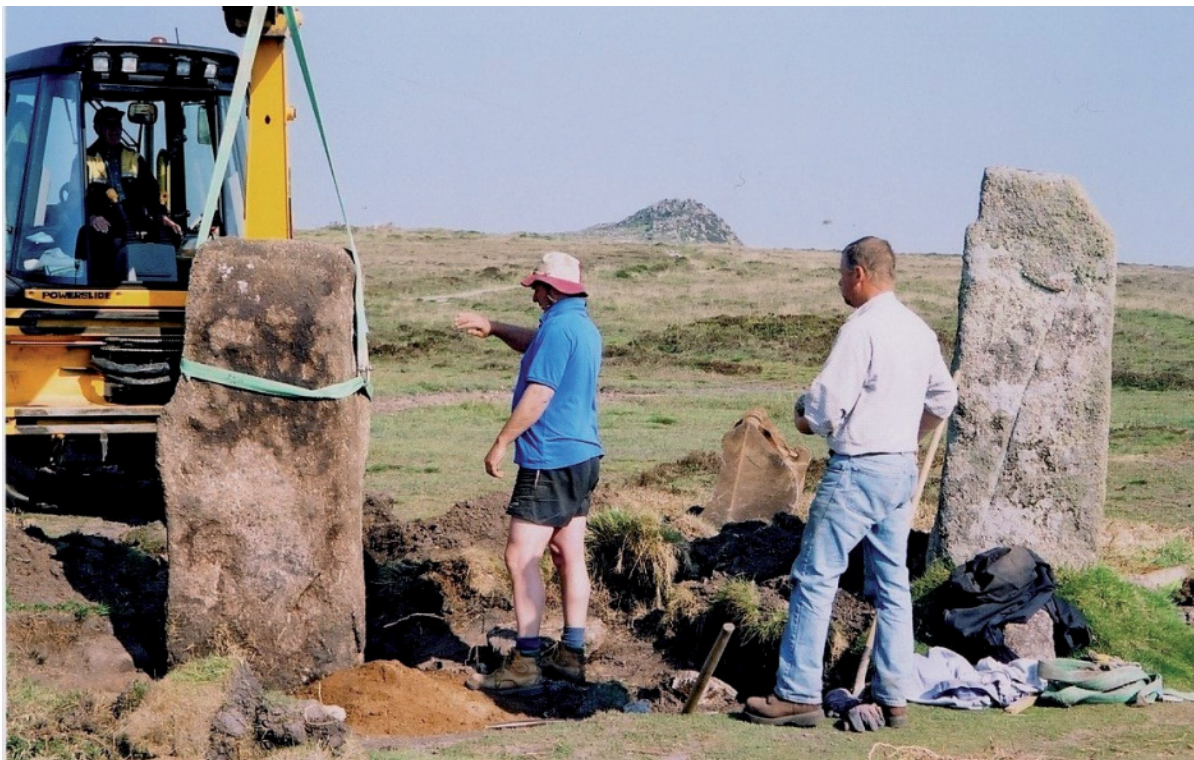
Fig 30 Stone 1 is re-erected
