The Nine Maidens Madron Cornwall

Restoration

**(scrub clearance, drainage, re-erection of
three fallen stones)**

Report No: 2008R048

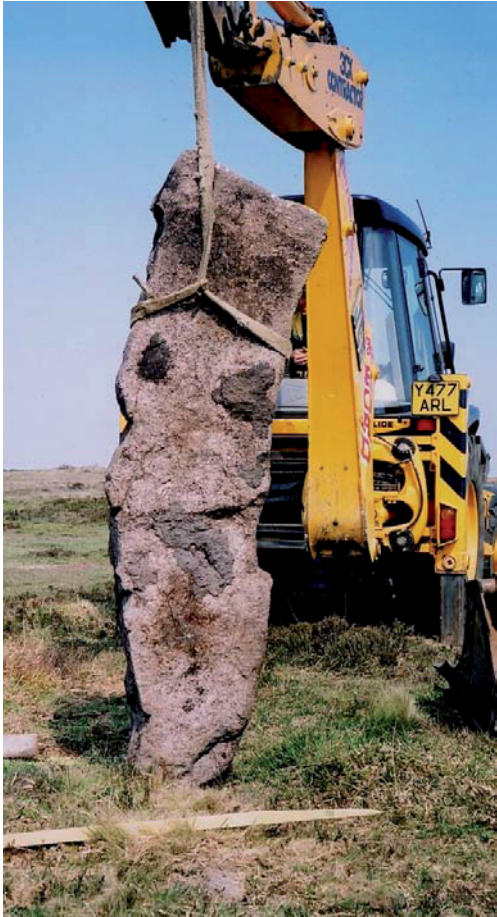
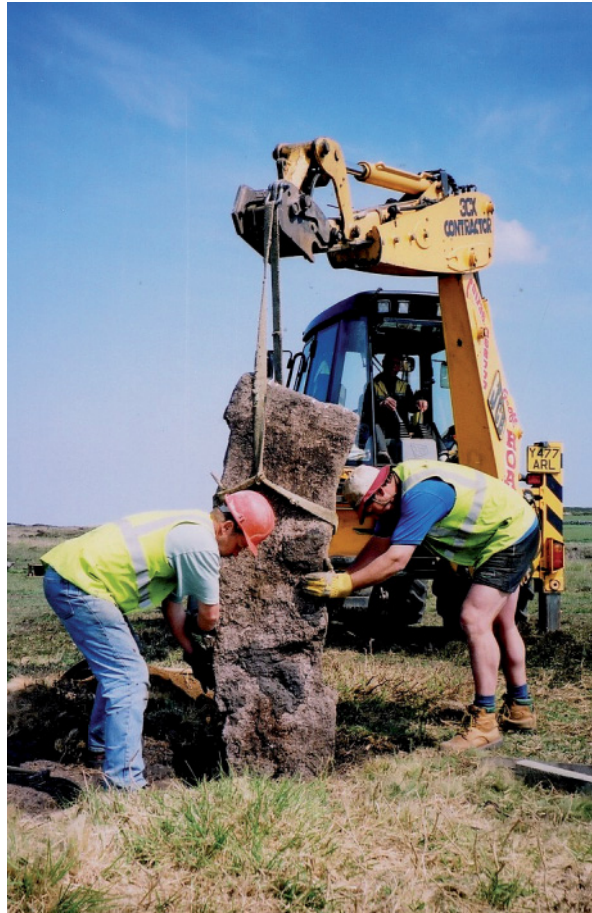
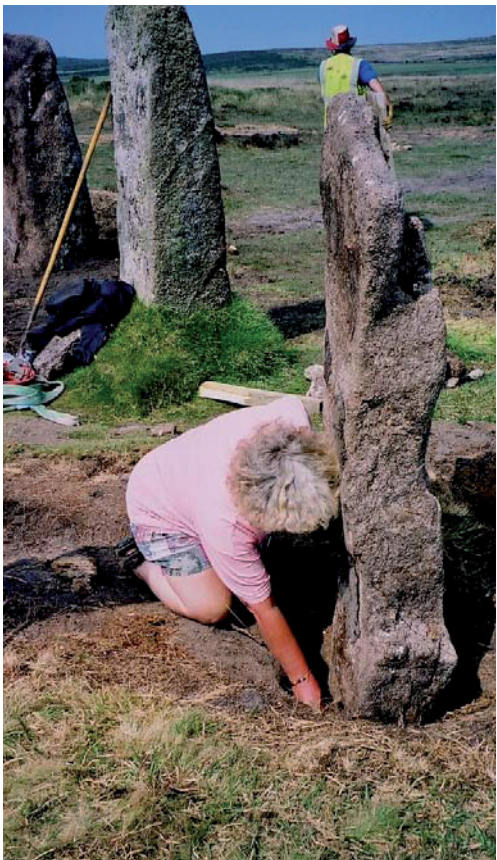
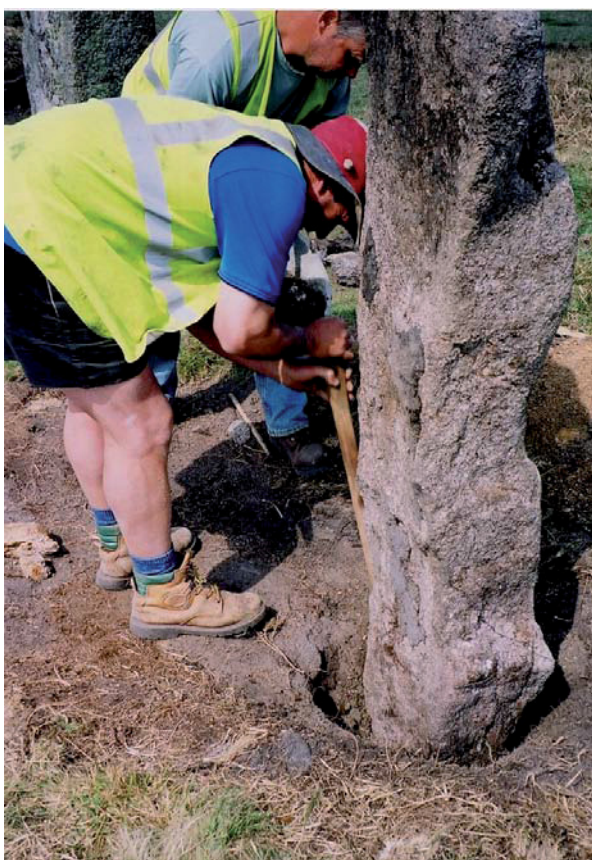
Fig 31 Stone 2 is lifted into the ground, an offering is placed and the socket back-filled

This stone, immediately to the east of the largest stone in the circle, was a long, tapering and rather irregularly shaped slab, with one end wedge-shaped and the other pointed. As noted above, logic suggested that it should go into the ground with the heaviest, wedge-shaped end down. However, as excavation had very clearly shown that it was the pointed end that had been in the ground originally, that was how it was restored, even though that felt wrong! Unfortunately, however, after an initial attempt using the original socket, the hole had to be deepened by about six inches, because the stone looked extremely unstable (see Figs 31 and 33). The hole was packed with a rab/lime mix, the lime being added to give additional strength and security.

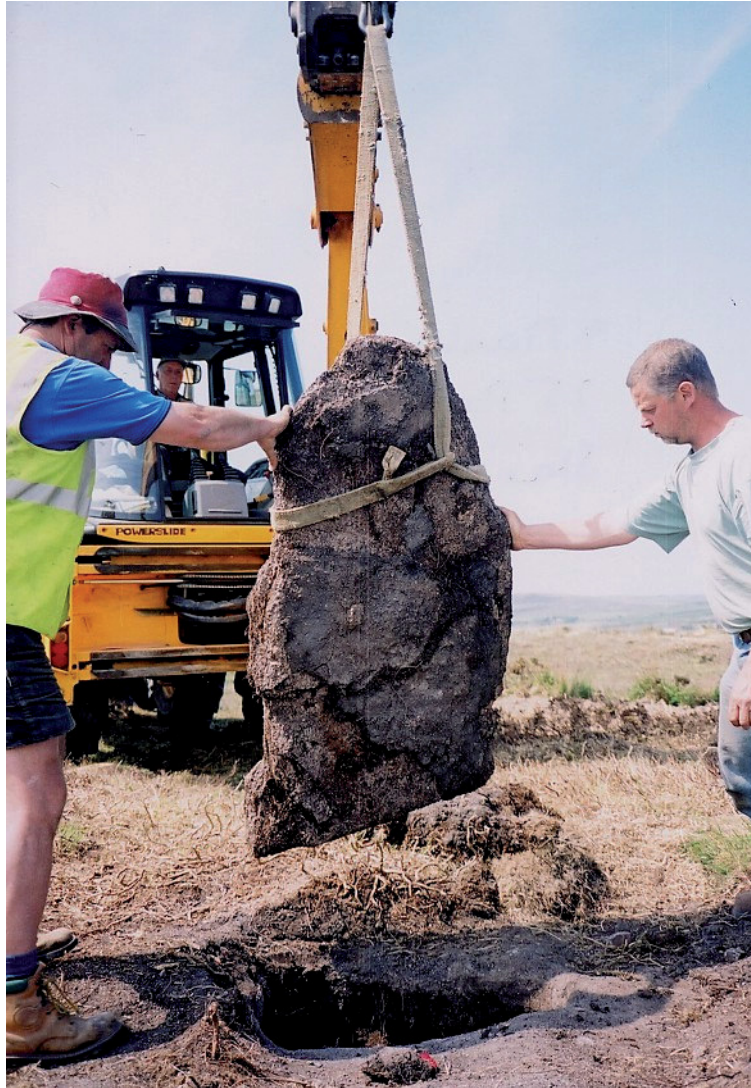
Fig 32 Stone 3 is restored

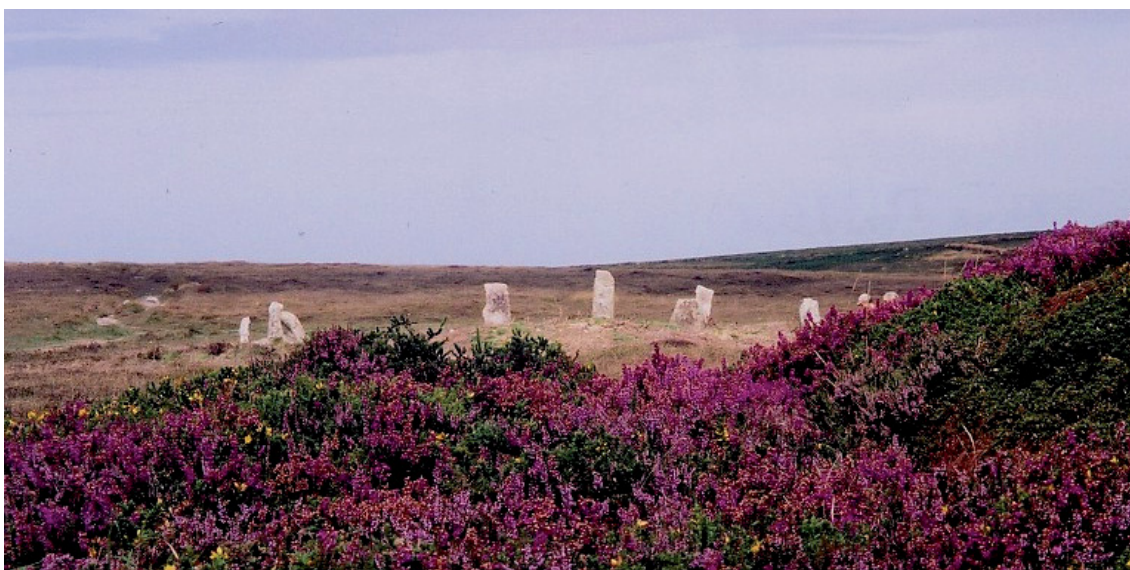
Fig 33 The restored circle

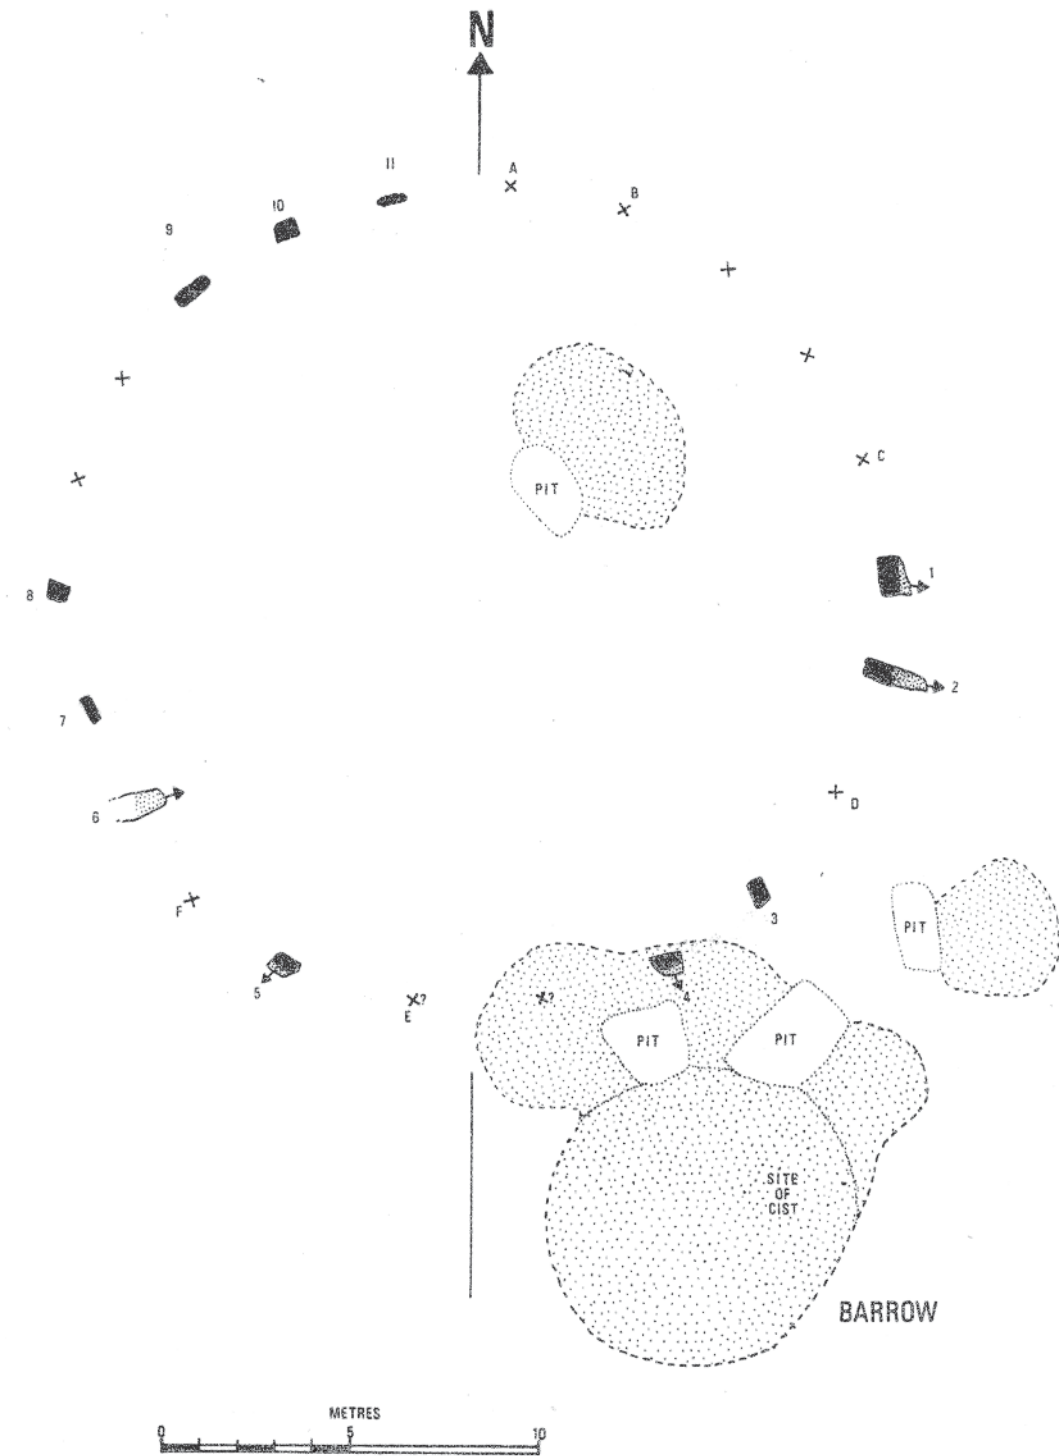
Fig 34 Sketch plan, based on Barnatt 1982, of the restored circle

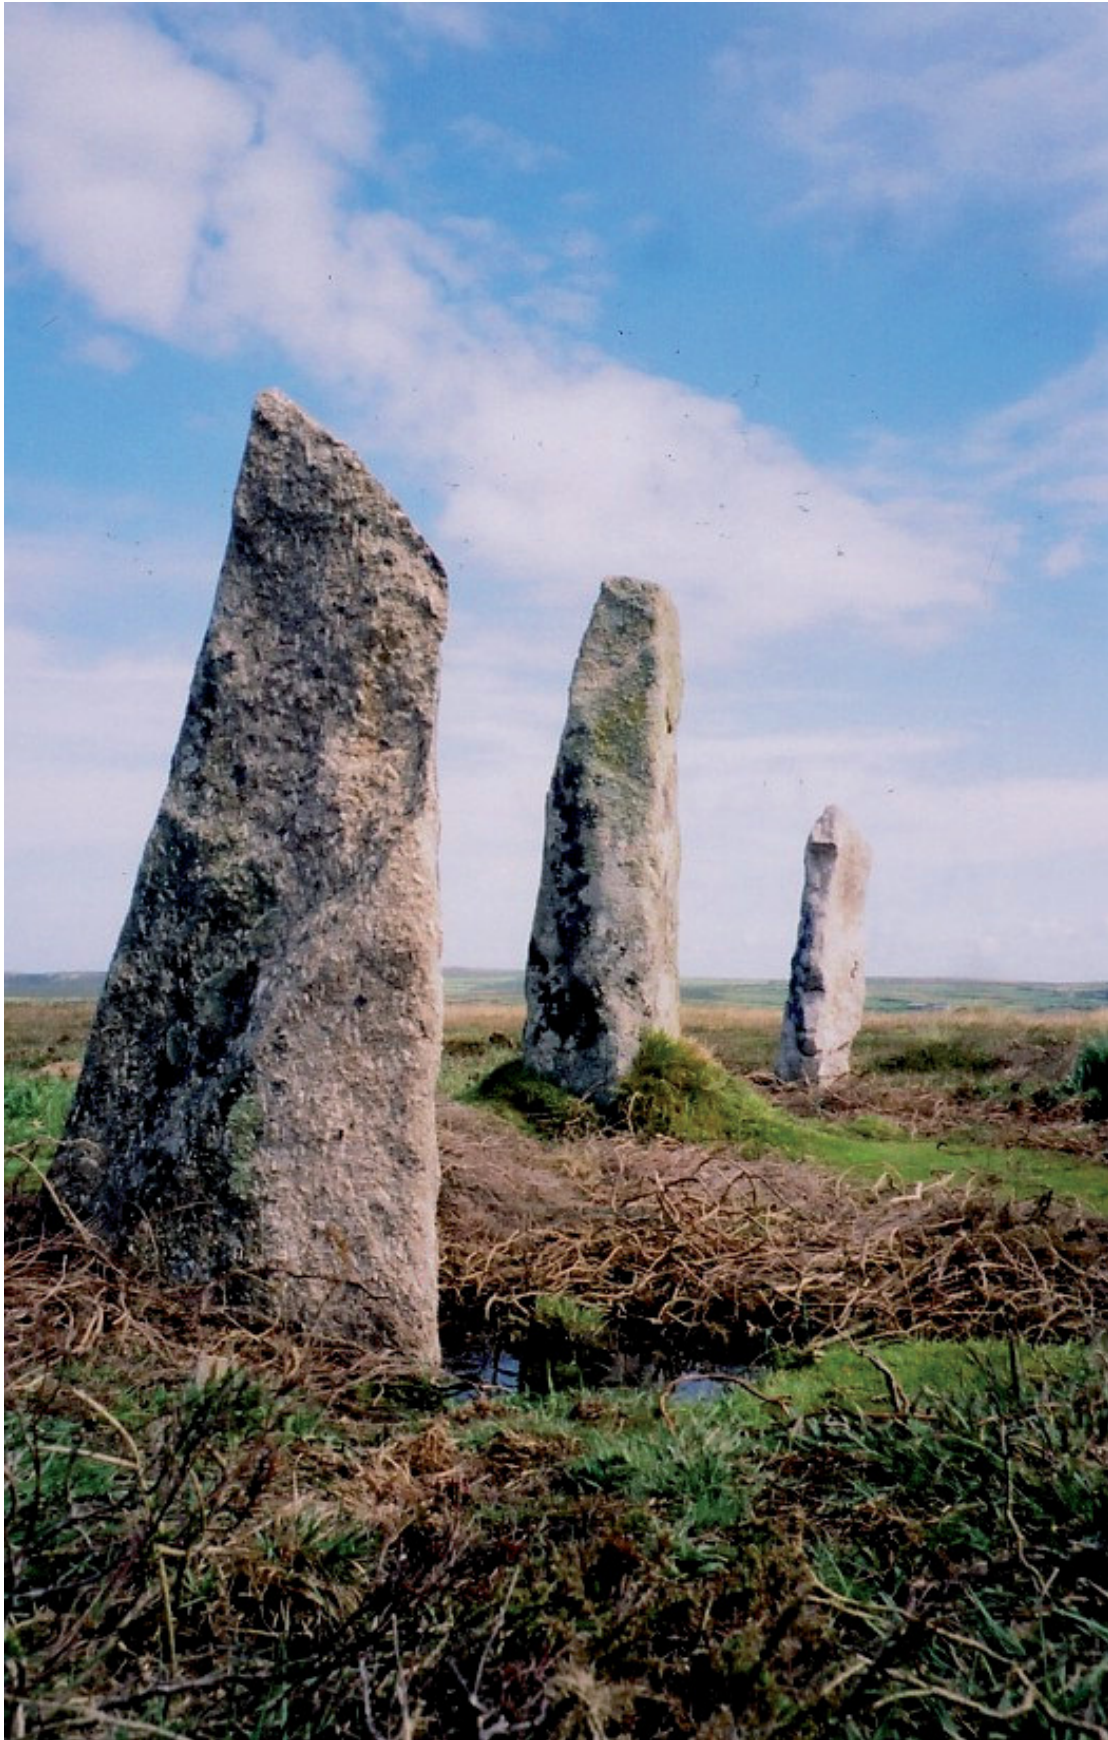
Fig 35 The restored stones on the north-north-west of the circle
