# Hallenbeagle, Scorrier, Cornwall

## Archaeological Assessment

Client	Property Location Services Ltd
Report Number	2011R068
Date	29/06/2011
Status	Final
Report author	Adam Sharpe BA MIFA
Checked by	Peter Rose, Projects Manager
Approved by

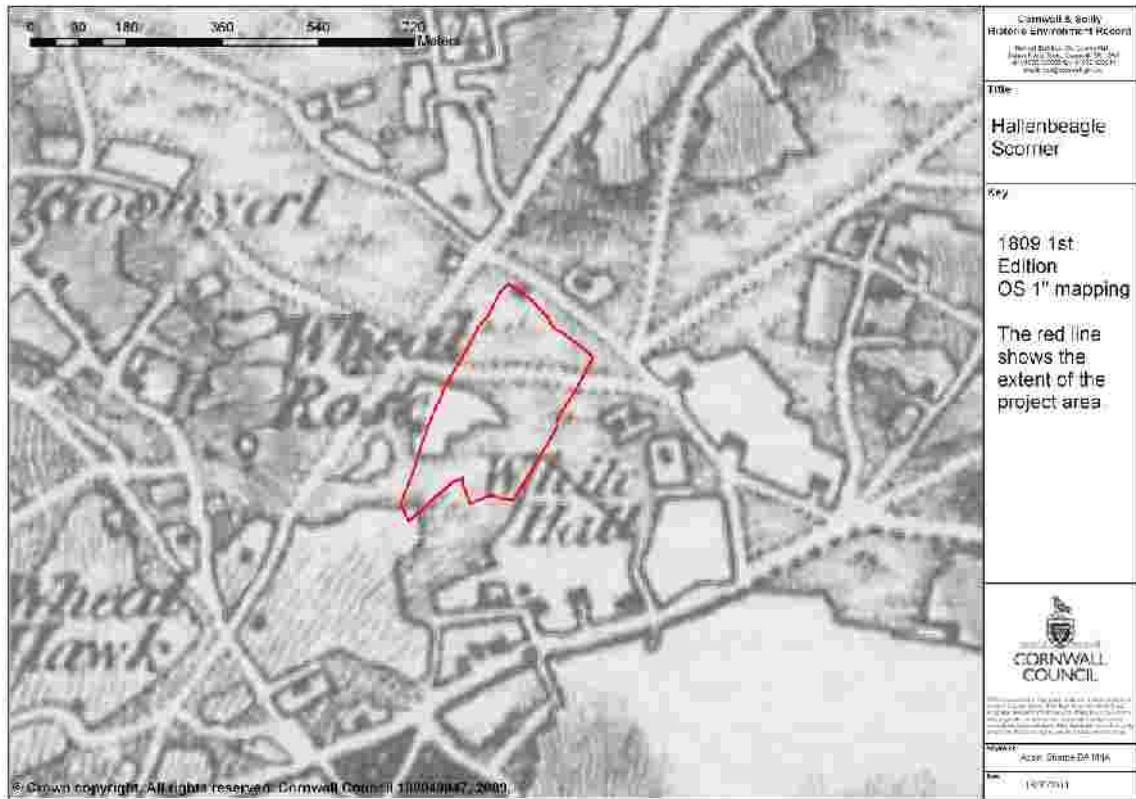
Fig 3. The Hallenbeagle site superimposed onto the 1809 OS 1" to a mile mapping, which depicts a landscape of mines, smallhold

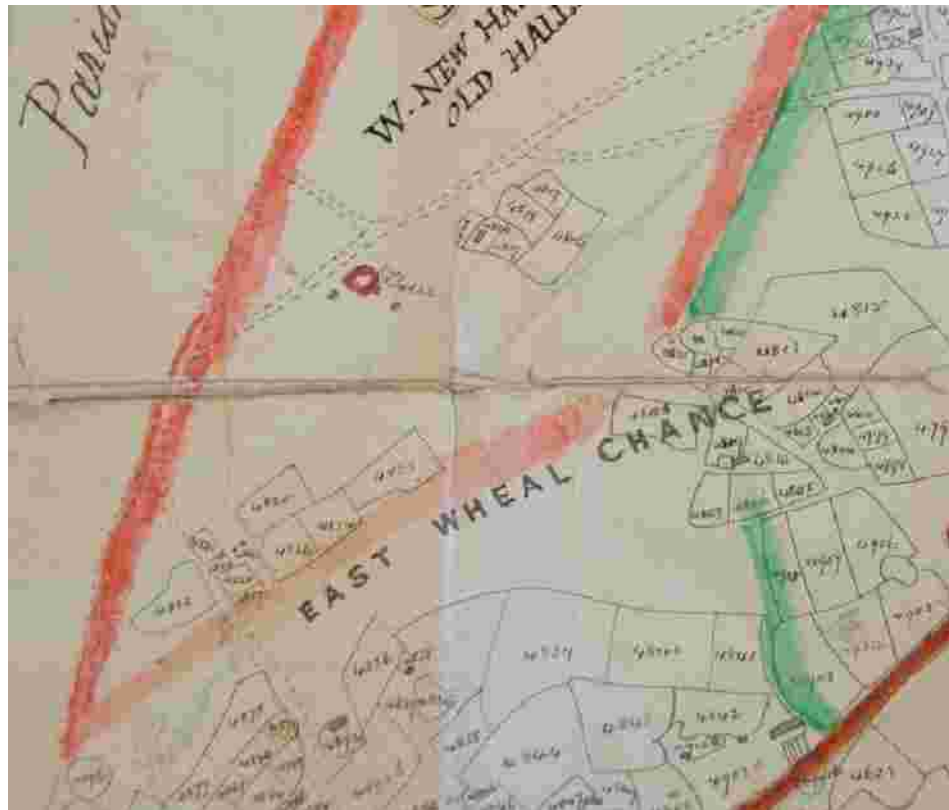
Fig 5. A sett plan in the Cornwall Records Office (CRO). Based on the Kenwyn Tithe Map, this shows the mine buildings at the northern end of the site.

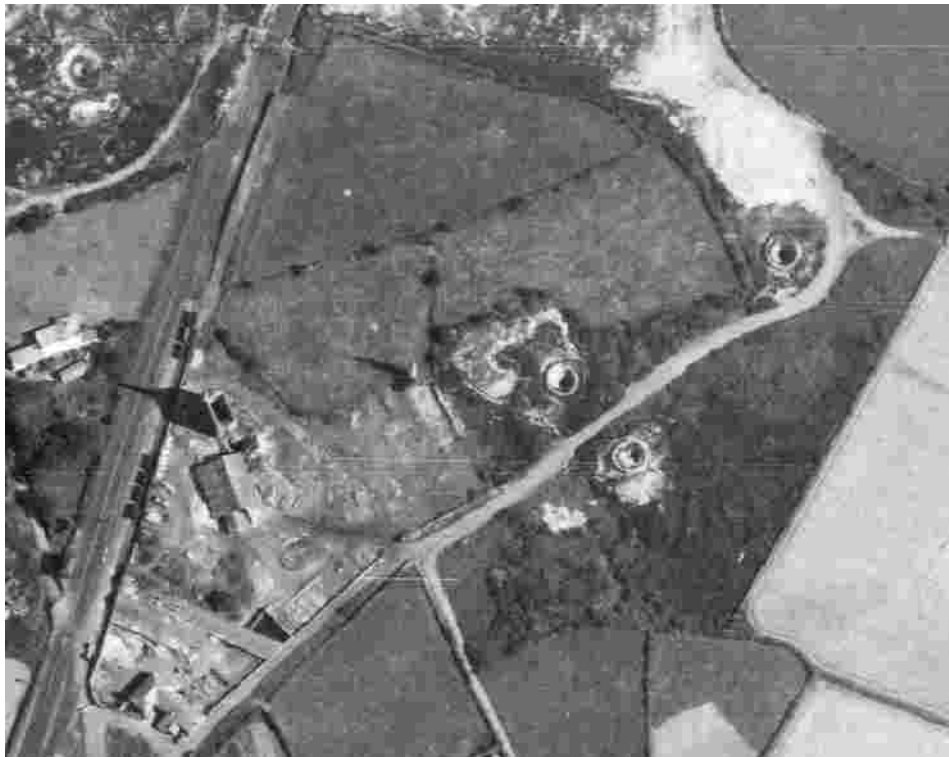
Fig 11. A detail from the 1946 RAF photograph, showing the complex of buildings in the southern part of the site Reade's Shaft.

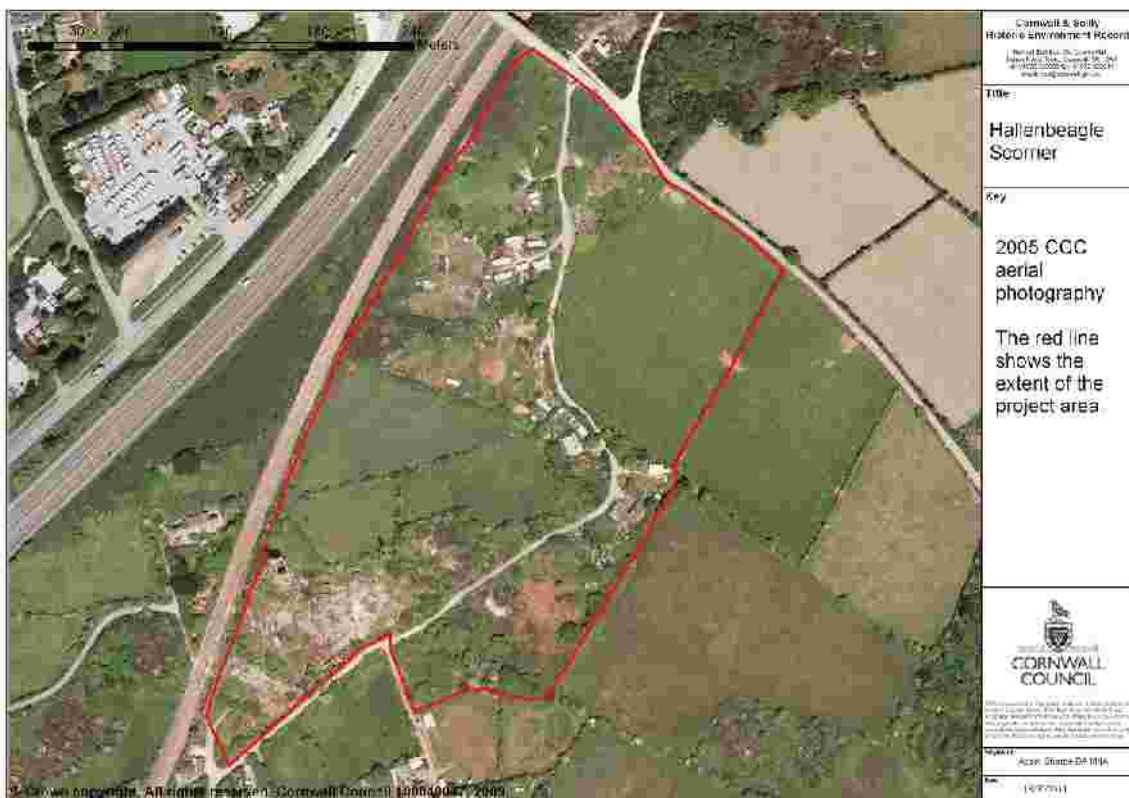
Fig 12. The Hallenbeagle site in 2005 as shown on the aerial photographs. By this date the travellers' site had been established whilst the sawmill and concrete plant buildings had substantially been demolished and the site had scrubbed in.

By 2005 (CCC aerial photographic evidence, Fig 12) the central and north-eastern areas of the wider site had been reclaimed to agriculture and the southern parts of the site were in scrubby heathland (Figs 20-21). The north-eastern part of the wider mine site (Zone 4 on the site development proposals dated 01/10/2010) remained in agricultural use, whilst the north-western part of the site (the northern part of Zone 1 on the October 2010 plan) and the central eastern part of the site (Zone 5) were occupied by a number of static caravans and their curtilages (Figs 20-22); the southern part of Zone 1 was occupied by a number of smallholders' fields first shown on the 1809 OS mapping (Figs 3, 27). The south-eastern part of the site (Zone 6) had scrubbed in, as had the southern corner of the site (Zone 3) and the area around Read's engine houses (Zone 2) (Figs 34-40, 45-6, 48).

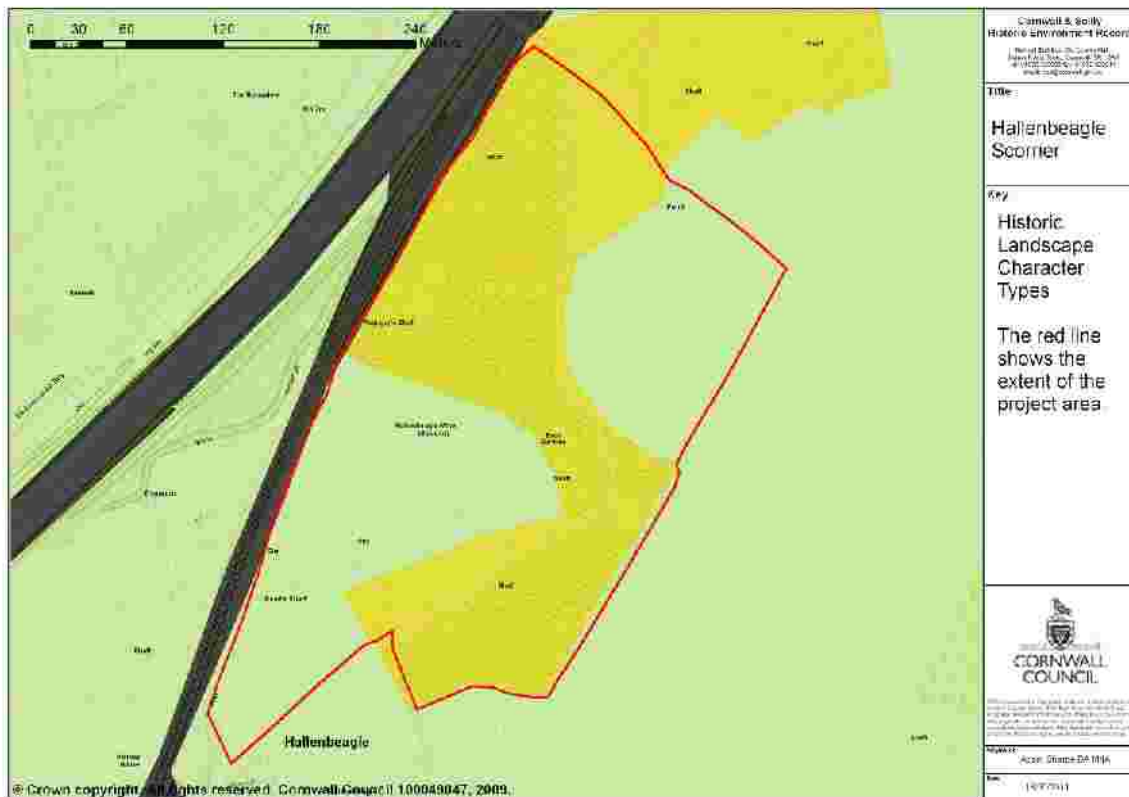
Fig 14. HLC mapping for Hallenbeagle. Black = Communications, Green = Recently Enclosed Land (post-medieval), yellow = Upland Rough Ground.

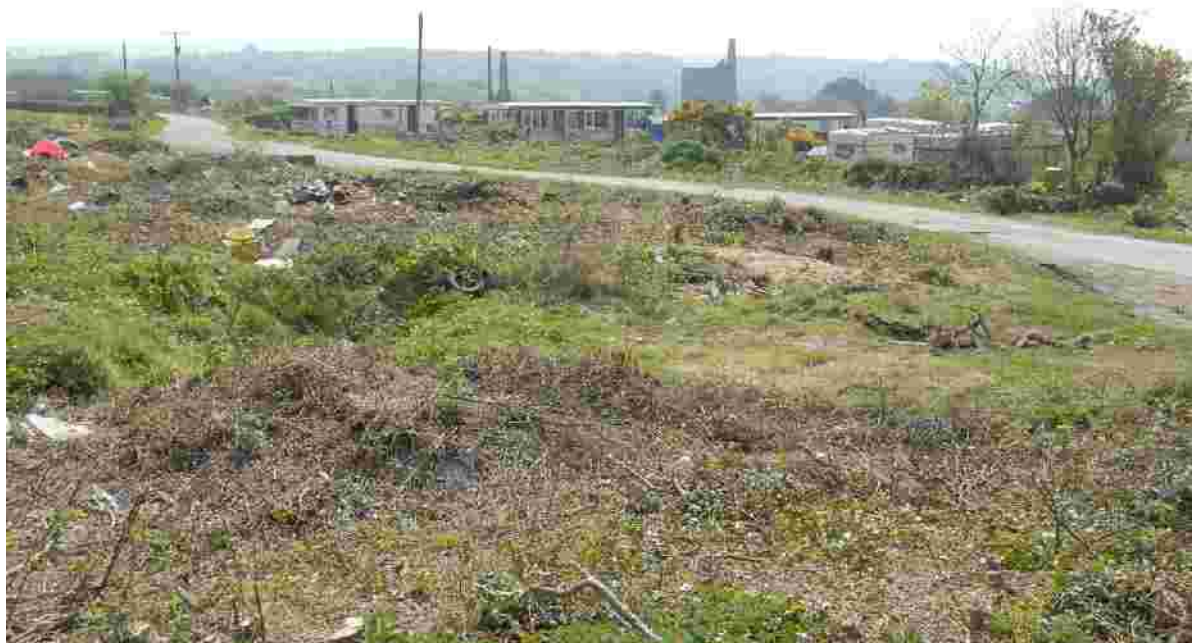
Fig 20. A view of the Hallenbeagle site from the north-east, looking across the northern part of the travellers' site towards the engine houses at Reade's Shaft.

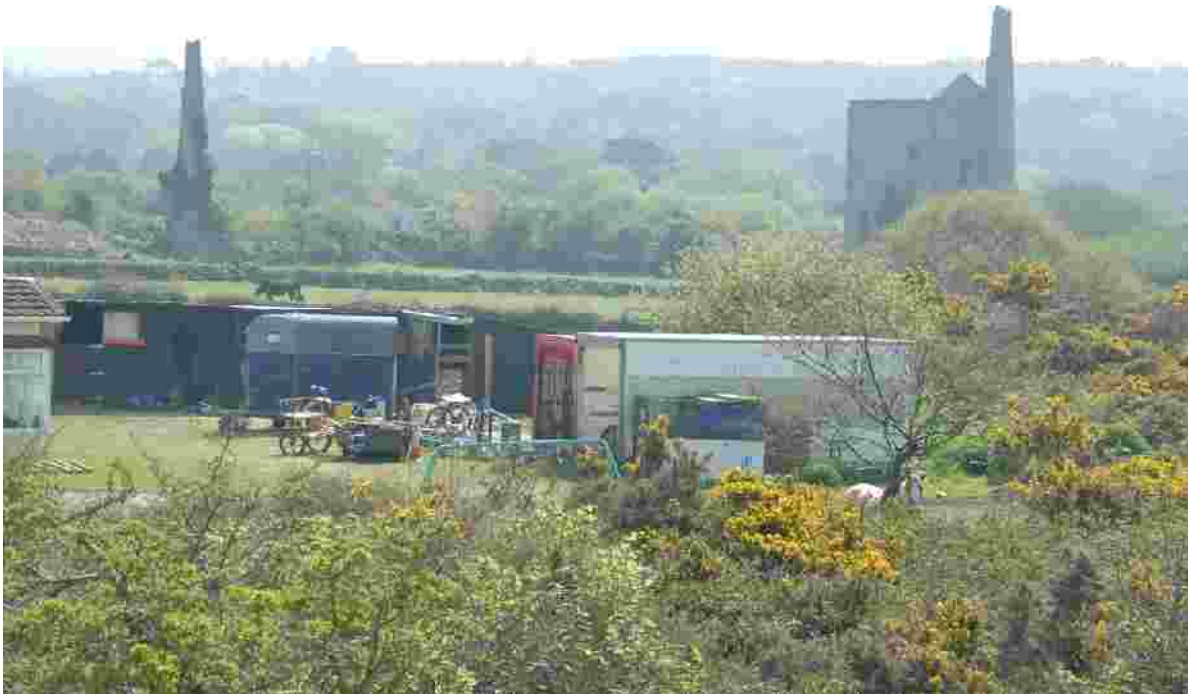
*Fig 21. A view looking southwards across the central part of the travellers' site and the engine houses at Reade's Shaft towards the woods around Scorrier House.*

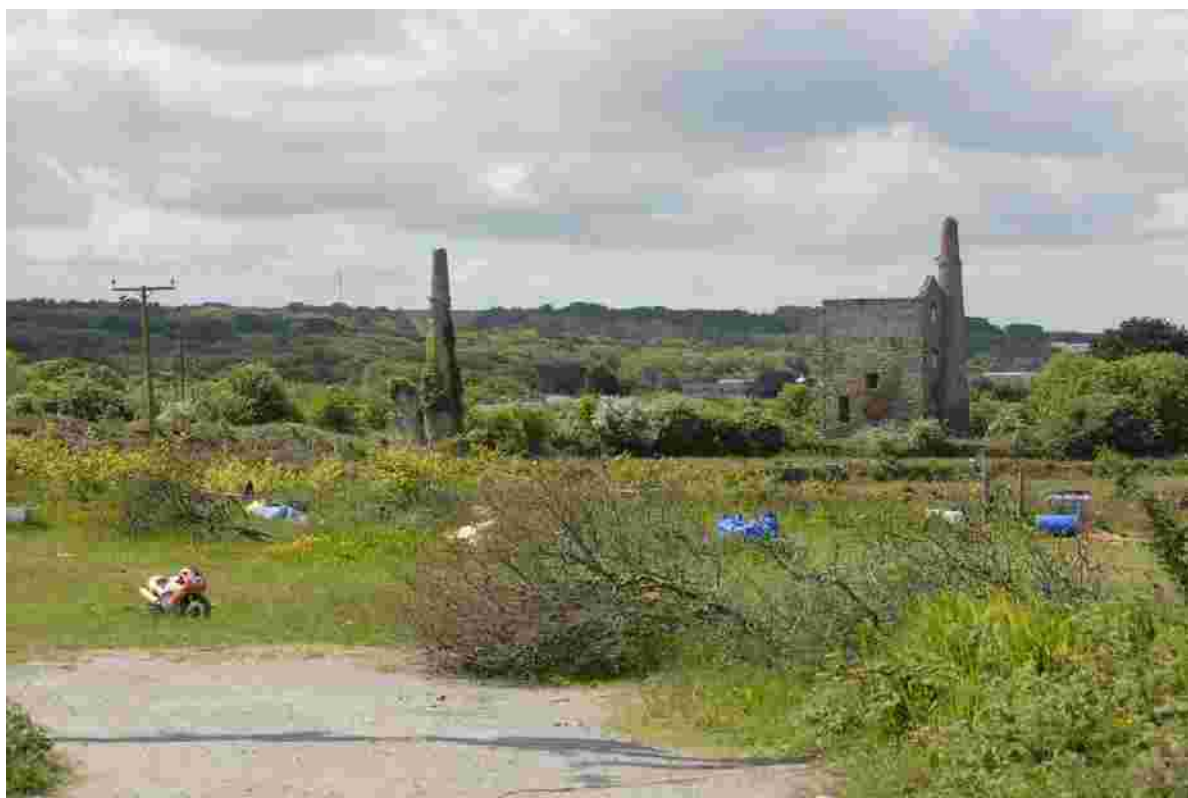
*Fig 22. The central part of the travellers' site. Note the stand of Japanese knotweed in the mid distance.*

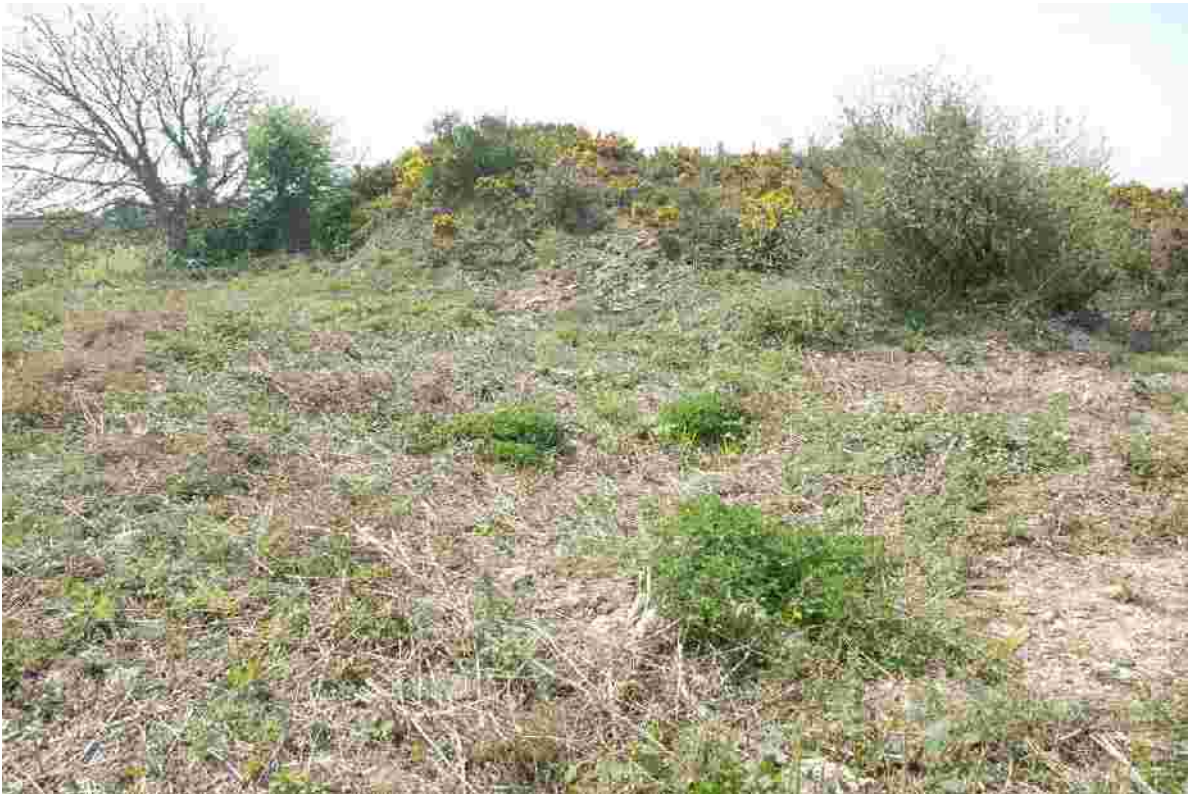
*Fig 23. Looking west towards the Engine Shaft spoil dump. The pumping engines [3/4] serving this shaft were sited adjacent to the tree to the left.*

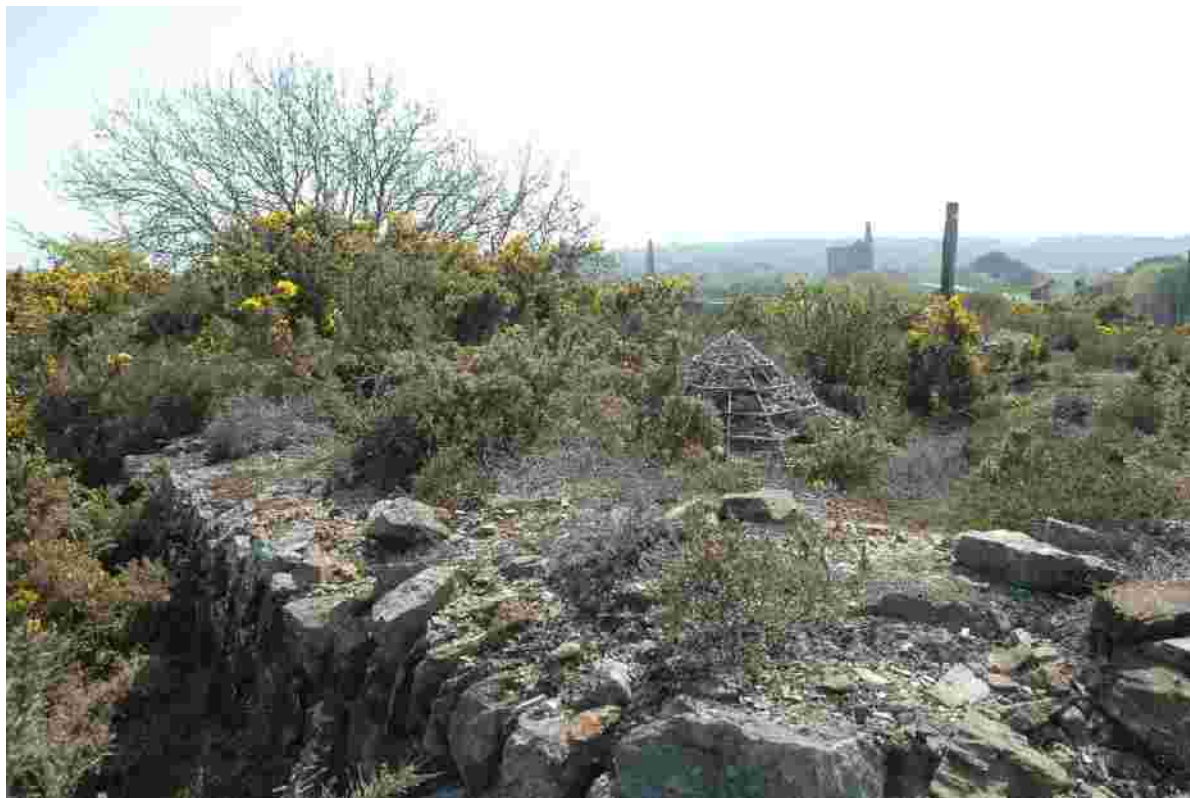
Set on the top of a remnant dump of heathy spoil between the edge of the development site and the railway cutting, a small Clwyd Cap (Fig 24) marks the site of the shaft worked by the whim engine depicted on the 1<sup>st</sup> Edition OS 25" mapping. This appears to be separate from Engine Shaft, which seems to have been sited just to the south, adjacent to the pumping engine house. The shaft is filled at surface, and its depth and condition below ground are unknown.

*Fig 24. The Clwyd Cap on Whim Engine Shaft [5] on the top of the spoil dump on the western part of the site at its northern end.*

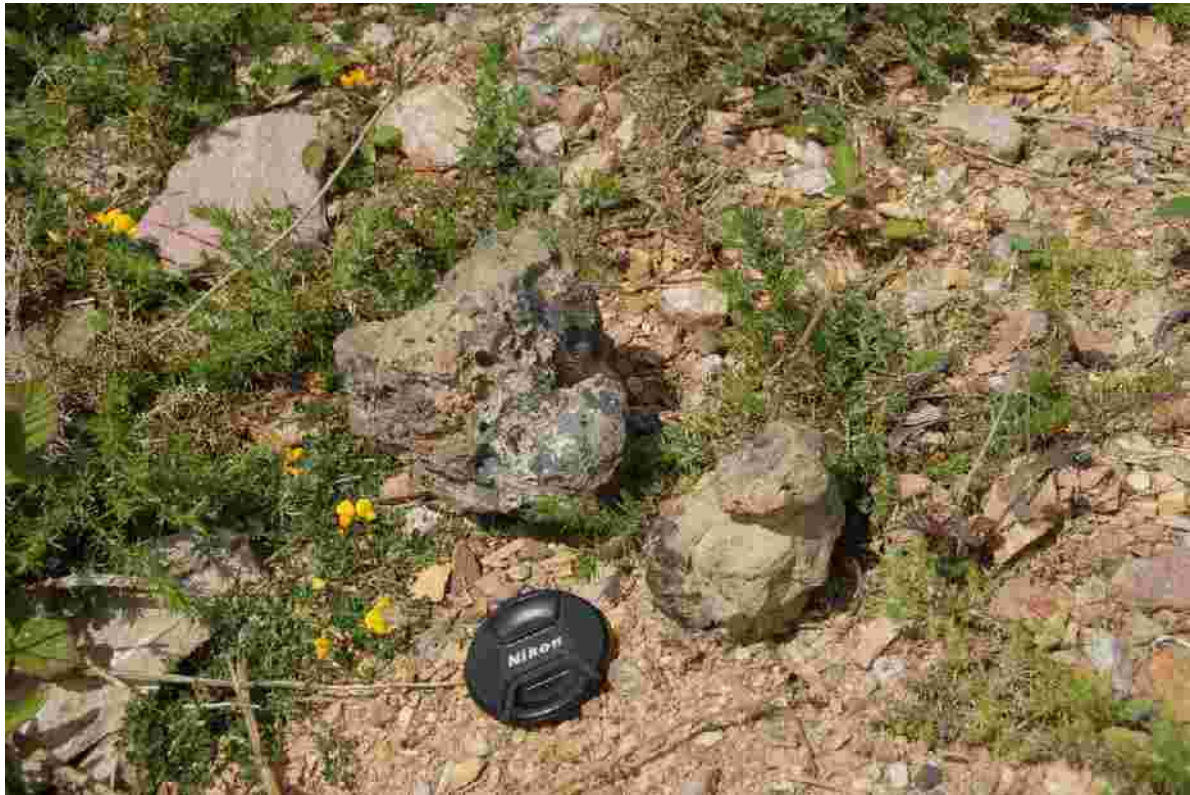
A scatter of large pieces of copper slag visible on and incorporated in the disturbed ground surface in the north-western part of the site (Fig 25) hints at the operation of an undocumented small-scale copper smelting works at Hallenbeagle, almost certainly during the 18<sup>th</sup> century. The majority of the slag is found within this area, suggesting that the smelter lay nearby, though a section of the northern face of the boundary of the smallholding field at SW 72666 44753 to the south is constructed of this material.

*Fig 25. Large pieces of copper slag exposed on the ground surface in the northern part of the site (lens cap for scale).*

No structural evidence for the site of the smelter was found, though may be exposed during groundworks associated with the redevelopment of the site. If this is the case, the site would be of considerable significance, and should be fully recorded before it is destroyed.

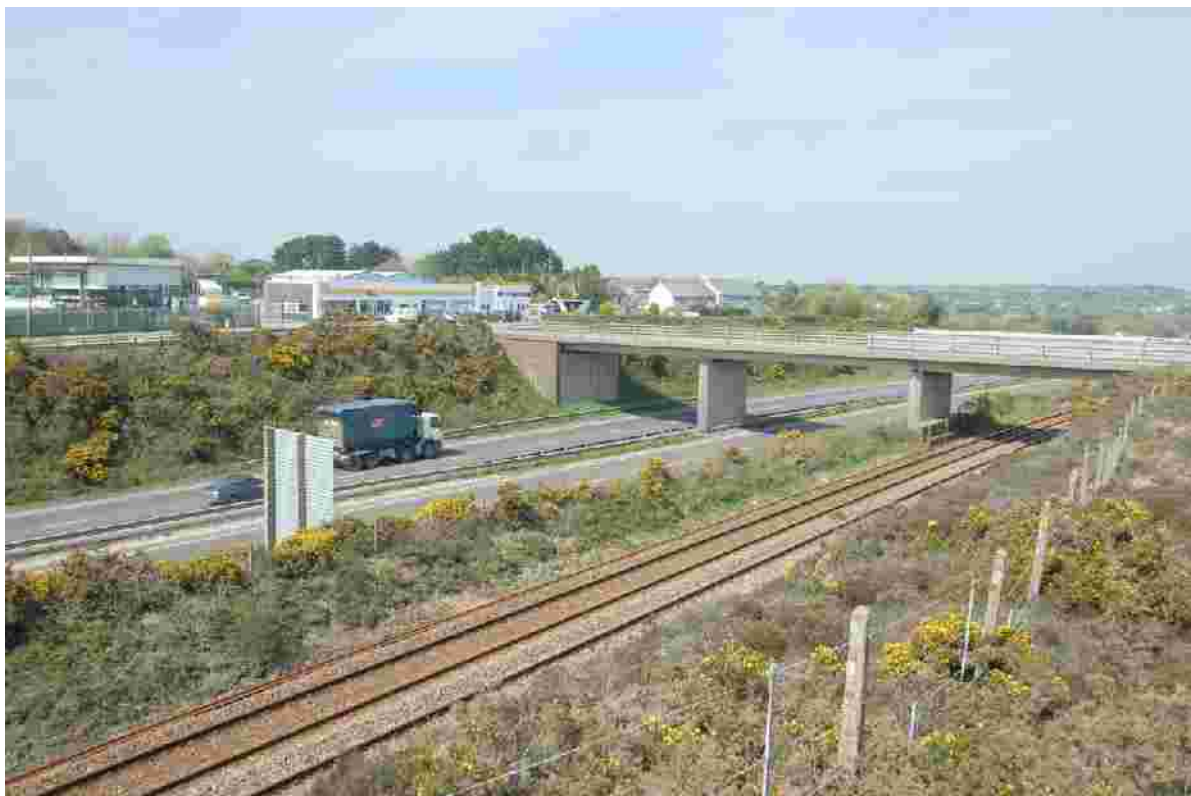
*Fig 26. The western boundary of the site, formed by the main line railway cutting, beyond which is the A30 trunk road.*

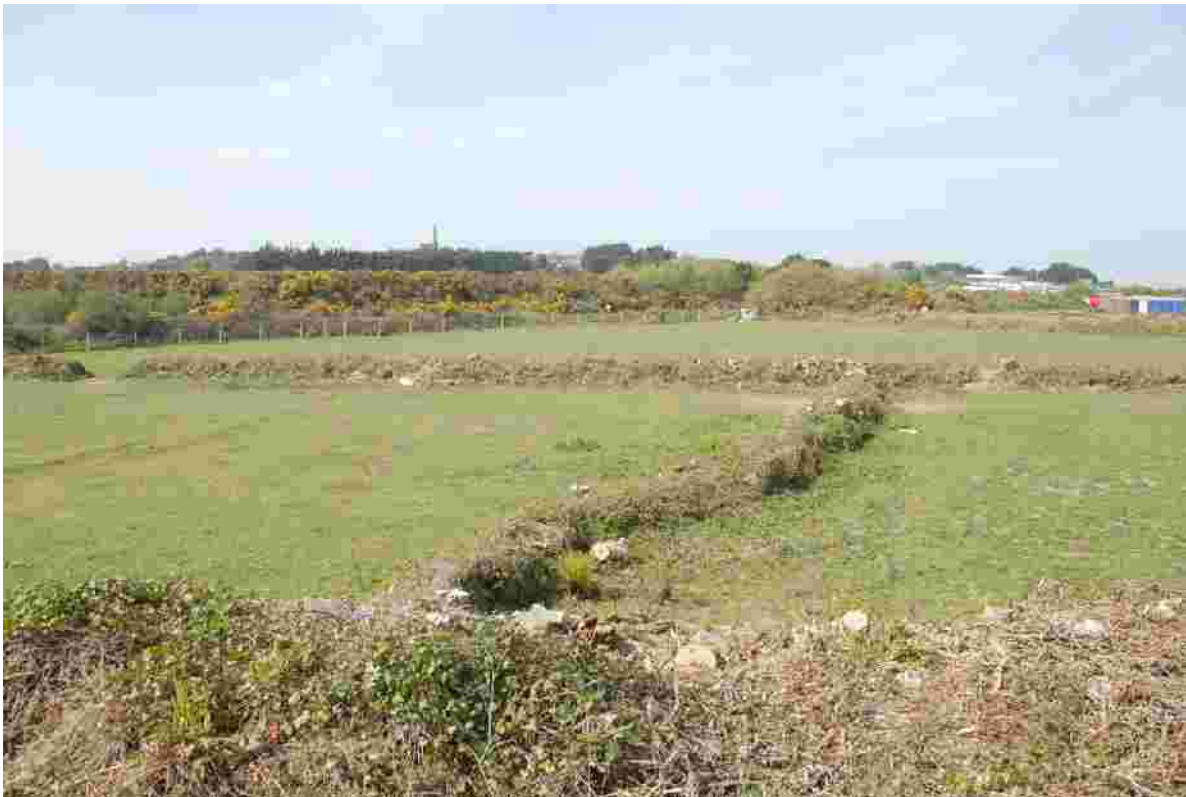
*Fig 27. The 18<sup>th</sup> century smallholders' fields [14] which occupy the central part of the Hallenbeagle site.*

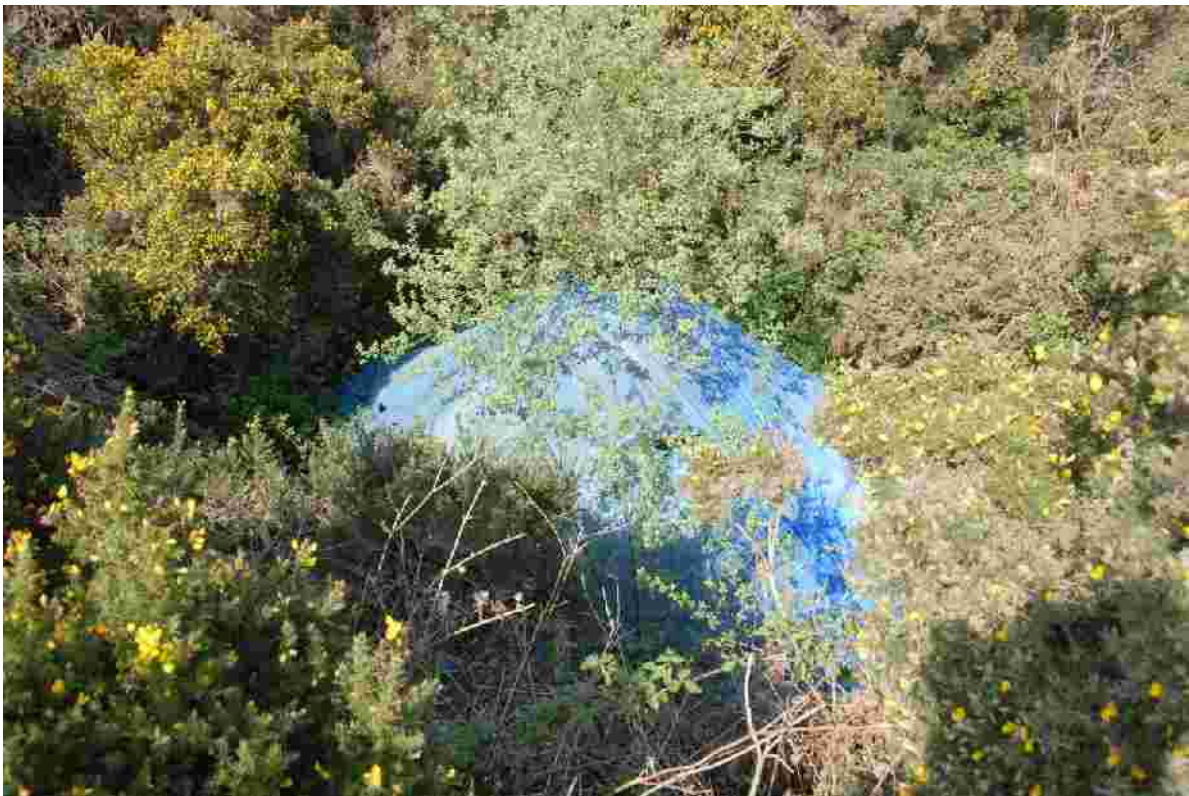
Pininger's Shaft is located at the south-western corner of this part of the site. The shaft itself was covered with a very large Clwyd Cap during the 1980s, but this has been adapted as a children's den by being covered over with a blue plastic tarpaulin, and it is not clear whether the shaft is open under this or is blocked (Fig 28). Dense scrub vegetation prevented access to the shaft to check its condition. The remains of a substantial waste dump surround the shaft opening, though material from the dump has been partially removed on its eastern side. No structures are documented as being located near this shaft though the substantial amount of spoil in the adjacent dump indicates that it would have been served by a nearby whim, though whether this was horse operated or steam operated is unknown.

*Fig 28. The tarpaulin-covered Clwyd Cap covering Piningers Shaft [10] set within a hollow at the centre of its spoil dump.*

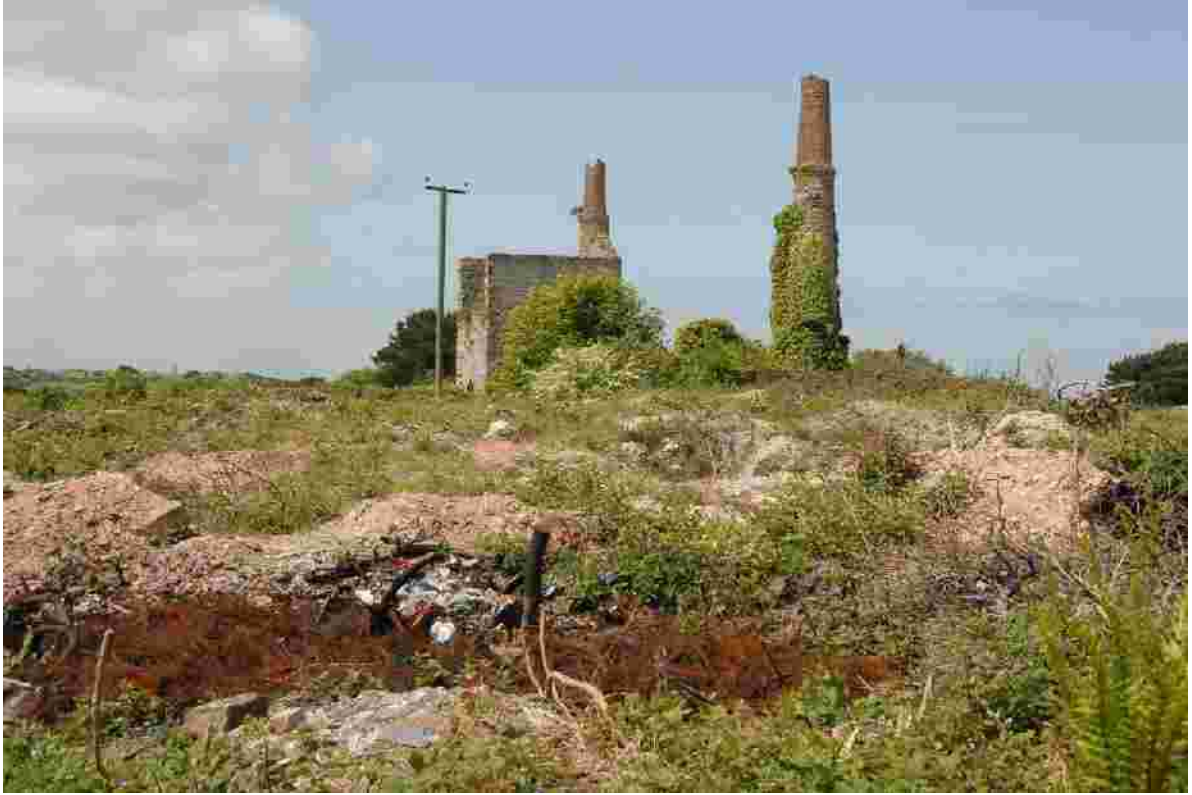
*Fig 29. Looking towards the buildings at Reade's Shaft from the edge of the spoil dump associated with Jeffrey's [18] and Oat's [19] Shafts.*

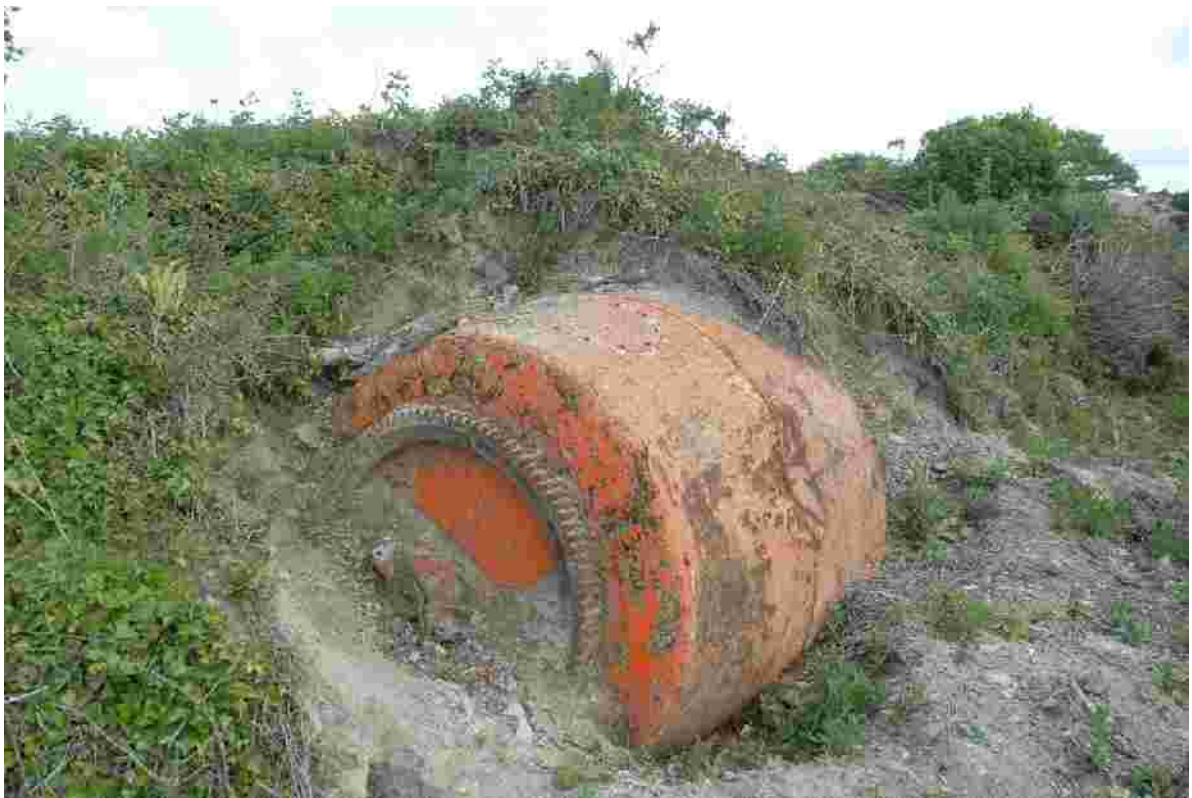
*Fig 30. An abandoned concrete wagon mixer butt partly-buried within material dumped onto the southern edge of the Jeffrey's and Oat's Shaft spoil tips.*

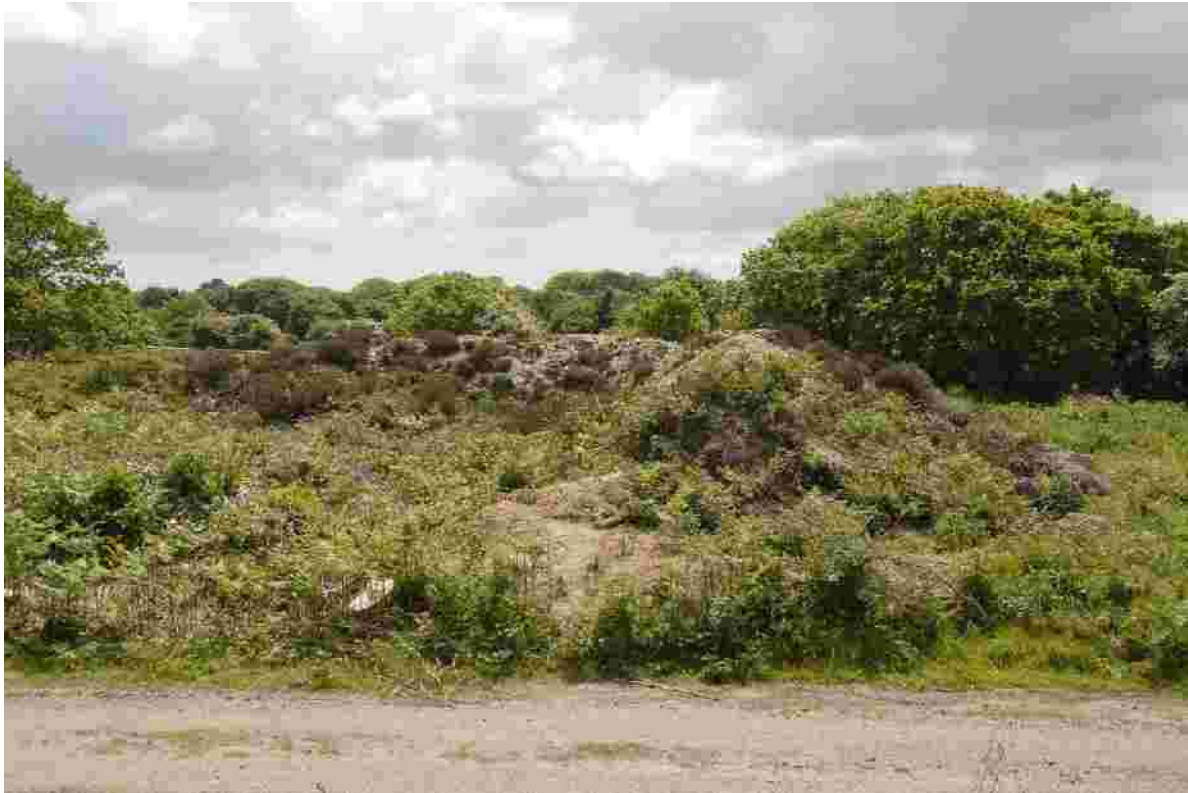
*Fig 31. The remains of the spoil dump partly surrounding a shaft [21] in the south-eastern part of the site.*

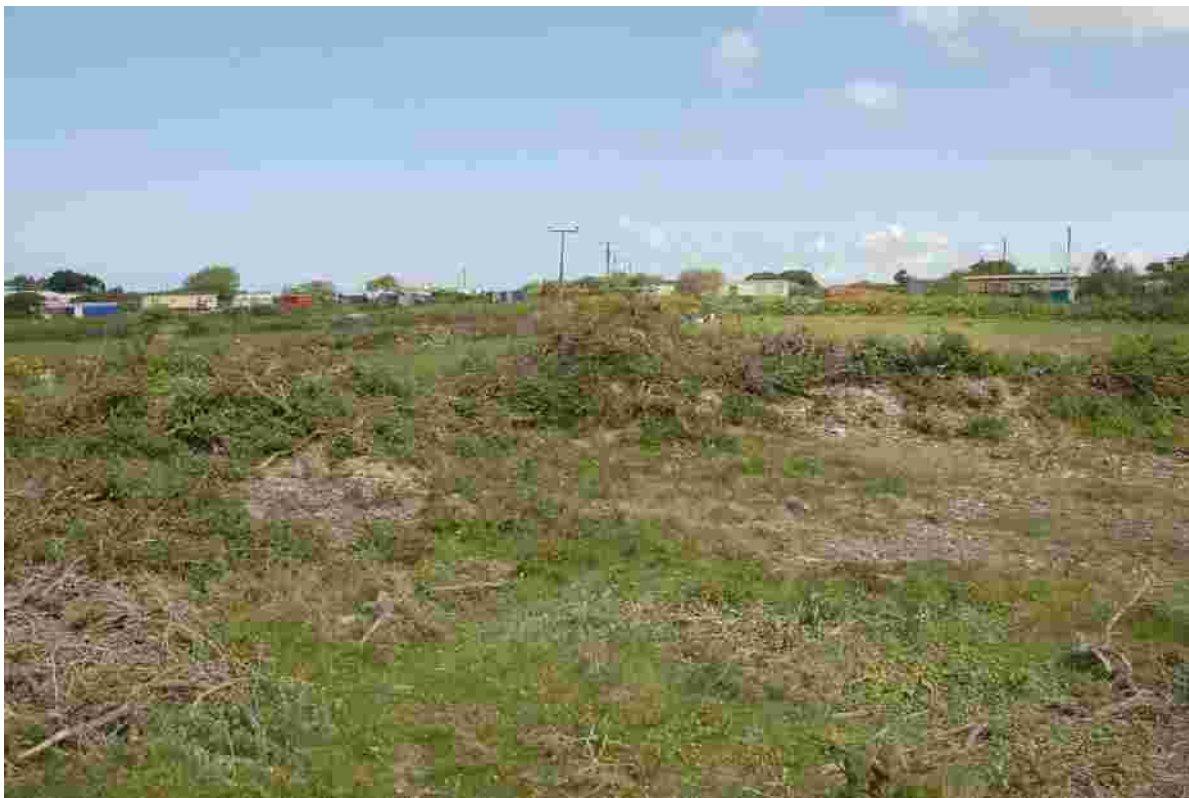
*Fig 32. Looking north towards the travellers' site from the spoil dump associated with Jeffrey's and Oat's Shaft. The site of Jeffrey's Shaft [18] lies under the level ground at the centre of this view.*

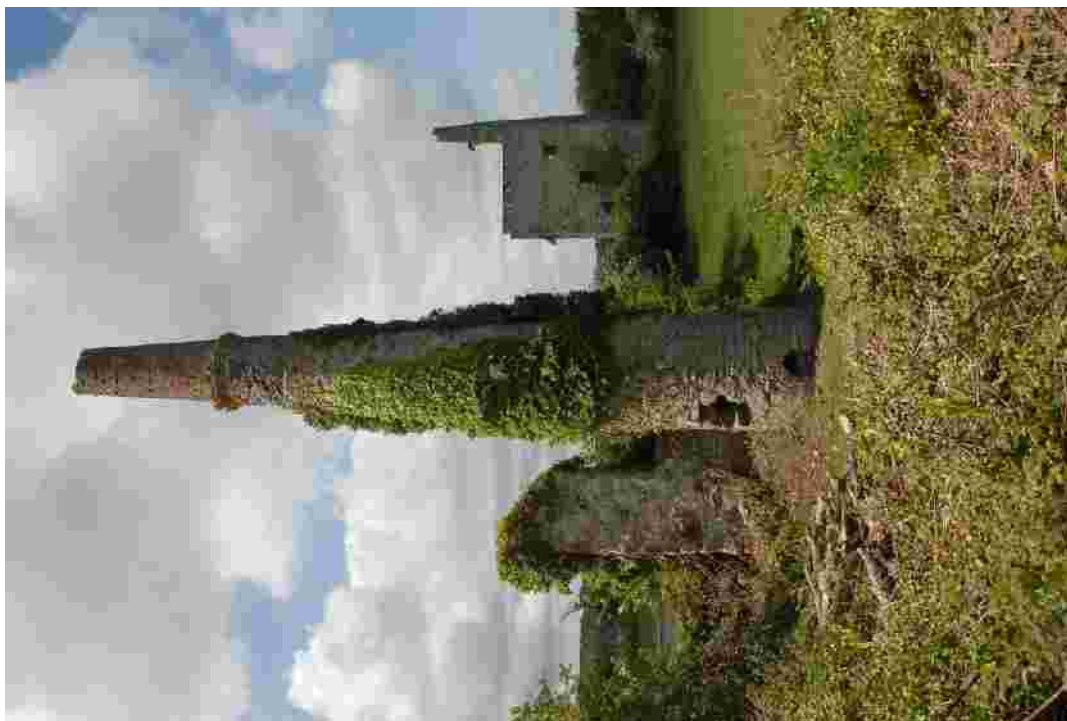
*Fig 34. Reade's whim engine house seen from the north. Its boiler house was sited in [16] the field to the right of the remains of the building*

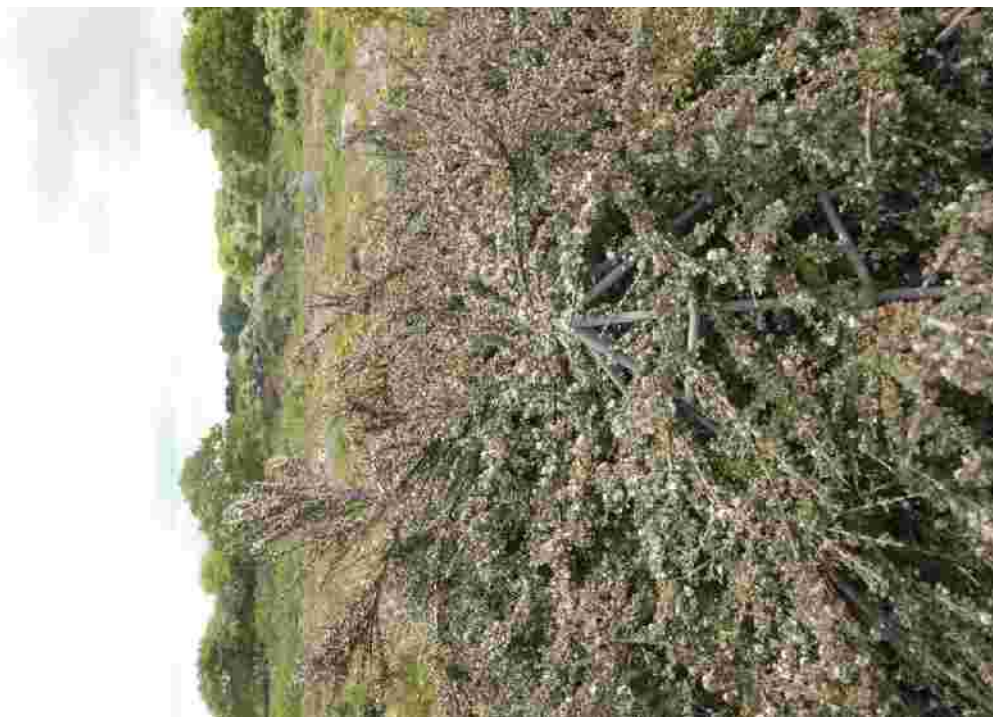
*Fig 33. The Cotoneaster-covered Clwyd Cap on Oat's Shaf. [19].*

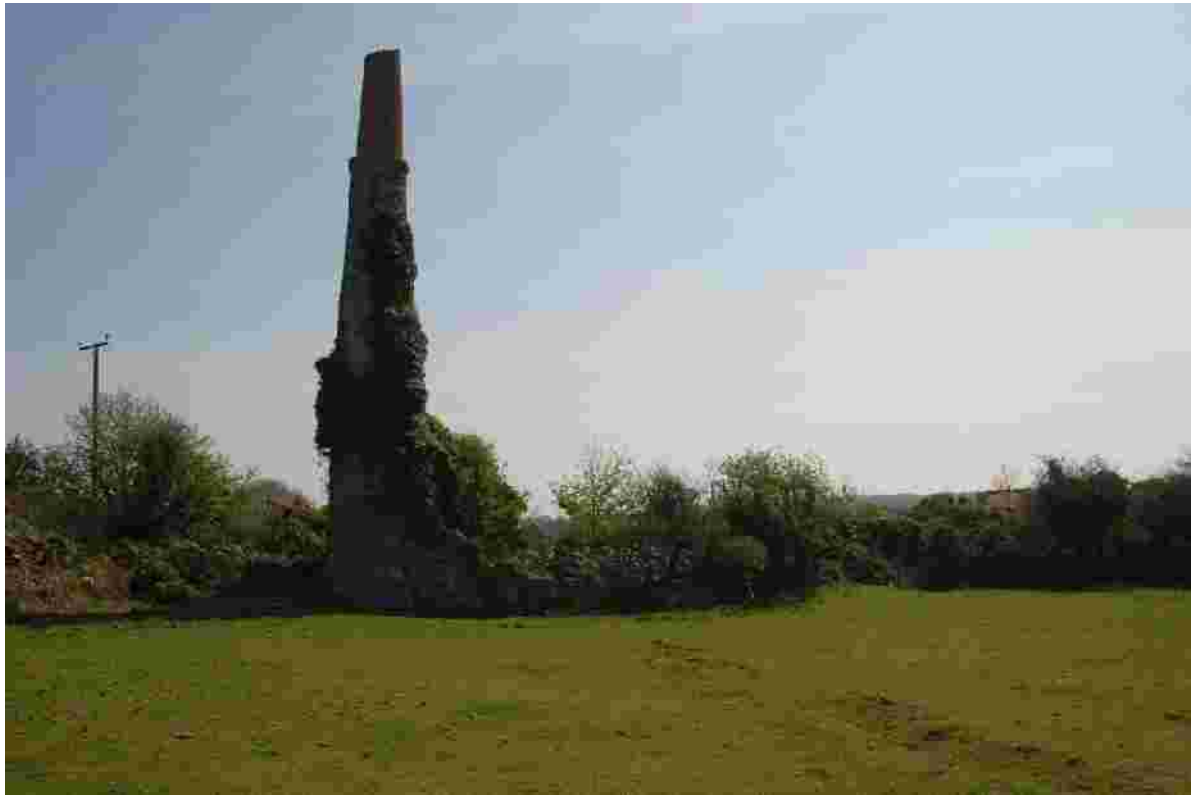
*Fig 35. Reade's whim engine house [16] seen from the east. The forward part of this Listed Building, together with its boiler house and loadings have been demolished. A shallow trench runs across the nearby field to this building.*

The building requires the removal of scrub from its walls and surroundings to determine its conservation requirements. These are likely to include full repointing in a lime-based mortar, limited reconstruction to confer structural stability and the installation on a lightning conductor. It is particularly important that the proposed redevelopment of the site does not unnecessarily impinge on this building, nor cut from it. It is also recommended that the conserved engine house (together Reade's pumping engine house) should be within the context of an amenity area, accessed by or from the Mineral Tramways path and bridleway network.

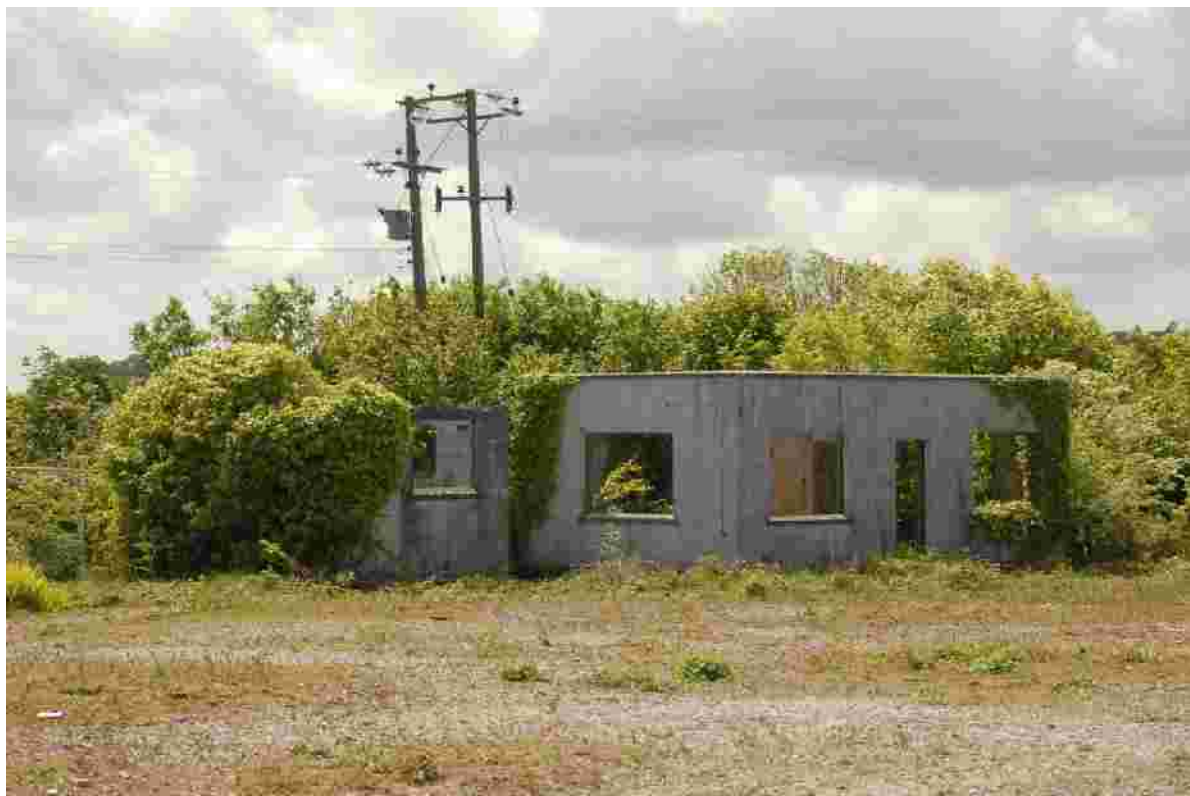
*Fig 36. Two of the abandoned concrete plant buildings [30/31] to the south of Reade's Shaft.*

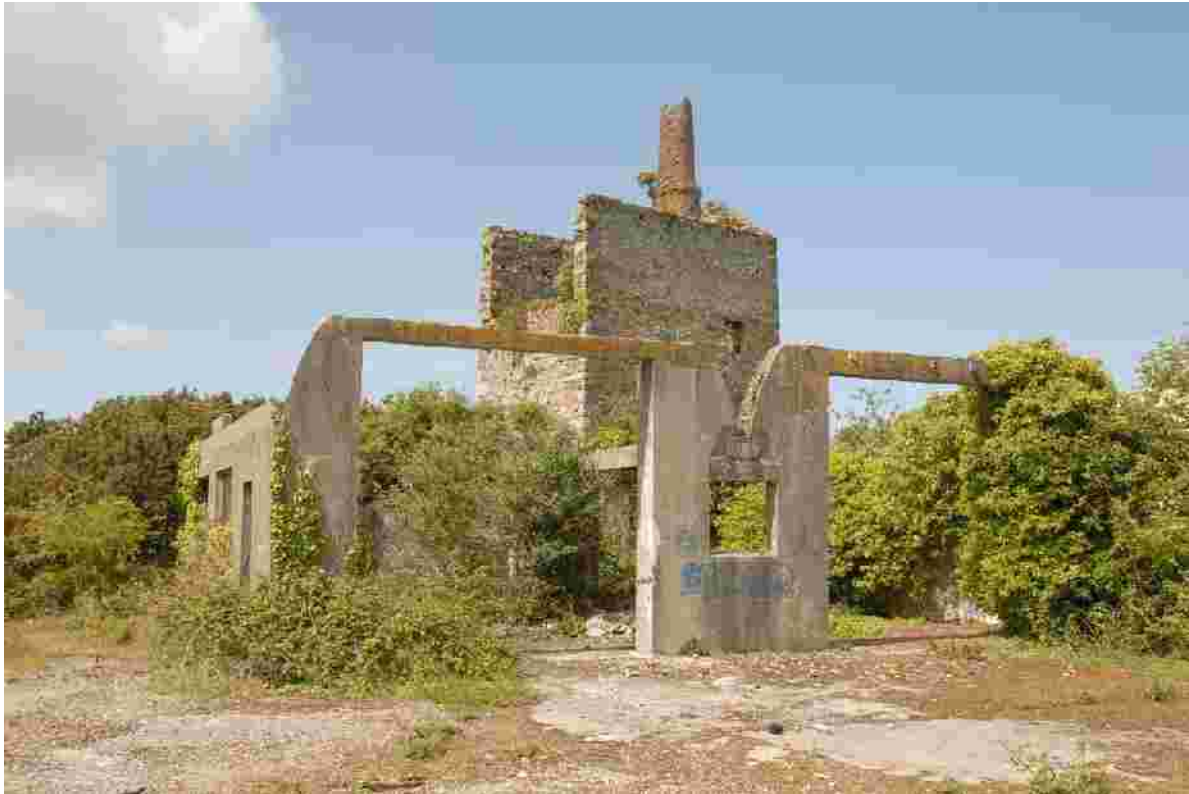
*Fig 37. The concrete plant vehicle maintenance building [28] adjacent to Reade's Shaft.*
