# Hallenbeagle, Scorrier, Cornwall

## Archaeological Assessment

Client	Property Location Services Ltd
Report Number	2011R068
Date	29/06/2011
Status	Final
Report author	Adam Sharpe BA MIFA
Checked by	Peter Rose, Projects Manager
Approved by

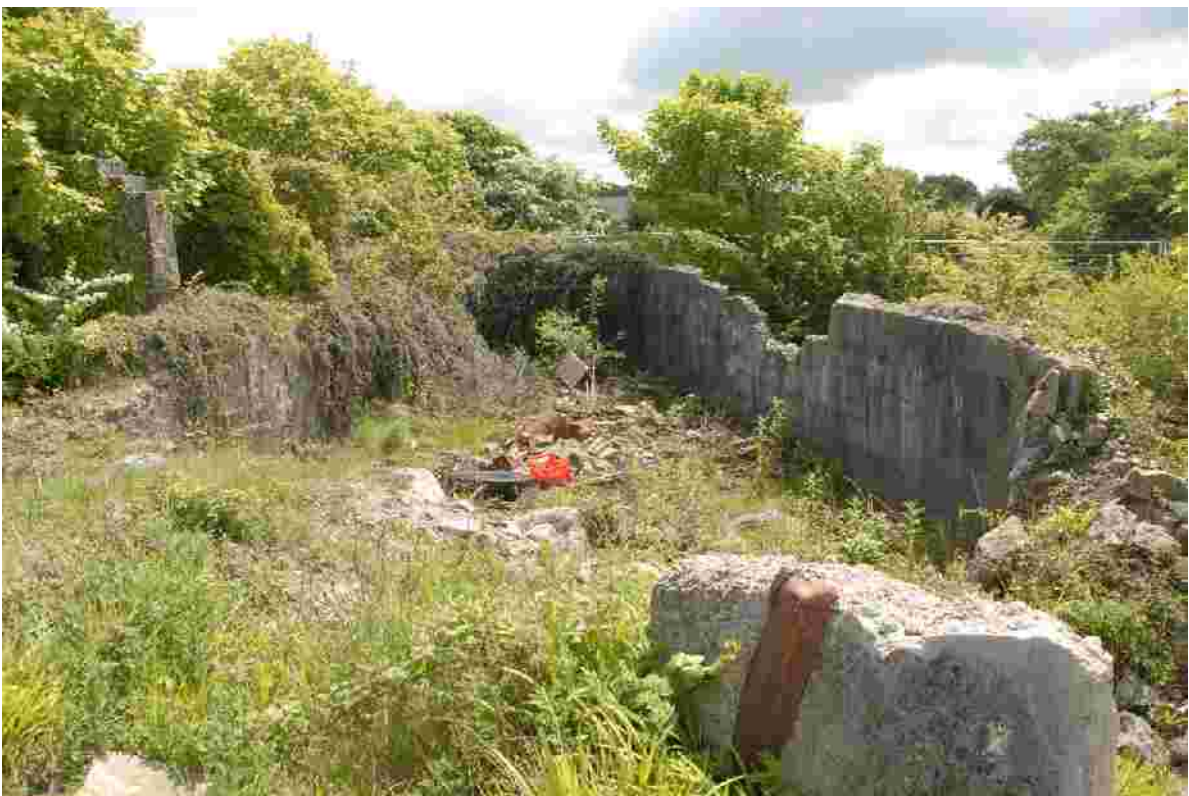
*Fig 38. The masonry and concrete tank [38] in the south-eastern part of the site, almost certainly constructed as part of the sawmill complex.*

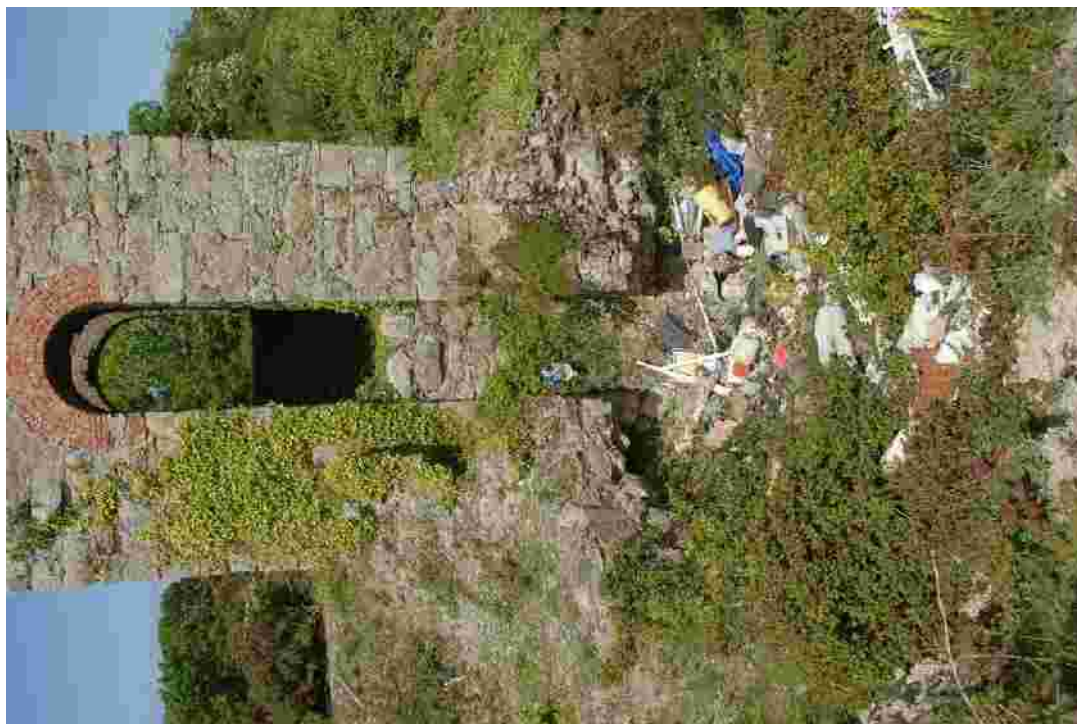
Fig 40. The rubbish-filled hollow marking the site of Reade's or Old Engine Shaft [34].

The removal of the rubbish choking the shaft will be necessary as a precursor to any safety works. If it is found that the shaft is open beneath this material, it is recommended that a grille or accessible cap is installed over the shaft opening and a level equivalent to the base of the condenser housing in order to provide suitable structural support to this feature and to the base of the bob wall. The masonry of the surface balance bob housing should remain visible following these works.

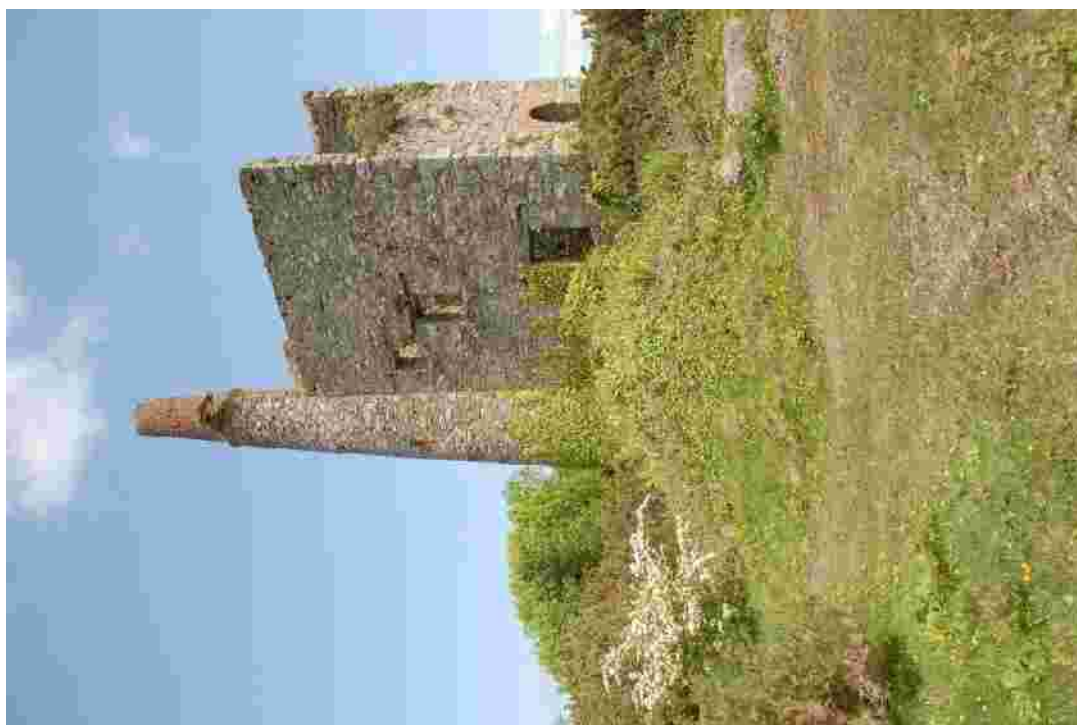
Internally, the engine house displays some unusual features such as the large number of sockets incorporated into the walls, these suggesting that the first floor support joists ran laterally rather than longitudinally (as is usually the case) – there are no joist pockets in the inner face of the bob wall. The many (often decayed) timbers incorporated into the wall to spread the working load and introduce a certain amount of flexibility into the structure reflect early 19<sup>th</sup> century construction practice, but (with the many wall pockets) now increasingly contribute to the structural instability of the building. Some missing stonework was found as a result of the decay of timberwork (Fig 41), the wing walls are beginning to lean inwards due to the loss of support which would have been conferred by the sole plate timbers and significant cracking was noted in the rear (north) wall and the eastern wall (Fig 42). The chimney is incorporated into the north-west corner of the engine house and incorporates a brick drip ring and upper section. The western wall of the engine house incorporates the boiler house door, but no evidence for roof flashing associated with the boiler house was recorded on this wall. The building is Listed Grade II.

Fig 39. Reade's pumping engine house [33] as seen from the south-west.

The building requires a range of works to make it safe, stable and accessible. This should include full repointing to all wall faces in a lime-based mortar, limited reconstruction to confer structural stability where masonry has been lost, repairs to the stack brickwork, the replacement of all failing timbers, the provision of structural support for the bob wall and condenser housing as part of shaft safety, the provision of a means of access to the interior of the building via the cylinder arch and the construction of a fence-type barrier on the southern edge of the cylinder plat to protect visitors from falling into the cock pit, together with the installation of a lightning conductor. Listed Building Consent will be required for these works.

It is particularly important that the proposed redevelopment of the site does not unnecessarily impinge on this building, nor detract from it. It is also recommended that the conserved engine house (together with Reade's whim engine house) should be within the context of an amenity area, accessed by or from the Mineral Tramways path and bridleway network.

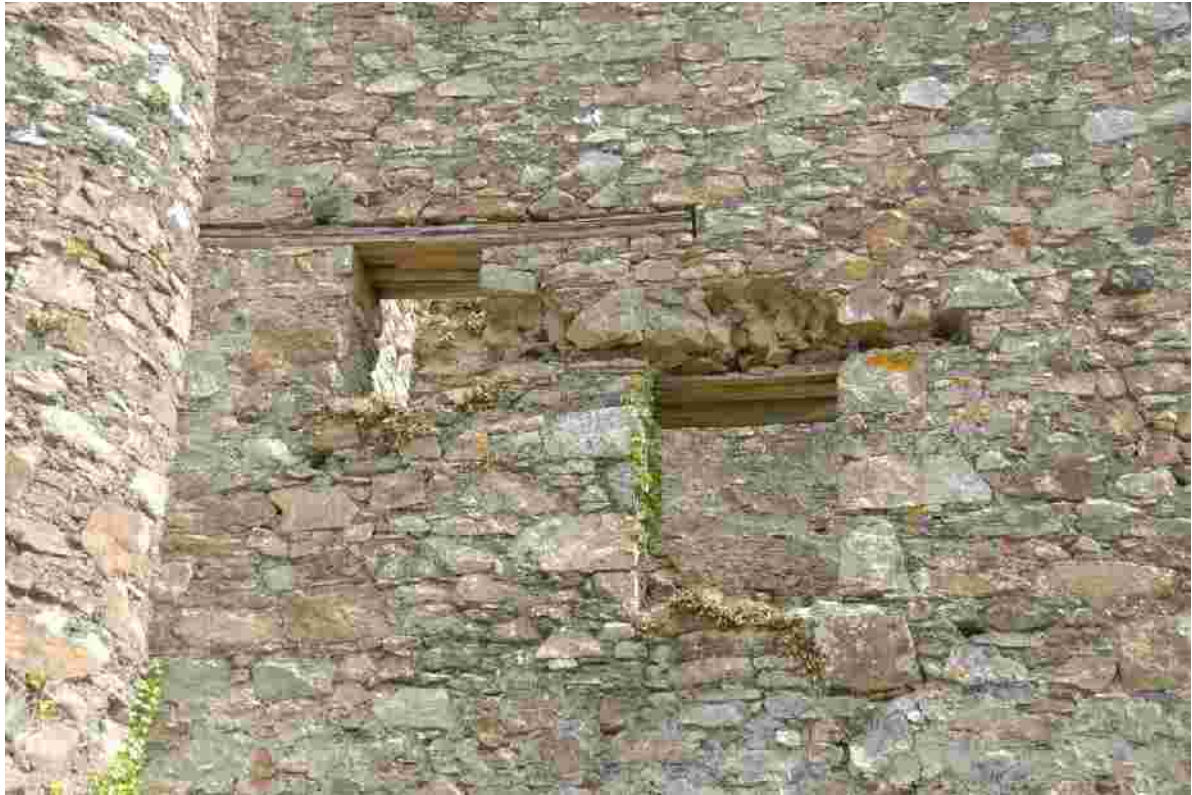
*Fig 41. The decay of timber lintels on the south-western elevation of Reade's pumping engine house has resulted in the loss of masonry in the walling above.*

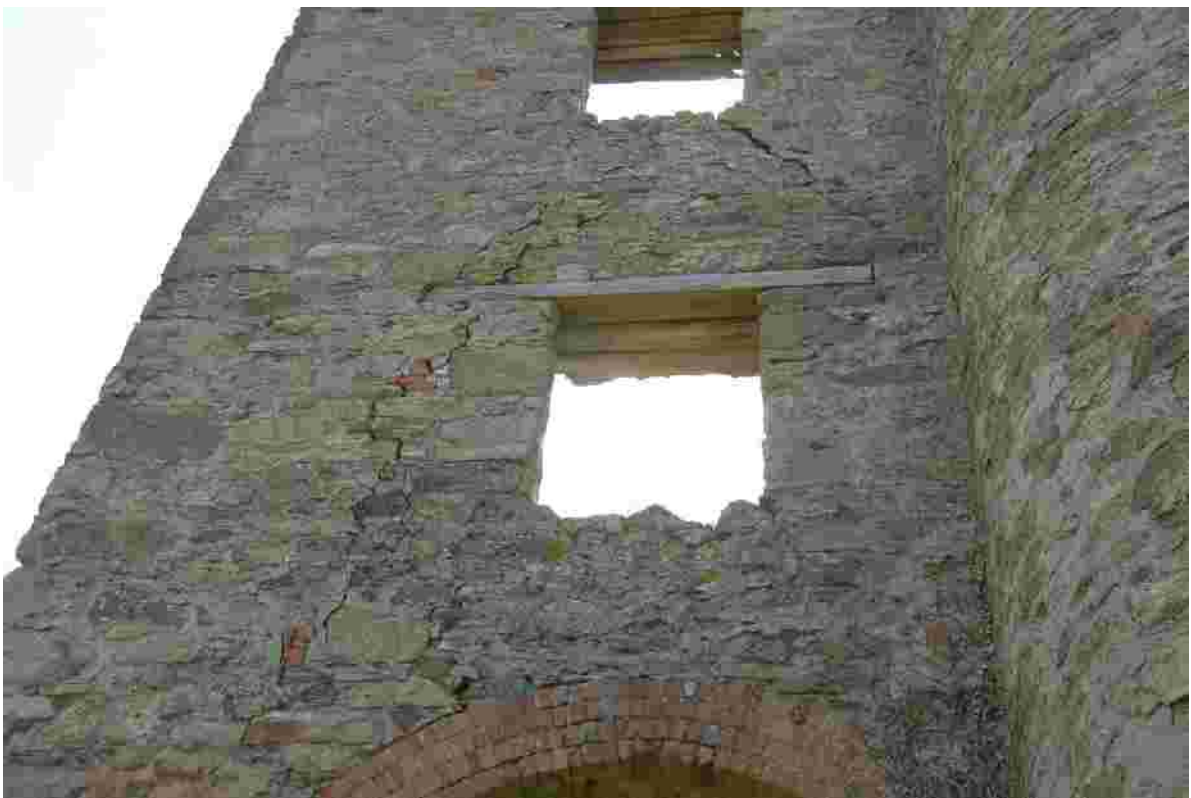
*Fig 42. Failure cracking in the rear elevation of Read pumping engine house needs to be addressed soon if major parts of this wall are not to collapse.*

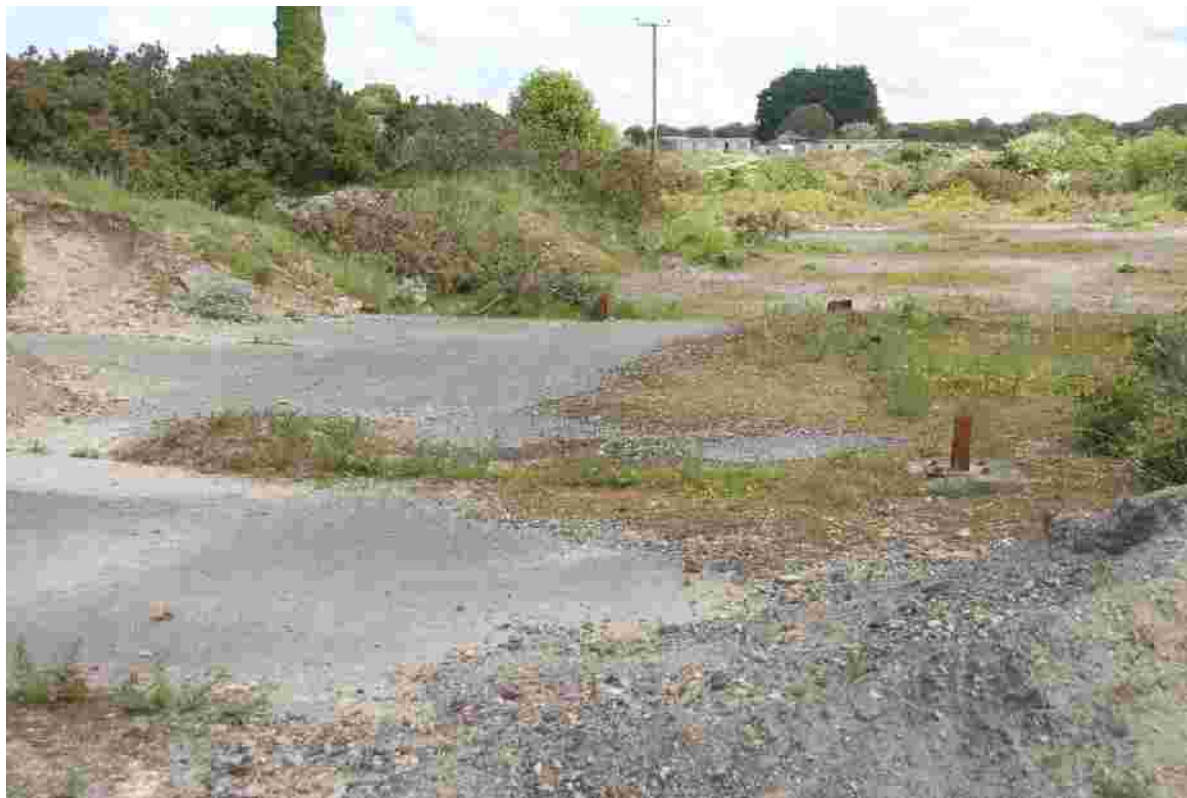
*Fig 44. The sites of at least two buildings [32/36a] adjacent to Reade's Shaft, the most recently demolished of which is marked by lines of cut-off RSJs protruding from the ground surface.*

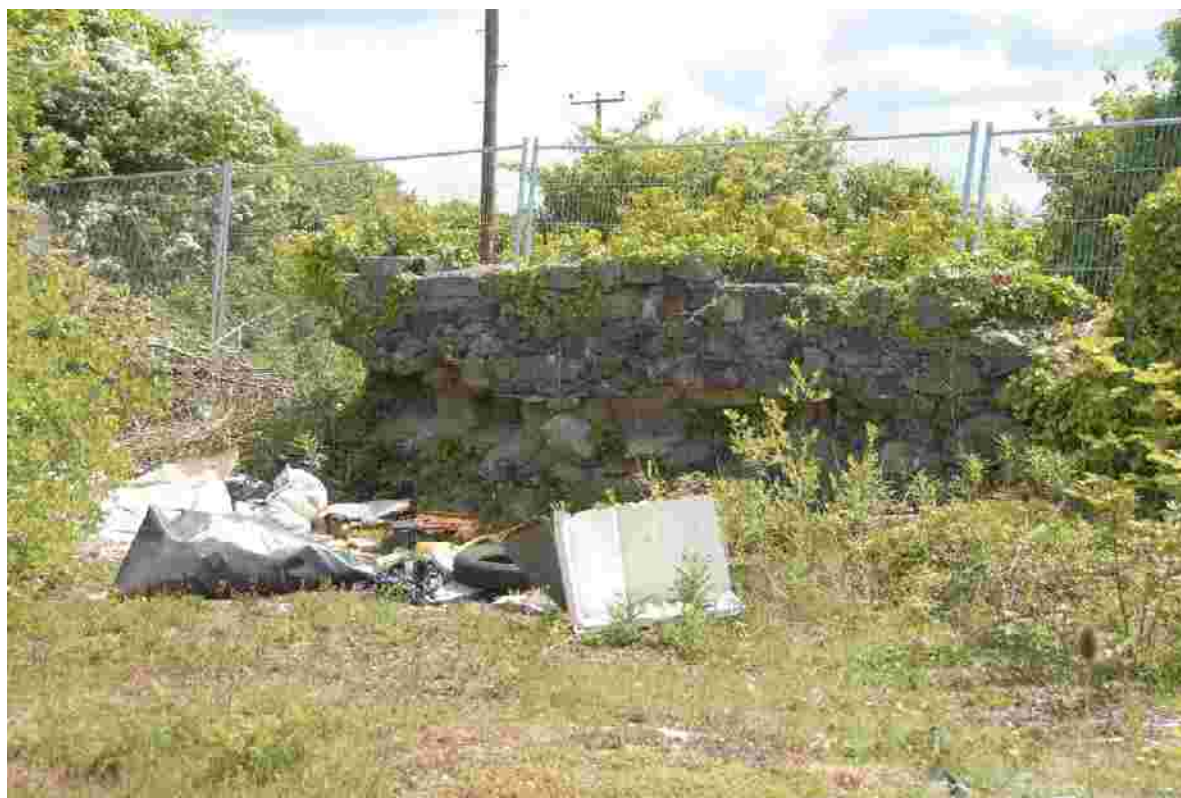
The wall edging the roadway and linking this building to its neighbour to the south-west is 1.6m high, constructed of masonry, though repaired in blockwork (Fig 45). This is a significant surviving feature in this part of the site and as such it should be repaired and conserved.

*Fig 45. The eastern boundary wall of the former sawmill, constructed from a mixture of masonry and brickwork. This area next to an adjacent land is particularly prone to fly tipping.*

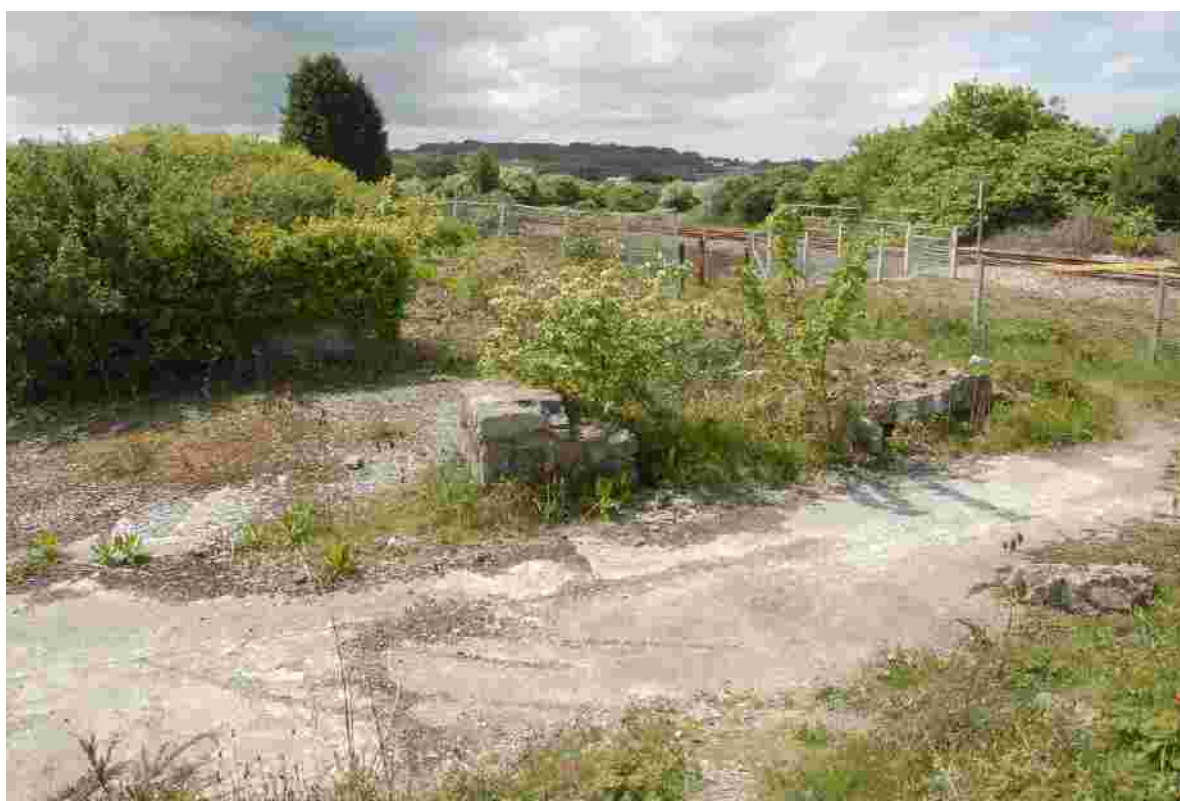
The majority of this building has been demolished (Fig 46), only its ivy-covered rubble masonry and brick northern wall standing to anything like its original height. The wall to the south-west appears to have been replaced in blockwork, but has now been demolished. The extension to the north is now represented by the remains of a wall return; the remainder has been demolished and over-dumped, though the lower course of its walling may survive. The extension to the south lay within an area which is now

*Fig 46. A view of the southern side of the western end of the elongated sawmill building [40]. Only foundations now remain of this building.*

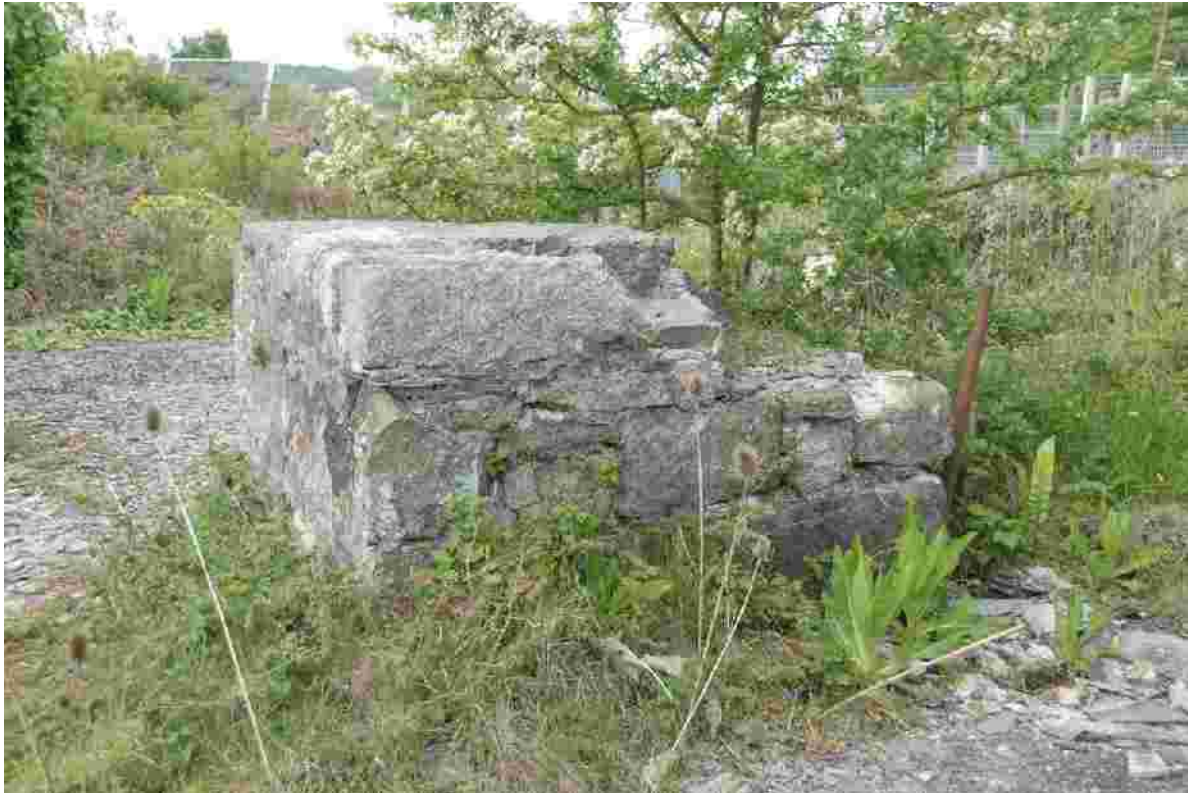
*Fig 47. A substantial masonry plinth at the western end of the central sawmill building [40]. A large threaded metal fixing protrudes from the ground adjacent to this.*

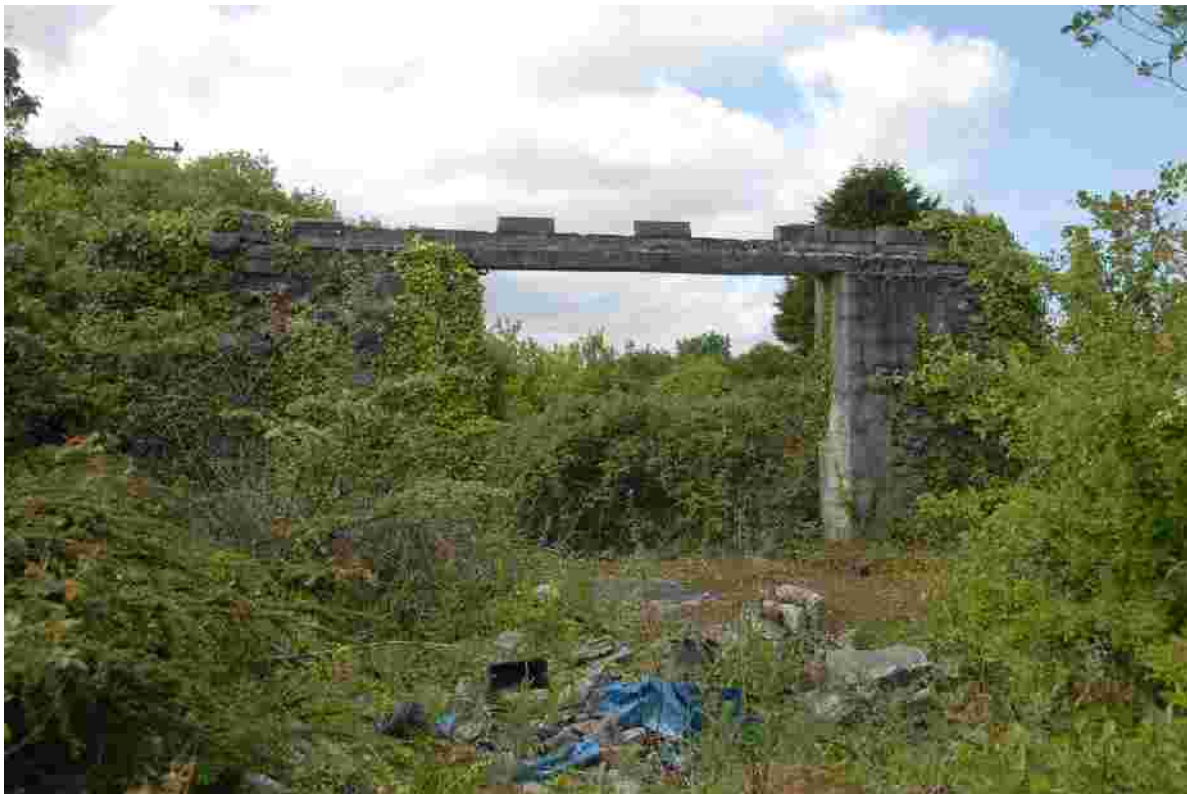
*Fig 48. All that remains of the L-shaped mid-19<sup>th</sup> century mine building [41] at the southern end of the Hallenbeagle site.*
