Lanteglos by Fowey Cornwall

Repair, cleaning and interpretation of churchyard crosses

**Churchyard Crosses,
Lanteglos by Fowey
Repair, cleaning and interpretation**

Report No: 2007R030

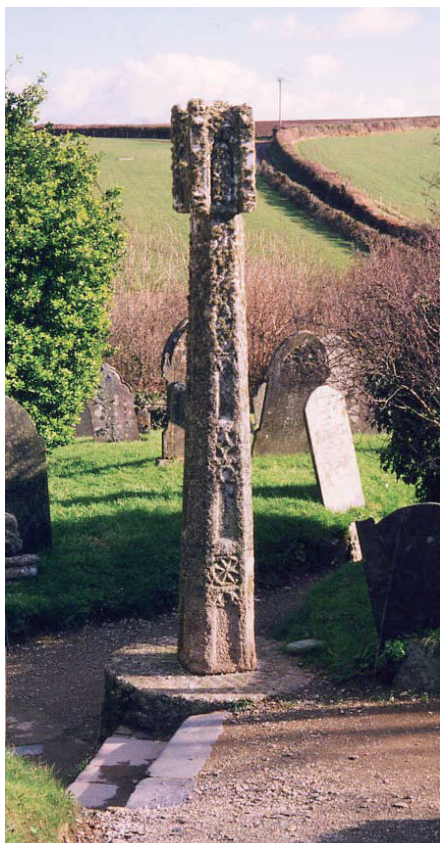
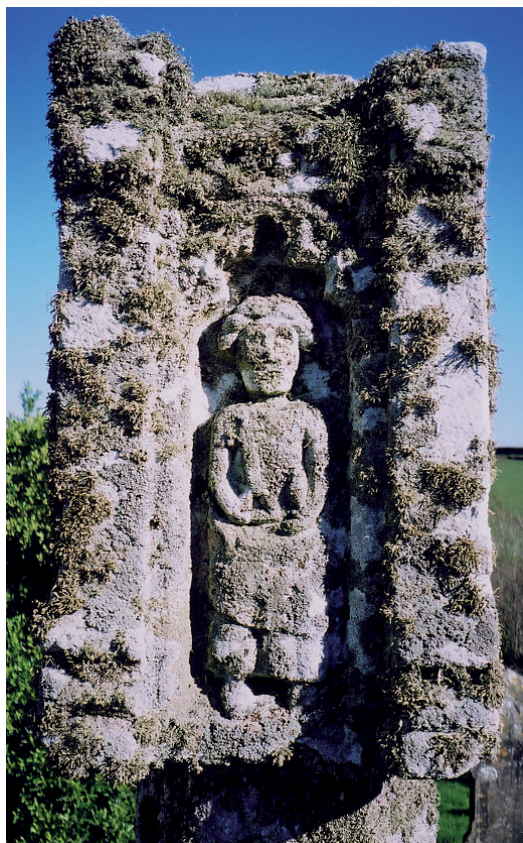
A thick growth of long frondy lichen, especially on the south and south-west faces of the head, was the main problem affecting the lantern cross. Although this was not considered

to be a concern for the long term conservation of the cross, it had the effect of obscuring the carving, which is the most important feature of the cross.

Fig 2 The lantern cross and the latin cross before conservation work.

Removal of the lichens from the head of the lantern cross proved a fascinating exercise in revealing the detail of the sculptured images. At present, it is intended that the lichens should be allowed to re-grow because they are not considered to be harming the stone, while the images will continue to be seen only through the medium of an information sheet. However, if local feeling dictates that they are too interesting to be hidden, then consideration should be given to periodic careful cleaning.

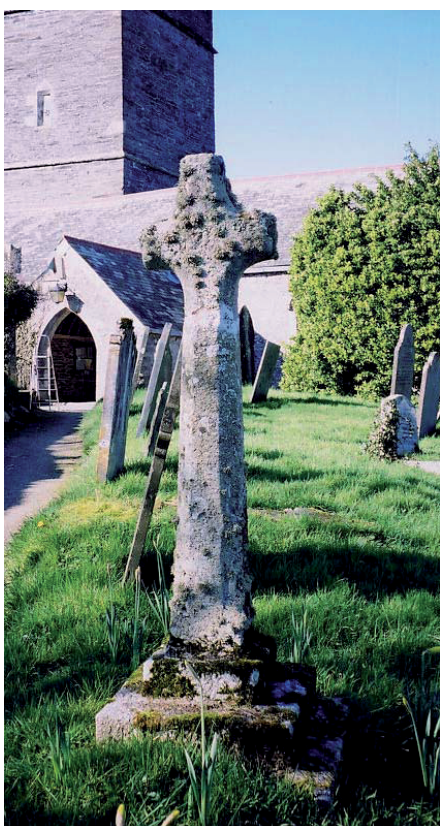
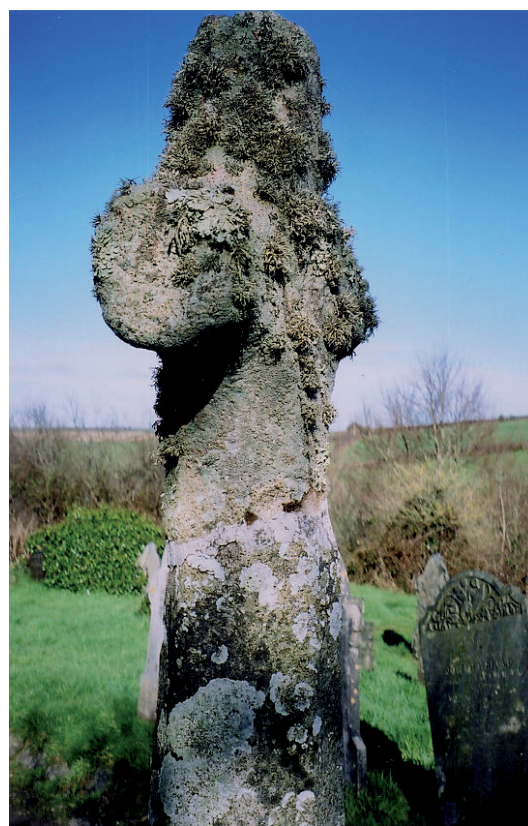
The latin cross

1. ‘As with the lantern cross, the surface of the Pentewan Stone is heavily pocked, with thick lichen growth....but otherwise is in good condition’.
2. ‘The head has been set back on with a pronounced step to the north. There is probably an internal iron dowel, perhaps set in lead; the holes for this in the head and shaft were probably set inaccurately, creating the step when the two were set together’.
3. ‘The joint is filled with white cement-based mortar. This is now cracked, suggesting there has been some movement, perhaps some corrosion of the fixing’ (Kelland 2005, 4).

1. The cement pointing around the joint between shaft and head of the cross was carefully removed.
2. The head was then lifted from the shaft and laid to one side.
3. The old fixing was removed, taking care not to damage the cross.
4. A new central hole was drilled in the cross head and shaft, and the old off-centre hole filled.
5. The joint was cleaned.
6. The new pin was fixed into the shaft with polyester stone glue.
7. The head was re-set on the shaft.
8. Finally, the joint between shaft and head was filled with a lime mortar, coloured to match the stone as closely as possible.

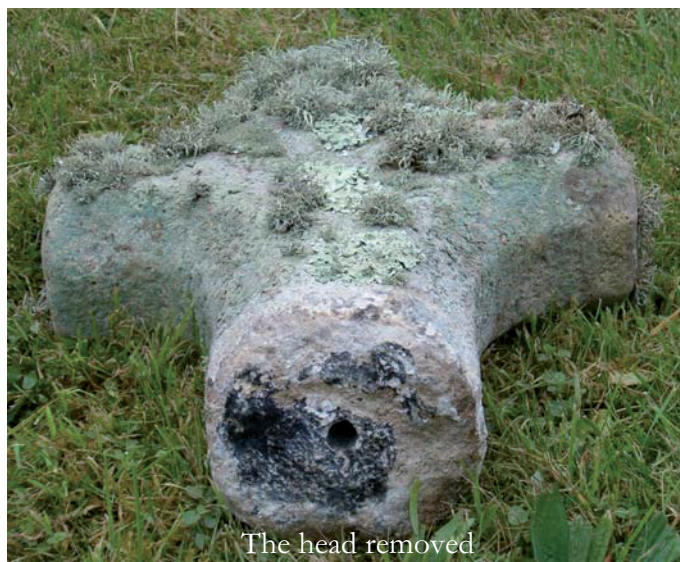
The head removed

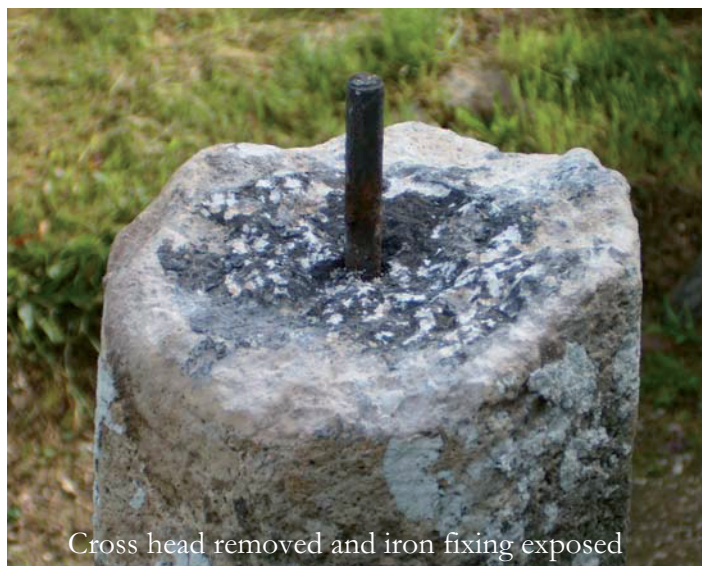
1. The original central fixing was a length of galvanised iron, 70mm long.

2. This was generally in good condition, but just starting to corrode at the centre, as a result of water penetration through the cracked cement pointing of the joint. If this pin had not been replaced then before long, corrosion of the iron would have caused the pin to expand, and eventually blown the cross apart. The work can therefore be regarded as very timely.
3. The fact that the head had spent part of its life in use at the nearby creek as a mooring stone was evident in the rounding and wear to the broken edge, as well as in the existence of a drill hole in one side. This means that unfortunately, the joint between the head and shaft is quite a wide one, necessitating a wide and conspicuous band of mortar to fill it.

Cross head removed and iron fixing exposed

II.3.1 The old dowel, 70 mm long, in galvanised iron, was removed. This dowel, which probably dates from the 1908 work, was bent, and this corresponds to the cracking in the mortar joint, indicating that the head had been wobbling slightly.

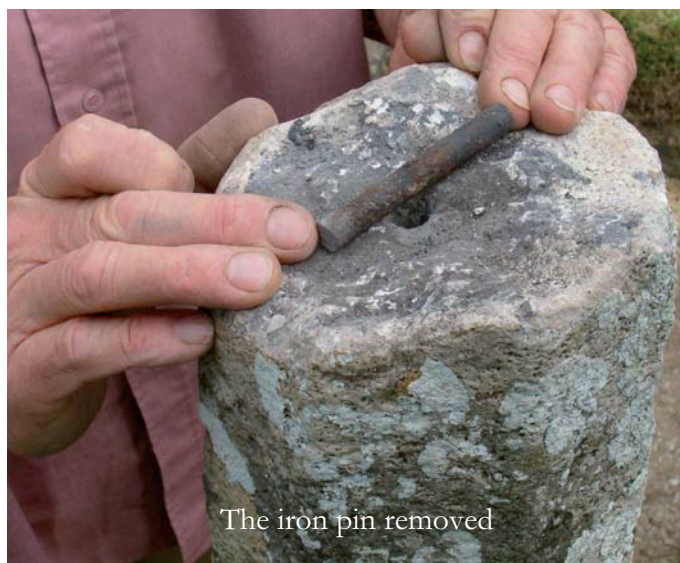
The iron pin removed

II.3.2 The old dowel was replaced with a new one in stainless steel (S316 marine grade) threaded rod 12mm in diameter by 90 mm long. This was packed with 'General transparent vertical' polyester resin.

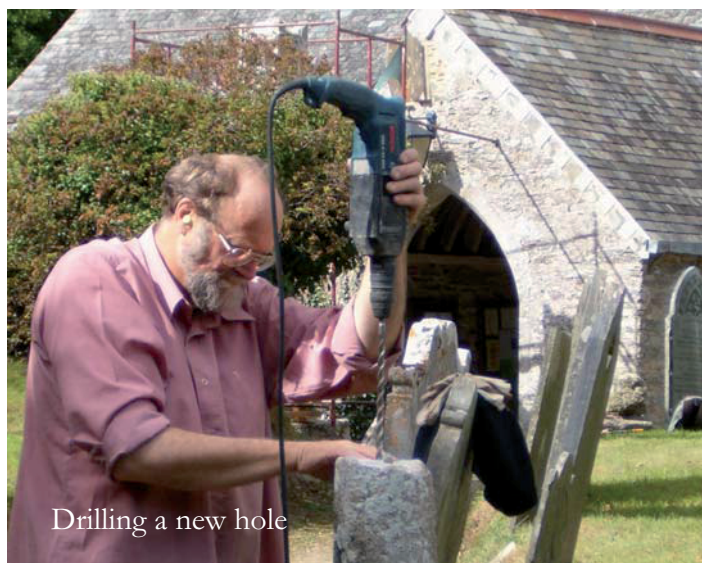
Drilling a new hole

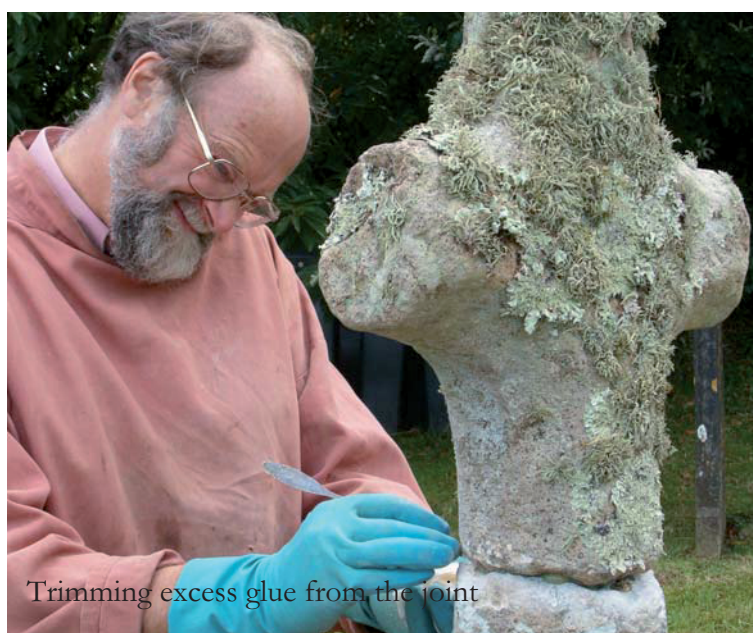
Trimming excess glue from the joint

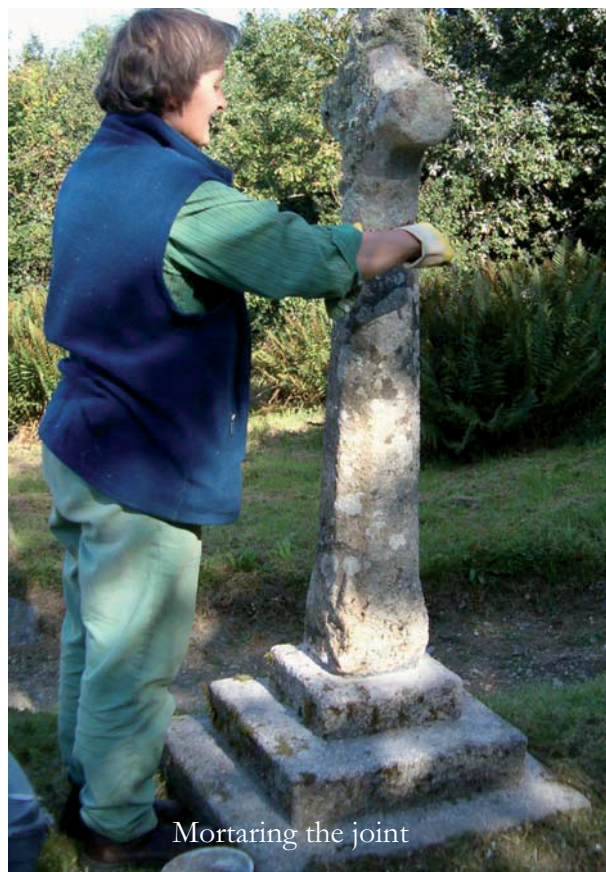
Mortaring the joint

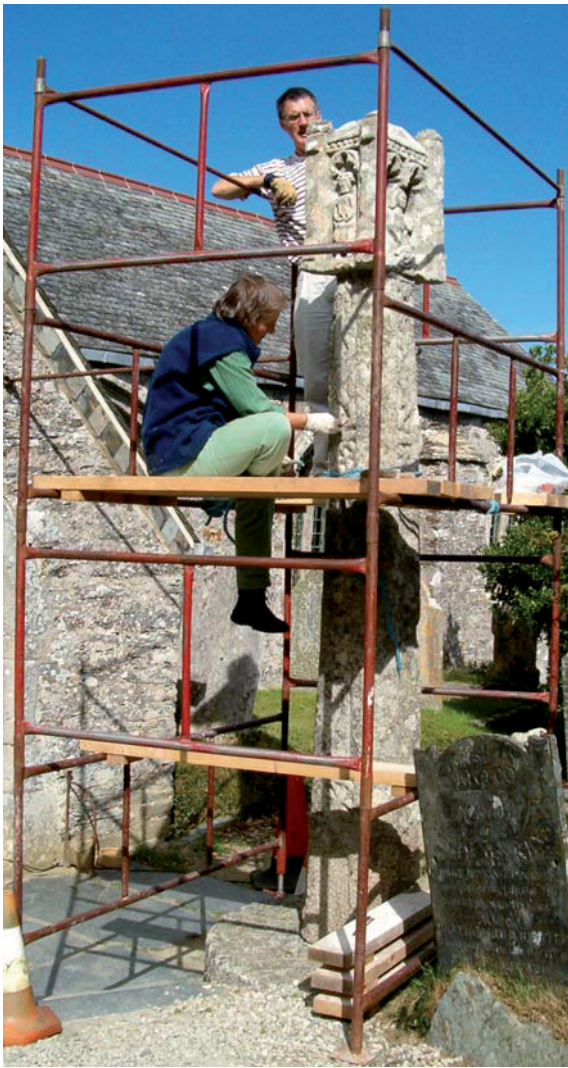
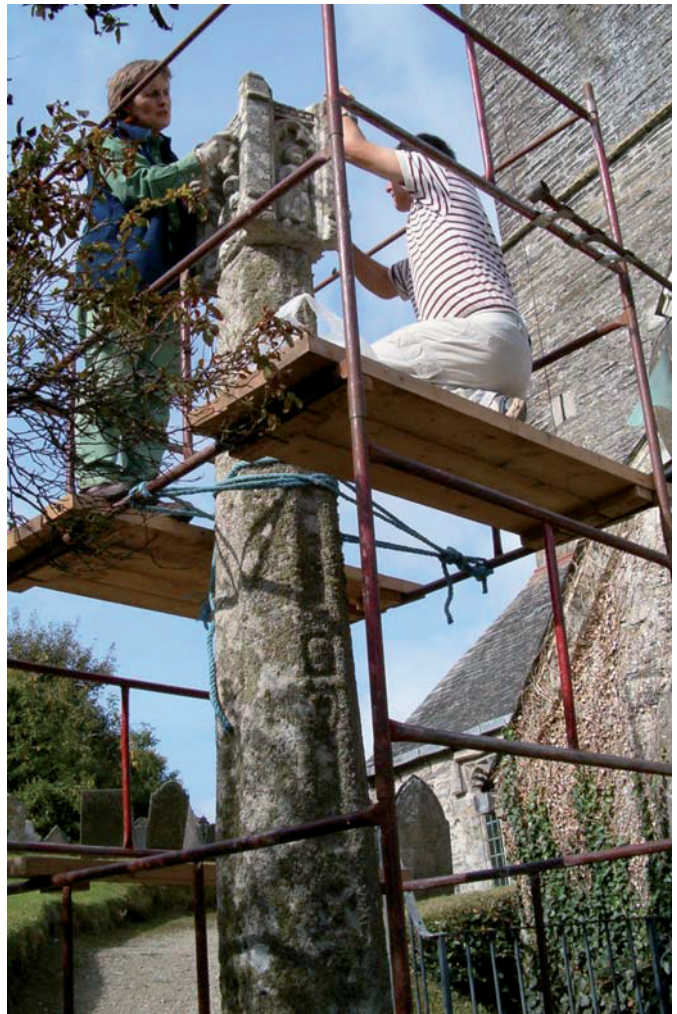
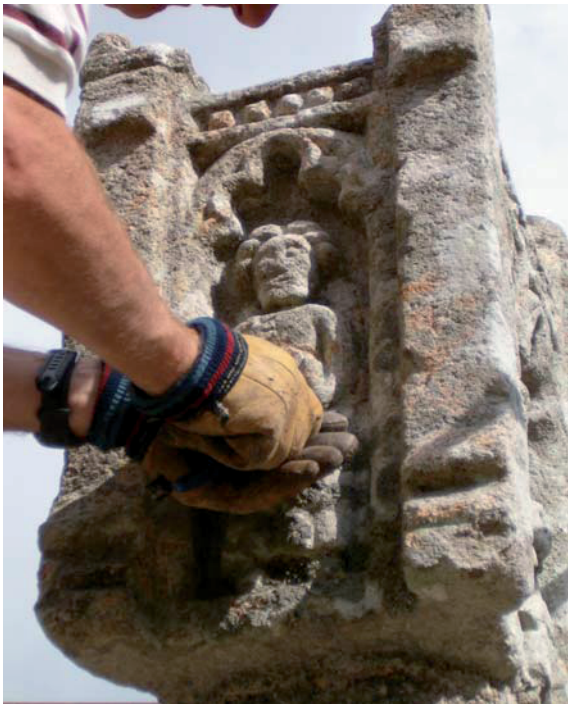
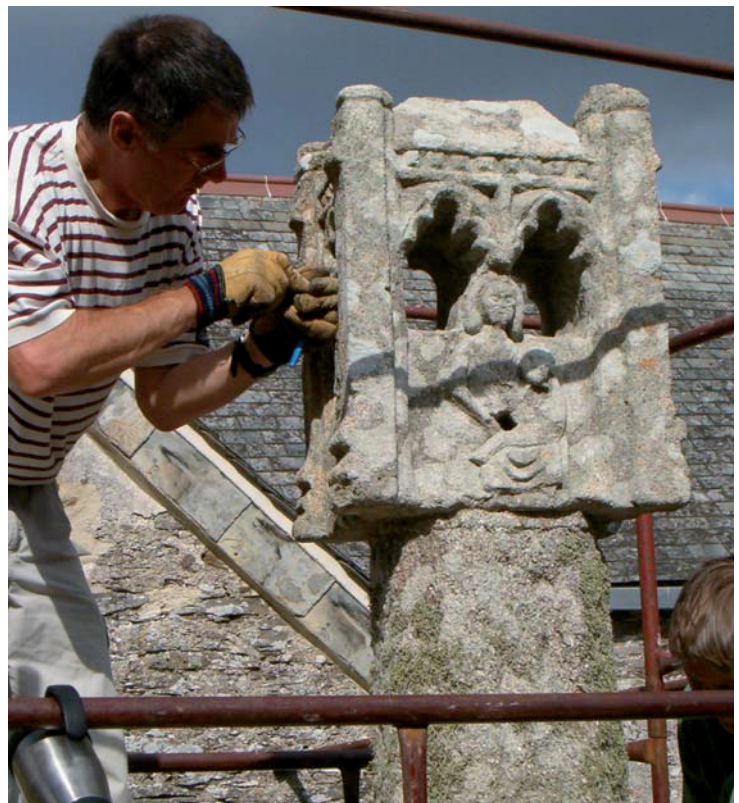
Fig 4. Cleaning the lichen from the lantern cross

The long hairy lichen, growing especially on the south and south-west faces of the head, was the main problem affecting the lantern cross. Although it is not a concern for the long-term conservation, the lichen growth had the effect of obscuring the carving, which is the most important feature of the cross. However, there were concerns that the lichen might also be of importance: so it was removed carefully by mechanical means only (not

The lichen was removed by rubbing, cutting and brushing and from beneath it, crisp clear sculpture emerged. The carving is so well preserved that even small details, like the moustache on Christ's face and St Peter's fashionably curly hair, can now be seen.

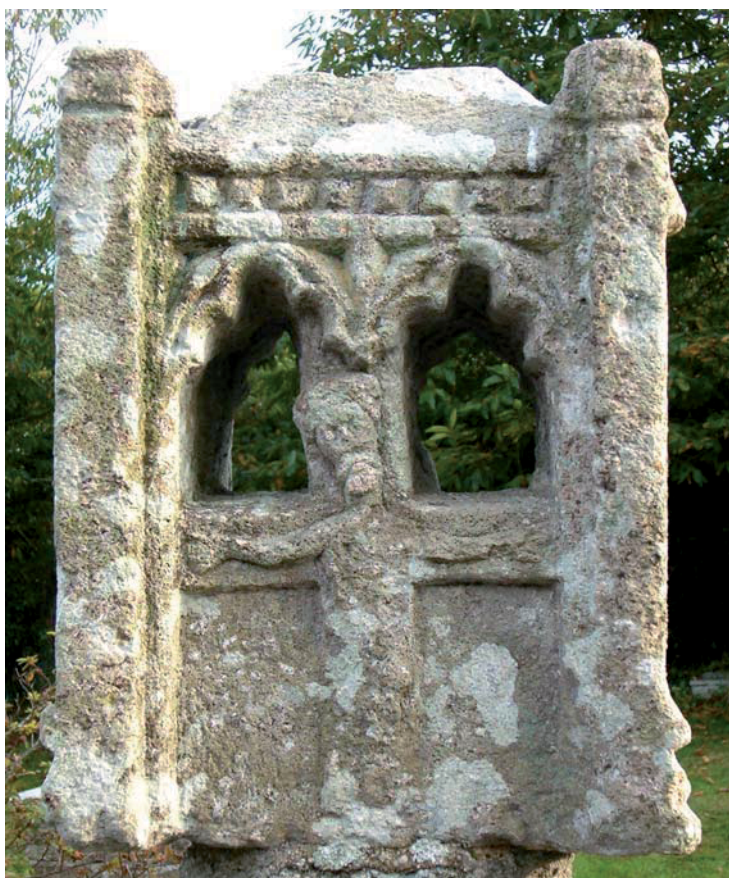
North side: Perhaps deliberately arranged to face the church door in the 19th century restoration is the image of the Crucifixion. The space above the cross arms is cut right through the thickness of the stone, with a double-headed niche above. Christ's head leans slightly to one side and he sports a sumptuous drooping moustache and beard. Above his head is a halo. Christ's body has been damaged, perhaps as an act of deliberate iconoclasm.

The Crucifixion

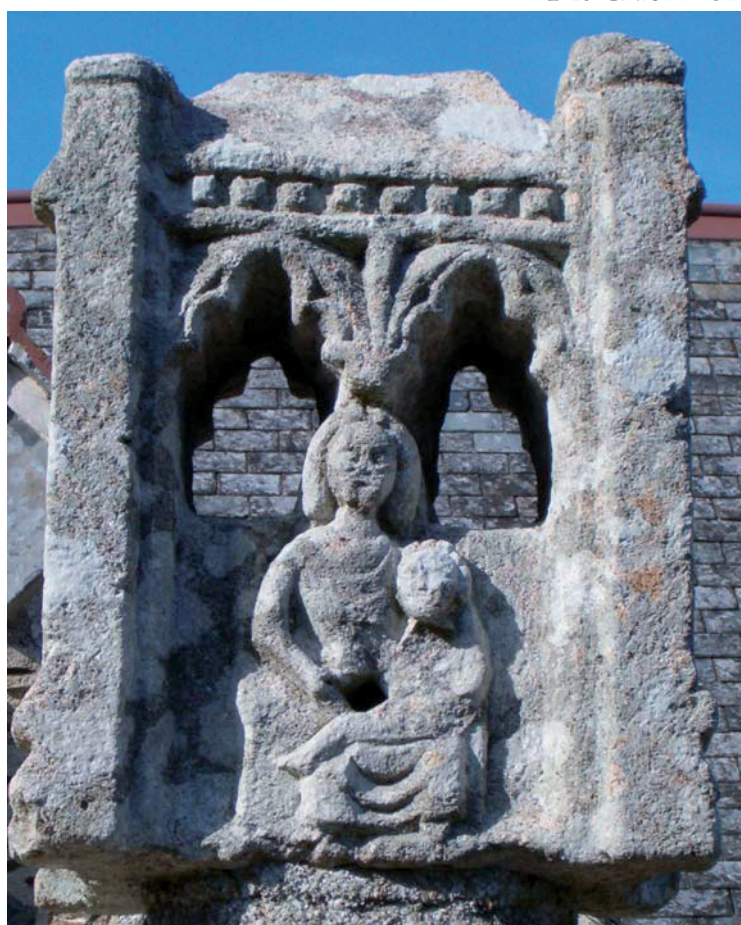
South side: Beneath a double-headed niche, is an image of Mary seated on a bench, with the Infant Christ supported in her left arm. Mary has shoulder-length hair and the features of her doll-like face, including a small and gentle smile, can be plainly made out. The folds and drapes of her long robe are clearly depicted, as are the curls on the Baby's head.

The monument on this face has been damaged at the point where Mary's arm enfolds the Child. This may be the result of deliberate iconoclasm, or may be related to the drilling of a small square hole in the face of the cross here. The reason for this hole is uncertain, but was perhaps to enable it to be displayed from a shelf or bracket at some time: a dowel in the hole could have helped to hold the head securely against a wall.

Mary and Christ

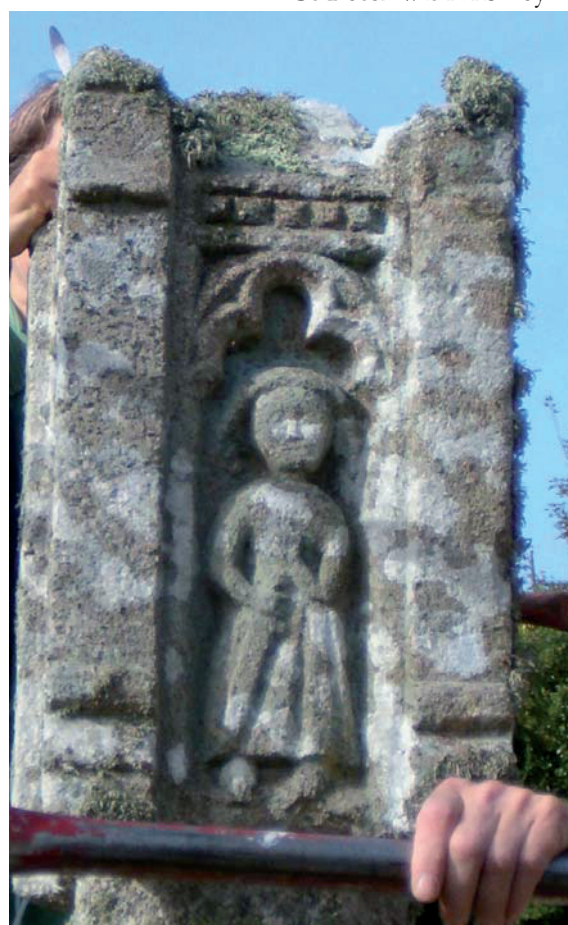
East face: On this face is an image of St Paul, in a long pleated robe, and head-dress, holding a sword in his right hand, while his left arm is bent.

St Paul with his sword

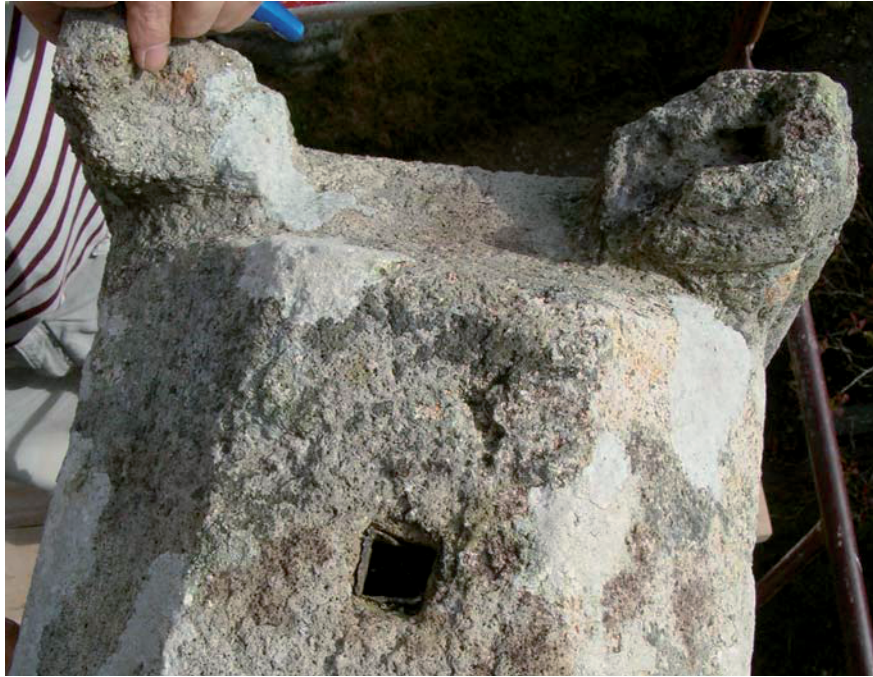
The cross in its present form consists of a rectangular head of Pentewan Stone, mounted on a granite shaft, standing on a base created from an old millstone. The fact that the head and shaft are of different stones raises the question of whether they are in fact parts of two separate monuments: yet even if they are not, the original monument(s) would nevertheless have had a similar appearance. At 3 metres high, it is one of the tallest lantern crosses in Cornwall, and yet (assuming the two stones do belong together) it may have stood over 4 metres high originally, for the cross in its present form is obviously incomplete. Comparison with other lantern crosses (see Fig 9 for examples) demonstrates the fact that the monument would originally have included some sort of decorated collar between the head and shaft and pinnacles on the top. Indeed, with access from the scaffolding, the top of the head could be inspected, and here the remains of five small square holes – mortices for the pinnacles that once crowned the head – could be seen. The four on the corners of the head are all broken, but that at the centre is well preserved and still contains the thin cushion of lead used to help hold the tenon of the central pinnacle in place (see Fig 6).

Top of the lantern head showing the sockets for pinnacles. That at the centre has a lead lining.

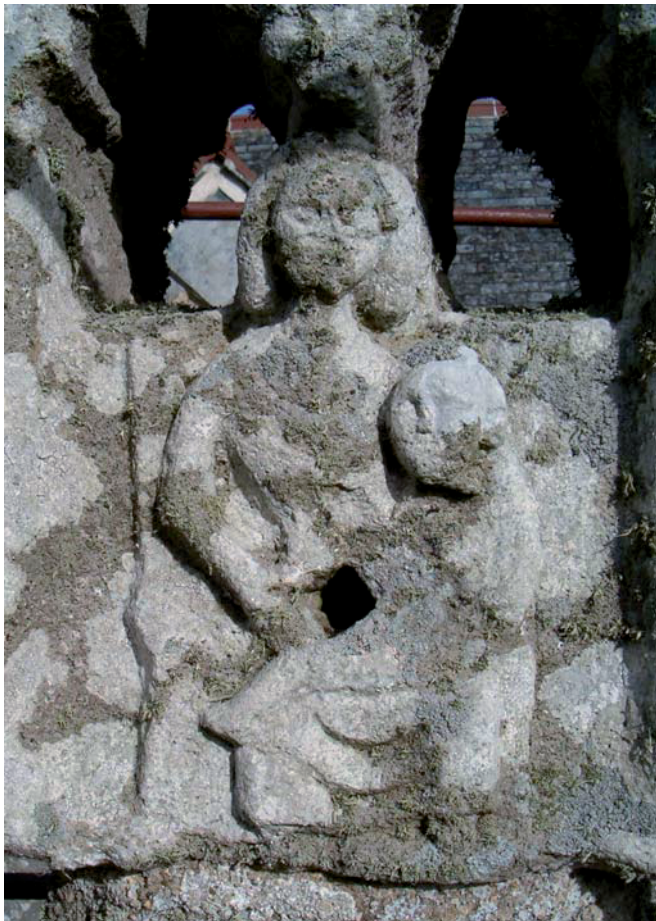
Square hole cut into the image of Mary, and mutilated body of Christ

3. At some time, the base of the lantern head has been trimmed flat and the square hole cut into Mary's body. It was suggested above that this could have been done to enable the cross to be displayed on a shelf or bracket, with the Crucifixion facing out and a dowel in the back helping to hold it against a wall. Again a date at around the time of the civil war is likely since the only symbol tolerated in Puritan times was the Crucifixion.

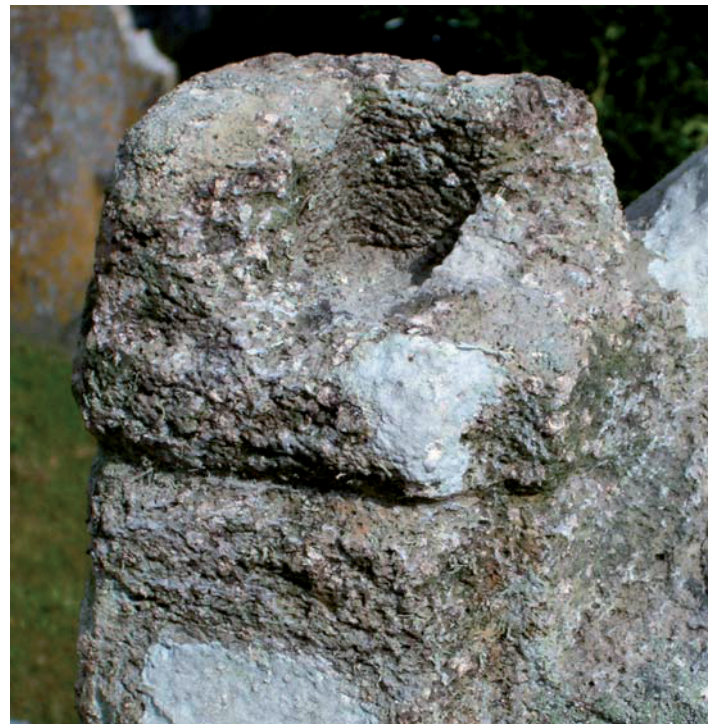
Broken socket for corner pinnacle

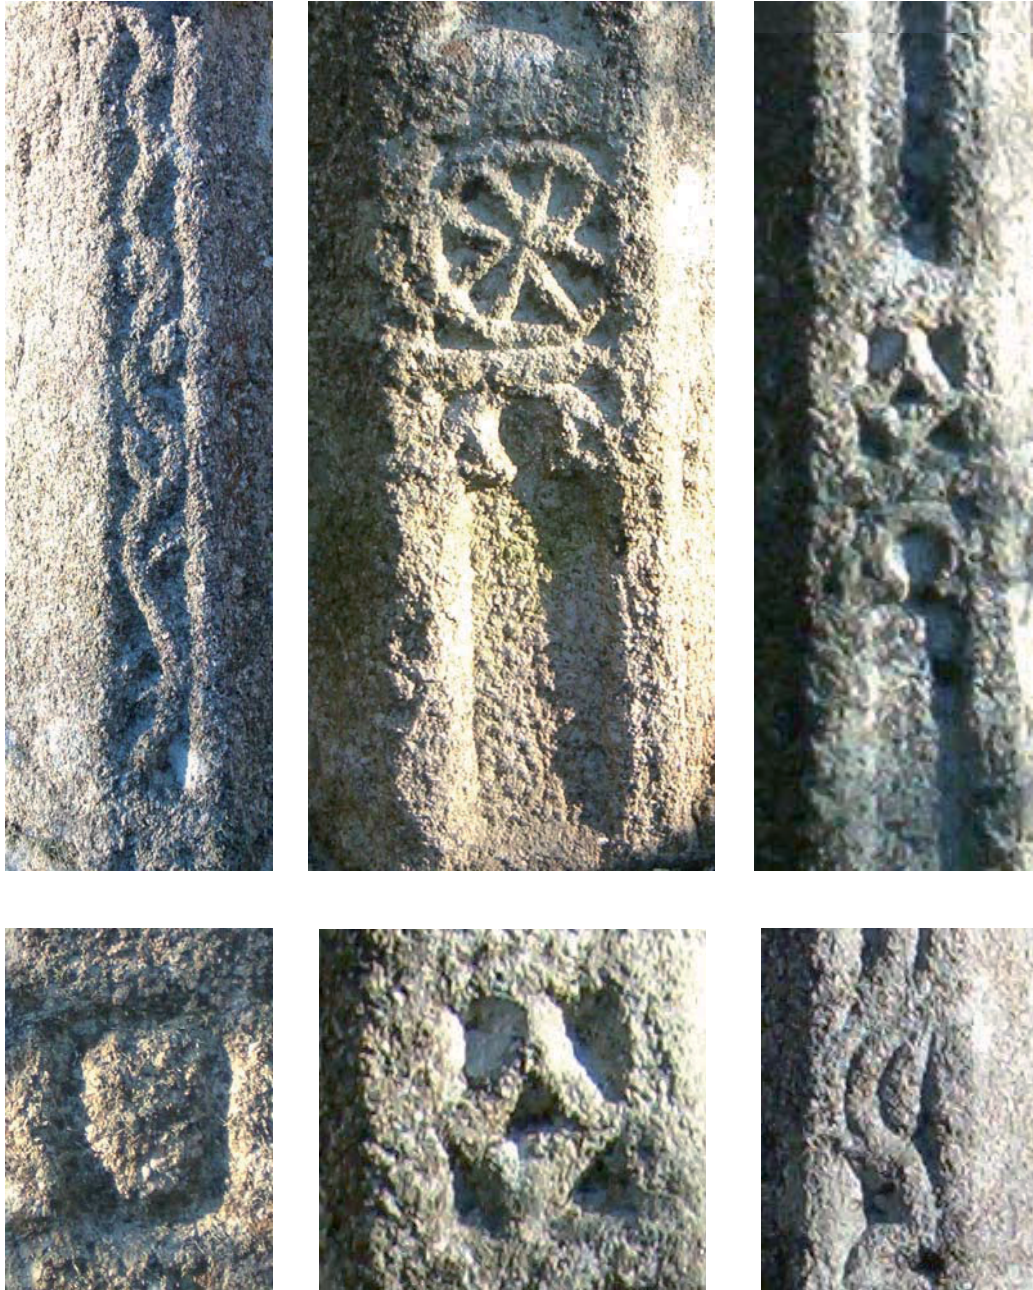
Fig 7 Examples of the sculpture on the shaft of the lantern cross

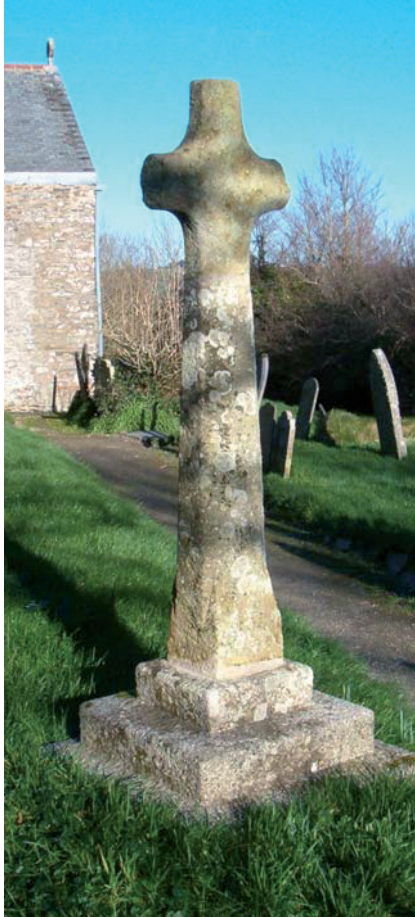
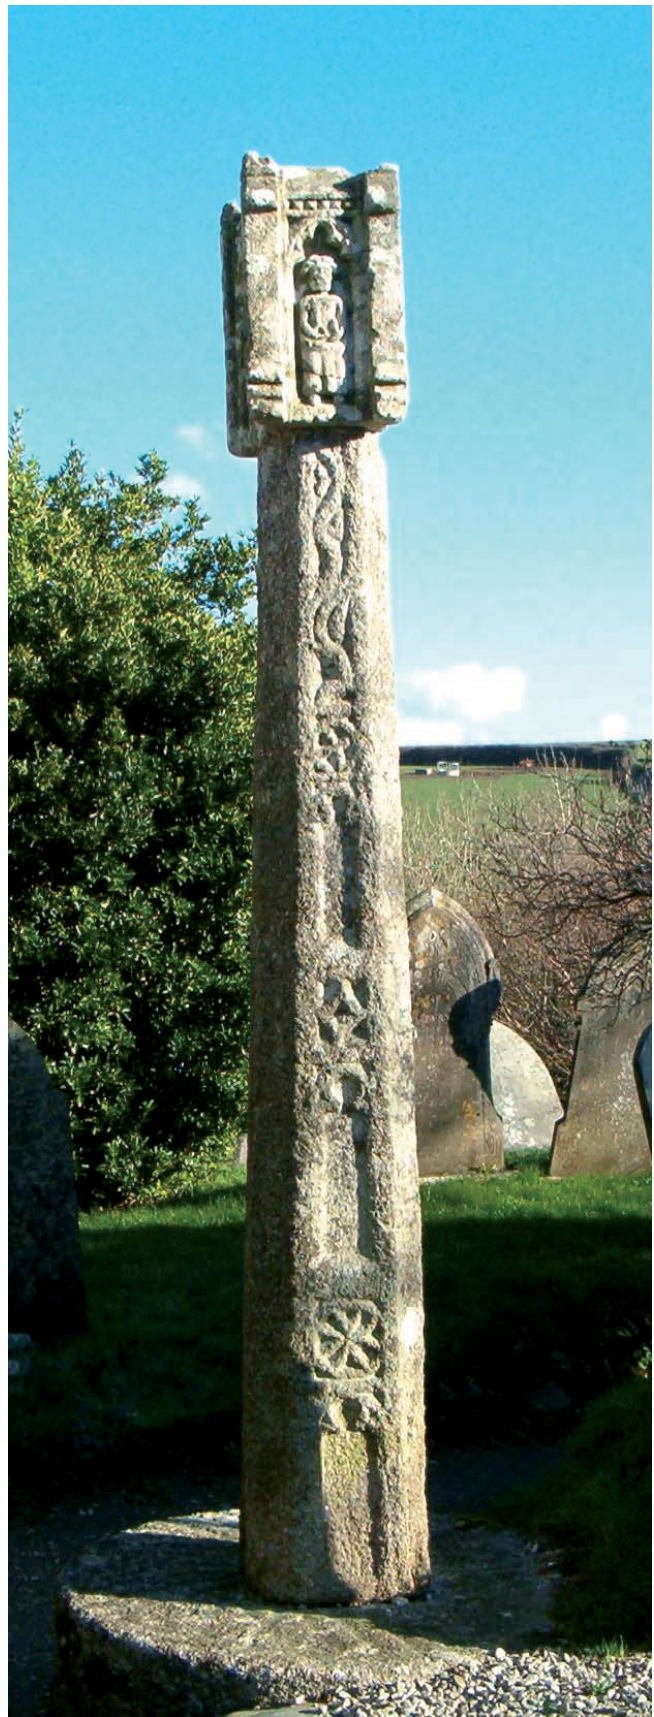
*Fig 8 The conserved monuments
(not to scale)*

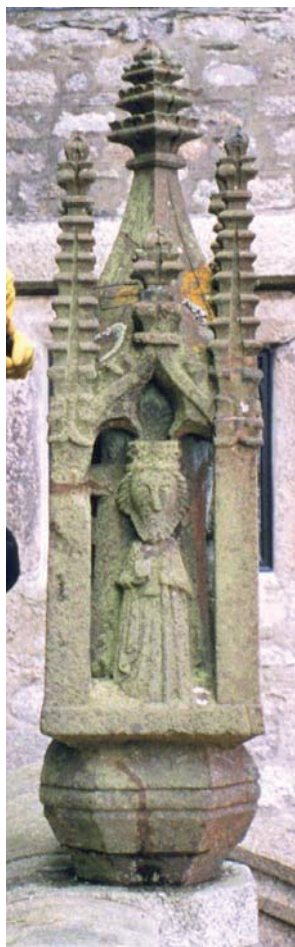
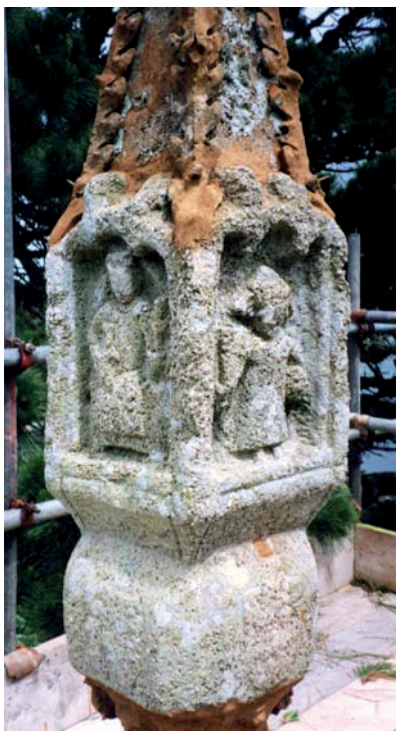
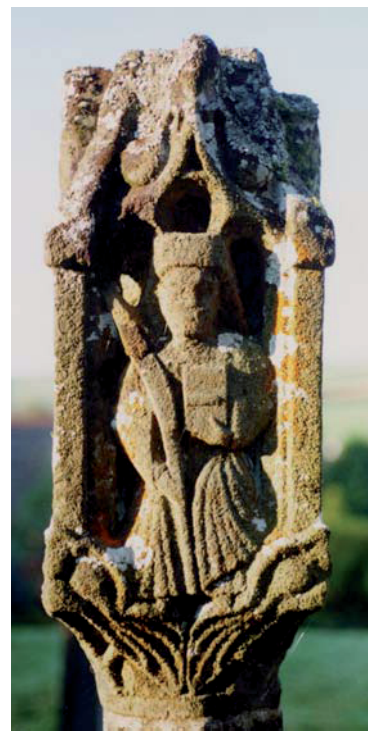
Fig 9 Other lantern crosses, for comparison.

Above, left to right: St Michael's Mount, outside the chapel (note 'cushion' base and restored pinnacles); St Michael's Mount garden; St Neot (note carving below lantern head).

Right: Grampound: note steps, chamfered base, octagonal shaft and collar decorated with rosettes.

The bottom edge of the lantern head is absolutely flat and appears to have been deliberately cut so. In this position there would originally have been a cushion or other moulding at the joint between the head and the shaft, as can be seen on the chapel cross at St Michael's Mount (Fig 9). The base too would have been a more elaborate affair, with the shaft probably set into a square moulded base, which in turn may have been mounted on a series of steps, like the cross shaft in Grampound's main street (Fig 9).

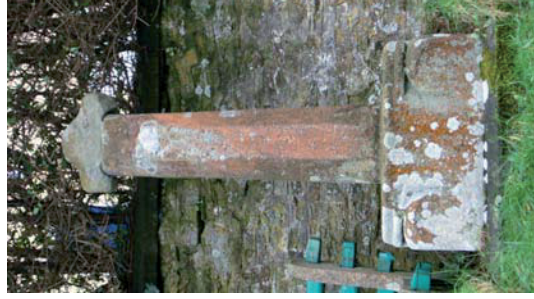
Fig. 1

The **Polruan or St Saviour's Cross** (*Fig. 1*) stands at the top of Fore Street, at the entrance to the village, and takes its name from the nearby ruins of an ancient chapel dedicated to Our Saviour. The monument consists of an octagonal sectioned cross-shaft only that tapers upwards from a gothic base-stone; both parts of the cross are cut from Pentewan stone. An additional piece of carved granite, allegedly part of another cross, has been bolted to the top of the shaft. During the 19th century, a spring situated below the cross flowed into a granite trough and was used as a public water supply for the village.

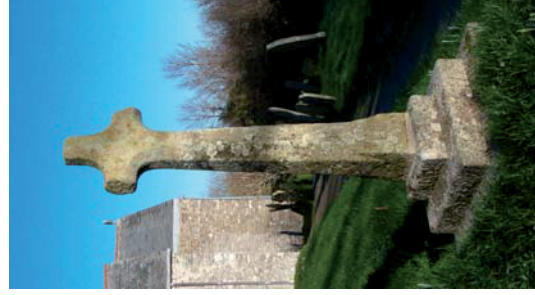
Fig. 2

Pont Creek Cross (*Fig. 2*) is a small Latin cross that stands near to the south-east entrance to the churchyard beside a pathway. This cross is carved from Pentewan stone from the medieval coastal quarries near Mevagissey. The head of this monument was discovered half-buried in the mud at Pont Creek, in the valley directly north of the church, where it had been utilized as a mooring post.

When the cross-head was rescued and removed to the churchyard at the beginning of the century the shaft was found lying in the churchyard and the two portions of the cross were re-united and set up on the modern base-stone. The lower step of the base-stone is inscribed in Roman numerals with the date 1908, the year it was restored in the incumbency of the Revd. C.F.Trusted.

The cross is octagonal in section, its shaft displays chamfered stops at the bottom and the modern stepped base complements the monument well. There is no way of knowing whether this cross originated in the churchyard or was a wayside cross marking the route from Bodinnick via Pont to the parish church of St Wyllow.

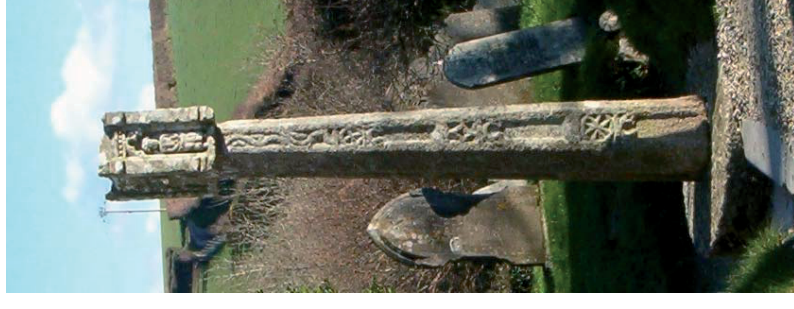
Fig. 3

The Lantern cross in the churchyard (*Fig. 3*) is fully described on the next page.

This tall lantern cross was re-erected in its present position in 1841 by the Hon. G. M. Fortescue of Boconnoc. The cross was recorded as being discovered deeply buried in a trench at the western end of the church in 1838. Some historians have suggested that the monument may have been deliberately hidden to avoid being destroyed by religious reformers during the Commonwealth. The rectangular cross-head is carved from Pentewan stone and displays images on each of its four faces, while the cross-shaft which supports it is cut from moorland granite and is decorated with blind niches, geometric motifs and plant trails.
