# **Tavistock-Bere Alston Railway, Devon**

## **Archaeological impact and mitigation recording report**

Report No 2011R093	Report Name TVMHP Tavistock - Bere Alston Railway Watching Brief Report		Report Author Colin Buck	
Event Type				
Site Consultancy	Archaeological impact assessment	Archaeological watching brief		
Client Organisation TVMHP (West Devon Borough Council)		Client Contact Chris Hariades (TVMHP)		
Monuments (Mon UID)				
DHER	22719 (Railway line)	51334 (Abbotsfield Bridge)	3956 (Crowndale mine)	51335 (Shillamill Viaduct)
Fieldwork dates (From) (To)		(Created By)	(Create Date)	
1/10/2008 23/12/2008		Colin Buck	31/8/2011	
Location (postal address; or general location and parish)				
Tavistock to Bere Alston Railway (from Abbotsfield bridge to east end of Shillamill Viaduct)				
(Town – for urban sites)		(Postcode)		
West of Tavistock				
(Easting) X co-ord		(Northing) Y co-ord		
From: SX	47084	73657		
To: SX	46649	72191

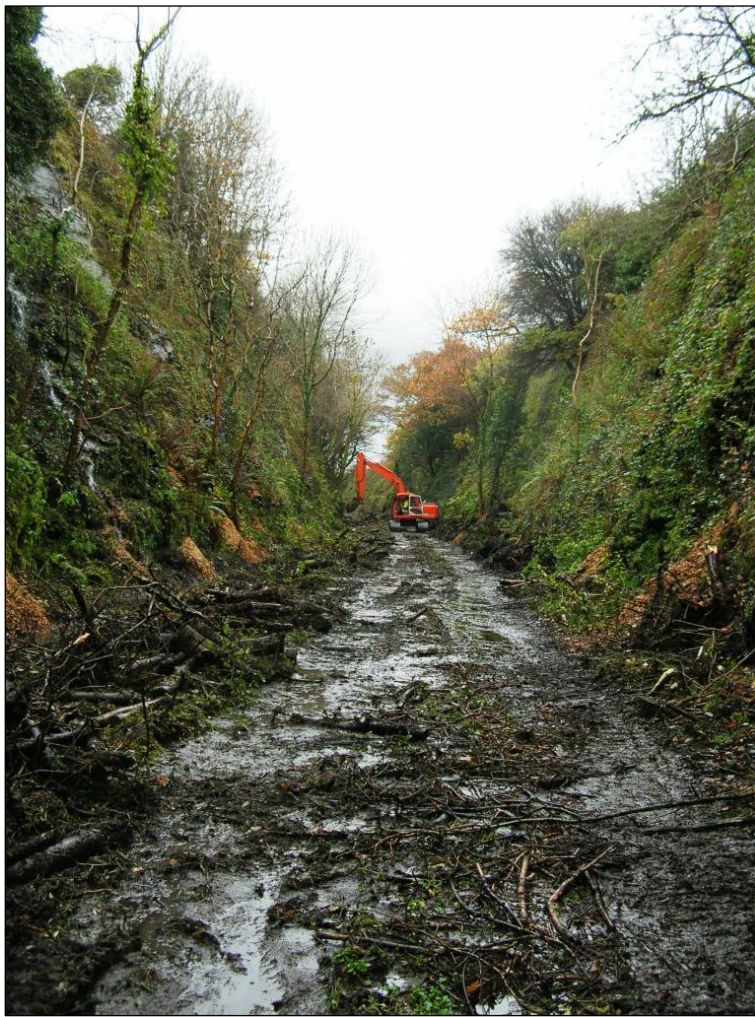
*Figure 4 Tavistock to Bere Alston railway track during vegetation/tree clearance/drainage works (© CC HE 2008)*

The initial site work from early October 2008, consisted of gaining access along the railway line (by brush cutting/chain sawing) of a large amount of vegetation and trees (mainly ash/hazel and sycamore), both on and overhanging the former railway line. This was then followed by the use of a tracked machine to remove the tree stumps from the track bed, and the excavation of a shallow drainage ditch (0.25- 0.4m deep and 0.5m wide), along the (lower) side of each of the two main track cuttings (both above and below the site of the two Crowndale mine shafts - see Figs 2 and 3). Figure 4 is a view of the railway track during clearance of trees and residual stumps, following extensive strimming/removal of track vegetation, and the excavation of a shallow drainage route next to the side of the railway. During periods of heavy rain, water poured out of the rock cut sides and into the track bed – causing ponding in places. There would have been a drainage system in place throughout the use of the railway line - but presumably this had become blocked. However, the drainage of water from the cuttings track bed (via the shallow surface drainage ditches), has been important to maintain and keep the tracks relatively clear and dry for public access all year round. The track bed (which still contains the original ballast stone), was scraped and levelled, to form a stable surface from which walkers can use the track. Figure 5 is a view of the trackbed over two years after the project was finished – it can be seen that vegetation is once again taking hold of the track bed; bi-annual cutting/clearance appears to be necessary.

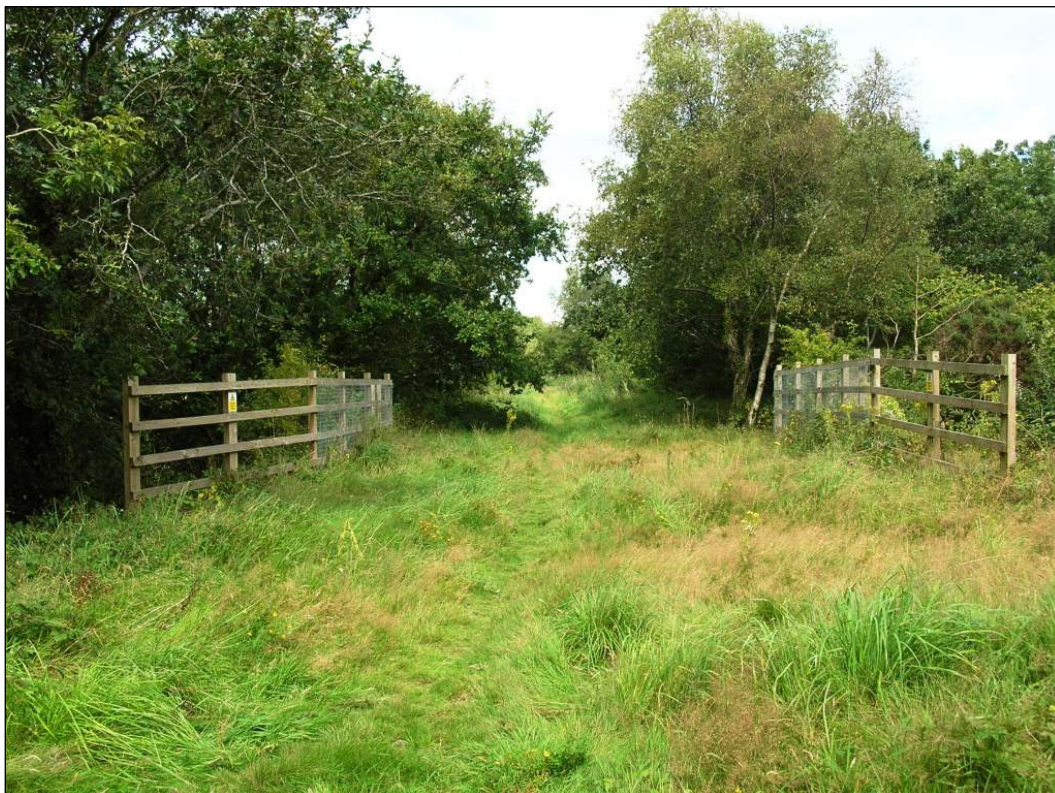
*Figure 5 Railway track after clearance works and bridge parapet fencing (© CC HE 2011)*

Sites 46 (Crowndale Bridge – No. 664) and 48 Crowndale Cattle creep – No. 663), were both fenced with 1.3m high tanalised post and rail fences (each fence overall approximately 12.0m long). In addition close steel mesh was fitted to the sections of fencing immediately parallel to the former railway line (see Fig 5). Site 50 (Abbotsfield Road bridge), was also fenced (8.0m long), where the bridge was removed as it went over the road – leaving a vertical drop from the railway line. However, vegetation covers this site from the public access track which deviates from the end of the railway bridge to go down the west side of the embankment to join Abbotsfield Road.

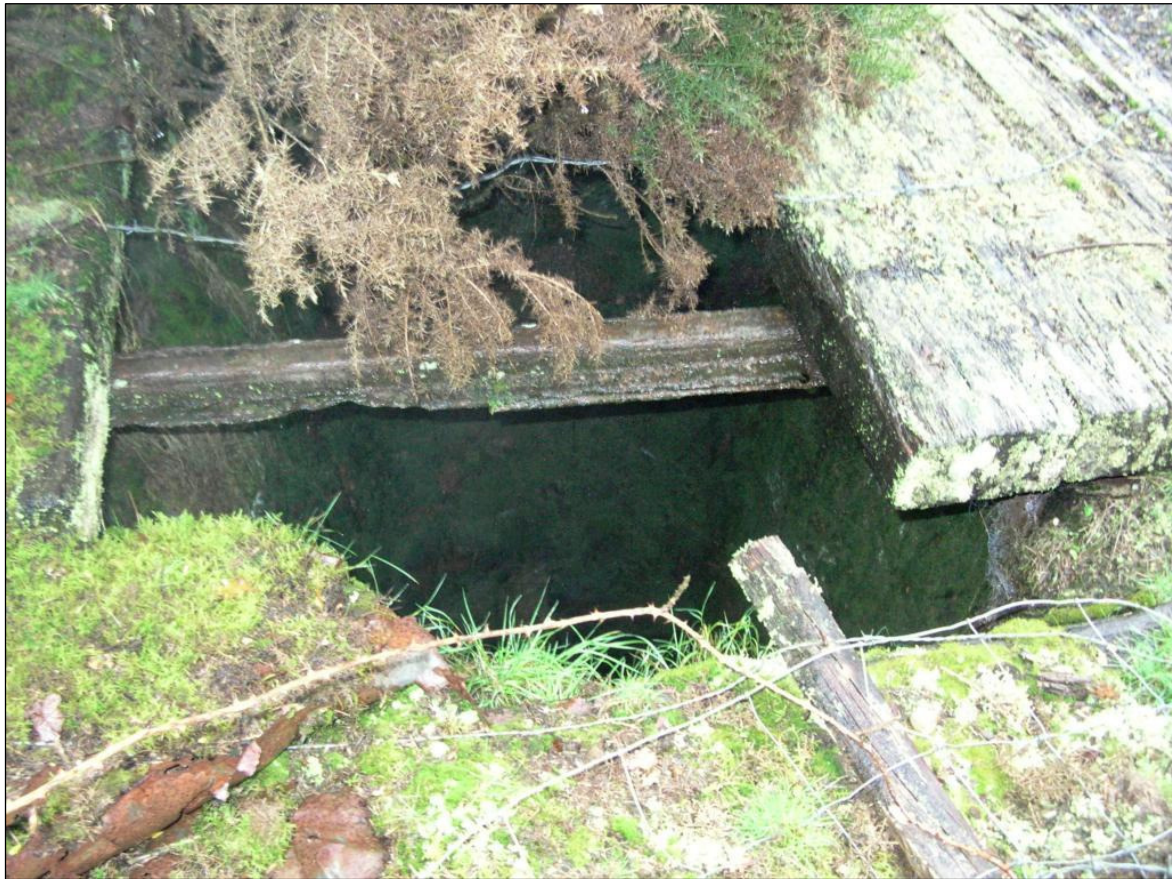
The railway passes close by the sett of Crowndale Mine. Immediately adjacent to the up (north-west) side of the line is a small open mineshaft cut into solid rock. It has been poorly capped with two wooden sleepers and some steel mesh.

During archaeological recording in mid October 2008, this partly open mine shaft was photographed before any works were undertaken. The opening was partly obscured by timbers supported across the shaft by a section of old tramway line (see Fig 8). The shaft was located on the south side of an inclined rock cutting of surface slate bedrock, close to the railway line. The opening was approximately 1.1m x 2.5m in plan, with a shaft depth in excess of 10.0m to solid ground. Sherrell's 2007 geotechnical letter report includes a detailed account of the underground stope and Main lode that was inspected from the open shaft. A sketch plan and section (Sherrell Figs 4 and 5) of the site inspection and the related underlying stope/lode extending under the railway line has been reproduced (with permission) in Figures 6 and 7 respectively, of this report.

*Figure 8 View of Unnamed Shaft before grilling/fencing works (© CC HE 2008)*

The stability of the shaft collar seems to be good, as it is in solid rock. Safety works will be required before the Trail can be opened, and it is suggested that a secure grill be fixed over the shaft mouth.

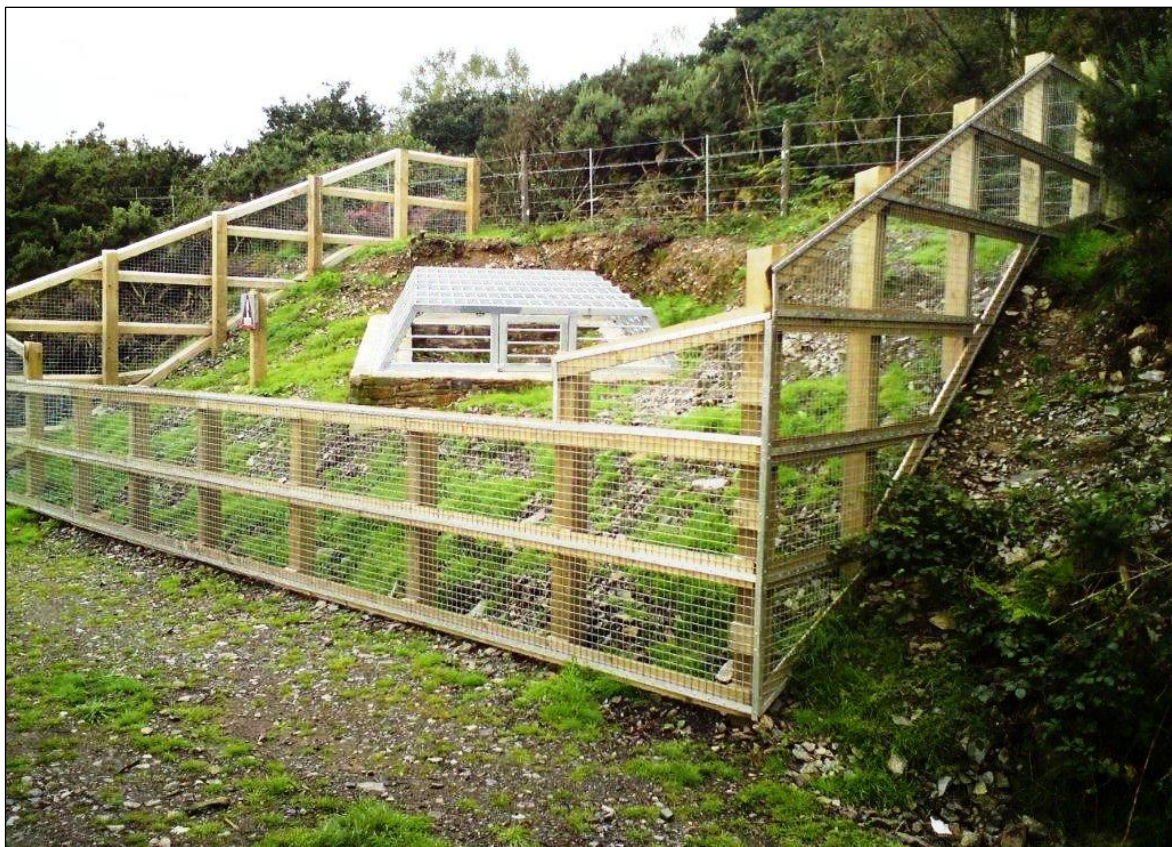
There is no doubt that any shaft fencing is obtrusive and affects the site's character and an impression of its original function. This site is no exception (see Fig 10). It is likely that the significant residual impacts in the long term would be the fencing itself, because the grille design is of relatively low impact. The positive residual aspect is an awareness of a mine shaft close to the railway, part of Crowndale Mine.

*Figure 9 View of Unnamed Shaft after grilling/fencing works (© RG 2009)*

By late October the site around the shaft had been levelled to a flattish surface with a machine digger to form an inclined surface (approximately 5.0m x 4.0m) around the shaft. Approximately 5.0m of ground varying from 1.0m in height at the east end and 0.7m at its west end for a width of 1.0m was removed to form the flat rock surface. A low masonry wall (on a concrete foundation) was constructed around the shaft to form a 0.25m high feature upon which a galvanised steel frame was formed and attached (see Figs 9 and 10, Grille specification). Figure 9 is a view of the shaft area after site excavation, after shaft grille erection and after shaft area fencing. The heavy duty timber and steel mesh fence is designed to be retained if the railway line is to be re-instated at a later date.

Given the extent of the Crowndale mine workings extending under the railway line (and beyond to other shafts), it was thought prudent to insert a geotex permagrid (Tensar Triax) at a depth of approximately 0.3m under the entire width of the railway line – to support the trackbed in case of sudden mine working collapse at depth.

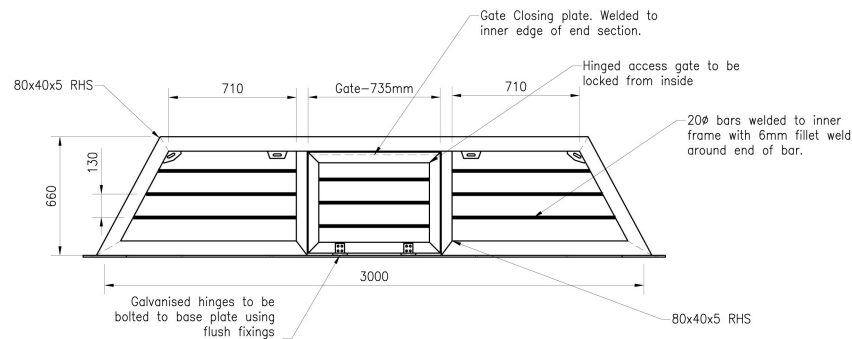
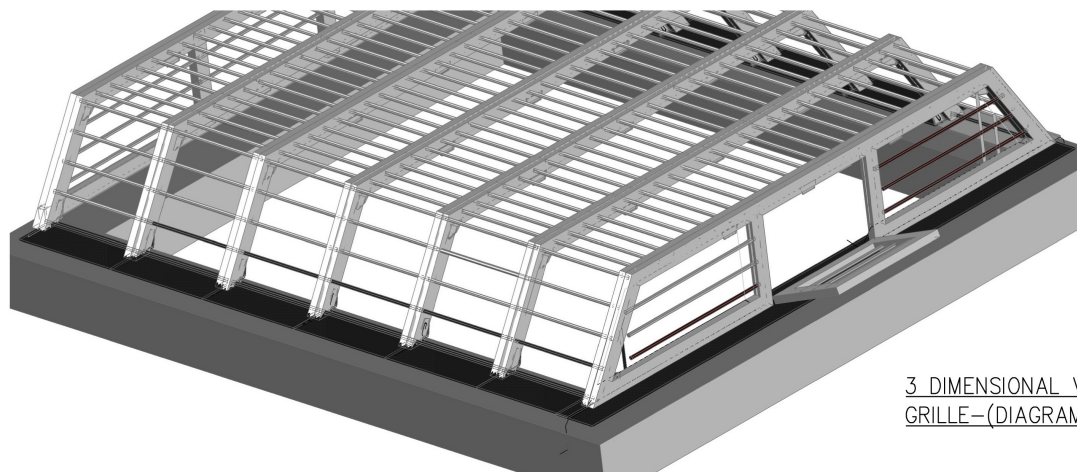
Figure 10 Specifications for the Unnamed Shaft surface grille (© DCC 2008)

ELEVATION ON END FRAME(Track side)  
SCALE 1:25

PLAN ON END FRAME(Track side)  
SCALE 1:25

3 DIMENSIONAL VIEW OF  
GRILLE-(DIAGRAMMATIC ONLY)

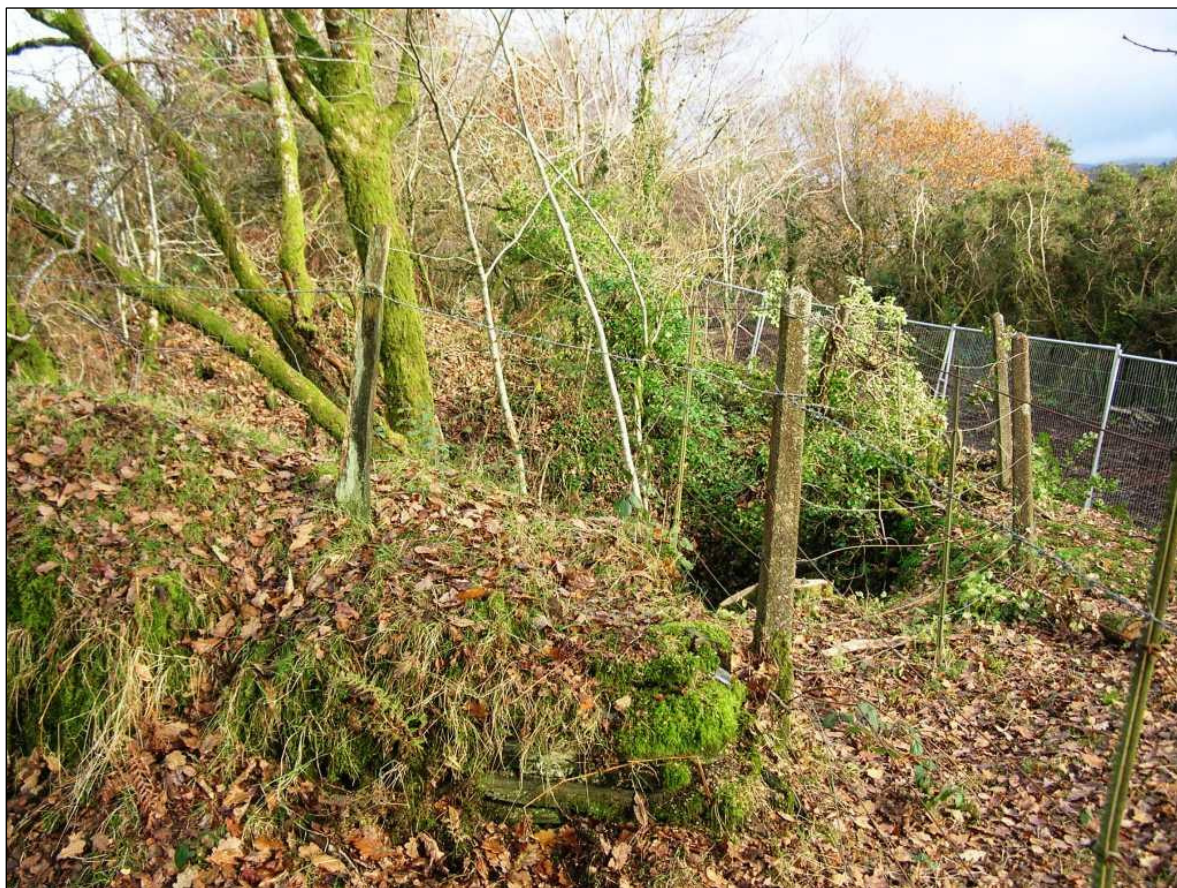
A second mine shaft stands adjacent to the up side of the railway. It has run-in to a choked cone at surface, and is surrounded by a railway fence which is no longer in good condition.

During archaeological recording in mid October 2008, this closed mine shaft was photographed before any works were undertaken. The shaft was fenced with wire and concrete/timber posts (see Fig 11). The shaft is located approximately 5.0m north of the railway line (see Fig 2) and is approximately 5.0m long and 3.2m wide. The shaft is visible to a depth of only 2.0m, where it is blocked. The western side of the site is partly enclosed by a stone wall that was presumably a remnant of an enclosing collar safety wall. Some trees are growing both within the shaft fencing and on its south east side. The shaft itself was re-fenced with timber posts and barbed wire, whilst another outer fence (adjacent to the railway line – see Fig 12) was also constructed, to the same specification as Site 45.

*Figure 11 View of Gill's Shaft before fencing works (© CC HE 2008)*

Safety works will be required before the Trail can be opened. The shaft should be securely fenced and warning signs erected.
