Codda, Bolventor, Cornwall

Historic building record

Client	Mr and Mrs P Moir
Report Number	2011R101
Date	May 2014 (interim report issued June 2011)
Status	Draft/2nd draft/Final
Report author(s)	Nigel Thomas
Checked by	Andy Jones
Approved by

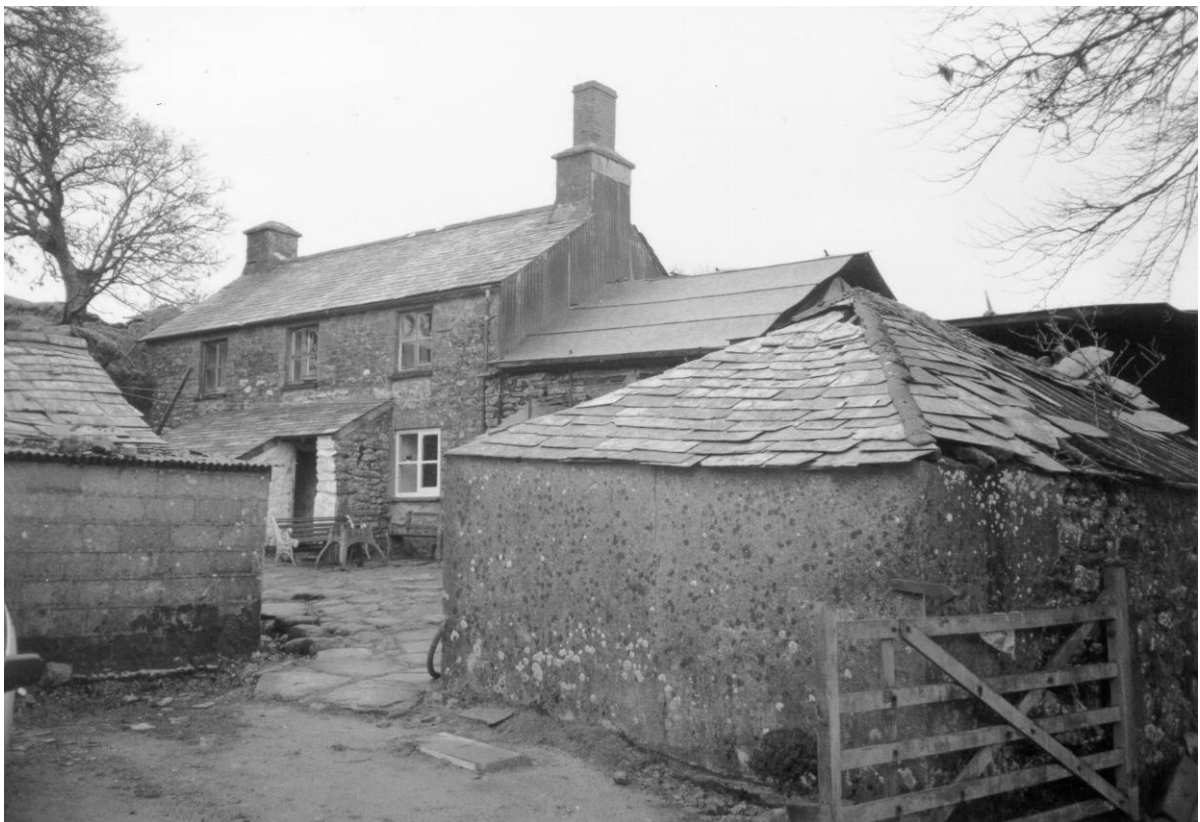
Fig 7 Codda in 1999, by which time the old roof on the lower end had fallen in, and had been replaced by temporary boarding.

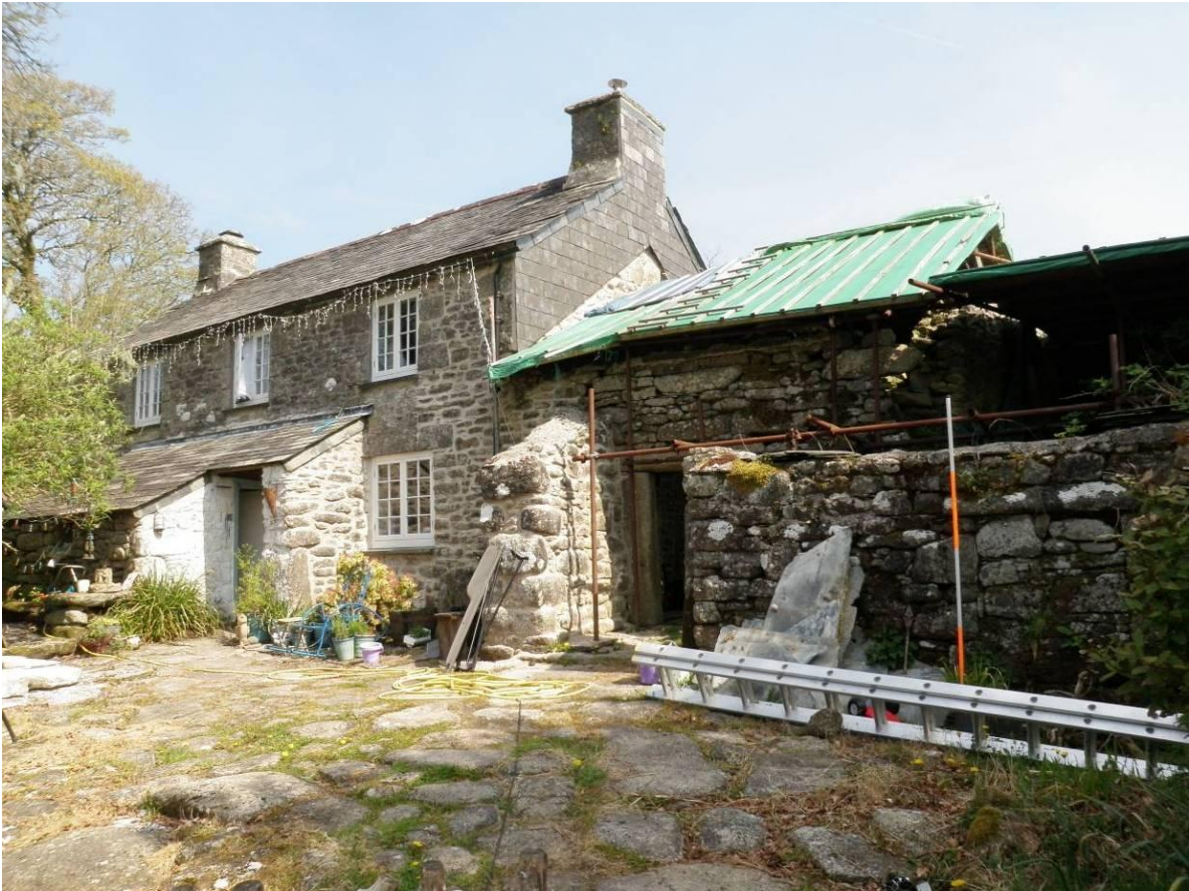
Within the time of the present ownership the brick chimney extension has been removed and the corrugated iron cladding on the gable replaced with slate hanging. The front windows have also been replaced with more appropriate wooden small pane casement designs (Fig 9).

Fig 9 Codda in 2011.

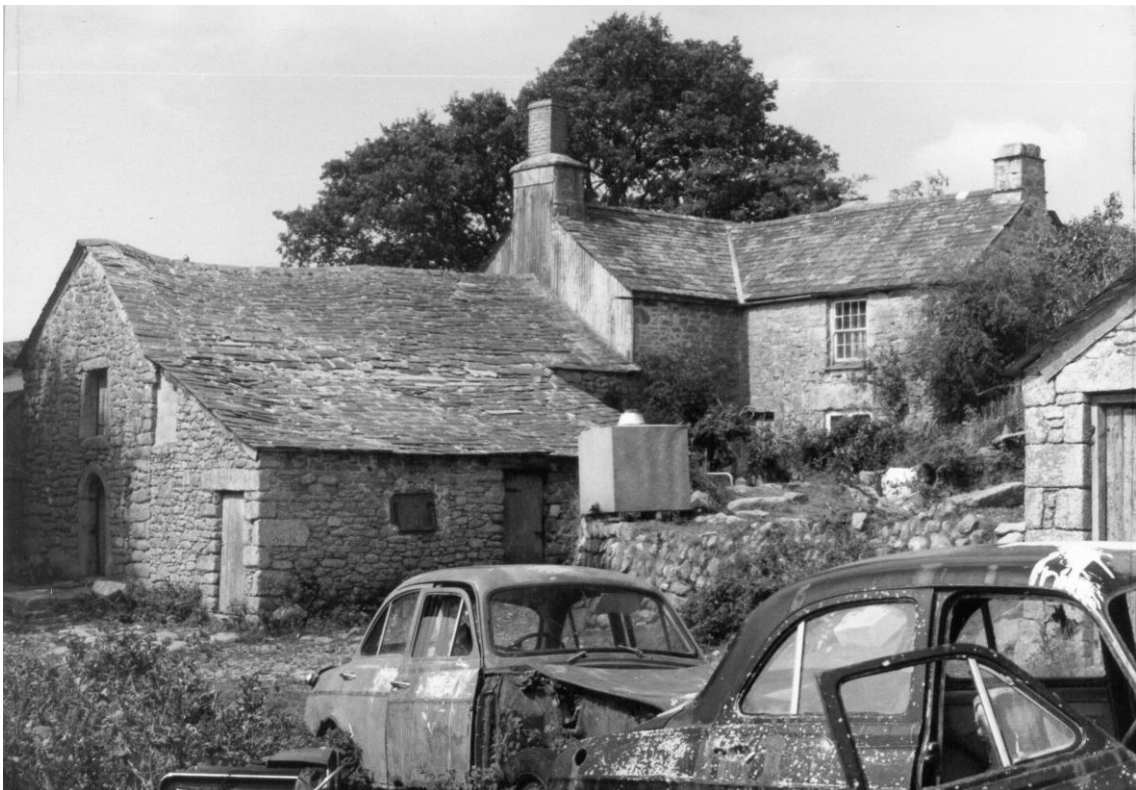
Fig 11 Rear view of the farmstead in 1981, when the roof of the lower end and lean-to were decaying but relatively intact.

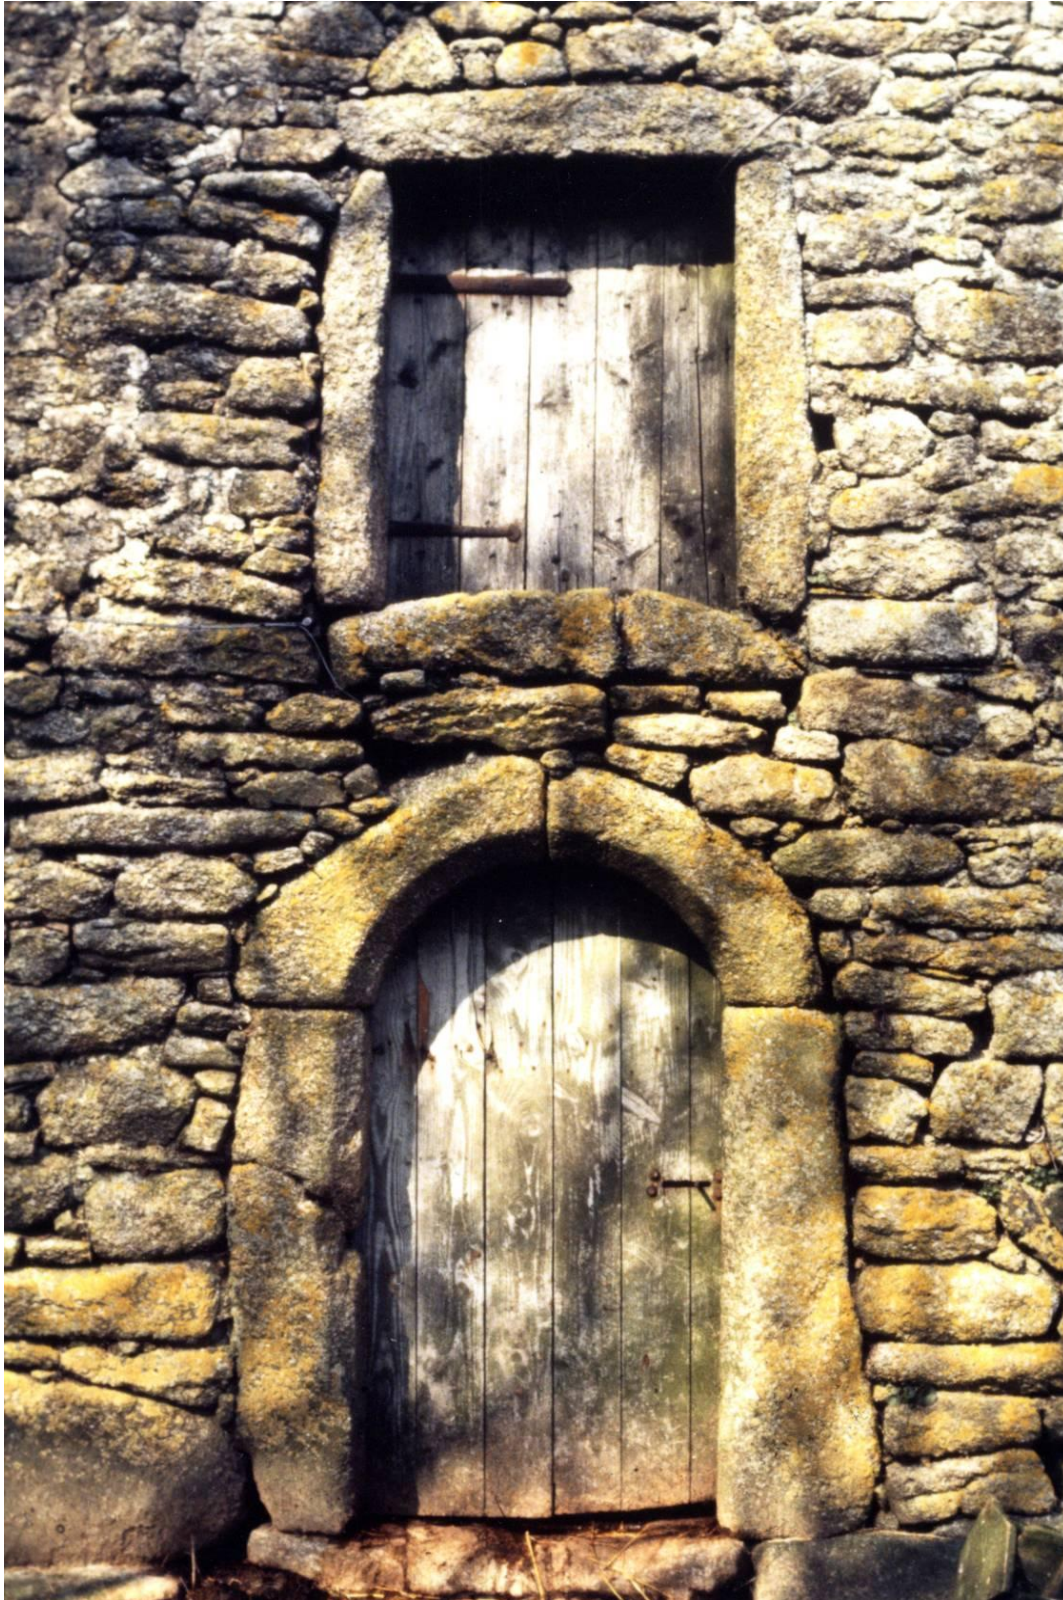
Fig 12 Detail of the lower end arched doorway and upper floor opening in 1981 (Photograph, copied from a slide, kindly supplied by Jacky Nowakowski).

The sill, LH jamb and lintel of the upper opening are roughly dressed and clearly not original, probably representing widening of the opening. Slight slumped masonry left of the jamb appears to be part of the associated rebuild.

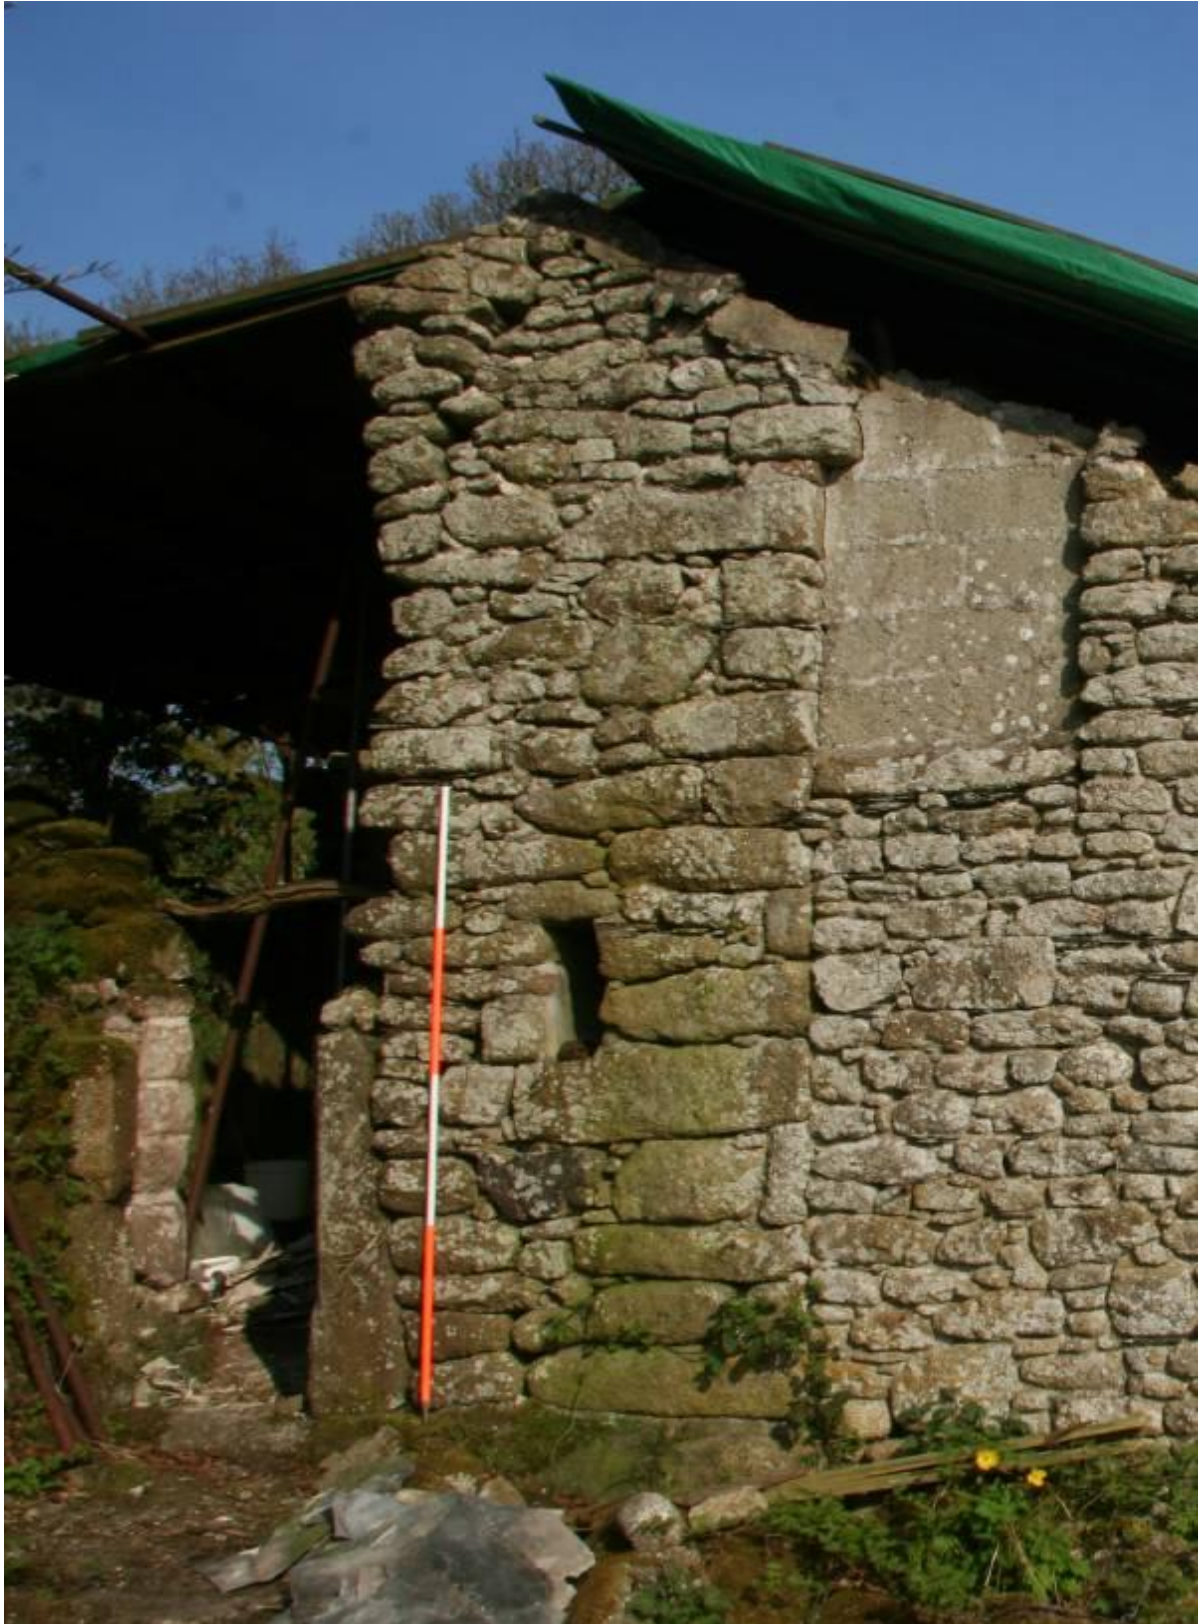
Fig 13 The remains of the lower end gable in 2011.

Arch stones from the doorway lie in the centre foreground. The concave line of the upper masonry is the 'shadow' left by the loss of the stone jamb of the former opening. All masonry surviving here appears to be original to the construction of the longhouse. Note also the projecting eave-stone, indicating the line of the 17th century roof.

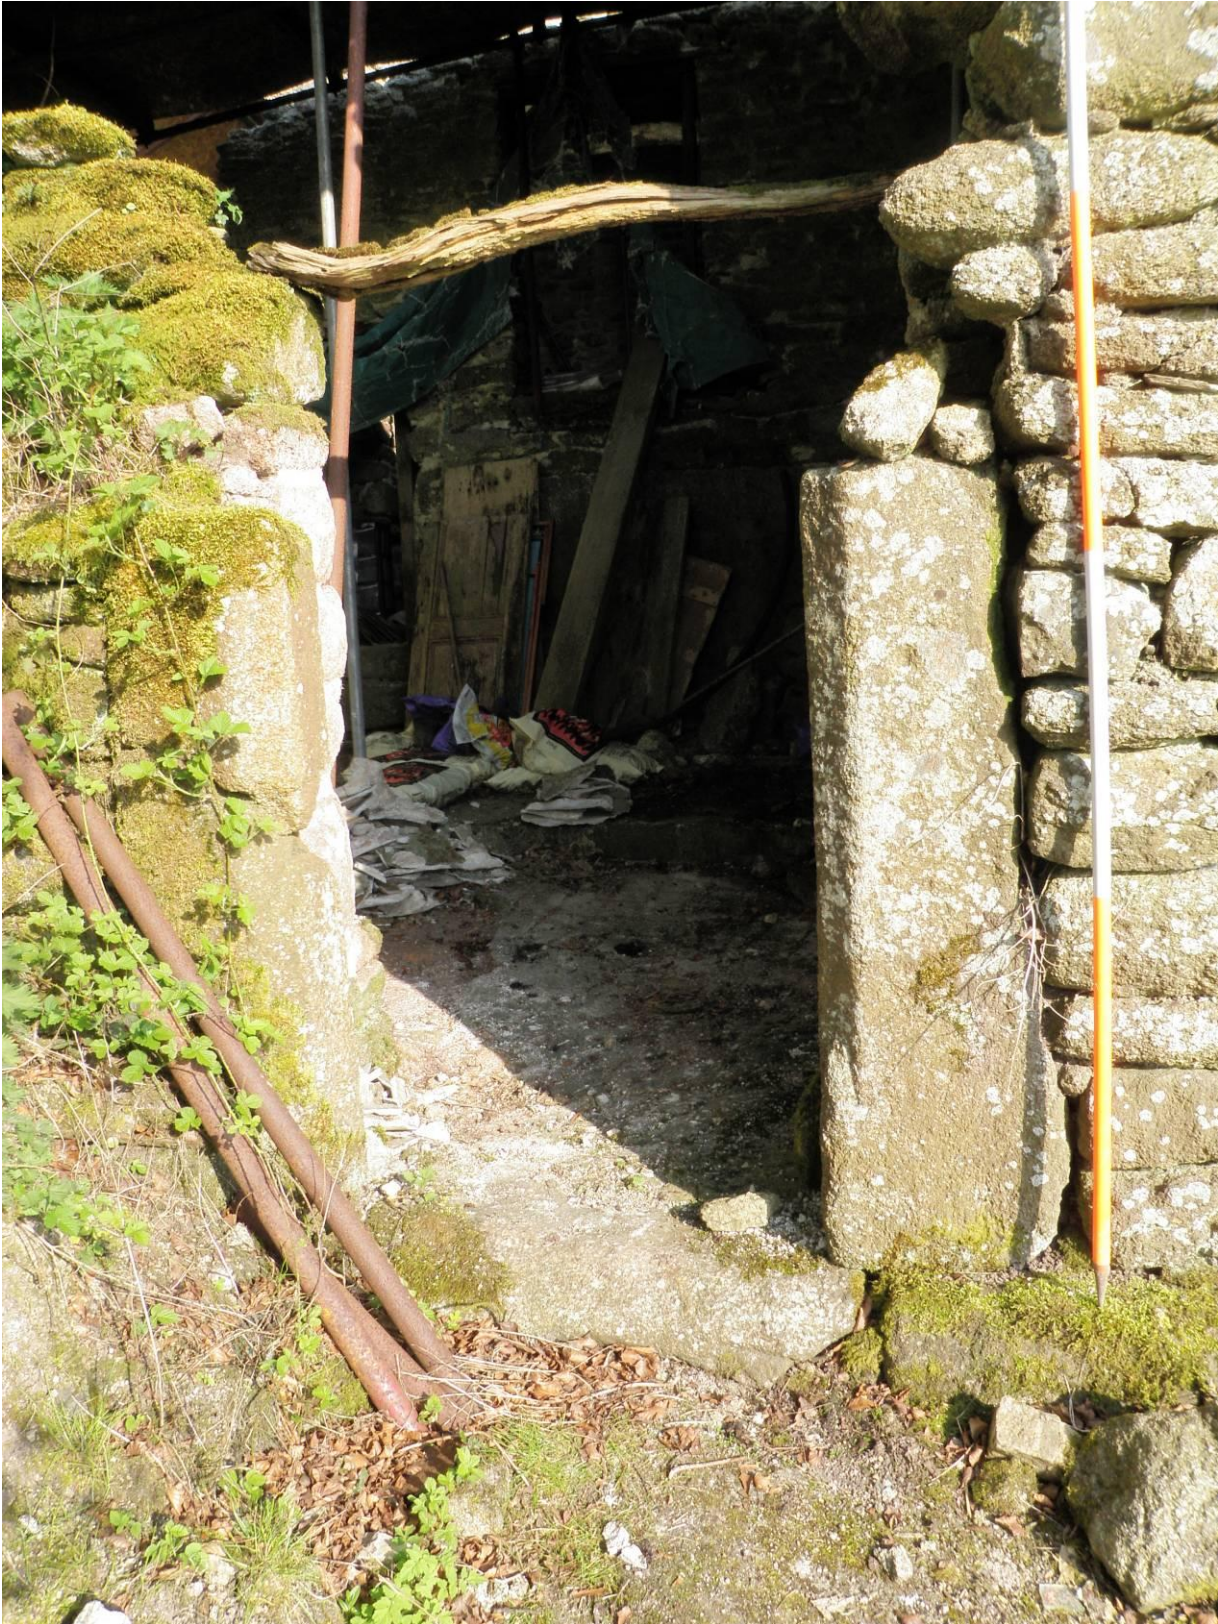
*Fig 14 Detail of the present remains of the doorway.
Note the remains of the timber inner lintel.*

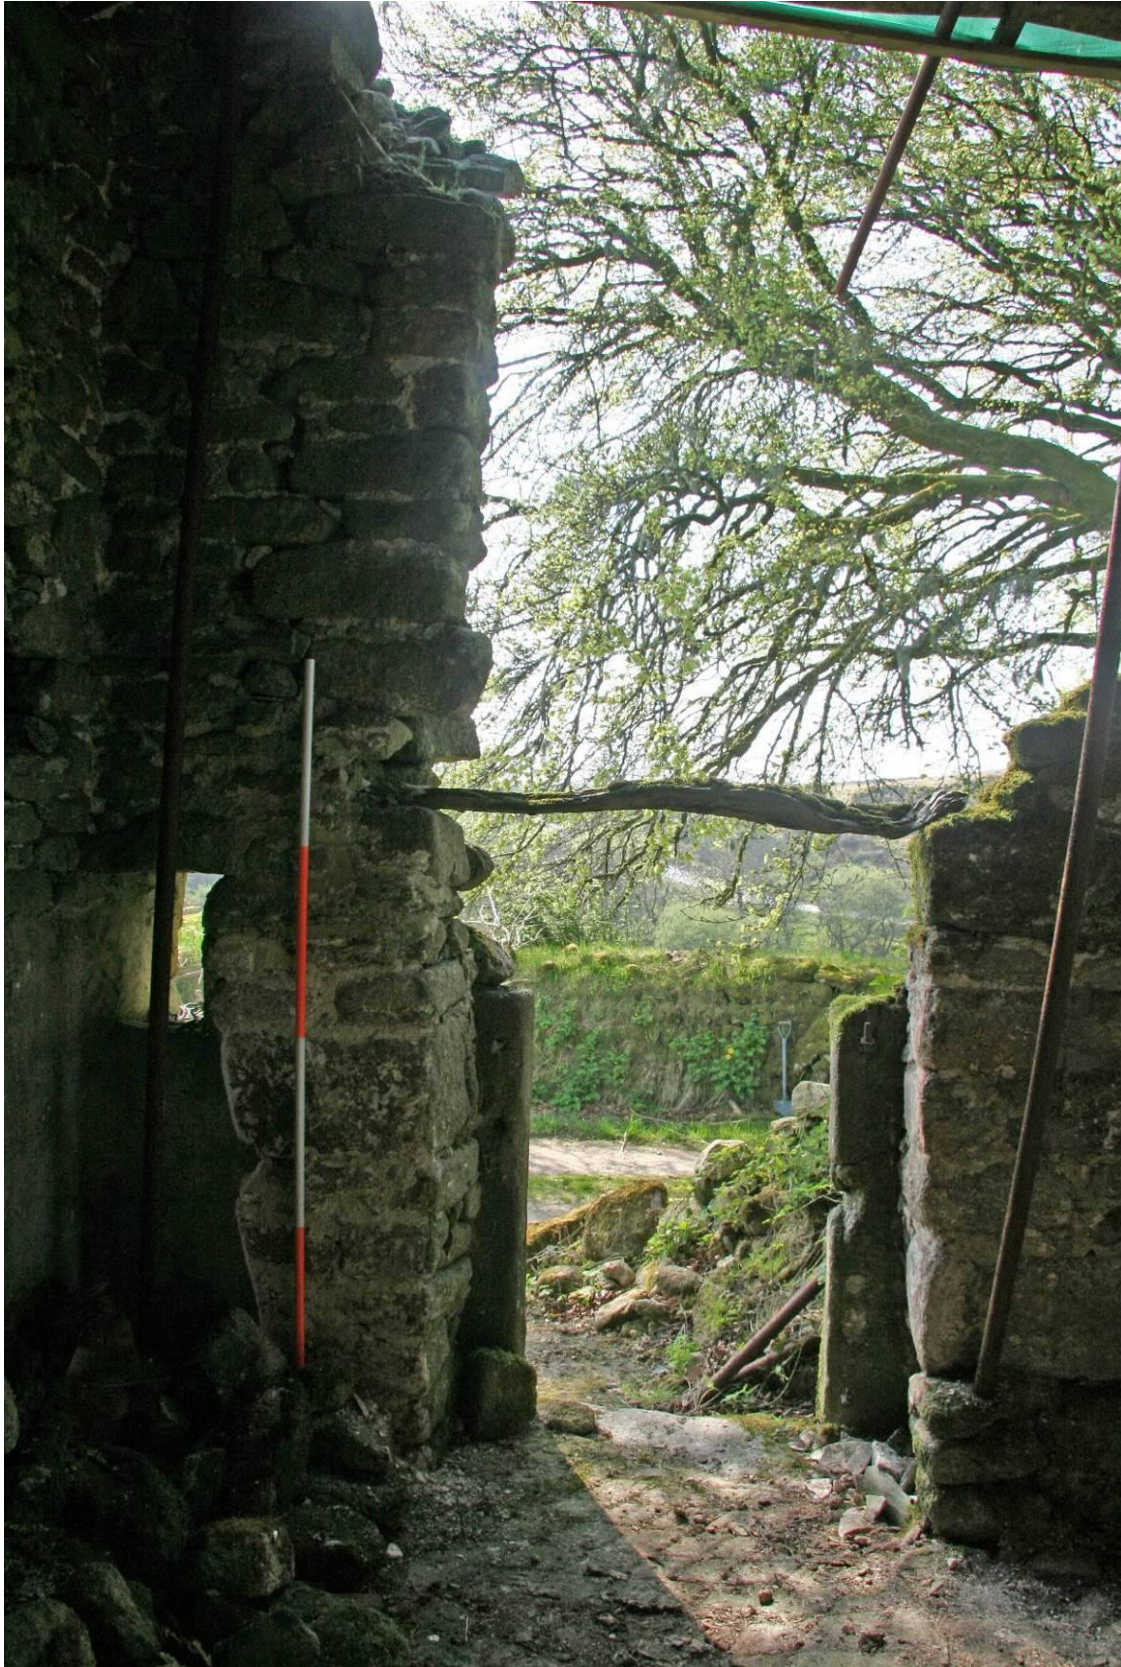
Fig 15 Inside view of the lower end openings.

The LH inner jamb masonry of the upper opening shows no sign of alteration so is clearly part of the building of the longhouse.

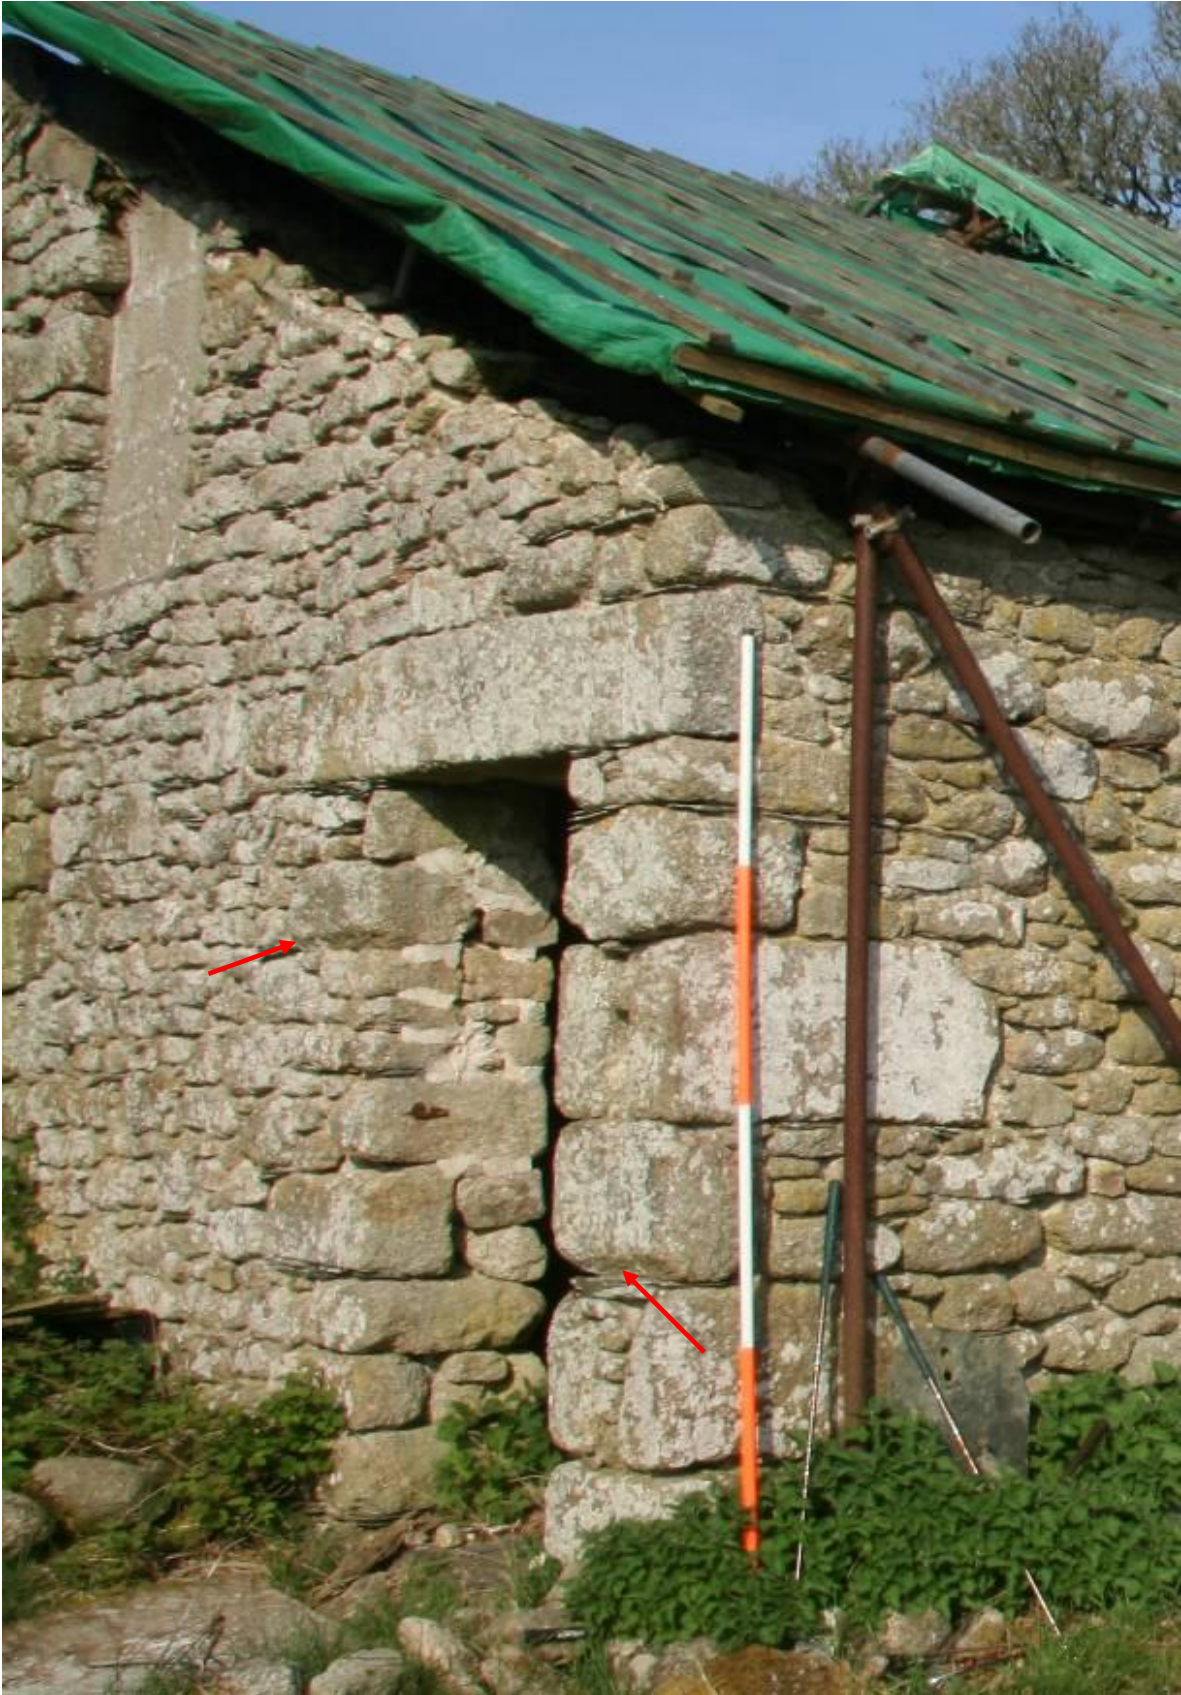
Fig 16 The later 19th century lean-to, showing chamfered stones reused in the jamb masonry (arrowed).

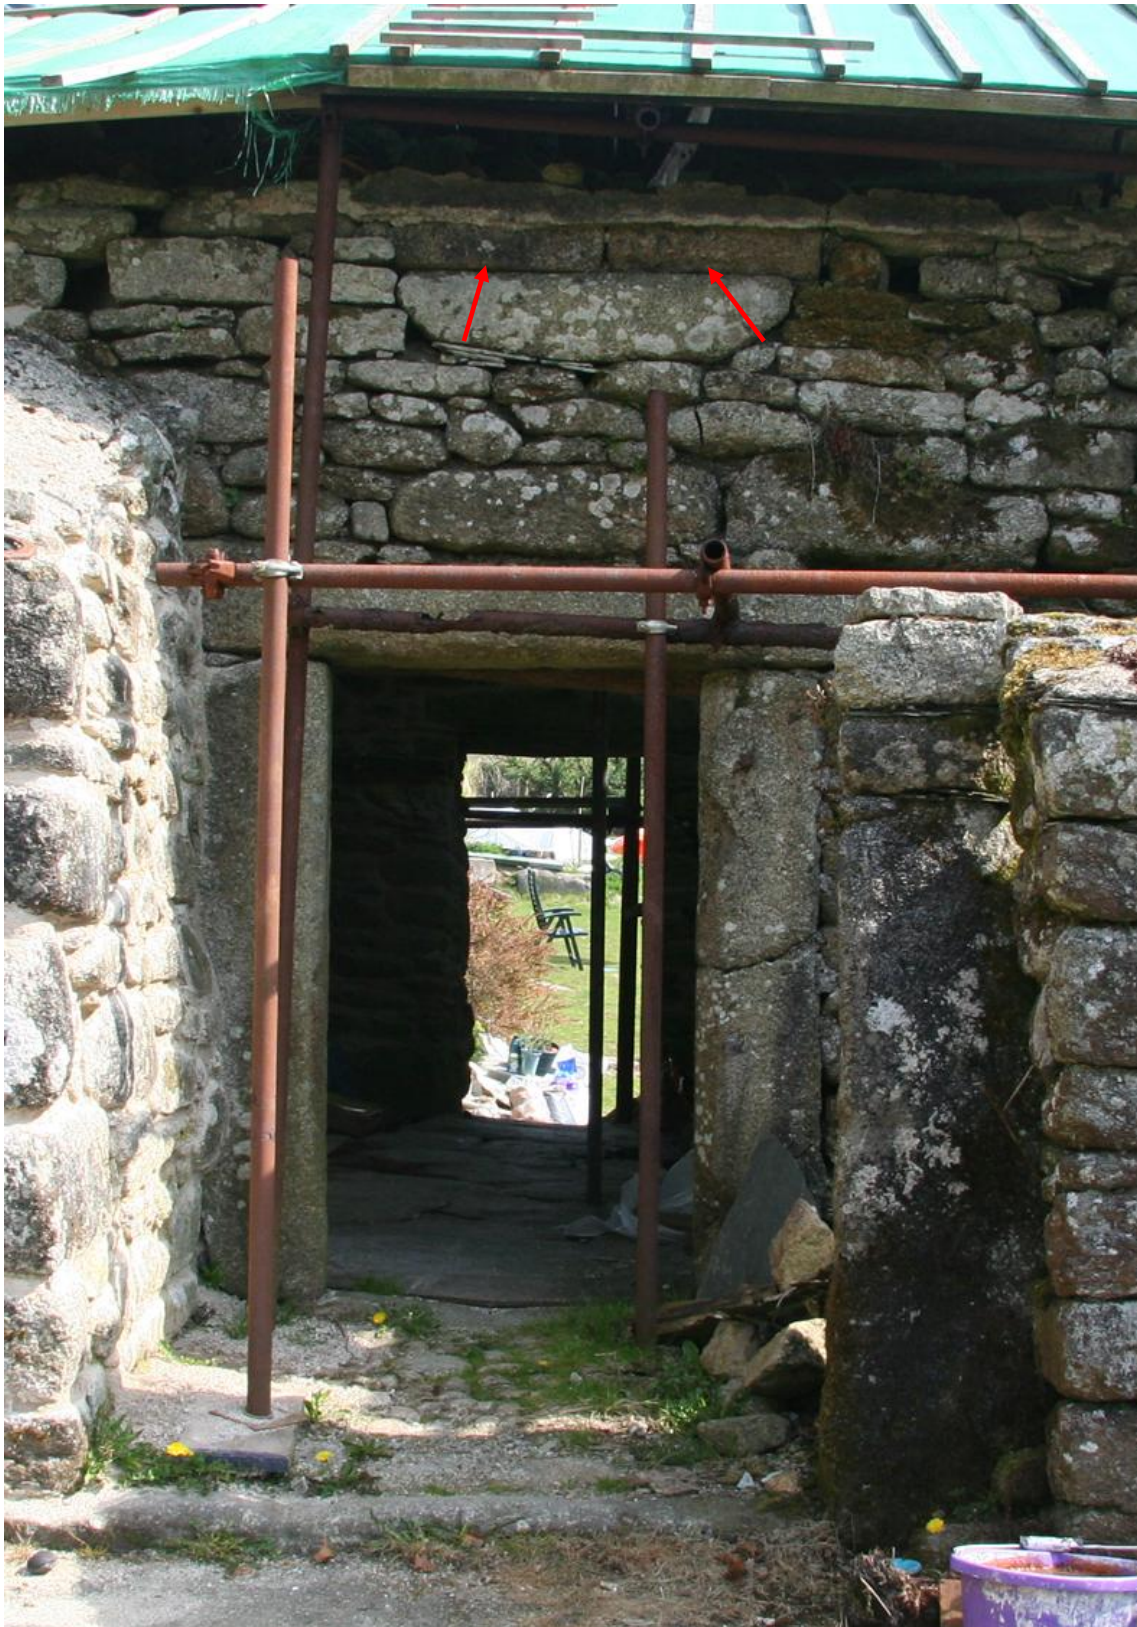
The porch has a cobbled floor comprising worn 'fist' size stones, probably gathered from the stream in the valley below the farmstead (Fig 17).

Fig 17 The front entrance to the through-passage

The jamb stones are part of the 17th century building. The single lintel stone, which has a shallow chamfer, may be a replacement for an arch-headed entrance. The masonry above the lintel includes two reused chamfered stones just below the wall plate (arrowed).

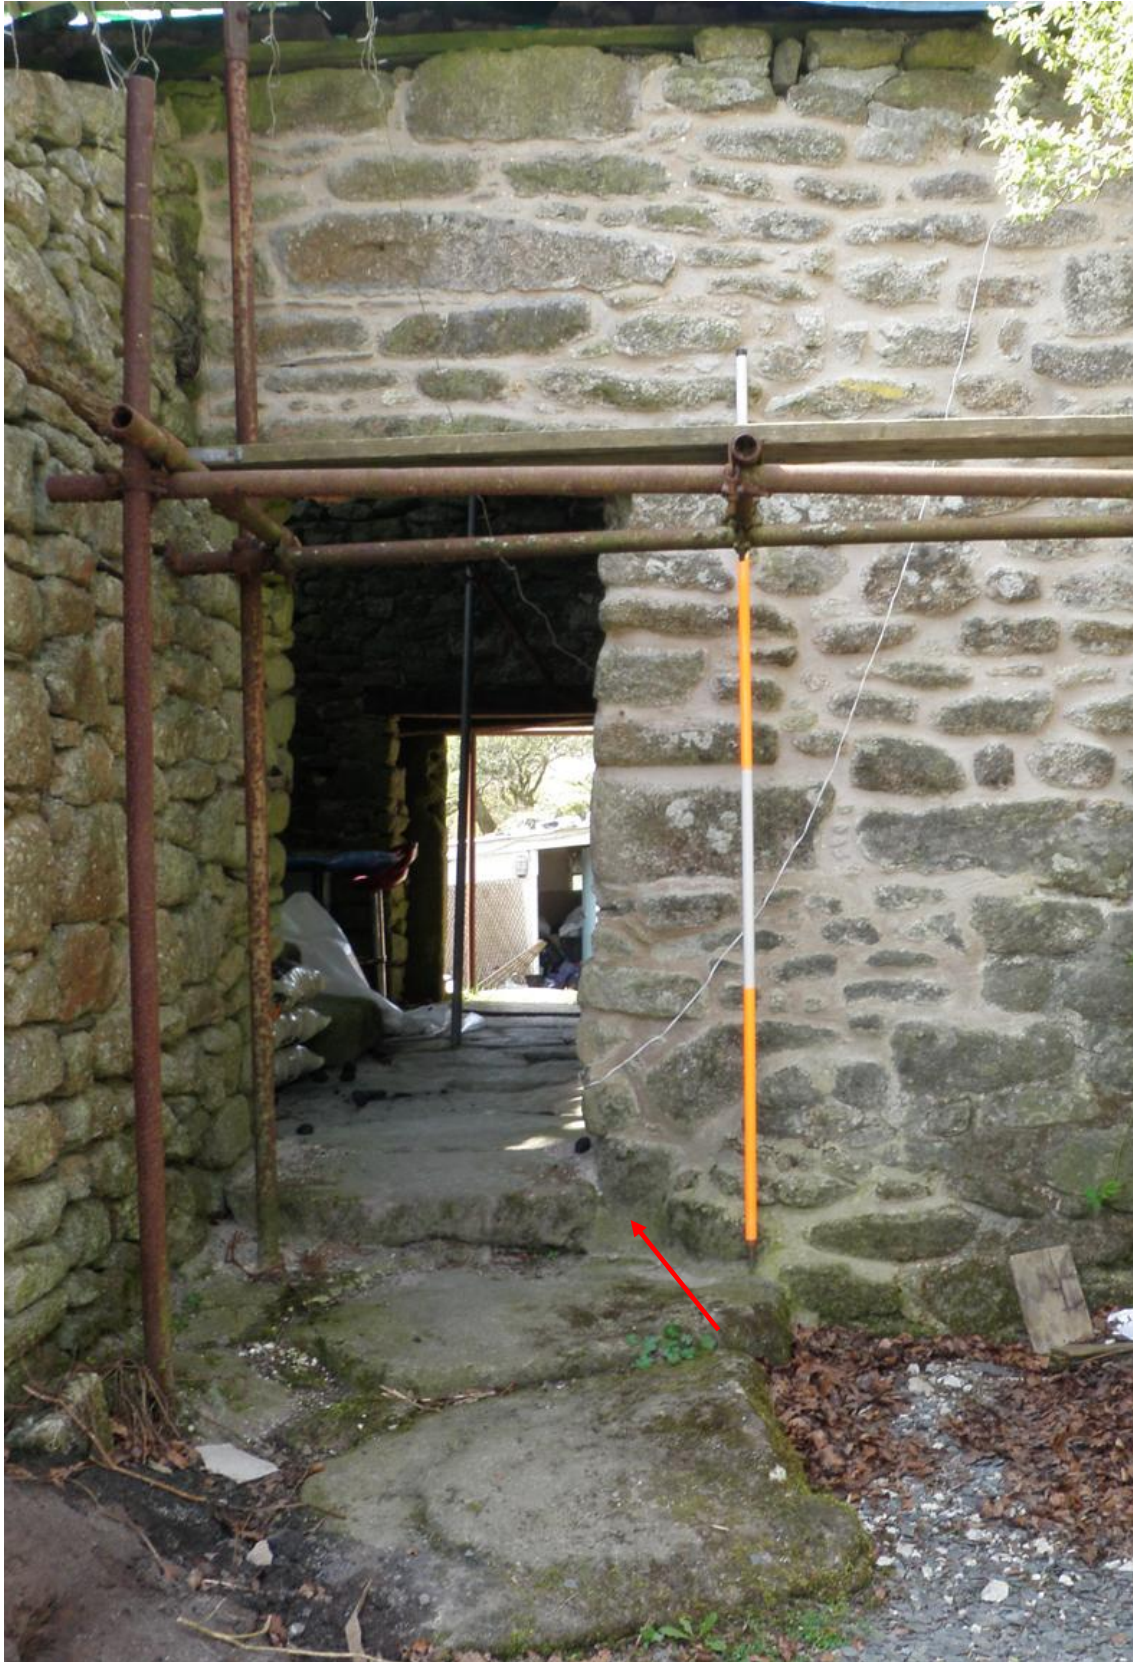
Fig 18 The rear doorway to the through-passage.

Masonry to the right and above the doorway has been replaced, with a chamfered stone, possibly one of the original outer jambs, reincorporated below the lintel. A stump of the original jamb (arrowed), together with the threshold, are extant.

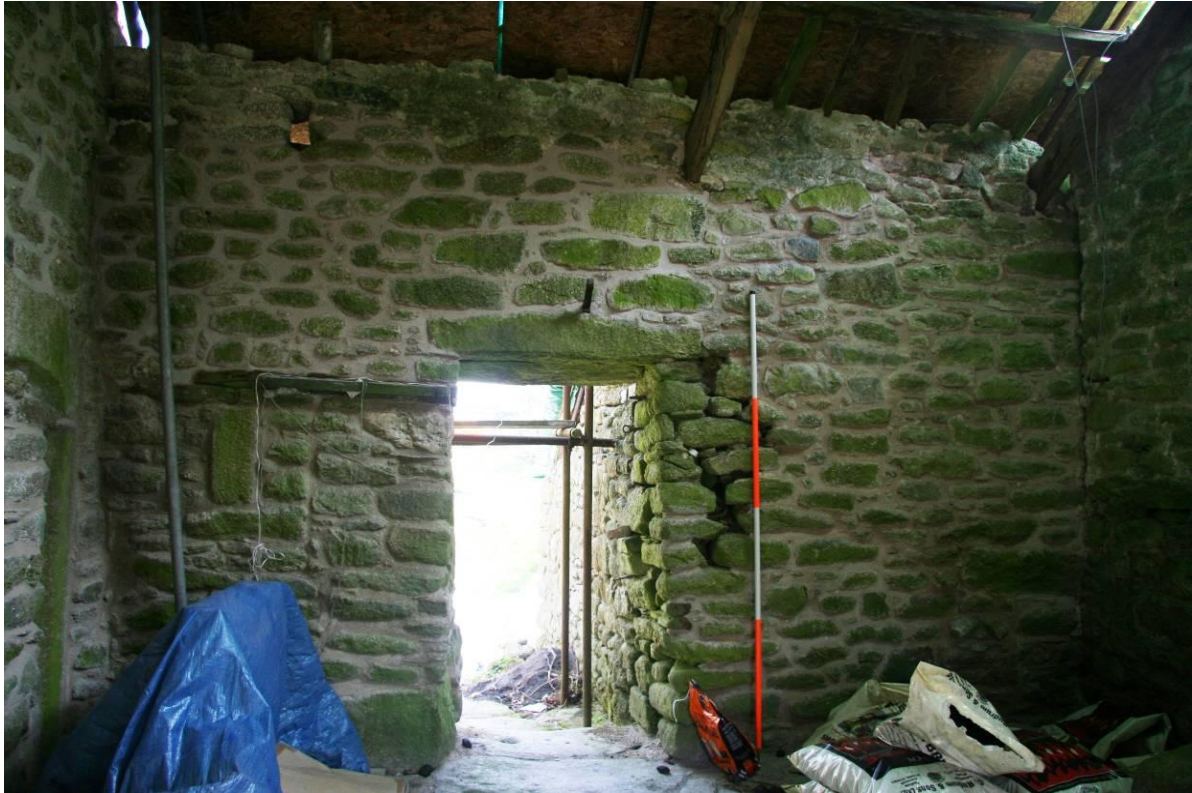
Fig 19 The interior of the through-passage, looking towards the rear doorway.

Both interior door jambs have been rebuilt but three courses of 17th century masonry appear to survive in the lower right hand jamb. Rebuilding of the left hand jamb has resulted in the blocking of a small 17th century window, whose jamb-stone and sill are still extant. The wall height has also been raised above the truss feet, presumably to help seal out the weather. Note that the masonry partition wall separating the through-passage from the cow-house (to the right) is not tied in, and appears to be substantially later.

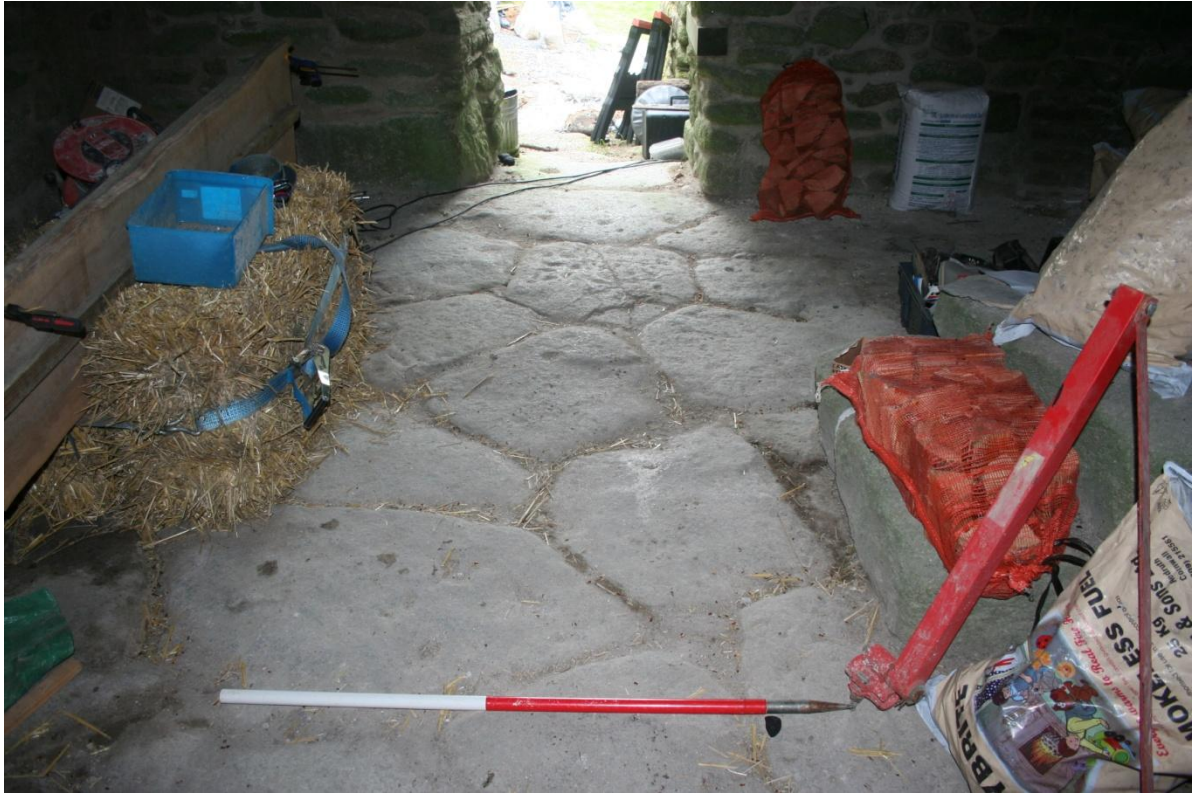
The through-passage area has a paved and relatively level floor of large worn granite slabs (Fig 29). The level of the paving is considerably higher than the sloping floor of the adjacent cow-house. Although it is possible that that this paving was added at the time of the 17th century rebuild it appears to be associated with the dividing wall between the through-passage and cow-house, and would therefore seem to be later, most likely 18th century. Similar external paving (forming the domestic courtyard) is probably contemporary.

Fig 29 Granite paving in through-passage.

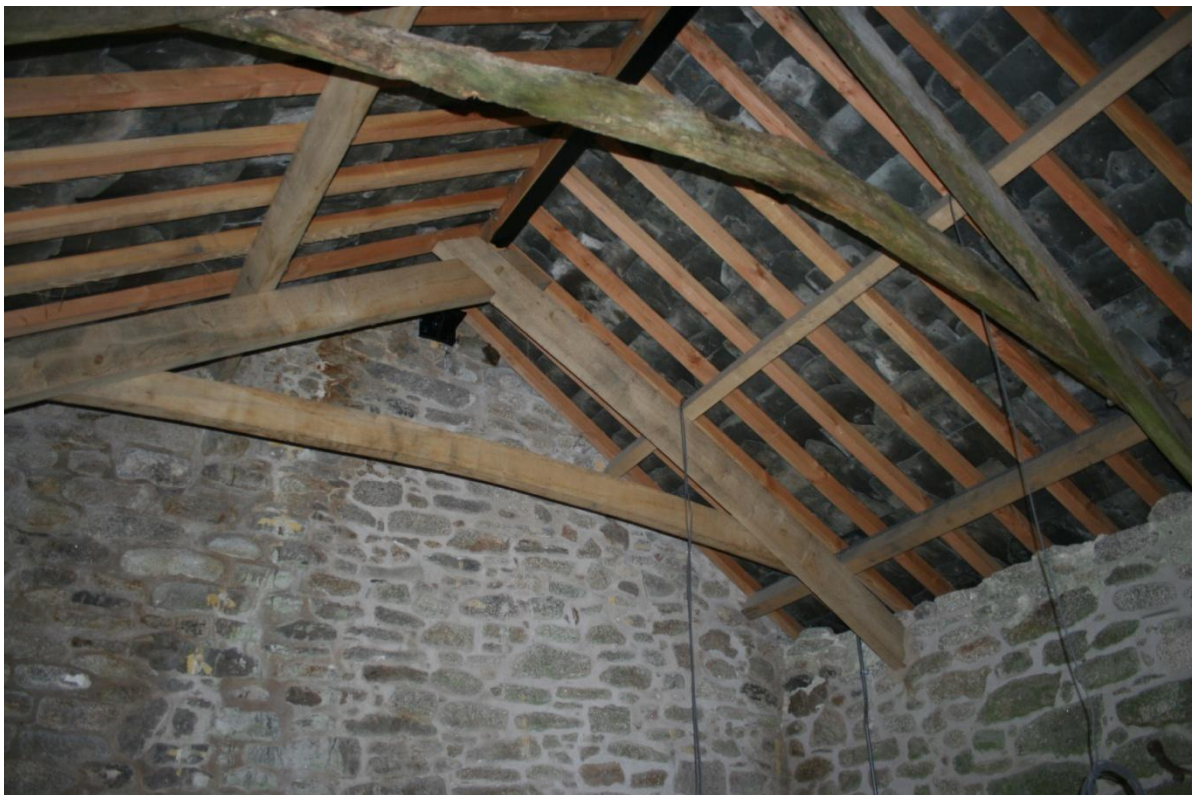
Fig 30 New roof structure above through-passage, showing earlier roof truss (in foreground) and strengthening steel purlin at apex.

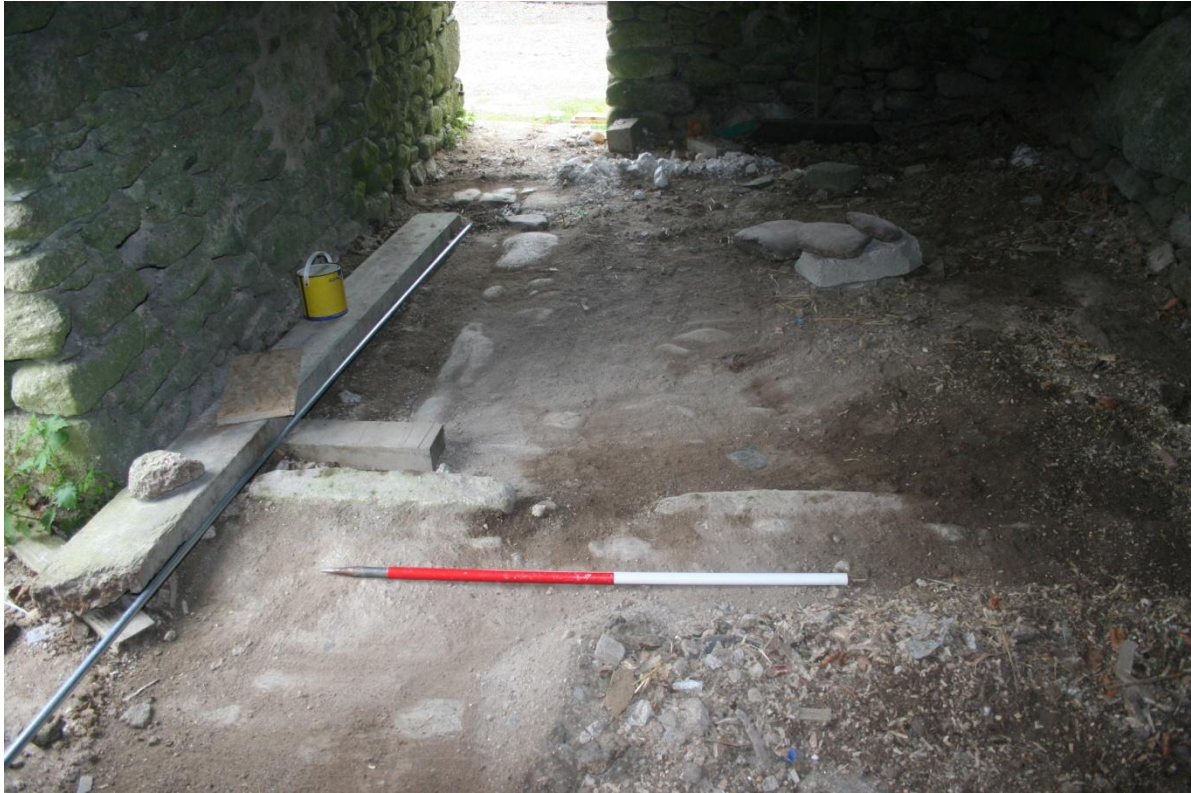
Fig 37 Floor of northern lean-to, showing stall division and part of a drain towards the lower doorway.

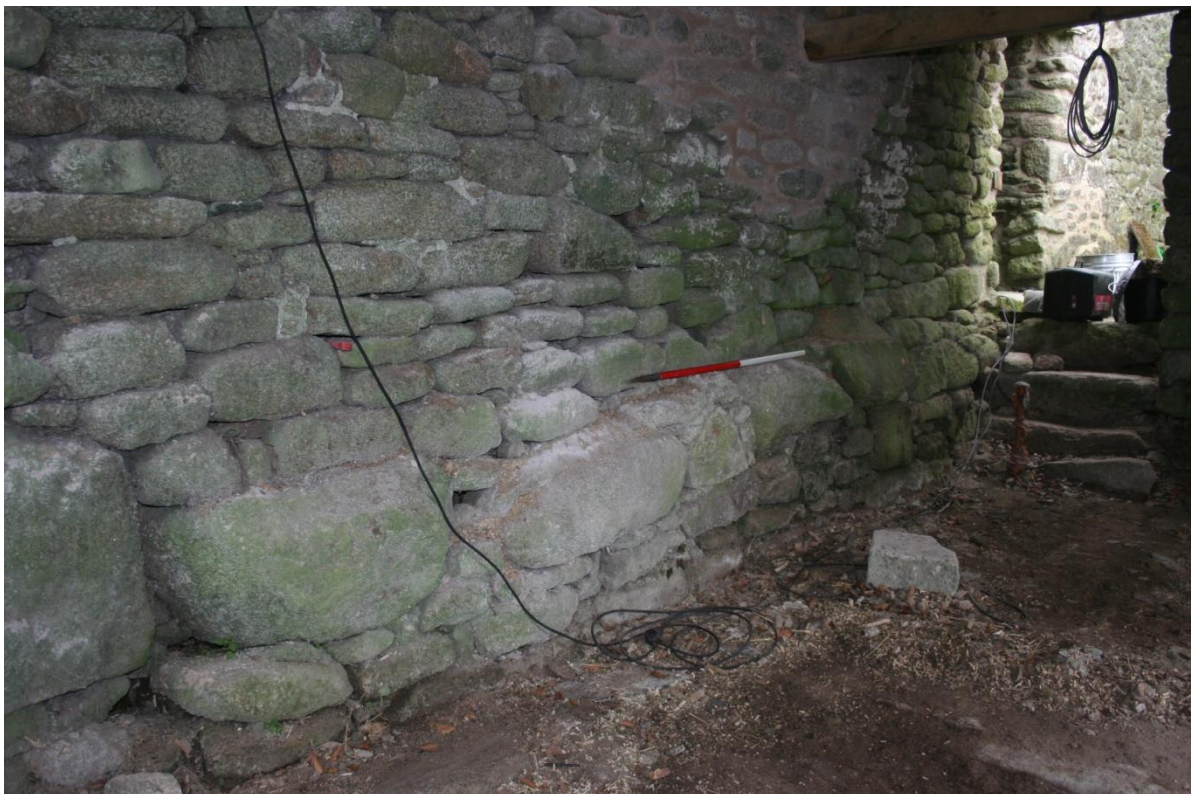
A rough plinth of large granite stones supports the upper masonry on the north side of the lower end. This is visible within the northern lean-to (see Fig 38). This may be a part of the 17th century rebuild (used where subsoil foundations may have been judged to have been poor) or might possibly represent a fragment of the medieval masonry.

Fig 38 Plinth masonry at base of lower end wall.
