Codda, Bolventor, Cornwall

Historic building record

Client	Mr and Mrs P Moir
Report Number	2011R101
Date	May 2014 (interim report issued June 2011)
Status	Draft/2nd draft/Final
Report author(s)	Nigel Thomas
Checked by	Andy Jones
Approved by

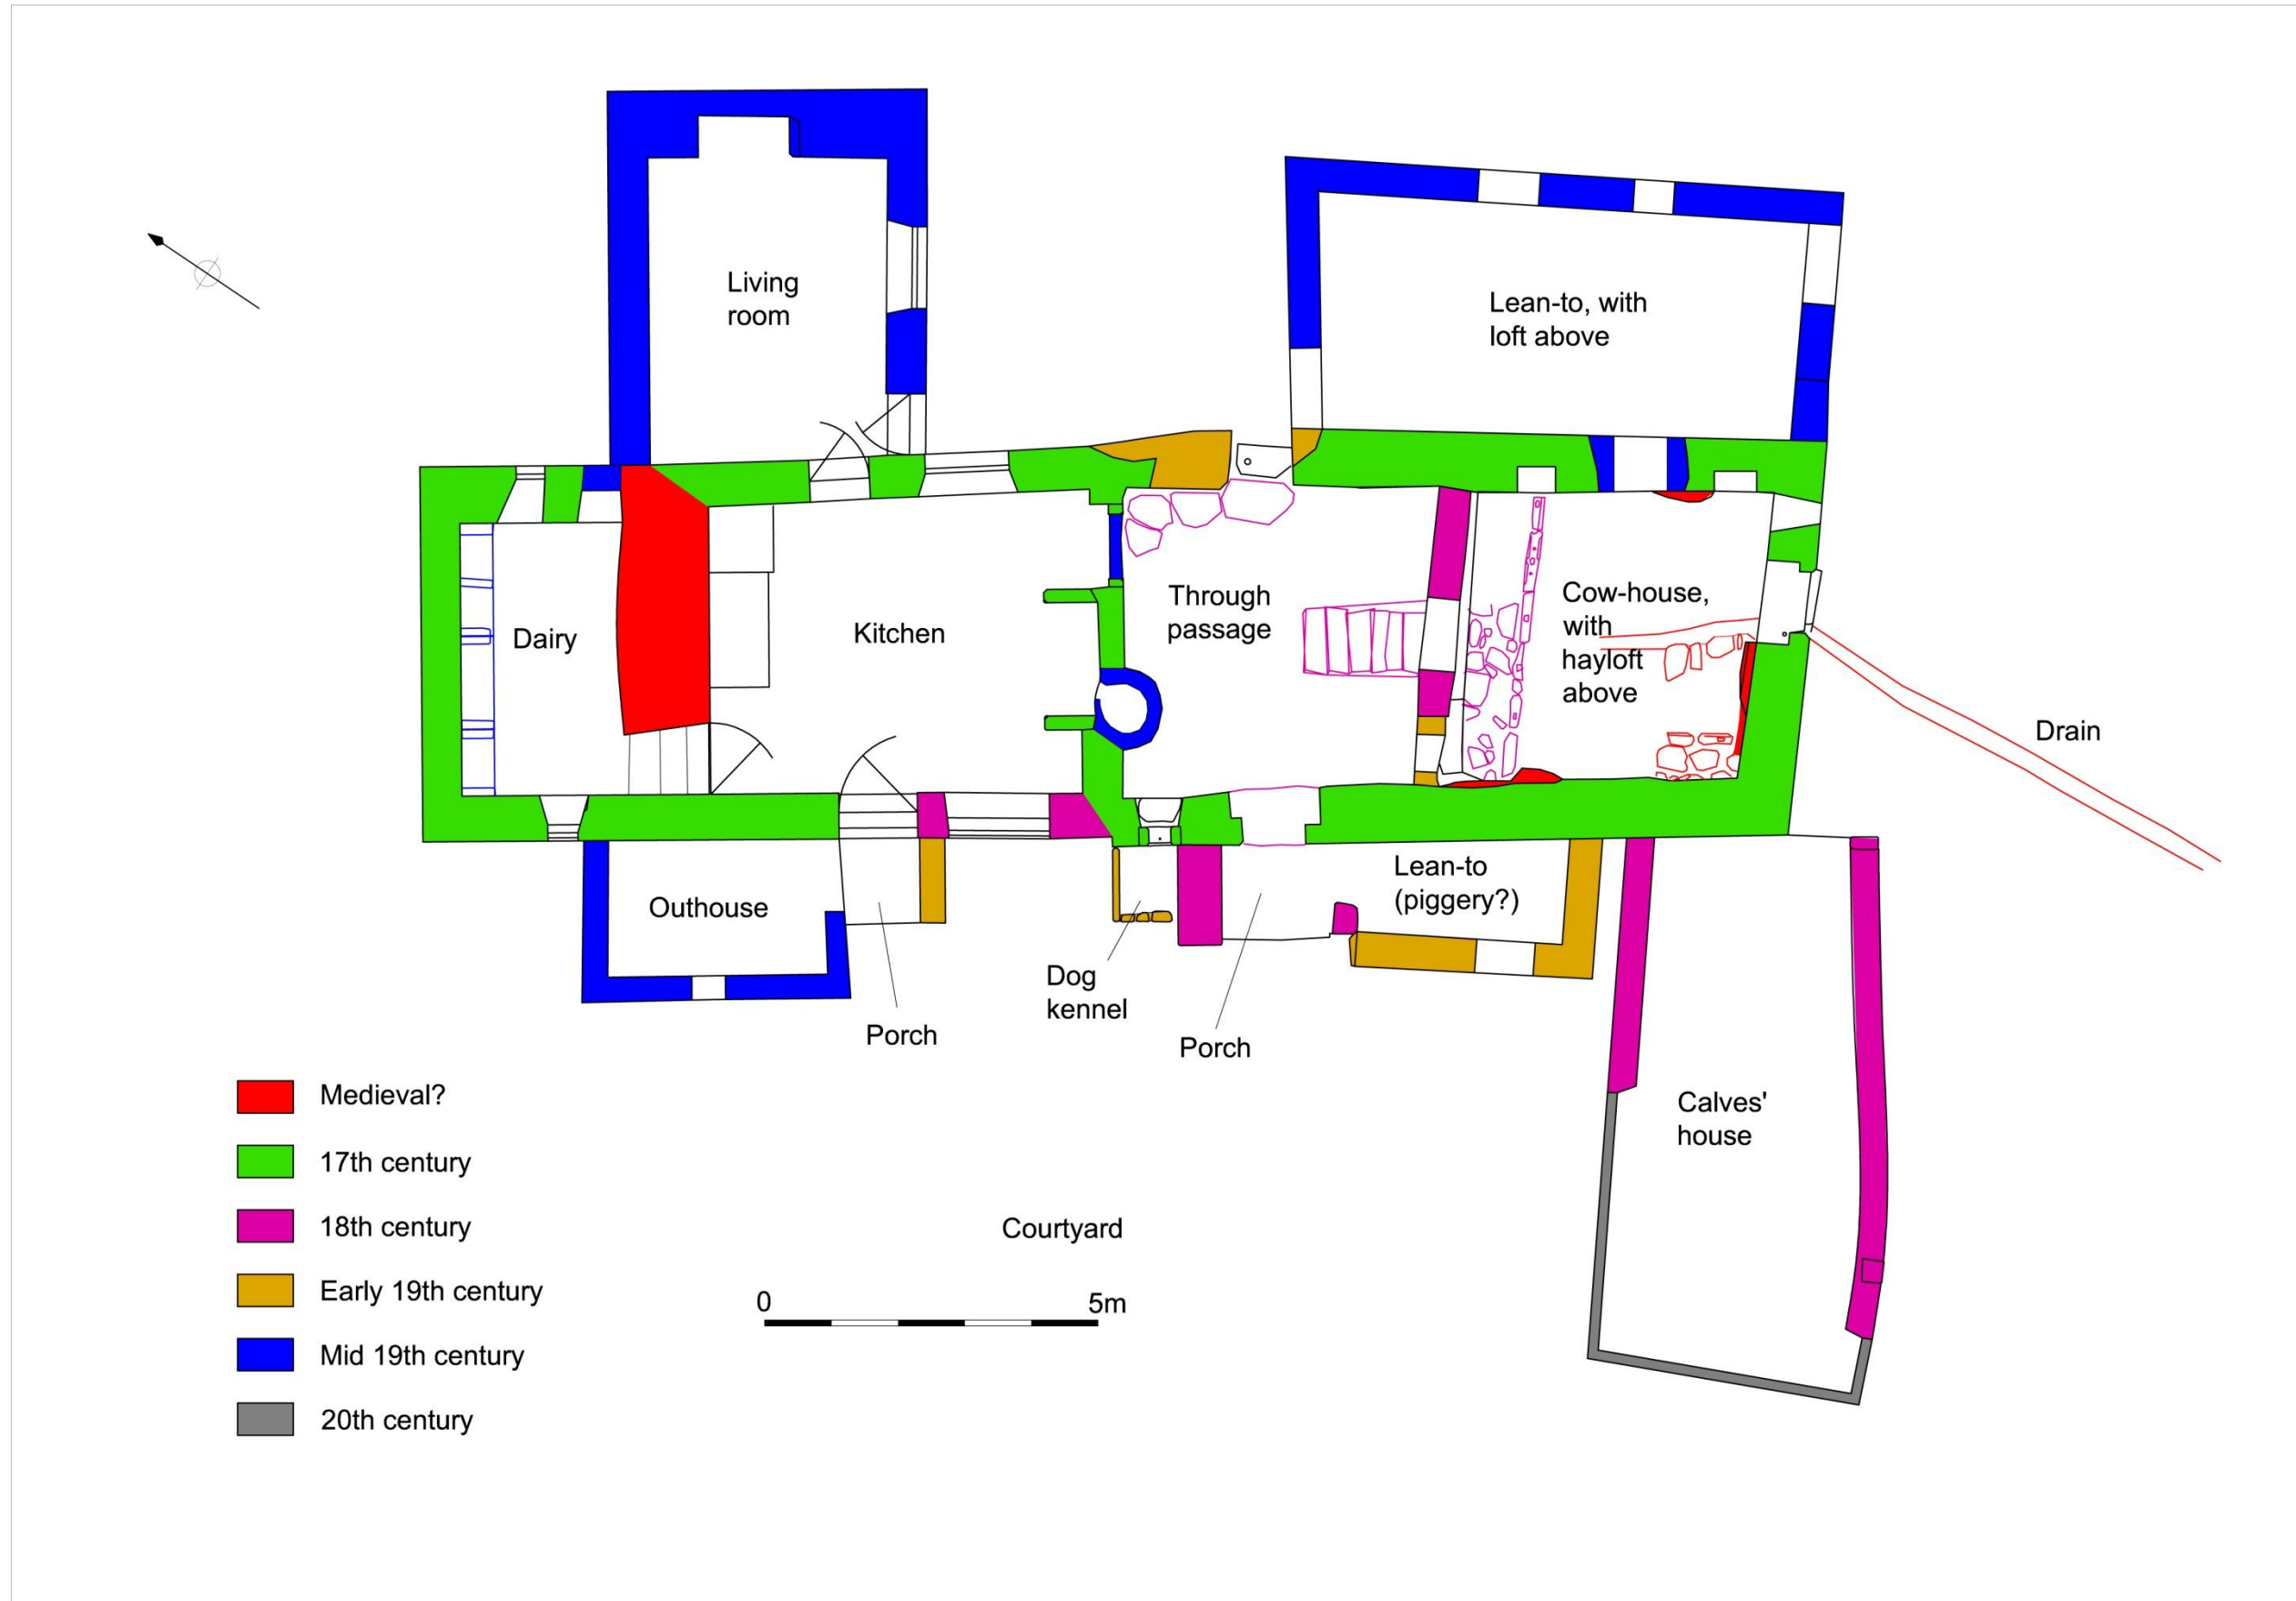
Fig 39 Conjectural phase plan of Codda farmhouse (Based on CAU 1999 survey, with sketch additions).
