# **Land at Manor Tannery, Grampound, Cornwall**

## **Archaeological assessment**

<b>Client</b>	<b>Linden Homes</b>
<b>Report Number</b>	<b>2011R108</b>
<b>Date</b>	<b>19<sup>th</sup> October 2011</b>
<b>Status</b>	<b>Final</b>
<b>Report author</b>	<b>Francis Shepherd</b>
<b>Checked by</b>	<b>Nigel Thomas</b>
<b>Approved by</b>	<b>Andrew Young</b>

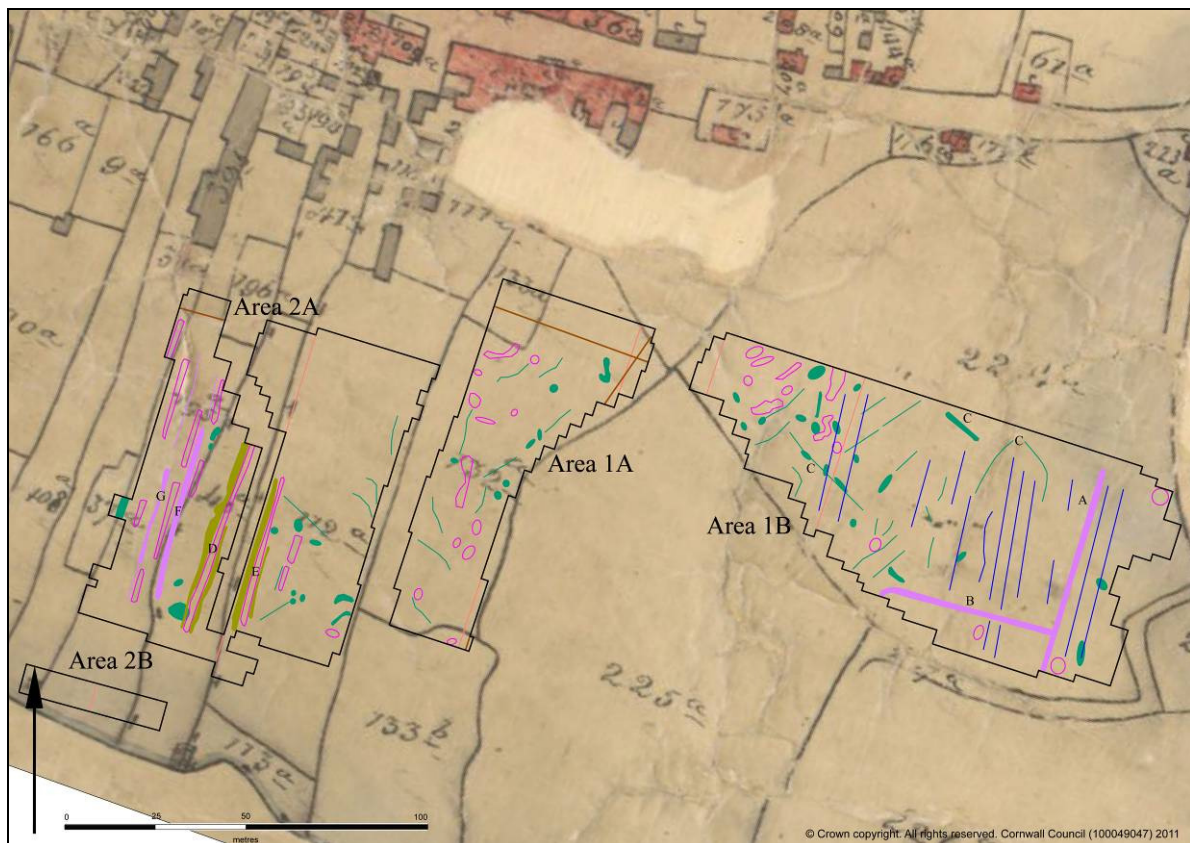
Fig 6 Tithe Map, 1840 - detail with geophysics overlain.

Field 1 (GSB Area 2A) shows by far the most complex geophysical results. They can largely be identified as different phases of development within the historic boundaries outlined in the site history (see section 5 above). Feature F identified by GSB appears to coincide with the boundary on the tithe map between apportionment numbers 40a and 195 and it seems likely that this is the cause for the effect (Fig 6). Features D and E may also be former boundaries. They appear to coincide with the historical divisions between the tanneries. Feature D appears to follow the division between Manor tannery and Forster's Yard on the c1880 Ordnance Survey, and on the same map feature E appears to trace the line of the boundary between Manor Tannery and Wellingtons Yard (Fig 7). Feature E seems to still appear on the 1907 Ordnance survey and follows the path of the modern track. GSB Prospection note that this may account for its slightly weaker response (GSB 2011). Feature G does not appear to coincide with any recorded historic boundaries and it is unclear whether it had a modern function (Fig 6).

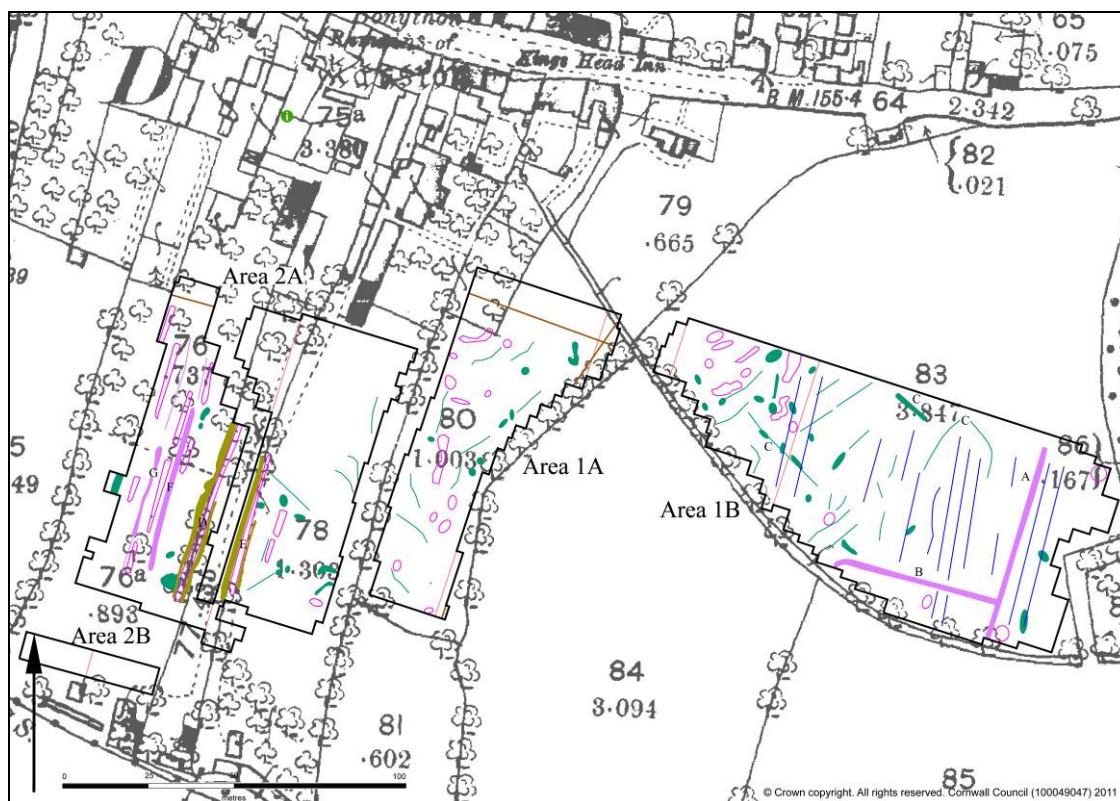
Fig 7 First Edition of the Ordnance Survey 25 Inch Map, c.1880 detail with geophysics overlain.

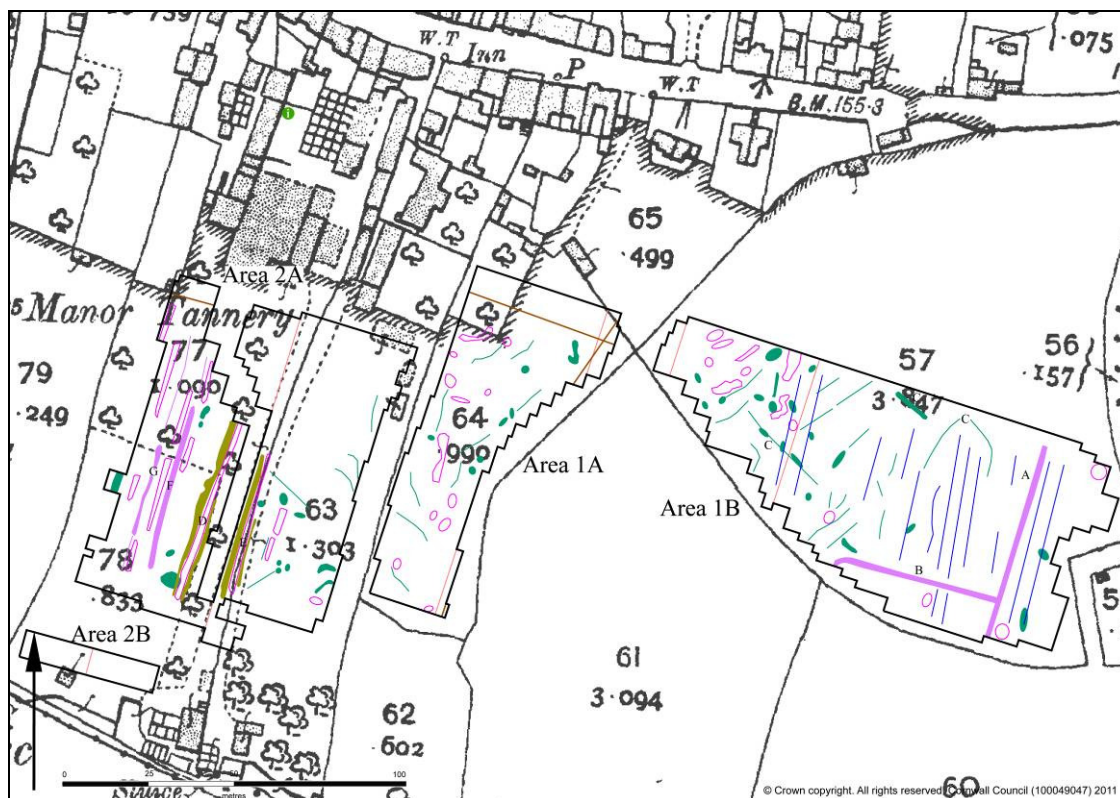
Fig 8 Second Edition of the Ordnance Survey 25 Inch Map, c1907 detail with geophysics overlain.

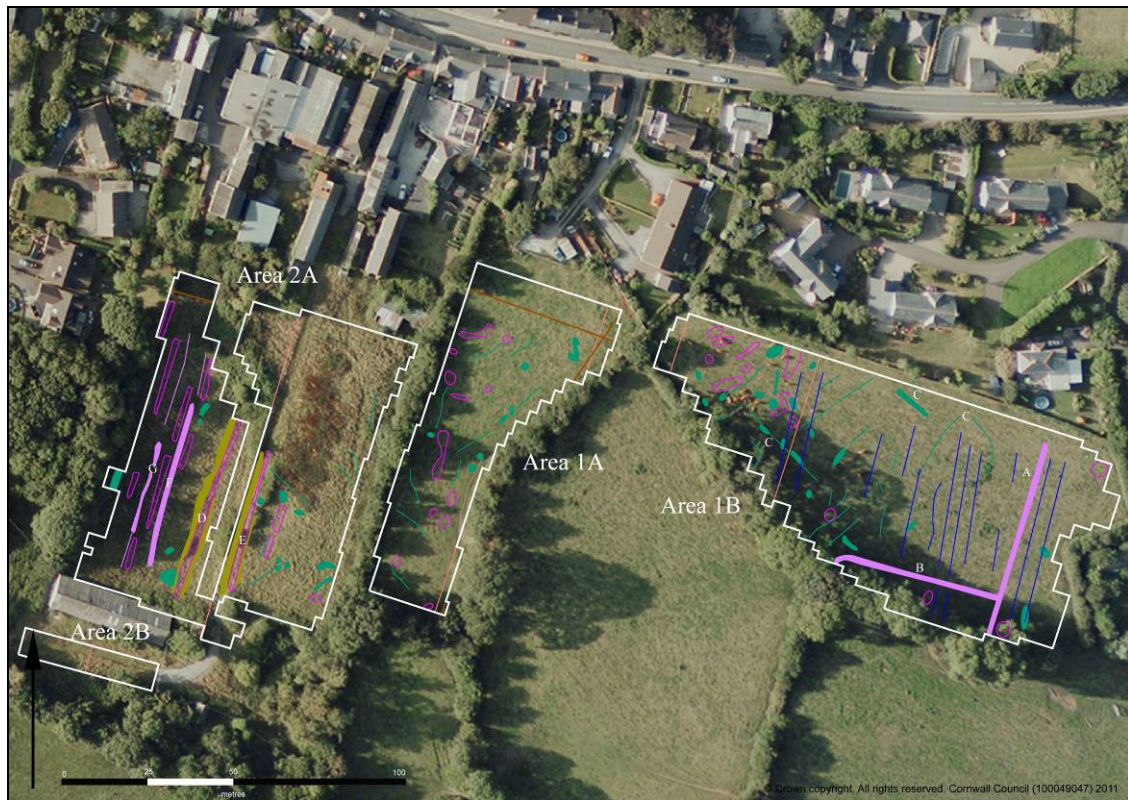
*Fig 9 Aerial photograph of the land at Manor Tannery and its environs with geophysics overlain.*

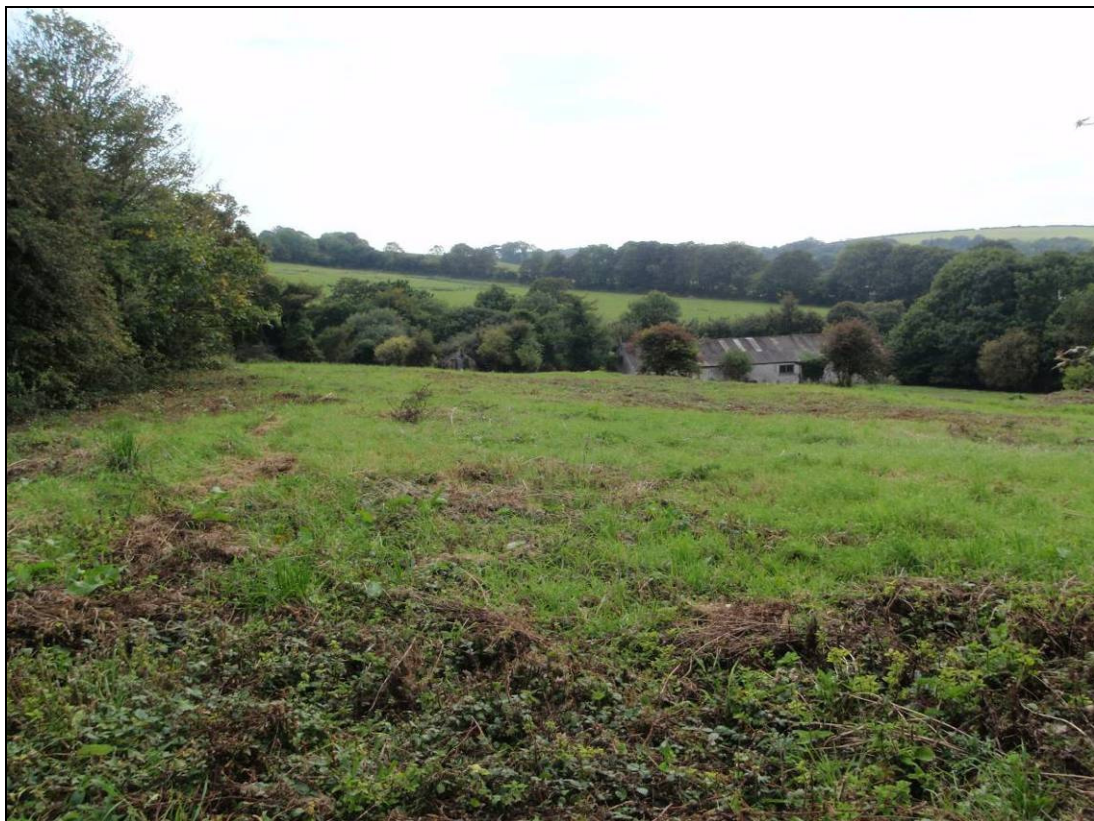
Field 1 is a 1.23 hectare field approximately 150 metres long by 88 metres wide situated directly south of the tannery buildings. It presents as derelict land not genuine pasture and at the time of the walkover had been recently strimmed. The surface is undulating and difficult to survey due to its uneven surface. Hollows are frequent especially to the east of the track (see below). There is significant hedge encroachment on the eastern boundary caused by overgrown trees. A flat terrace extends out from the back of a corrugated roofed building. This terrace banks steeply into the field to the west. A possible quarry is located in the south eastern corner and a track runs down the middle of the field. The track banks to the west approximately three quarters of the way down the field before leaving the site in the south western corner.

*Fig 10 Field 1 from the north east corner looking south west.*

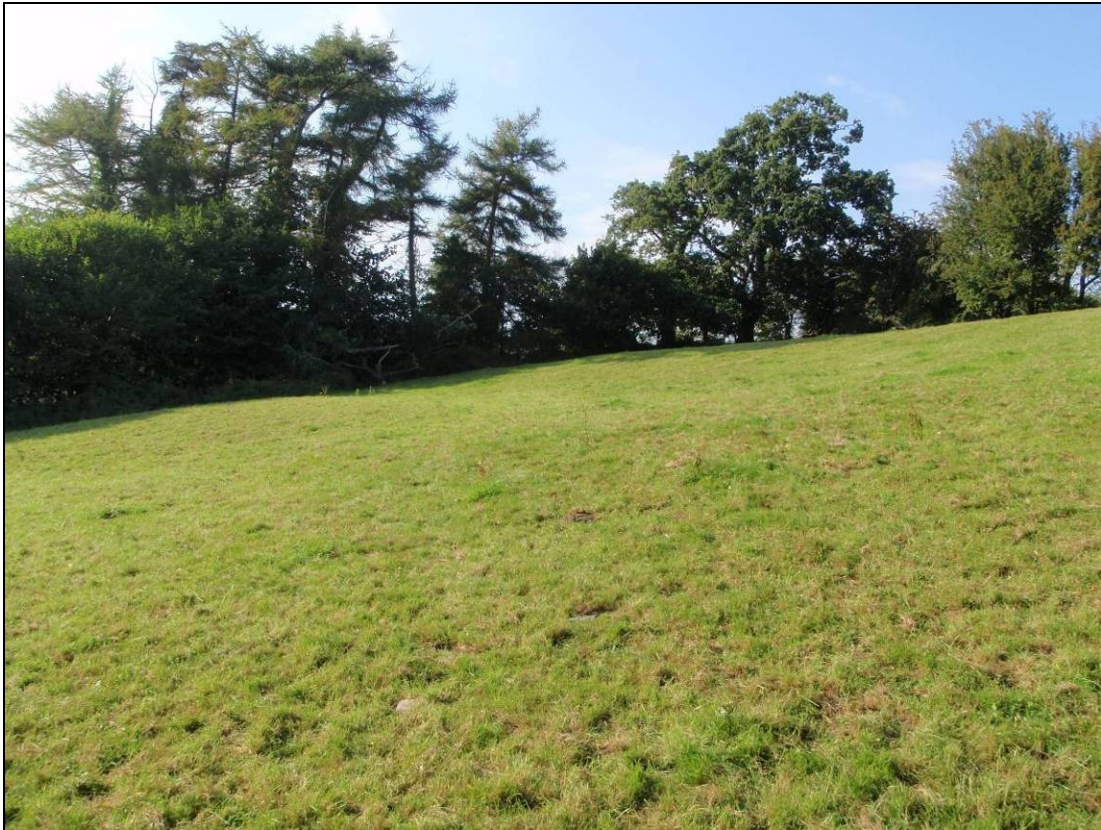
Field 2 is a narrow pasture field with a gentle gradient from north to south. It covers approximately 0.45 hectare with an average length of 120 metres by 45 metres wide. Both eastern and western boundaries have significant encroachment from overgrown hedges. It lies to the north of field 3, to the east of field 1, and to the west of field 4

*Fig 11 Field 2 Showing terraces on the western side and Boundary 1 beyond.*

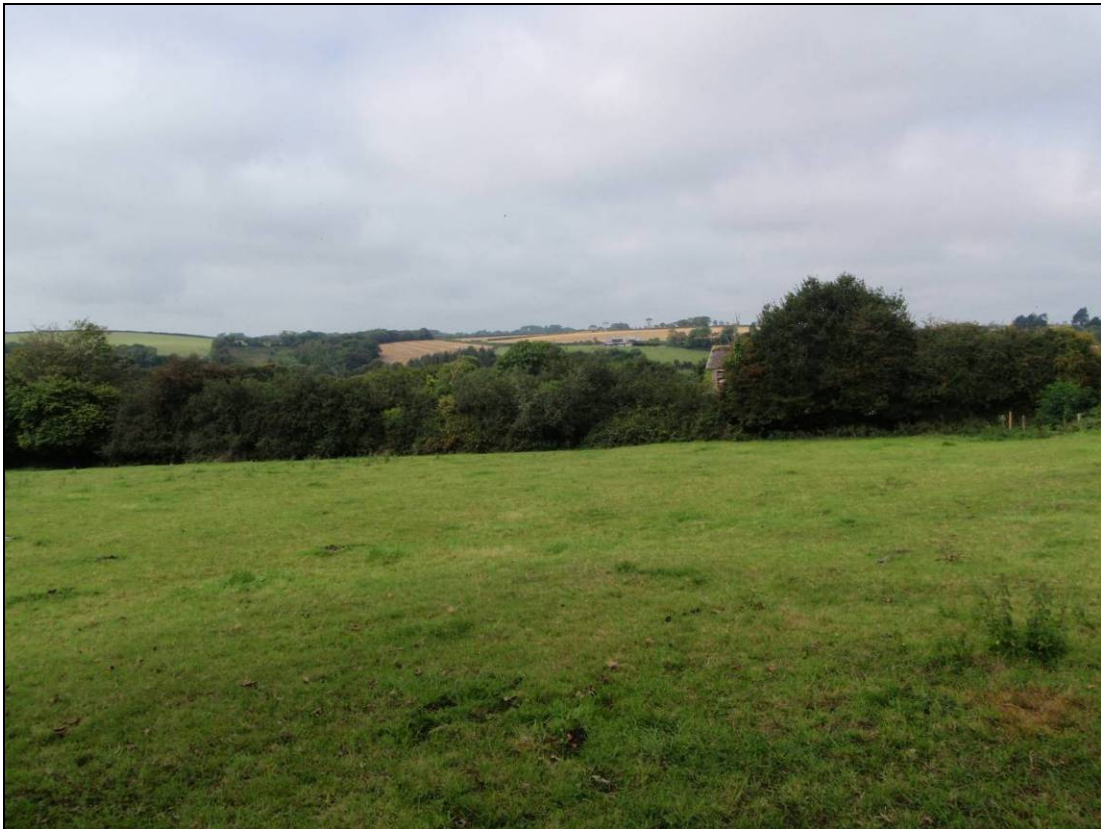
Field 3 is a 0.26 hectare steeply sloping pasture field: its length is approximately 165 metres and its width 40 metres. There are two slight terraces on its western side and banks towards the south where a small stream runs from east to west within the field. The stream runs into the limes complex (of the former tannery) beyond the field's south western border. It lies to the east of field 1 and to the south of field 2.

*Fig 12 Field 3 looking south west from north east corner showing Boundary 1.*

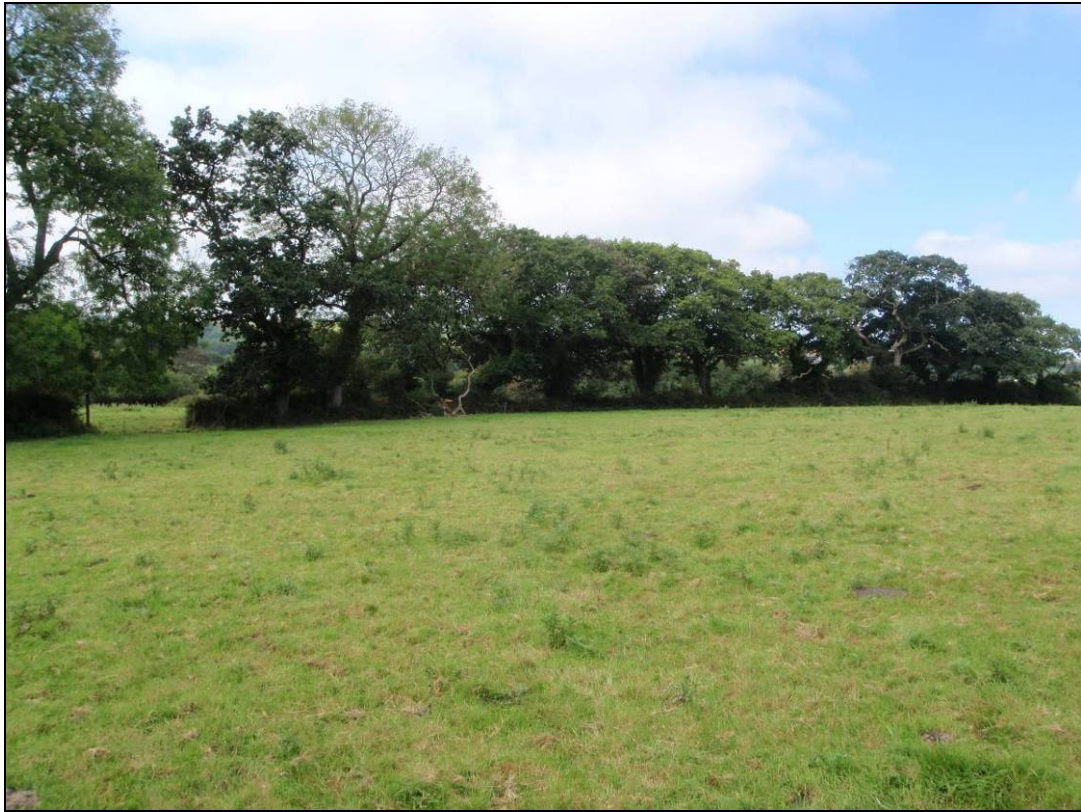
Field 4 is a 0.8 hectare pasture field running east to west. It is approximately 156 metres long and 68 metres wide. It has a gentle gradient from the north to the south and its southern boundary is noticeable for the mature oak trees growing along its length. Its northern boundary is composed of various fencing panels. Modern inspection covers are visible in the south eastern corner. It lies to the east of field 2.

*Fig 13 Field 4 Looking south west from the north east corner showing Boundary 13.*

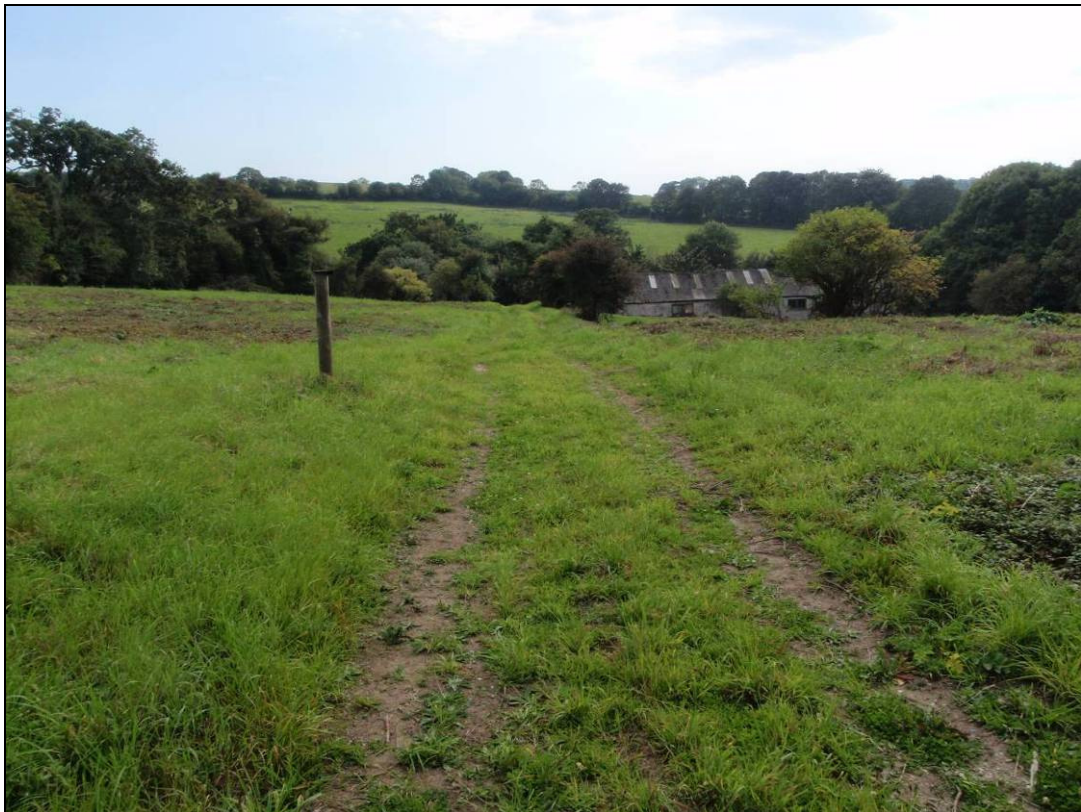
A track-way running from SW 93610 48200 and leaving the survey area at SW 93511 48086. The track extends 120m south along a raised bank until it reaches a sharply banking corner to the west at SW 93572 48091 where it becomes tarmac. The tarmac runs around the bend before reverting to track beyond at SW 93563 48076. The track exits the site 60m from the banking corner in the south west corner of Field 1 before emerging onto Creed Lane at SW 93479 48114.

*Fig 14 Looking south along the trackway in Field 1.*

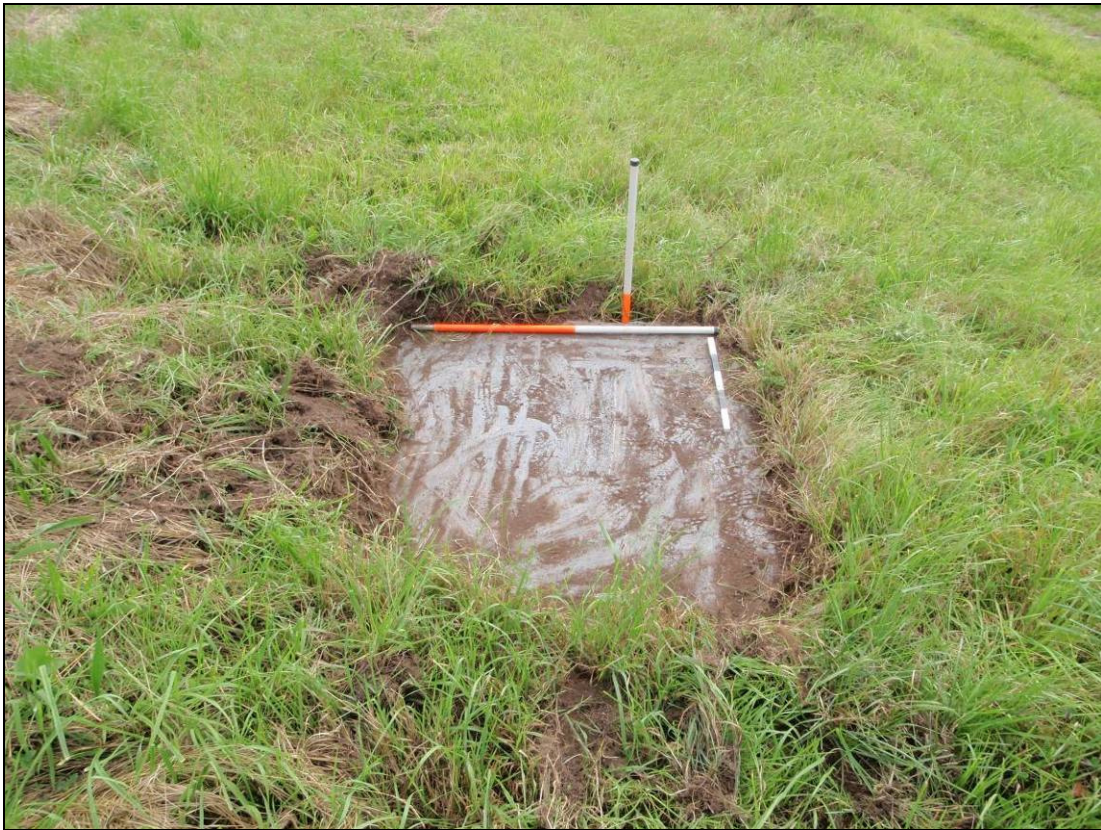
1.4m x 1.4m slate flag stone, laid flat on the ground and likely to cover a built feature. This much of the slate was revealed for survey purposes but part is under vegetation and it therefore appears to be larger. It is situated approximately 2m east of the track and approximately 2m south of the corrugated building at SW 93602 48186. It could possibly be a slate tank or well capping. It was probed with a 1m ranging pole but the depth is unknown. It is possibly related to the suggested power conduit running from the water wheel sited at The Limes to the Upper Yards.

*Fig 15 Flagstone in Field 1.*

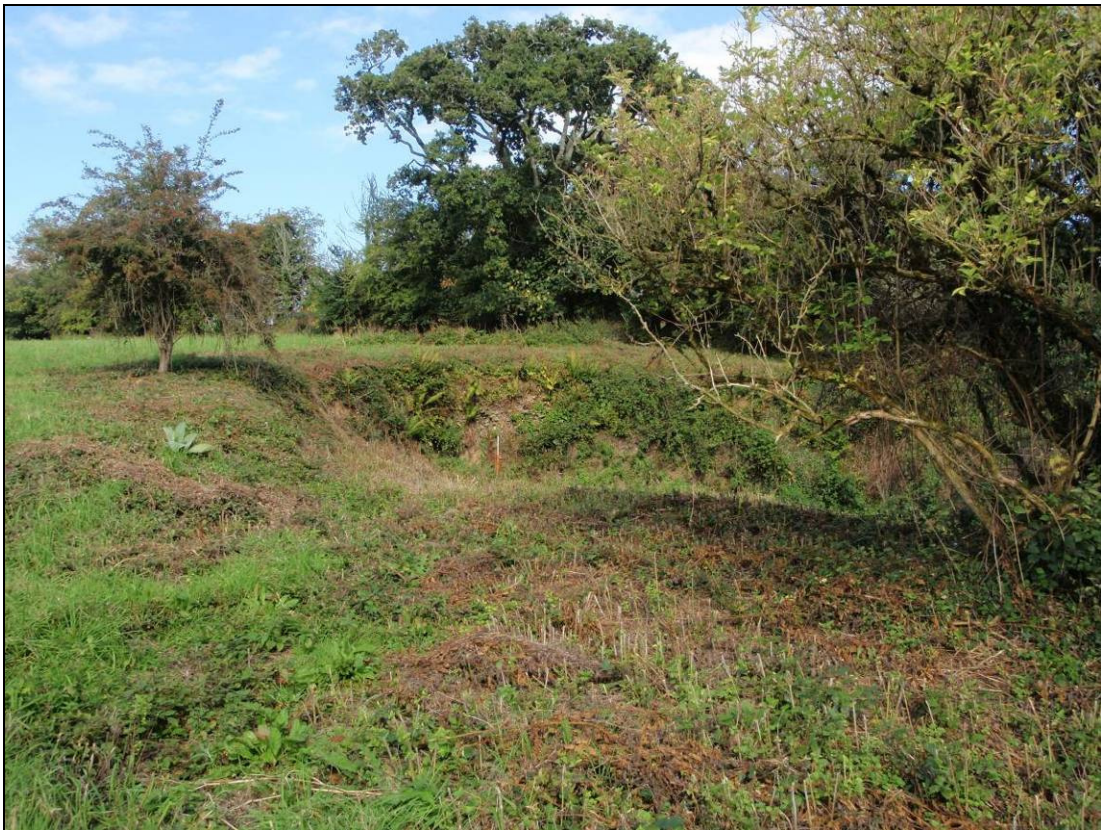
Towards the southern end of Field 1 a 3m deep, 14m wide cut into a folded band of shillet / Cornish slate-like material. This type of material is used locally as walling and facing stone and it seems likely that this was a small quarry, now partially infilled with soil and debris.

*Fig 16 Quarry in Field 1.*

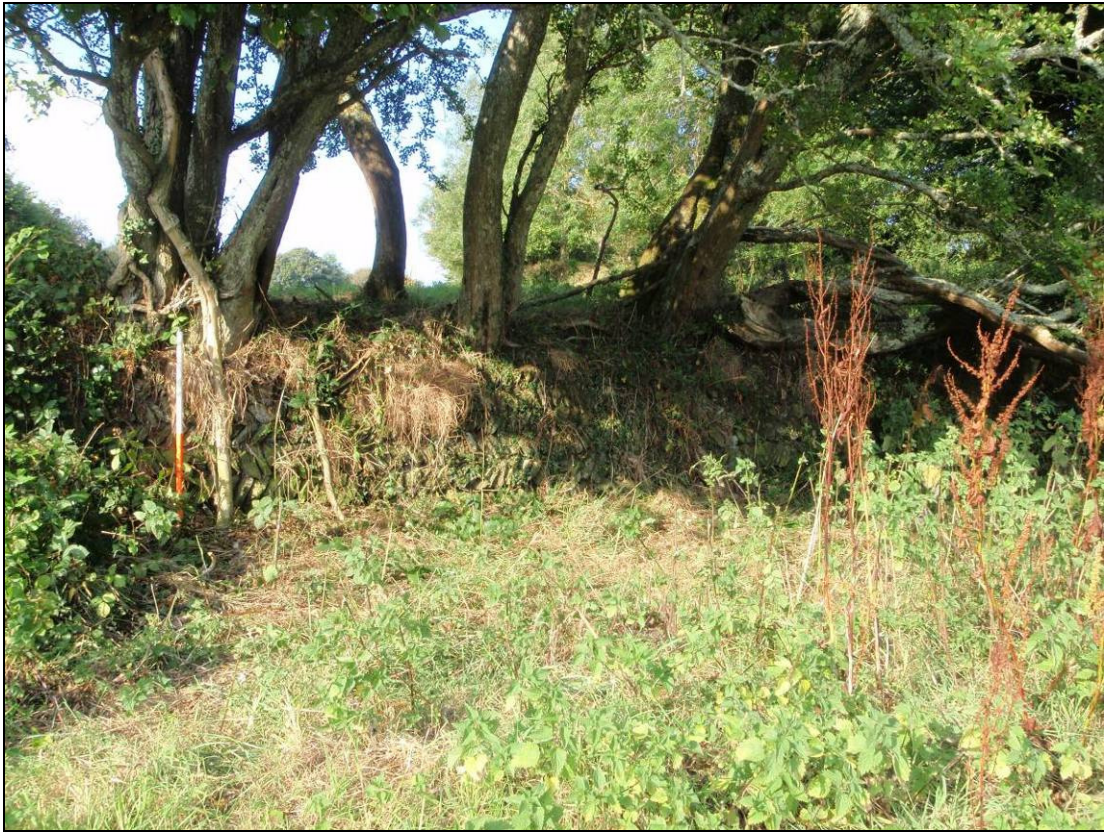
The northern boundary of Field 3 running east to west is a 1.2m high stone faced lynchet. Its vertical face is to the south and has a herringbone facing style. Hawthorn and oak are growing along its length.

*Fig 17 Stone faced lynchet between Fields 2 and 3.*

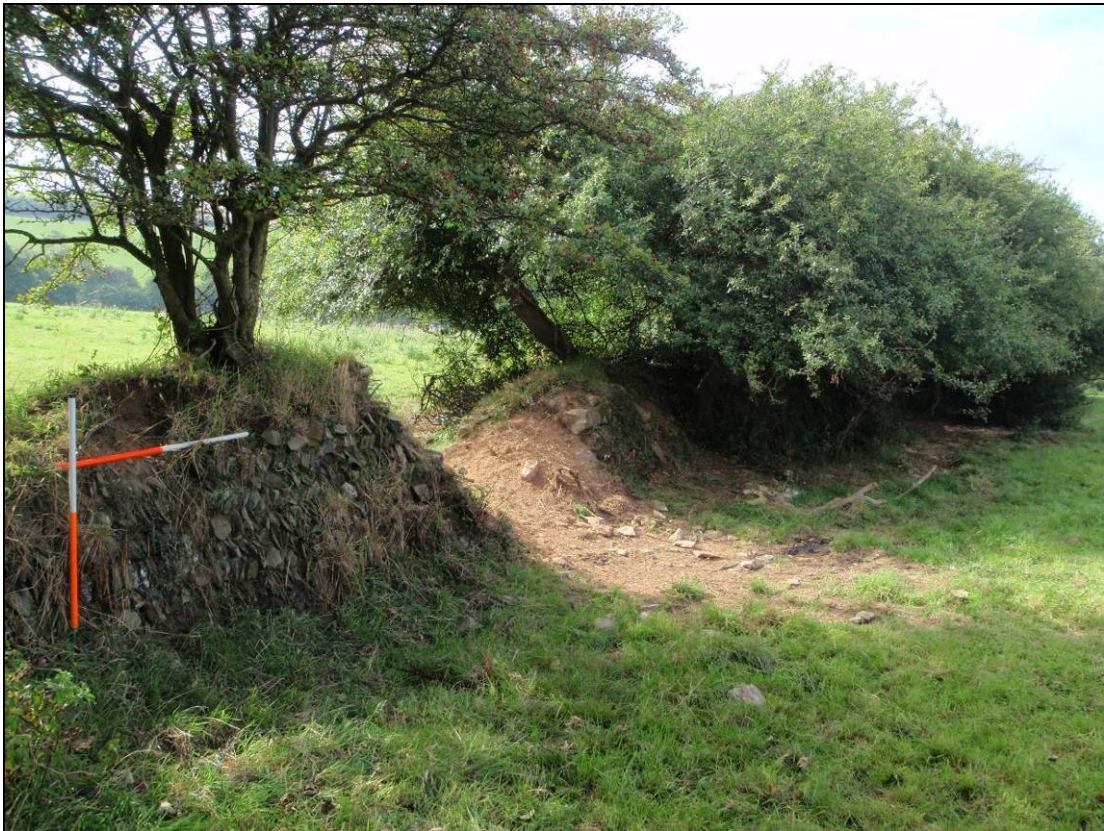
The eastern boundary of Field 2 is a 1.5m high by 1.3m wide stone faced earth wall inclined towards the top. The boundary has a regular horizontal base course with frequent vertically coursed pillars interspersed with a herringbone facing style. Mature blackthorn and occasional holly trees grow along its length.

*Fig 18 The northern end of Boundary 8 between Fields 2 and 4.*
