# Field Boundaries on the Isles of Scilly Historic Environment Study to Inform Management for Conservation

### **Historic Environment Study to Inform Management for Conservation**

<b>Client</b>	<b>The Isles of Scilly AONB Unit</b>
<b>Report Number</b>	<b>2011R095</b>
<b>Date</b>	<b>25 October 2011</b>
<b>Status</b>	<b>Final</b>
<b>Report author(s)</b>	<b>Graeme Kirkham, Francis Shepherd, Charles Johns</b>
<b>Checked by</b>	<b>Charles Johns</b>
<b>Approved by</b>	<b>Andrew Young</b>

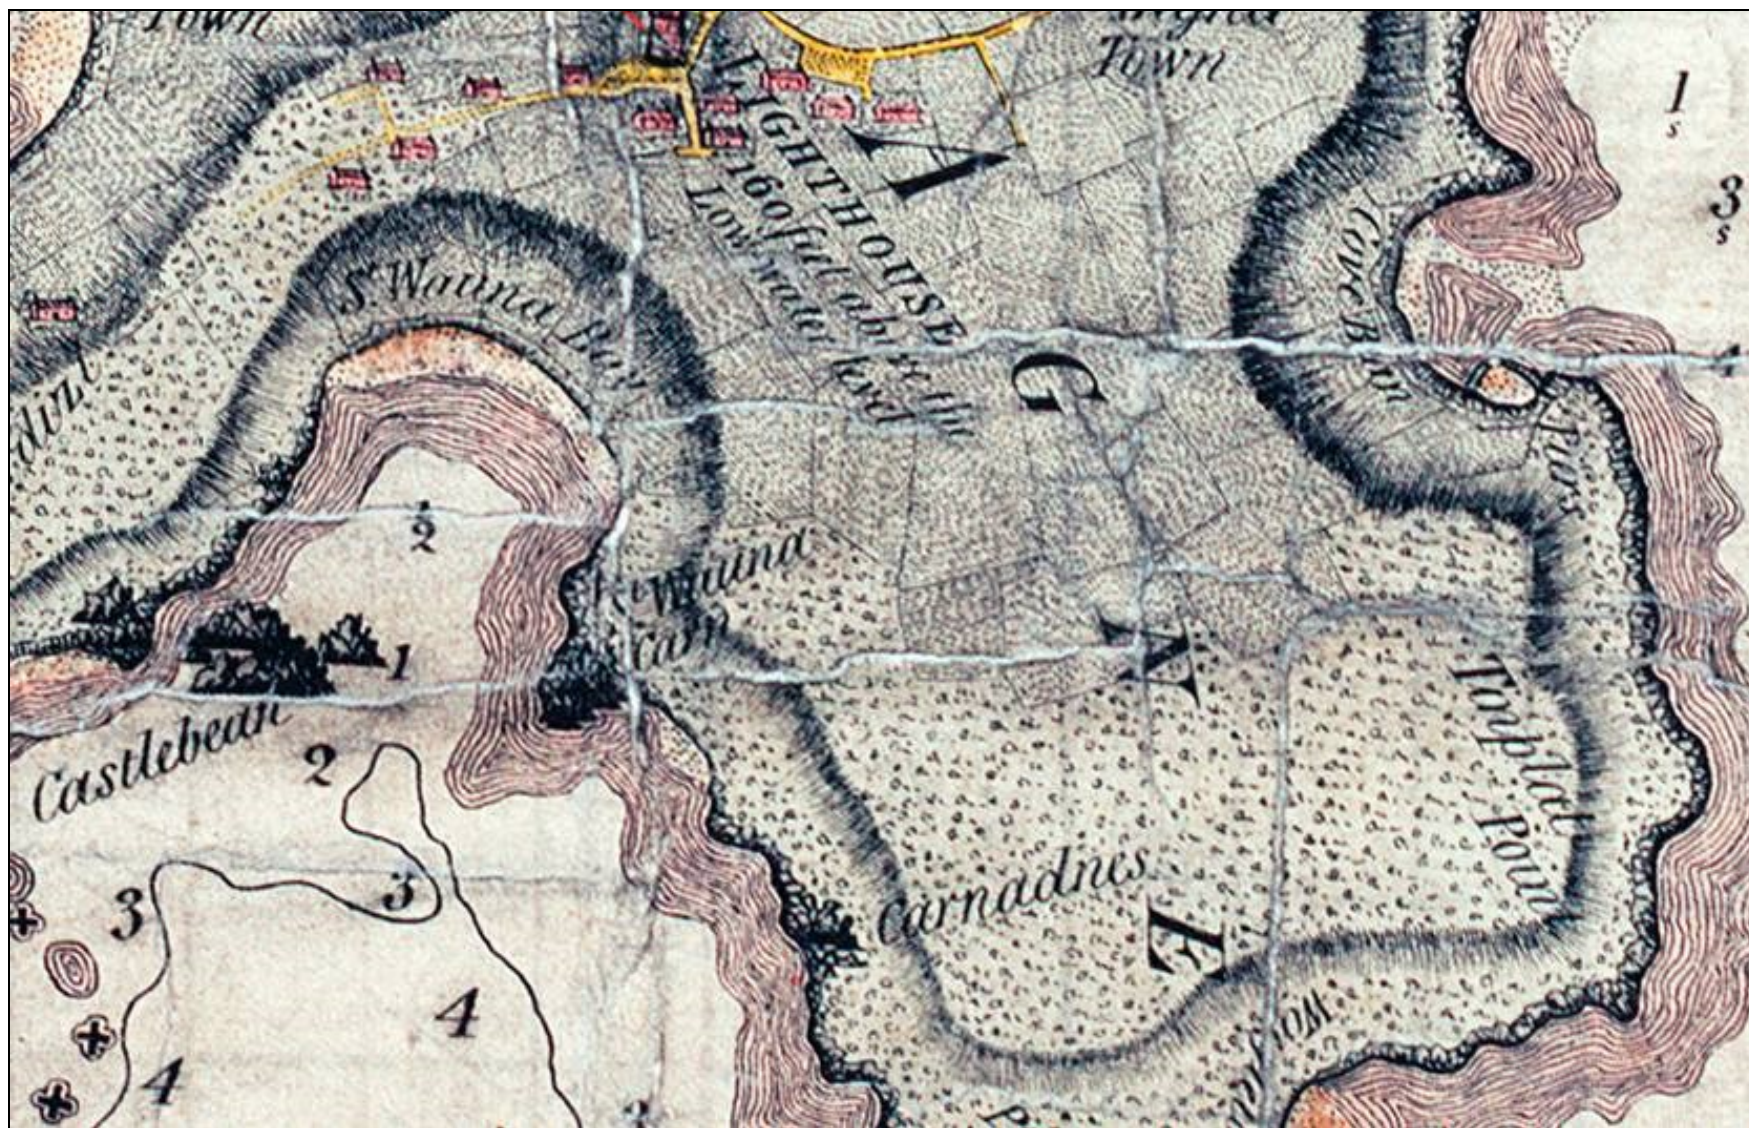
Fig 11 Part of St Agnes, including the St Agnes 2 survey area, shown by Spence (1792).

The Parliamentary Survey of 1650 (Pounds 1984, II, 132) noted enclosures lying 'against St Awanie Sound and a pasture close adjacent to Wingletang Bay', and Spence's map of 1792 shows much if not all of the study area as enclosed (Fig 11). Comparison of the present boundaries with the 1st edition Ordnance Survey 6-inch map of c 1890 indicates that some rationalisation took place during the twentieth century.

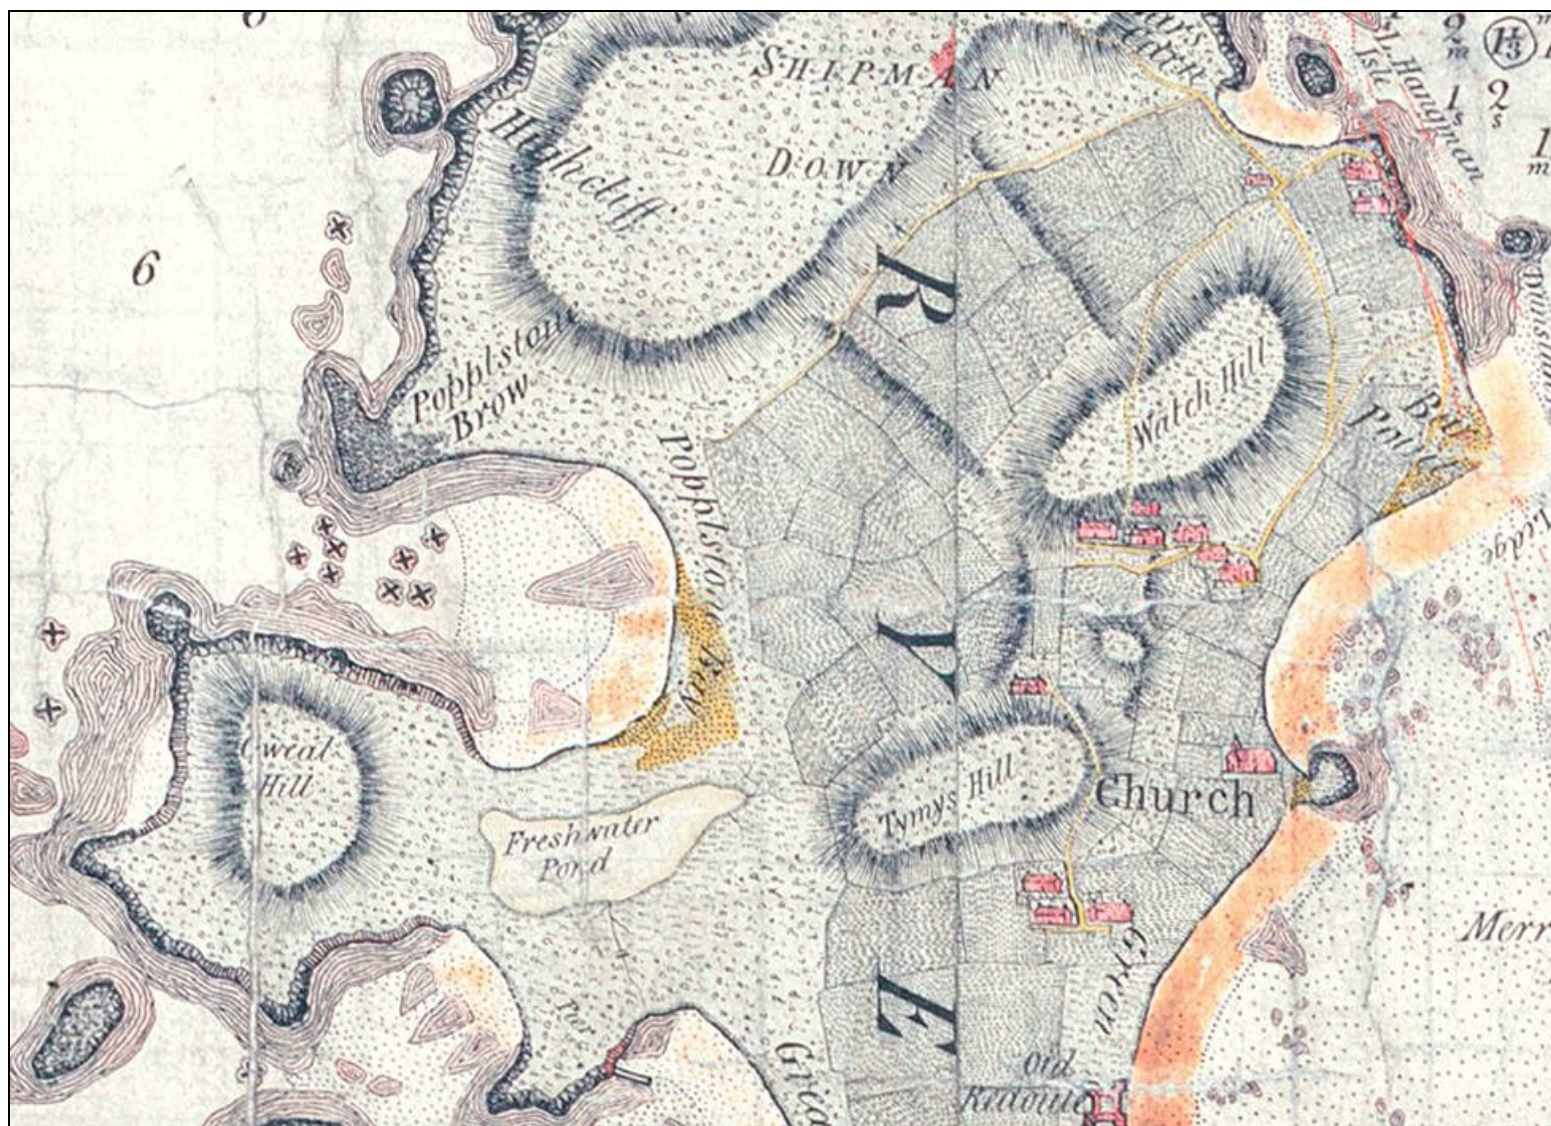
Fig 12 Part of Bryher, including the Bryher 2 and 3 survey areas, depicted on Spence's map of 1792.

This is a small, discrete and isolated group of enclosures on the eastern flank of Gweal Hill. They are not depicted on Spence's map of 1792 (Fig 12) but may be plausibly identified with the '5 closes of arable and pasture lying together on the east side of a hill called Gwithiall Hill', recorded by the Parliamentary Survey of 1650 as part of a tenement named as 'Banton' (Pounds 1984, II, 134). Five adjoining enclosures are shown on the 1st and 2nd edition Ordnance Survey 6-inch maps of c 1890 and 1909 but there has been some subsequent subdivision in one of these. This field was accordingly not characterised as Anciently Enclosed Land and thus omitted from the study area. The western enclosure in this group falls within the area of a prehistoric field system (Scheduled Monument 15458; HER PRN 7385) which extends around the southern and western sides of Gweal Hill. This is defined by turf-covered rubble banks up to 2m wide and 0.25m high, with a single row of closely spaced slabs, mostly edge-set and 0.5m-1m apart and 0.4m-0.5m high, projecting along the midline of the banks. The Scheduling description notes that

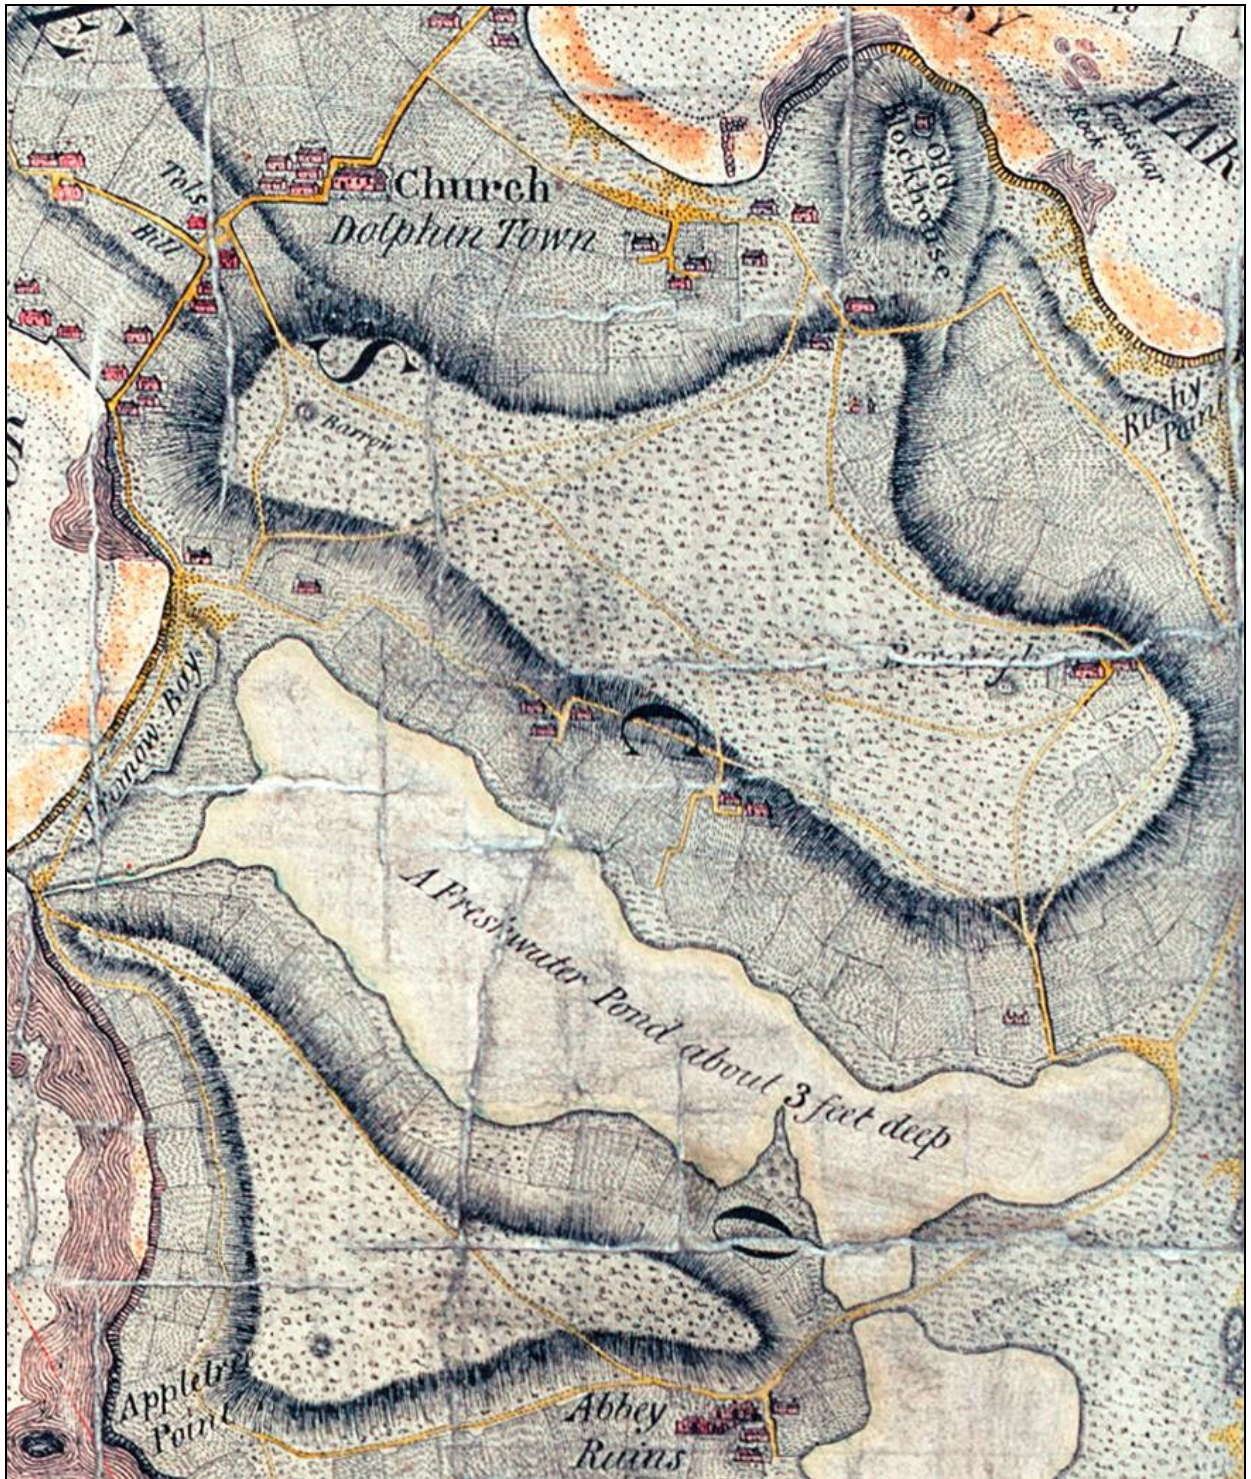
*Fig 16 Dry stone wall 36 facing a low lynchet in the Bryher 3 survey area. Grown-out hedging material along the boundary is partly responsible for the instability of this and a number of other nearby boundaries. Tumble is readily apparent and repair of boundaries of this type would be relatively easily achieved. (Photograph: Historic Environment, Cornwall Council.)*

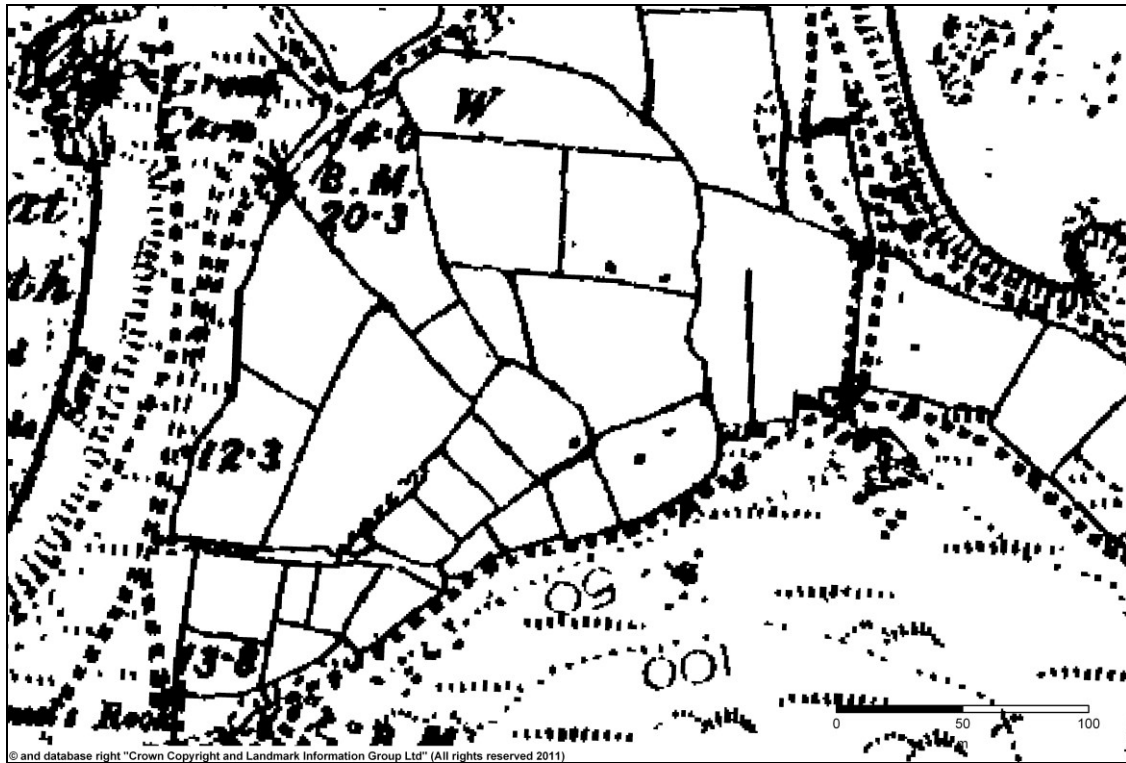
Fig 17 The Hillside Farm area, part of the Bryher 1 survey block, depicted on the 1st edition Ordnance Survey 6-inch map of c 1890. The apparently ring-fenced block of fields centre and left incorporates remains of late prehistoric and Roman-period settlement, midden deposits and a lyncheted field system (Johns 2002-3).

This survey block was not visited during fieldwork. Survey and excavation following the discovery of an Iron Age sword and mirror burial at Hillside Farm identified late prehistoric – Romano-British occupation and an associated lynched field system within the study area (Johns 2002-3), again indicating the long history of agricultural use of many areas of AEL on Scilly. Part of this study area underwent significant re-organisation for bulb / flower cultivation in the decades just before and after 1900 (Figs 17, 18).

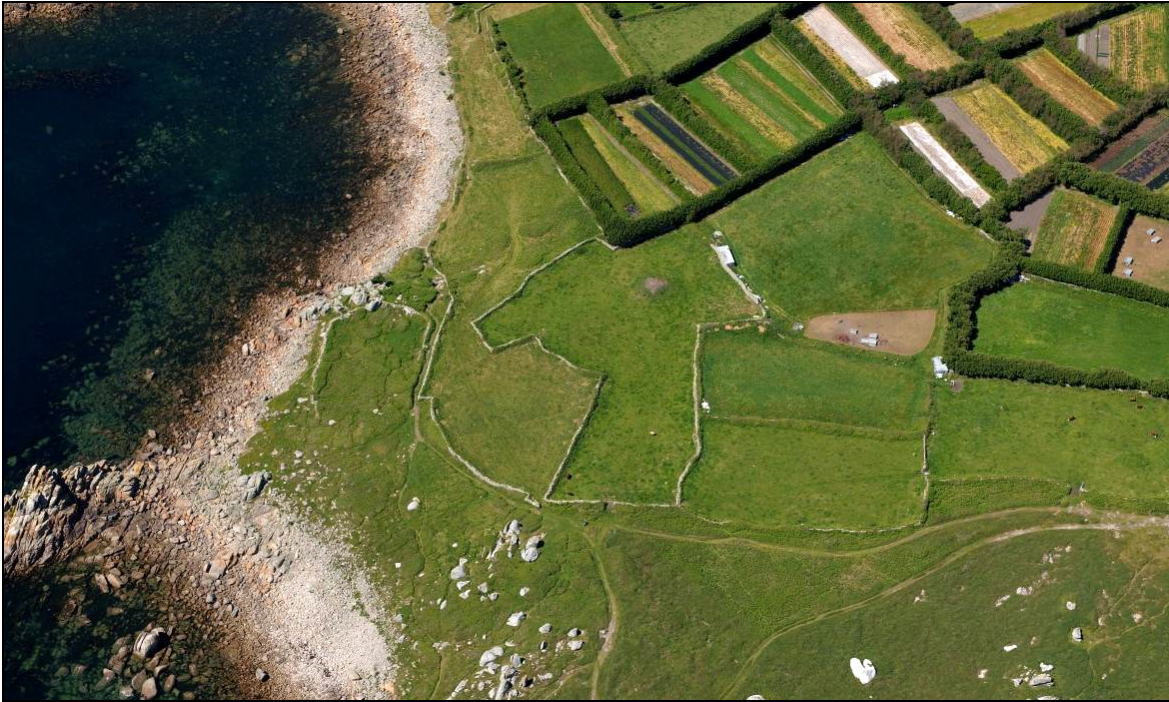
*Fig 19 Part of the St Agnes 2 survey area, with some boundaries probably deriving from prehistoric enclosures. Others have 'taken in' portions of coastal rough ground, and some have been adapted or rebuilt as part of shelter belts for bulb and flower cultivation. (Photograph: Historic Environment, Cornwall Council, 2009; F92-463.)*

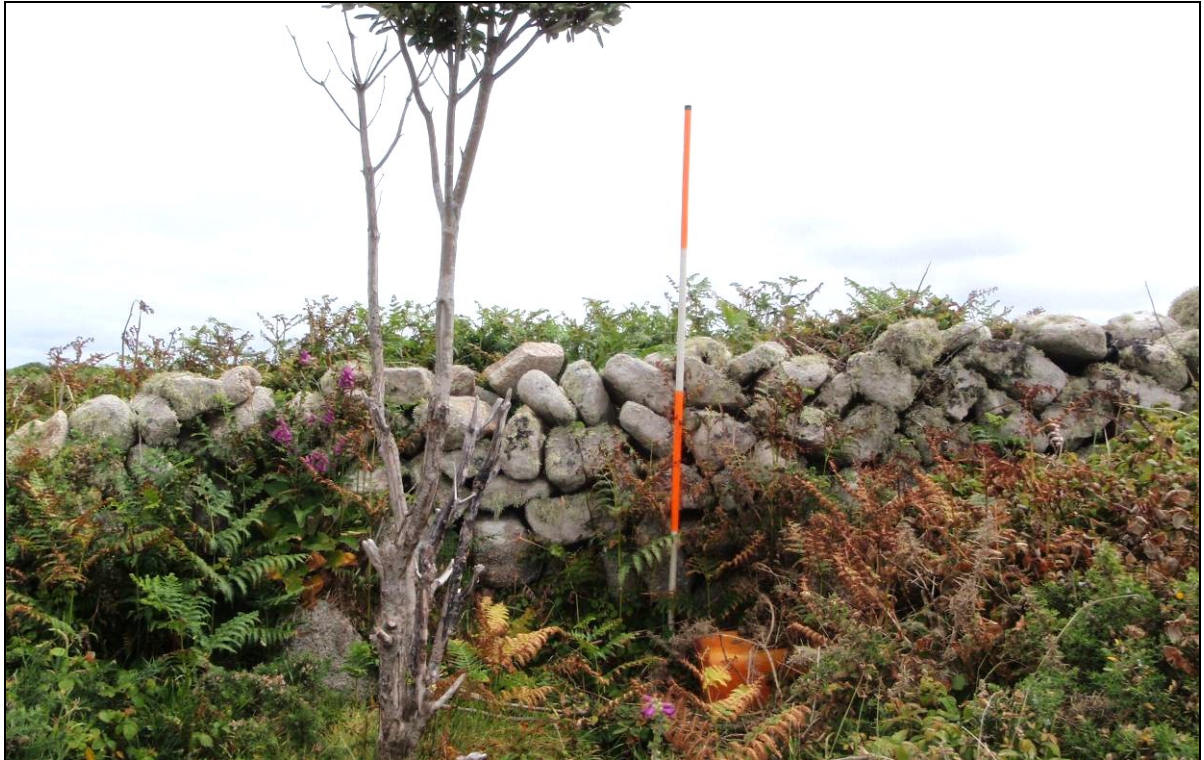
*Fig 21 St Agnes 2 boundary 75 is the stone-faced stone wall immediately behind the girls in the historic photograph reproduced as Fig 20. The difference in vegetation cover resulting from the cessation of rough ground grazing and reduced intensity of exploitation of the enclosed area is readily apparent. The boundary remains in good condition over at least part of its length. (Photograph: Historic Environment, Cornwall Council.)*

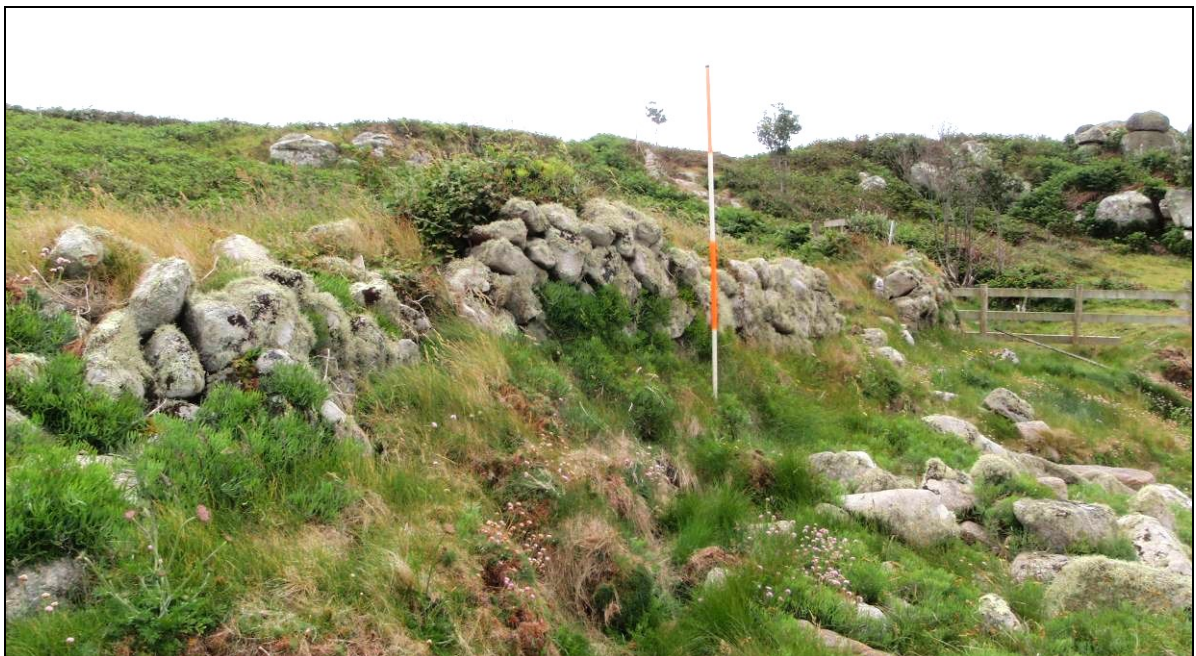
*Fig 22 St Agnes 2 boundary 76 is visible in the middle distance on the left hand side of Fig 20. It has survived less well than boundary 75 and now needs extensive repair. Its location alongside the coast path means that it is a highly visible element in this distinctive landscape. (Photograph: Historic Environment, Cornwall Council.)*

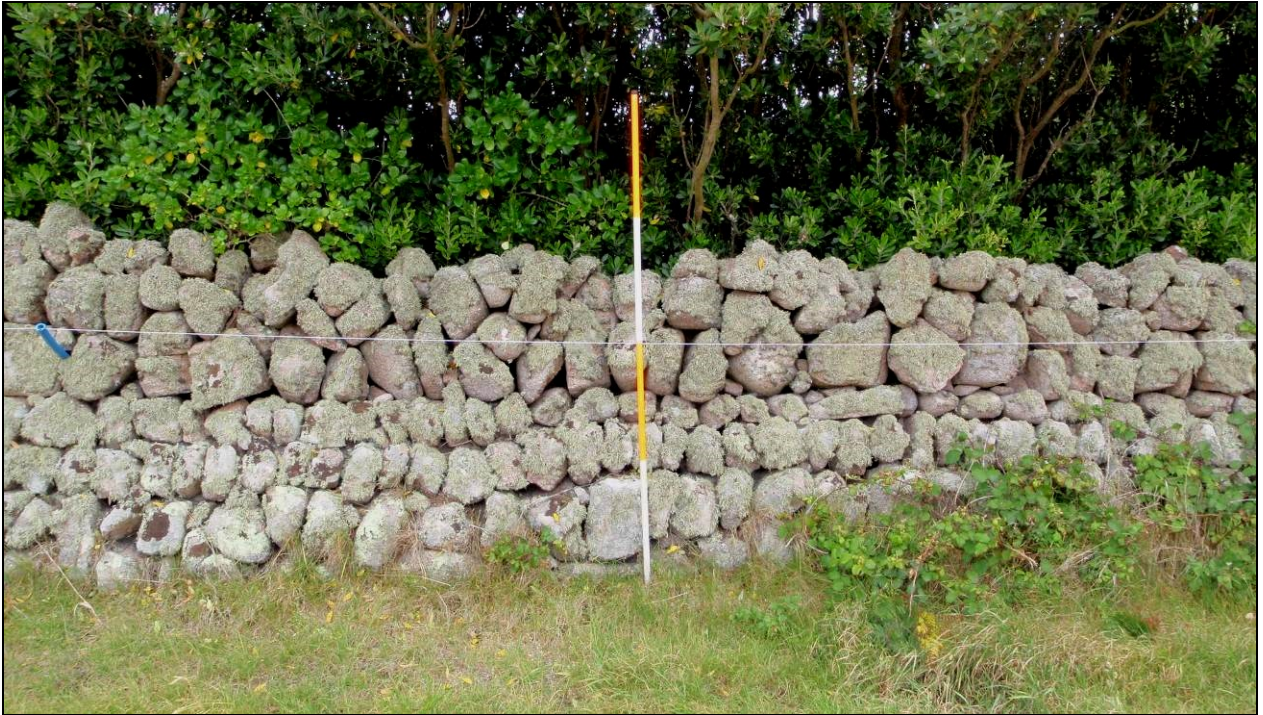
*Fig 23 Stone-faced stone wall (St Agnes 2, boundary 81), probably on the line of an older boundary and re-built to shelter the vegetated 'fence' behind it when first planted, with the upper courses added subsequently in a different style. (Photograph: Historic Environment, Cornwall Council.)*

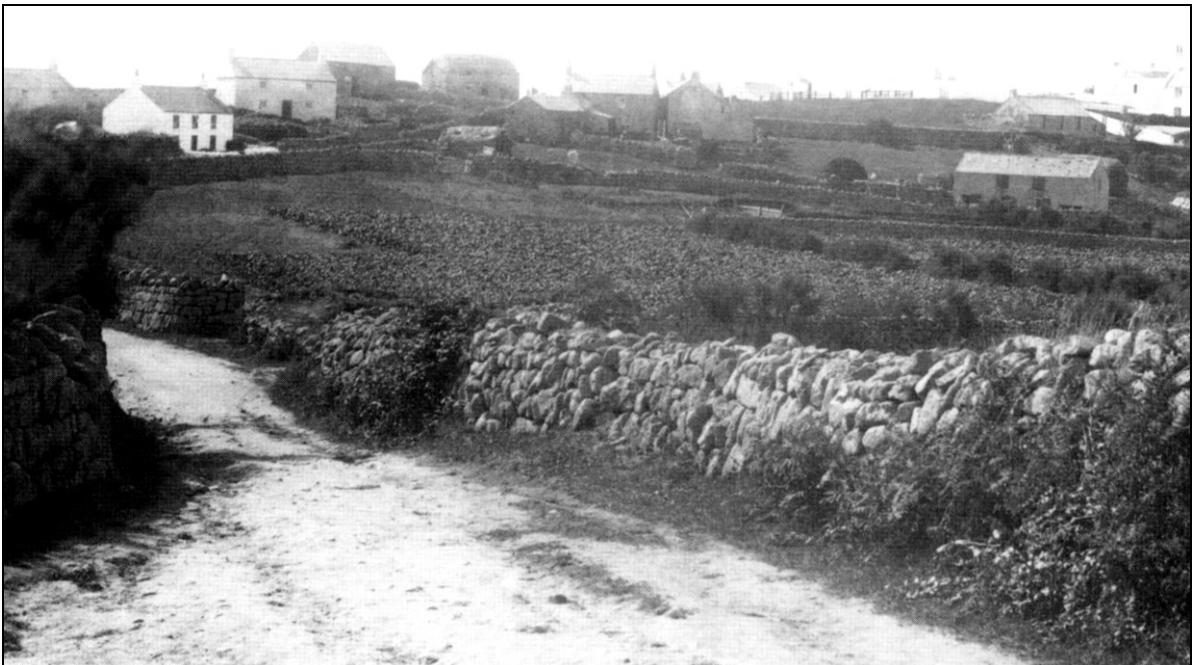
*Fig 24 A Francis Frith photograph of St Agnes in 1892. The random stonework of the 'traditional' stone-faced stone wall in the foreground contrasts with the boundary of gradated, coursed stones and transversely-set capstones visible in the middle distance. The latter is probably to be attributed to the Augustus Smith period on Scilly. (Photograph: © Francis Frith Collection. Reproduced from Cowan 2001, 62-3.)*

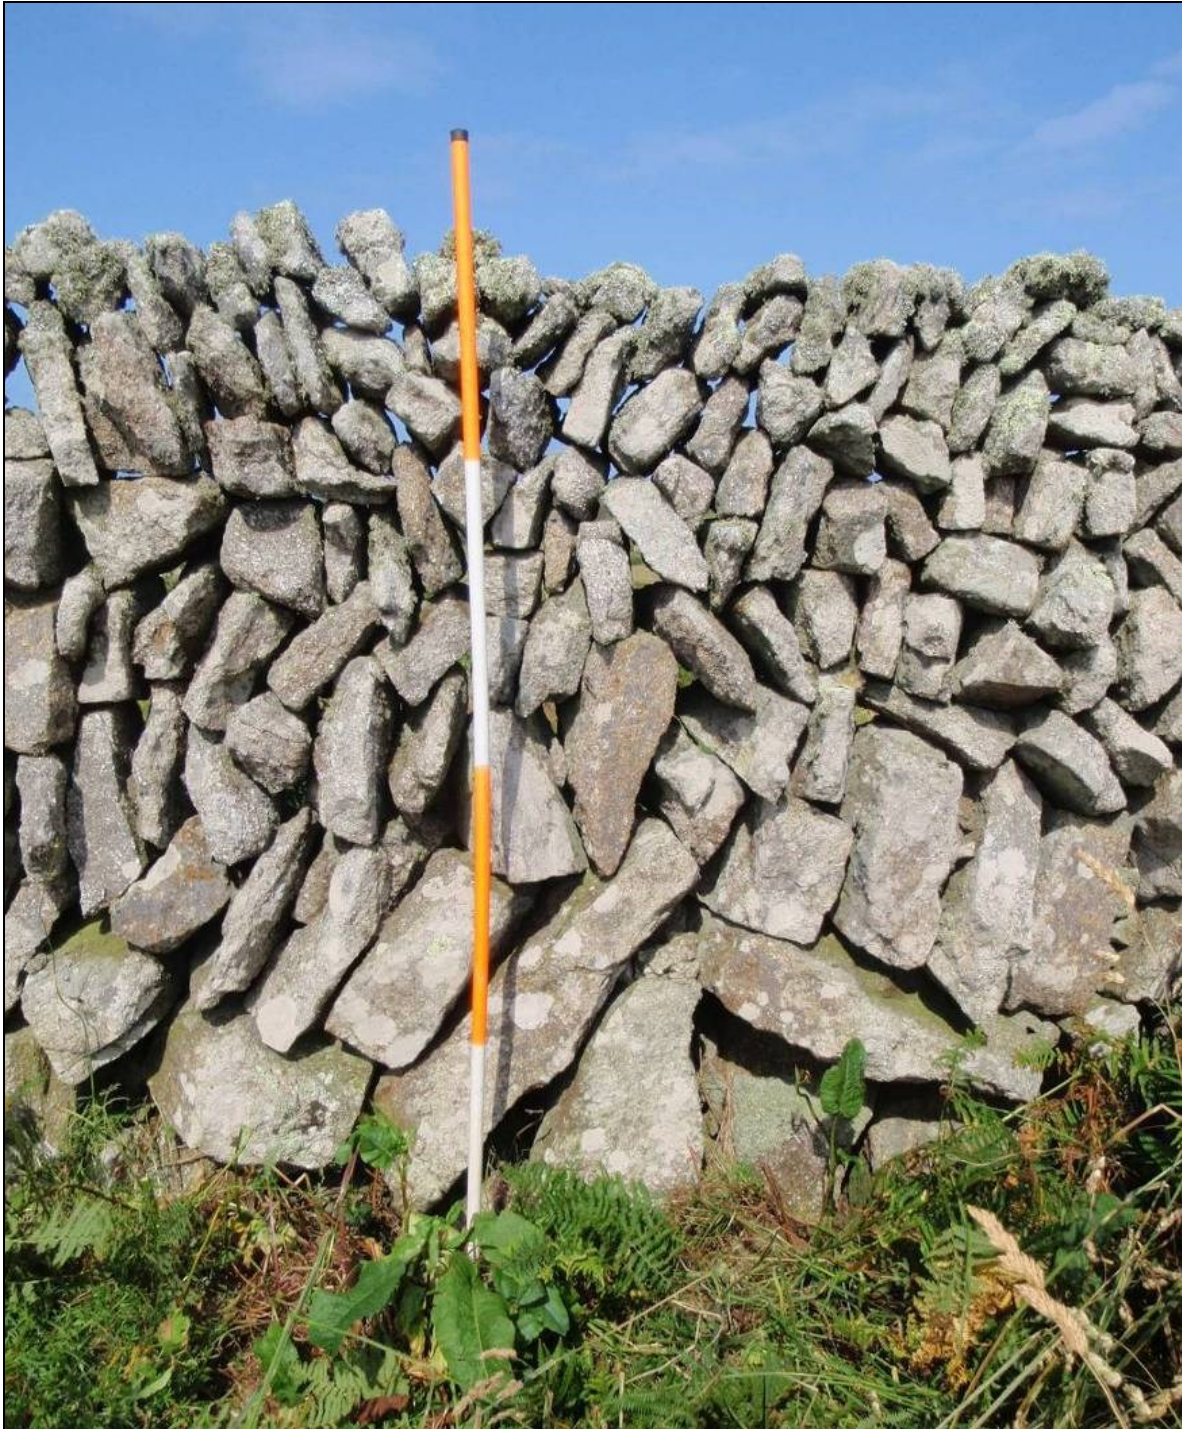
*Fig 25 Dry-stone wall 55 in St Martin's 2a survey area, an example of a distinctive boundary type known to have been constructed by Sidney Bond in the 1920s (Keith Low, pers comm). These walls are based on low earth-set orthostats at approximate 2.4m intervals; one is visible just to the right of the ranging pole. (Photograph: Historic Environment, Cornwall Council.)*

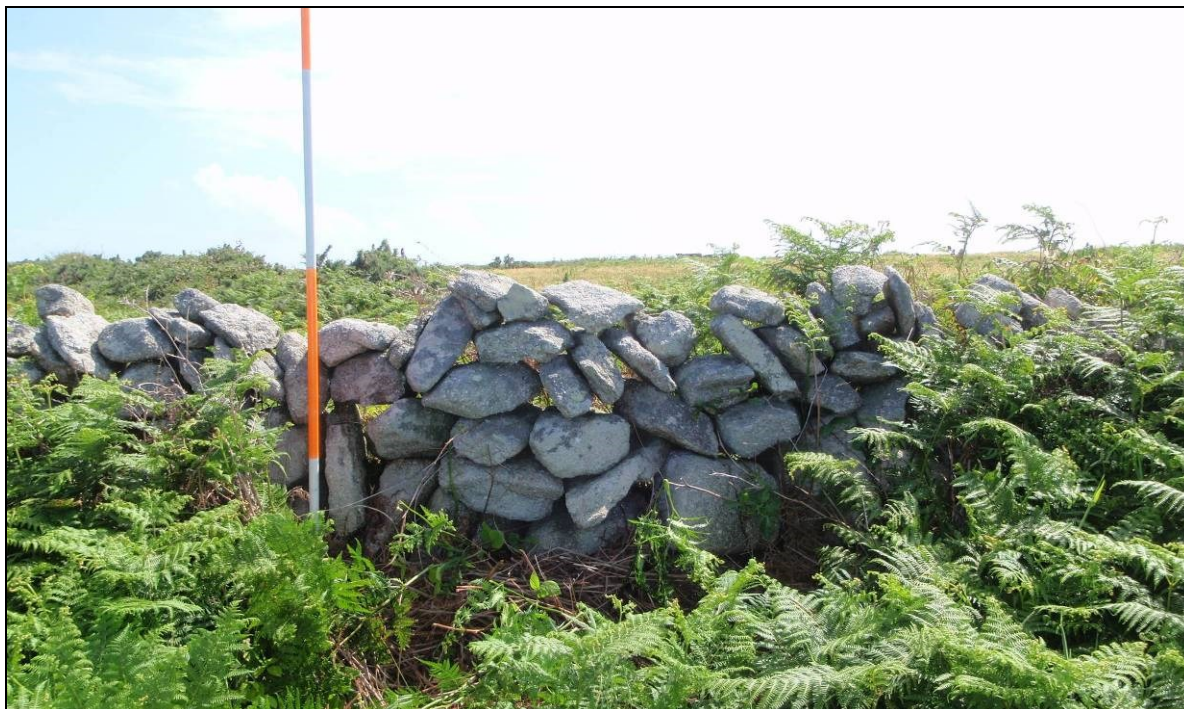
*Fig 26 St Martin's 2a boundary 202 was created after c 1909 to enclose an area of rough ground adjoining existing fields. (Photograph: Historic Environment, Cornwall Council.)*

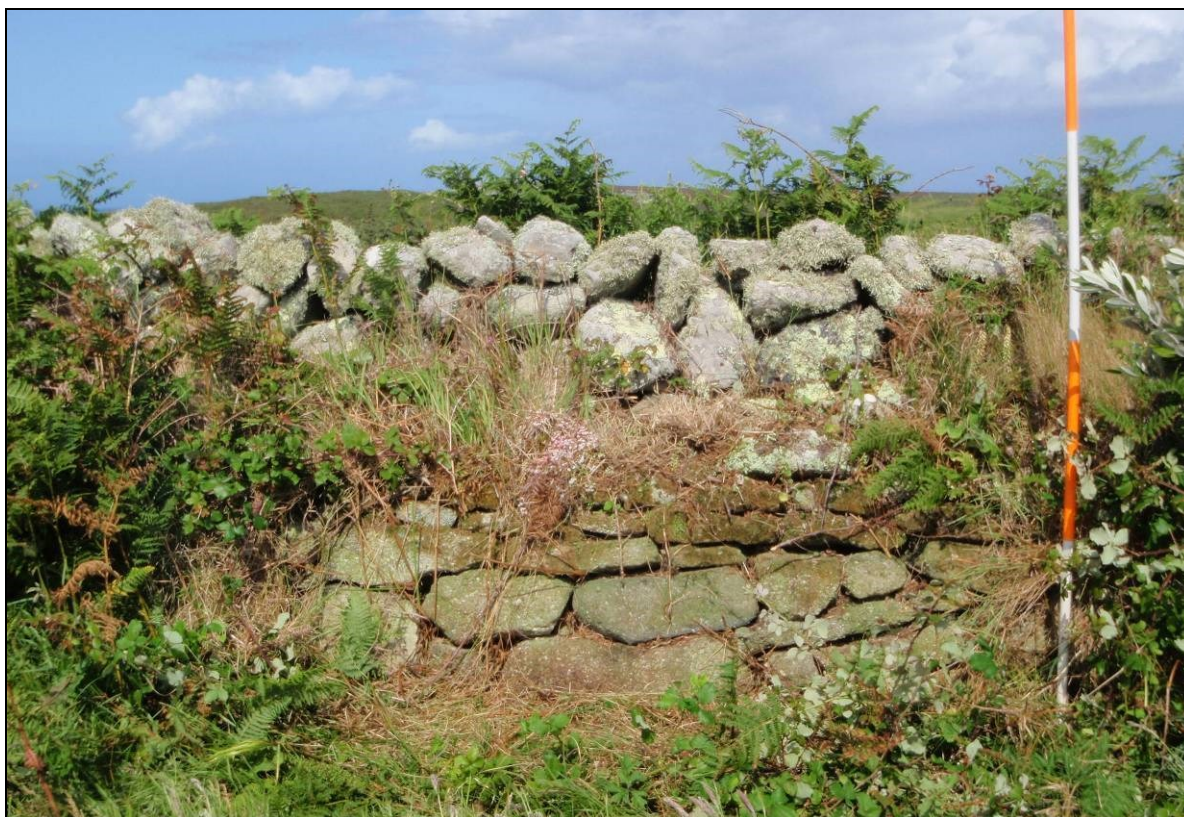
*Fig 27 St Martin's 2a, boundary 41: a dry-stone wall imposed on an unusual stone-faced earth wall of semi-coursed horizontally-laid stonework. (Photograph: Historic Environment, Cornwall Council.)*

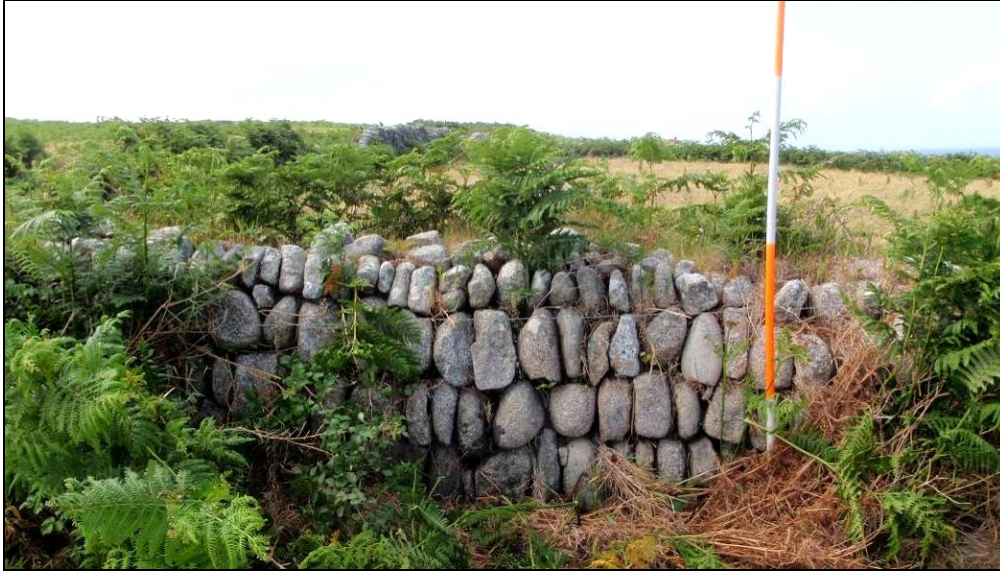
*Fig 28 Boundary 66 in St Martin's 2a: a stone-faced earth wall of regular coursed and graded stonework; many of the stones are rounded and appear to be beach cobbles. The style is unusual within the survey area and emphasises the diversity of boundary types found in this block. (Photograph: Historic Environment, Cornwall Council.)*

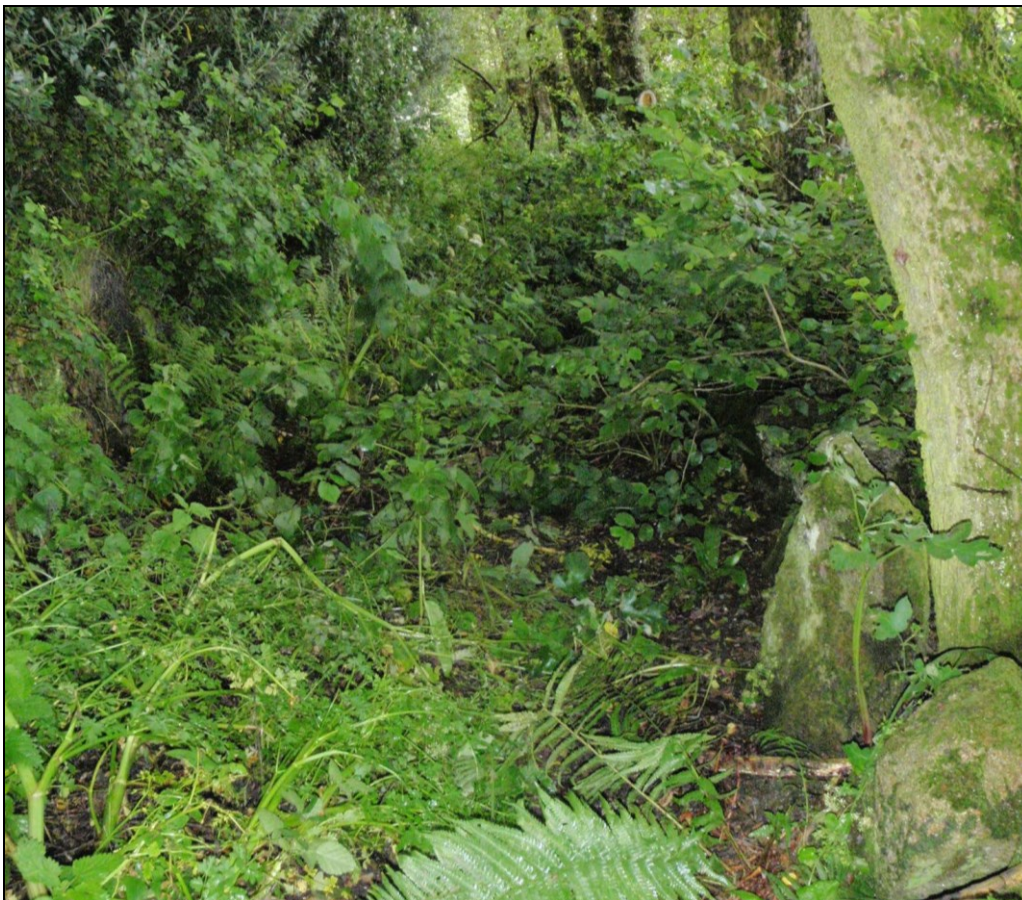
*Fig 29 Overgrown terraced track on Lunnon Farm (St Mary's 2) between a stone-faced lynchet on the left and boulder wall with outgrown hedging trees on the right. (Photograph: Historic Environment, Cornwall Council.)*

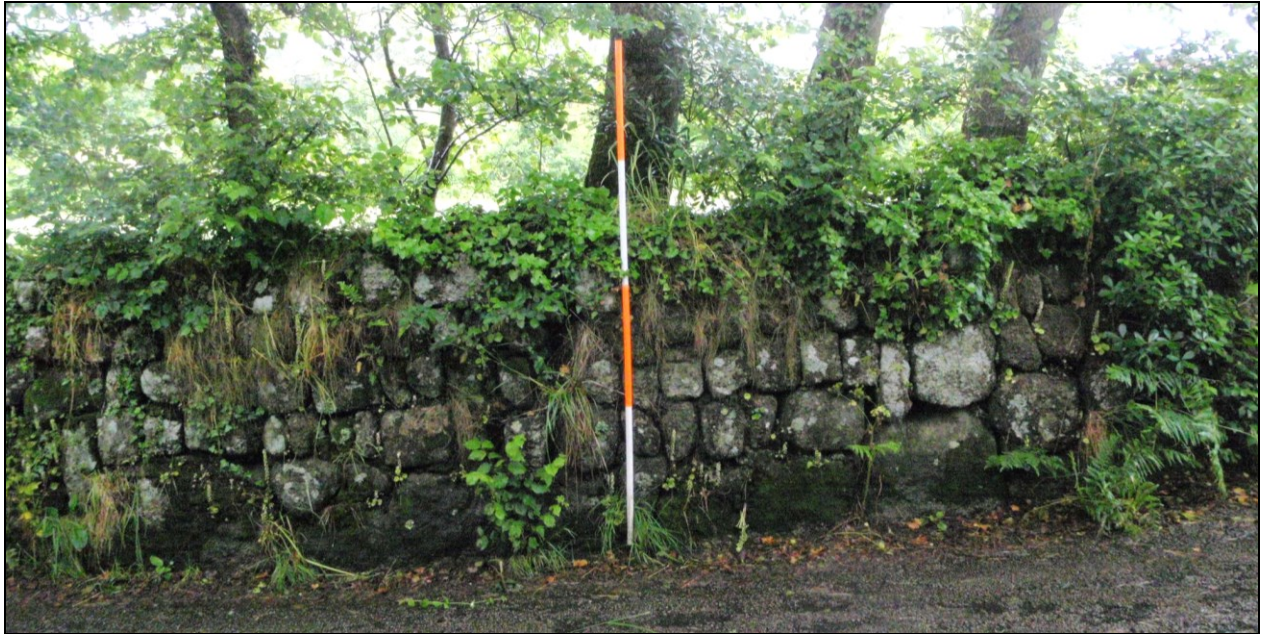
Fig 30 St Mary's 2 boundary 39, a stone-faced earth wall bordering the public road, is of fairly regular coursed stonework based on substantial horizontally-laid grounders. (Photograph: Historic Environment, Cornwall Council.)

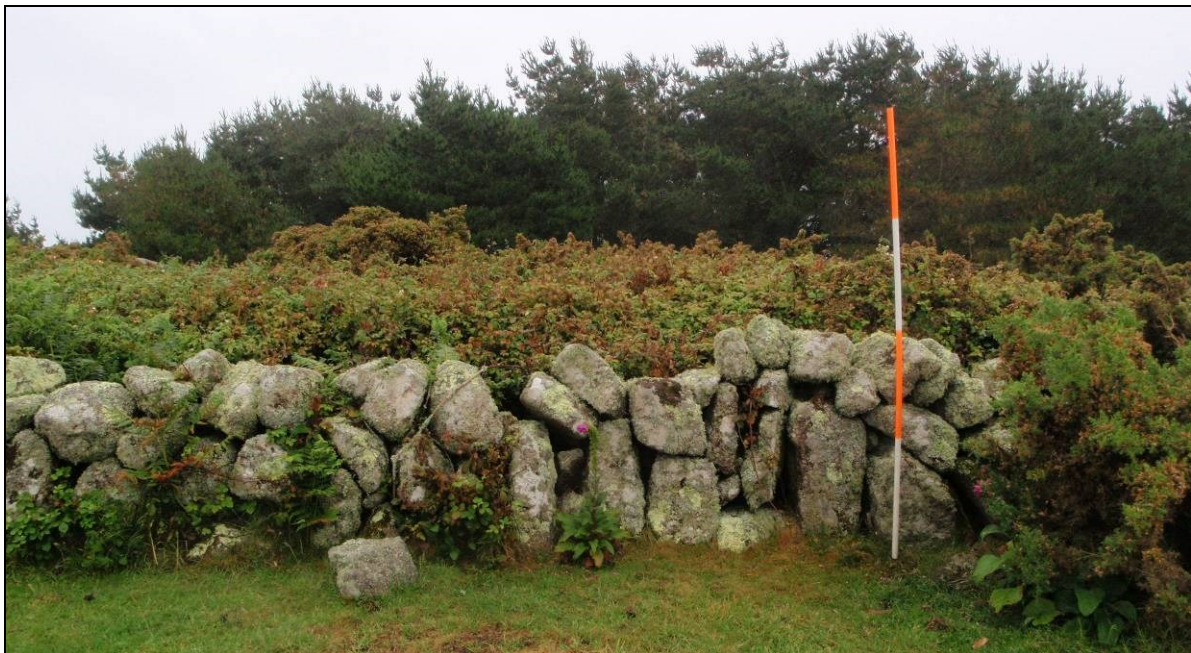
Some of the dry stone walls recorded evidently replace earlier boundaries: 26/56/34, for example, above the coastal cliff at Carn Vean, and 47/51/53/54 probably replacing an earlier boundary slightly further east between the rough ground of Mount Todden Down and the enclosed land. The dry stone walls making up this eastern boundary are substantial and appear to incorporate some earth-set orthostats (Fig 31)

Fig 31 St Mary's 3 boundary 53: the dry-stone wall dividing the enclosed land from adjacent rough ground incorporates some earth-set orthostats. (Photograph: Historic Environment, Cornwall Council.)

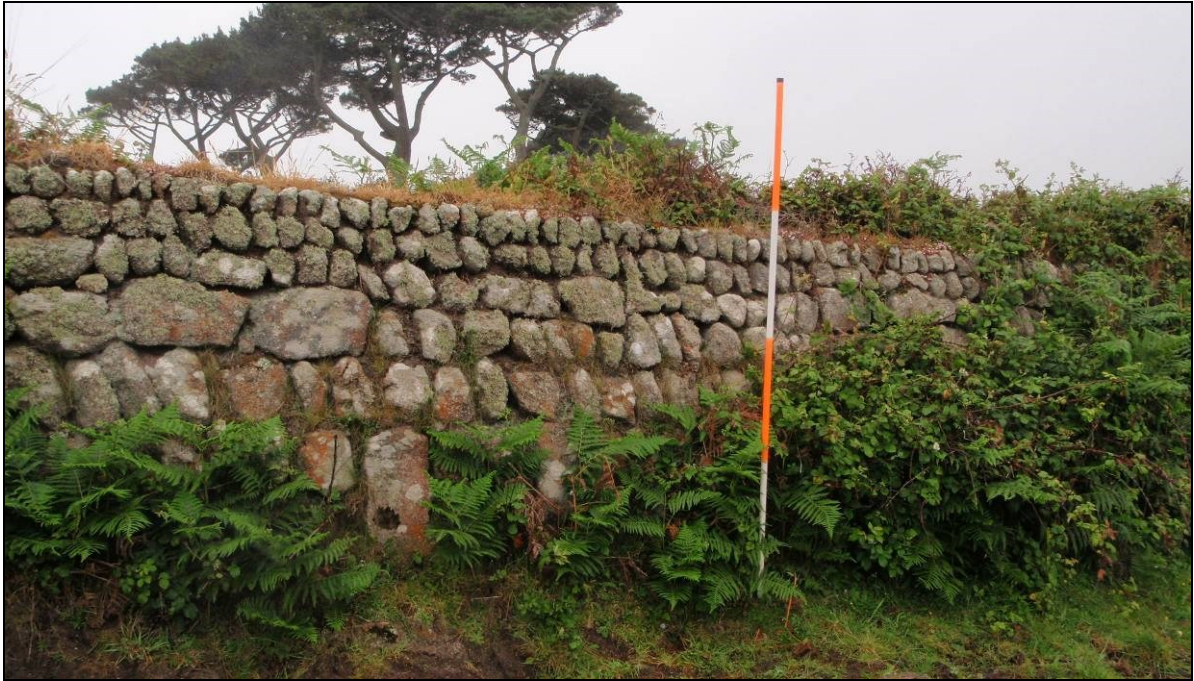
Fig 32 Mount Todden Farm (St Mary's 3), boundary 8. This is one of the stone-faced earth walls attributed to the work of Charlie Guy in the inter-war period (Arthur Swift, pers comm). (Photograph: Historic Environment, Cornwall Council.)

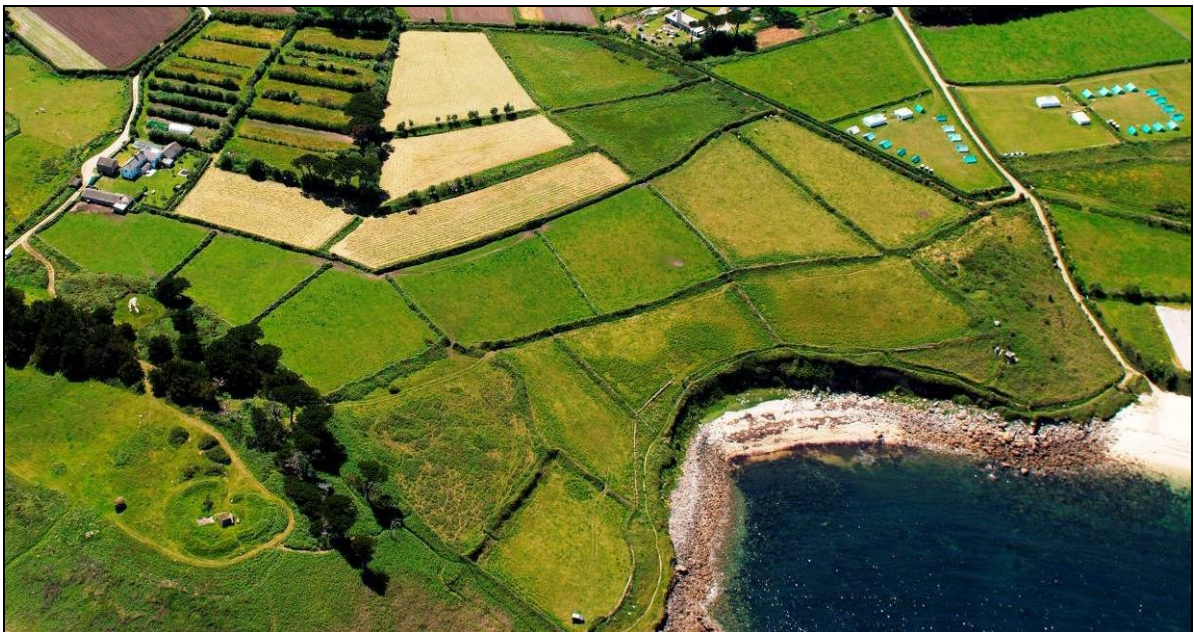
Fig 33 Mount Todden Farm, St Mary's. Contour-following lynchets are a key element of the historic enclosure pattern here, with a significant proportion of boundaries in the form of stone-faced lynchet revetments. Some boundaries on the farm are known to have been straightened in the period between the two World Wars and the historic boundary to the shore of Gilbert's Porth is threatened by coastal erosion and is in the process of being rebuilt on the landward side of the coast path (A Swift, pers comm). A Scheduled field system defined by cross-slope lynchets and stony banks lies within the overgrown field to the right of the end of the shelter belt in the left foreground. (Photograph: Historic Environment, Cornwall Council, 2009; F92-417.)

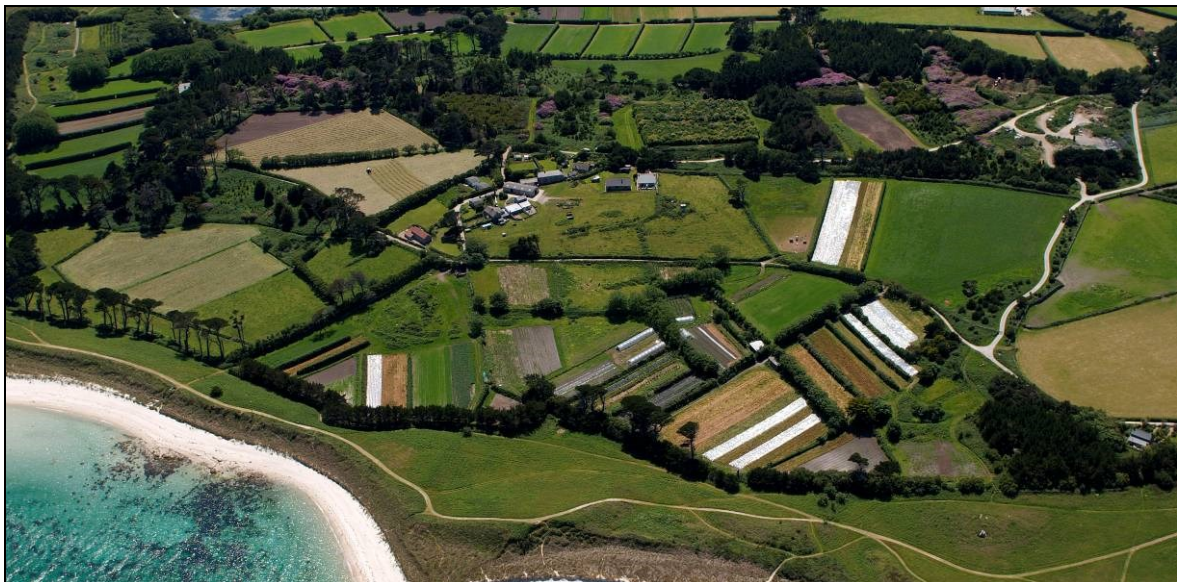
Fig 36 Tresco study area 2, Borough Farm. Anciently Enclosed Land survives with relatively minor modification in the area below the farm complex. (Photograph: Historic Environment, Cornwall Council, 2009; F92-150.)

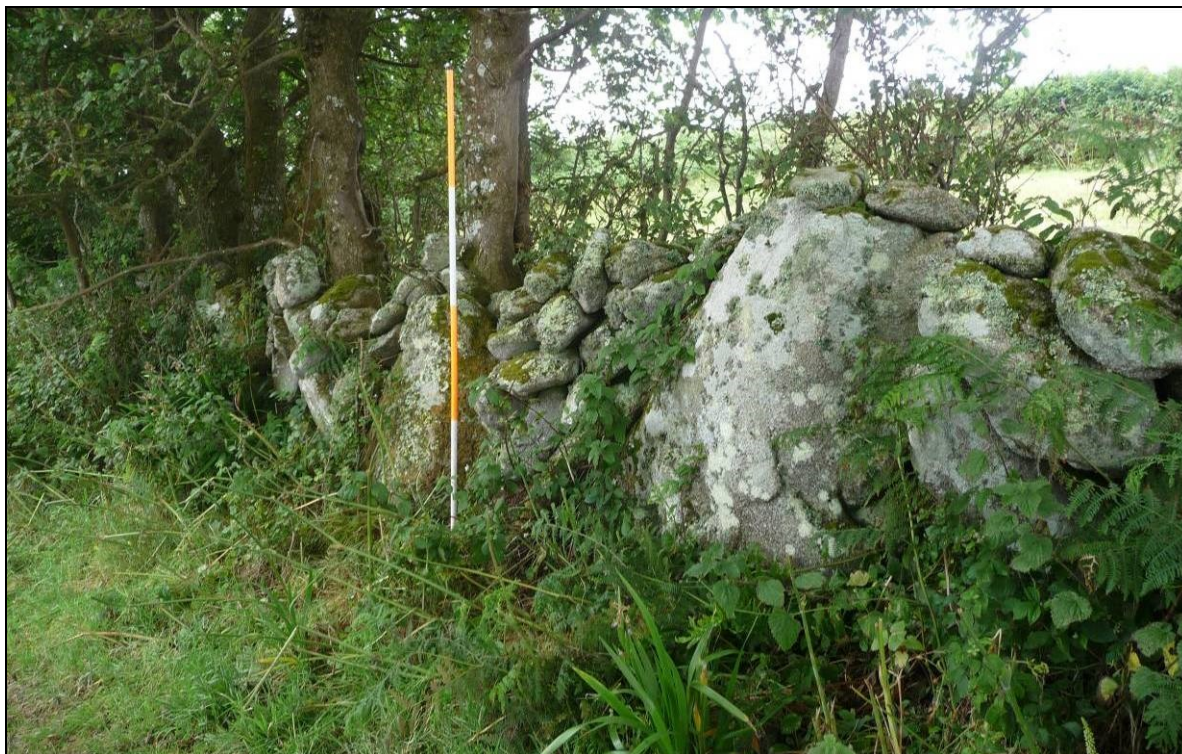
Some relatively slight lynchets between fields have stone revetments, most spectacularly boundary 5, where a boulder wall of large grounders is the base for a loosely piled dry stone wall, but also boundaries 2 and 10. Small elm trees, probably the remains of grown-out hedging, and sycamores appear on some of these.

*Fig 37 The substantial boulder wall of Tresco 2 boundary 5, accompanied by grown-out elm hedging. (Photograph: Historic Environment, Cornwall Council.)*
