# Field Boundaries on the Isles of Scilly Historic Environment Study to Inform Management for Conservation

### **Historic Environment Study to Inform Management for Conservation**

<b>Client</b>	<b>The Isles of Scilly AONB Unit</b>
<b>Report Number</b>	<b>2011R095</b>
<b>Date</b>	<b>25 October 2011</b>
<b>Status</b>	<b>Final</b>
<b>Report author(s)</b>	<b>Graeme Kirkham, Francis Shepherd, Charles Johns</b>
<b>Checked by</b>	<b>Charles Johns</b>
<b>Approved by</b>	<b>Andrew Young</b>

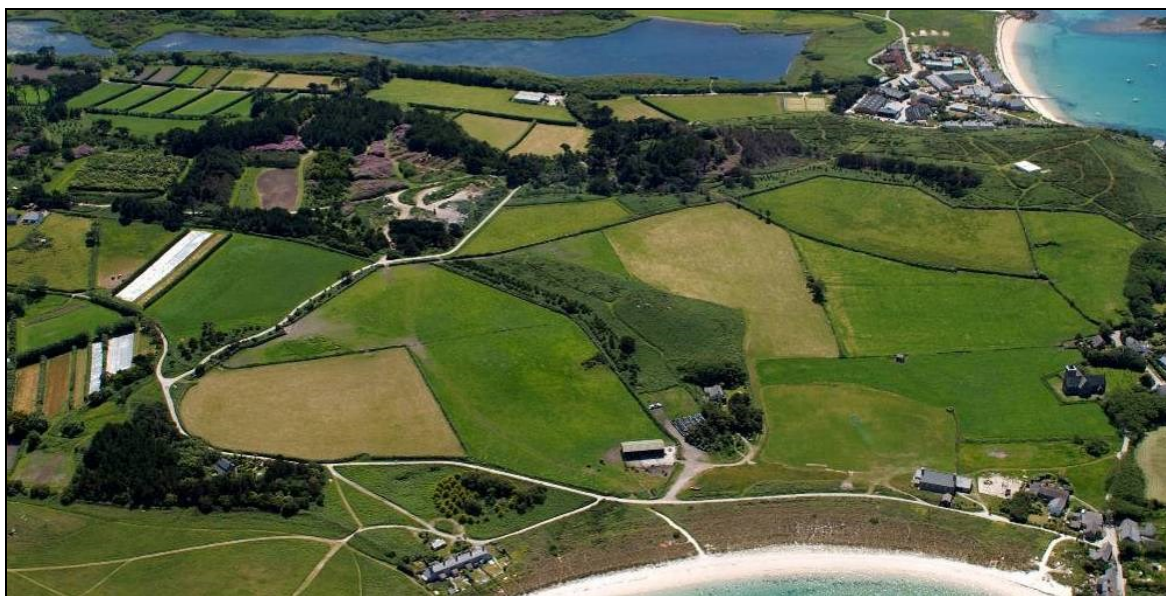
*Fig 38 Tresco study area 3, Dolphin Town, is to the right-hand side of the photograph. (Photograph: Historic Environment, Cornwall Council, 2009; F92-147.)*

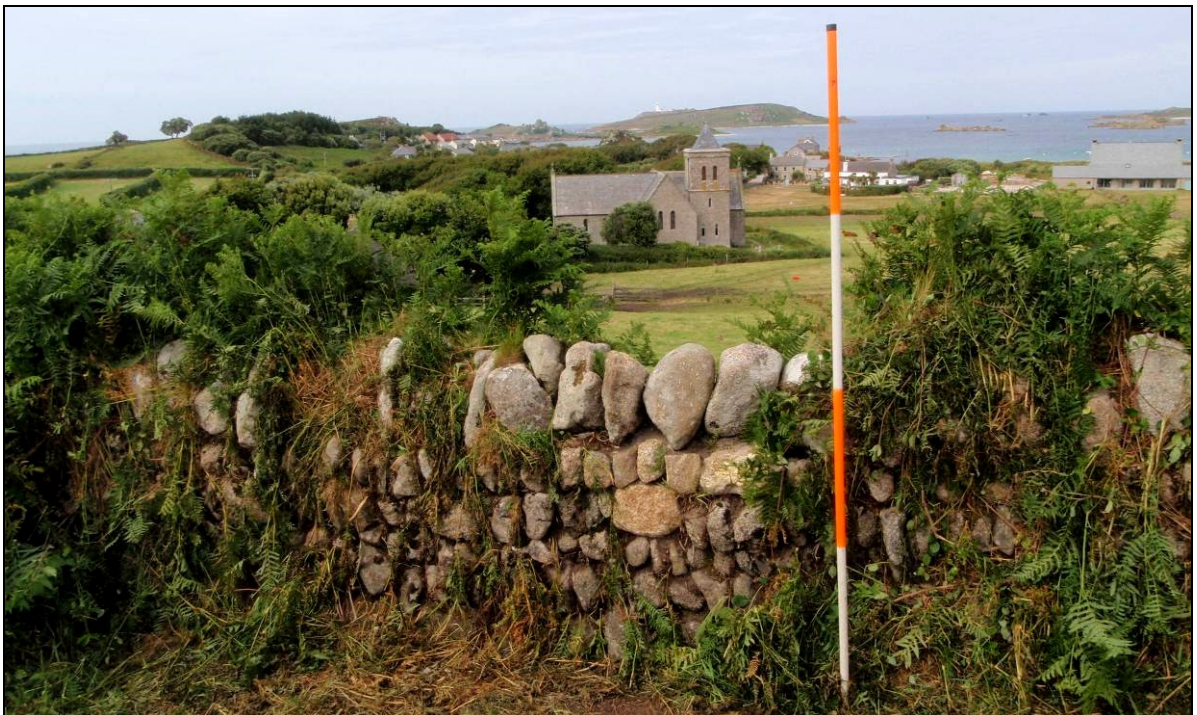
*Fig 40 Tresco 3 boundary 13 has clearly slumped a little and undergone some minor repair or patching since it was built in the mid nineteenth century (cf Fig 39), making the original regular coursed form of its facing stonework less obvious. (Photograph: Historic Environment, Cornwall Council.)*

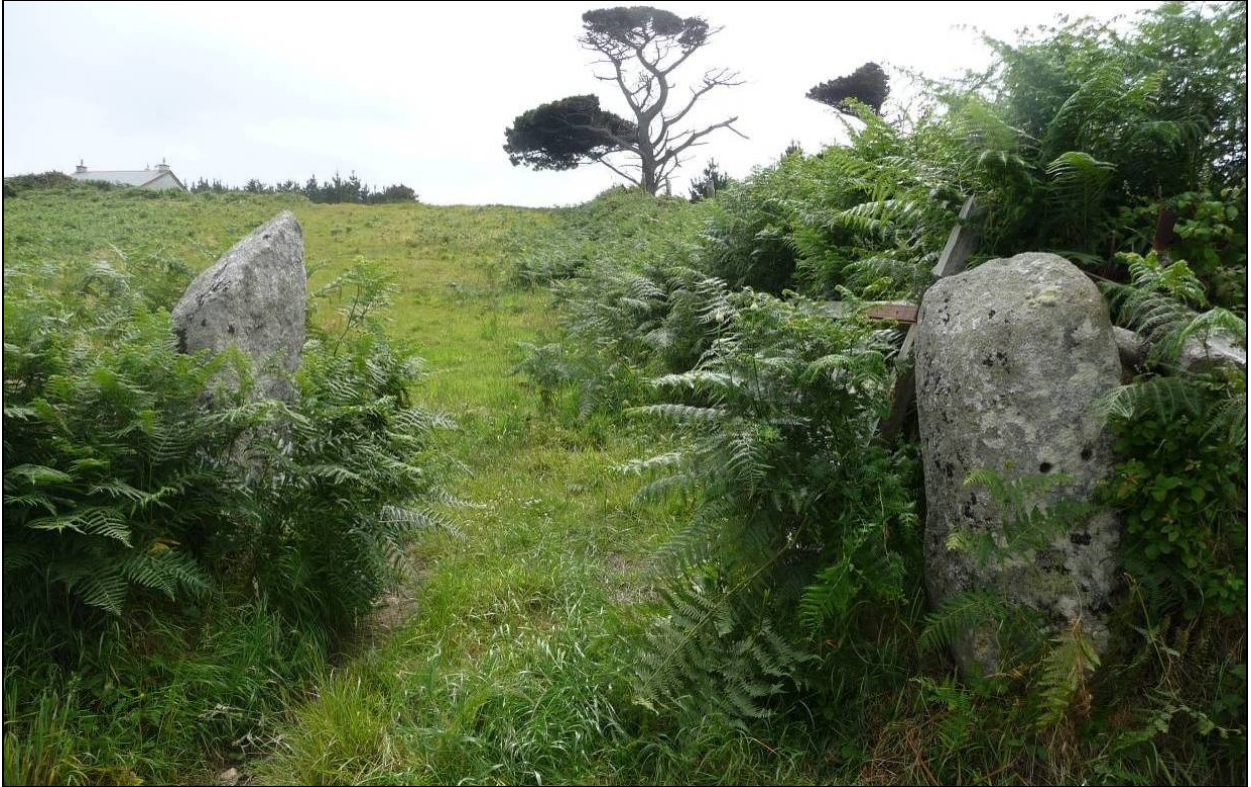
*Fig 41 Granite orthostats used as gateposts on Borough Farm, Tresco. (Photograph: Historic Environment, Cornwall Council.)*

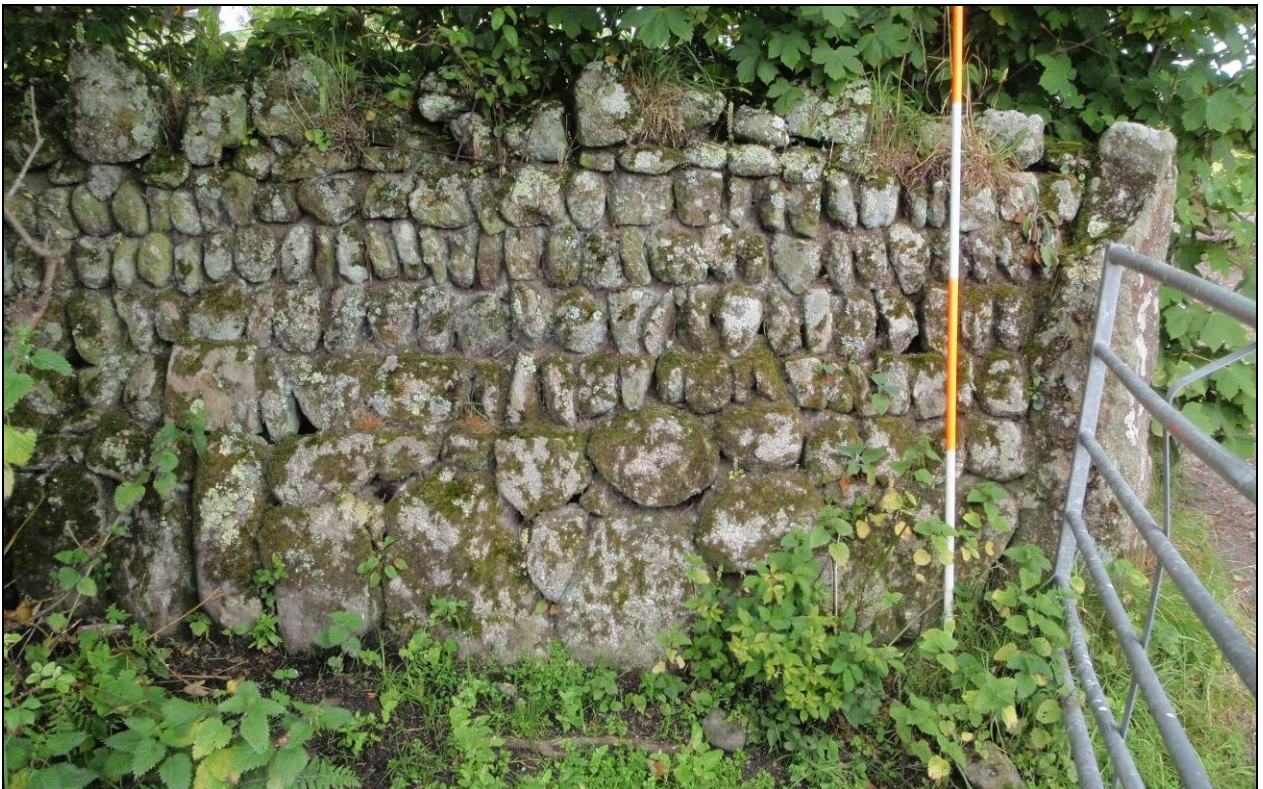
*Fig 42 A granite orthostat used as a gatepost and the terminal for a stone-faced earth wall at Borough Farm, Tresco. (Photograph: Historic Environment, Cornwall Council.)*

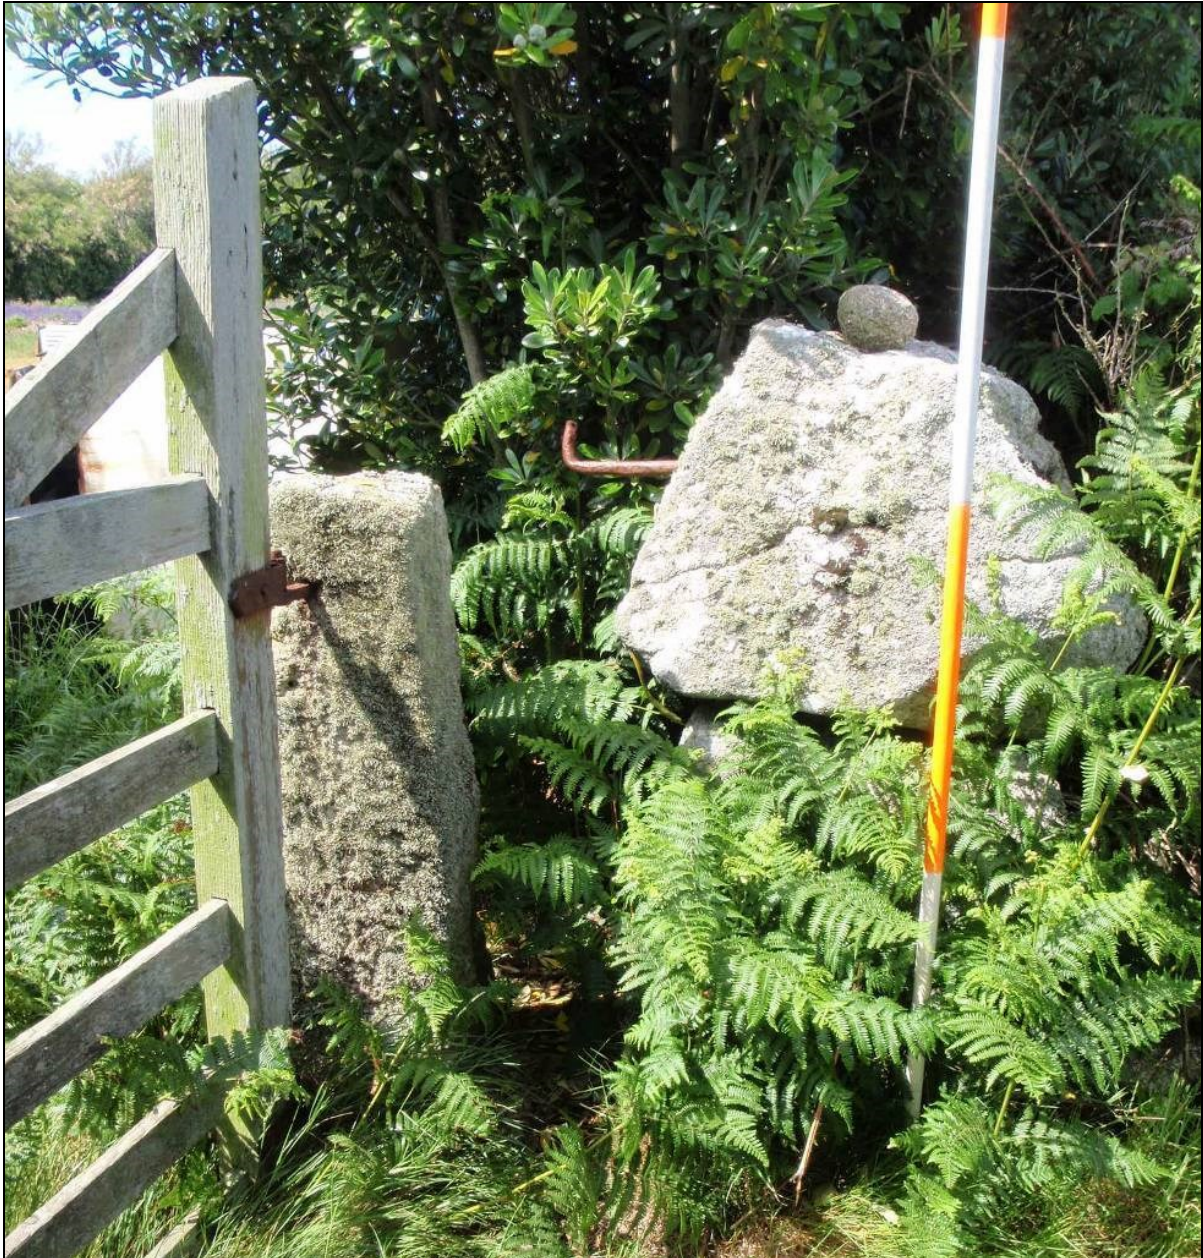
A number of granite gateposts were noted, mostly natural orthostats but in a few cases squared and dressed. Adjacent to Barnaby Lane a substantial granite boulder is perched on the end of a stone boundary to accommodate a gate hanging (Fig 43).

*Fig 43 Two phases of stone gate supports in a boundary adjoining Barnaby Lane, St Agnes. To the left a squared and roughly dressed gatepost, with an earlier provision for gate-hanging in the form of a large boulder with an iron gate support set in it perched on the end of a stone boundary. (Photograph: Historic Environment, Cornwall Council.)*

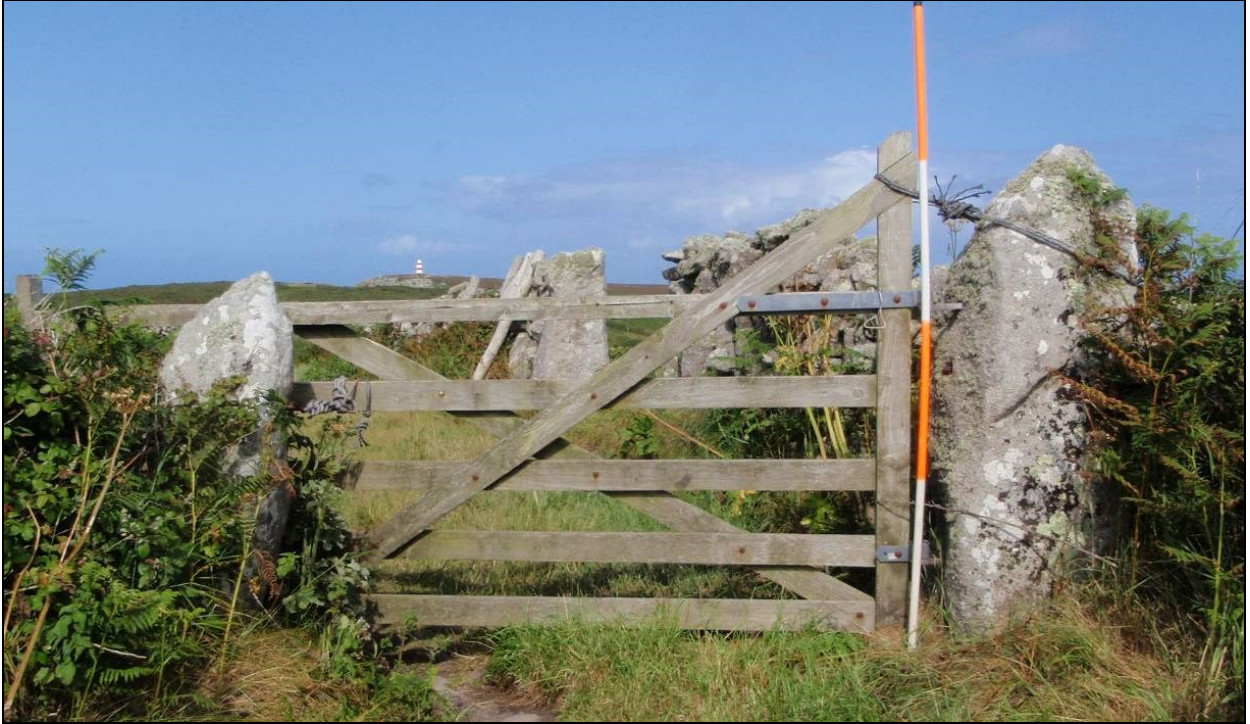
*Fig 44 Large, undressed granite orthostats used as gateposts in the St Martin's 2a survey area. In this instance a standard-width wooden gate has been hung, somewhat incongruously, to close the narrow historic gateway. (Photograph: Historic Environment, Cornwall Council.)*

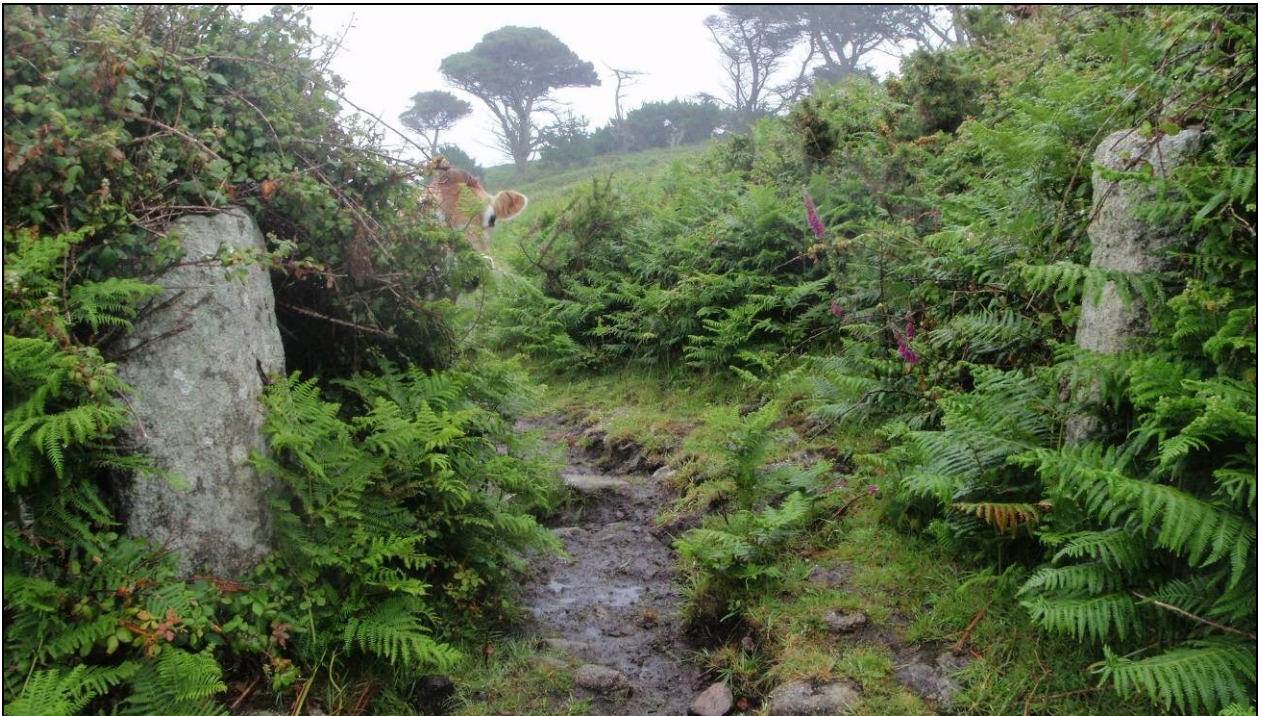
*Fig 45 Granite orthostats flanking a gateway on Mount Todden Farm, St Mary's (survey area St Mary's 3). (Photograph: Historic Environment, Cornwall Council.)*

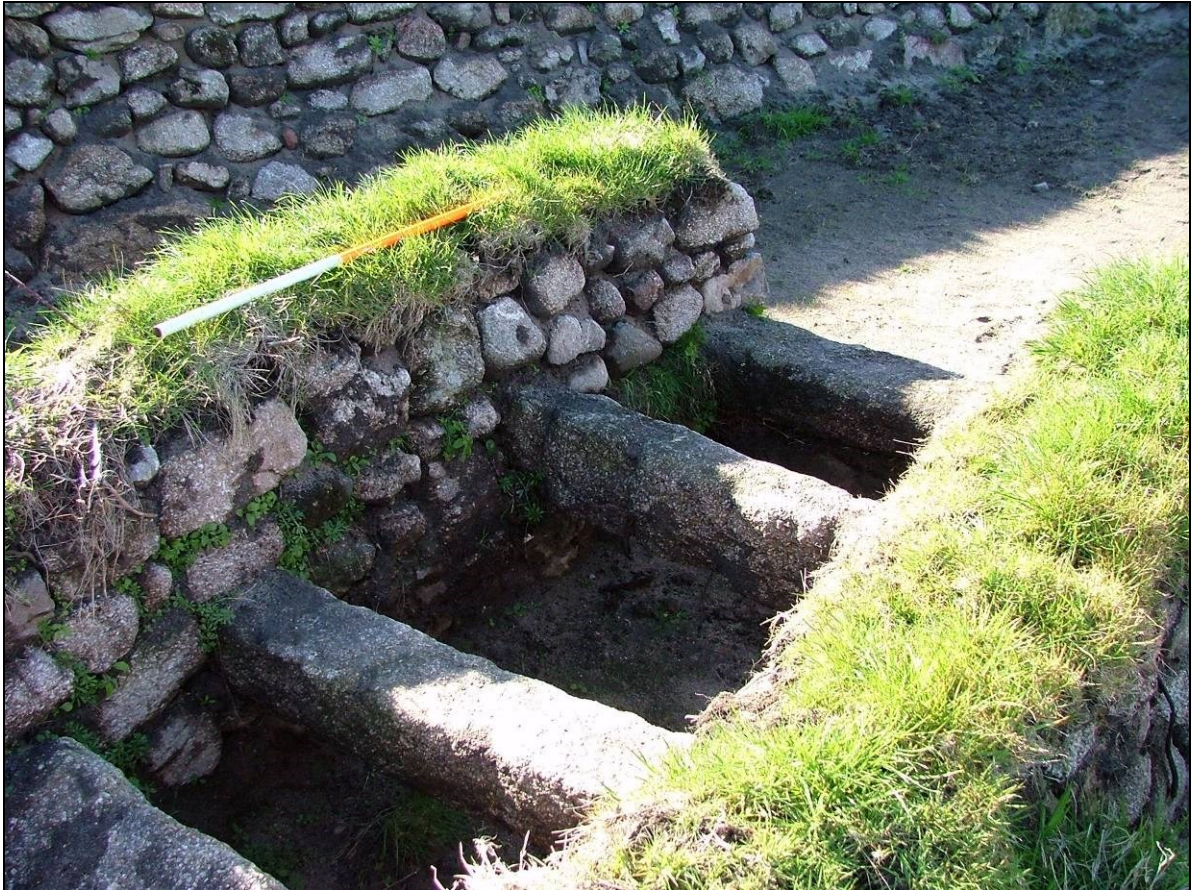
*Fig 46 Tresco survey area 3: the restored cattle grid in boundary 31 with modern boundary 32 behind; photographed after reconstruction in 2003. (Photograph: Historic Environment, Cornwall Council.)*

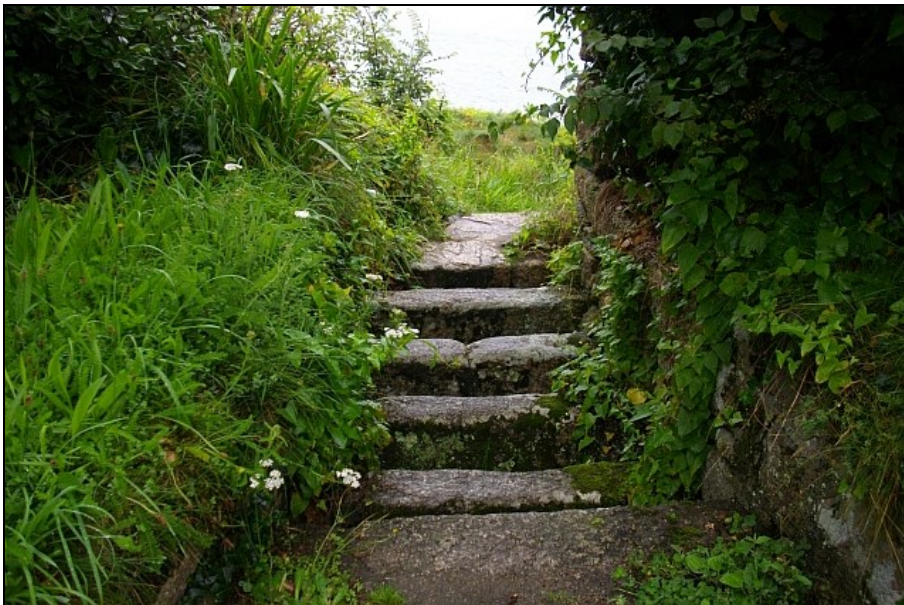
*Fig 47 A stile of cattle grid form at Old Town church, St Mary's. The church was restored by Augustus Smith in the 1830s and the cattle grid may date from this period. (Image © copyright Bob Embleton. This work is licensed under the Creative Commons Attribution-Share Alike 2.0 Generic Licence.)*
