Treen fields, St. Levan, Cornwall

Archaeological assessment

Client	The National Trust
Report Number	2011R116
Date	5/12/2011
Status	Final
Report author	Adam Sharpe BA MifA
Checked by	Andrew Young, HE Projects Manager, Jim Parry: NR Regional Archaeologist
Approved by	Andrew Young, HE Projects Manager

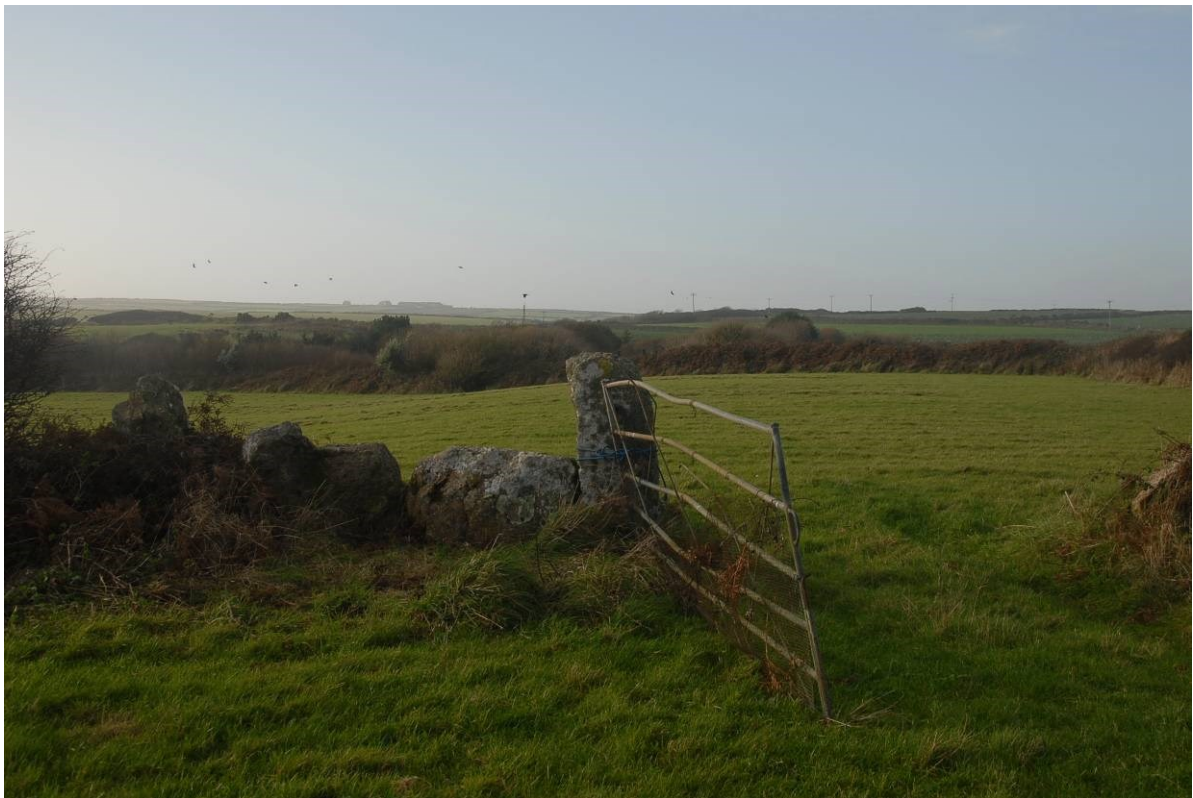
Cover illustration

Looking westwards through a field gate across one of the substantial ploughed out lynchets at Treen, evidence for an underlying late prehistoric field system.

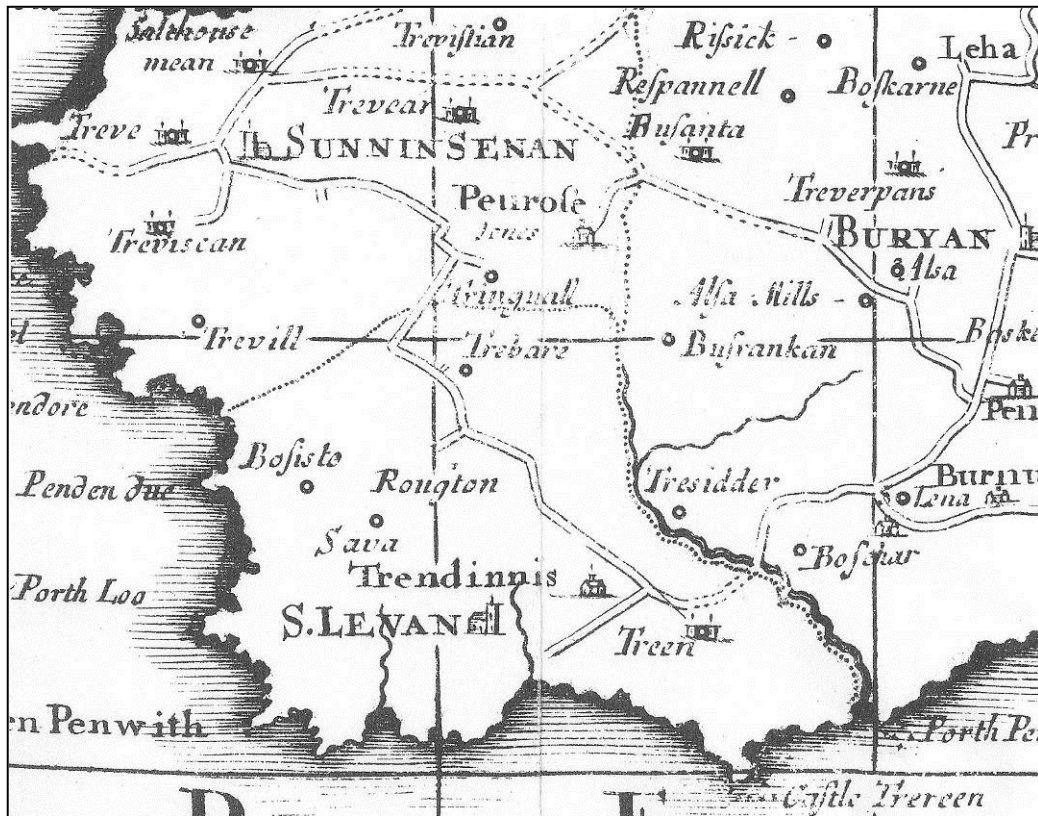
Fig 3. Treen and the surrounding area as shown on Gascoyne's 1699 map of Cornwall.

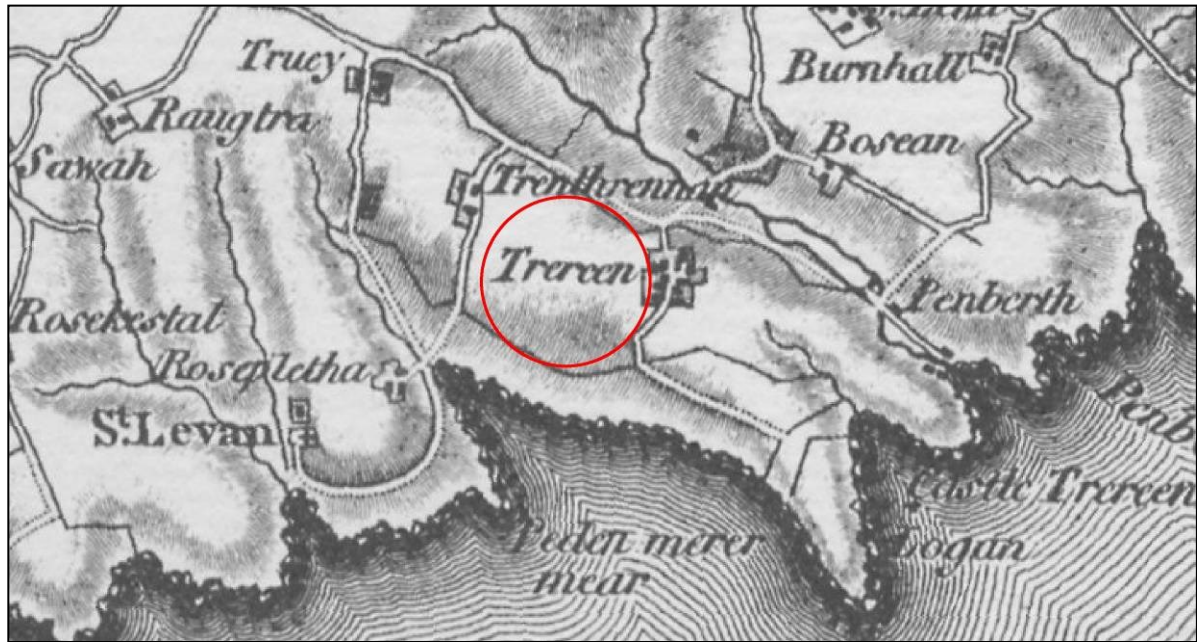
Fig 5. Treen and the surrounding area as shown on the circa 1809 1st Edition 1" to a mile mapping. The survey area is circled in red.

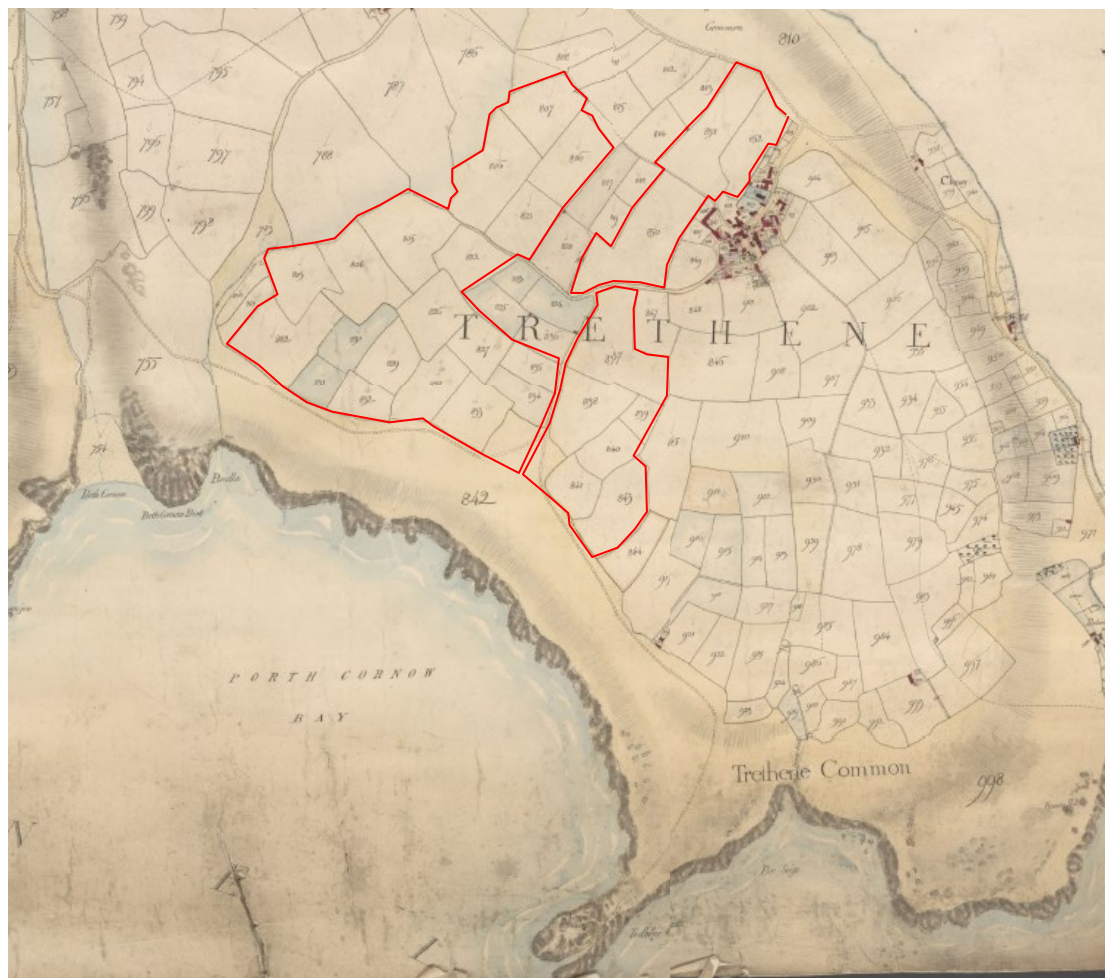
Fig 6. An extract from the circa 1840 St. Levan Tithe Map centred on Treen, here spelt 'Trethene'. The survey area is bounded in red.

See Fig 6.

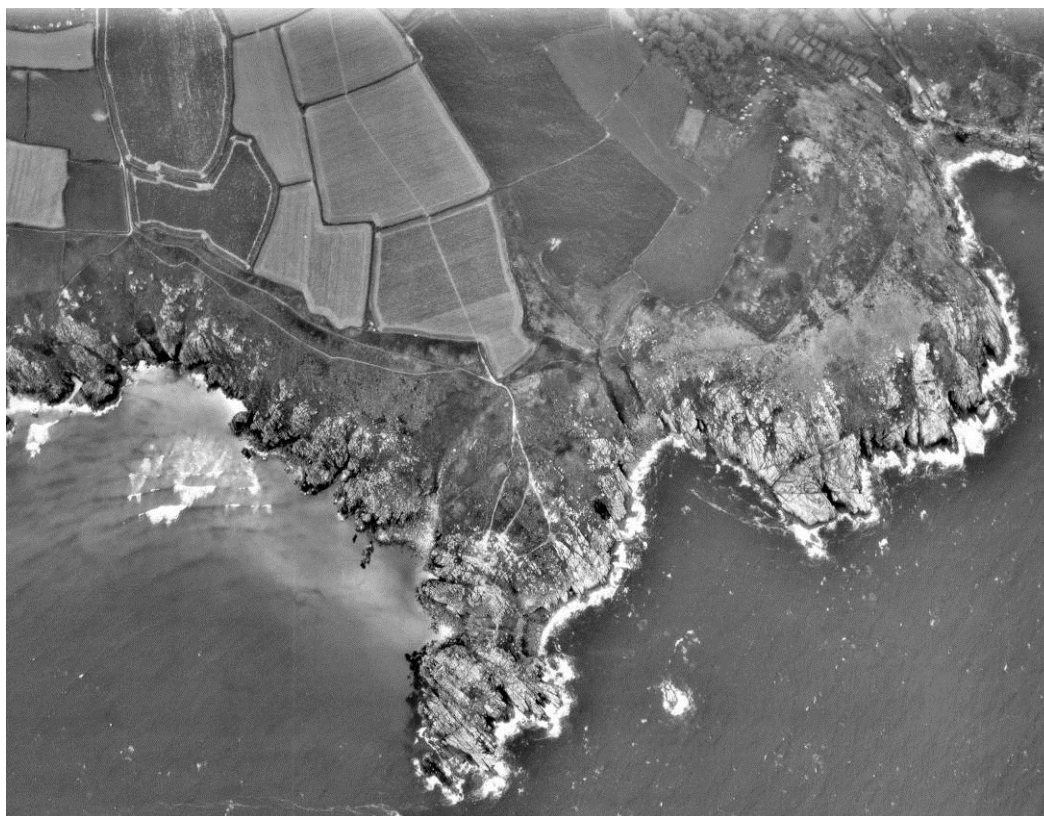
Fig 9. The south eastern part of the survey area at Treen as shown on a 1985 PMB aerial photograph.

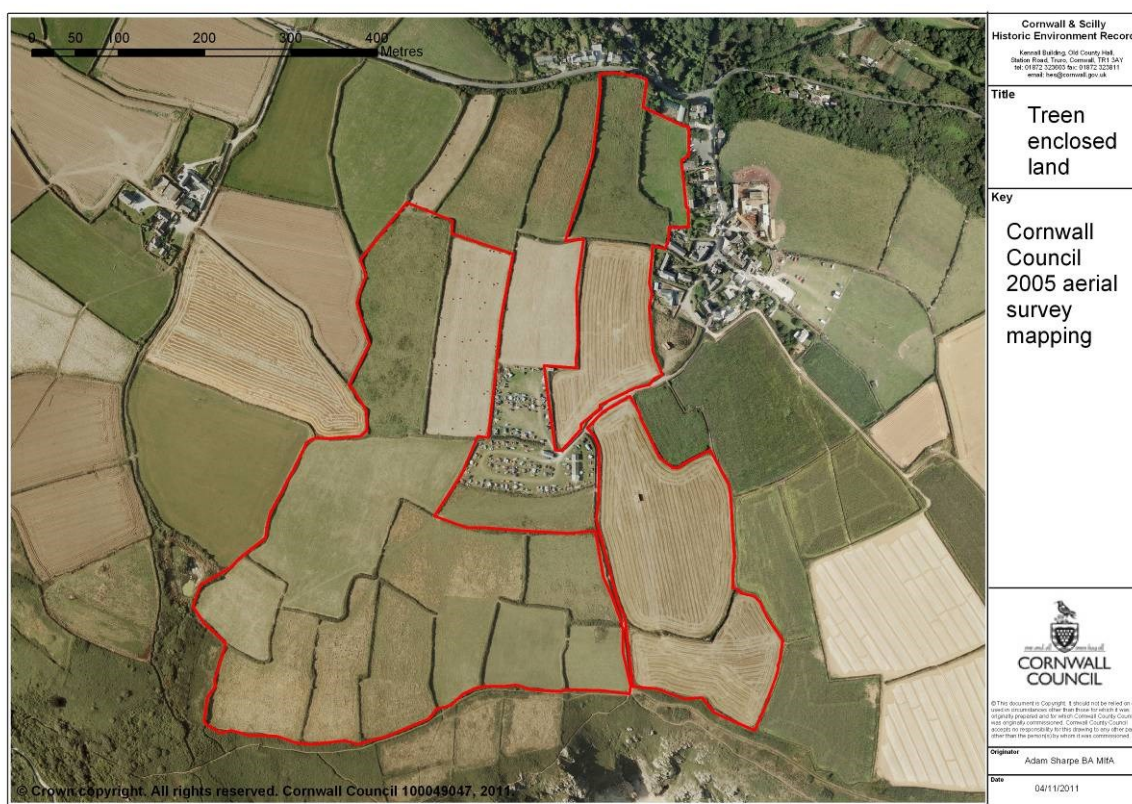
Fig 10. The survey area at Treen as shown on the 2005 Cornwall County Council aerial survey mapping.

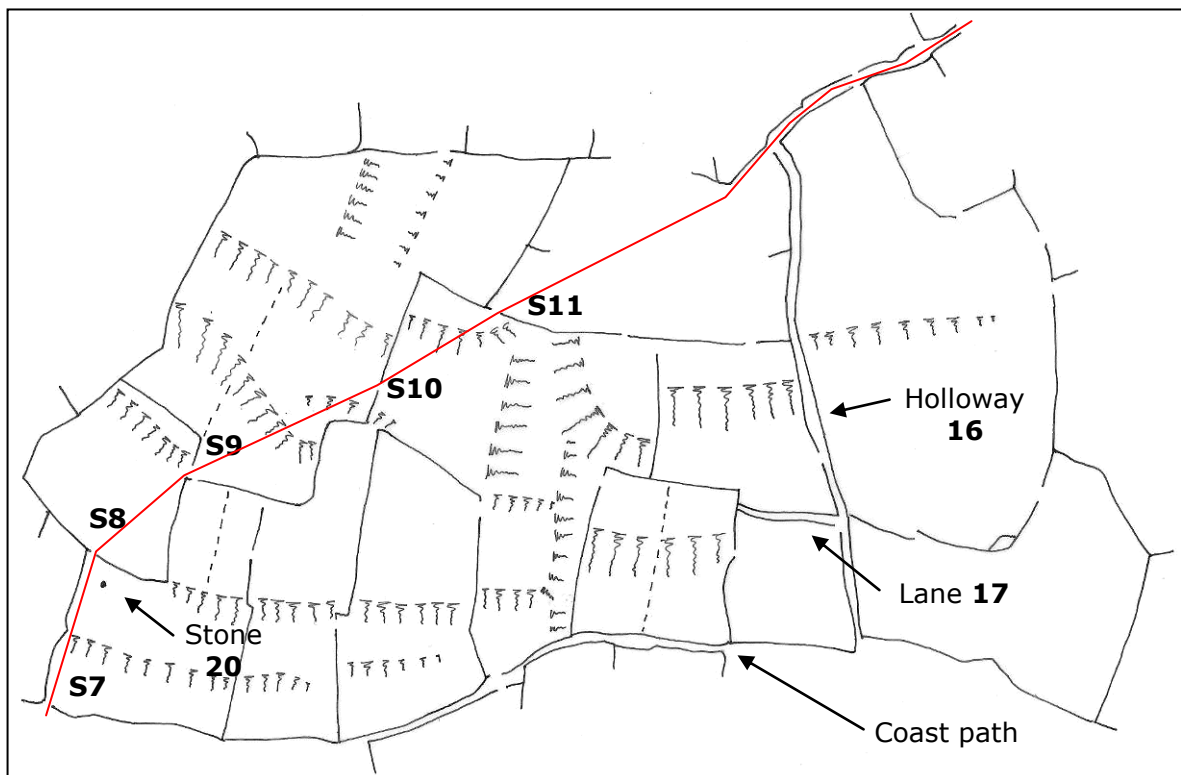
Field survey revealed a series of contouring, ploughed down lynchets on broadly parallel alignments in the southern area of fields at Treen. Some of the component lynchets appear to be approximately aligned with former boundaries documented on archive mapping (see Fig 16), though these may have perpetuated earlier boundary alignments as has been found in, for example, Zennor and Morvah parishes. Others, however, appear to be on alignments where no former boundary is documented. A further group take the form of revetted lynchets – one of the most prominent of these being the boundary between the southernmost fields and the cliffland at the western end of the enclosed land. Here, the boundaries have negligible height to the north, but the revetted faces, which incorporate basal boulders, can be up to 2.0m high.

Fig 20. Survey results in the southern section of Treen Fields. Whilst some of the lynchets shown here (hachured) represent removed post-Medieval boundaries, others appear to be part of a late prehistoric contouring field system. Pecked lines represent banks. **s** = stile. Red line = footpath route from Treen to St. Levan.

Further ploughing within these fields will inevitably further degrade the archaeological evidence for this early field system, and should be avoided. Where ploughing is necessary (to create new grass leys, for example), this should be kept to the minimum possible depth. Where any fields are cultivated they should be field walked to collect and log the find spots of any artefacts which may be revealed in the ploughsoil.

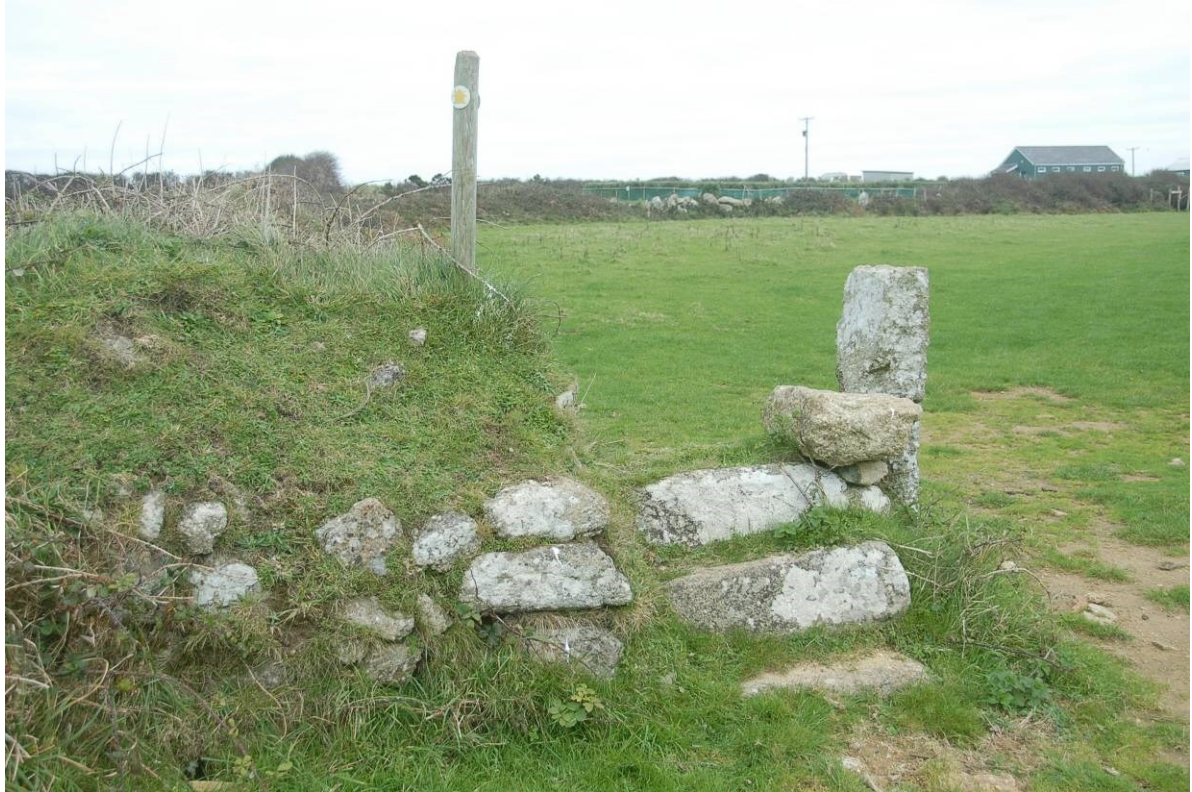
Fig 21. A step stile (11) on the footpath leading from St. Levan churchtown to Treen from the south. The construction of the hedge adjacent to the stile is typical of the southern Treen fields.

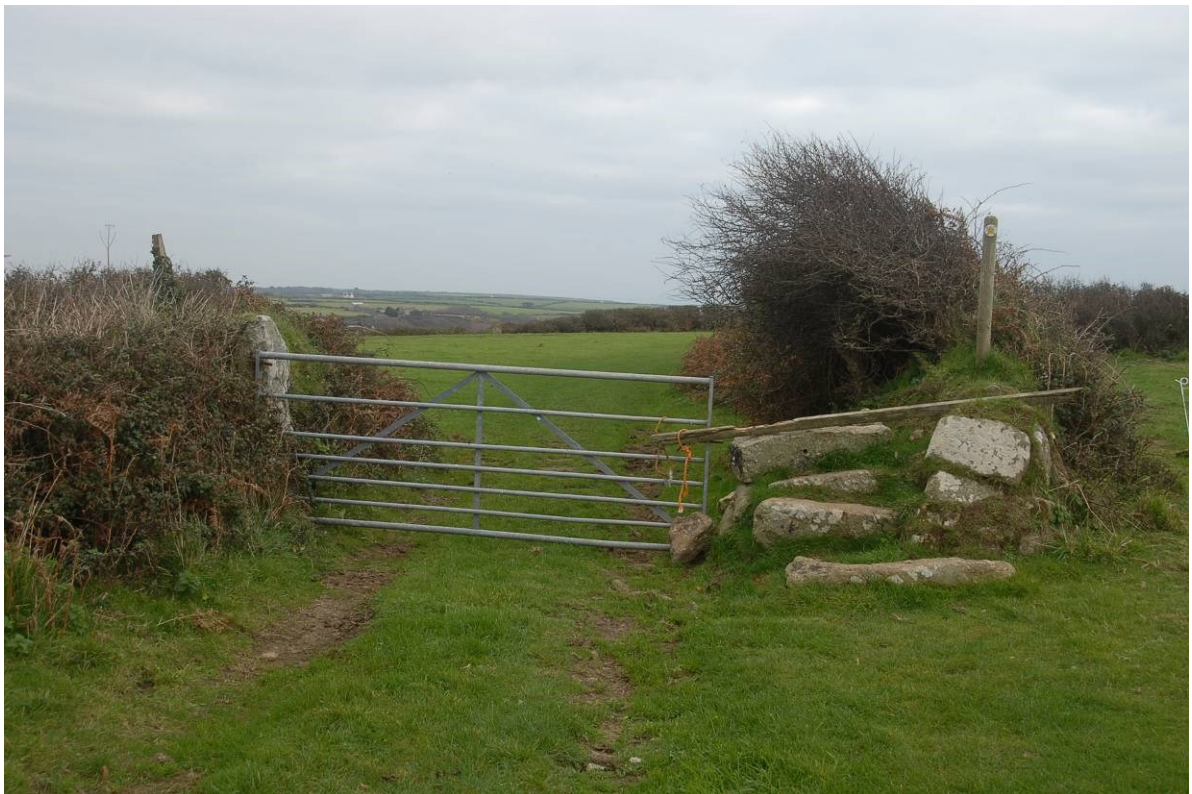
Fig 22. A rather derelict step stile (13) and adjacent gateway on the northern footpath leading from Treen towards Sennen churchtown viewed from the west.

13	Stile	Reset top stone if required	Low
14	Stile	Cut back encroaching hedge vegetation	Low
15	Stile	None	None
16	Sunken lane	None	None
17	Lane	Clear thorn and scrub to reveal this feature	Low
18	Cropmark enclosure	Minimise ploughing depth to avoid damage to surviving sub-surface archaeology Fieldwalk area of cropmark enclosure if ploughing takes place	Medium Low
19	Water tank	None	None
20	Standing stone	None	None

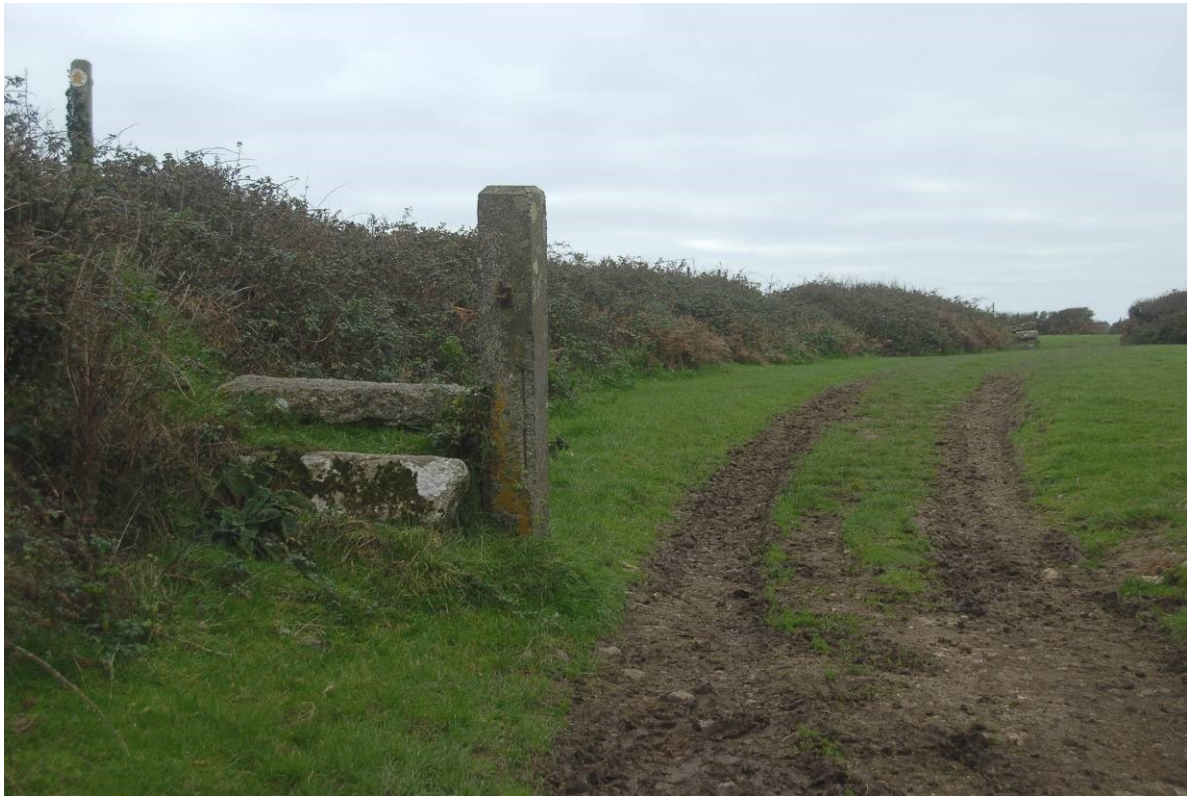
Fig 23. One of the step stiles (14) on the northern footpath leading west from Treen towards Sennen churchtown seen from the east. Hedge vegetation is encroaching onto this stile.

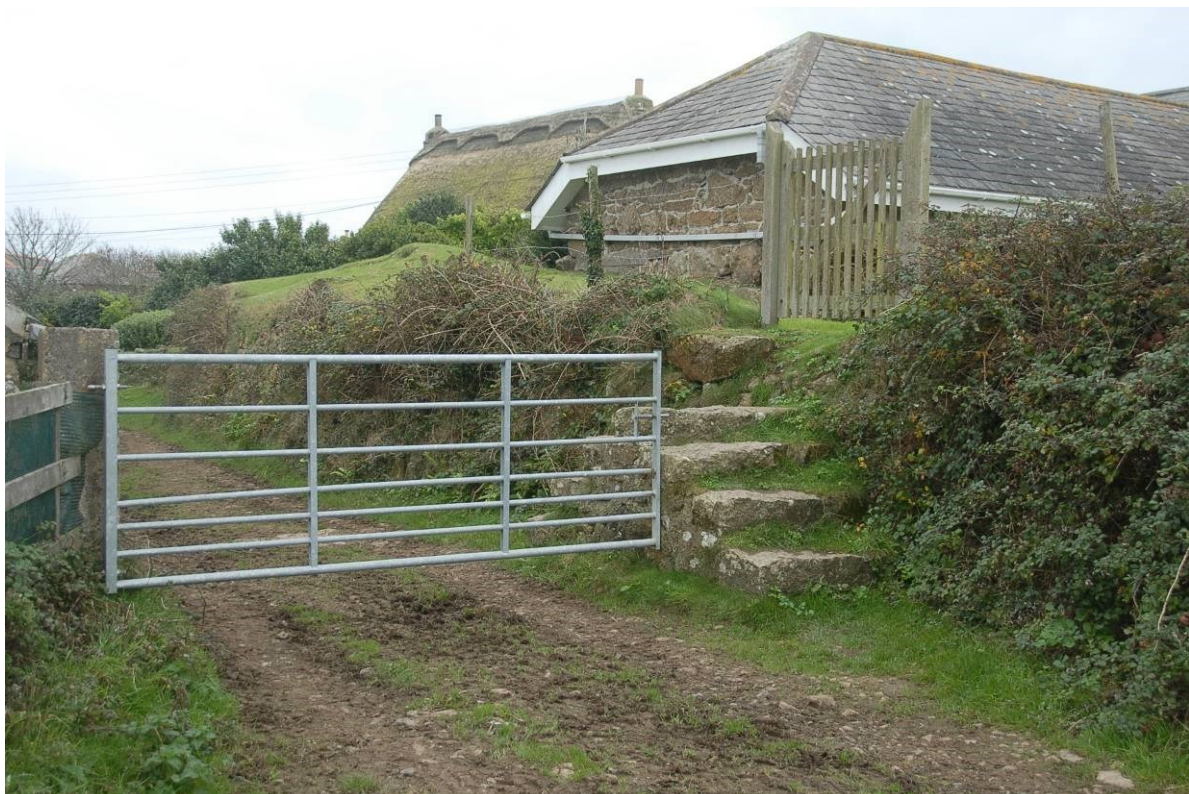
Fig 24. The stile (15) on the northern footpath to Treen, adjacent to a lane which would have led from the settlement out into the adjacent former medieval fields, seen from the west.

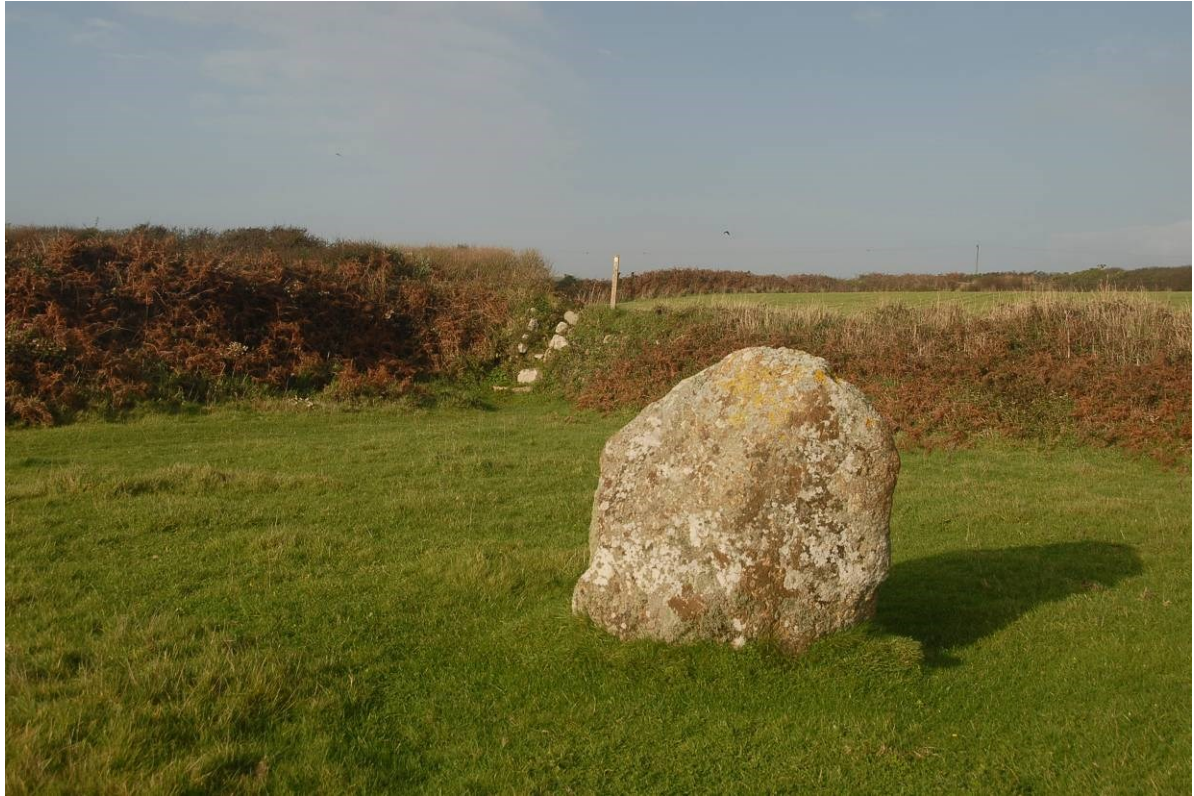
No above ground traces of the documented barrow (MCO3611, NT 93,677) were found. A substantial granite upright (NT 93,694) at SW 38840 22552 (Fig 25) is likely to be a cattle rubbing stone rather than a standing stone, and is more or less identical to another just outside the survey area to the north at SW 39160 23074.

Fig 25. The probable cattle rubbing stone (20) in the western part of the southern fields from the south. In the background (left) can be seen one of the stiles (8) on the path leading from Treen to St. Levan churchtown.

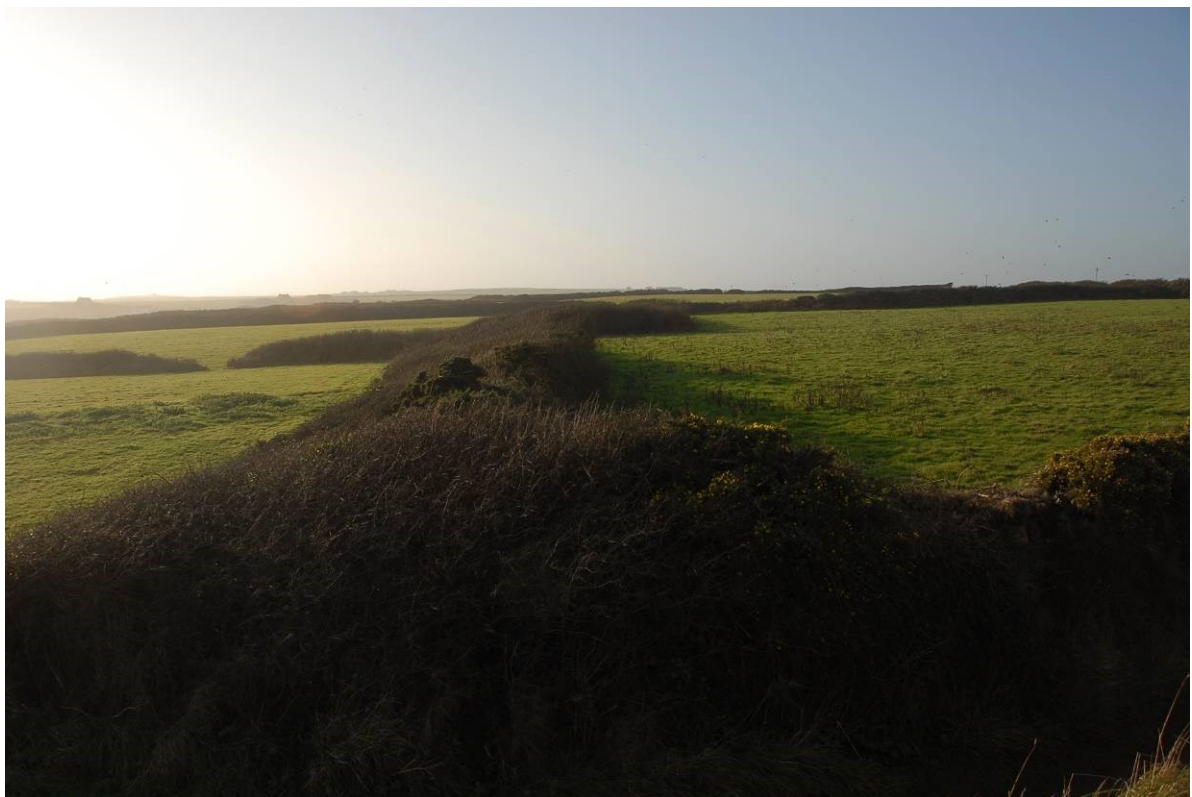
Fig 26. Looking from sunken lane (16) along the blackthorn-shrouded short section of lane (17) running to the west. Ploughed out barrow (3) is sited just right of centre in the field to the right.

It is recommended that any further ploughing in this field should be to minimal depth and that the area within which the barrow has been plotted is avoided when excavations take place for the currently proposed water supply to the cliffs.

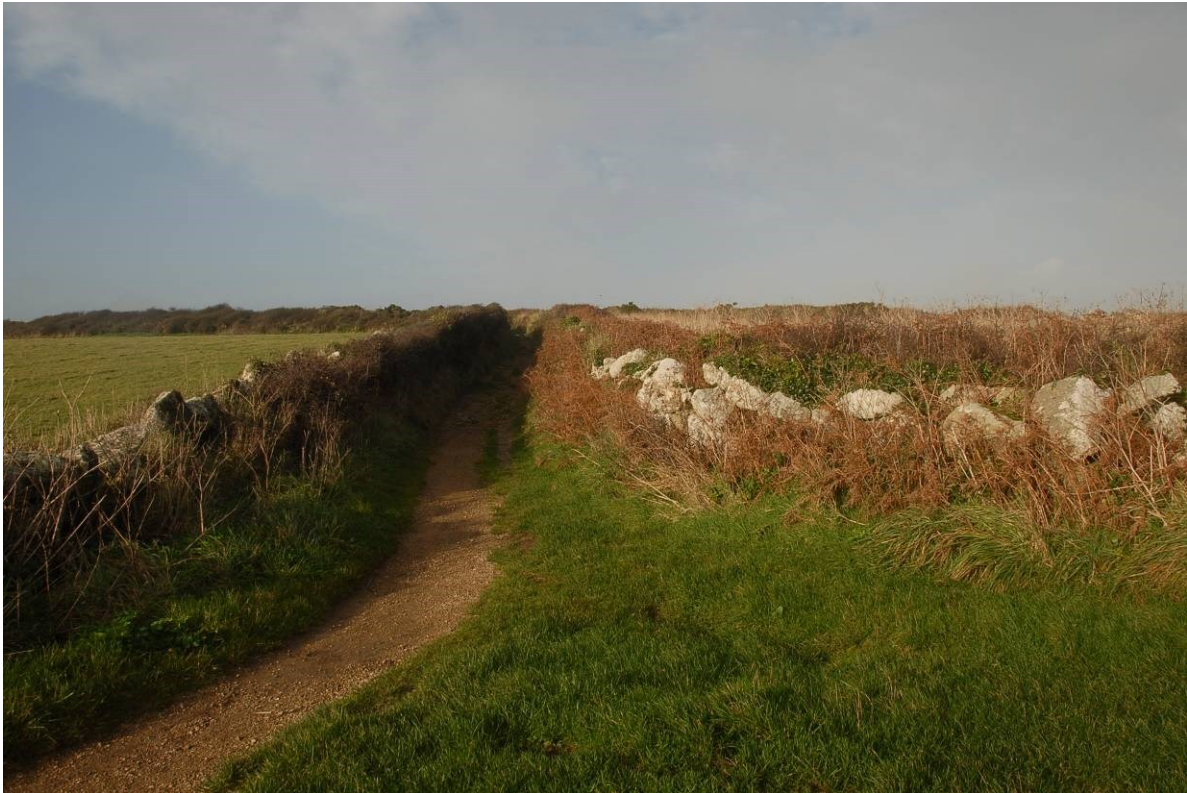
Fig 27. The southern end of sunken lane (16) looking north. The enclosures to either side were created between 1840 and 1878; unusually whilst the wall to the left is orthostatic, that to the right is essentially a piled boulder wall.

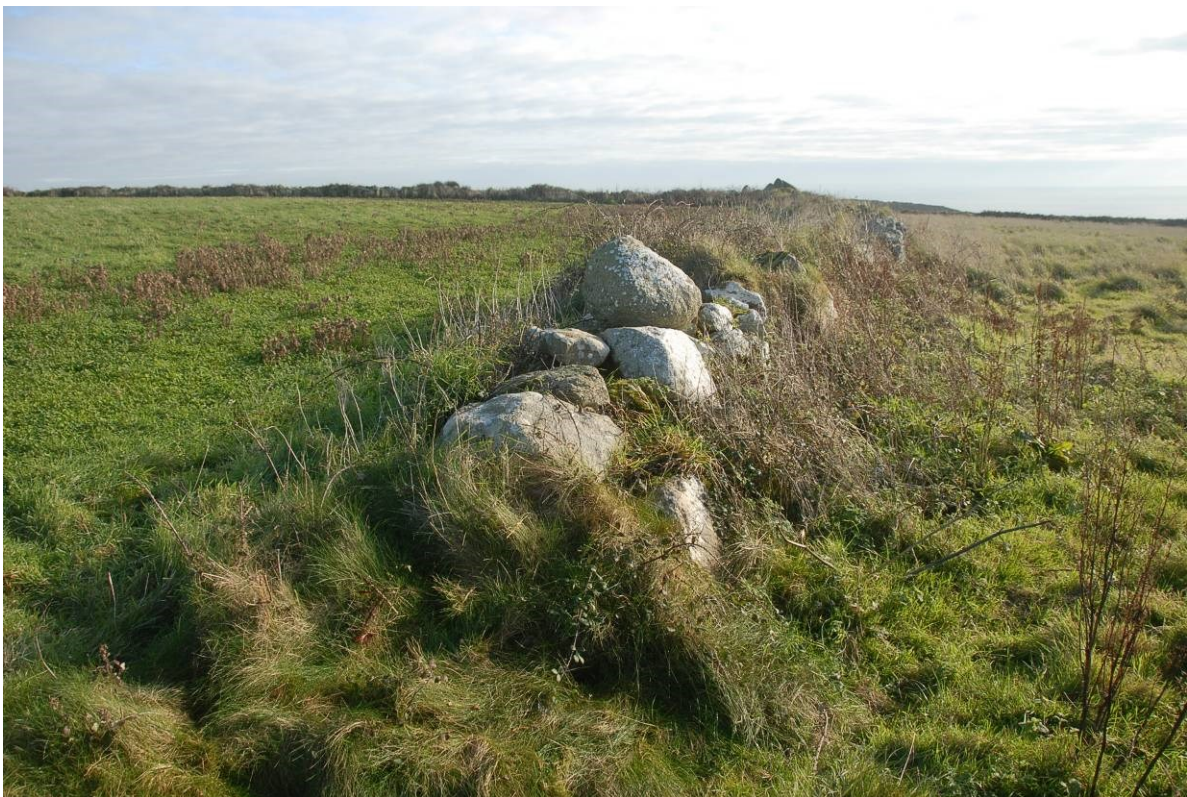
Fig 28. A typical low orthostat and boulder wall at Treen, this example defining the inland edge of the south-eastern field at Treen. View looking east.

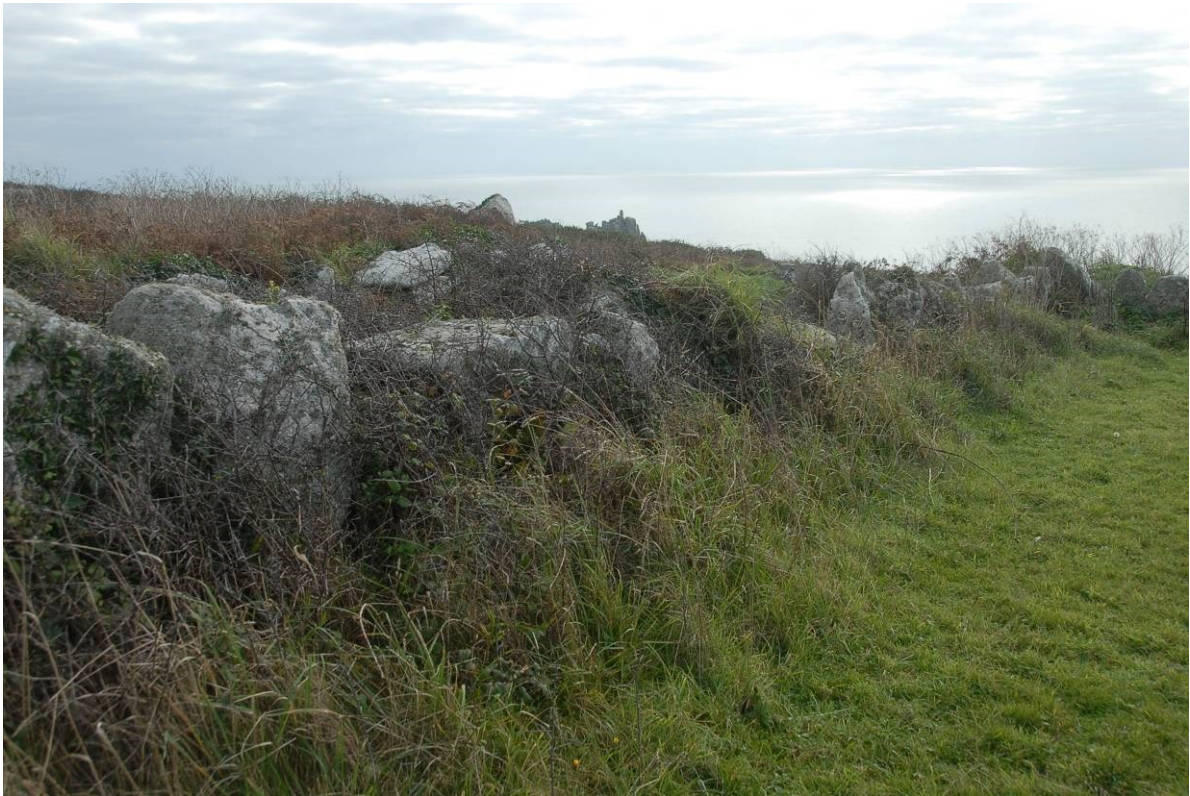
Fig 29. An orthostatic boulder wall bounding one of the enclosures adjacent to the cliffs. View looking south.

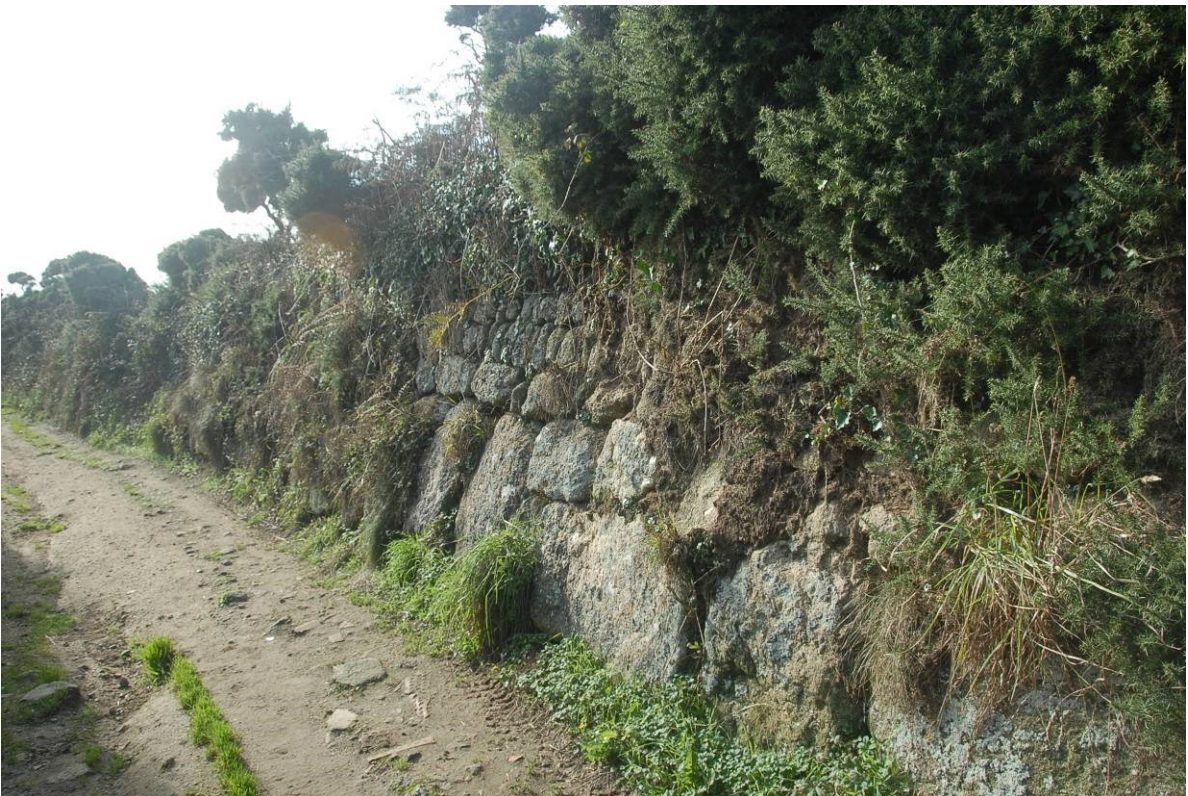
Fig 30. Hedging typical of that revetting sunken lane (16) running from Treen campsite towards the cliff. The surfaces of the fields on either side are at the level of the top of the hedge. View looking south.

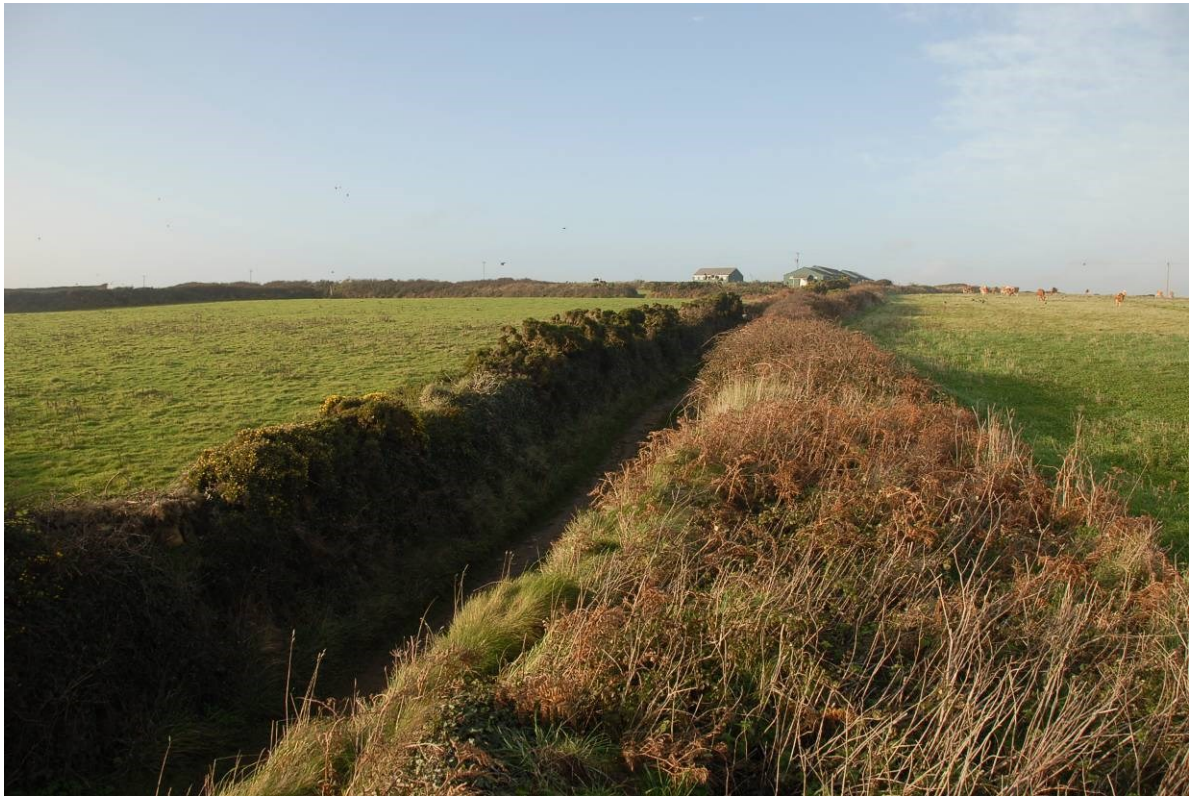
Fig 31. Looking north along the central section of sunken lane (16), showing how it has become cut down below the prevailing field level.

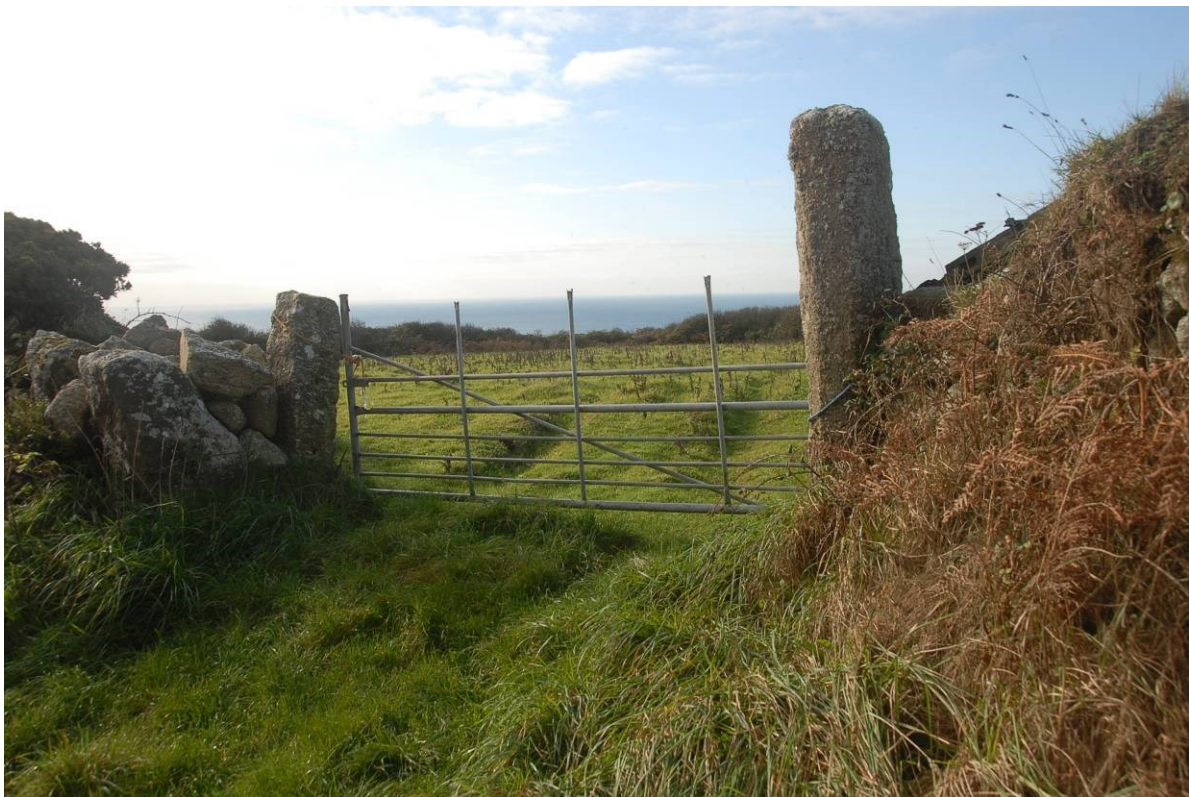
Fig 32. A typical gateway at Treen, with its tall hanging post and shorter closing post.

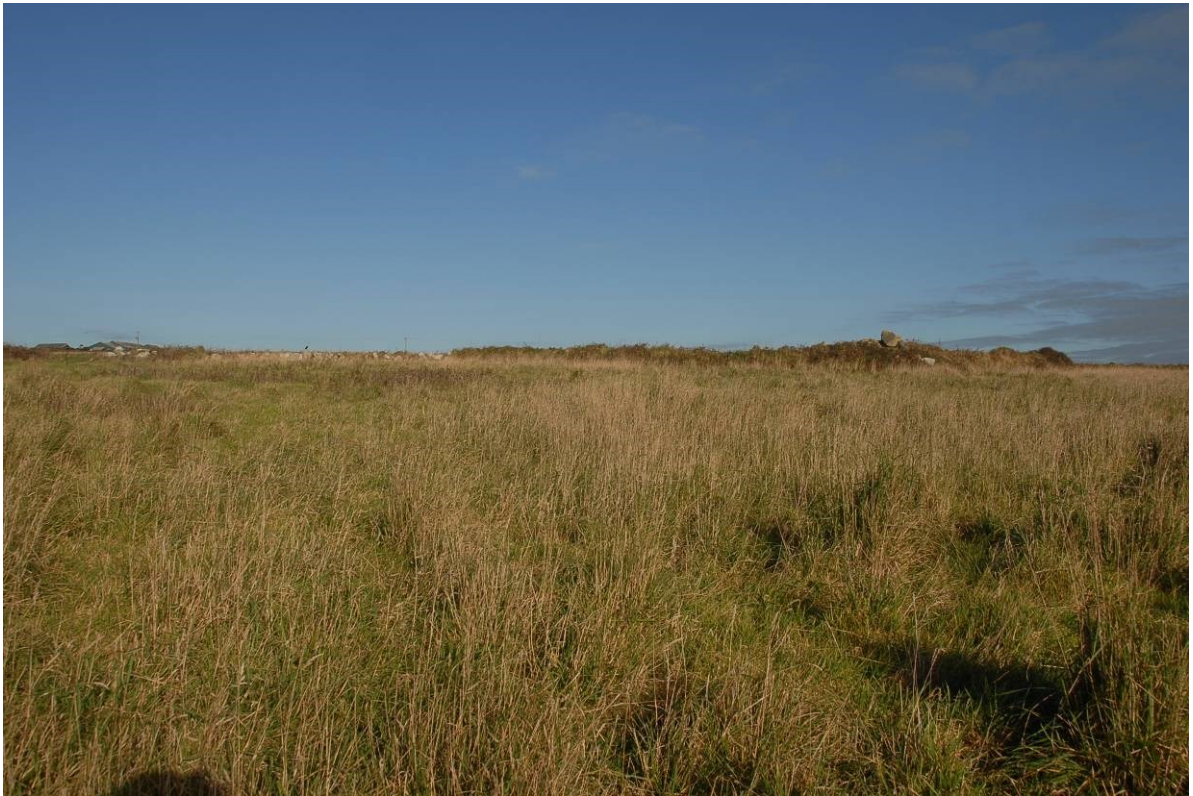
Fig 33. Looking inland across the south-eastern field at Treen, which is in notably rougher pasture than the other fields. The boulder dump on the hedge top (right centre) probably derives from the removal of a former boundary in this field.

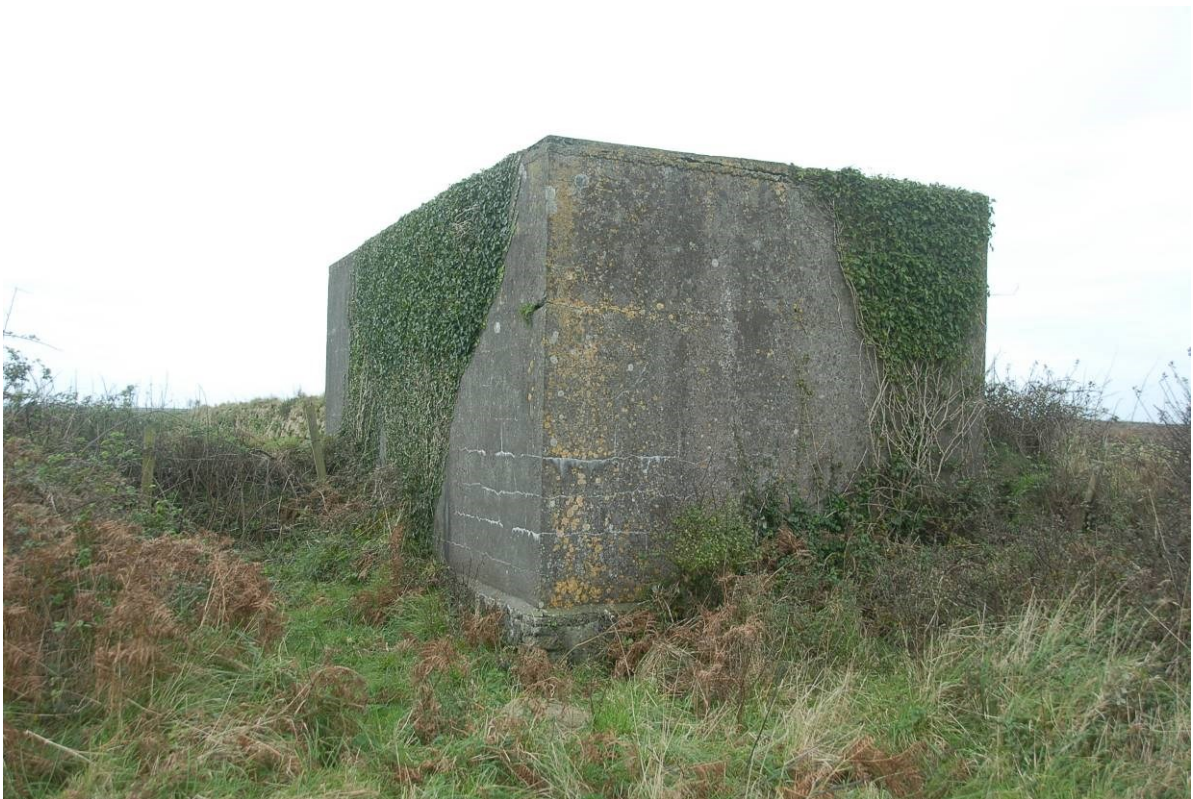
Fig 34. The concrete water tank just to the north of Treen camp site.

It is unknown whether the water tank is still in use. It appears to be in reasonably good condition and does not require any management attention.

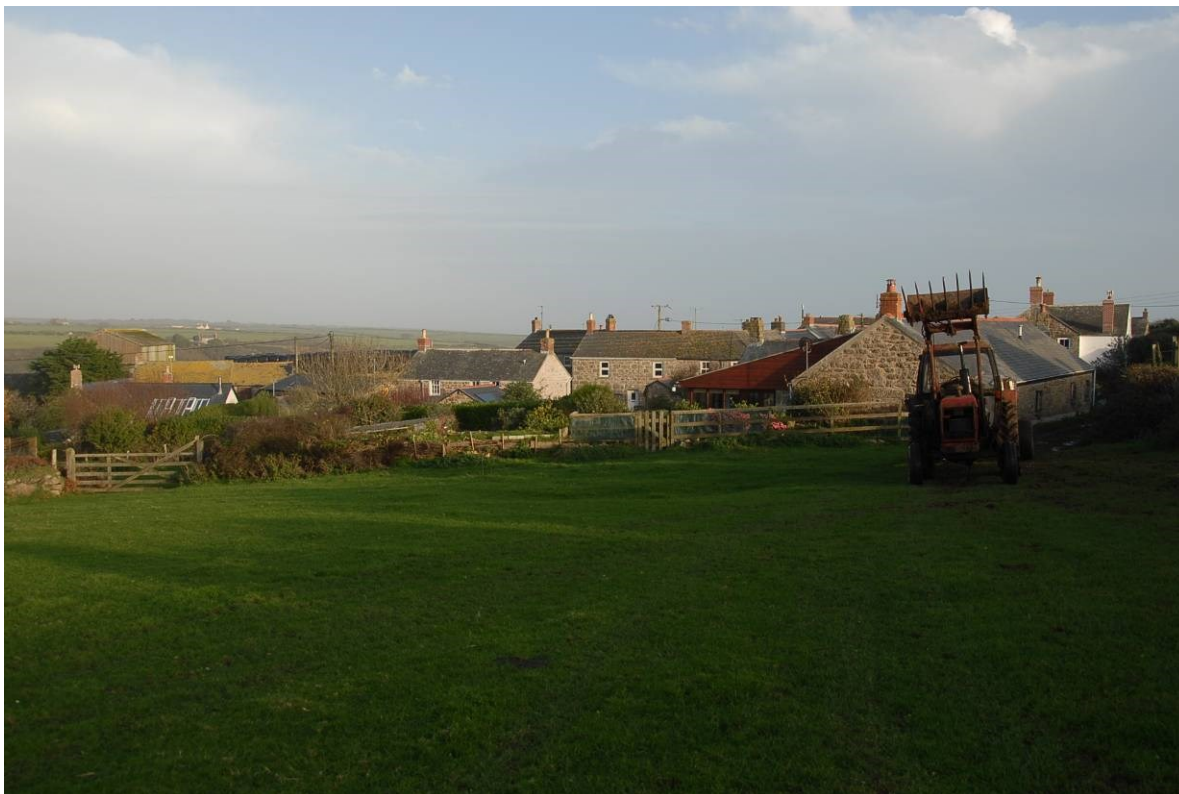
Fig 35. The eastern boundary of one of the north-eastern fields, here defined by a collection of rather flimsy fences.
