Treen fields, St. Levan, Cornwall

Archaeological assessment

Client	The National Trust
Report Number	2011R116
Date	5/12/2011
Status	Final
Report author	Adam Sharpe BA MifA
Checked by	Andrew Young, HE Projects Manager, Jim Parry: NR Regional Archaeologist
Approved by	Andrew Young, HE Projects Manager

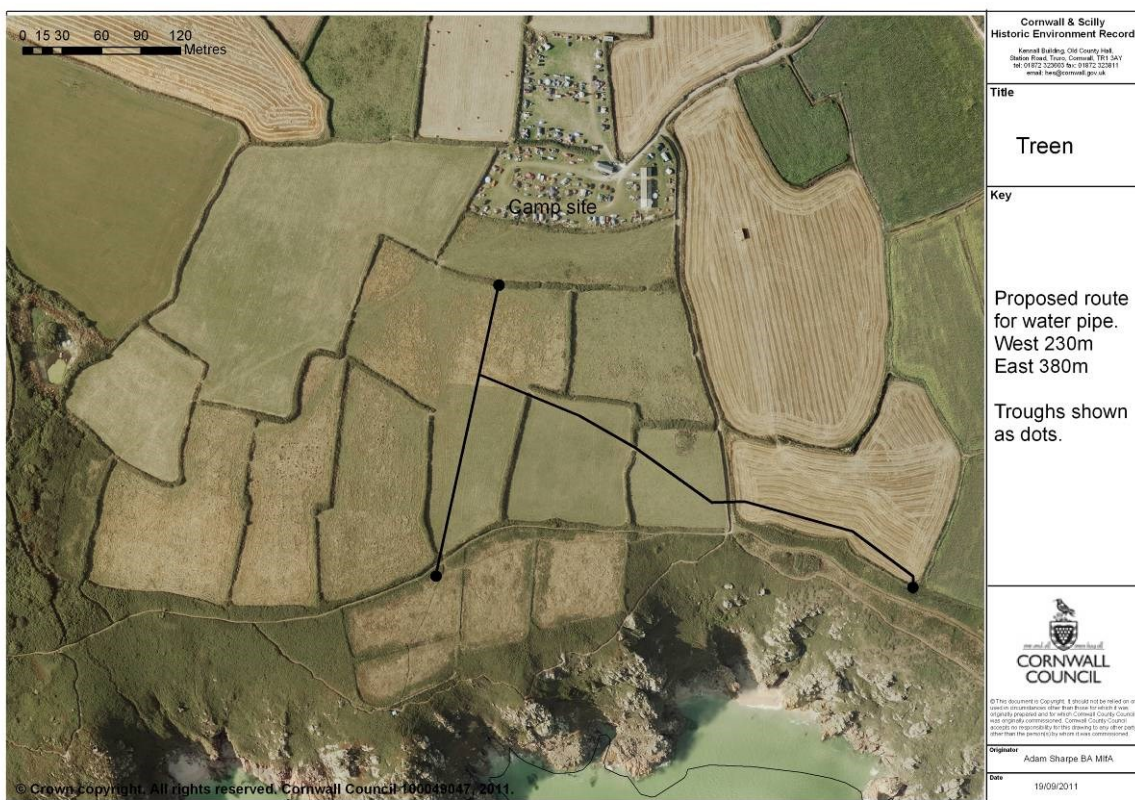
Fig 36. Draft proposal for water pipe routes to water troughs in the cliffland at Treen.

Following discussions with the NT Ranger, it is suggested that the eastern pipeline route is routed so as to pass through existing gateways in two fields to the west of the sunken lane. This route also transects a ploughed down lynched and the low remains of a dividing bank in the westernmost of these fields. It will be necessary to take the pipe through or under the two hedges dating to between 1840 and 1878 which flank the southern end of the sunken lane. It is important that this is undertaken in a fashion which minimises any damage to these features and ensures appropriate reinstatement where such damage cannot be avoided. Given the form of the flanking walls (orthostats to the west and piled boulders to the east, see Fig 27), it should be possible to achieve this with minimal archaeological damage. The first part of the section of this route to the east of the lane passes through an enclosure created between 1840 and 1878, crossing the sites of two removed boundaries to terminate in the hedge at the south-eastern corner of the Treen fields, the intention being that this trough would be accessible from both the cliff and from within the field.
