Kenidjack holed stone, St Just, Cornwall

Repair and restoration

Client	English Heritage
Report Number	2011R119
Date	November 2011
Status	Final
Report author(s)	Ann Preston-Jones
Checked by	Andrew Young, Nick Russell
Approved by	Andrew Young

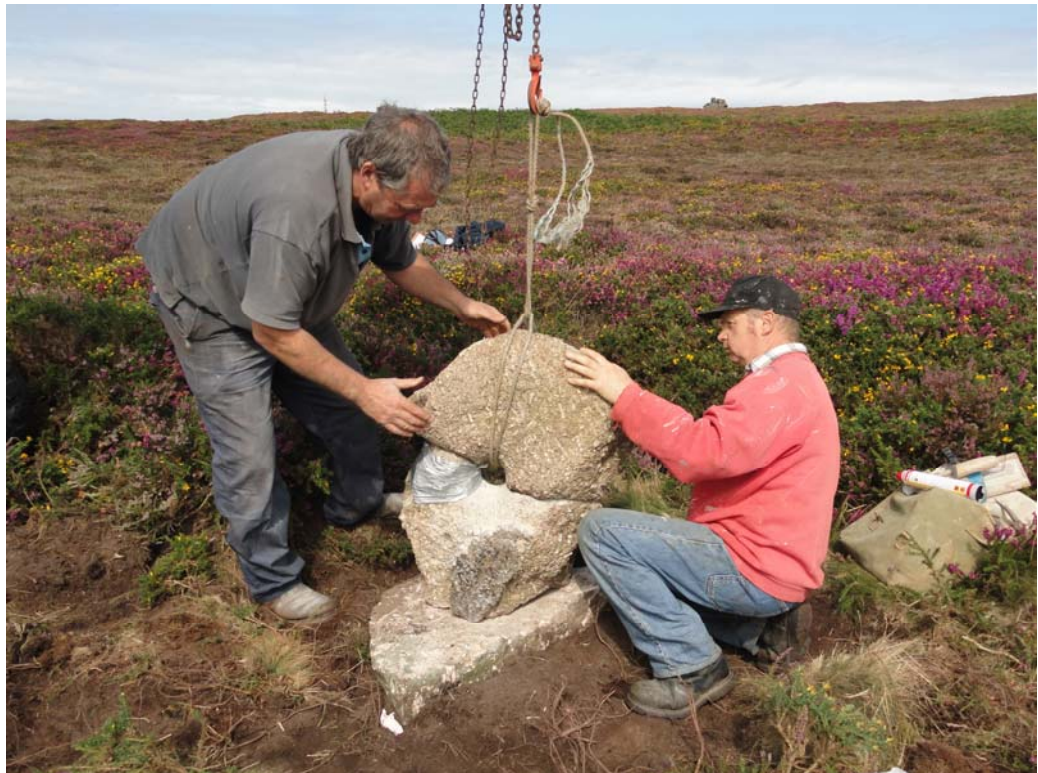
Repair work in progress: the top part of the stone is lowered into place.

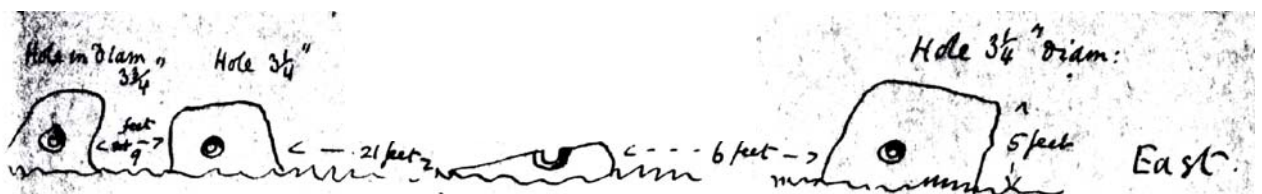
Fig 5 Thumbnail sketch of the four main stones, by Charles Henderson.

Nineteenth century records show that the stones were recumbent at that date. The drawing that accompanies Henderson's 1922 scheduling shows three of them upright (Fig 5), while his description states that they had been recently thrown down and they were under threat from stone cutting. Perhaps they were saved from complete destruction by the designation resulting from Henderson's visit. At any rate, they were amongst the earliest of sites to be included in the schedule of ancient monuments for Cornwall. In the 1960s and 70s, the stones were still recumbent, but Straffon records that 'some time prior to 1985, local farmer Egbert Rowe undertook to re-erect the fallen stones'. The three complete stones in the main group were set upright, but the broken stone left lying on the ground. From discussion with Egbert Rowe, Straffon gathered that the stones were simply placed upright in roughly the place where they lay (Straffon 2003). Sir Norman Lockyer noted that they had been knocked down and set up again (not necessarily in their old places) 'two or three times', although he was informed that they had not been moved far from their original positions' (Kirkham 2008).

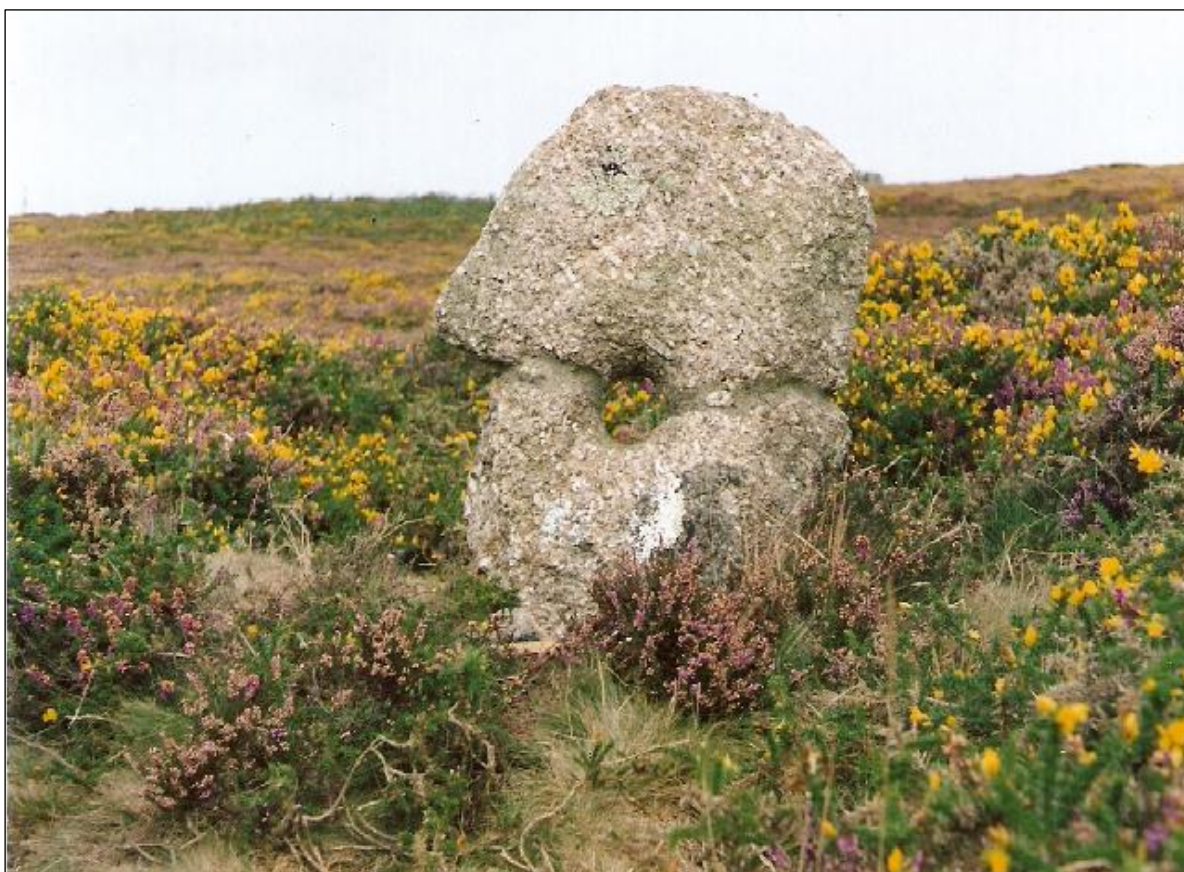
Fig 6 A photo of the holed stone taken by Cheryl Straffon between 1986 and 1992. An illustration by Cooke (1996, 167) shows the stone at a similar angle

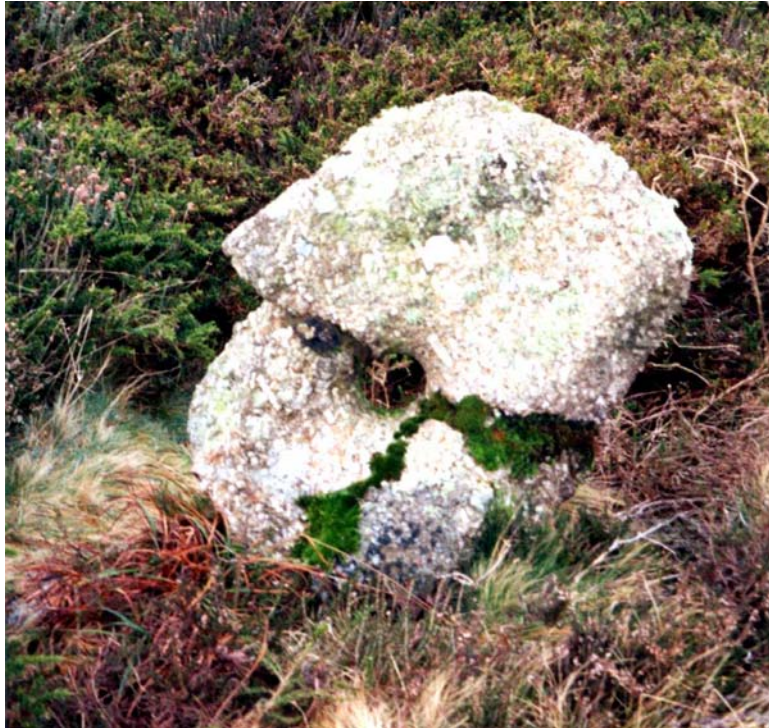
Fig 8 The holed stone in 2002 (English Heritage Field Monument Warden's photo)

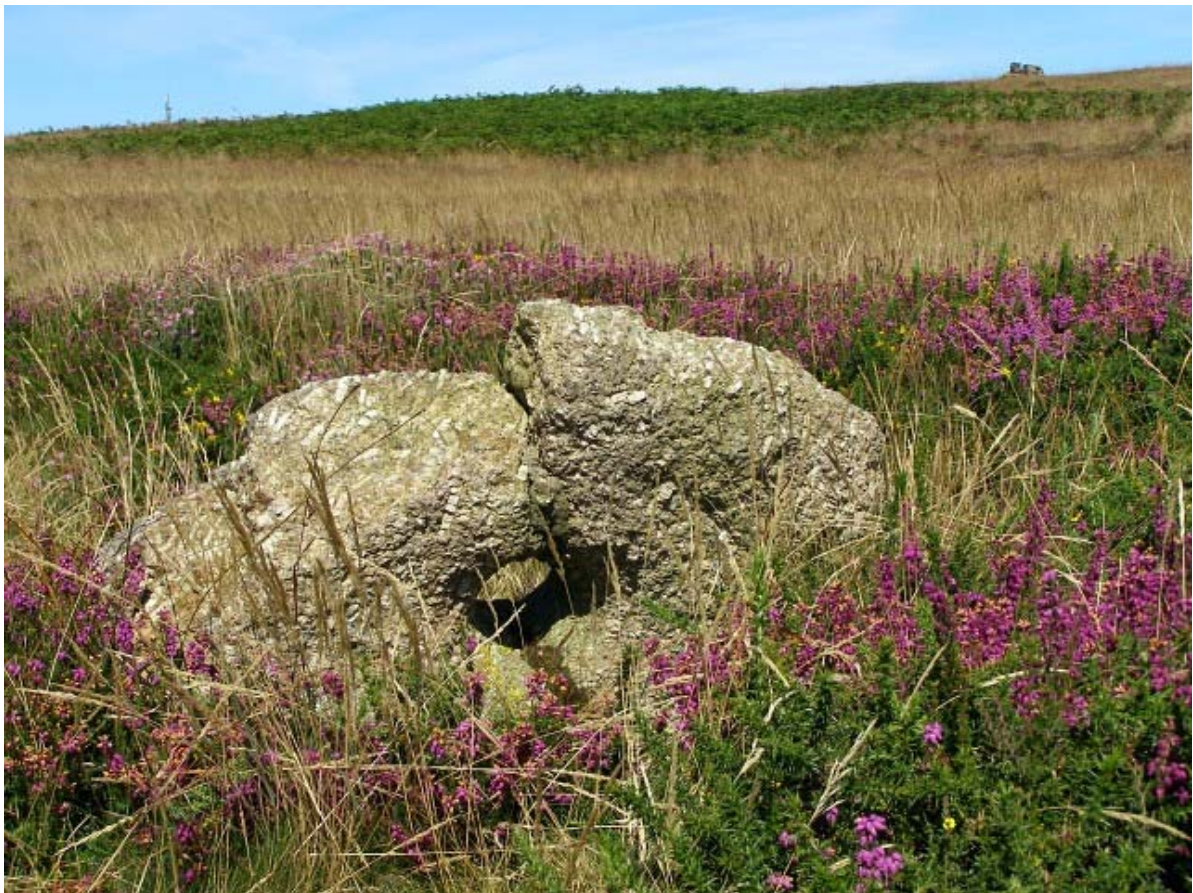
Fig 9 The stone in 2007 (Copyright [Jim Champion](#) and licensed for reuse under this [Creative Commons Licence](http://www.geograph.org.uk/photo/526044) <http://www.geograph.org.uk/photo/526044>)

1. A hole was excavated to take the base (Fig 13).
2. The base was set in the ground in the position in which the stone had stood before it fell over. This is on the slight bank on the lower edge of a shallow leat (seen in Fig 9). The base was placed with its long edge parallel with the leat and its apex pointing downhill. It was placed so that the stone, once erected, would be facing Carn Kenidjack, thus close to the stone's pre-damage orientation and reflecting its likely original relationship with the Carn (see above, page 11).

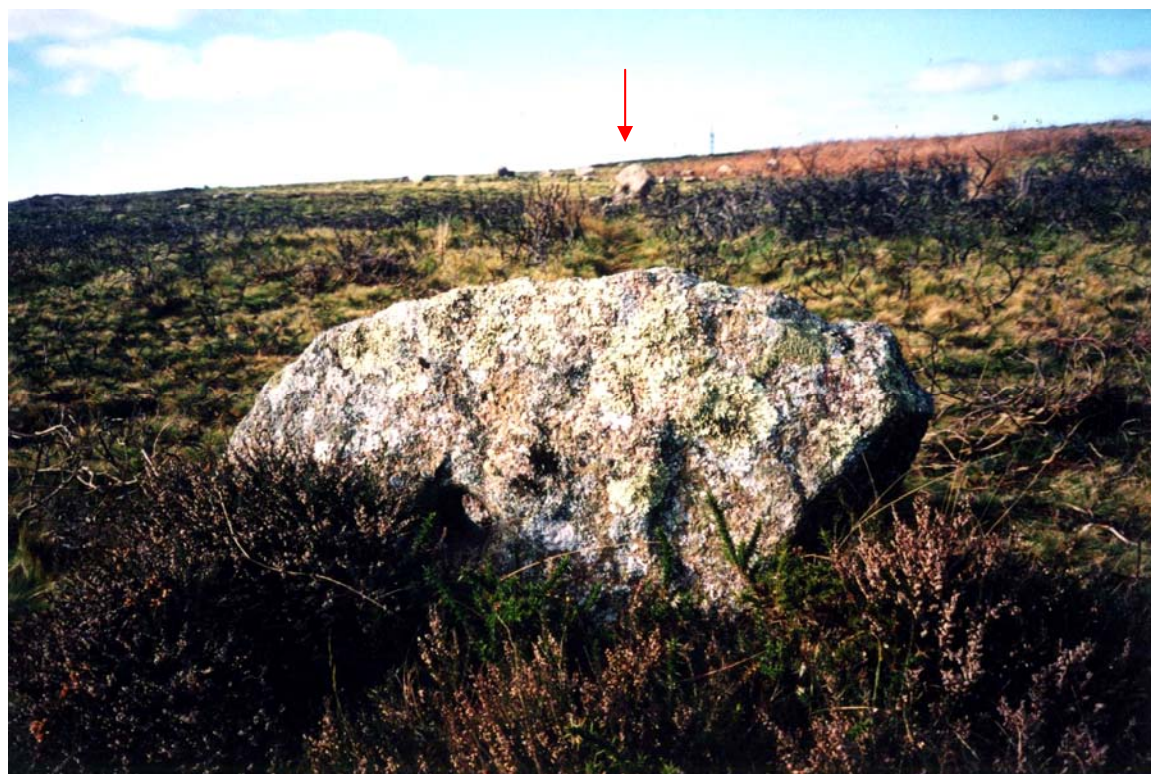
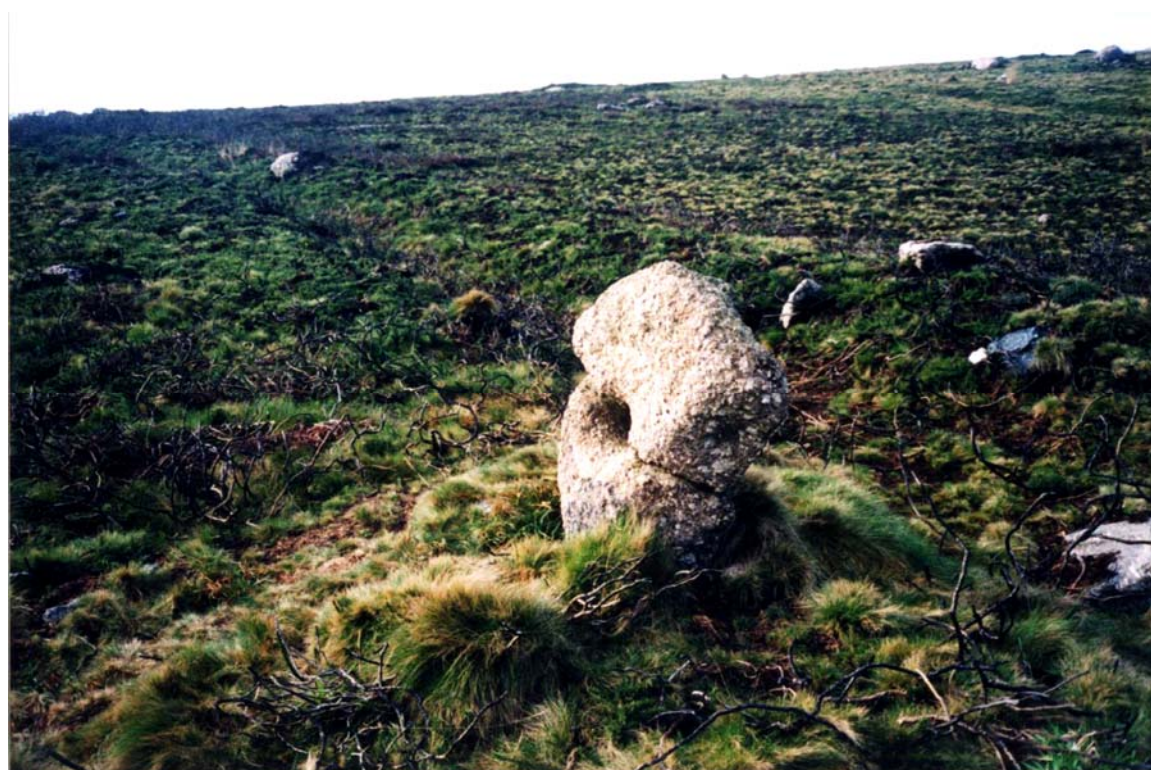
Fig 10 The holed stone in 2004, after a fire on the common. Above: with one of the stones in the main group in the foreground. Below: with the stone's position on the edge of a small leat clearly seen (English Heritage Field Monument Warden's photos)

Subsequently, reports of the English Heritage Field Monument Wardens confirm the fact that the fifth stone was loose and not fixed, while also doubting whether it was actually a part of the scheduling since it was not described in the original documentation (Sheppard 1981, 1985, Preston-Jones 2004). (It is certainly, however, part of the very large Scheduled area of Co 1086, Field System on Truthwall Common). Various images (Figs 6-9) indicate that stone 5 has been moved around slightly over the years; Fig 10 shows the stone in its setting after a moorland fire which burnt all the vegetation in the area. However by the time of the work described in this report, the vegetation had regenerated to a roughly knee-high cover of heather and gorse.

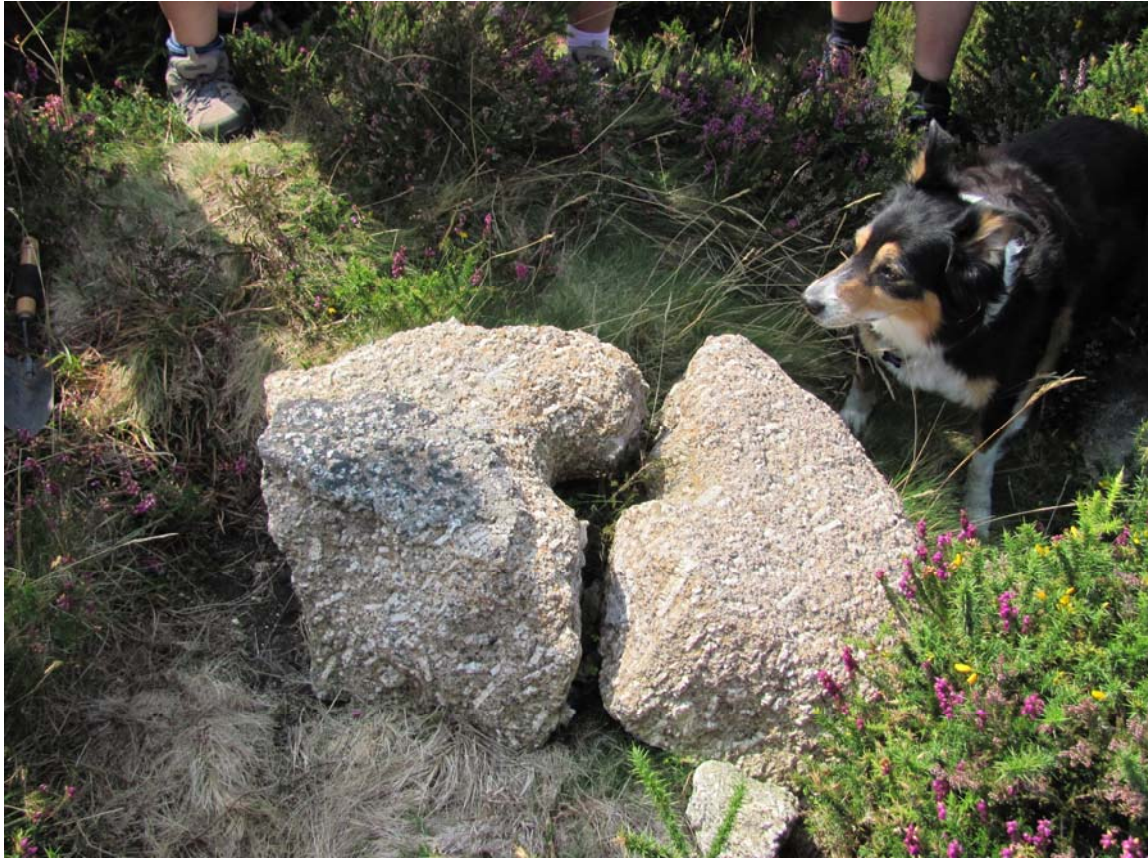
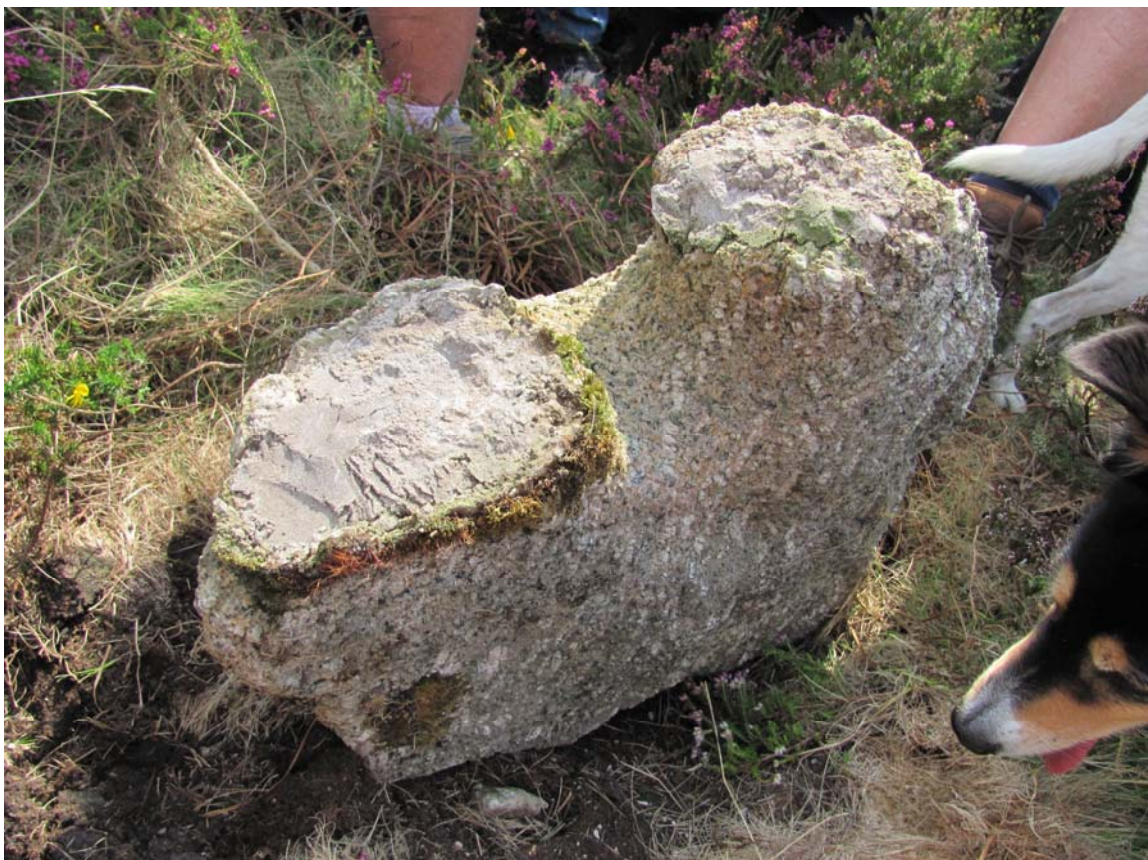
Fig 11 The holed stone in 2010, after the two pieces had fallen apart: the cement which had held the stone together for nearly 30 years can be seen adhering to the broken face

Cornwall Ancient Sites Protection Network (CASPN) had been concerned about the stone's condition for some years and when it broke again in 2010, along the line of the old cement repair, it was they who asked if English Heritage or Historic Environment would be able to help with the necessary repair.

The two parts of the stone do not fit perfectly together. This suggests that they had been separate for a considerable period and had eroded on the broken faces before they were restored by Egbert Rowe in the 1980s.

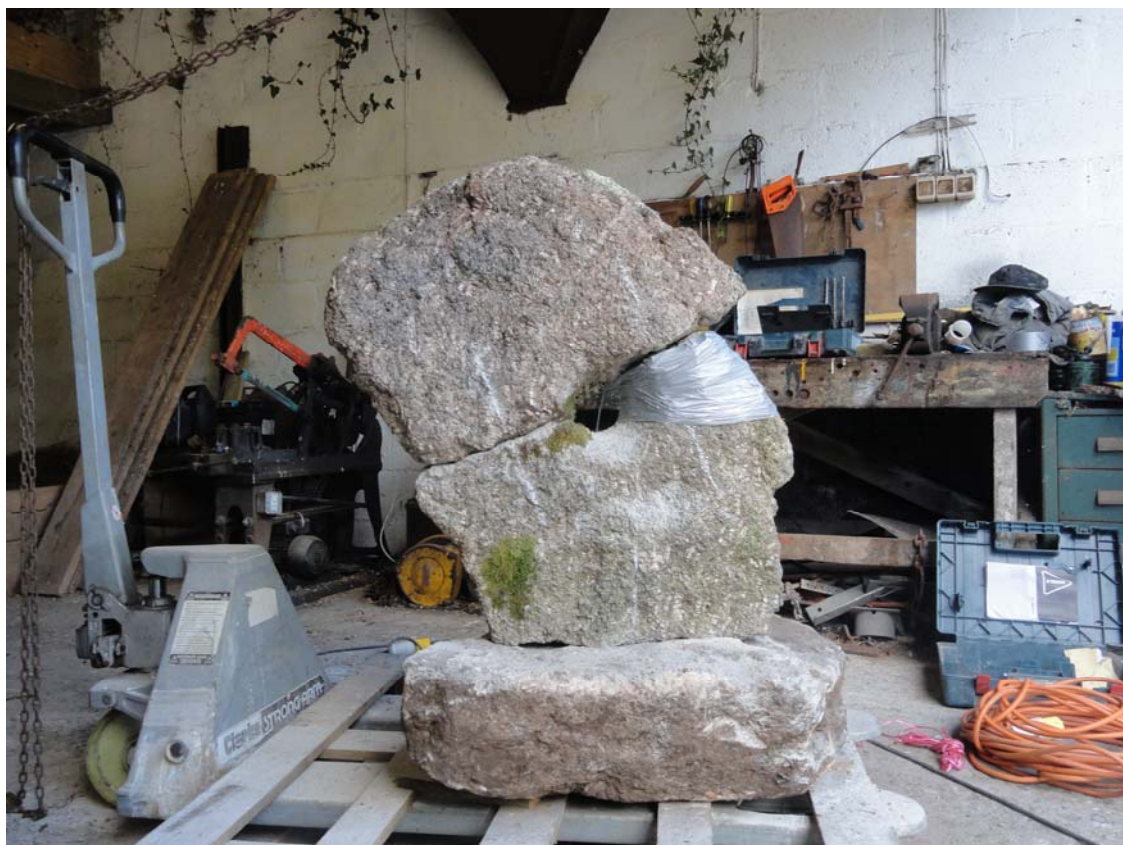
Fig 12 The holed stone in the workshop. The positions (but not the actual length) of the three dowel holes and internal pins are indicated with chalk lines on the stone

The bottom of the holed stone and the broken faces of the two parts of the stone were measured and carefully drilled to make dowel holes for the stainless steel pins used to repair the stone.

A trial fitting was carried out in the workshop before the stones were taken back onto the site for reassembly. Because of the stone's fragility, the final assembly was done on site, to avoid any damage to the stone or the fixings in transit.

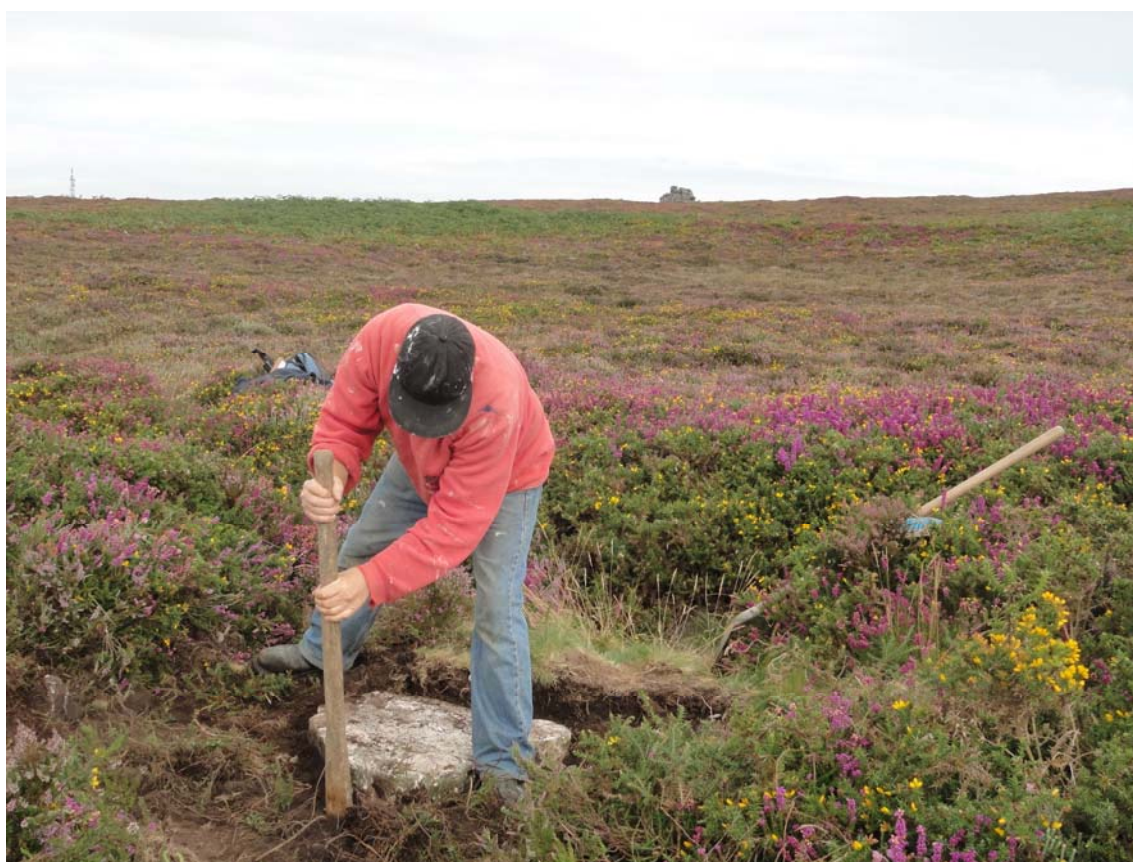
Fig 13 Installing the base-stone

A hole 0.2 m deep was excavated for the base in the position in which it stood previously, that is on the bank running alongside a leat. Below the heather and grass, excavation revealed a fine dark brown/black peaty topsoil, with no stone. In all possibility this represents silt arising from cleaning out of the leat.

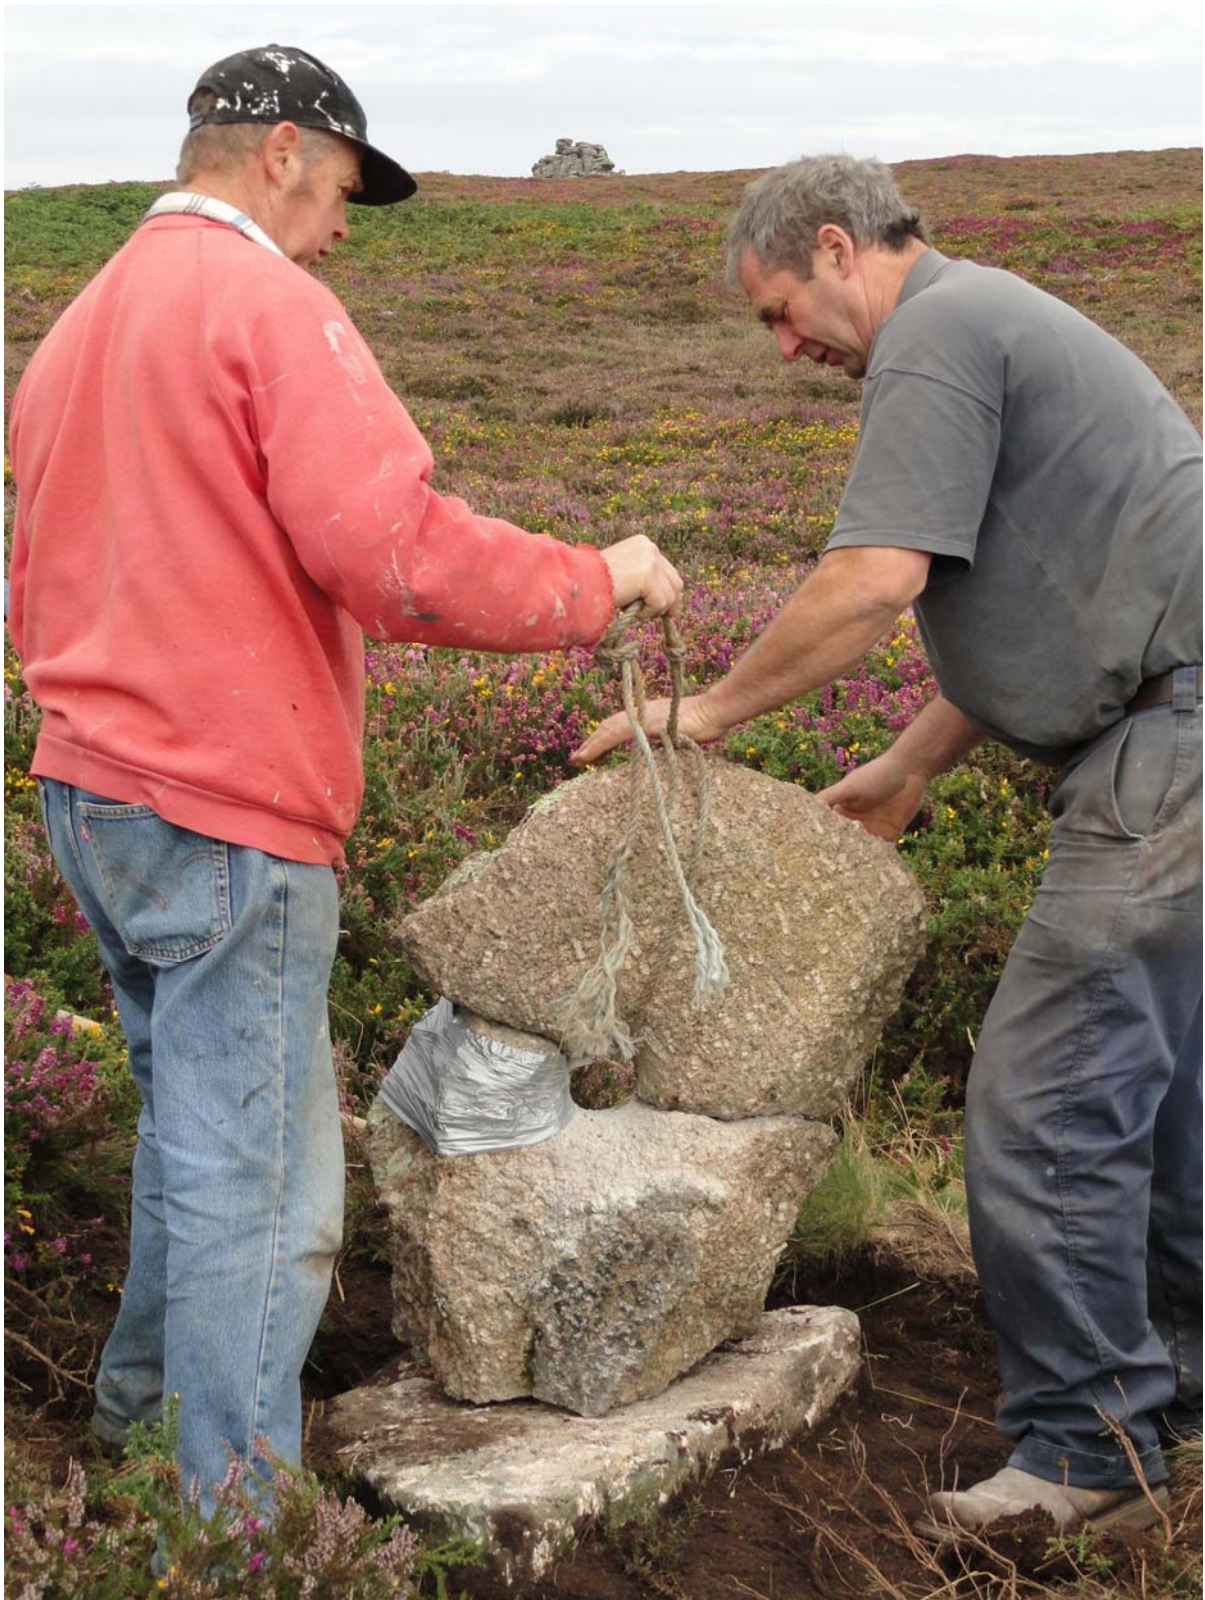
Fig 14 The first trial assembly of the stones out on site

3. A trial fitting was carried out, to ensure that all was well and that the alignment and positioning of the stone was satisfactory, before going ahead with the final pinning and mortaring. The lower part of the holed stone was lifted into place by hand and the pins inserted into the lower dowel holes. The upper half was then lifted into place by hand. Two trials were undertaken before we were satisfied that the positioning of the stone was right (Fig 14).

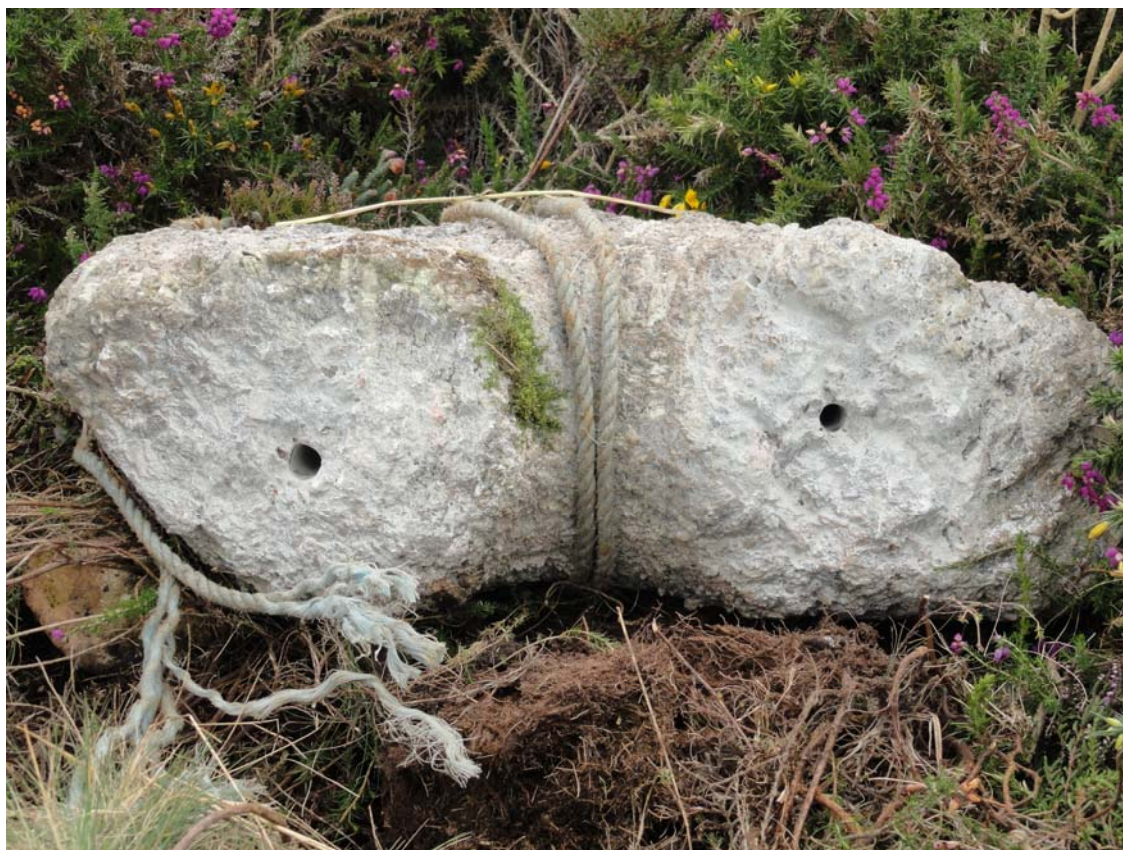
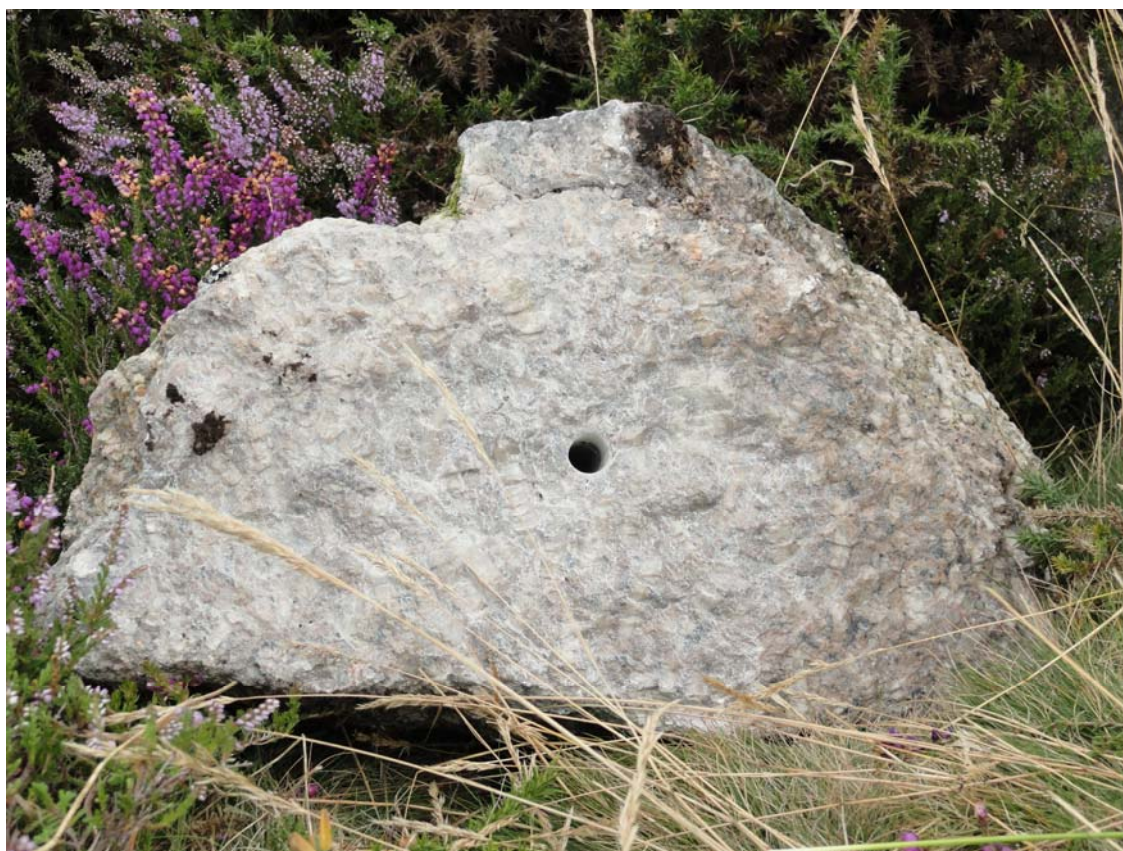
Fig 15 The positions of the dowel holes in the broken faces of the stone: above, the two holes in each segment of the upper half, and below, the single hole for the dowel which holds the stone to its base

In the workshop, the granite base was prepared for the holed stone by levelling it slightly to enable the stone to sit more securely, and a single hole 14 mm in diameter and approximately 15 mm deep was drilled to receive the stainless steel pin which now holds the stone on the base.

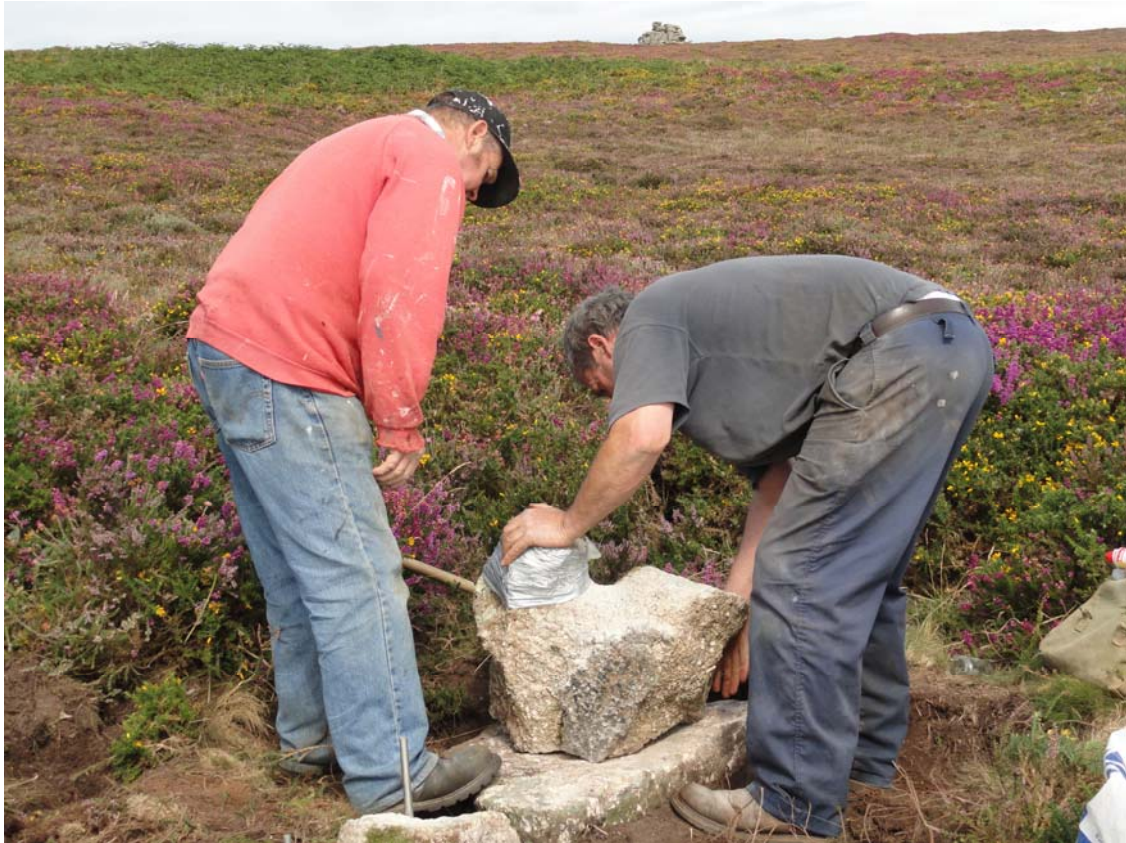
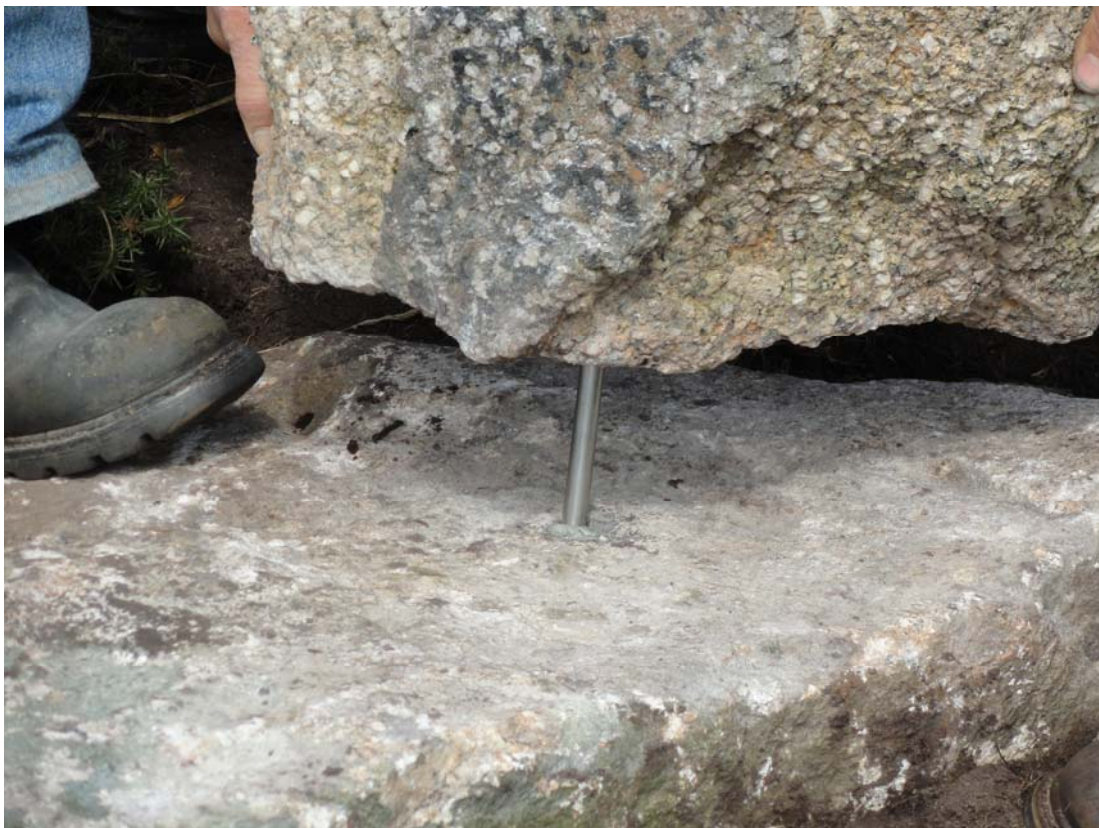
Fig 16 Final assembly begins, as the bottom half of the stone is lowered onto the stainless steel dowel, which is held in place in the base-stone with polyester stone resin

4. All parts apart from the base were then removed again and the final restoration begun. The pin was glued into the base first of all, using a polyester stone resin.

5. The lower part of the stone was then firmly bedded on this (Fig 16).
6. Once the resin had gone off, and the lower part of the stone secured, resin was injected into the dowel holes in both halves of the stone and the pins inserted. Using a pulley suspended from the bucket of the digger, the upper part of the stone was quickly and carefully lowered onto the bottom half of the stone. It was checked for positioning and stability (Fig 17).
7. Once the resin had all set firmly, the joints were pointed with a hydraulic lime mortar: NHL 3.5 in a 1:2.5 mix with sand. Though it had been hoped to avoid the use of mortar so that the stone would remain as natural-looking as possible, pointing was considered essential to help protect, support and stabilise the fragile granite (Fig 18).
8. Finally, earth and vegetation were replaced around the base.

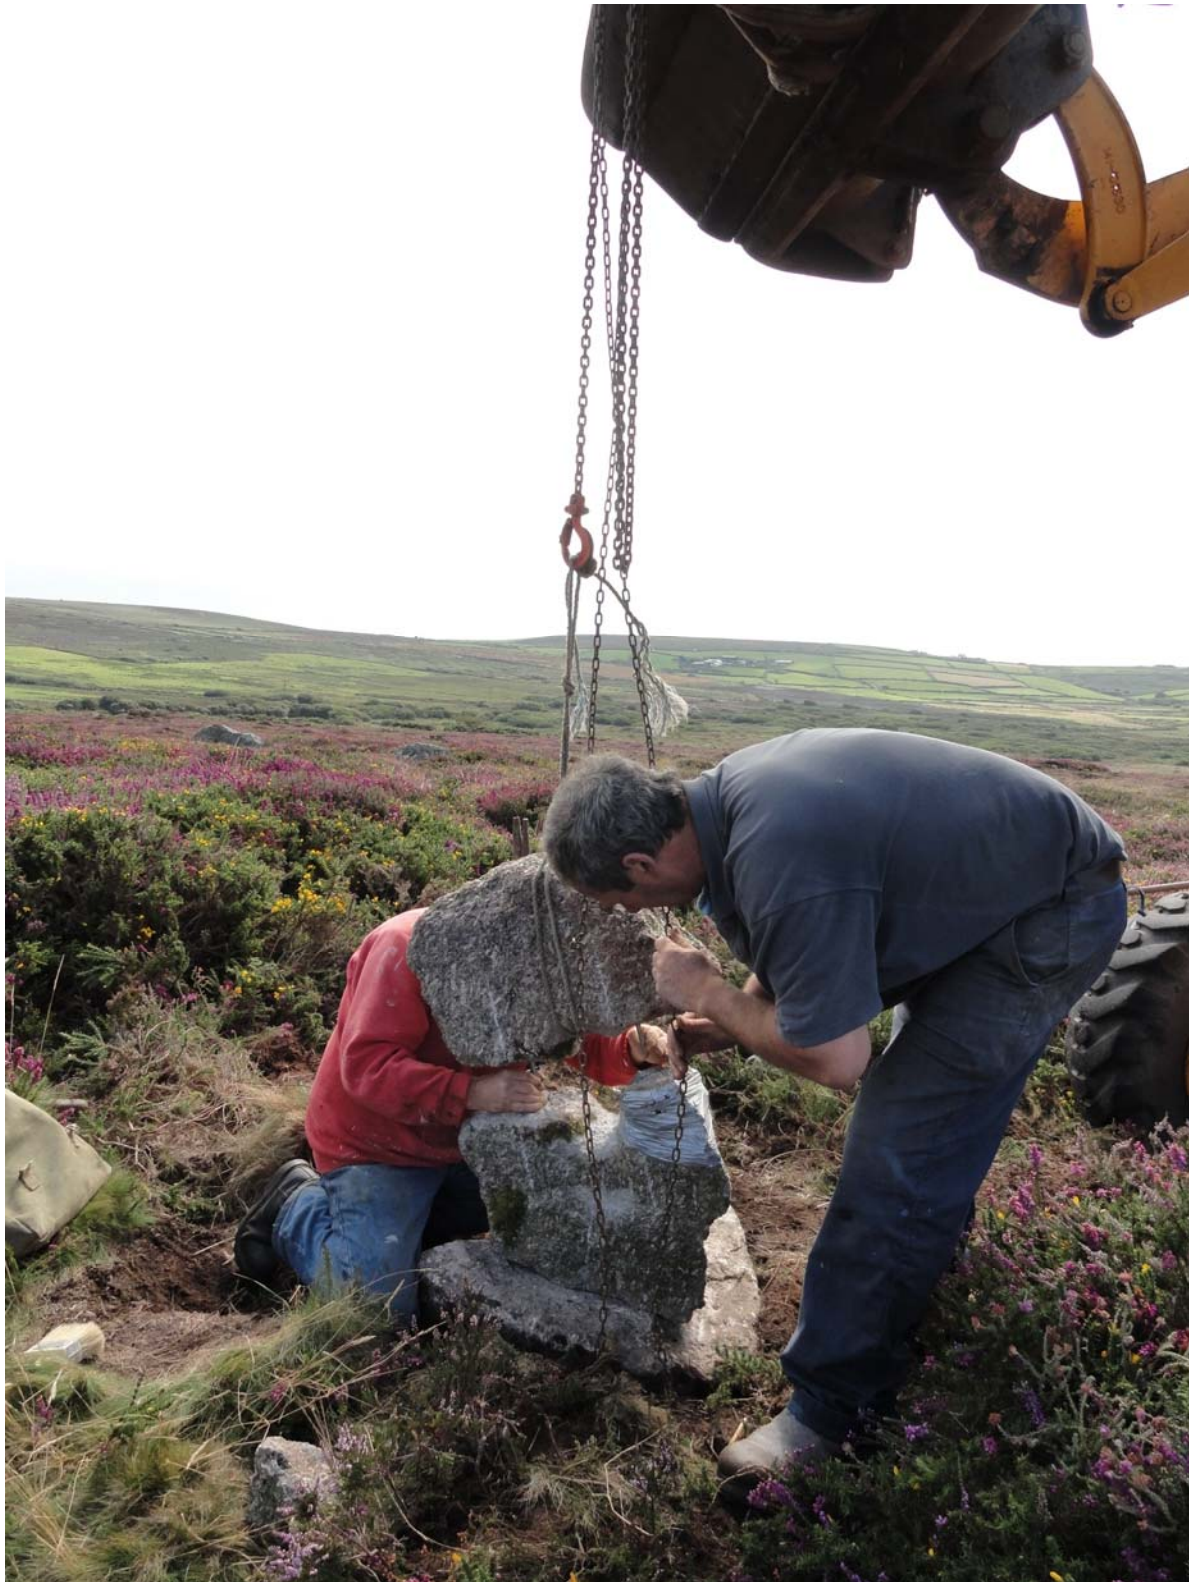
Fig 17 Supported by a pulley attached to the digger's bucket, the upper half of the stone, with stainless steel dowels resined in place, is lowered onto the bottom half of the holed stone

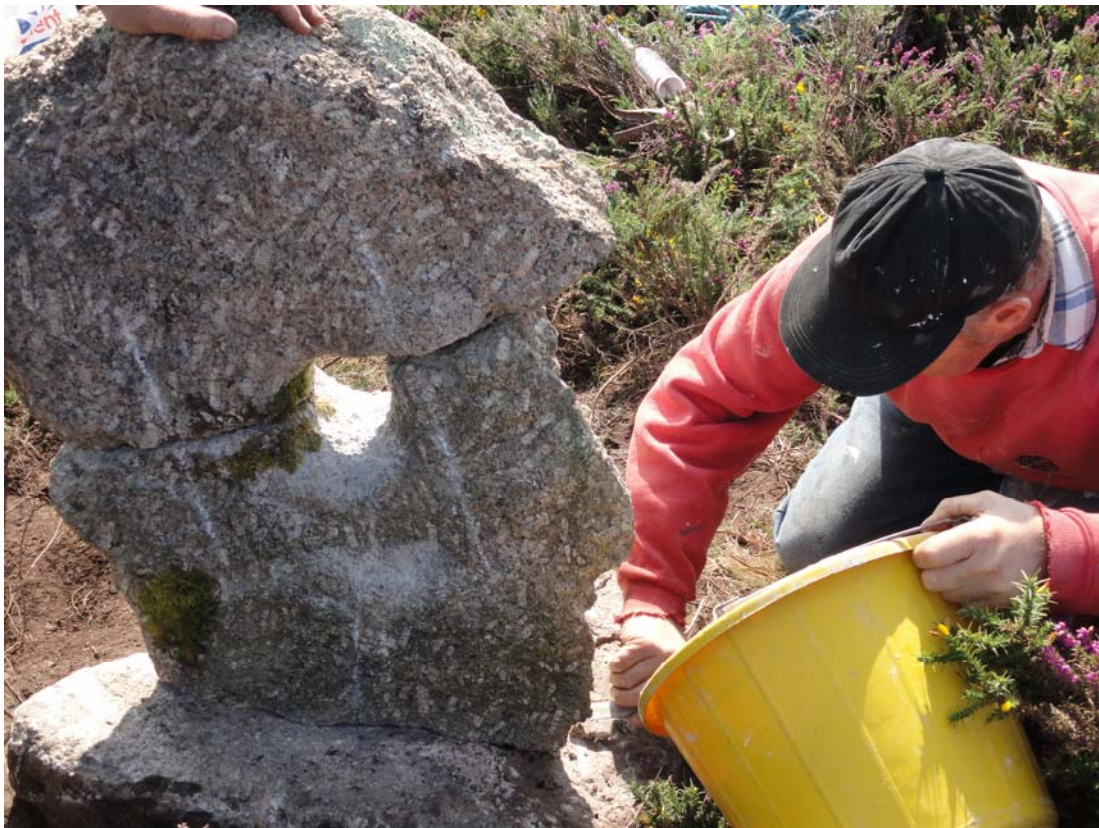
Fig 18 Mortaring the joint between the base and the holed stone. The position of the internal dowels, indicated with chalk marks, can be clearly seen in this picture

The repair of the stone was carried out by Adrian Thomas and David Cutting of St Just. In summary, the two halves of the stone were pinned together using stainless steel pins, and the joint pointed in lime mortar. The stone was mounted on a base, part-sunk in the ground, to provide security and strength while leaving the full height of the stone, including its hole, visible.

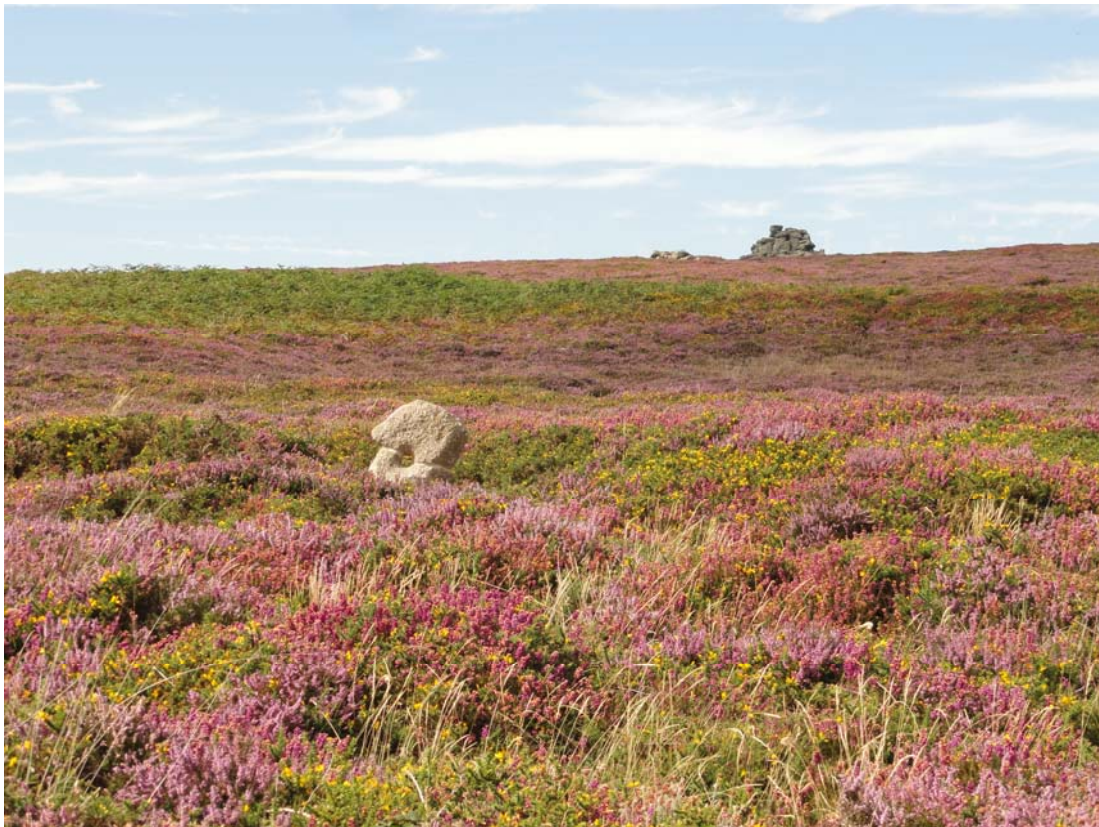
Fig 19 The restored stone, in its setting

The stone has been satisfactorily repaired and now is not only more stable than it has been for many years, but also better presented, safe from theft and restored as a more prominent member of the monument as a whole (Figs 19 and 20).
