Kenidjack holed stone, St Just, Cornwall

Repair and restoration

Client	English Heritage
Report Number	2011R119
Date	November 2011
Status	Final
Report author(s)	Ann Preston-Jones
Checked by	Andrew Young, Nick Russell
Approved by	Andrew Young

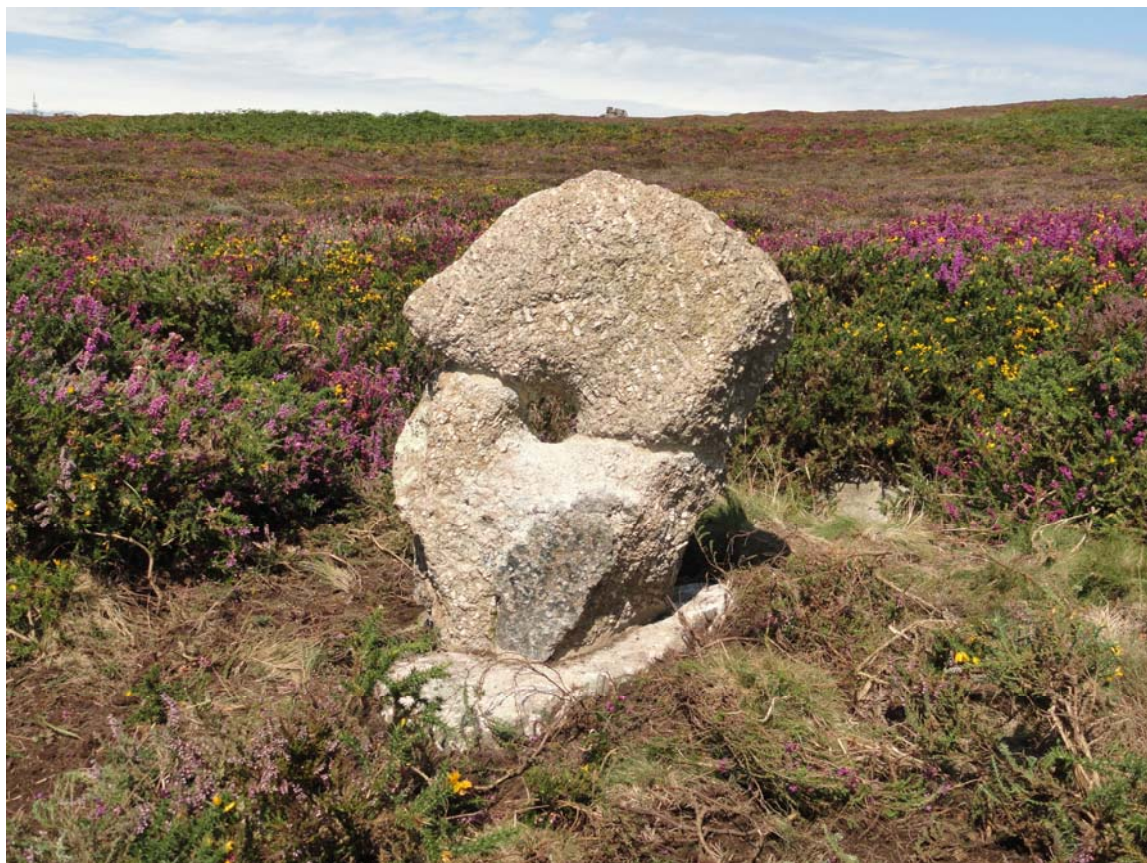
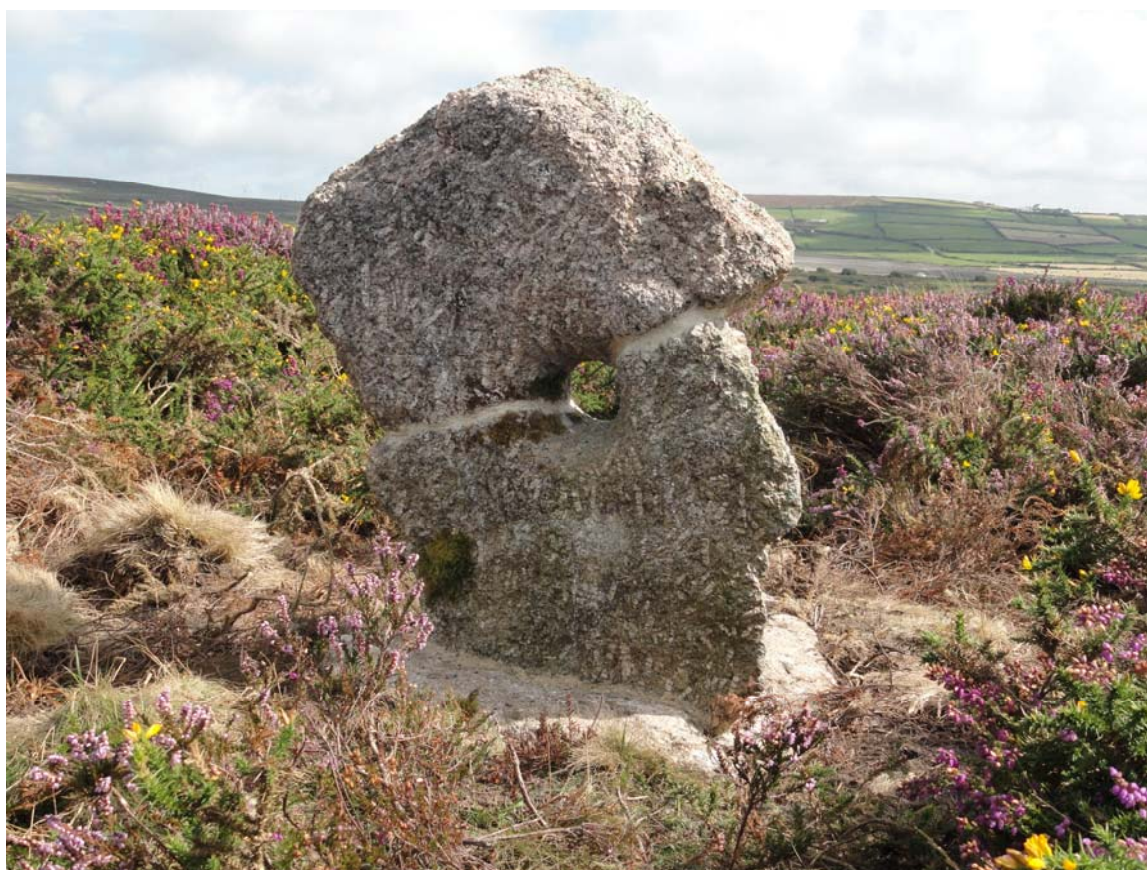
Fig 20 The restored holed stone

The stone has been satisfactorily repaired and now is not only more stable than it has been for many years, but also better presented, safe from theft and restored as a more prominent member of the monument as a whole (Figs 19 and 20).

However, the work has revealed the fact that the granite of which the holed stone is made is extremely fragile – perhaps due to its small size, great antiquity and long exposure to the elements. The stone should therefore be treated with the greatest of care and should be regularly monitored. It may be that in the long term the stone would be best housed in a museum; Penlee House in Penzance would be an obvious choice. If such a move were ever contemplated, it would be worth considering carving a replica to put on site in the place of the original stone.
