# Nance Round, Illogan, Cornwall

## Scrub Clearance

November 2006

Report No: 2006R076

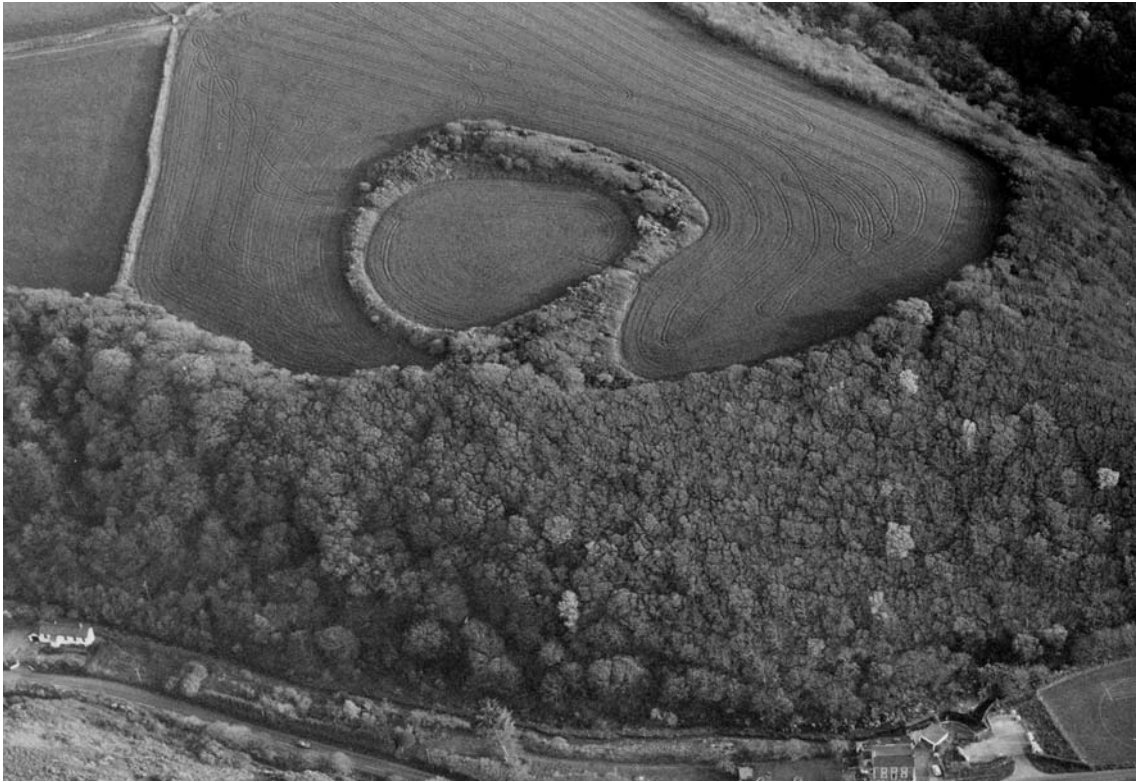
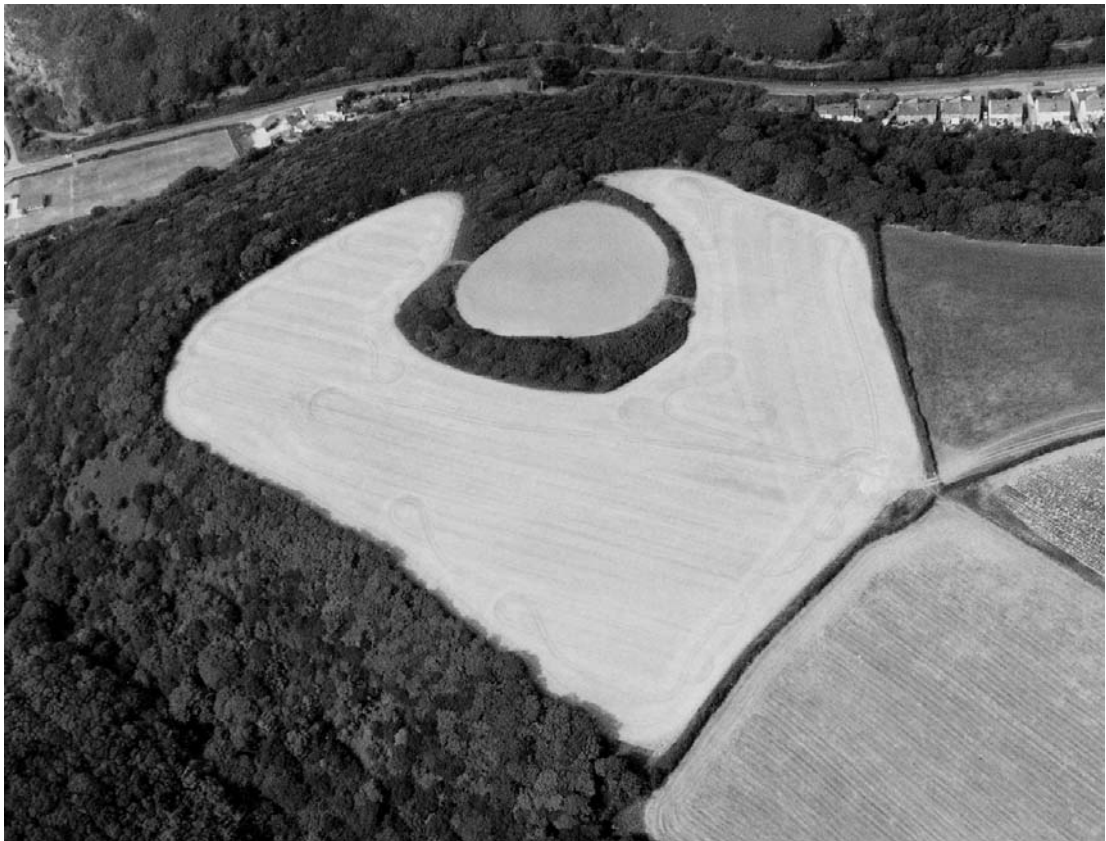
*Figs. 6 and 7 Nance Round in 1989 (photographed from north) and 1992 (photographed from south).*

photos (see Figs. 6, 7 and 8) indicate a far more complex monument, with up to three ramparts. Examination of air photographs suggest a possible annexe to the south-east (as noted above), which may consist of two smaller enclosures, as well as a third enclosure bank to the south-west (Fig. 5).

Located within Anciently Enclosed Land (ie. land farmed from medieval times or before) (Cornwall County Council 1996), there is a history of intensive cultivation in and around Nance Round. It was assessed as arable for the purpose of the 1840 Tithe Map. When Scheduled in 1976, the ground both inside and outside the Round was cultivated, with only the banks and part of the ditches left unploughed, and covered in trees and scrub. This was still the case until recently and Figs 6 and 7 show the extent of cultivated ground in 1989 and 1992.

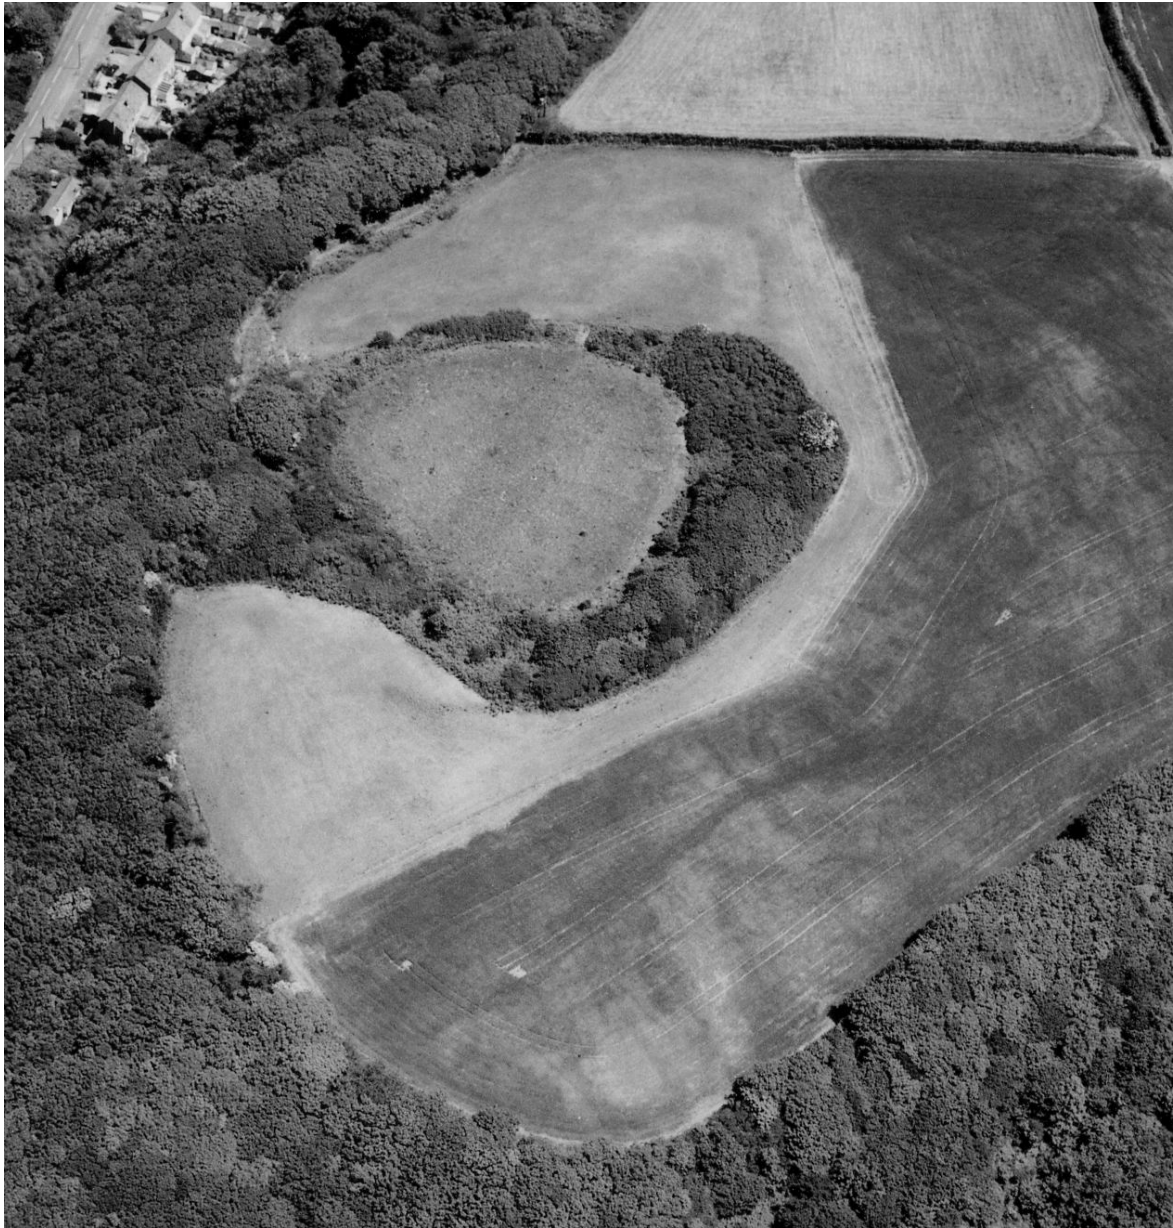
*Fig. 8 Nance Wood photographed on the 15<sup>th</sup> June 2004 which shows the position of the recently erected fence.*

Following this work, Mr Alway fenced the Round and its immediate area from the remainder of the field so that controlled grazing could be re-introduced on the monument (Figs. 8 and 9). The fence along the inner side of the boundary with Nance Wood was erected during the winter months of 2004-2005.

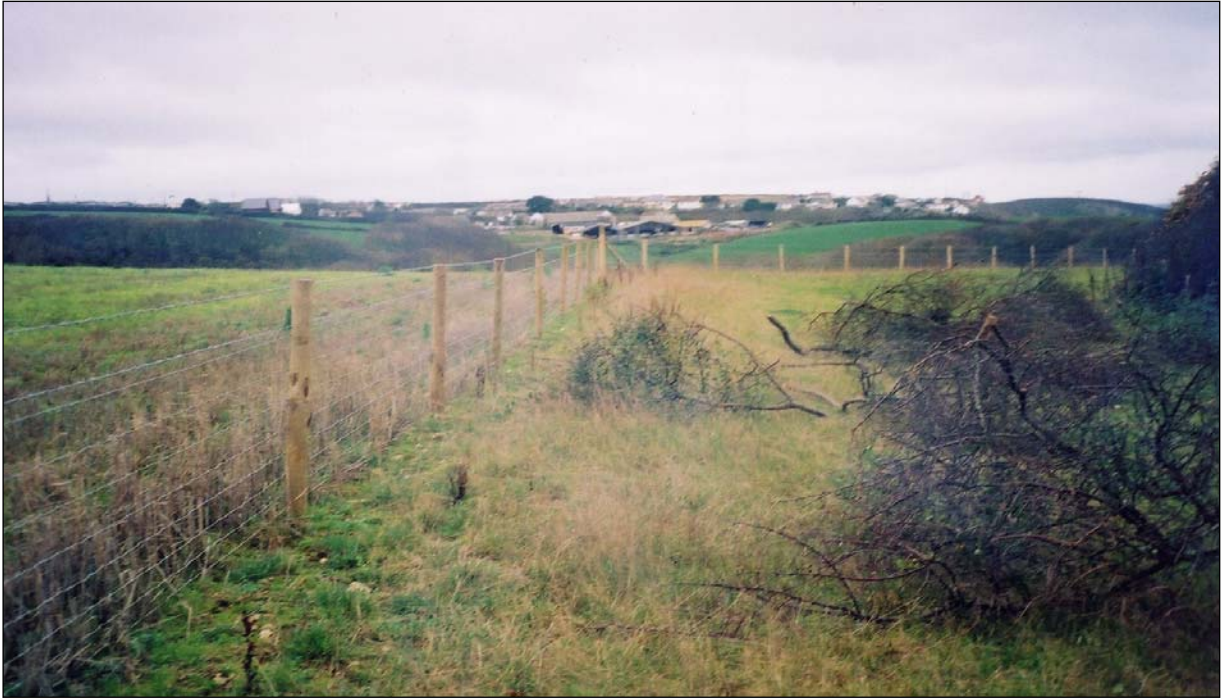
*Fig. 9 Fence erected to protect the archaeological remains in 2003.*

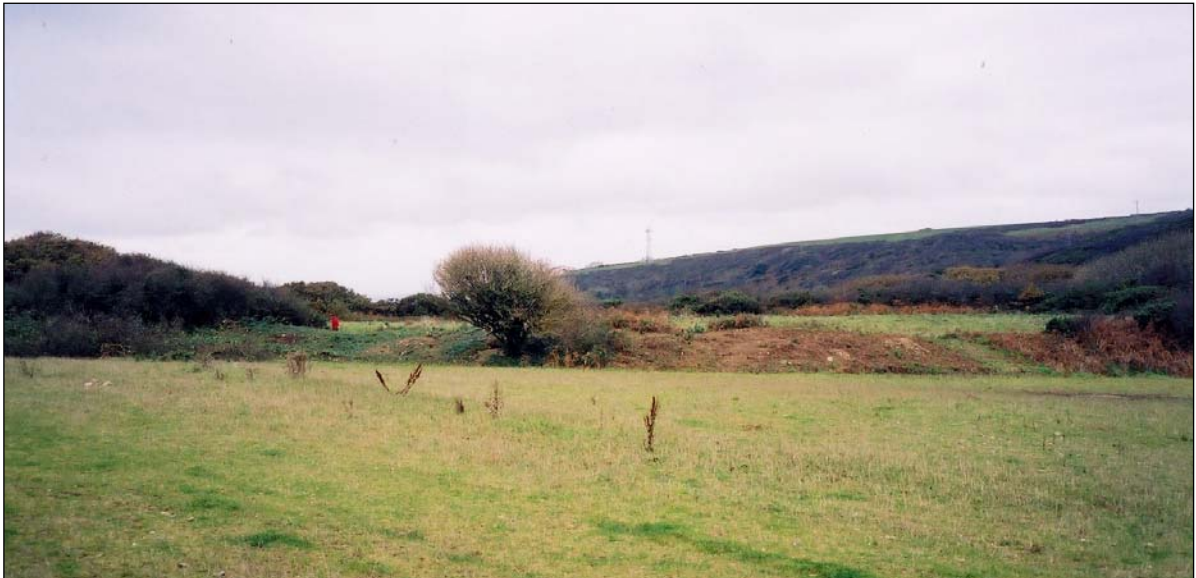
*Fig. 10 Clearance along eastern bank of Round in November 2004.*

The second phase of vegetation clearance was undertaken by a nine-strong, all-female, team of volunteers though BTCV's 'natural break' holiday scheme. The work concentrated on the south-west corner of the monument, where an area of bracken and extremely dense thorn and gorse were removed (Figs. 10 and 13). The work was carried out by hand, using bow saws, hooks and loppers.

The scrub was cut as close to ground level as possible, with clearance limited to blackthorn and gorse. All the cuttings from this period of work were burnt on a site, a short distance away from the monument.

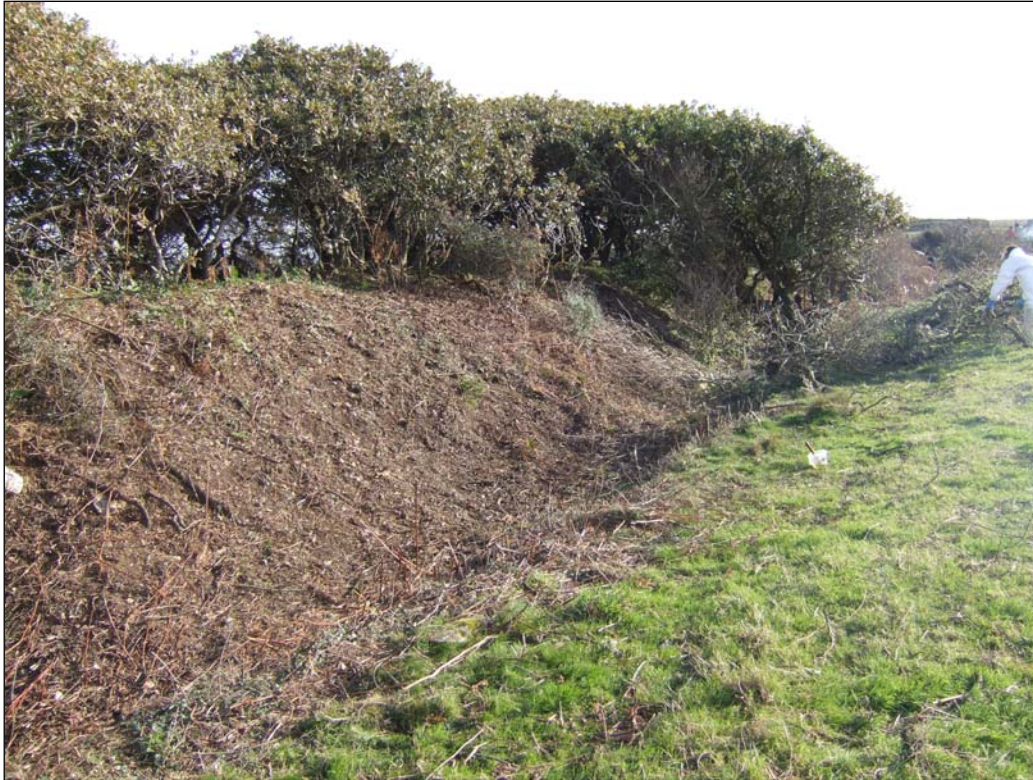
*Fig. 11 Southern rampart of Round during scrub clearance in November 2006.*

To complete the scrub clearance, there were two final visits from BTCV's mid-week team, which took place in the first week of November 2006. The works concentrated on the south-western part of the monument, around the elongated stretch of small oaks and holly which were left in place. Both chainsaws and hand tools were used to remove the thorn and gorse, with fresh stumps treated with herbicide. The loppings were again successfully burnt with help from the farmer (Figs. 11-13).

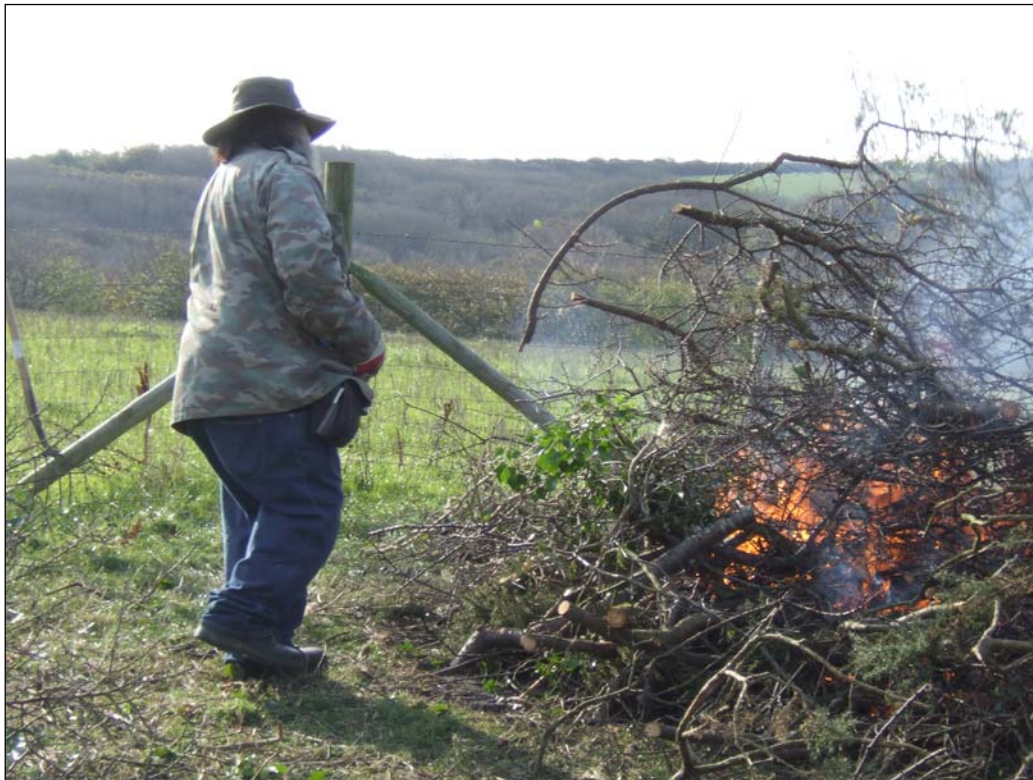
*Fig. 12 Burning the loppings in November 2006.*

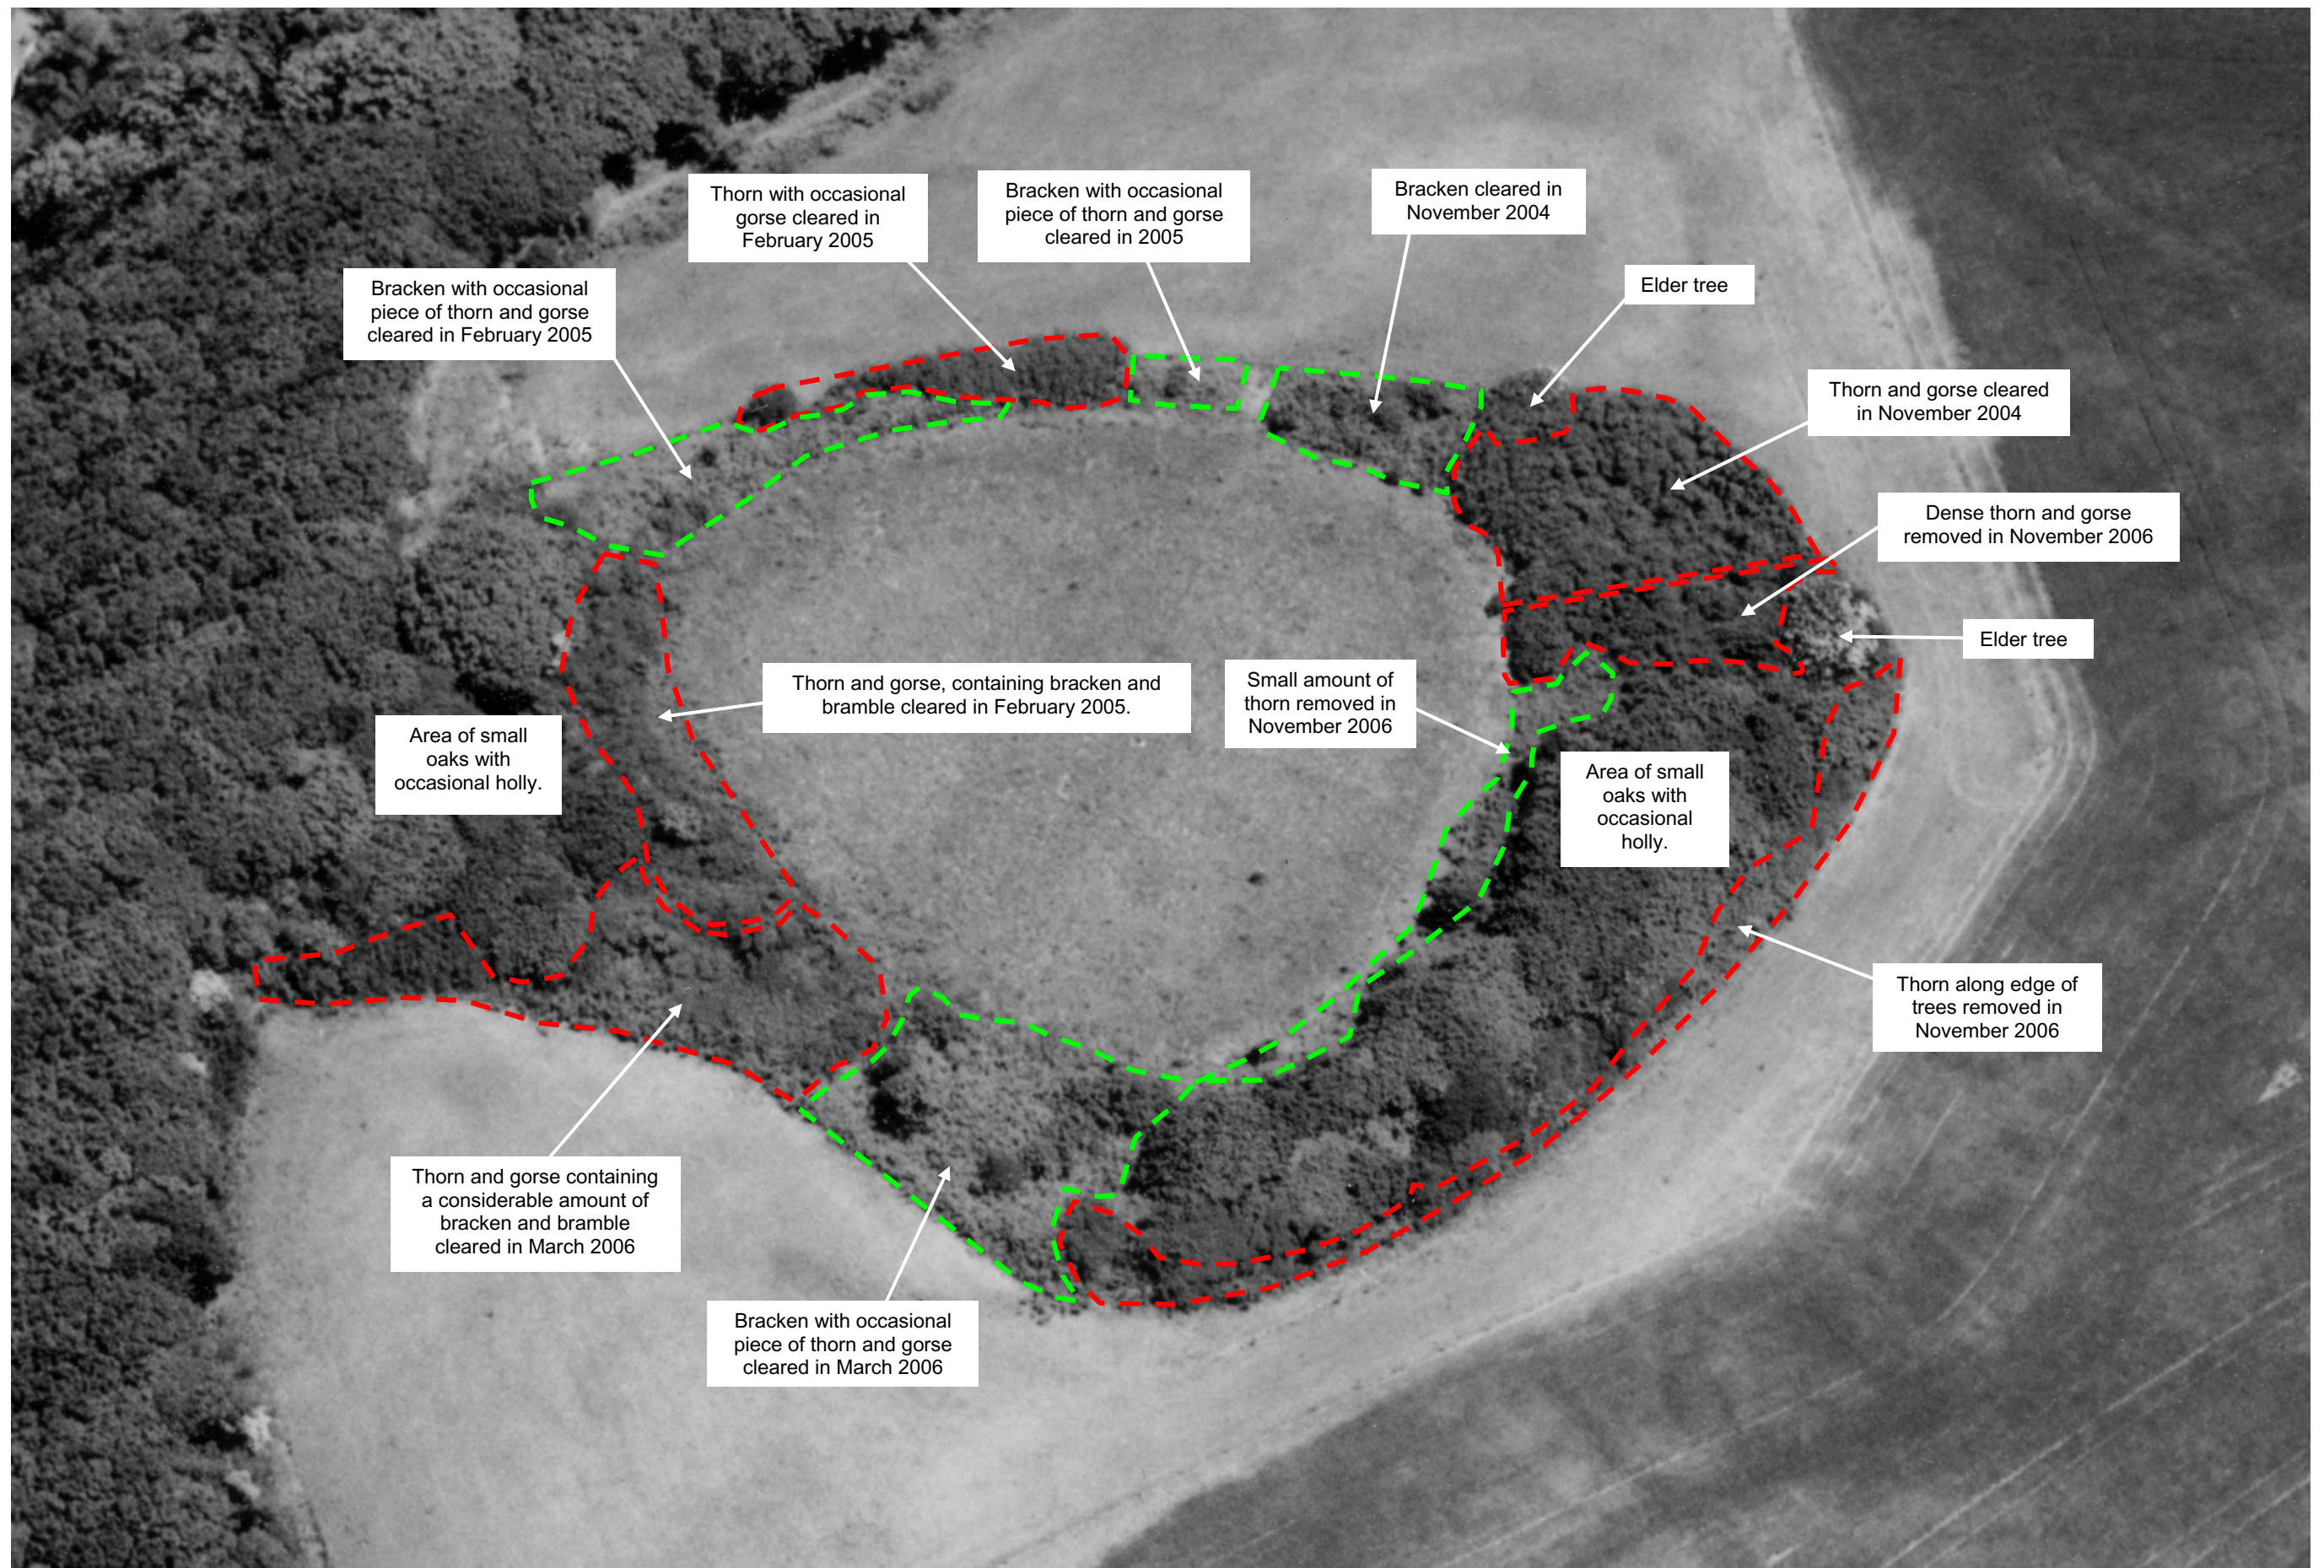
Fig. 13 Sketch survey showing areas of vegetation clearance at Nance Round (November 2004-November 2006).

As an alternative to this, two further visits from BTCV's mid-week team were arranged in March 2006. This concentrated on the north-western part of the monument (Fig. 13). Once again, the larger trees were cut down with a chainsaw while the areas of less substantial thorn were removed with hand tools. At this point, various stumps of thorn trees cut down during the most recent works, but also in previous years, were treated with herbicide to prevent re-growth. All loppings were burnt, with assistance from the farmer who rounded up the bonfires in the evening after the volunteers had left.
