Halliggye Fogou Mawgan-in-Meneage Cornwall

Archaeological watching brief and survey

December 2005

Report No: 2005R088

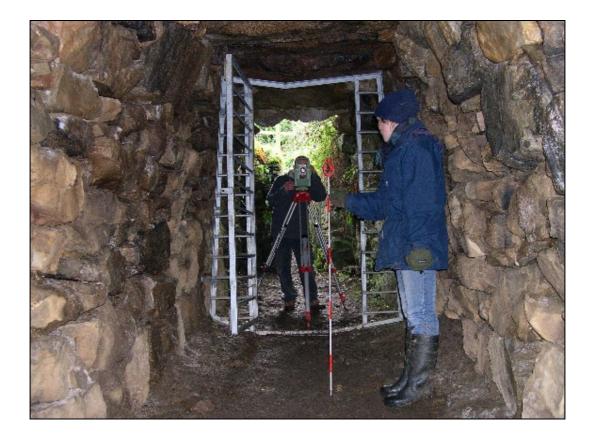
Cover illustration

EDM survey of the fogou in progress (photo: HES GDP 0018)

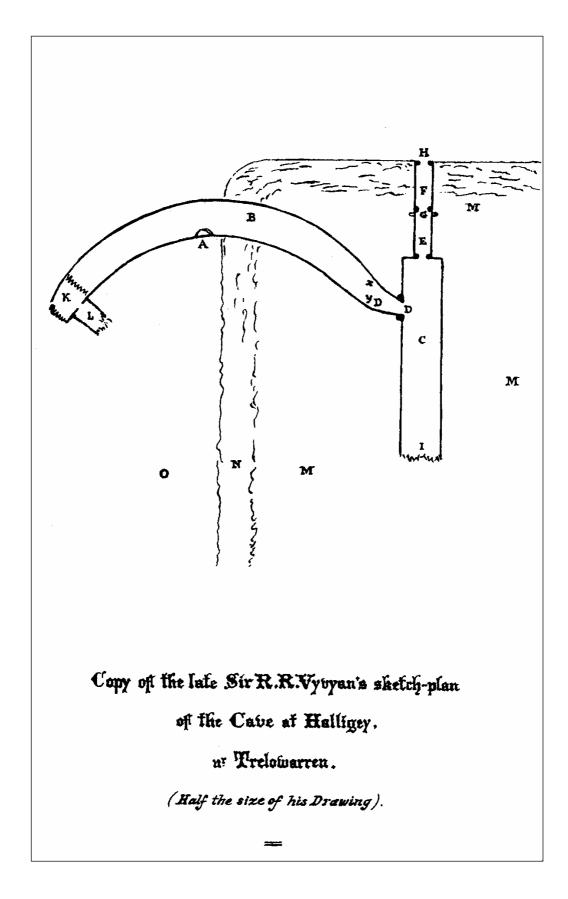
Fig 3 Revd Iago's copy of Sir Richard Rawlinson Vyvyan's plan, c1885

'A – Place where part of one of the side walls fell in:- the present entrance' (Vyvyan 1885, 256) – referring to his plan of the fogou (Fig 3).

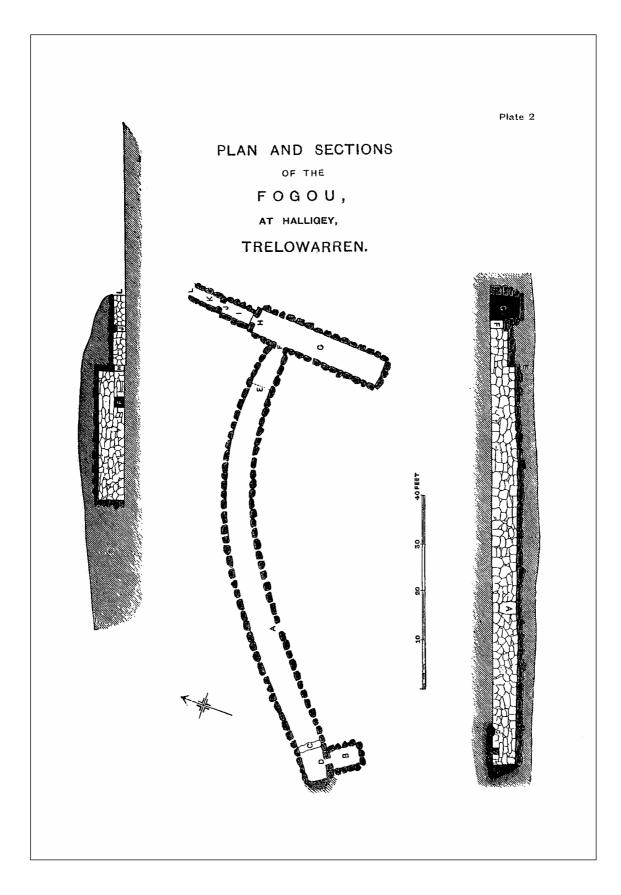
Fig 4 Plan and elevations by JT Blight, c1885

"The present entrance is A on the accompanying plan [Fig 4] - however this is not the original one, but simply a hole pierced in the side in modern times' (Blight 1885, 260).

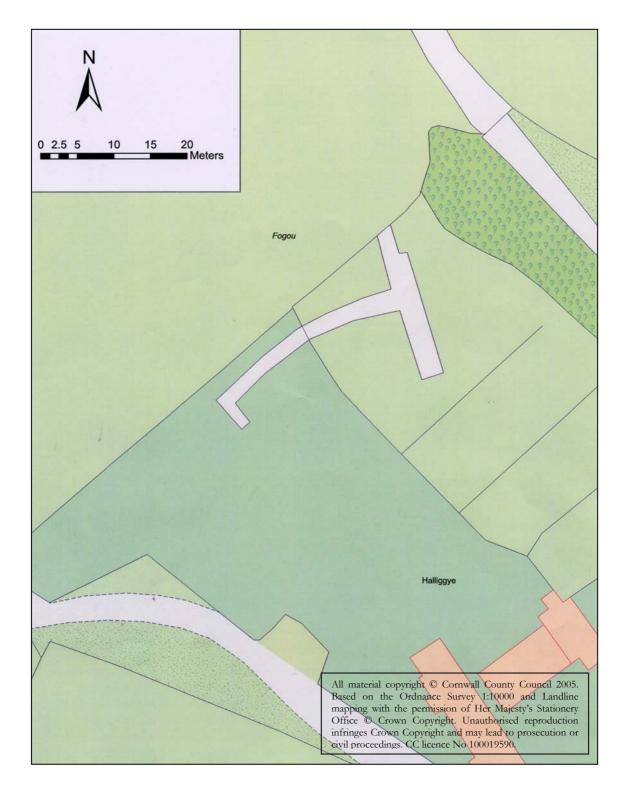
Fig 7 OS Landline mapping of the site

It proved unfeasible to carry out the sketch survey of the fogou and 19th century hole based on the OS Landline mapping as specified in the project proposal because field boundaries some 3m wide are shown as single lines on the Landline (Fig 7). After discussion with the FMW it was decided to undertake a total station (EDM) survey of the fogou and environs. Survey data from the instrument was drawn up using AutoCAD software and overlaid onto the Landline mapping and the 1982 survey of the fogou by Startin (Fig 8).

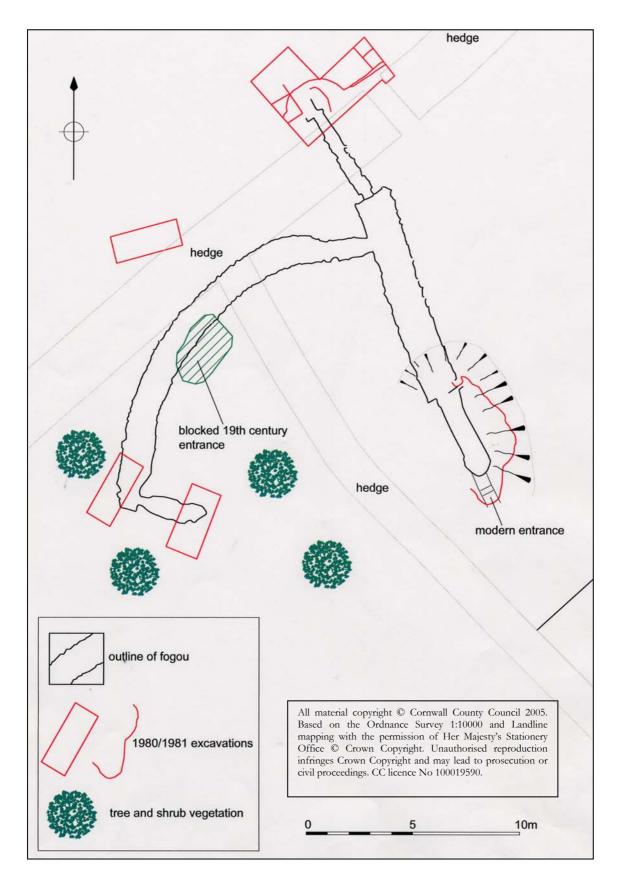
Fig 8 HES EDM survey 2005 overlaid onto Ordnance Survey digital mapping (2003) and Bill Startin's 1982 survey of the fogou

The conservation work did not disturb or damage the existing fabric of the fogou. No finds were recovered. The EDM survey indicated that the actual position of the fogou lies to the east of that shown on the Landline mapping and will be a useful tool in future management of the site.

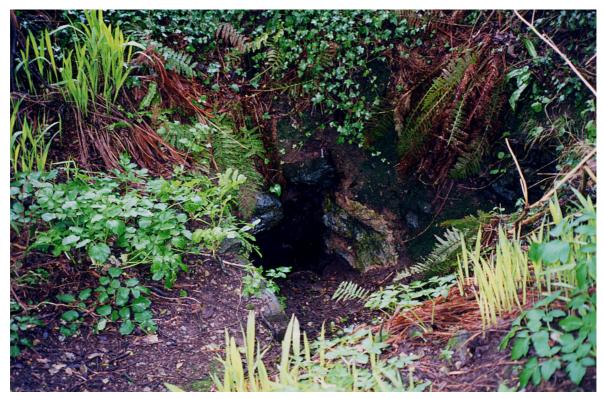
Fig 9 The 19th century hole in September 2004 (photo HES GDP/ antiquarian hole Sept 04)

The hole in the fogou wall was blocked using stonework that would blend with the existing walls of the fogou. The hole was backfilled with earth brought by wheel barrow from outside the scheduled area (Figs 9-13).

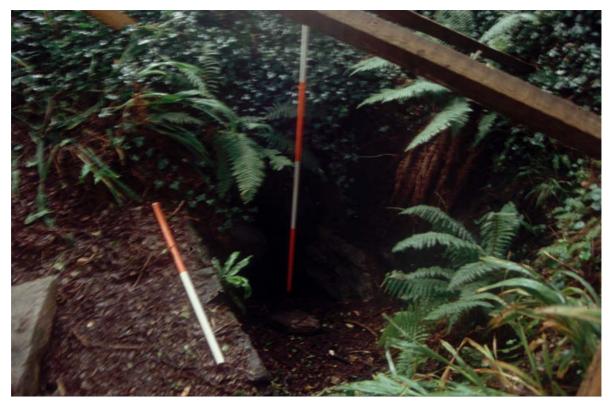
Fig 10 The hole just before blocking, November 2004 (photo: HES GCS 34692)

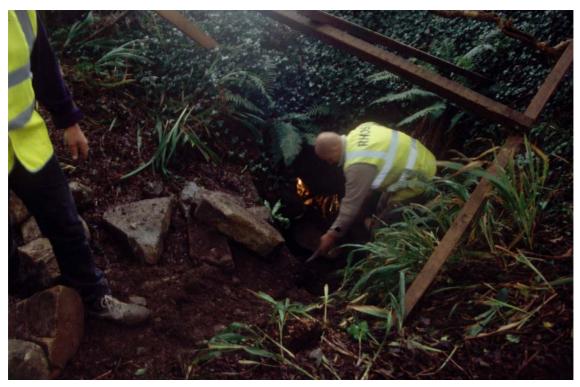
Fig 11 Blocking in progress (photo HES GCS 34698)

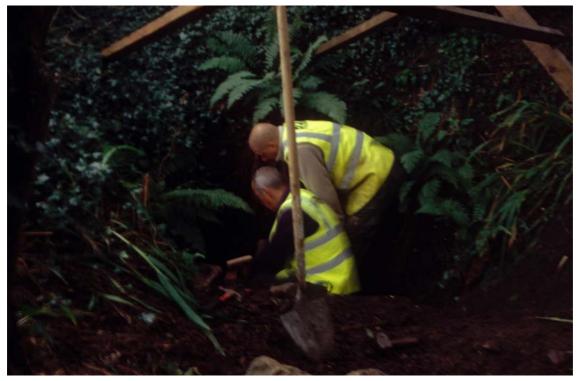
Fig 12 Blocking in progress (photo HES GCS 34696)

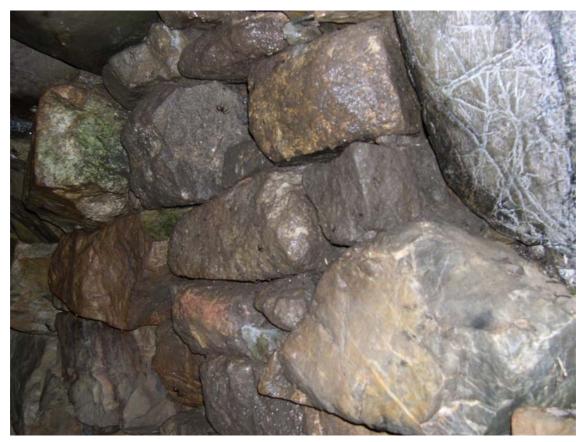
Fig 13 The stone blocking from inside the creep (photo HES GDP /0002)

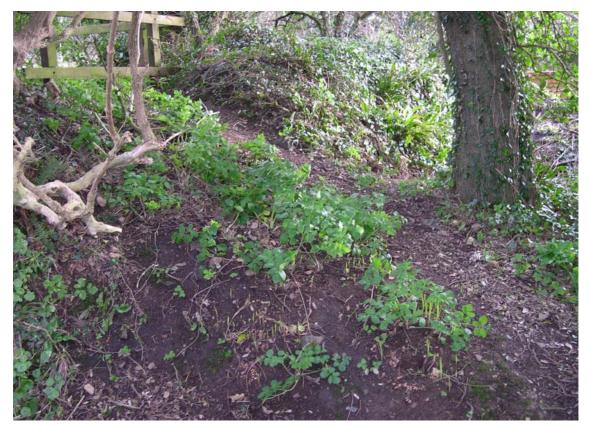
Fig 14 The site of the 19^{th} century hole, January 2005 (photo HES GDP / 00012)
