Perran Round, Perranzabuloe, Cornwall

Excavation to investigate root damage from gorse

A Report for the St. Piran Trust

Report No: 2005R020

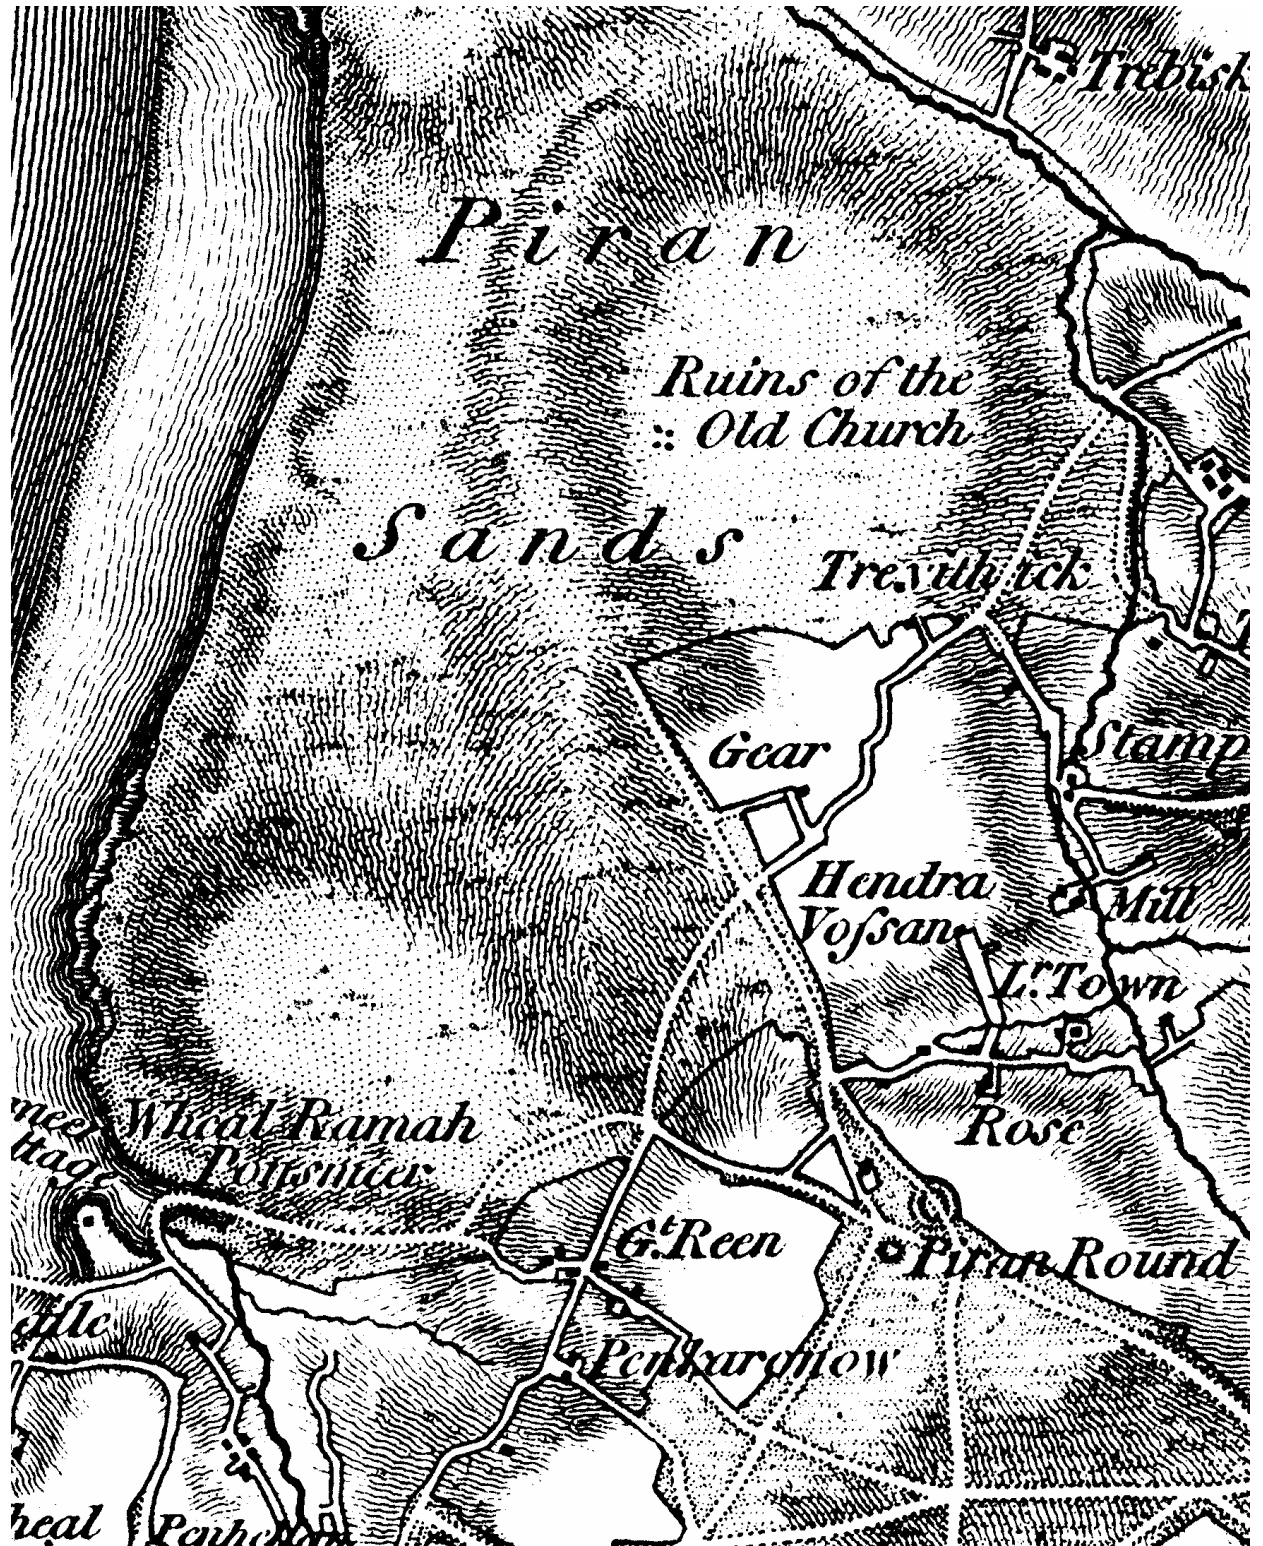
Fig 3 Perran Round in 1813 (from OS Map).

On the 1813 OS Map (Fig. 3), a roadway is shown as still extending through Perran Round, as well as a nearby route which is now the present road (B3285), leading from Goonhavern to Perranporth. To the east, there was enclosed land associated with the settlement of Rose

whereas to the immediate north-west and south of the monument the land was shown as unenclosed.
