# **Sancreed Churchyard Cornwall**

## **Repair and restoration of medieval granite wayside crosses**

Ann Preston-Jones

Report No: 2005R060

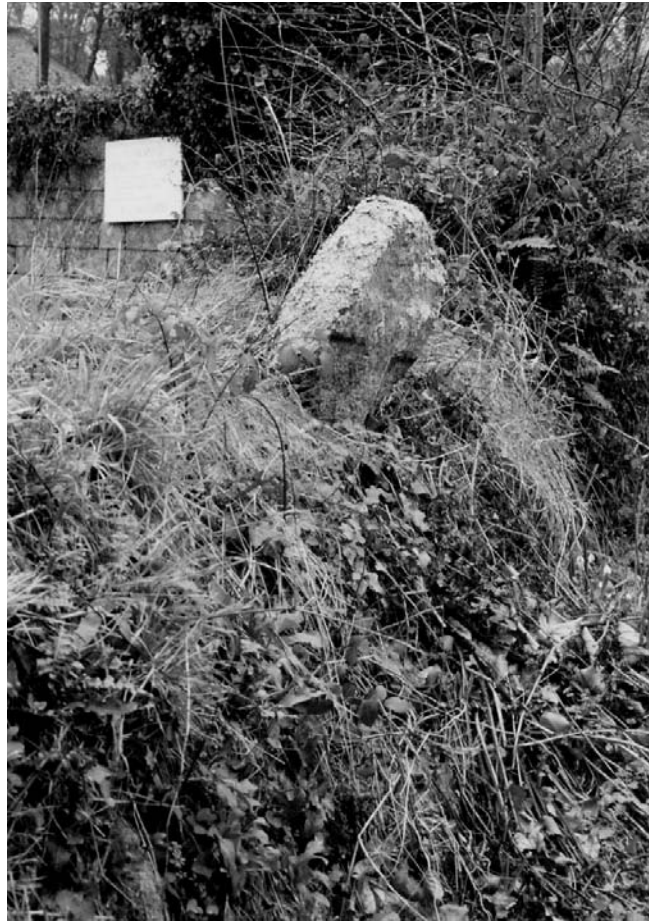
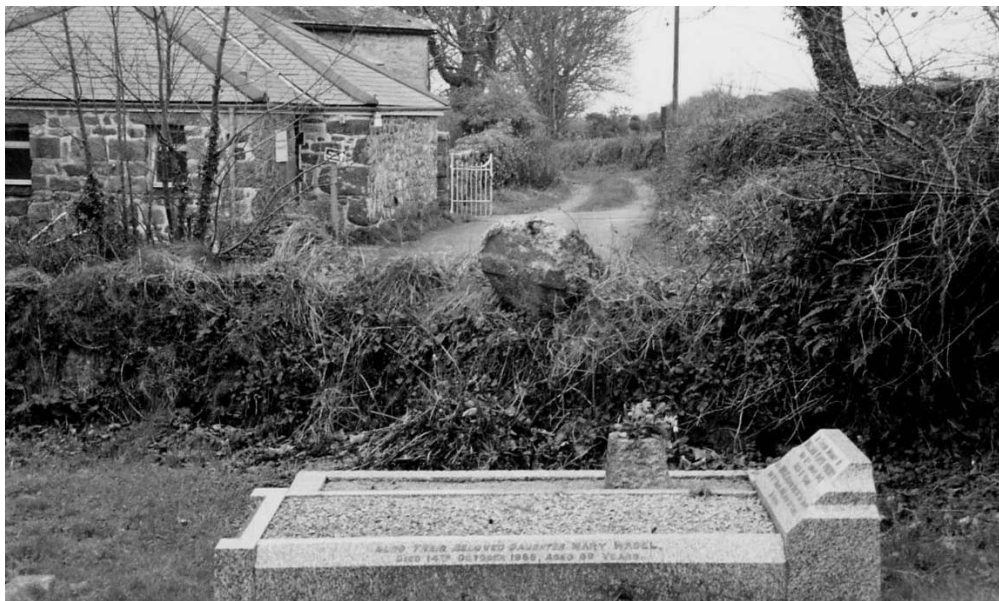
*Fig 7 The Anjarden Cross before conservation*

This cross was very loose and unstable, and leant at an angle of nearly 45 degrees from the vertical, into the graveyard extension. The problem was presumed to be the result of deterioration of the hedge into which it was set – the loss of the earth core causing a loosening of stones and lack of support for the cross.

The Anjarden Cross was lifted from the churchyard wall in July 2004, and taken back to the workshop at Nanquidno, to enable the new base to be properly cut and fitted for the cross. On December 22<sup>nd</sup>, 2004, it was finally restored to the churchyard. In order to achieve greatest stability, and to accommodate the shape of the chunky and rectangular new base, the cross was set in exactly the same location, but on the inner edge of the hedge, with the bottom of the base at about the ground level of the churchyard, and the cross facing into the churchyard. It remains visible from the road, however, as it stands up above the level of the top of the hedge by about half a metre (Fig ). Scrub was cut from the outer face of the hedge in order to improve visibility from this side.

The base, of granite, measures 1 x 0.55 metres wide and 0.18 m high. The cross now stands 0.83 metres above the level of the base, with 0.4 m of its shaft now visible – a considerable gain on the previous situation, giving the cross far more stature and presence than formerly, and making it quite a feature in this part of the churchyard.

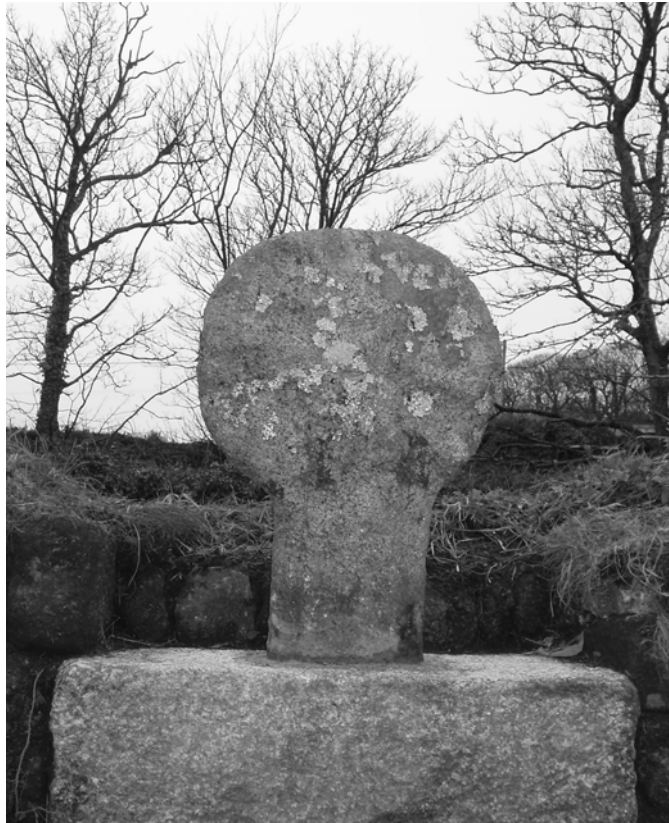
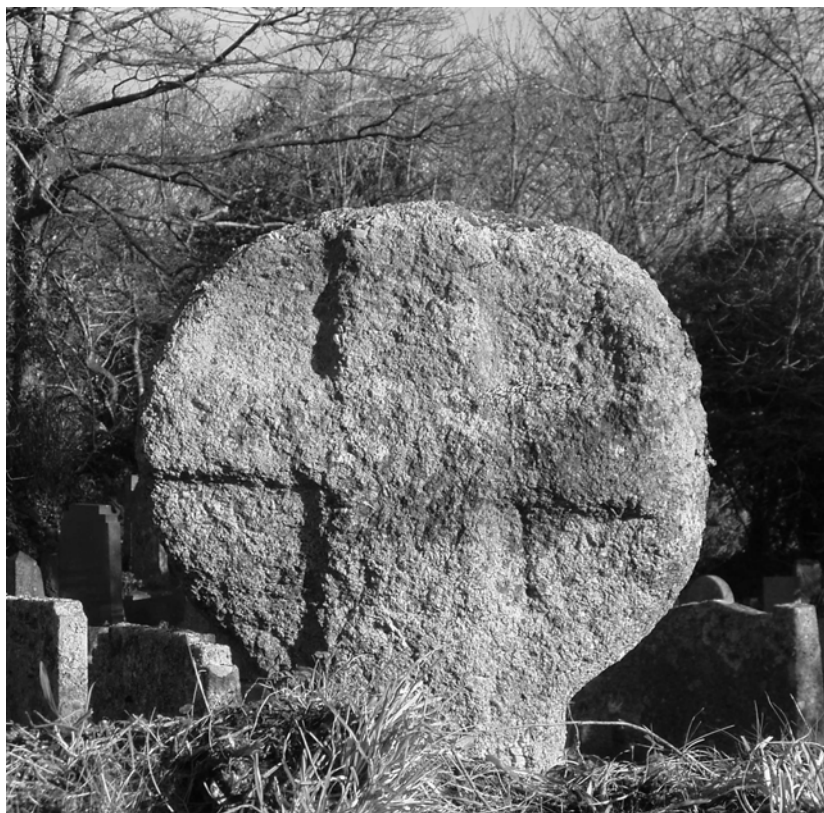
*Fig 12 The Anjarden Cross: restoration complete (above, from the churchyard and below, from the road)*

The significant new discovery about this cross was that the head is large and out of proportion in relation to the shaft which, apart from being narrow, has the unusual feature of a hollow chamfer. This chamfer, which can be seen clearly in Fig 12, blends smoothly into the cross head where, as Langdon notes, the whole of the head is sunk, so that there is no bead around the edge, as with the Sellan Cross. On the upper part of the head, however, vestigial traces of a former bead do remain. The narrowness of the shaft compared to the head, taken in conjunction with the chamfer, may suggest that the shaft has been re-cut to create this form, which is unusual for a wayside cross. Perhaps the lower part of the head was re-dressed at the same time, by removing any bead, in order to help the re-dressed shaft merge with the head. With a good light, possible slight traces of a former bead around the lower part of the head may be detected, though there is nothing

completely conclusive about this. The hollow shape of the chamfer would suggest a date in the later part of the medieval period: perhaps the 15<sup>th</sup> century.

The full length of the cross when out of the ground was found to be 1.06 metres (3 ft 6 ins); with the 0.28 x 0.18 metre wide (11 x 7 in) shaft completely parallel-sided, not tapering or uneven in any way as many crosses are: this may be a further indication of a re-cutting.

The Anjarden Cross is now entirely secure in its new position and because it sits in a solid base, it should not be at risk of collapsing from the hedge again. As noted above, it also looks a good deal more impressive than previously, and an additional gain is the fact that a good deal more of the cross is now visible, with its neat, possibly re-cut shaft a puzzle for future cross-enthusiasts to mull over.
