Chirgwidden Vean, Sancreed, Cornwall

Archaeological Assessment and Management Survey

Peter Dudley, BA, MA

Report No: 2005R082

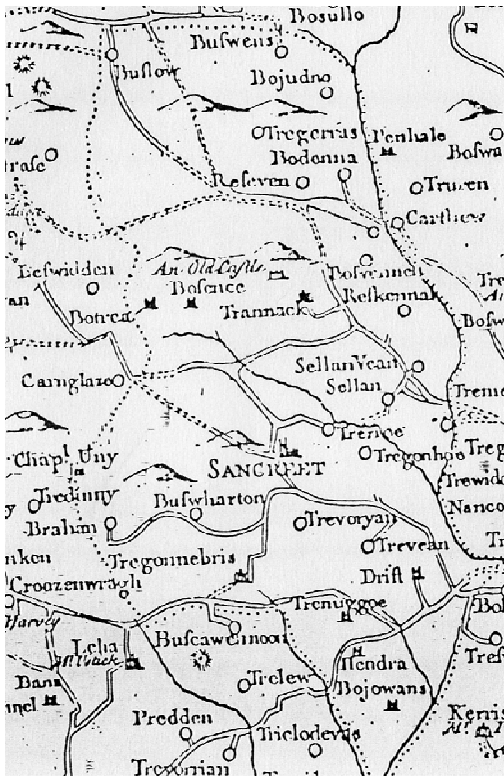
Figure 2, an extract from the Martyn map of 1745 showing Chirgwidden enclosure (Copyright reserved)

The enclosure itself was first recorded on the Martyn map of 1745 as 'An Old Castle' (see Figure 2). Farther to the north Martyn also records 'Choon Castle'. Chirgwidden settlement was not recorded although Trannack and Bosence were.

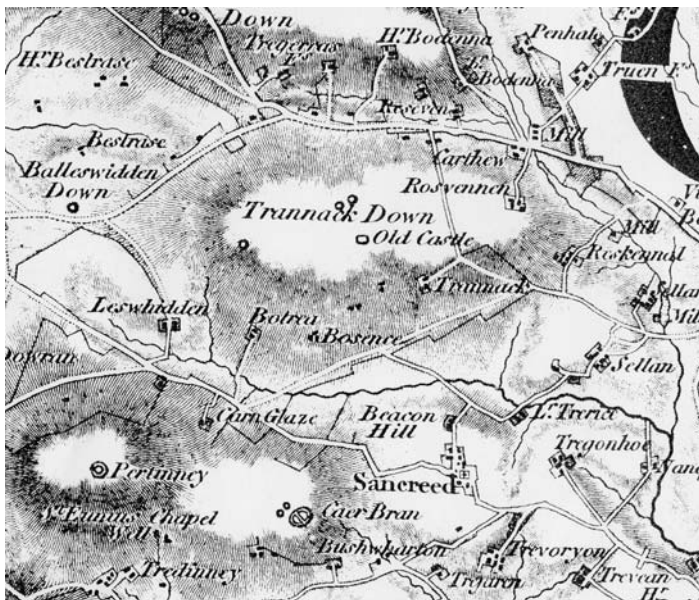
Figure 5, Extract from the 1813 OS map (Copyright reserved)

The OS surveyors' drawings of 1809 (Figure 4) and map of 1813 (Figure 5) record Chirgwidan as an 'Old Castle' on the seemingly unenclosed slopes of 'Trannack Down' (both maps recording an entire sub-rectangular enclosure).

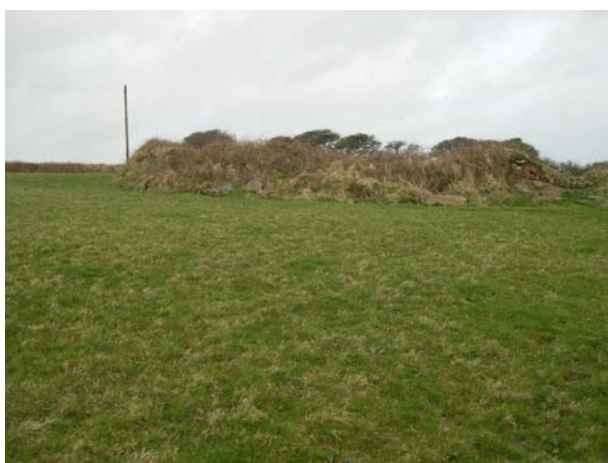
The ditch surrounding the rampart is visible on the ground as a subtle dip in the hillside $\approx 0.5\text{m}$ deep and $\approx 4\text{m}$ to 5m wide (from the base of the rampart). It is clearly visible on the northern and western sides of the site; the feature not evident on the southern side (as on the 1878 and 1908 OS maps). The feature is visible on aerial photographs and has been plotted by the NMP.

The 5 foot thick (1.5m) counterscarp recorded by Dr W Borlase in the 18th century and destroyed with the creation of the 19th century small holding (see WC Borlase 1871) is traceable as an ephemeral $\approx 0.2\text{m}$ high low earthwork on the western section of the ditch.

Figure 8, looking east to the western rampart of the enclosure. Note the slight dip of the ditch in front of the rampart

The ditch and remains of the counterscarp are currently under pasture and are occasionally ploughed as part of the field. The features would be best preserved under permanent pasture or a 10m arable margin.

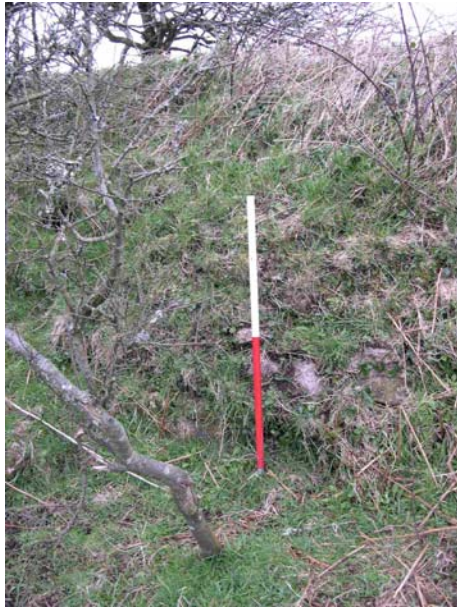
The most conspicuous feature of the Chirgwithden enclosure is its sizeable rampart which survives to between 2m to 3m high externally (see Figure 8 above), and 1m to 1.6m high internally. On its north and western sides the rampart is a steep sided ($>60^\circ$) stone and earth bank, except where recent erosion has spread the bank (see Figure 22). The odd moorstone block removed during modern field clearance and improvement has been placed at the base of the external rampart (see Figure 15). Internally, short sections of internal walling faced with granite rubble survive up to 1.2m high (see Figure 9).

Figure 9, a better preserved section of the interior wall facing on the northern rampart

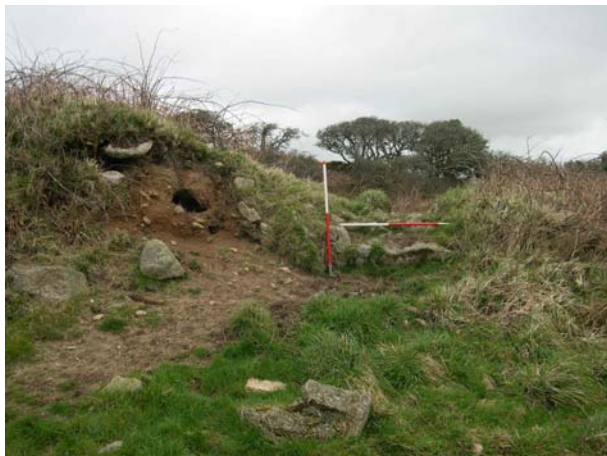
While a large breach in the south western corner of the rampart has been affected by modern rabbit activity, the original damage here appears to date to the creation of the entranceway *8 (as part of the creation of the 19th century small holding). Here a short length of drystone walling up to 0.4m high (externally, see Figure 10) has been built to block the gap. This overlies the internal rab fill of the rampart and was probably built to make the garden to the west of the buildings *3 and *4 stockproof.

Figure 10, looking eastwards to the damage to the rampart on the south western corner of the enclosure. Note the low walling which may date to the 19th century and the exposed rab infill of the rampart.

Although the vast majority of the rampart survives in good condition there are three areas of active erosion by livestock (see Figure 22). These areas could be cleaned up under archaeological supervision so that any remaining walling or features can be recorded. A few mature thorn trees cover the banks but appear to be causing little damage (and probably dissuade stock from climbing certain sections of the rampart). In other areas the bank is covered by brambles and bracken but appears to be kept under control by the grazing and movement of livestock. An electric fence running around the base of the exterior and interior side of the rampart would help to prevent animals running over the bank. Any developing scrub on the top of the ramparts could then occasionally be cleared as part of the maintenance of the electric fence.

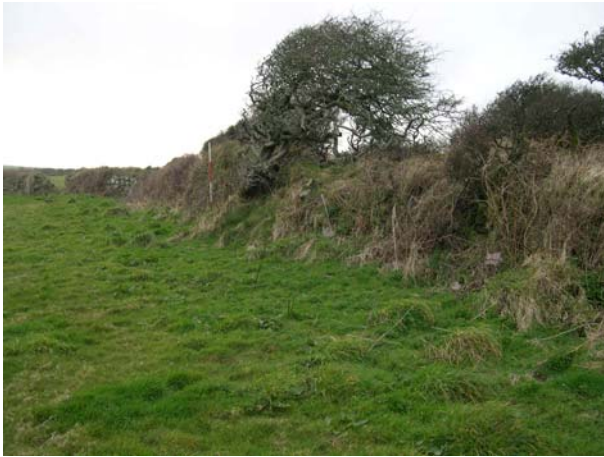
This survey suggests that the southern side of the inner rampart still survives fossilised in the hedge line. Differences in the facing together with the curvature of the boundary and the difference in thickness and vegetation, help to distinguish it from the later lengths of Cornish hedging to its east and west. The OS landline doesn't pick up the difference in curvature of the boundary well and is more obvious from aerial photographs and ground photos (see below).

Figure 11, looking westwards across the remains of the southern rampart.

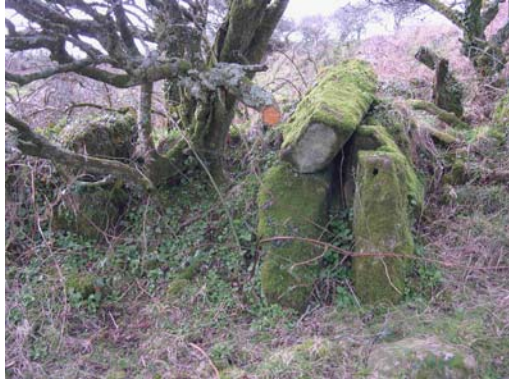
the building measures 6.4m long and 3.9m wide with a possible internal sub-division visible as a line of stones \approx 0.1m high. On the western side of the building is an *in situ* granite orthostat 0.8m high with a 0.07m deep drill hole towards its top, behind which is a second granite orthostat, with two recumbent stones close by; the stones perhaps marking the remains of the fireplace.

Figure 12, showing the possible fireplace and niche to the left (occupied by the tree) perhaps for a cloam oven

Close to the south western return of the wall the facing of an internal niche is visible perhaps marking the site of a cloam oven. On the southern wall of the building a 1m wide doorway is marked by a granite door jamb and a large granite boulder (which was incorporated in to the wall fabric)

The interior of the building has a number of hoof prints and has been churned up in the past presumably by cattle seeking shelter under the thorn trees which surround the site. The eastern wall (collapsed bank) of the building is covered by dense young thorn growth whilst the interior is open and easily accessible, low branches of the mature thorn trees hang down. The walls are grass covered with some patches of encroaching brambles.

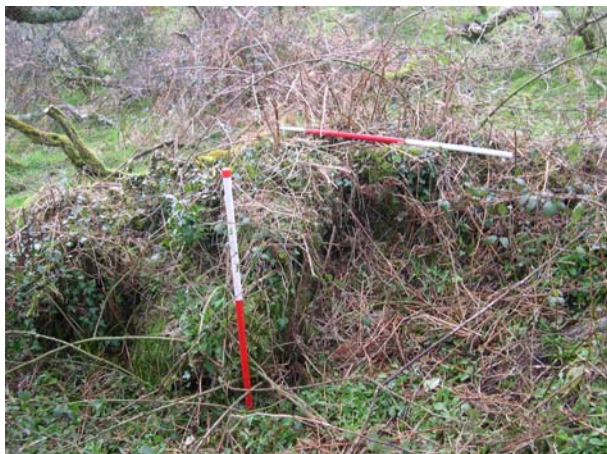
All that survives of this building is a return of walling \approx 0.6m high of two skin granite rubble construction. The building was recorded on WC Borlase's 1871 survey of Chirgwidde and was cut in to the enclosure bank, the building opening up to the compartment recorded as a waste place for pigs; the structure presumably a small shelter for livestock.

*Figure 13, showing the remaining walling of building *4*

The remaining walling survives in good condition and is covered by brambles and ivy; the interior of the building covered by brambles and bracken (although quite clear in late winter) could be occasionally cleared using hand tools.

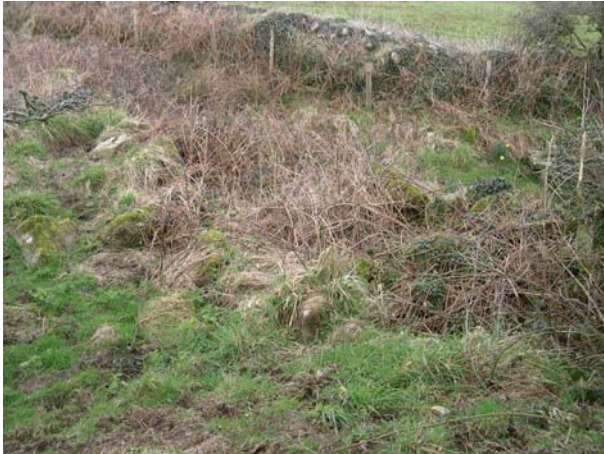
The remains of the two conjoined 'crows' recorded by WC Borlase in 1871 and the OS maps of 1878 and 1908 survive in a dilapidated but reasonable condition. The features are cut in to the hillslope (possibly within the original curve of ditch), their granite rubble walling surviving between 0.3m and 0.6m high. A 0.9m high granite orthostat with a drill hole on its exterior side, and a corresponding drill hole on the walling on the northern side, clearly mark the entrance of the southernmost crow. The doorway of the northernmost crow is marked and blocked by a fallen granite orthostat.

The interior of the crows are filled by loose granite rubble, the probable remains of their corbelled roofs.

Figure 14, the bramble choked interior of the crows viewed from the south

The features are clearly visible and have been recorded on modern OS landline data. Their interiors are covered with brambles and any future management should seek to reduce the present cover of brambles and prevent any thorn trees from establishing within the interior or on the walls of these interesting features.

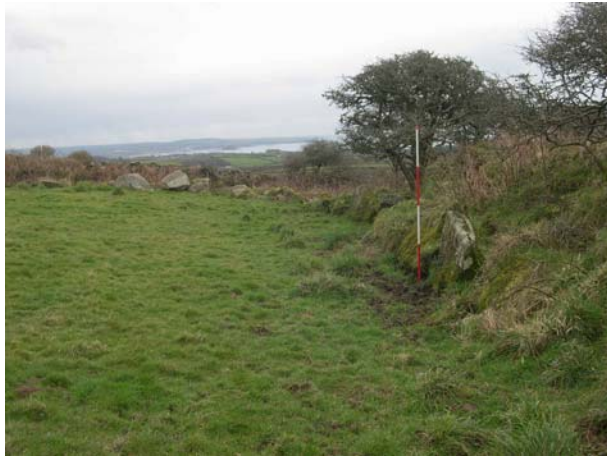
Figure 15, the northern rampart of the enclosure looking eastwards towards the cleared stone

The stones are an interesting landscape feature demonstrating the clearance of former moorstone to create easier ground to cultivate and could be used to provide stone for boundary repairs. If not, these could be left in place.

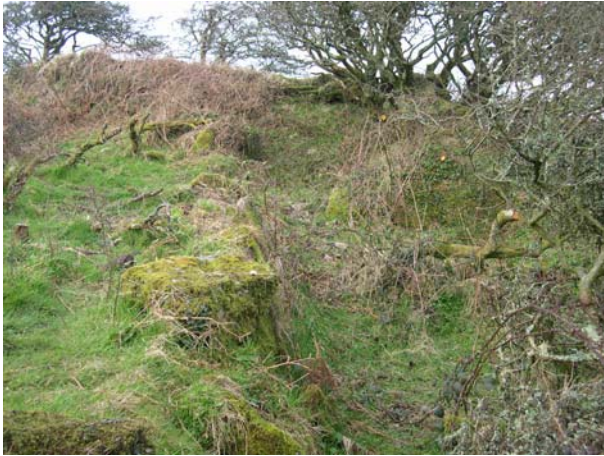
for pigs'; its western boundary recorded on both the 1878 and 1908 OS maps. The western boundary drops $\approx 0.5\text{m}$ from the interior of the enclosure to the west and is lined with large granite orthostats set end-to-end on edge. The stones apparently taken from the ramparts of the enclosure (see H, Figure 8).

Figure 16, looking northwards along the granite orthostats marking the western boundary of the reduced ground.

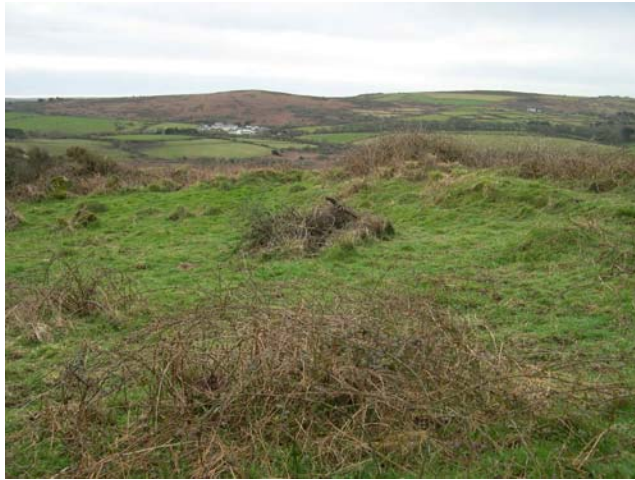
The area covers the largest part of the Chirgwiddden enclosure site and is the most open. On its western side the area is open grass with encroaching brambles close to the rampart. On its eastern side there is a scatter of mature thorn trees and patches of brambles and bracken. The encroaching scrub and majority of the thorn trees could be removed by hand and the area seasonally grazed. The mature thorn tree on the northern side of the area should not be removed. A number of piles of recently cleared thorn trees should be removed and disposed of or burnt away from the interior of the site.

Figure 17, looking southwestwards to Sancreed Beacon across the interior of the enclosure. Note the brambles in the foreground and the pile of thorn cuttings in the mid ground.
