# **Barn at Trehan, St Stephen, Saltash Cornwall**

## **Historic building record**

<b>Client</b>	<b>Richard Kingsnorth</b>
<b>Report Number</b>	<b>2011R130</b>
<b>Date</b>	<b>December 2011</b>
<b>Status</b>	<b>Final</b>
<b>Report author(s)</b>	<b>Jo Sturgess</b>
<b>Checked by</b>	<b>Nigel Thomas</b>
<b>Approved by</b>	<b>Jacky Nowakowski</b>

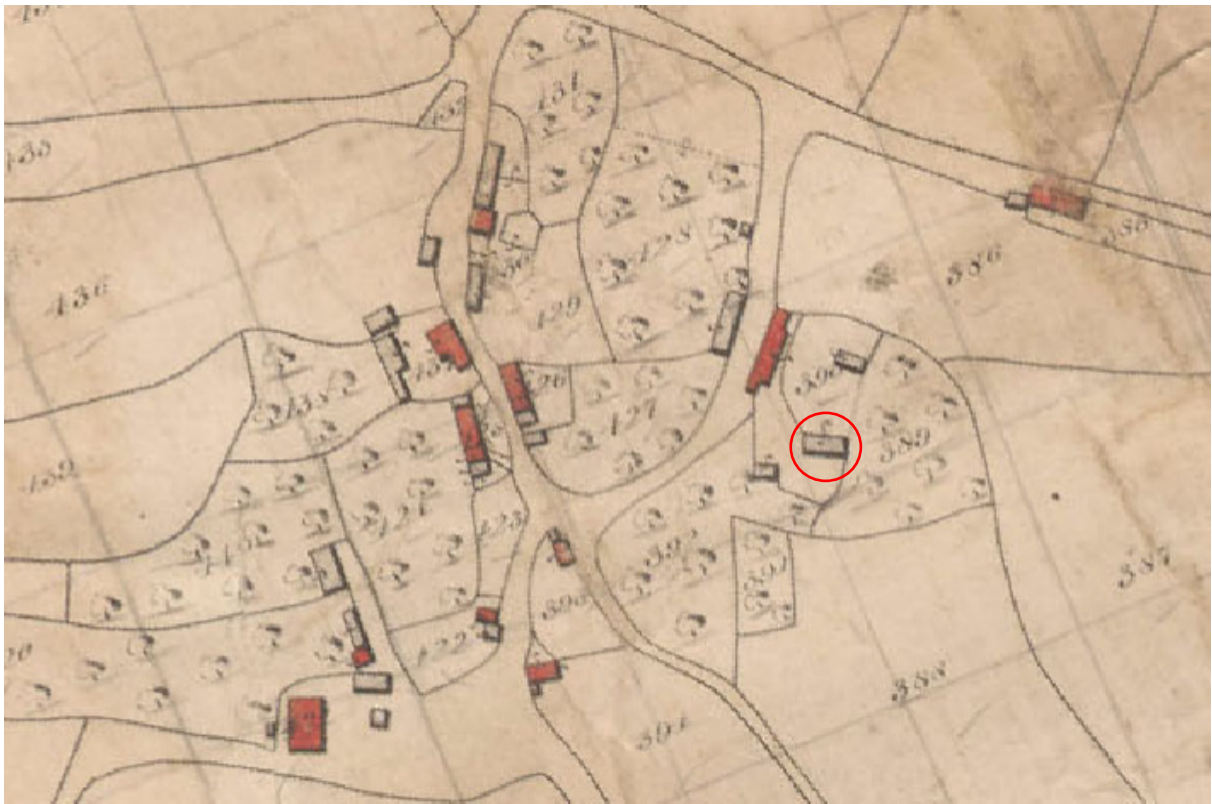
*Fig 4 Parish Tithe Map for St Stephen-by-Saltash, c1840*

The first available map to show a detailed plan of the village is the Tithe map of c1840 (Fig 4). This shows the barn as a simple rectangular building with no extensions towards the southern side of an enclosed yard containing four buildings. On the northern side of the yard another farm building is shown (still *in situ*) and another smaller building to the south-west of the barn (no longer extant except the south-west corner fossilised in the remains of the yard wall). A farmhouse or row of cottages (no longer extant) is depicted to the north-west of the barn fronting the road. To the east, south and west of the yard orchards are shown along with a small enclosure to the south listed as a herb garden on the Tithe Apportionment. The owner at this date is listed on the Apportionment as James Buller and the occupier (of the whole village) as John Williams. The yard containing the four buildings is described as 'houses, curtalage and mowhay'.

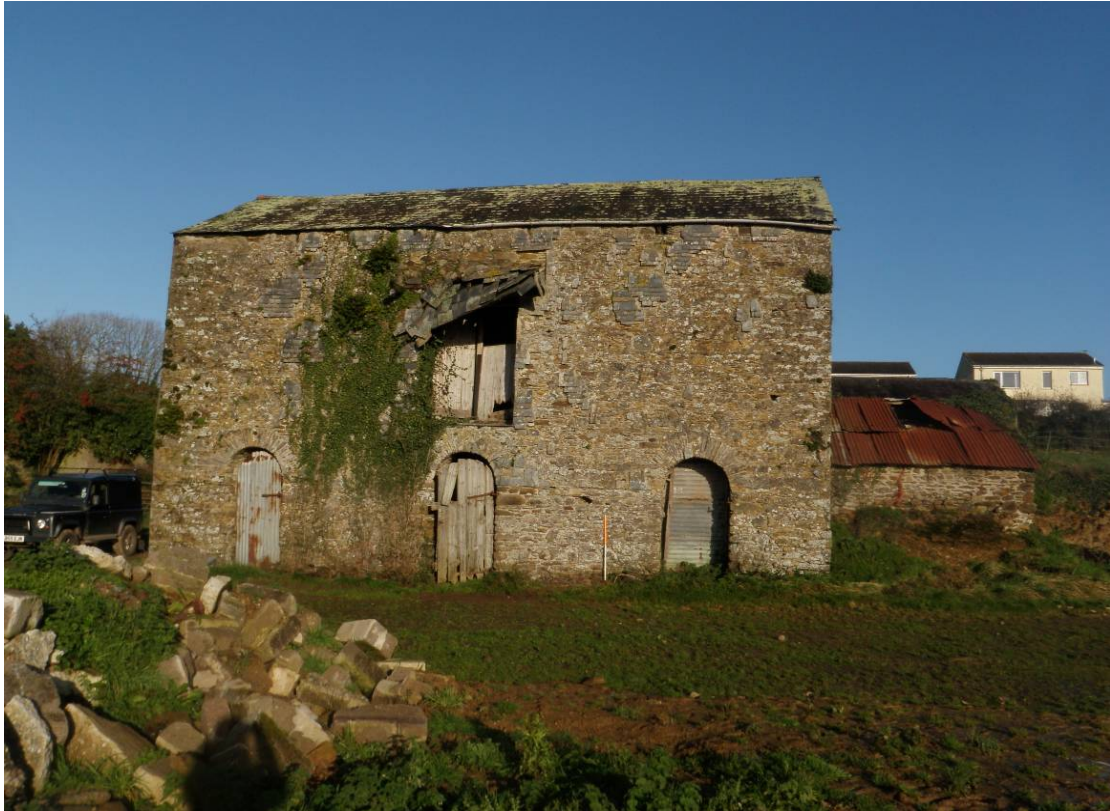
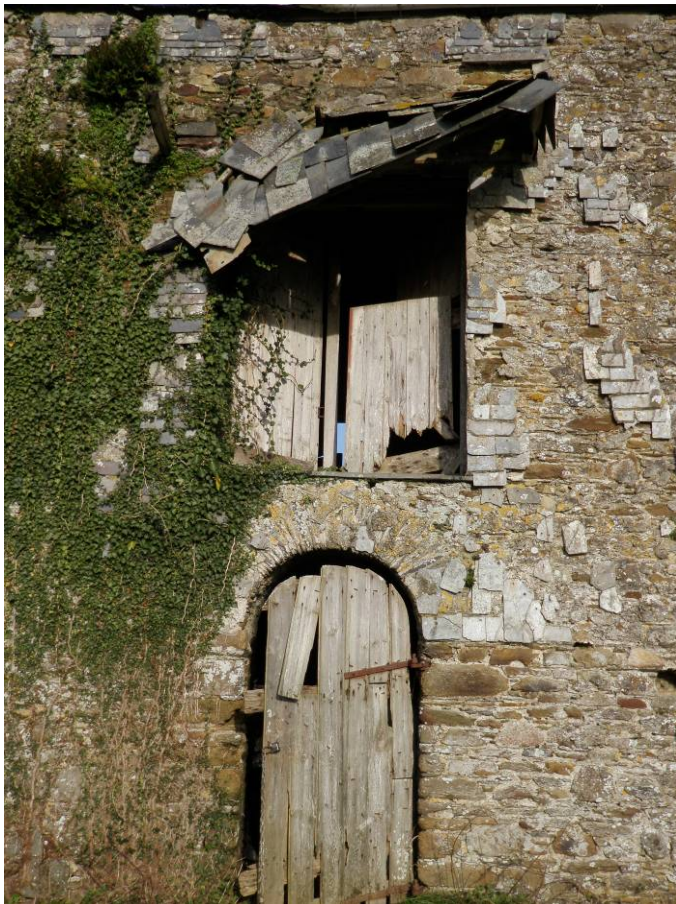
*Fig 7 Exterior south (front) elevation*

This elevation of the barn has three arched door openings of equal size on the ground floor and one threshing door opening on the first floor, all of which are original. The central ground floor door opening retains its original timber planked door and slate threshold whilst the other two ground floor doors have been replaced with corrugated iron sheeting. The first floor threshing doors are original planked, split doors and above them is a timber hood structure with a slate covering, and below, a slate threshold. At a later date slate hanging was applied to this elevation from a level at the springing of the door arches on the ground floor right up to eaves level. Most of the slate is now missing but small areas remain *in situ*.

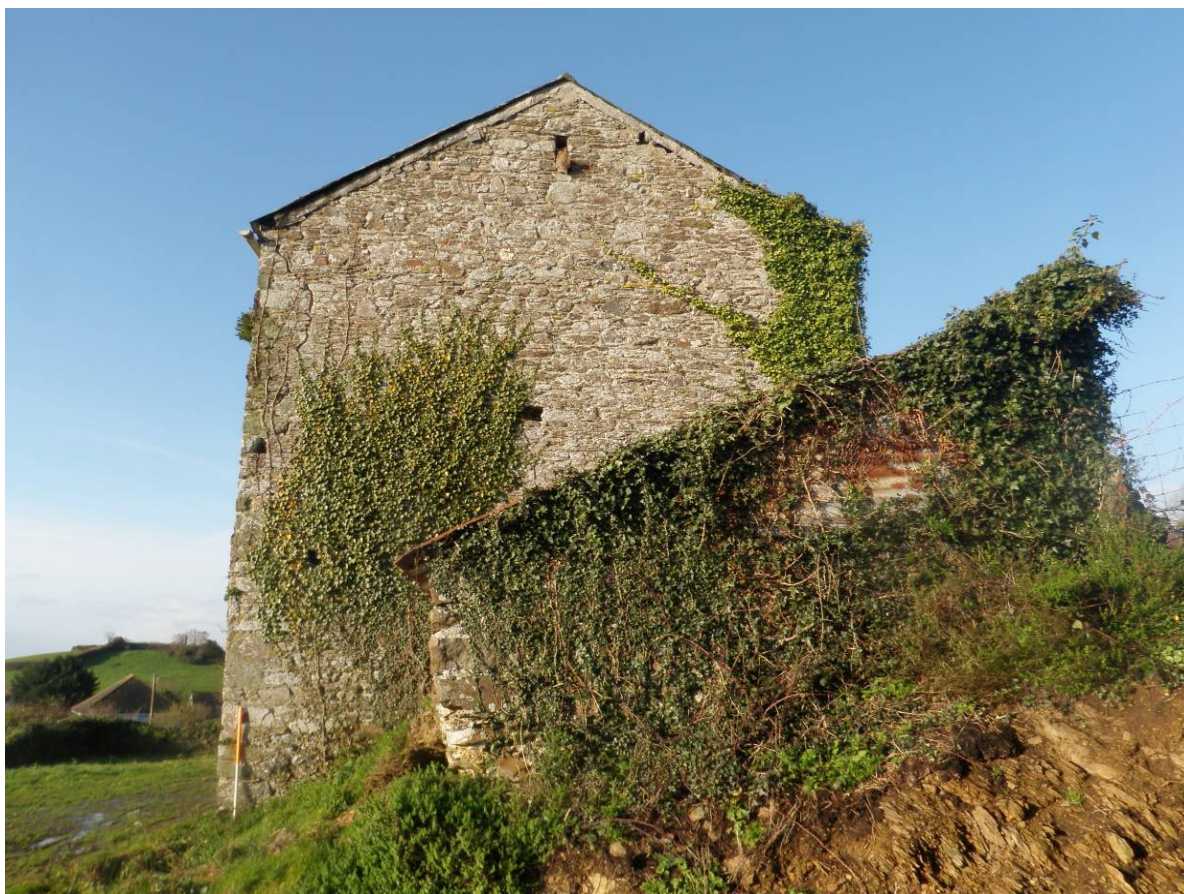
*Fig 9 Exterior east elevation*

The east end of the barn was originally a plain wall with two slit ventilator openings (still *in situ*), one at ground floor level and the other close to the apex. However, in the early 20<sup>th</sup> century when the root house was added, a door opening was inserted at ground floor level at the north end of the wall giving access from the root house providing a feeding passage at the rear of the cow house. Three sockets inserted in the original wall face indicate the position of the roof timbers for either an earlier pitched roof lean-to structure or, perhaps the roofline intended for planned extensions to the barn. The root house, a single storey building (with roof sloping from north down to south) obscures part of the original exterior elevation and is terraced into the natural slope on the north side to a depth of approximately 1.5m below ground level. There is a small window opening towards the north end of its east elevation with a timber lintel (now obscured externally by corrugated iron sheeting).

Adjoining the cow house at the eastern end of building is the lean-to root house added in the early 20<sup>th</sup> century (Figs 9-10, 20-21 ). Internally it is a small square building and has a rock-cut floor. The original slate roof has been replaced with corrugated metal sheeting. There is a wide chute opening in the north wall, an inserted door opening with timber lintel in the west wall leading through to the feeding passage in the cow house, and a small window opening with timber lintel in the east wall.

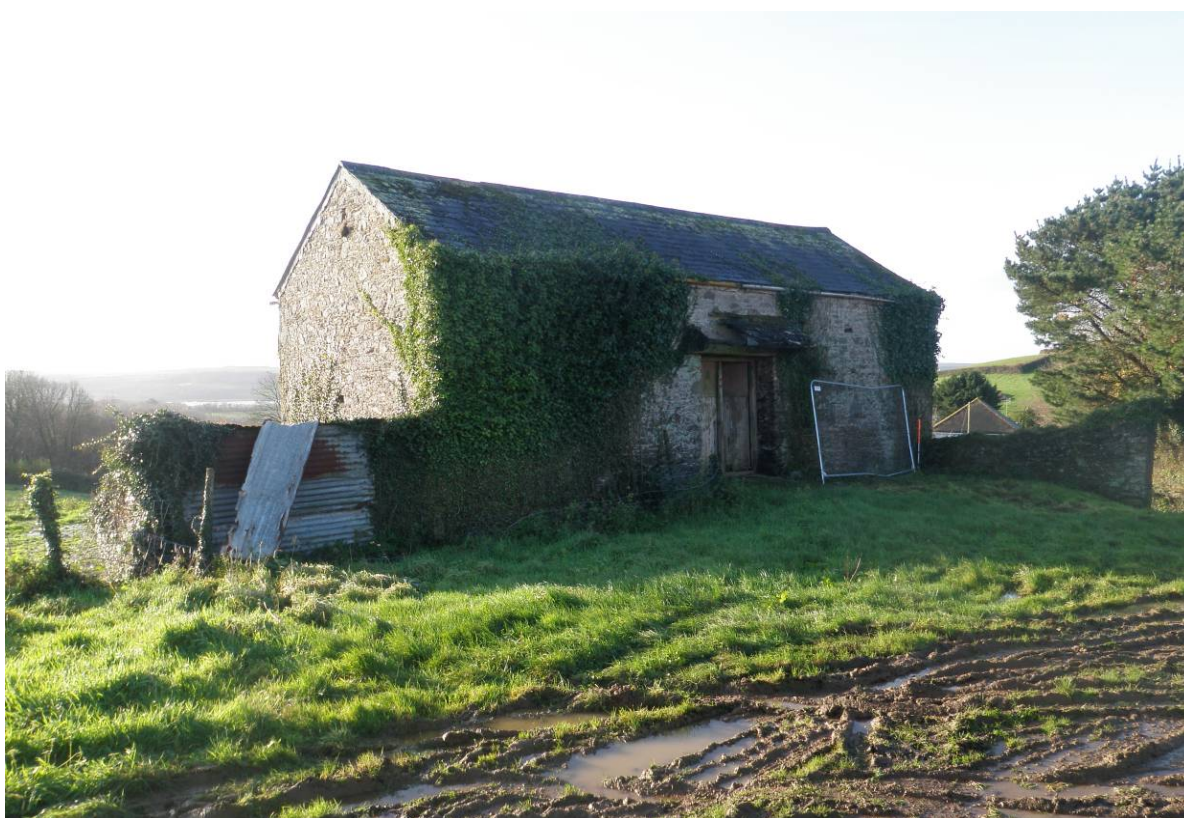
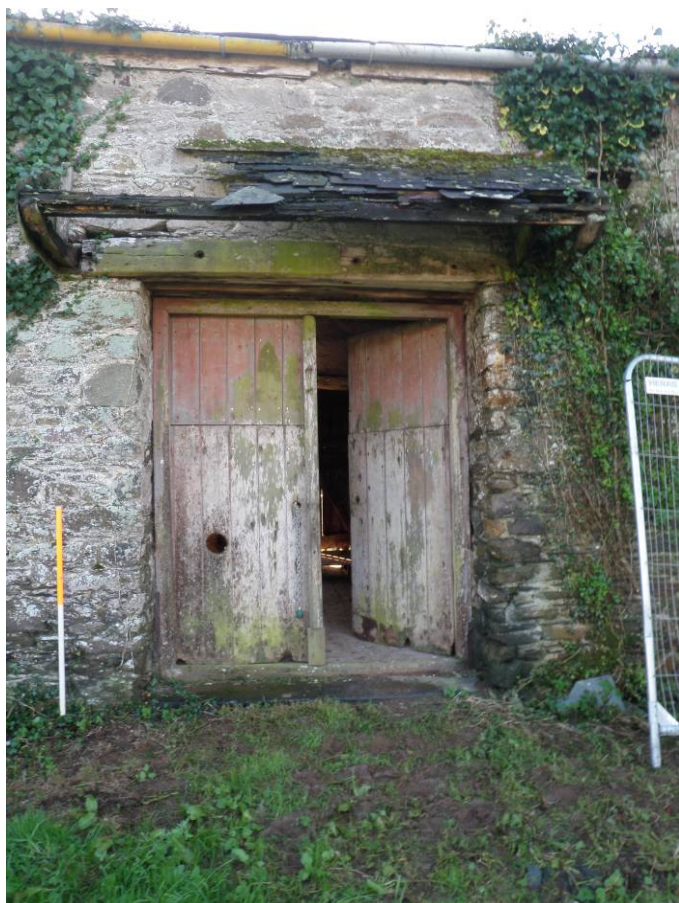
*Fig 10 Exterior north (rear) elevation*

This elevation includes the first floor level of the barn itself, the lean-to engine house to the west and the lean-to root house at the east end. This rear elevation of the barn was originally exposed to ground floor level. There is a centrally set threshing door opening

at first floor level of the same dimensions and design as the opposing door on the front (south) elevation. The opening has a slate threshold, reused (probably 18<sup>th</sup> century) timber lintel and 19<sup>th</sup> or early 20<sup>th</sup> century timber hood structure with a slate covering. The split threshing doors are original with original hinges. To the west of the threshing door opening is the location of the former engine house; a lean-to structure added in the late 19<sup>th</sup> or early 20<sup>th</sup> century when the ground level here was raised. The surviving west wall of the structure adjoins the barn at its western quoin and two of the sockets for its roof structure are visible inserted in the barn wall (a probable third to the west is obscured by ivy). Immediately to the west of the threshing door hood covering there is an inserted opening for a drive shaft to transmit power into the barn and on the ground directly in front of the barn wall the machine base for the engine remains *in situ*.

At the eastern end of the barn wall is the root house. The elevation of the root house has a single wide chute opening used for tipping root crops for cow fodder directly into the store.

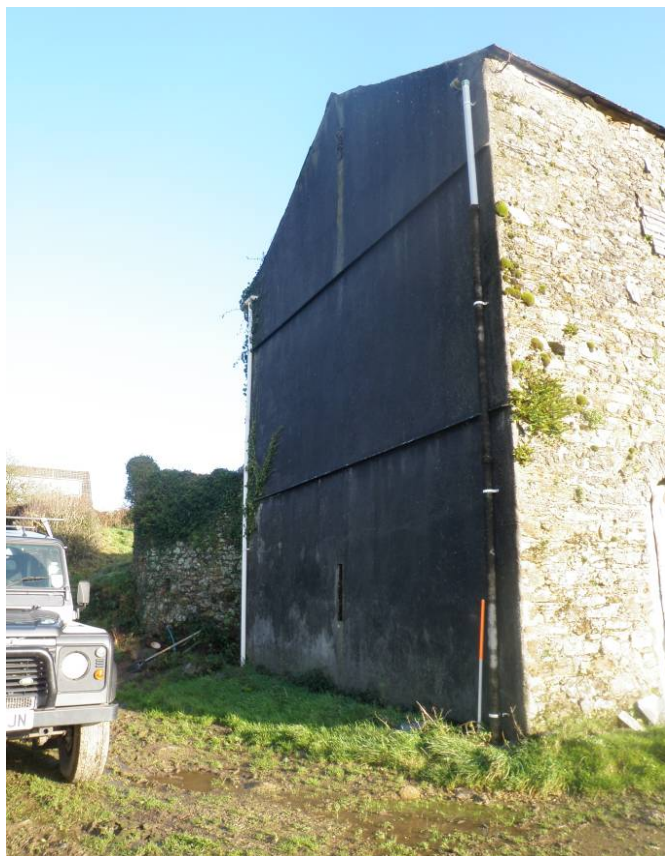
*Fig 12 Exterior west elevation*

This is the west gable end of the barn and includes the remains of the west wall of the engine house. The elevation of the barn has been covered entirely with modern cement render and there are two added modern downpipes at each quoin. There are two original slit ventilator openings, one set centrally at ground floor level and the other set centrally just below the apex of the roof. The west wall of the former engine house abuts the northern quoin of the barn and is set at a slight angle to it. This performs as a retaining wall for the built-up ground behind it to the east. The wall does not survive to its full height. At approximately 0.8m from ground level just off centre to the north is a small square drainage opening.

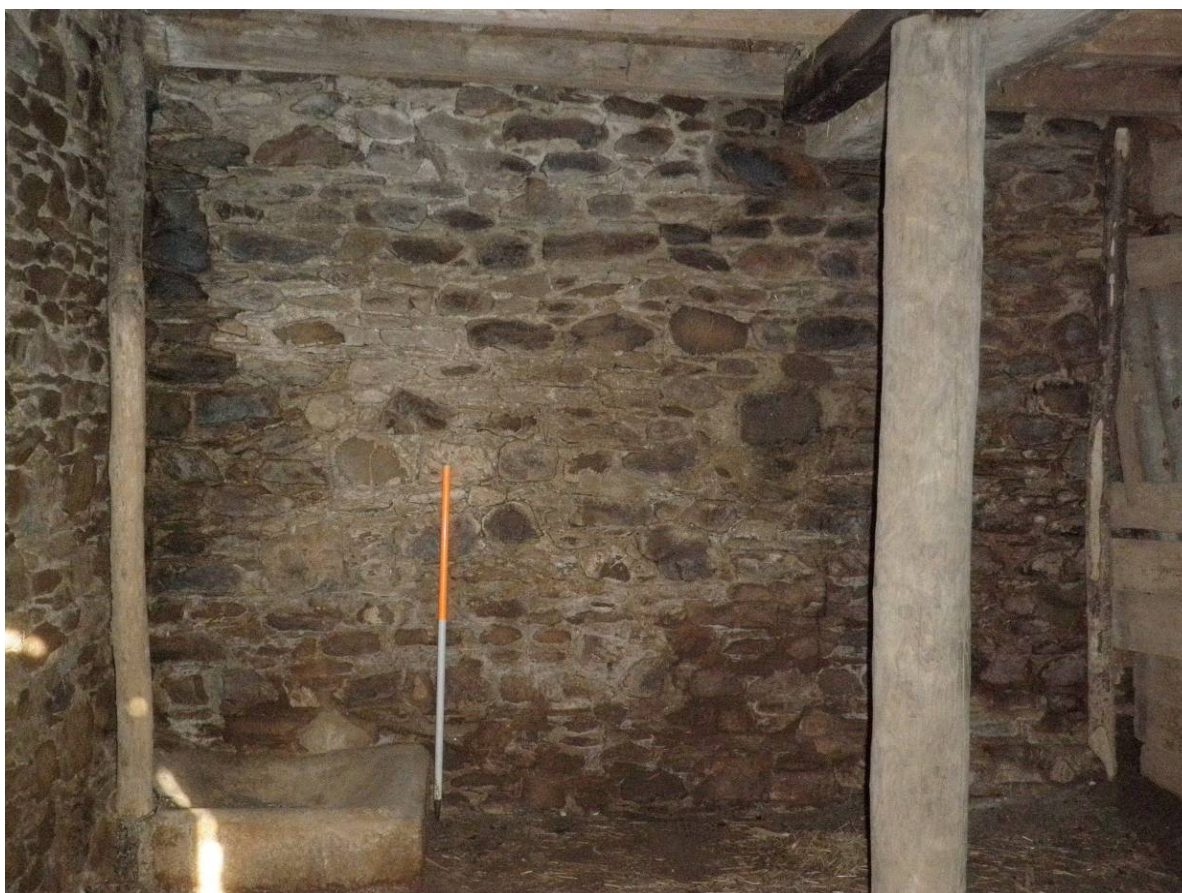
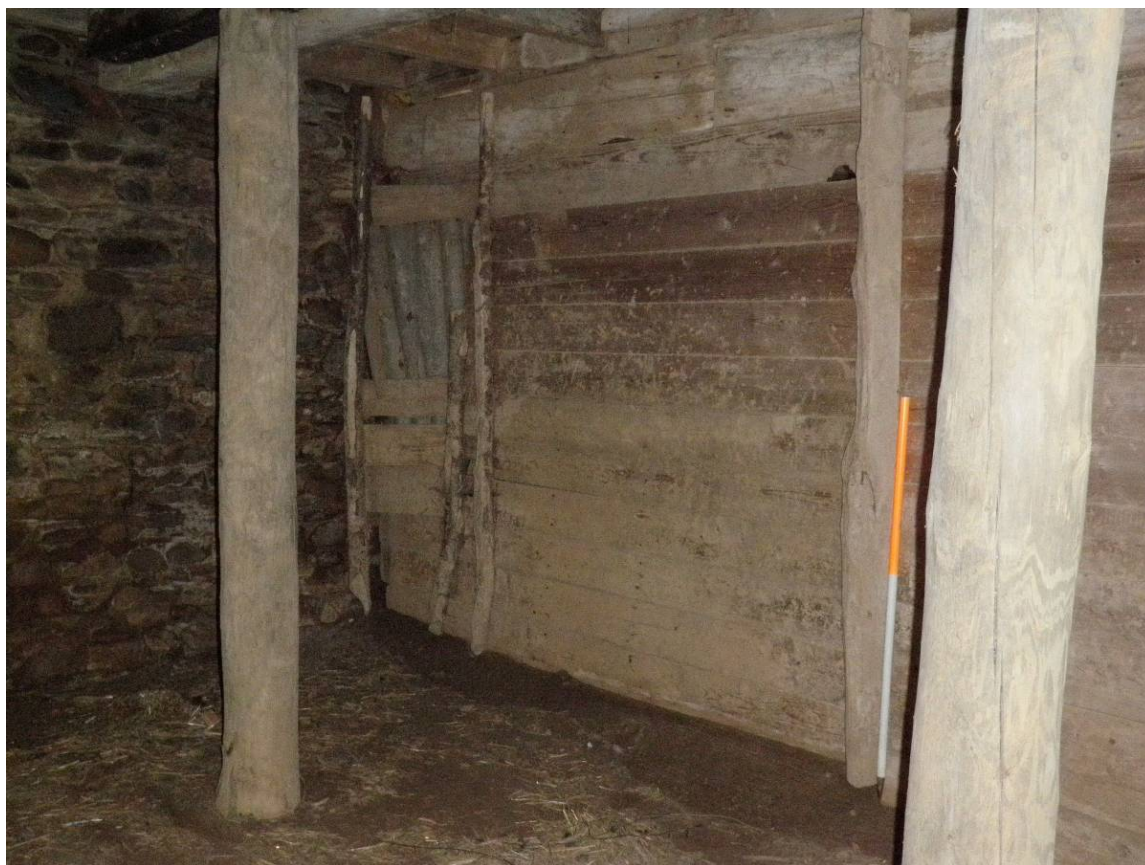
*Fig 14 Interior of west ground floor room showing area of probable rebuild in north wall*

The interior of the barn is divided into two room spaces by a timber planked partition wall towards the western end of the building creating a smaller room at the west end. This smaller room (Figs 14 and 15) may have functioned as loose box, animal house or store originally. There is now a concrete feeding trough in the north-west corner of the room and the earlier cobbled floor has been removed and replaced with concrete. The room is accessed from the exterior via an arched door opening at the western end of the south wall and also from the cow house through a door opening at the south end of the partition wall. In the west wall there is a splayed slit ventilator opening and in the north wall there is an area of walling which appears to have been rebuilt. It is possible that there was originally a window here which was removed when the ground level to the north of the building was built up to first floor level. Two modern timber pillars have been inserted to give extra support to the first floor structure.

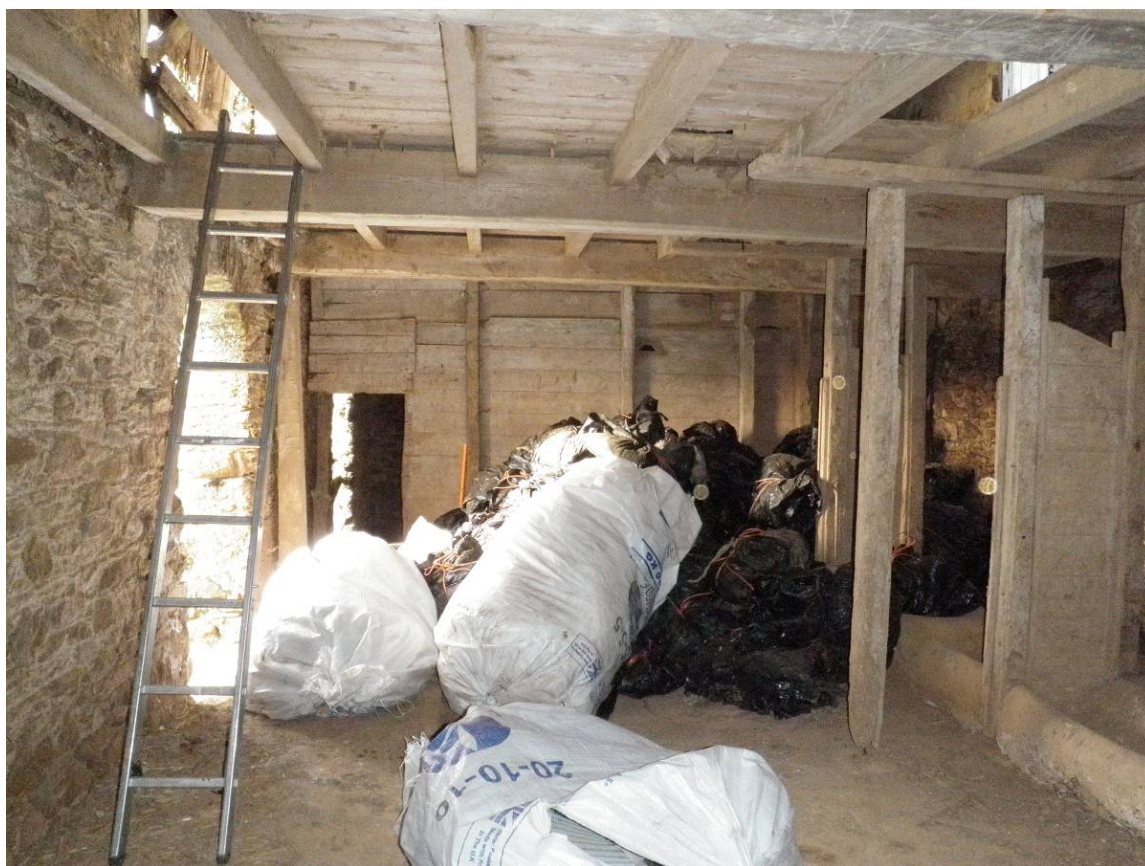
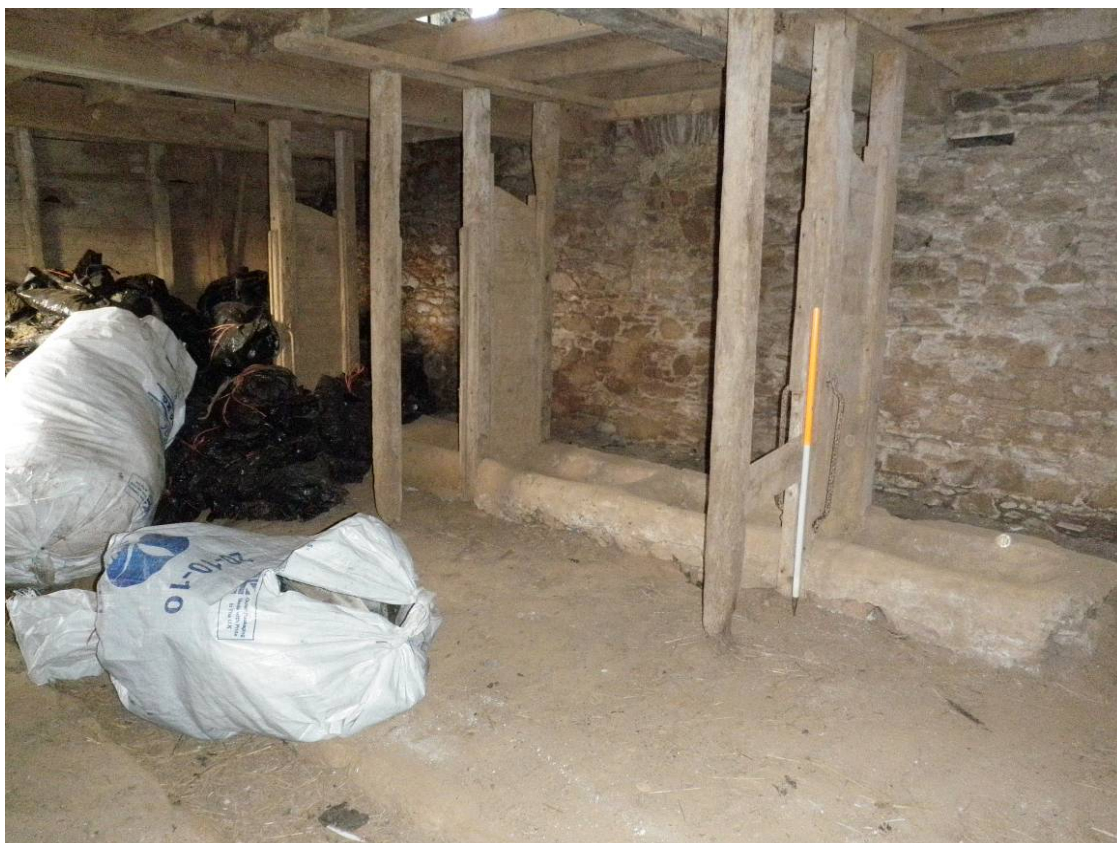
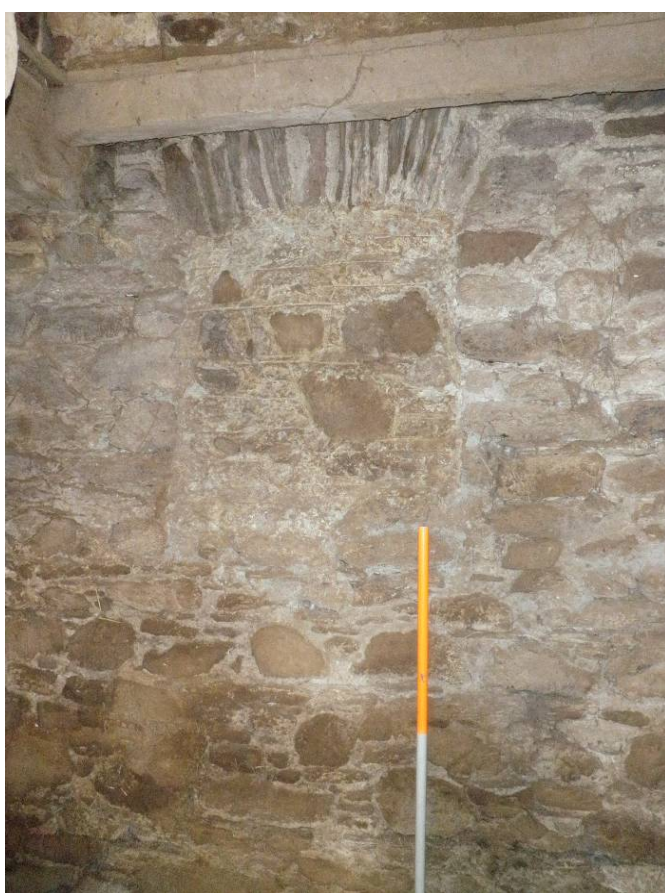
*Fig 16 Interior of east ground floor room (cow house) looking west*

To the east of this small room is the former cow house (Figs 16-18) which occupies the rest of the ground floor area of the barn. It is accessed externally via two arched door openings in the south wall. Four timber stall divisions remain *in situ* along with a stone built, but cement rendered feeding trough with seven divisions. The original cobbled floor remains intact with an open drainage gully running the length of the room within the southern half. The former feeding passage is located along the length of the northern wall and at the eastern end there is an inserted door opening through to the root house. The rubble-built walls all show traces of lime-wash. In the north wall and set centrally within the room space there is an original window opening with a stone arch, now blocked (Fig 18). This is constructed in the same style as the ground floor door openings in the south wall. The opening was blocked when the ground level to the north of the building was built up to first floor level in the late 19<sup>th</sup> or early 20<sup>th</sup> century. The original slit ventilator in the east wall is splayed internally and lies to the south of

door opening to the root house inserted in the early 20<sup>th</sup> century. The first floor support structure throughout the barn and the threshing floor above are original features. The support structure comprises large, square-section joists running the width of the building at approximately 2m between their centres and which divide the floor into 5 bays. Some of the joists have visible carpenters marks (Fig 19).

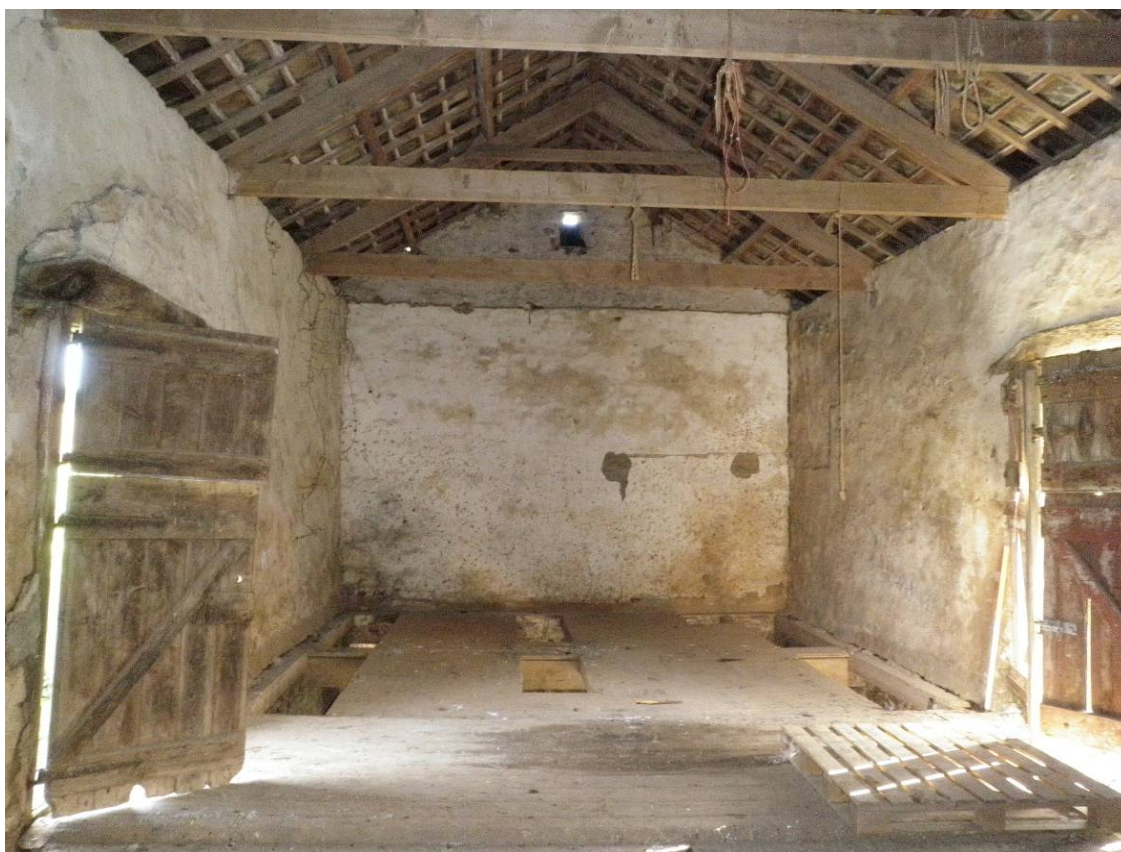
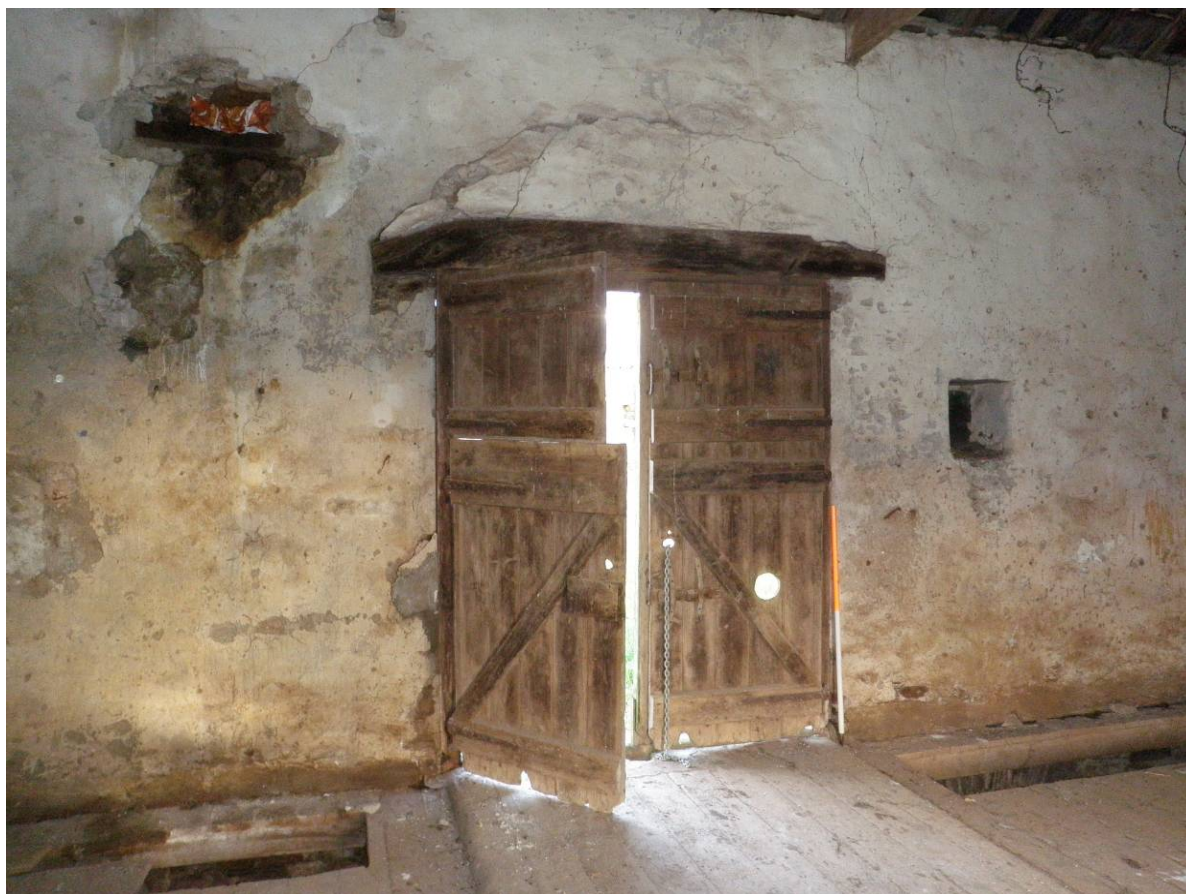
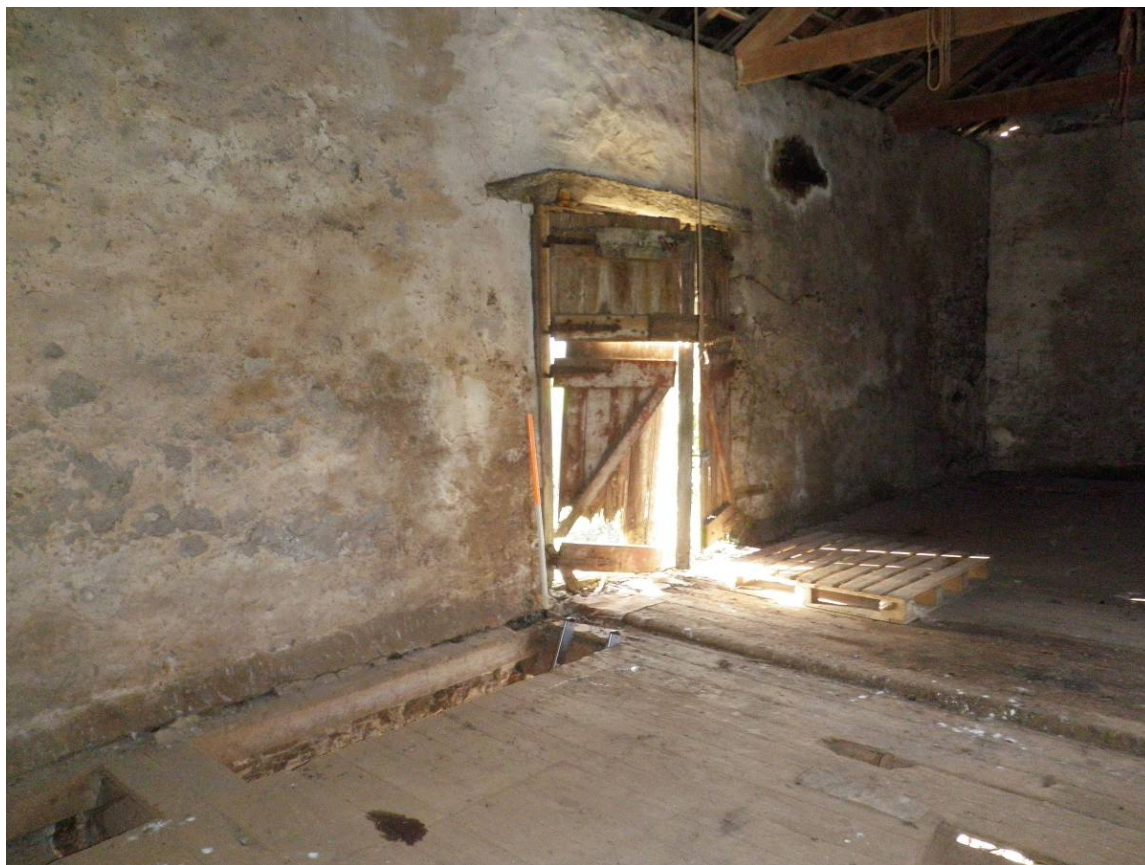
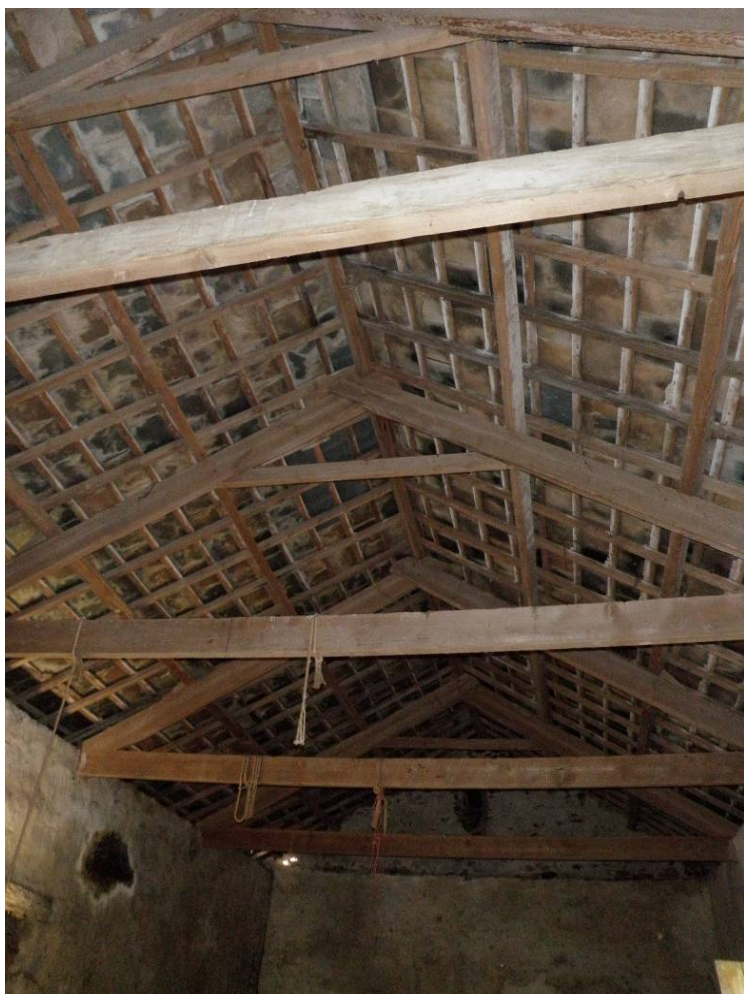
*Fig 22 Interior of first floor threshing barn looking east*

This is the former threshing floor of the barn with its original timber floor still intact although with many holes inserted later. The original boards measure approximately 0.2m (8 inches) wide and the floor is slightly raised with a double thickness of boards in the centre of the building between the two doors where the actual threshing and winnowing took place. The walls have a lime plaster covering which is lime-washed. This plaster is thickened at the base where it meets the floor boards to create a skirting.

The opposing threshing door openings in the front (south) and rear (north) walls have timber lintels and slate thresholds. The doors themselves are the original threshing doors. On the east side of the north door opening there is a small, square slate-lined recess in the wall designed as a keeping place. Immediately to the west of threshing door in the north wall just above lintel level is the inserted opening for a drive shaft for transmission of power from the engine house outside. At the base of the opening is a worn timber support and opposite it in the southern wall is an identical opening. It can be assumed that an axle with belt drive pulleys was once supported here to power internal machinery. There is a slit ventilator in the apexes of both gable ends, both of which have splayed openings.
