Towan Holy Well, St Austell, Cornwall

Recording and repointing

Report No: 2006R070

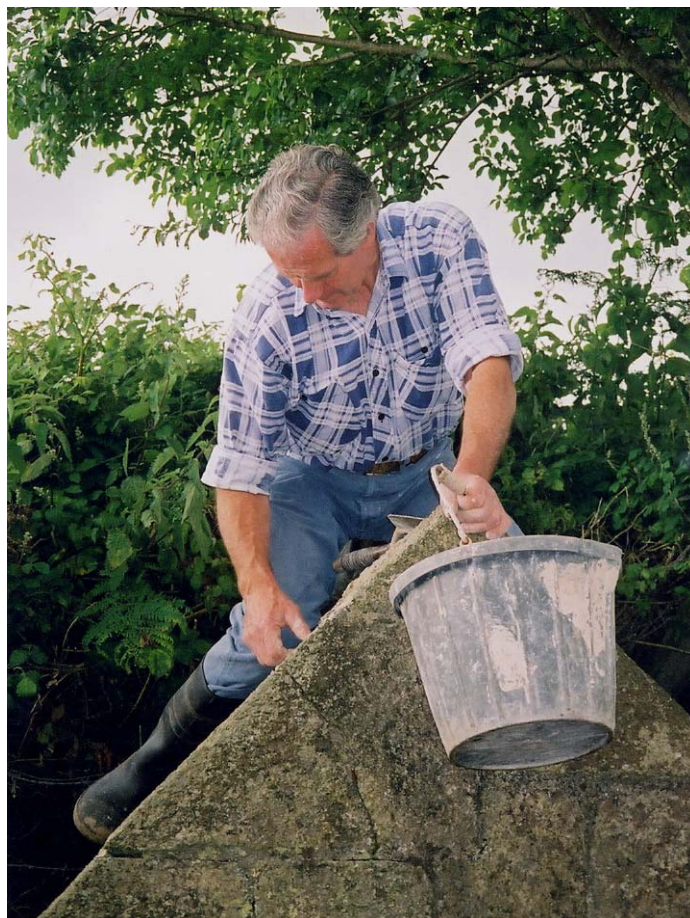
Dave Stark of Pentewan Old Cornwall Society re-pointing the roof of Towan holy well.

Repointing of Chapel Well, Towan, was carried out on 28th June 2004 by Graham Honey, Geoffrey Prettyman and Dave Stark of Pentewan Old Cornwall Society. Only pointing that was in poor condition was replaced, this being primarily in the roof and in the upper part of the front elevation. Vegetation had been treated with a herbicide two weeks earlier to kill it and prevent a regrowth. The work was done carefully and according to the specification, using a mortar consisting of hydraulic lime (St Astier, NHL 5) in a 2:5 mix with New Milton Sand. This aggregate proved rather coarse for repointing the very fine joints in this structure, but by carefully sifting out some of the coarser particles, a workable mortar was achieved.

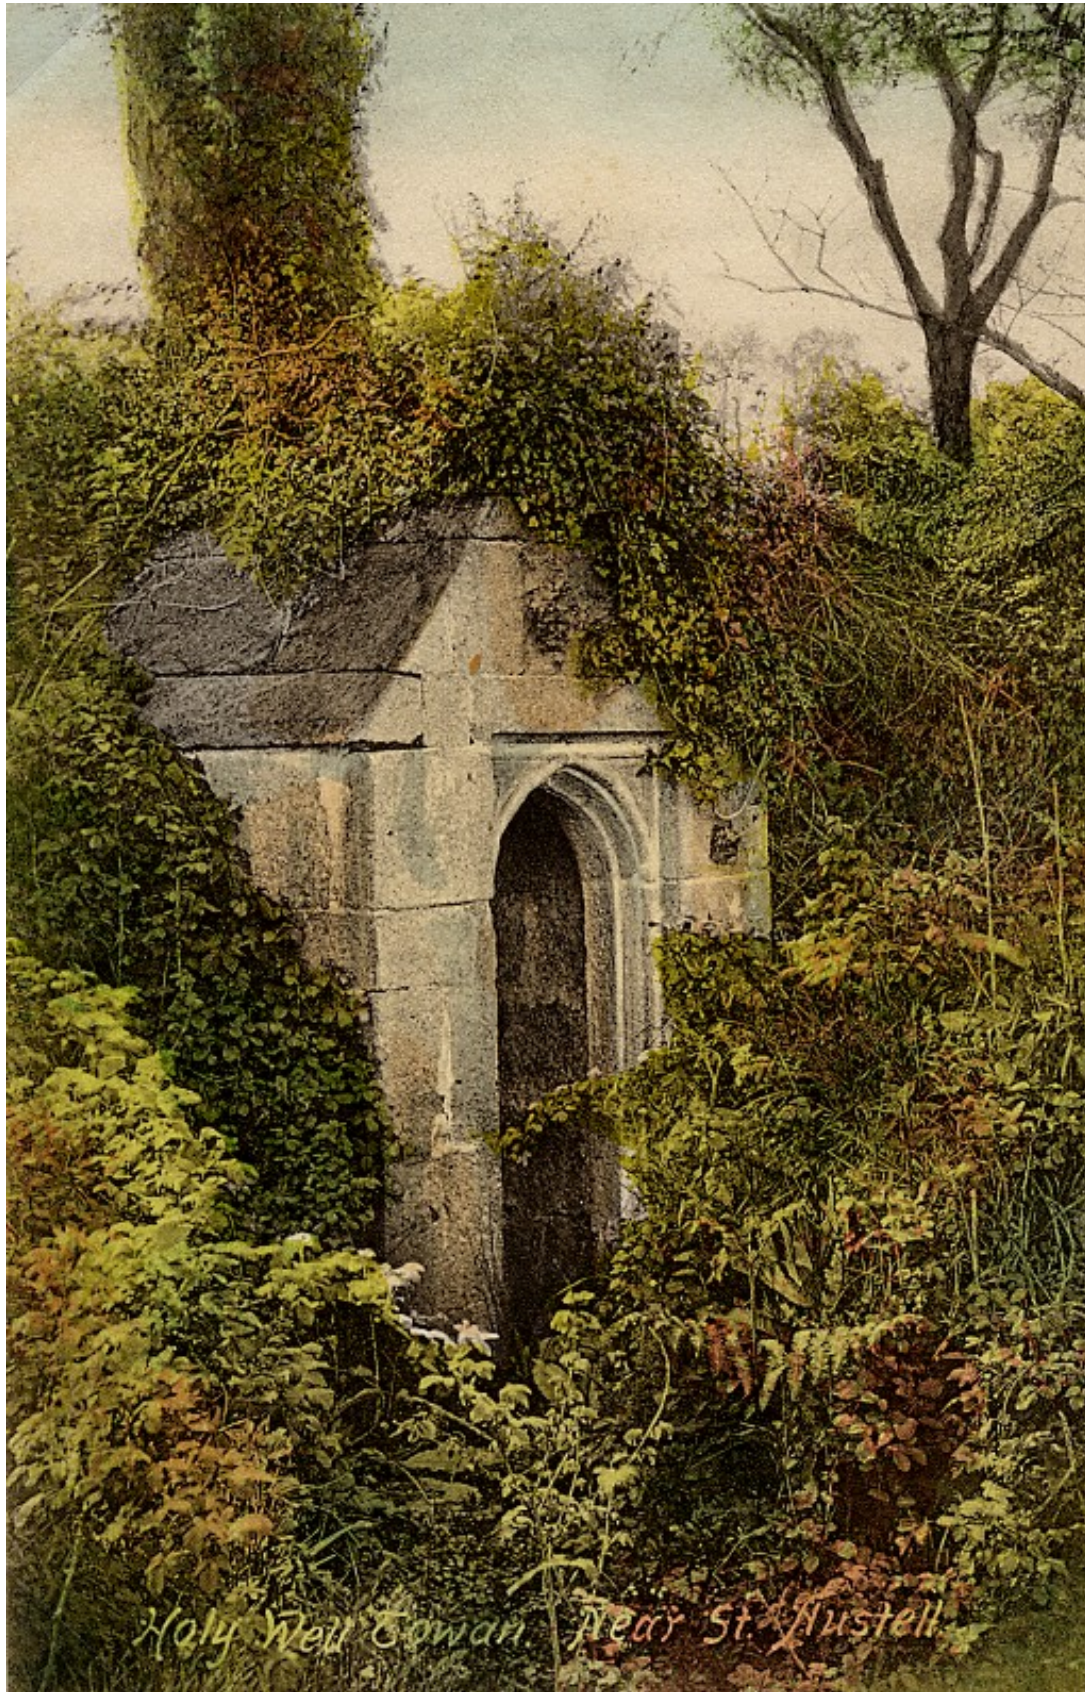
Fig 4 Towan Well before the 1930s restoratio, (from a post card in Rob Evans personal collection)

The twentieth century saw the well alternately overgrown and reclaimed from encroaching scrub. Henderson, in the 1920s, found it covered in nettles, brambles and branches (Henderson 1923-4, 33; 1955, 30) and Fig 4 shows the well at about this time. In 1937 it was restored by St Austell Old Cornwall Society (OCS), under the direction of architect Cuthbert Atchley (Lane-Davies 1972, 36; Evans and Prettyman 1994, 37; Evans, personal collection). 'Mr Atchley said "in restoring the building no concrete has been used, the only new material employed is Pentewan Stone, to make good the missing ridge which had been of that stone".'

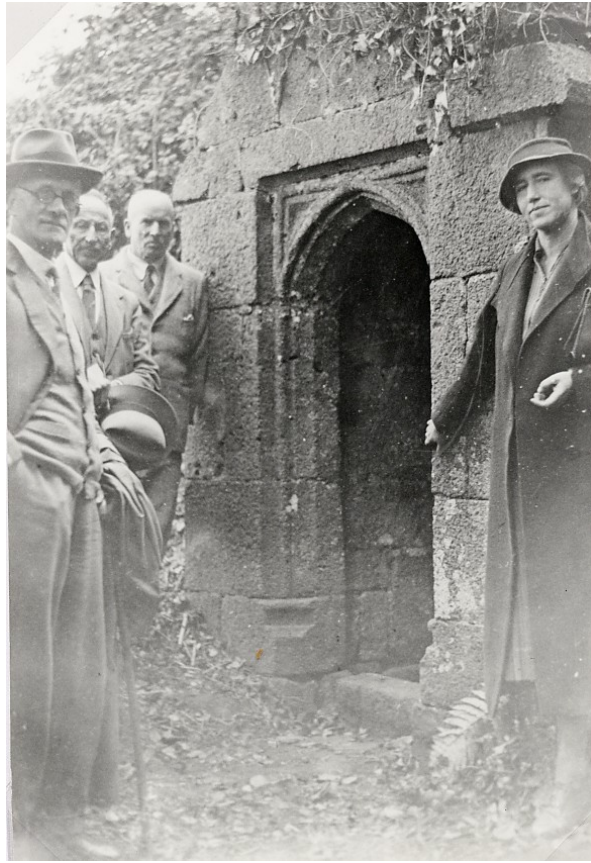
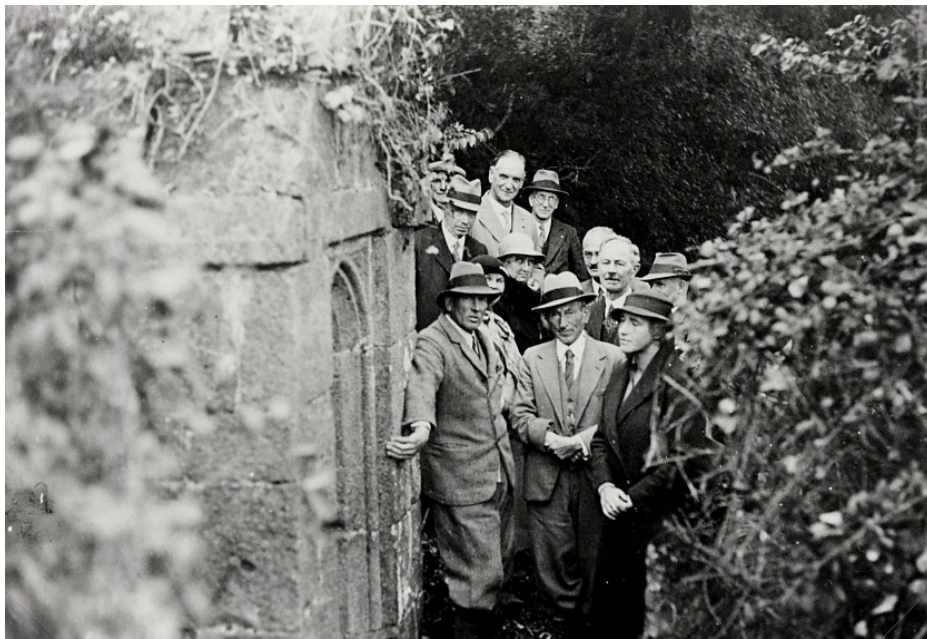
Fig 5 Towan Well in the 1930s, before restoration, being inspected by the landowner, Mrs Rosemary Cobbald Sawle (from post cards in Rob Evans' personal collection)

7. The wall plate stone to the right of the lintel is set a little unevenly in relation to the lintel, but this may be due to the fact that it had to be levered back into place during the

20th century restoration – it can be seen projecting significantly in the pre-restoration photo featuring Mrs Cobbold Sawle at the well (Fig 5).

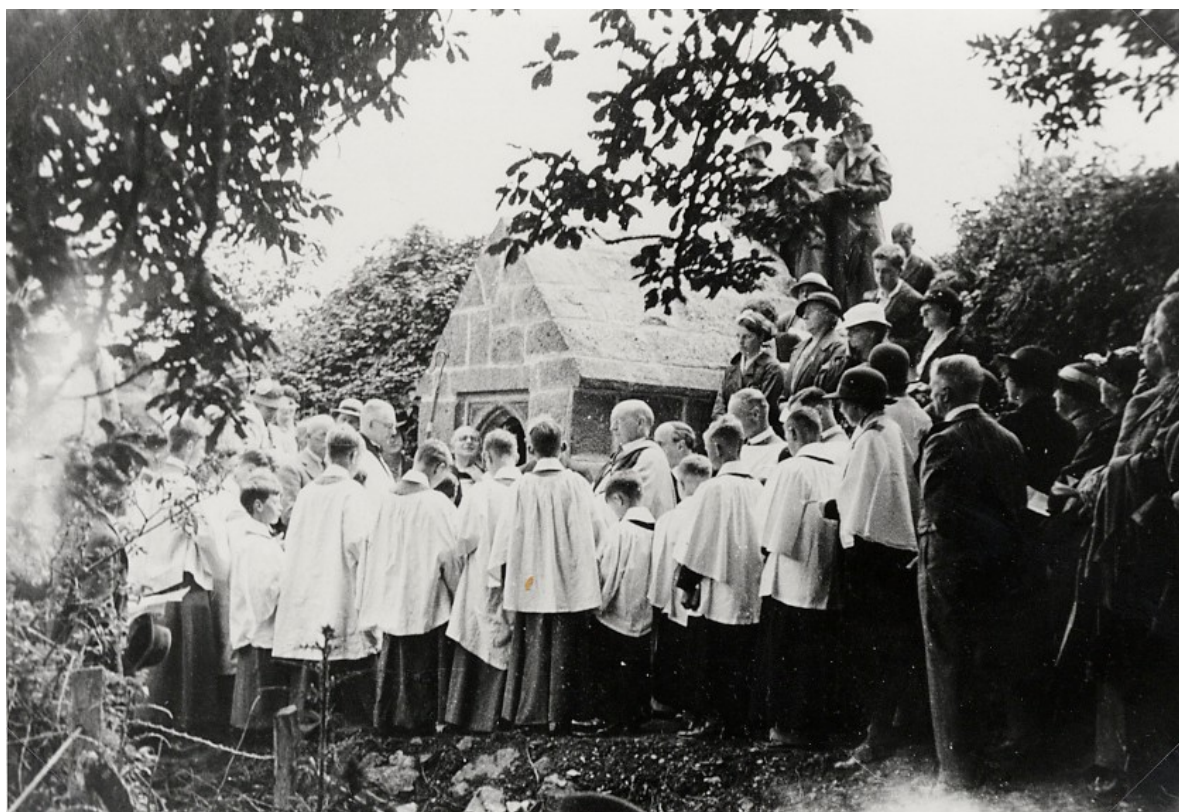
Fig 6 Towan Well being re-dedicated after its resoration in 1937, by the Bishop of Truro (from a post card in Rob Evans' personal collection)

The well was re-dedicated by the Bishop of Truro Dr Joseph Wellington Hunkin on Thursday 10th June 1937, using the Cornish Well Service. This included an address by the Bishop and a declaration by Mrs Rosemary Cobbald Sawle of Penrice, giving the well and the approach to the people of St Austell for all time. Figs 5 and 6 are photos from Rob Evans' archive recording the well at this time, both before and after restoration.

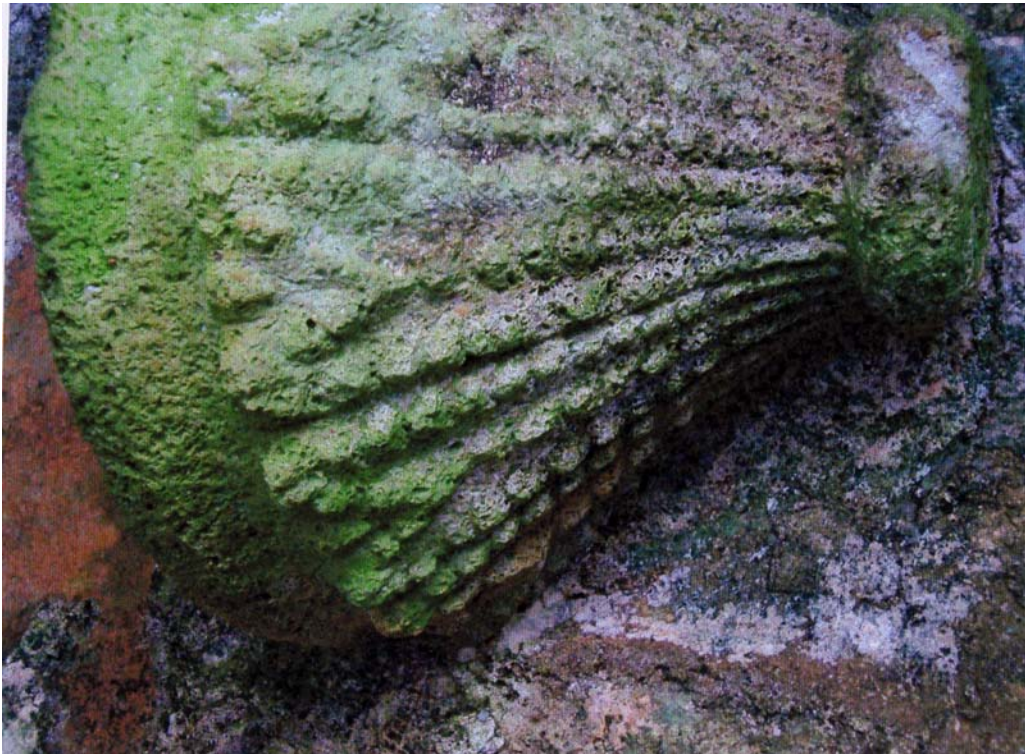
Fig 7 The back internal wall of Towan Well and the carved bracket

In the back wall of the well is a small semi-circular bracket, 25cm high and 24cm across (Fig 7). This delicately carved piece has a small plain foot-ring from which beadwork decoration fans outwards and up to a plain rim. The stone of which it is carved is uncertain, as it is covered with a fine algae or lichen of a different colour and type (a very light bright green) from that which grows naturally on the rest of the well. It is possible that the bracket is a later insertion, for the wall to the right and above it is uneven and has probably been rebuilt.

The bracket is not considered to be an original feature of this building. Some of the figures on the tower of St Austell Church, which is of late 15th century date, stand on not-dissimilar pedestals, but above and around them are very ornate canopies with ogee arches and pinnacles, and this is more the sort of thing that would have been appropriate here, rather than the isolated pedestal. Moreover, the wall around and above it has certainly been rebuilt and includes a very red stone (elvan?) in the wall directly above the bracket.

The bracket is decorated with lines of small raised balls, like strings of beads, fanning out and up to culminate in 'M' shapes below the rim. The Oxford Dictionary of English Architecture (Curl 1999) describes beading, beadwork or pearlwork as an enrichment consisting of a row of small balls resembling a string of beads, which was common in Romanesque work and revived in the 18th century, although in the 18th century it was more commonly used in plasterwork, ceramics and silverware (Curl 1992, 46). Examples of beadwork are certainly found in Cornish Romanesque work (see Sedding 1909, 88 for the doorway at Cury and for example, on the fine late 12th century font in St Austell Church) but there are no known brackets of this sort, so far as I am aware.

So the bracket is unlikely to be of 16th century date but may have been introduced at one of the well's restorations and may have been re-used from a very much earlier structure on the site: an earlier well-house, or perhaps the associated chapel; or it might even be of 18th century origin.

- The overall shape of the roof is slightly asymmetrical (compare front and back internal elevations, see Figs 7 and 10).
- The distance from the top of the door arch to the apex of the vault looks too high.

- Inside, the lower levels of coursing all follow round (not as neatly as the outside of the building, but in overall layout) up to the level of the bracket. From the level of the bracket up, they do not. This may suggest re-building/re-assembly from this level up, and may suggest that the bracket was inserted at a later date.

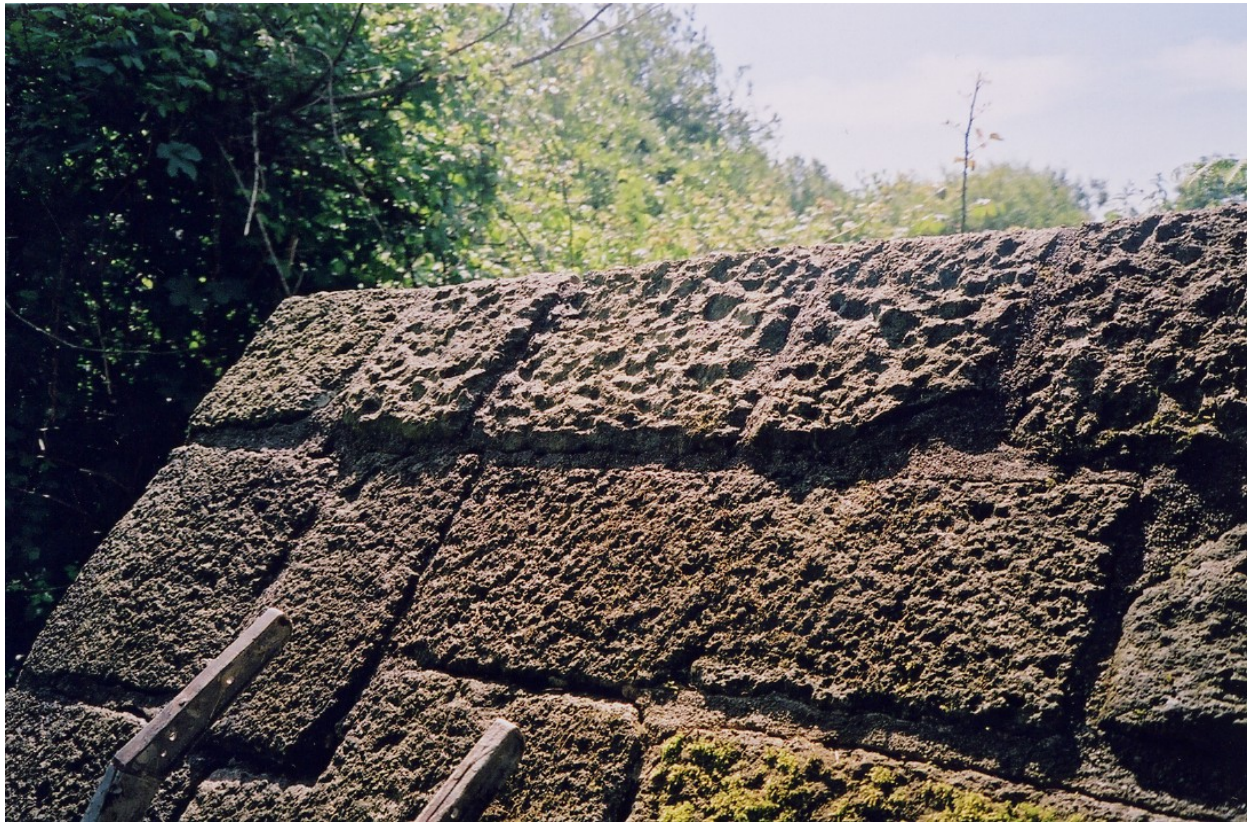
Fig 8 The roof of Towan Well. This photo shows the ridge, added in 1937, and a rebated, re-used stone (bottom left)

1. Various rebated stones are built into the structure. These may have originated as jamb stones or may have come from a box-framed (sash) window. Most of these are at roof

level, but one can be seen to the left (south side) of the doorway, indicating that there has been some rebuilding/repair at this level.

6. The roof-ridge is entirely new. The stones are much smaller and less regularly cut, they project slightly, they have a slightly rusticated finish and although of Pentewan Stone, they do not fit the style of the building particular well. These are thought to date to the 1930s restoration.

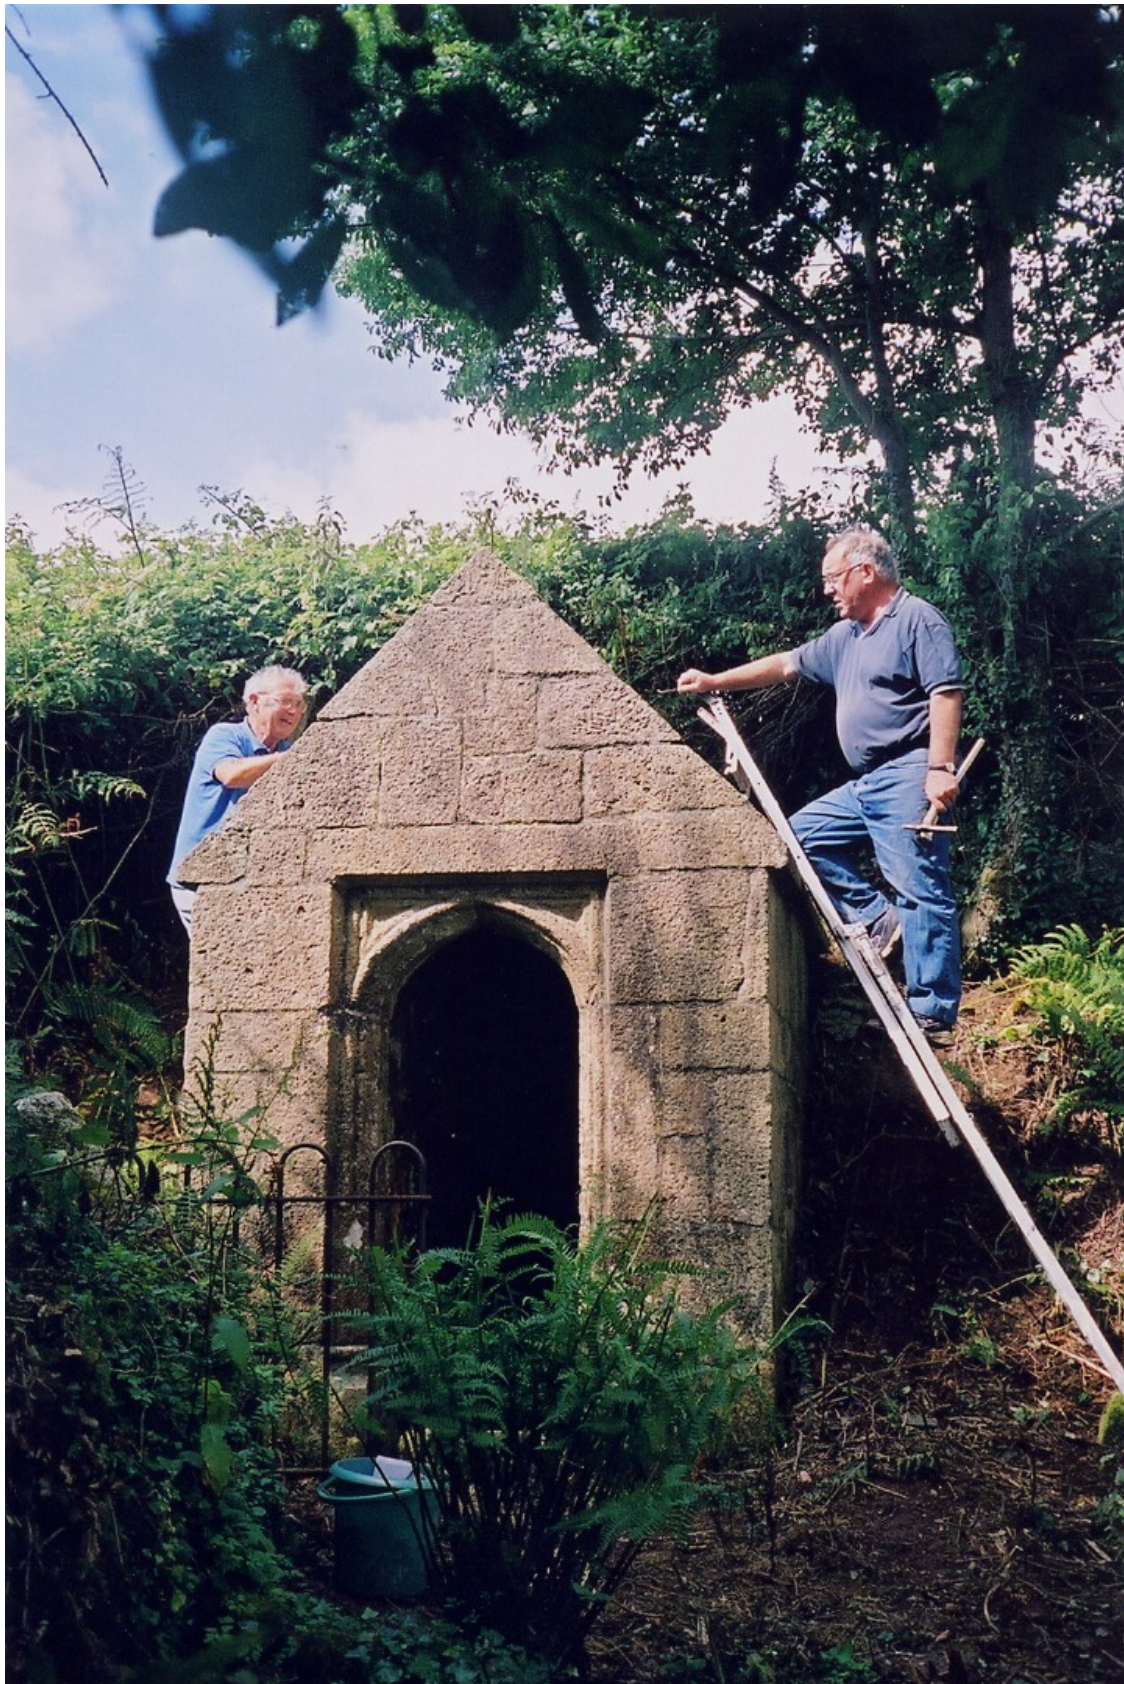
Fig 12 Graham Honey and Geoff Prettyman of Pentewan Old Cornwall Society, repointing Towan Well

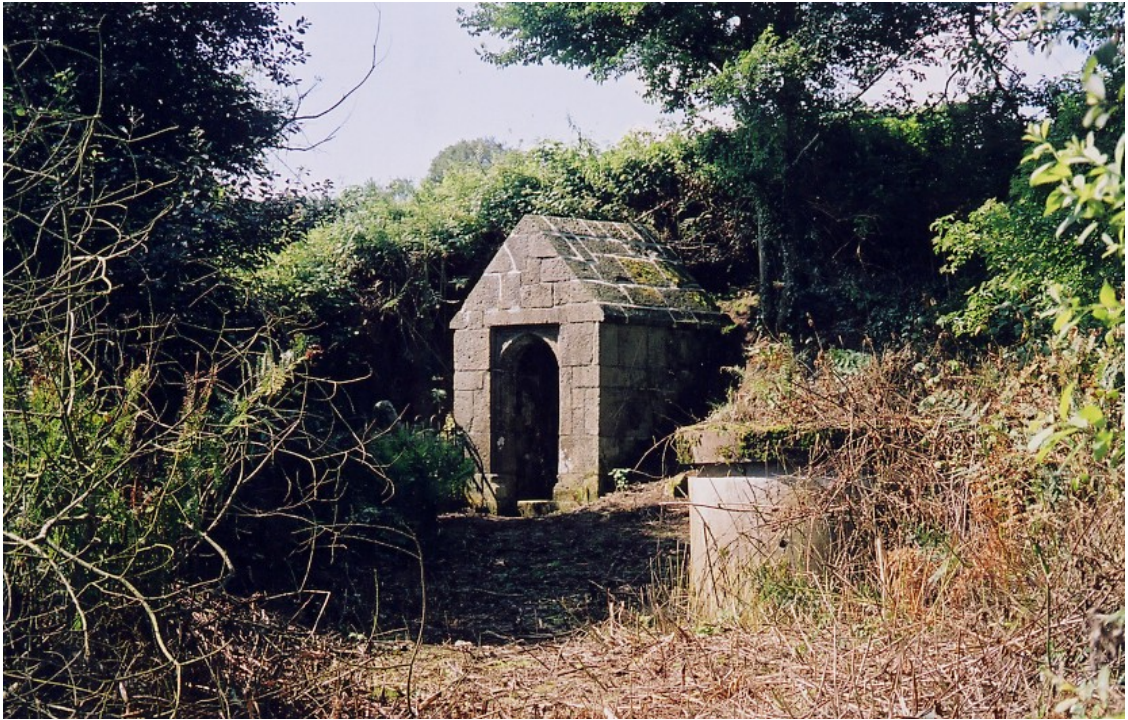
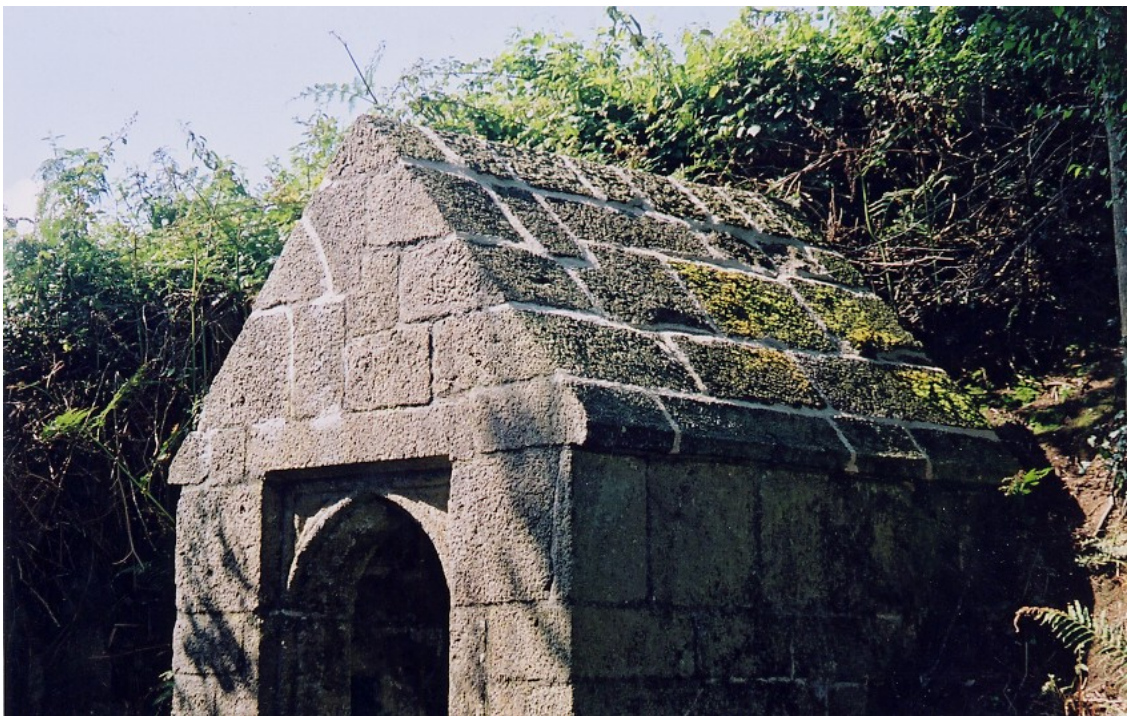
Fig 13 Towan holy well in July 2004, after re-pointing of the roof
