# St Michael's Mount, Cornwall

## Conservation and recording of lantern crosses

April 2003

2003R044

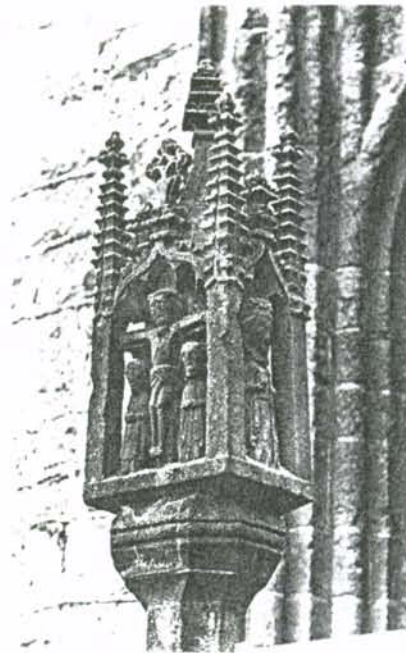
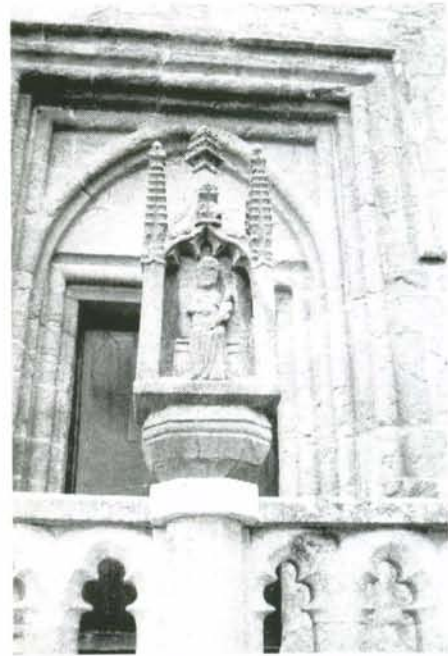
Fig 4. The lantern cross outside the chapel: 20<sup>th</sup> century changes

An aspect of the history of this lantern cross which has only emerged recently is the fact that it has been severely damaged, and restored, and then moved again, within the last hundred years. The changes are summarised in Fig 4 . Blight produced several drawings of this cross-head, one of which was published in his book *Ancient Crosses and Antiquities of West Cornwall* in 1856 and others which are preserved in his sketch books (undated) at the Morrab Library in Penzance. When first recorded by Blight the cross-head was aligned with the Crucifixion scene facing north, the face with the Virgin Mary and Child facing south, the monk facing east and the King west. Photographic evidence suggests that the cross-head remained intact and in a good state of preservation until at least 1937 (Mee, 1937, 241). But by 1949, it is clear that the monument had received considerable damage and had again been restored. A postcard reproduced in Herring's *Archaeological Evaluation of St Michael's Mount* (1993, 73) shows that by this date, all of the small crosses on the pinnacles and the on the central finial had been replaced with bud-like terminations. Only one of the crosses from the Victorian restoration survived and that was the one which had been placed centrally above the canopied arch of the Crucifixion panel. In this postcard, the orientation of the cross remained as it had been in Blight's day.

A photo taken by Mary Henderson (now in Andrew Langdon's possession) shows that the cross-head stayed in the same alignment until at least 1954, but that by 1987 (the occasion of a visit by one of the authors), or perhaps considerably earlier, it had been turned through 180 degrees so that the figure of the Crucifixion faced south towards the chapel. As well as this, the octagonal shaft, which had been incorporated into the balustrade, was slightly shortened and a new granite octagonal support pieced into the top of the balustrade rail, probably to give additional support to the monument. The cushion-like support of the cross-head is now fixed directly onto this new piece of stone. It is not known when the cross-head was re-aligned in this way, or whether it had fallen a second time between 1954 and 1987. The fact that a new granite plinth was added at this time may suggest the monument had suffered a further accident, or had become unstable.

Although it is not immediately obvious, there is, on close inspection, plenty of evidence of damage to the monument. This includes cracks in the cushion-like support, replacement of the complete buttress or column between the canopied figures of the King and the Virgin Mary and Child, as well as the removal of the decorative rosettes below the collar on the octagonal shaft. It is now difficult to know whether all this damage was sustained when the cross was damaged on the first occasion, between 1937 and 1949, or whether some was associated with the realignment between 1954 and 1987.

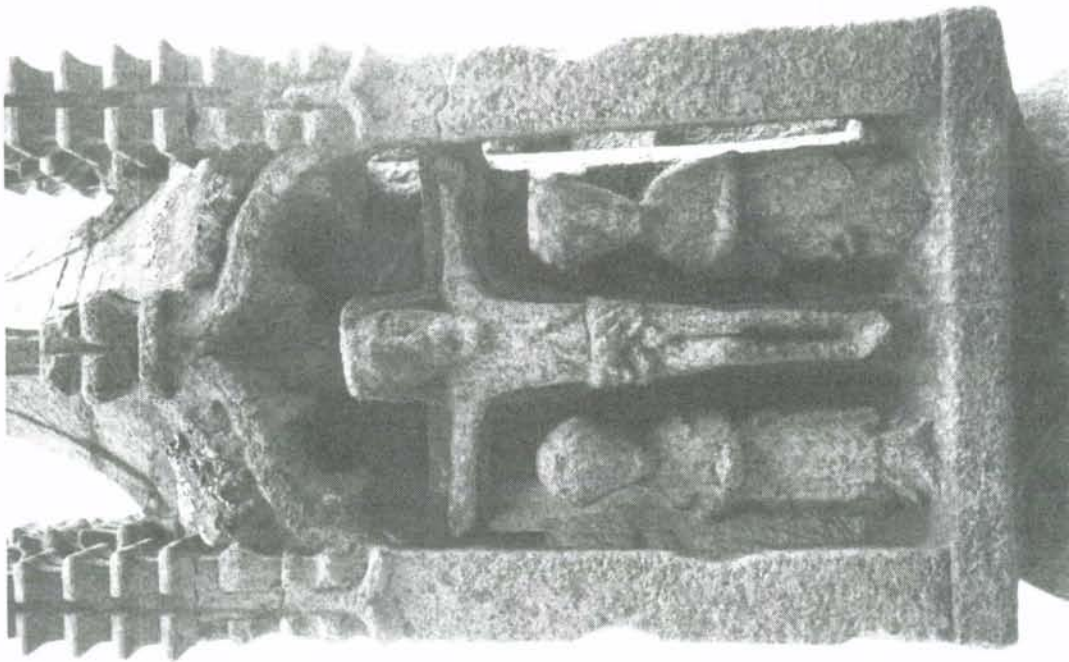
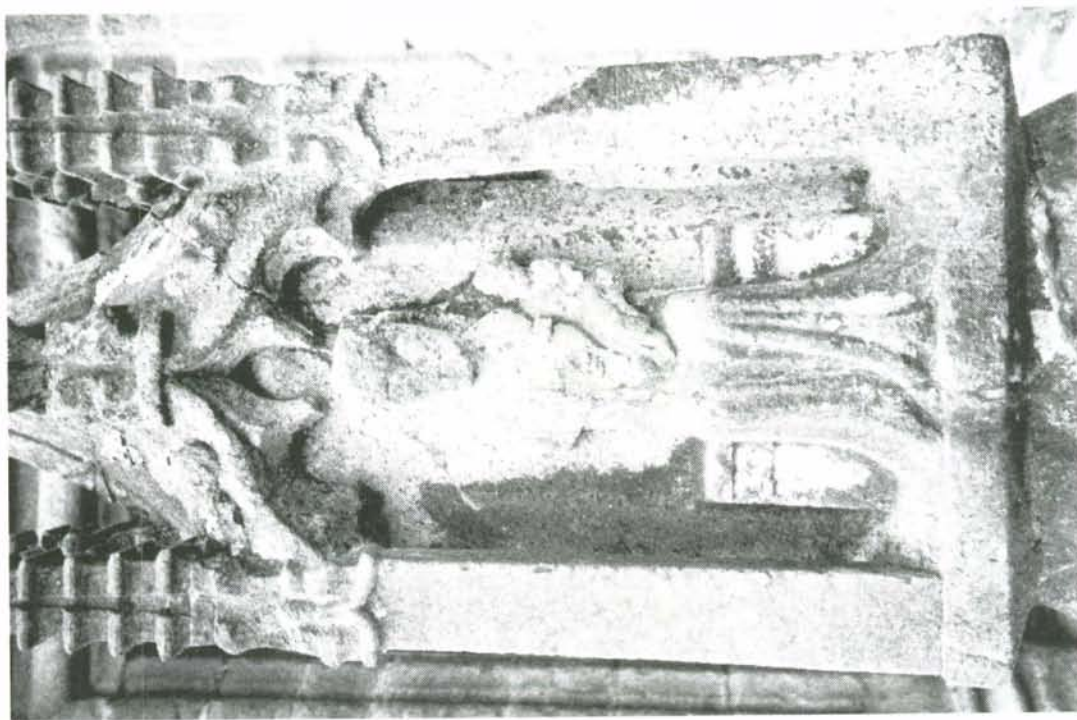
On what is now the south face of the cross-head is carved the Crucifixion scene with a figure of Christ on the cross and two attendant figures, one each side, presumed to be Mary and St John. Christ is depicted with arms outstretched and head upright, in a stance which is more reminiscent of the depictions of Christ on earlier medieval Cornish crosses (ie 12<sup>th</sup> or 13<sup>th</sup> century, for example the Mount Cross – Fig 3) than of the typical late medieval rendering where Christ hangs on the cross in agony: head leaning, arms stretched up, legs bent. The misery in Christ's over-large face is emphasised by his long pointed beard, heavy brow, and large eyes. Compared to this, his bare arms and legs are thin and emaciated and on his body, the ribs are protruding above the folds of the loin-cloth. On Christ's right is a female figure (Mary) with hands held together in front. Details of her face have worn away, but her garments can still be clearly seen. She wears a long gown, which extends to her ankles, with an additional over-garment across her shoulders. The figure on Christ's left (St John) has a rather larger face with discernible facial features. He also stands with hands together. His elegantly-flowing robes fall to the ground, hiding his feet.

The reverse face (now facing north) displays the Virgin Mary and Child. Mary is shown seated on a bench and appears to be gently smiling. The infant Christ, remarkably well-proportioned for a carving of this period, is cradled in Mary's left arm, while her right arm reaches towards him. He wears a long robe, from which his ankles and feet poke out. Mary wears a head-dress, a long flowing dress which covers her feet, and an over-garment whose fine carved detail includes lapels.

*Fig 6. The lantern cross outside the chapel (Mary and Child on left, Crucifixion on right)*

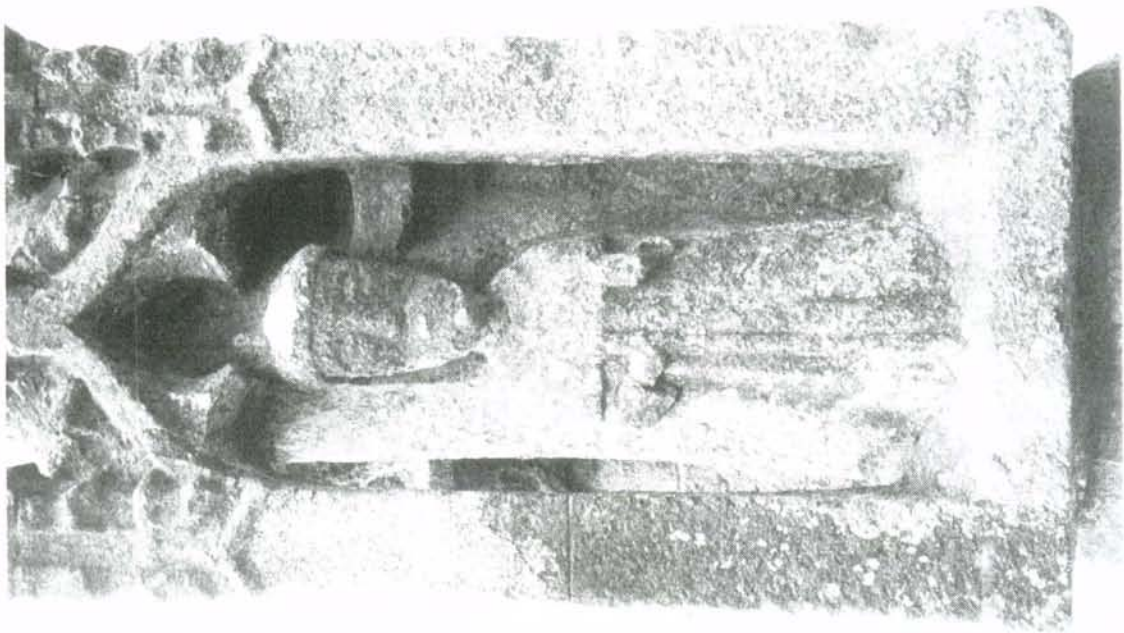
The western face shows a figure of an ecclesiastic, with a particularly large head in proportion to his body. He wears a simple skullcap and is clean-shaven. The simple features of his face appear appropriately austere. Beneath a cope, he wears a long, flowing, sleeved robe with possibly, a dangling tasselled cord. In his right hand he holds a staff, while in his left hand he

Under the eastern canopy is displayed a king, reputed to be Edward the Confessor, who is said to have founded the monastery on the Mount in the 11<sup>th</sup> century (St Aubyn guide, chapter on 'Early history of the priory', Taylor 1916, 145 – 7). His simply carved and serious face is crowned, and encircled by stiff spiky hair and a beard. He wears a long robe, tied at the waist, and a cloak over his shoulders. In his left hand he holds a staff and in his right, a small square object, possibly a book (or a box, or even his charter?).

*Fig 7. The lantern cross outside the chapel (monk on left, and king on right)*

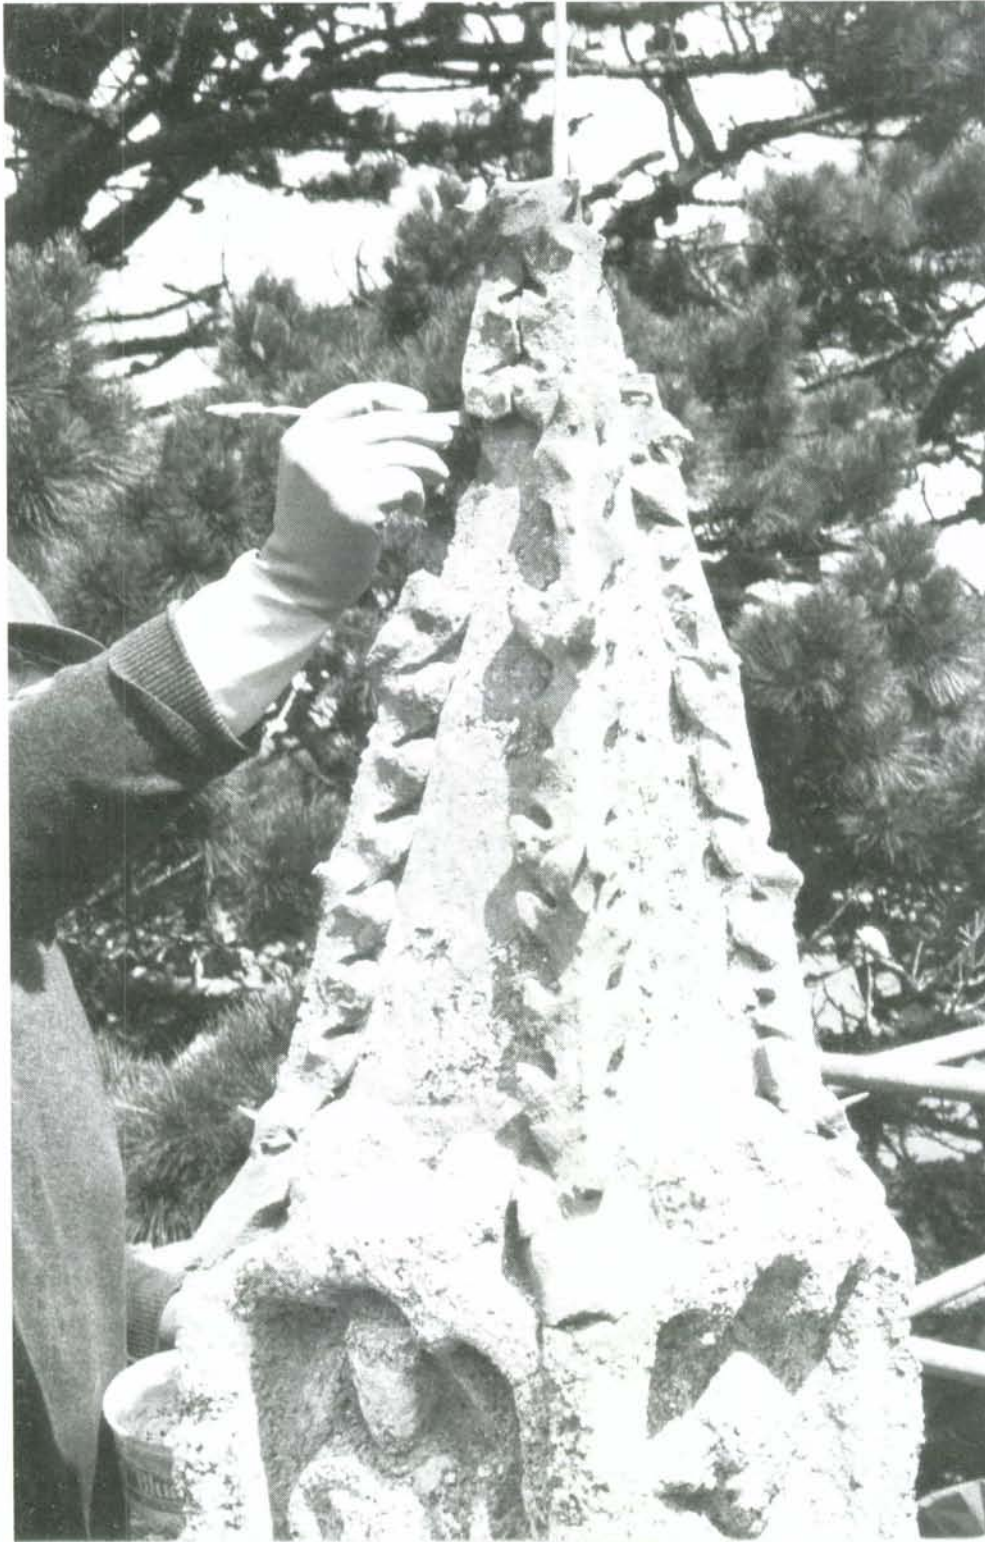
The Roman Cement finial was moulded onto the top of the granite cross-head around a central copper rod and armatures. The main body of the finial was made up with a coarse-grained aggregate; on top of this a finer coating of cement was applied and finished with separately attached and presumably pre-formed crockets.

*Fig 12.. Conservation work in progress on the Roman Cement pinnacle of the lantern cross in the gardens.*

- The long hairy lichen was removed with a small spatula, from the medieval cross-head only, to reveal the carving. The purpose of this was to allow photography and description of the hitherto unrecorded sculpture. A lower-growing dense layer of lichen close to the stone was left.
- The Roman Cement areas were consolidated by injecting a dilute Paraloid B72 acrylic resin solution into the cracks.
- Following this, the cracks were repaired with a hydraulic lime mortar, coloured to match the Roman Cement.
- The joints of the base stones were raked out and re-pointed in a hydraulic lime mortar, packed with small stone.
