St Michael's Mount, Cornwall

Repairs to base of cross-shaft on western summit

Cross shaft and base on the western approach to St Michael's Mount, Cornwall

Repairs to the base

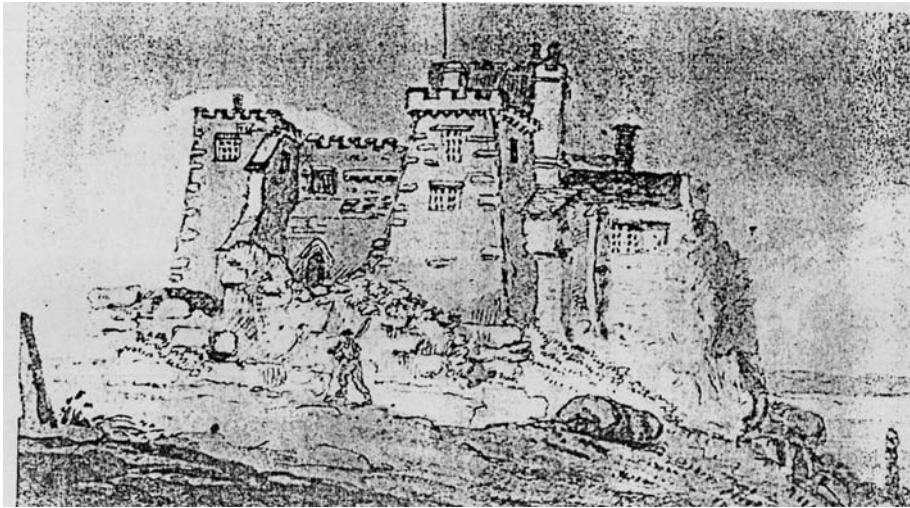
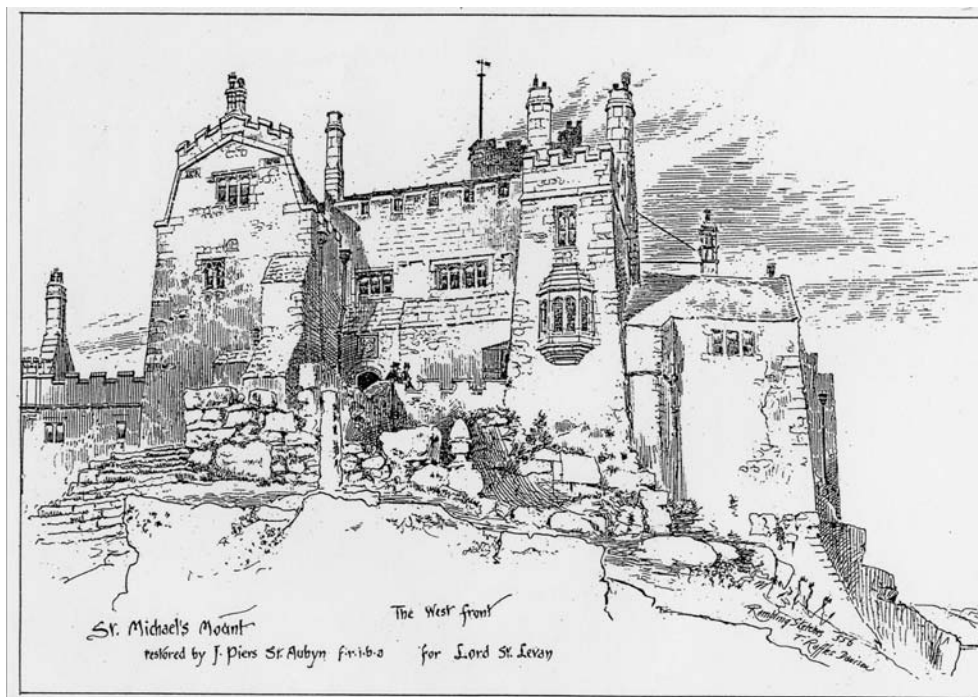
Fig 4. 19th century illustrations showing the cross-shaft. That above is a water colour dated c 1812, by John Nixon. Below is a drawing of the 1870s by Piers St Aubyn. Copies of both these illustrations were supplied by Pete Herring.

cross standing upon 2 square steps of stone' (Herring 1993, 74 and Appendix VI). From its context in Borlase's description, it seems likely that he was referring to this stone. On the other hand, illustrations by Nicholas Prideaux, dated 1716 and 1727, and on display at the Mount, do not appear to show it. A watercolour by John Nixon, dated 1812, is the first undoubted illustration of the shaft standing where it is now, and already leaning, and it appears on various subsequent illustrations, such as that by Piers St Aubyn (Fig 4). On the other hand, there are a couple of features which suggest that it may have been moved, since it was originally set up. Drill-holes in the side of the shaft are a clear indication that it was used at some time as a gate-post or door-jamb. Moreover, the base may not be original: a chamfered shaft of this sort would normally be supported on a solid, square granite base-stone, itself perhaps then set upon a further plinth or set of steps.

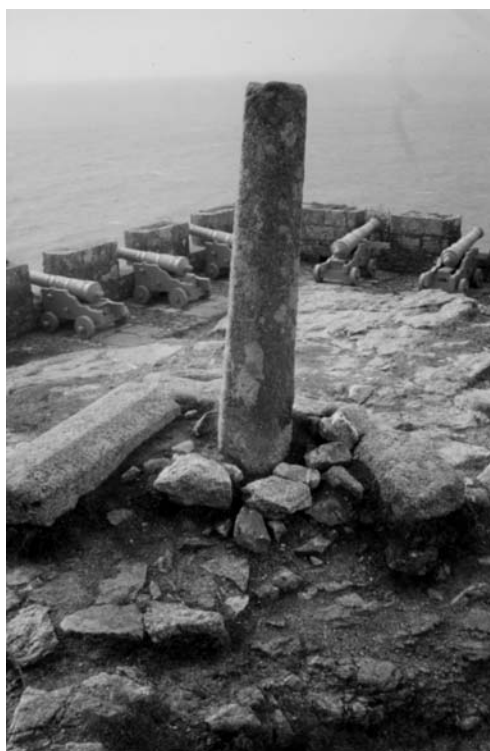
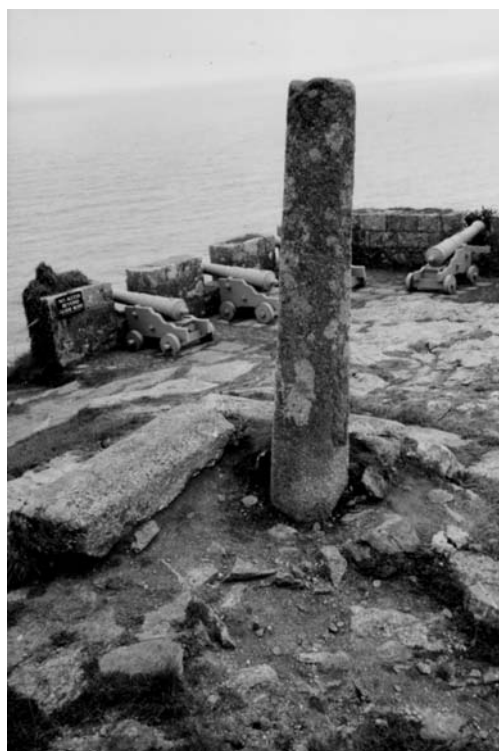
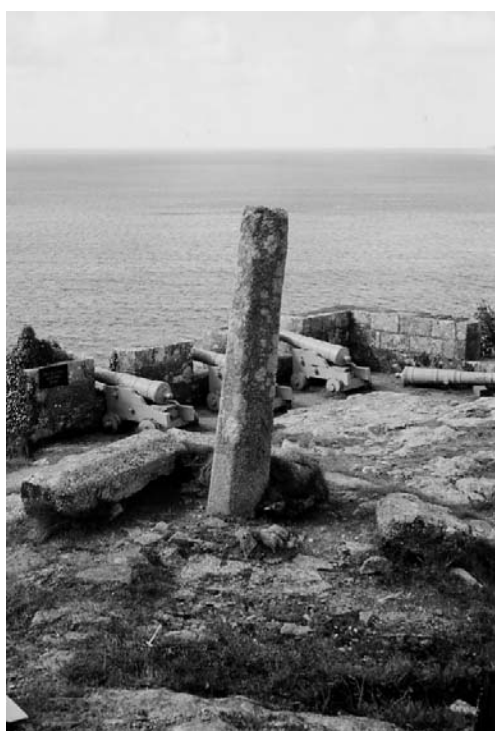
Fig 5. Photos illustrating the deterioration of the base

If it is assumed that at one time, the upper part of the base was completed with four chamfered blocks of granite to create a square, then it is now severely denuded, to the extent that two-thirds to one half has disappeared. (Though Malcolm Earley, who has worked on the Mount for forty years or so, says that there have only been two chamfered stones for as long as he can remember.) Monitoring over the last ten years confirms the

fact that erosion to the surviving portion of the base is active and ongoing and that stones and earth are being slowly but progressively lost from the base, presumably as a result of visitor erosion (see Fig 6).

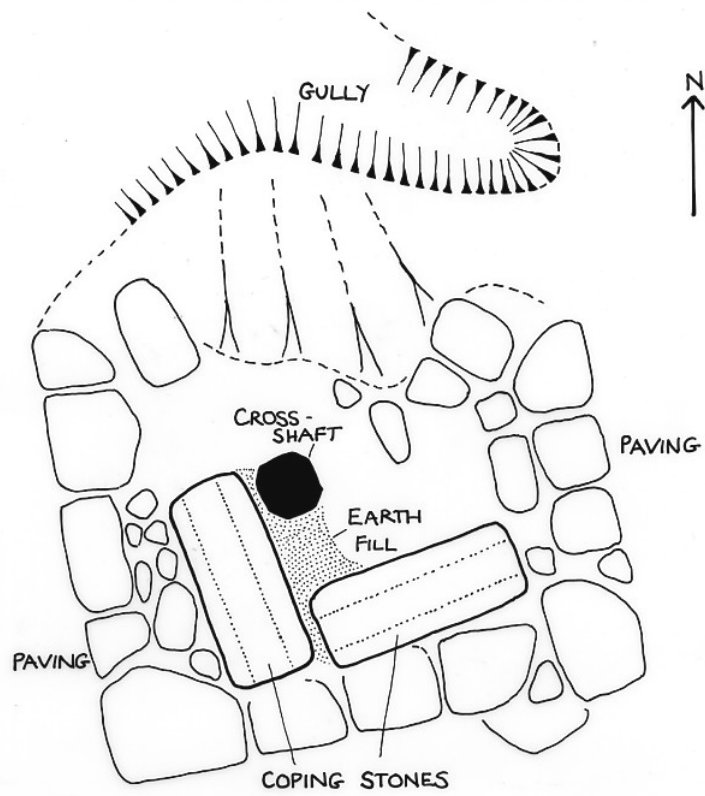
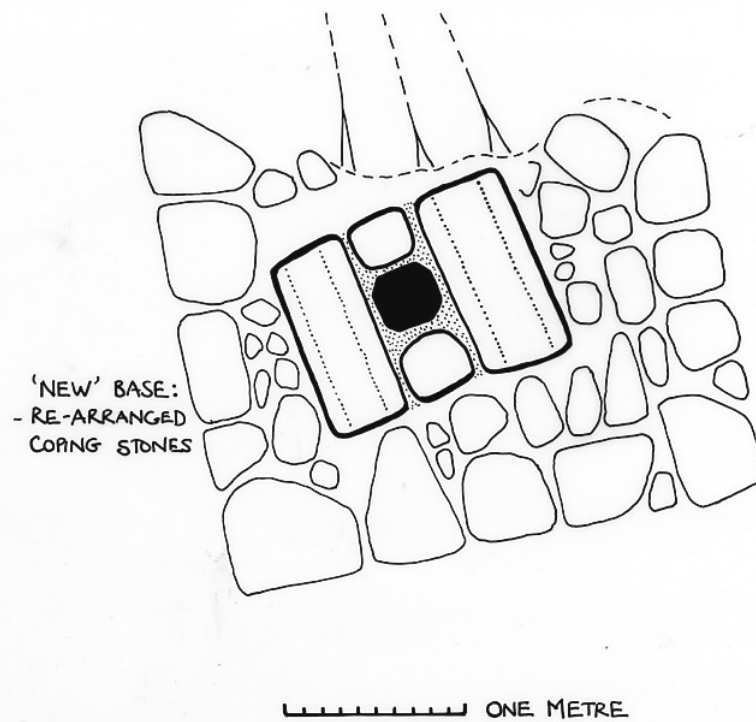
Fig 6. Sketch plan of the base before and after conservation work

Prior to the commencement of the work described in this report, the cross consisted of a 1.4m high tapering octagonal granite shaft, standing off-centre and leaning slightly in the remains of a two-stepped rectangular (2.3m x 1.6m) stone pedestal, the lower step formed of irregular granite paving, the upper of two chamfered rectangular blocks of granite (Fig 5: presumably there would have been four originally, if it was symmetrical).

CROSS-BASE BEFORE RESTORATION

CROSS-BASE AFTER RESTORATION

The base and shaft were surveyed in July 2002, and the resultant drawing used to create a plan for the proposed restoration. The final plan, an amended version of the original, was

made after the work had been completed, in June 2003 (see Fig 6). Before and after photos were taken at the same time as the surveying took place.

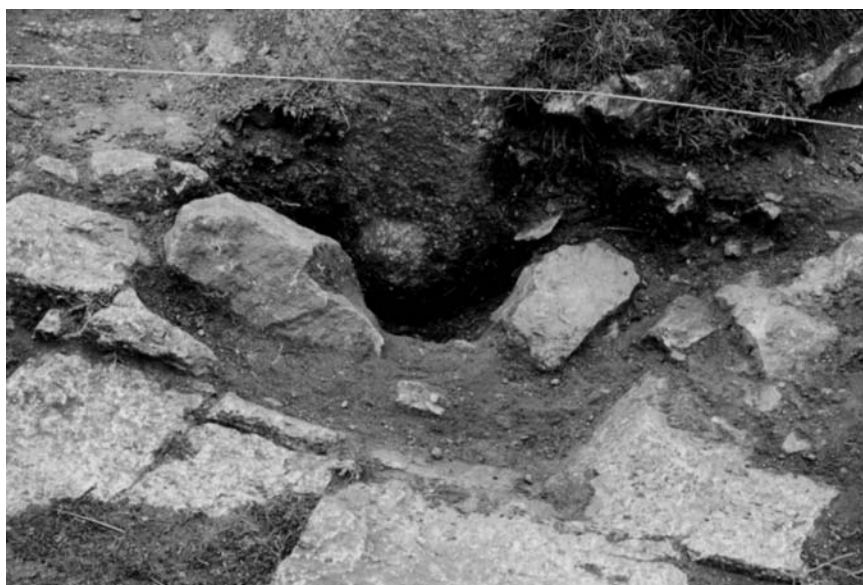
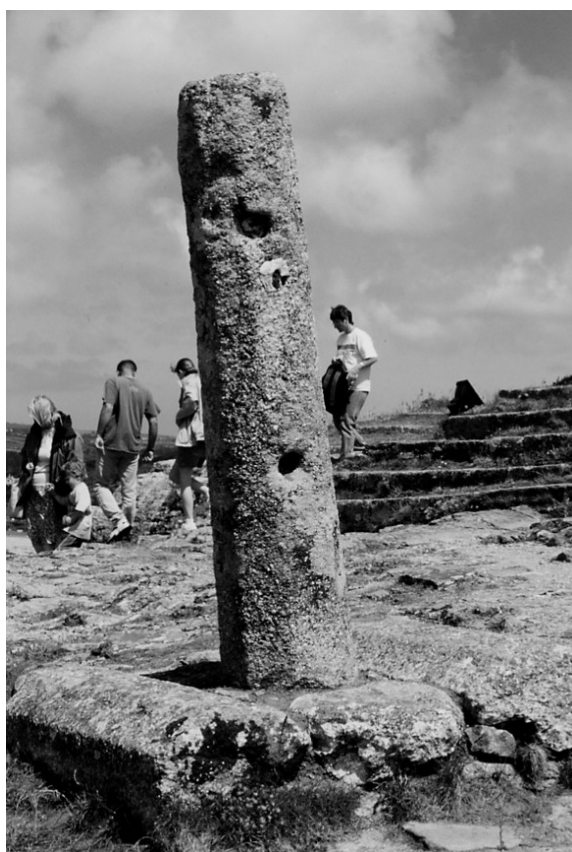
Fig 7. Details of the shaft: the chamfer-stop (above) and the holes for gate-hangings (below)

1. No material relating to the early medieval period on the Mount was retrieved.
2. The top part of a chamfer stop was discovered at the bottom of the shaft. This was not visible prior to the restoration and is not visible now, as it was sunk below the level of the lower, 'paving', element of the base. This was found as a result of a small 'sondage', dug to check for the depth to which the shaft was buried and to allow for an assessment of the shaft's future stability to be made. The stop appears to be a circular raised boss or ball, approximately 8 centimetres in diameter (Fig 7).

8. Removal of the chamfered stone on the south revealed a fourth, hitherto invisible, hole for a gate-hanging near the bottom of the shaft (see Fig 7). This shows that the shaft was used as a gatepost before the coping part of the base was put in position, and that (with a total of four gate-hanging holes) the shaft had been used on two occasions for hanging a gate.

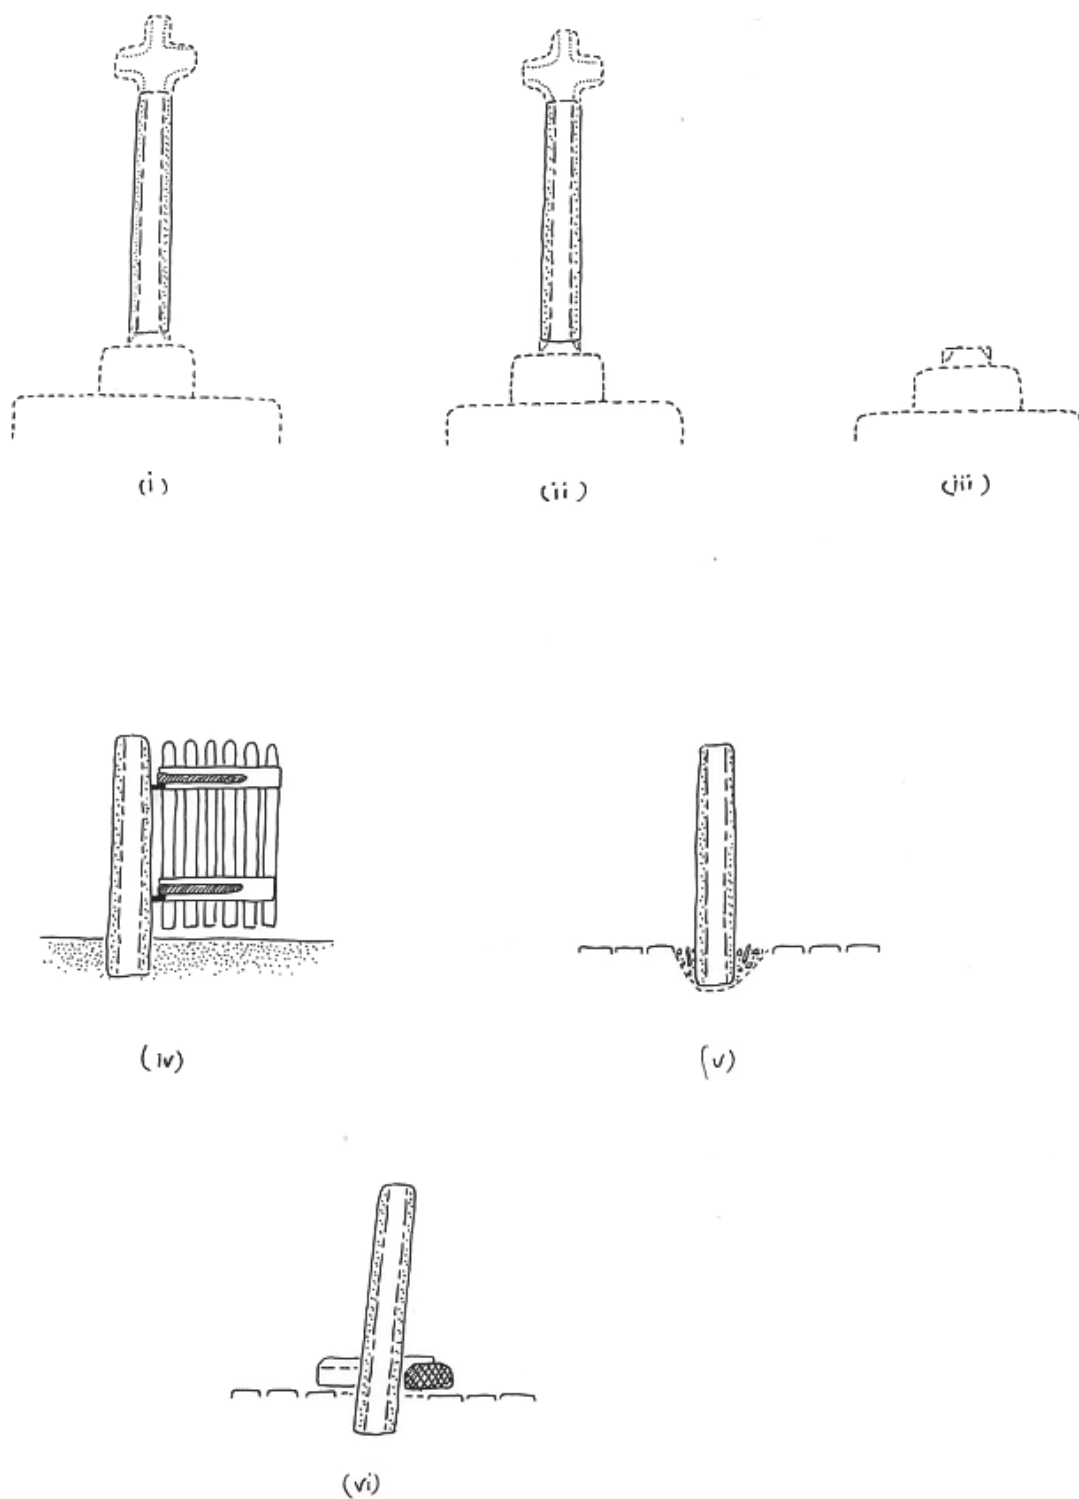
Fig 10. Drawing illustrating the possible phases in the life of the monument

- (i) The complete cross in the 16th century (ii) Shaft broken from base - Civil War? (iii) Base plus stump of cross - now lost (iv) Shaft used as a gatepost - 17th century (v) Shaft re-erected outside west front, into medieval paving - early 18th century? (vi) Coping stones added to support leaning shaft - late 18th/early 19th century?

A tentative history of the shaft is summarised below and in figure 10. This revises and refines the sequence suggested previously by Herring (2000, 81).

1. Assuming that the shaft is indeed part of a cross, then it may have begun its life in the yard to the north of the chapel. The octagonal form of the shaft, and the chamfer stop, which can be tentatively compared with one on a part of a doorway from Sancreed holy well, considered by Eric Berry to be of 16th or even 17th century date (Preston-Jones et al 1998, 13 and 14), places it very late in the medieval period – if medieval at all. A cross of this date would probably have been set on a stepped base, of which the upper part would have been a solid block of dressed granite. A cross-shaft of this sort would normally be expected to have had a chamfered latin cross-head like that, for example, in the churchyard at Lanteglos by Fowey (Langdon 1996, 36), although Peter Herring has recently argued that this shaft could once have supported the greenstone lantern cross-head which is now displayed outside the chapel (Herring 1993, 74; 2000, 78). A lantern-head is certainly a possibility at this period, although in this case, the difference in the geology of the two monuments probably argues against their one-time union.

2. The shaft is broken at the bottom, as though it had been severed from its original base by a blow, fracturing it at the point it was sunk into the original base. A possible context for this might be during the Civil War, when the mount was re-fortified by Royalists under Sir Francis Bassett. The shaft may have been desecrated as an act of iconoclasm, or for the more mundane reason of providing a gatepost. (It was also at this time that a medieval grave slab was re-used as a lintel in the Civil War watch tower on the approach to the summit, north of the castle (Herring 1993, 105-6; site 91555).

3. After destruction of the cross, the shaft was re-used as a gatepost. This was probably not in its present location (despite Herring's suggestion that this was the case - 2000, 80). As it stands now, the hangings would have been facing towards the curtain wall, and simply could not have functioned efficiently.

4. At some point, perhaps in the late 17th or early 18th century, the shaft was set up in its present position. The reason for this is not known, but if we assume that Borlase's description was accurate, then it must have been prior to 1731.

5. In fact, Borlase's description suggests that the coping stones may also have been added to help stabilise the base before his visit, for he remarks upon 'a small cross standing upon 2 square steps of stone' (above, 5). He does not say whether it was leaning at this date, but if the copings had been added by then, and the reason for this was indeed to help stabilise a lean, then we may assume that it was. Certainly it was leaning by the early 19th century (Fig 4) and so far as we can tell, it has remained so ever since.
